west virginia department of environmental protection

MEMORANDUM

Re: WVU LARGE IMPOUNDMENT / PIT STUDY
[Volume capacity designs greater than 5000 barrels]

Date: December 3rd, 2012

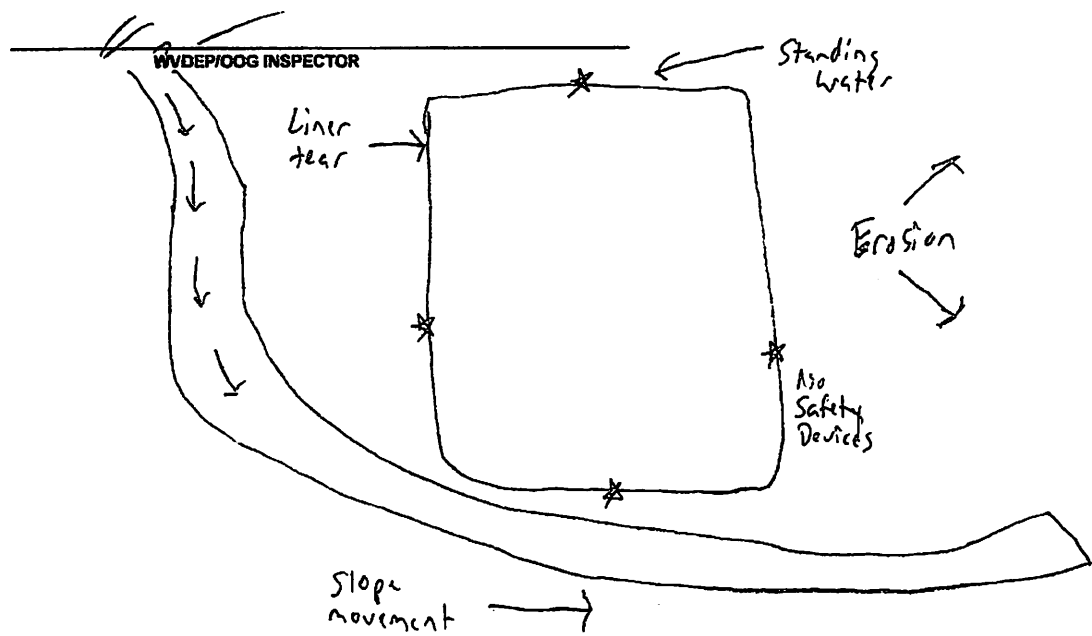
1. There are no safety devices around impoundment.
Stone has agreed to install safety equipment
2. Liner has small tear near anchor trench.
Stone has agreed to patch.
3. Minor slope movement along access road.
Stone has agreed to make necessary repairs to prevent further movement.
4. There is erosion on fill slope.
Stone has agreed to dress slope and re-seed/mulch.
5. There is standing water on the crest.
Stone has agreed to work crest to ensure proper drainage.

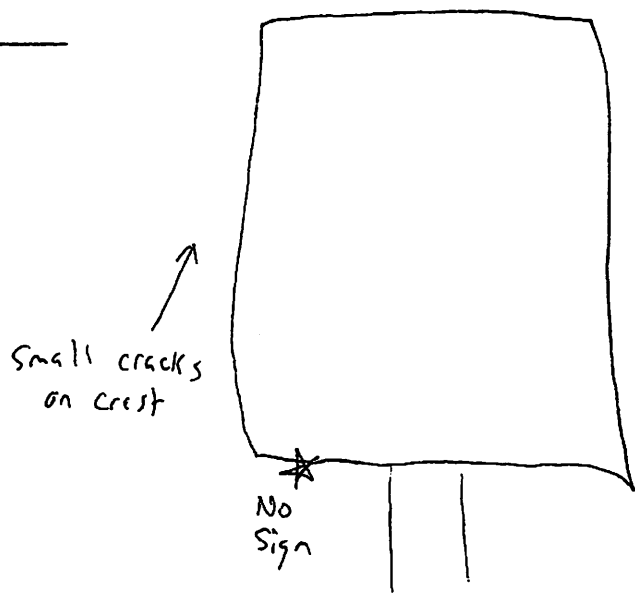
1. There is no sign.
Gaster has agreed to have signs made and installed at all pits.

2. There are cracks on crest where water has been standing during wet periods.
Gaster has agreed to dress crest and seed/mulch.

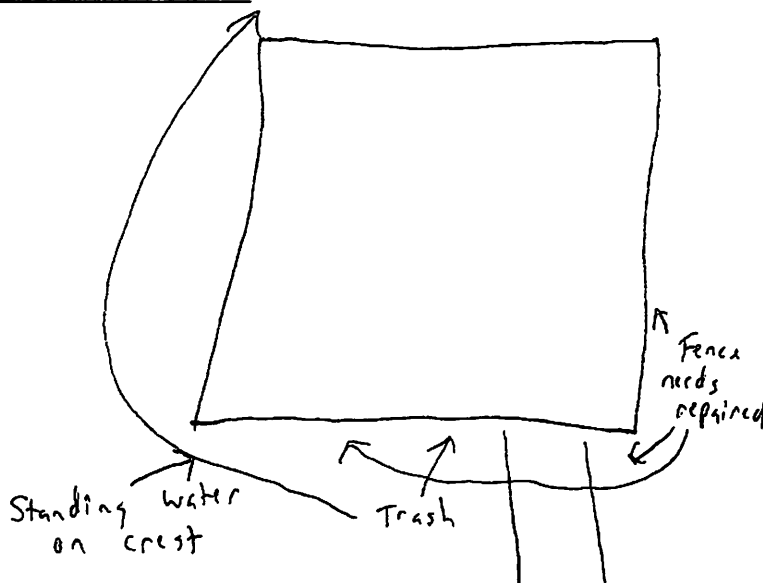
1. Trash observed around impoundment.
Stone has agreed to address.
2. Fence is down in areas.
Stone has agreed to repair.
3. There is water standing on crest during wet periods.
Stone has agreed to work crest and ensure proper drainage.

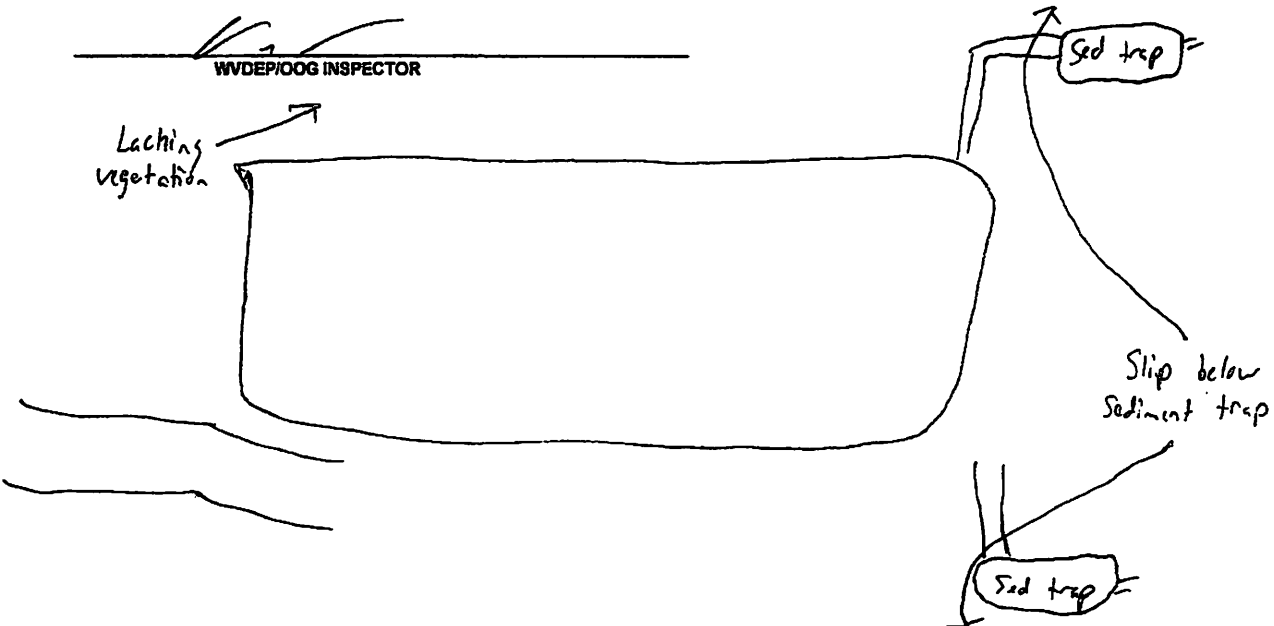
1. There are areas where the vegetation could be improved.
 Noble has agreed to address vegetation concerns next spring.

2. There are slips below both sediment traps.
 Noble has agreed to repair slips. In order to repair, sediment traps will be removed and replaced by vegetative strips.

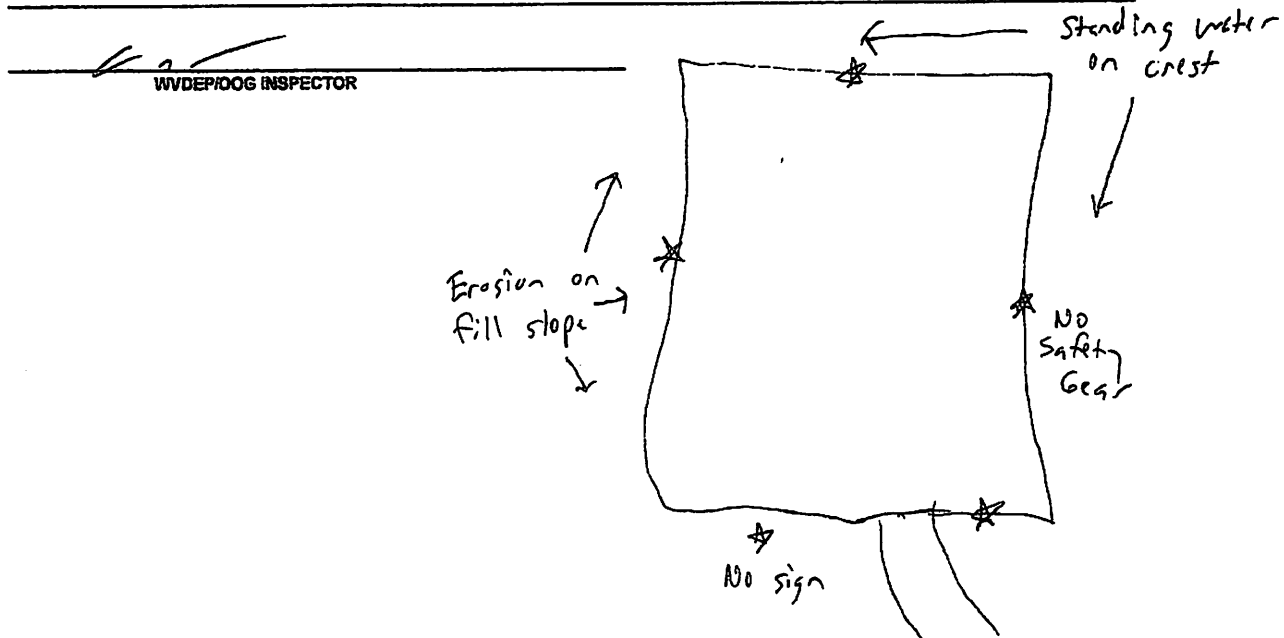
1. There is no sign or safety equipment
 Gaster has agreed to install sign and safety equipment.

2. There are minor erosion areas on fill slope.
 Gaster has agreed to dress areas and install straw matting.

3. There is standing water on crest.
 Gaster has agreed to work crest to ensure proper drainage.
