**CONSENT ORDER  
ISSUED UNDER THE  
WATER POLLUTION CONTROL ACT  
WEST VIRGINIA CODE, CHAPTER 22, ARTICLE 11**

TO: Arsenal Resources LLC  
6031 Wallace Rd. Ext Suite 300  
Wexford PA 15090

DATE: October 8, 2020

ORDER NO.: 9923

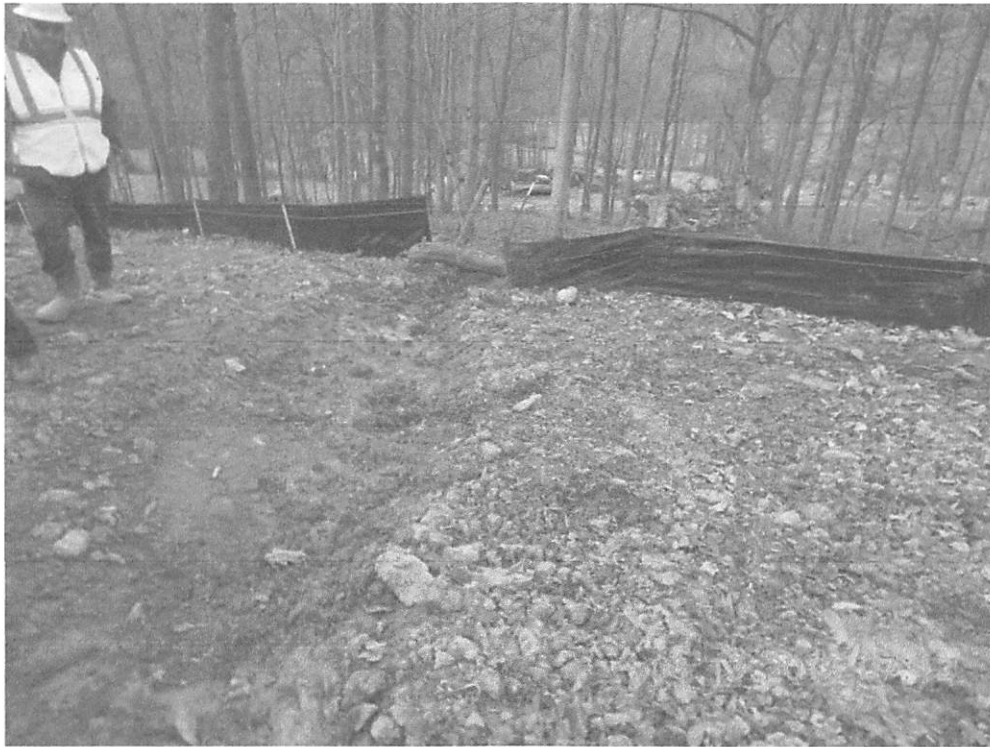
Stat. 218+00, Failure to implement water bar terminus treatment as detailed on page ENV D12 of the SWPPP.

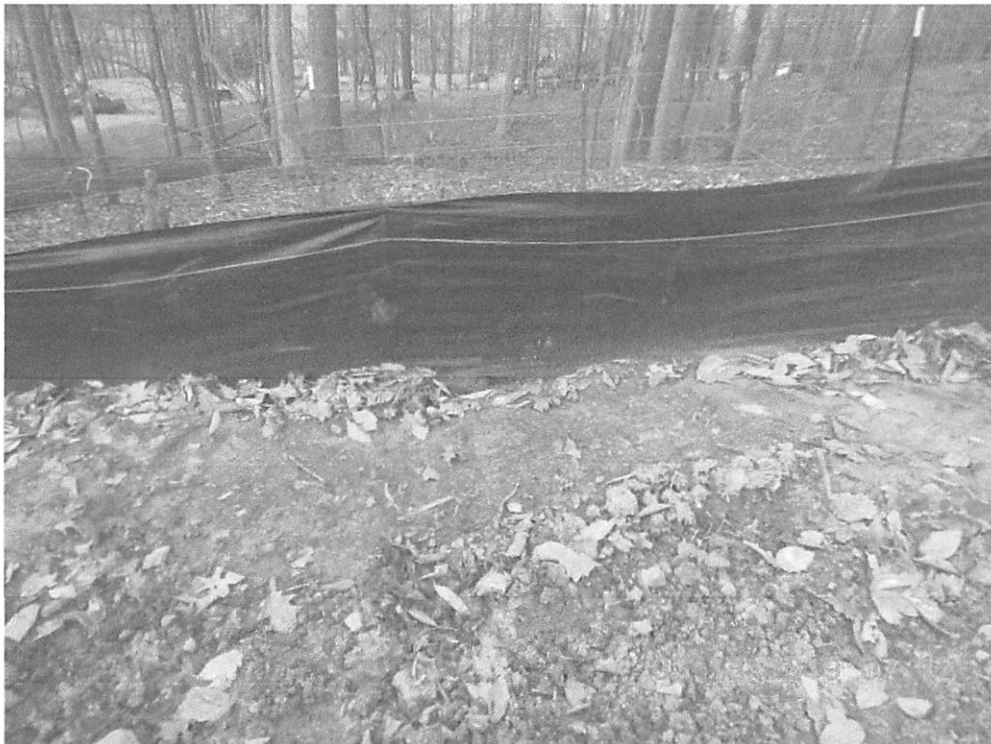
Stat. 217+25, Perimeter controls throughout site were nonfunctional due to bypasses. Silt fence not toed-in correctly.

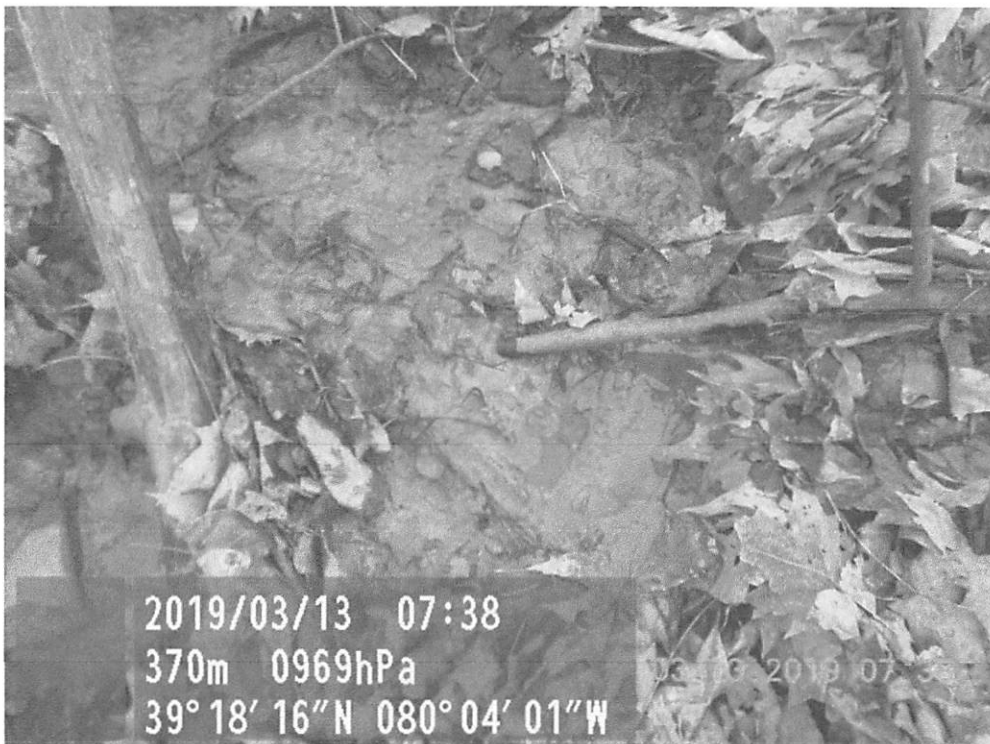
Stat. 210+00, UNT 12, Arsenal caused conditions not allowable in UNT of Shelby Run at 39°18'16" N 80°04'01" W

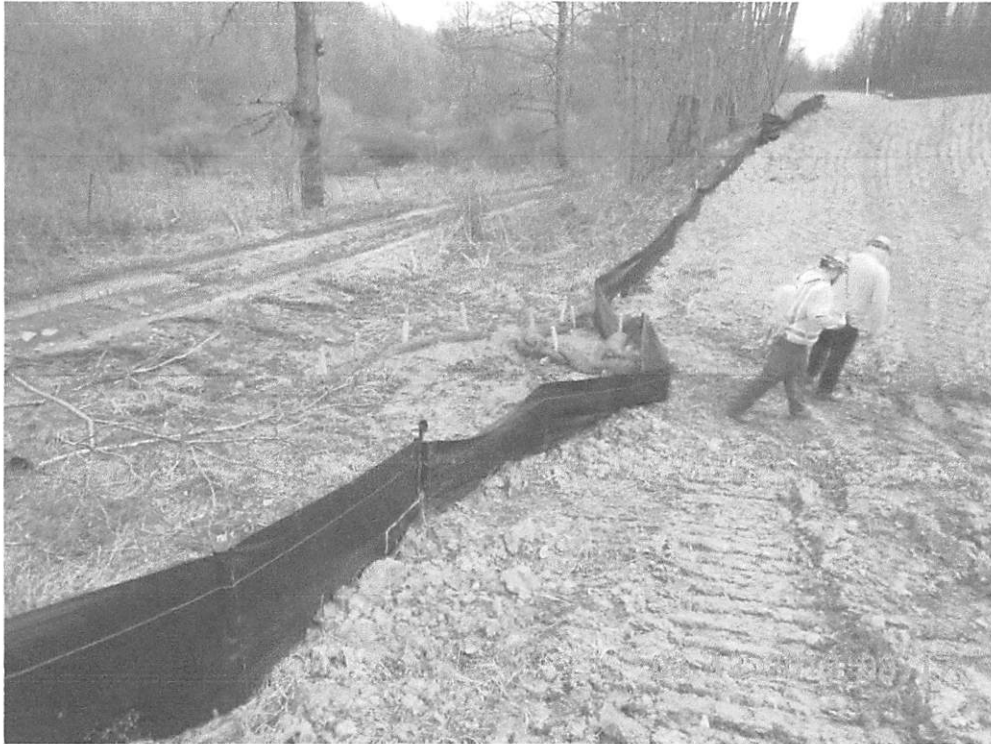
Stat. 175+00, CFS was not conjoined with SF correctly, creating a bypass.

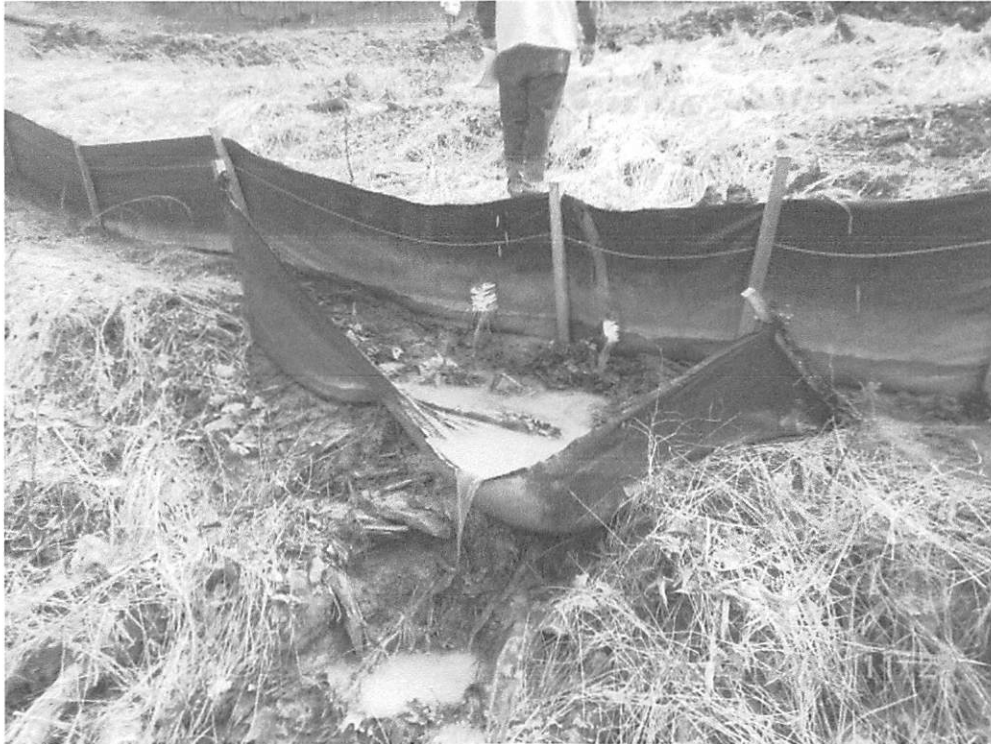
Maintenance is lacking throughout project site.

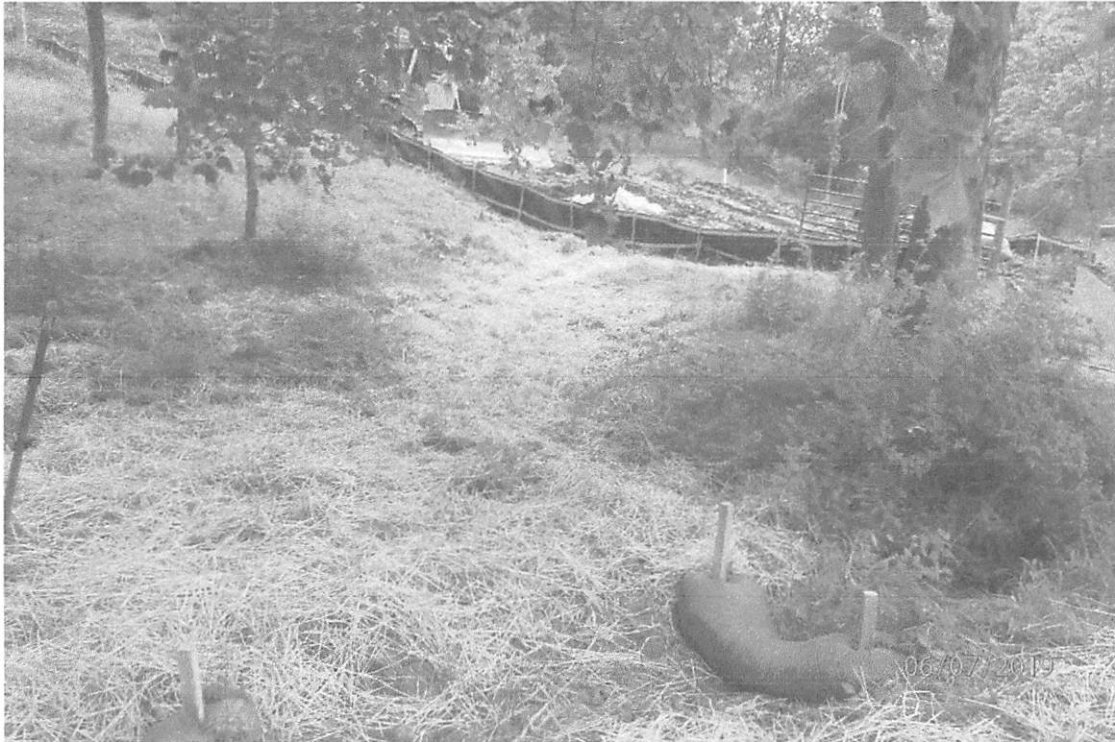
Offsite sediment deposits as a result of improperly installed water bars leading to the old CR 17 conveyance. Perimeter controls were recently installed in this area as well.

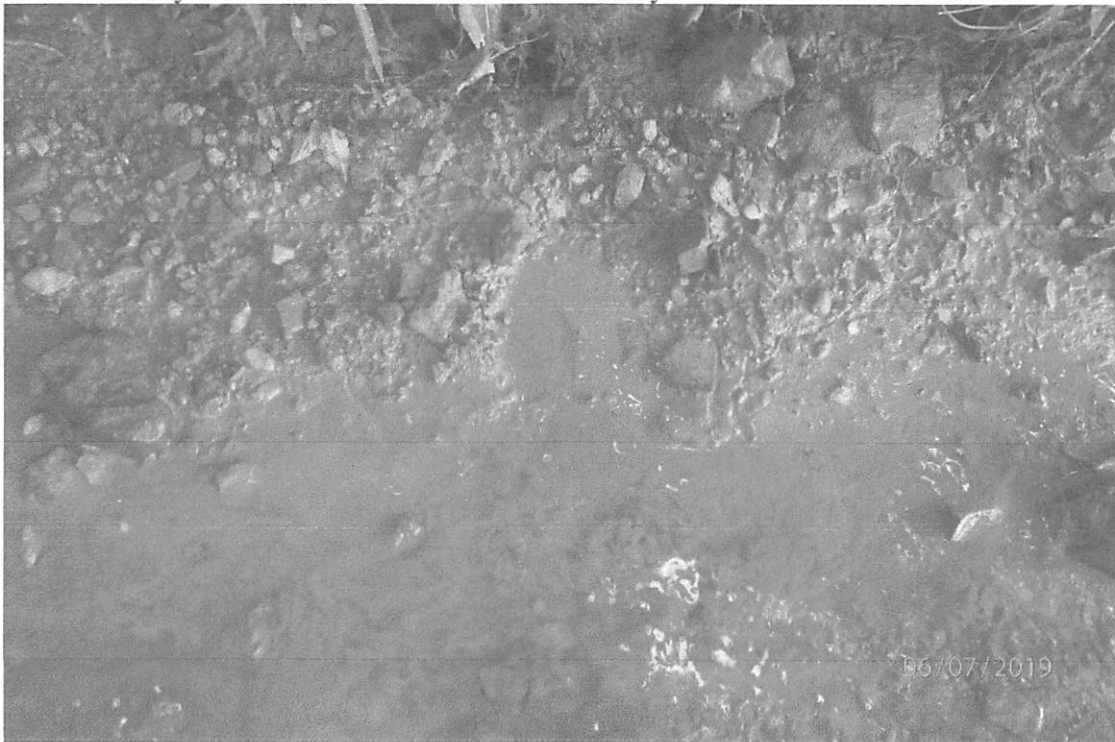
Offsite CNA deposits in UNT Beards Run conveyance (39° 15.023' X 80° 10.561').

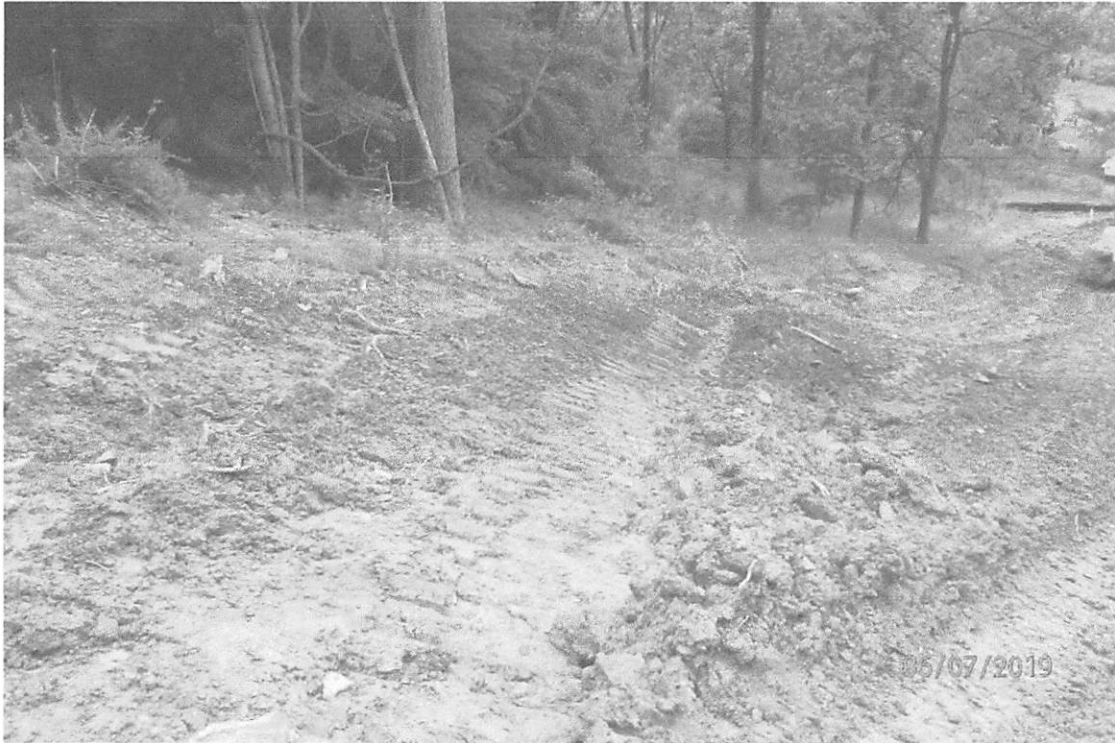
Improperly installed water bar upslope of 479+00. The water bar is installed at a steep angle and has a height less than 12". The water bar allows stormwater to flow back across the right of way. The water bar also lacks outlet treatment.

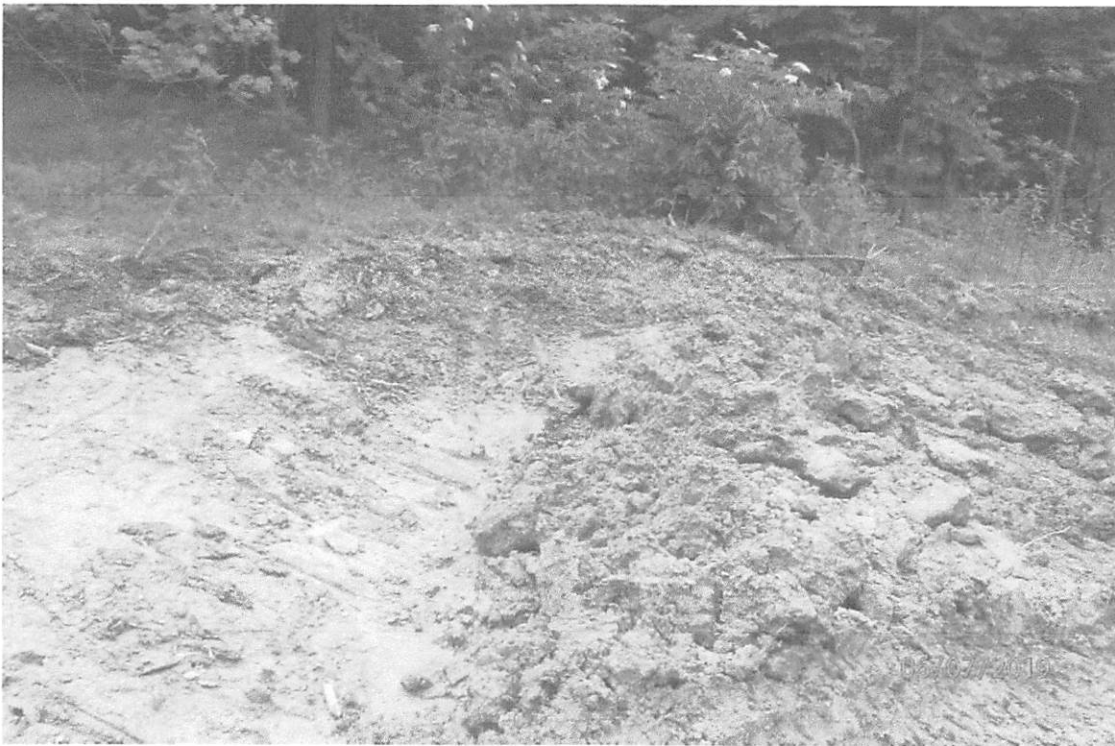
Improperly installed water bar upslope of 479+00. The water bar allows stormwater to flow back across the right of way. The water bar also lacks outlet treatment.

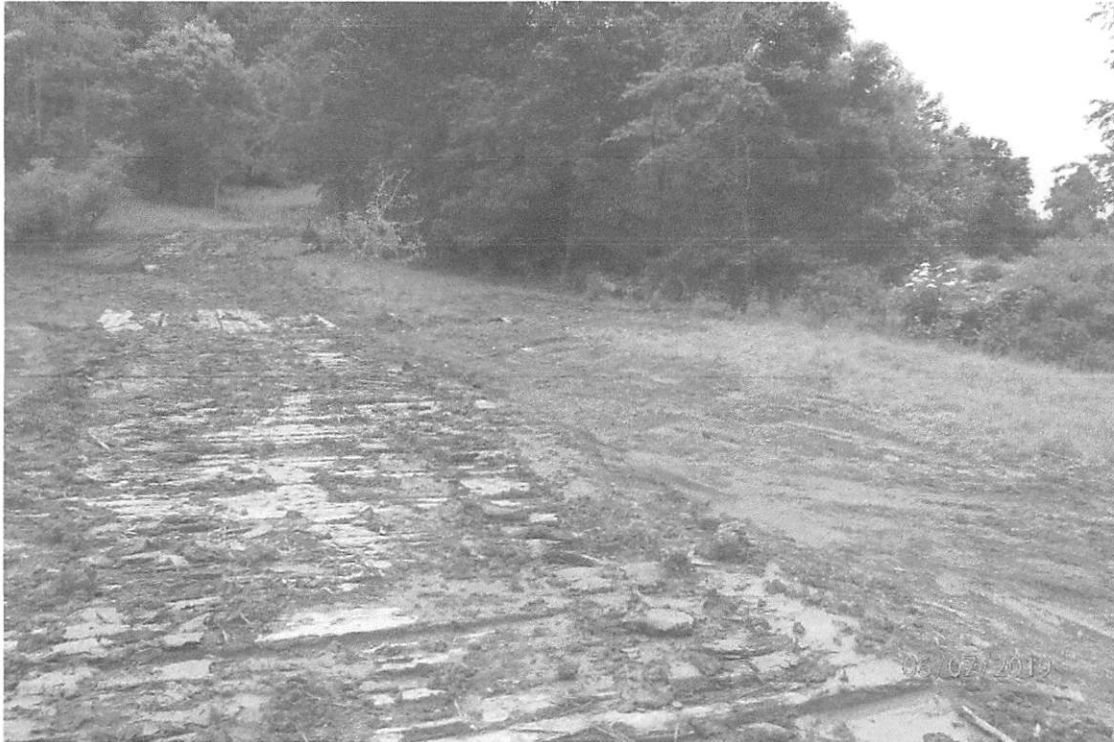
Wetland WL-28 showing the lack of installed perimeter controls that are indicated in the approved SWPPP.

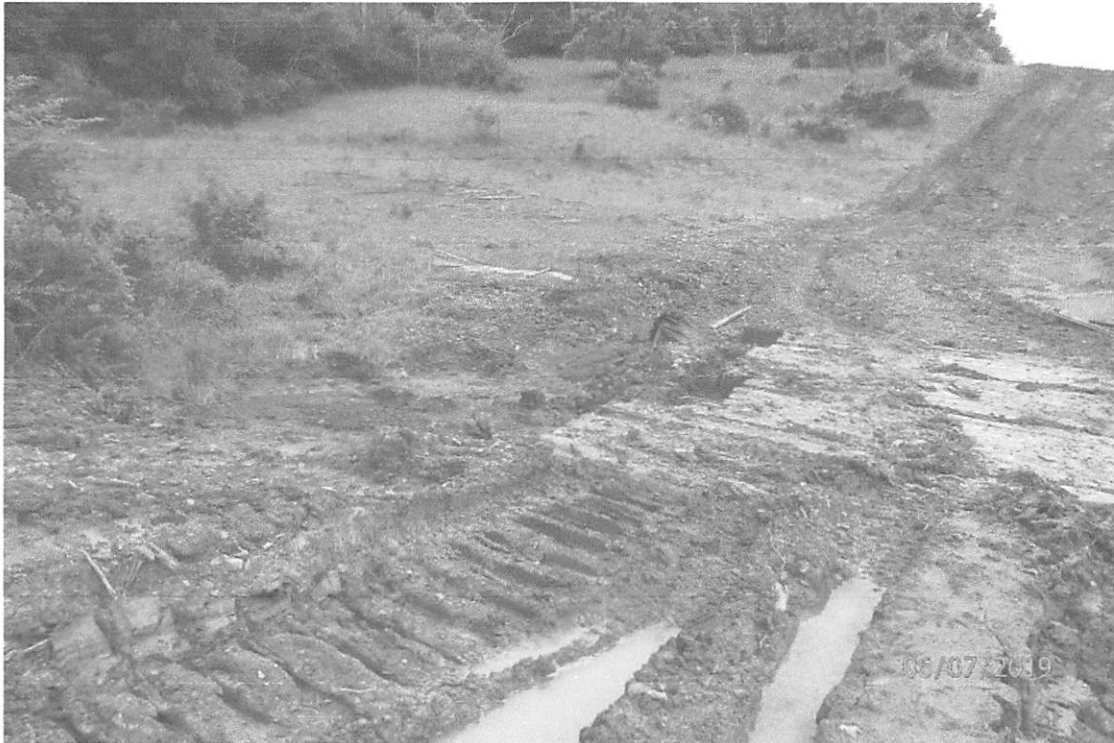
Installed timber mat crossing of UNT 23 showing its improper installation and need for maintenance.

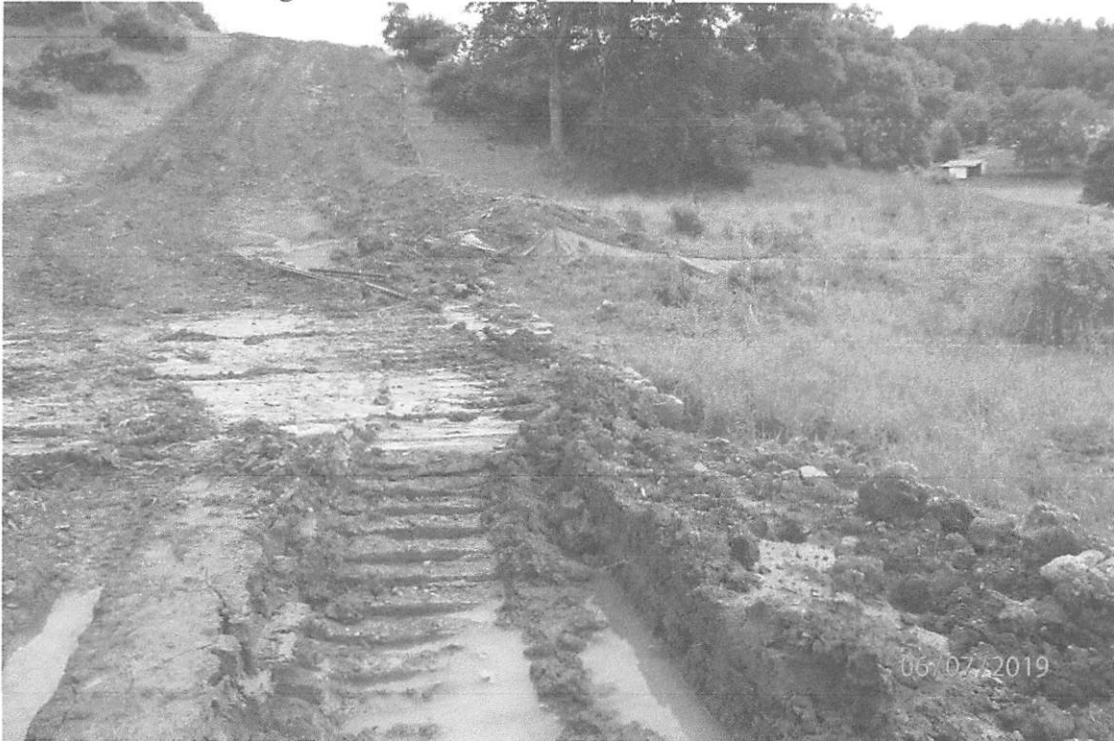
Installed timber mat crossing of UNT 23 showing its improper installation and need for maintenance.

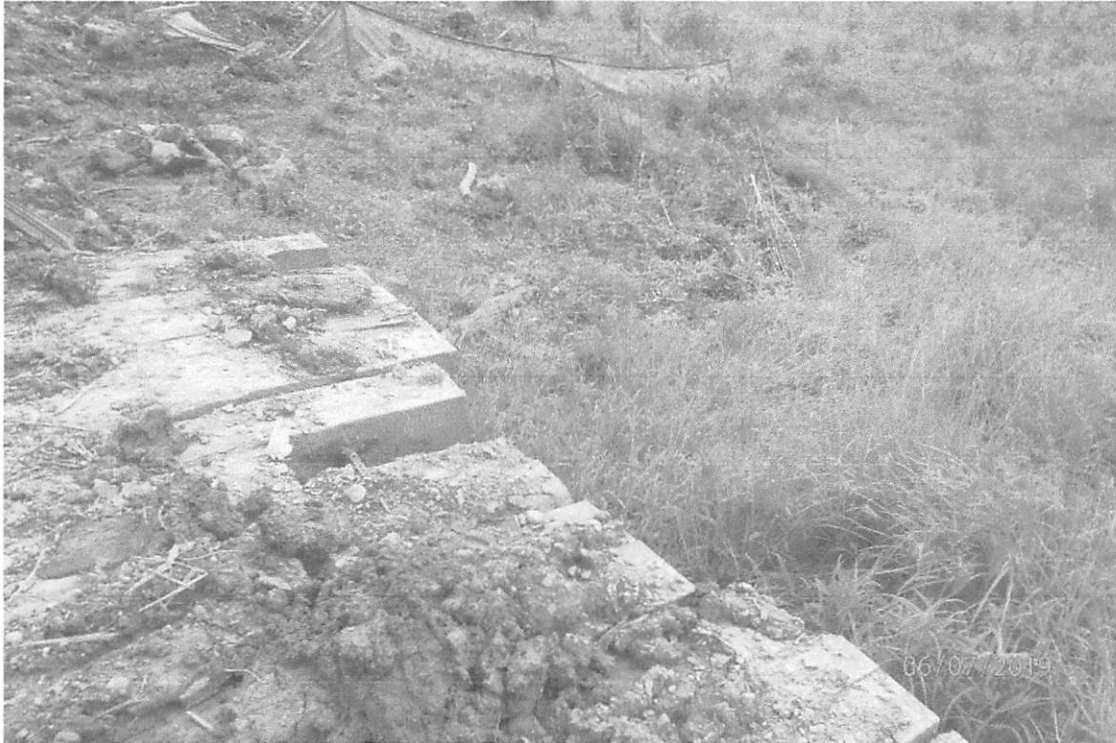
Installed timber mat crossing of UNT 23 showing its improper installation and need for maintenance.

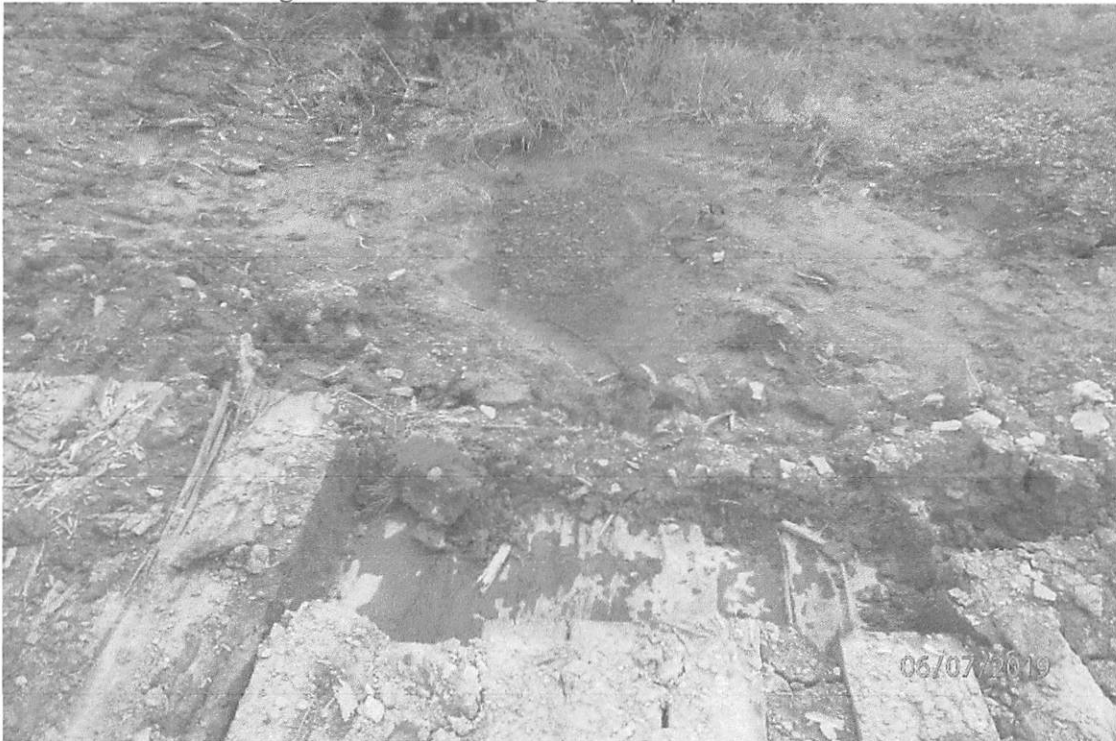
Installed timber mat crossing of UNT 23 showing its improper installation and need for maintenance.

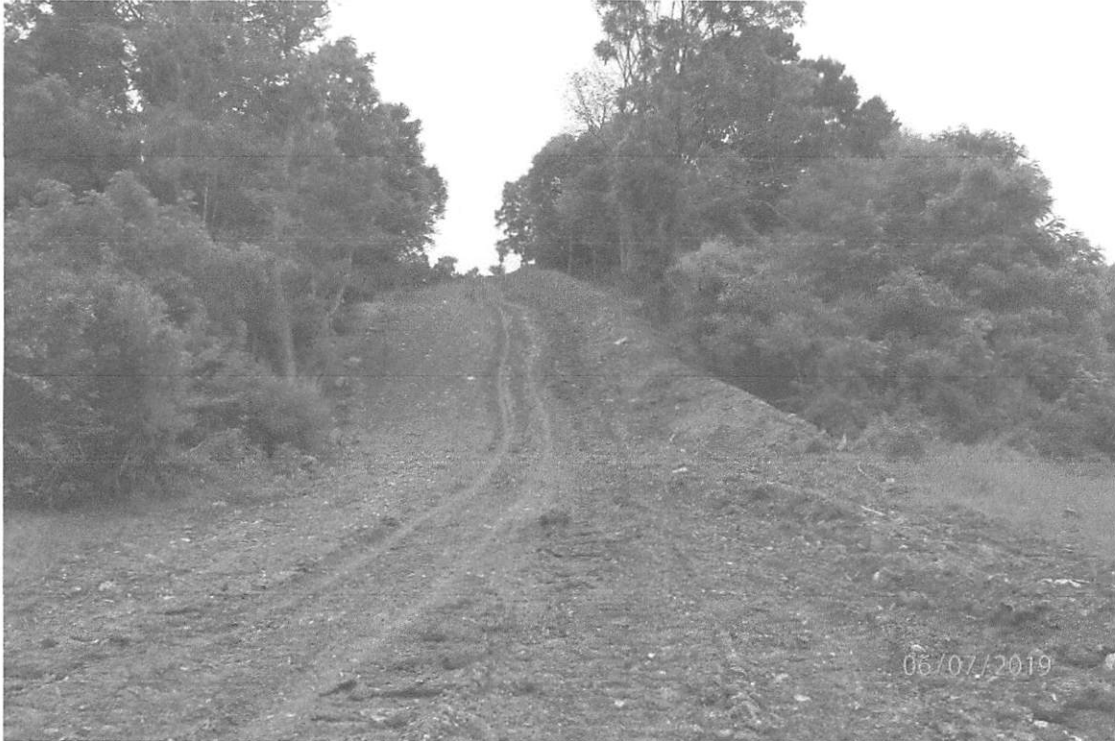
Hillside upslope of 490+00 showing the lack of installed water bars and silt saver 2 slope interceptors.

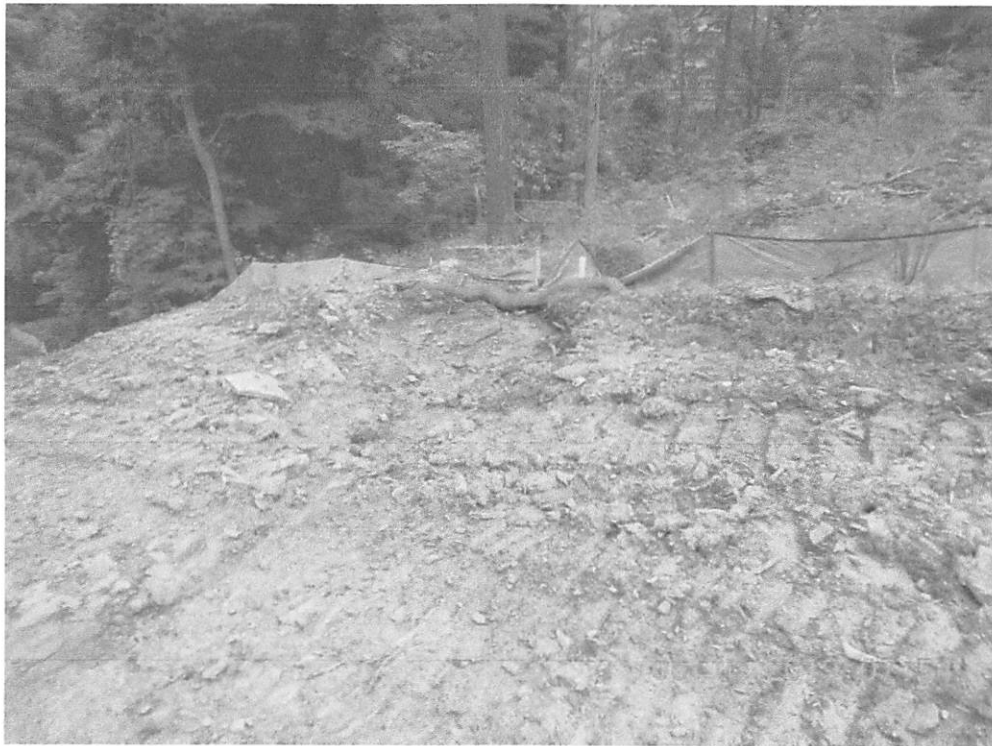
Station 207+50, Only water bar noted out of 9 required by SWPPP. Maintenance needed on sump. Water bar is ineffective, and erosion rills are starting to form.

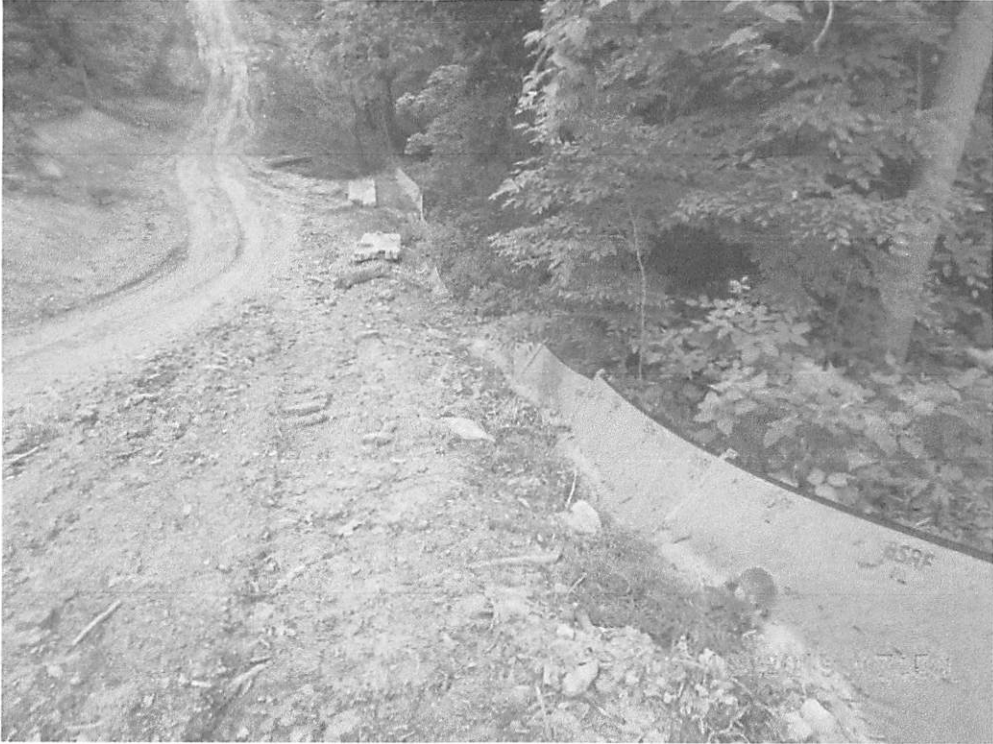
Station 208+00, Erosion rill is present, and SS2 is overwhelmed with sediment.

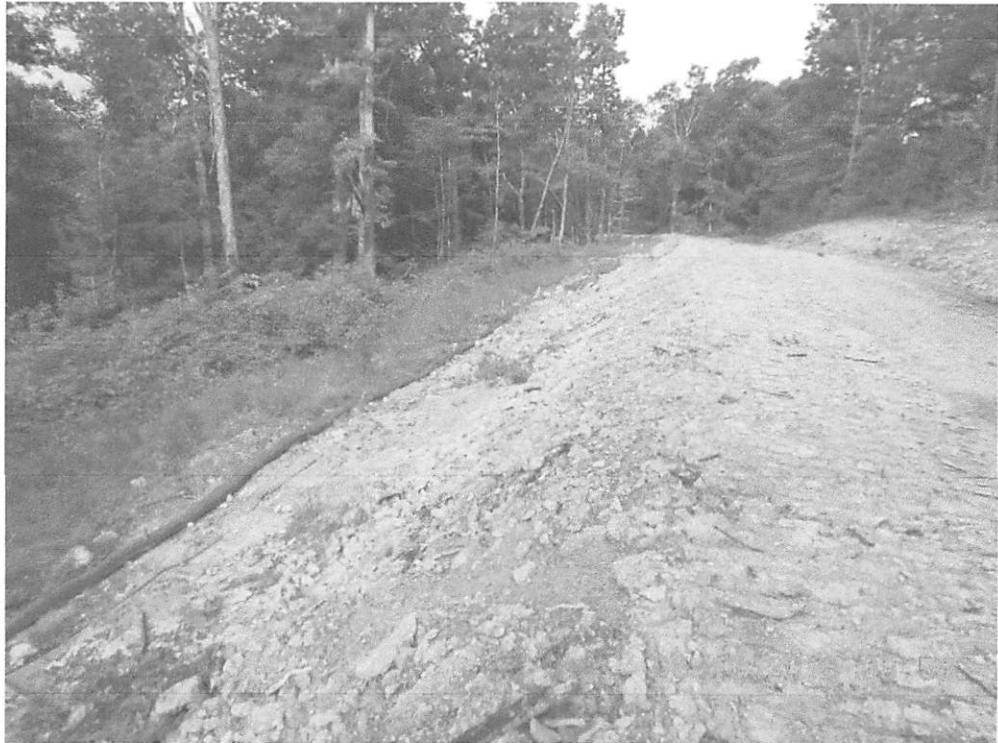
Station 260+00, SWPPP requires SS2 slope interceptors. When controls were damaged by pulling pipe strings, 8 inch CFS was installed in its place.

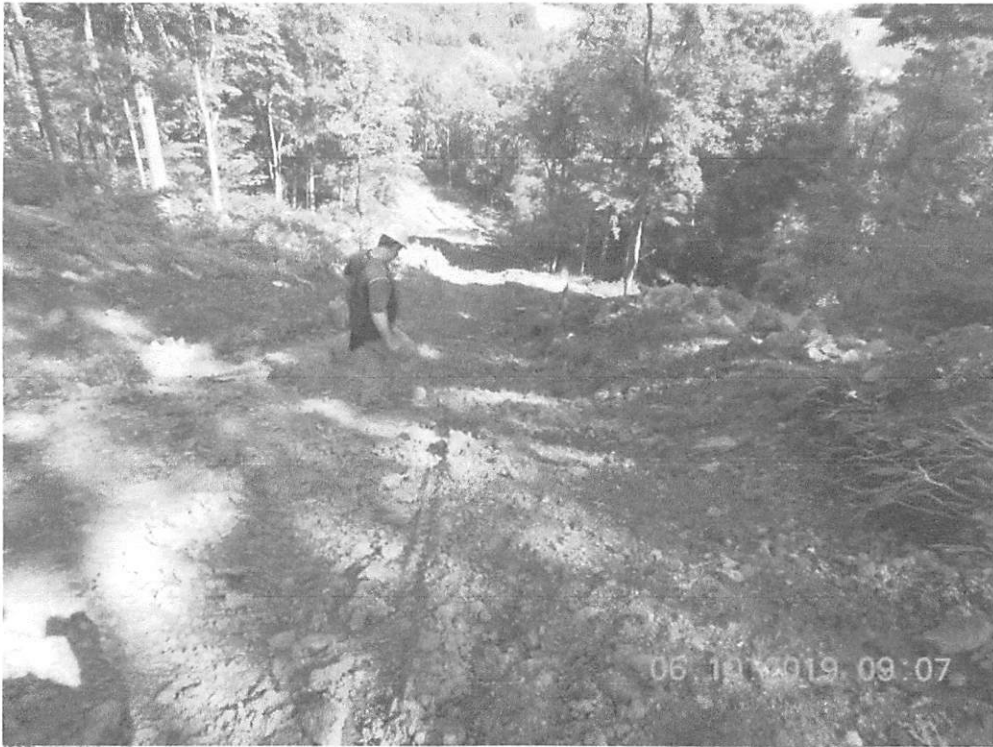
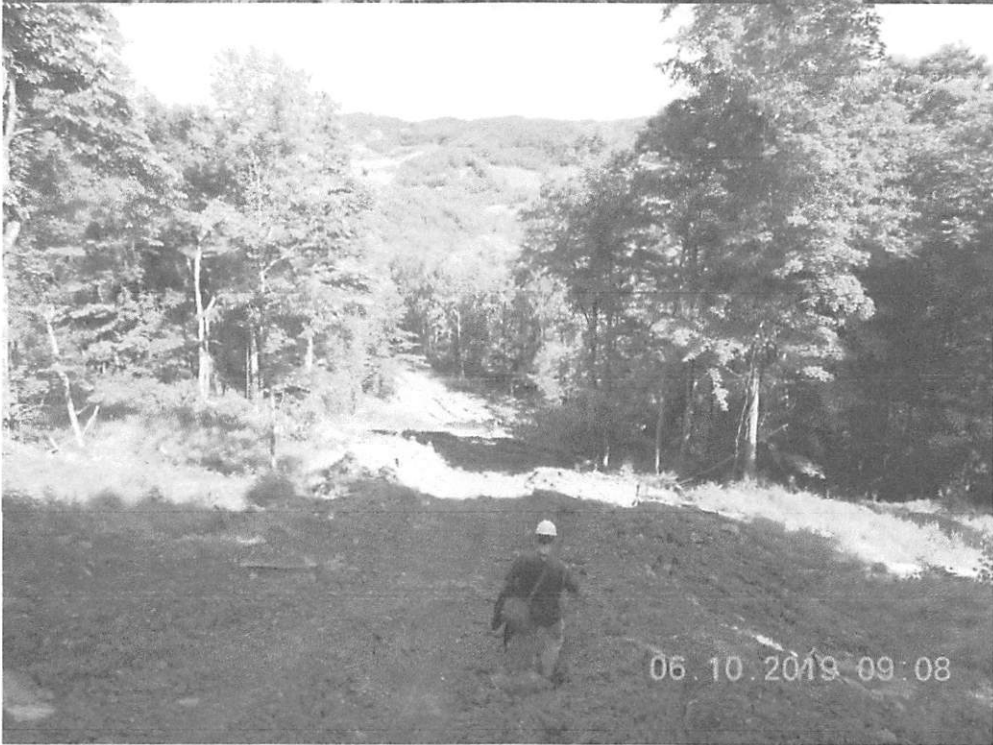
Station 265+50, SWPPP requires 10 water bars. This section of ROW was entrenched, and all water stayed on right of way until about Station 271+00.

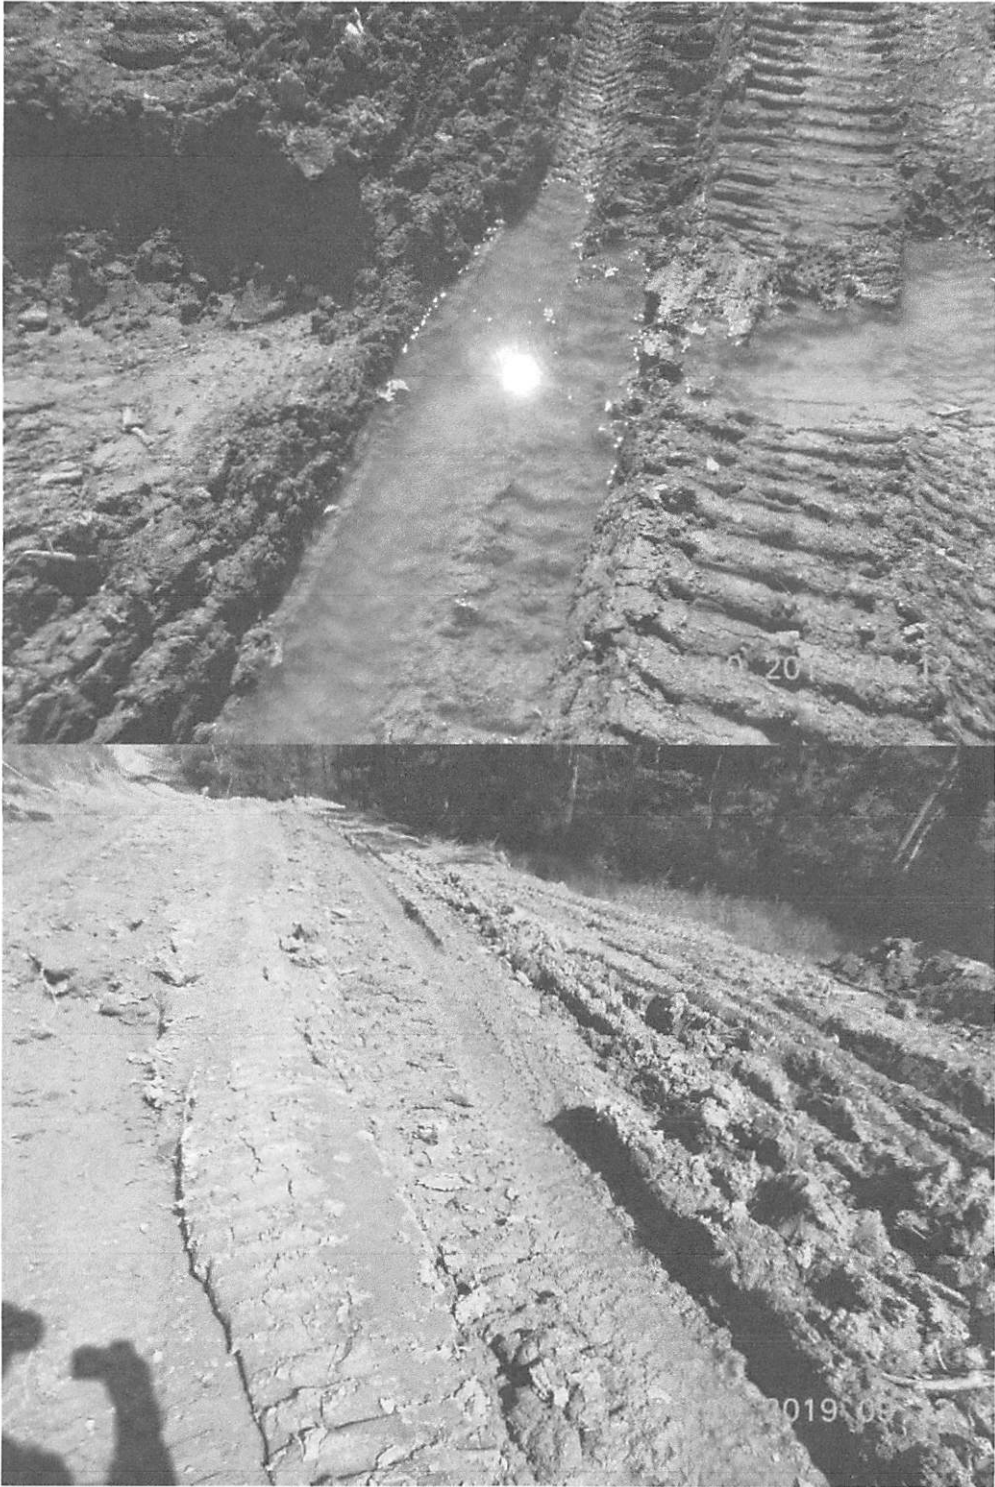
Station 271+00, Water bars are tracked through, causing them to fail. Water can bypass and form erosion rills in tracks.

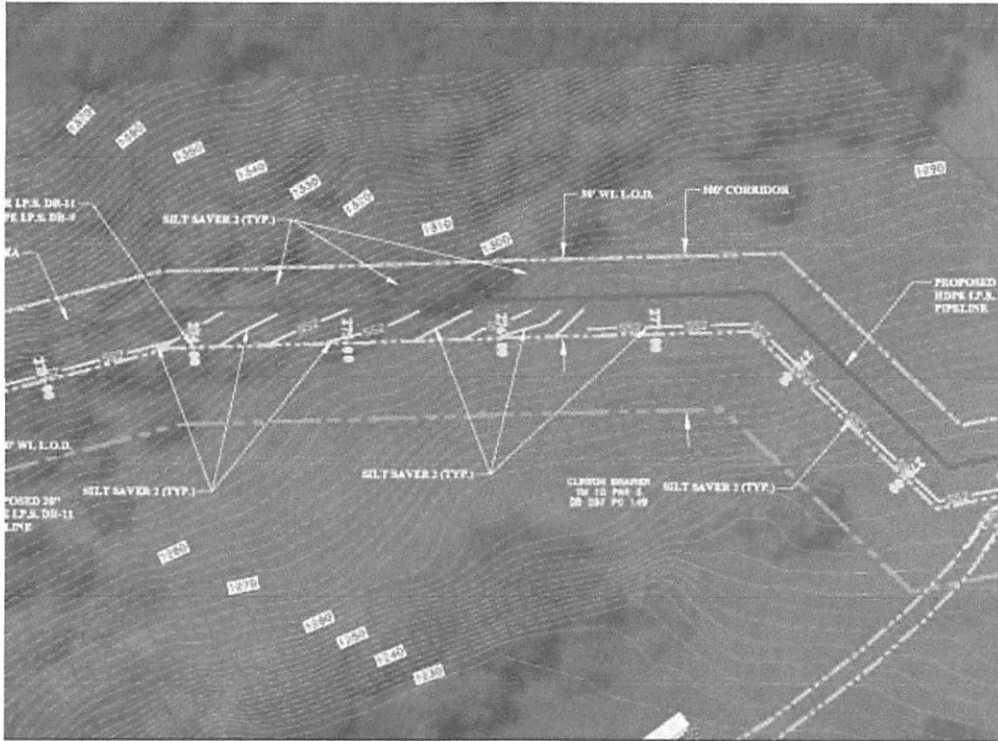
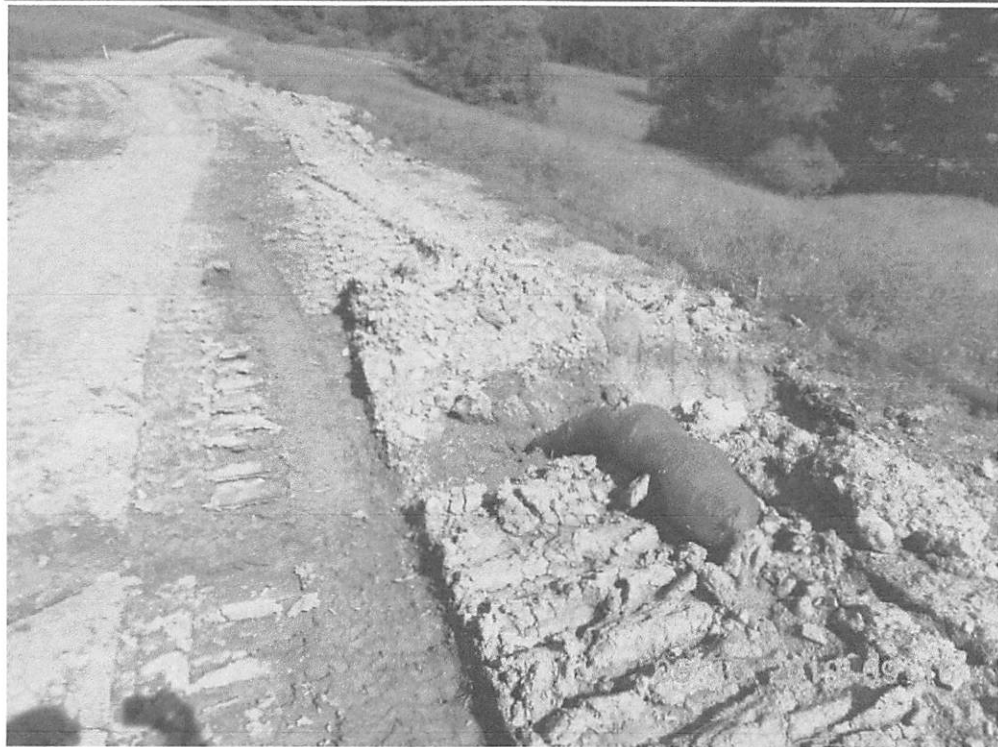
Station 274+00, SWPPP requires SS2 slope interceptors.

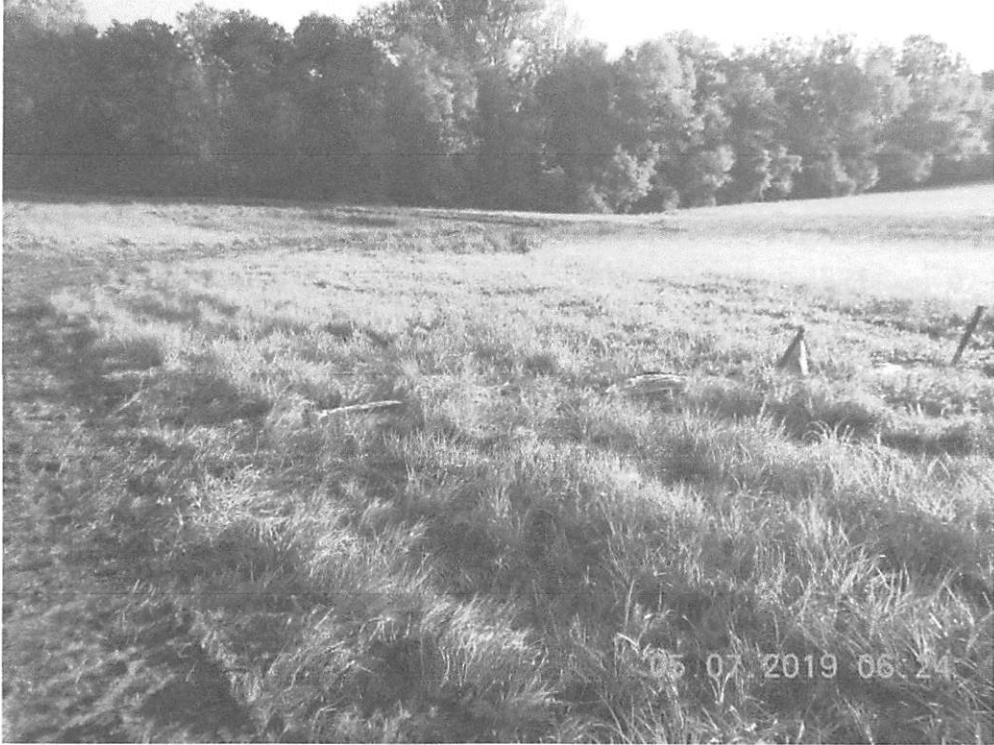
Controls, as observed and documented on May 7, 2019.

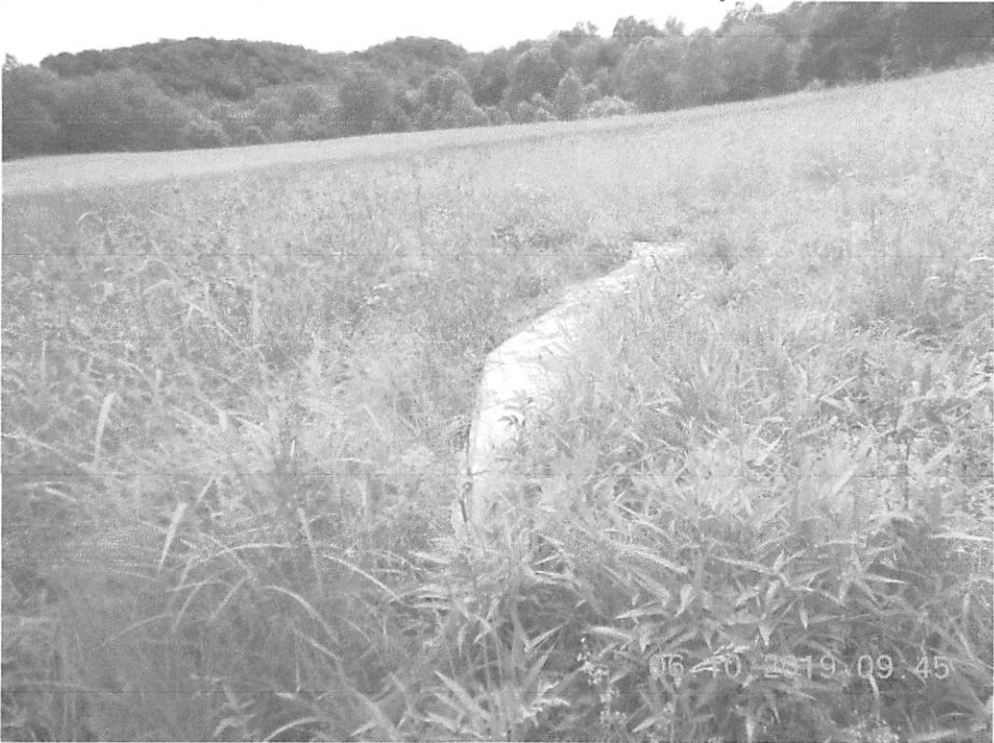
Controls continued to be down since the May 7, 2019 inspection.

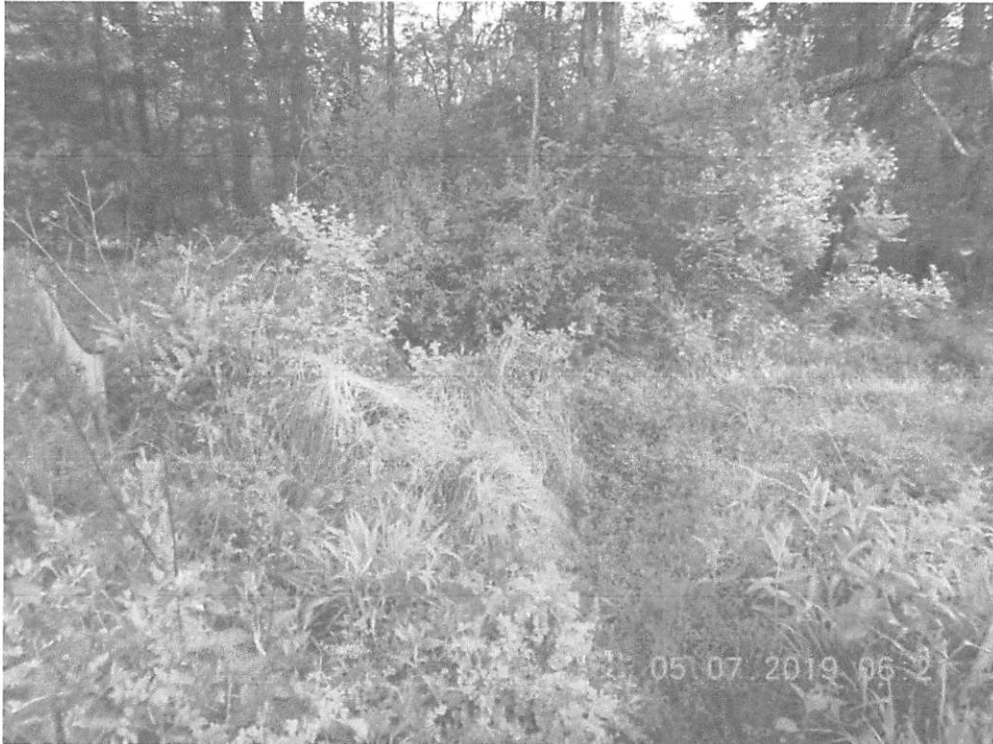
Controls, as observed and documented on May 7, 2019.

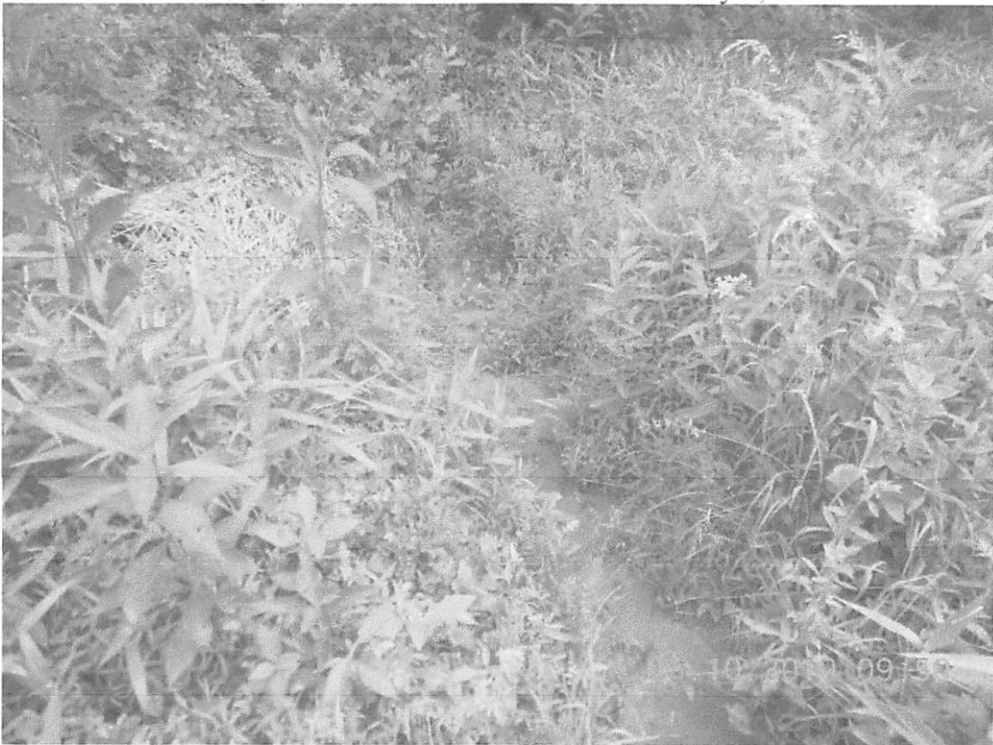
Sediment laden water leaving site without going through an appropriate device. Deficiency had continued since the May 7, 2019 inspection.

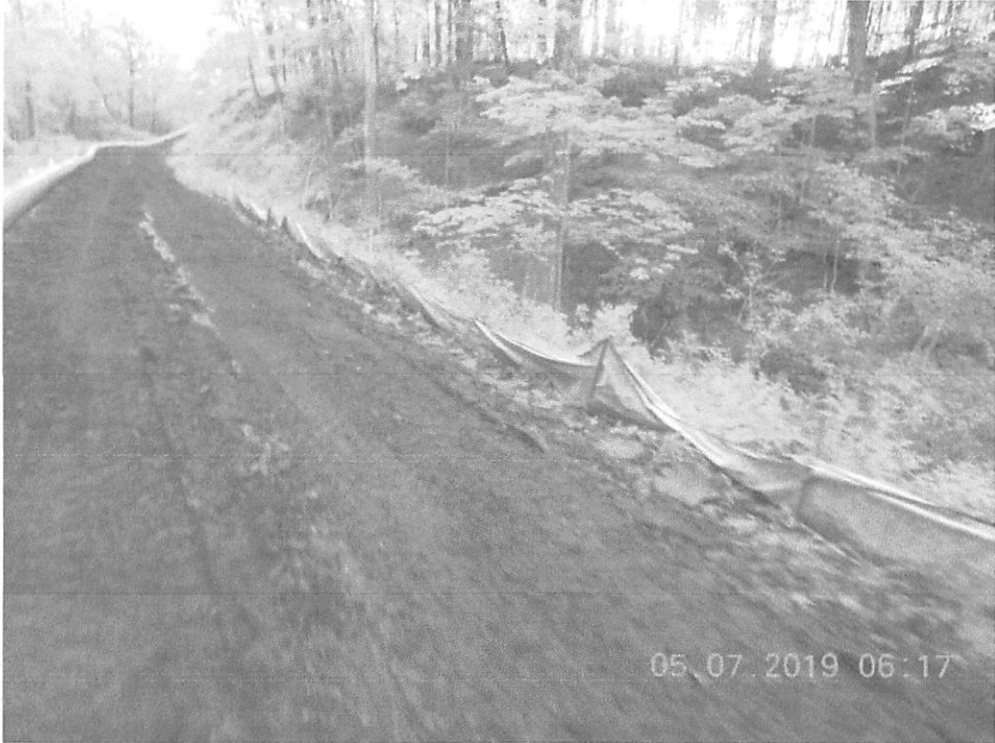
Lack of controls, as observed and documented on May 7, 2019.
