**CONSENT ORDER  
ISSUED UNDER THE  
WATER POLLUTION CONTROL ACT  
WEST VIRGINIA CODE, CHAPTER 22, ARTICLE 11**

TO: Arsenal Resources LLC  
6031 Wallace Rd. Ext Suite 300  
Wexford PA 15090

DATE: October 8, 2020

ORDER NO.: 9923

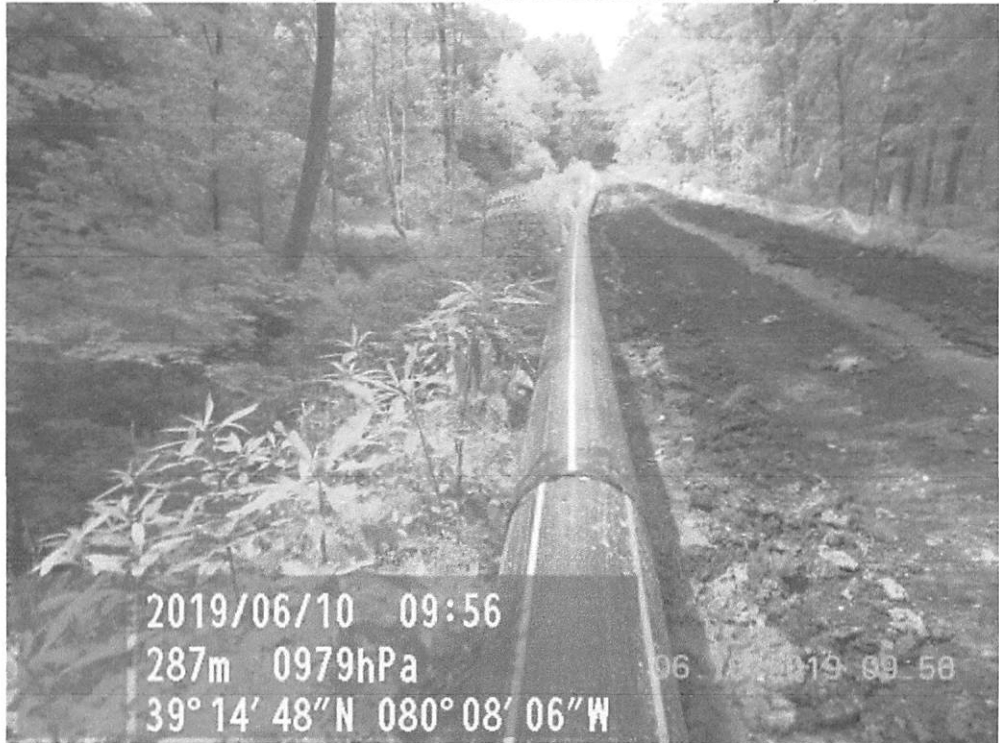
Station 317+00, Lack of controls had continued since the May 7, 2019 inspection.

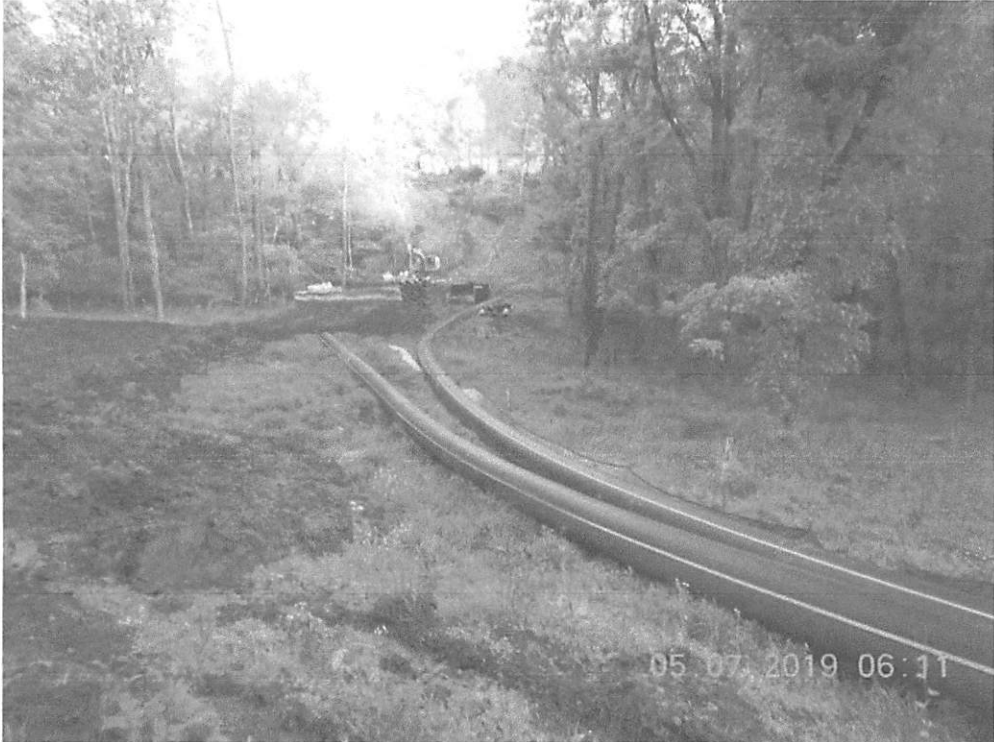
Lack of controls, as observed and documented on May 7, 2019.

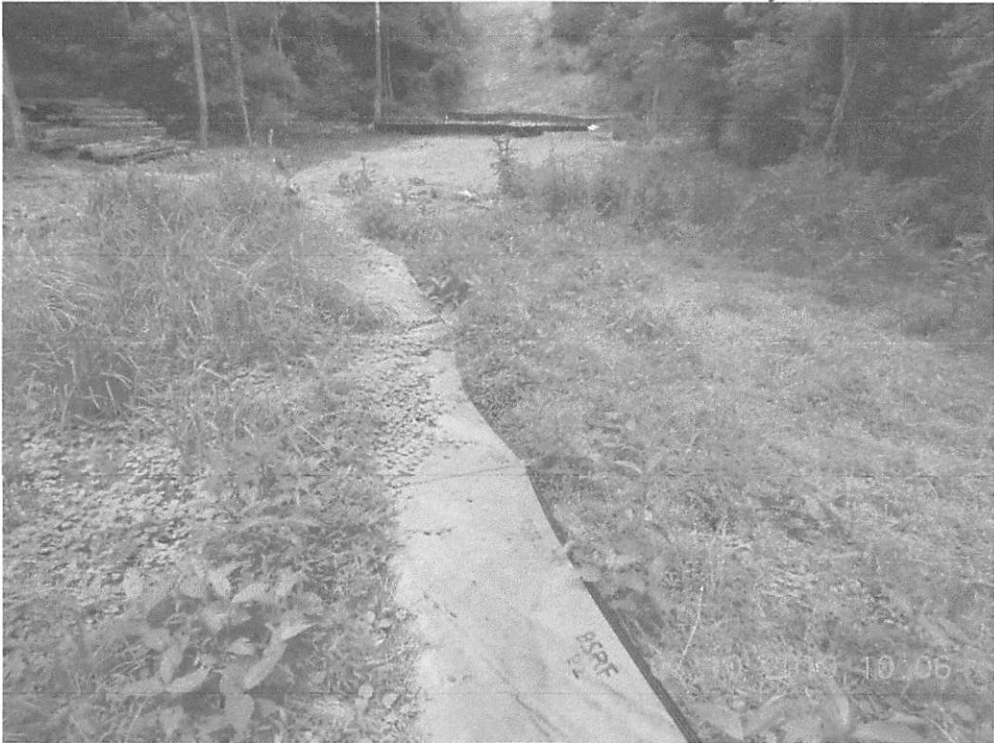
Station 311+00, Lack of controls had continued since the May 7, 2019 inspection.

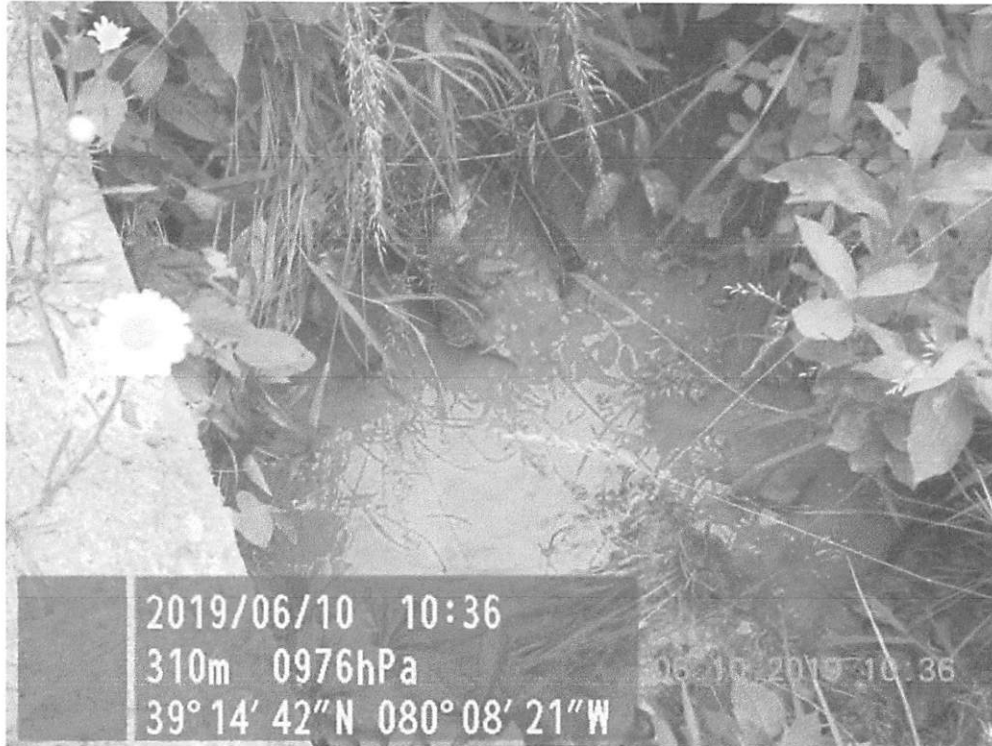
Sediment deposit on bottom of Rt. 76 conveyance caused conditions not allowable on the bottom of UNT of Simpson Creek (39° 14' 42'' N, 80° 08' 21'' W).

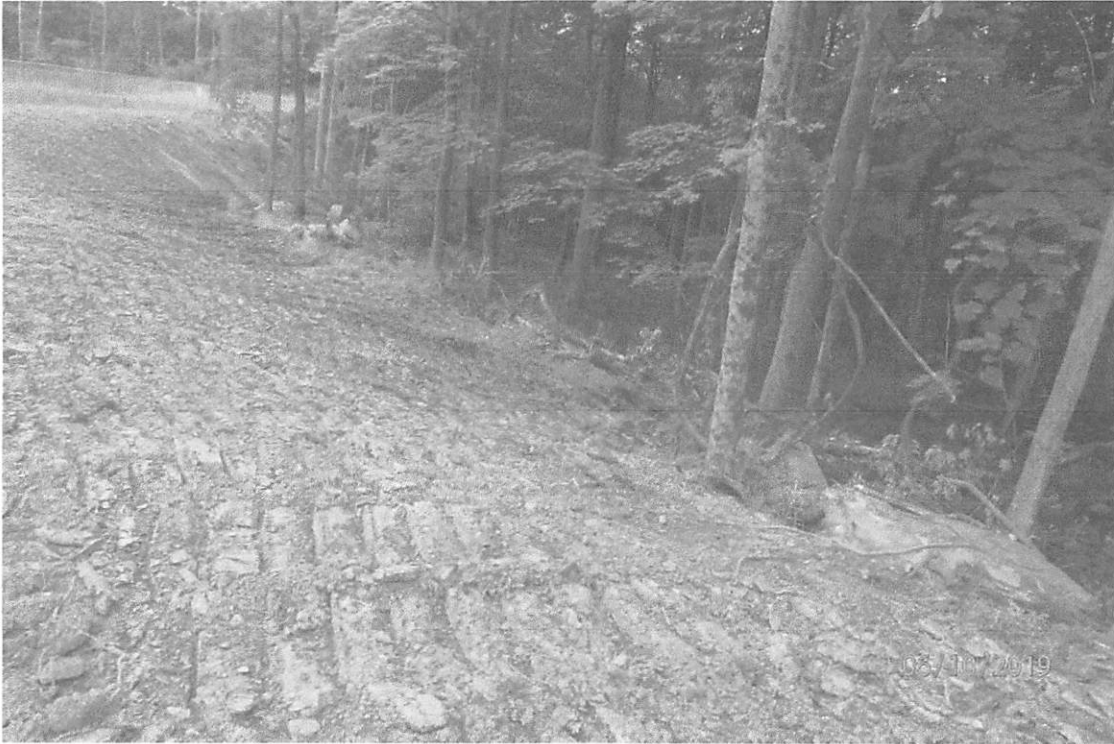
Area lacking perimeter controls that are indicated in the approved SWPPP adjacent to 519+00.

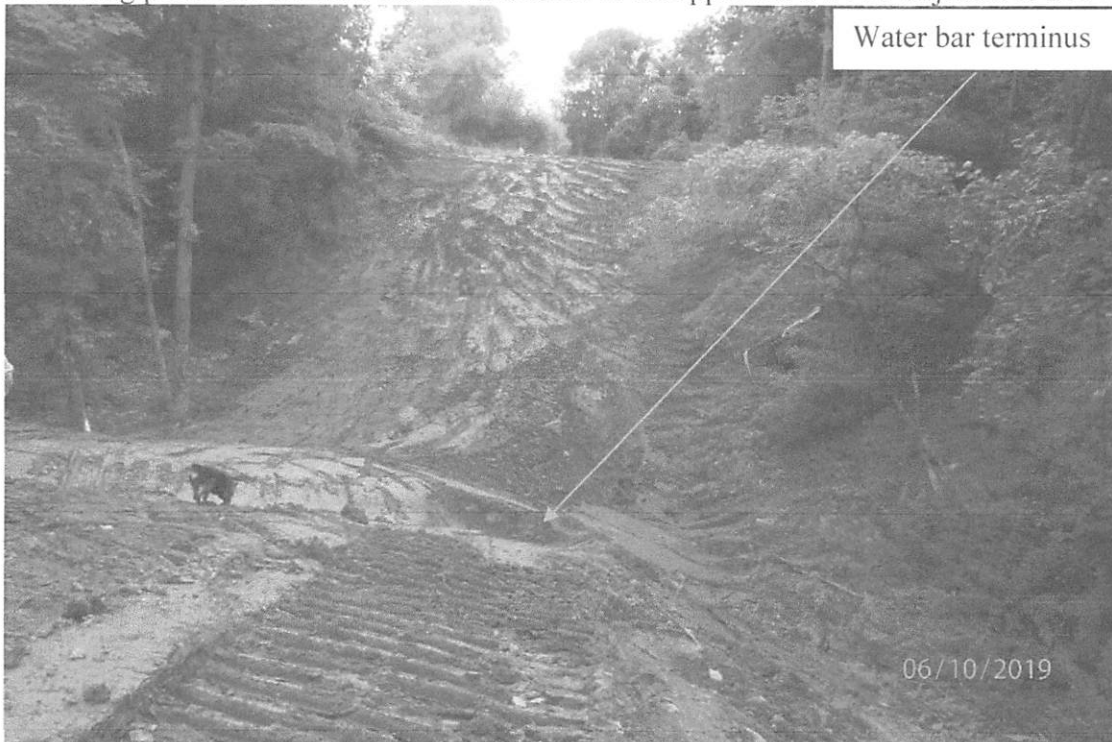
Area lacking perimeter controls that are indicated in the approved SWPPP adjacent to 502+00.  
Improperly installed waterbar that lacks water bar terminus treatment.

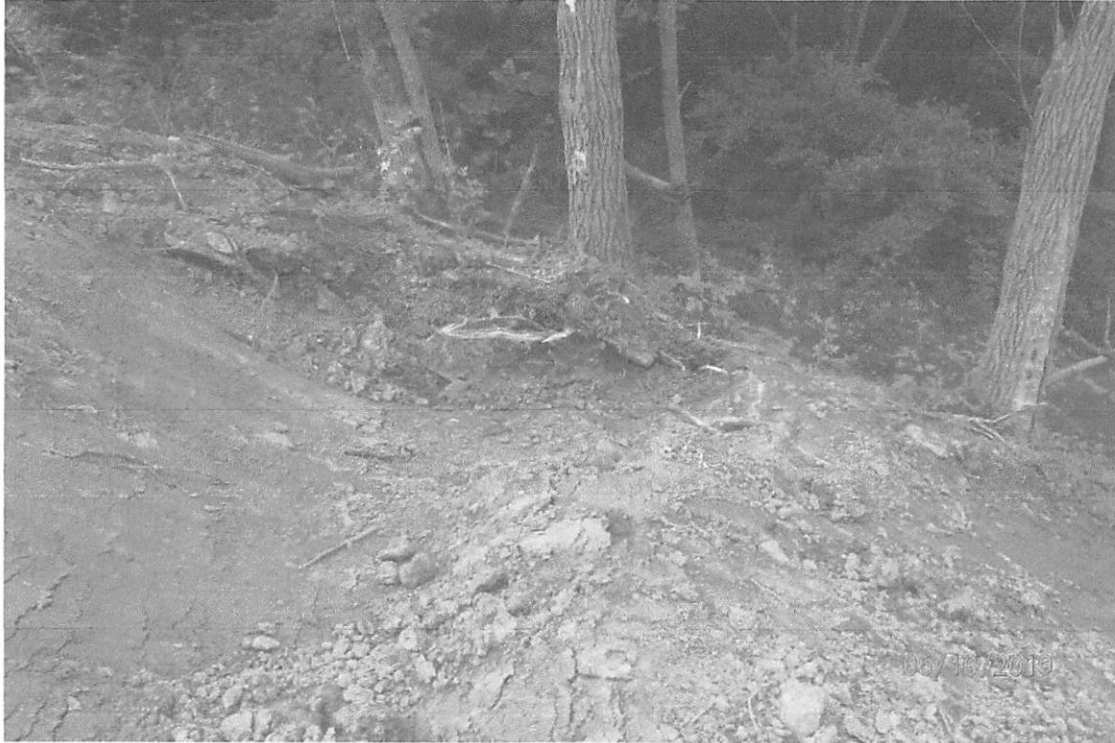
Waterbar in the Beards Run watershed that lacks waterbar terminus BMPs indicated in the approved SWPPP.

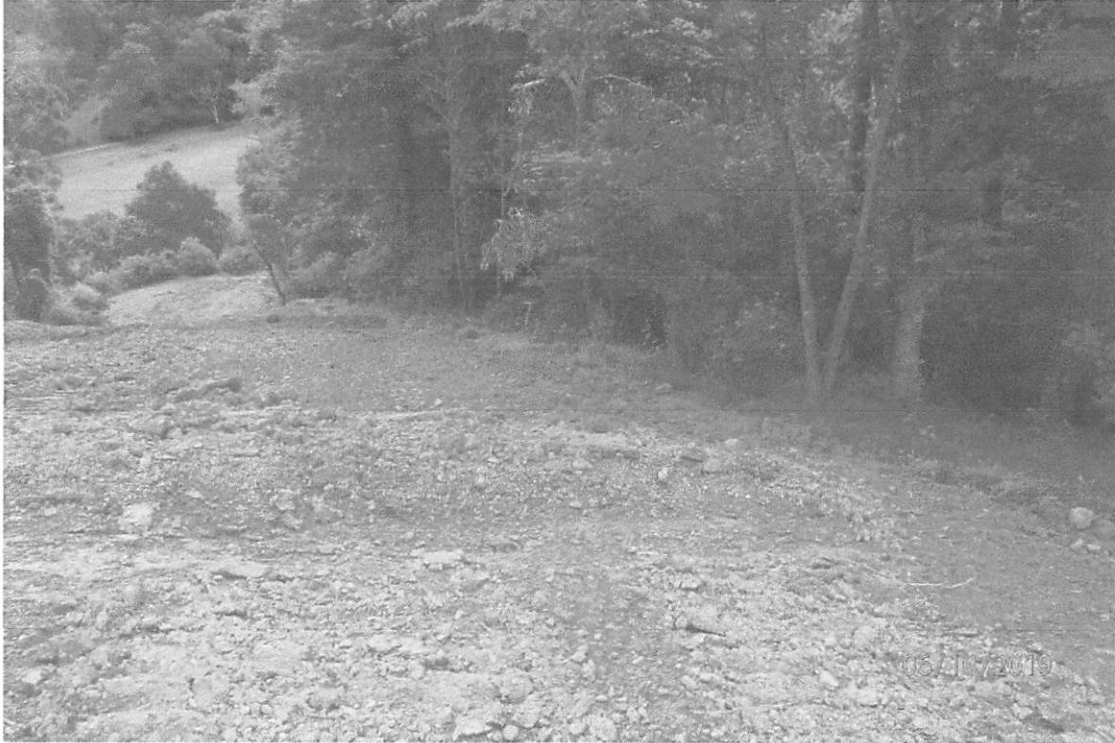
Waterbar in the Beards Run watershed that lacks waterbar terminus BMPs indicated in the approved SWPPP. Improperly installed waterbar (shallow height) pictured.

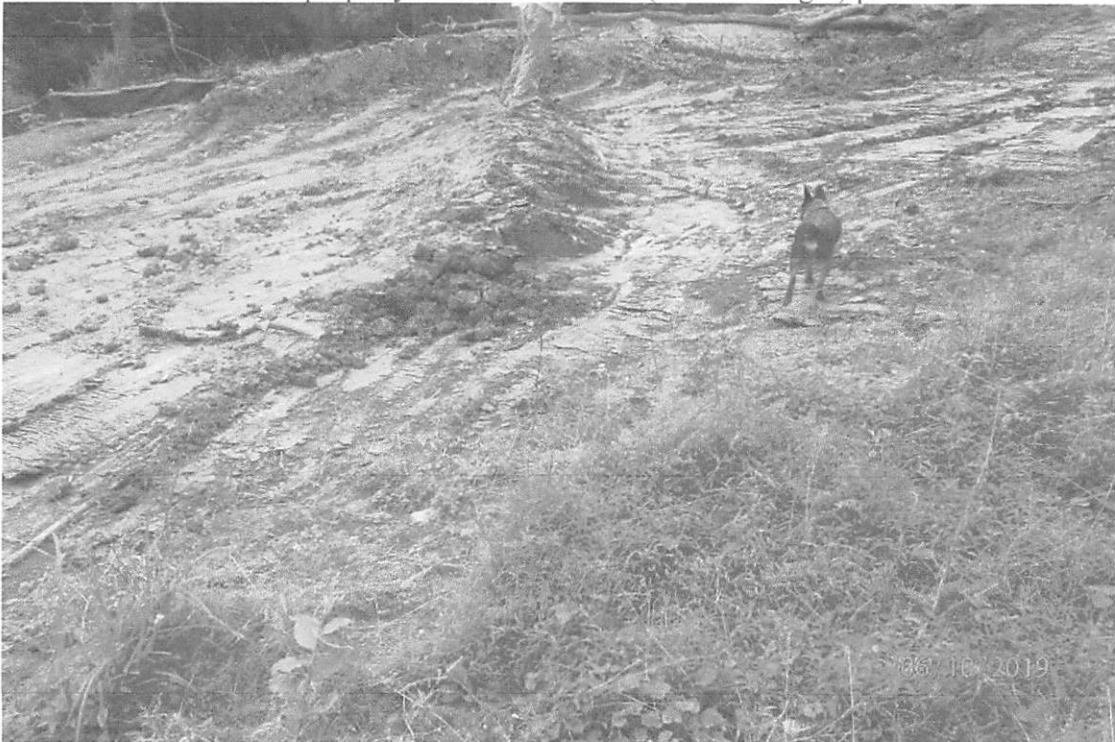
Waterbar in the Beards Run watershed that lacks waterbar terminus BMPs indicated in the approved SWPPP.

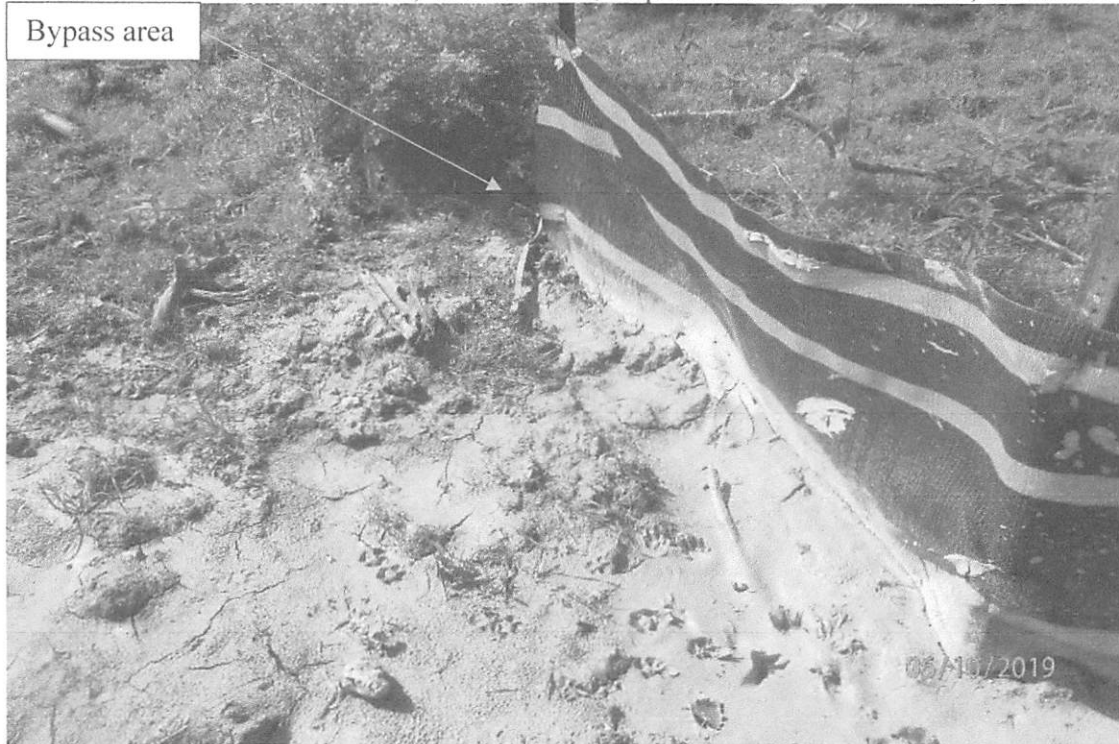
Improperly installed perimeter controls (no J-Hook) adjacent to 433+50, showing accumulated sediment deposits as a result of the lack of installed waterbars upslope of this location. Area of sediment laden water bypass.

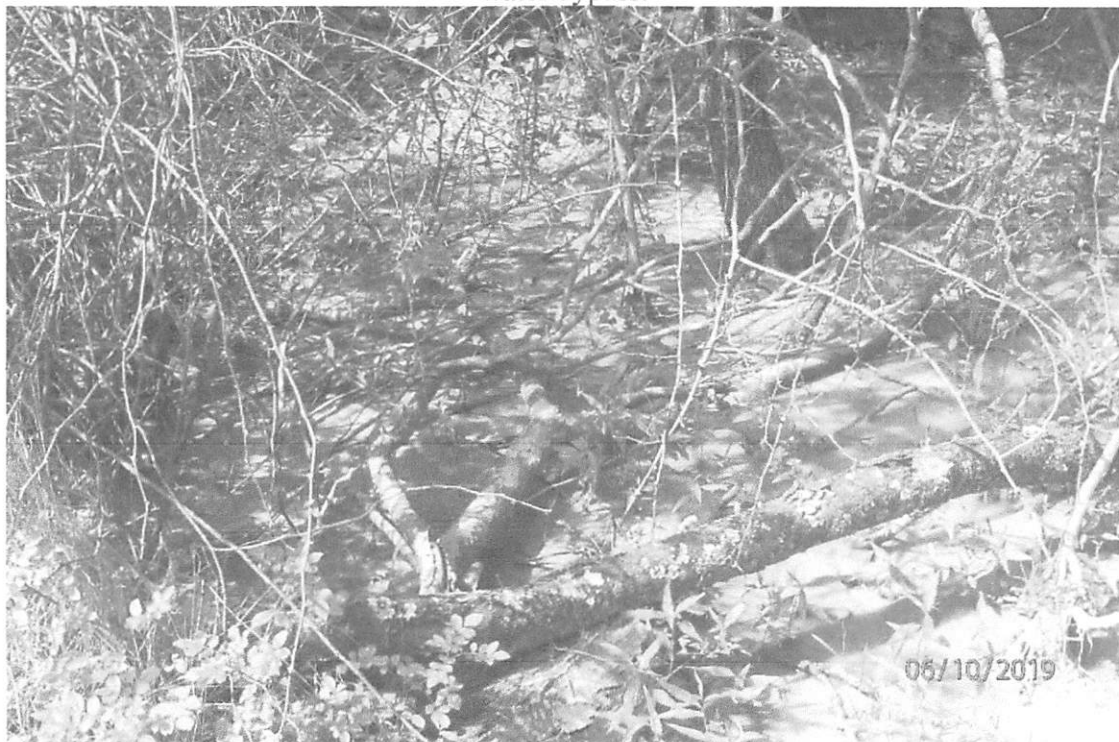
Offsite CNA deposits in wetland UNT Simpson Creek (WL-22) (39° 15.378' X 80° 09.827') that originated from the site as a result of a lack of waterbars and improperly installed BMPs.

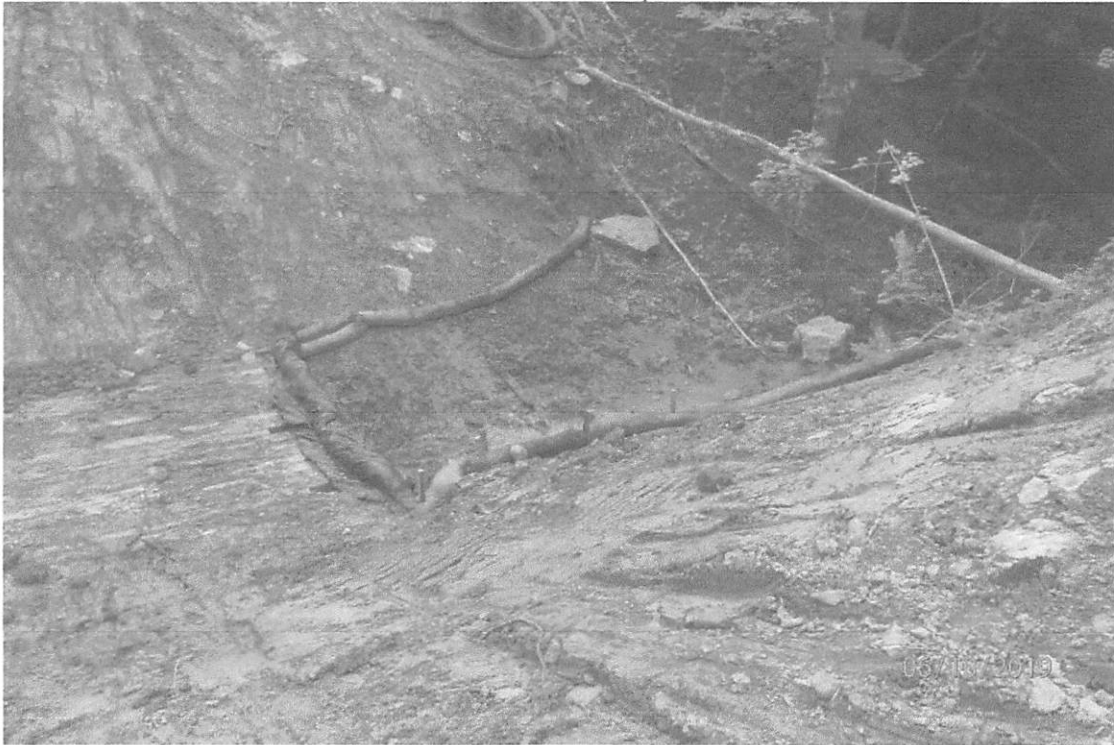
Improperly installed perimeter control at the UNT 26 crossing. The approved SWPPP indicates that silt saver 2 will be installed, but 8-inch compost filter sock was in place.

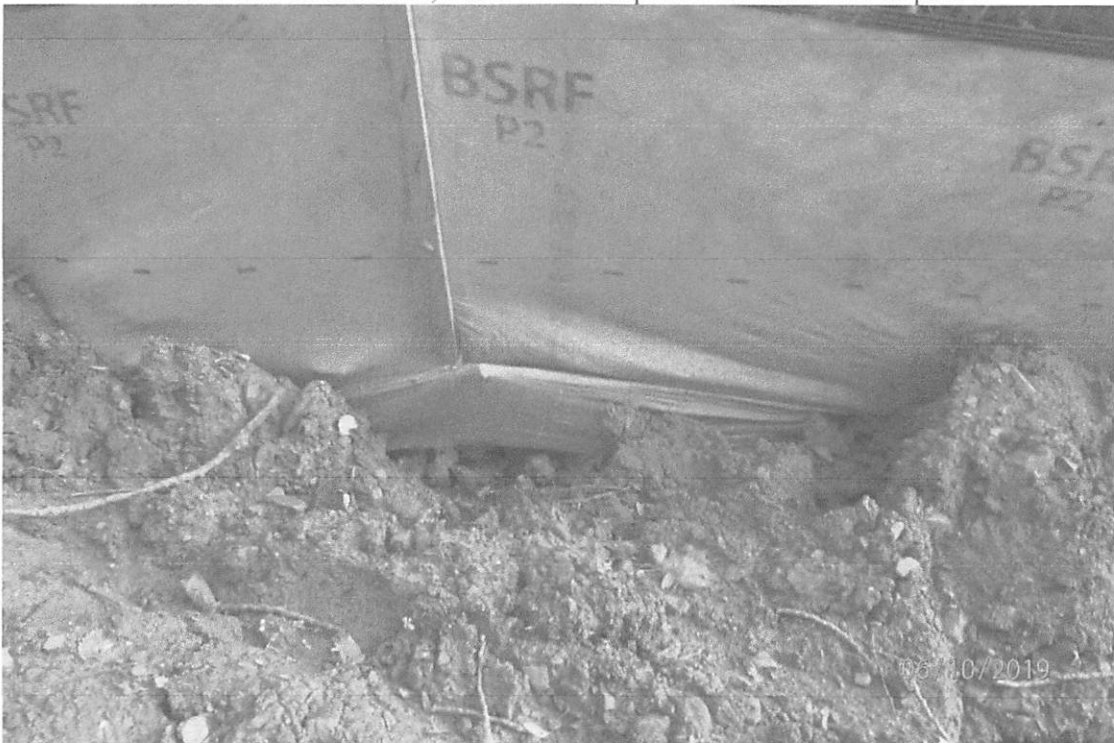
Improperly installed perimeter control on access road 9 showing an area where sediment laden water can bypass treatment under the BMP.

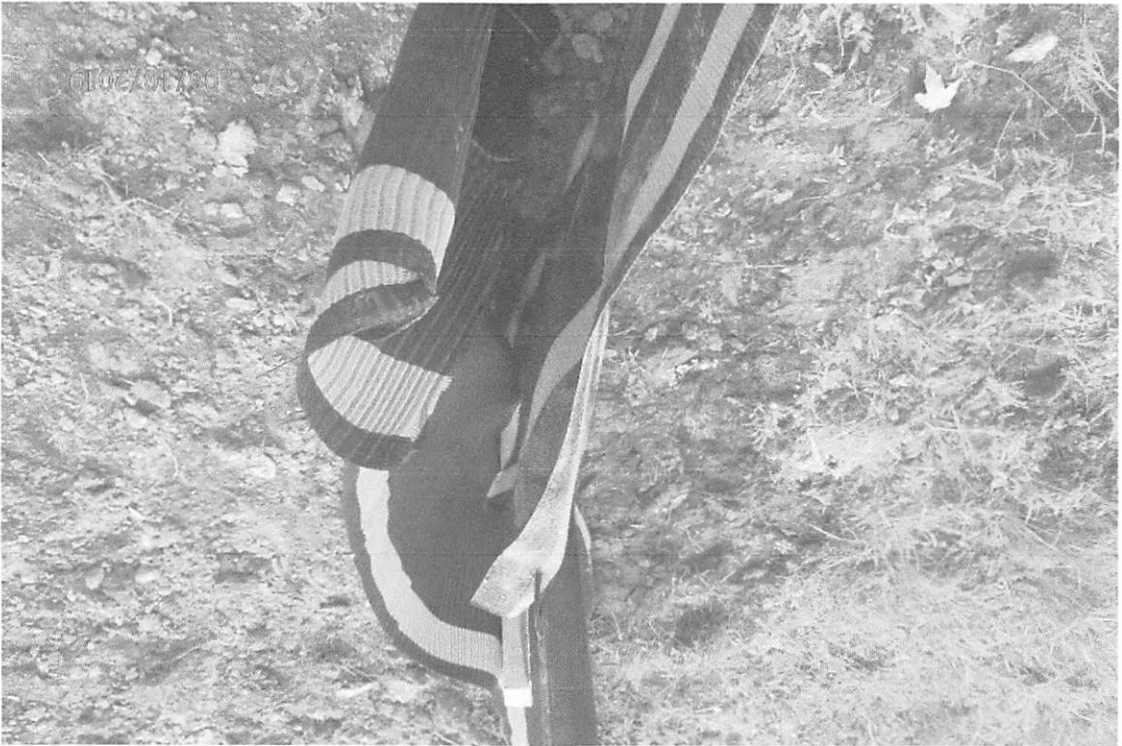
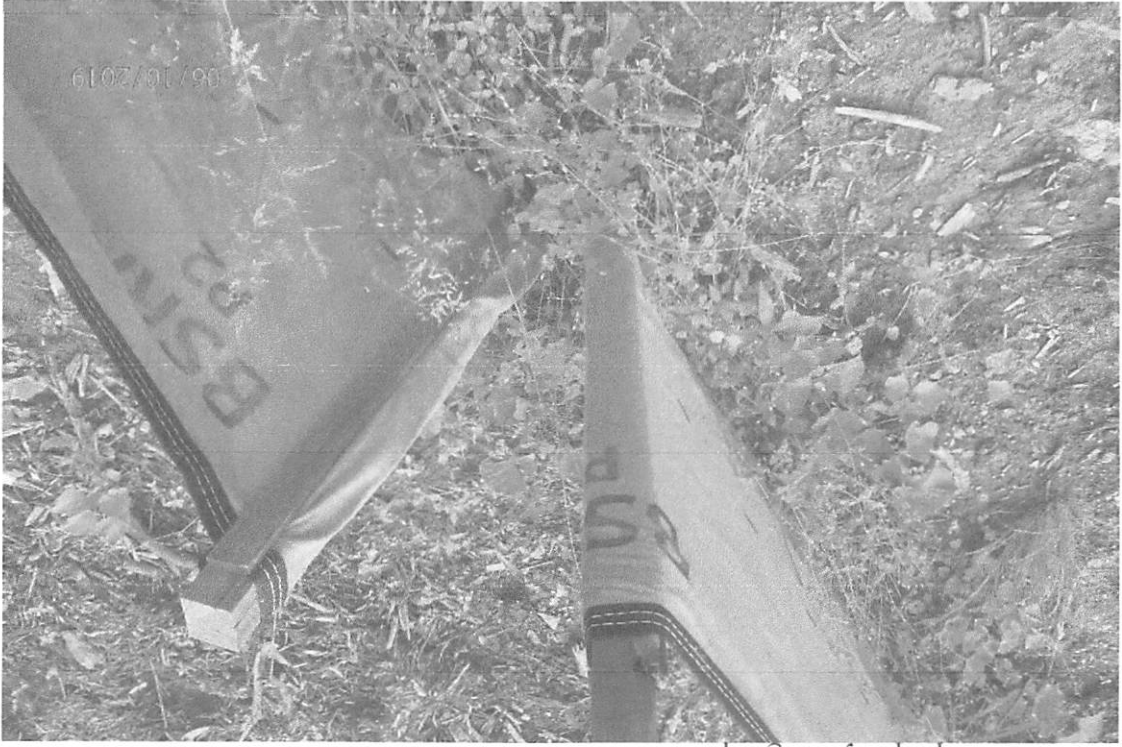
Improperly merged perimeter control in the Simpson Creek watershed.

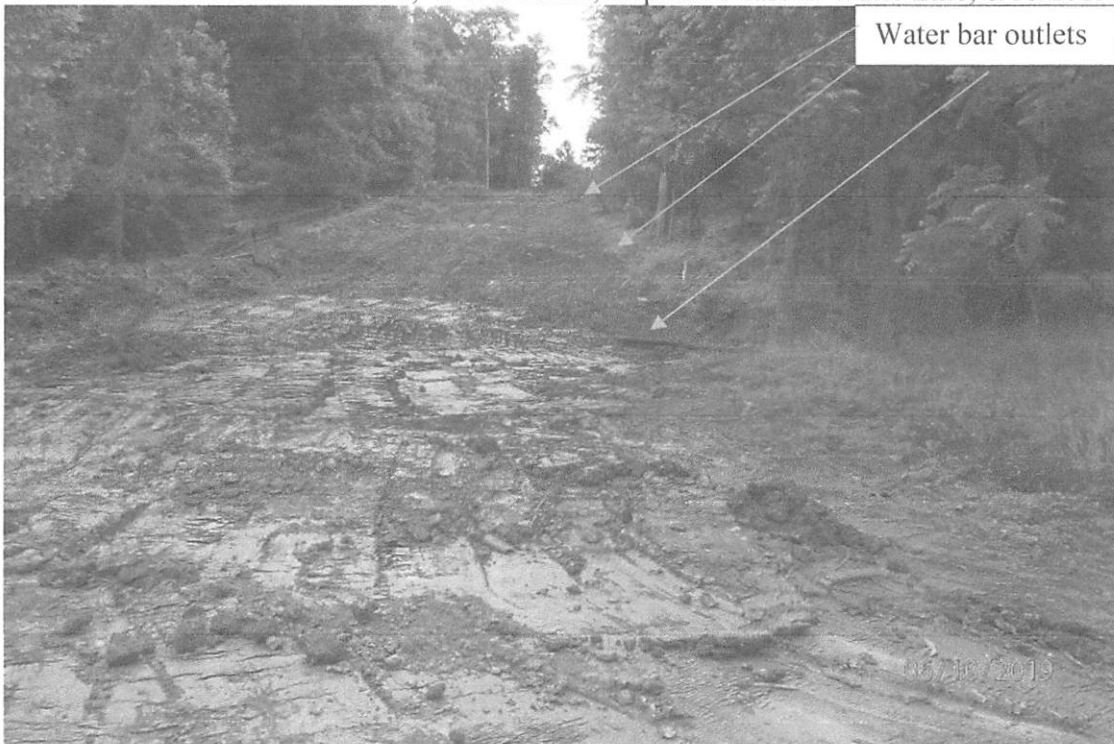
Improperly installed waterbars in the Beards Run watershed showing waterbar outlets that do not have positive drainage and allow water to flow back onto the right-of-way.

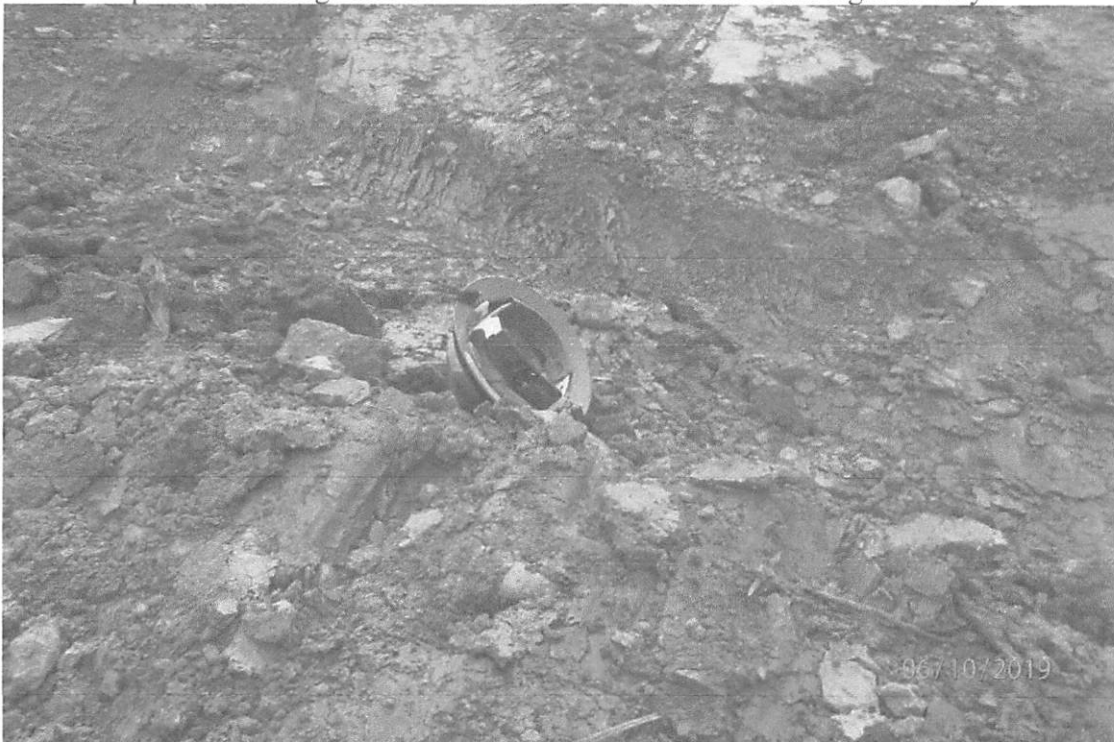
Improperly installed waterbar in the Beards Run watershed that is less than 12 inches high on the uphill side.

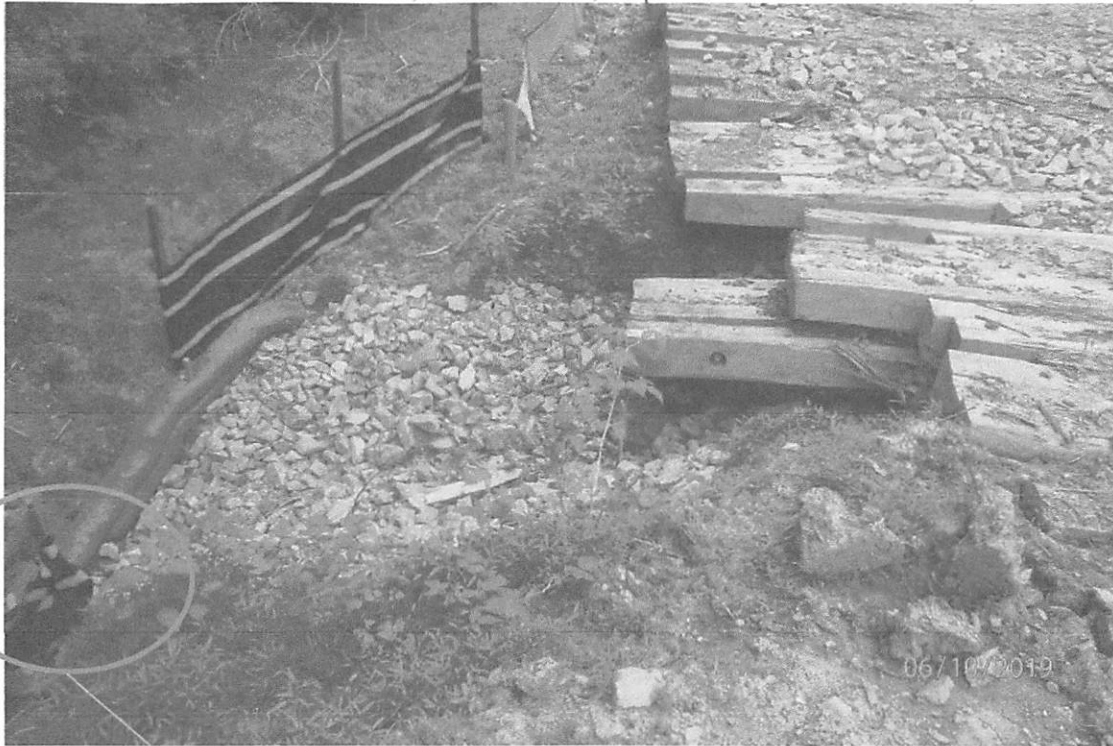
Improperly installed perimeter control adjacent to 374+00 (WL-17-B) showing the BMP placed on a large stone which allows sediment laden water to bypass treatment.

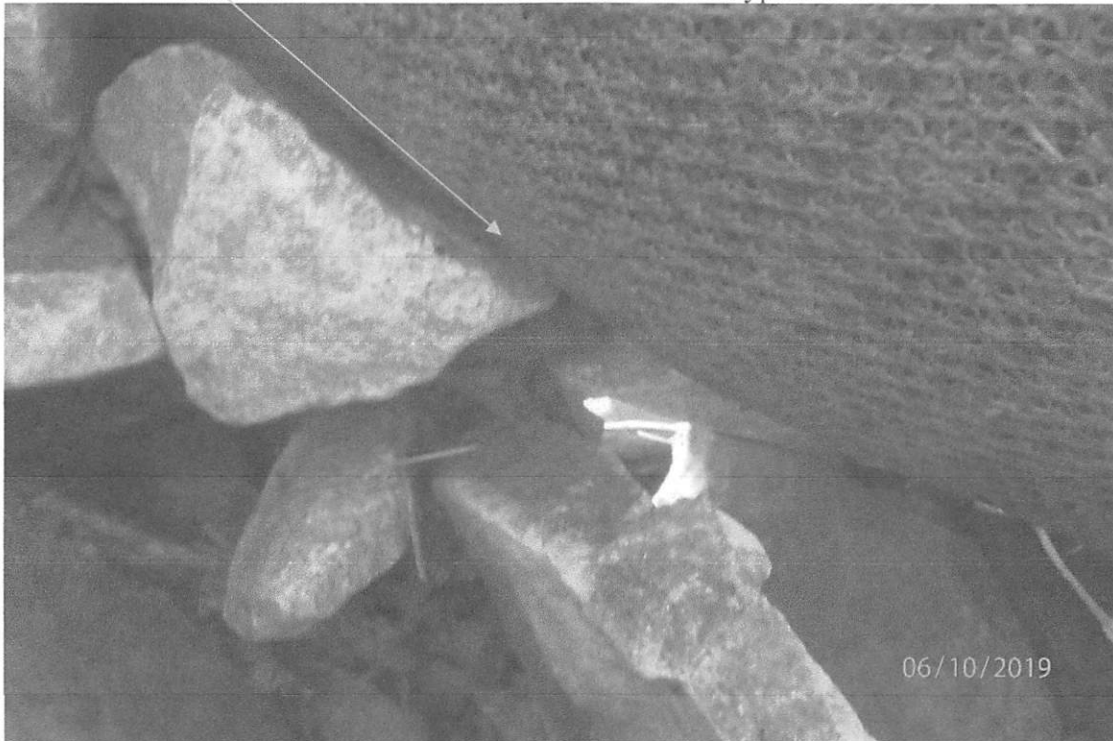
Improperly installed perimeter control adjacent to 374+00 (WL-17-B) showing the BMP placed on a large stone which allows sediment laden water to bypass treatment.

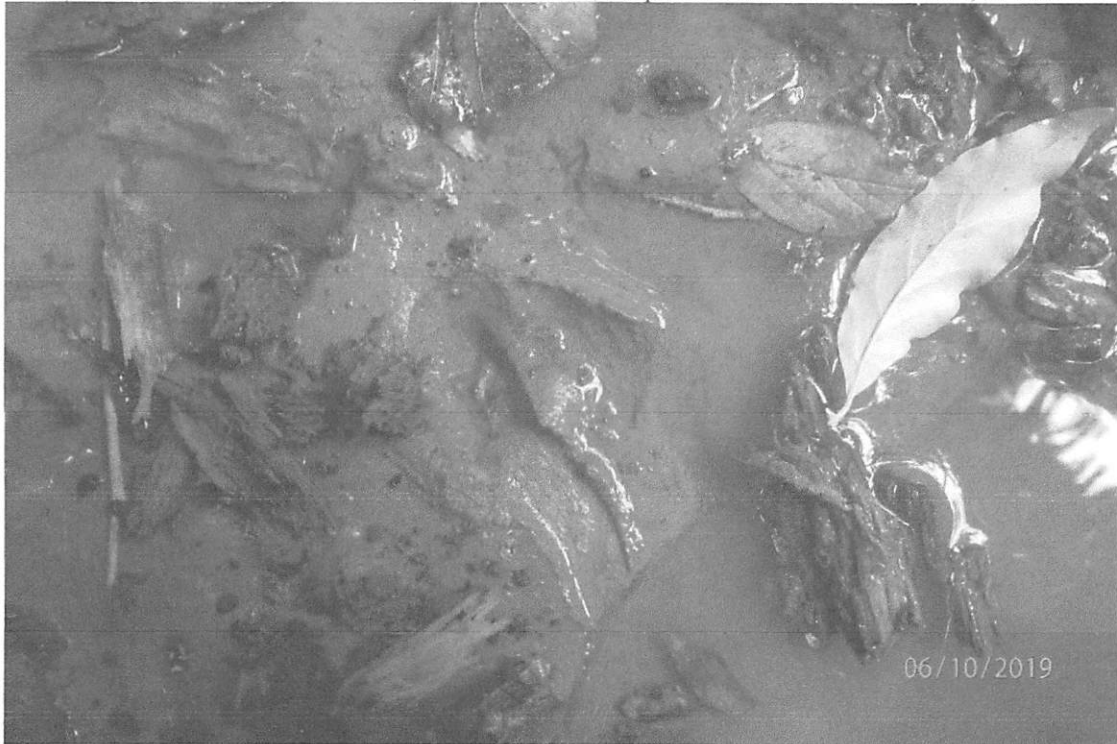
Offsite CNA deposits in UNT Simpson Creek (39° 14.883' X 80° 08.877') that originate from the previously pictured improperly installed perimeter control.

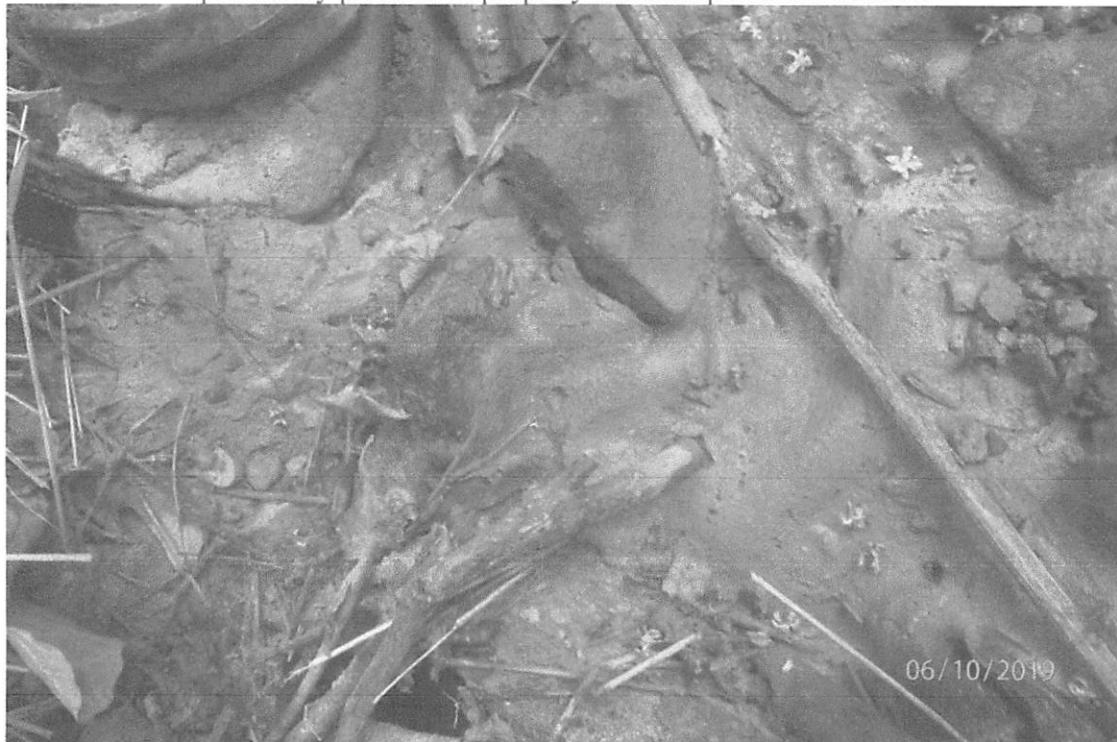
Offsite CNA deposits in UNT Simpson Creek (39° 14.883' X 80° 08.877') that originate from the previously pictured improperly installed perimeter control.

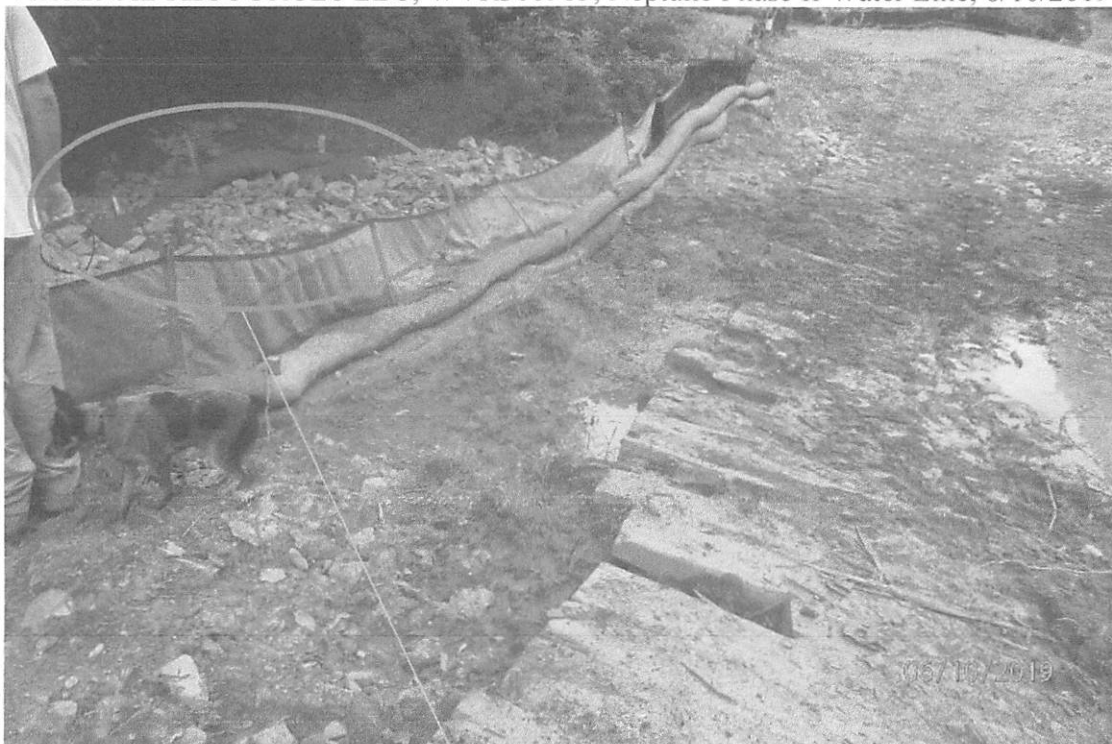
Project area adjacent to 365+00 (WL-14) showing a perimeter control with evidence of being overtopped and the need to modify the approved SWPPP.

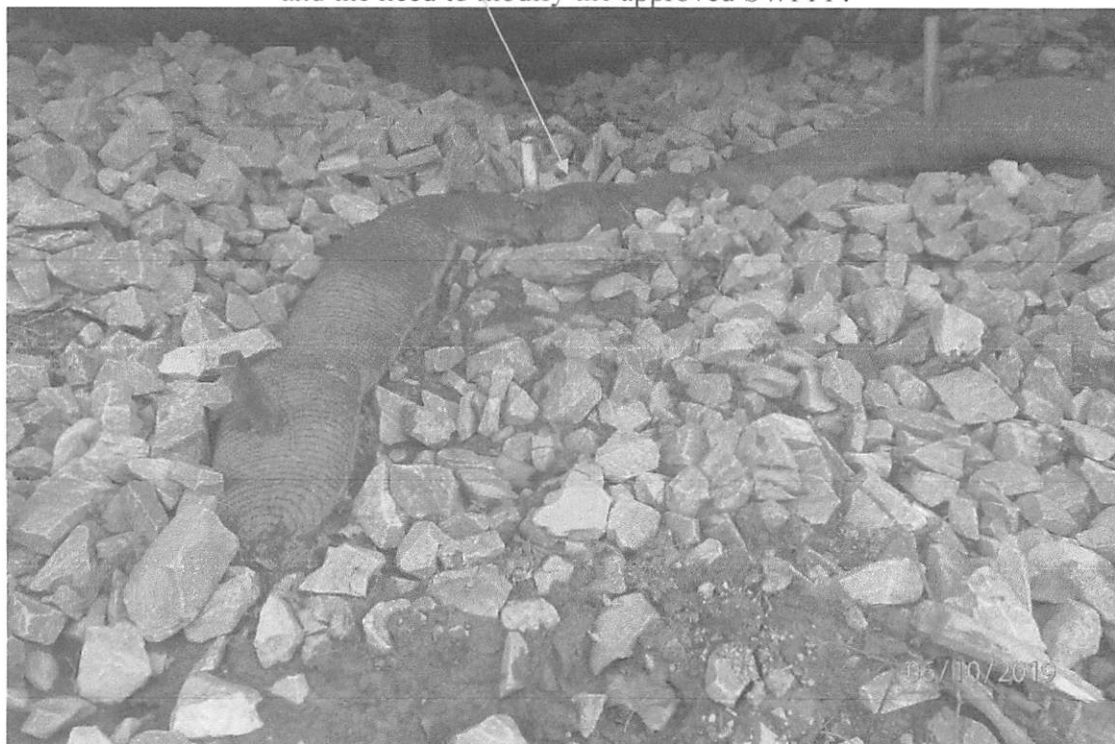
Improperly installed secondary compost filter sock BMP that was placed on large stone and allowed sediment laden water to bypass under the device. BMP and stone are placed off-site and in-stream at UNT Simpson Creek.

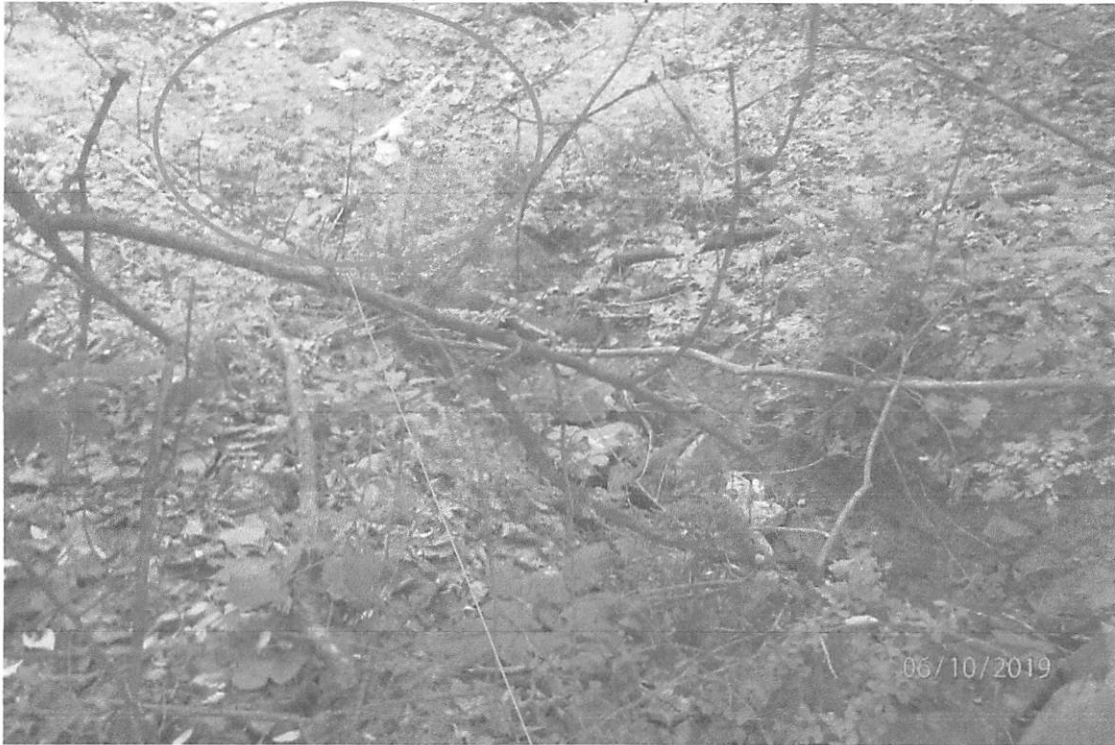
Offsite CNA deposits in UNT Simpson Creek ( $39^{\circ} 14.951'$  X  $80^{\circ} 08.701'$ ) as a result of the previously pictured deficiency.

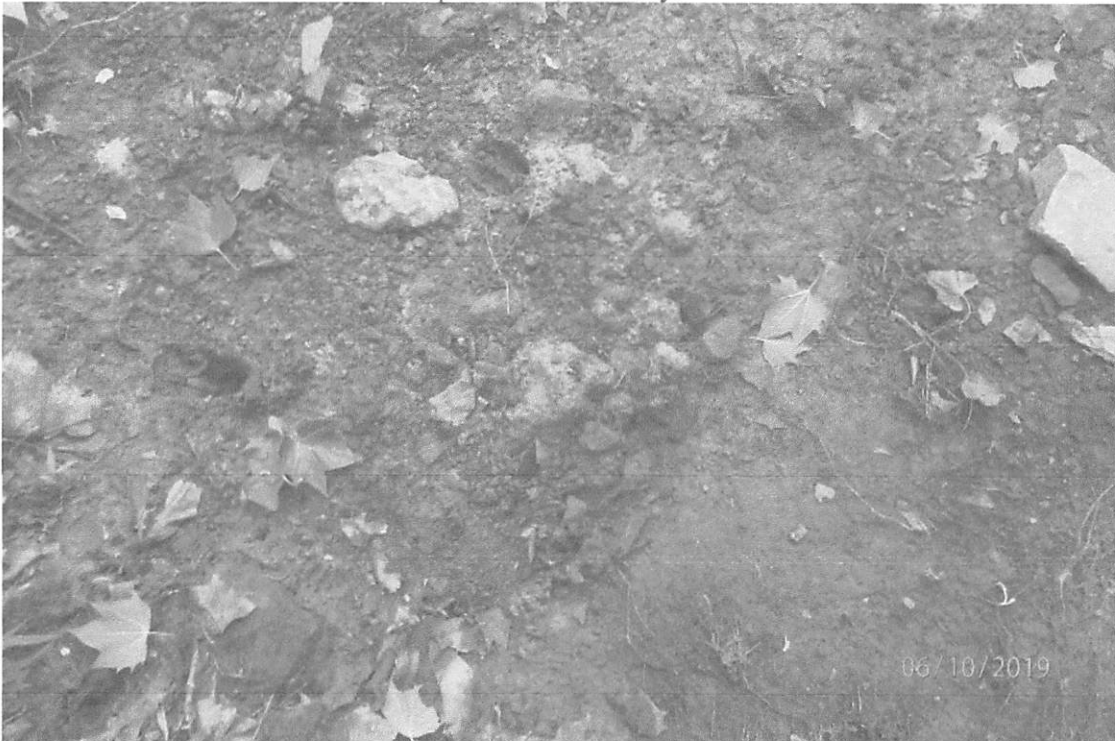
Offsite CNA deposits in UNT Simpson Creek ( $39^{\circ} 14.951'$  X  $80^{\circ} 08.701'$ ) as a result of the previously pictured deficiency.

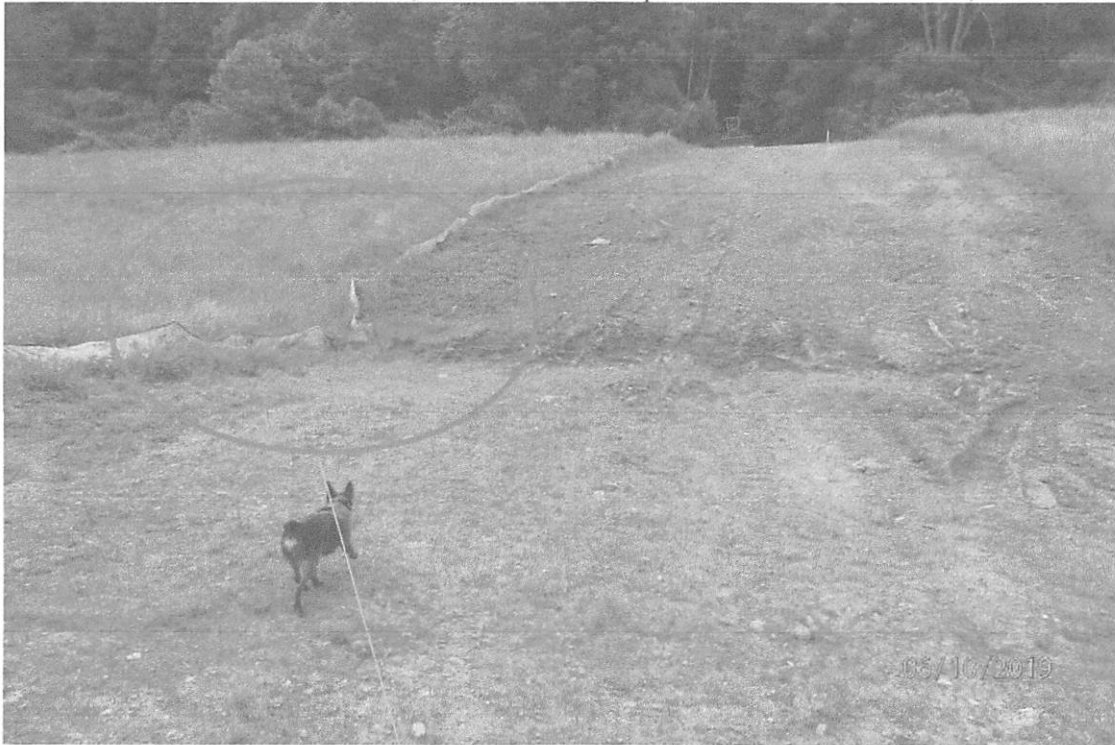
Project area adjacent to 400+50 (WL-18) showing where run-on stormwater is overwhelming the installed BMPs.

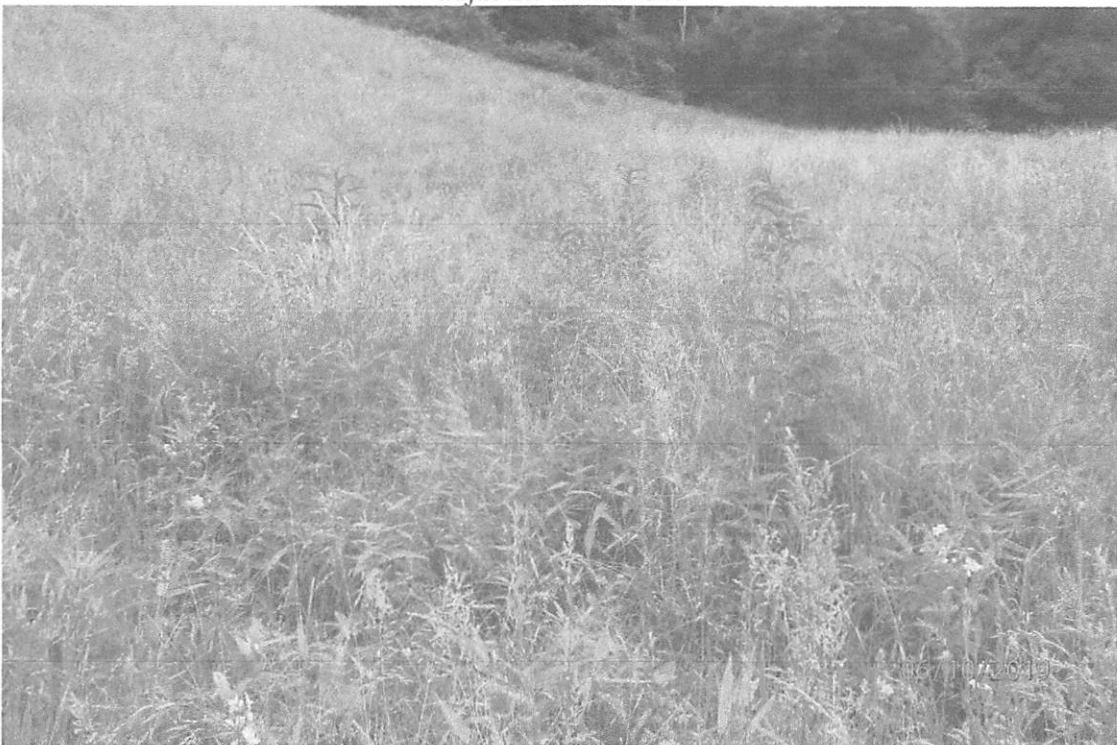
Project area upslope of 400+50 showing the stream condition and the drainage area that is producing run-on stormwater for the project.
