**CONSENT ORDER  
ISSUED UNDER THE  
WATER POLLUTION CONTROL ACT  
WEST VIRGINIA CODE, CHAPTER 22, ARTICLE 11**

TO: Arsenal Resources LLC  
6031 Wallace Rd. Ext Suite 300  
Wexford PA 15090

DATE: October 8, 2020

ORDER NO.: 9923

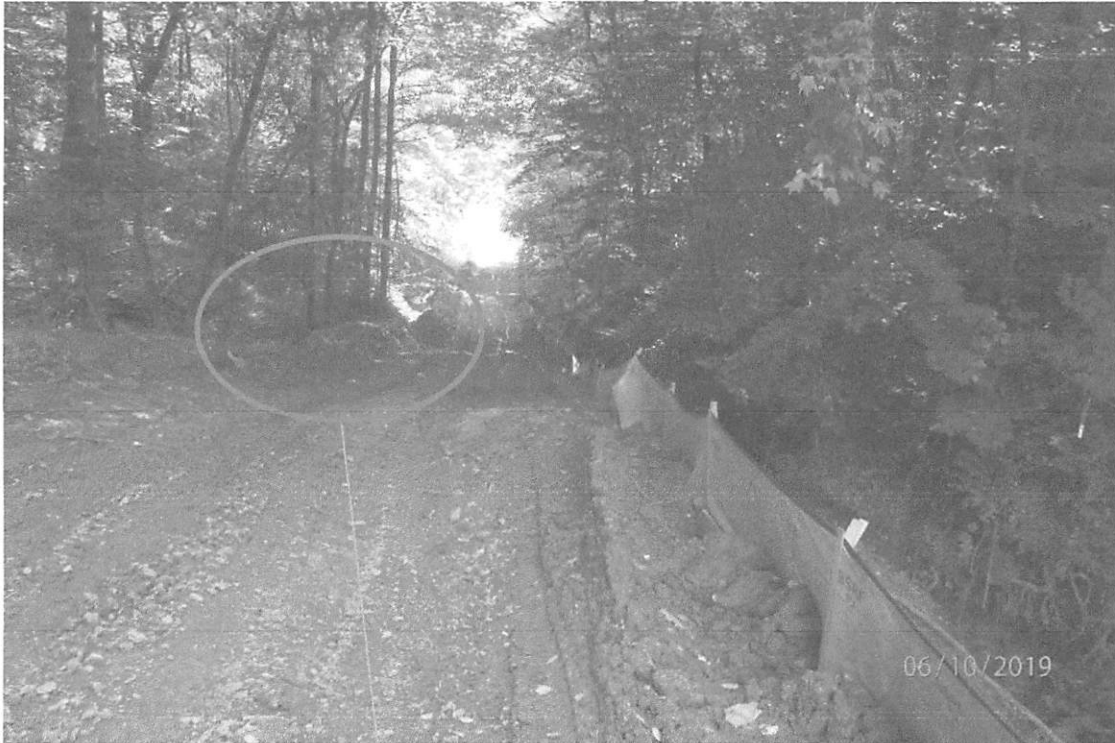
Access Road 7 showing the lack of a stabilized surface as indicated in the approved SWPPP. Area on the left lacking the perimeter controls indicated in the approved SWPPP.

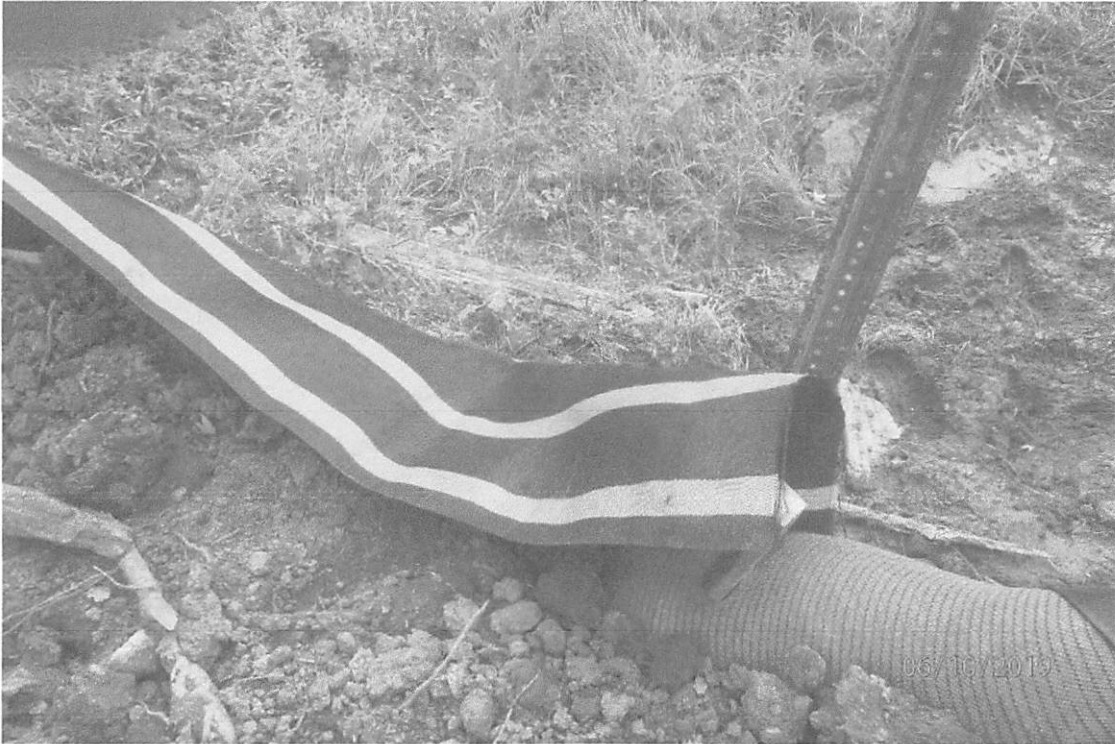
Improperly merged perimeter control and temporary bridge BMP at the UNT 23 crossing.

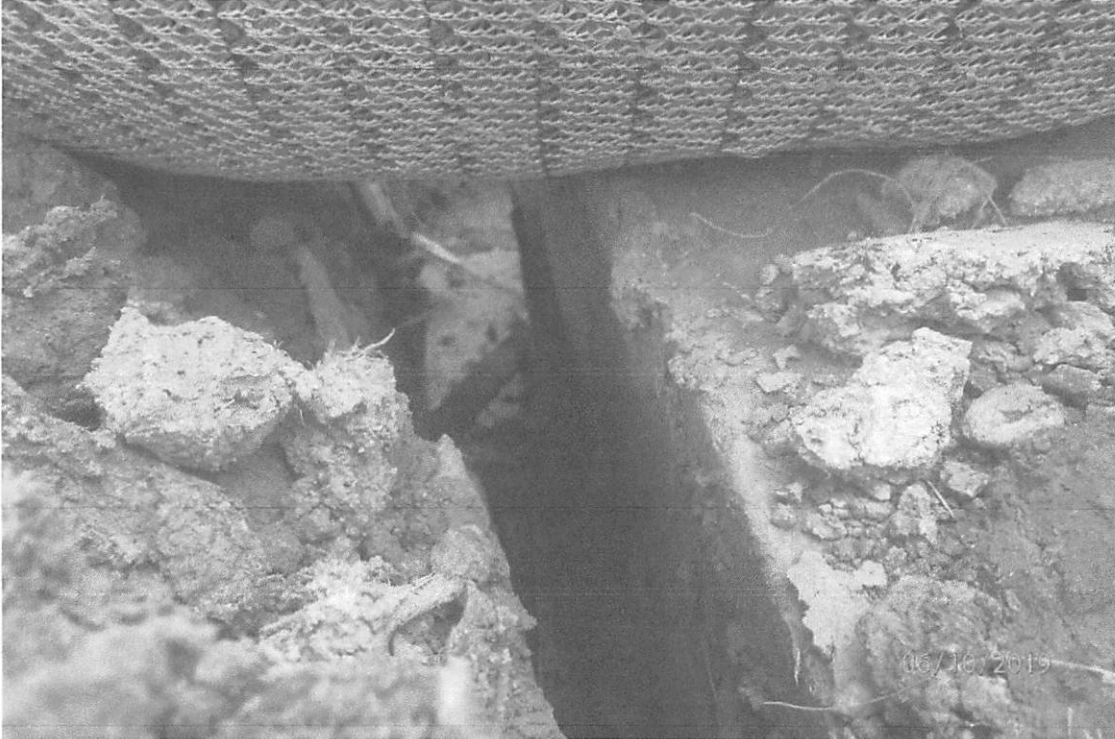
Improperly installed temporary bridge BMP at the UNT 23 crossing.

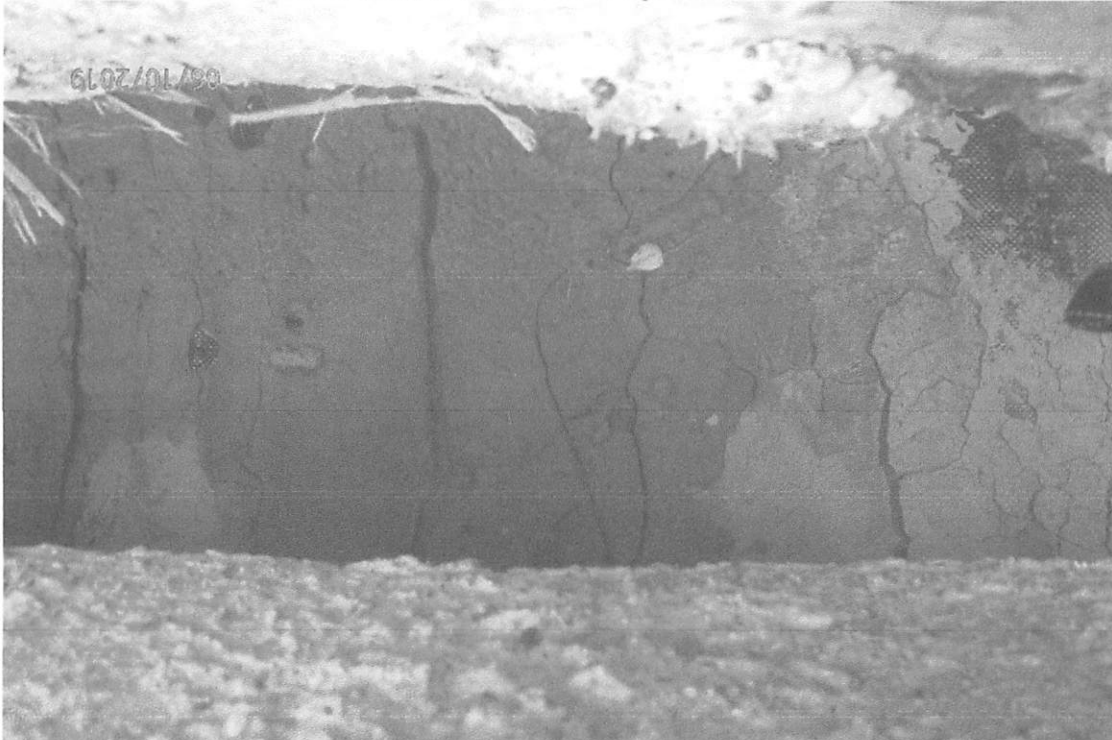
Temporary bridge BMP at the WL – 19 crossing showing the installed geotextile fabric sagging due to the lack of a second timber mat layer to hold the fabric in place.

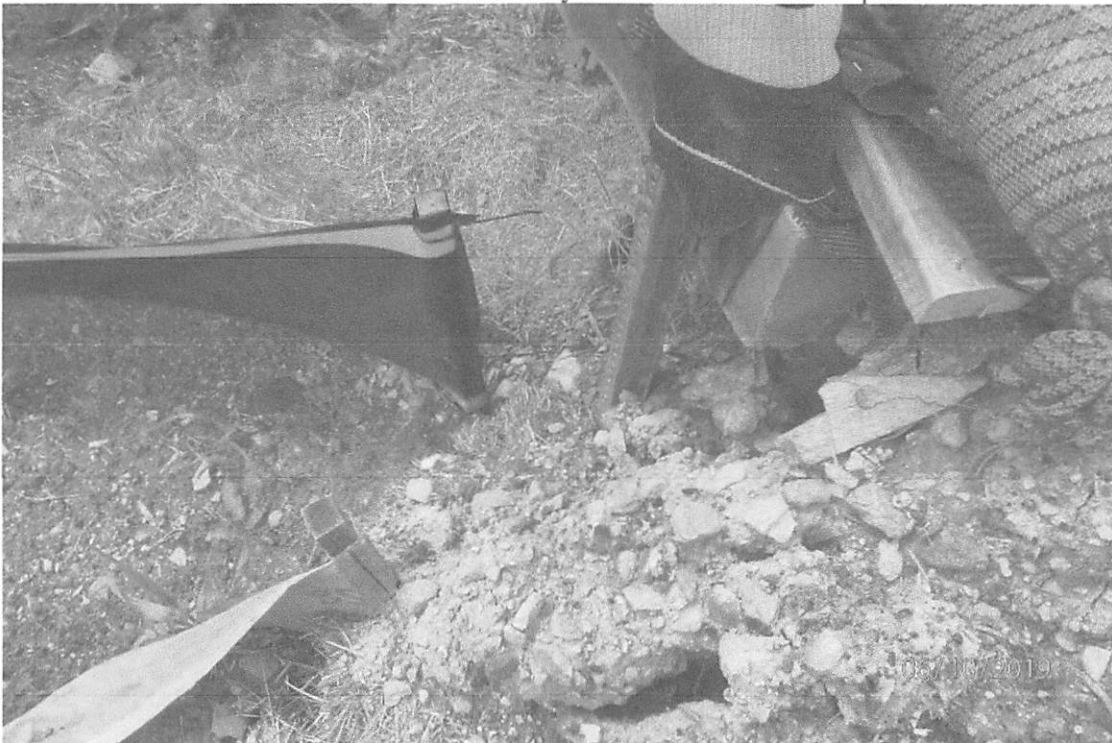
Improperly merged perimeter control and temporary bridge BMP at the UNT 22 crossing.

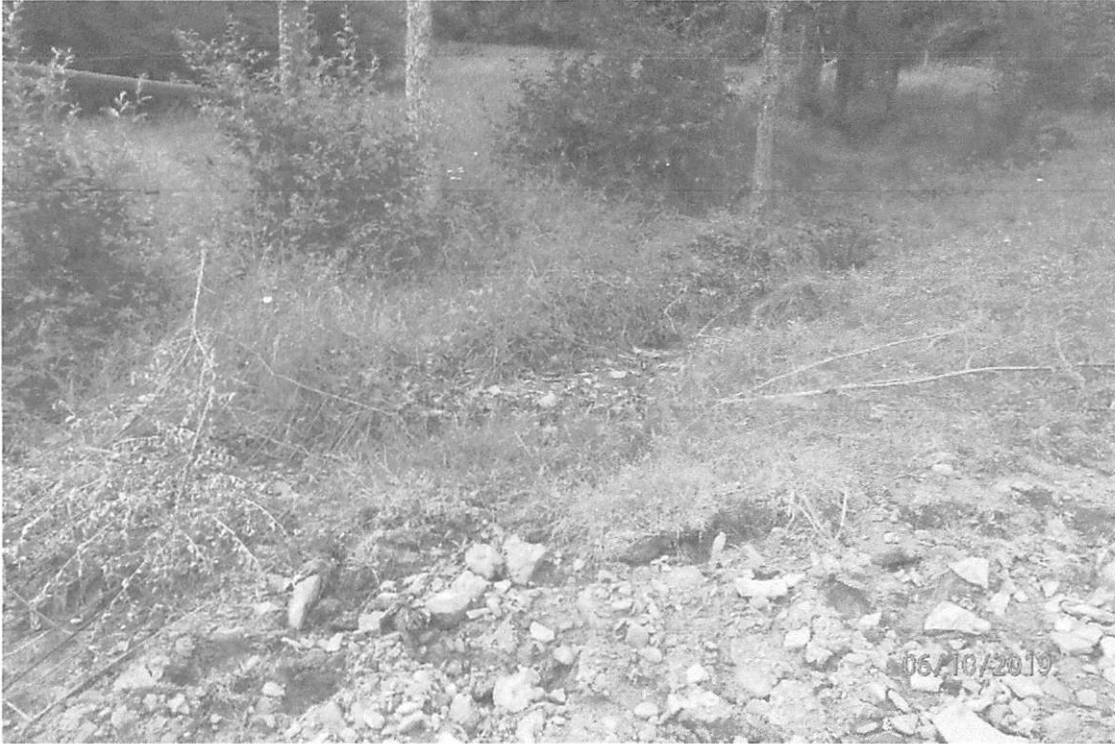
Run-on ephemeral UNT Beards Run adjacent to 482+85 showing the need to modify the approved SWPPP and install additional BMPs to adequately treat stormwater from this area of the project. The approved SWPPP does not indicate a stream in this area even though the stream channel is evident.

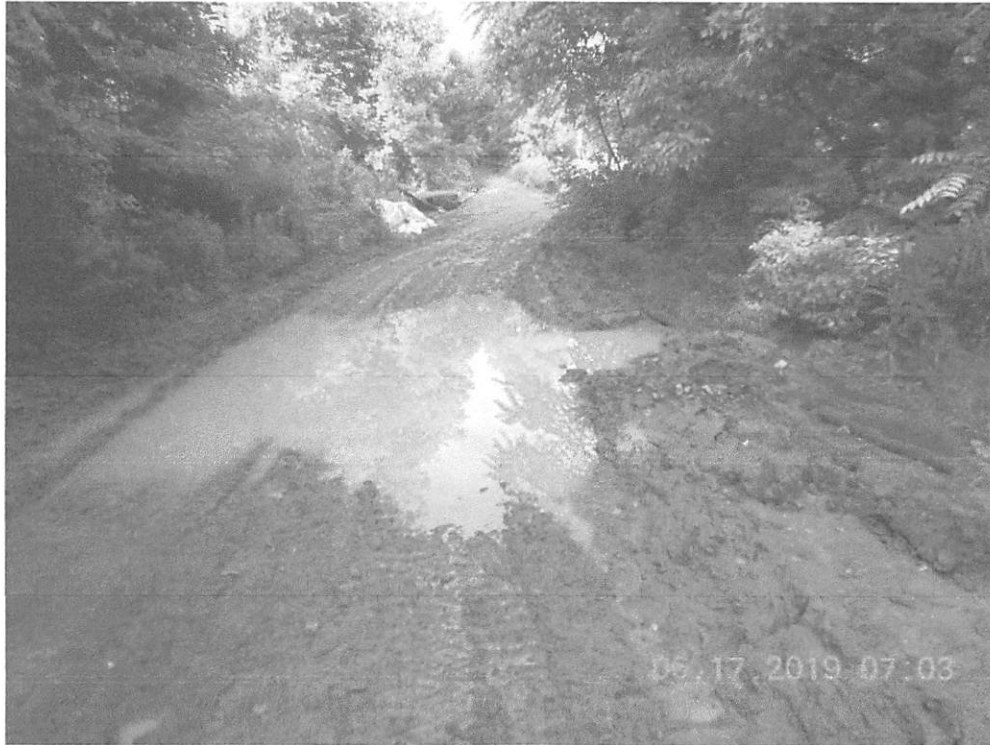
SWPPP indicates that all unpaved roads on the site shall be graveled or have other durable surface. AR 5 was not graveled and shows signs of significant wear.

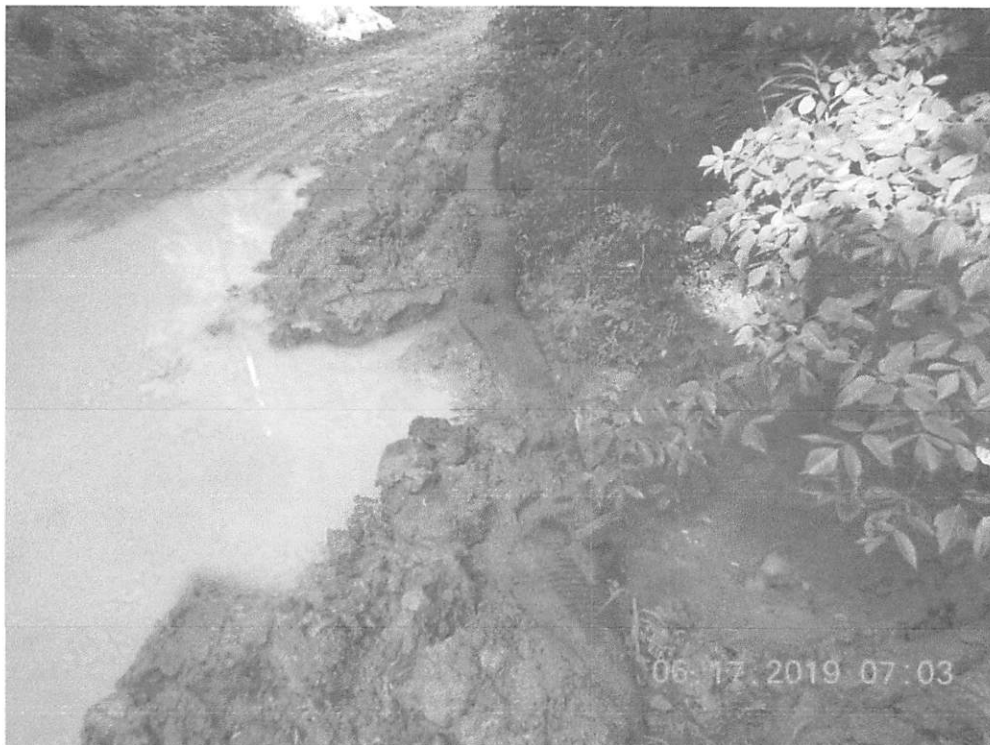
Perimeter controls consisted of inequivalent 8" CFS. The SWPPP indicates that SS2 be used along AR 5. Maintenance is not being performed on the controls to remove the buildup of sediment.

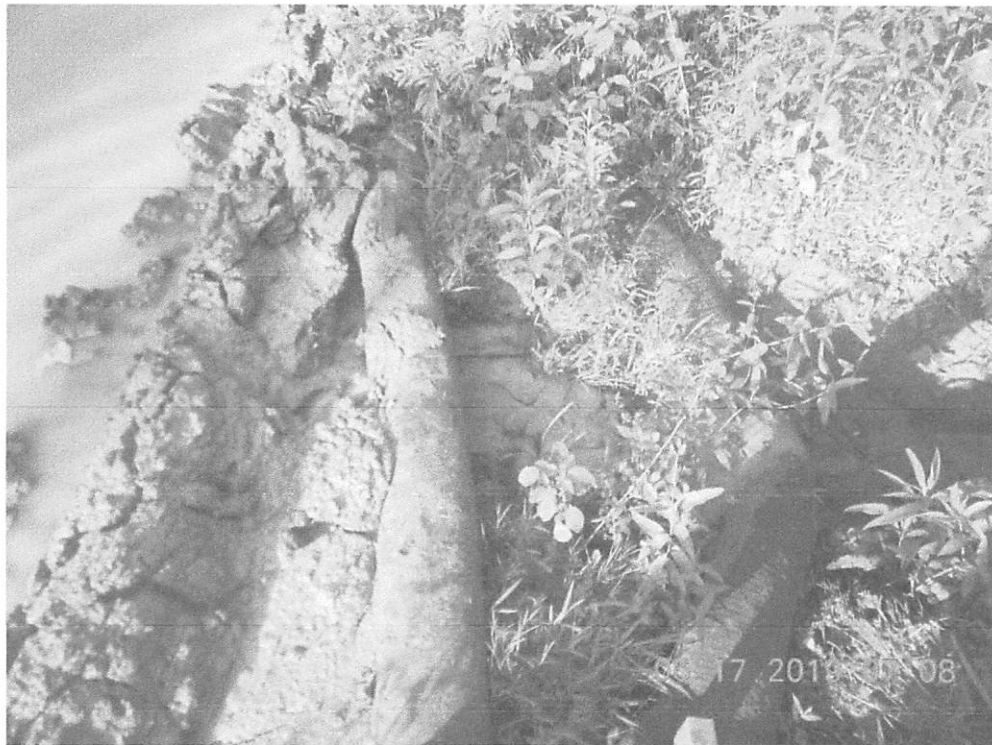
Sediment laden water entered the UNT of Simpson Creek at the mud hole that developed at the culvert where controls were not being maintained.

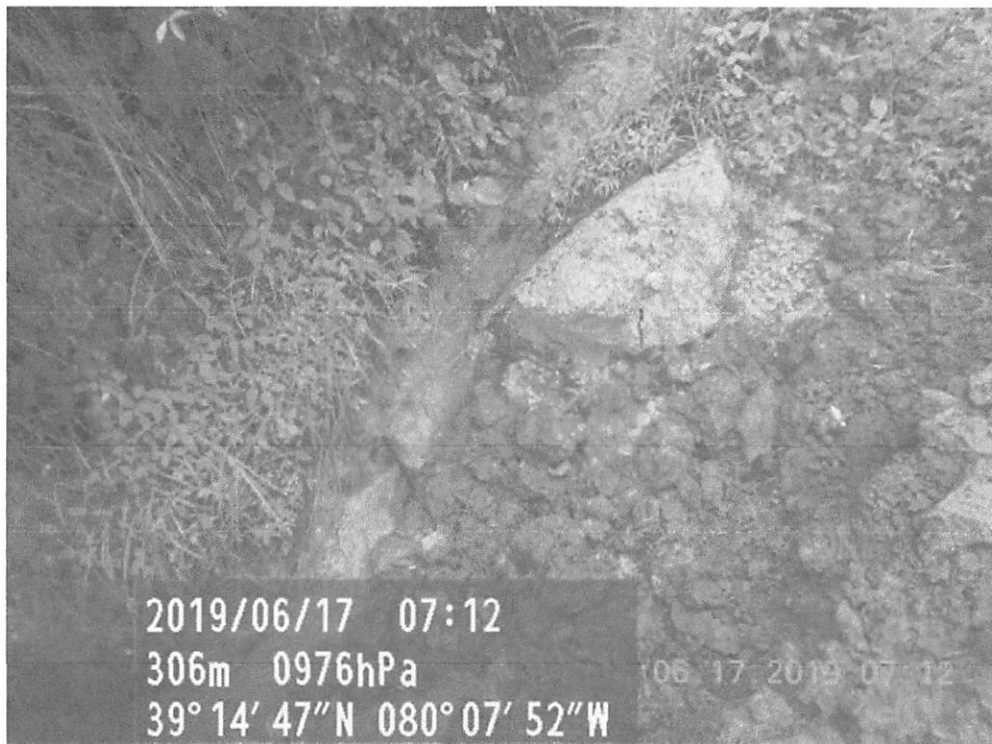
Conditions not allowable in the form of sediment deposits on the bottom of UNT of Simpson Creek (39°14'47"N, 80°07'52"W) resulting from roll-out off AR 5 in multiple locations.

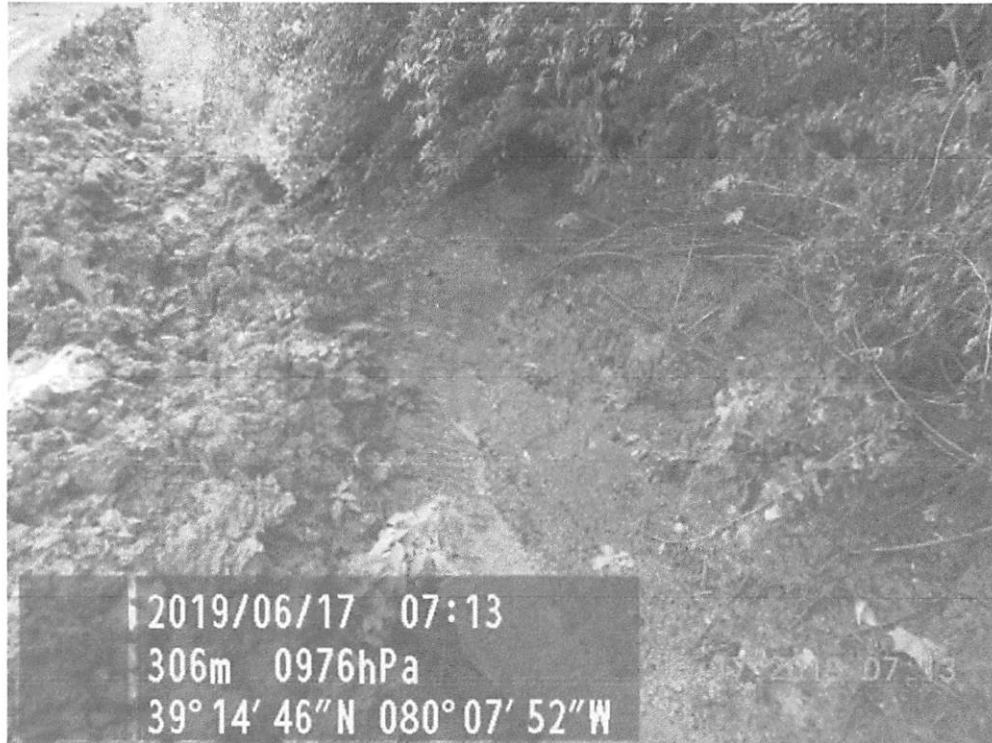
Conditions not allowable, in the form of sediment deposits, on the bottom of UNT of Simpson Creek, resulting from roll-out off of AR 5 in multiple locations.

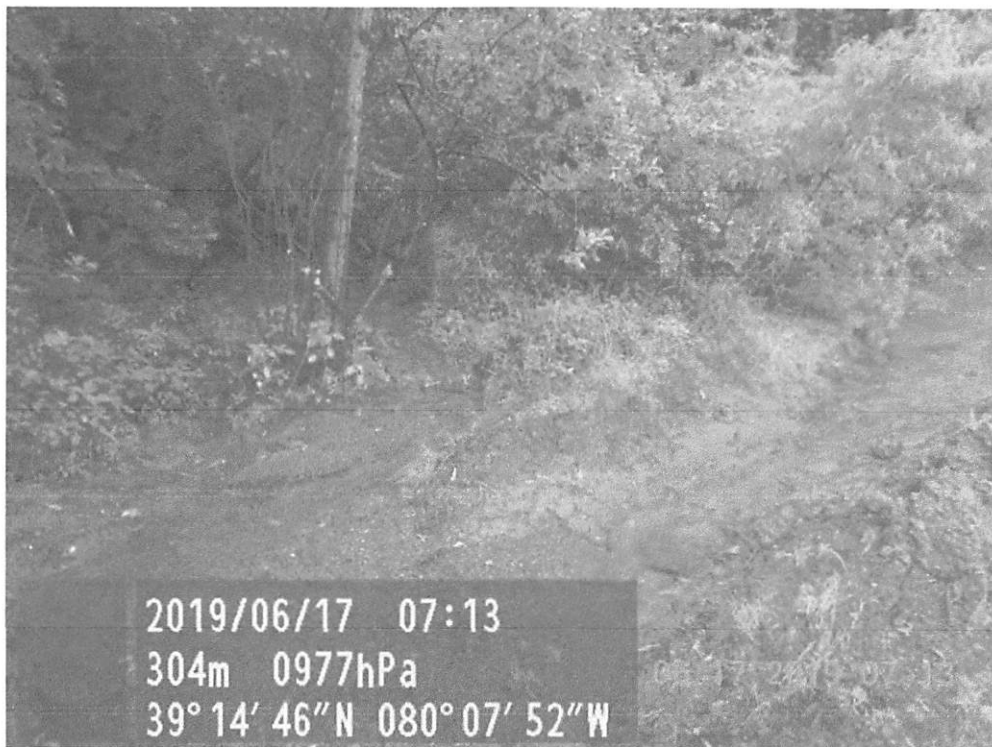
The UNT coming off the hillside runs along AR 5, is culverted under AR 5, and travels to Simpson Creek. Conditions not allowable, in the form of sediment deposits on the bottom of UNT of Simpson Creek, resulting from roll-out off AR 5 in multiple locations.

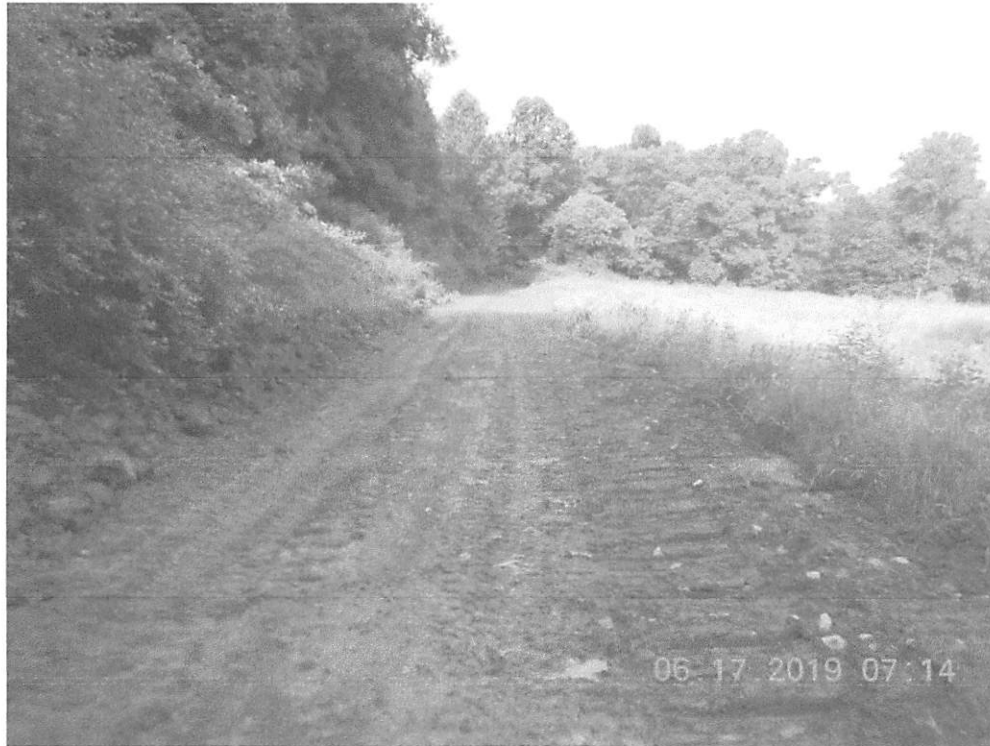
No controls were installed on this section of AR 5.

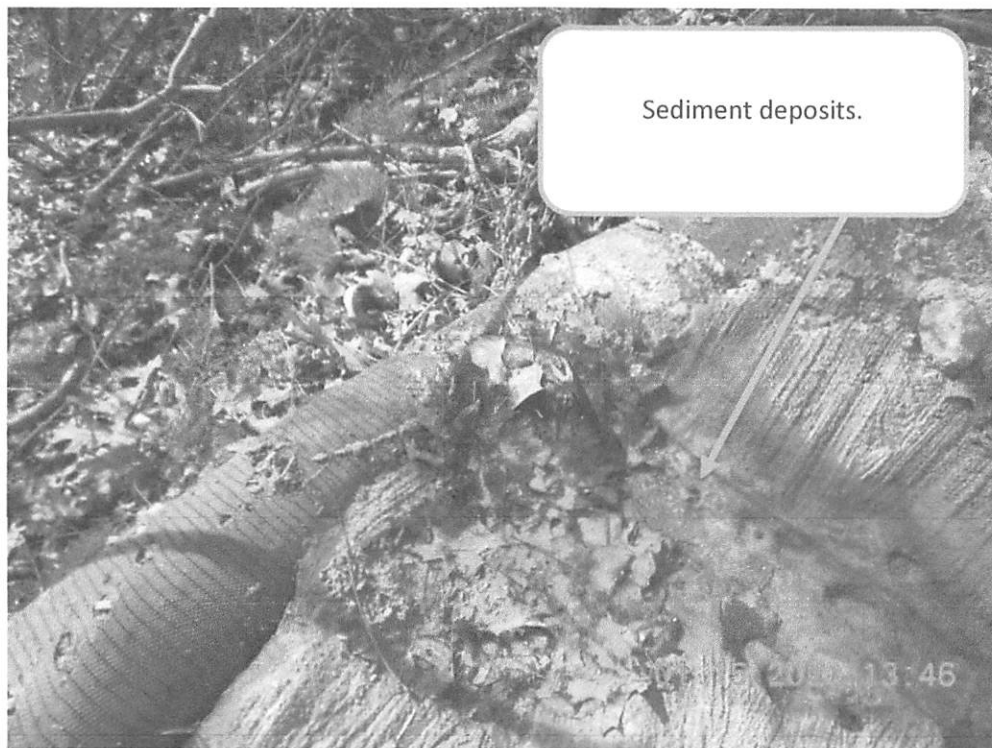
Concrete slurry outlet protection overtopped perimeter controls, allowing sediment laden water to leave site without going through an appropriate device.
