# Carswell Eroding Refuse AML Project

**Location:** Kimball, McDowell County, West Virginia

**Date Submitted:** 5/12/2008

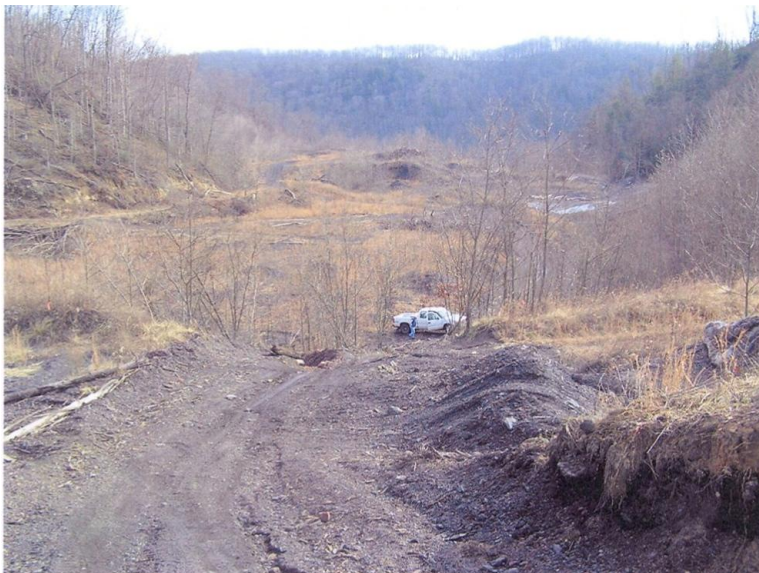
Photo #2

Coupled with the looming potential for catastrophic property damage along Laurel Branch, located nearby was another abandoned mine lands site, Site #2, which consisted of a 20-acre refuse pile. This pile had steep slopes and the easily erodable material was very unstable. Numerous homes as well as a public road located at the pile's toe were in danger of being flooded or destroyed by a landslide, should one develop. Local residents and abandoned mine lands officials alike were concerned that this site could also cause serious damage to downslope properties should these issues go unresolved.

This photo shows the abandoned, partially vegetated 20 acre refuse area with its highly erodable and unstable outcrops.

Field conditions at Site #2 also required special design considerations. Of greatest concern was establishing an adequate toe and subdrainage system for the re-graded 20 acre refuse area. These concerns would be satisfied by the installation of a large rock toe fill to serve as both a supporting buttress that would hold the material in place as well as provide drainage, along with a drainage blanket to collect subsurface water.

The unstable refuse at Site #2 was then graded to a 2:1 slope with drainage benches placed at 50 feet intervals. A total 191,000 cubic yards of refuse were excavated in the process and a rock toe fill consisted of 6,450 cubic yards of sandstone shot rock. Also, a drainage blanket 40 feet wide, 4 feet thick, and 510 feet long was placed to collect subsurface water.
