**CONSENT ORDER
ISSUED UNDER THE
WATER POLLUTION CONTROL ACT
WEST VIRGINIA CODE CHAPTER 22, ARTICLE 11**

TO: CD DG Wallace, LLC
ATTN: Josh Allen
9461 Kenwood Road
Cincinnati, OH 45242

DATE: April 23, 2024

ORDER NO.: 10227

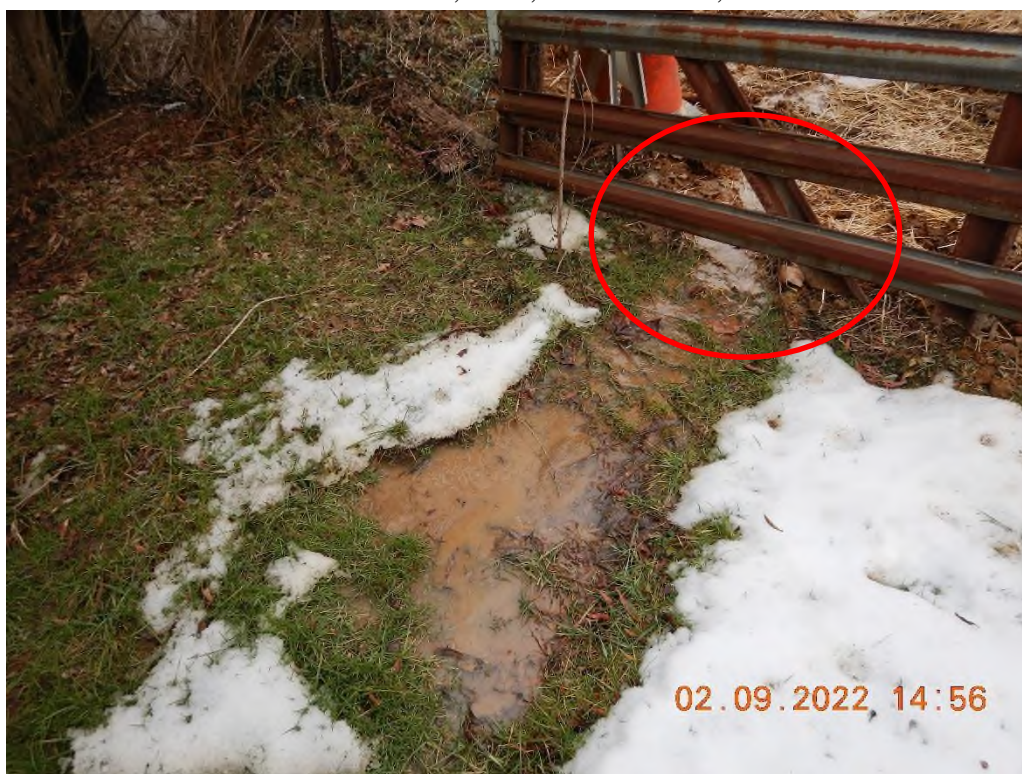
Sediment laden water that has left the site.

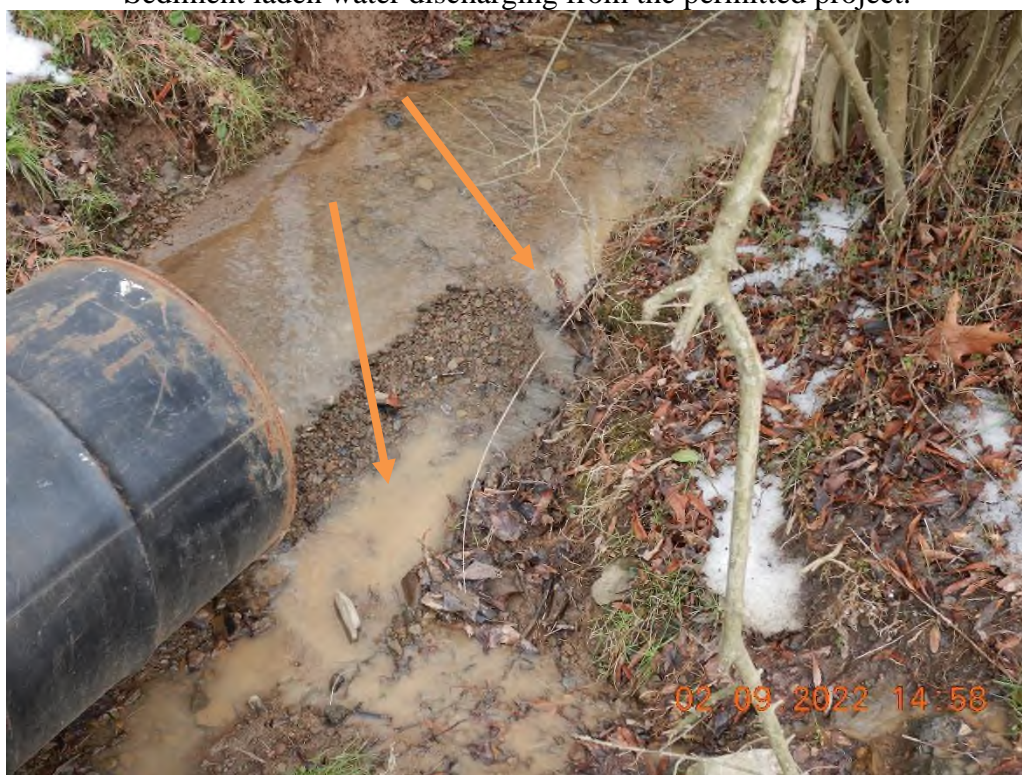
Sediment laden water discharging from the permitted project.

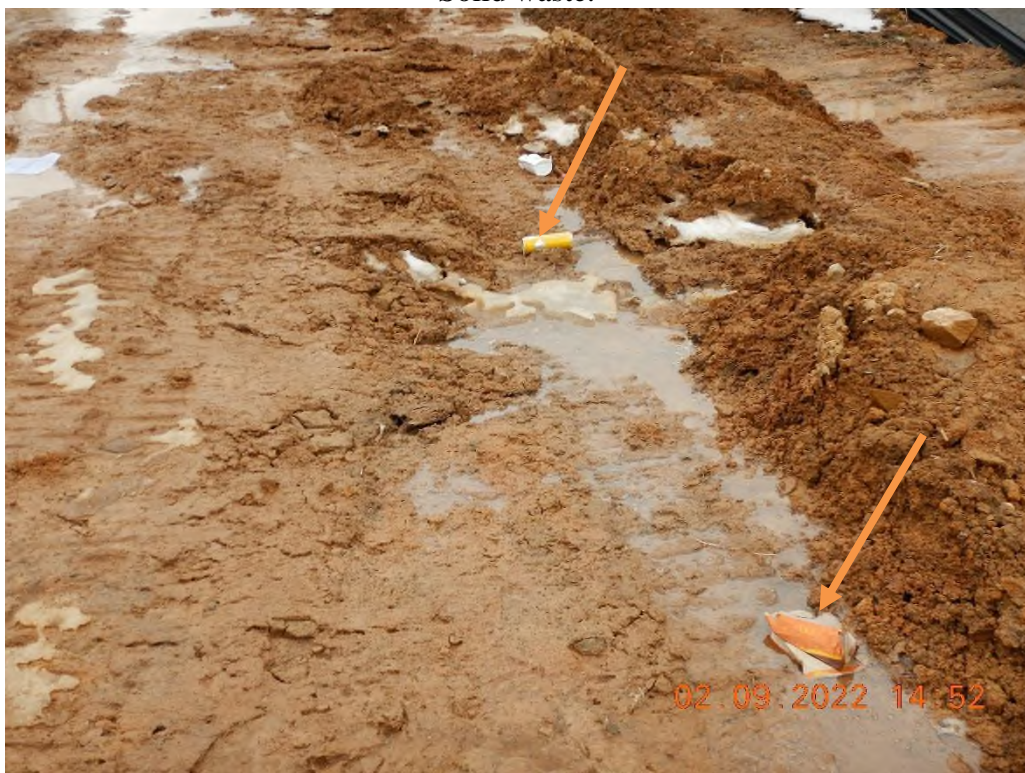
Solid waste.

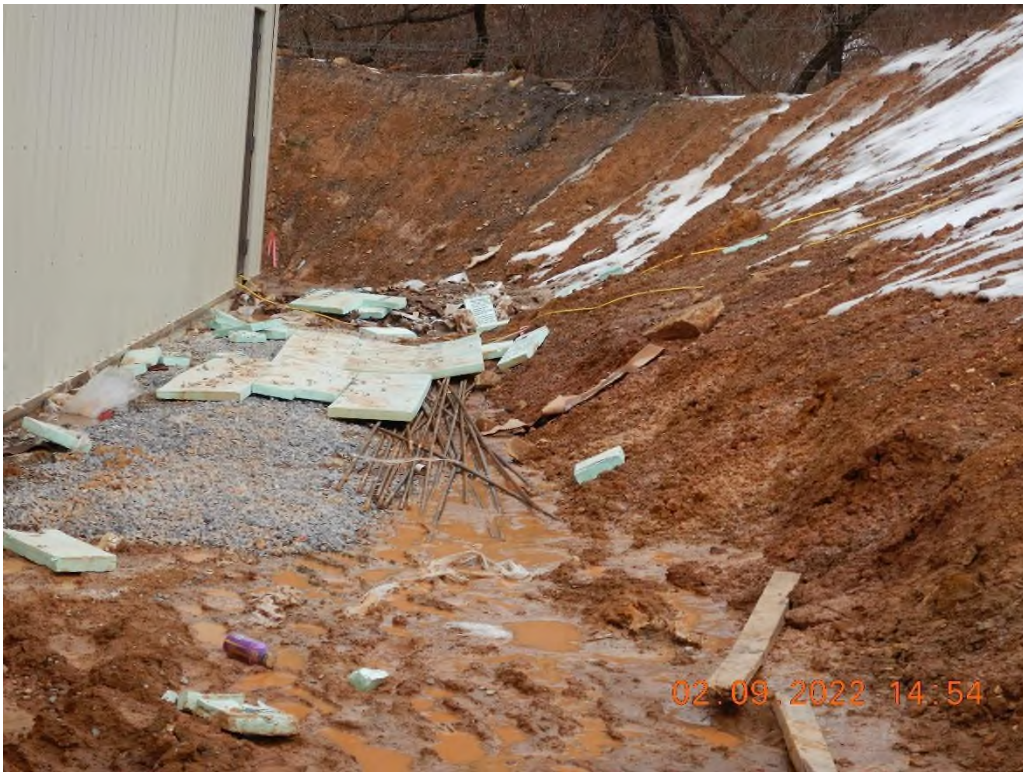
Solid waste.

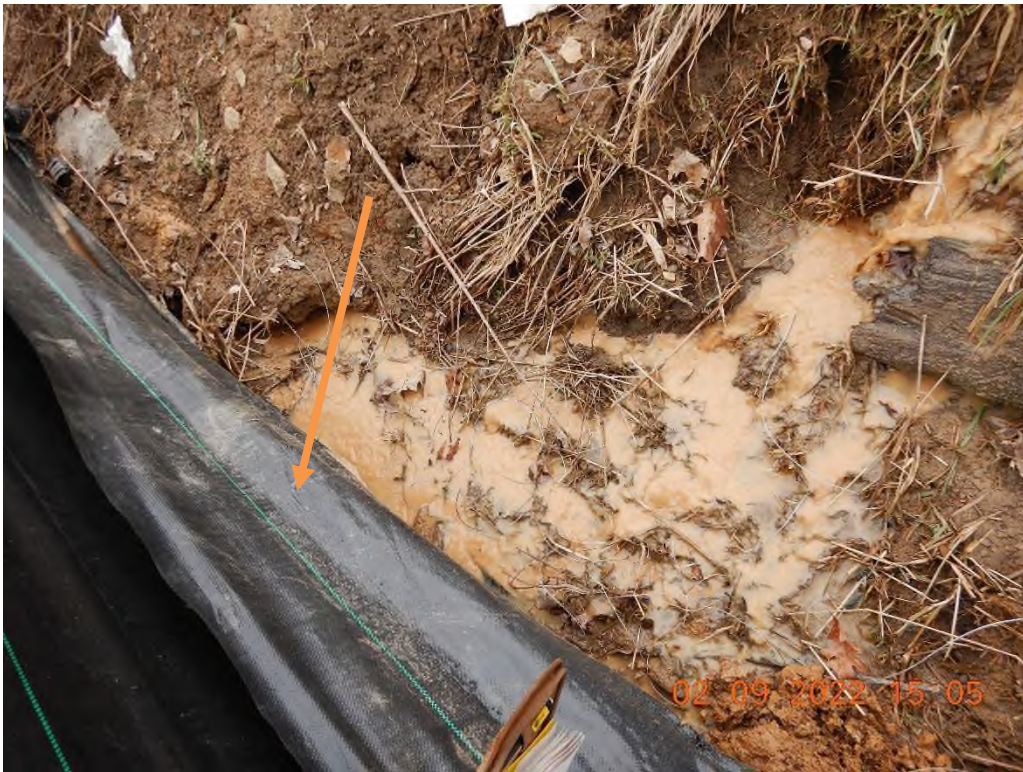
Area where Sediment Trap 2 should have been installed.

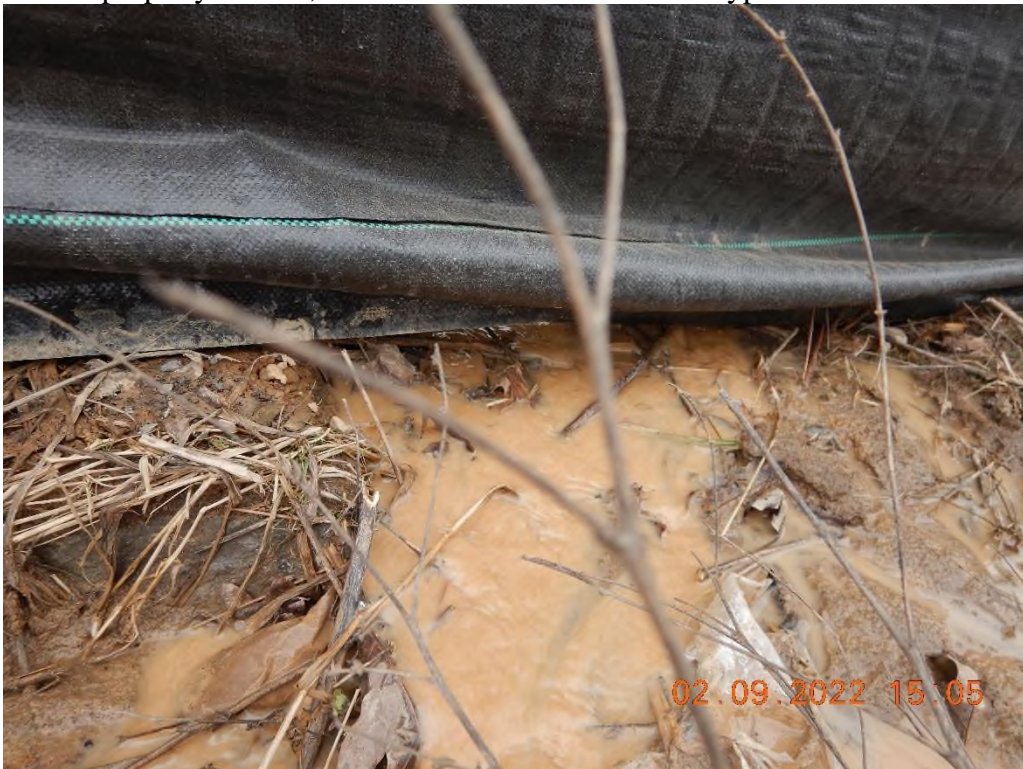
Silt fence was not properly toed-in, and sediment laden water can bypass treatment and leave the site.

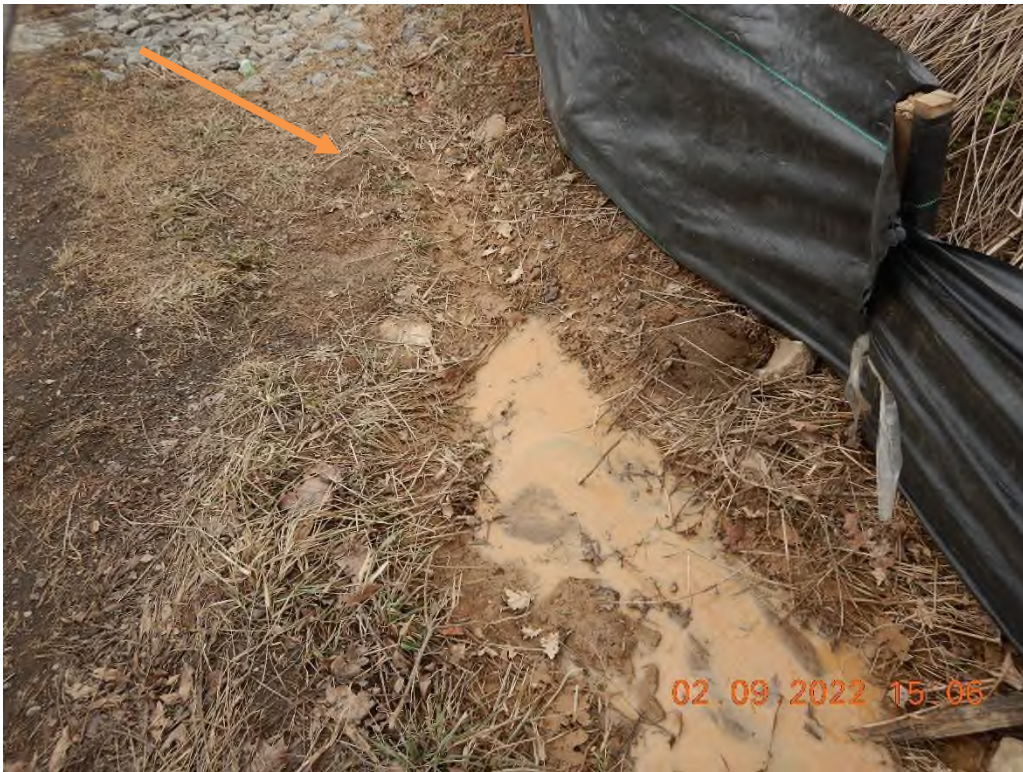
Sediment laden water bypassing improperly installed silt fence and leaving the site.

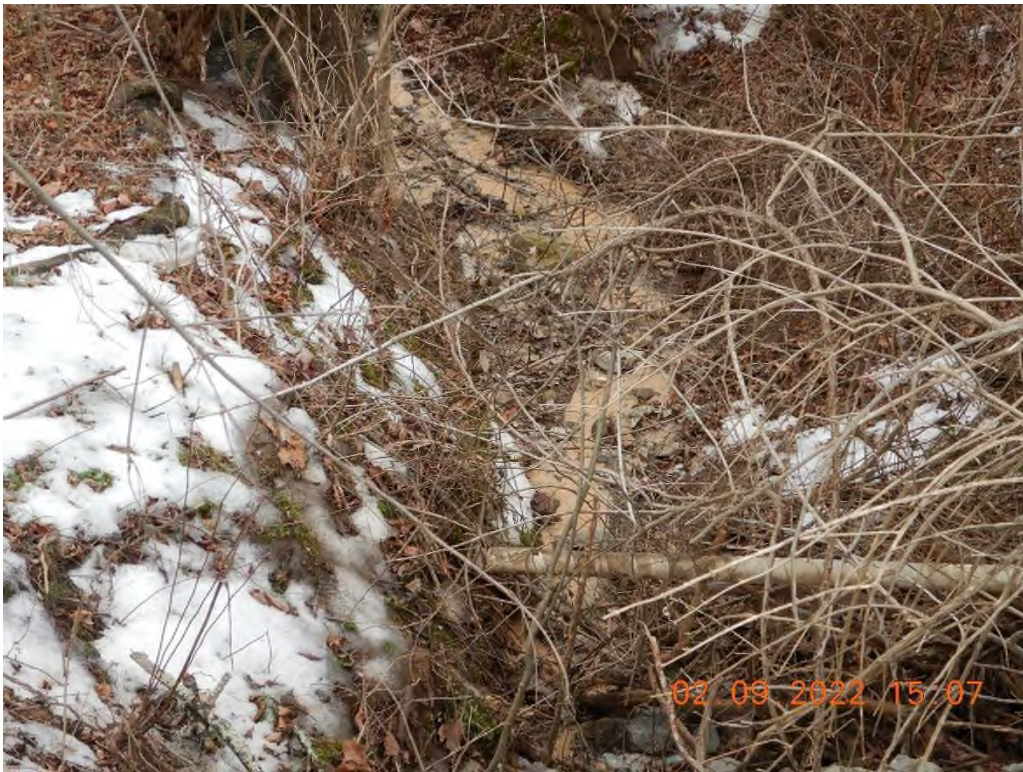
Sediment laden water discharging through the underdrain and leaving the site via culvert. There is no protection for the existing drop inlet.

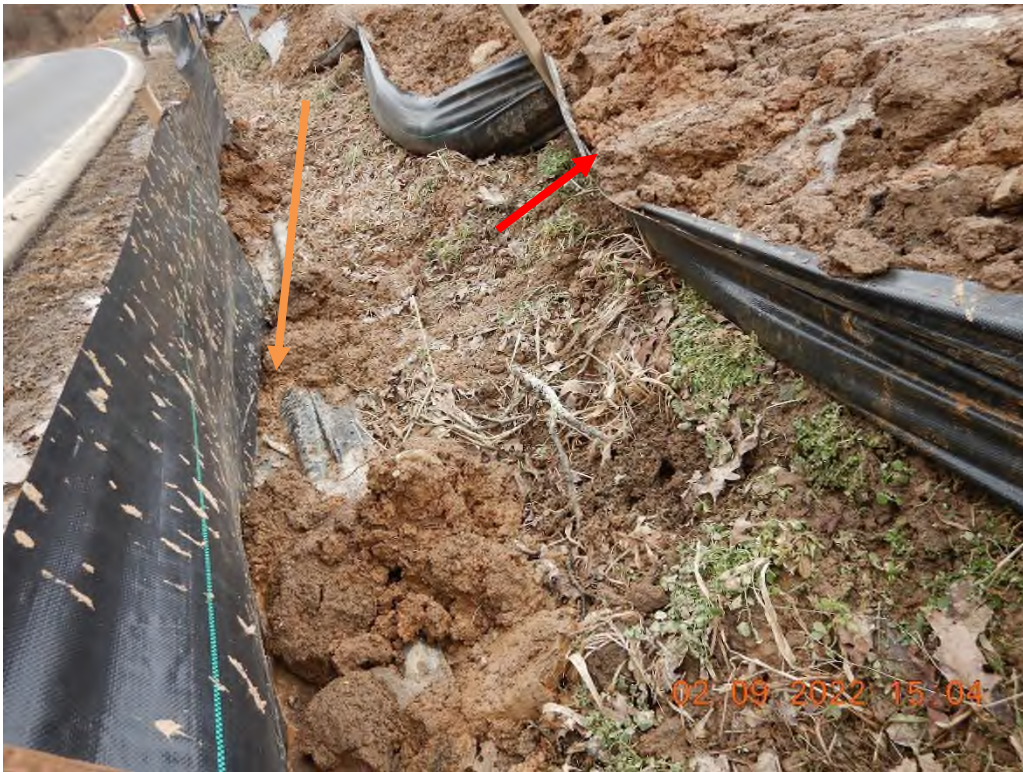
Silt fence was not properly merged (orange arrow) and needed maintenance (red arrow).

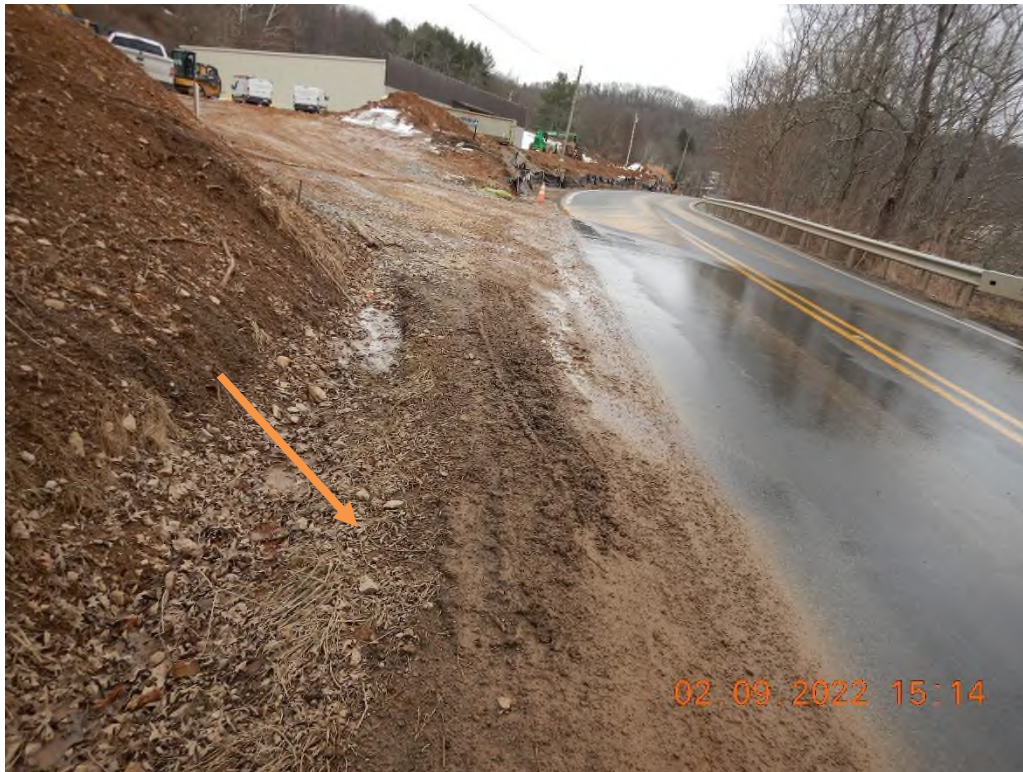
Silt fence that was improperly implemented in a concentrated flow area.

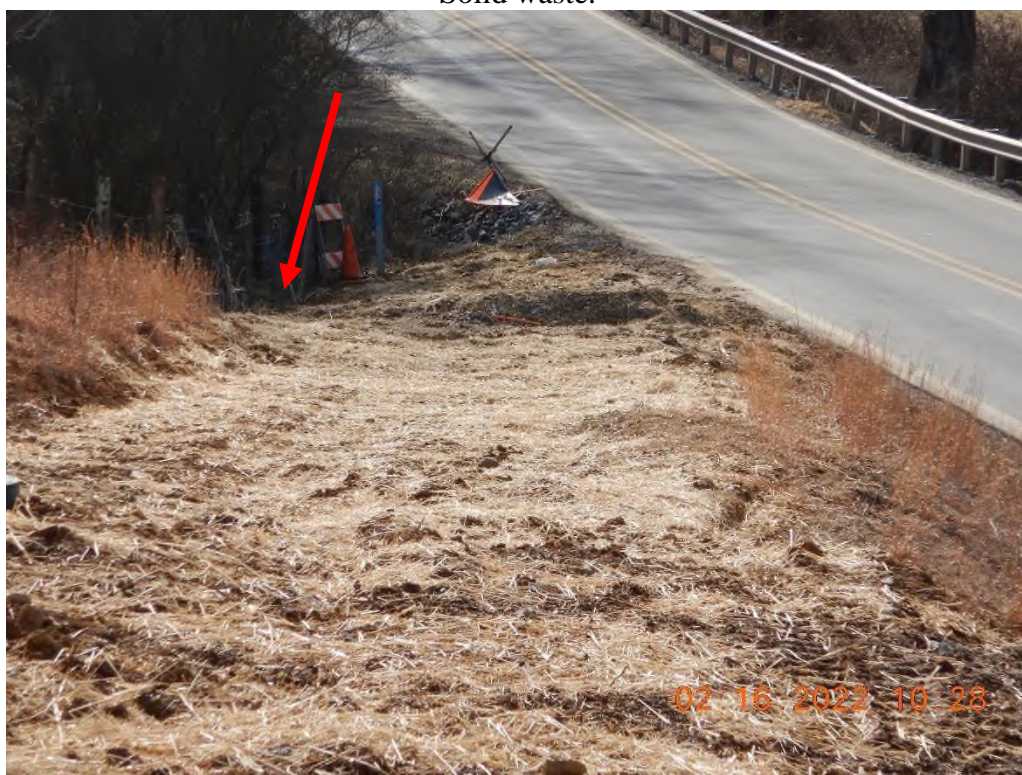
Solid waste.

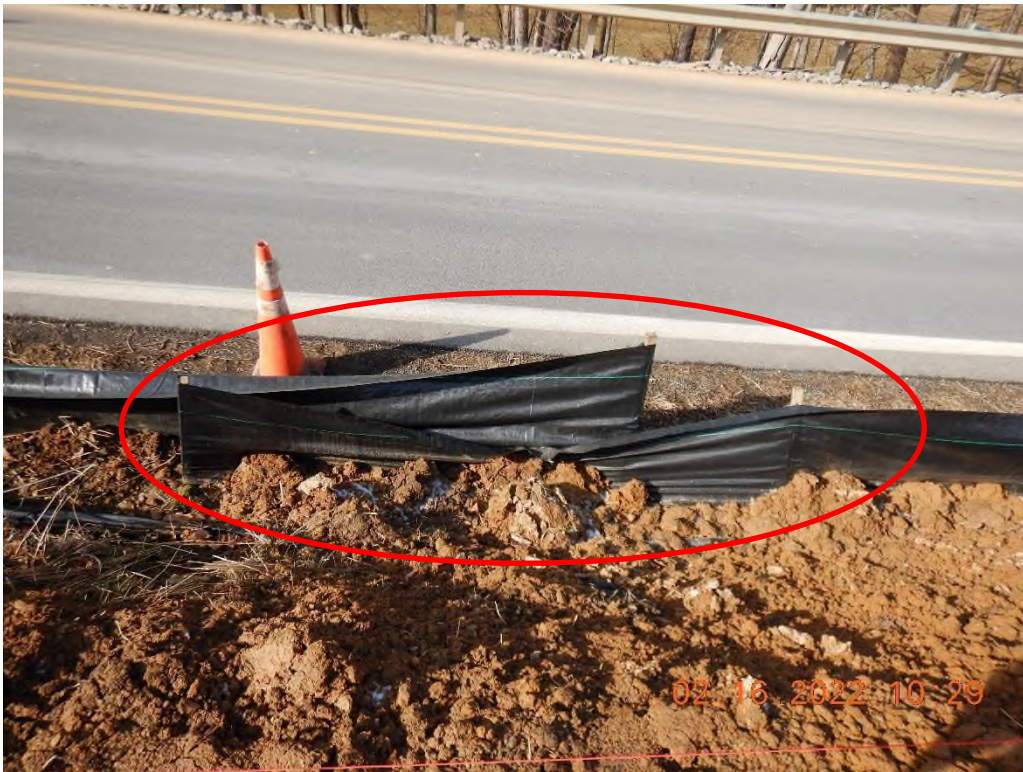
Area where the SWPPP was not modified to add perimeter controls.

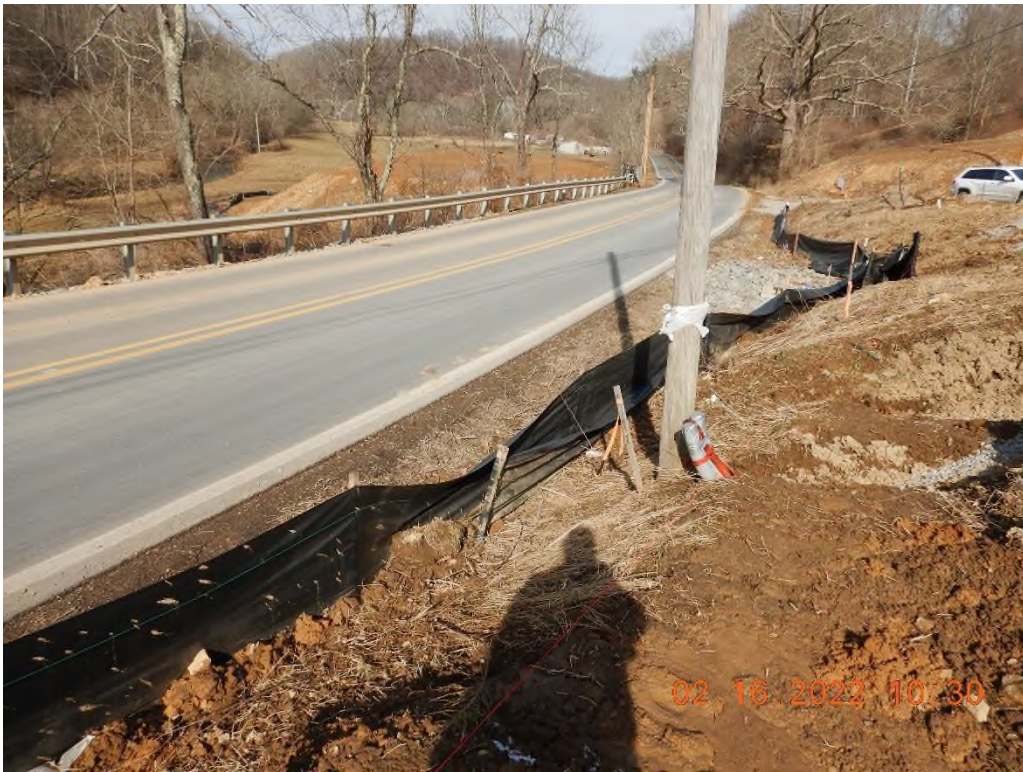
Silt fence not properly toed into the ground.

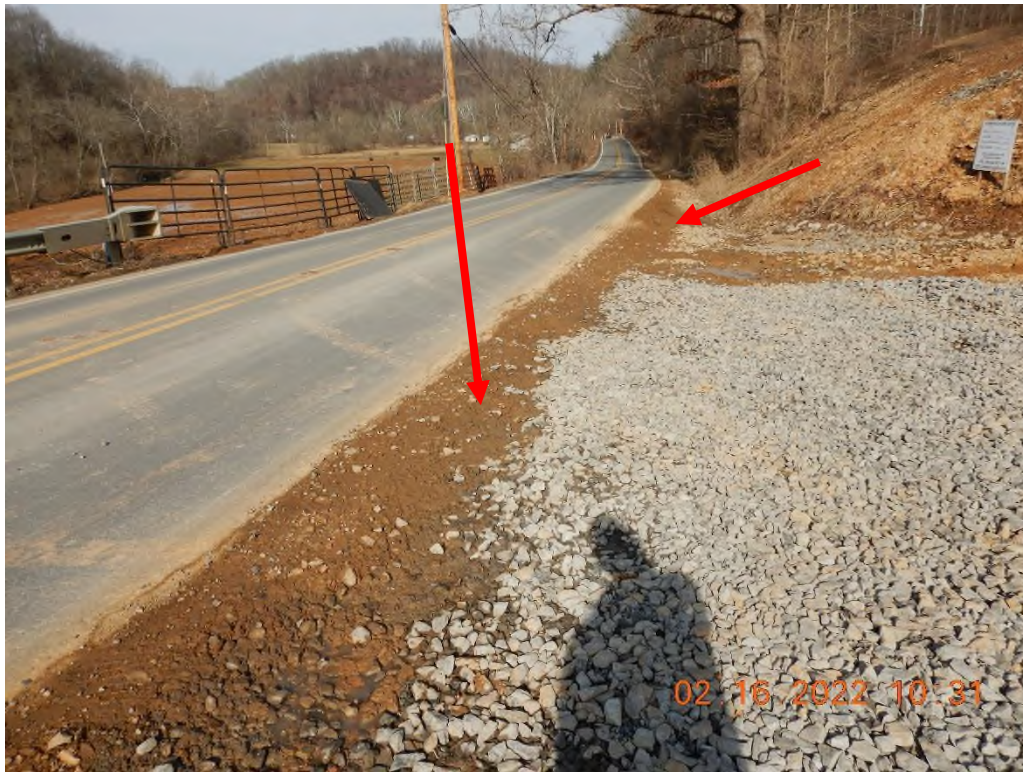
Multiple pieces of silt fence needed maintenance.

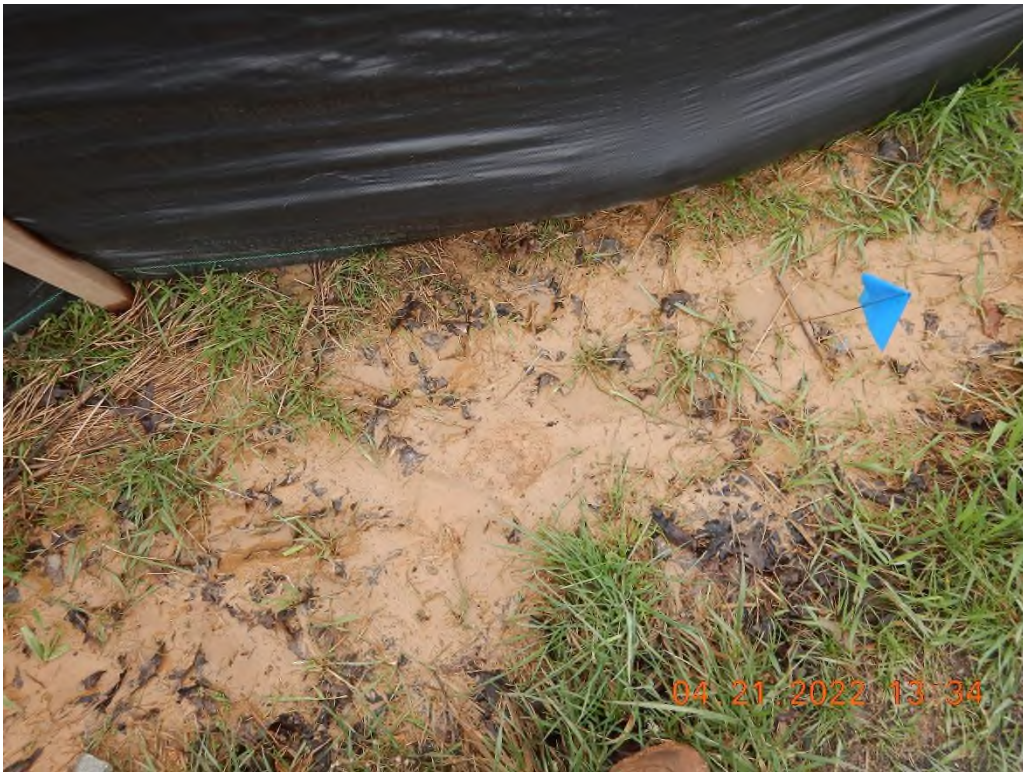
Silt fence was not toed into the ground.

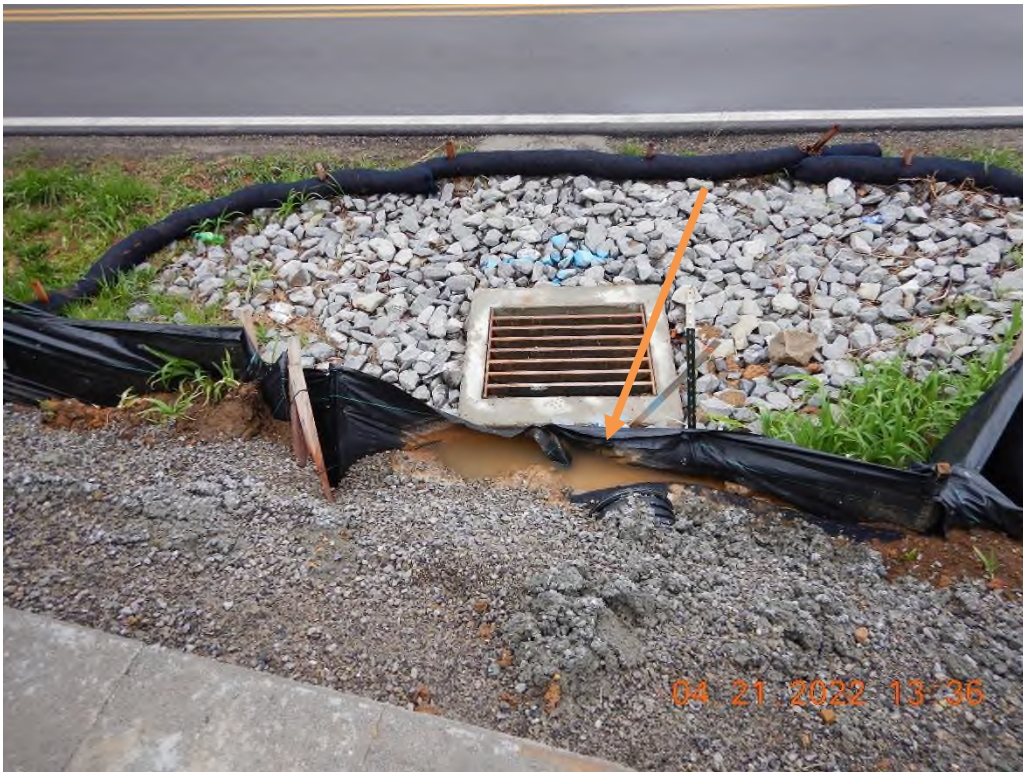
Silt fence needed maintenance.

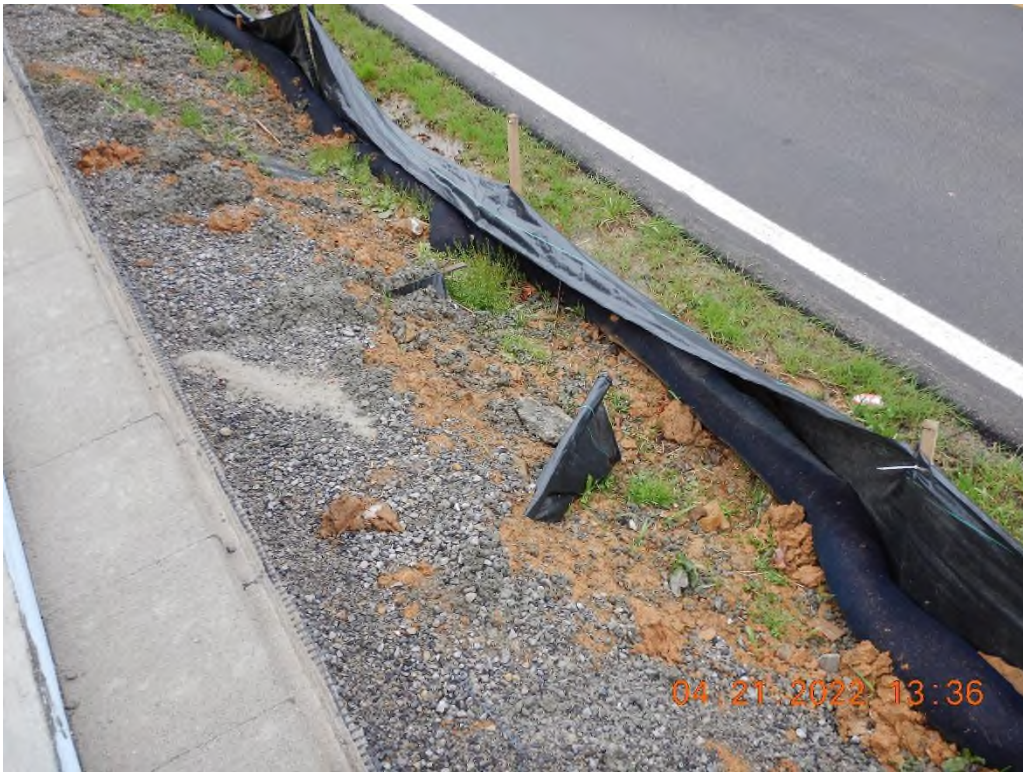
Compost filter sock that lacks the required staking.

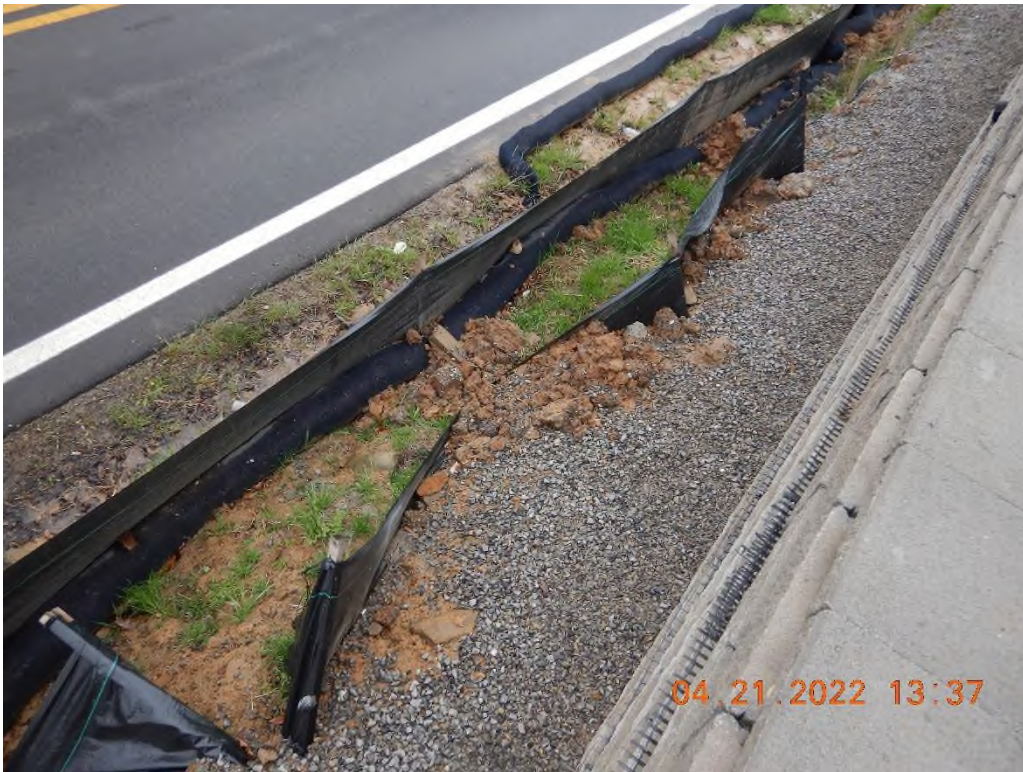
Compost filter sock lacking the required staking.

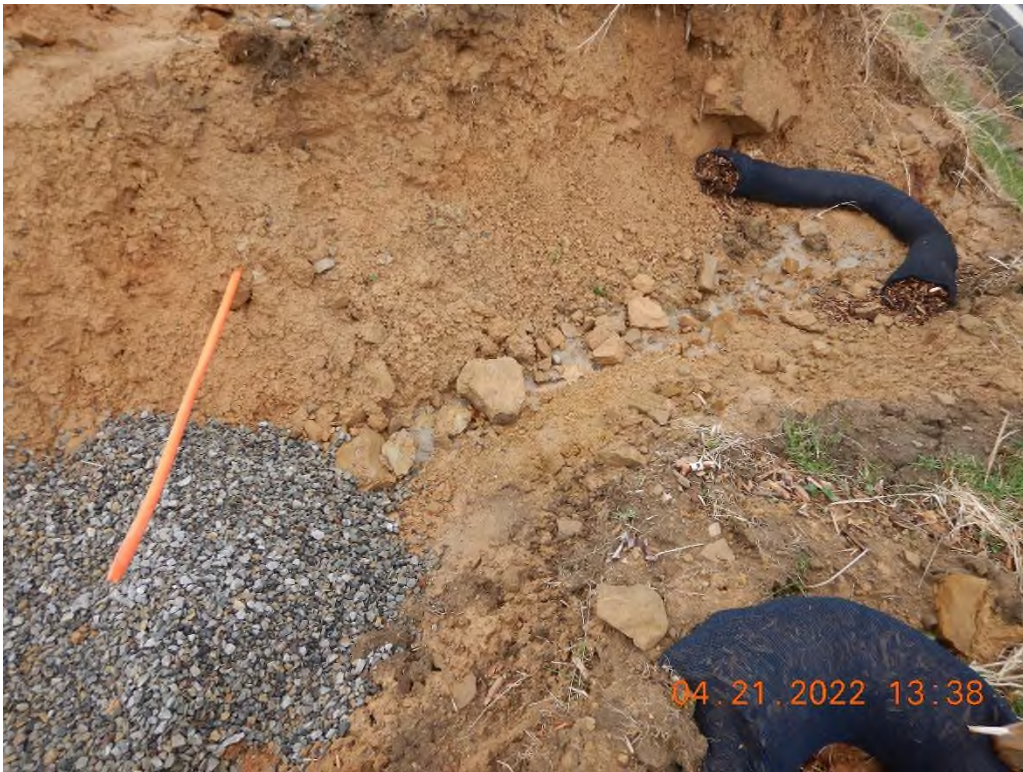
Unstable inlet.

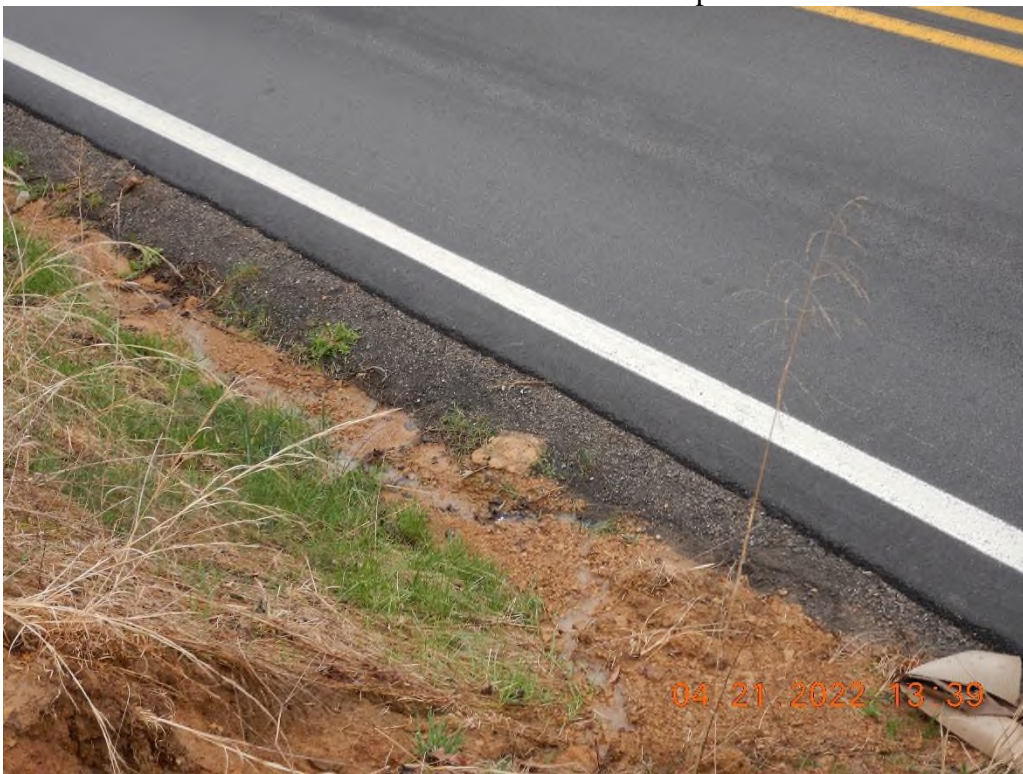
Unstable outlet of Sediment Trap 2.

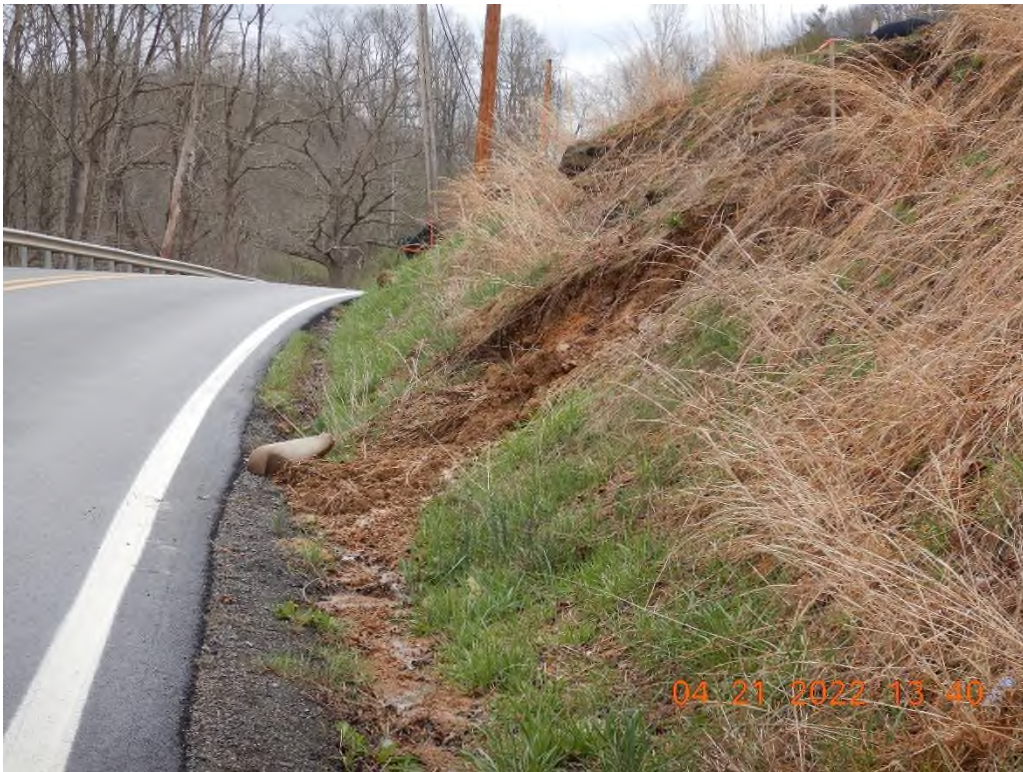
Sediment and sediment laden water in the adjacent ditch.

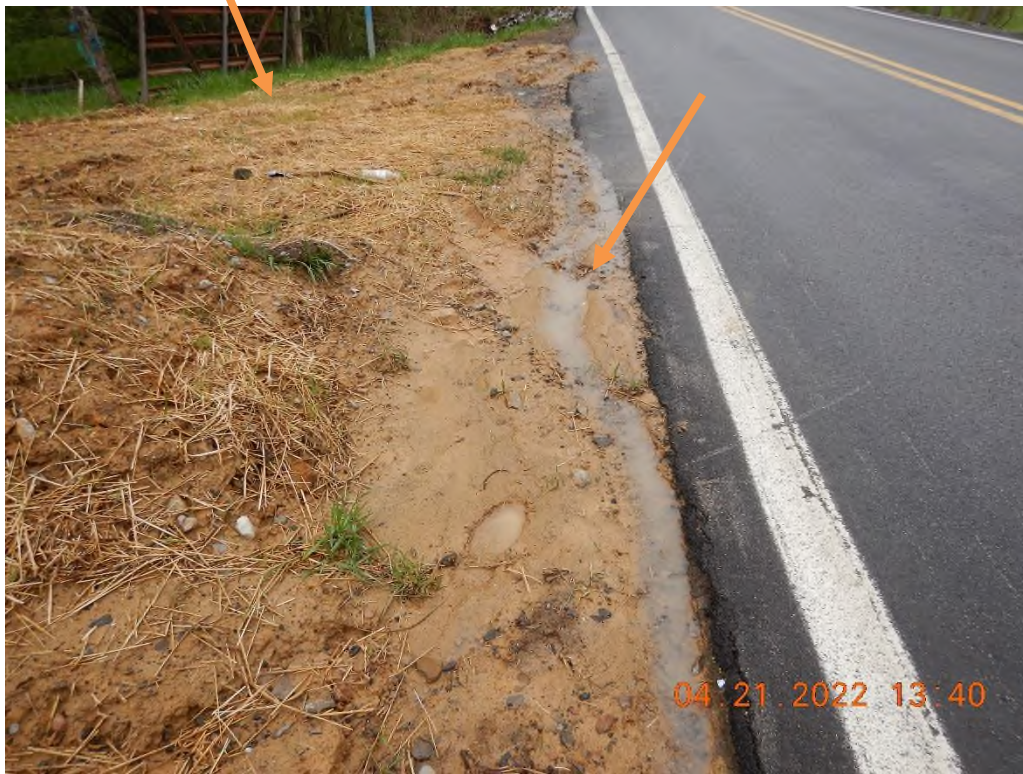
Fresh sediment deposits in the adjacent ditch.

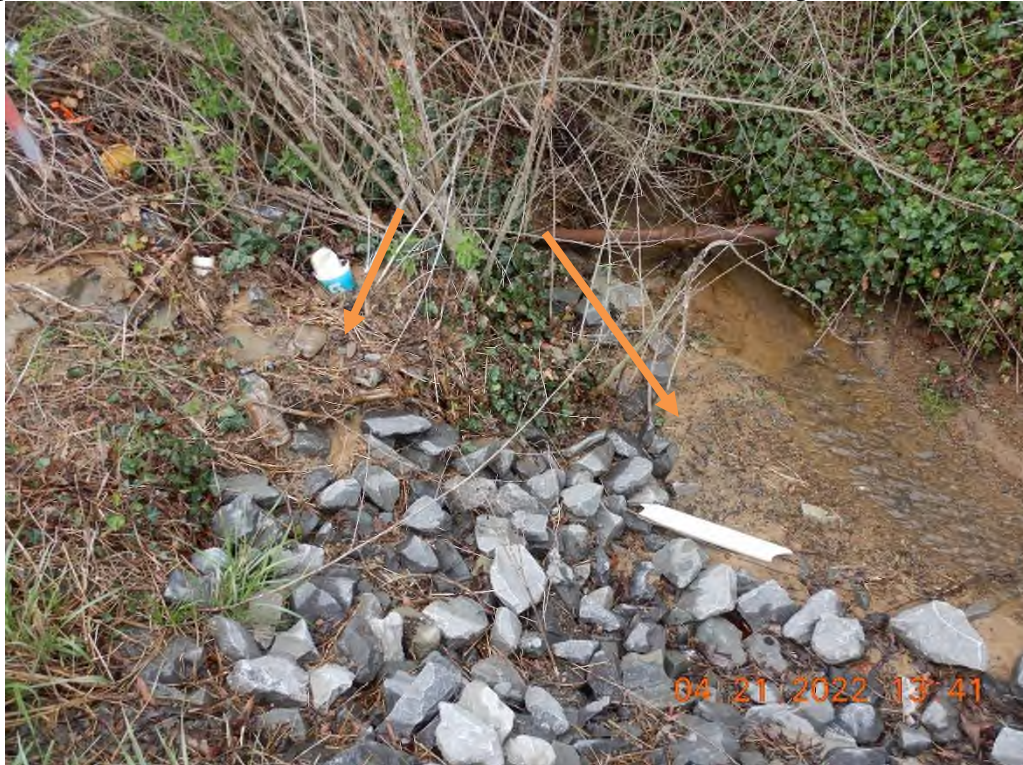
Sediment and sediment laden water leaving the site. The southern portion of the site was not within the permitted LOD, and the SWPPP has not been modified to add perimeter controls.

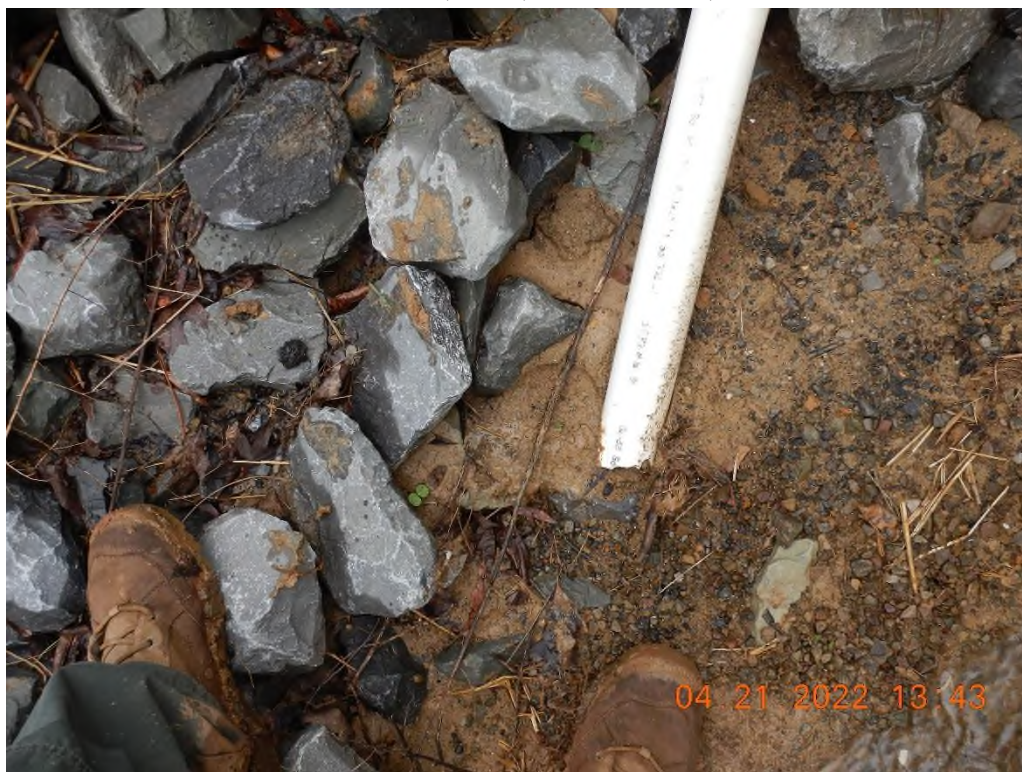
The sediment trail entering the ephemeral stream, causing Conditions Not Allowable in the UNT of Little Tenmile Creek (39° 23'28.01" N, -80° 27'41.02" W).

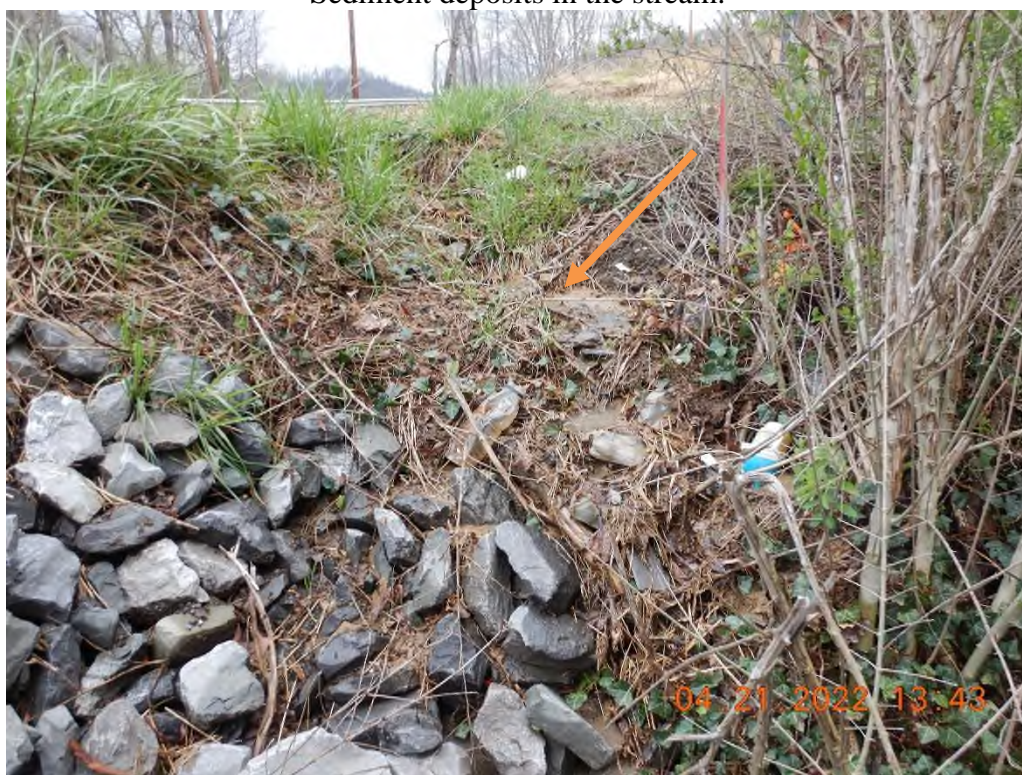
Sediment deposits in the stream.

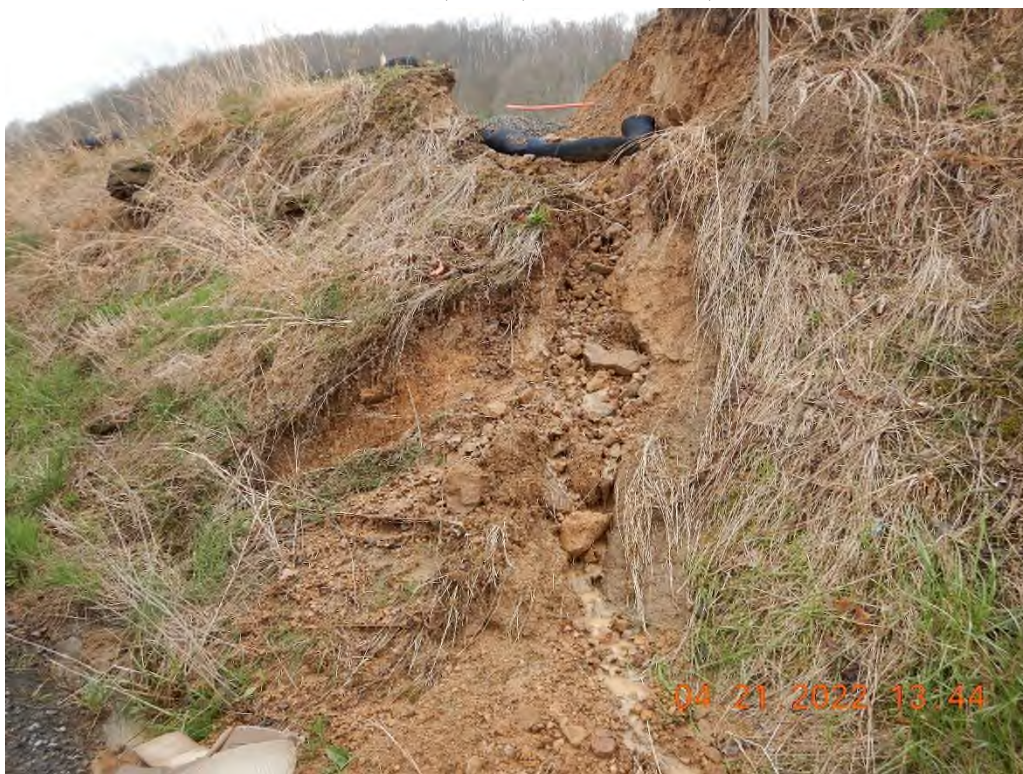
The ditch and the sediment and sediment laden water that has discharged into it.

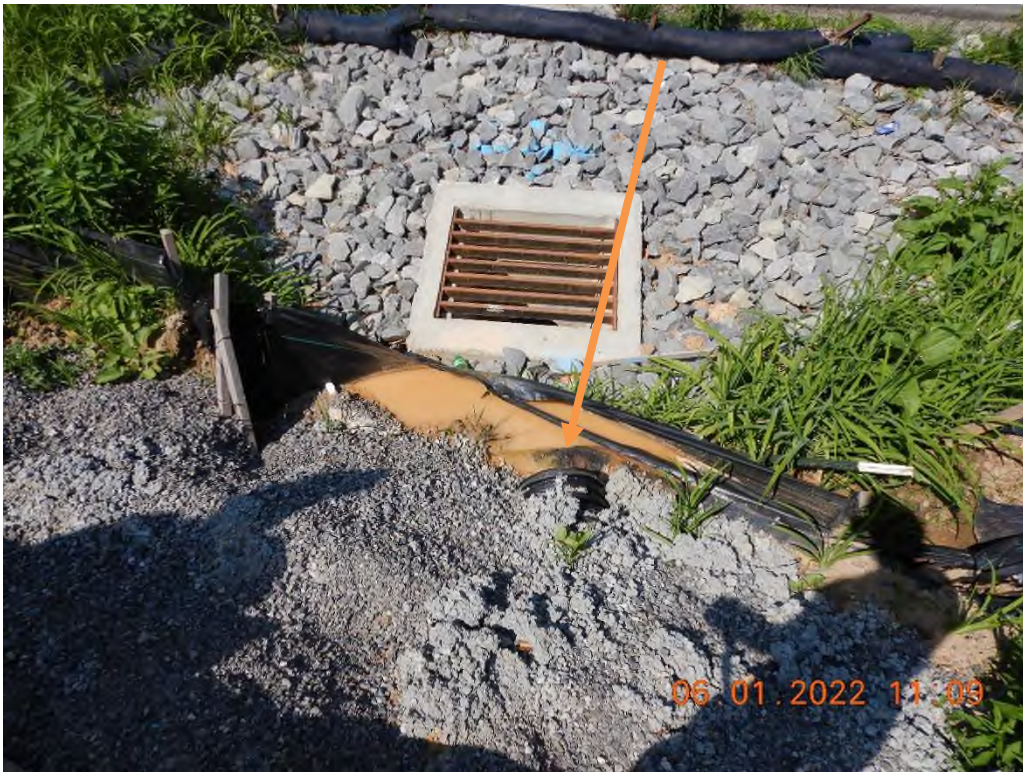
Sediment Trap 1 is not functional or fully installed.

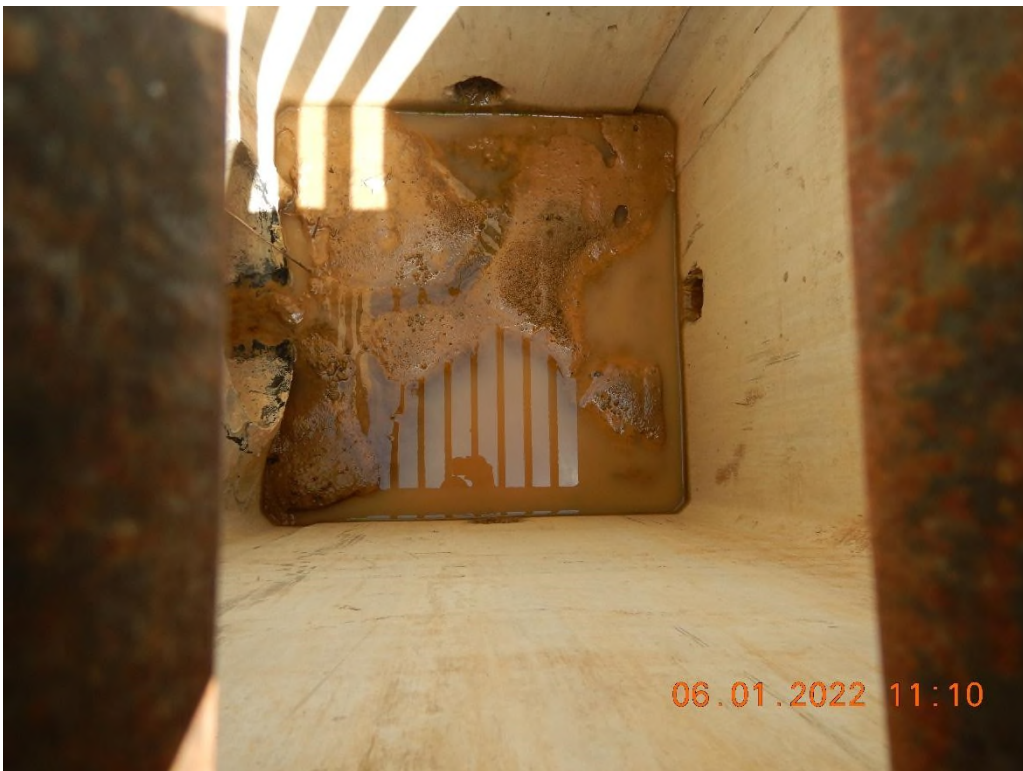
Silt fence installed in a concentrated flow area at the outlet of non-functional Sediment Trap 1.
