**CONSENT ORDER
ISSUED UNDER THE
WATER POLLUTION CONTROL ACT
WEST VIRGINIA CODE CHAPTER 22, ARTICLE 11**

TO: CD DG Wallace, LLC
ATTN: Josh Allen
9461 Kenwood Road
Cincinnati, OH 45242

DATE: April 23, 2024

ORDER NO.: 10227

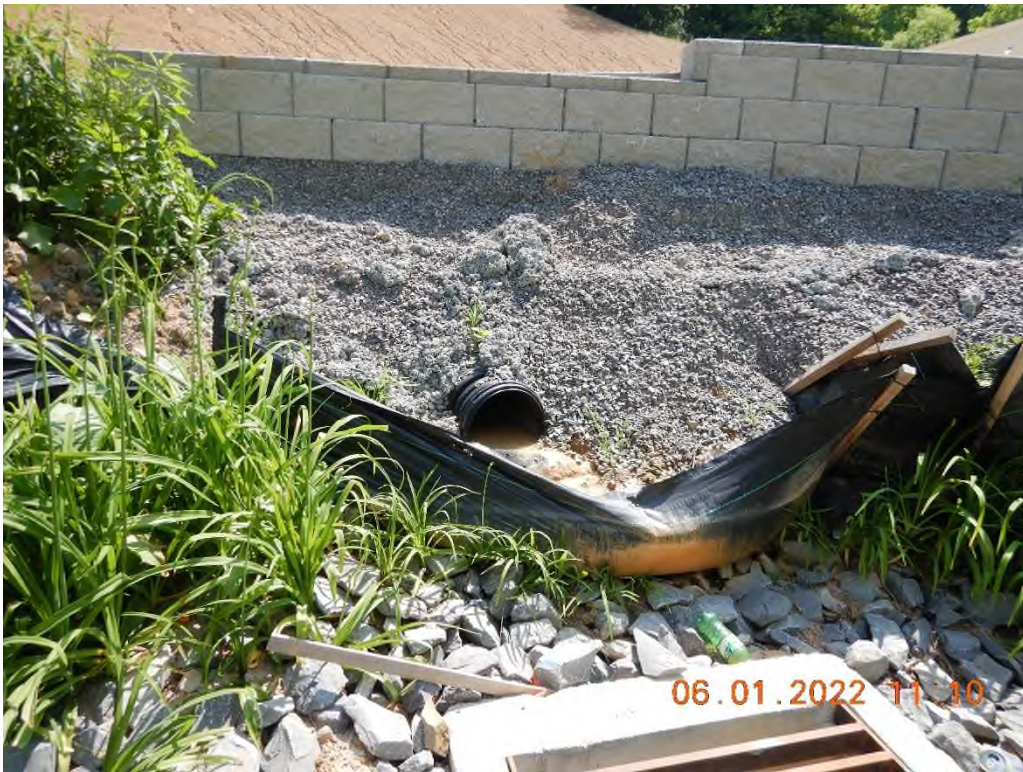
Sediment laden water and sediment deposits in the bottom of the drop inlet, as a result of improper implementation of silt fence.

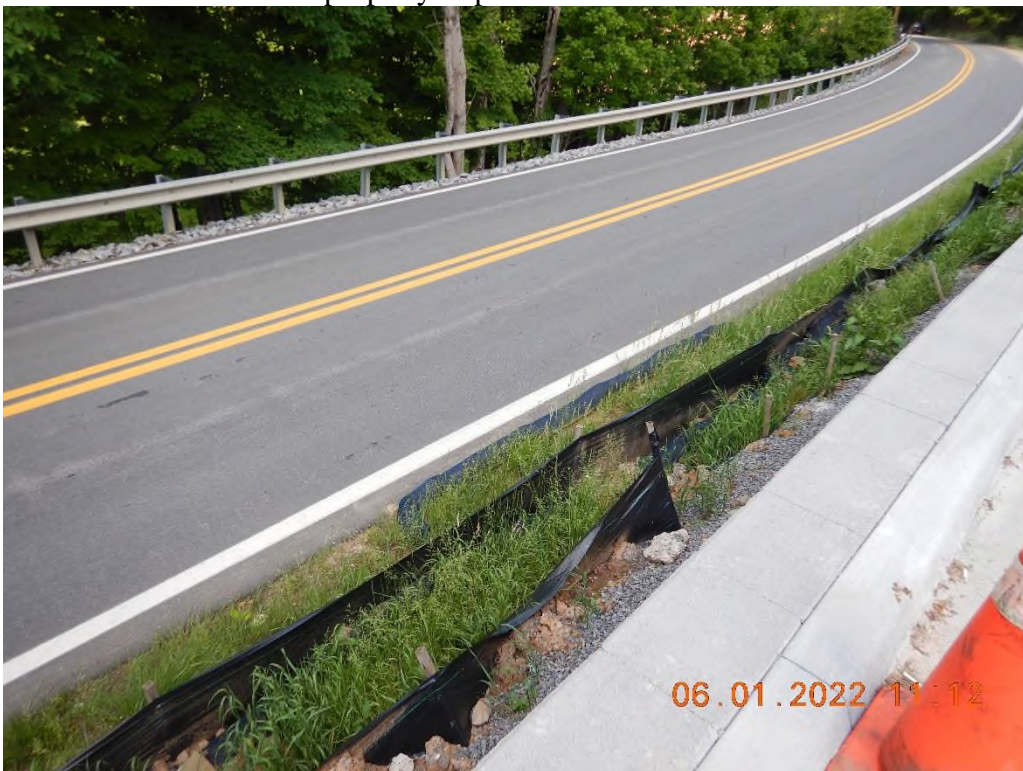
Improperly implemented silt fence.

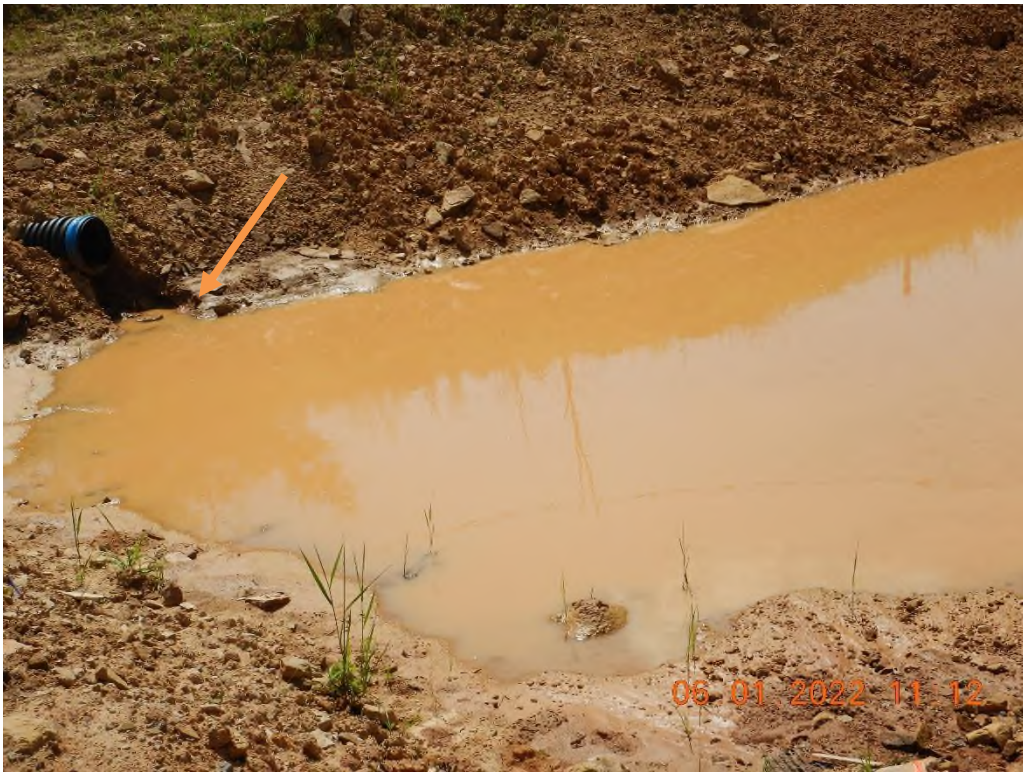
Perimeter controls needed maintenance.

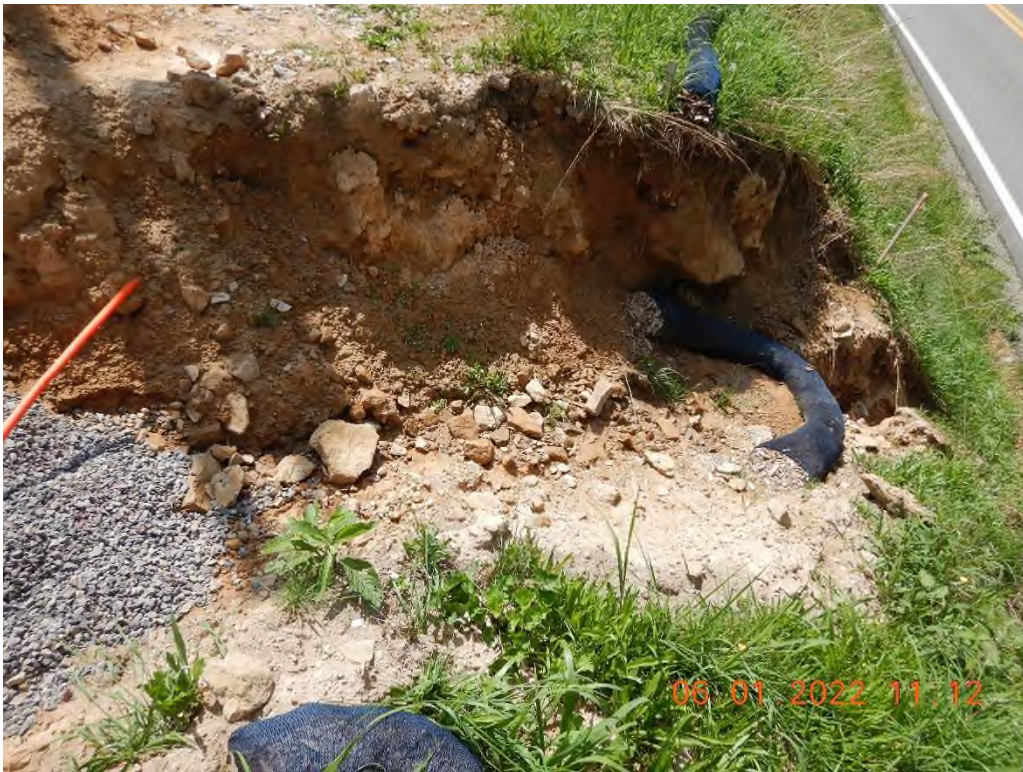
An unstable inlet for Sediment Trap 2.

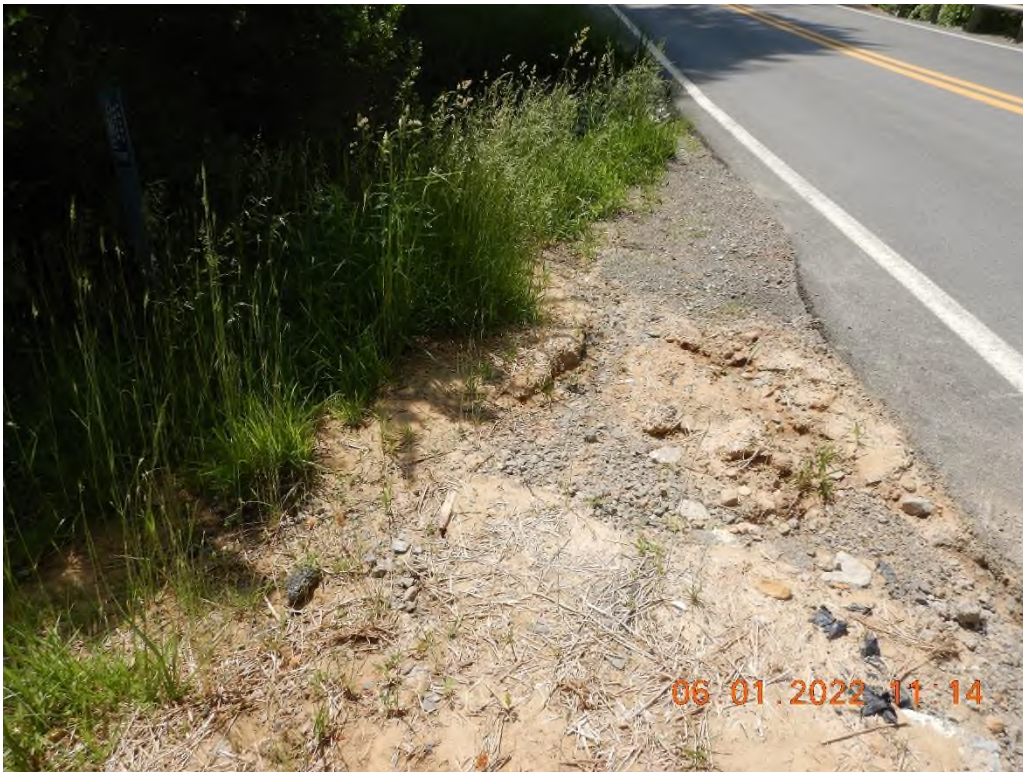
Sediment deposits discharging off the LOD.

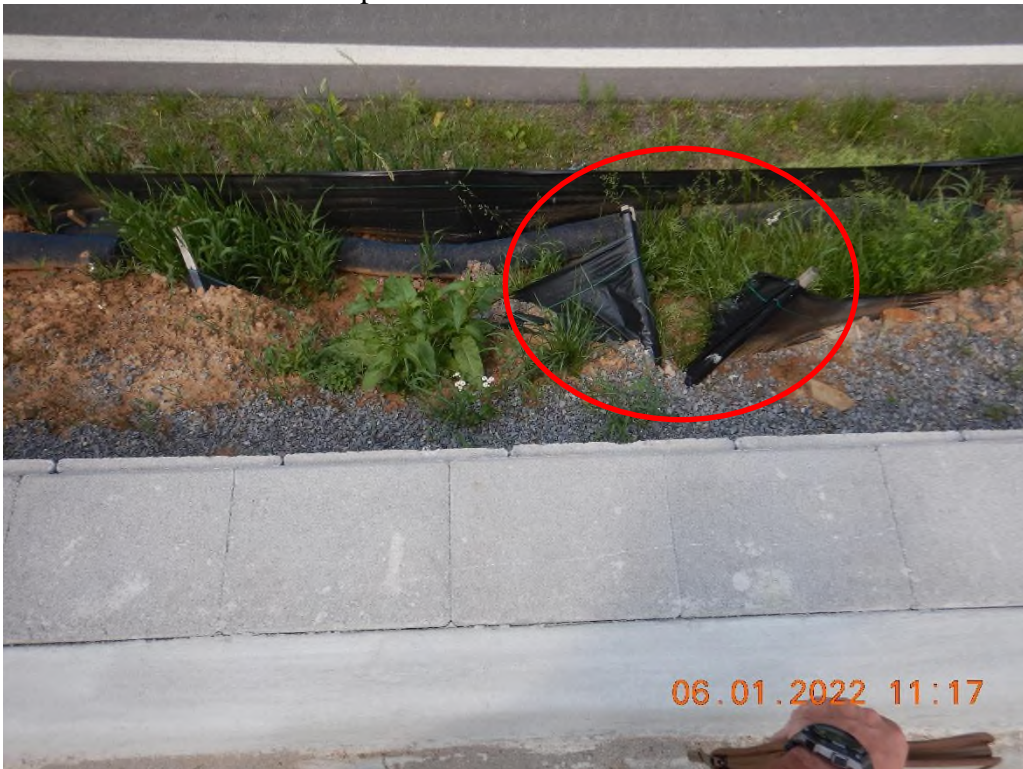
SWPPP has not been modified to install perimeter controls in the area where the sewer line was installed.

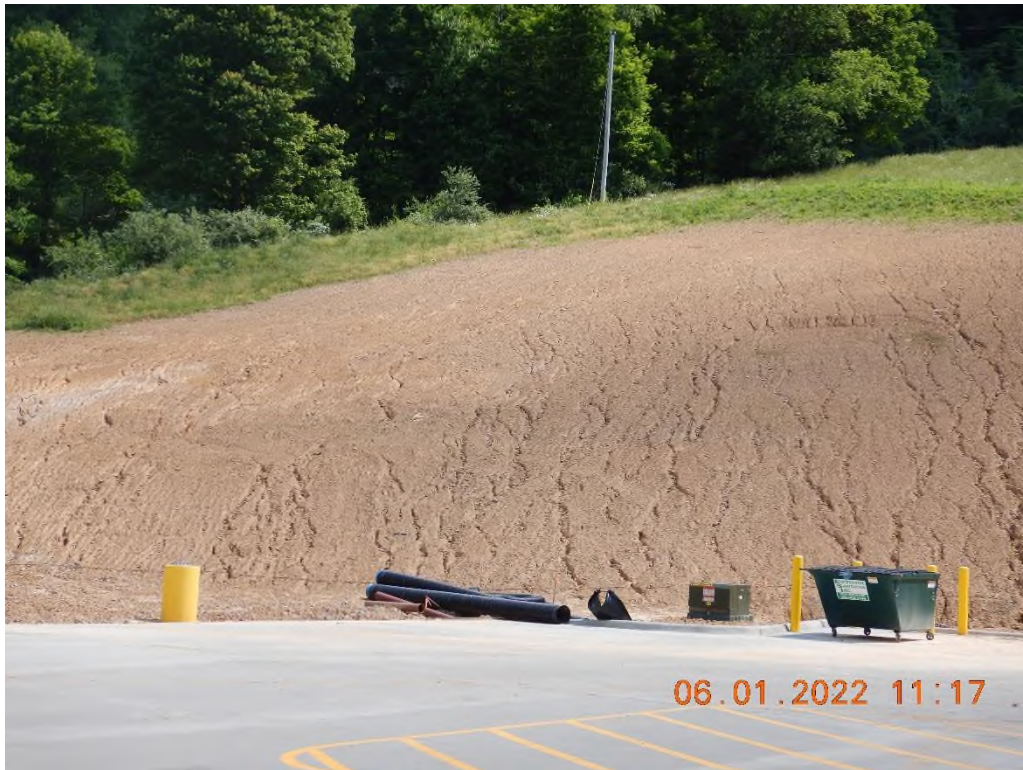
Improper merging of perimeter controls.

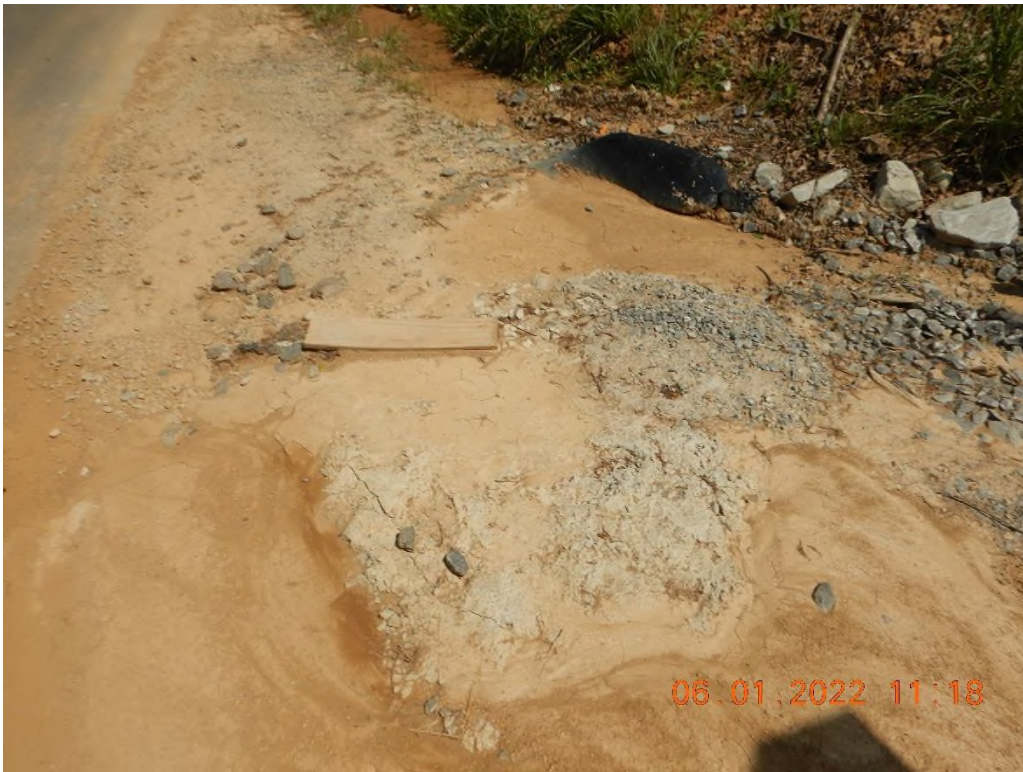
Sediment discharging off the LOD.

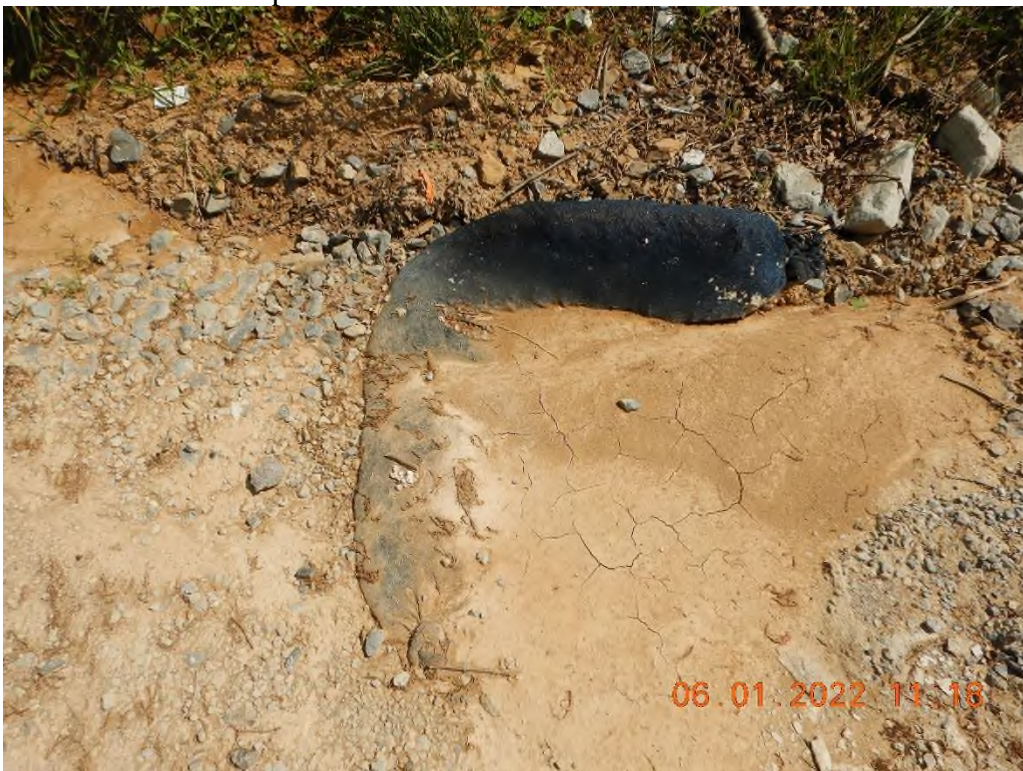
Compost filter sock check needed maintenance.

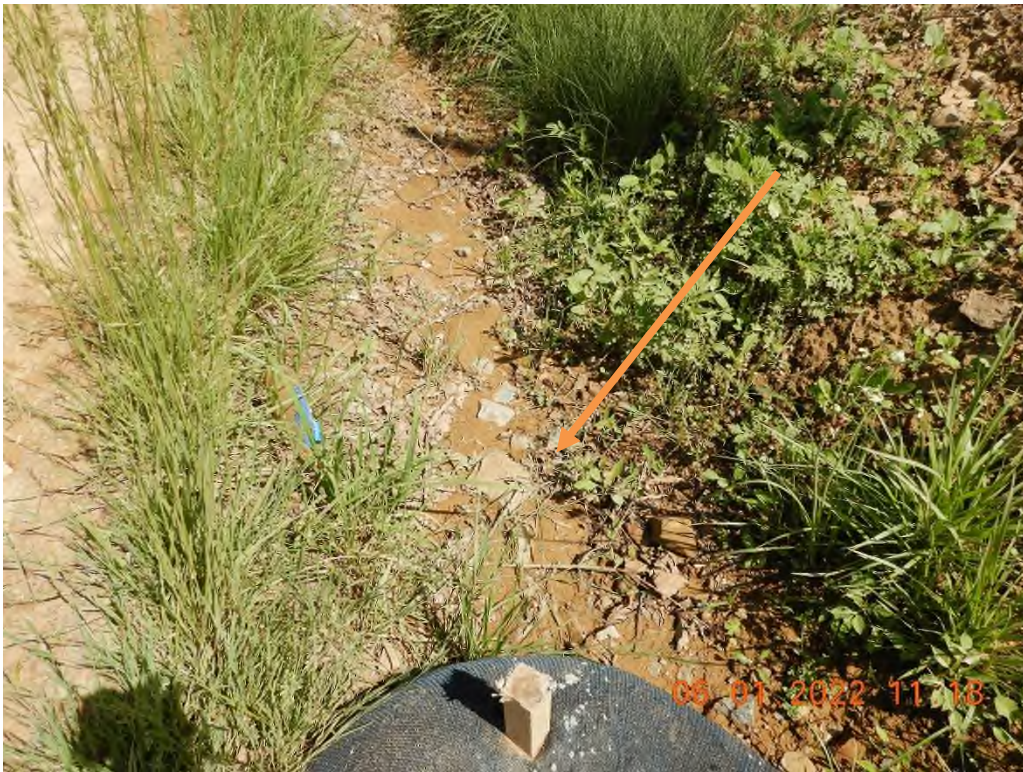
Compost filter sock is missing the required staking.

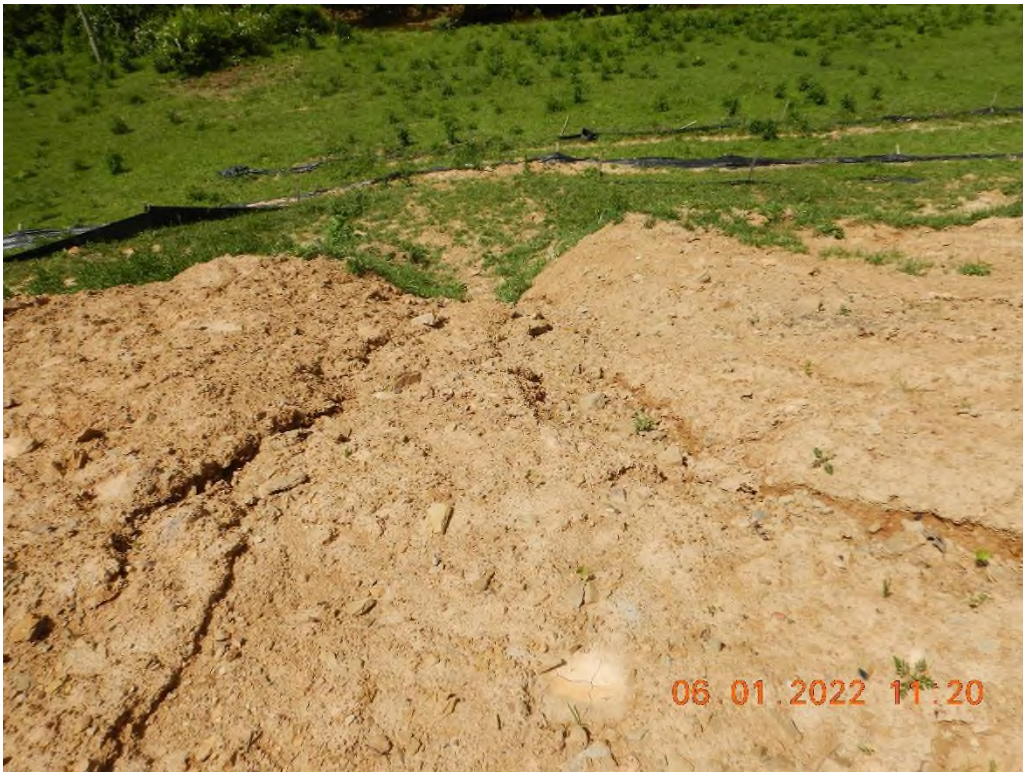
Sediment bypassing the compost filter sock, which needed maintenance.

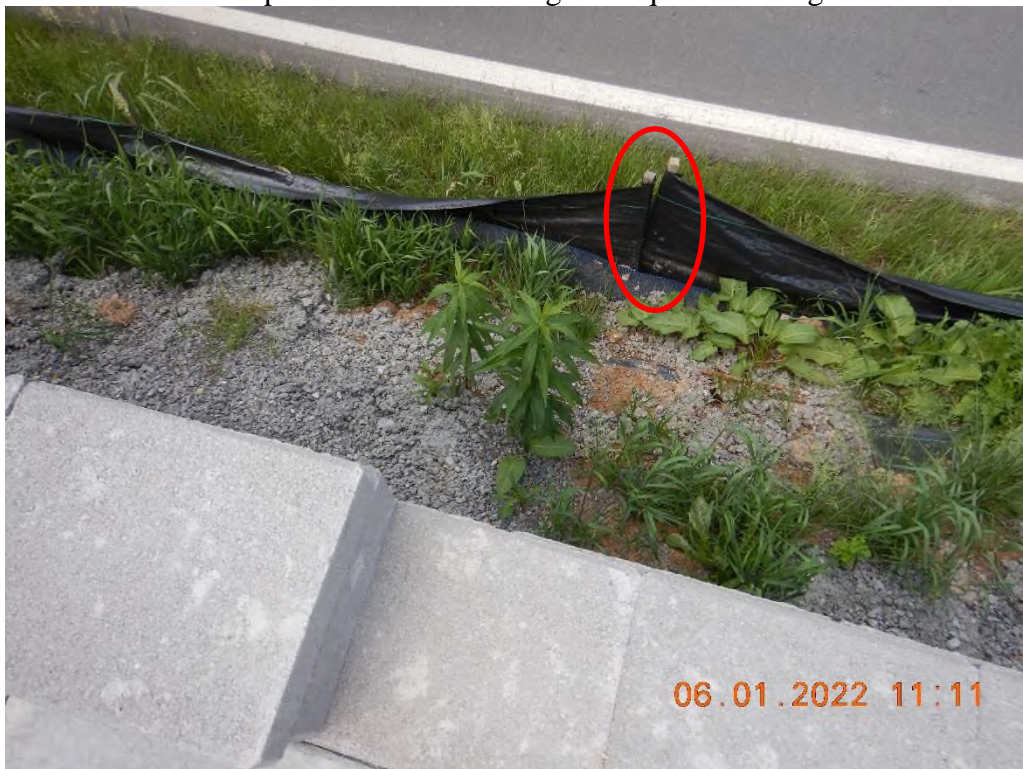
Compost filter sock missing the required staking.

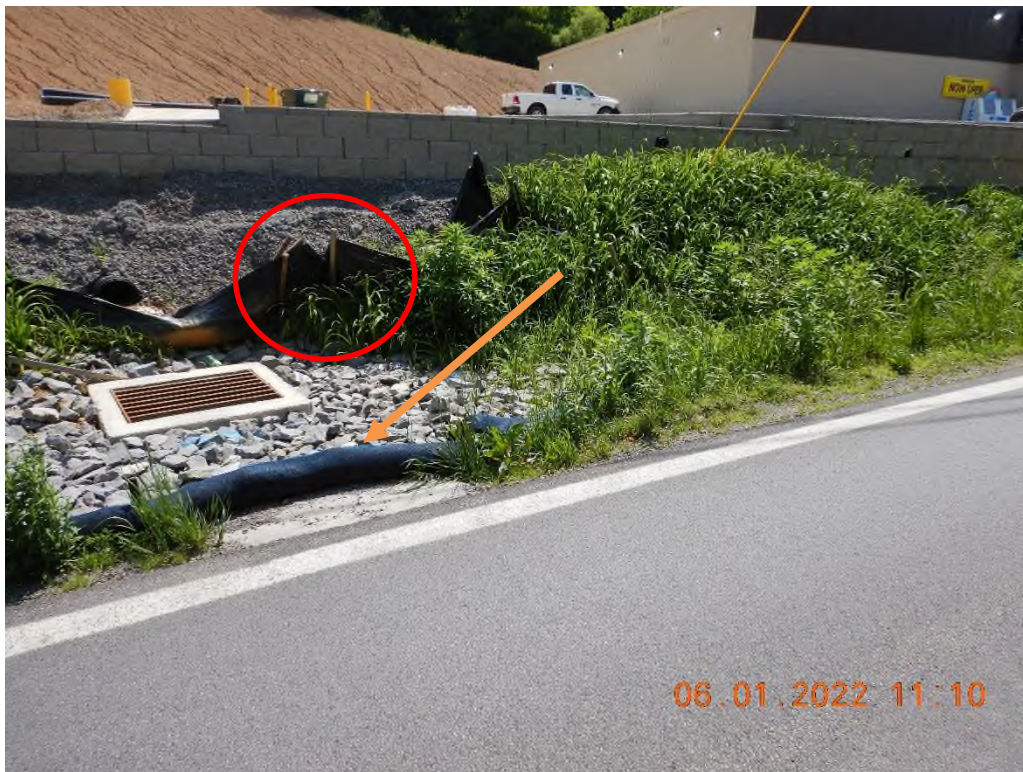
Perimeter controls not properly merged.

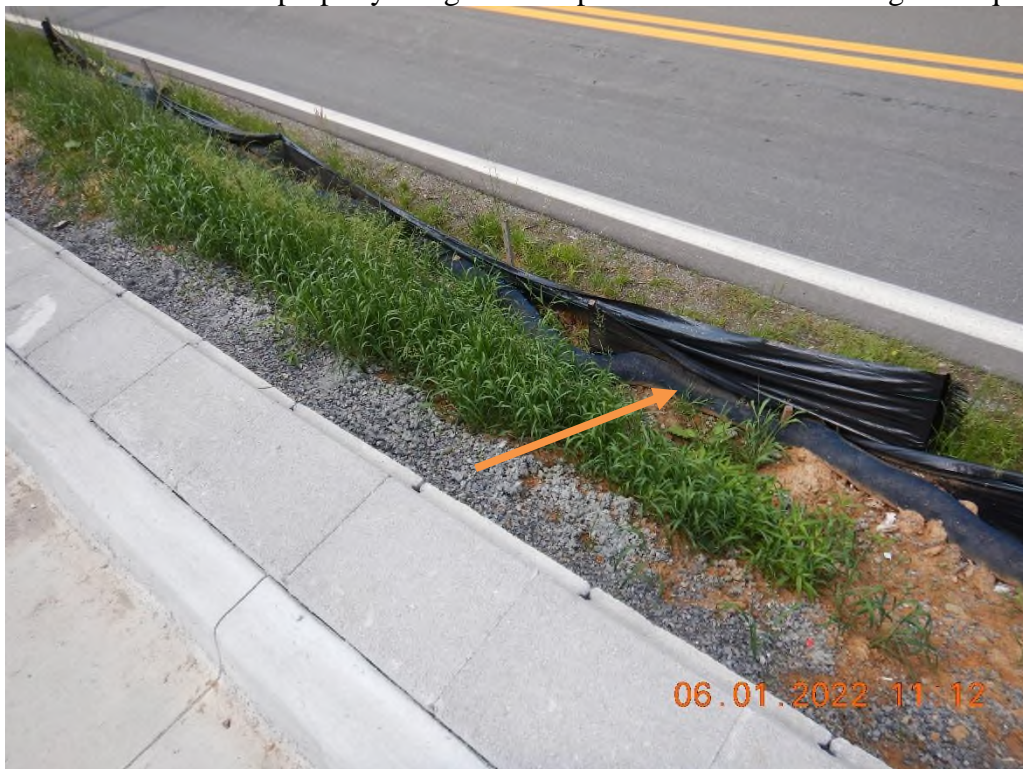
Perimeter controls that were not properly merged. Compost filter sock is missing the required staking.

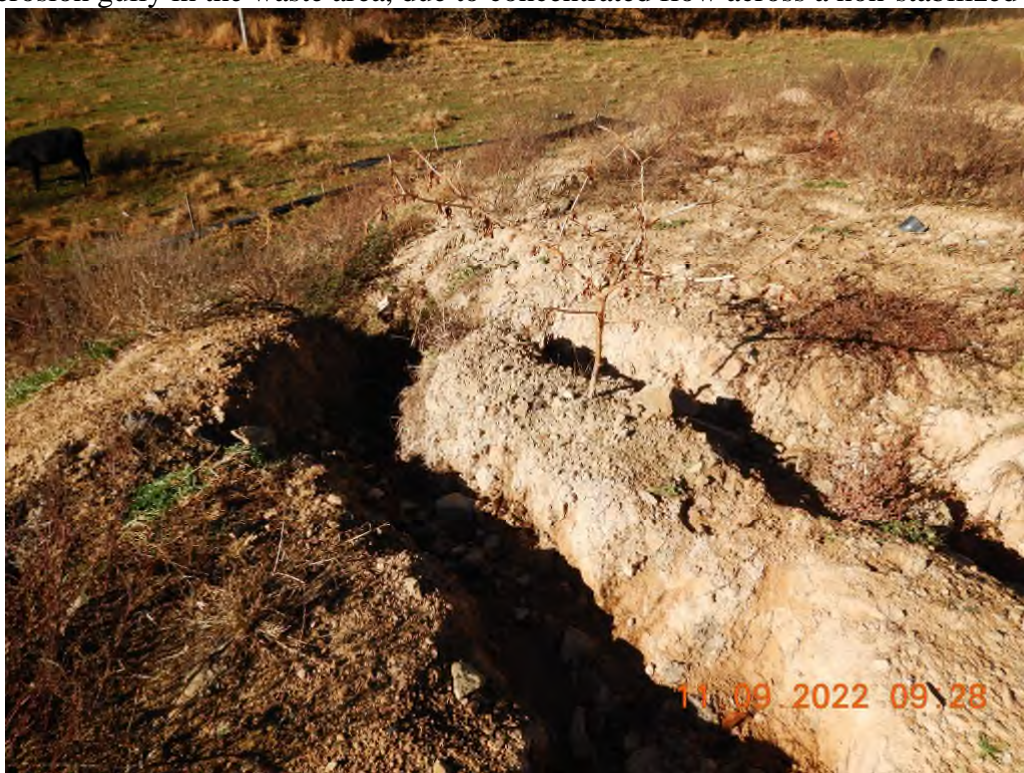
An erosion gully in the waste area, due to concentrated flow across a non-stabilized area.

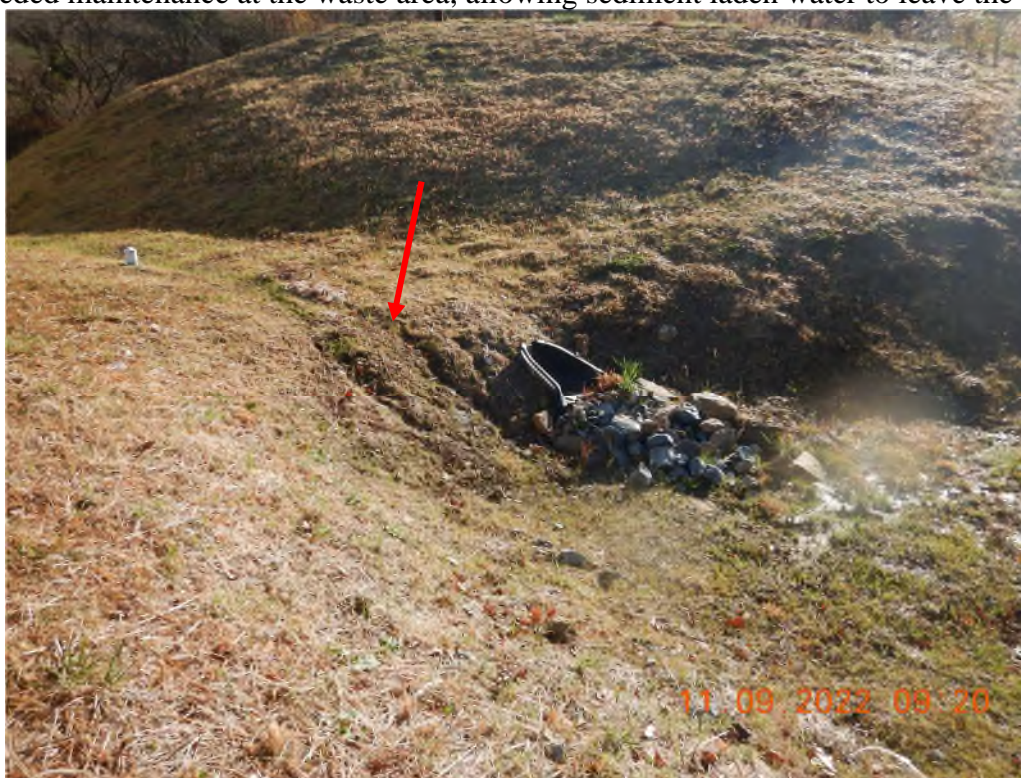
Silt fence needed maintenance at the waste area, allowing sediment laden water to leave the site untreated.

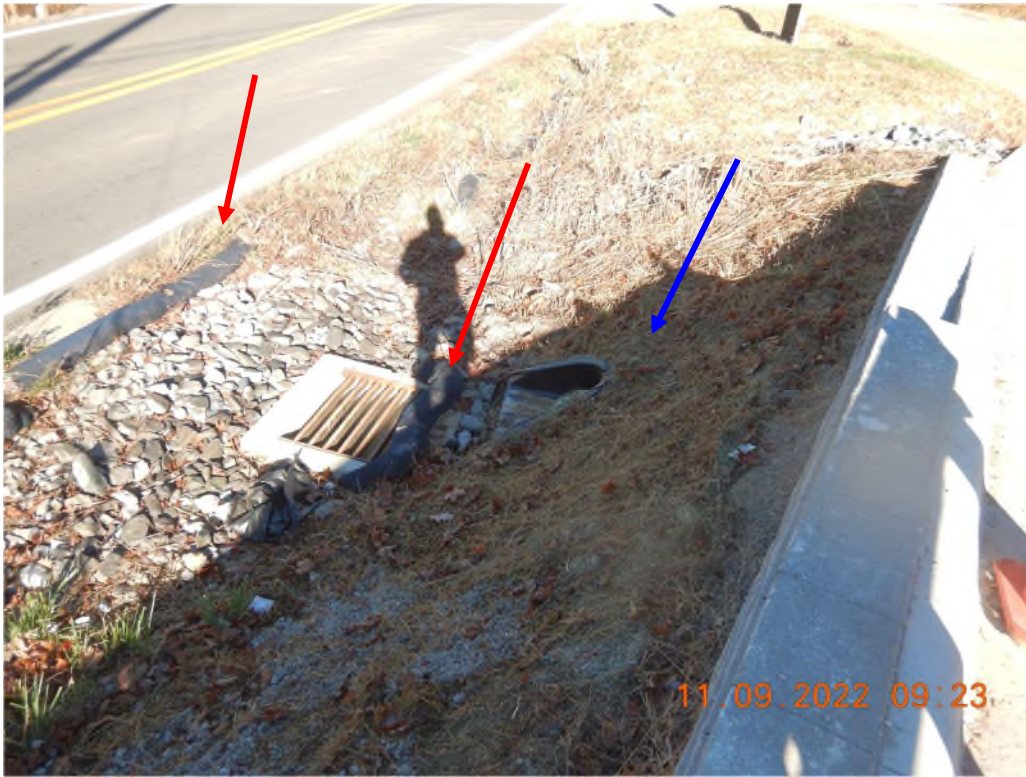
Compost filter sock lacking the required staking.

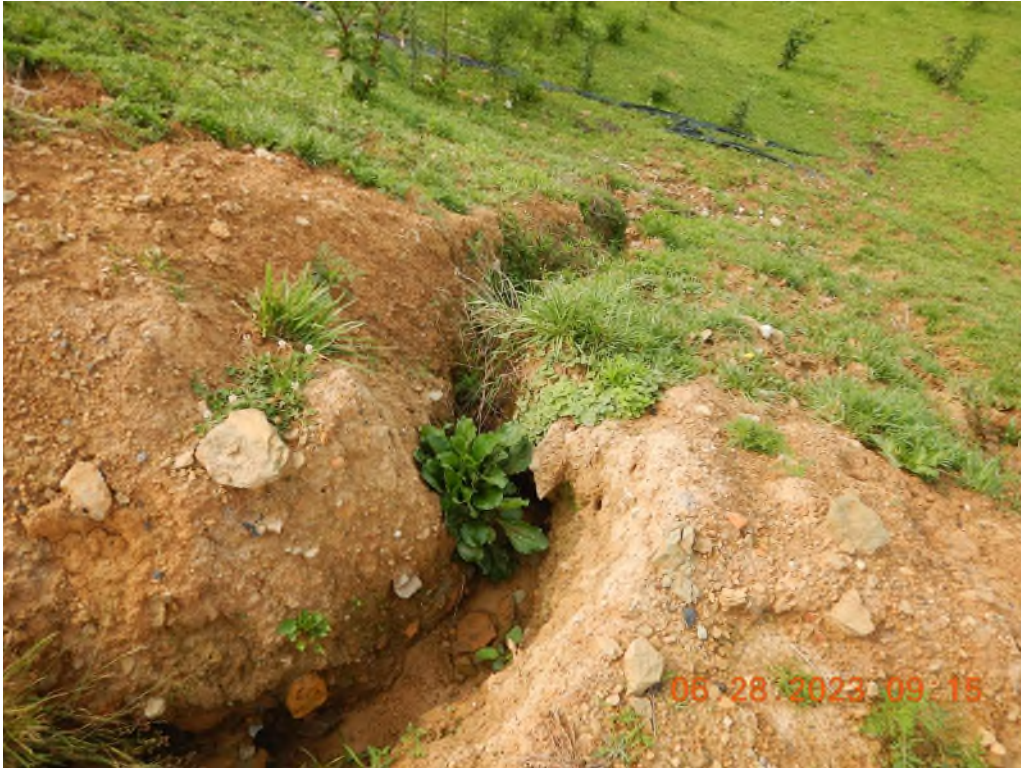
As shown, natural vegetation has started to germinate and there is no evidence of the company reseeding the waste area.

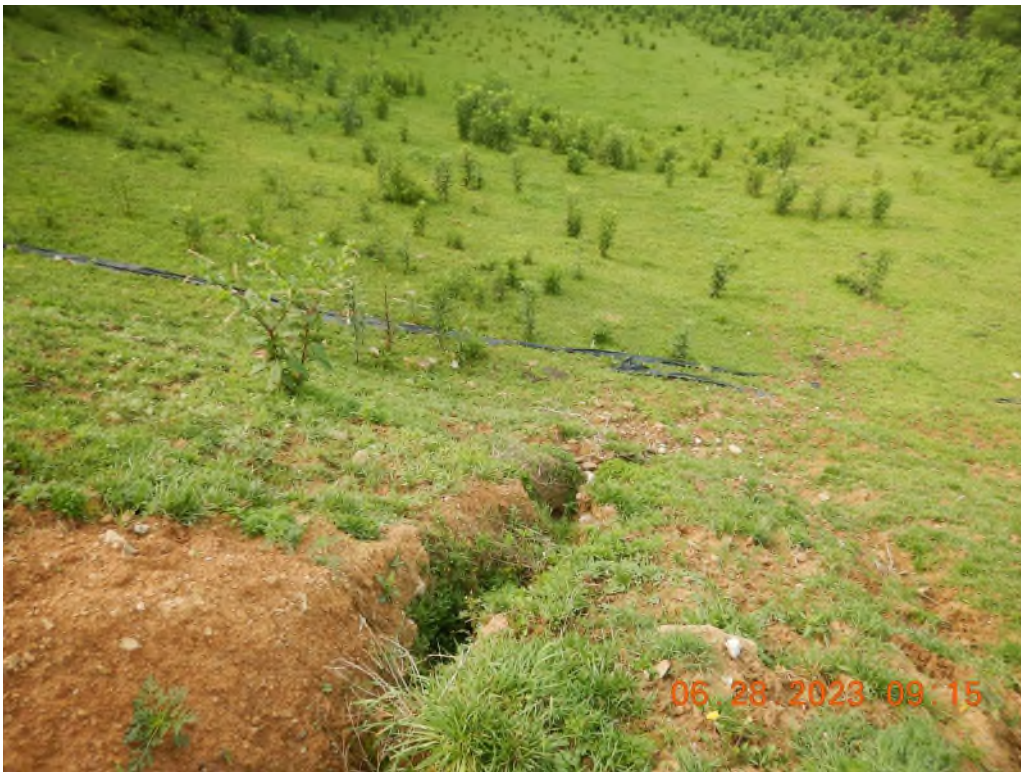
An erosion gully noted in the waste area. This is due to a concentrated flow going across a non-stabilized surface.

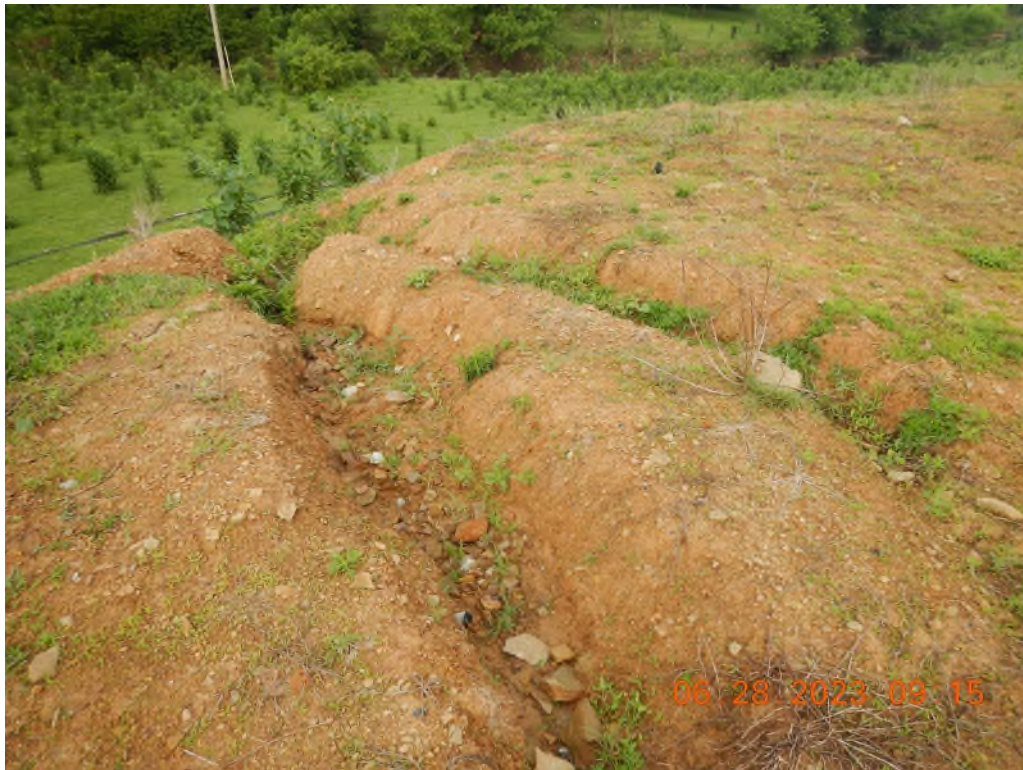
More silt fence showing the need for maintenance.

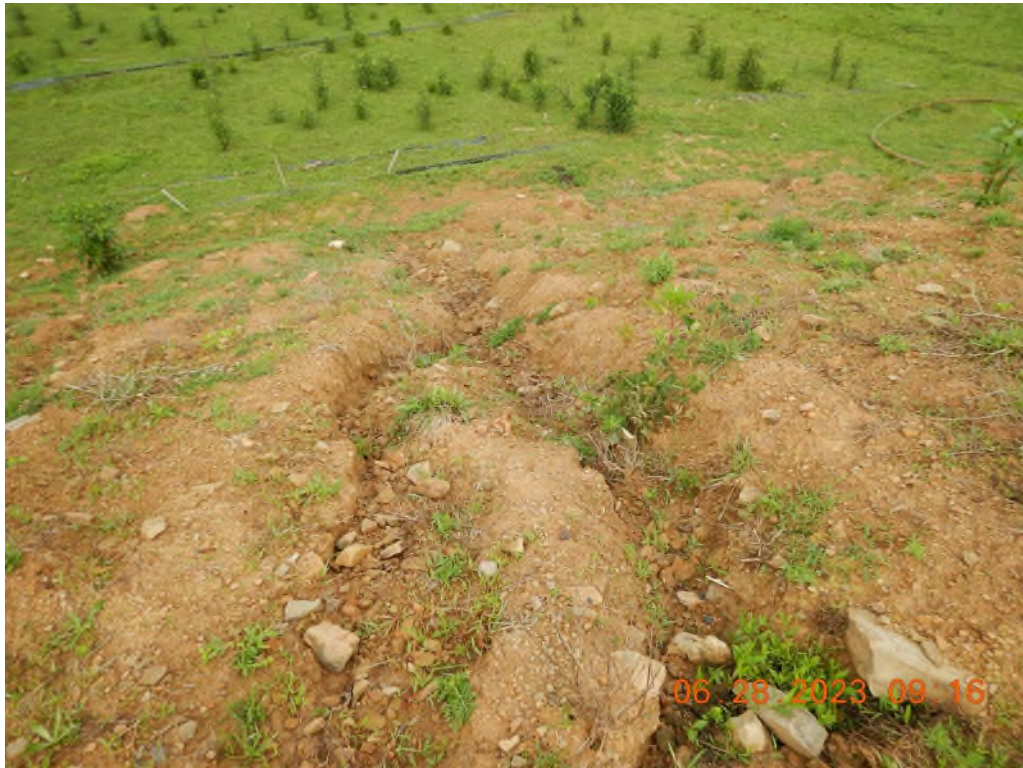
More erosion gullies noted in the waste area. This is due to a concentrated flow going across a non-stabilized surface.

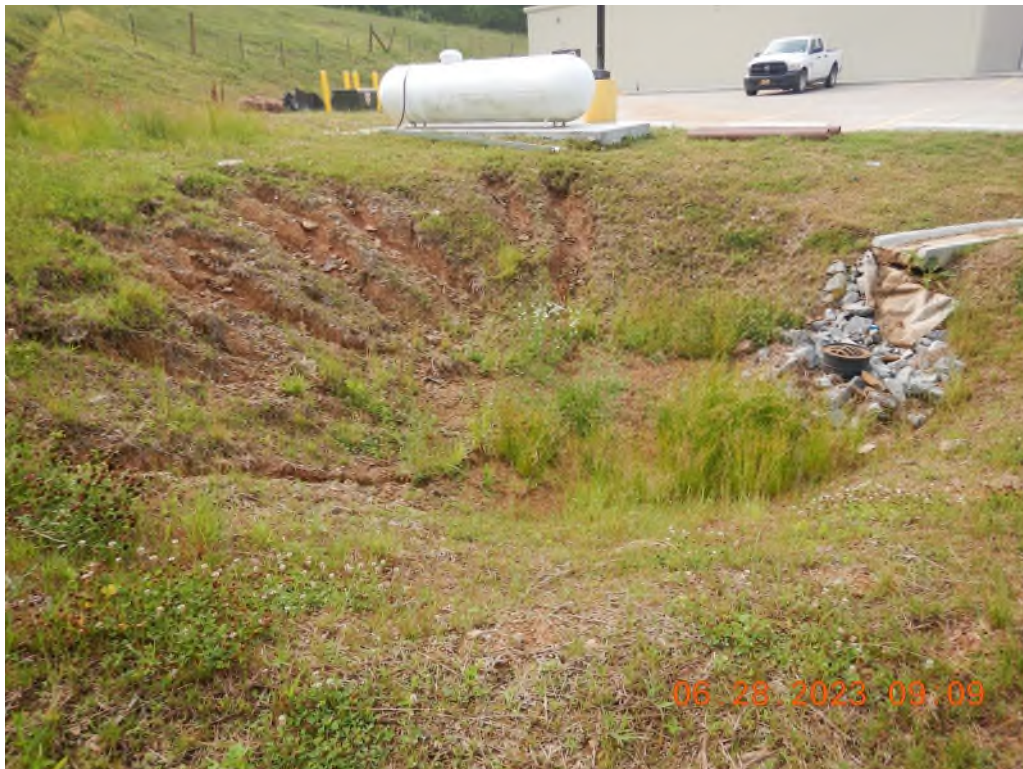
Silt fence showing the need for maintenance. As a result, sediment deposits were noted beyond the installed controls. Also shown are more erosion gullies. This is due to a concentrated flow going across a non-stabilized surface.

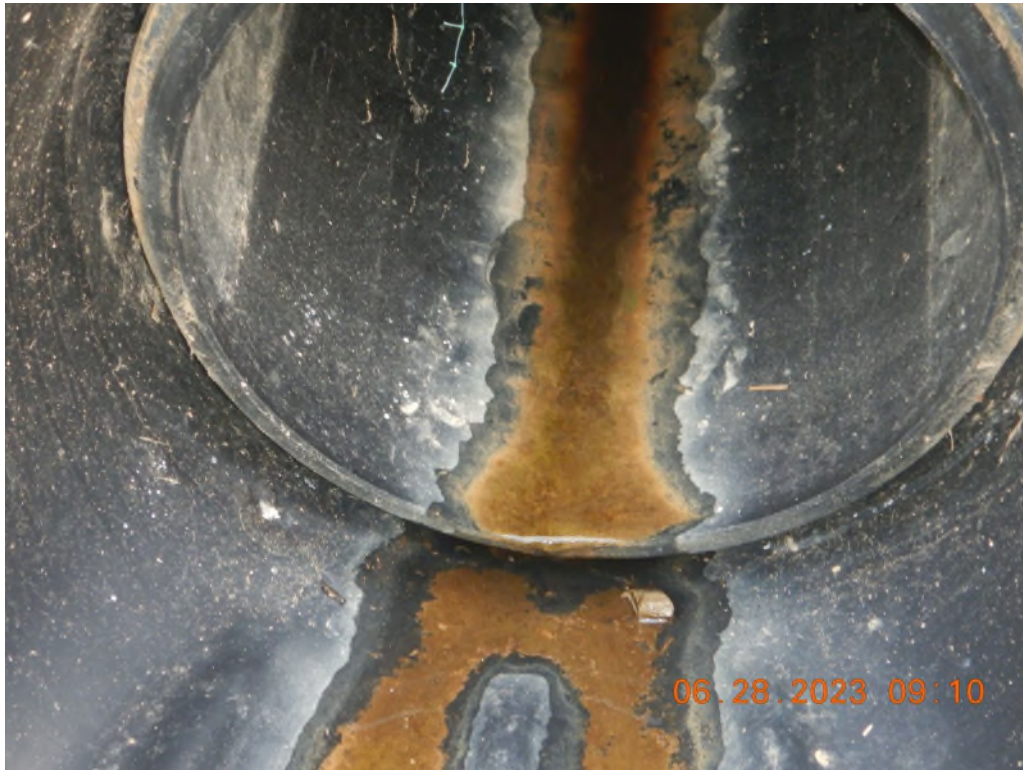
Unstable inlets traversing into Sediment Trap 1. Also shown is a lack of a 50% wet storage as required in the SWPPP.

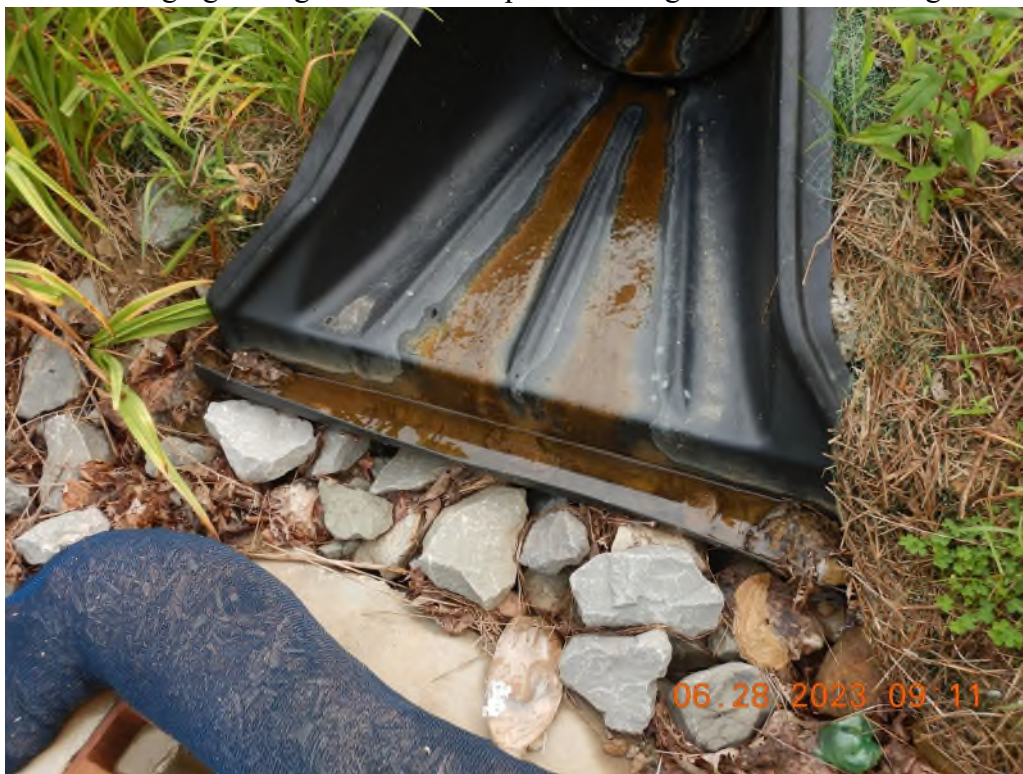
This is the outlet of Sediment Trap 1 showing evidence of a leak within the structure as water is discharging through the outlet despite not being at a 50% wet storage.

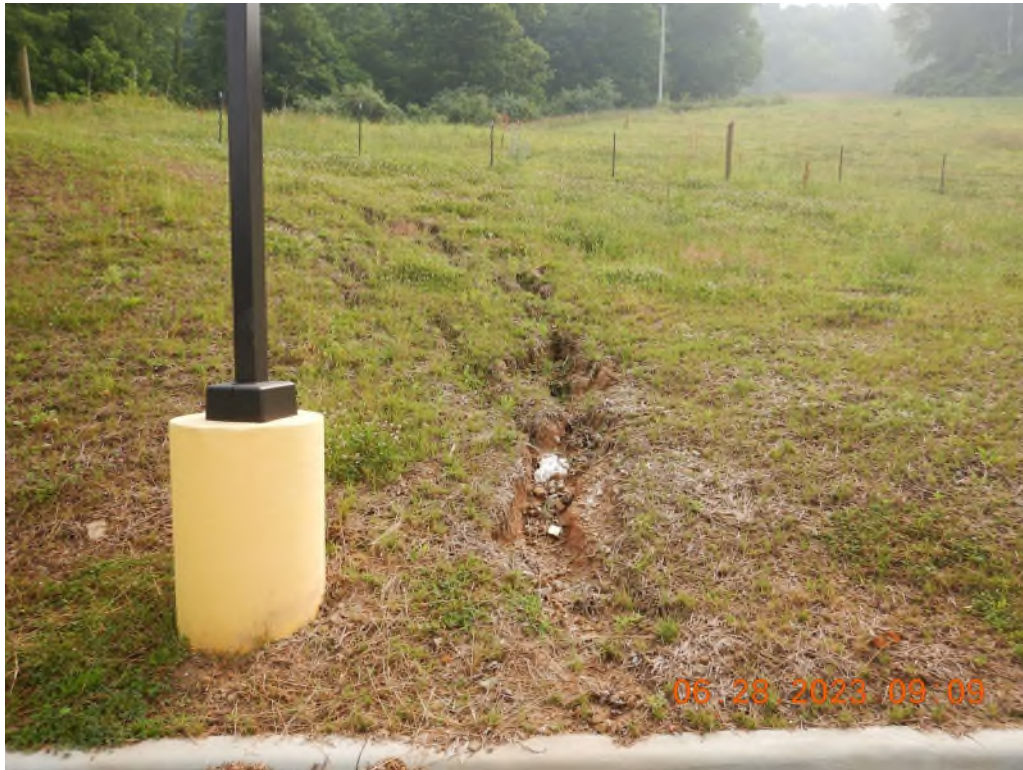
Evidence of sediment deposits off of the company's LOD.

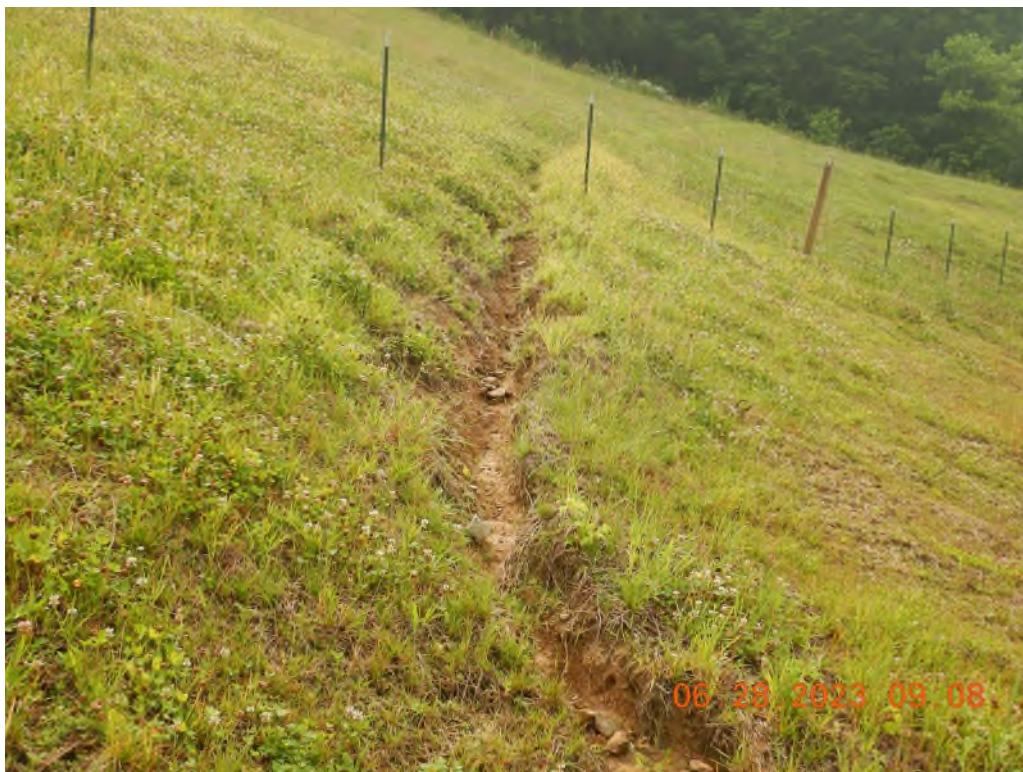
An erosion gully noted near the earthen slip portion of the site. This is due to a concentrated flow going across a non-stabilized surface.

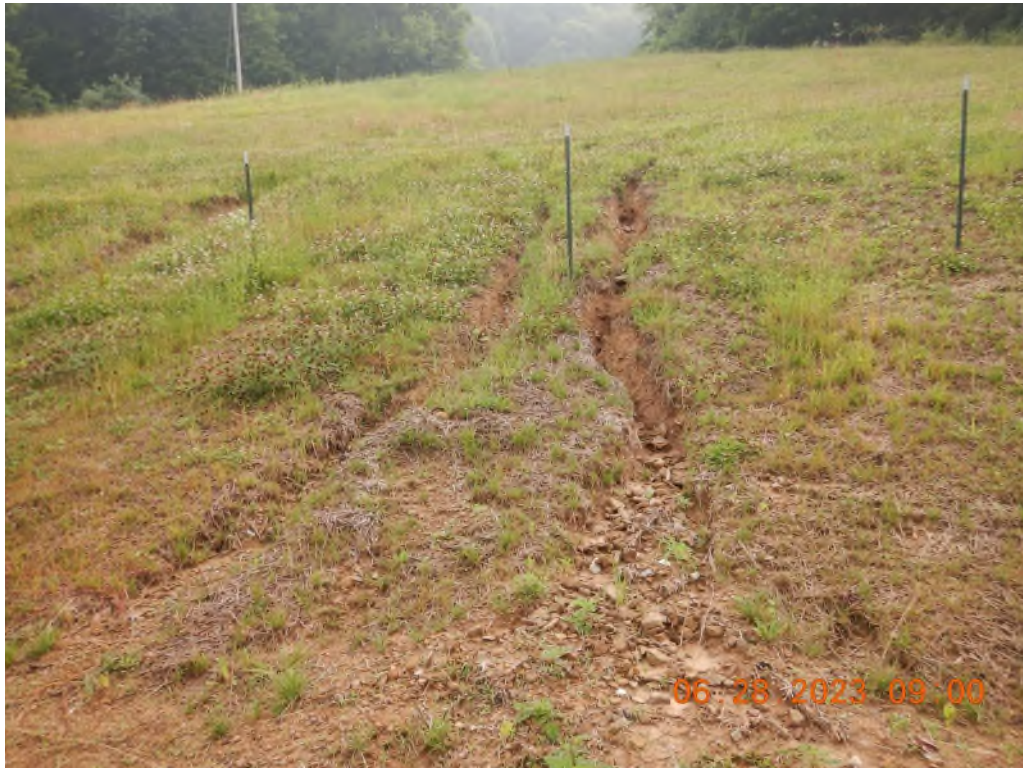
Another erosion gully noted near the earthen slip portion of the site. This is due to a concentrated flow going across a non-stabilized surface.

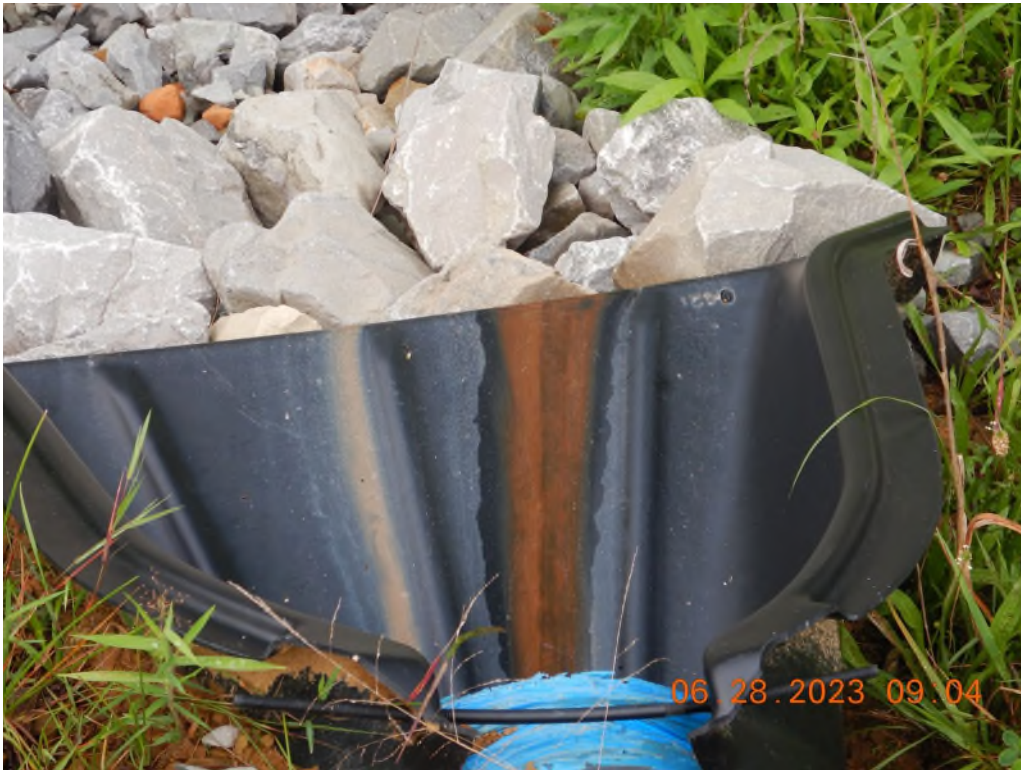
The drainage point of the sediment trap.
