**CONSENT ORDER
ISSUED UNDER THE
WATER POLLUTION CONTROL ACT
WEST VIRGINIA CODE CHAPTER 22, ARTICLE 11**

TO: CD DG Wallace, LLC
ATTN: Josh Allen
9461 Kenwood Road
Cincinnati, OH 45242

DATE: April 23, 2024

ORDER NO.: 10227

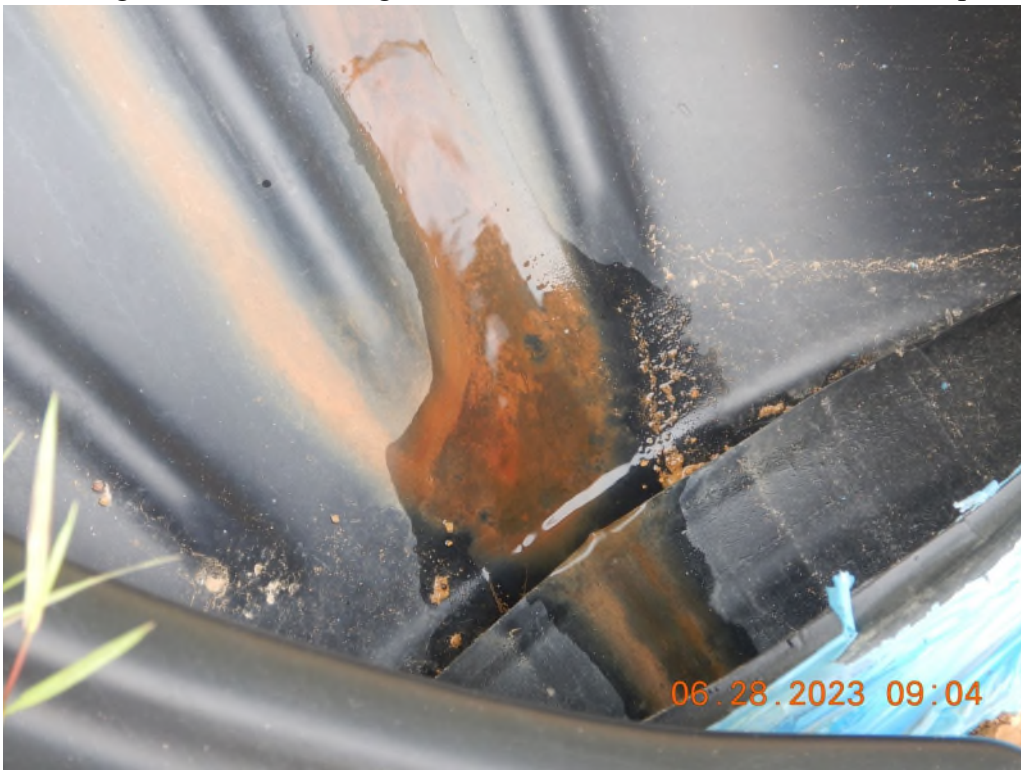
A photo taken at the outlet of the Sediment Trap 2. As shown, there is evidence of water discharging through the outlet meaning there is a leak within the structure of the trap.
