**CONSENT ORDER
ISSUED UNDER THE
WATER POLLUTION CONTROL ACT
WEST VIRGINIA CODE CHAPTER 22, ARTICLE 11**

TO: Harrison County Coal Resources, Inc.
Attn: James R. Turner, Jr.
46226 National Road West
St. Clairsville, OH 43950

ORDER NO.: 10302

Rymer I & II Stream Restoration Site – WVR112355

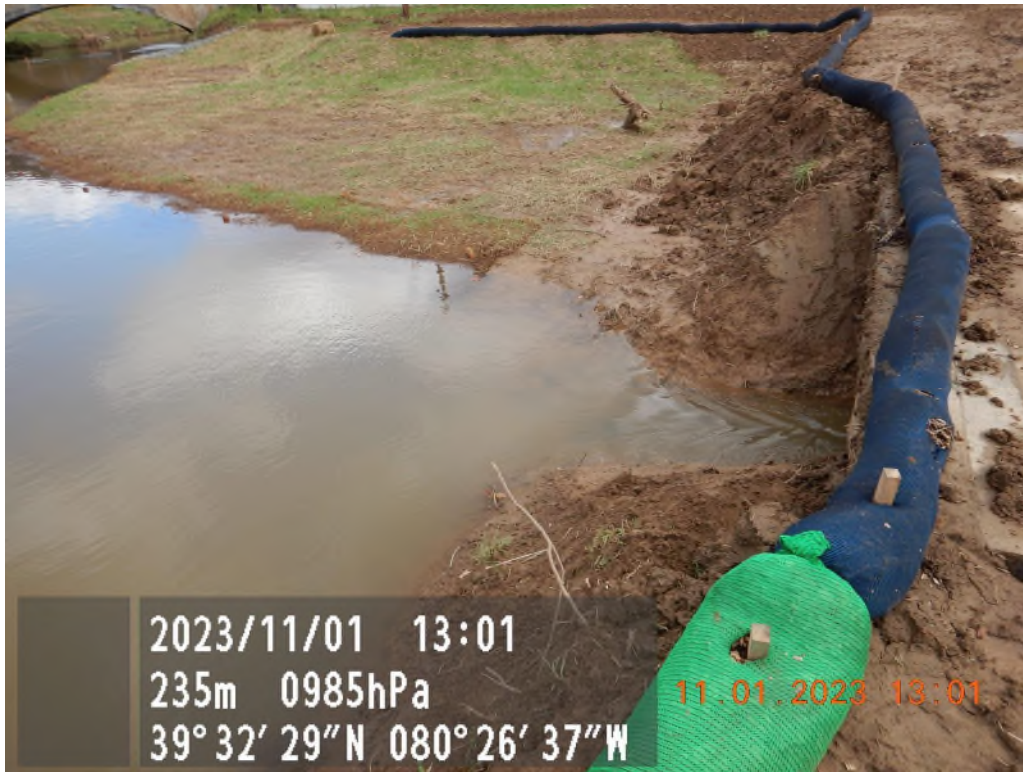
Conditions not allowable as sediment deposit on bottom of Warrior Fork (39° 32 '29"N, 80° 26' 37"W).

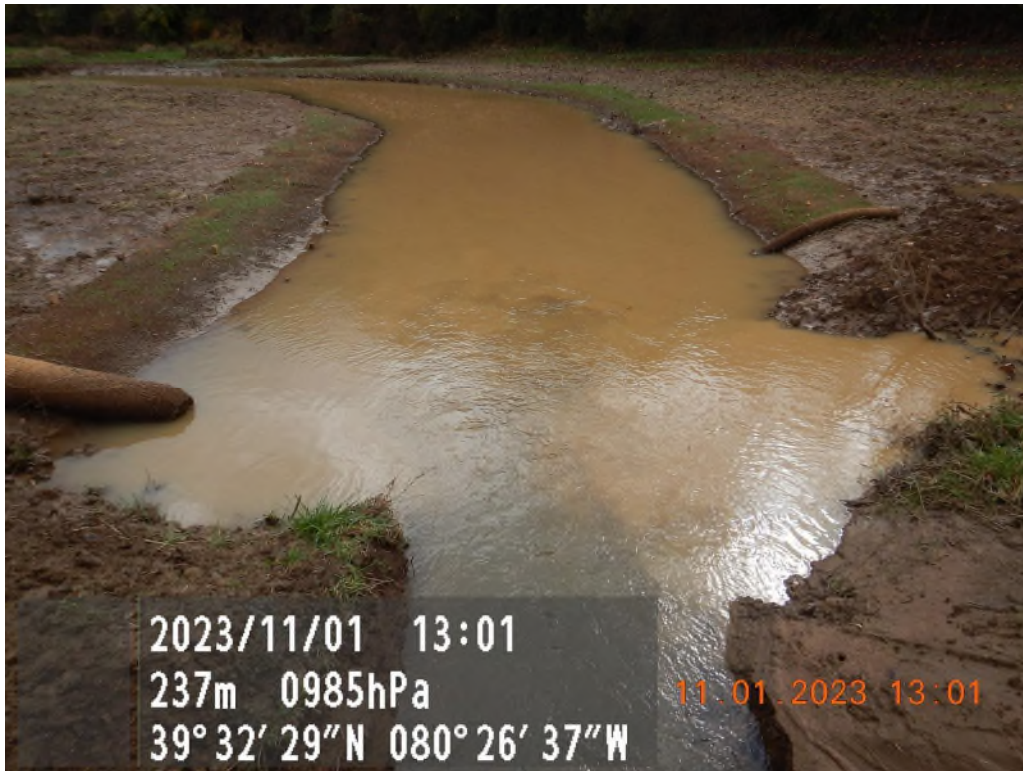
Confluence of Warrior Fork and Buffalo Creek.

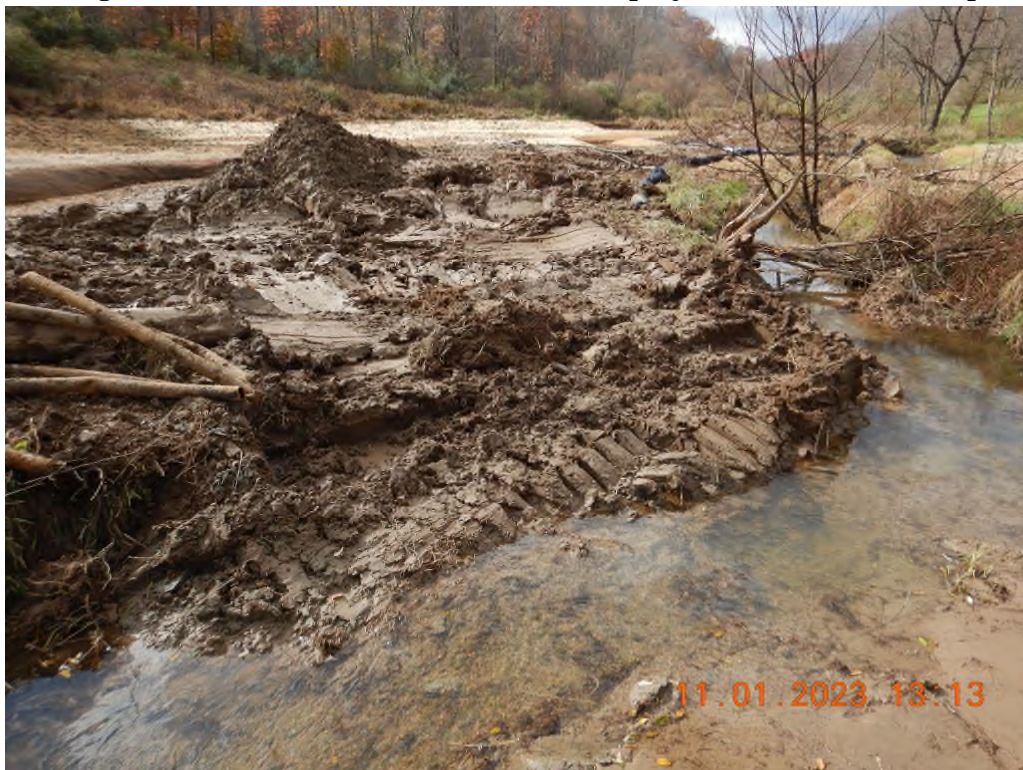
Conditions of Buffalo Creek above the pumping operation.

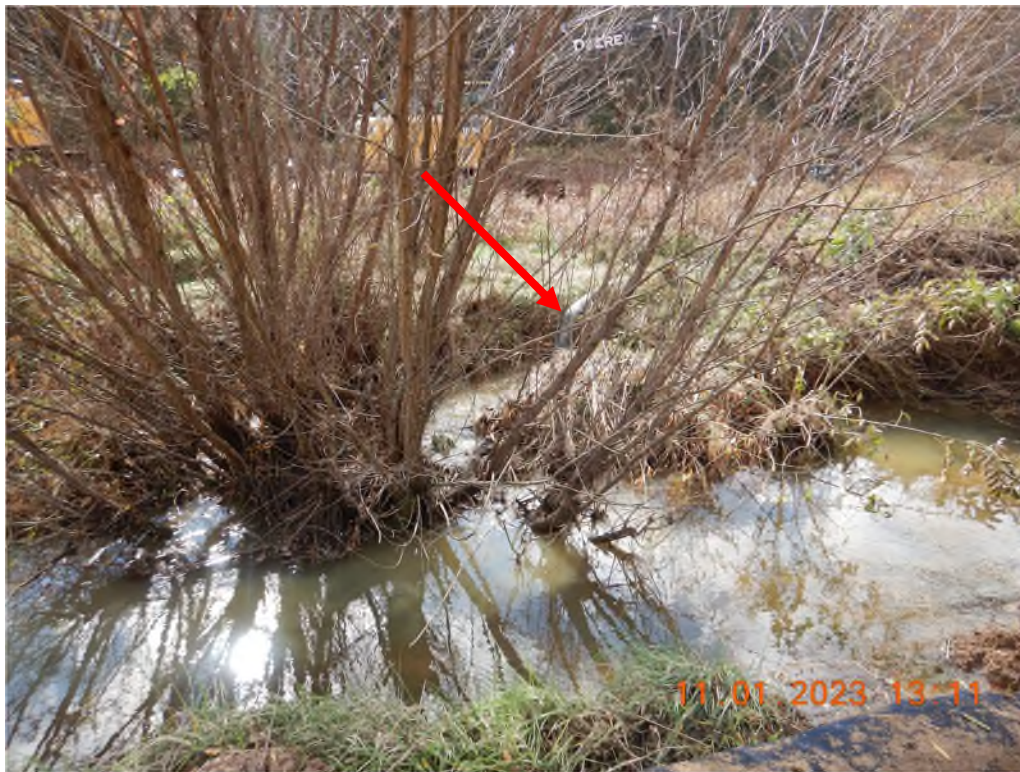
Red arrow shows discharge end of pump is directly in Buffalo Creek.

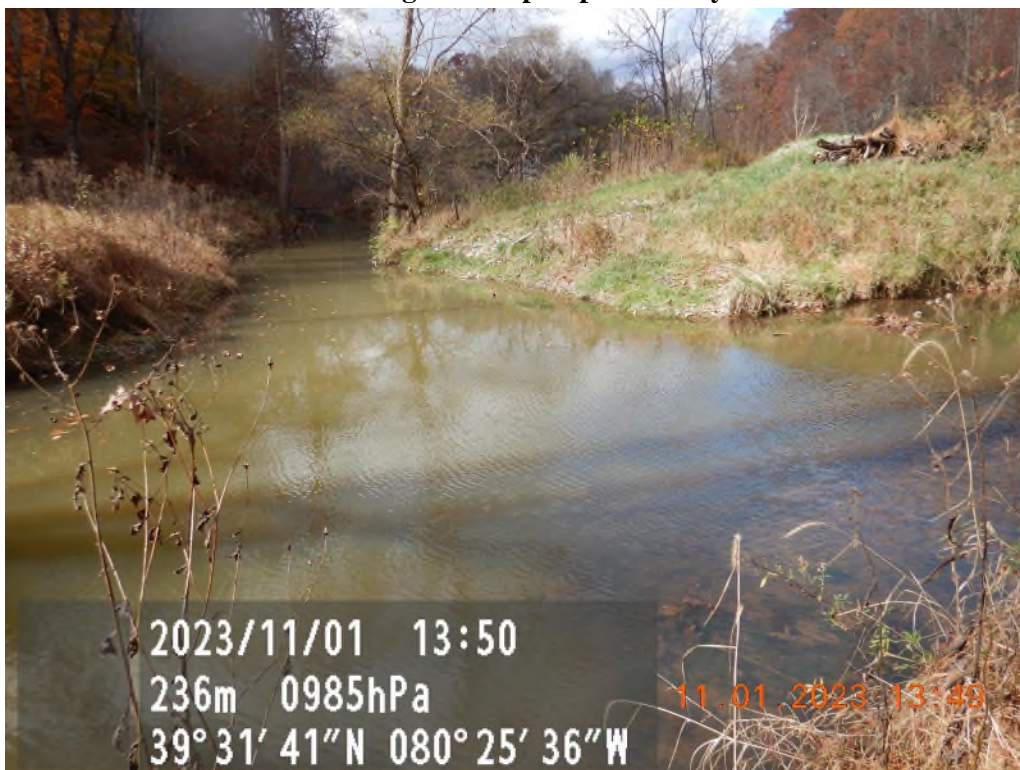
Conditions not allowable as visible settleable solids at the Confluence of Buffalo Creek and Bartholomew Fork (39° 31 '41''N, 80° 25' 36''W).

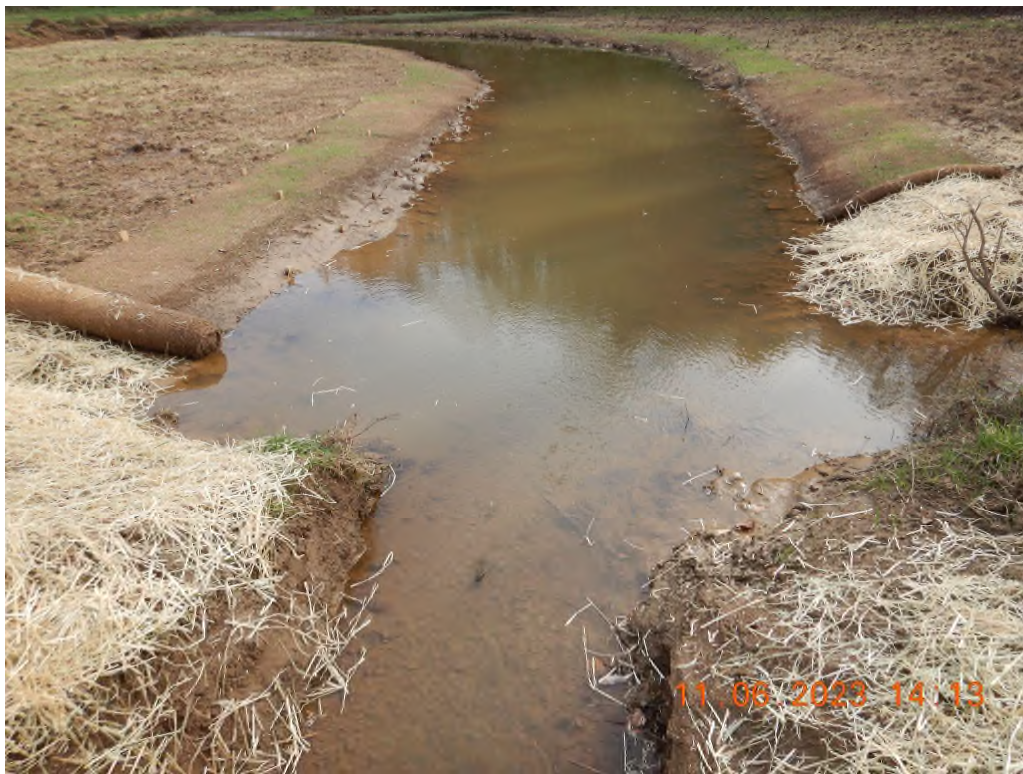
Confluence of Warrior Fork and Buffalo Creek.

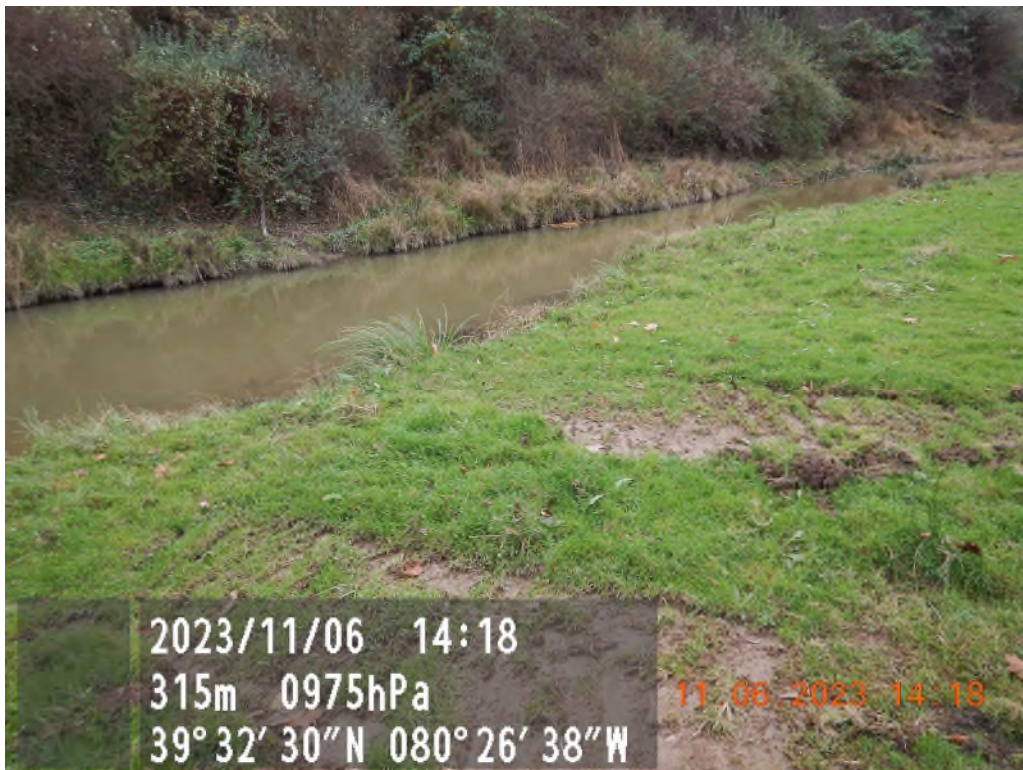
Conditions not allowable - visible settleable solids in Buffalo Creek (39° 32 '30''N, 80° 26' 38''W).

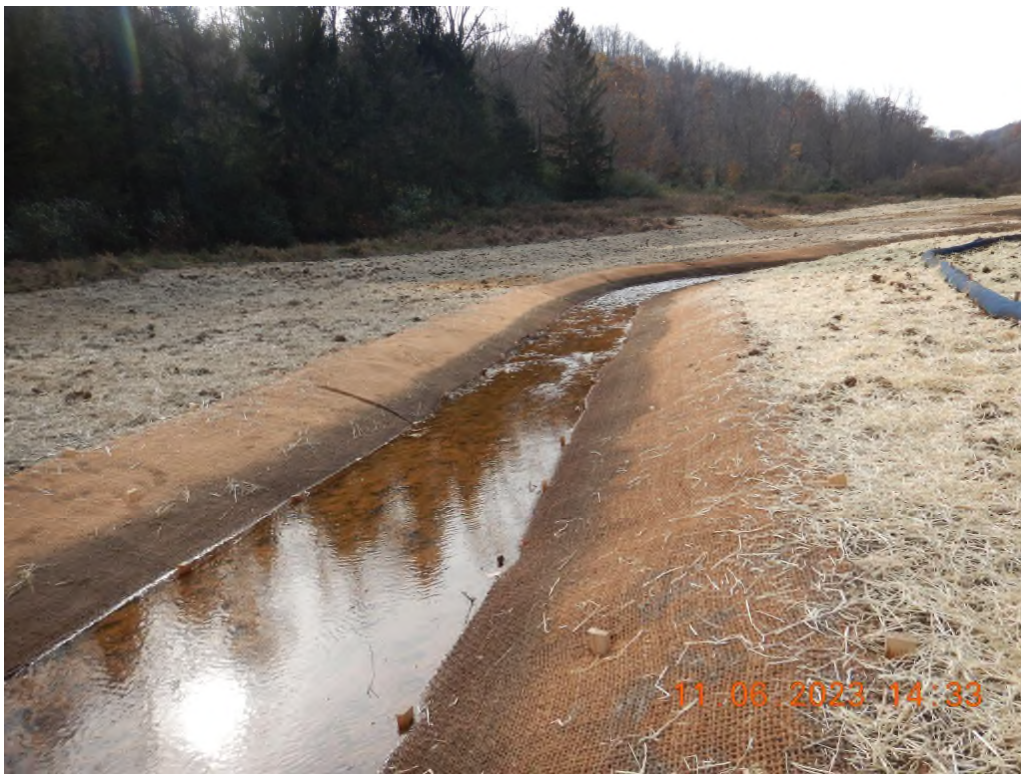
Area above active work area where water is clear in Buffalo Creek. Missing perimeter controls along the edge of the stream.

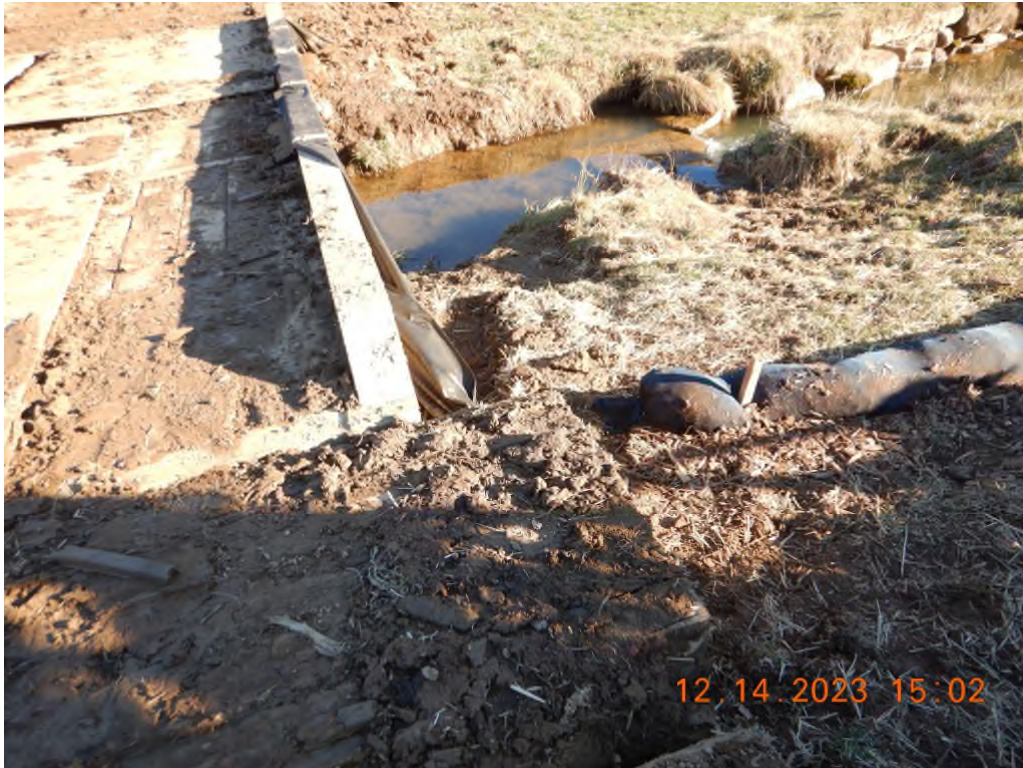
Perimeter controls were not tied to the bridge correctly creating bypasses in the controls.

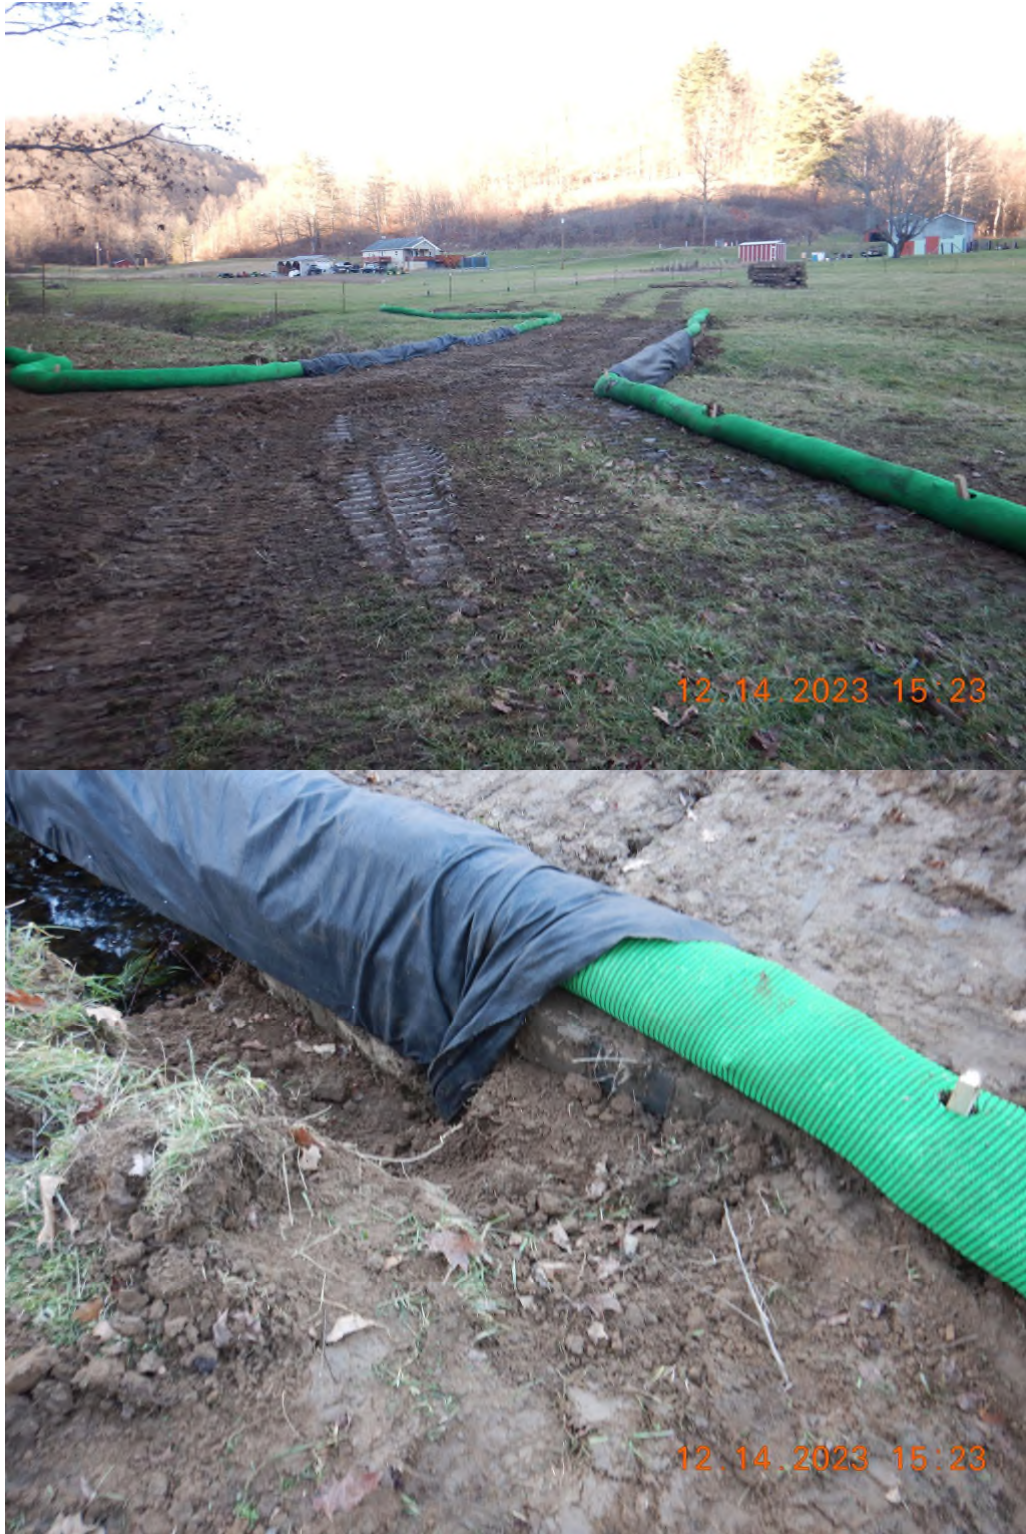
Temporary stream crossing bridge was excavated to ground level to be installed. Temporary bridge was not installed as depicted in the SWPPP.

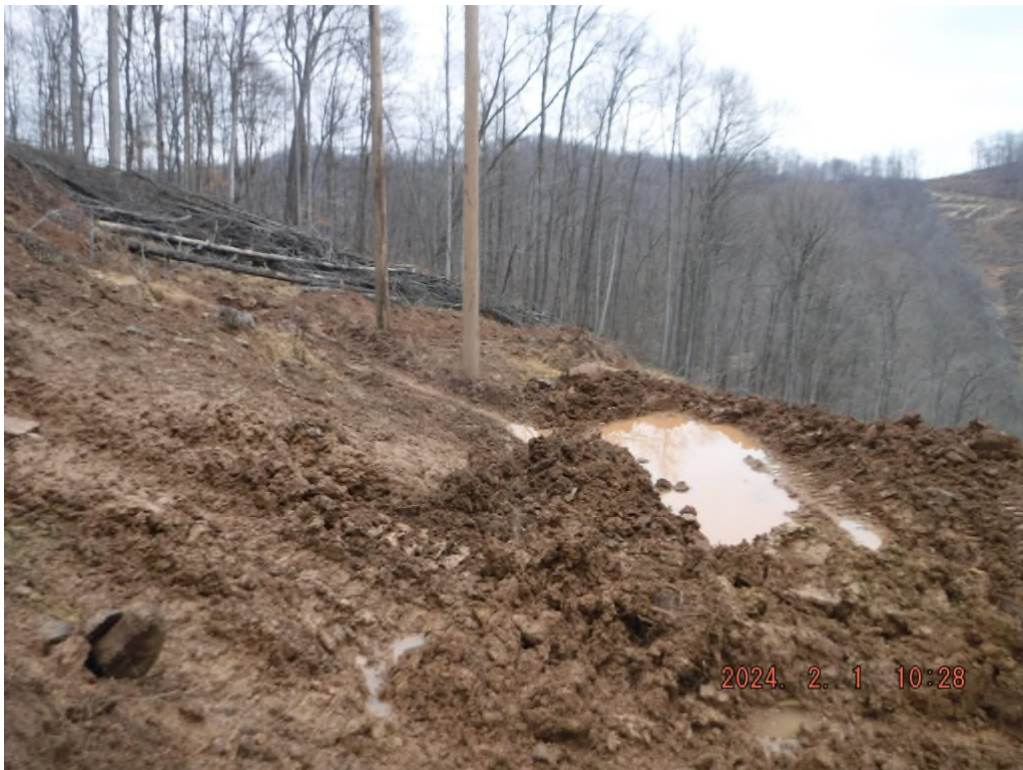
Photo # DSCF1501: Area at or near station 165+00 that is missing BMPs (BSRF or super silt fence).

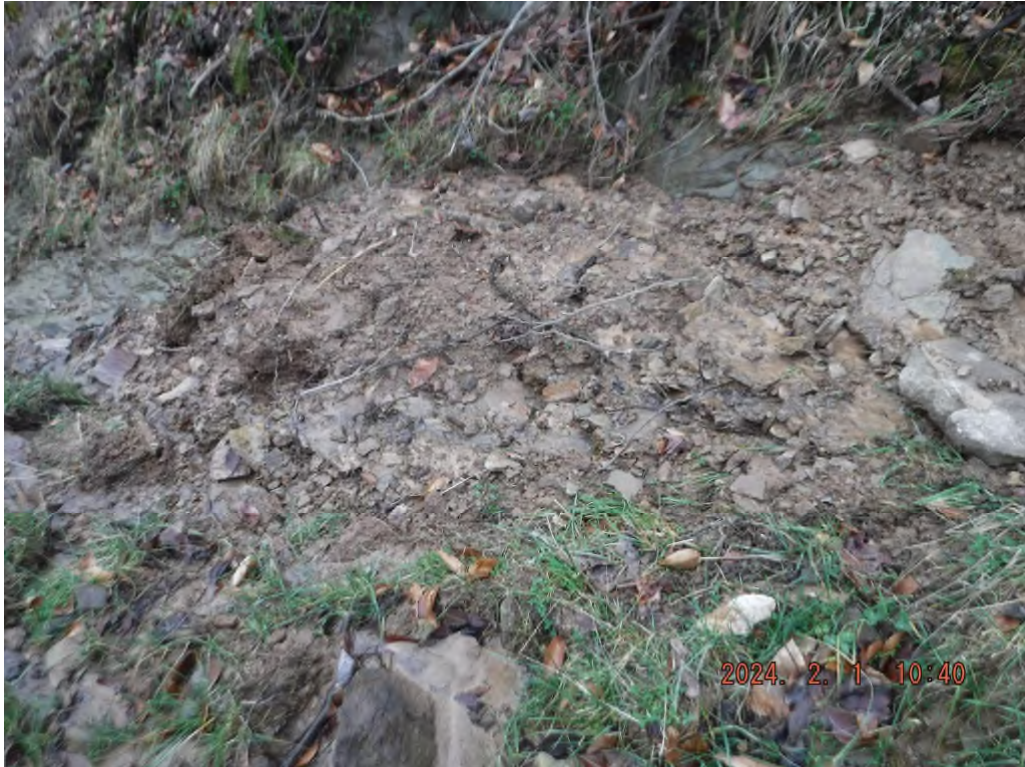
Photo # DSCF1523: Sediment deposits in Ephemeral UNT Price Run at or near N 39° 30.7128', W 80° 32.0076.

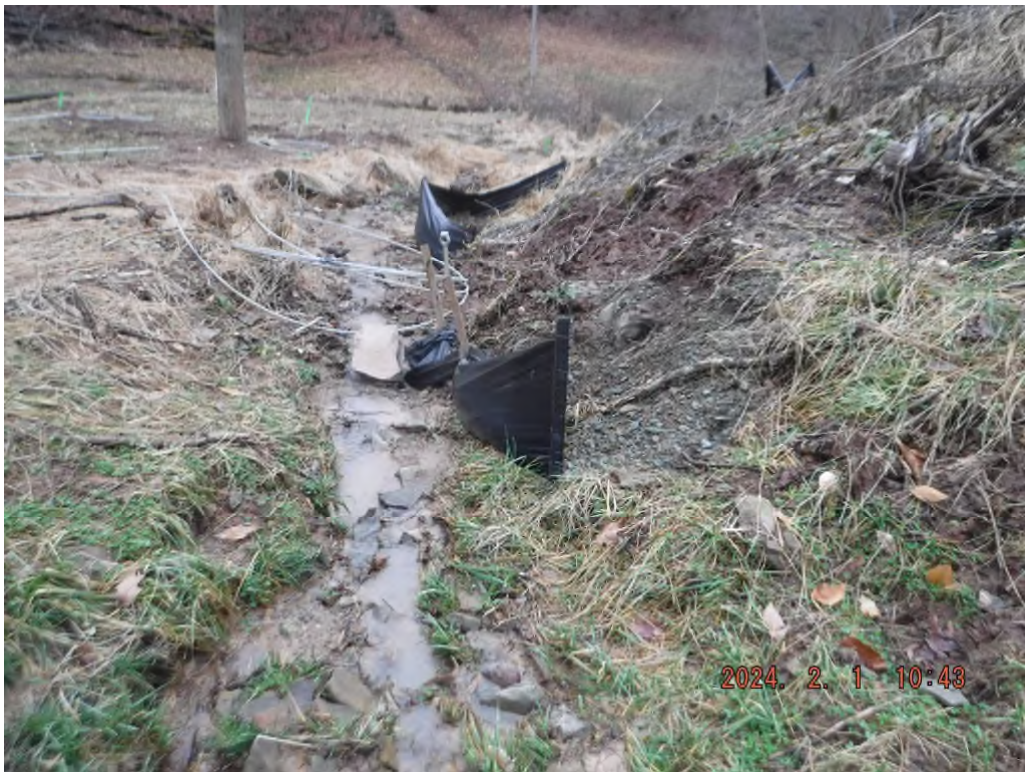
Photo # DSCF1531: Sediment laden water and non-maintained BMPs. The BMPs are not installed as detailed in the SWPP.

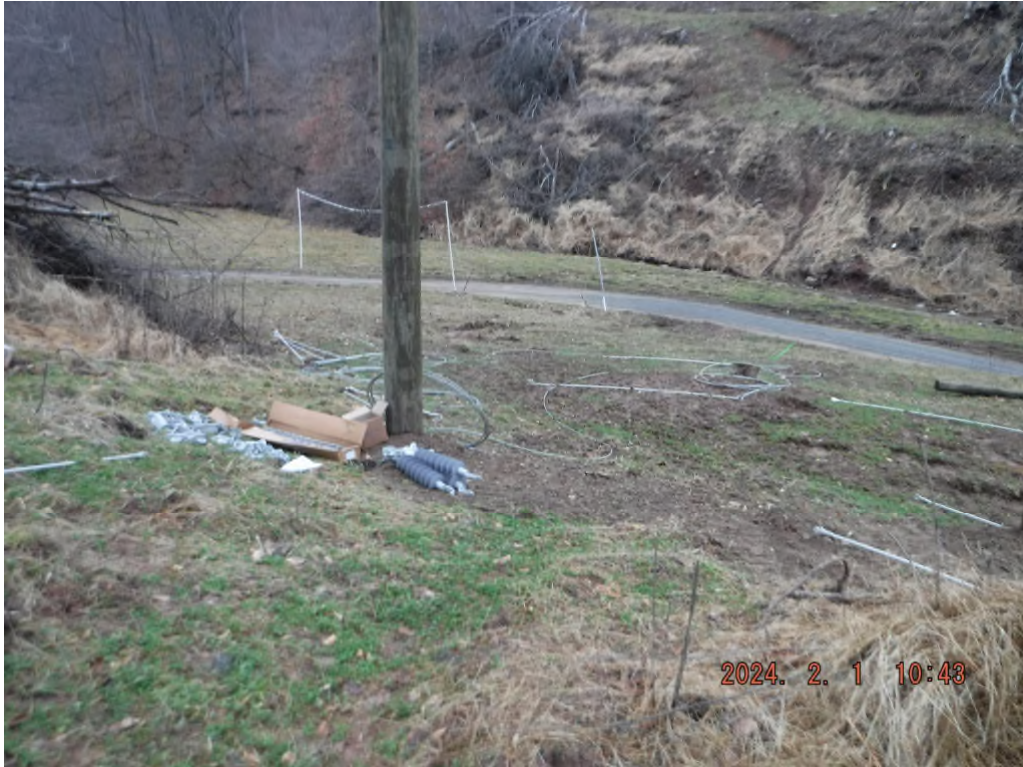
Photo # DSCF1532: Area at or near station 152+00 that is missing BMPs.

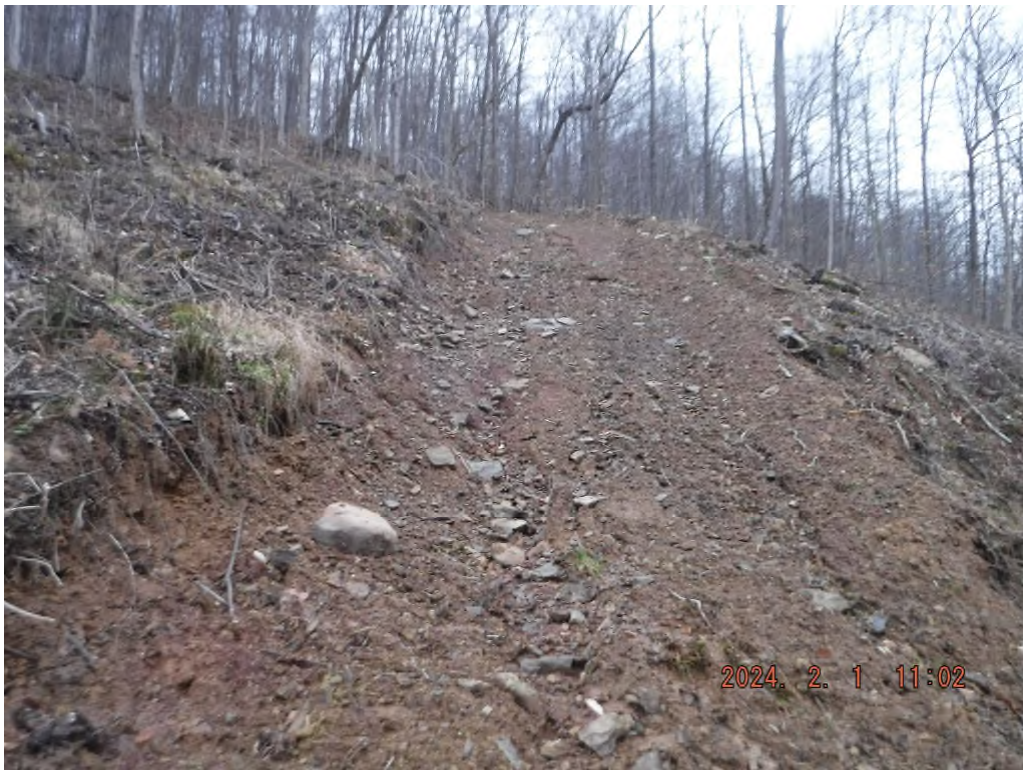
Photo # DSCF1566: Disturbed travel lane off LOD between stations 137+00 and 150+00.

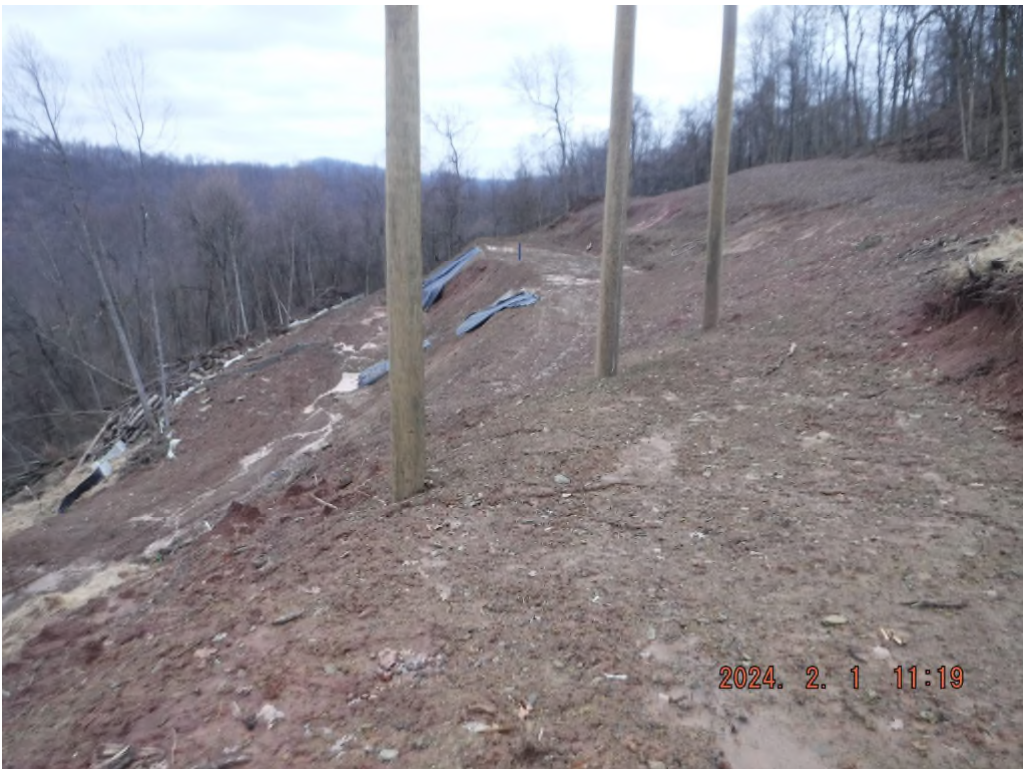
Photo # DSCF1595: Area that is missing BMPs (BSRF or super silt fence) at or near station 137+00.

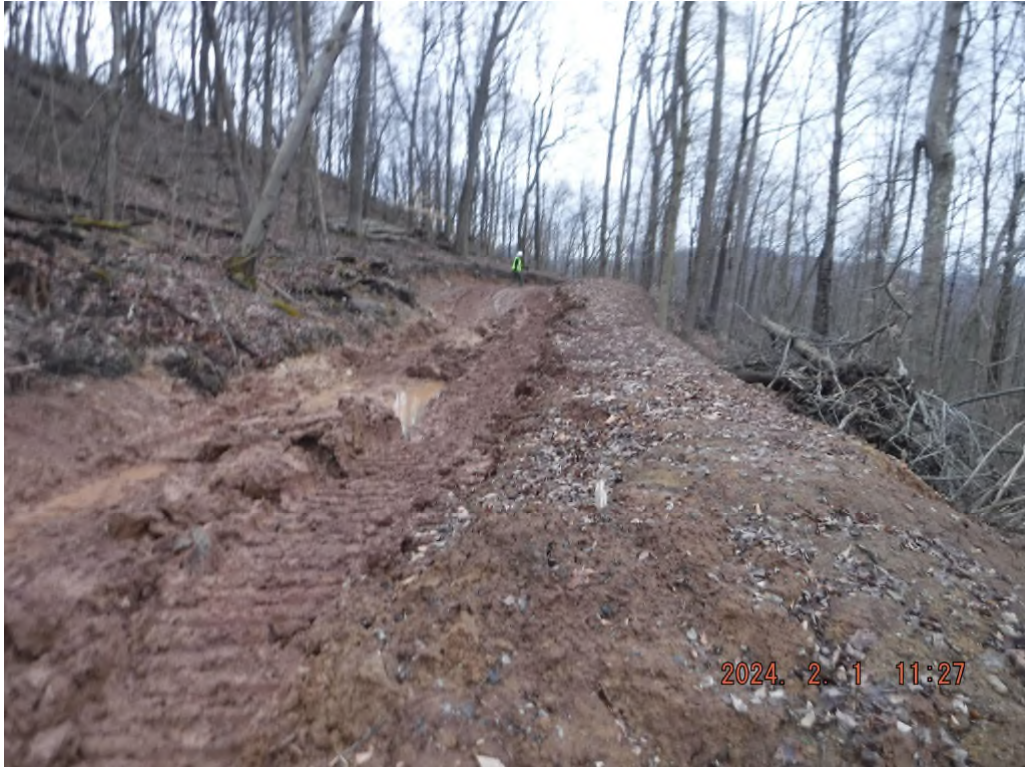
Photo # DSCF1607: Unpermitted access road that leaves the ROW at or near N 39° 30.8151', W 80° 31.7010'.

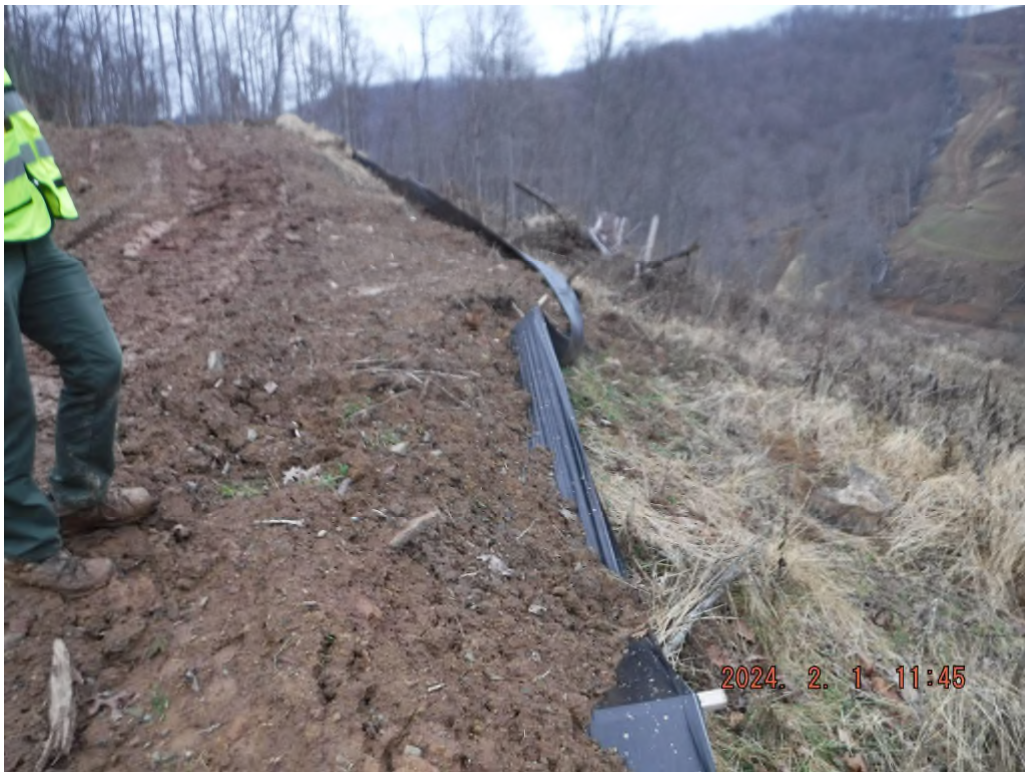
Photo # DSCF1632: Silt fence lacks maintenance at or near station 123+00 and is not the BMP (BSRF or super silt fence) described in the SWPPP.

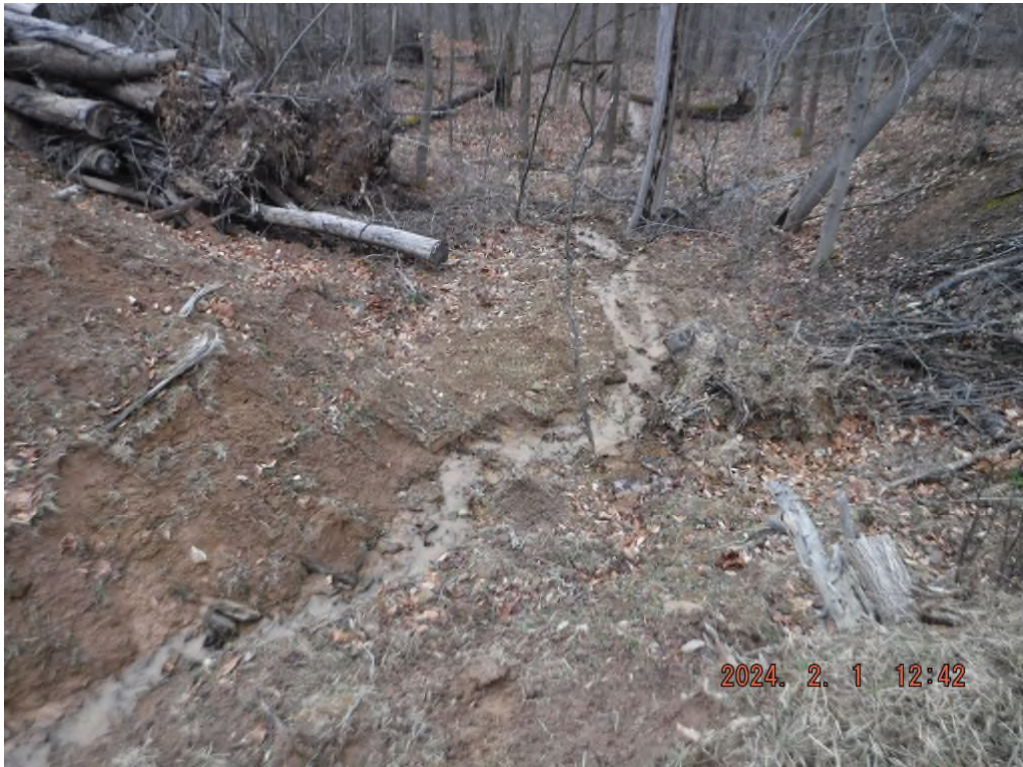
Photo # DSCF1718: Conditions not allowable at or near N 39° 31.0515', W 80° 31.0495'.

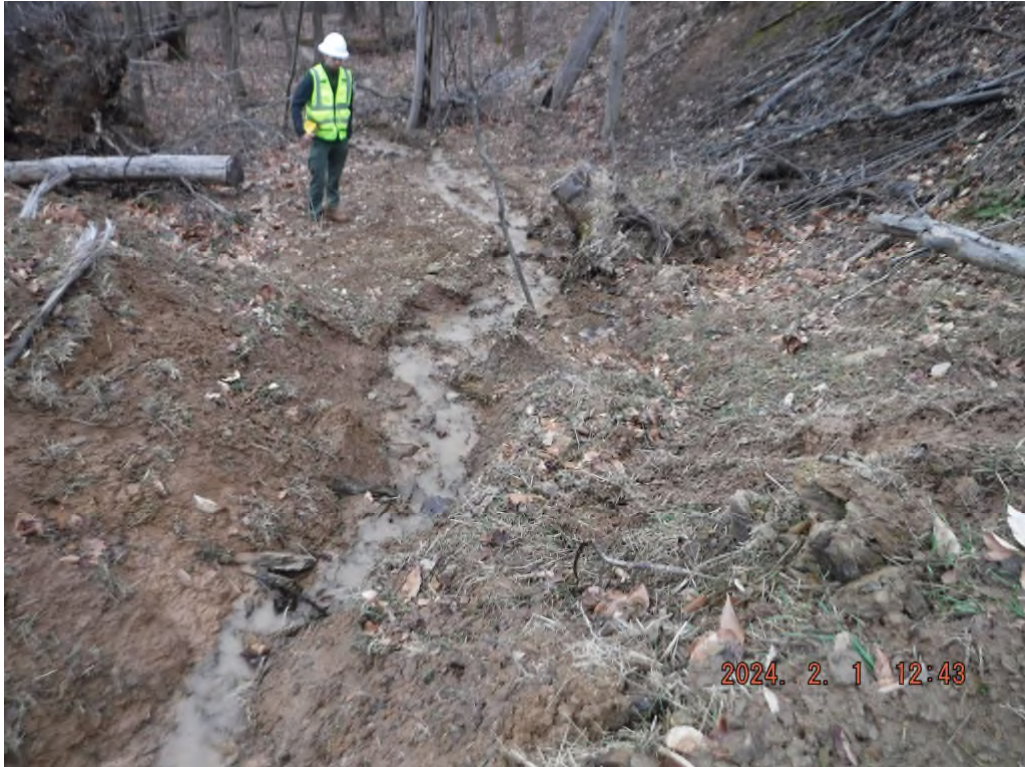
Photo # DSCF1722: Conditions not allowable in UNT Buck Run at or near N 39° 31.0515', W 80° 31.0495'.

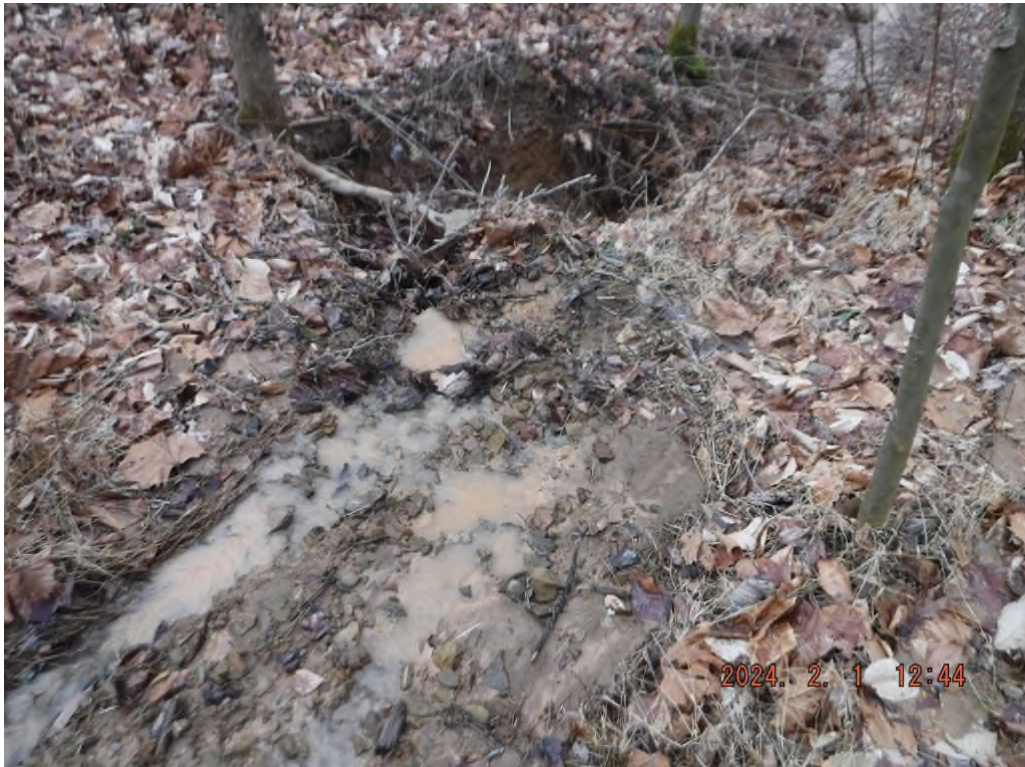
Photo # DSCF1725: Conditions not allowable in UNT Buck Run downstream of N 39° 31.0515', W 80° 31.0495'.

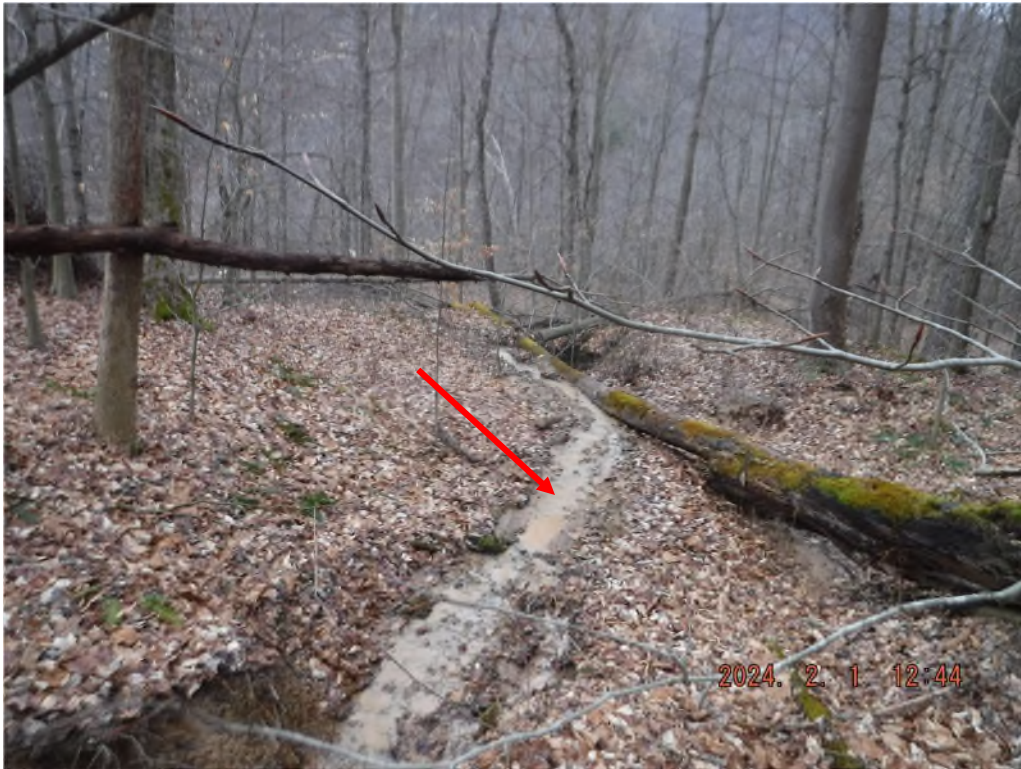
Photo # DSCF1728: Conditions not allowable in UNT Buck Run (red arrow) with visibly settleable solids downstream of N 39° 31.0515', W 80° 31.0495'.

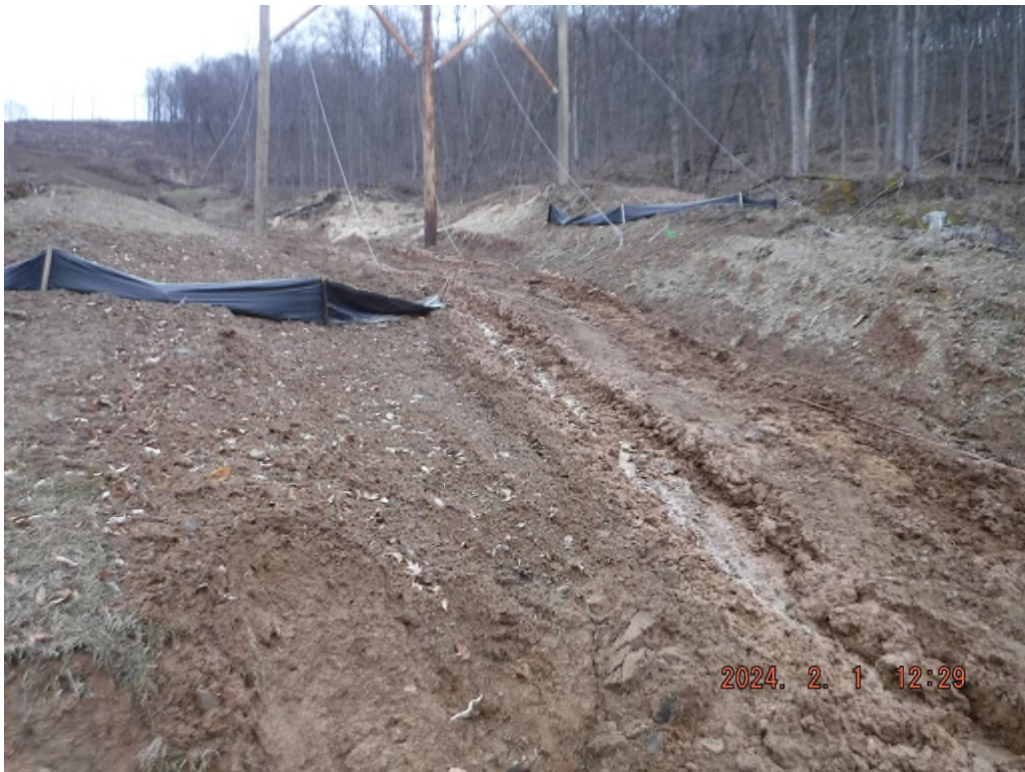
Photo # DSCF1704: BMPs at or near station 110+00 lacked maintenance and are not the BMPs detailed in the SWPPP.

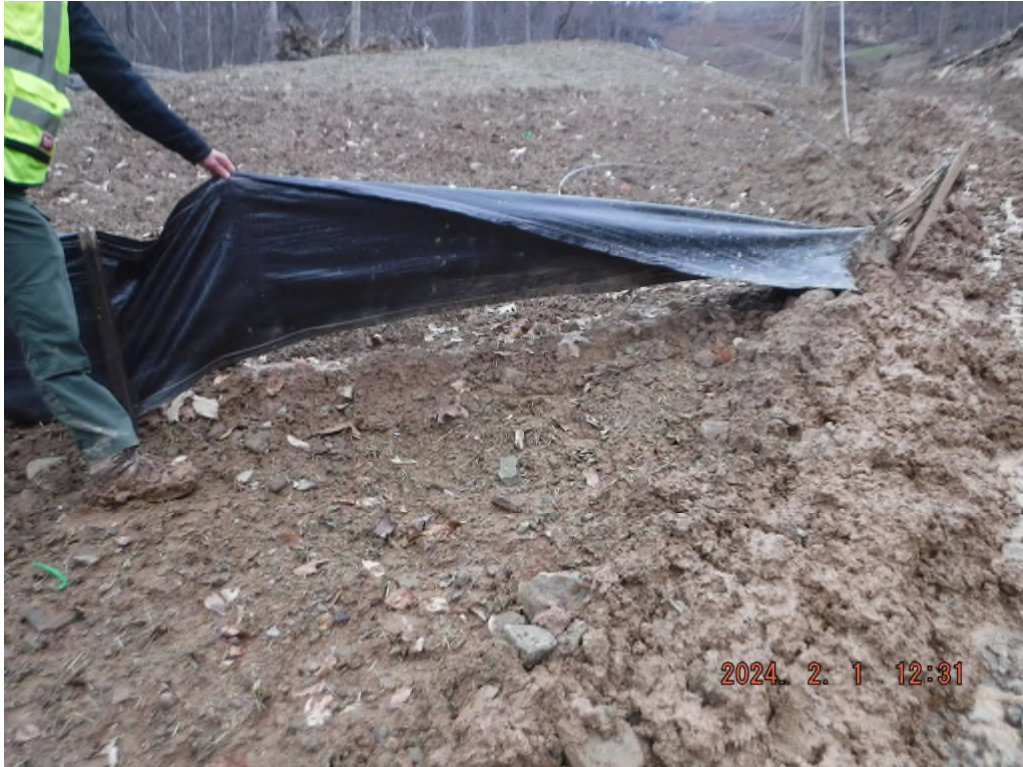
Photo # DSCF1707: Improperly installed silt fence, which is not the BMP detailed in the SWPPP.

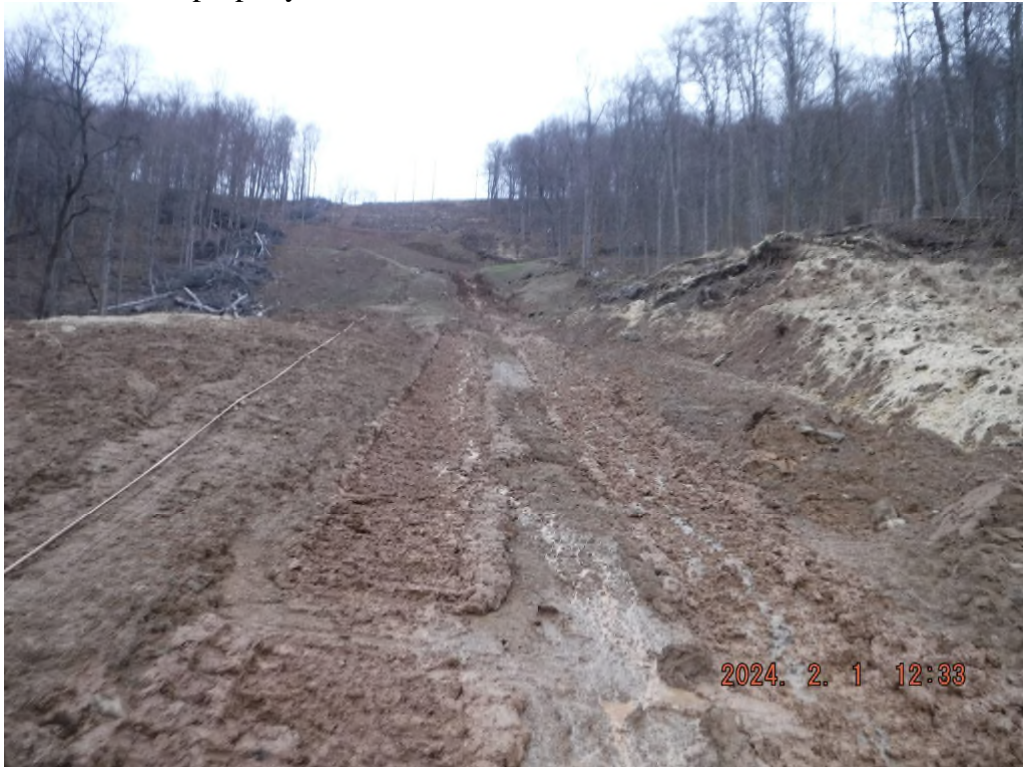
Photo # DSCF1710: Disturbance outside of the permitted LOD.
between stations 110+00 and 100+00

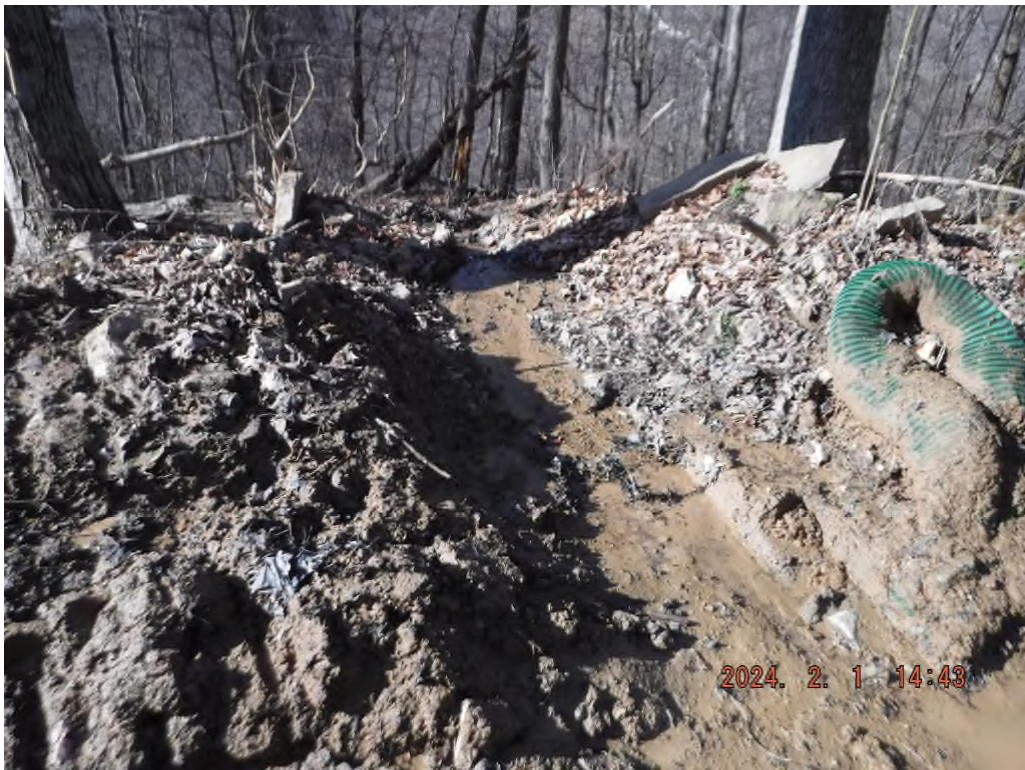
Photo # DSCF1789: Sediment laden water leaving the unstabilized existing access road found on Sheet 2 of the drawings in the SWPPP.

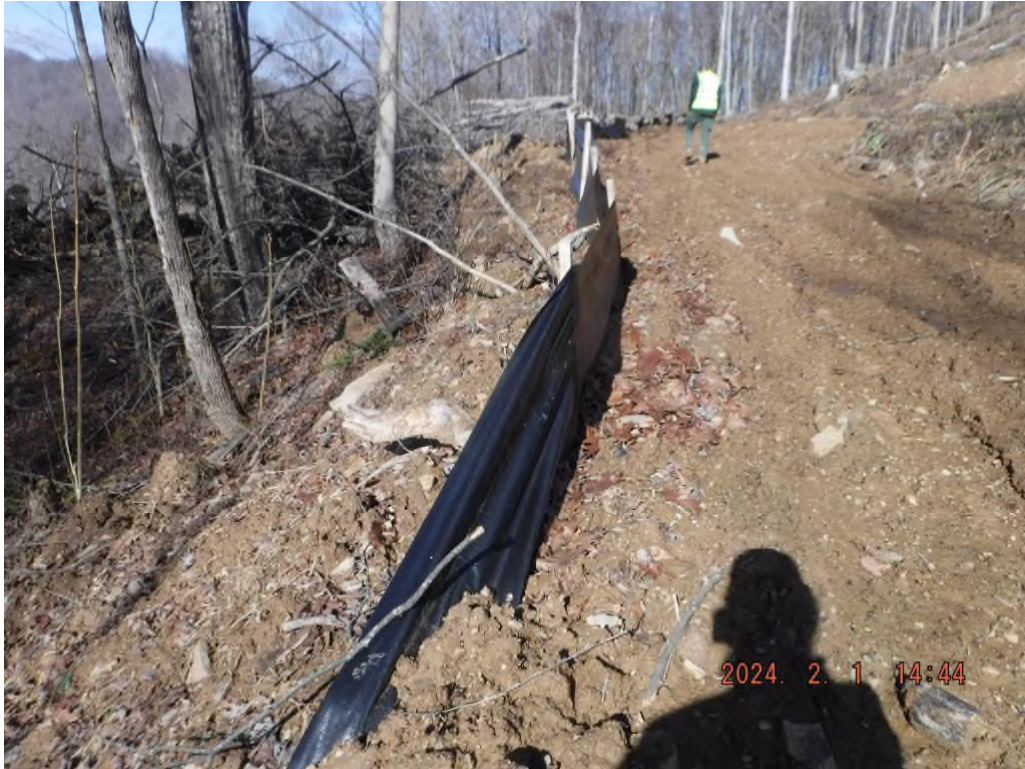
Photo # DSCF1792: Incorrect BMPs installed at or near station 63+00. The SWPPP calls for BSRF or super silt fence.
