**CONSENT ORDER
ISSUED UNDER THE
WATER POLLUTION CONTROL ACT
WEST VIRGINIA CODE CHAPTER 22, ARTICLE 11**

TO: Harrison County Coal Resources, Inc.
Attn: James R. Turner, Jr.
46226 National Road West
St. Clairsville, OH 43950

ORDER NO.: 10302

Rymer I & II Stream Restoration Site – WVR112355

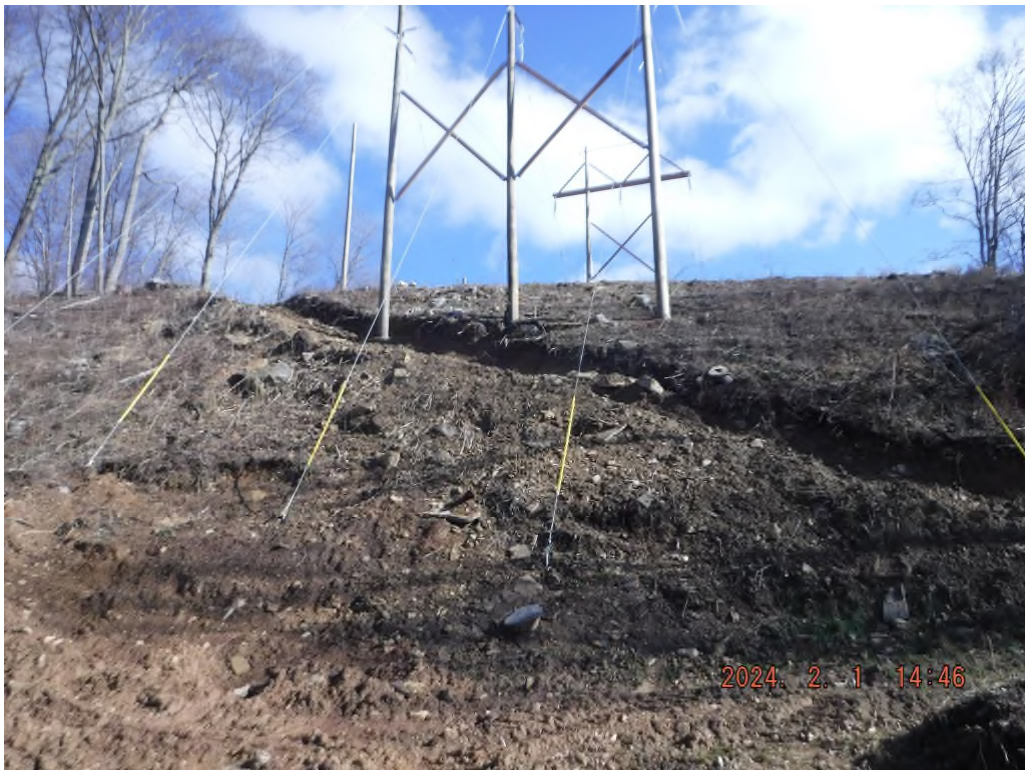
Photo # DSCF1798: Area missing BMPs (BSRF or super silt fence) at or near station 63+00.

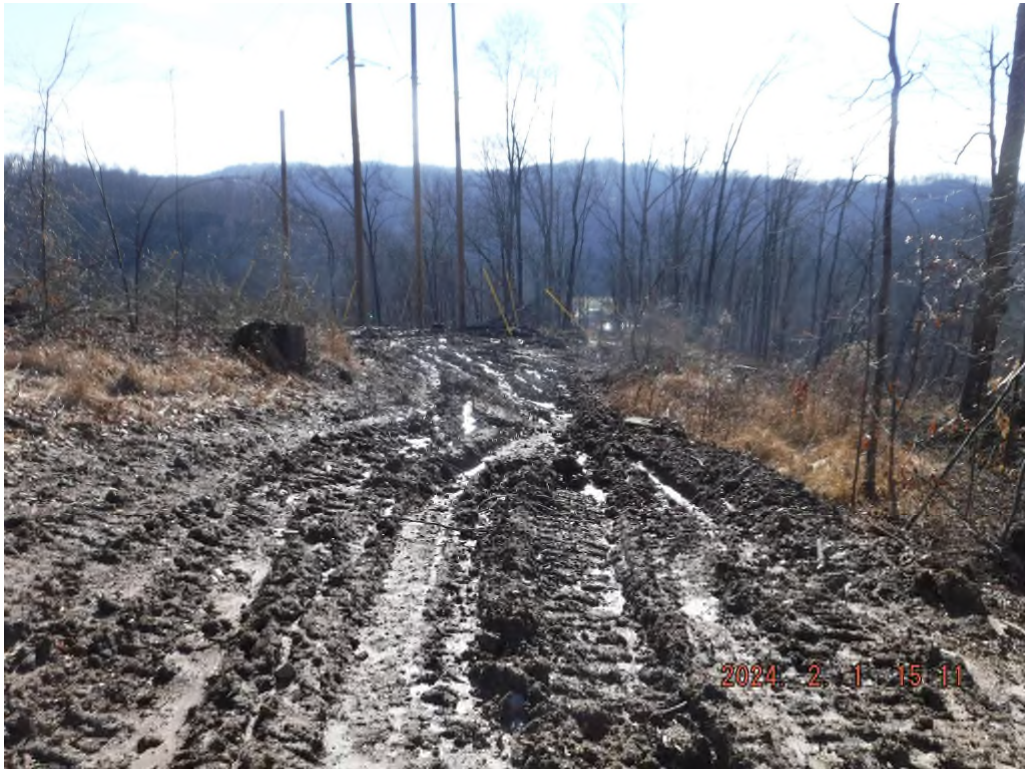
Photo # DSCF1828: Proposed access road found on Sheet 2 of the drawings in the SWPPP lacks stabilization.

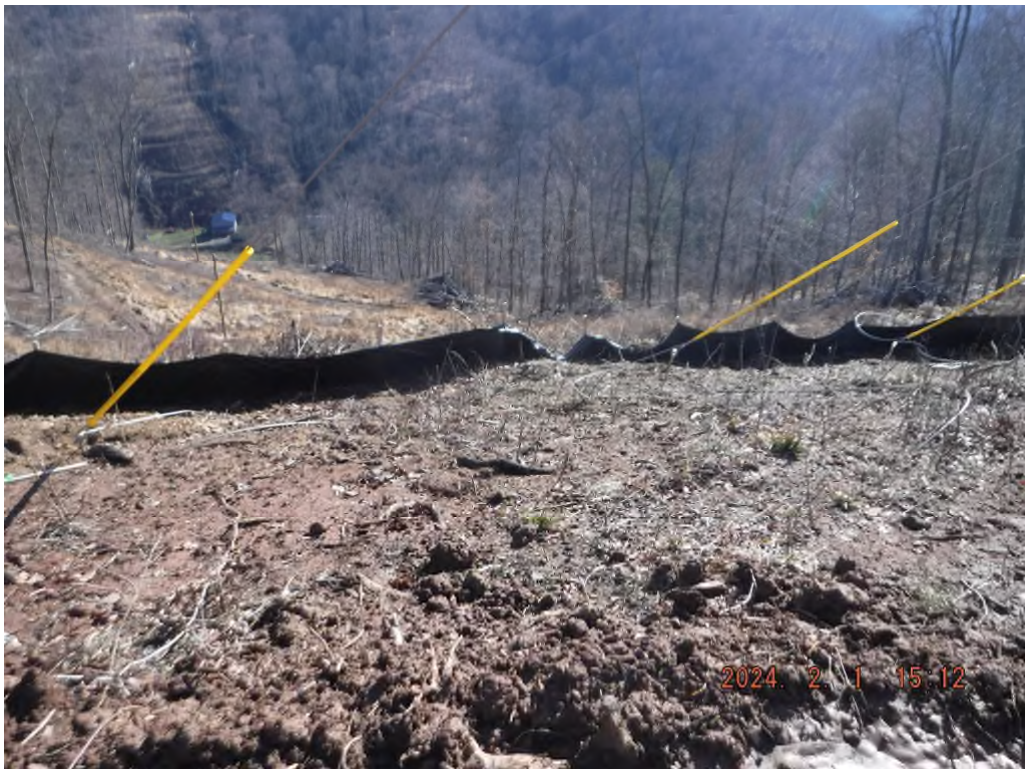
Photo # DSCF1830: Incorrect BMPs installed which lack maintenance at or near station 47+00. The SWPPP calls for BSRF or super silt fence.

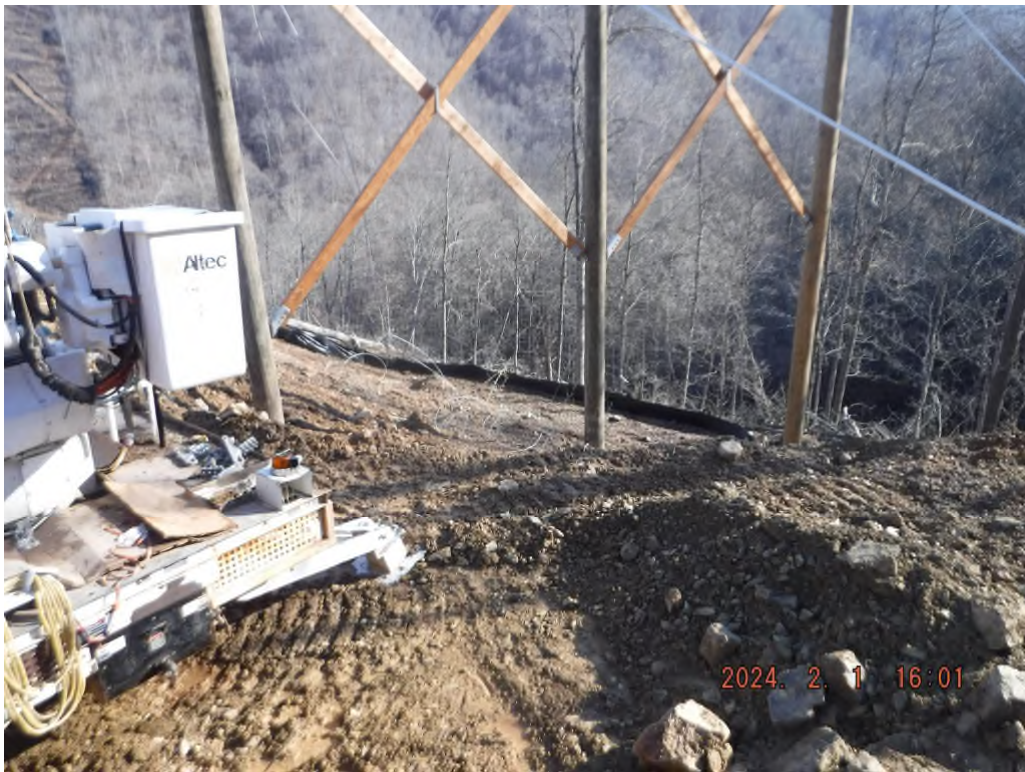
Photo # DSCF1877: BMPs are not installed as detailed in the SWPPP at or near station 80+00.

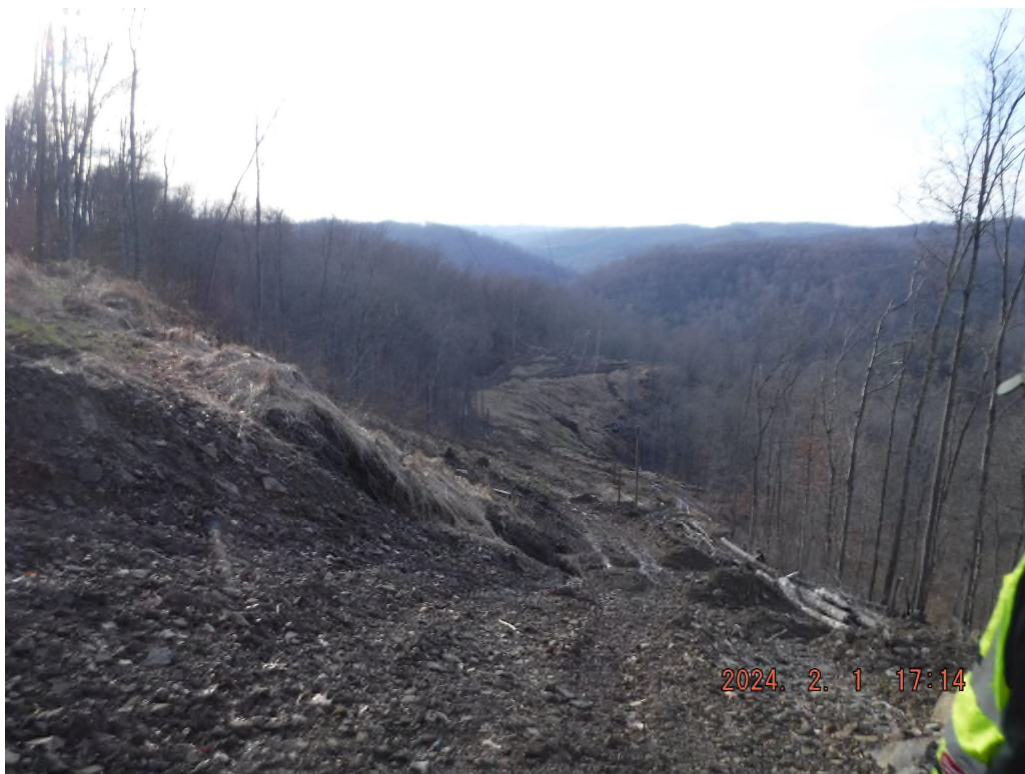
Photo # DSCF1894: Disturbed area outside of the LOD between station 12+00 and 25+00

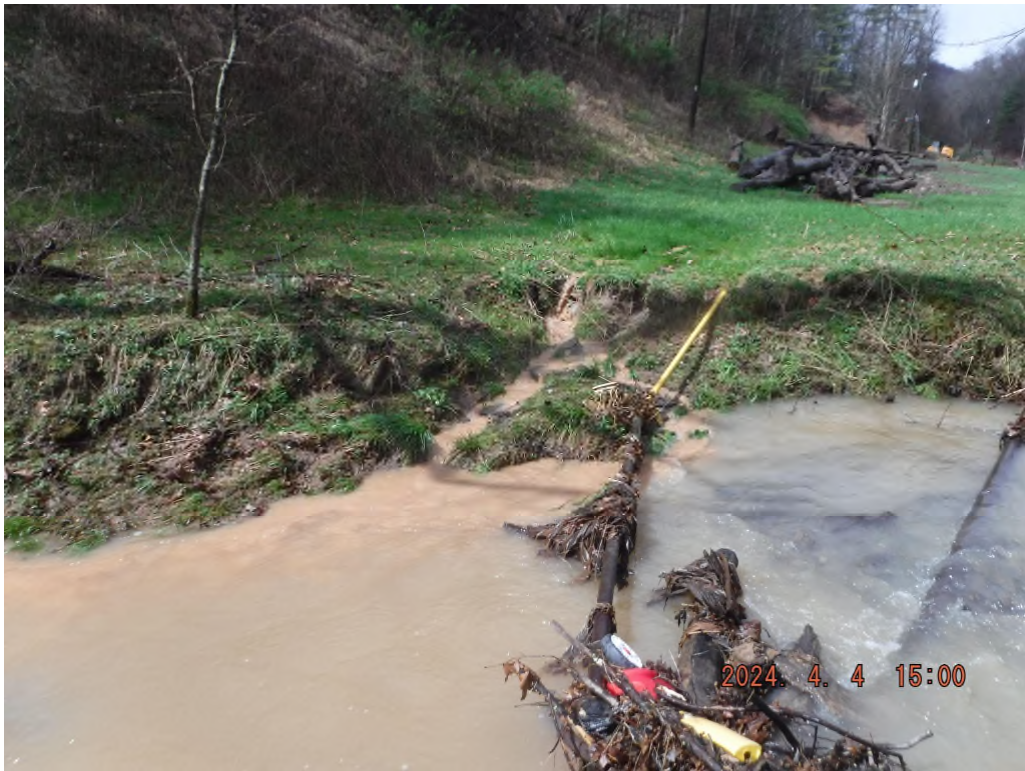
Photo # DSCF3995: Sediment laden water entering Buck Run at or near N 39° 31.1185', W 80° 31.2579' creating conditions not allowable in the form of distinctly visible settleable solids.

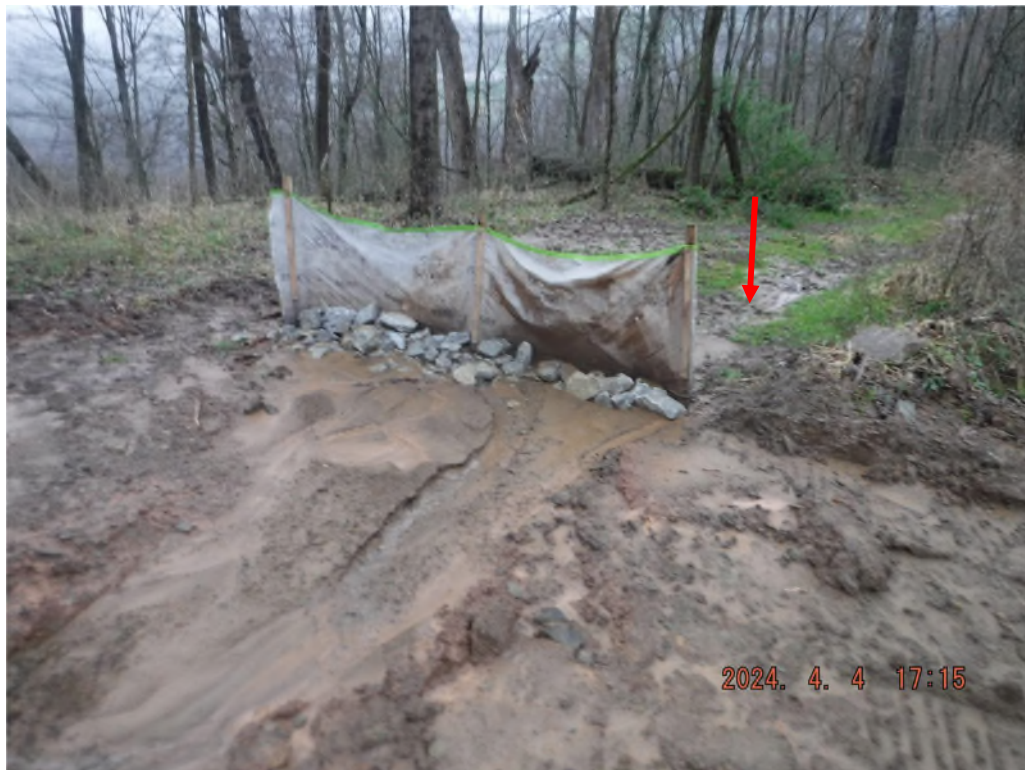
Photo # DSCF4153: Sediment laden water leaving the proposed access road on sheet 1 at or near N 39° 30.4346', W 80° 29.3473'.

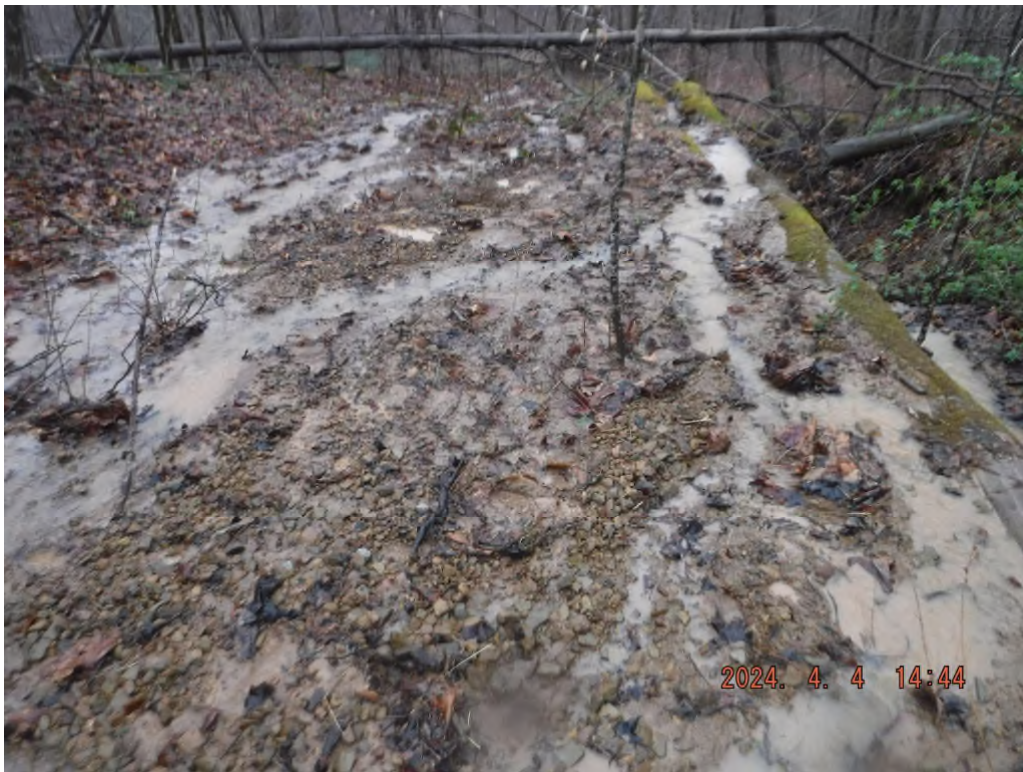
Photo # DSCF3962: Sediment deposits creating conditions not allowable in UNT Buck Run at or near N 39° 31.0503', W 80° 31.1356'.

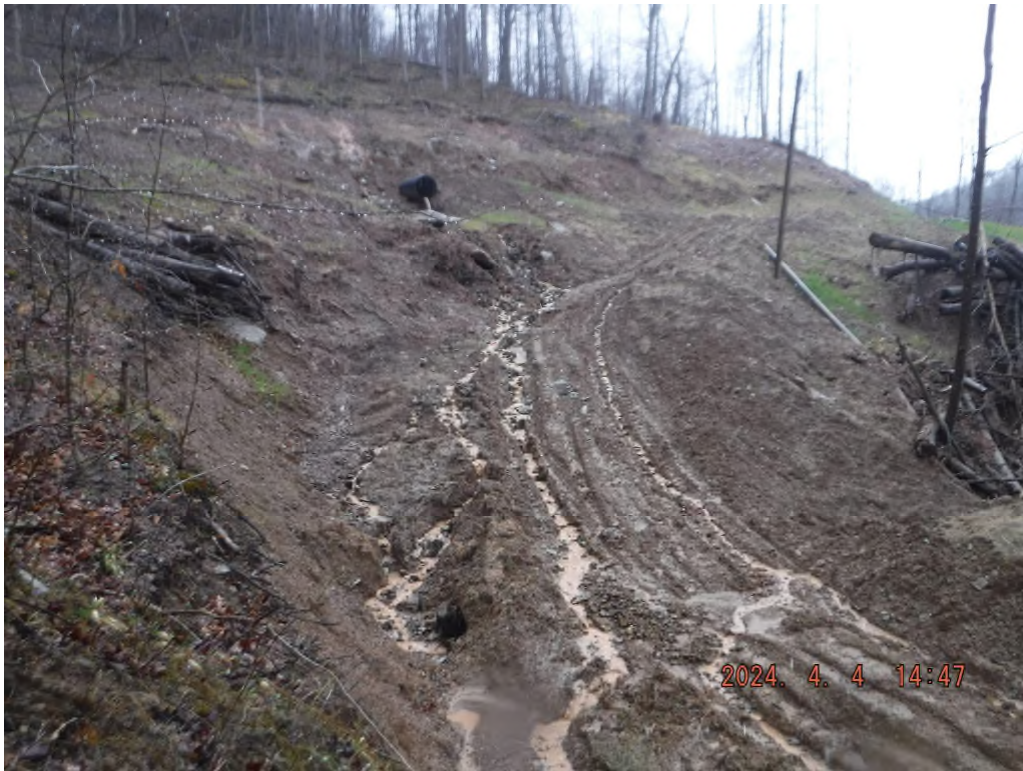
Photo # DSCF3967: Unpermitted road from Buck Run Rd. at station 115+00.

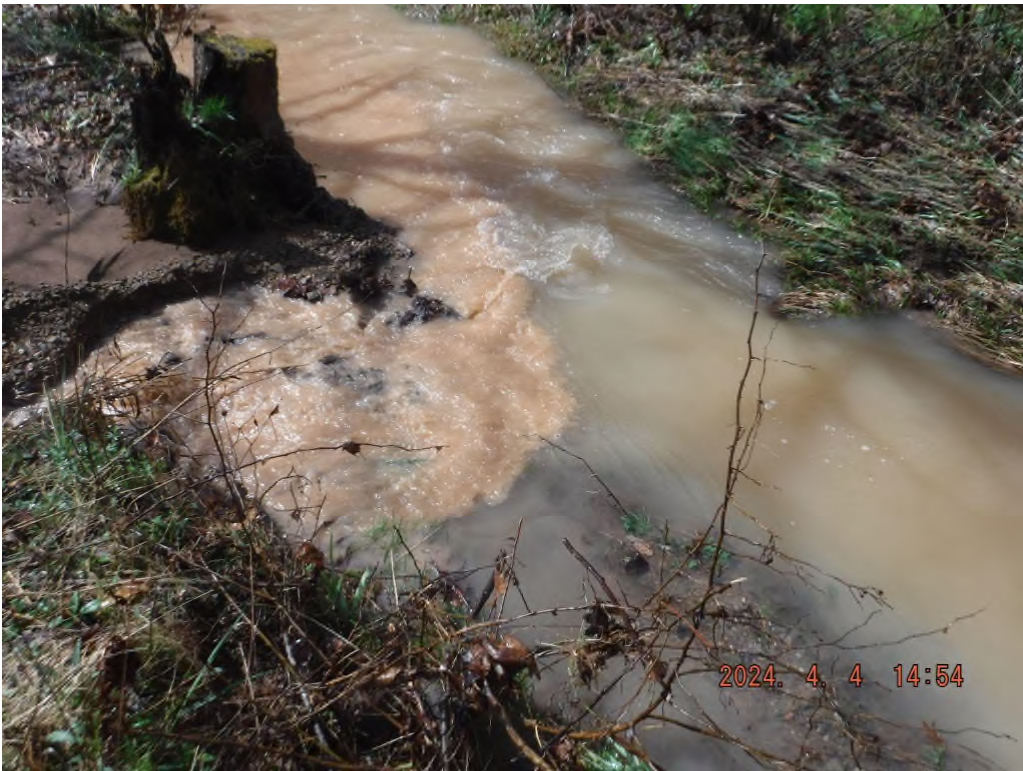
Photo # DSCF3986: UNT Buck Run (left) entering Buck Run (right) creating conditions not allowable in the form of distinctly visible settleable solids at or near N 39° 31.0584', W 80° 31.2407'.

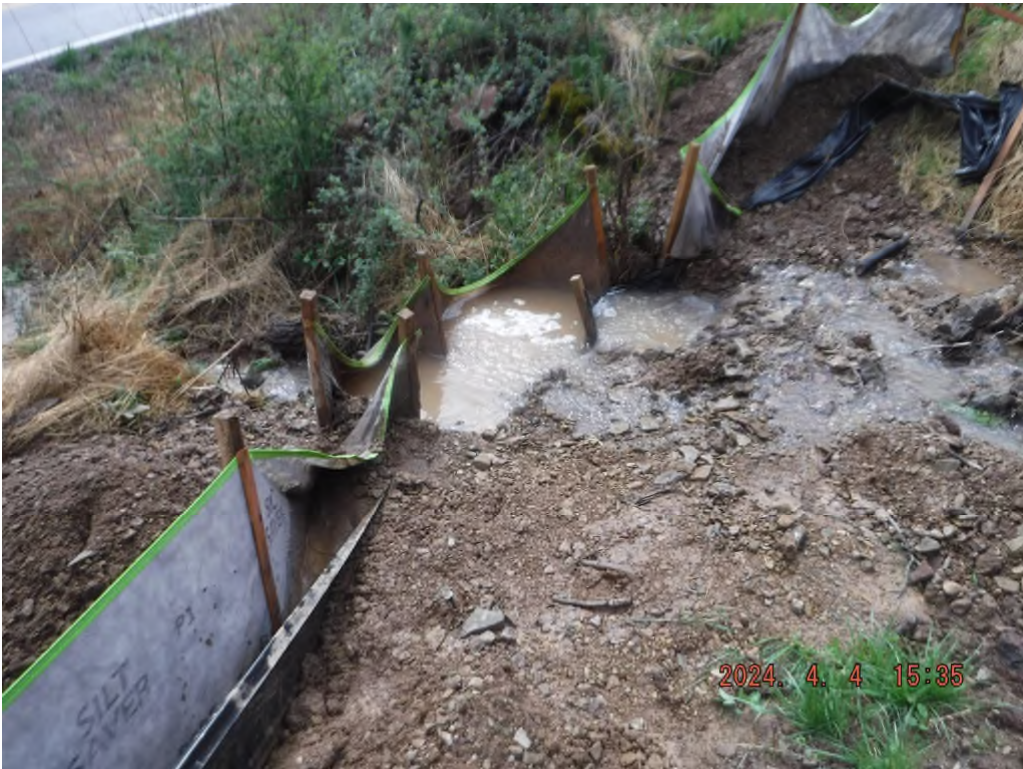
Photo # DSCF4003: Sediment deposits creating conditions not allowable in UNT Glade Fork at or near N 39° 30.5966', W 80° 29.8266'.

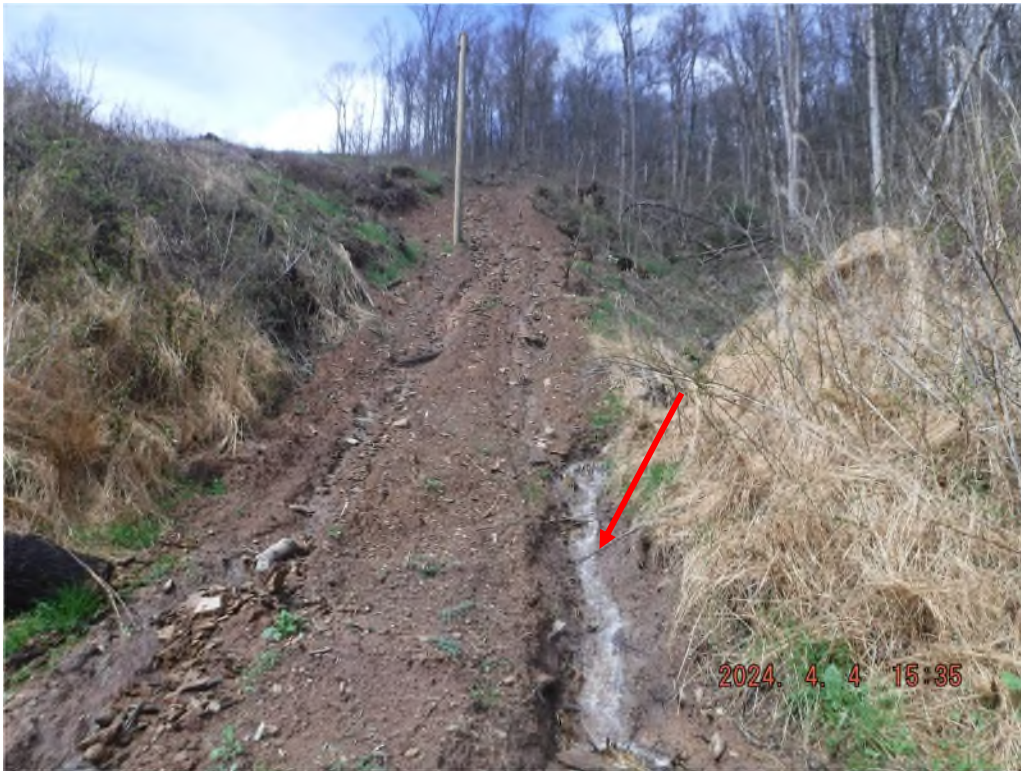
Photo # DSCF4004: Travel lane on disturbed ROW off LOD at station 39+00 with no BMPs. UNT Glade Fork noted by red arrow.

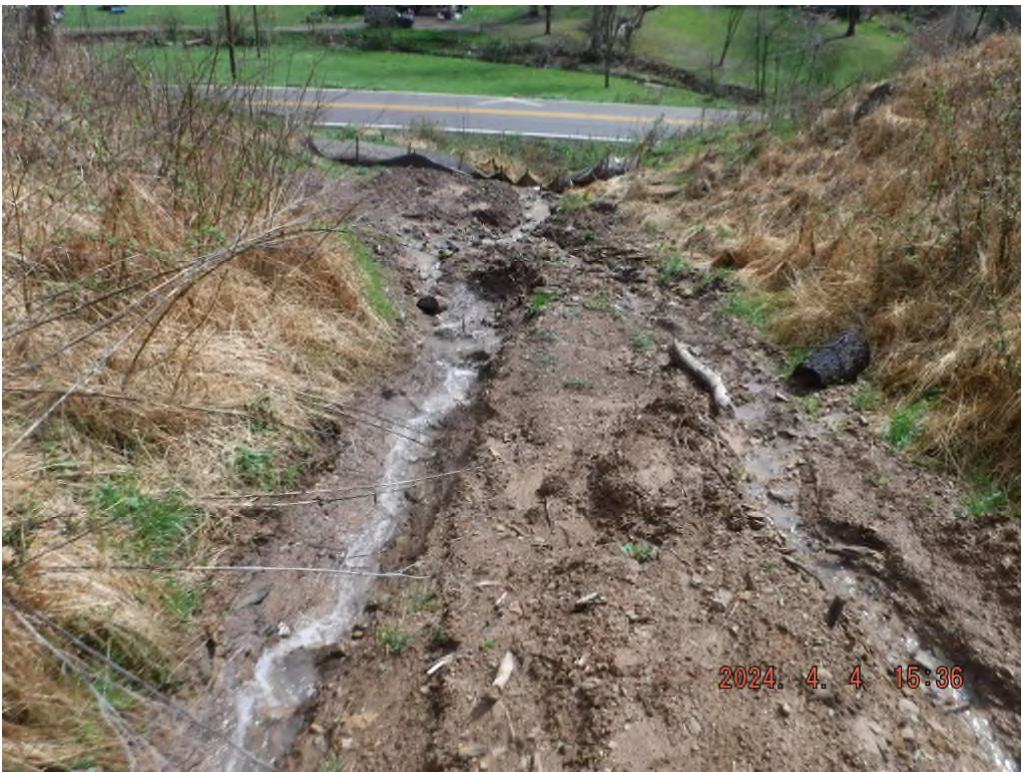
Photo # DSCF4007: Sediment deposits creating conditions not allowable in UNT Glade Fork at or near N 39° 30.5966', W 80° 29.8266'.

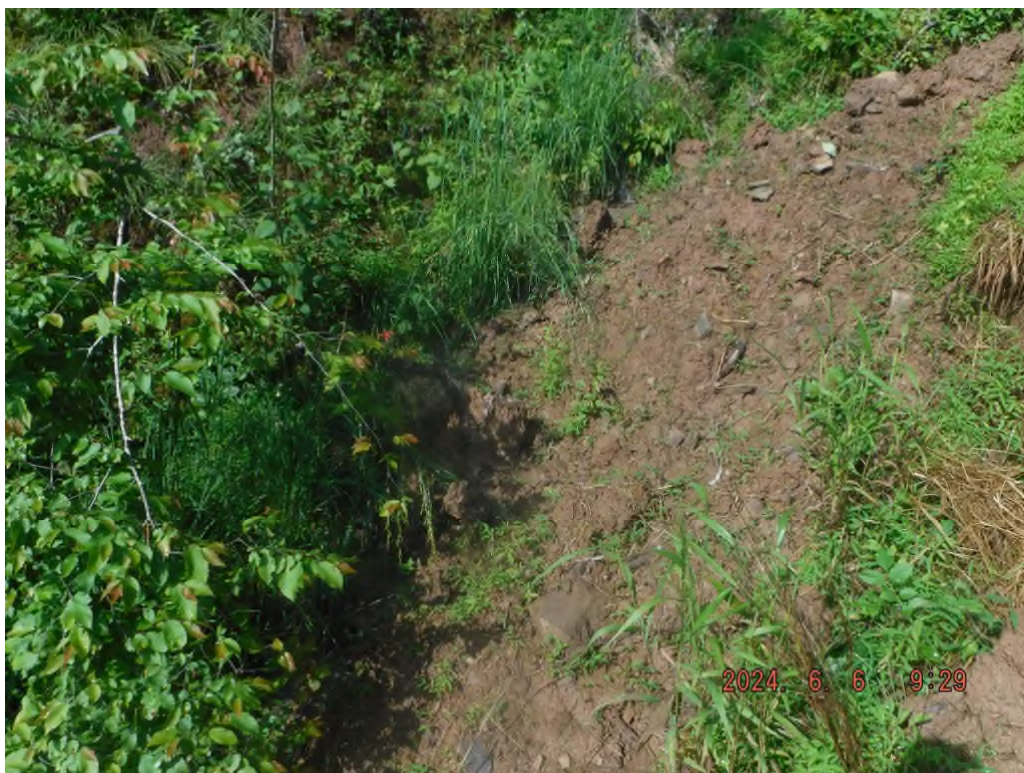
Photo # DSCF5121: Sediment deposits at or near N 39° 30.7209', W 80° 32.0479' in UNT Price Run.

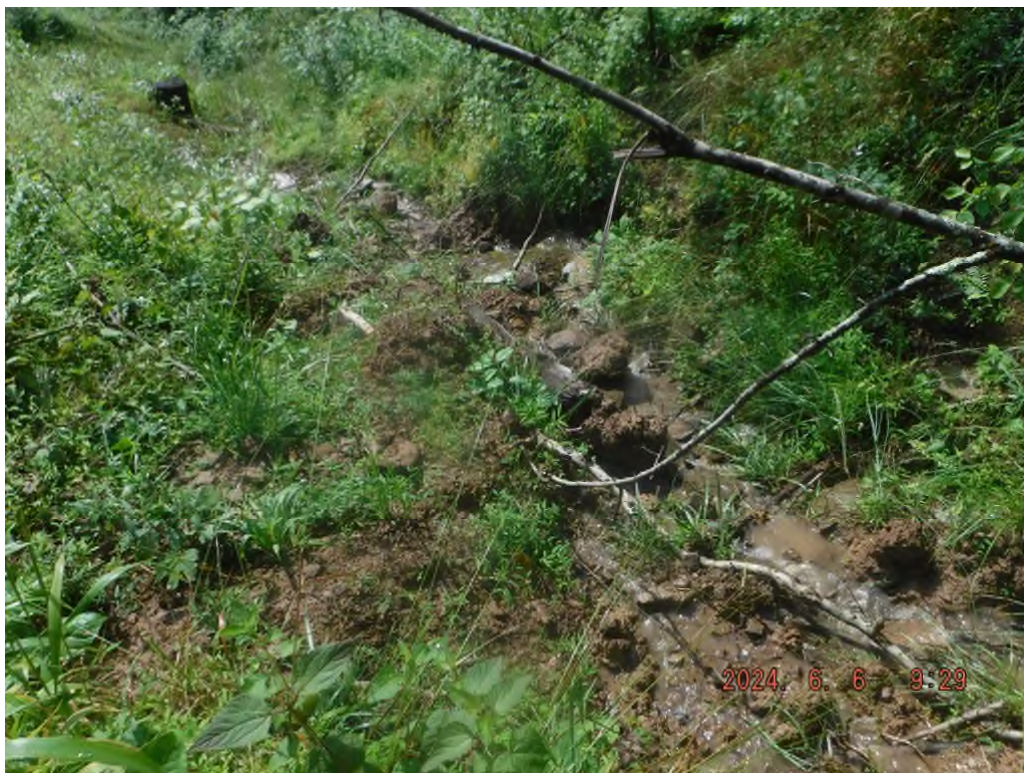
Photo # DSCF5130: Sediment deposits at or near N 39° 30.7209', W 80° 32.0479' in UNT Price Run.

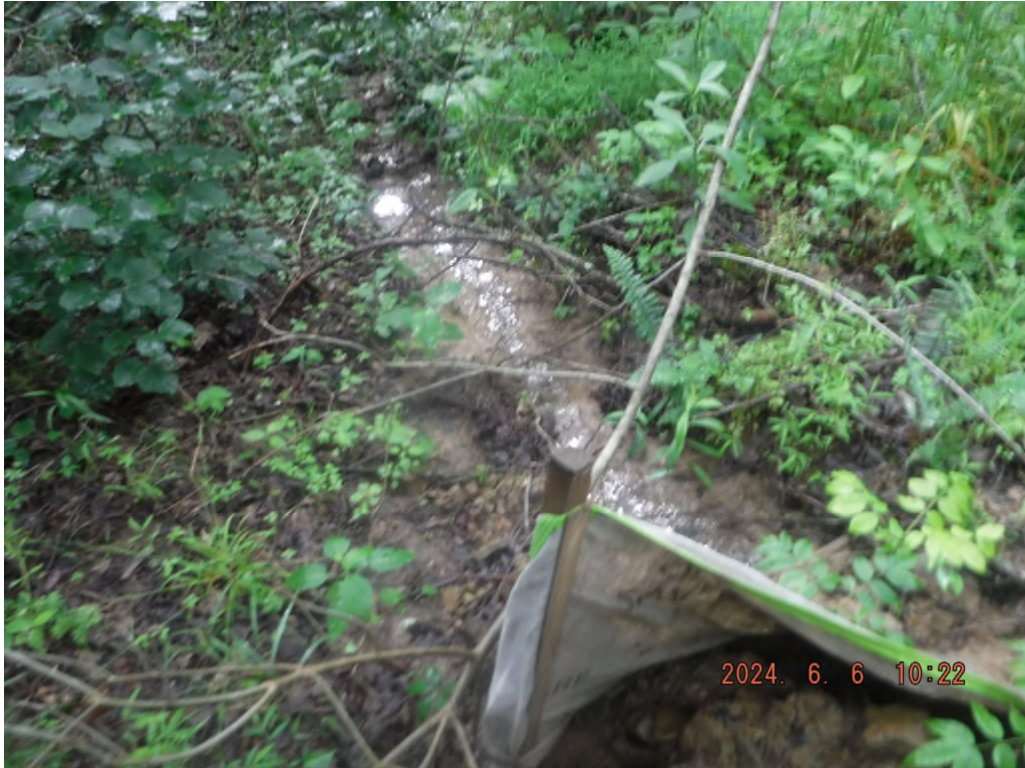
Photo # DSCF5189: Sediment laden water leaving the proposed access road found on sheets 3 and 4 of the approved SWPPP drawings.

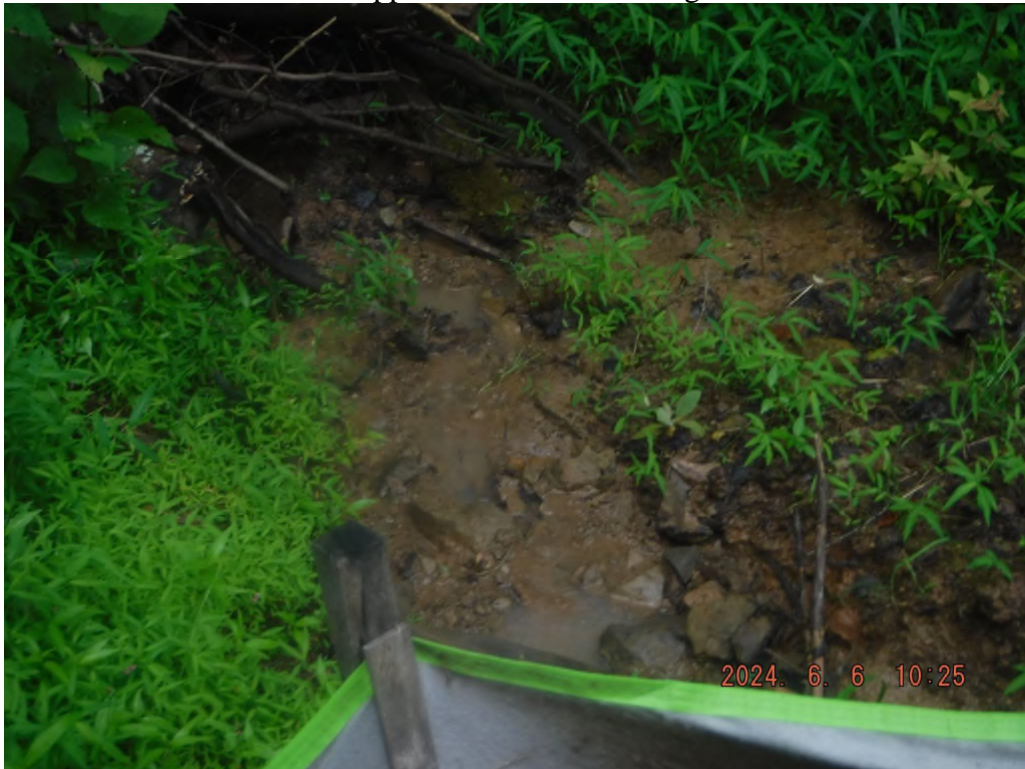
Photo # DSCF5201: Sediment laden water leaving the proposed access road found on sheets 3 and 4 of the approved SWPPP drawings.

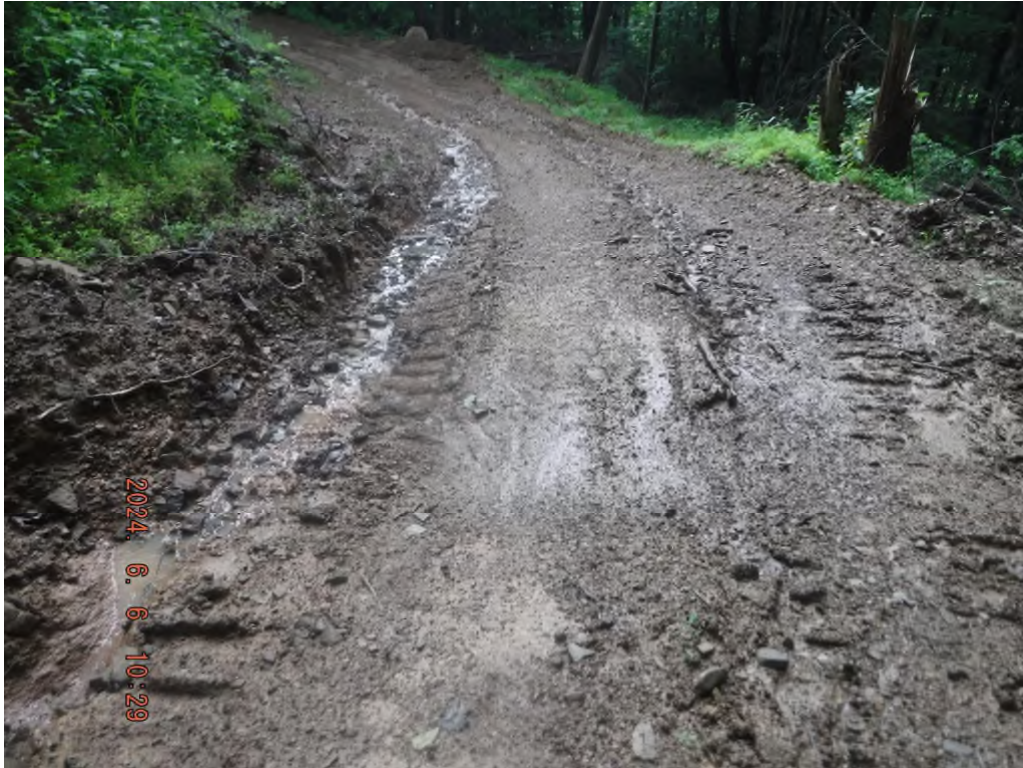
Photo # DSCF5217: Erosion rilling starting on the proposed access road found on sheets 3 and 4 of the SWPPP drawings.

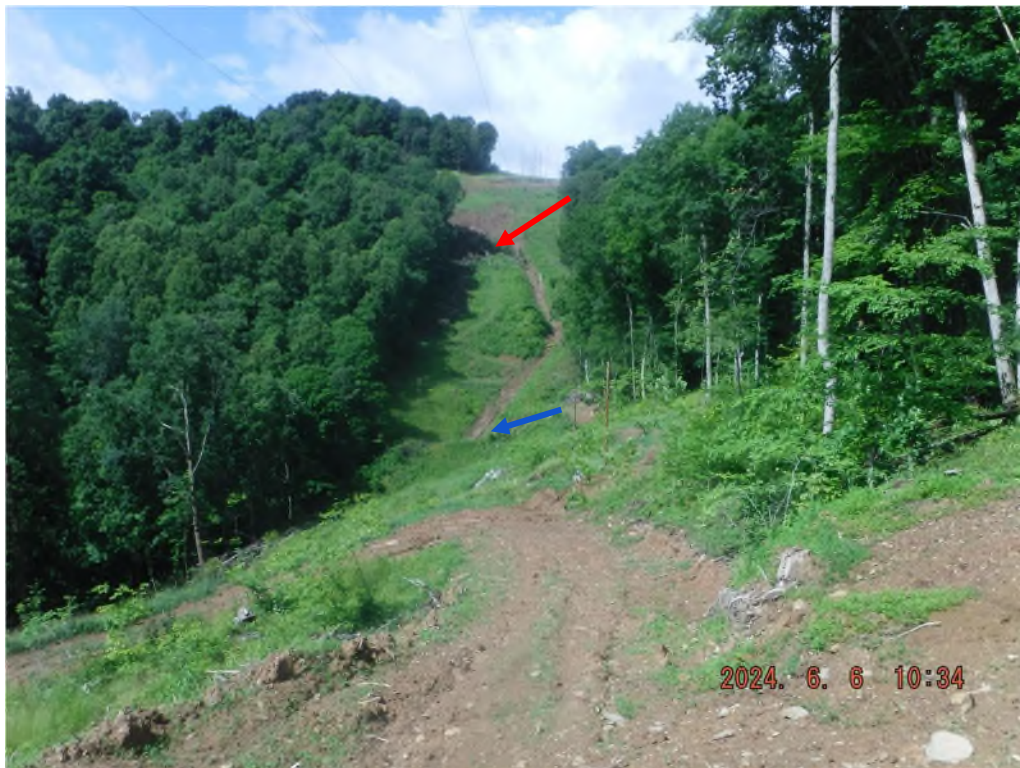
Photo # DSCF5226: Slip (red arrow) on the ROW that settled at the bottom of the slope at or near N 39° 30.9039', W 80° 31.5246' in UNT Buck Run.

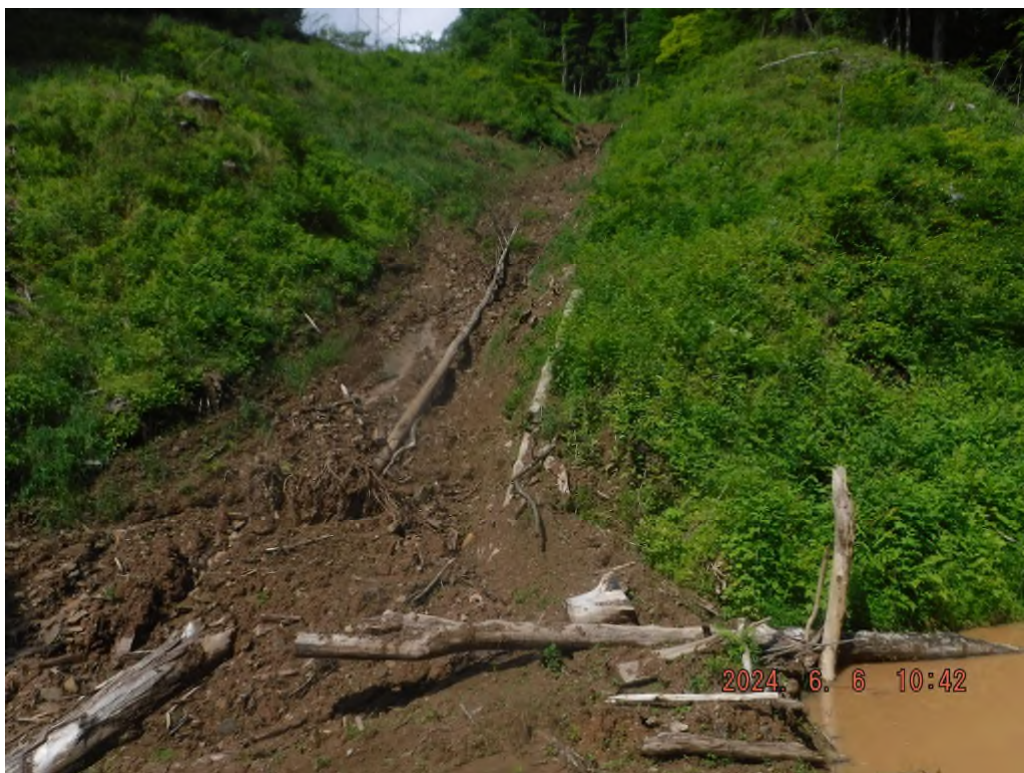
Photo # DSCF5240: Slip material in UNT Buck Run at or near N 39° 30.9039', W 80° 31.5246'.

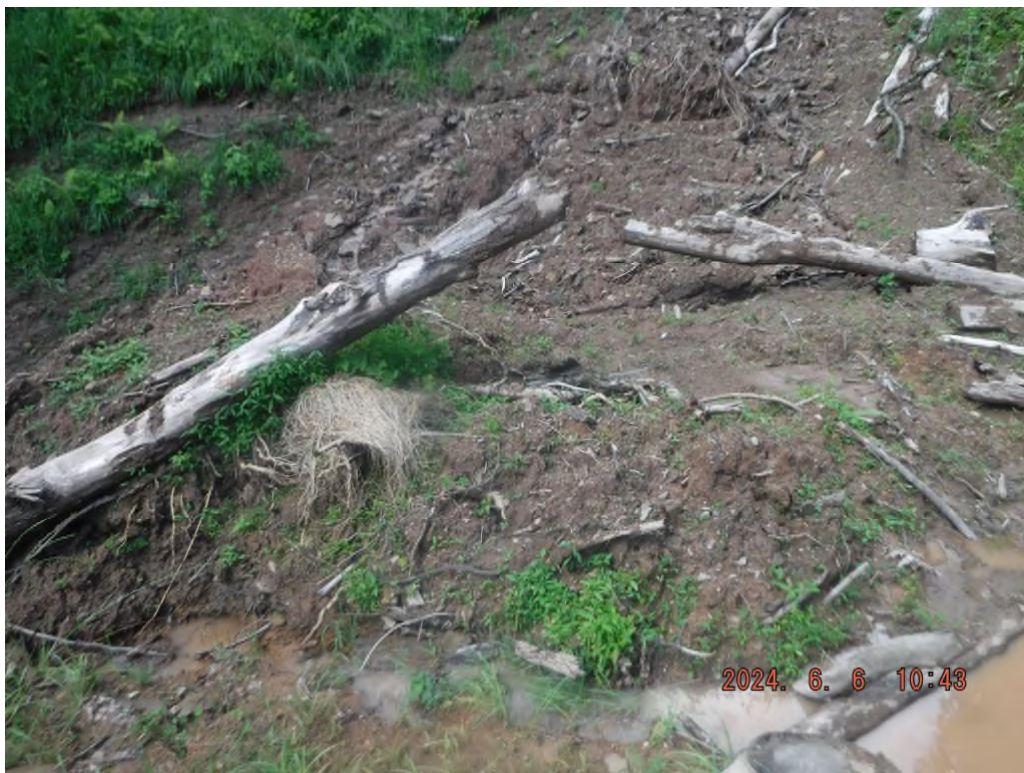
Photo # DSCF5241: Slip material in UNT Buck Run at or near N 39° 30.9039', W 80° 31.5246'.

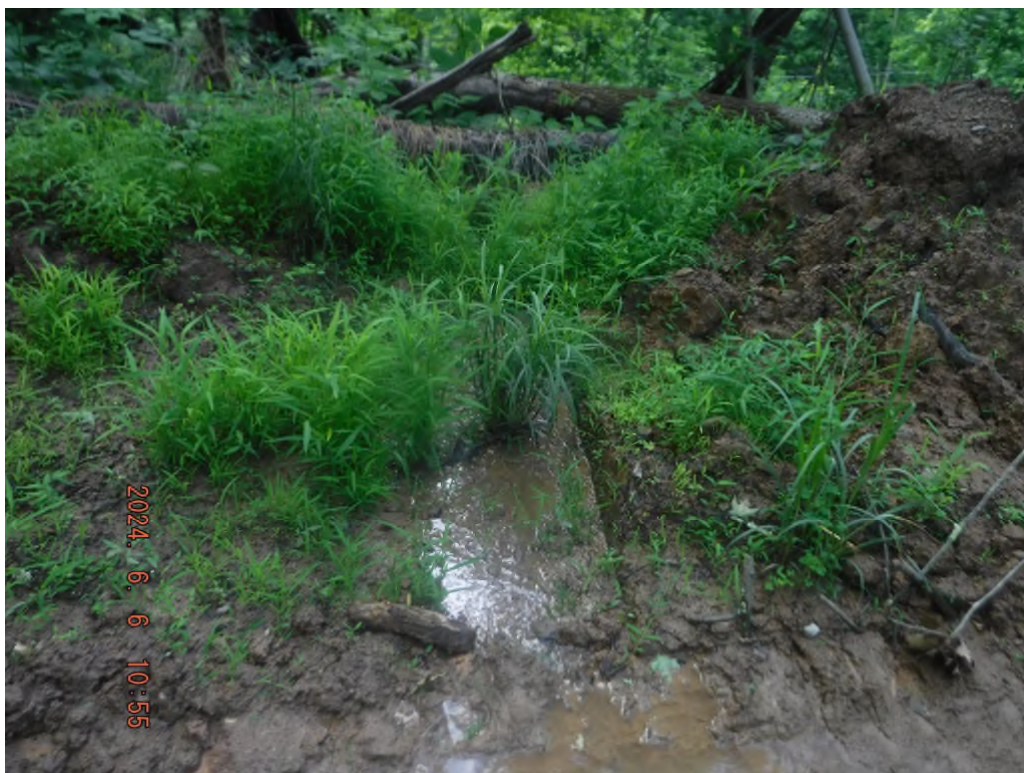
Photo # DSCF5258: Sediment laden water leaving the unpermitted access road to buck run that begins at or near N 39° 30.9806', W 80° 31.3774'.

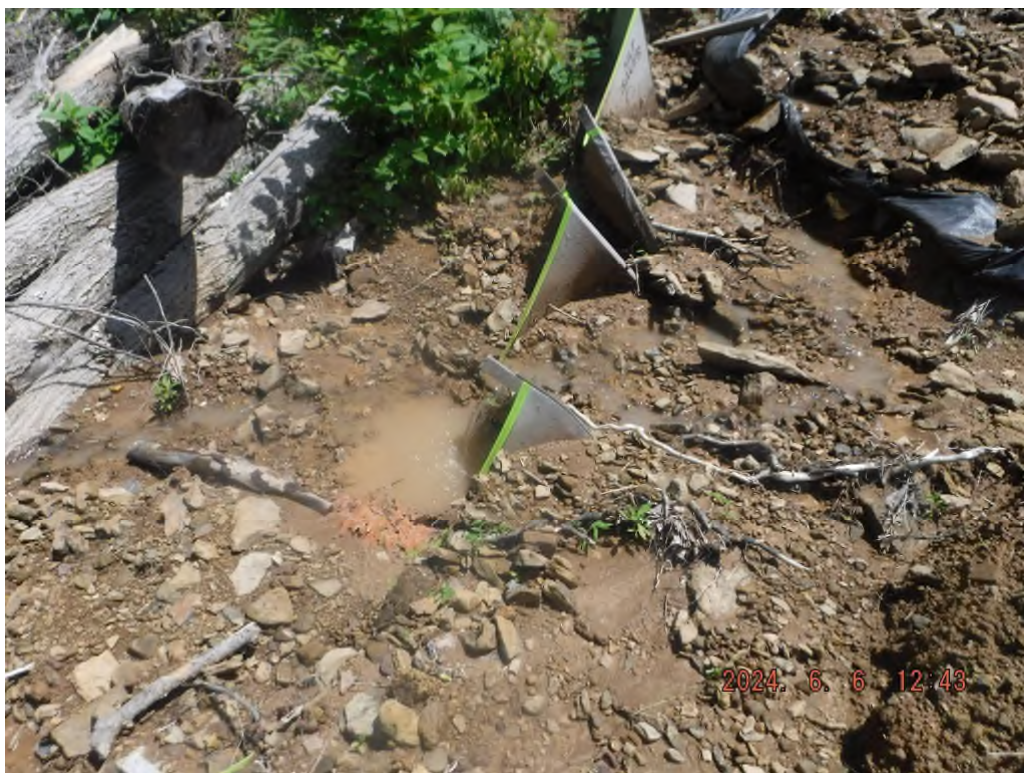
Photo # DSCF5374: silt fence lacks maintenance and sediment laden water leaving the site at station 110+00 at or near N 39° 31.0430', W 80° 31.0574'.

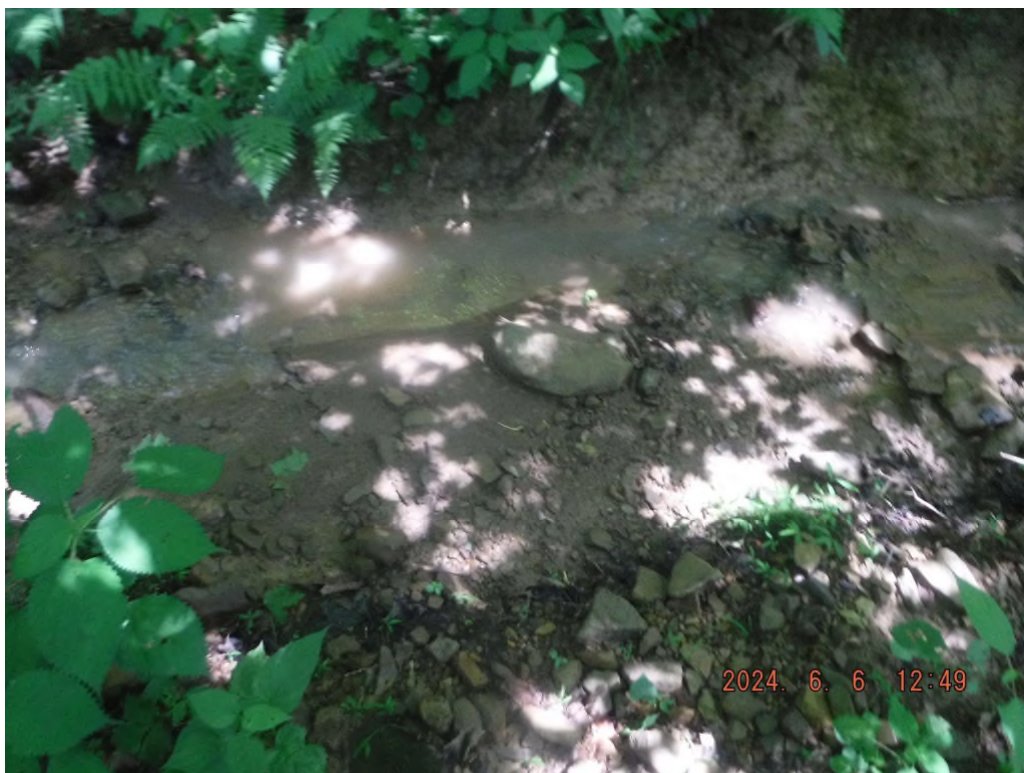
Photo # DSCF5392: Sediment deposits in UNT Buck Run at or near N 39° 31.0451', W 80° 31.1414'.

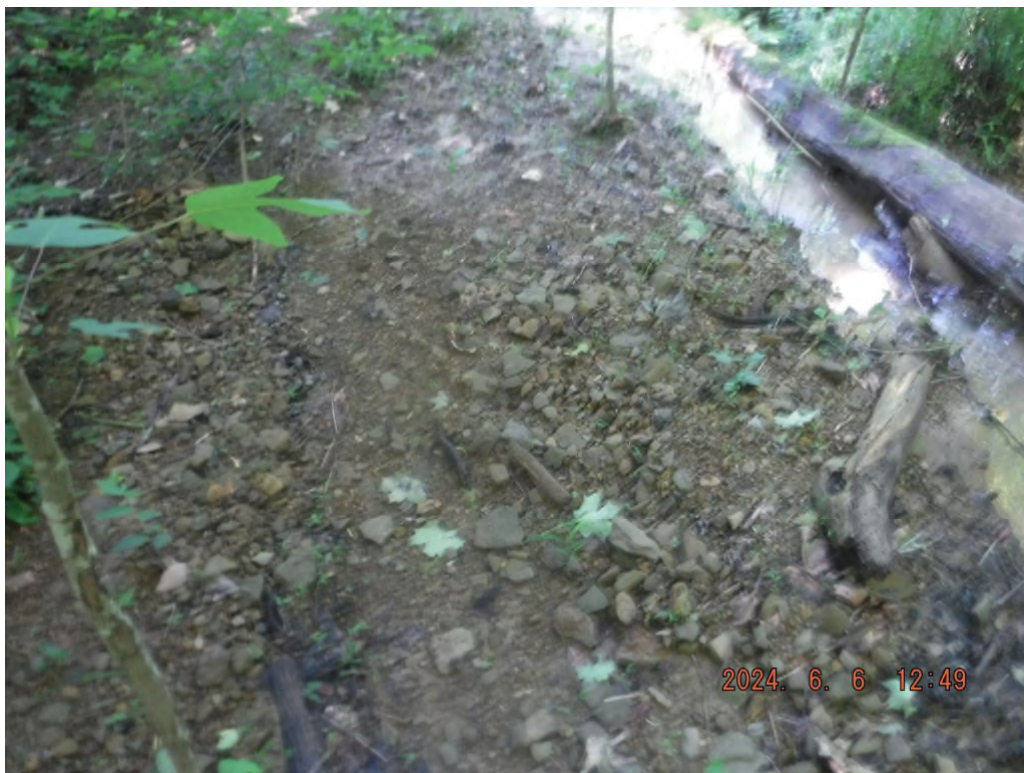
Photo # DSCF5395: Sediment deposits in UNT Buck Run at or near N 39° 31.0451', W 80° 31.1414'.

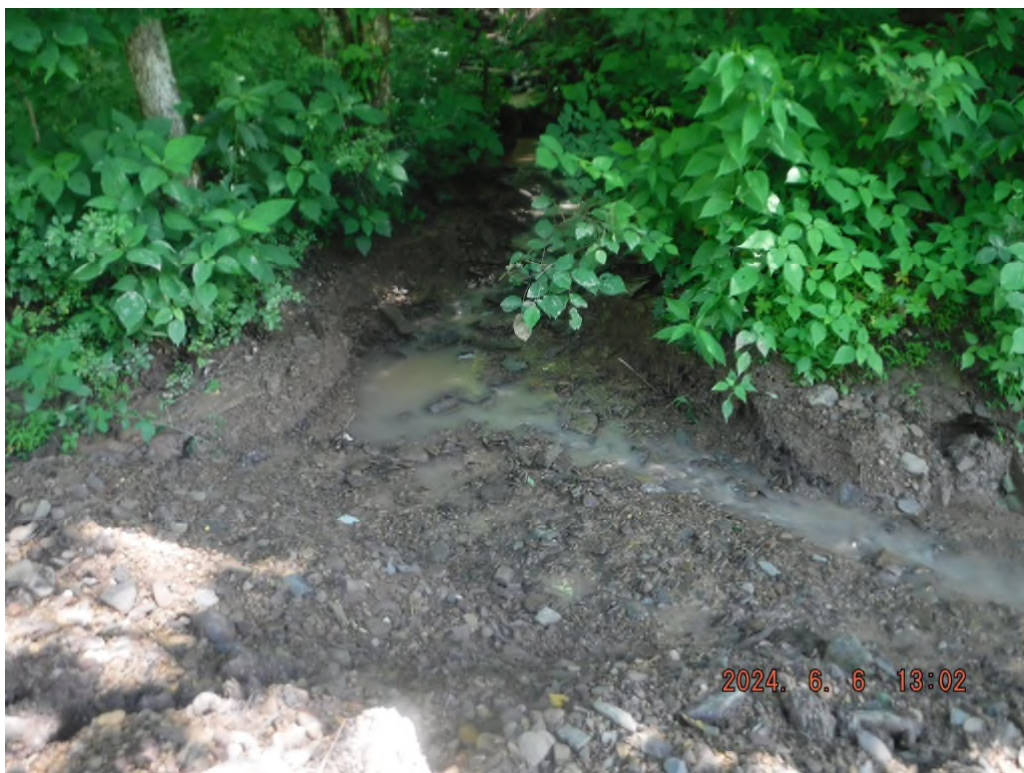
Photo # DSCF5422: Distinctly visible settleable solids in UNT Buck Run at or near N 39° 31.0767', W 80° 31.2218'.

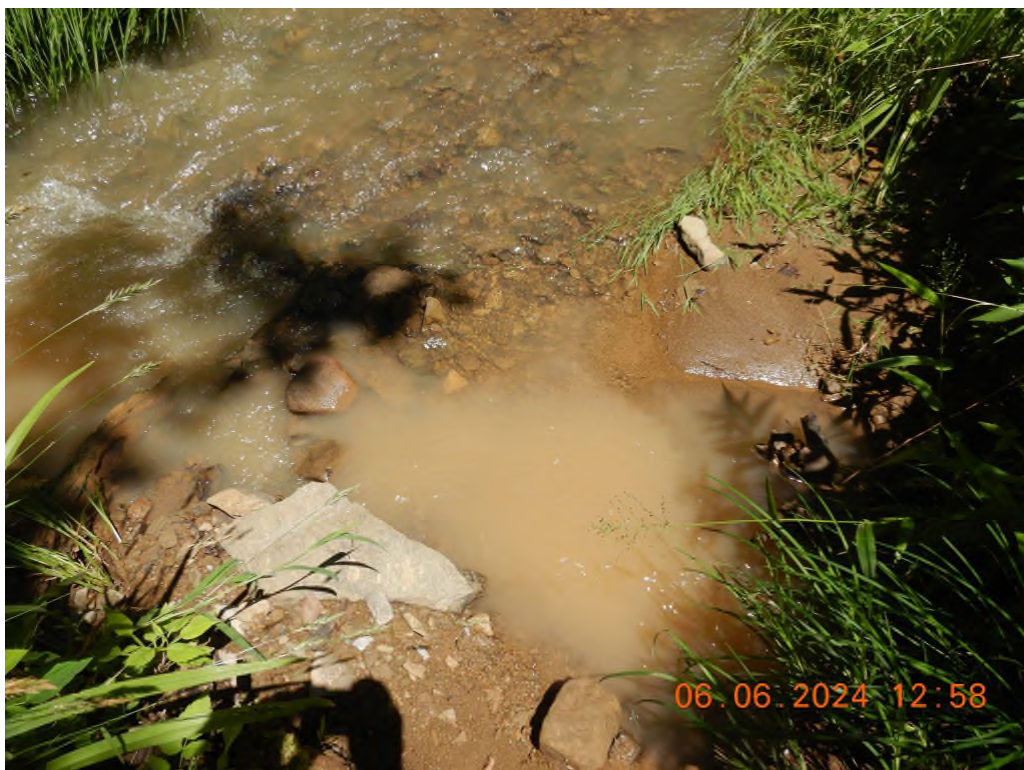
Photo # DSCN0080: Conditions not allowable in Buck Run at or near 39°31'02.0"N 80°31'14.0"W.

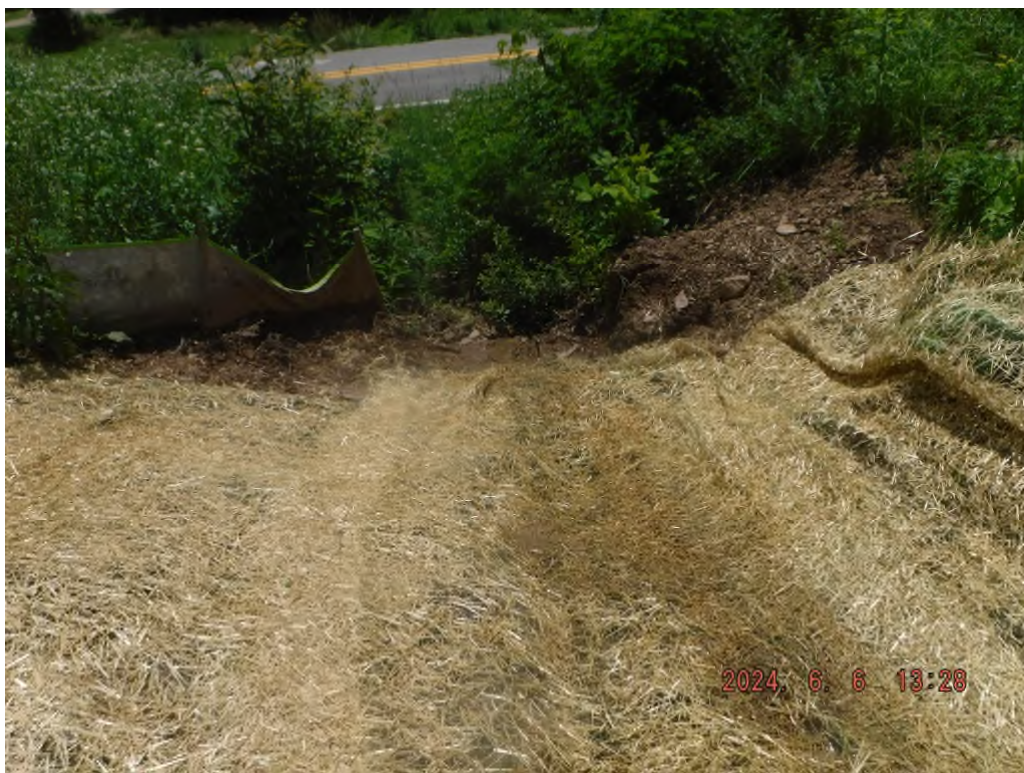
Photo # DSCF5429: Sediment deposits and straw matting in UNT Glade Fork at or near N 39° 30.6051', W 80° 29.8265'.
