**CONSENT ORDER
ISSUED UNDER THE
WATER POLLUTION CONTROL ACT
WEST VIRGINIA CODE CHAPTER 22, ARTICLE 11**

TO: Harrison County Coal Resources, Inc.
Attn: James R. Turner, Jr.
46226 National Road West
St. Clairsville, OH 43950

ORDER NO.: 10302

Rymer I & II Stream Restoration Site – WVR112355

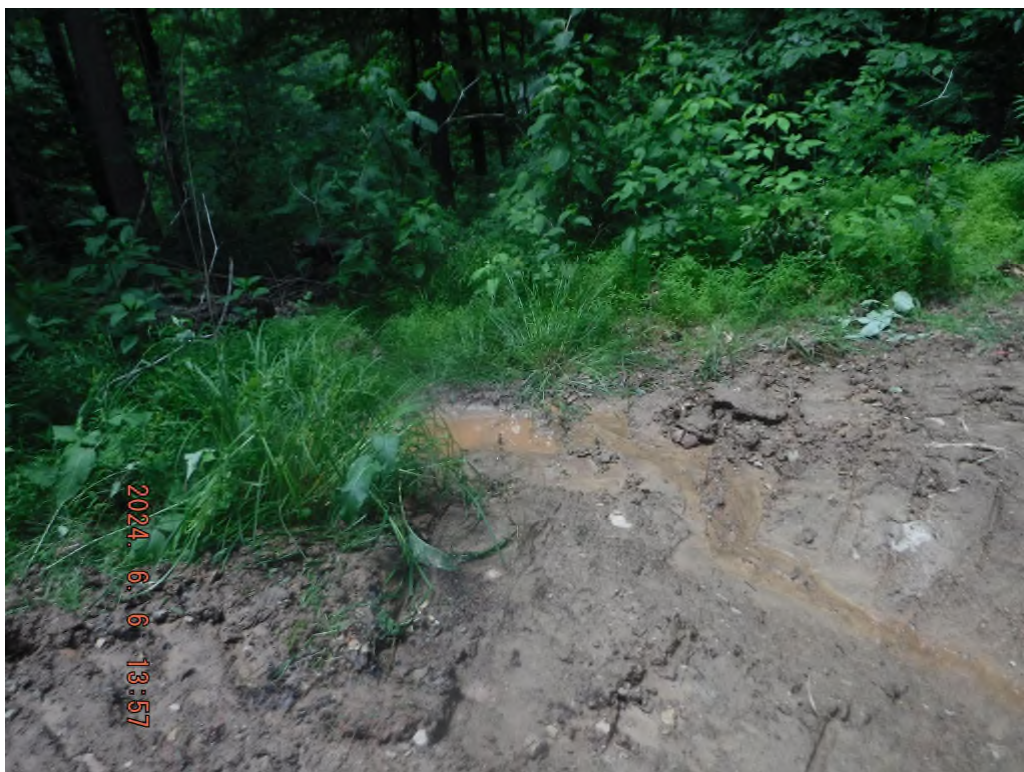
Photo # DSCF5451: Sediment laden water leaving the proposed access road found on drawing sheets 1 and 2 of the approved SWPPP.

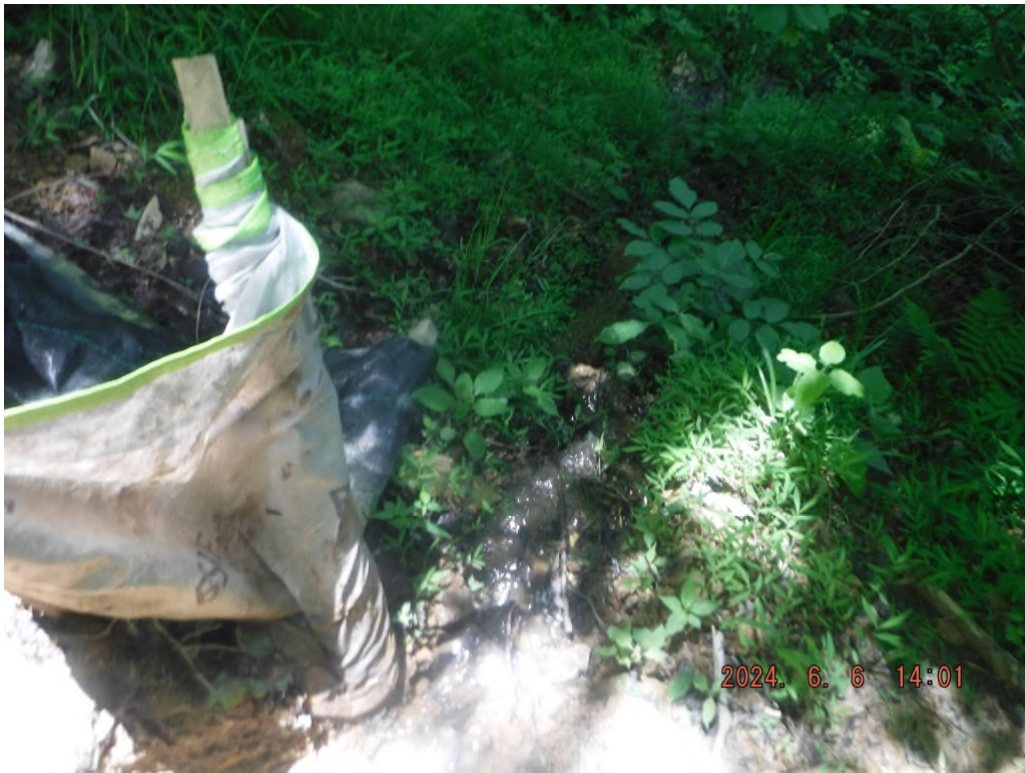
Photo # DSCF5464: Sediment laden water leaving the proposed access road found on drawing sheets 1 and 2 of the approved SWPPP.

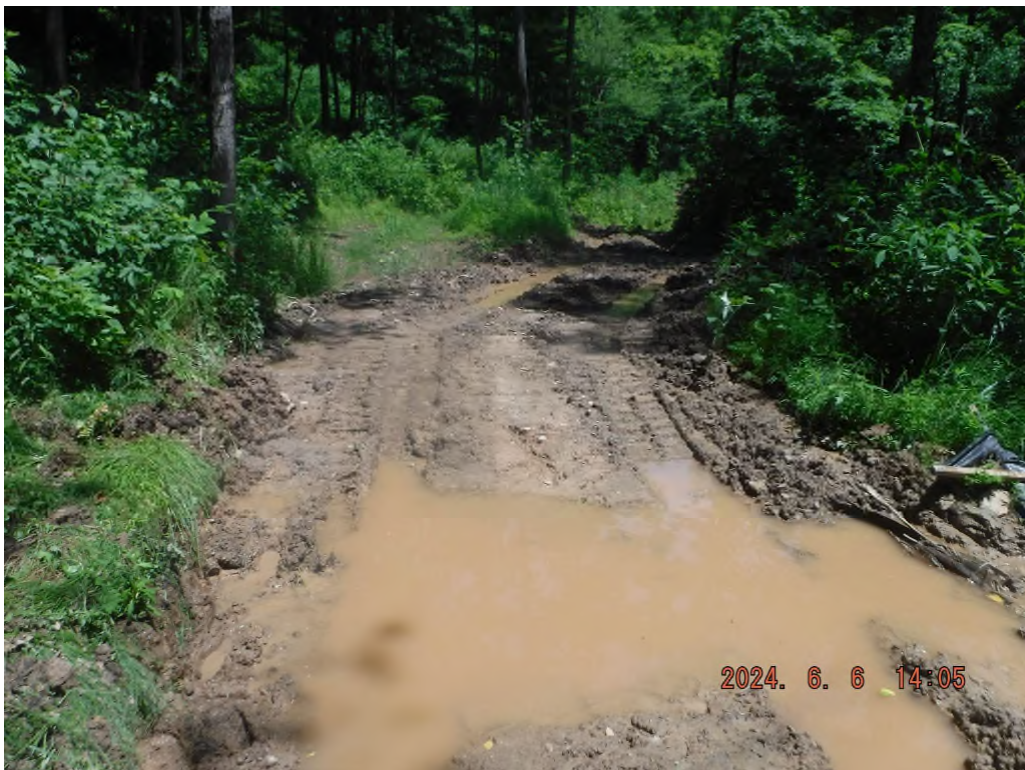
Photo # DSCF5468: Proposed access road found on sheets 1 and 2 of the approved SWPPP is unstabilized.

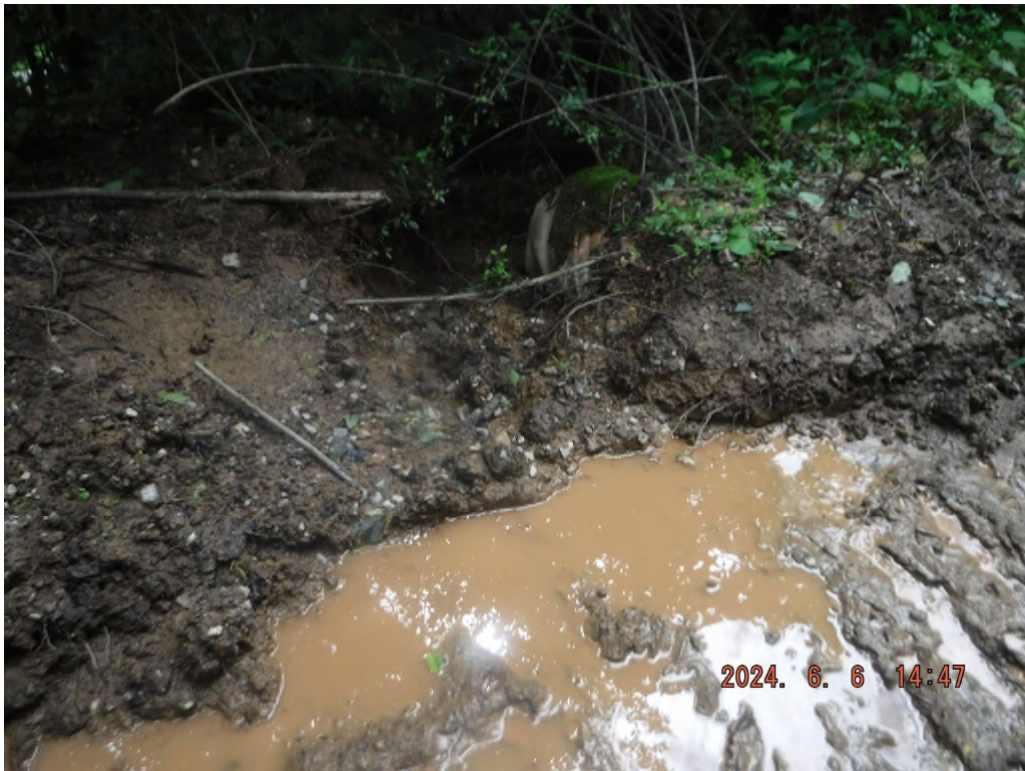
Photo # DSCF5515: Sediment laden water leaving the existing access road found on drawing sheet 2 of the approved SWPPP.

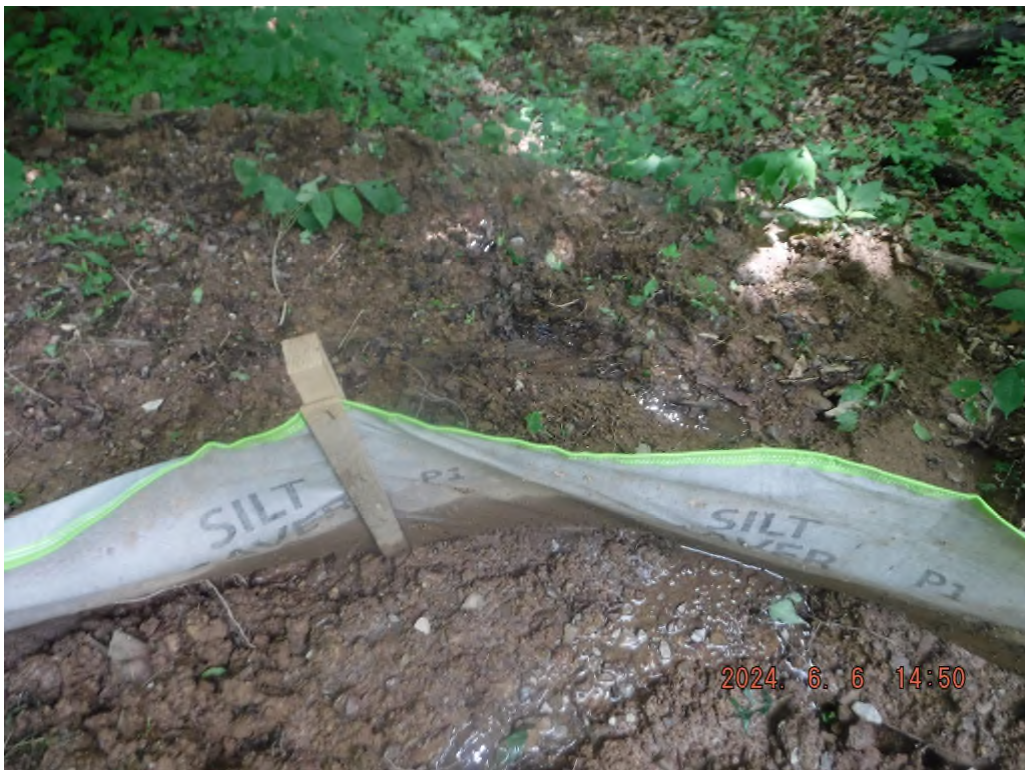
Photo # DSCF5521: Sediment laden water leaving the existing access road found on drawing sheet 2 of the approved SWPPP.

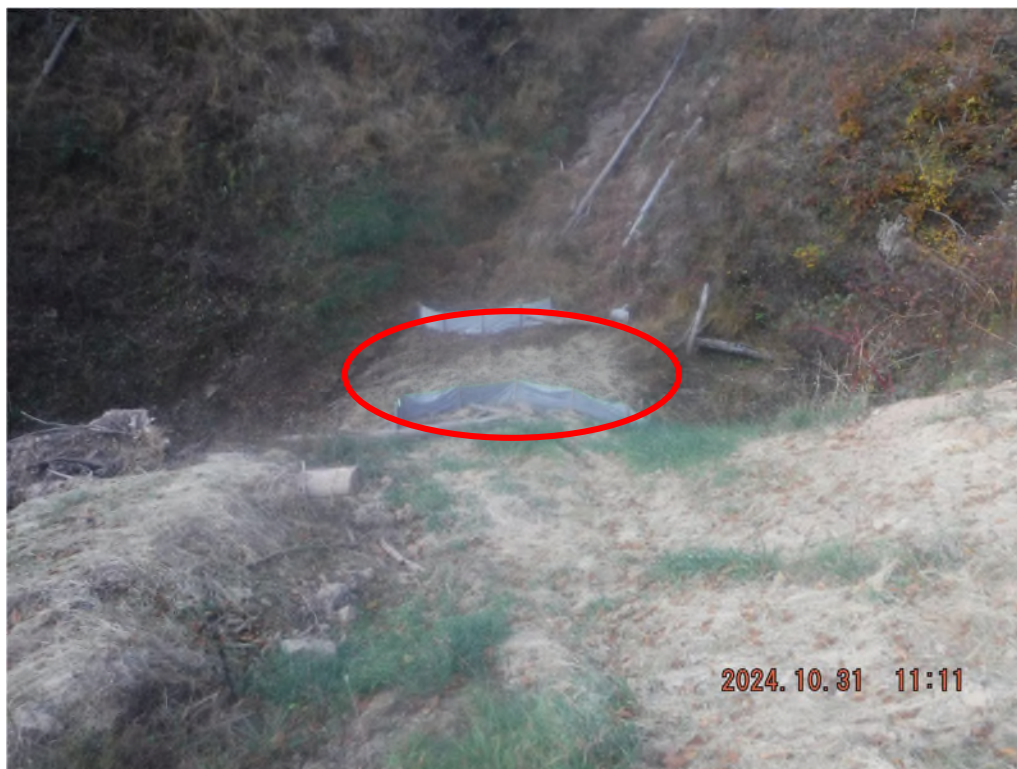
Photo # DSCF0008: Slip material remaining in UNT Buck Run at or near N 39° 30.9039', W 80° 31.5246' at approximately station 130+00.

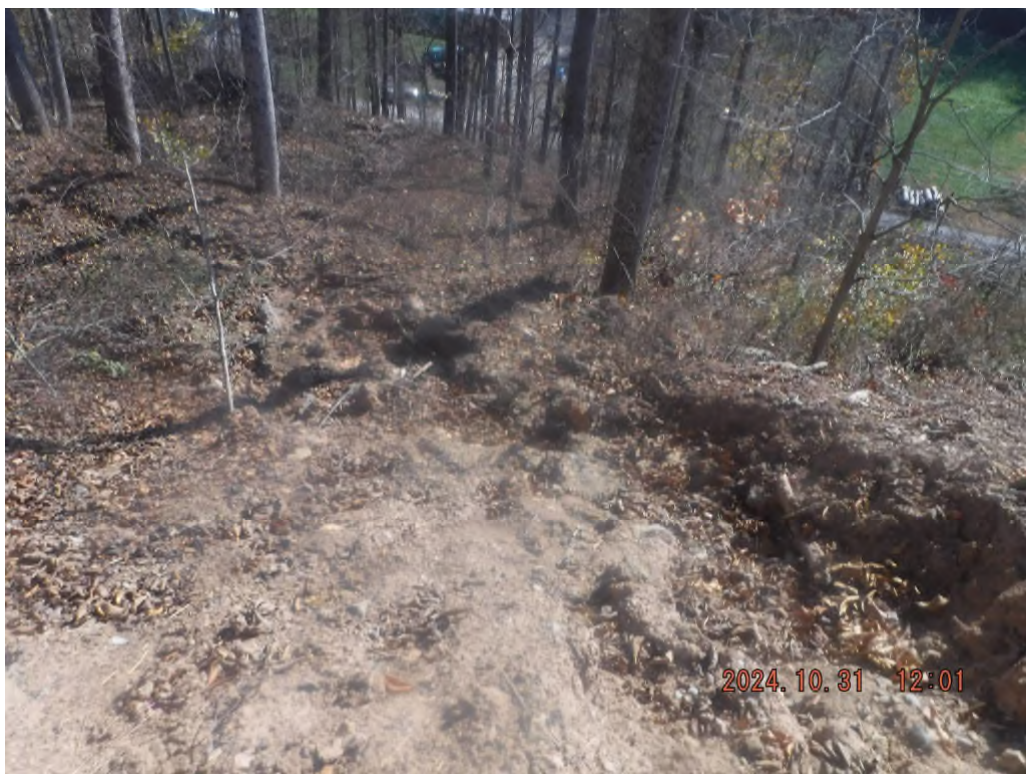
Photo # DSCF0036: Sediment offsite adjacent to the waterbar outlet at station 77+50.

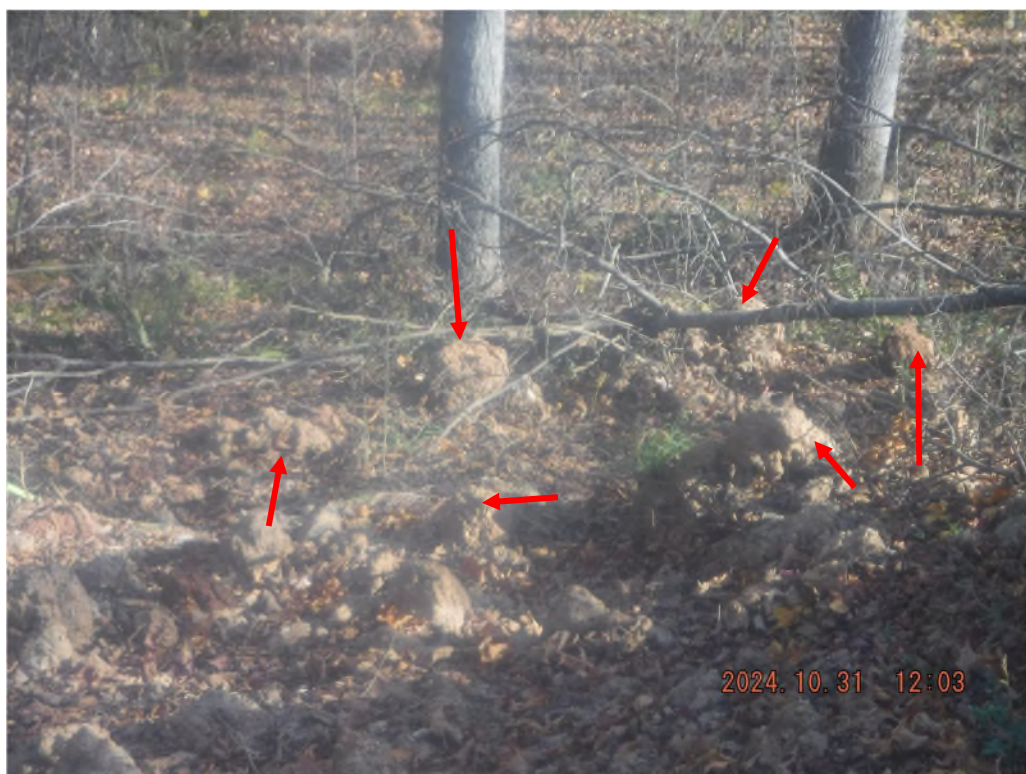
Photo # DSCF0039: Rollout at or near N 39° 30.9679', W 80° 30.5184'.

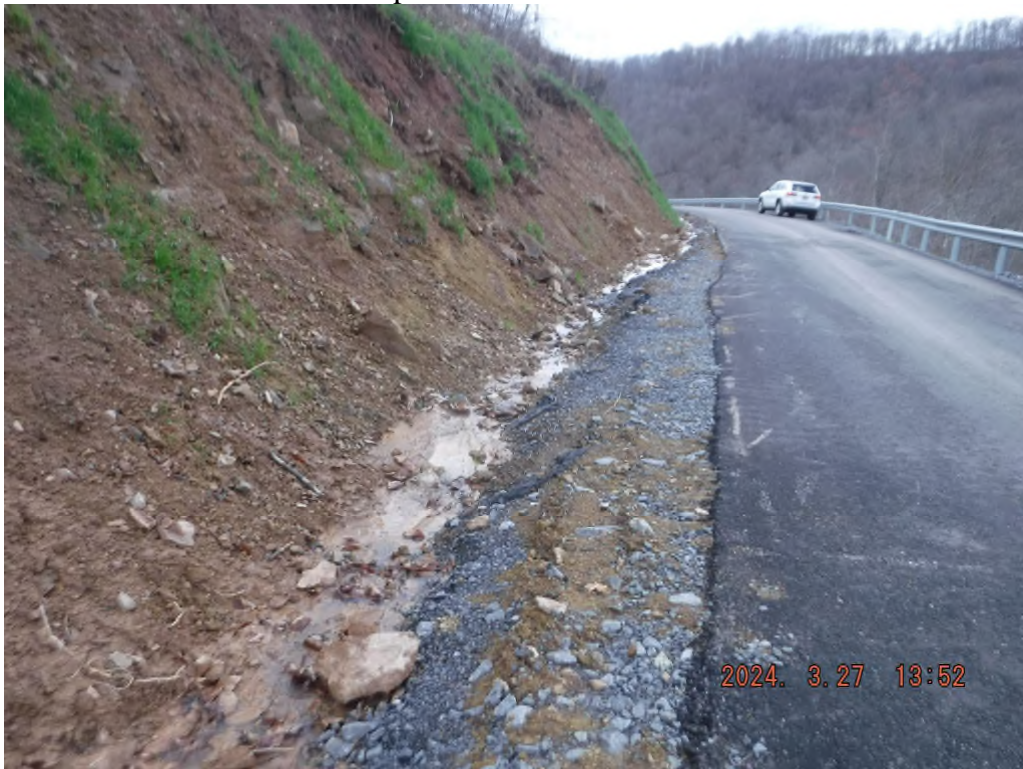
Photo # DSCF3340: Rock checks missing in roadside ditch near station 36+00.

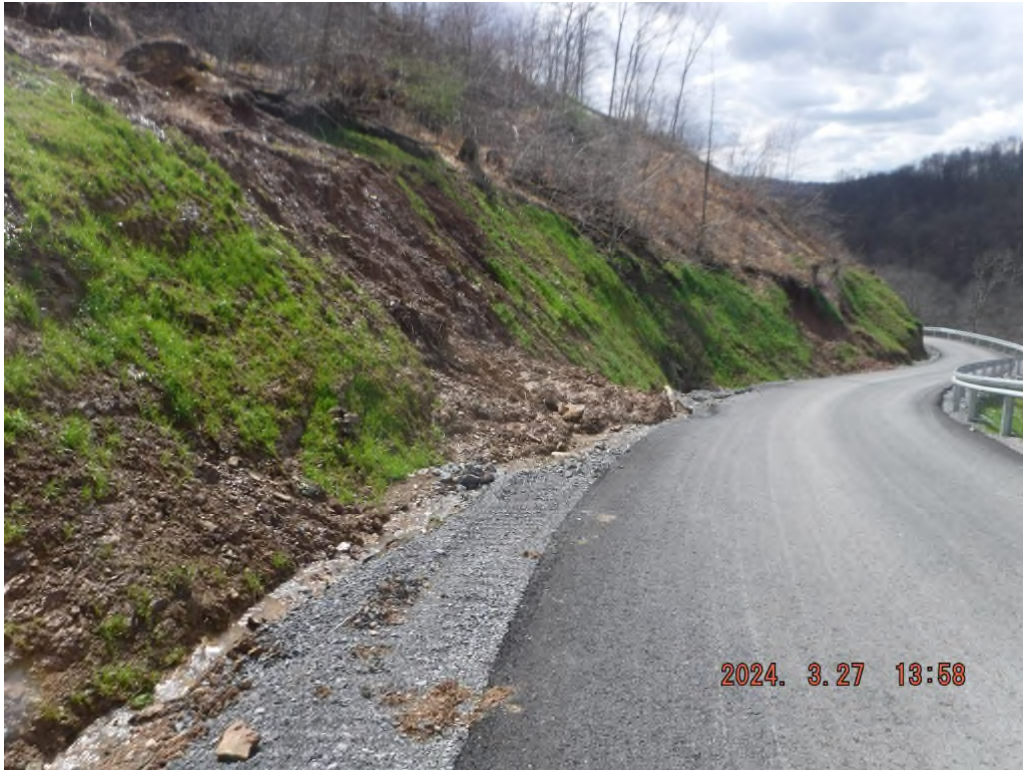
Photo # DSCF3352: Slip in roadside ditch at or near N 39° 30.7076', W 80° 32.7174'.

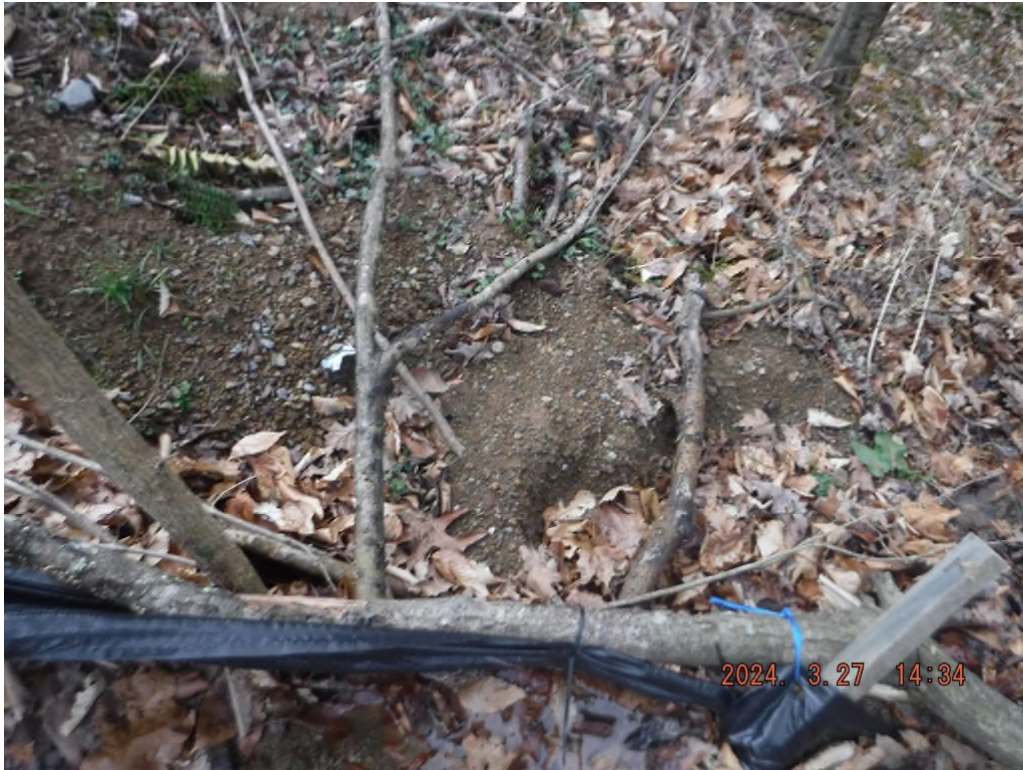
Photo # DSCF3412: Sediment deposits in UNT Bear Run at or near N 39° 30.5461', W 80° 32.9112 below discharge point 7 at station 15+50. These were observed last inspection on 2-13-2024.

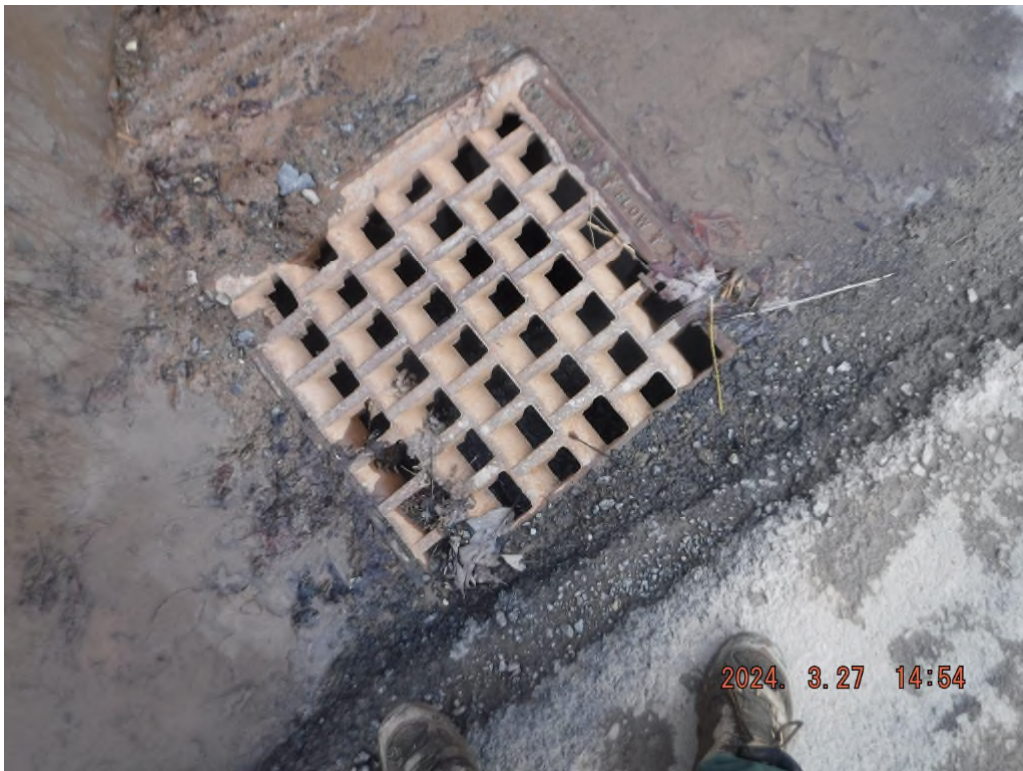
Photo # DSCF3444: Drop inlet protection missing from drop inlet B1.
