**CONSENT ORDER
ISSUED UNDER THE
WATER POLLUTION CONTROL ACT
WEST VIRGINIA CODE, CHAPTER 22, ARTICLE 11**

TO: Columbia Gas Transmission, LLC
Attn: Troy Tally, Vice President
1700 MacCorkle Ave
Charleston, WV 25314

DATE: October 1, 2020
ORDER NO.: 9061

1. Columbia Gas Transmission, LLC is conducting land disturbance activity associated with construction of the Mountaineer Xpress Project in Marshall, Wetzel, Tyler, Doddridge, Ritchie, Calhoun, Wirt, Roane, Jackson, Mason, Putnam, and Cabell Counties, West Virginia. On January 31, 2018, Columbia Gas Transmission, LLC was issued Water Pollution Control Permit No. WV0116815, Registration No. WVR310872, for Stormwater Associated With Oil and Gas Related Construction Activities.

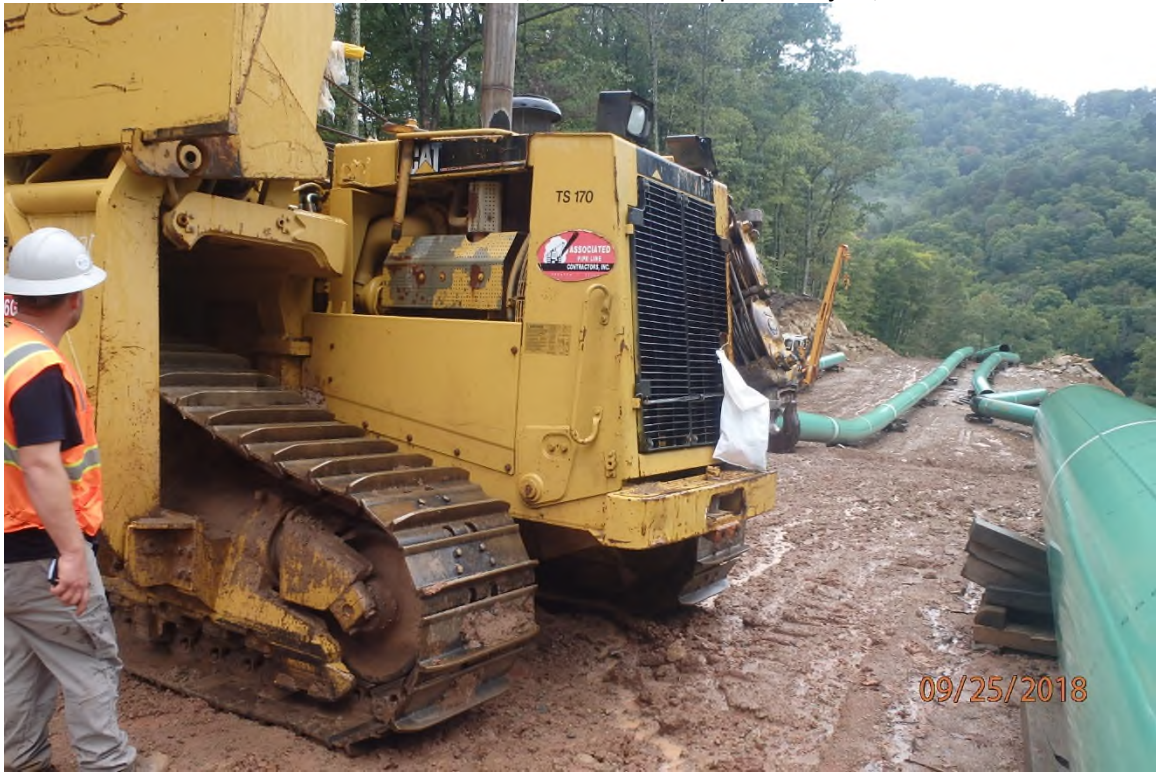
Piece of equipment that was leaking diesel fuel onto the ground.

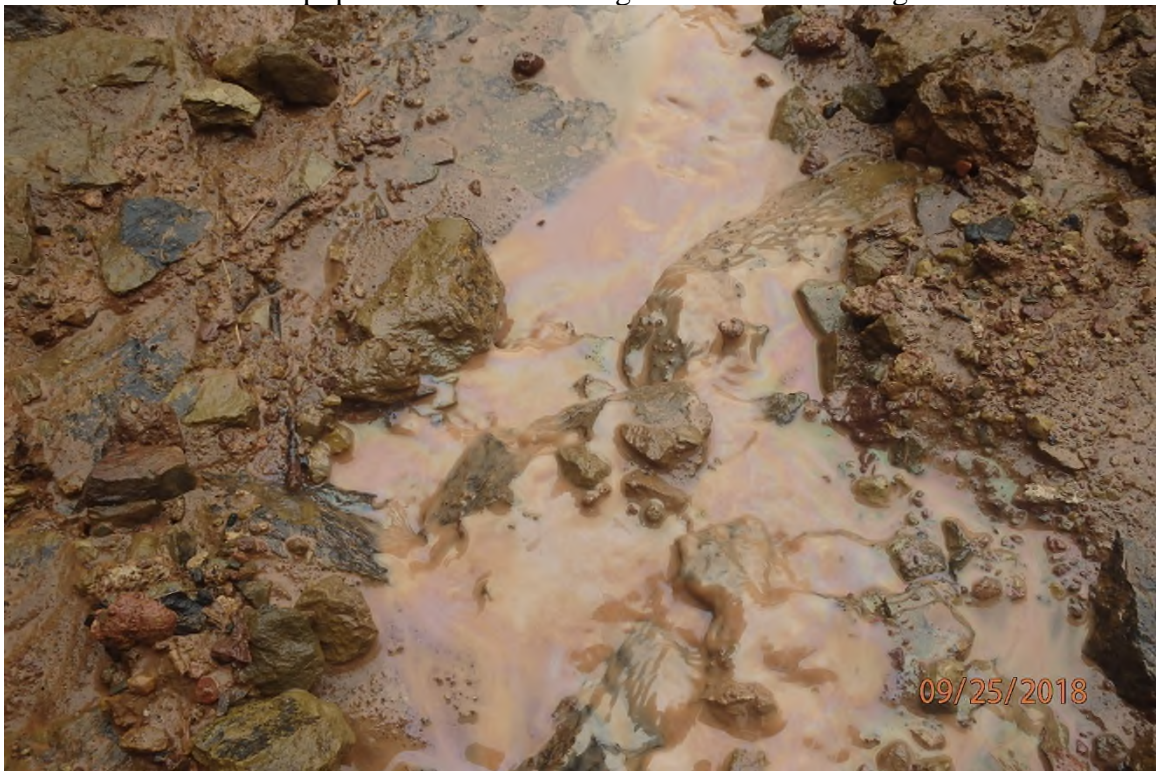
Oily slick on stormwater downslope of the above pictured equipment.

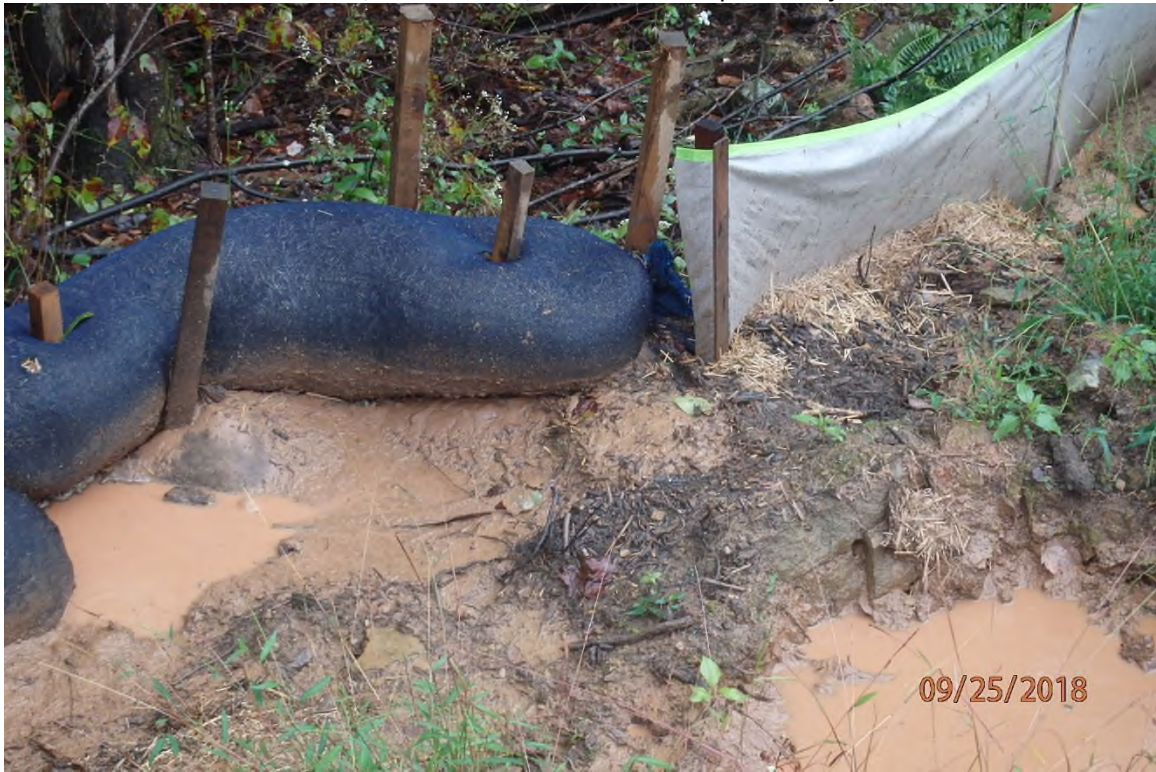
Improperly operated water bar terminus BMP adjacent to 2255+00.

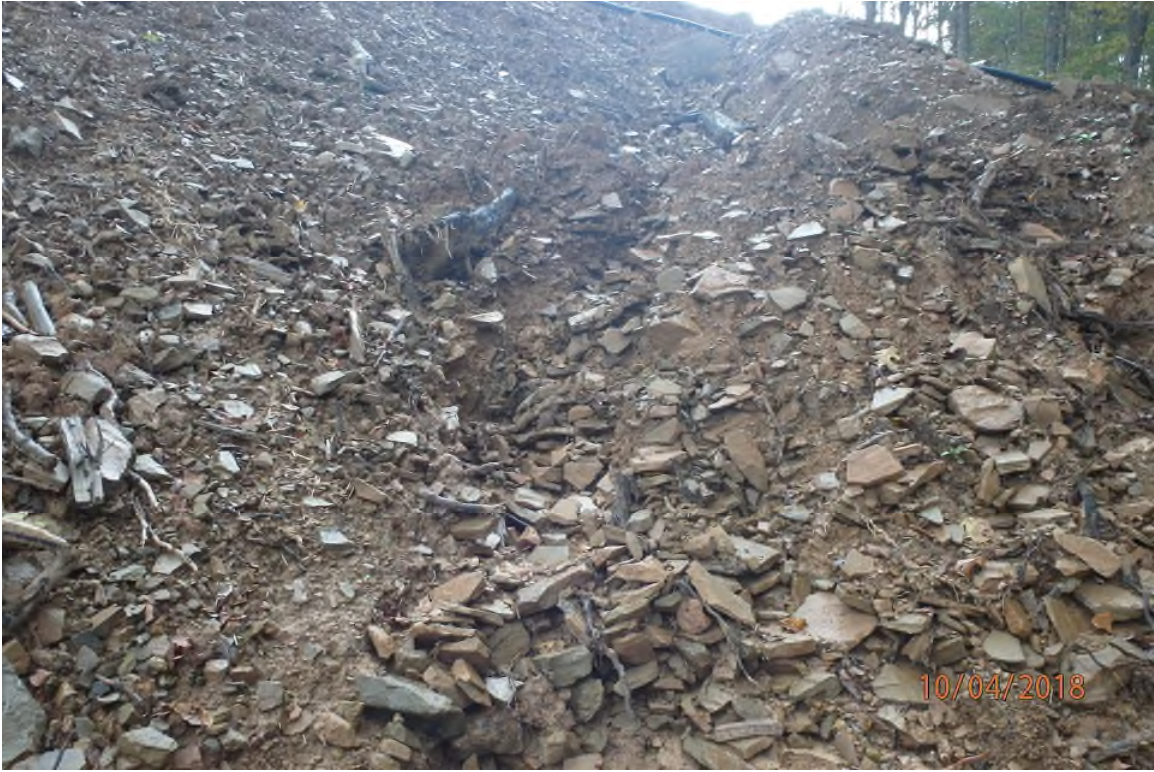
Erosion gullies upslope of SDOI008.

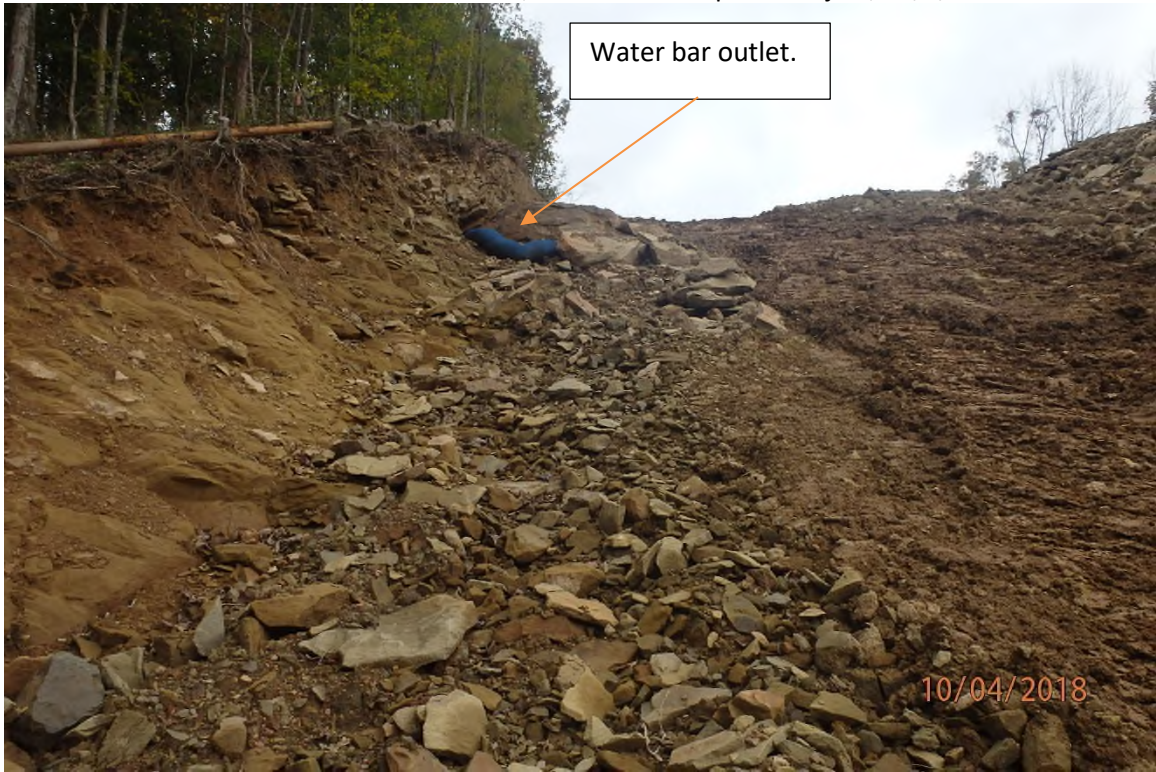
Fill slope erosion as the result of an improperly constructed water bar in the Riggins Run watershed.

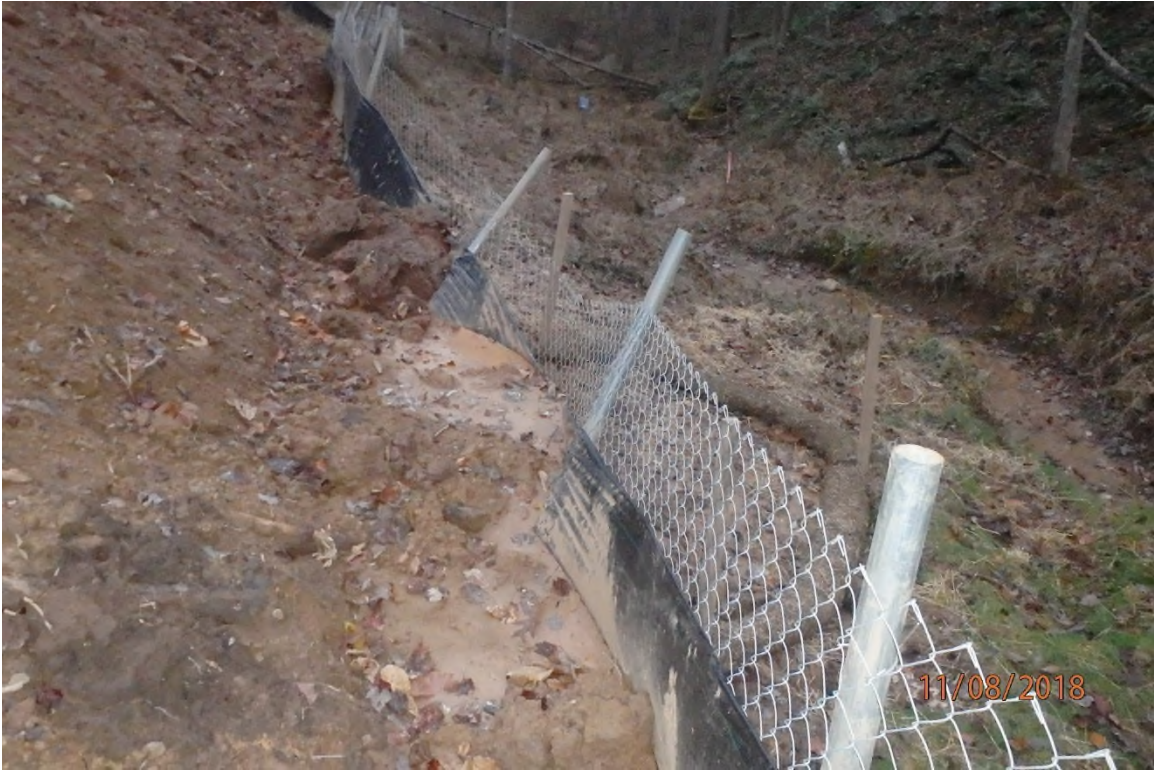
BMP in need of maintenance that caused offsite CNA deposits in UNT Sugar Run (SDOH008) (39°11.070' X 80°51.112').

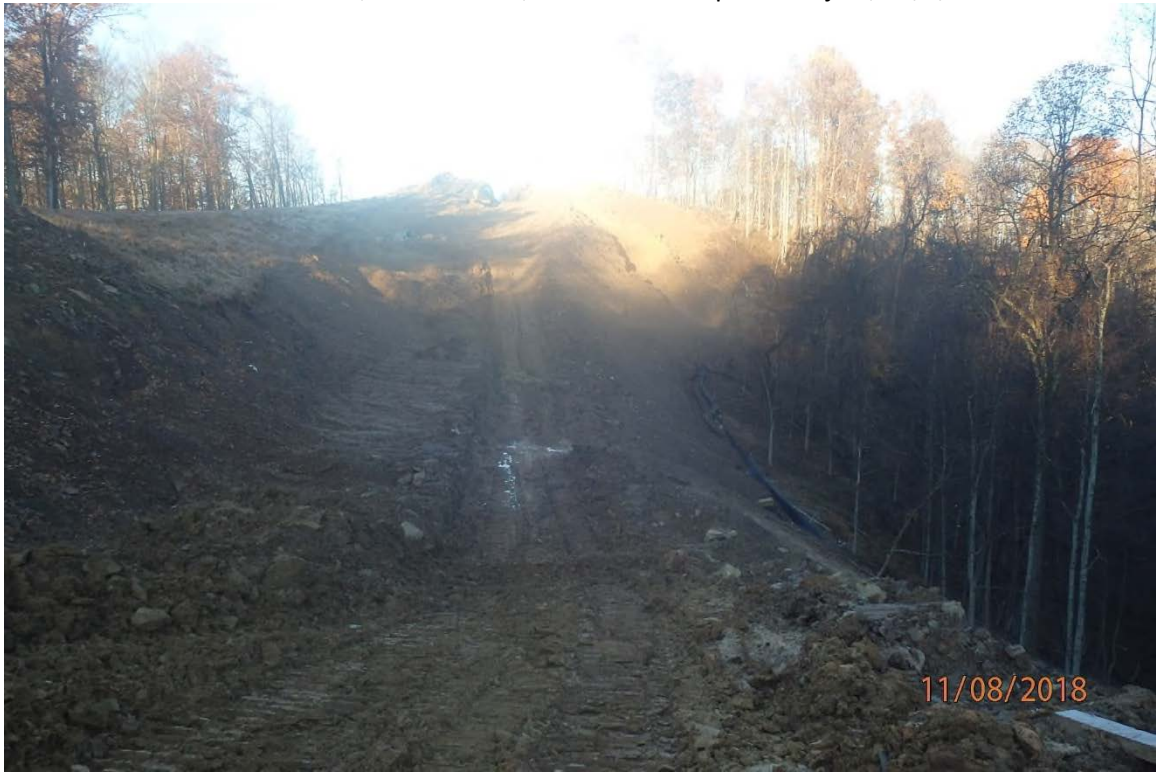
Improperly installed water bars adjacent to 2822+00.

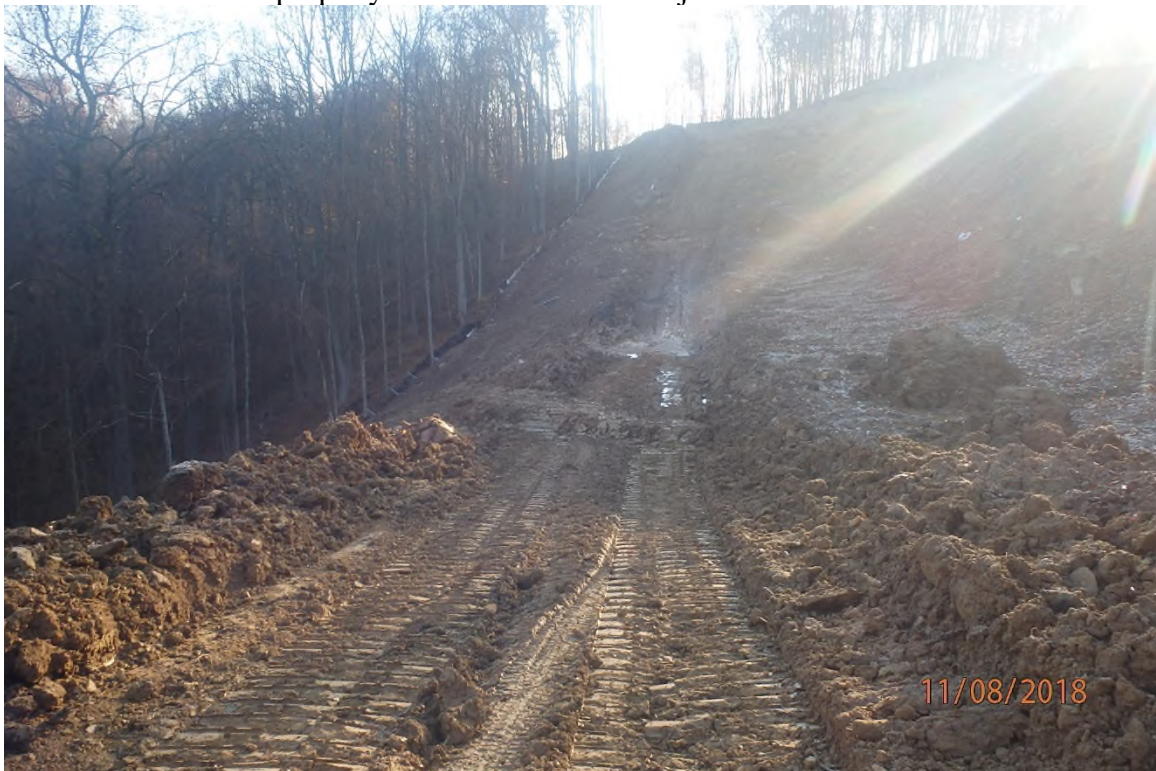
Improperly installed water bars adjacent to 2822+00.

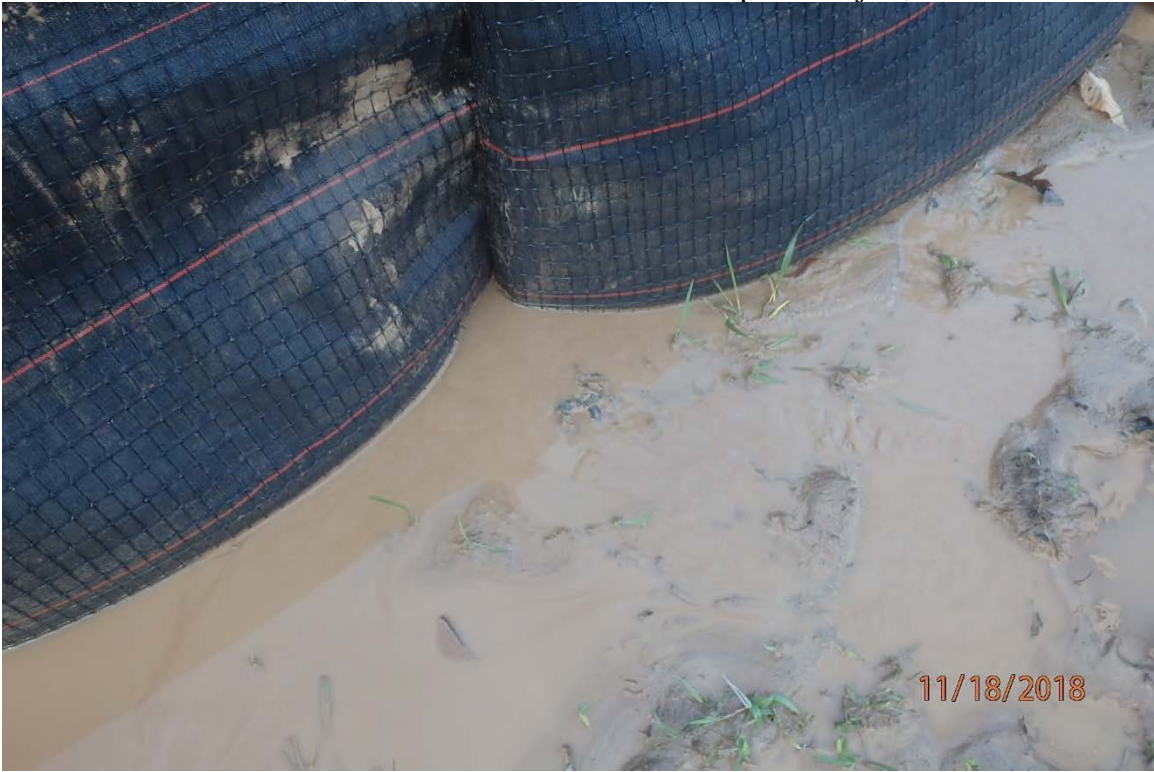
Improperly installed perimeter control on ARDO008.2 allowing sediment laden water to bypass under the installed BMP.

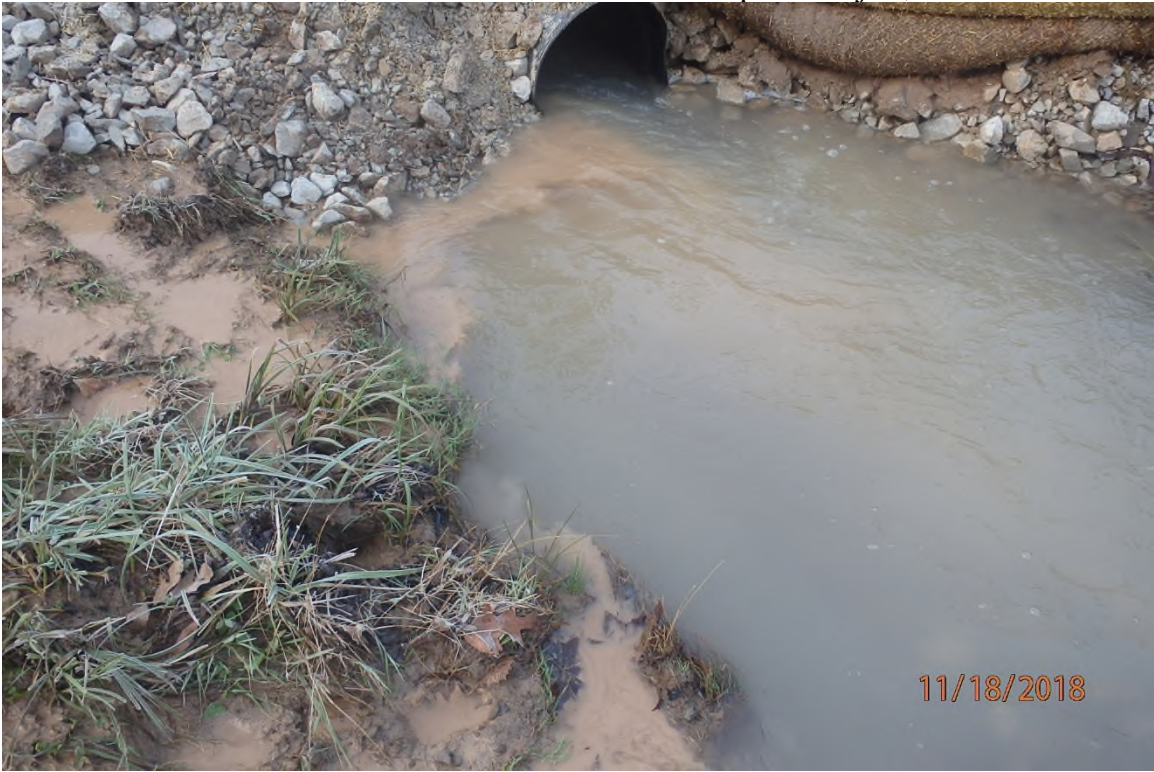
CNA distinctly visible settleable solids in Georgescamp Run (39° 15.092' X 80° 43.970') on ARDO008.2 due to a bypass from an improperly installed perimeter control.

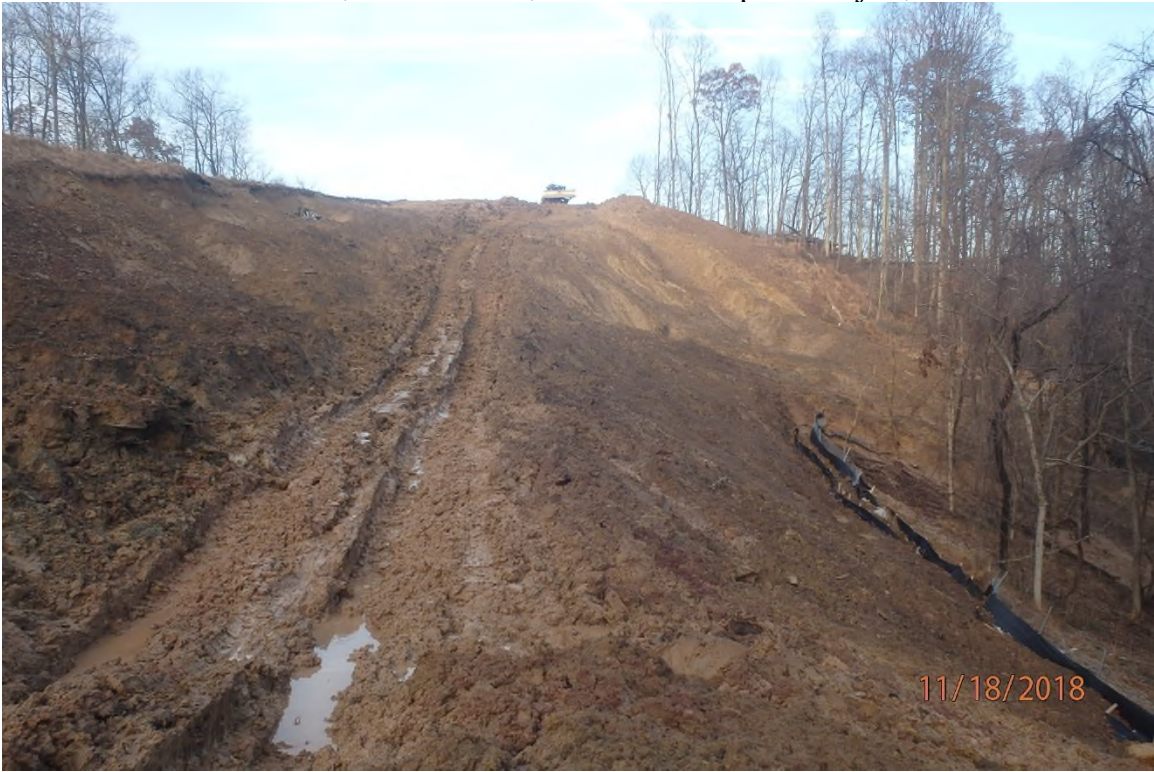
Overview of slip near 2822+00.

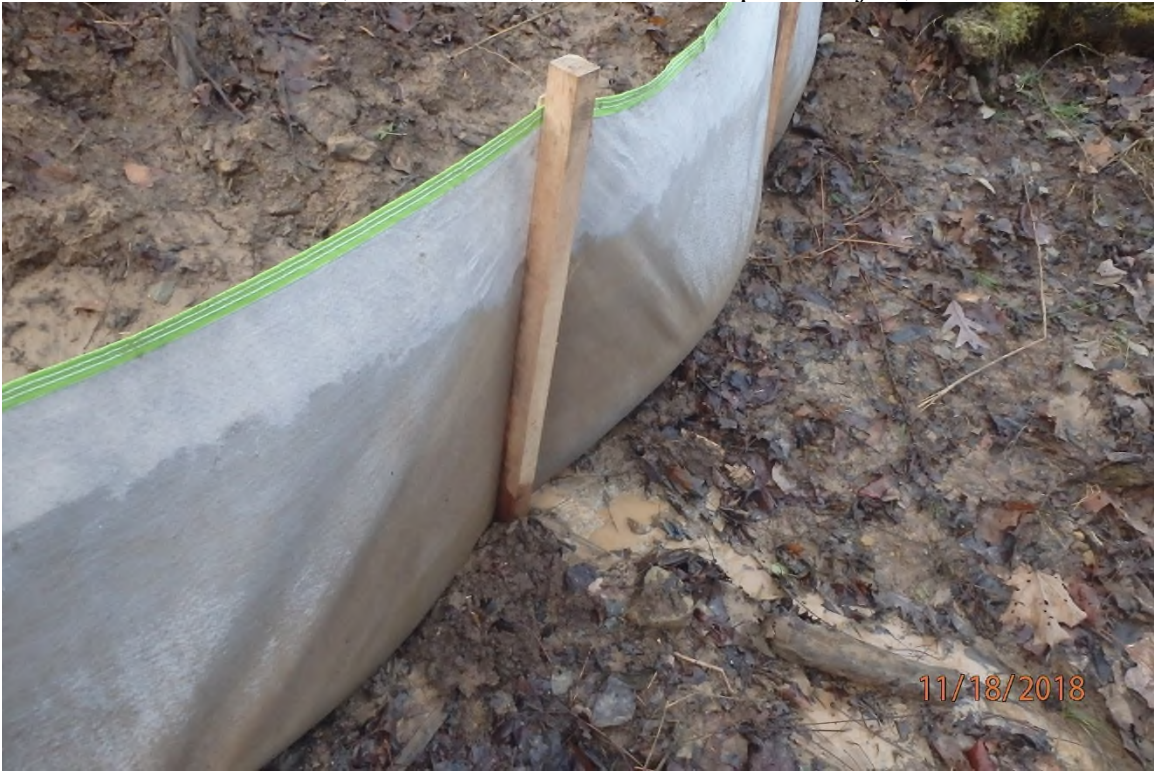
Improperly installed perimeter control allowing sediment laden water to bypass under the device on the offsite slip near 2822+00.

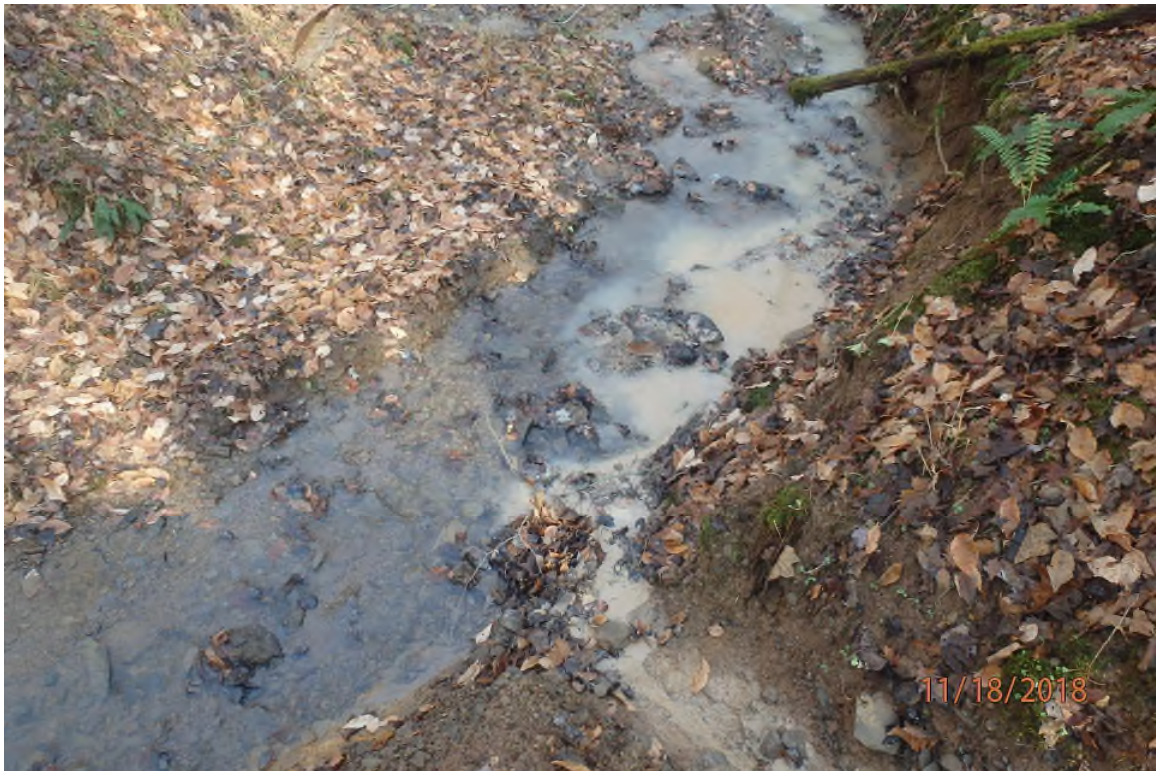
Visible plume at the confluence of UNT Georgescamp Run and Georgescamp Run.

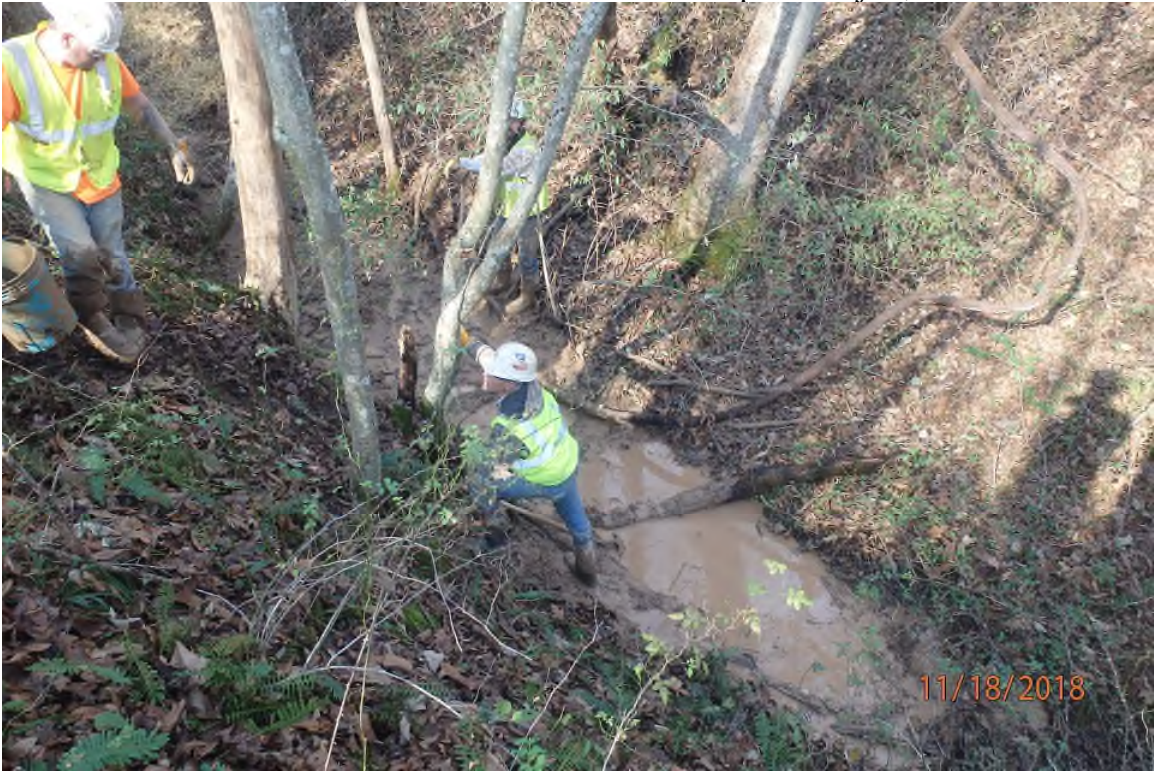
CNA distinctly visible settleable solids and deposits in UNT Bluestone Creek (39° 14.425' X 80° 45.817') as a result of the previously pictured deficiency.

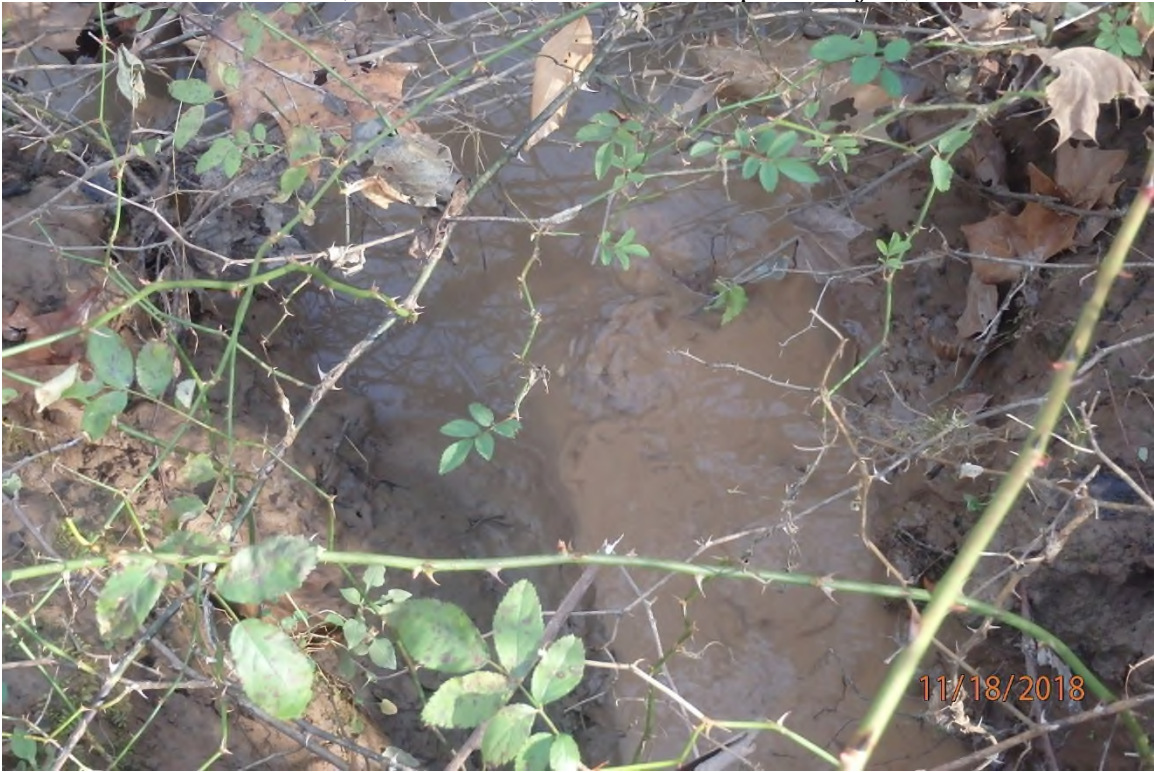
Visible plume at the confluence of UNT Bluestone Creek and Bluestone Creek.

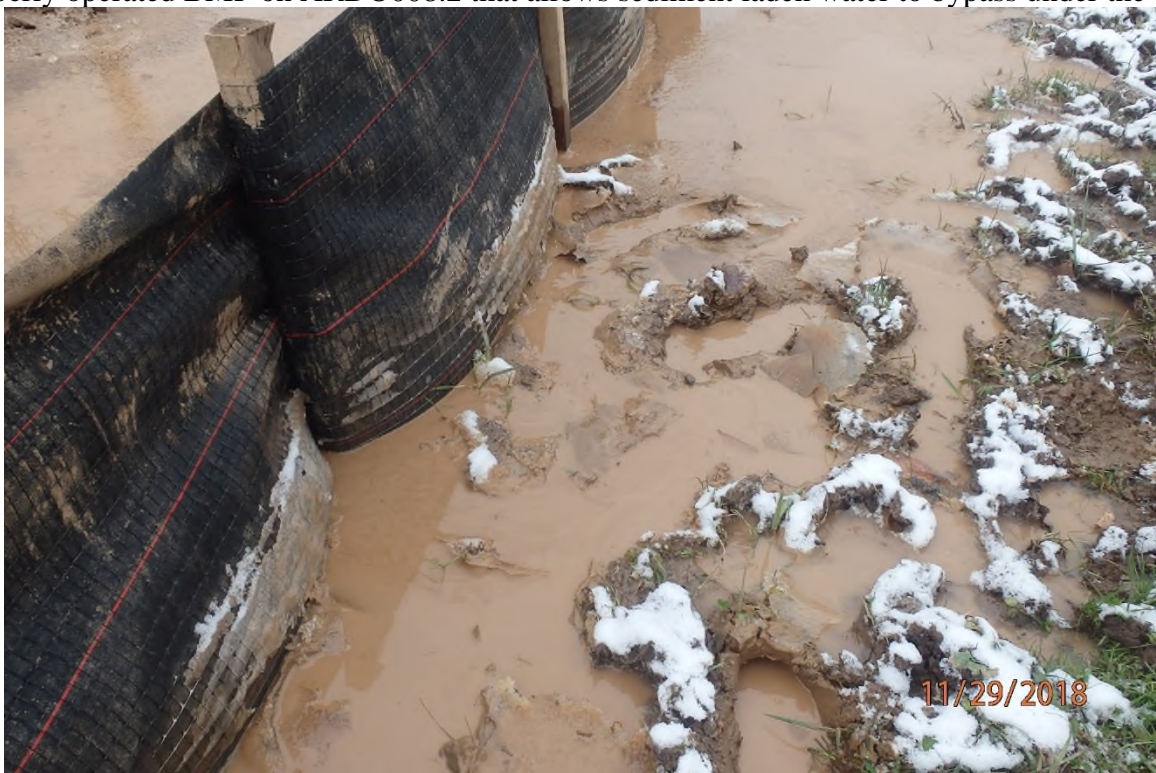
Improperly operated BMP on ARDO008.2 that allows sediment laden water to bypass under the device.

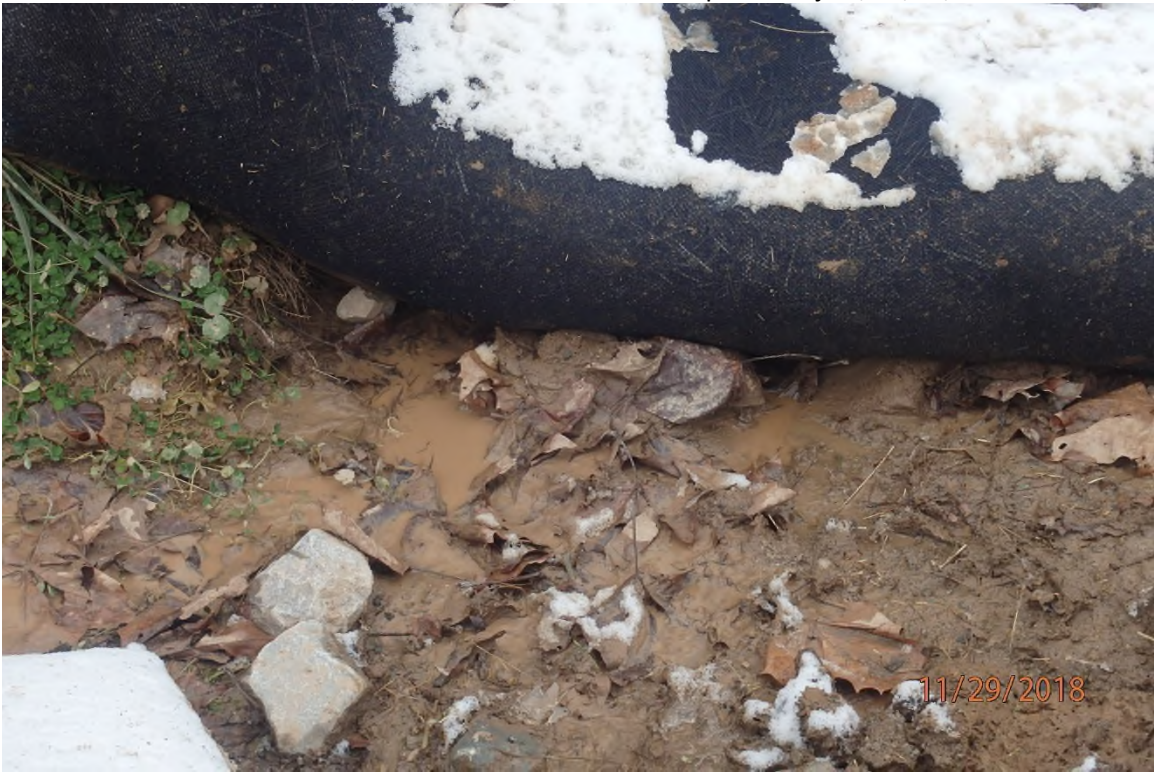
Improperly operated BMP on ARDO008.2 that is allowing sediment laden water to bypass the device.

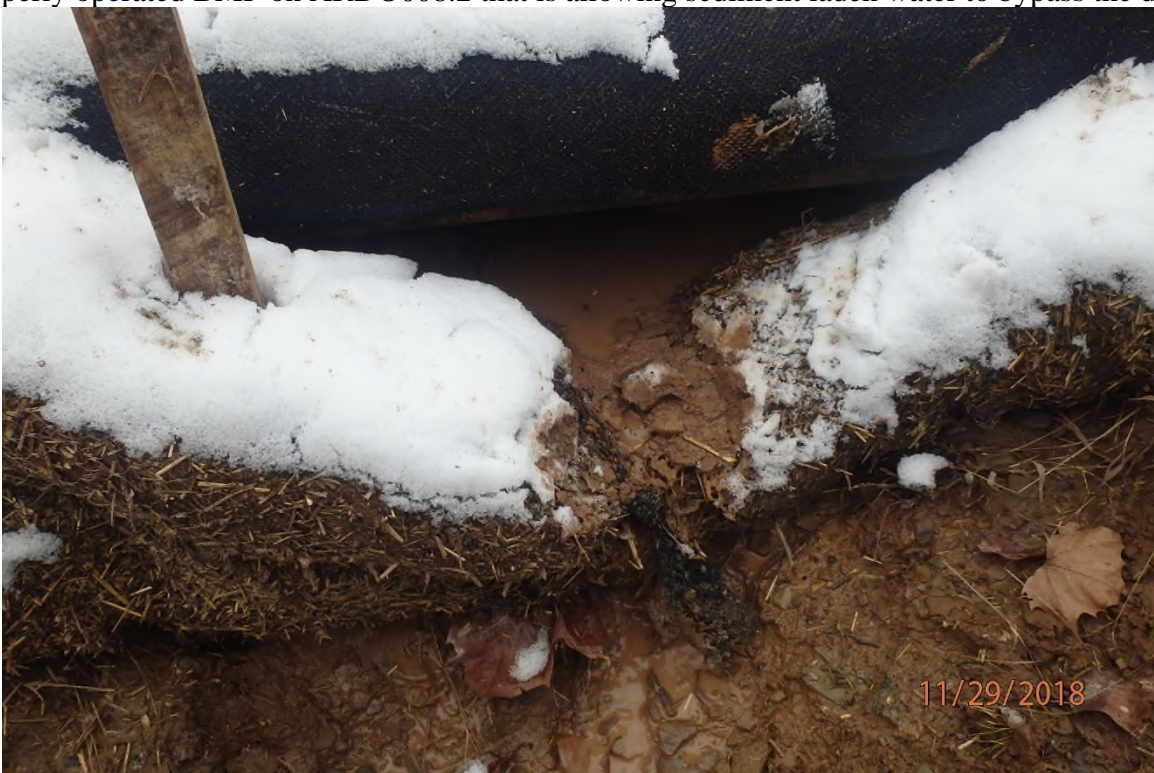
Improperly operated BMP on ARDO008.2 that is allowing sediment laden water to bypass the device.

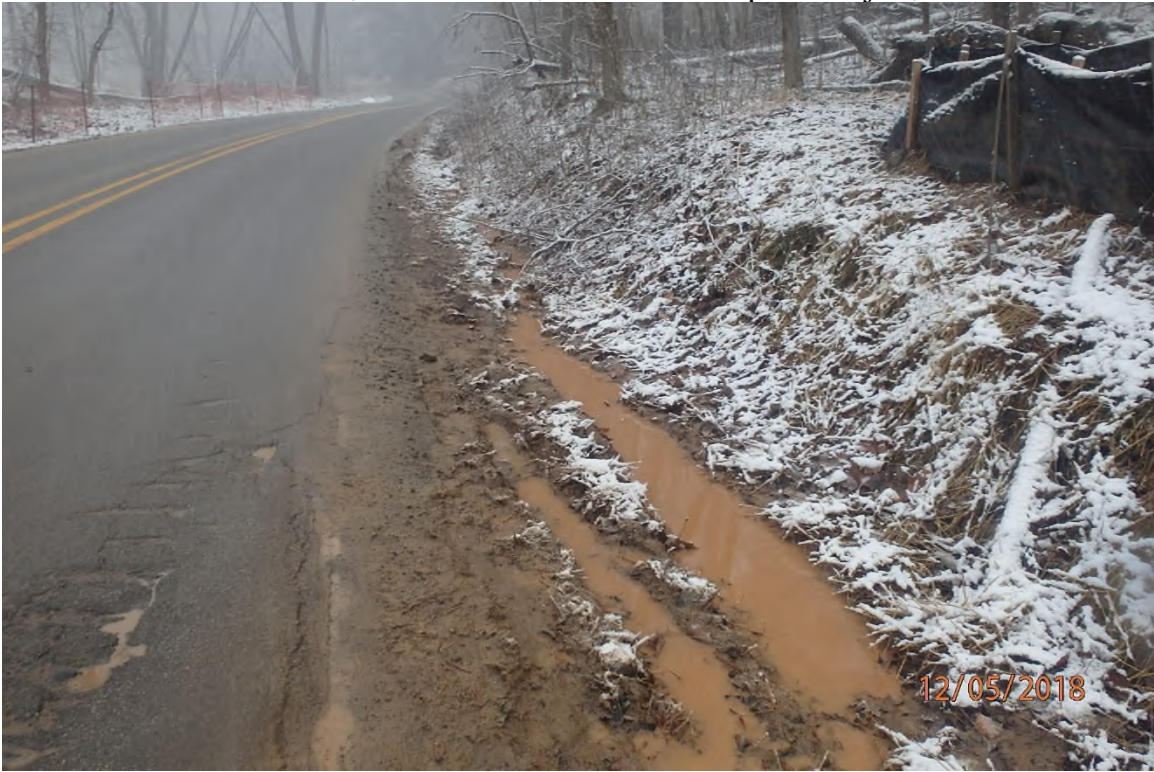
Sediment laden water that originates from the site (ARDO002.9) in DOH conveyance.

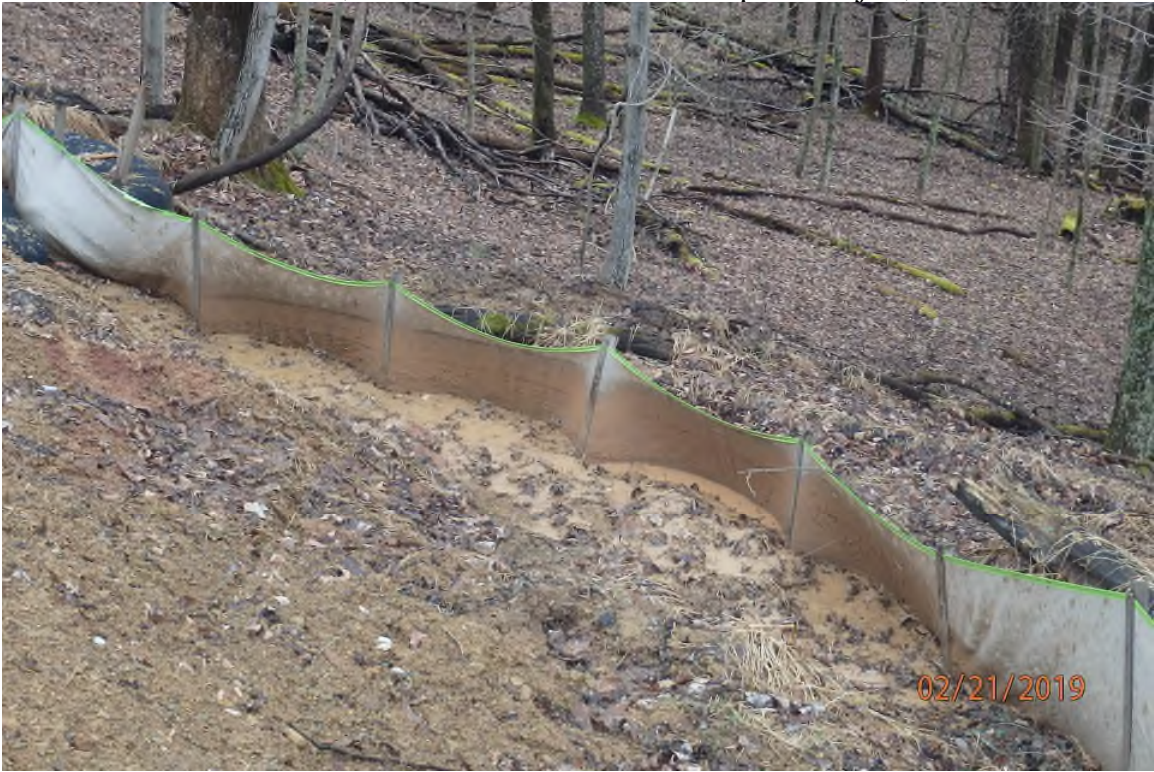
Installed perimeter control adjacent to 2256+00 that has been overwhelmed due to improperly installed water bars.

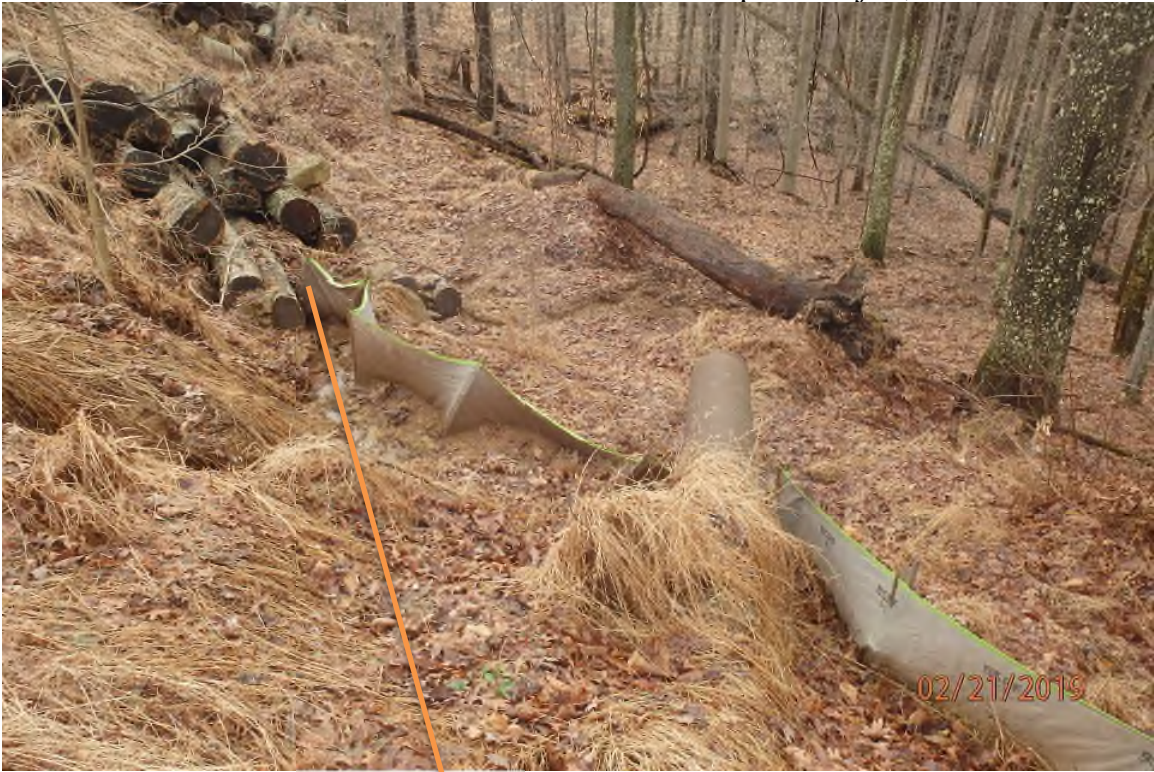
Improperly installed perimeter control adjacent to 2260+00 that allows sediment laden water to bypass the device.

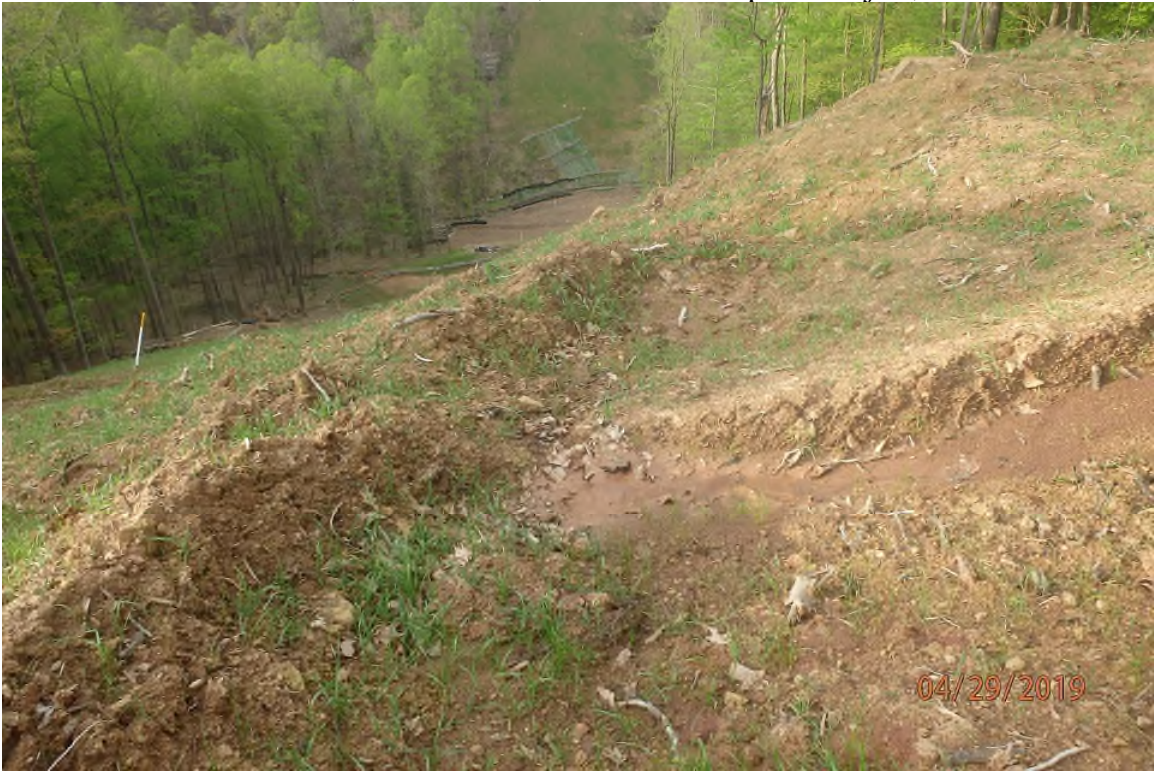
Improperly installed water bar with varying angles that is installed with a height less than 16" adjacent to 2226+50.

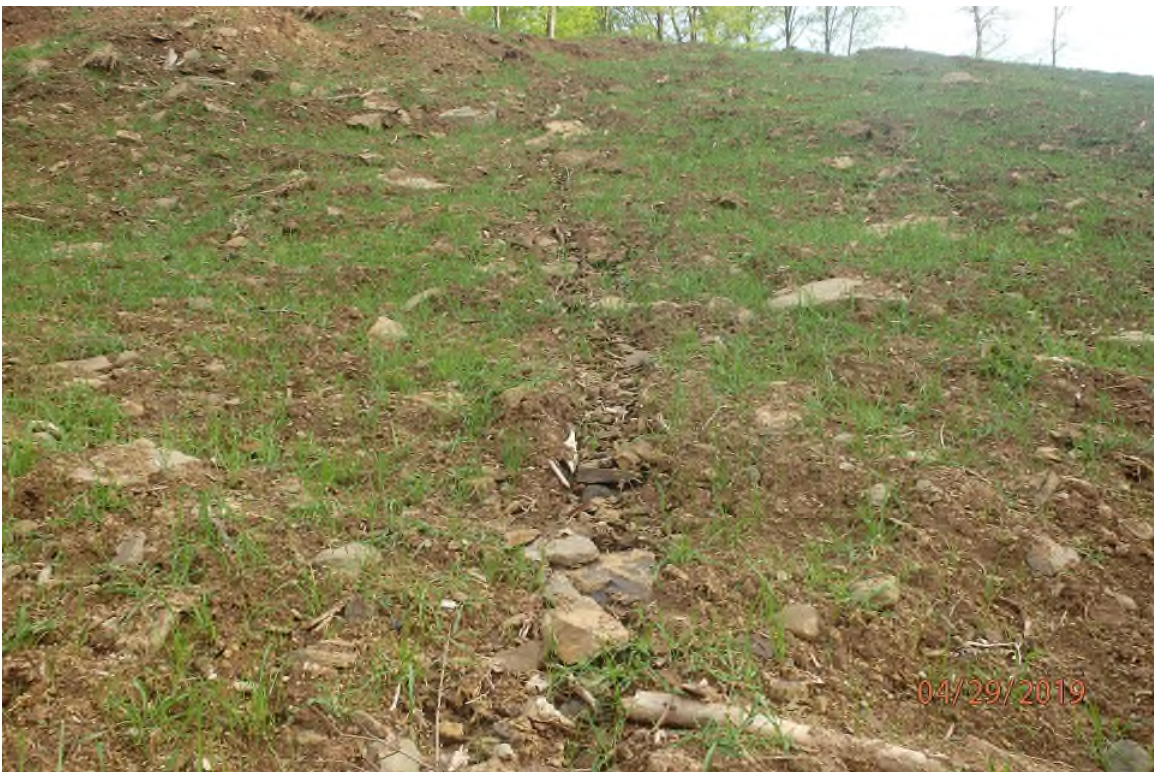
Erosion gully downslope of the above pictured water bar adjacent to 2226+50.

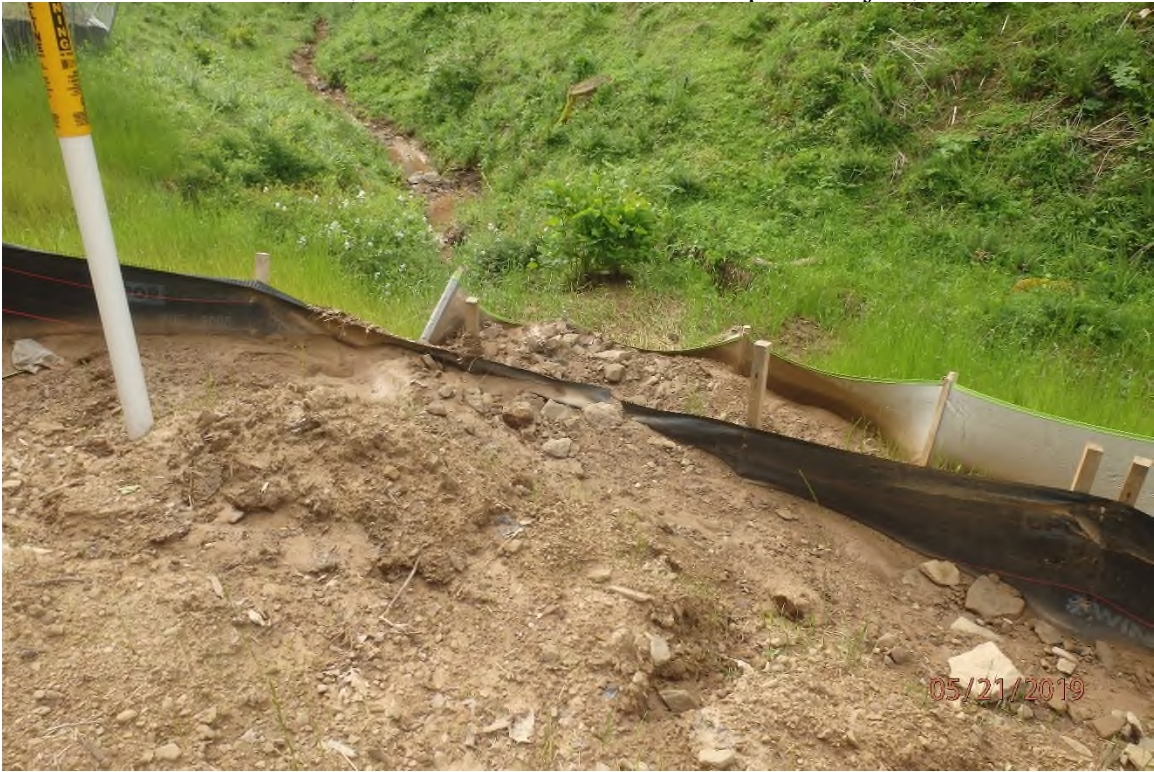
Unmaintained BMP in the UNT Sugar Run watershed.

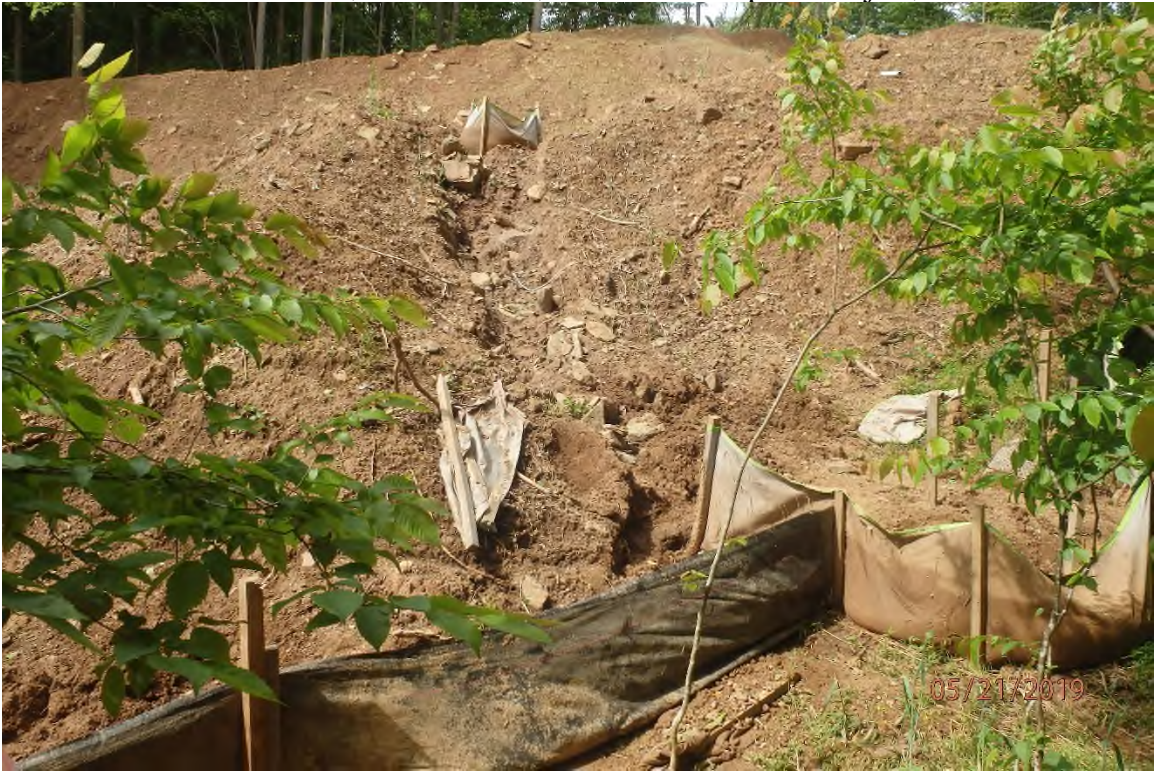
Unmaintained BMP in the Tylor Drain watershed.
