**CONSENT ORDER
ISSUED UNDER THE
WATER POLLUTION CONTROL ACT
WEST VIRGINIA CODE, CHAPTER 22, ARTICLE 11**

TO: Columbia Gas Transmission, LLC
Attn: Troy Tally, Vice President
1700 MacCorkle Ave
Charleston, WV 25314

DATE: October 1, 2020
ORDER NO.: 9061

1. Columbia Gas Transmission, LLC is conducting land disturbance activity associated with construction of the Mountaineer Xpress Project in Marshall, Wetzel, Tyler, Doddridge, Ritchie, Calhoun, Wirt, Roane, Jackson, Mason, Putnam, and Cabell Counties, West Virginia. On January 31, 2018, Columbia Gas Transmission, LLC was issued Water Pollution Control Permit No. WV0116815, Registration No. WVR310872, for Stormwater Associated With Oil and Gas Related Construction Activities.

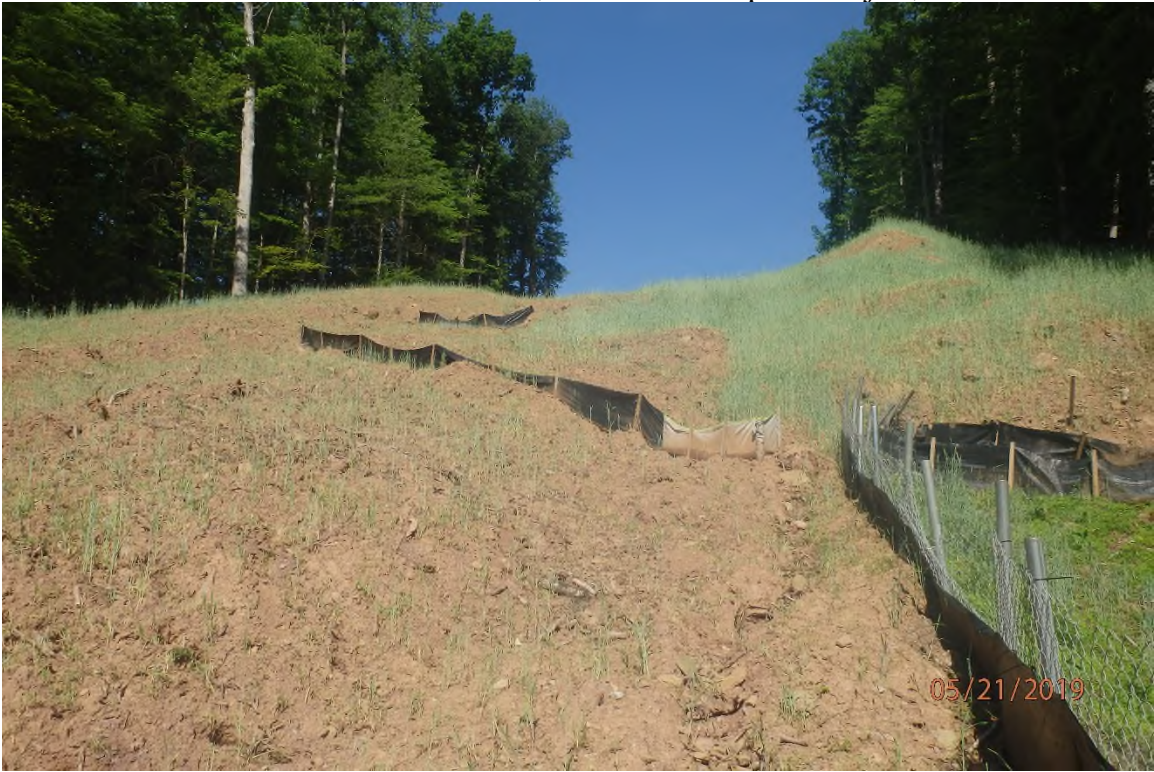
Improperly installed water bar in the Georgescamp Run watershed. Water bar installed at a steep angle and discharges over an unprotected fill slope instead of off project as designed.

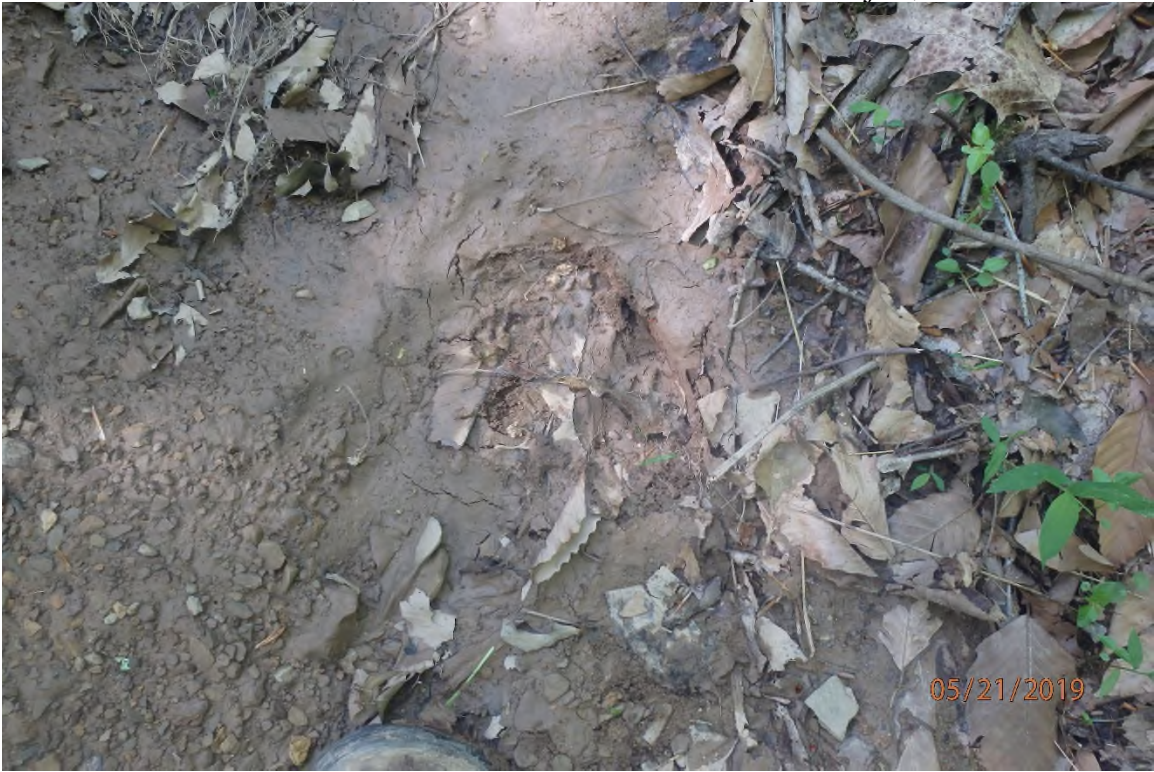
Offsite CNA deposits in UNT Georgescamp Run (39° 15.134' X 80° 44.327') that originate from the previously pictured improperly installed water bars.

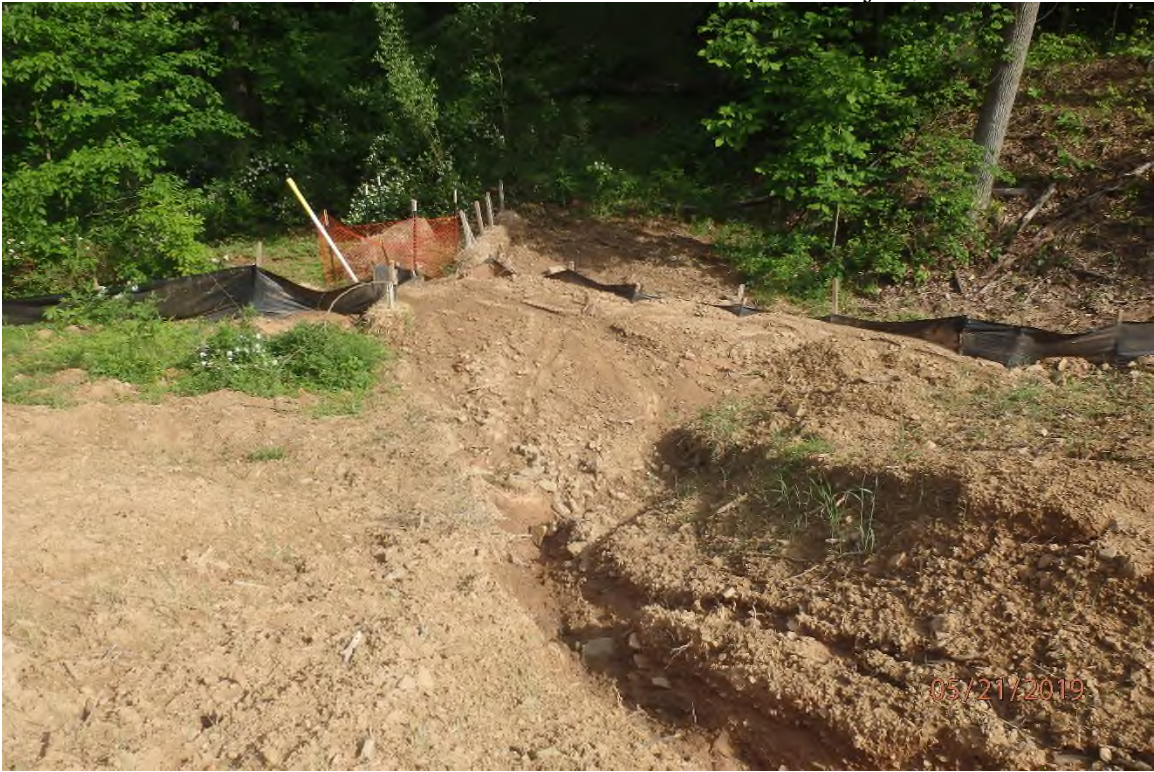
Installed BMP that is overwhelmed adjacent to UNT Taylor Drain as a result of a failure to install water bars.

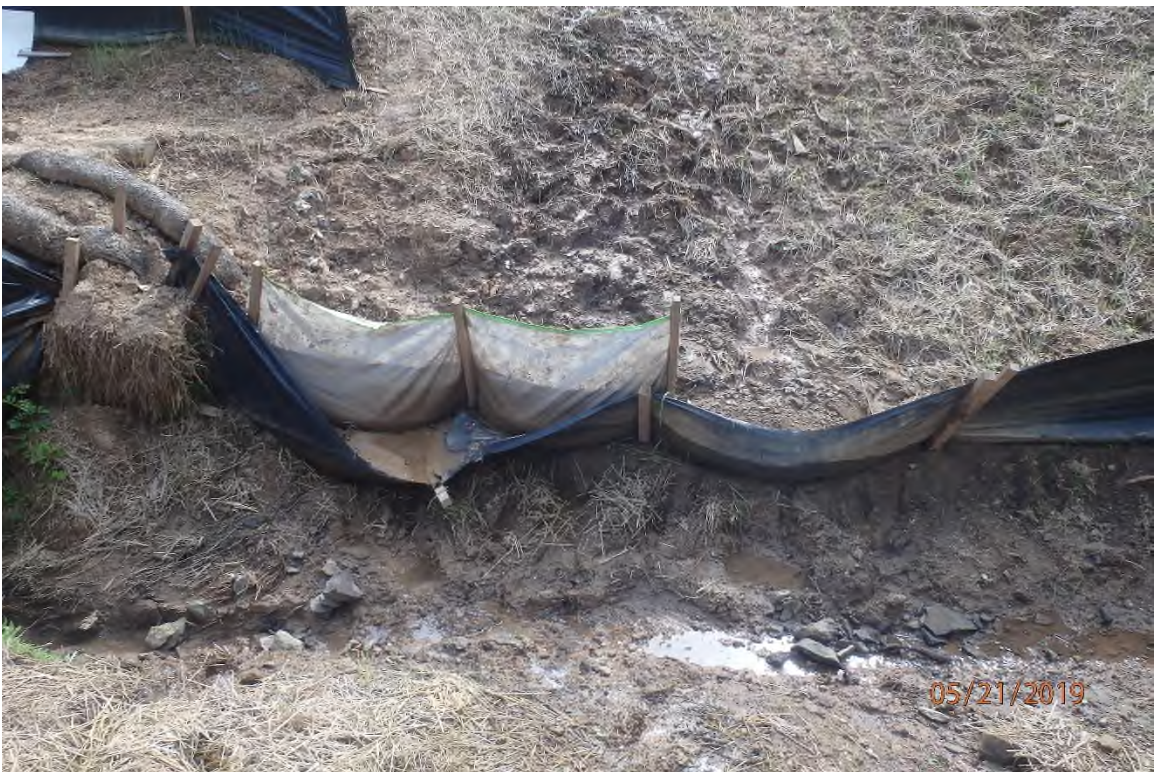
Installed BMP that is overwhelmed adjacent to UNT Taylor Drain as a result of a failure to install water bars.

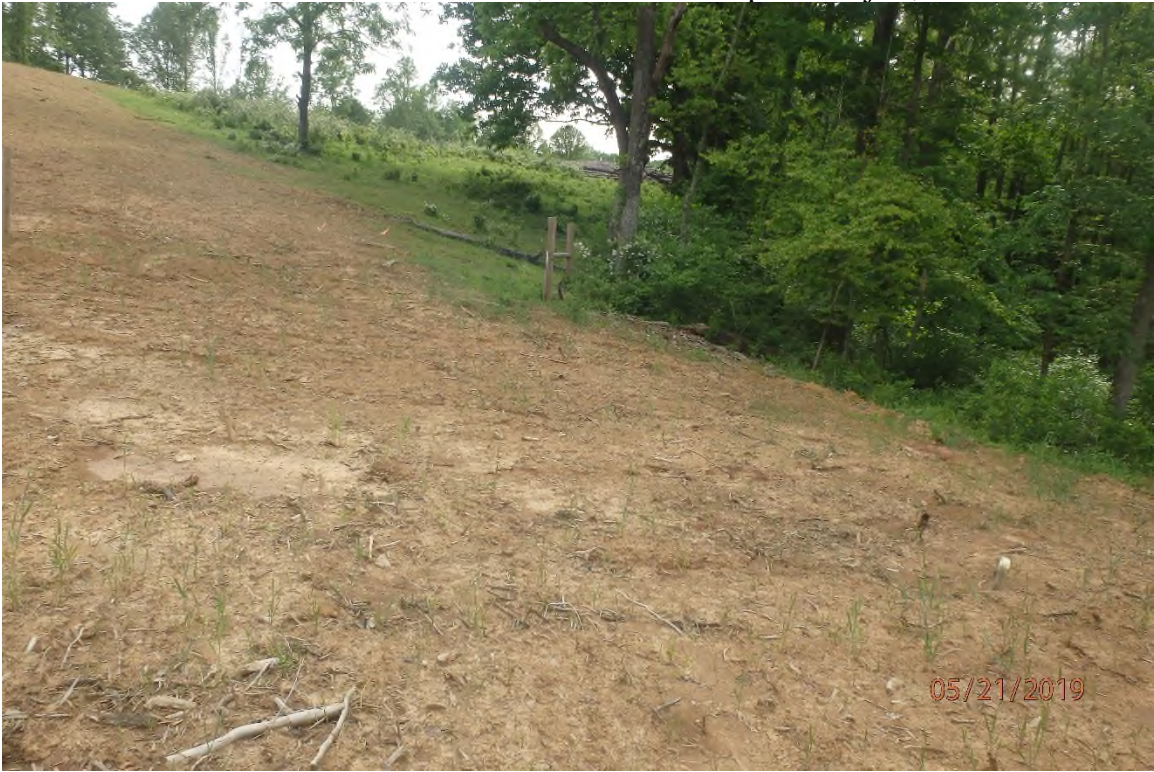
Area adjacent to 3314+00 where the approved SWPPP does not indicate the need for perimeter controls and the plan has proved inadequate. Offsite sediment deposits documented in lower photo.

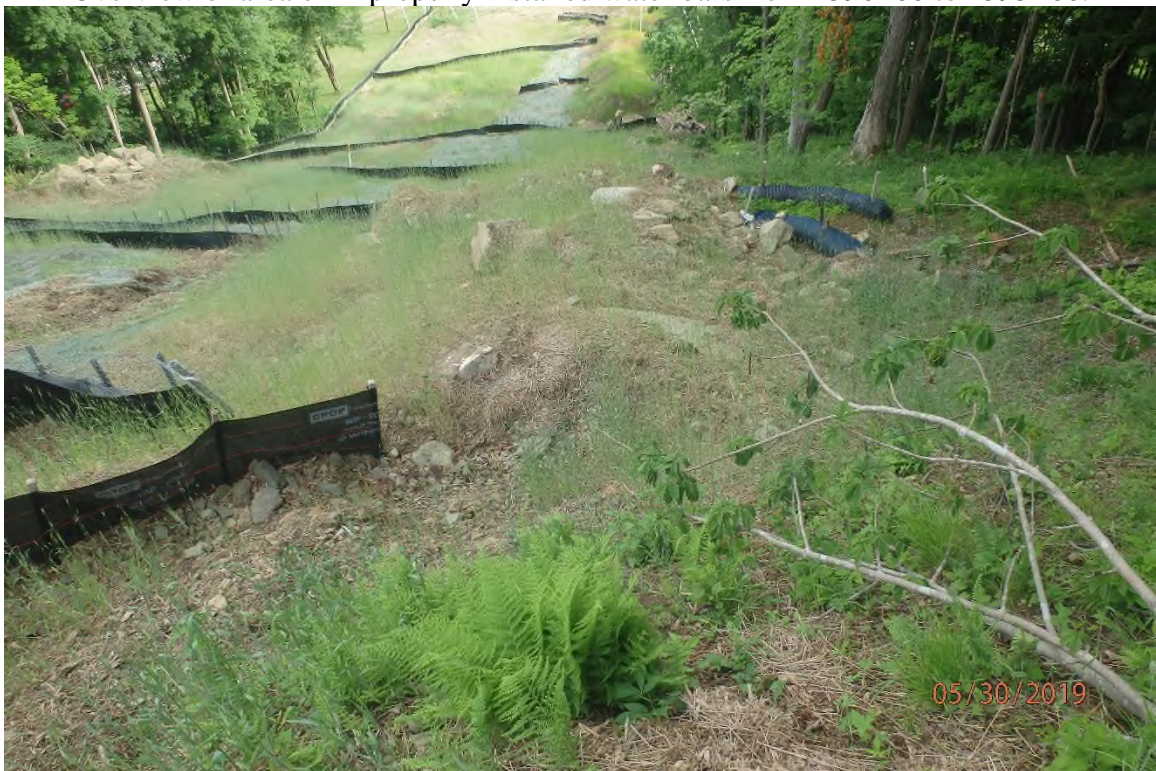
Overview of area of improperly installed water bars from 2590+00 to 2595+00.

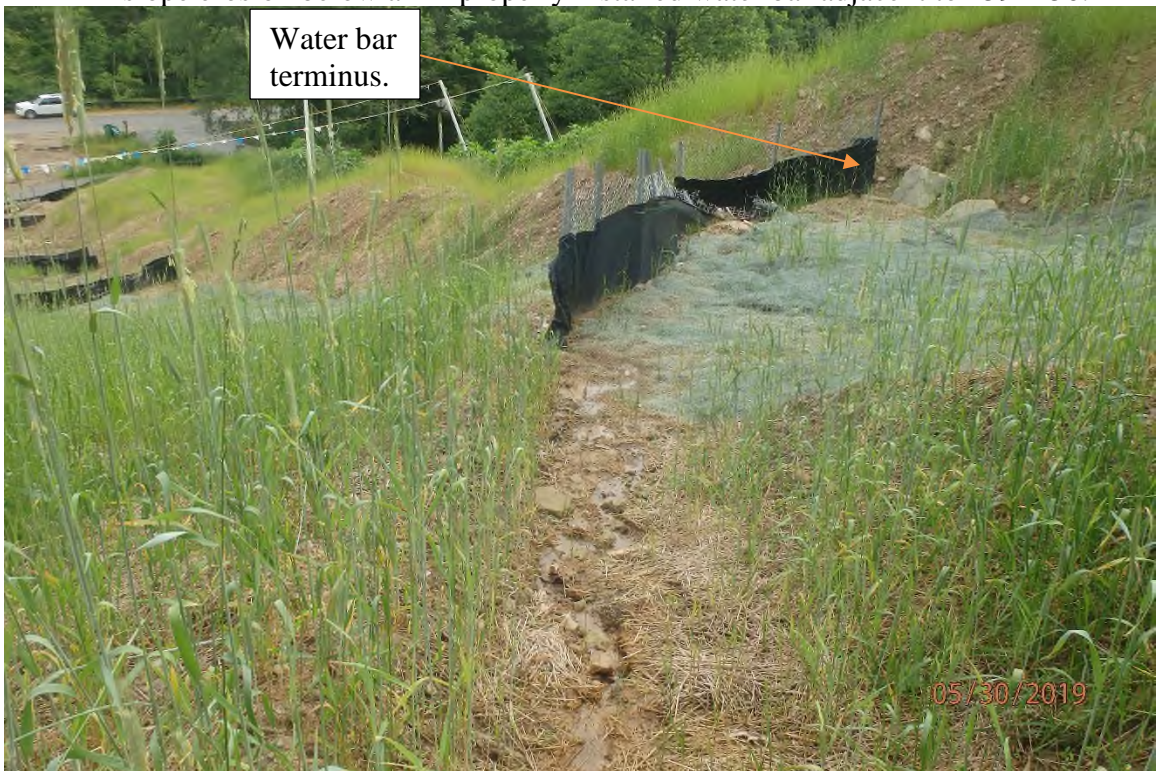
Improperly installed water bar adjacent to 2591+00.

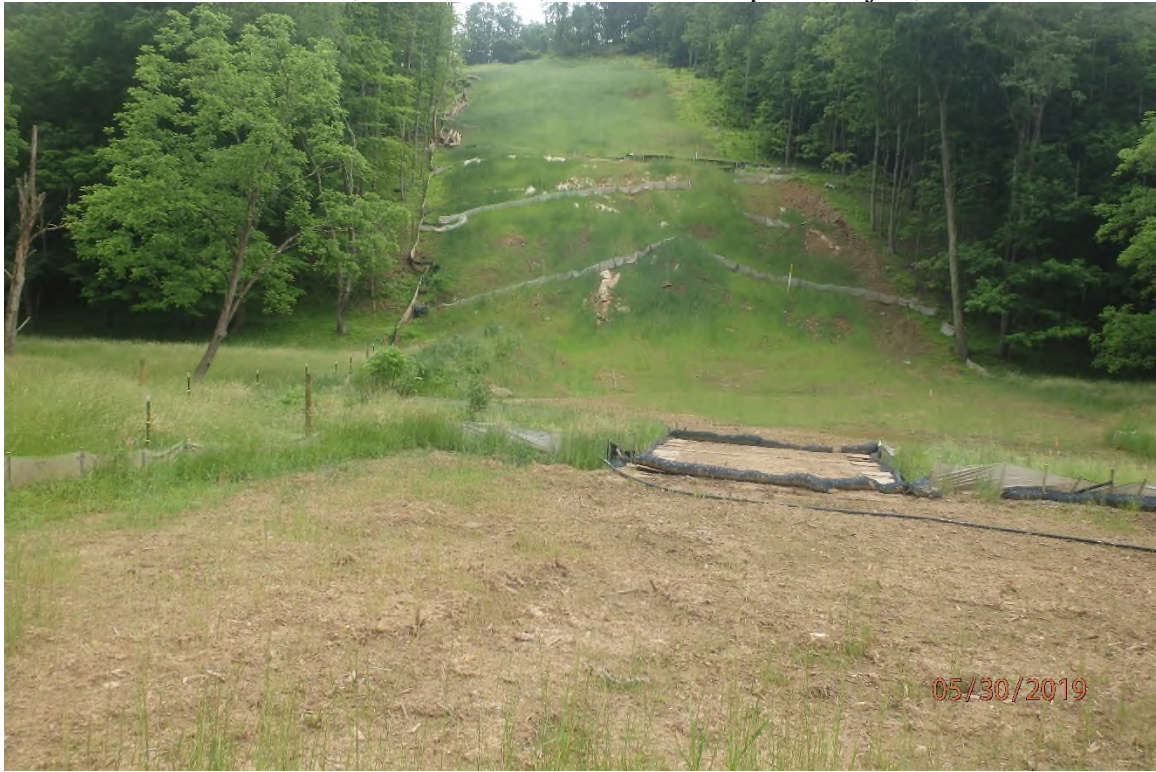
Project area adjacent to 2452+14 showing improperly installed water bars.

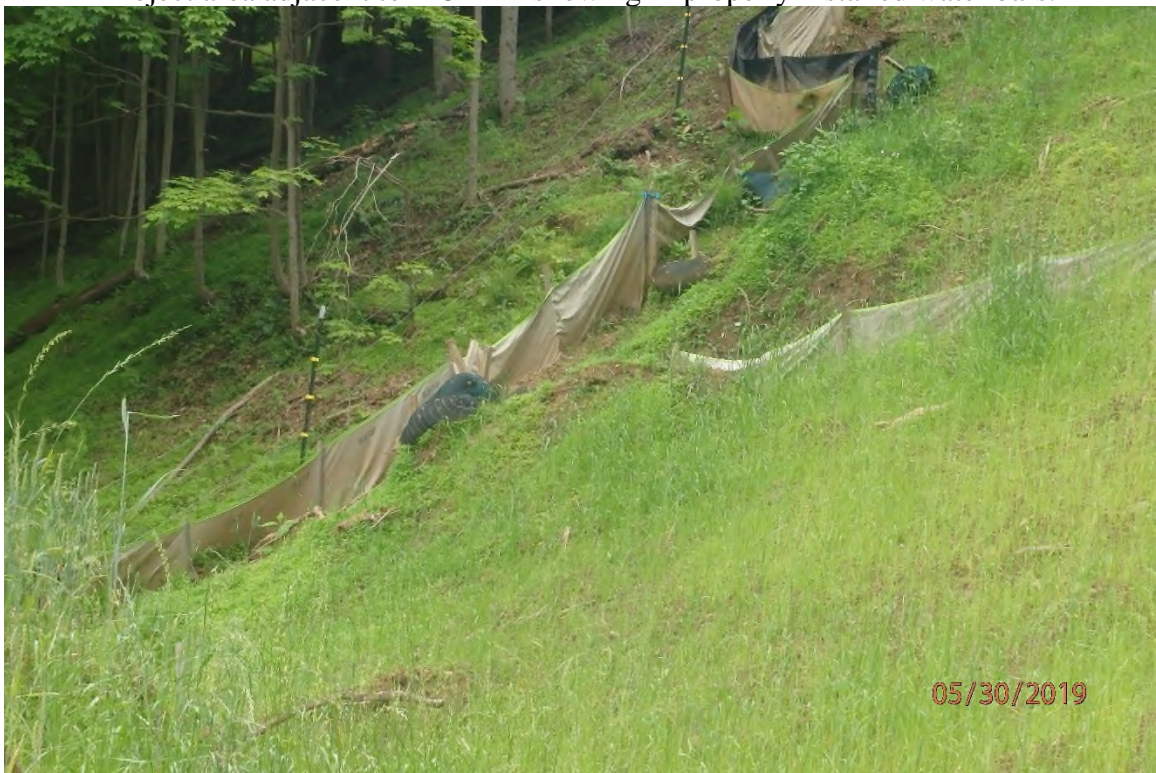
Water bar that terminates inside of the installed perimeter control adjacent to 2452+14.

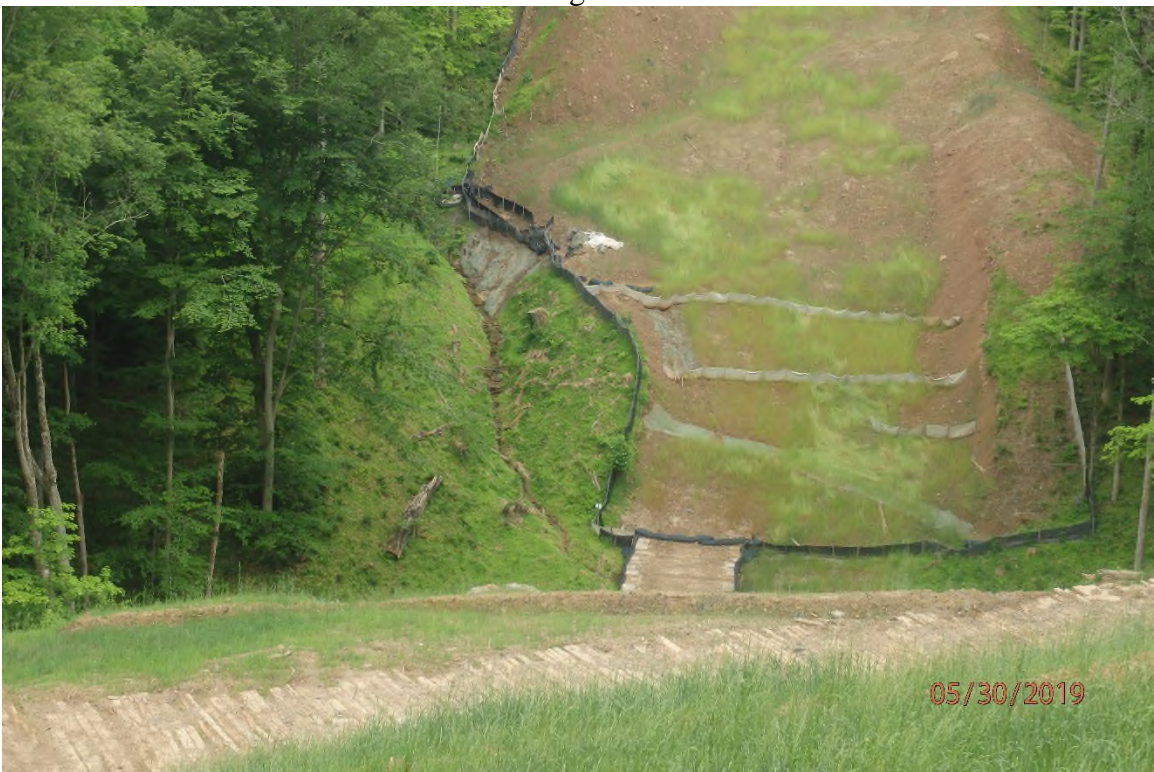
Improperly installed water bars in the Wolfepen Run watershed.

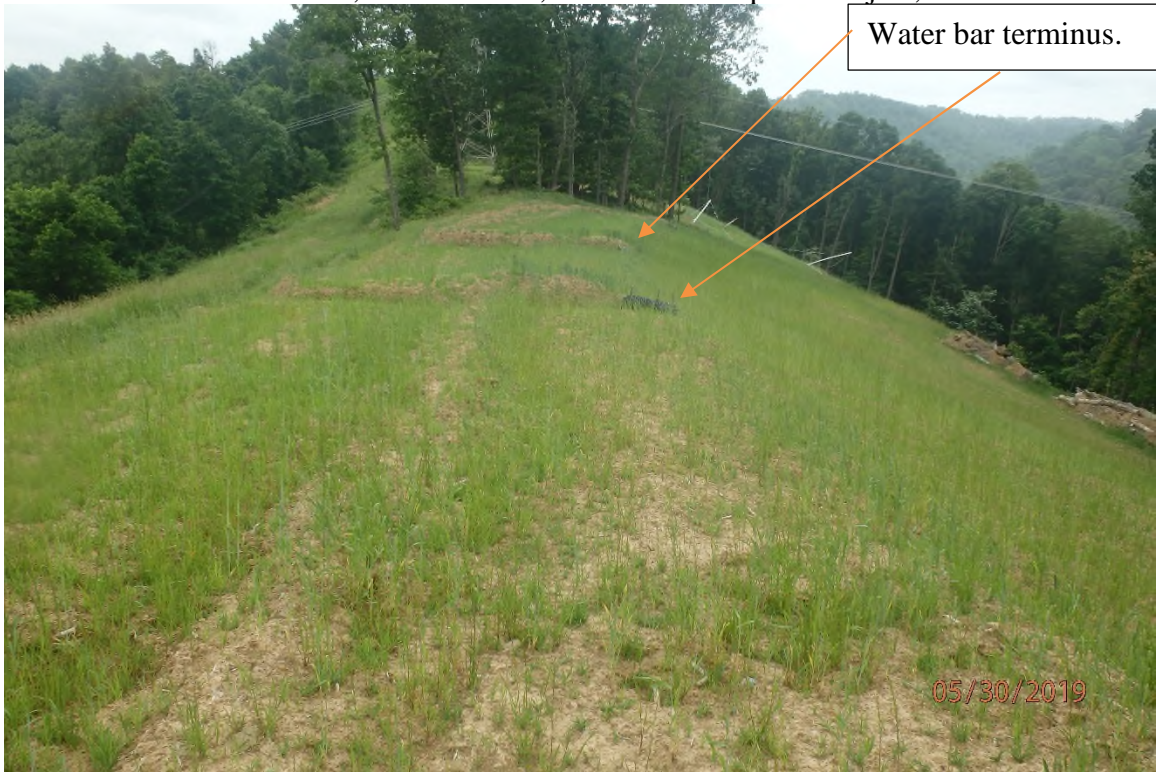
Improperly installed water bars in the Englands Run watershed.

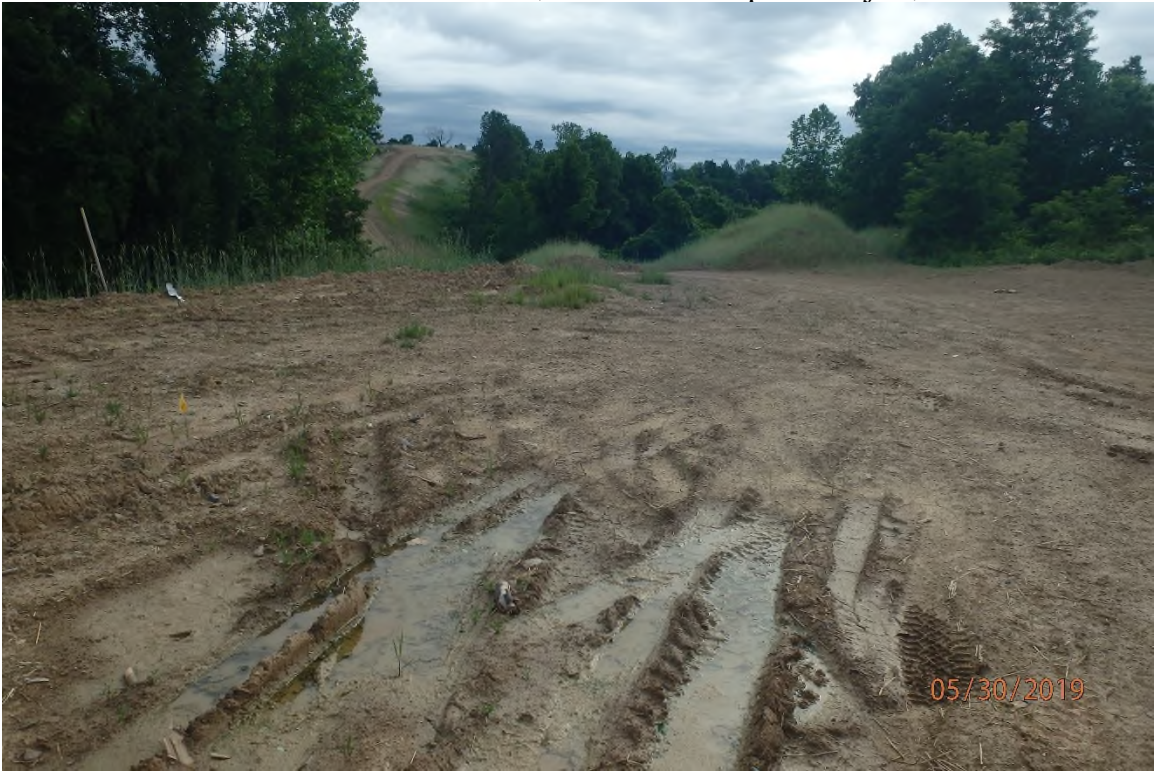
Area in the Meathouse Fork watershed of the MXP-100 that has failed to germinate and has recently been reseeded.

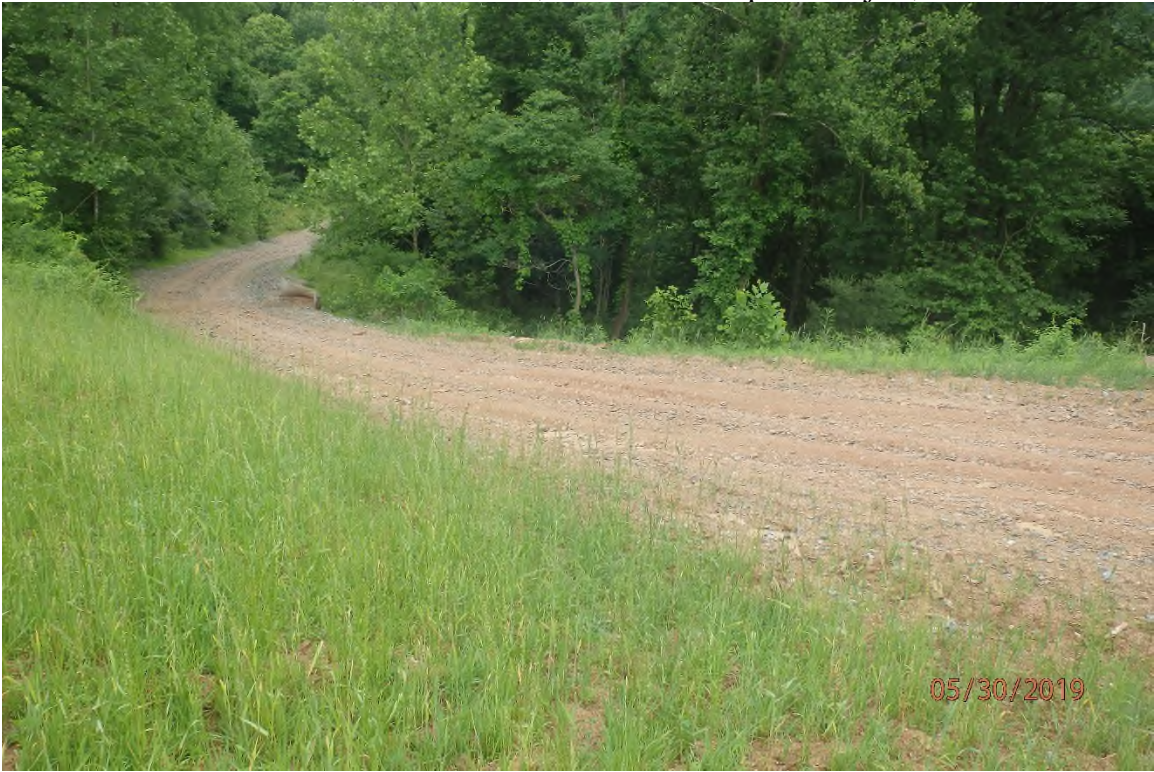
Access road ARDO004 showing the need for maintenance and stabilization.

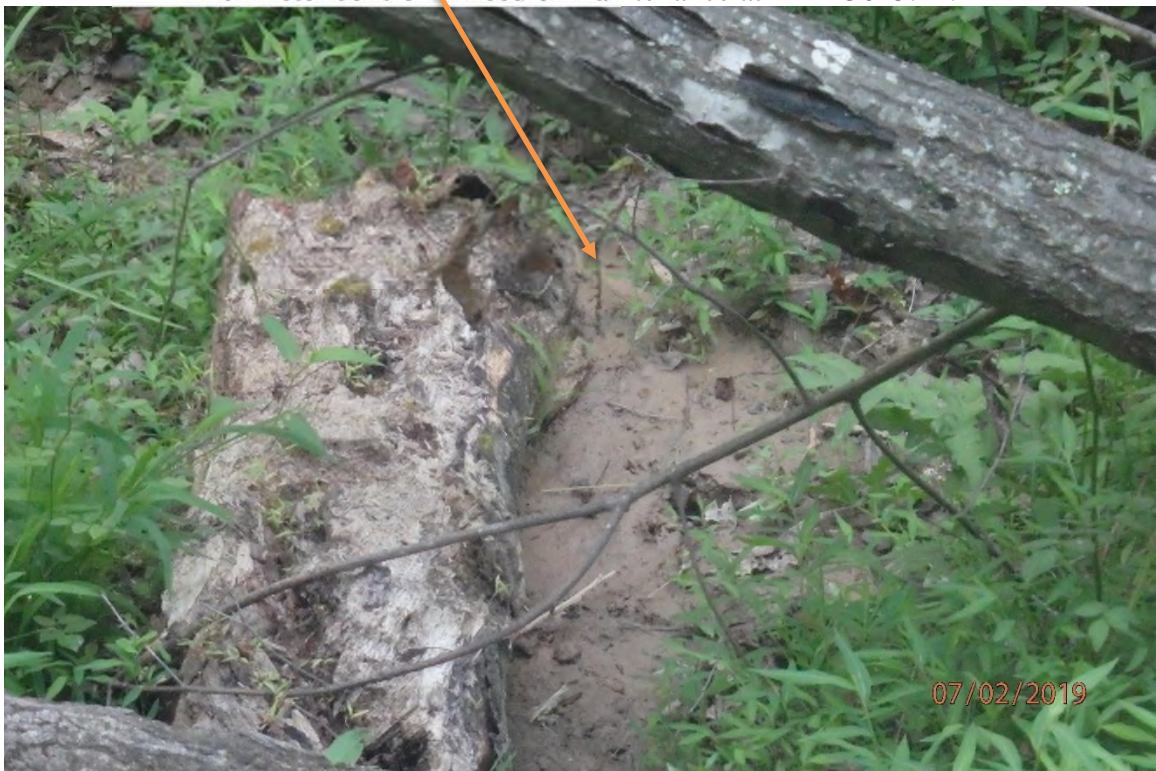
Offsite sediment deposits as a result of the above pictured deficiency.

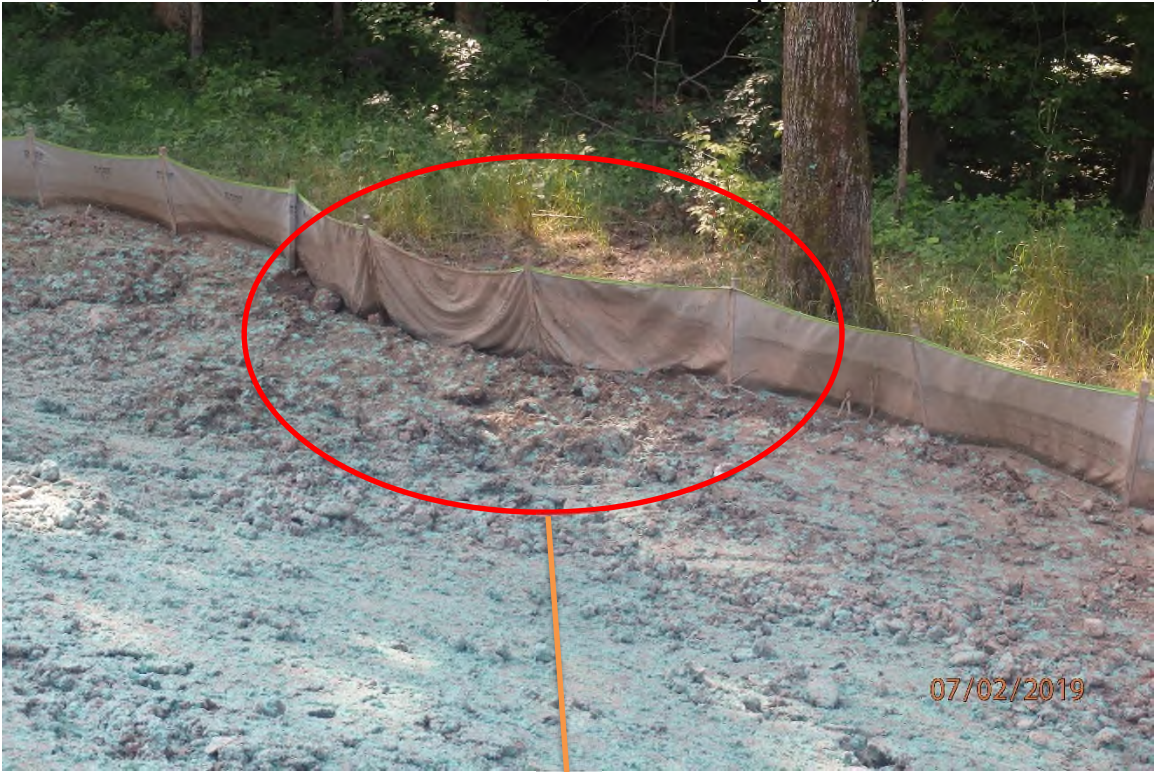
Recently maintained perimeter control adjacent to UNT Sugar Run (SDOH11).

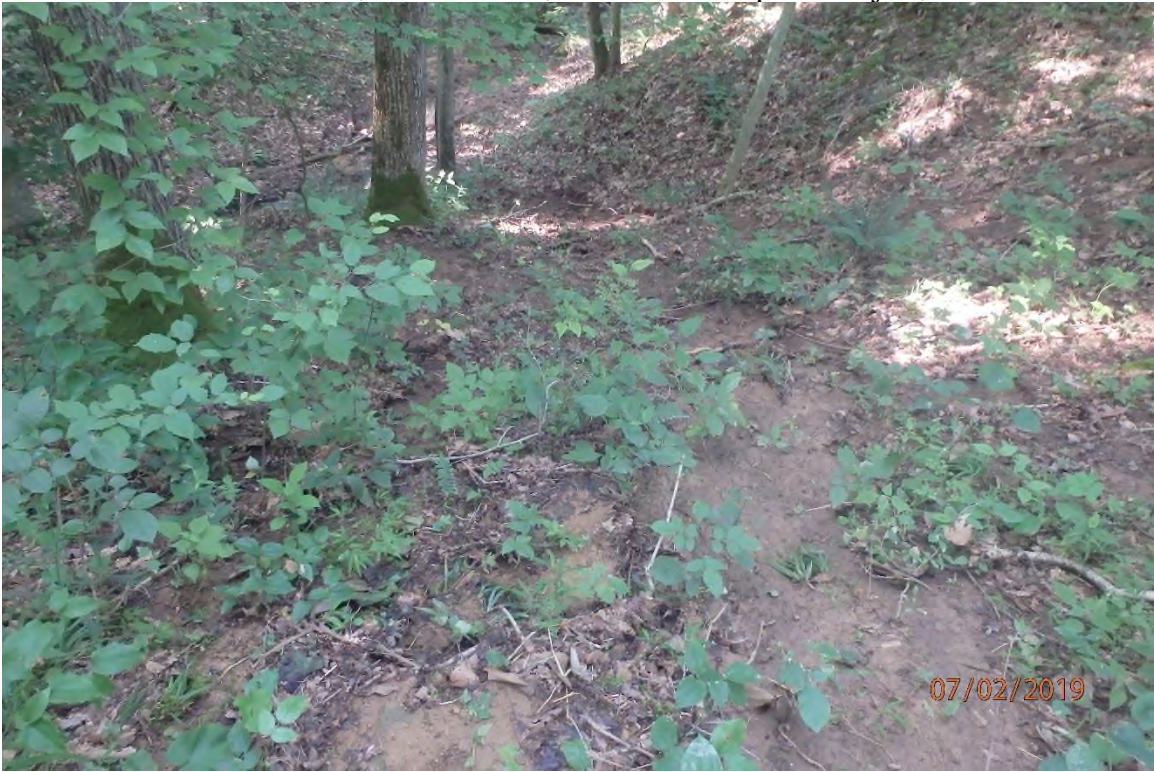
Offsite sediment trail leading to UNT Sugar Run (SDOH11) as a result of the previously pictured deficiency.

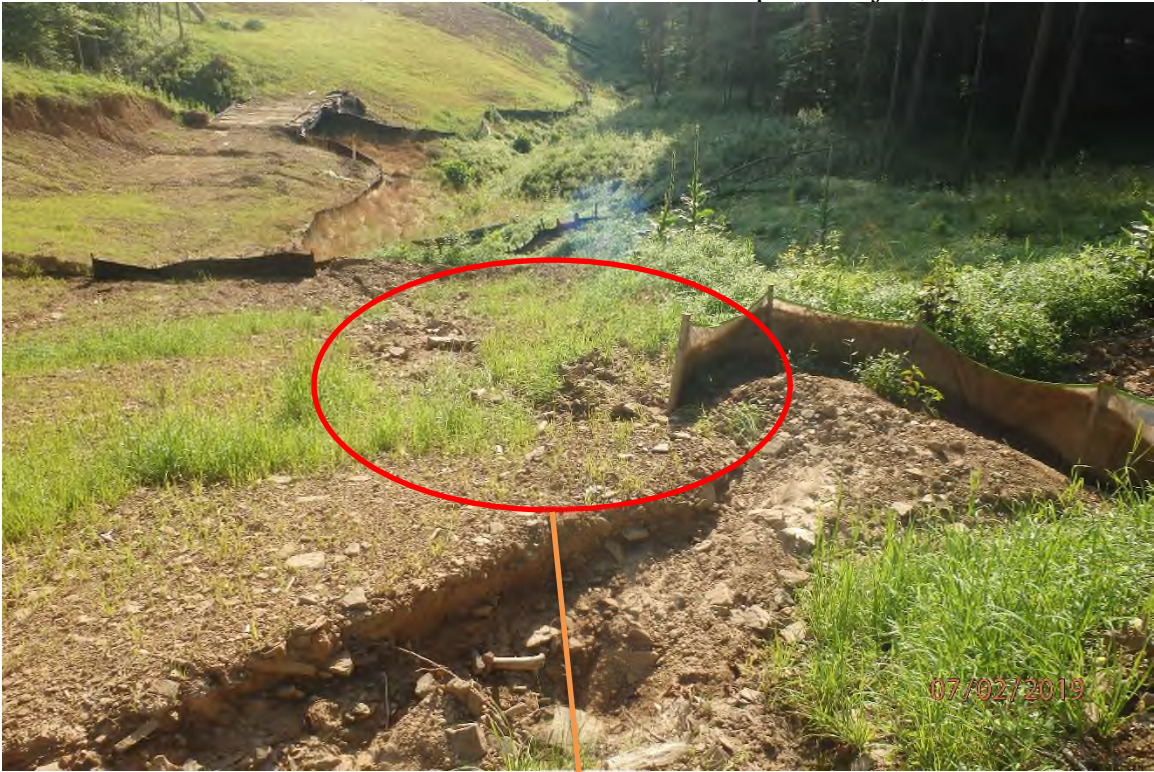
Water bar in need of maintenance in the Sugar Run watershed.

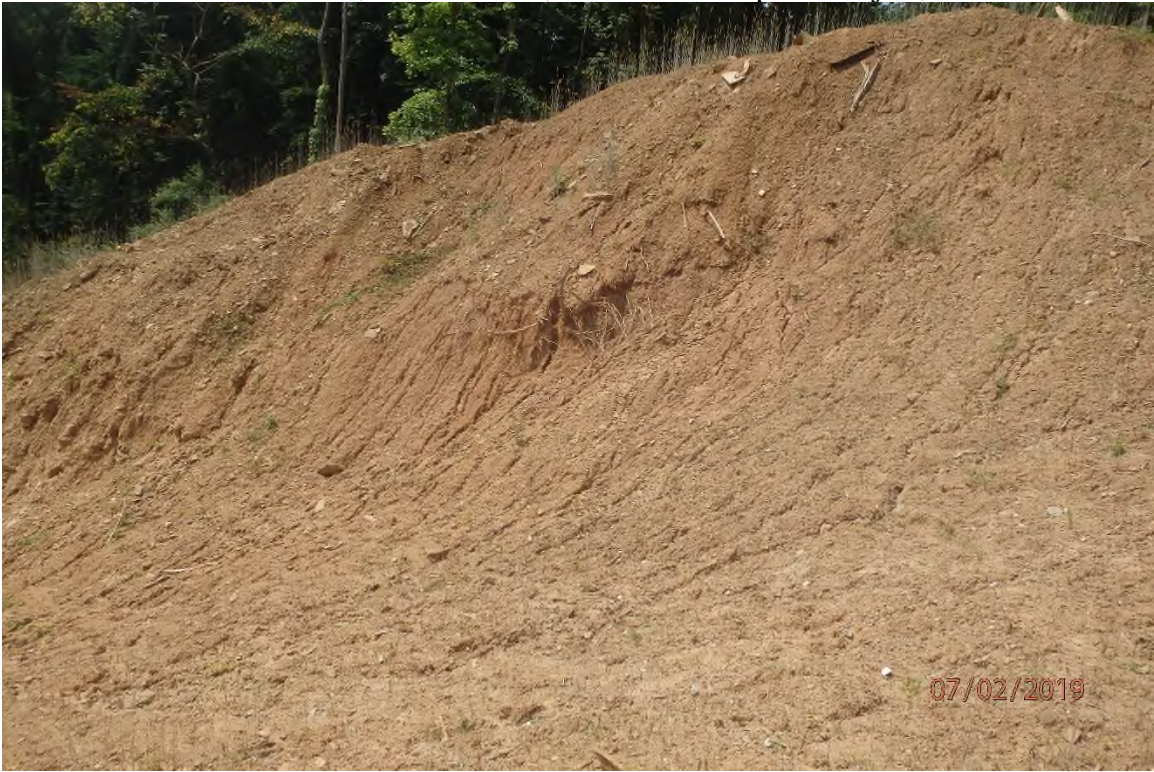
Area in the Trap Run watershed where the applied seed has failed to germinate, and the area was not reseeded.

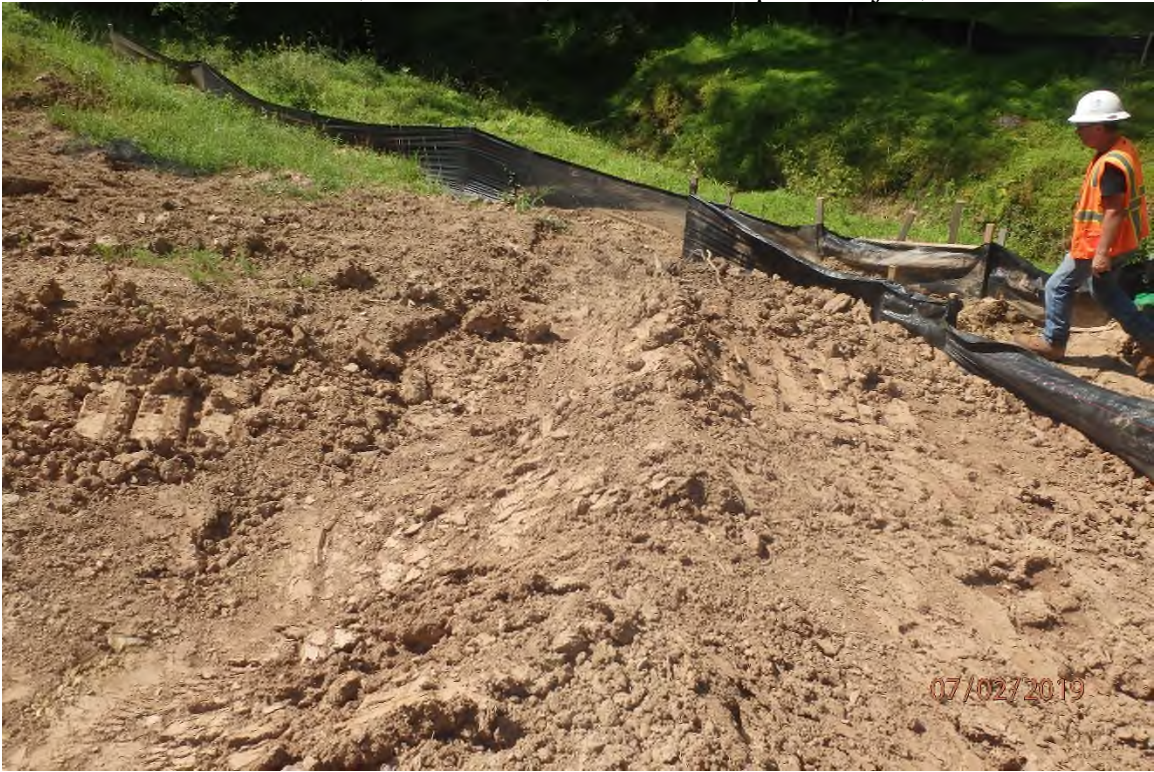
Improperly installed water bar in the Taylor Drain watershed. Water bar terminates prior to the installed perimeter control (sheet flow silt fence in concentrated flow area).

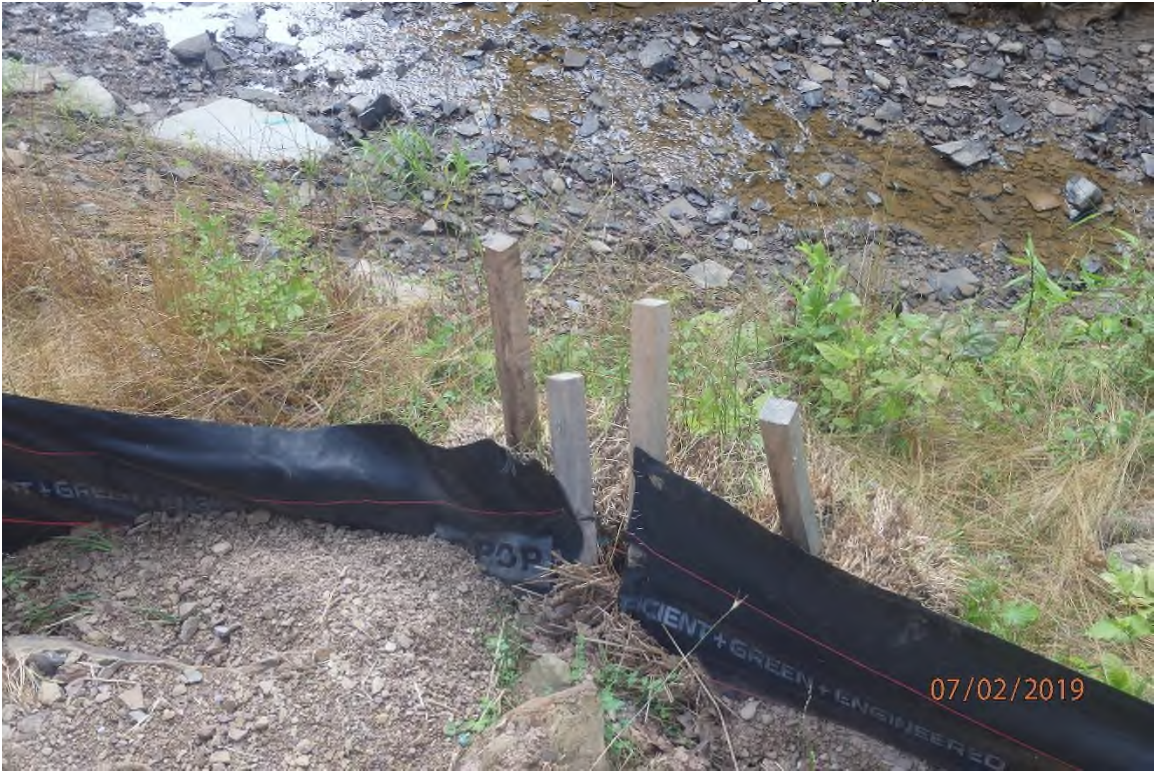
Improperly merged perimeter control adjacent to Sugar Run.

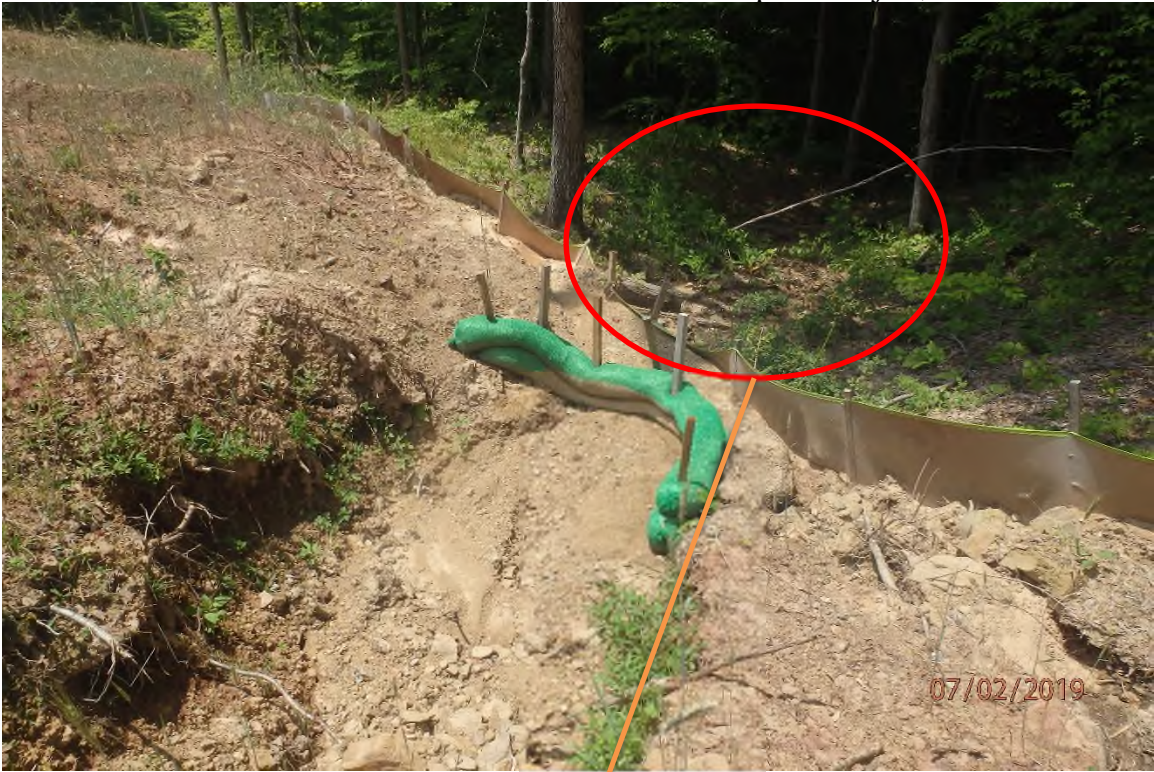
Low area adjacent to UNT Left Fork of Arnolds Creek (SDOG057) where stormwater from a large area is directed due to improperly installed water bars that don't discharge stormwater offsite in small quantities as designed. BMPs are inundated with sediment and in need of maintenance as a result.

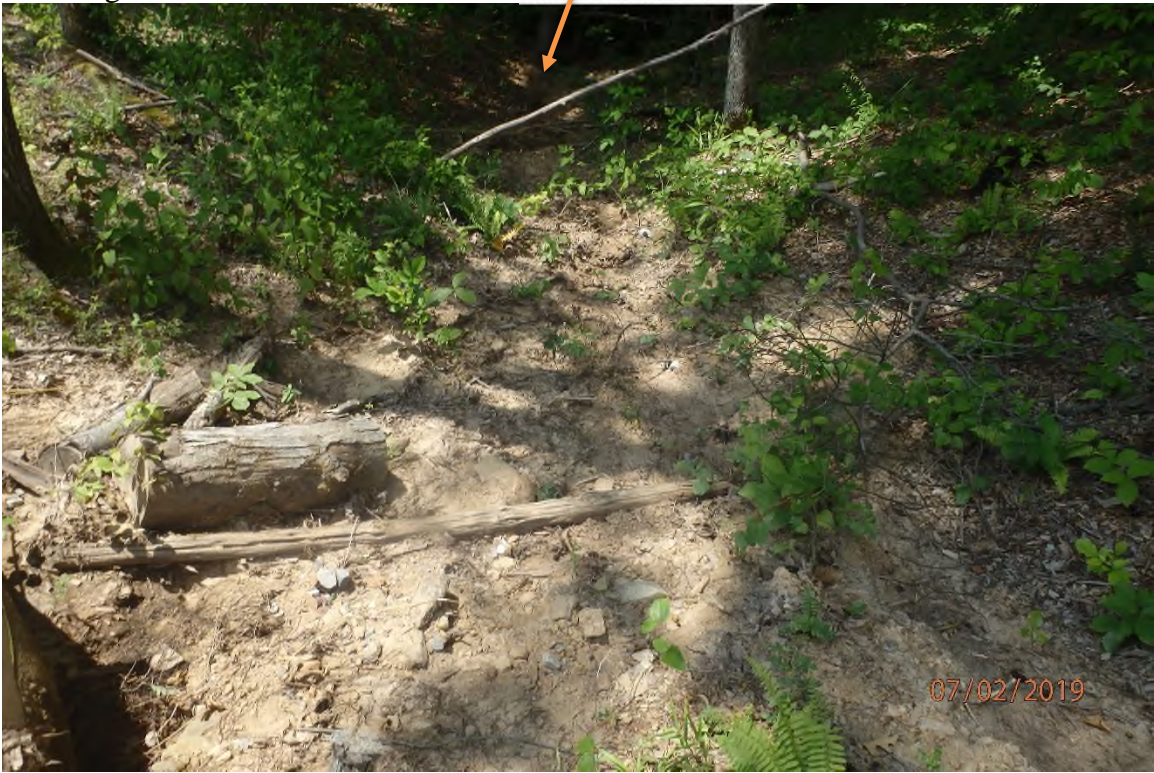
Trail of offsite sediment deposits that leads to UNT Left Fork of Arnolds Creek (SDOG057).

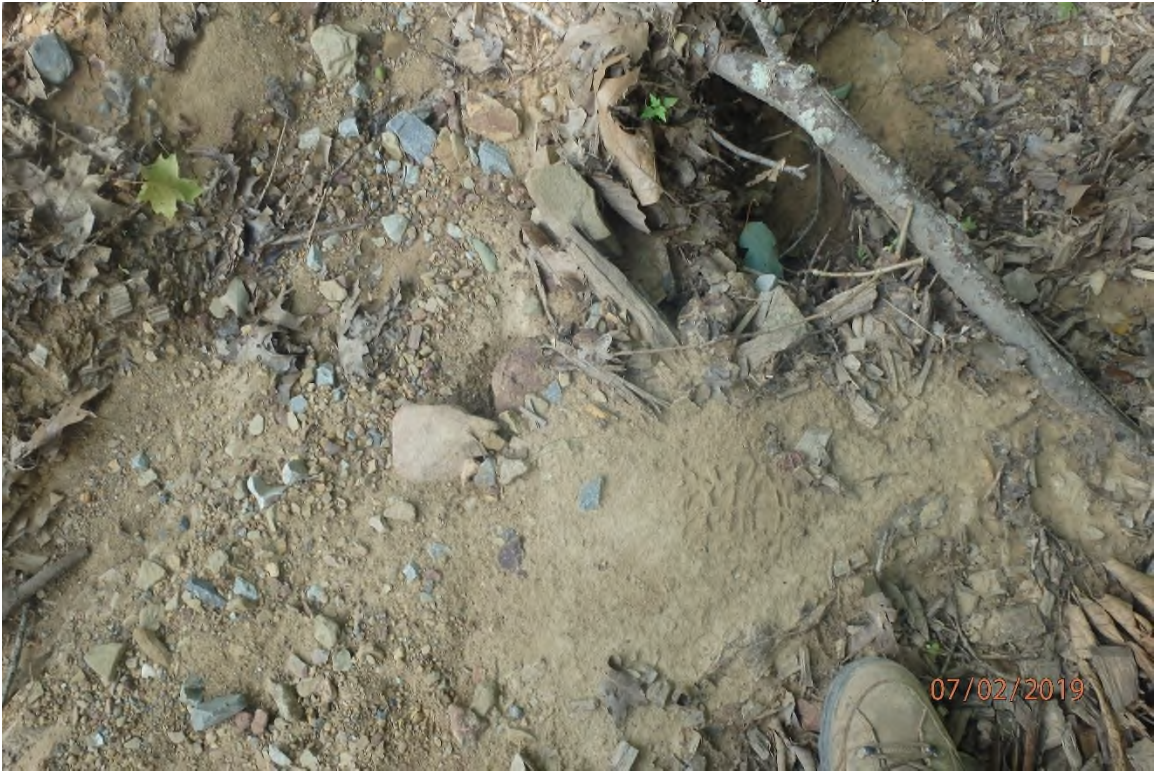
Offsite CNA deposits in UNT Left Fork of Arnolds Creek (SDOG057) (39° 13.355' X 80° 46.851') as a result of the previously pictured improperly installed water bars and unmaintained perimeter controls.

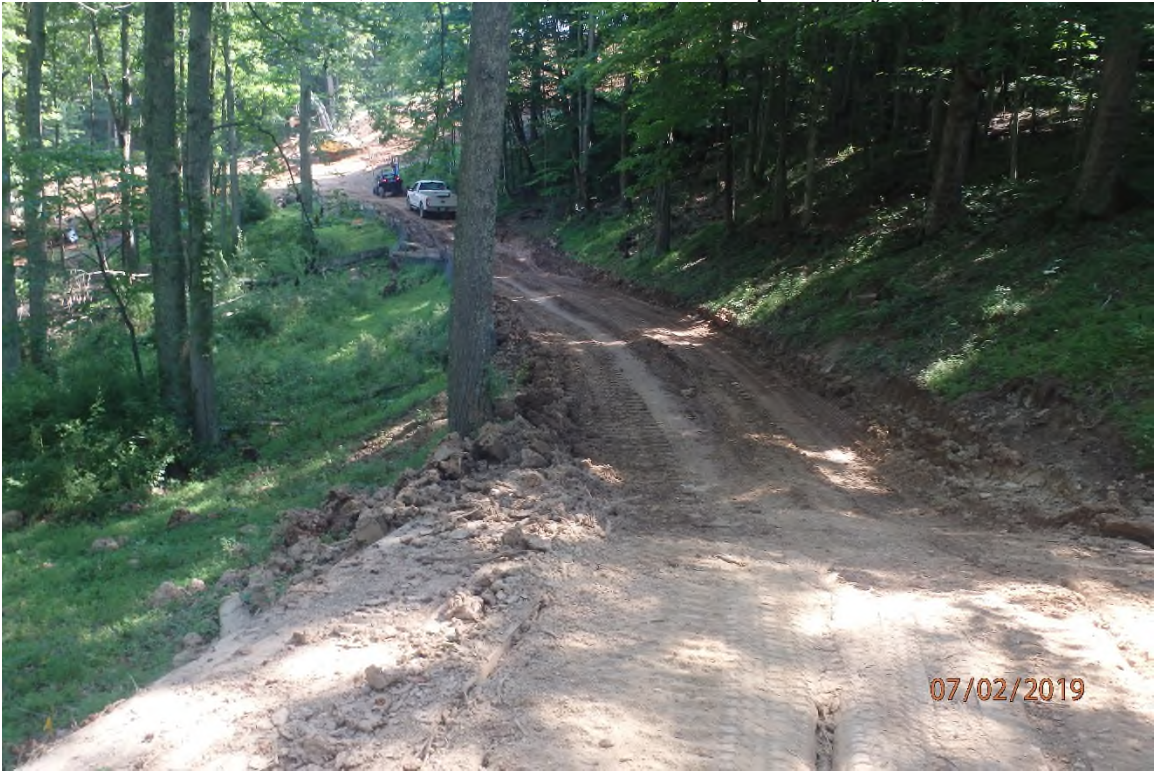
ARDO015.12 - lack of installed BMPs and lack of a graveled surface as indicated in the approved SWPPP.

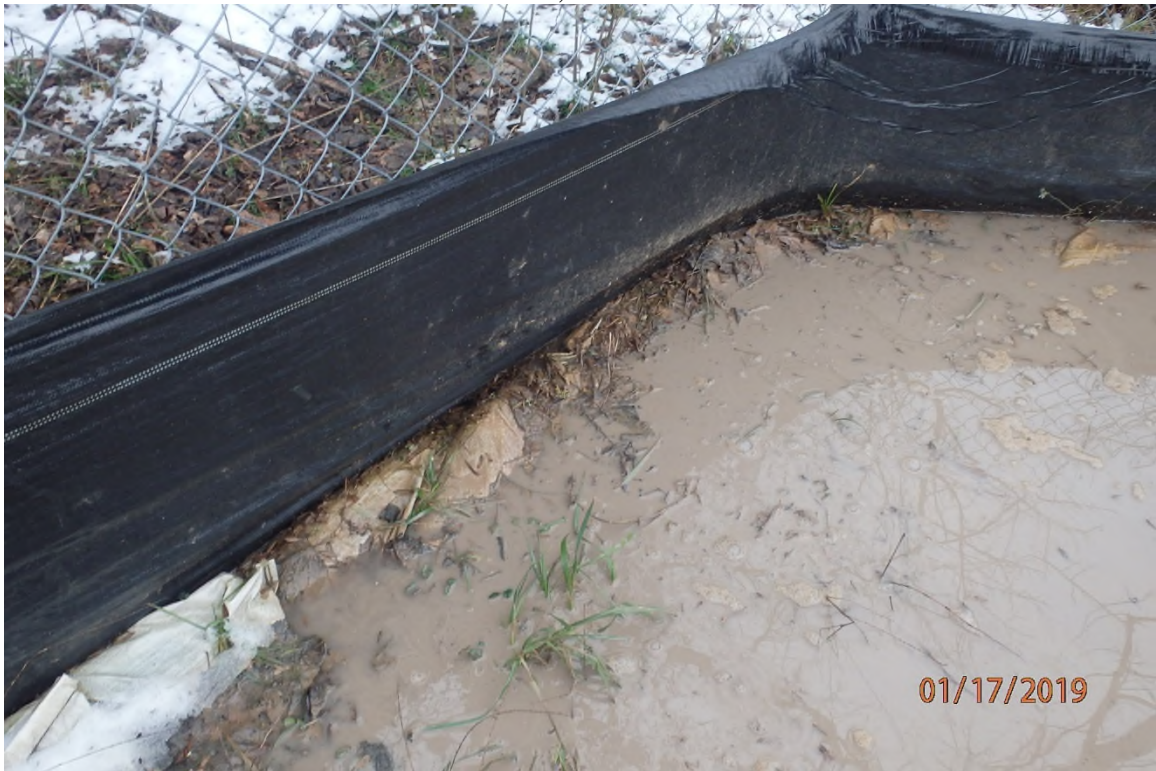
Improperly installed silt fence in the eastern portion of the project.
