**CONSENT ORDER
ISSUED UNDER THE
WATER POLLUTION CONTROL ACT
WEST VIRGINIA CODE, CHAPTER 22, ARTICLE 11**

TO: Columbia Gas Transmission, LLC
Attn: Troy Tally, Vice President
1700 MacCorkle Ave
Charleston, WV 25314

DATE: October 1, 2020
ORDER NO.: 9061

1. Columbia Gas Transmission, LLC is conducting land disturbance activity associated with construction of the Mountaineer Xpress Project in Marshall, Wetzel, Tyler, Doddridge, Ritchie, Calhoun, Wirt, Roane, Jackson, Mason, Putnam, and Cabell Counties, West Virginia. On January 31, 2018, Columbia Gas Transmission, LLC was issued Water Pollution Control Permit No. WV0116815, Registration No. WVR310872, for Stormwater Associated With Oil and Gas Related Construction Activities.

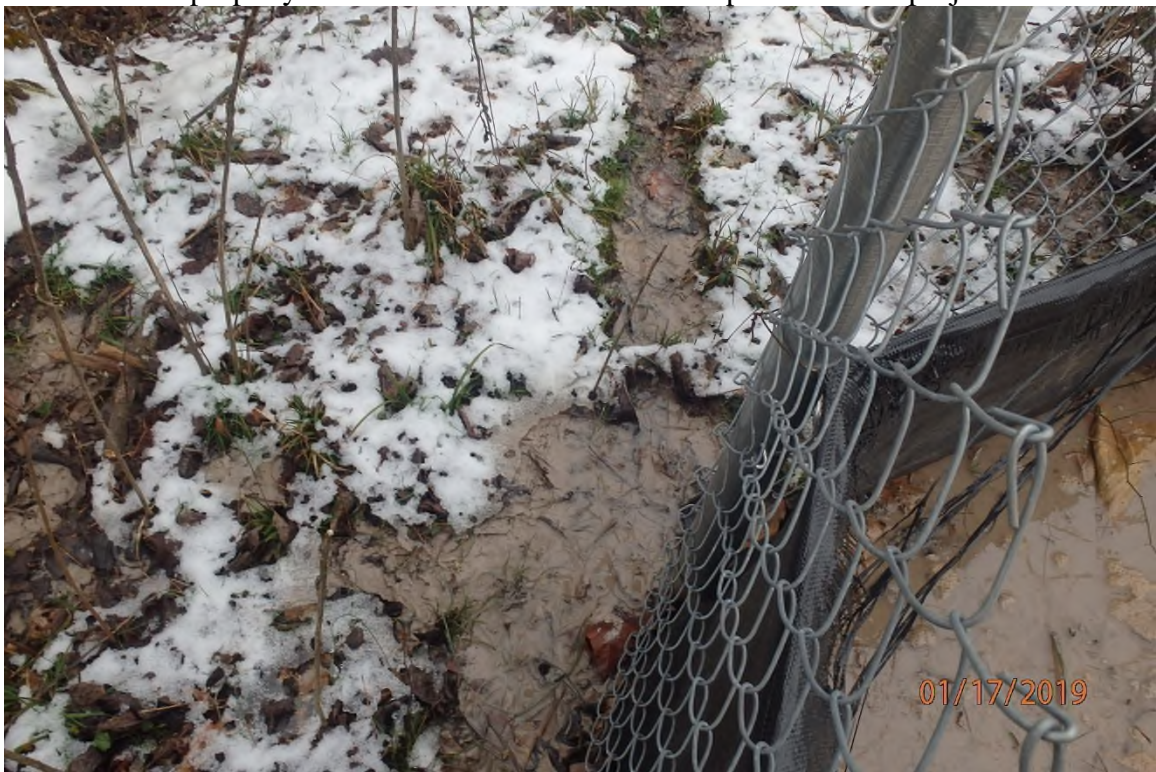
Small amount of offsite sediment deposits as a result of the above pictured deficiency.

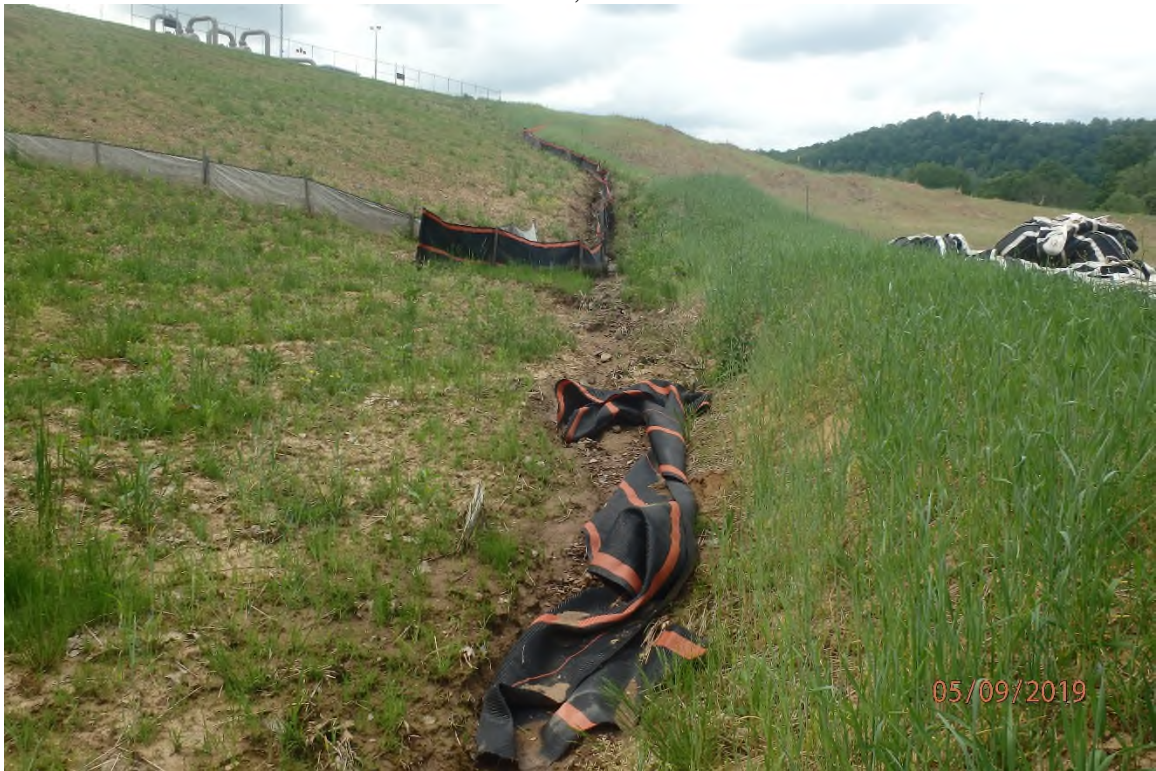
Diversion in need of maintenance adjacent to the fill pad. Perimeter controls improperly installed and in need of maintenance.

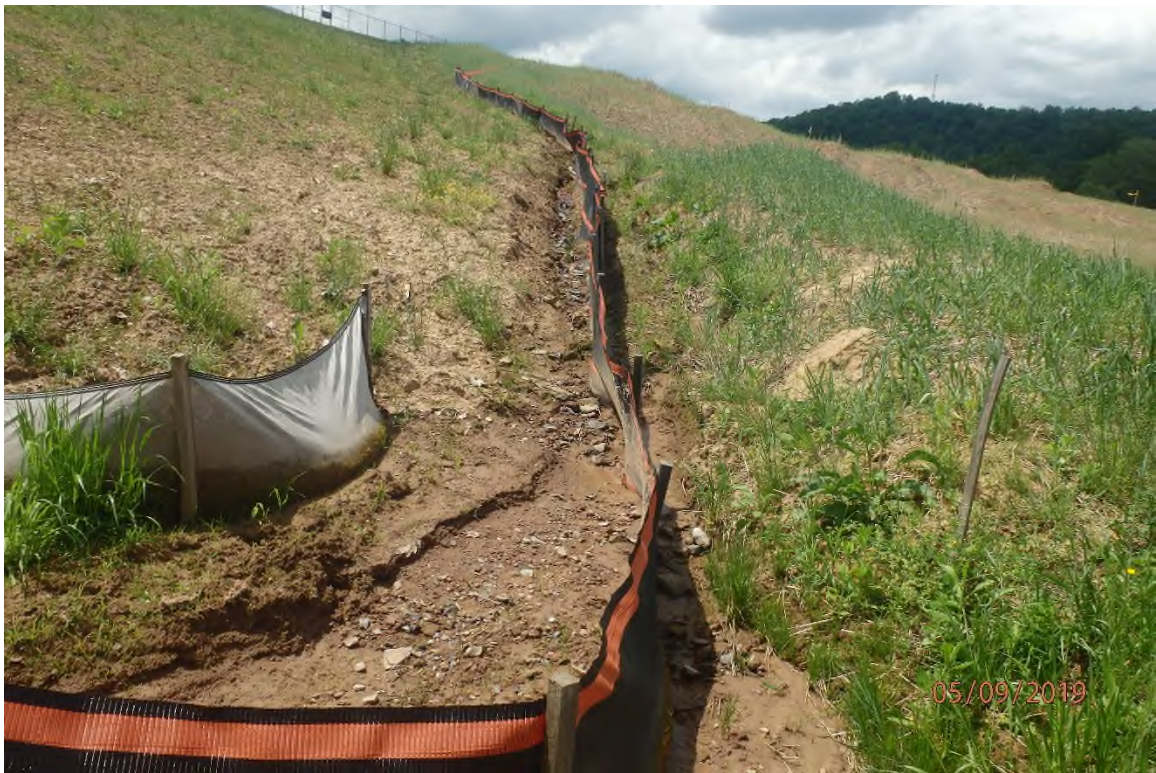
Diversion in need of maintenance adjacent to the fill pad. Perimeter controls improperly installed and in need of maintenance.

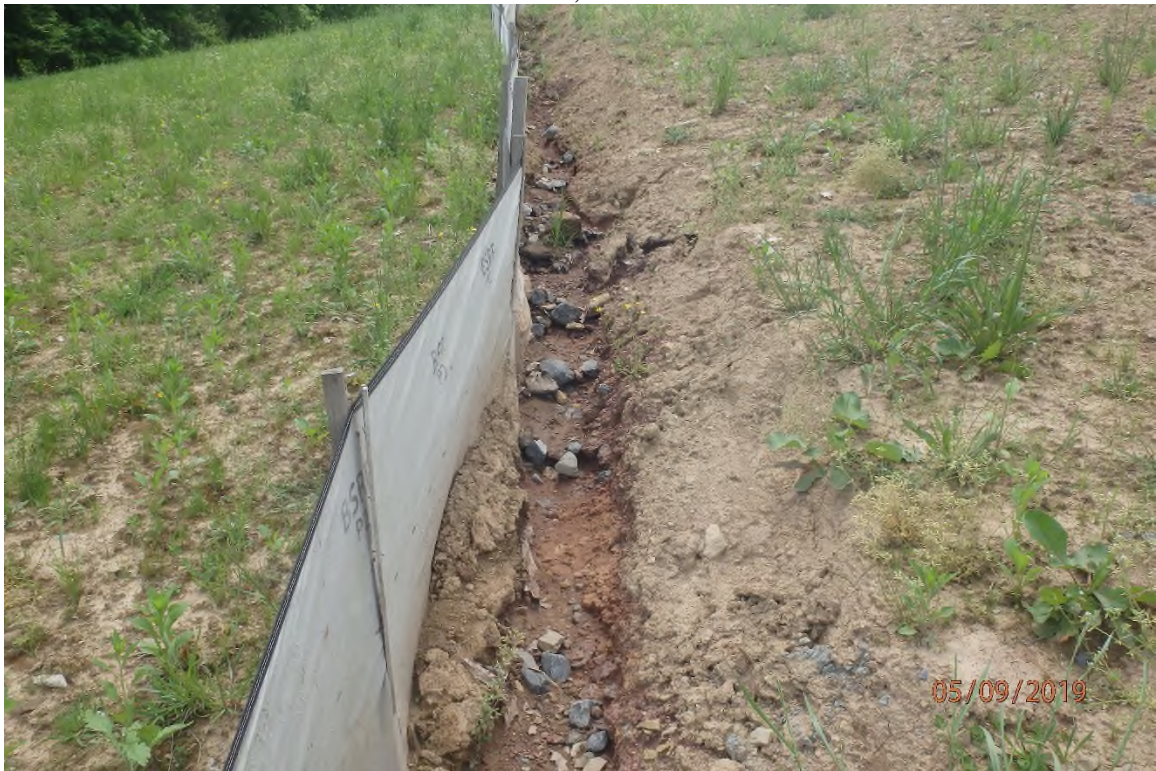
Diversion in need of maintenance adjacent to the fill pad. Perimeter controls improperly installed and in need of maintenance.

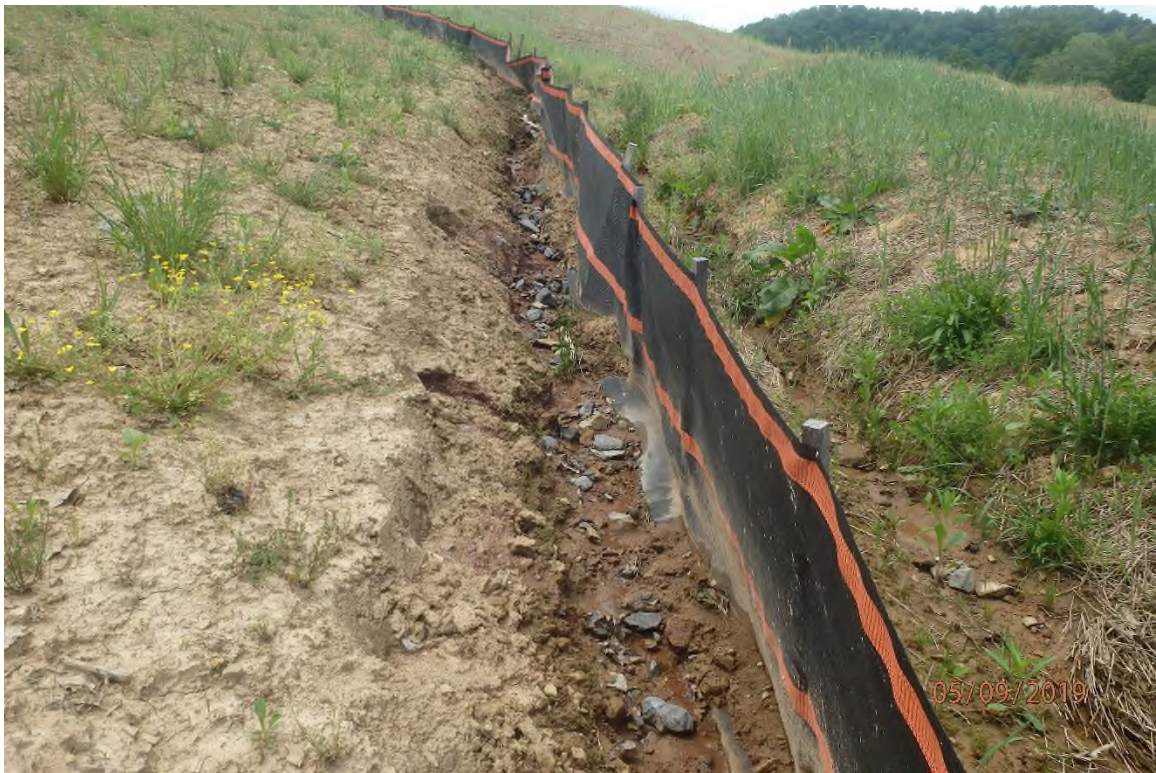
Diversion in need of maintenance adjacent to the fill pad. Perimeter controls improperly installed and in need of maintenance.

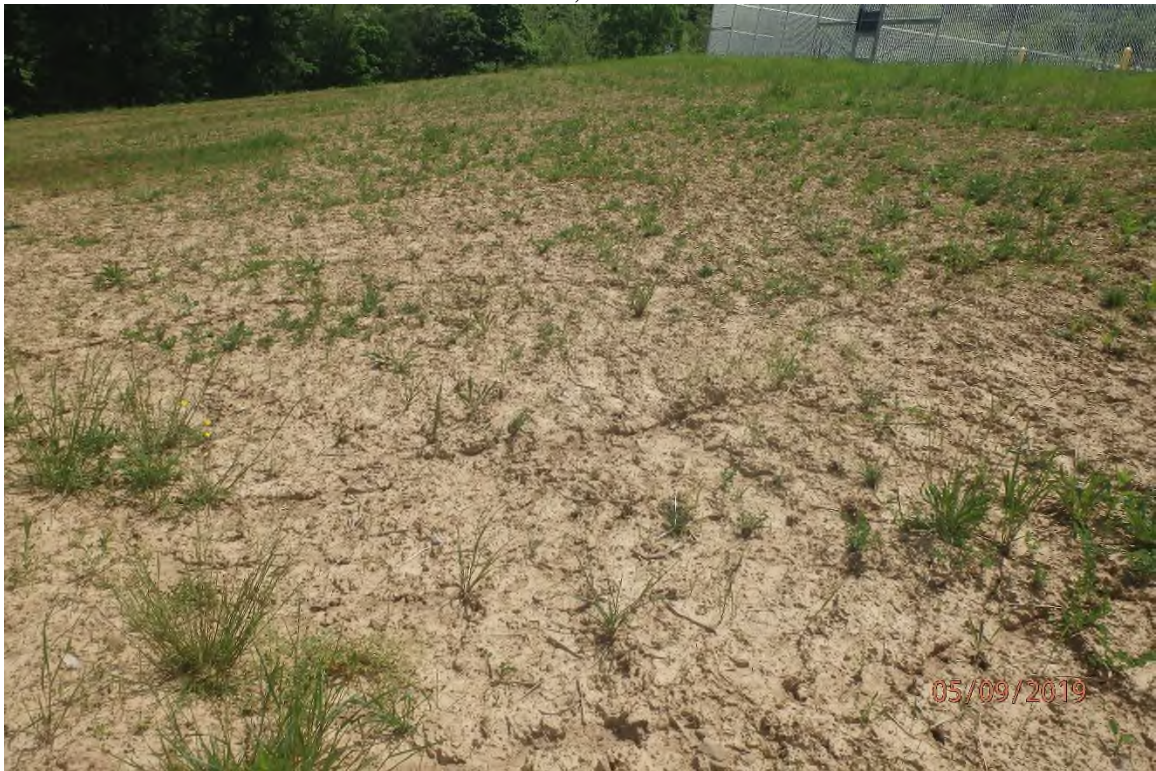
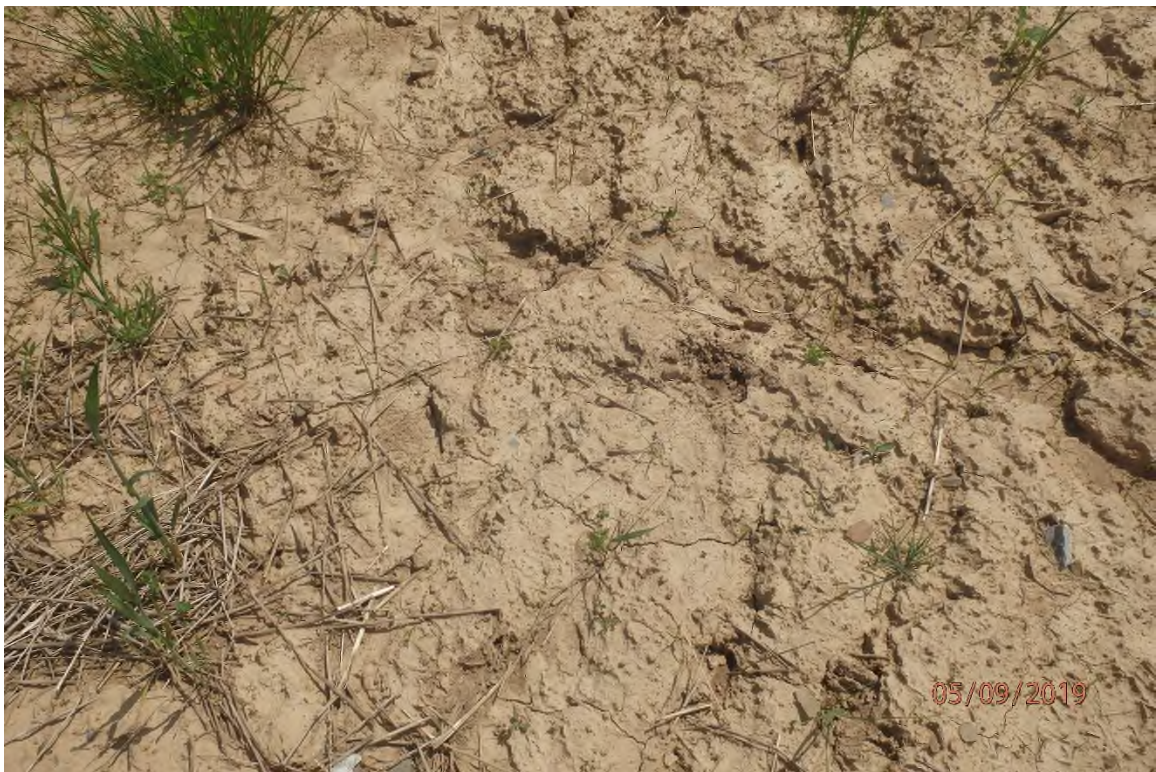
Areas of inadequate vegetative cover that are in need of reseeding.
