**CONSENT ORDER
ISSUED UNDER THE
WATER POLLUTION CONTROL ACT
WEST VIRGINIA CODE, CHAPTER 22, ARTICLE 11**

TO: Mountain Valley Pipeline, LLC
Robert J. Cooper
2200 Energy Drive
Canonsburg, PA 15317

DATE: December 17, 2020

ORDER NO.: 9925

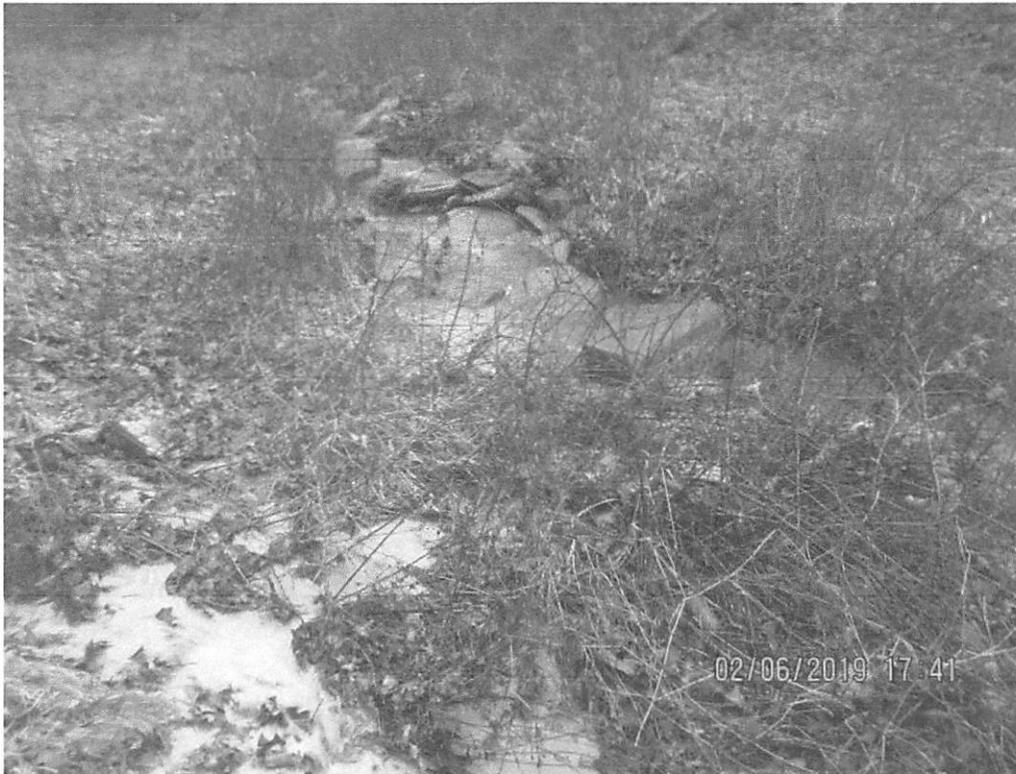
SLW flowing toward and entering UNT of Brammer Branch.

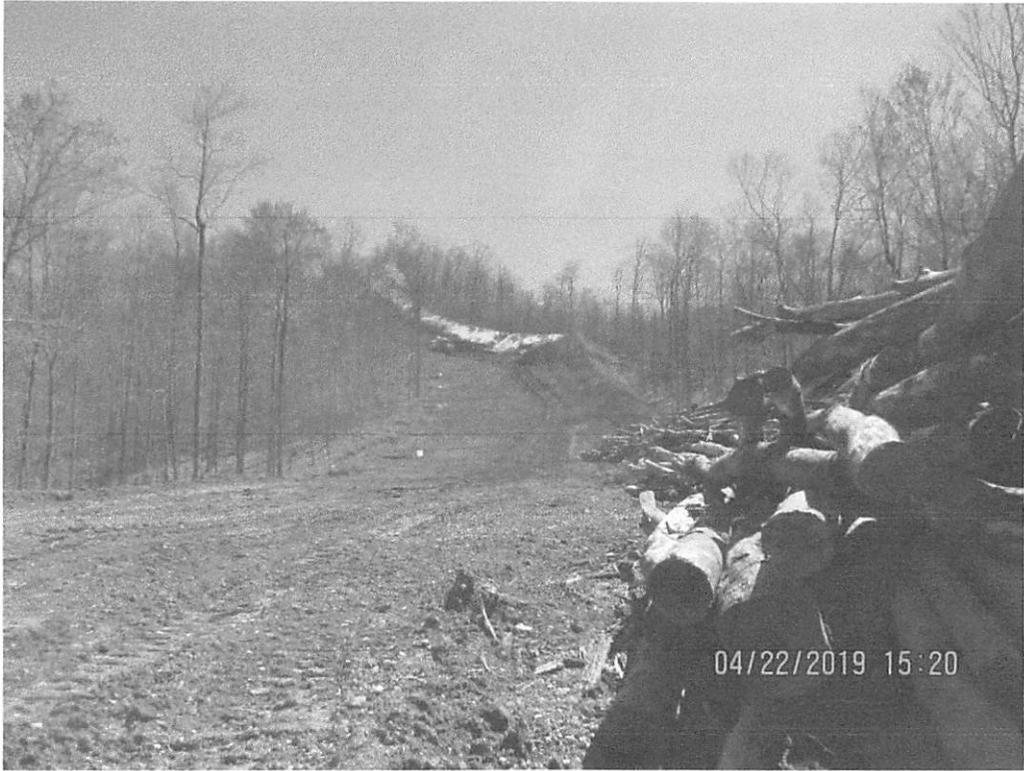
Facing South toward slope with waterbar failure near station 8628+00.

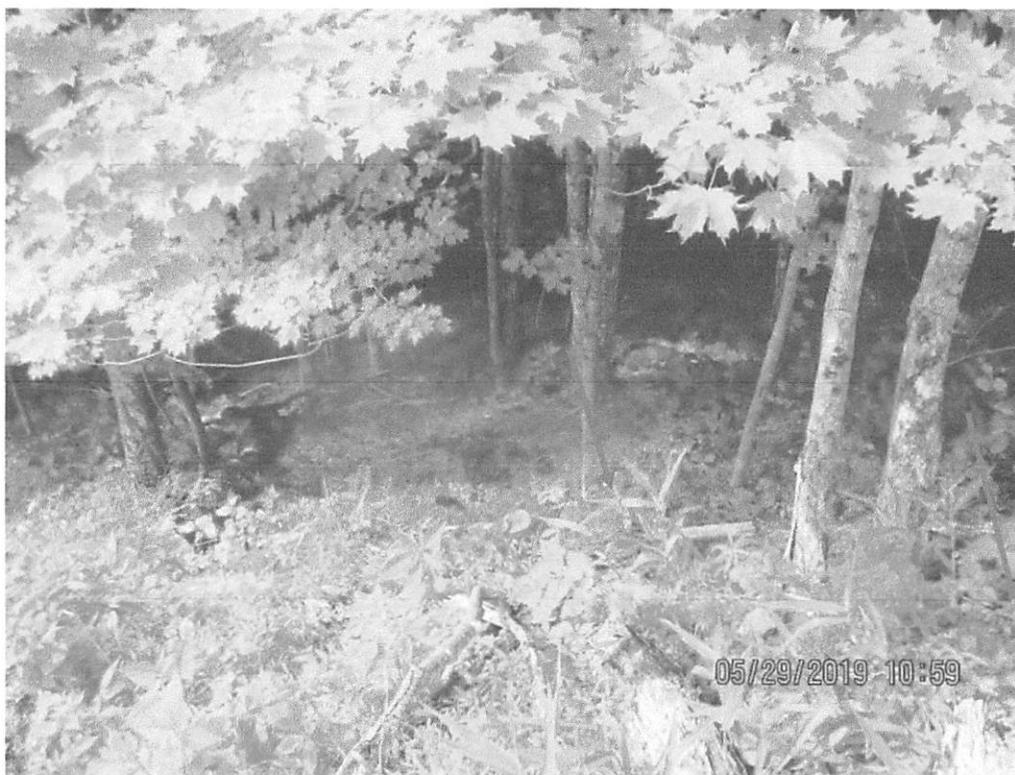
Downslope of diversion berm Outlet 1. Sediment deposits past LOD. Vegetation was stained from SLW leaving site.

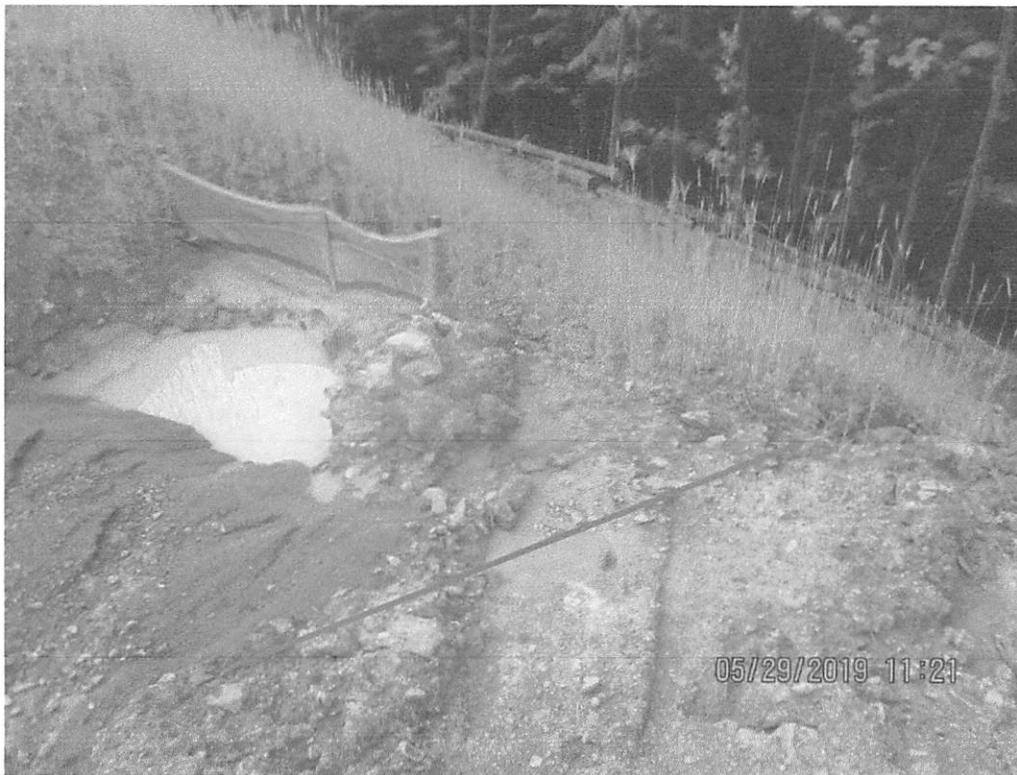
Waterbar outlet above diversion berm Outlet 3. Sump full of sediment and concentrated flow on slope was observed due to controls not functioning as designed. Arrow depicts flow.

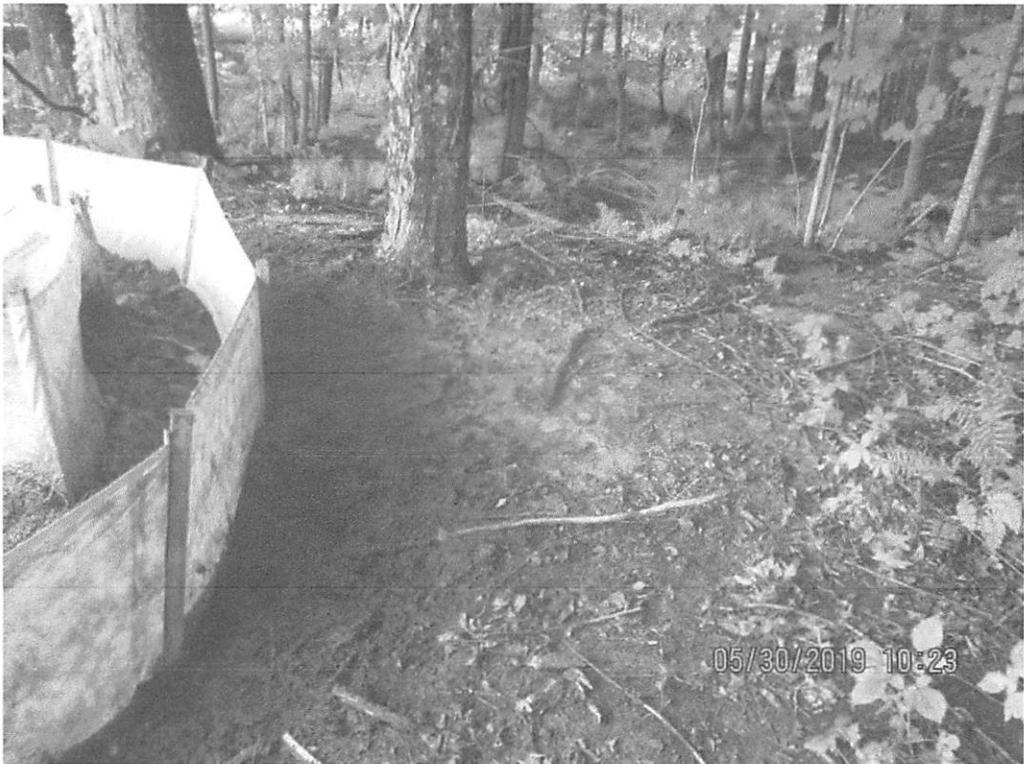
Facing downslope toward Stream S-N10. Scouring of vegetation and sediment deposits were observed below these controls.

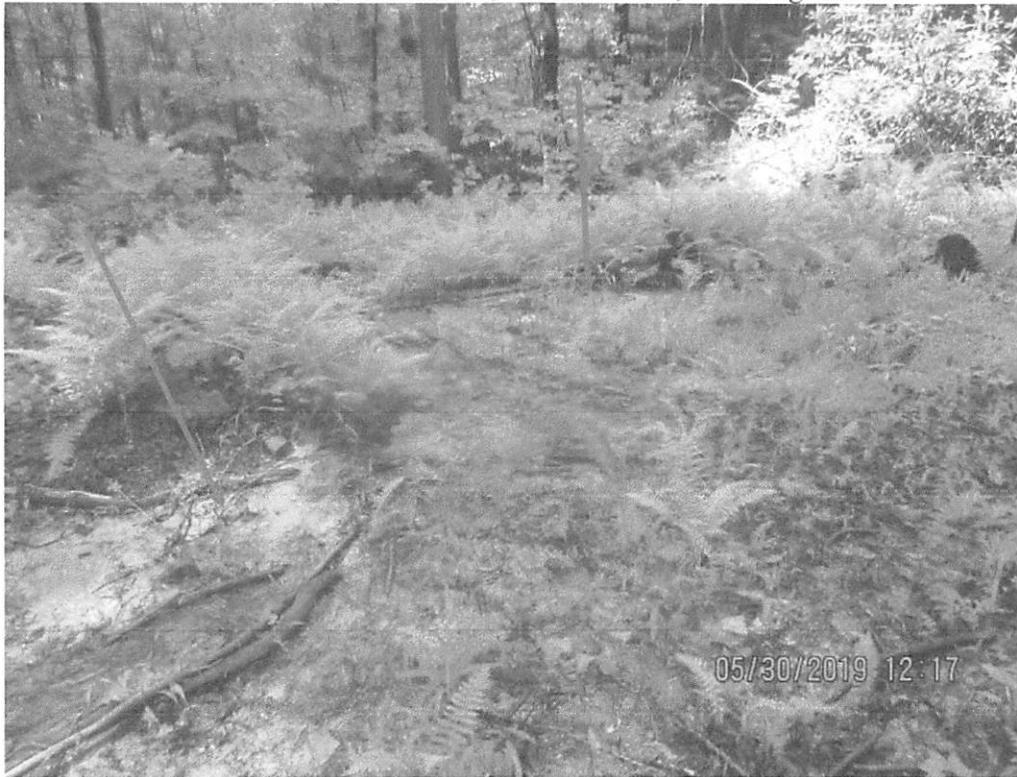
SLW and sediment deposits observed past controls and LOD near station 6510+40 approximately 200 ft past LOD and downslope of sump outlet.

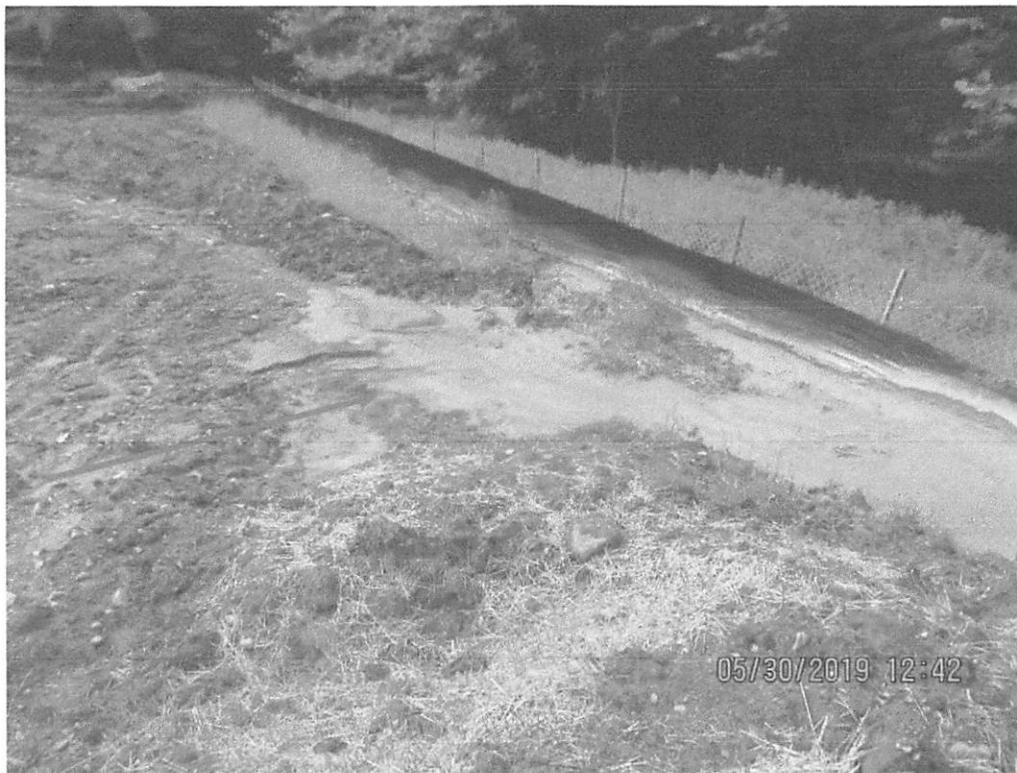
Erosion (Red Arrow) and Sediment/SLW overwhelming perimeter controls at ATWS-22-7A at station 6514+60. Sediment deposits observed past controls and LOD.

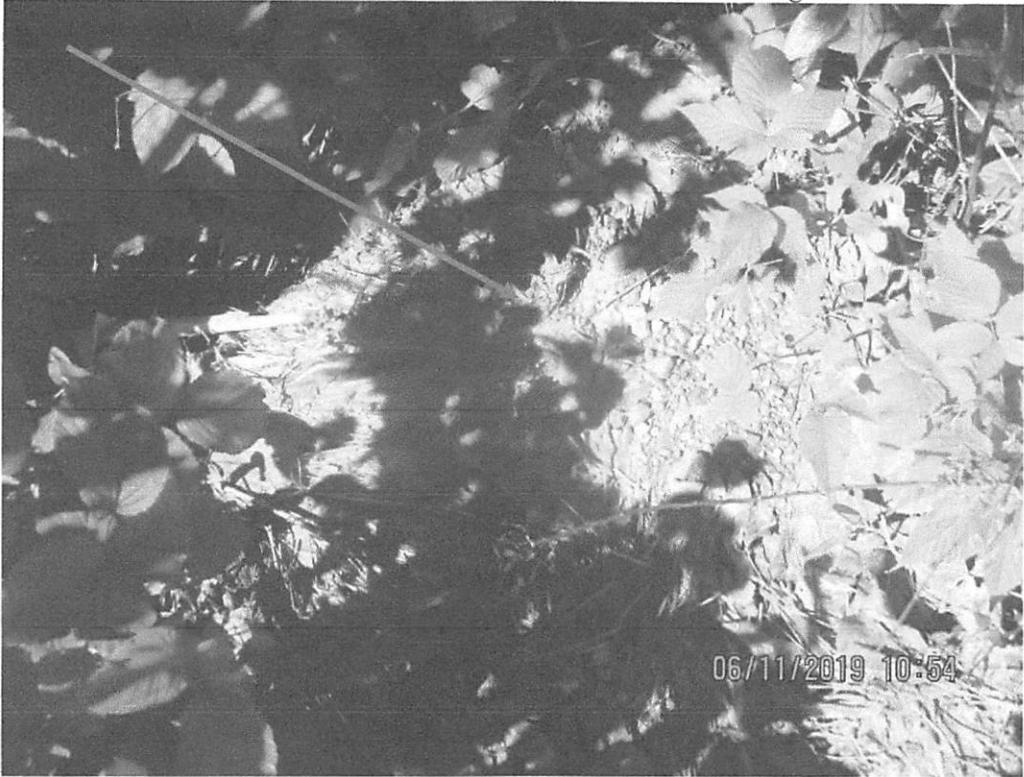
Above station 7604+41. Perimeter controls overwhelmed with sediment. Sediment deposits observed past controls and LOD.

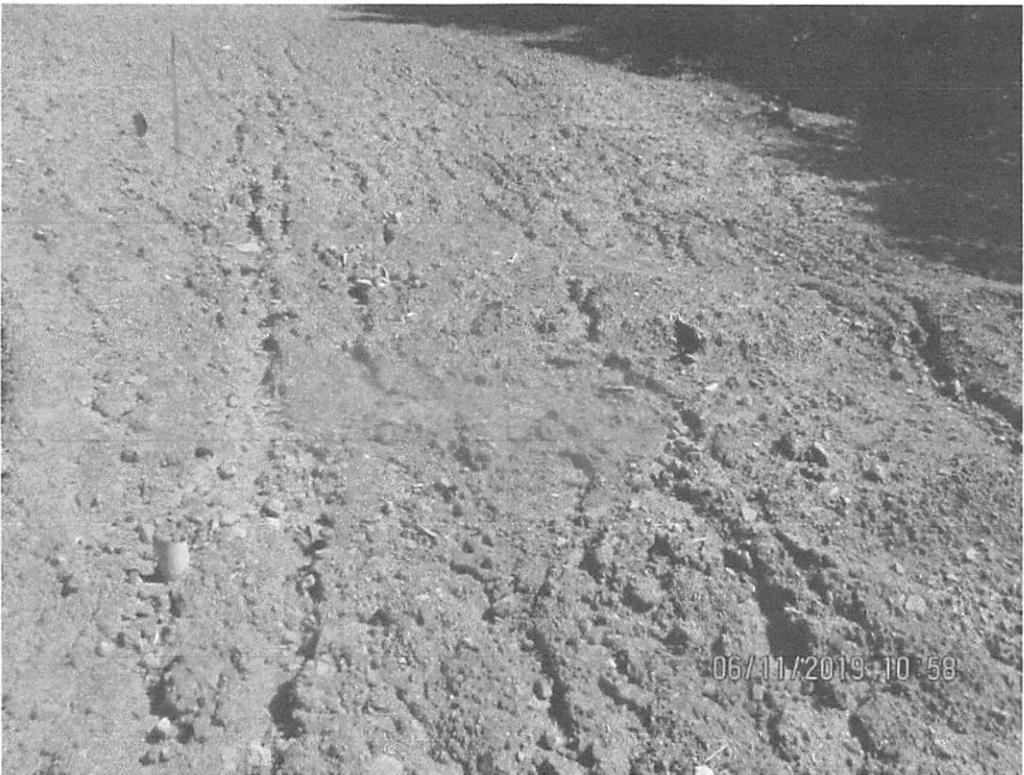
Above Lower Krosier Road crossing. Erosion present on ROW above Waterbar. Facing upslope near station 7604+41.

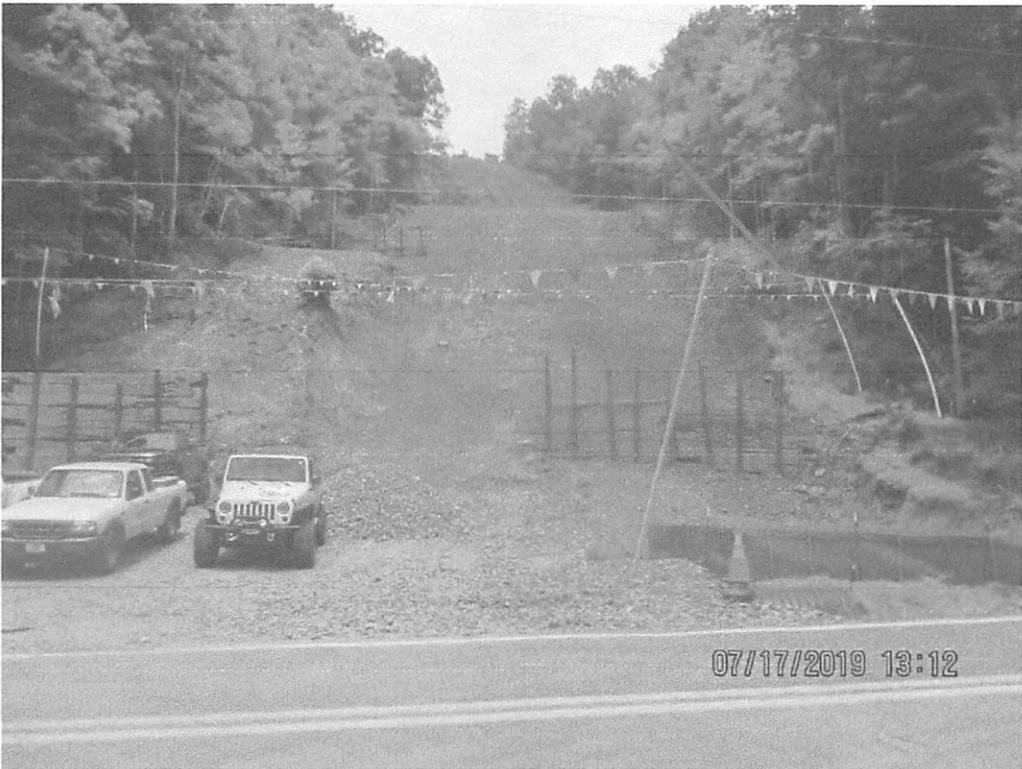
Facing North at MVP ROW near station 3192+50. Arrow depicts where waterbar was terminating onto ROW and failed causing pipe trench to become overwhelmed with sediment-laden water.

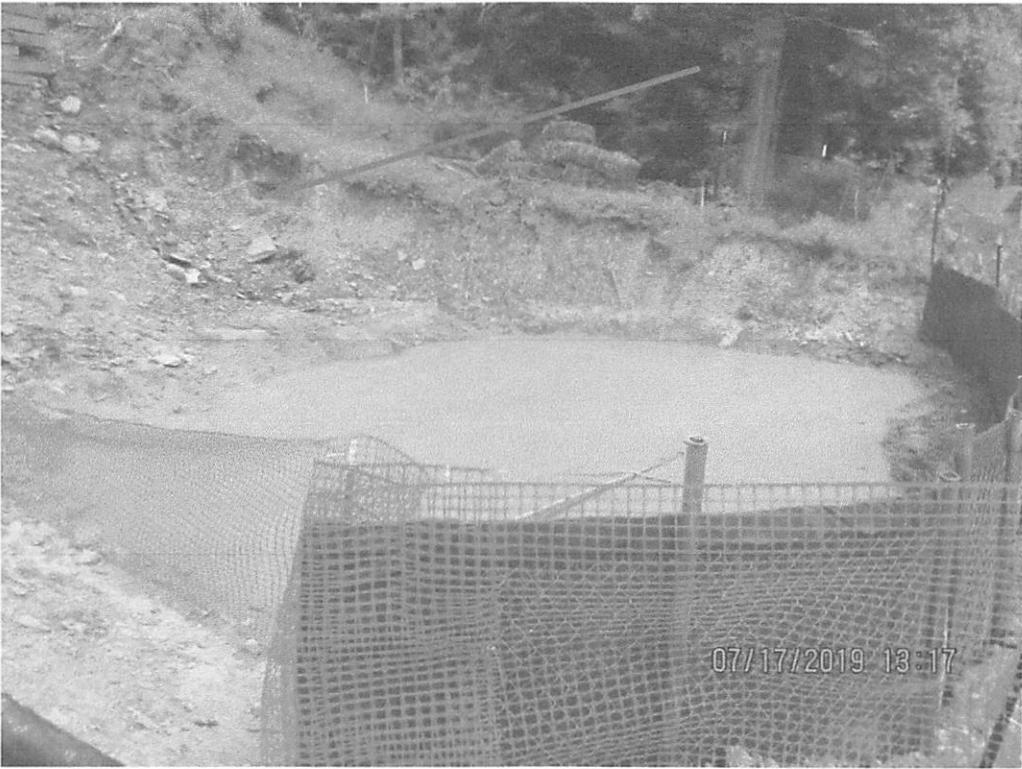
Open trench at base of slope that was overwhelmed with sediment-laden water at station 3192+50. Arrow depicts erosion present on slope above open trench/sump.

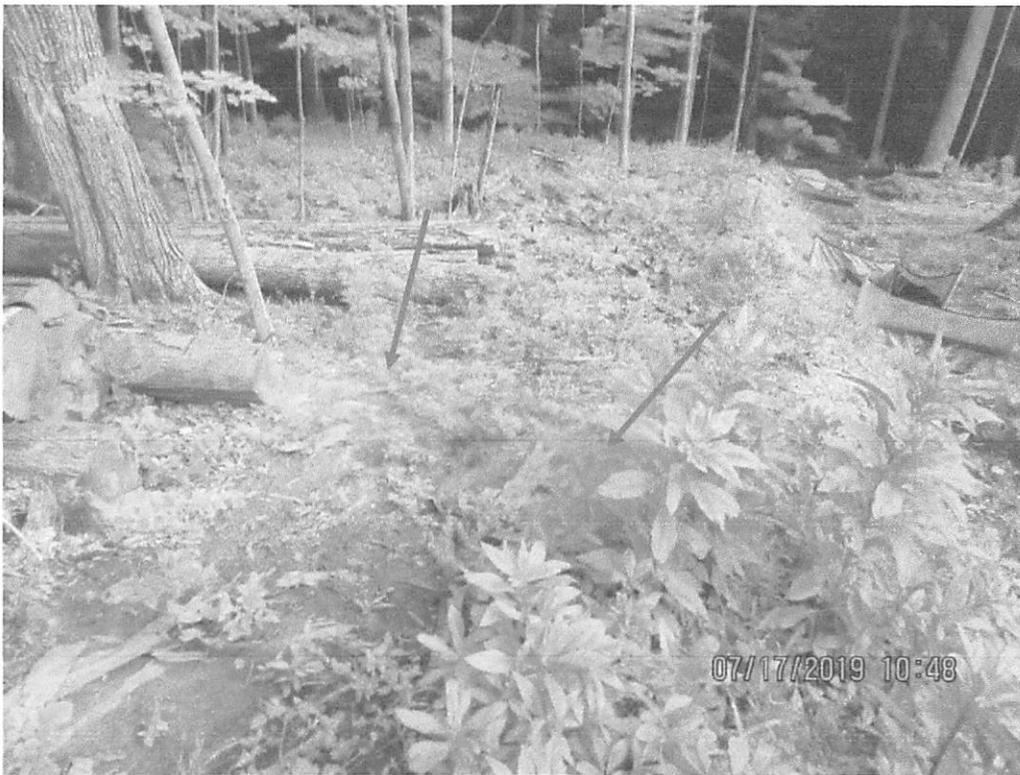
Below waterbar terminus at station 3149+00. Sediment deposits observed past LOD.

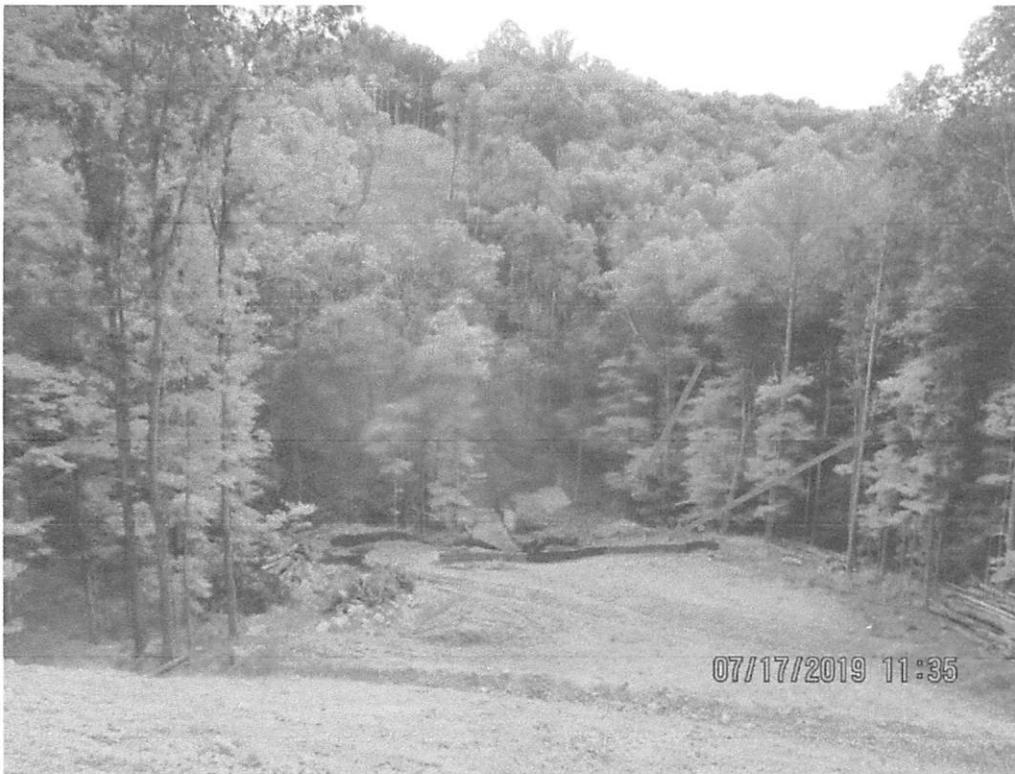
Facing downslope on opposite side of Stream S-H153. Arrows depict where control failures occurred.

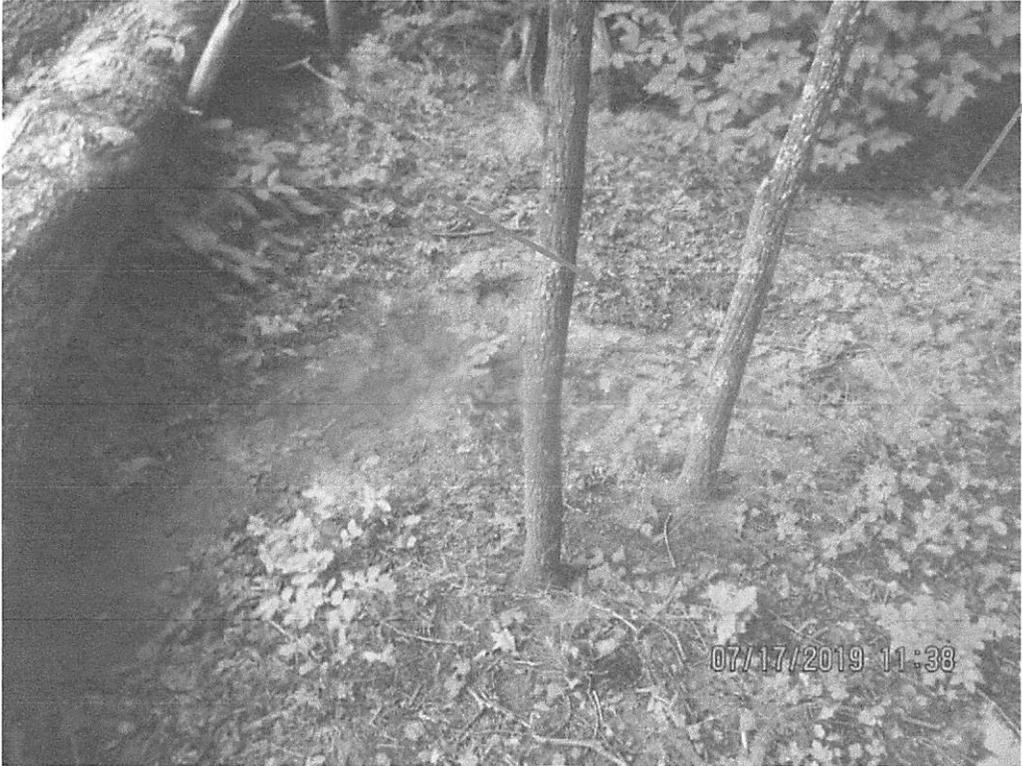
Sediment deposits past controls and LOD at station 3136+00. Log piles placed behind controls.

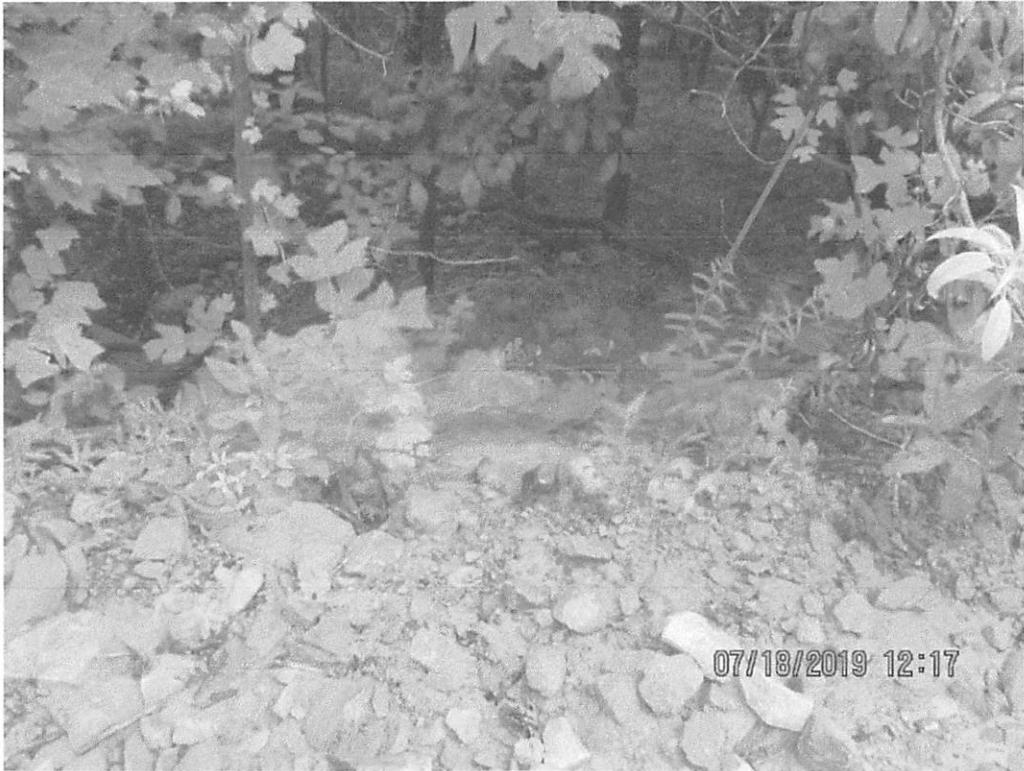
Section along Access road MVP-WB-119 where rock washed out past LOD. No controls present on downslope edge of road. Sediment deposits observed past LOD.

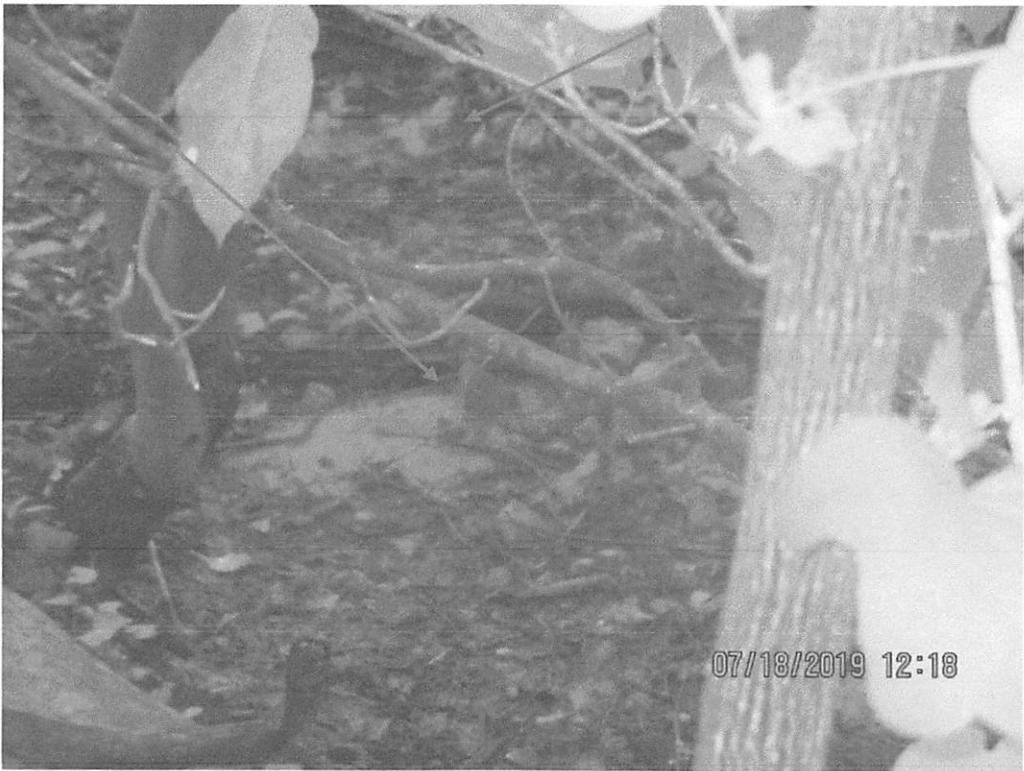
Section along Access road MVP-WB-119 where rock washed out past LOD. No controls present on downslope edge of road. Sediment deposits observed past LOD. Arrow depicts deposits.

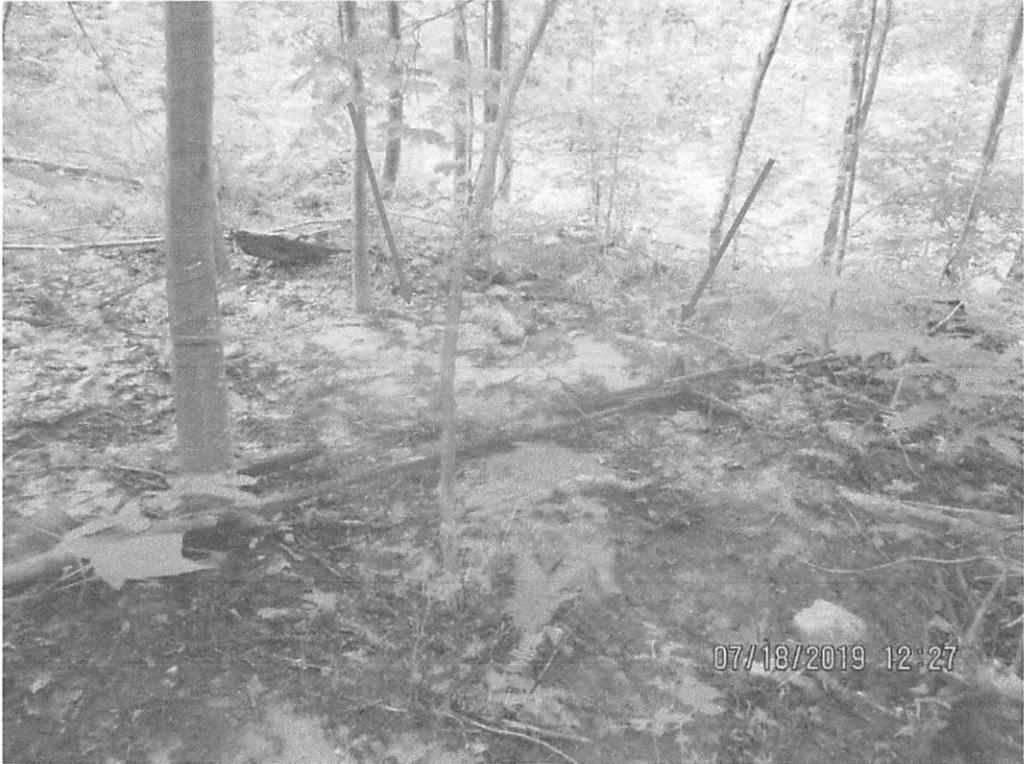
Downslope of culvert outlet. Significant sediment deposits present past controls and LOD. Arrows depicts examples of deposits observed.

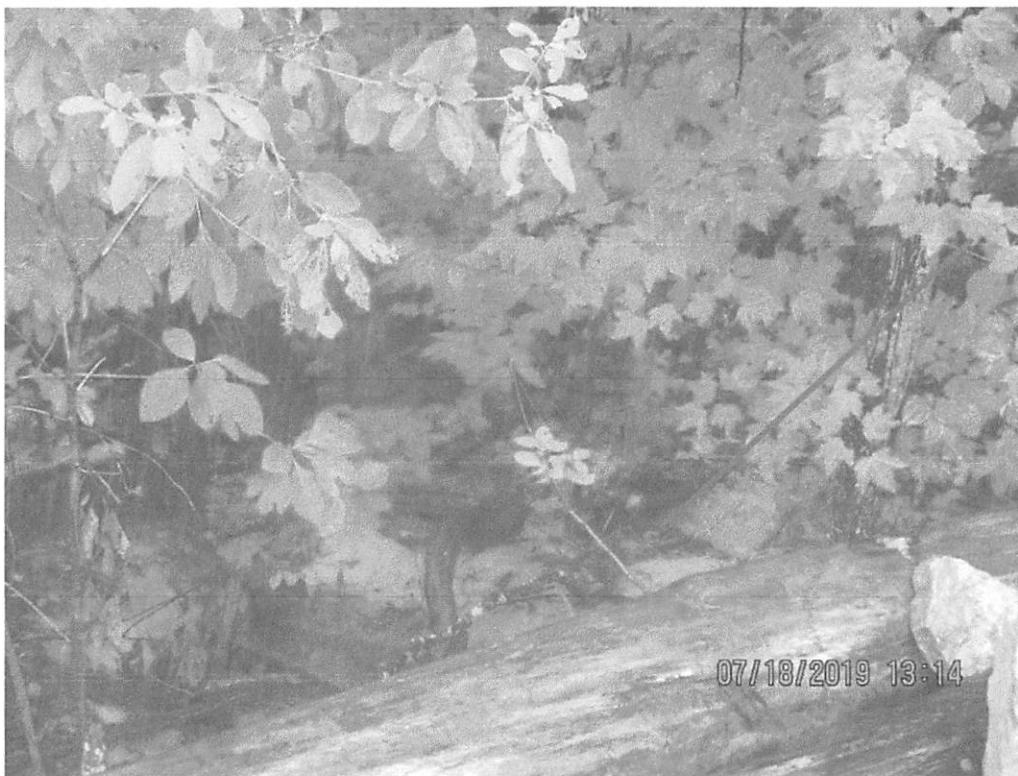
Downslope from waterbar terminating onto fill slope at station 4539+00. SLW observed past controls and LOD conveying downslope.

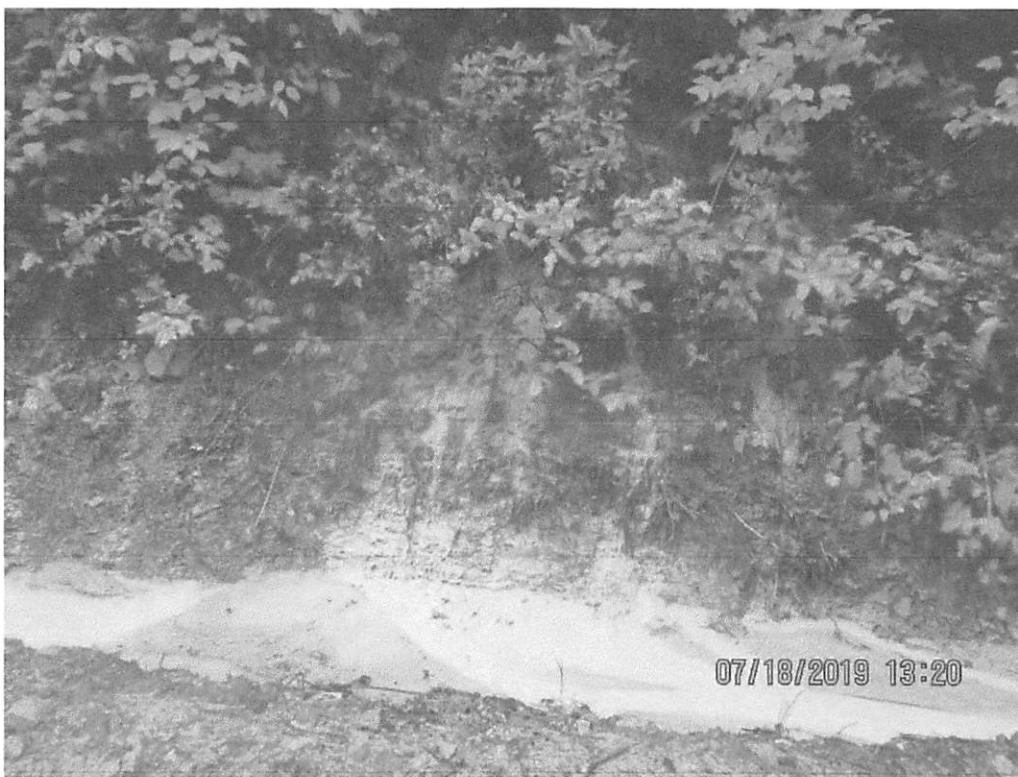
Downslope of failed controls post rain event along Access Road MVP-WB-119. SLW was entering/cascading into the ditch that conveys back downslope toward ROW crossing with access road.

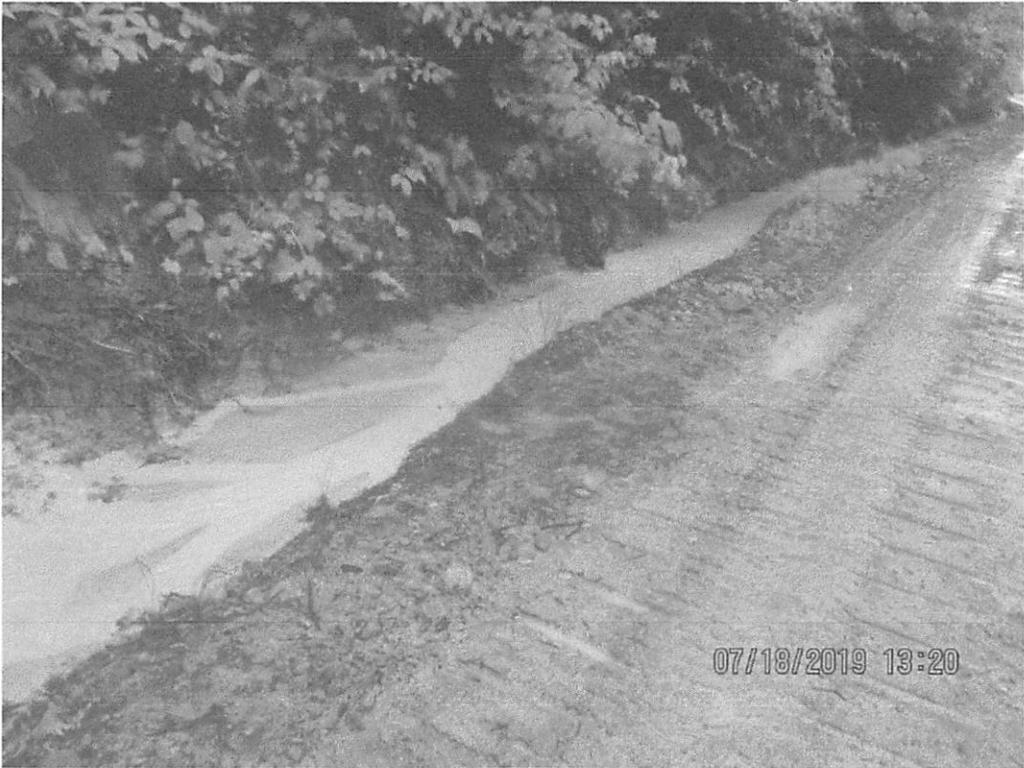
Downslope of failed controls post rain event along Access Road MVP-WB-119. SLW was entering/cascading into the ditch that conveys back downslope toward ROW crossing with access road.

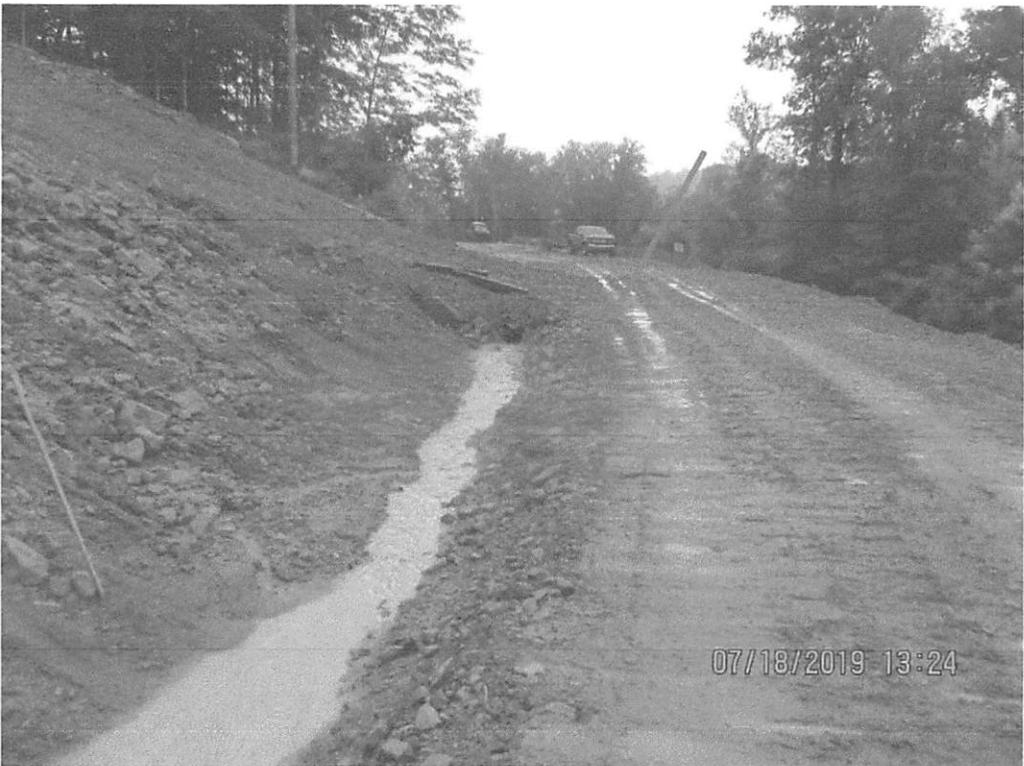
Downslope from where SLW was entering ditch. Arrow depicts culvert that conveys under ROW crossing. No controls present upslope of ditch below station 4539+00.

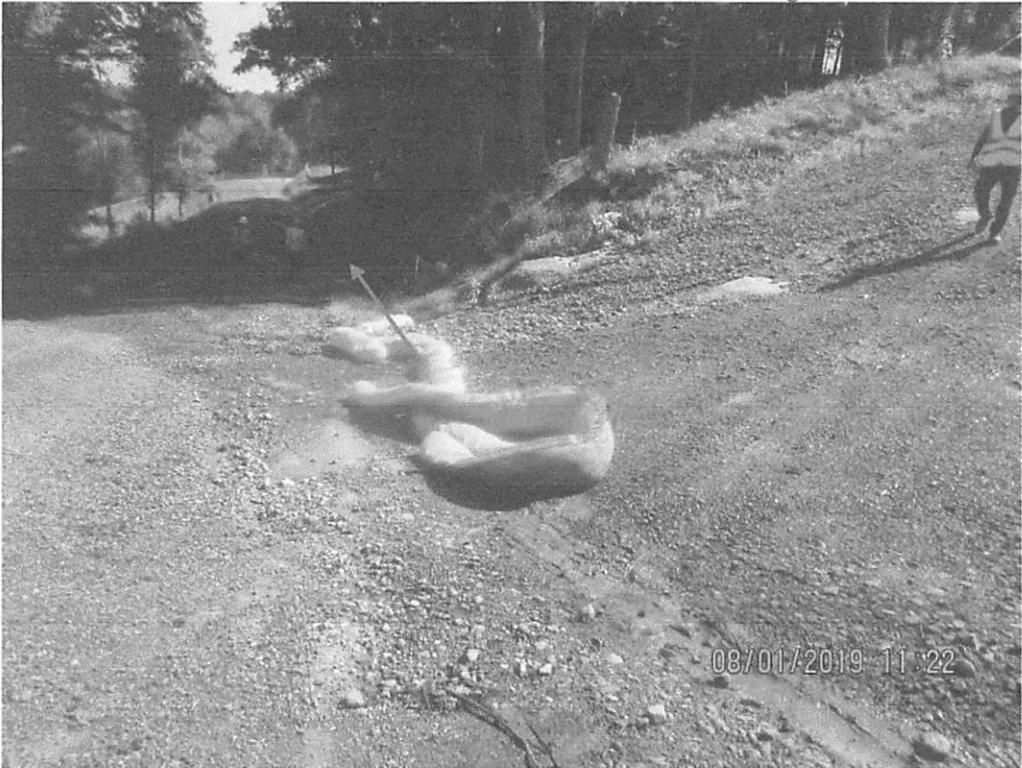
Facing downslope at intersection of BR-099 and CR24. Arrow depicts ditch line and where sediment deposits were observed.

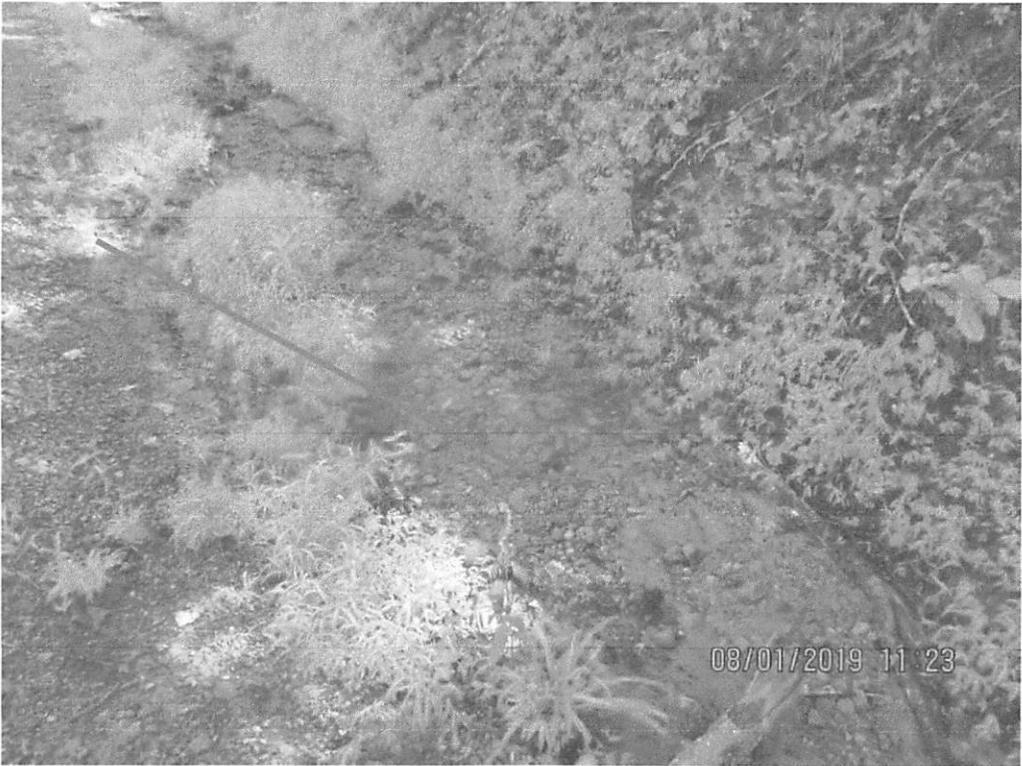
Sediment deposits observed along CR 24 downslope of Access Road MVP-BR-099 near station 3897+75.

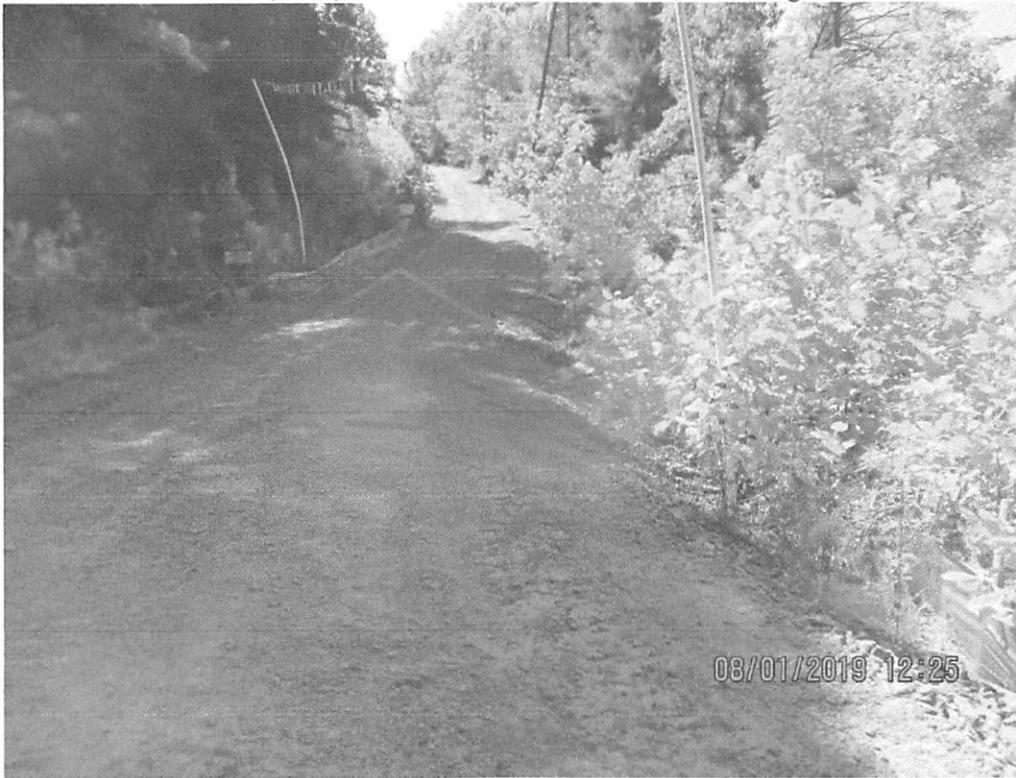
MVP-BR-095 facing upslope above US 19/Hwy 4. Arrow depicts where road was eroded out, overwhelming downslope controls.

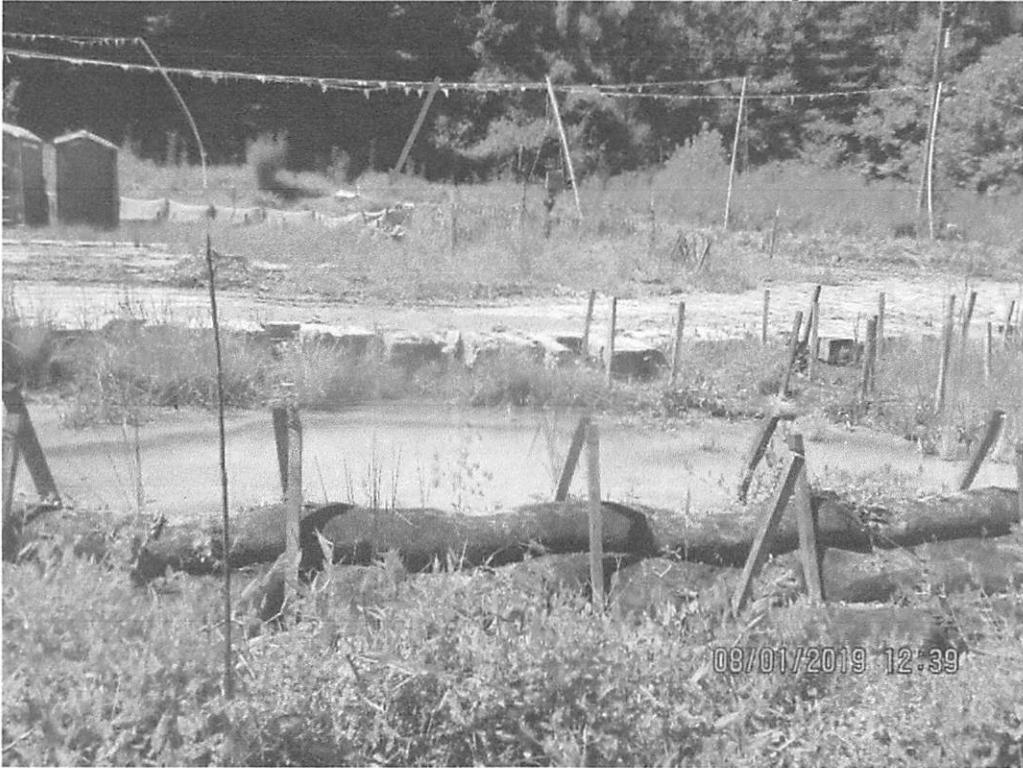
Facing upslope at MVP-BR-097. Arrow depicts where run-on was coming onto site. Sandbags had been installed to divert run-on away from site but had failed due to concentrated flow upslope of LOD.

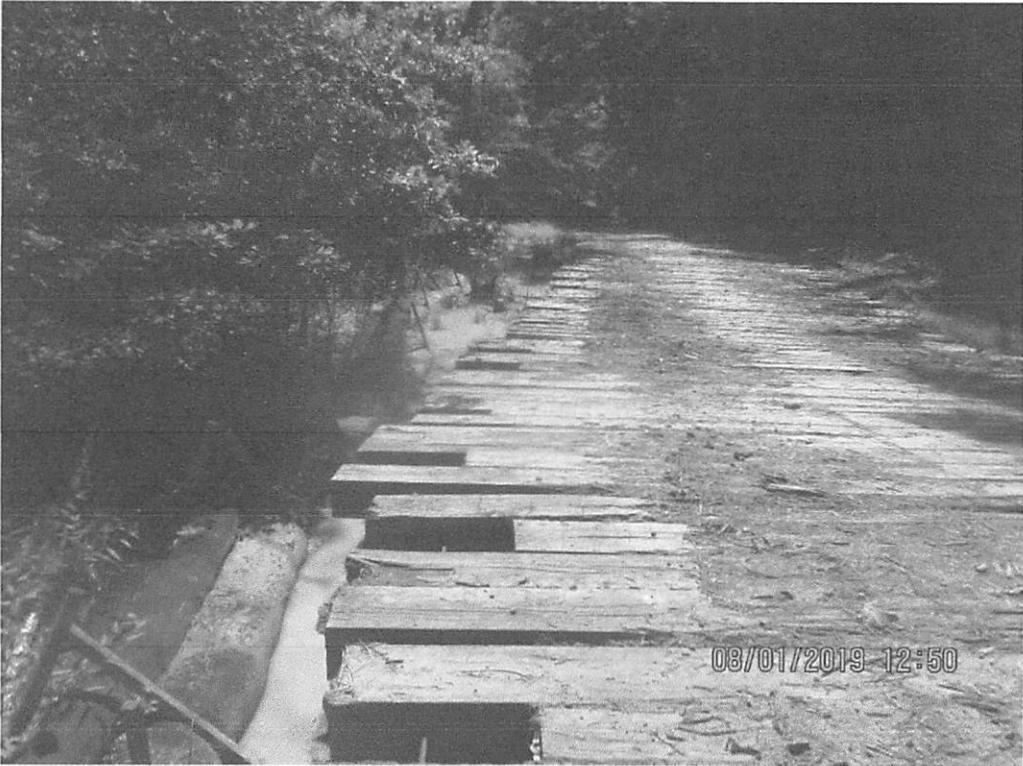
Perimeter controls below MVP-BR-097. Sediment-laden water ponded behind controls.

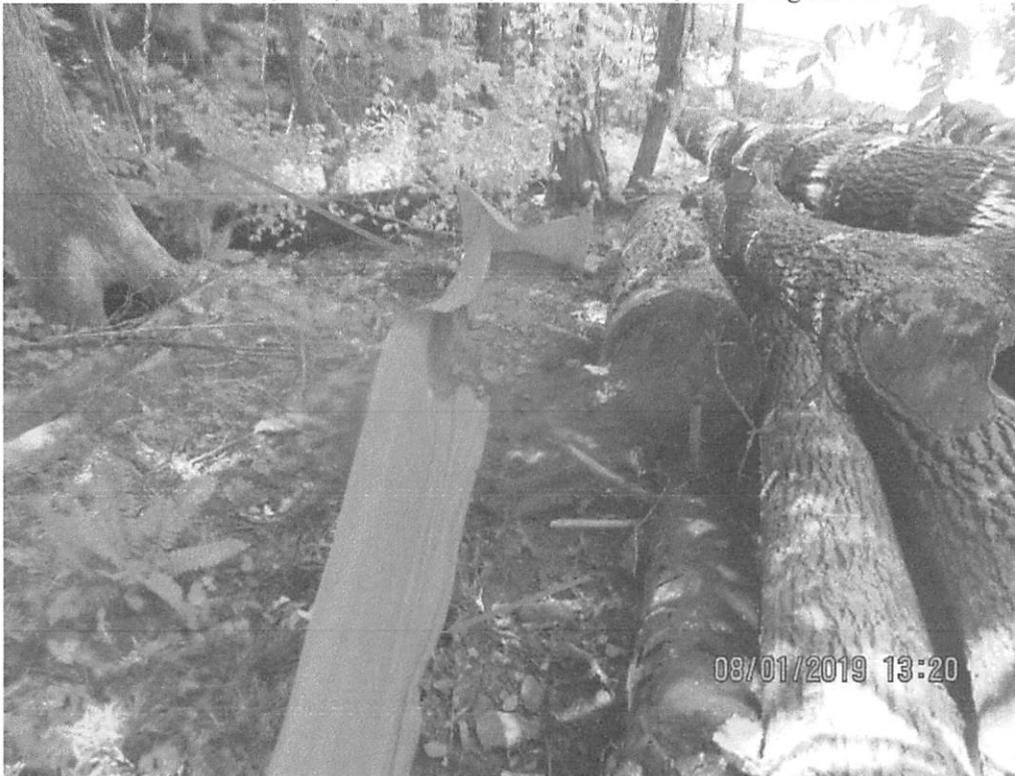
Downslope of waterbar terminating onto ROW at station 3831+00. Arrow depicts where perimeter controls were undercut from run-off and sediment deposits were observed past the LOD.

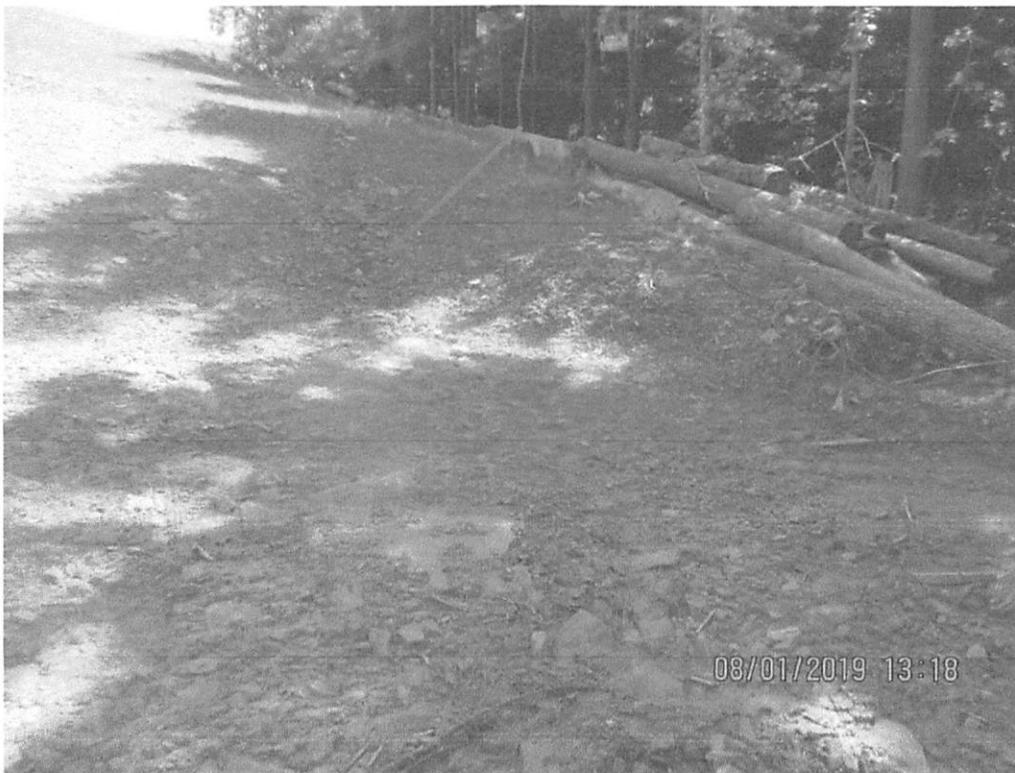
Further downslope from station 3831+00. Arrow depicts erosion present below waterbar on slope.
