**CONSENT ORDER
ISSUED UNDER THE
WATER POLLUTION CONTROL ACT
WEST VIRGINIA CODE, CHAPTER 22, ARTICLE 11**

TO: Mountain Valley Pipeline, LLC
Robert J. Cooper
2200 Energy Drive
Canonsburg, PA 15317

DATE: December 17, 2020

ORDER NO.: 9925

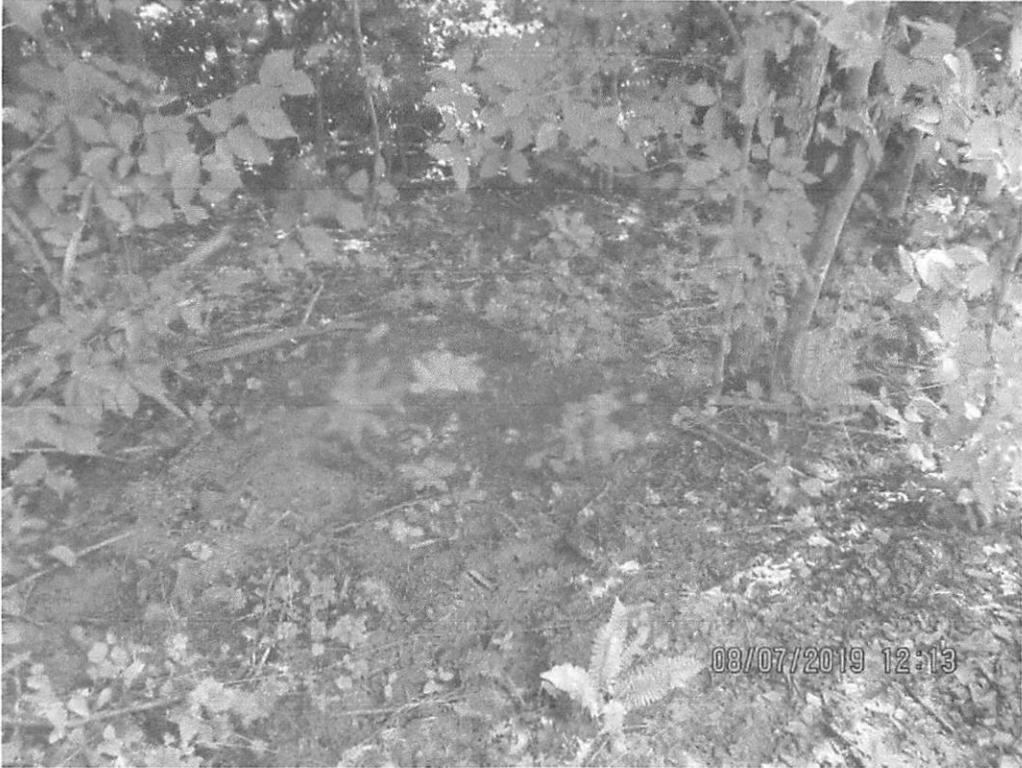
Further downslope near station 8951+00. Perimeter Controls below waterbar termini with no outlet control, terminating onto fill slope and above LOD. Sediment deposits observed past the LOD.

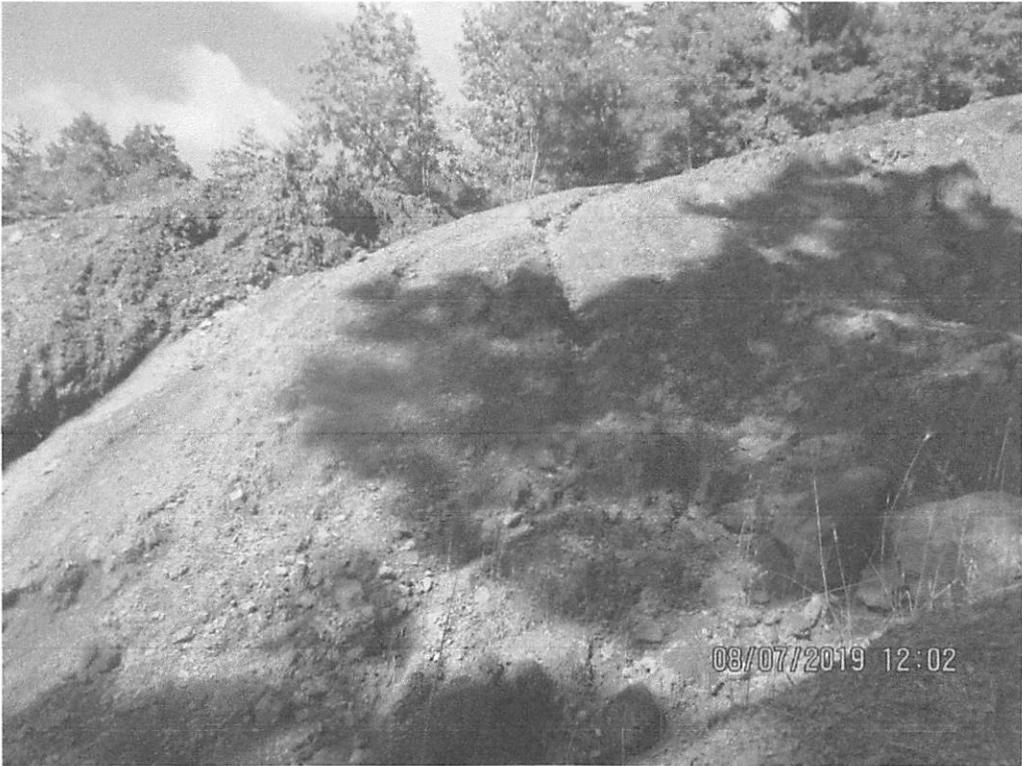
Near station 8954+00. Waterbar terminating onto fill slope.

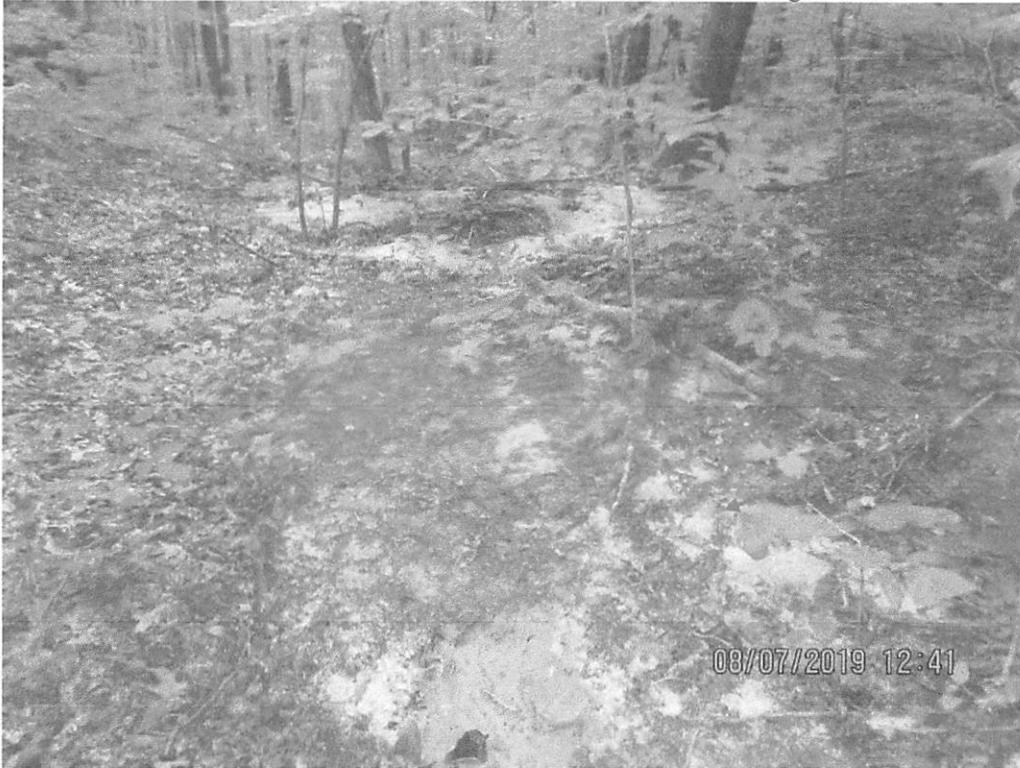
Approximately 150 ft past LOD near station 8929+00. Sediment deposits observed in Stream S-K16.

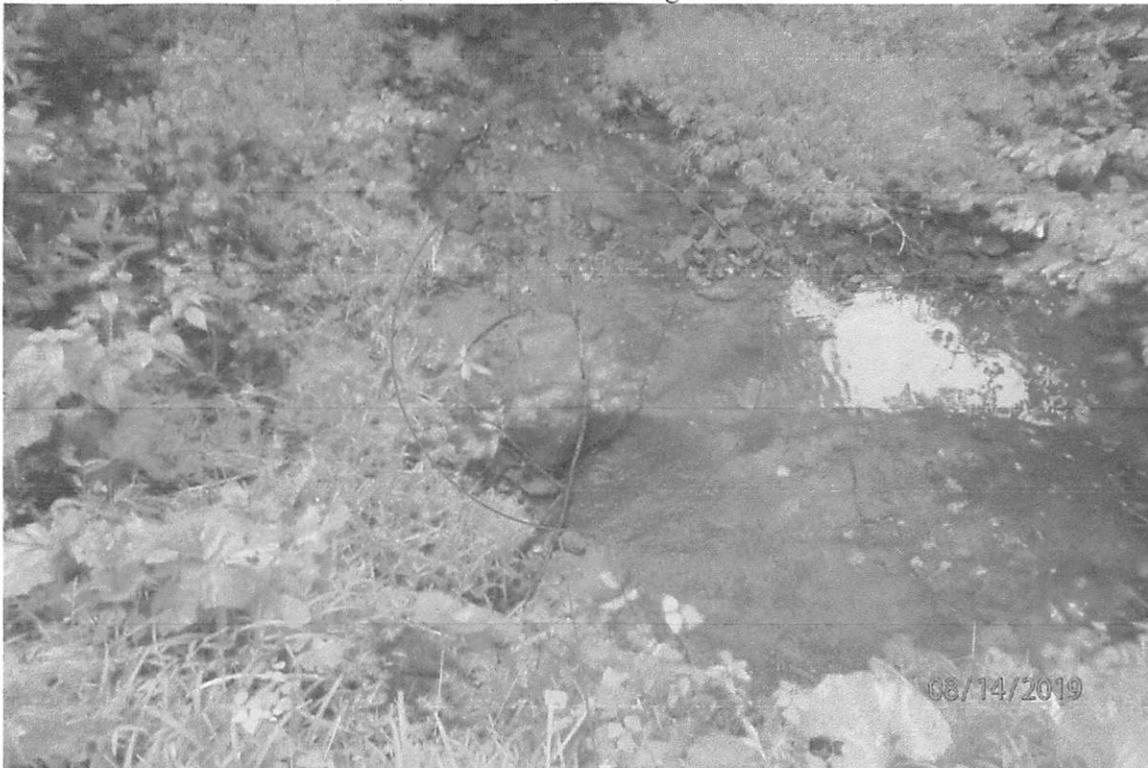
CNA deposits in Keith Run ($38^{\circ} 47.179'$ X $80^{\circ} 31.816'$) as a result of the previously pictured deficiencies.

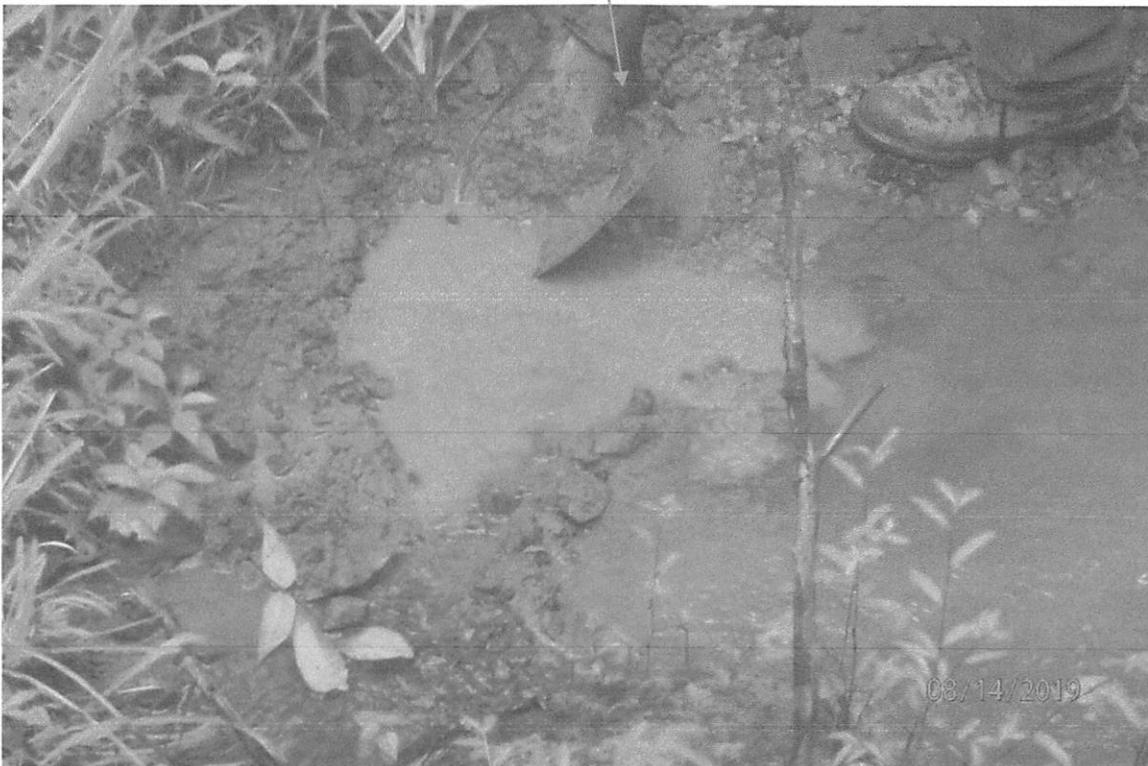
CNA deposits in Keith Run ($38^{\circ} 47.179'$ X $80^{\circ} 31.816'$) as a result of the previously pictured deficiencies.

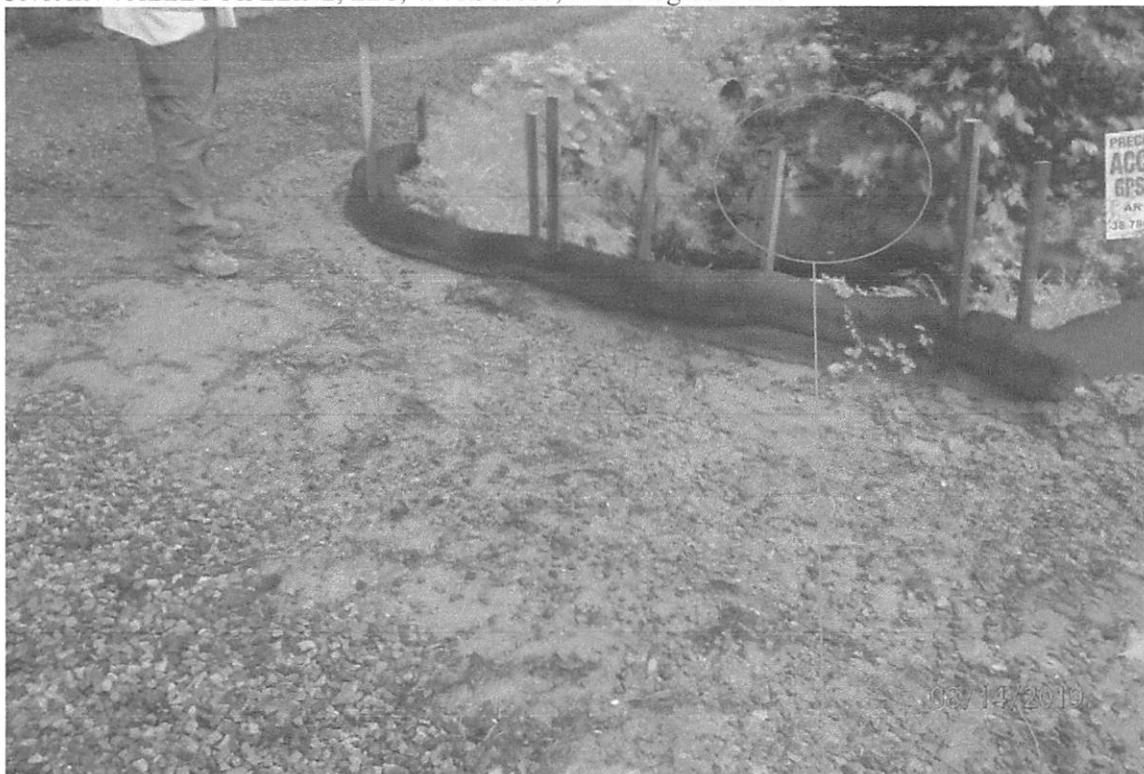
Trail of sediment from access road MVP-BR-092.01 that leads to Keith Run.

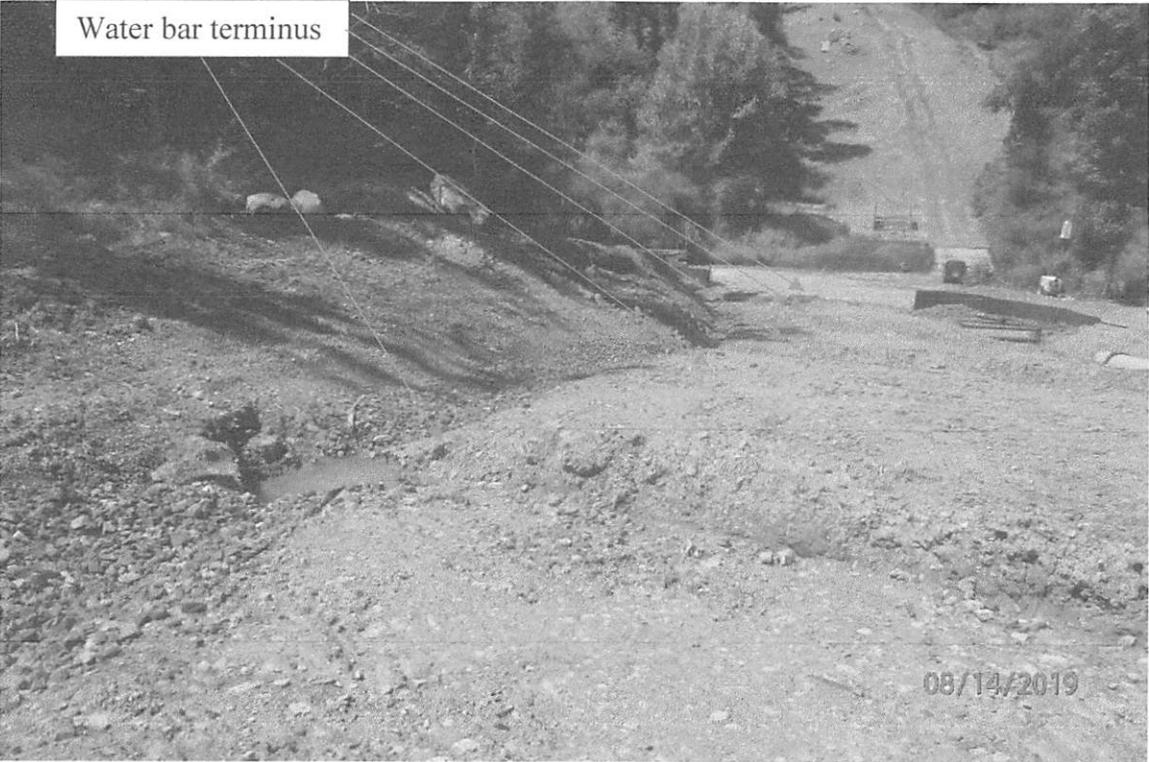
Water bars in inspected area 5 installed at a steep angle and discharging prior to the installed perimeter controls.

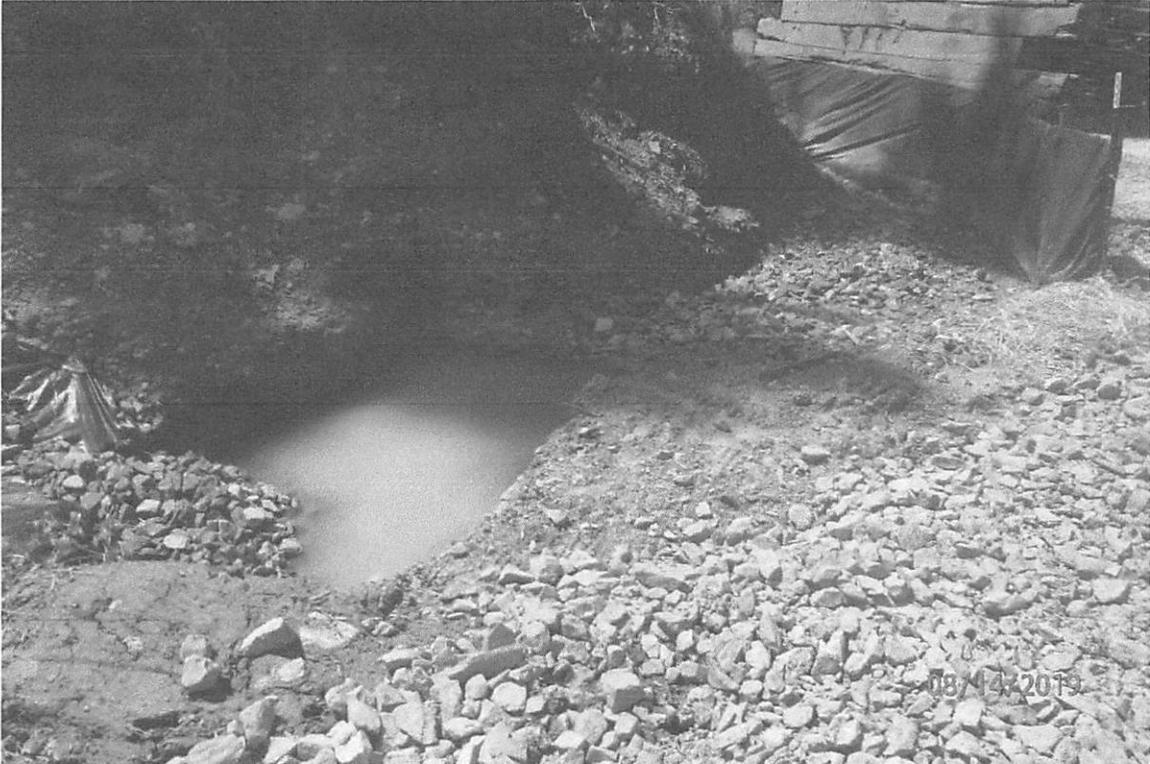
Improperly installed water bars in inspected area 8 that are discharging into a diversion, with stormwater from the diversion being directed at two pieces of installed perimeter controls.

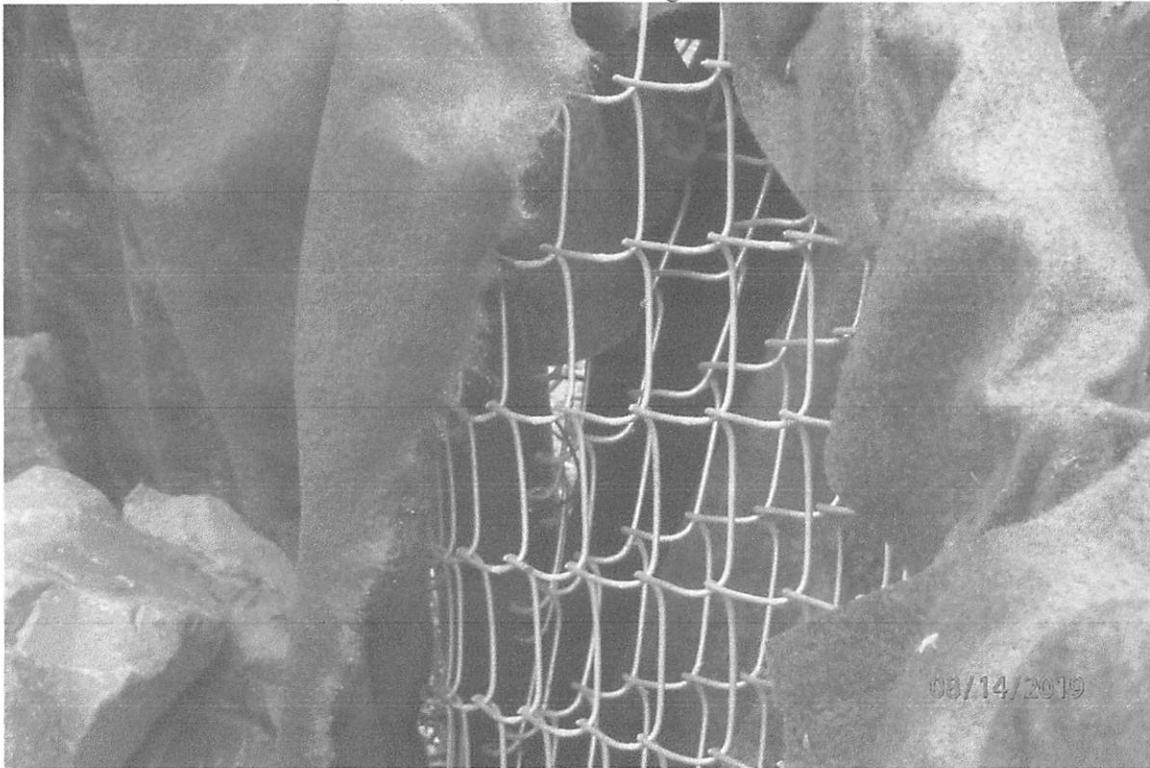
Improperly installed timber mat equipment bridge at the Clover Run (inspected area 1) crossing, showing areas where sediment-laden water can bypass treatment.

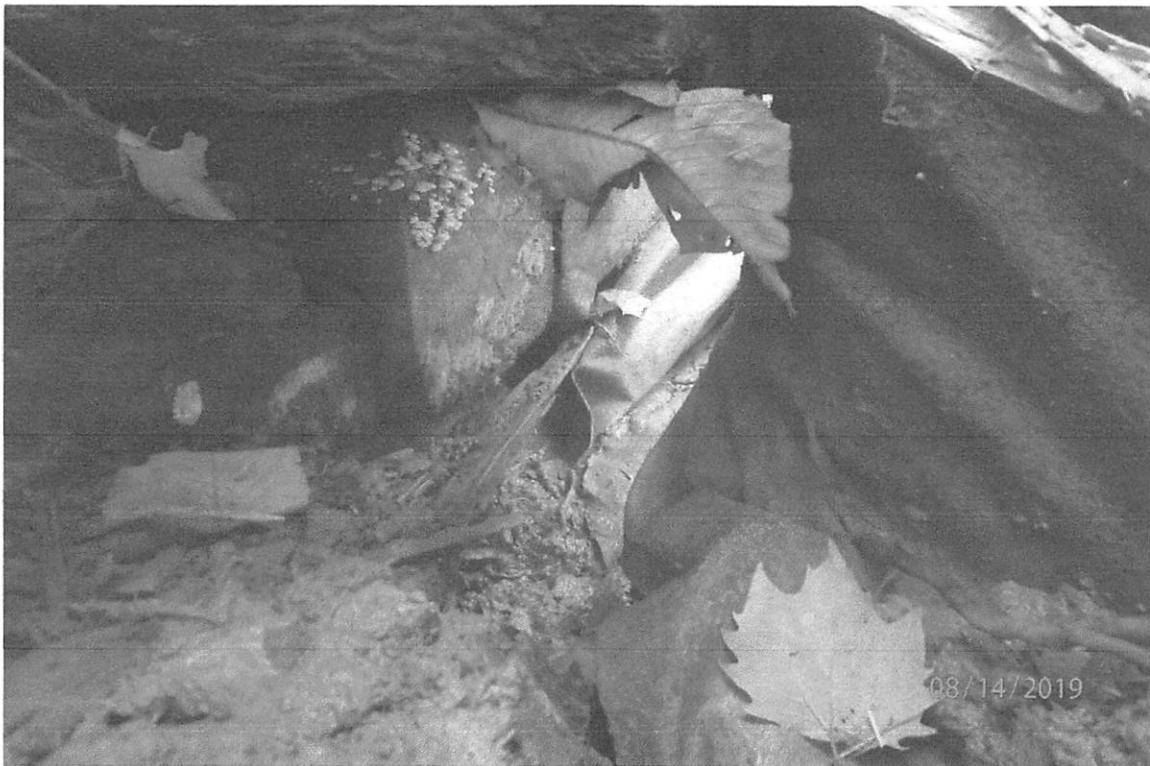
Improperly installed timber mat equipment bridge at the Oil Creek (inspected area 3) crossing, showing an area where sediment-laden water can bypass treatment.

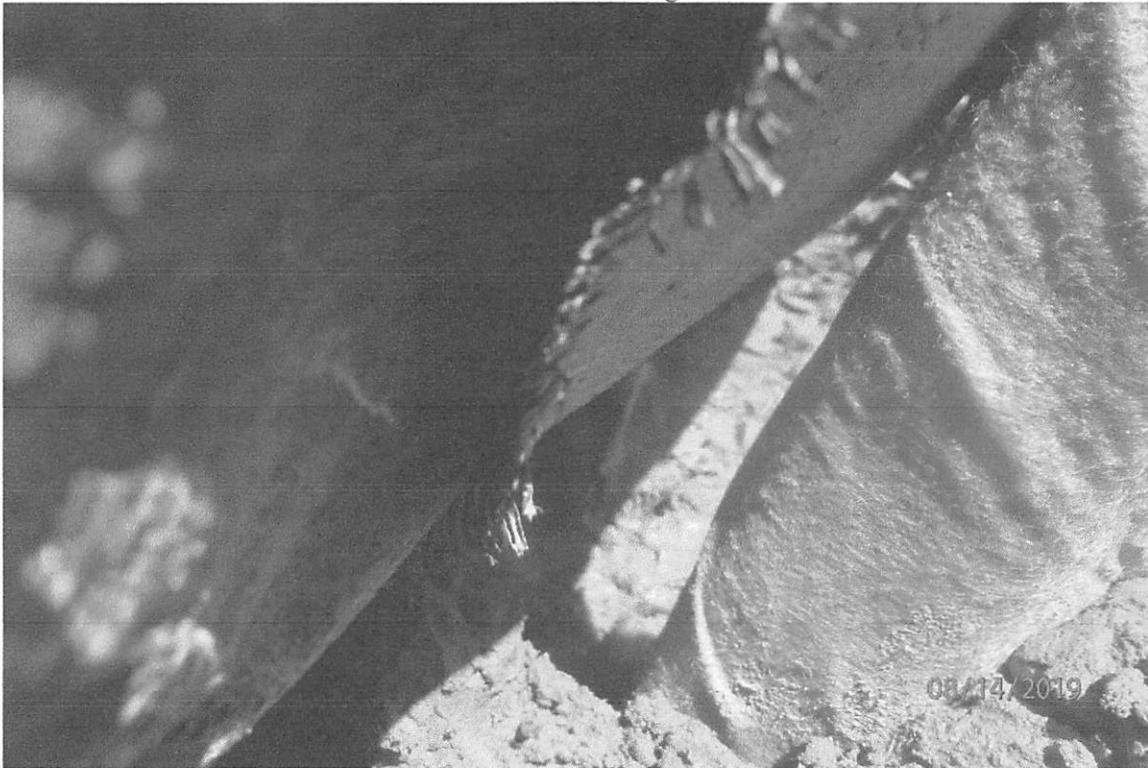
Improperly installed timber mat equipment bridge at the Cove Run (S-K-45) (inspected area 8) crossing, showing an area where sediment-laden water can bypass treatment.

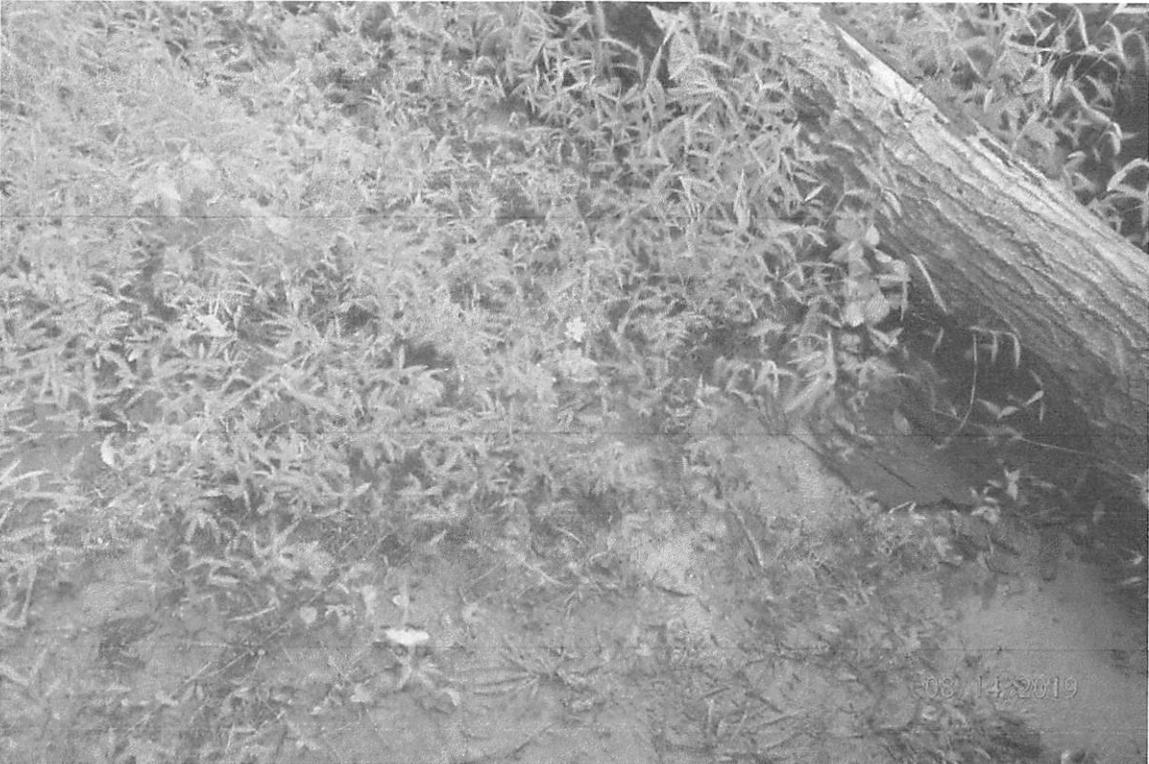
Offsite sediment deposits as a result of the previously pictured deficiency in inspected area 3.

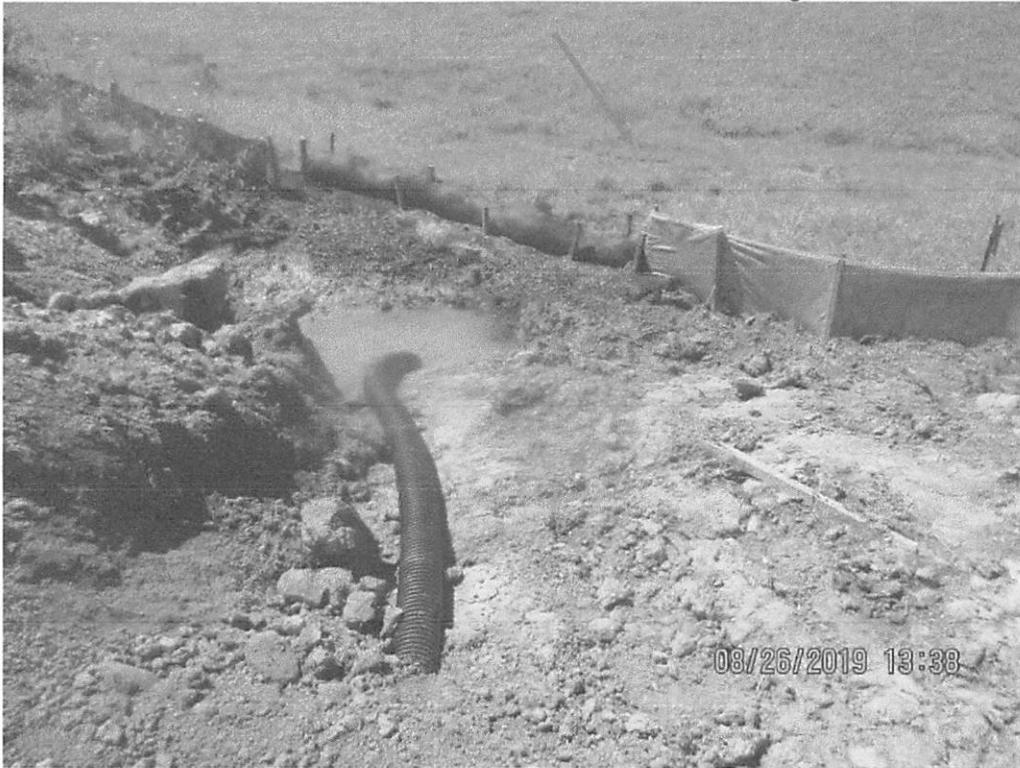
Slope drain extending from waterbar outlet terminating into sump above perimeter controls. Arrow depicts where sediment deposits were observed past controls above Wetland W-K48 at station 1730+00.

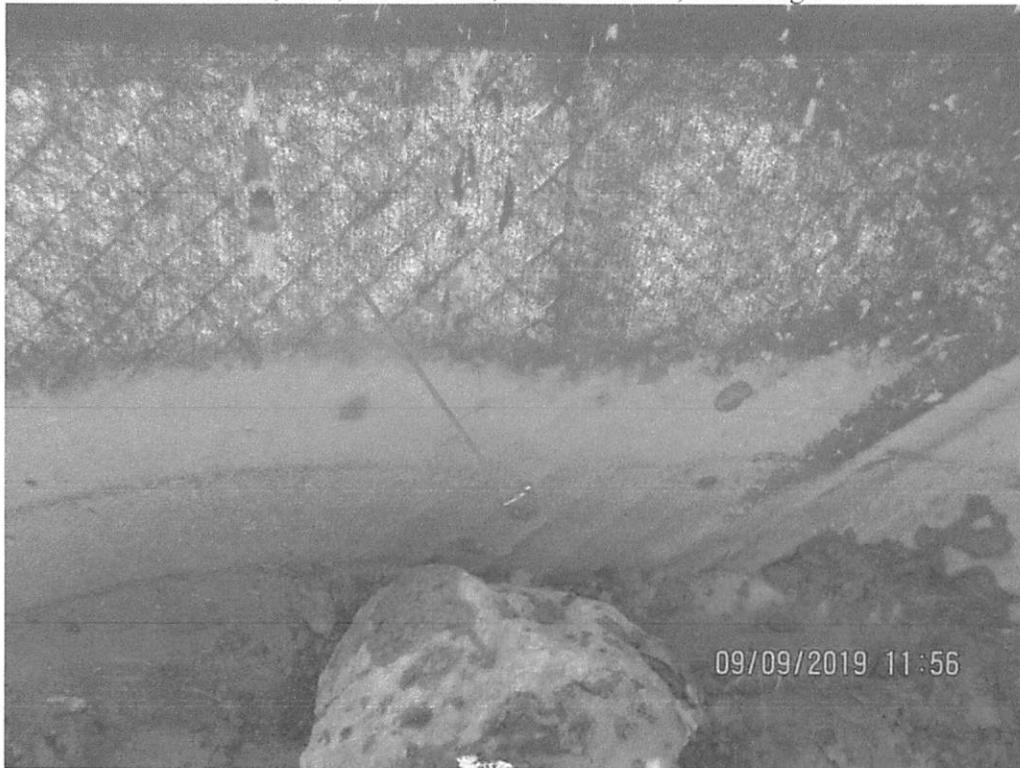
Super silt fence below unmaintained controls at station 3089+00. Hole present in silt fence below where sediment stain line was observed.

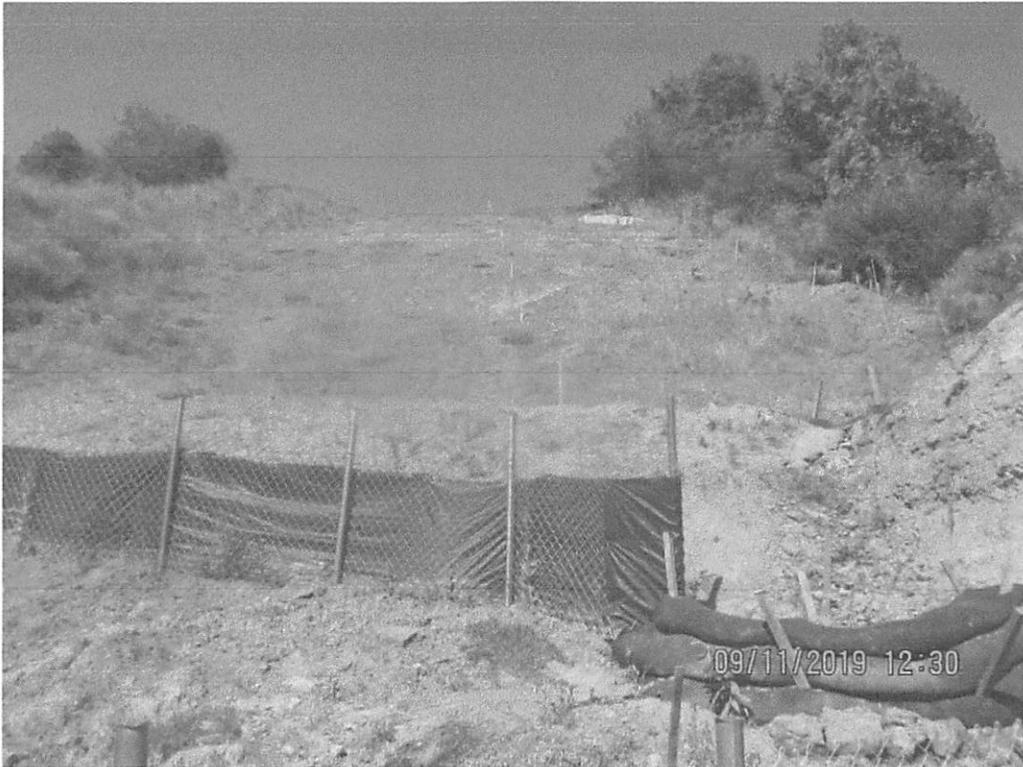
South slope at station 645+00 above the Big Elk Creek crossing. Winter stabilization no longer adequate, and reseeded/re-stabilization had not occurred.

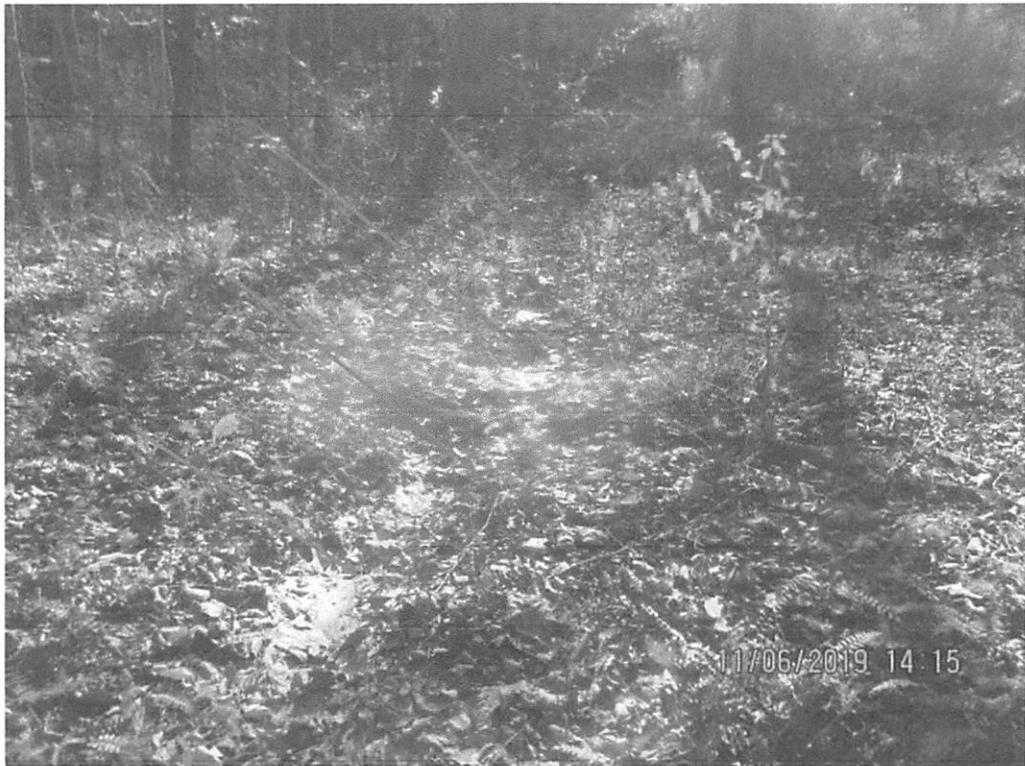
Downslope of AR-114 bridge near station 4364+00 facing toward AR-114. Deposits observed past LOD in conveyance.

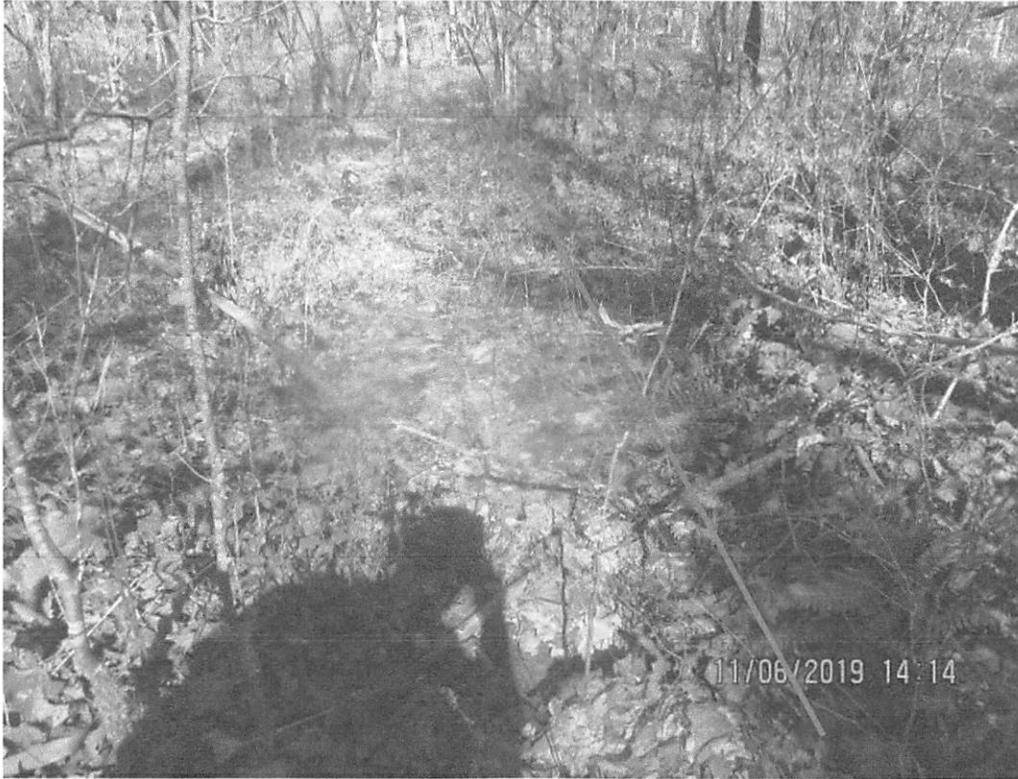
Downslope of AR-114 bridge near station 4364+00 facing toward Oddlick Creek. Deposits observed in conveyance past LOD.

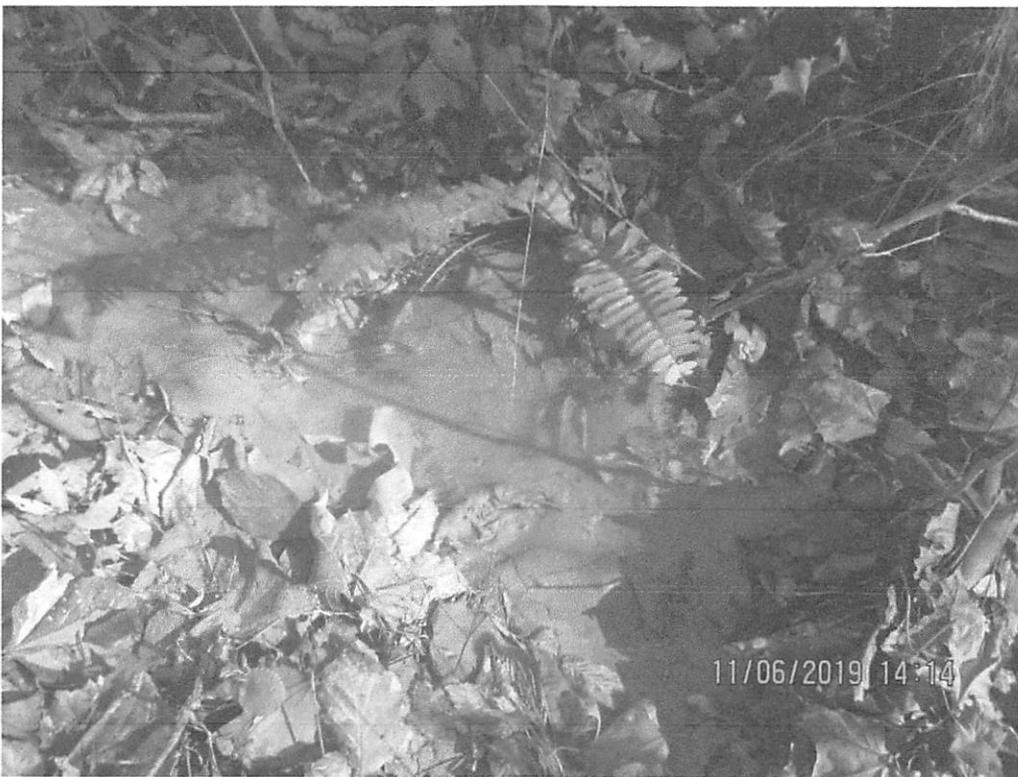
Example of sediment deposits observed in the conveyance between S-S2 crossing and Oddlick Creek near station 4364+00.

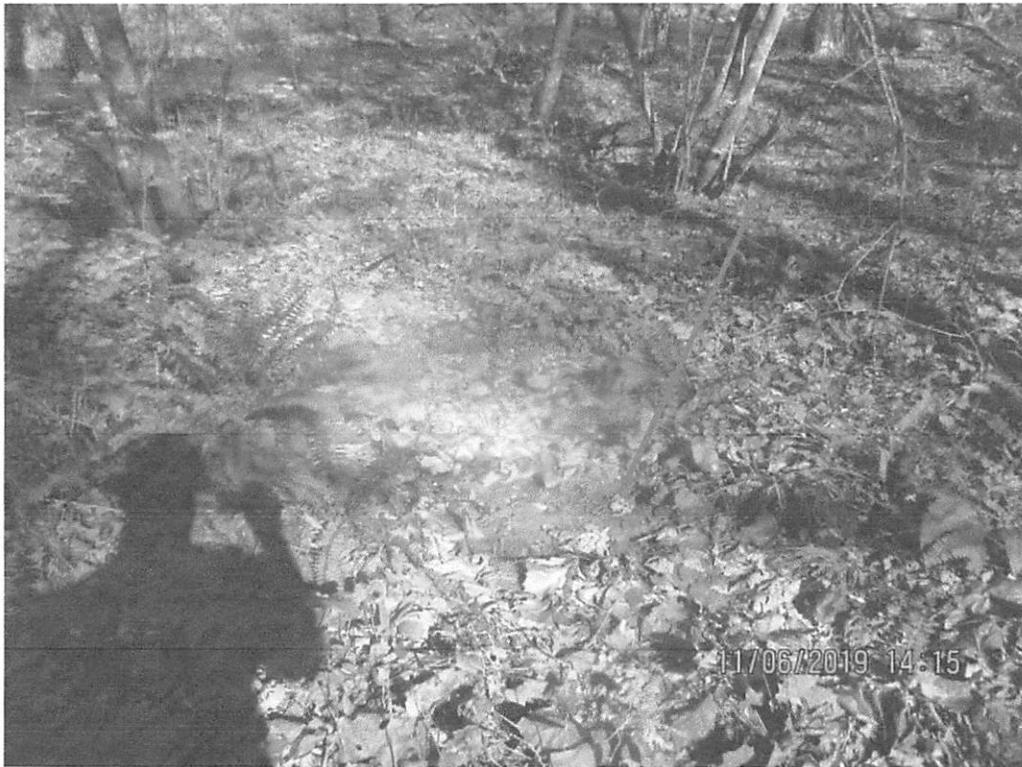
Near station 4364+00 and upslope of Oddlick Creek. Stained leaves observed up to edge of Oddlick Creek with sediment deposits present (red arrow).

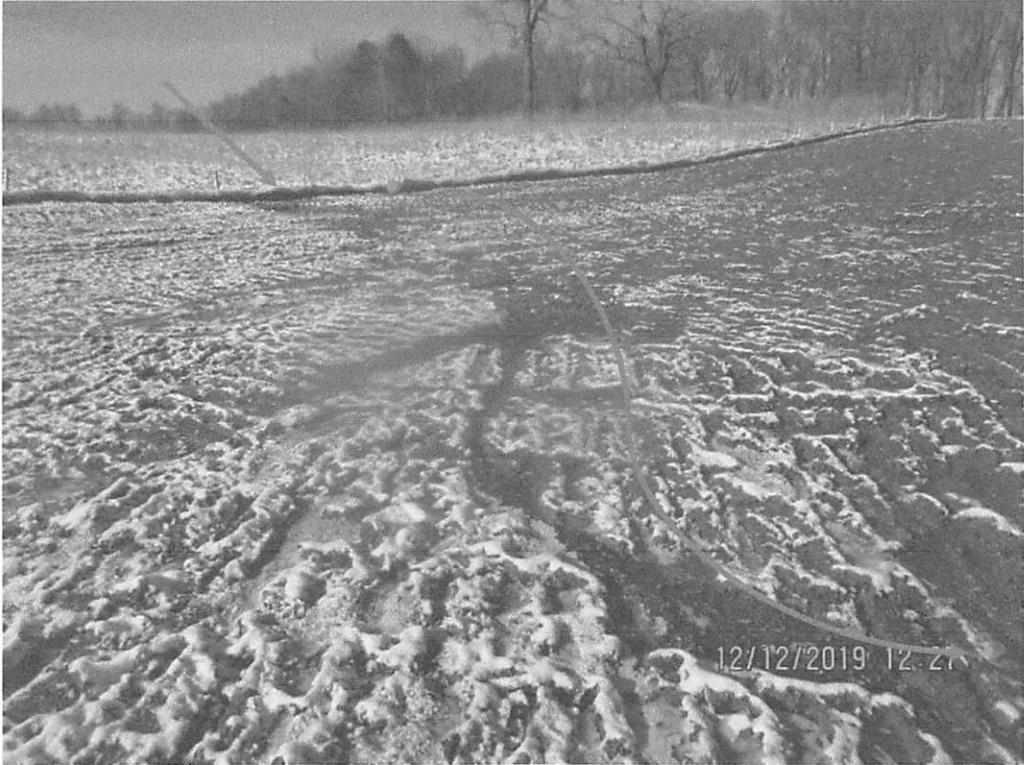
Run-on originating from seep at edge of LOD at station 8433+50. Erosion occurring on ROW. Arrow depicts seep and erosion that was observed.

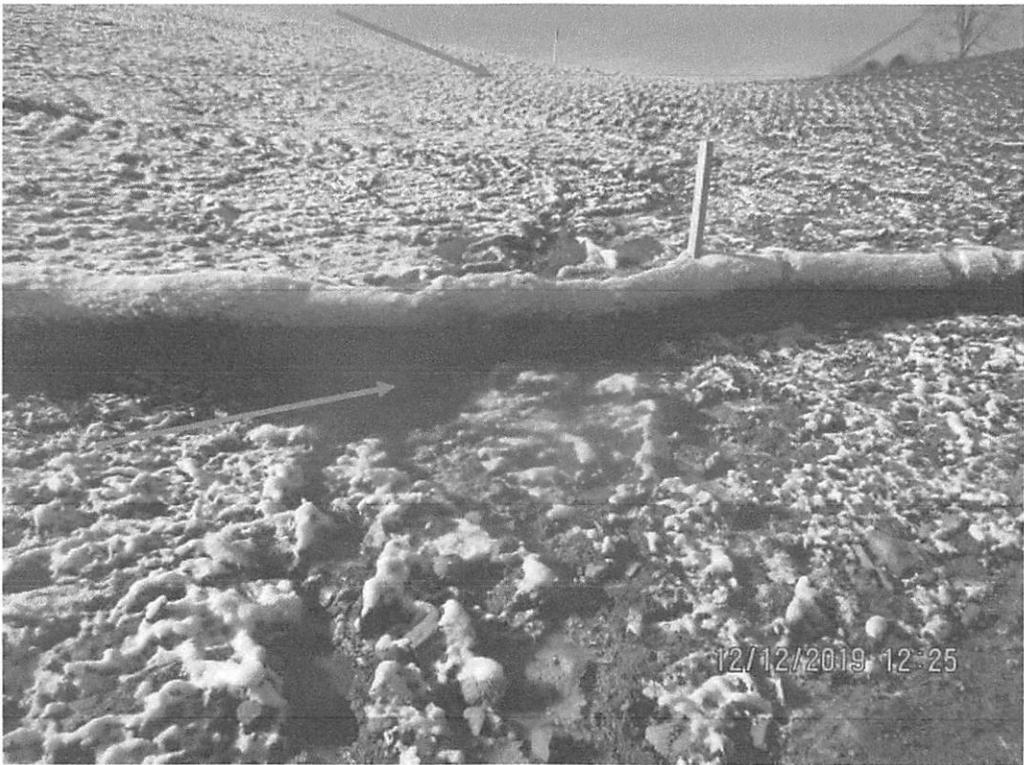
Section of ROW at station 8433+50 that was not tracked-in properly, causing enhanced erosion upslope of controls. Arrow depicts where CFS was undermined due to concentrated flows and area of ROW not tracked-in properly.

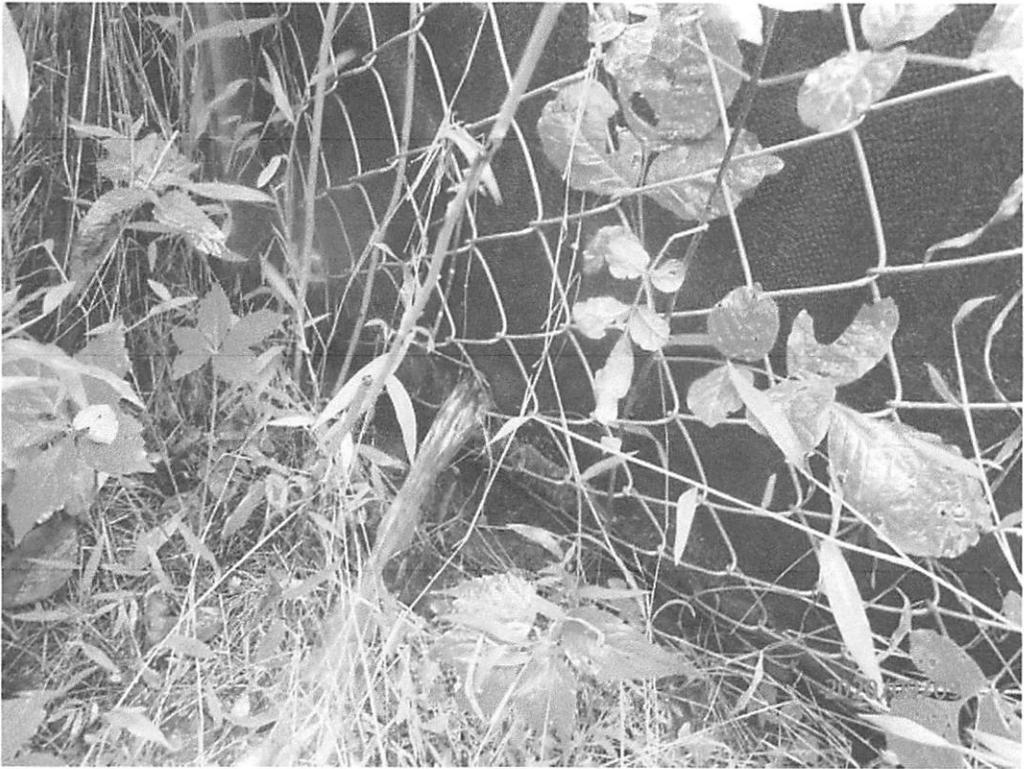
Silt fence is damaged near Stout Run bridge
