**CONSENT ORDER
ISSUED UNDER THE
WATER POLLUTION CONTROL ACT
WEST VIRGINIA CODE, CHAPTER 22, ARTICLE 11**

DATE: January 26, 2012

ORDER NO.: 7487

1. WVDOT operates a land disturbance associated with construction activity, referred to as King Coal Highway Red Jacket Mountainview Paving located near Red Jacket, Mingo County, West Virginia. WVDOT was issued WV/NPDES Water Pollution Control Permit No. WV0115924, Registration No. WVR104797, on January 12, 2010.
2. On July 25, 2011, West Virginia Department of Environmental Protection (hereinafter "WVDEP") personnel responded to a citizen complaint. Upon investigation, it was discovered that a large stream blockage had occurred in Spice Branch, a tributary to Pigeon Creek. An unnamed tributary to Spice Branch was observed to be severely eroded, which resulted in a large amount of material being deposited in Spice Branch.

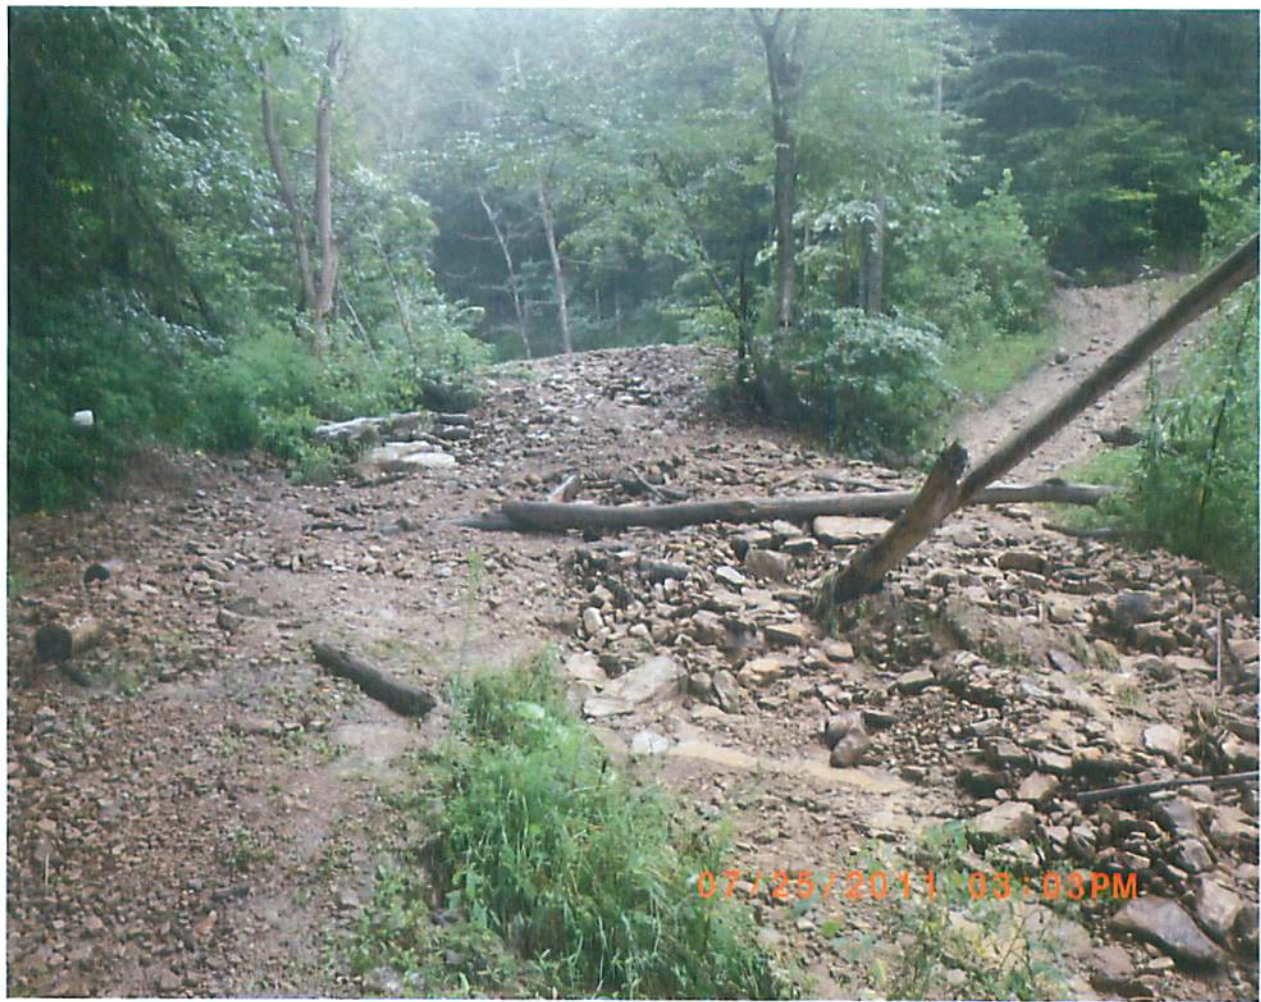
- Large amount of material shown completely blocking Spice Branch. Material is approximately 10-12 feet tall and 30-40 yards in length. The remnants of the AEP access road that crosses Spice Branch can be seen in the upper right.

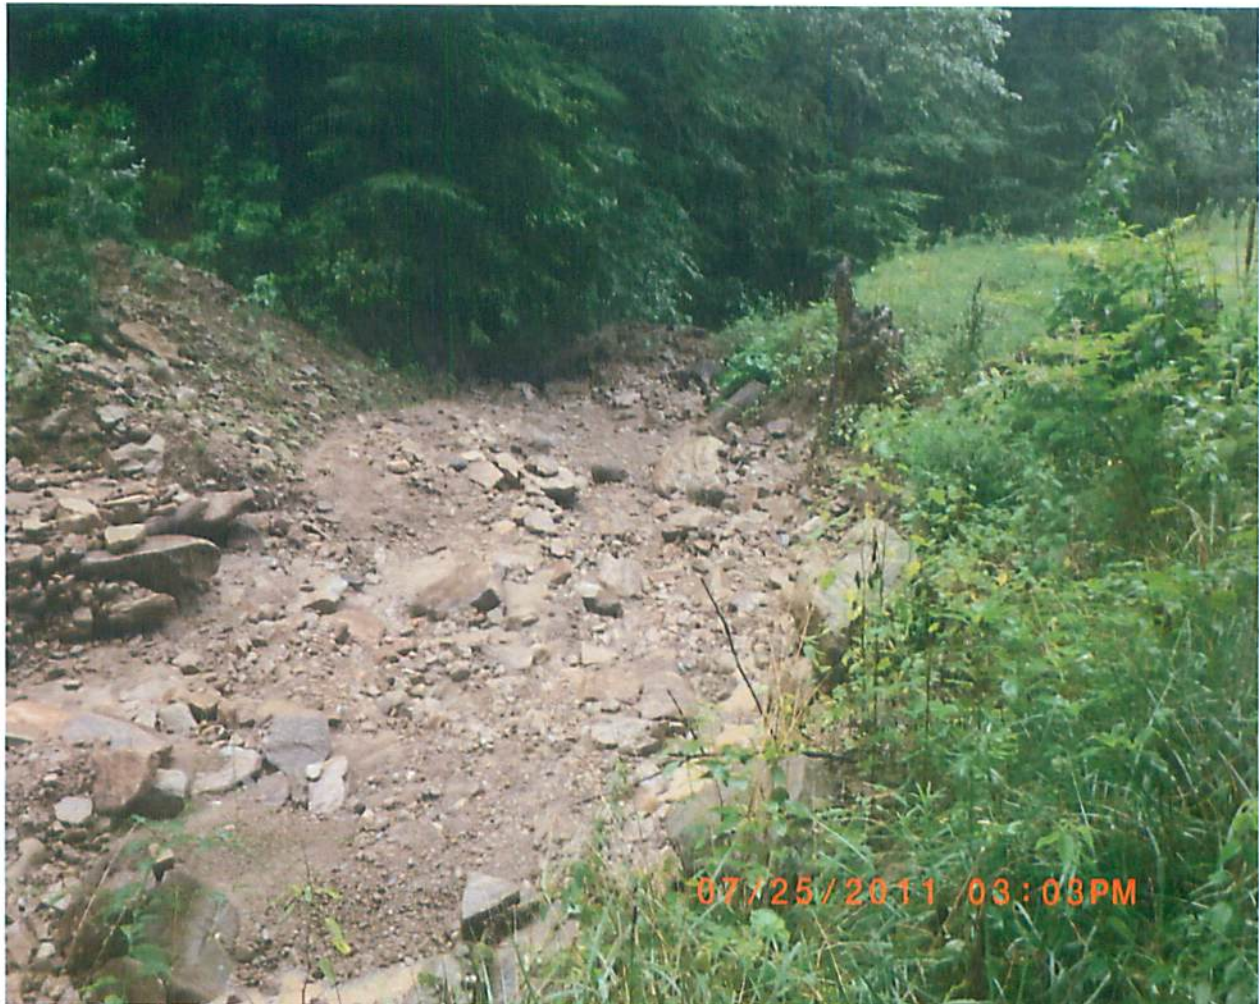
- View facing downstream at the bottom of the deposit/blockage. No flow in Spice Branch. Large amount of deposits downstream for several hundred yards.

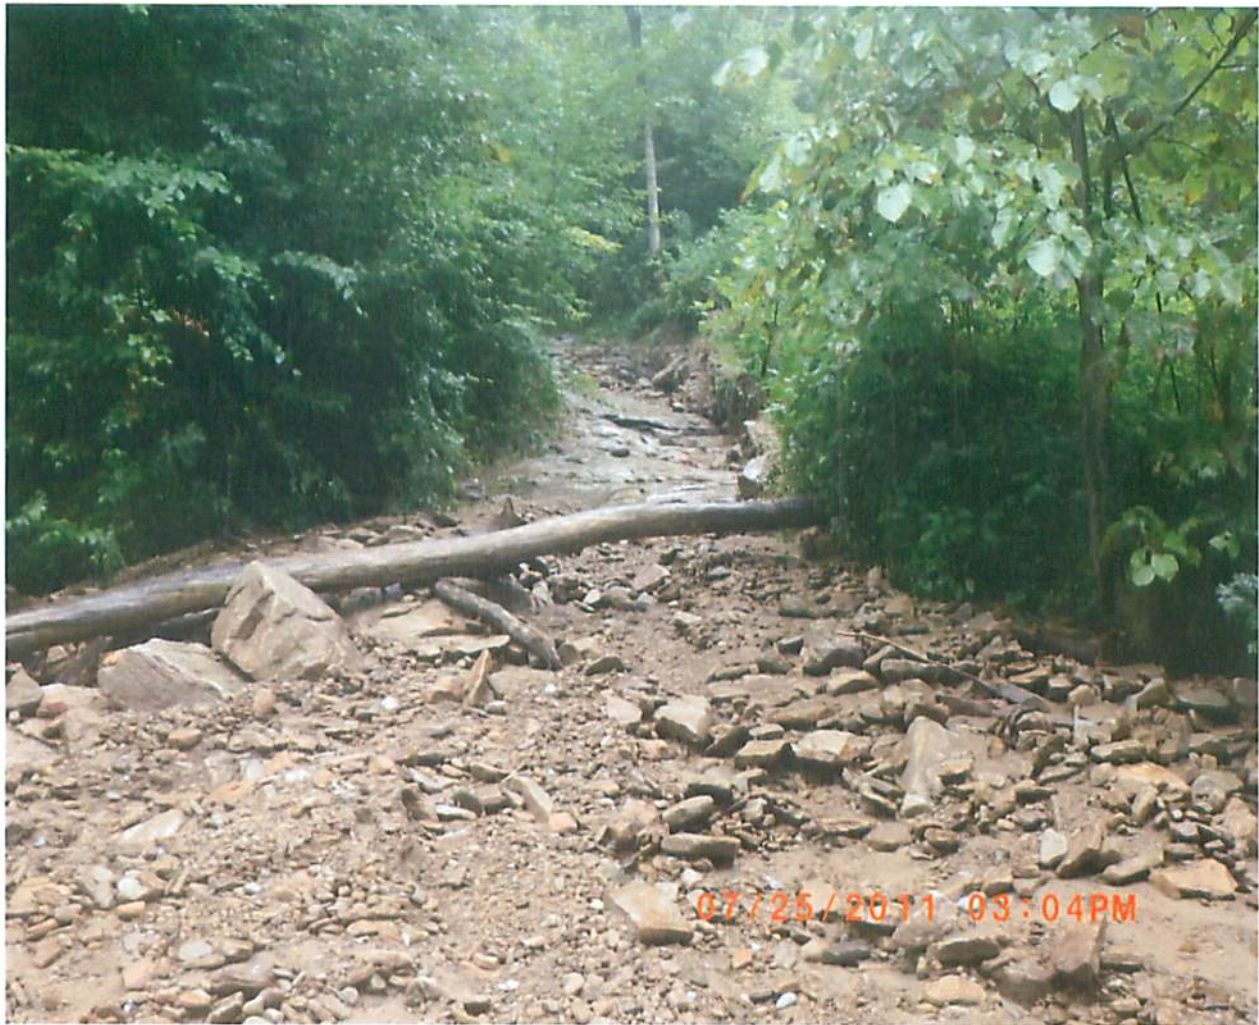
- Severely eroded unnamed tributary to Spice Branch, shown from the mouth, where it meets Spice Branch and blockage occurred. Stream has eroded down to bedrock in several places, causing all the rock and sediment shown to deposit in Spice Branch.

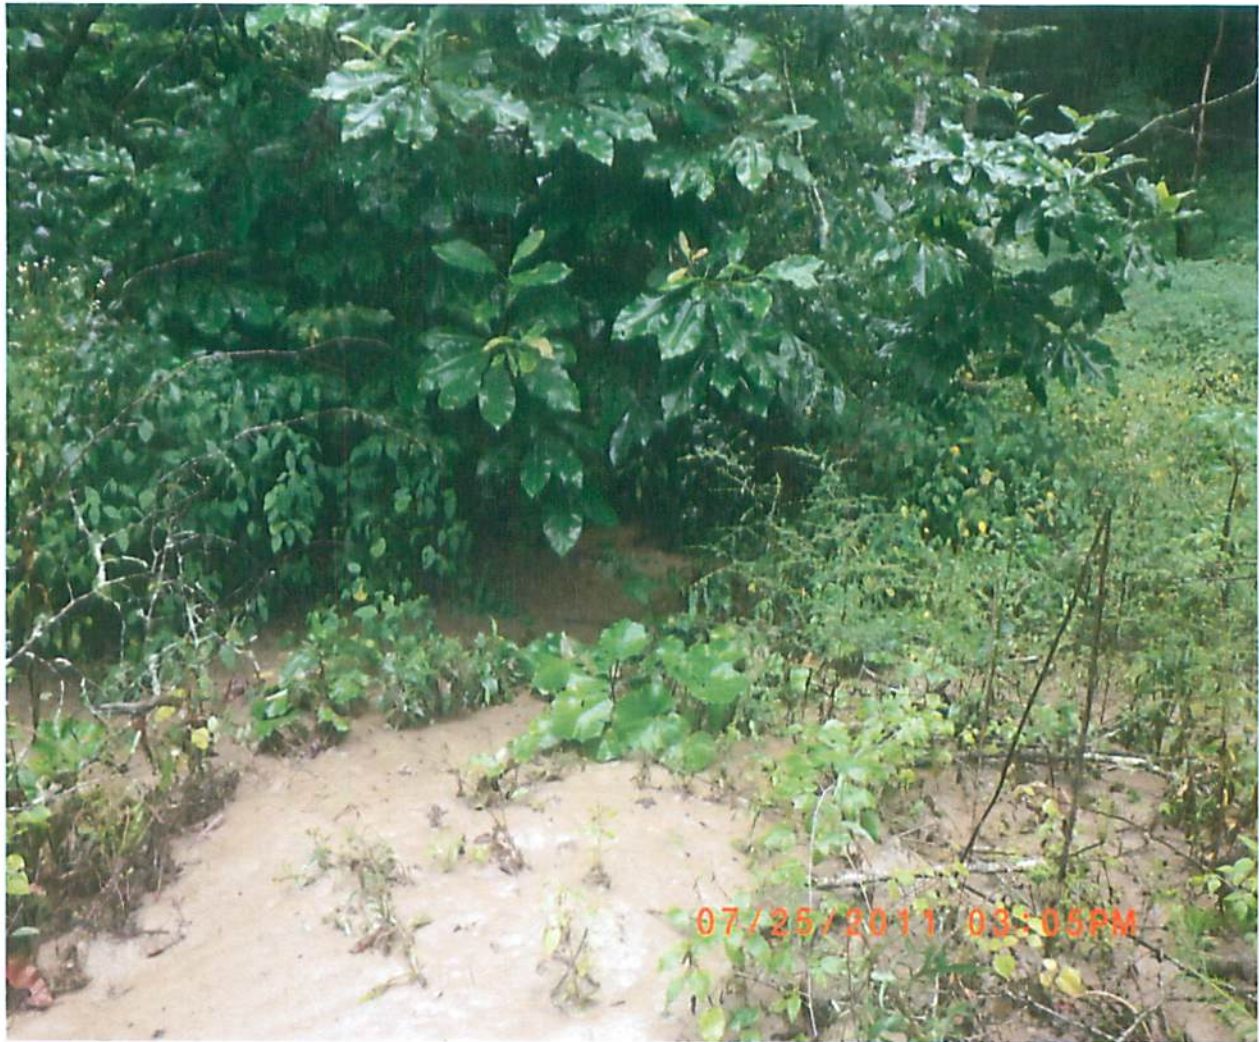
- Spice Branch shown flowing from under the trees into the mud, which is the upper portion of the blockage. Stream was approximately 2ft wide at this point and maybe a couple inches in depth. It does not reappear below the blockage.

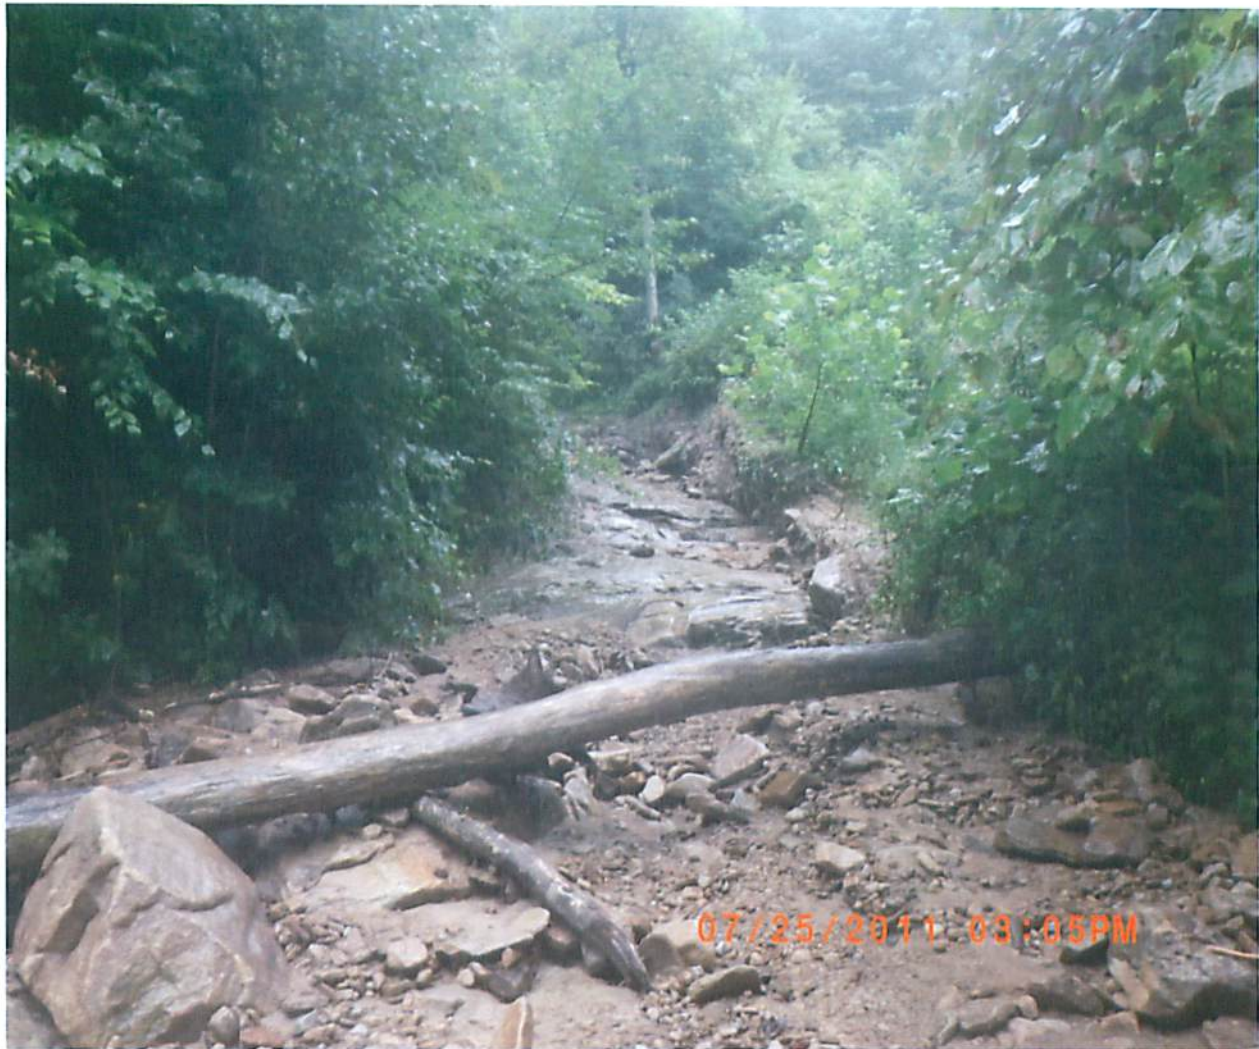
- Another view of the scoured unnamed tributary to Spice Branch. Just above the log on the right was evidence where this stream jumped its banks and into the AEP access road, which is just on the other side of the trees.

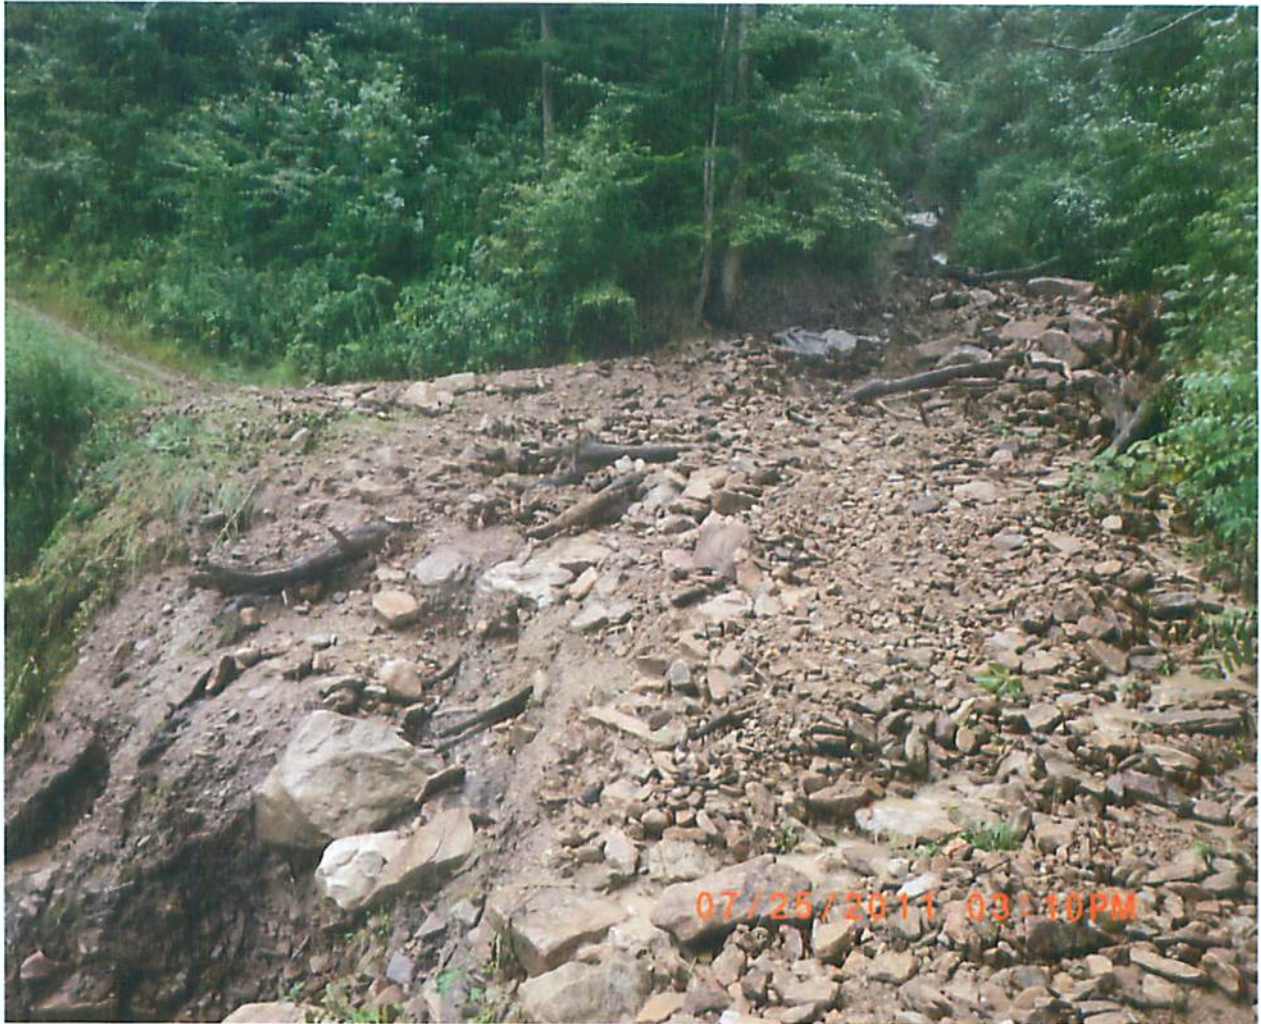
- View looking upstream on the unnamed tributary to Spice Branch, approximately 100-150 yards upstream of its confluence with Spice Branch. What's left of the existing AEP access road can be seen in the upper left. The bottom left portion of the photo shows where the road has collapsed, leaving an approximately 20ft sheer cliff in the unnamed tributary of Spice Branch.

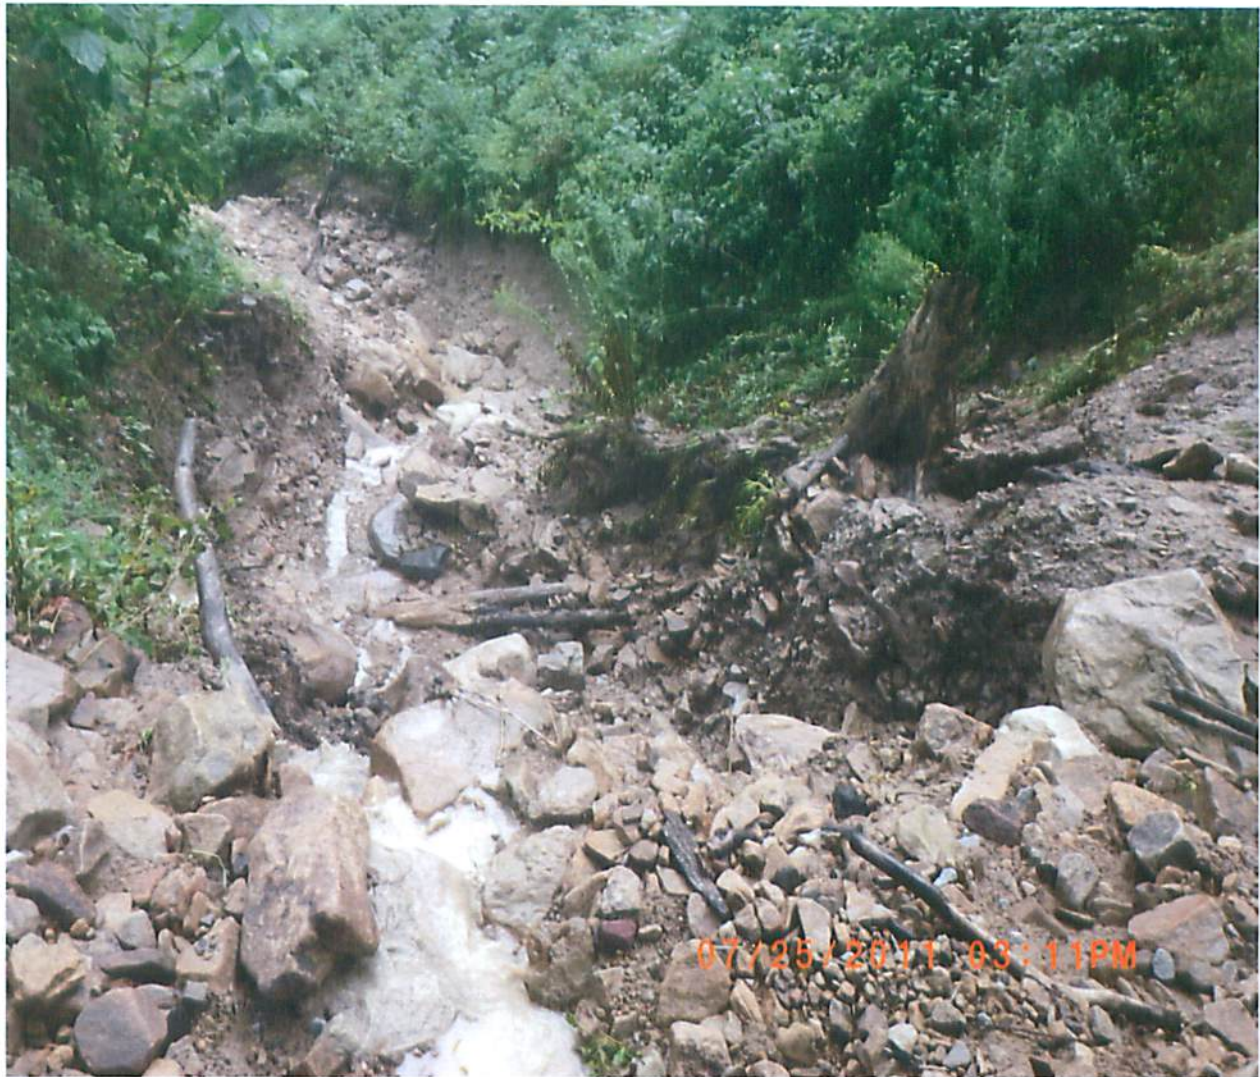
- View looking down the unnamed tributary of Spice Branch, from the location shown in the above photo. The sheer cliff can be seen where the AEP access road crossed the tributary and collapsed. The severe erosion and scouring can be seen down this tributary.

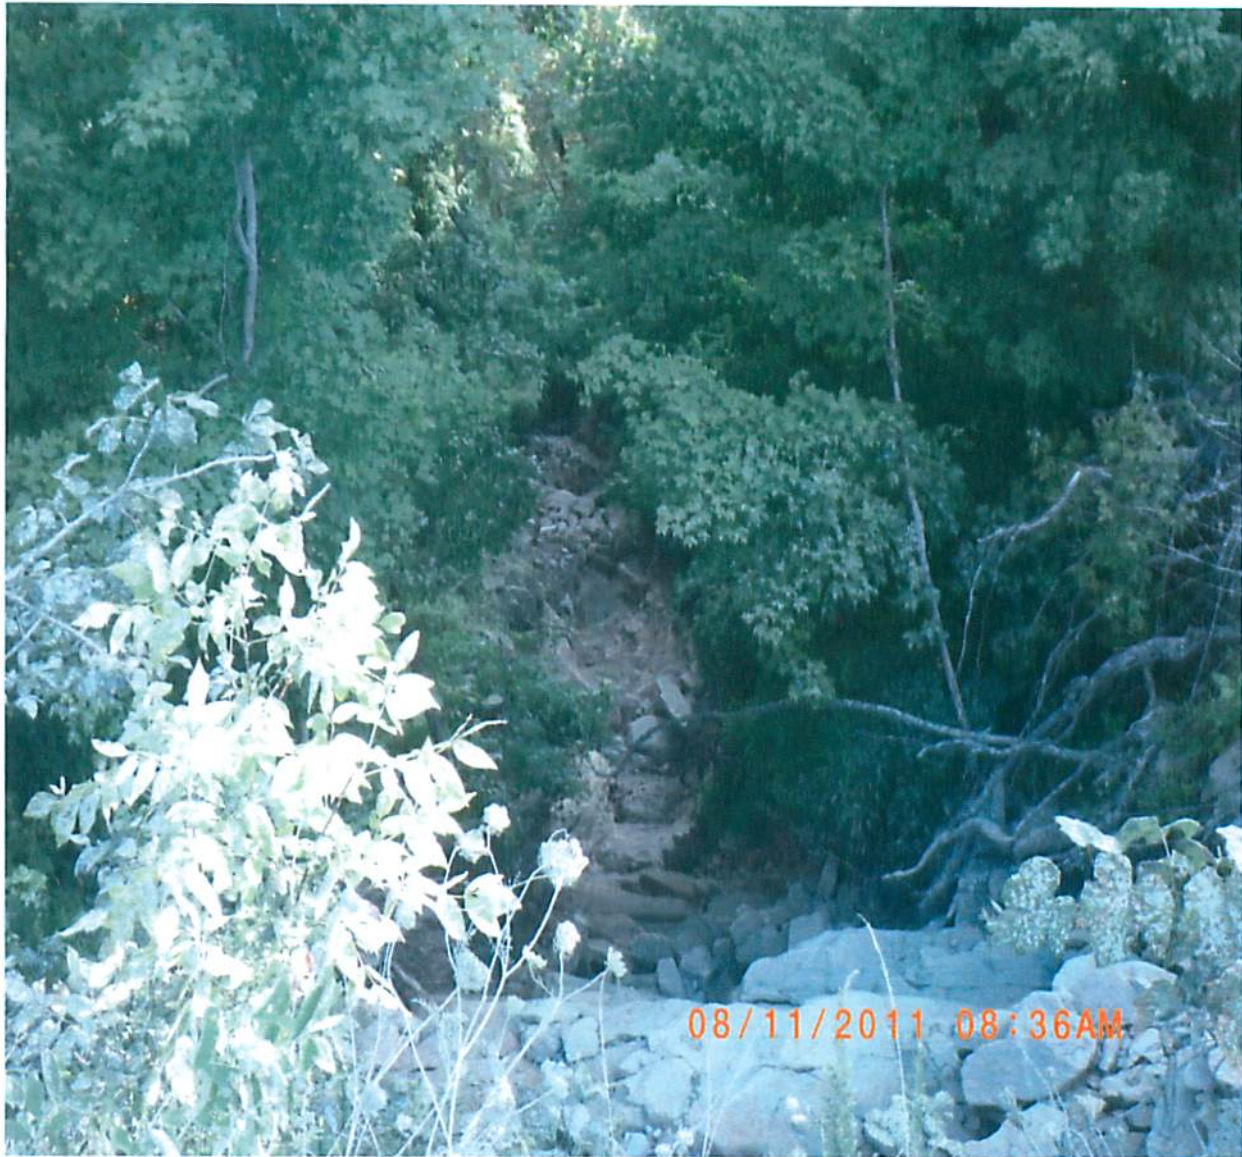
- f. The permittee failed to convey stormwater runoff in a manner that protected both the site and receiving stream from post-construction erosion, specifically at Outlet 016. This is a violation of the WV/NPDES Permit Section G.2.

- Scouring evident below Outlet 016 discharge point.

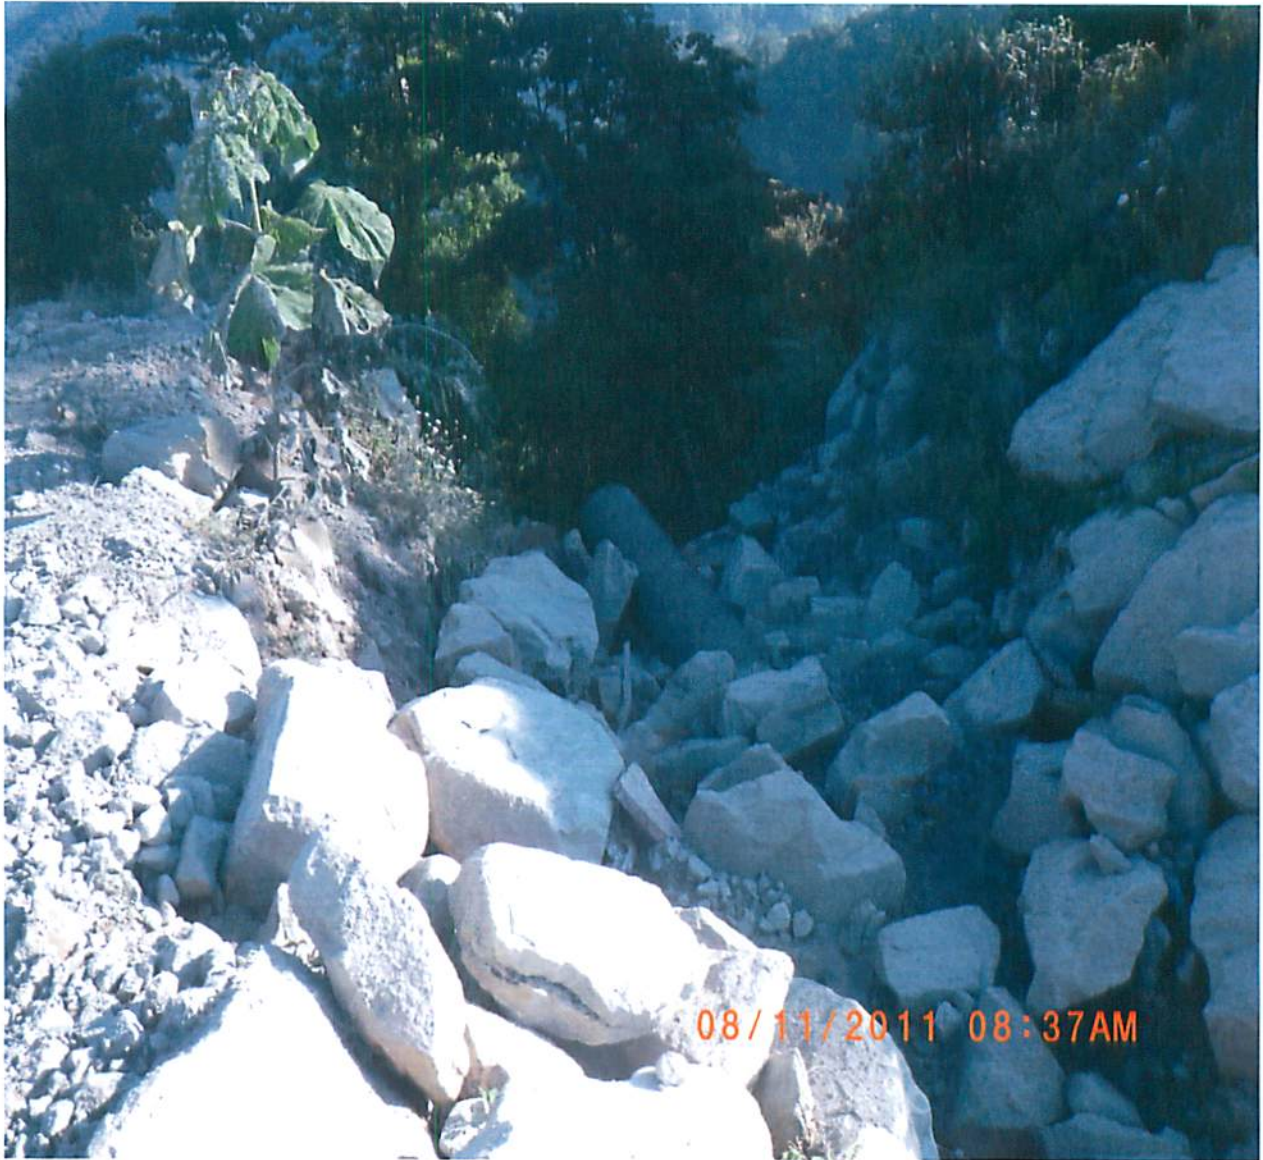
- View of Outlet 016, including both surface runoff from side ditch, as well as the small pipe from the median drains in the area. 3-5 median drains are supposed to drain to this point, through this pipe.

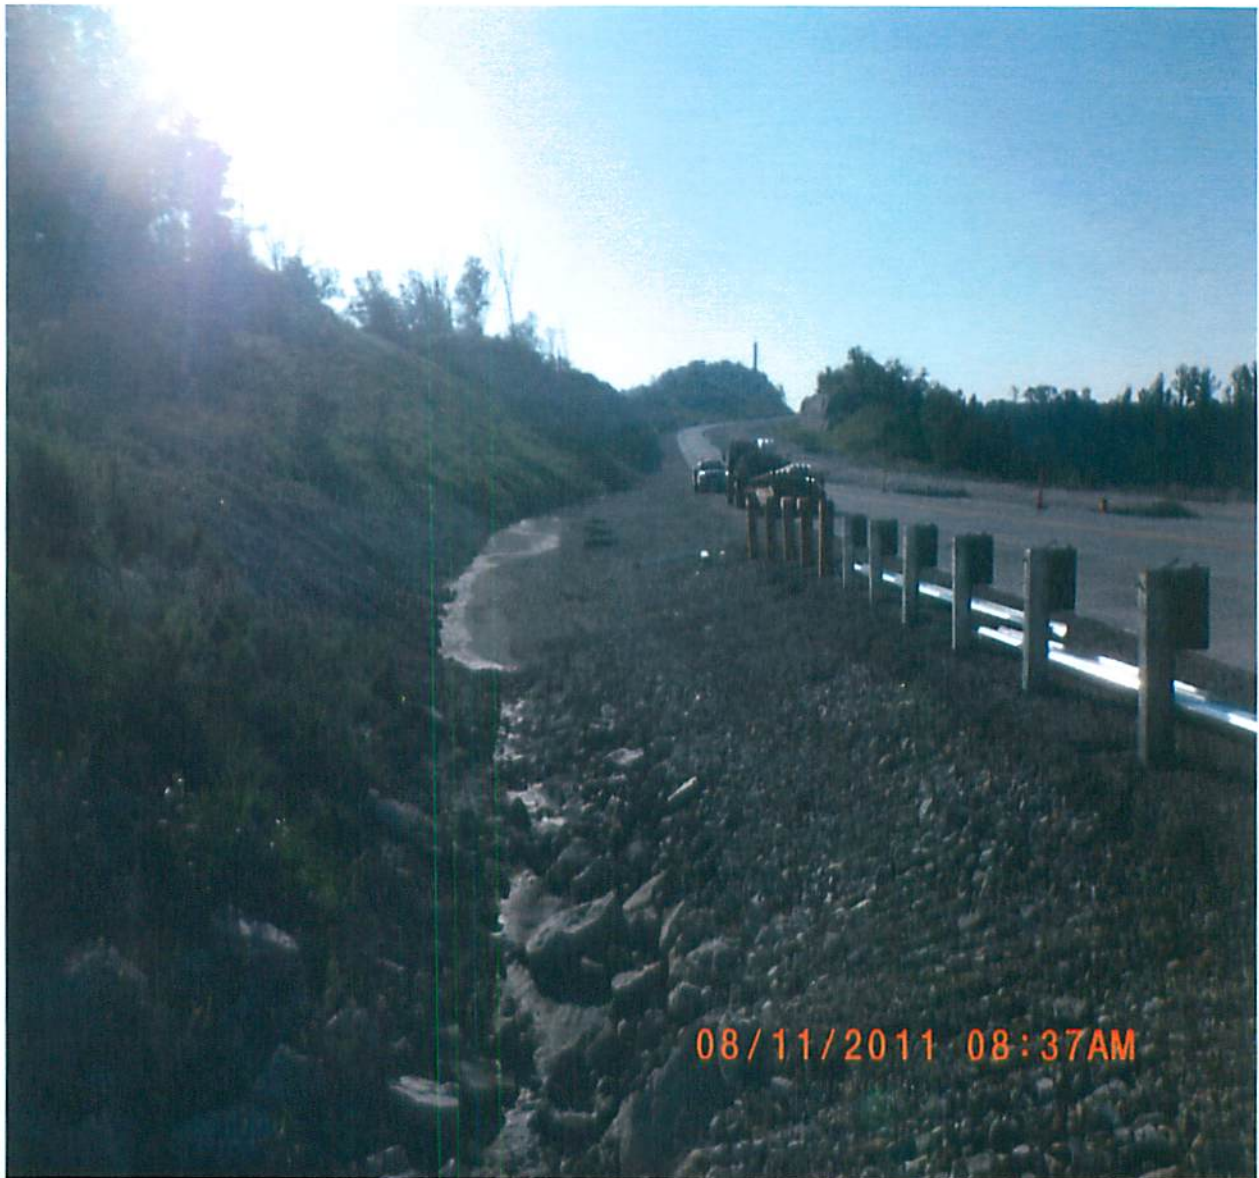
- Eastern drainage shown. Ditch line is not stabilized, not ditch checks, all leading toward Outlet 016.

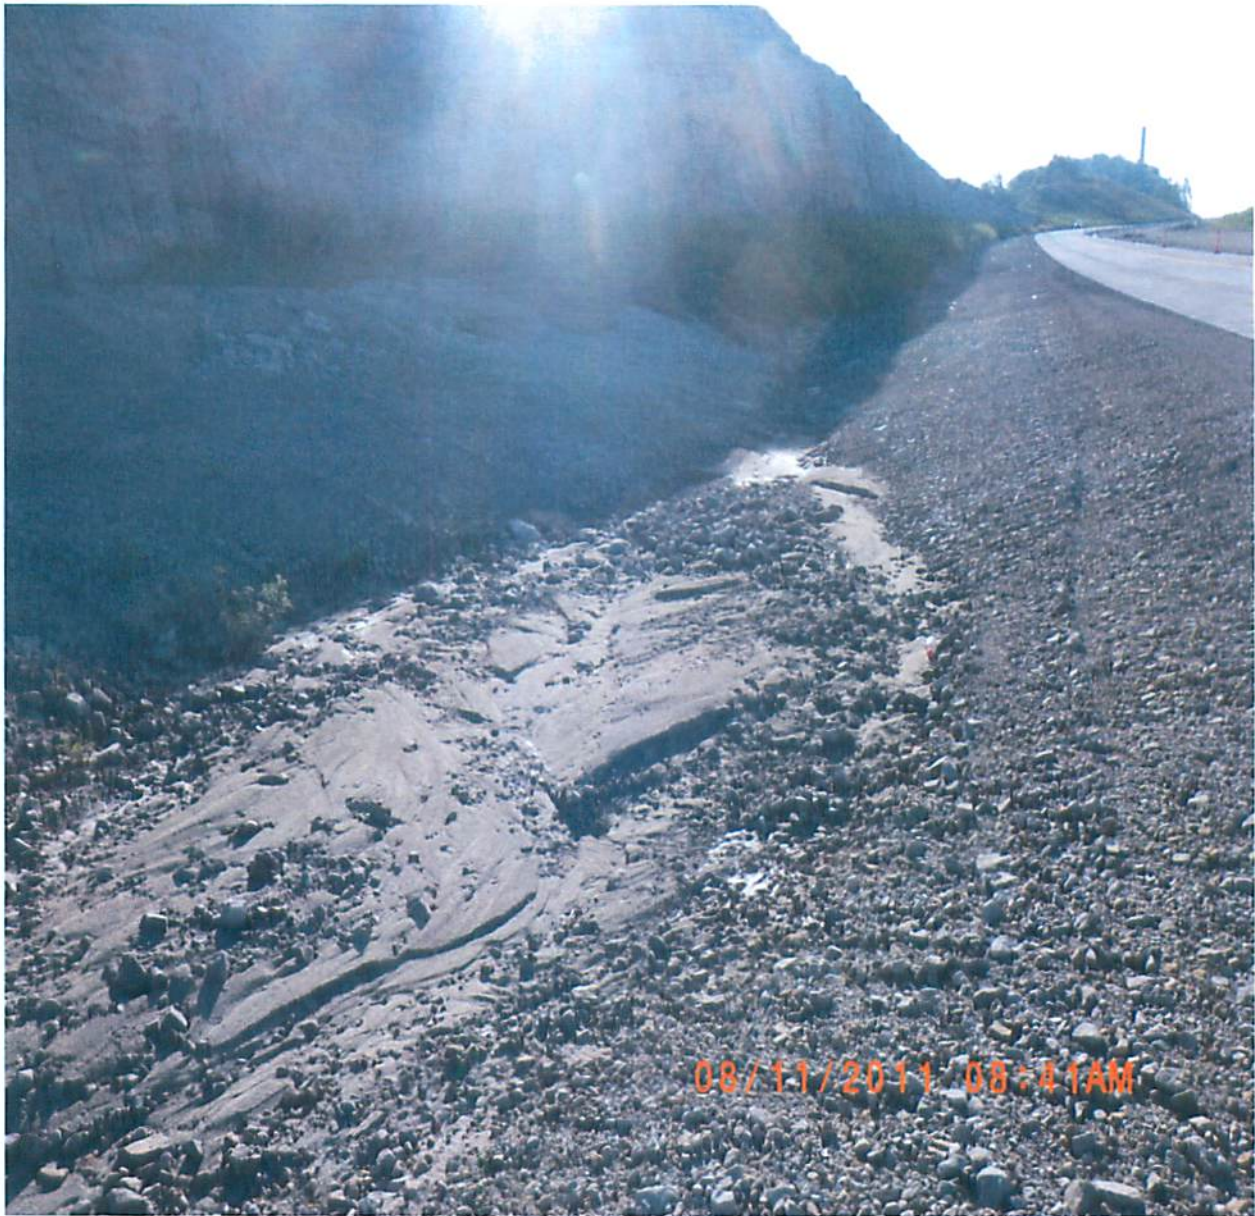
- Location of drop inlet that is buried. Runoff bypassing this inlet and flowing to Outlet 016, rather than into the inlet and across the road to the DRG down Fill #4.

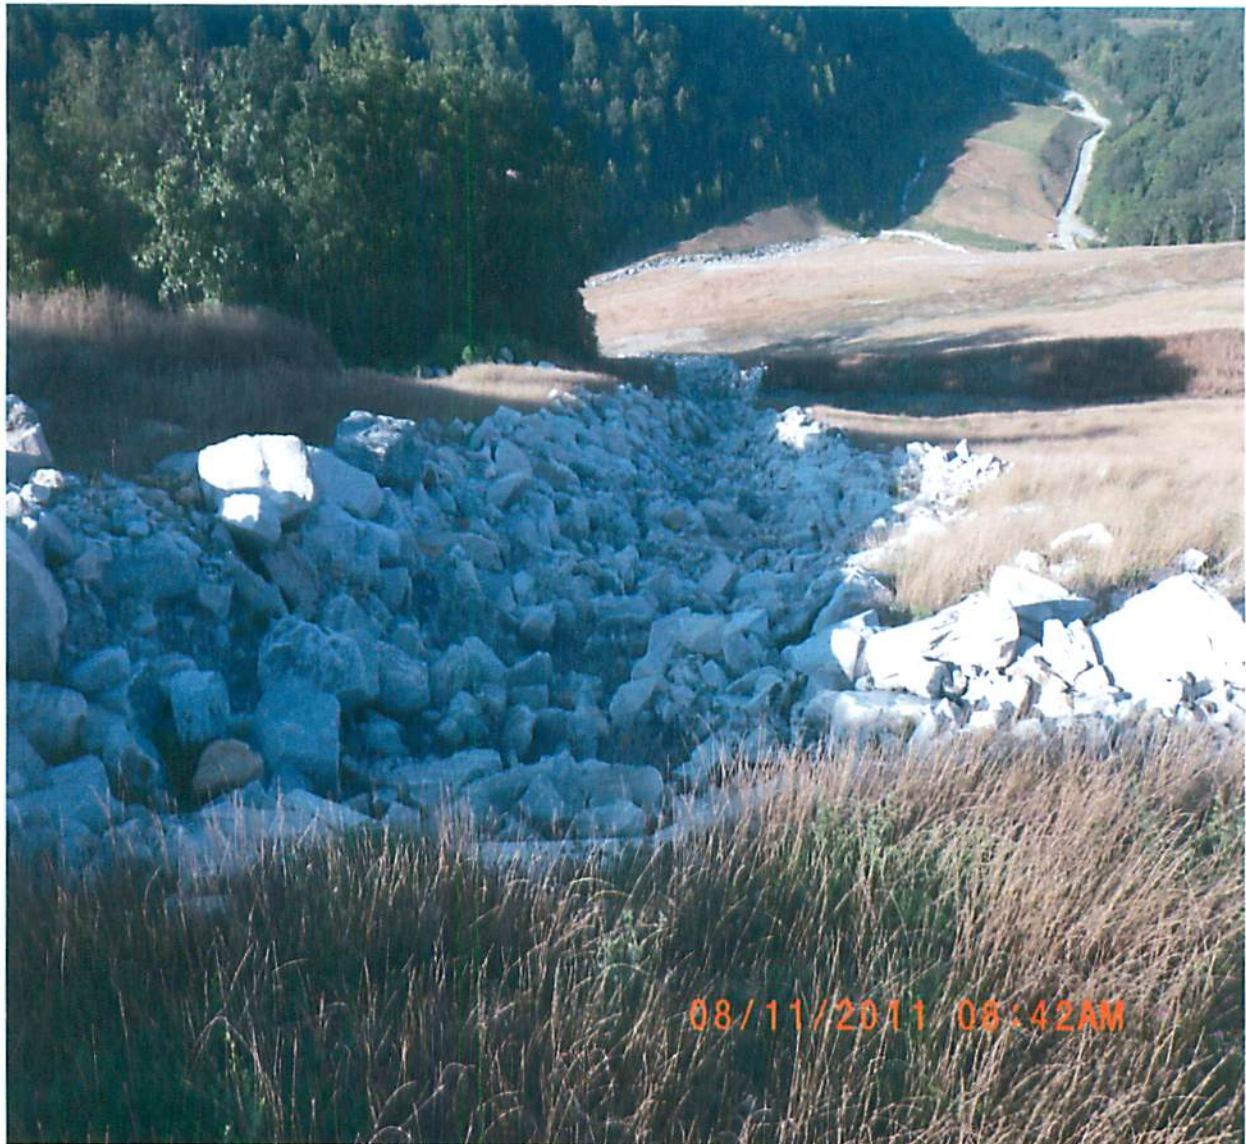
- DRG on the east side of Fill #4, with the concrete wingwall shown on the edge of the grass line, which is where the median and side ditch drainage is supposed to discharge.

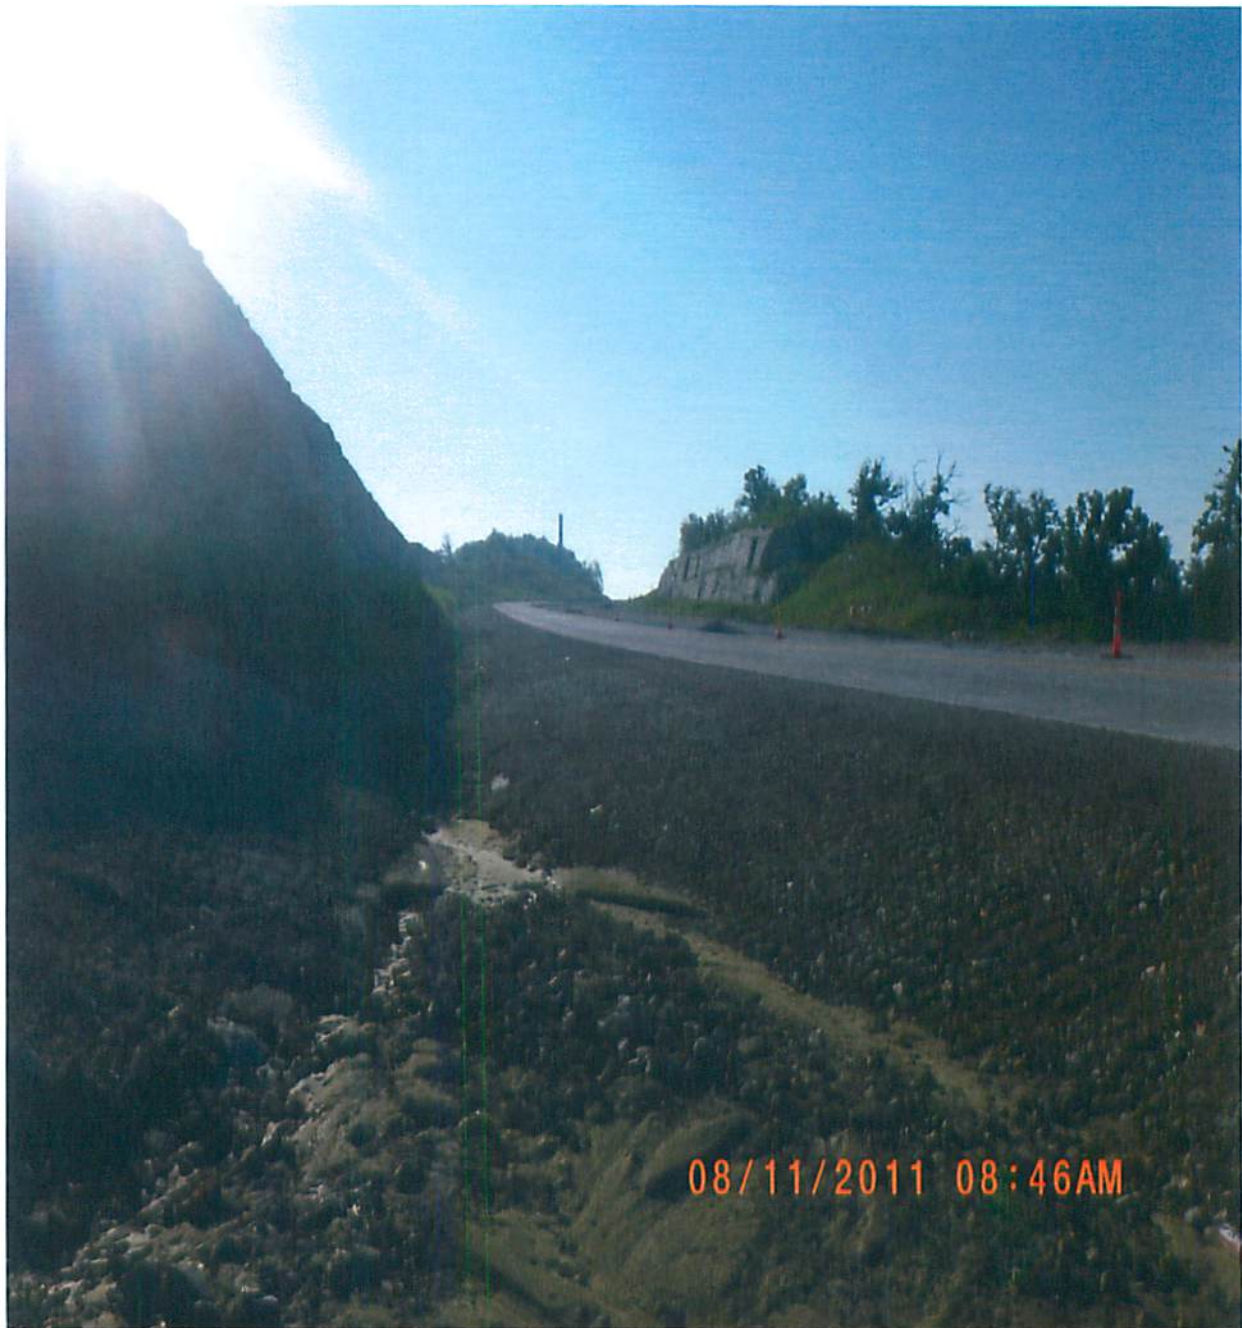
- View from the buried drop inlet showing another $\frac{1}{2}$ mile of drainage coming towards it, which then goes toward Outlet 016.

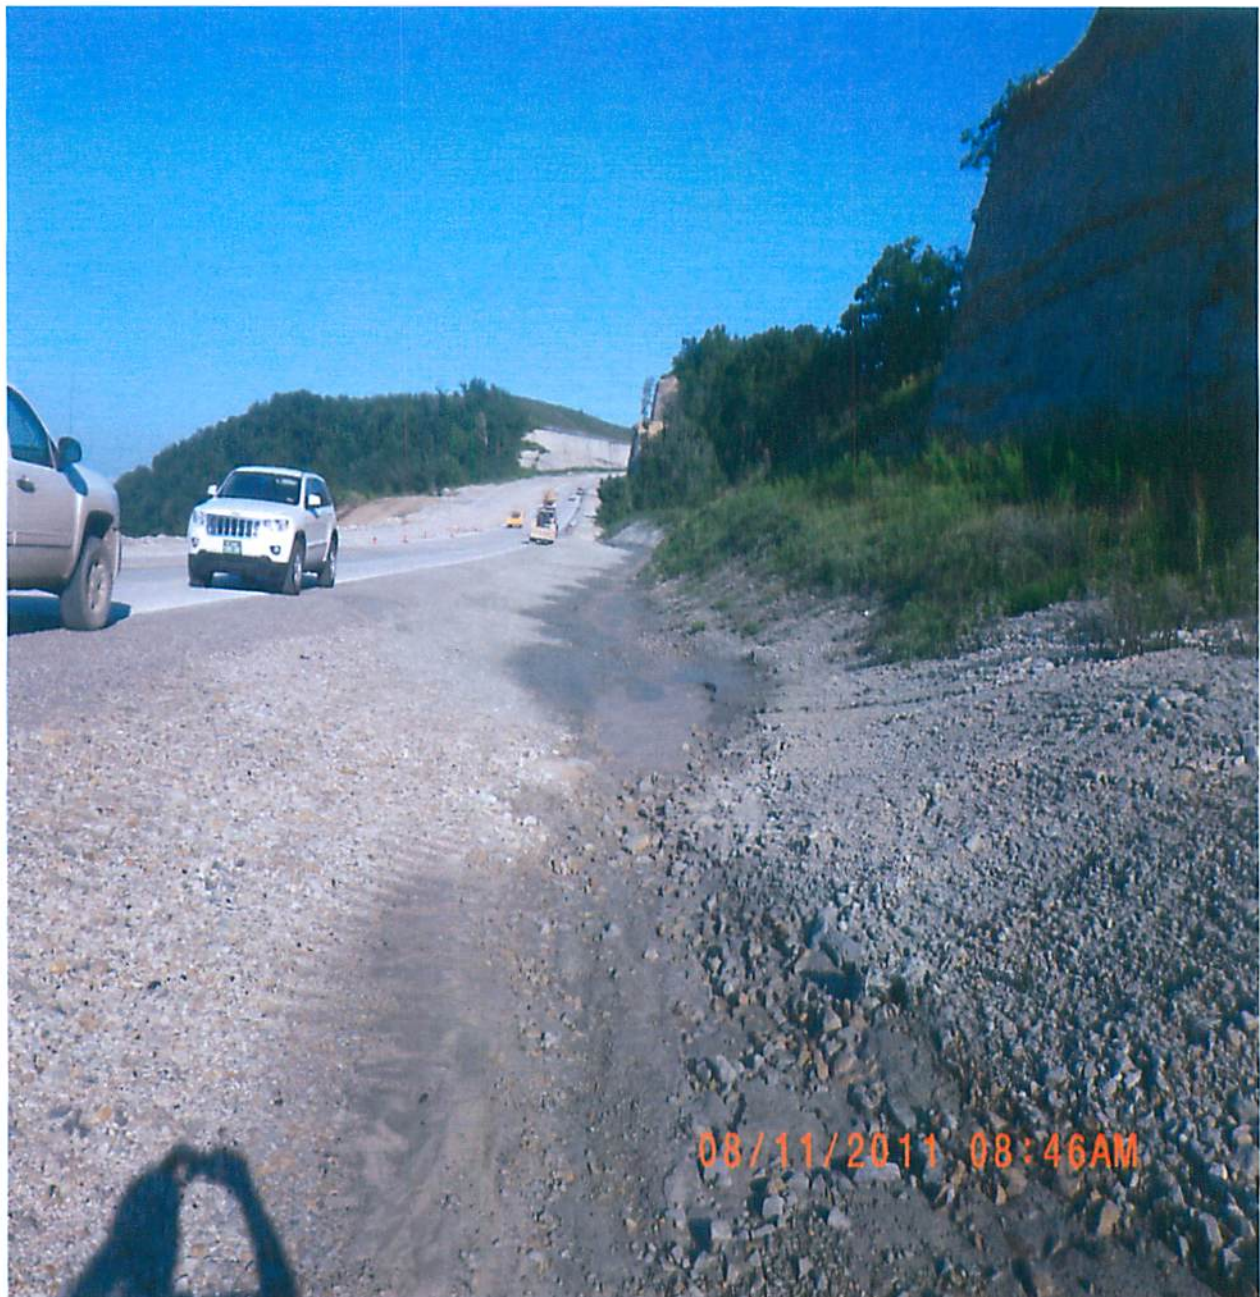
- View from the buried drop inlet, showing drainage toward Outlet 016, which is approximately located near the vehicle in the foreground. No ditch checks, ditch not stabilized, only recently hydroseeded.

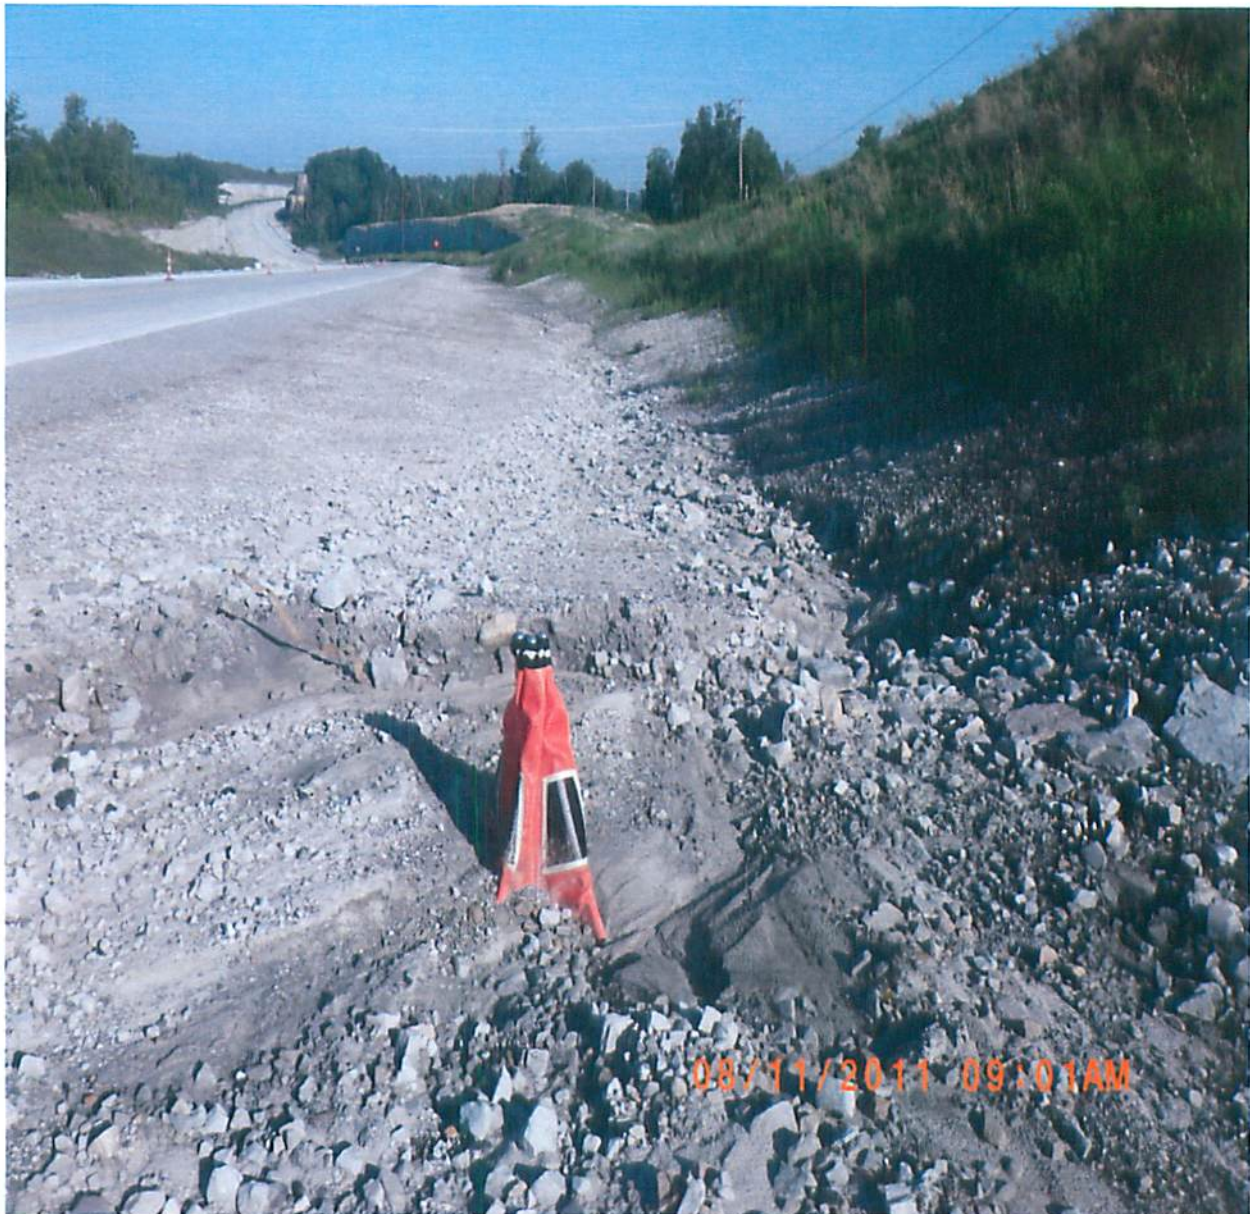
- Another drop inlet, shown with the orange DI protection over it, that has not been maintained. This DI is uphill of the buried one and evidence shown of water bypassing this DI, heading towards the buried one and then to Outlet 016. Sediment build up of around 8 inches on this DI protection.
