**CONSENT ORDER
ISSUED UNDER THE
WATER POLLUTION CONTROL ACT
WEST VIRGINIA CODE, CHAPTER 22, ARTICLE 11**

DATE: January 26, 2012

ORDER NO.: 7487

1. WVDOT operates a land disturbance associated with construction activity, referred to as King Coal Highway Red Jacket Mountainview Paving located near Red Jacket, Mingo County, West Virginia. WVDOT was issued WV/NPDES Water Pollution Control Permit No. WV0115924, Registration No. WVR104797, on January 12, 2010.
2. On July 25, 2011, West Virginia Department of Environmental Protection (hereinafter "WVDEP") personnel responded to a citizen complaint. Upon investigation, it was discovered that a large stream blockage had occurred in Spice Branch, a tributary to Pigeon Creek. An unnamed tributary to Spice Branch was observed to be severely eroded, which resulted in a large amount of material being deposited in Spice Branch.

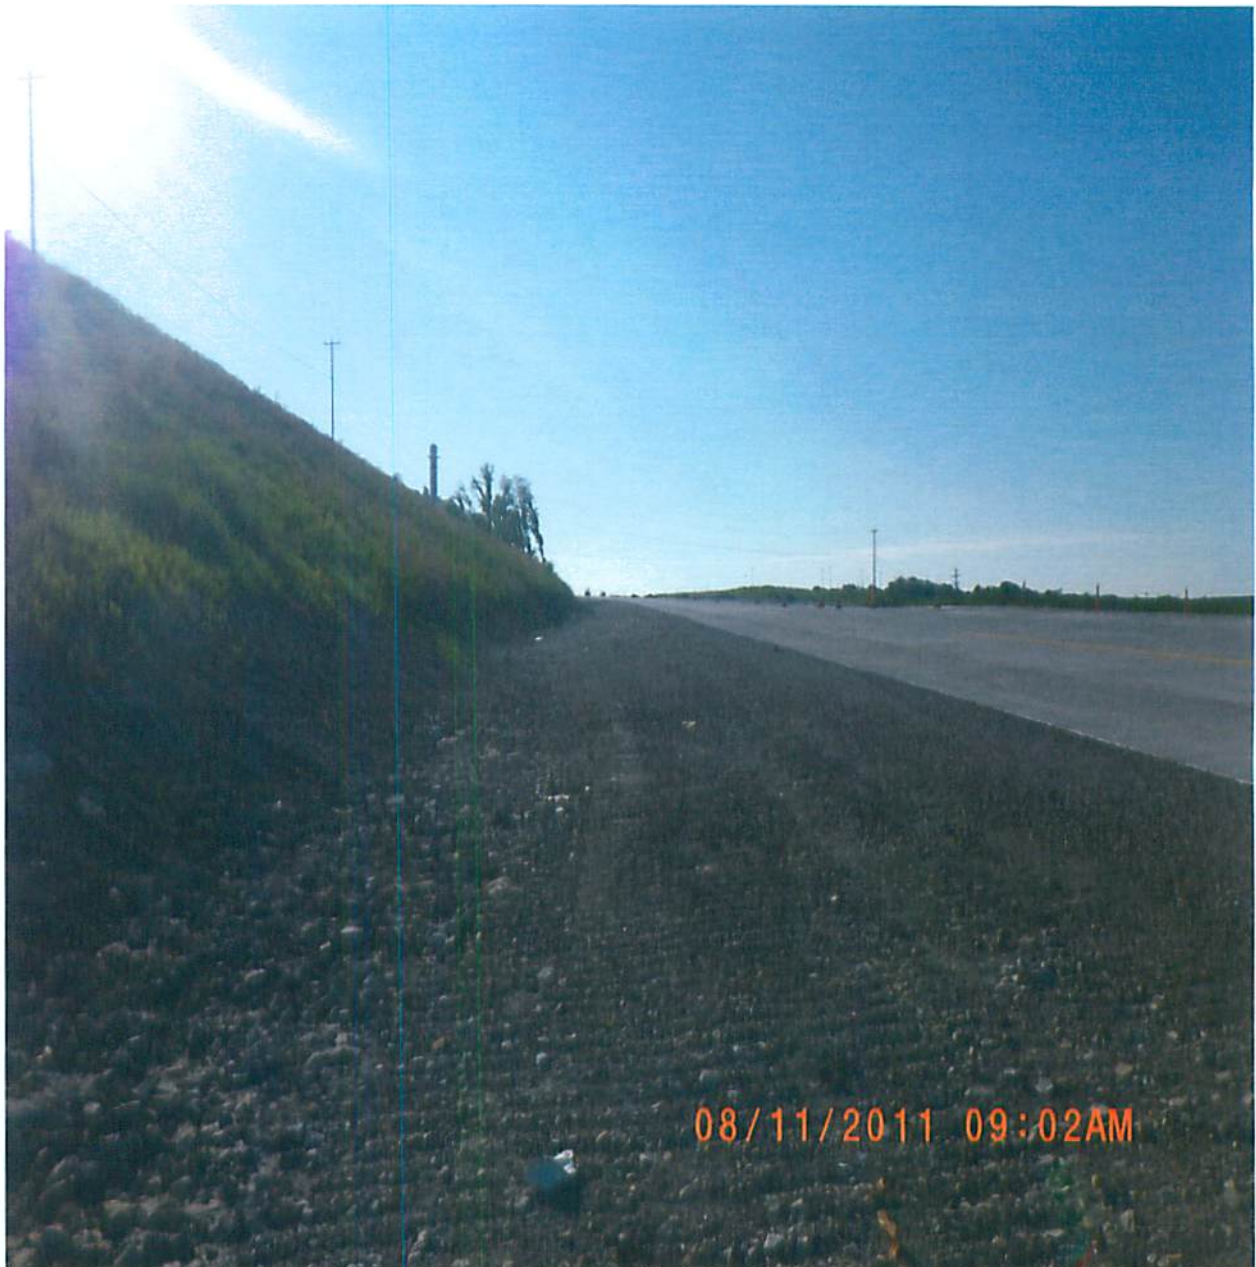
- View from the above photo, showing the uphill drainage coming toward this drop inlet that isn't being properly maintained. Un-stabilized ditch, no ditch checks, with a total of $\frac{3}{4}$ of a mile of drainage going to Outlet 016.

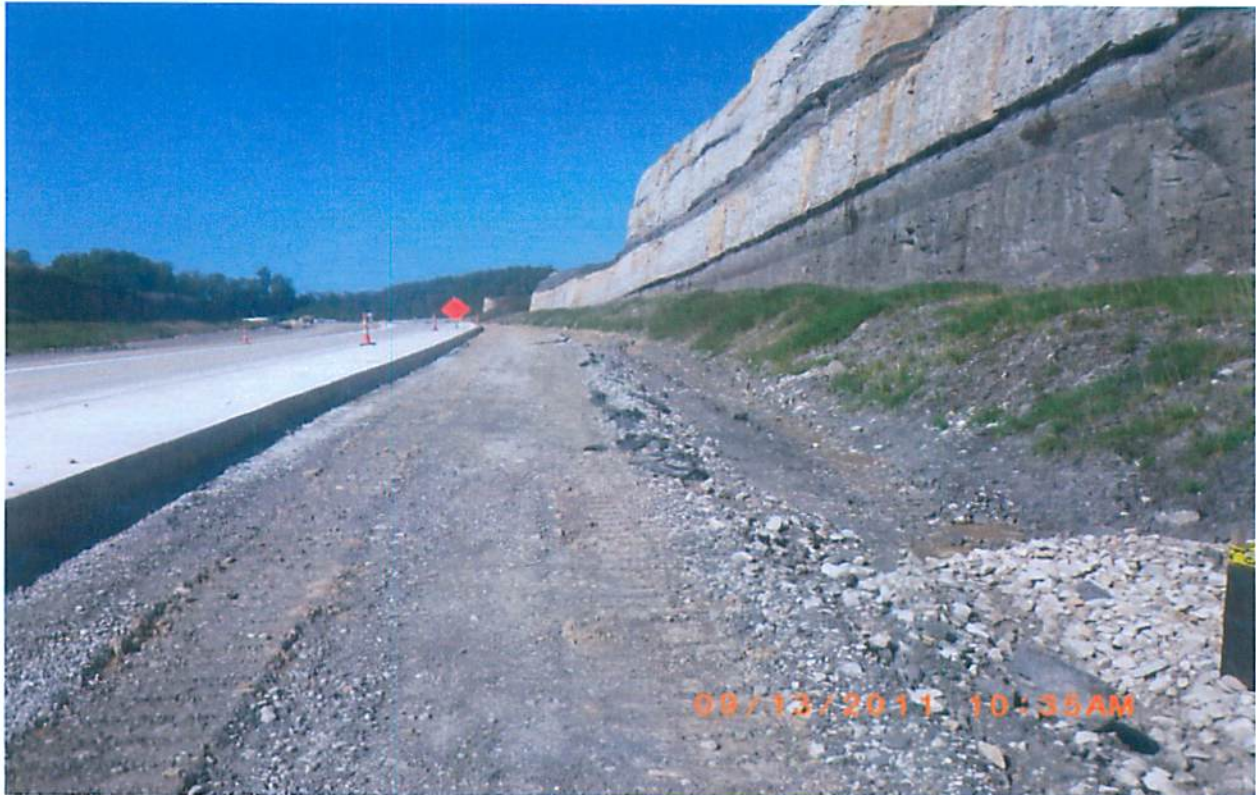
- Ditch lines have not been stabilized prior to becoming functional and ditch checks have been prematurely removed.

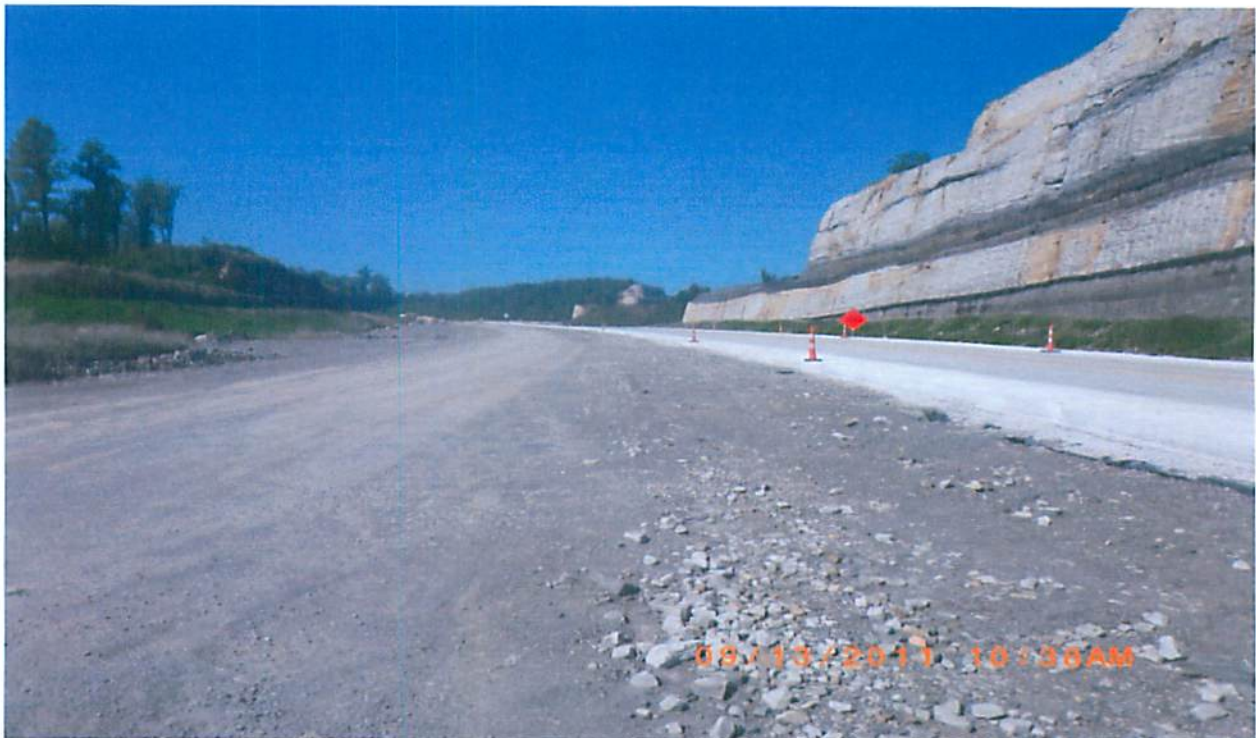
- Numerous drop inlets in the median have been buried, which does not allow water to drain where it is designed to go.

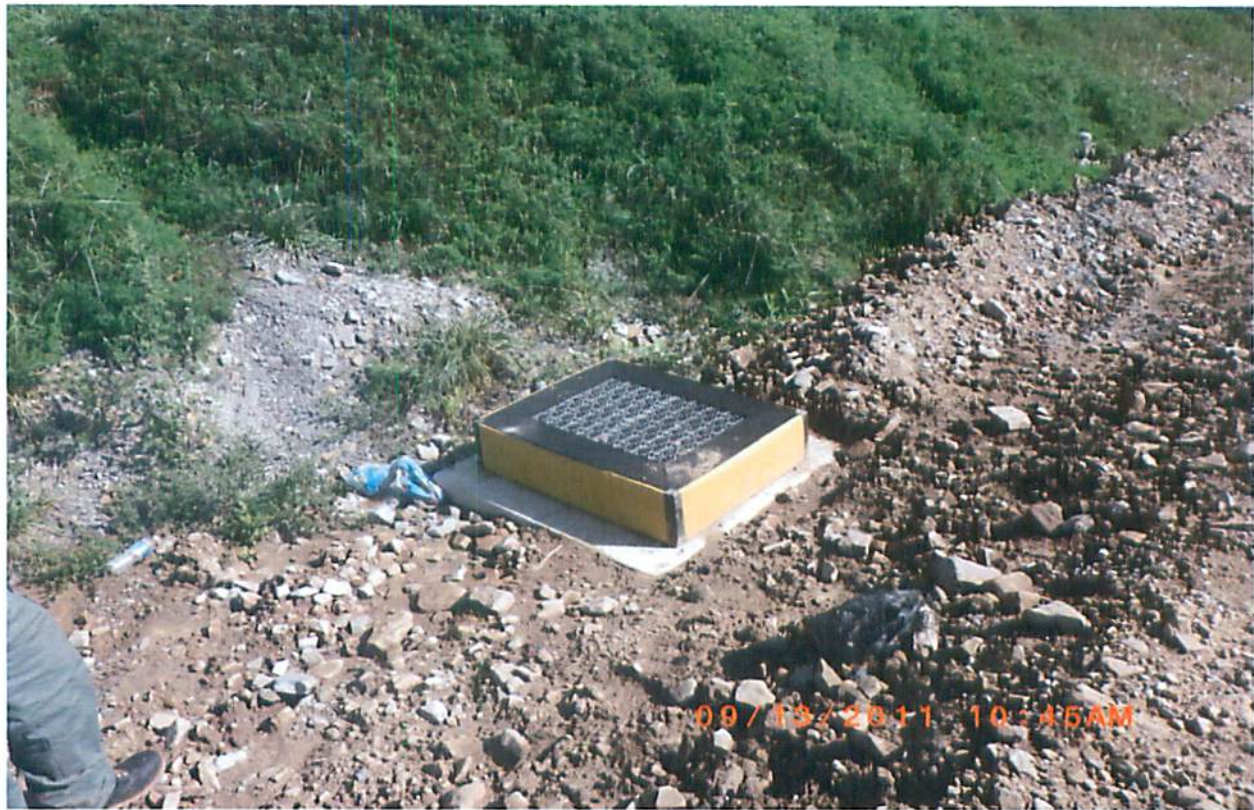
- Numerous silt boxes have not been properly clamped to the drop inlet grates.

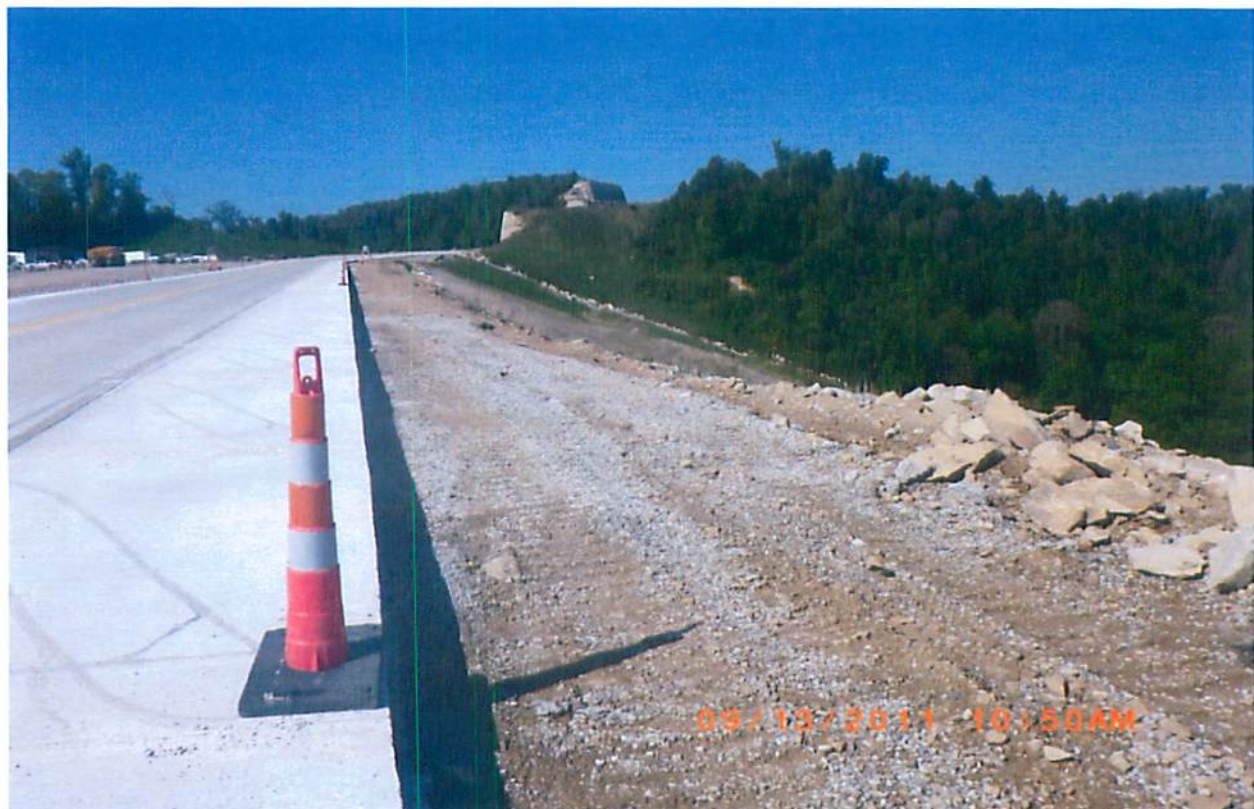
- Silt fence needs re-installed and maintained near Sta. 2026+00.

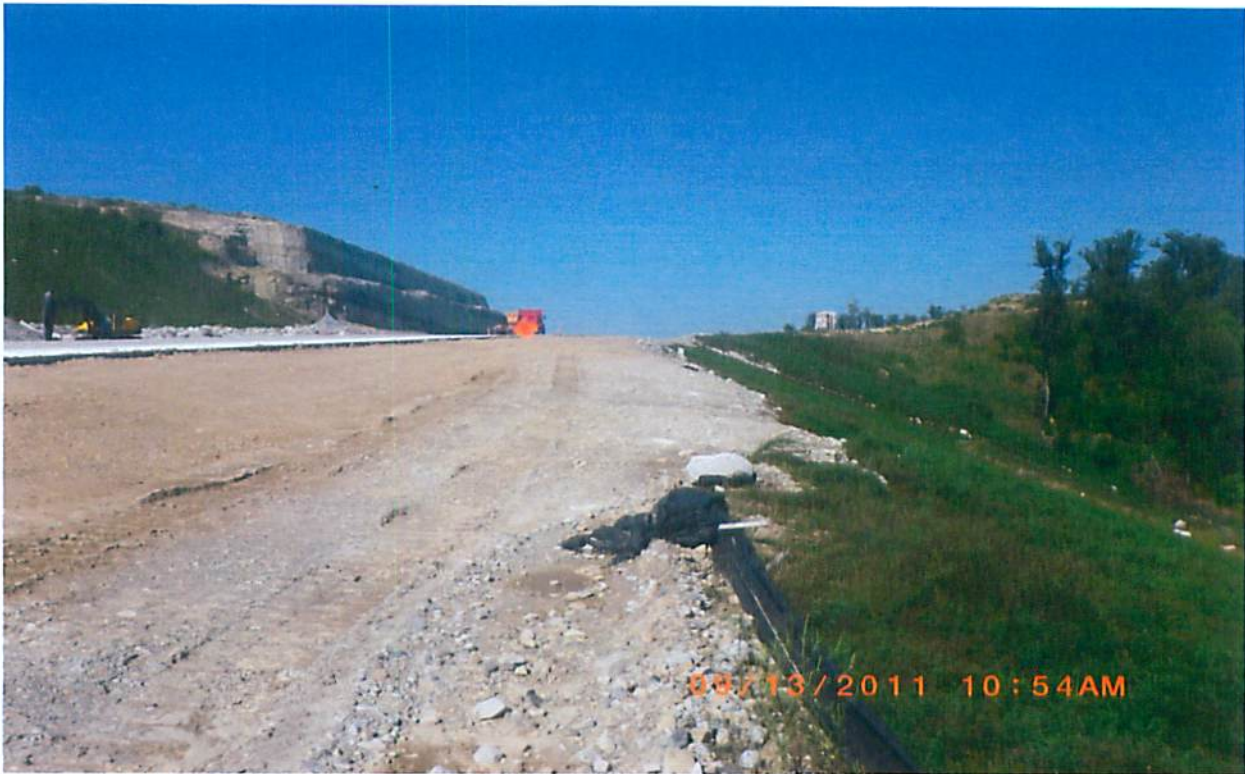
- Silt fence needs re-installed and maintained near Sta. 1997+00.

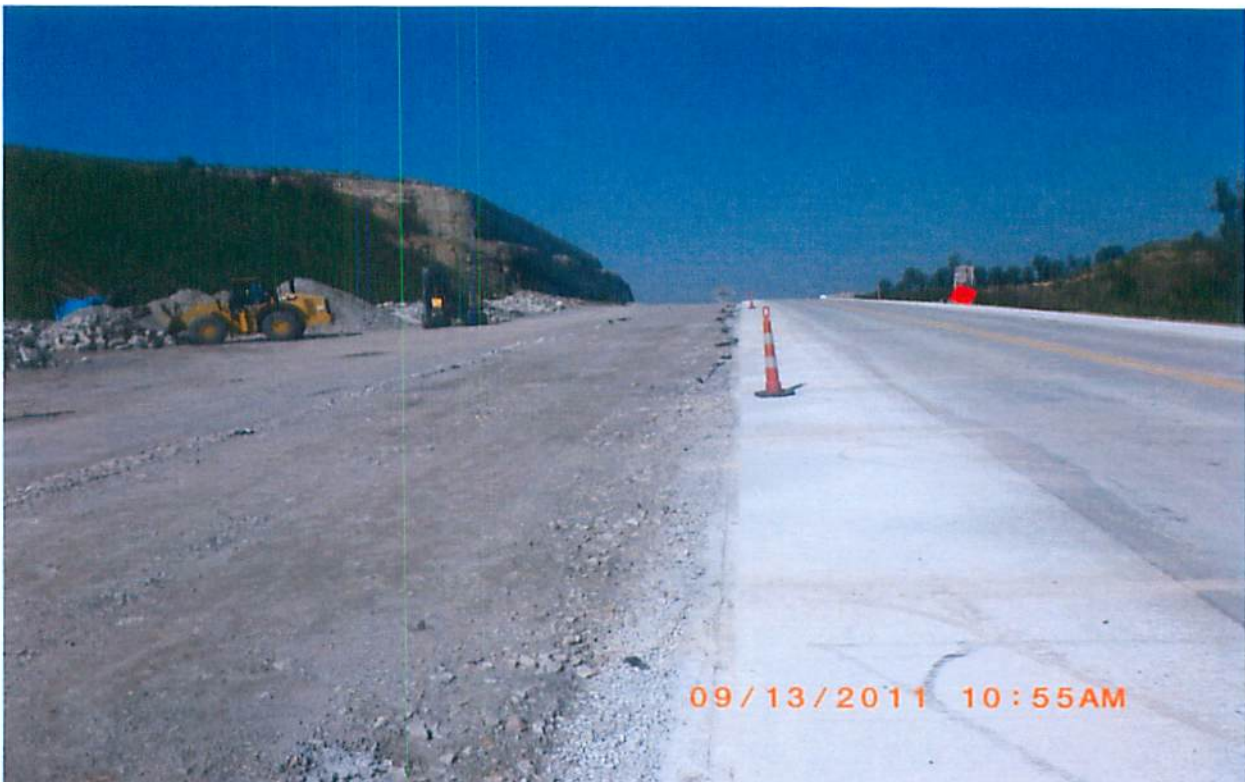
- Median drop inlets continue to be buried from the Horsepen connector end to a point near the new high school.

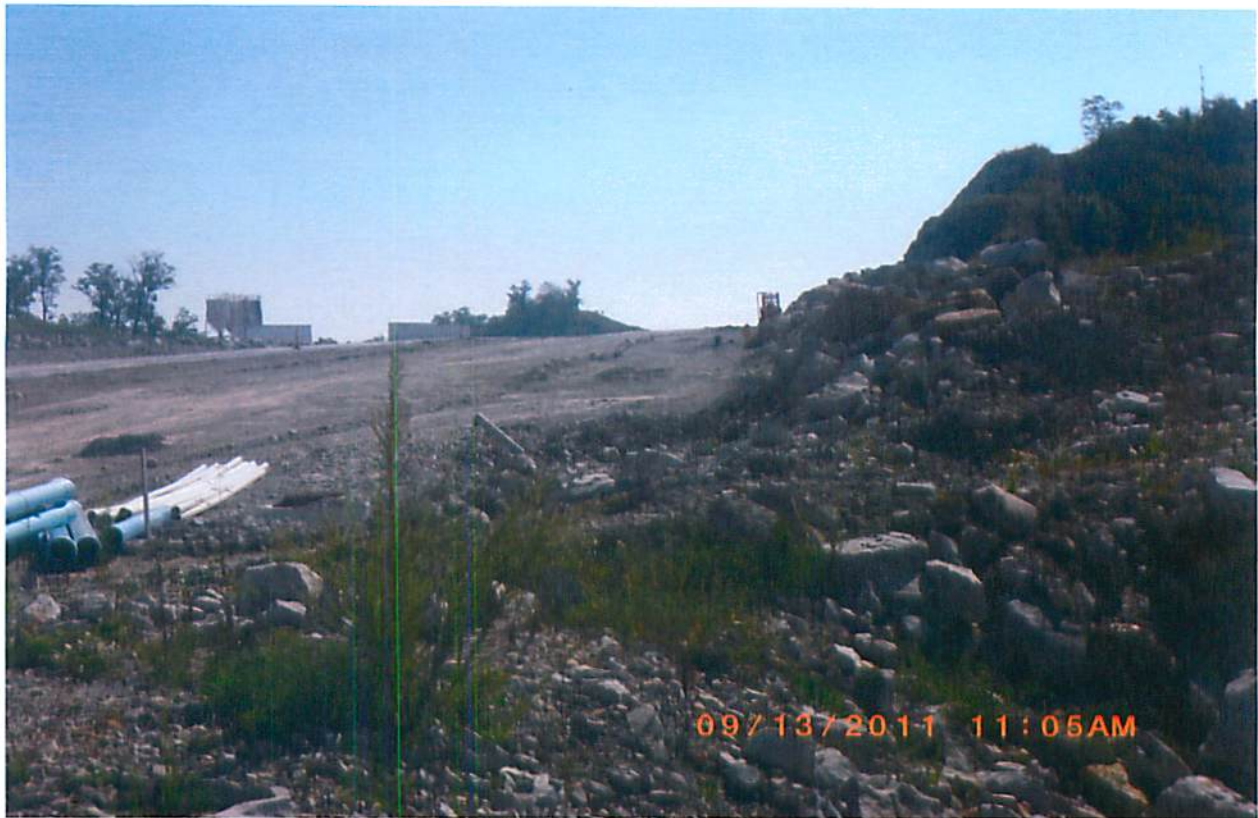
- Sediment traps need re-installed, including across from Sta. 1977+00.

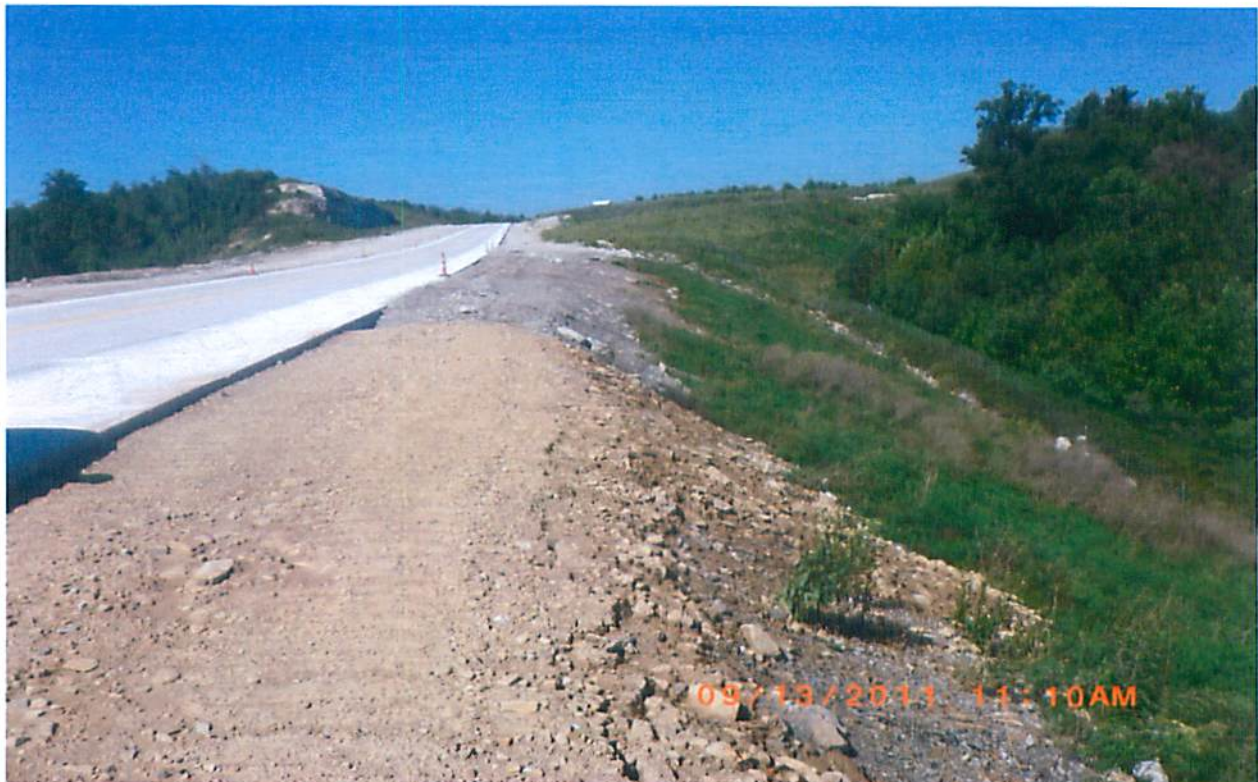
- Silt fence needs re-installed and maintained near Sta. 1968+00.

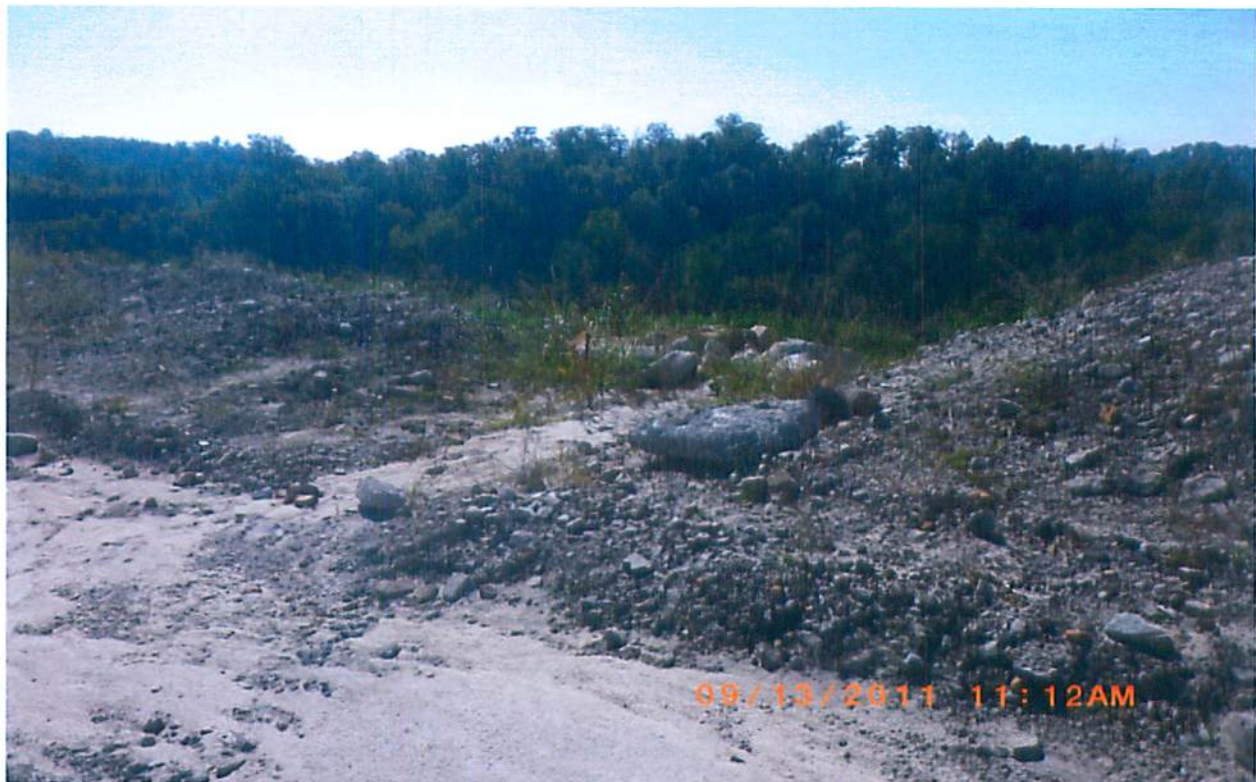
- Breach in the berm across from Sta. 1968+00 needs repaired.

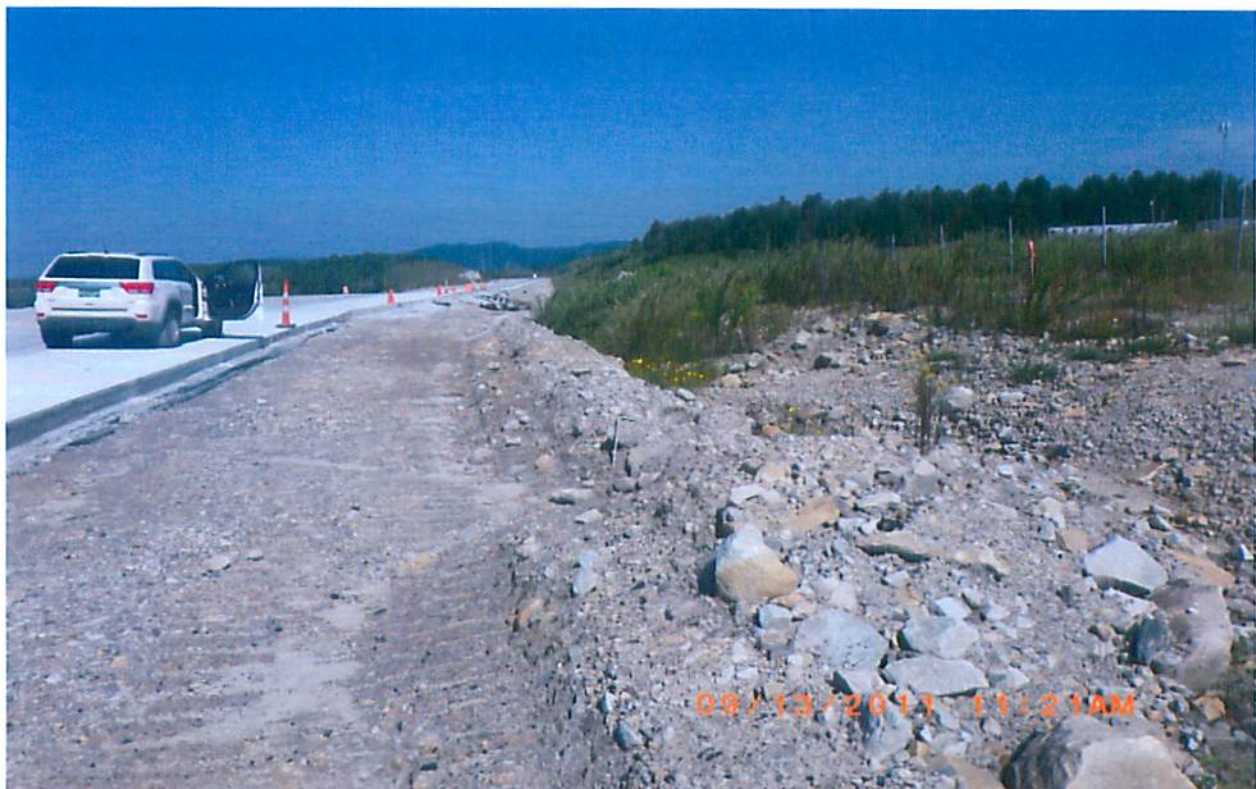
- Portions of ditch line needs established and stabilized, with check re-installed, near Sta. 1956+00 and 1938+00.

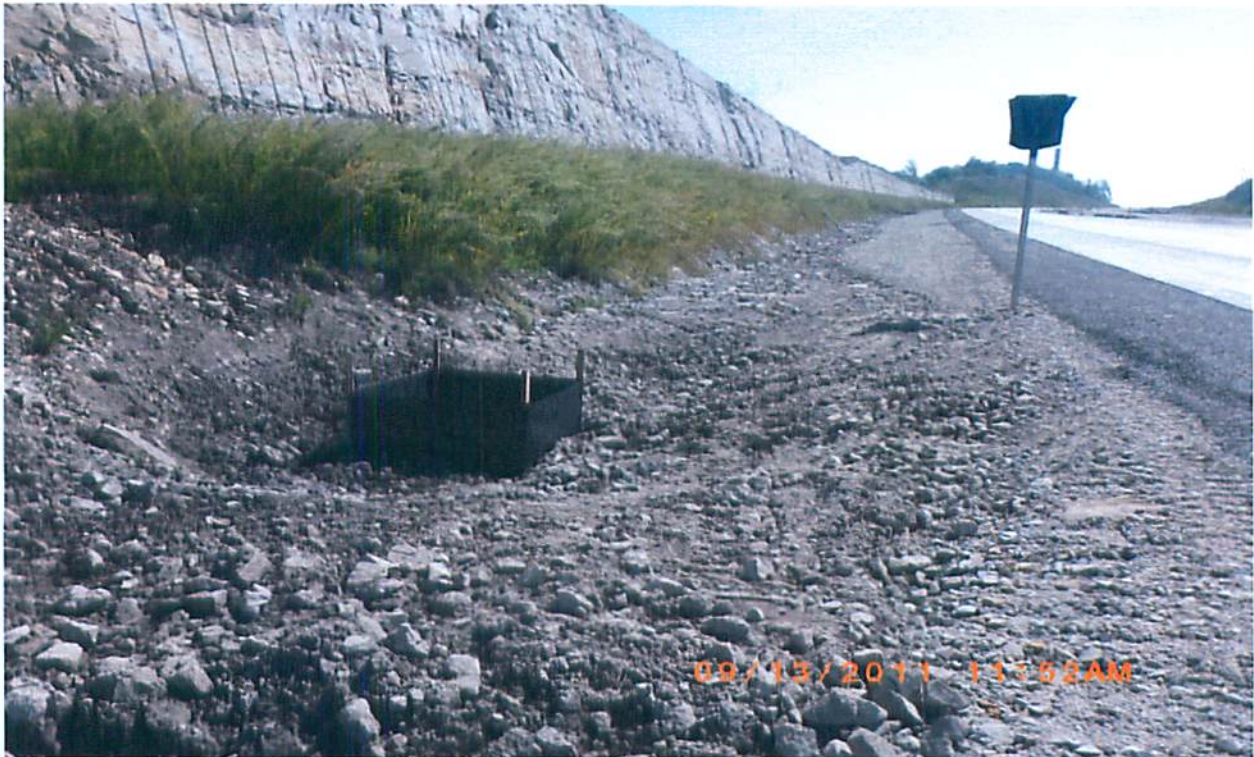
- Several drop inlets in the side ditch leading uphill of Outlet 016 have been uncovered and proper protections installed.

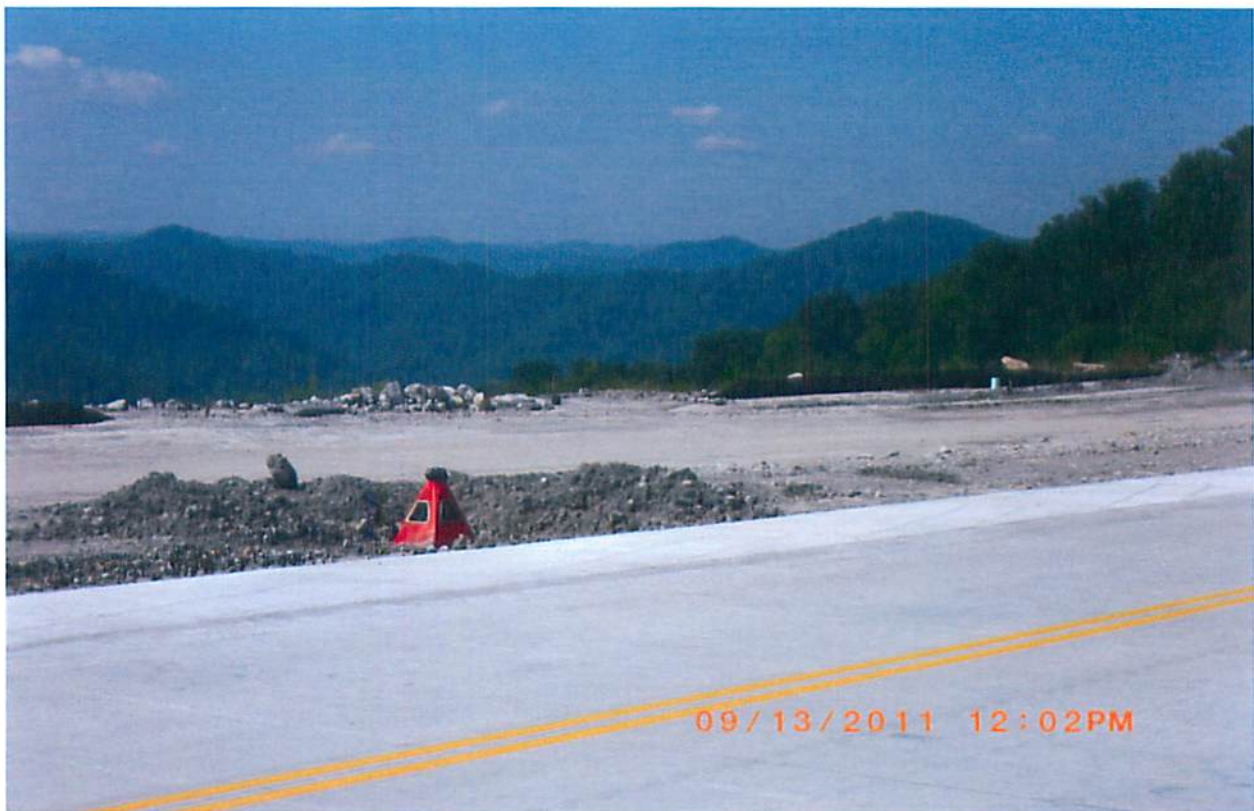
- Silt fence across from Sta. 1691+00 needs to be properly maintained.

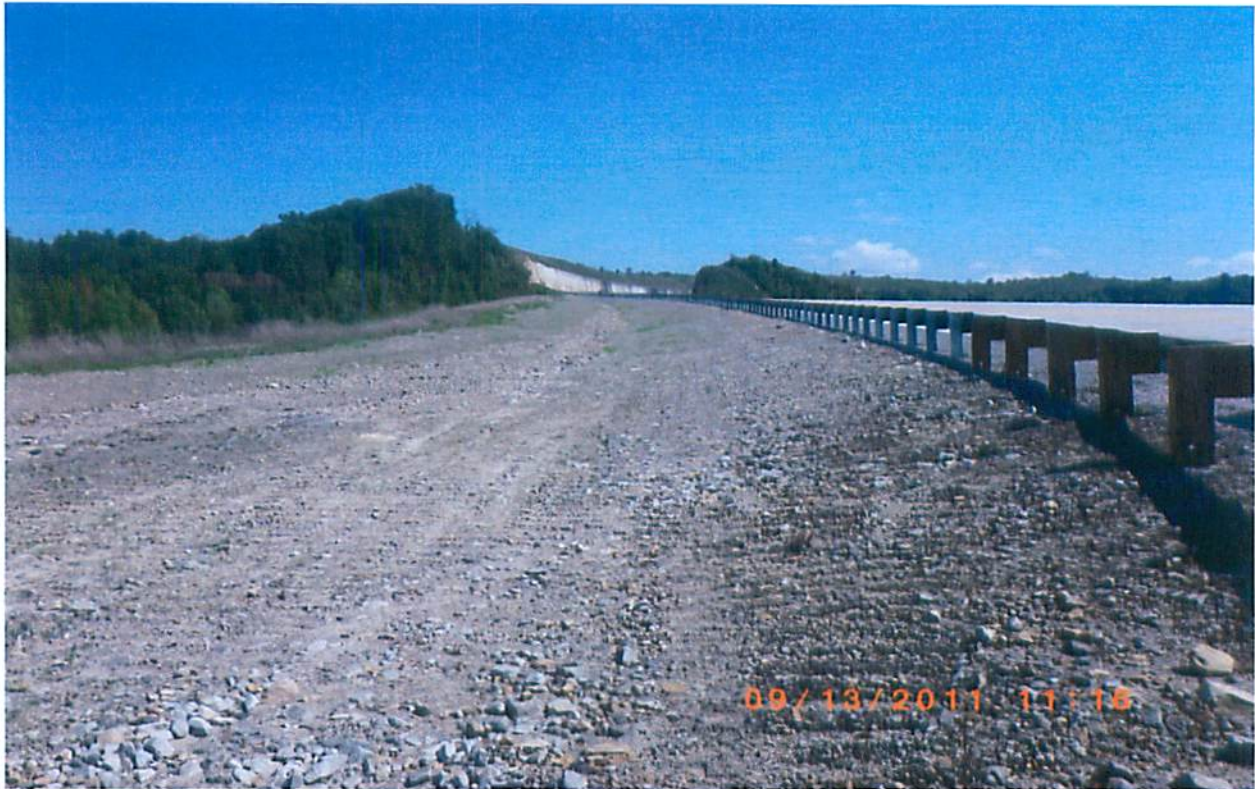
- Ditch line above the sediment basin that is being left in place, near Sta. 1627+00, needs to be properly stabilized and ditch checks installed.

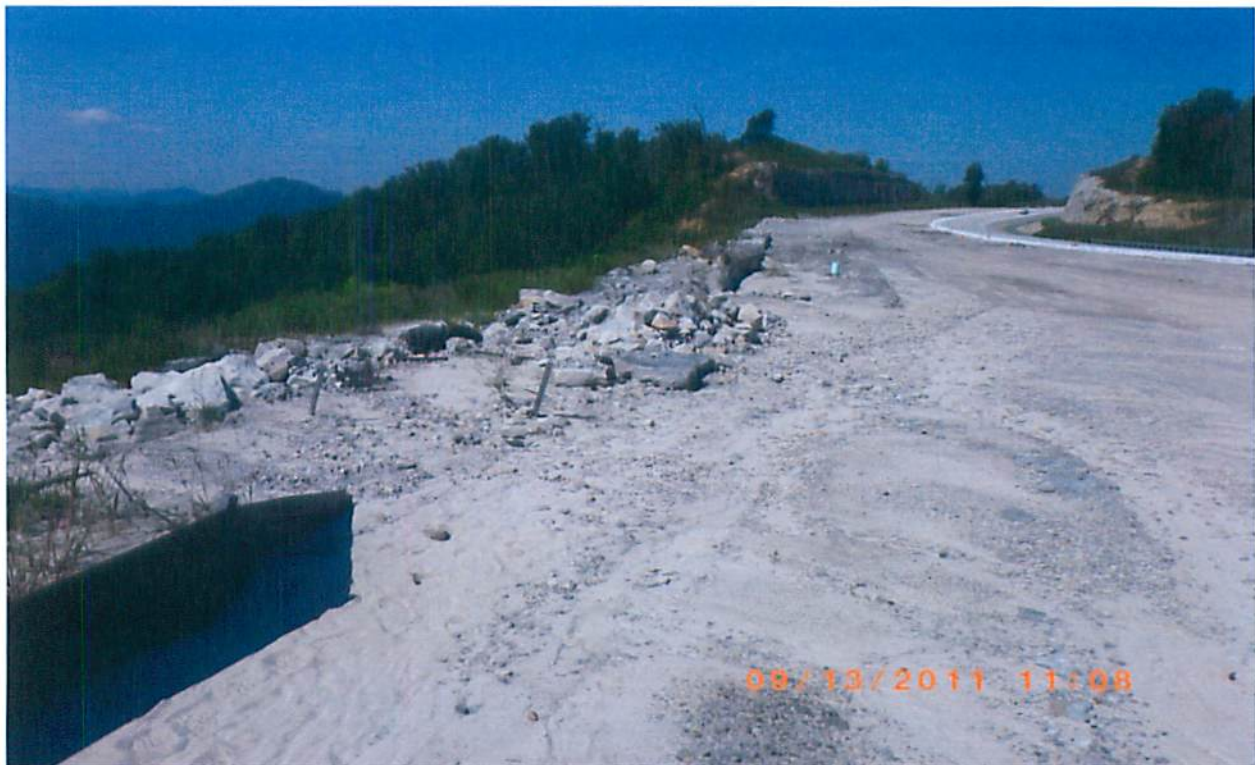
- Silt fence across from Sta. 1627+00 needs to be properly maintained.

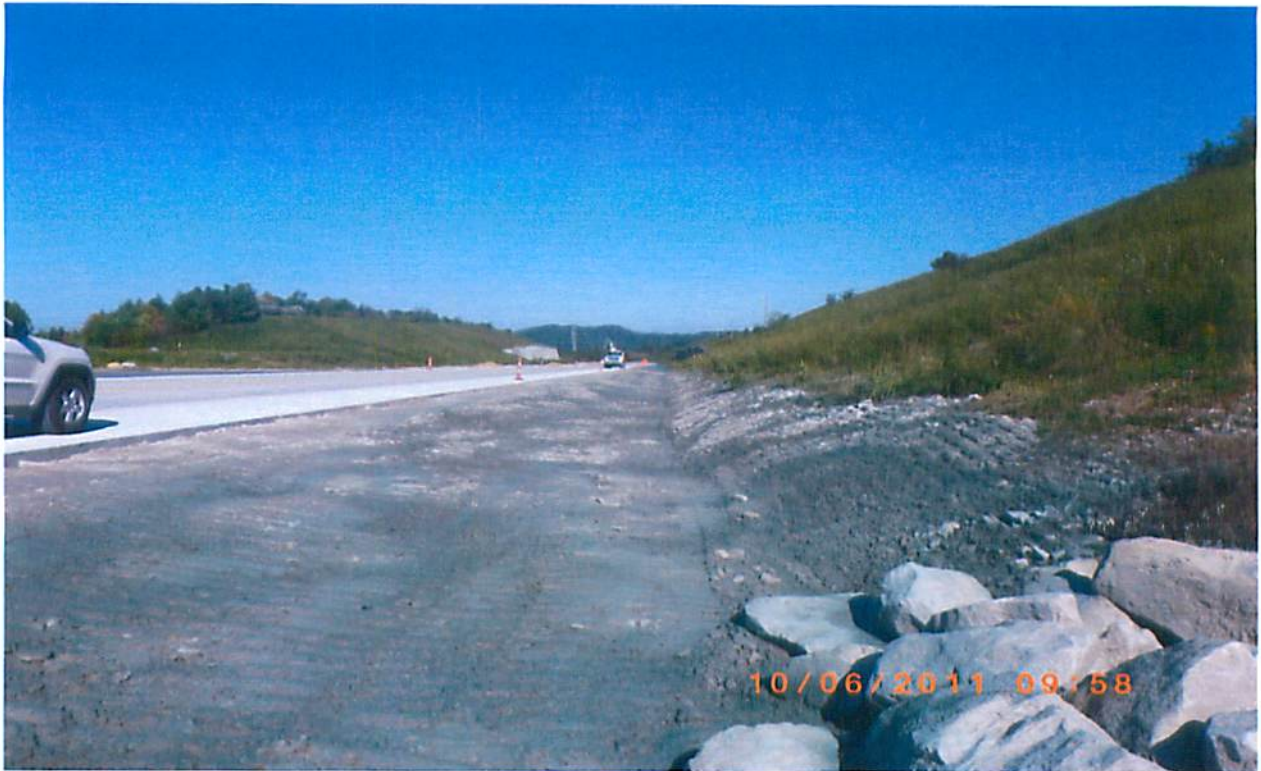
- Ditchlines have been re-established and seeded, however ditch checks have yet been installed.

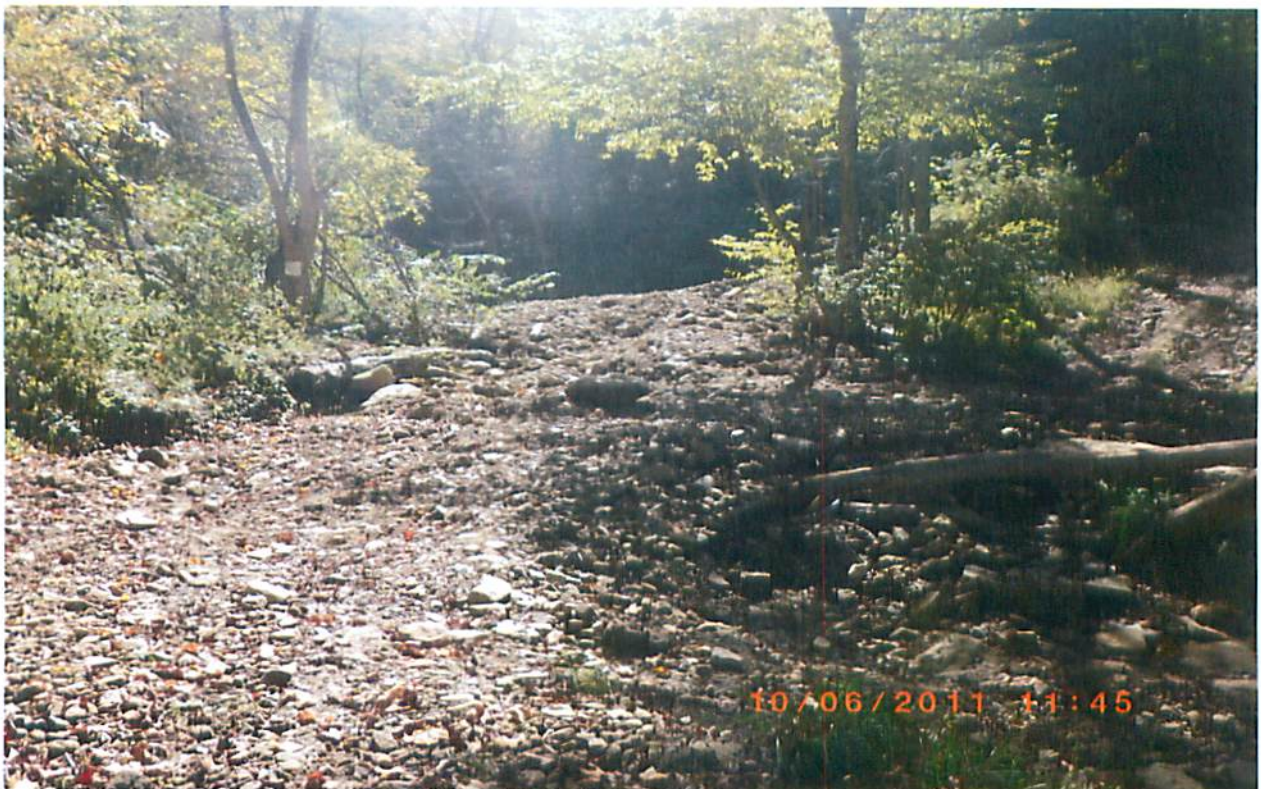
- Deposits again noted in Spice Branch.
