**FINAL REPORT**

**Development of Shenandoah River PCB TMDL**

September, 2001

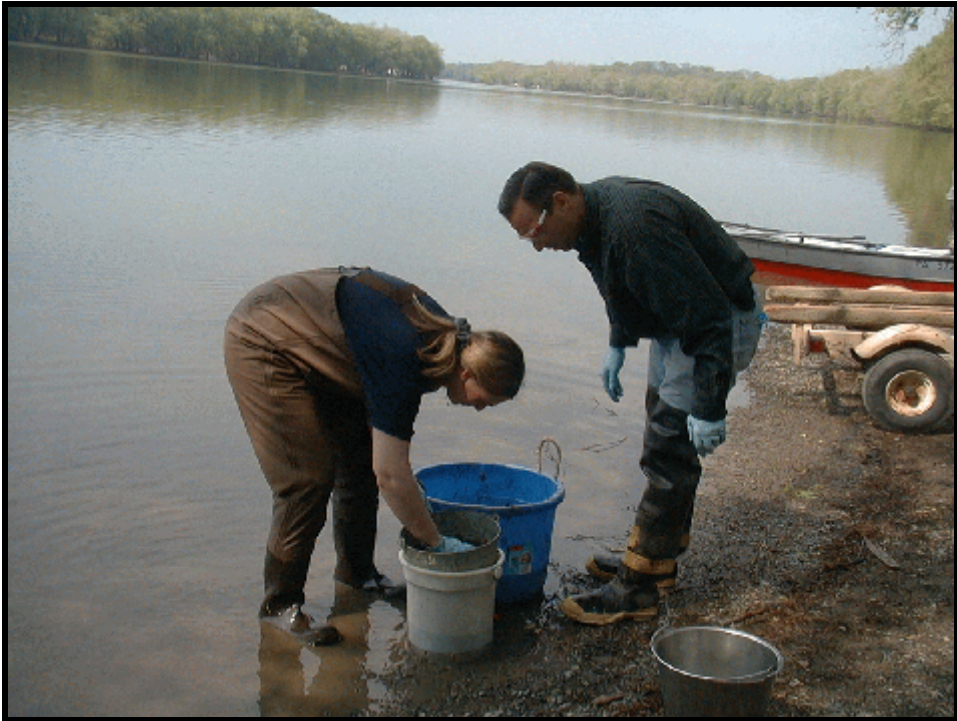
Figure E-1: Shenandoah River, Sieving for Clams

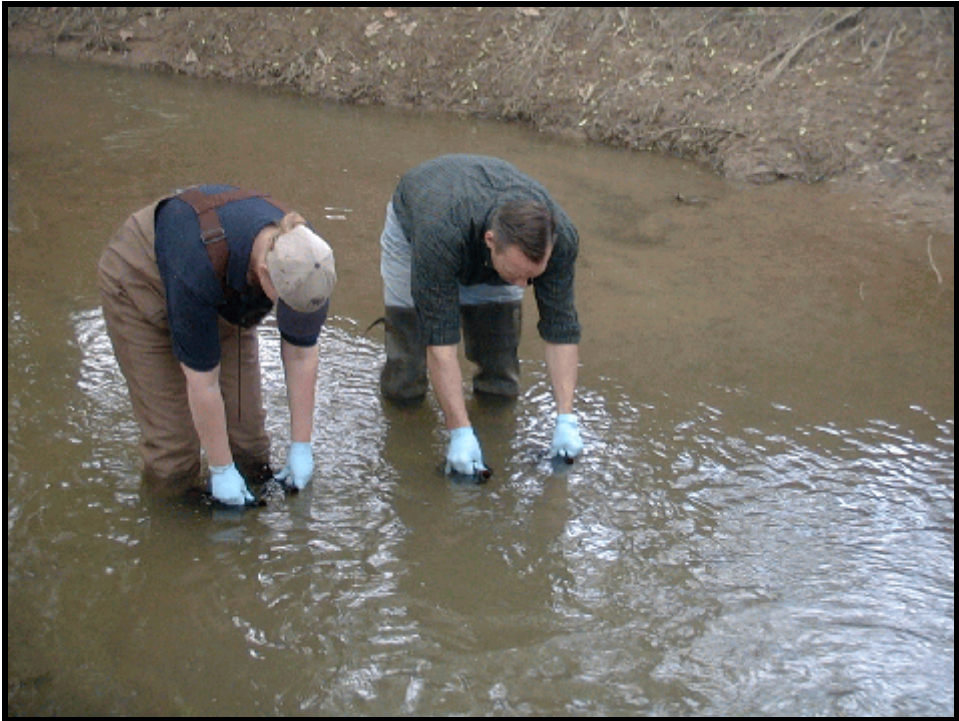
Figure E-2: Dog Run, Collecting Water Samples

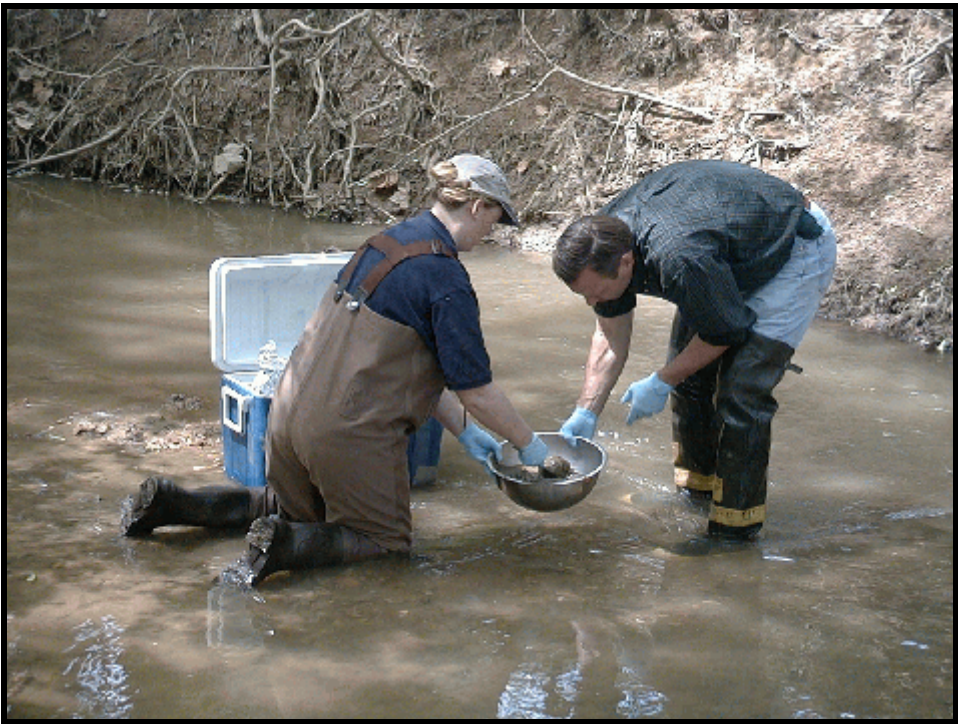
**Figure E-5: Dog Run, Grab Sediment Sampling**
