VRP Project #: 15017
Brownfield Site: Yes No
Report Date: 1-28-16
Page 1 of 3

OFFICE OF ENVIRONMENTAL REMEDIATION
VOLUNTARY REMEDIATION PROJECT
SITE VISIT/INSPECTION REPORT

On-site at Freedom Industries AST release site @ ~ 1000 hrs. Overcast, temperature ~ 28°; Brian Liptock & Kinder Tuckwiller of CORE on-site. No SPSI workers on-site. CORE is on-site to continue groundwater and sump sampling.

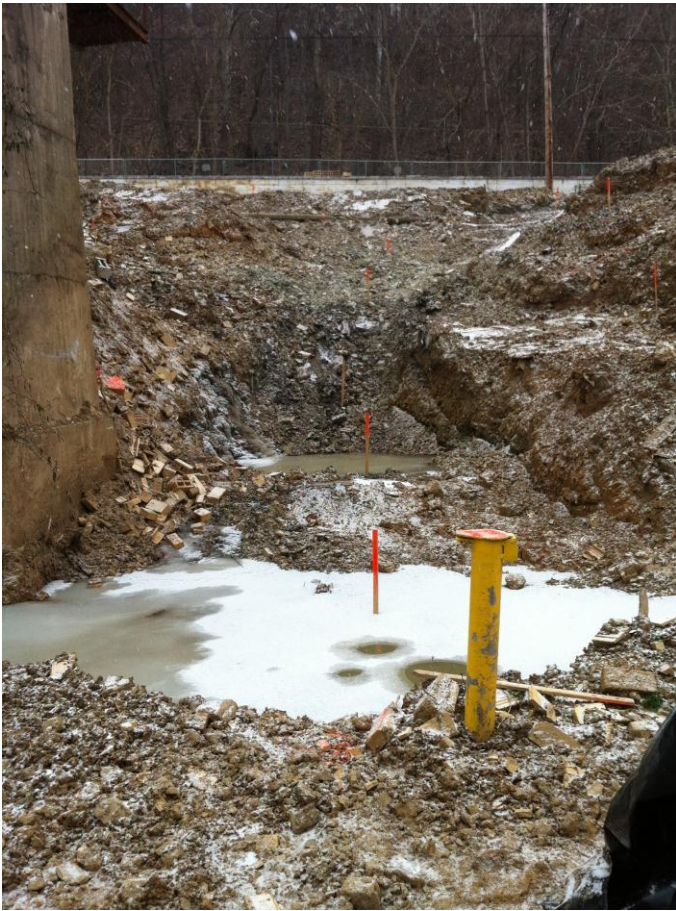
1. Petroleum-stained soil and frozen water at base of excavation in Area 4.
2. View of Elk River below collection trench.
3. CORE groundwater sampler sampling MW-5.
