RCRA CORRECTIVE ACTION PERMIT

UNION CARBIDE CORPORATION

TECHNOLOGY PARK

Permit ID # WVD060682291

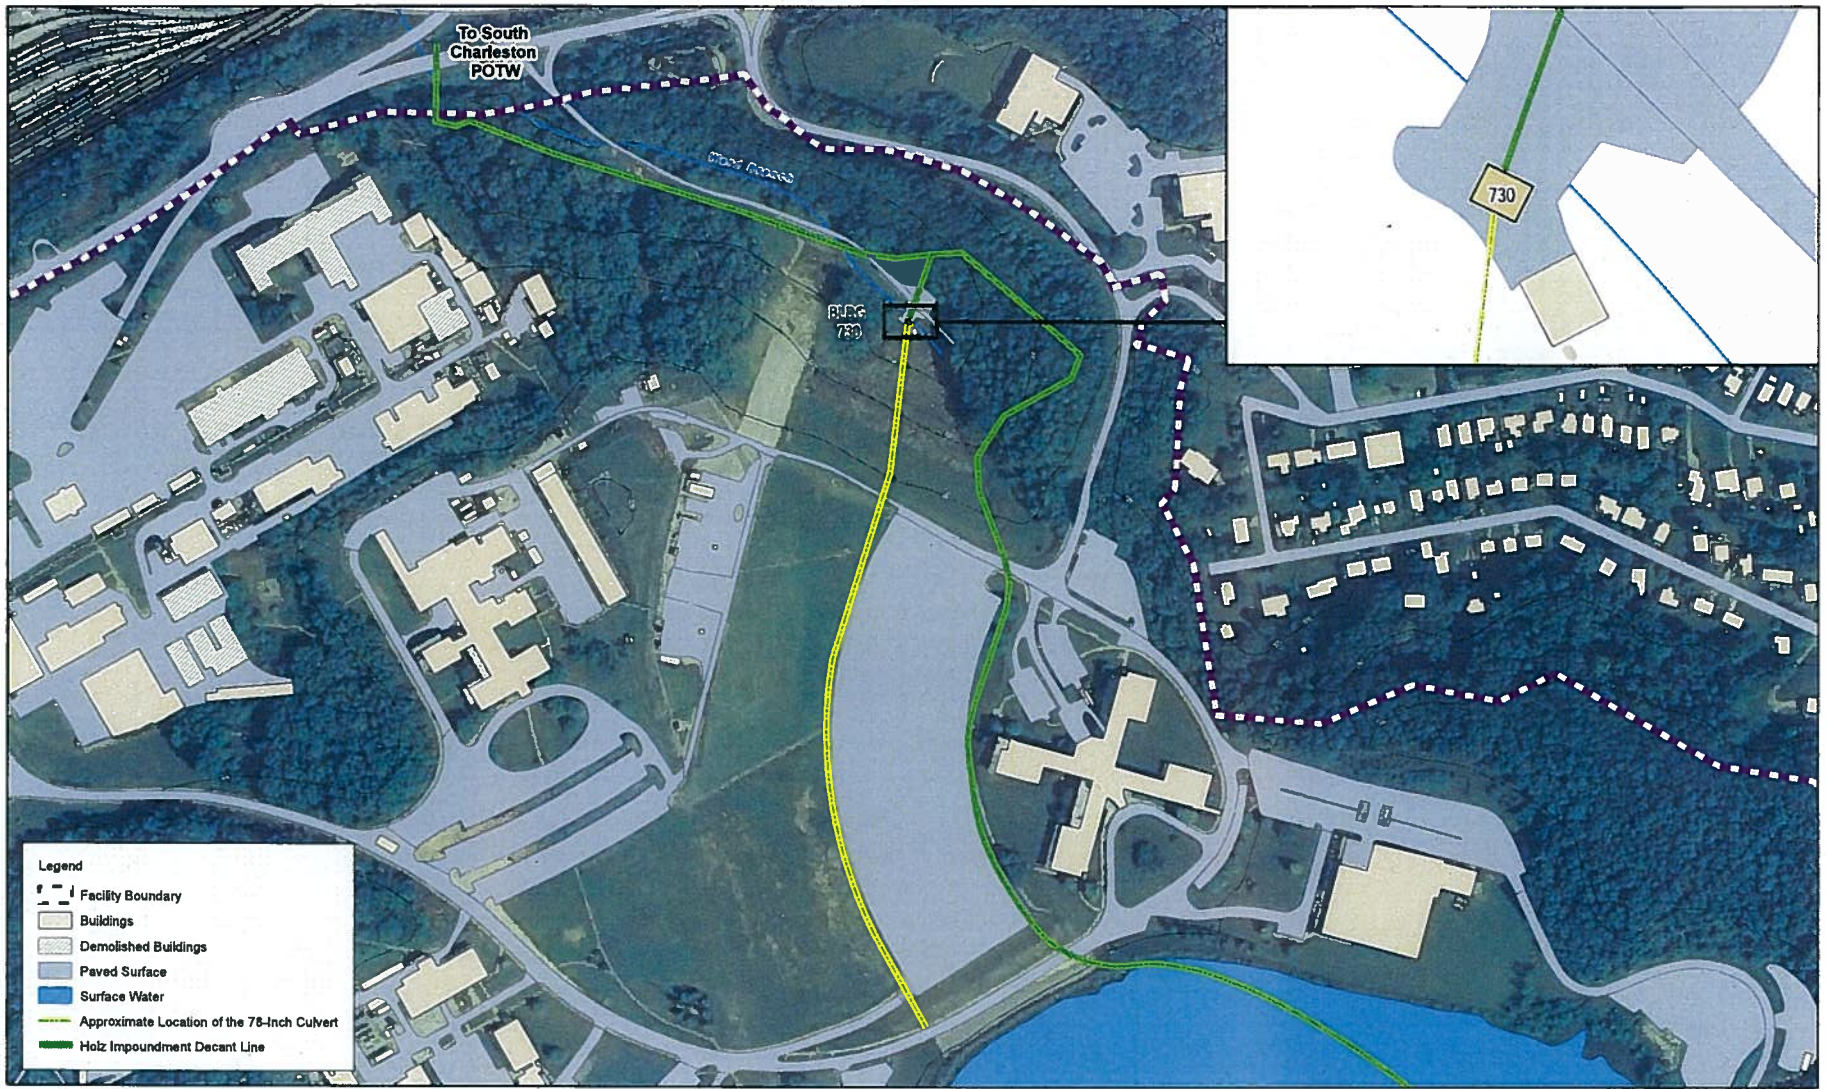
Figure 3
 Lower Ward Leachate Collection System
 Statement of Basis
 UCC Technology Park
 South Charleston, West Virginia

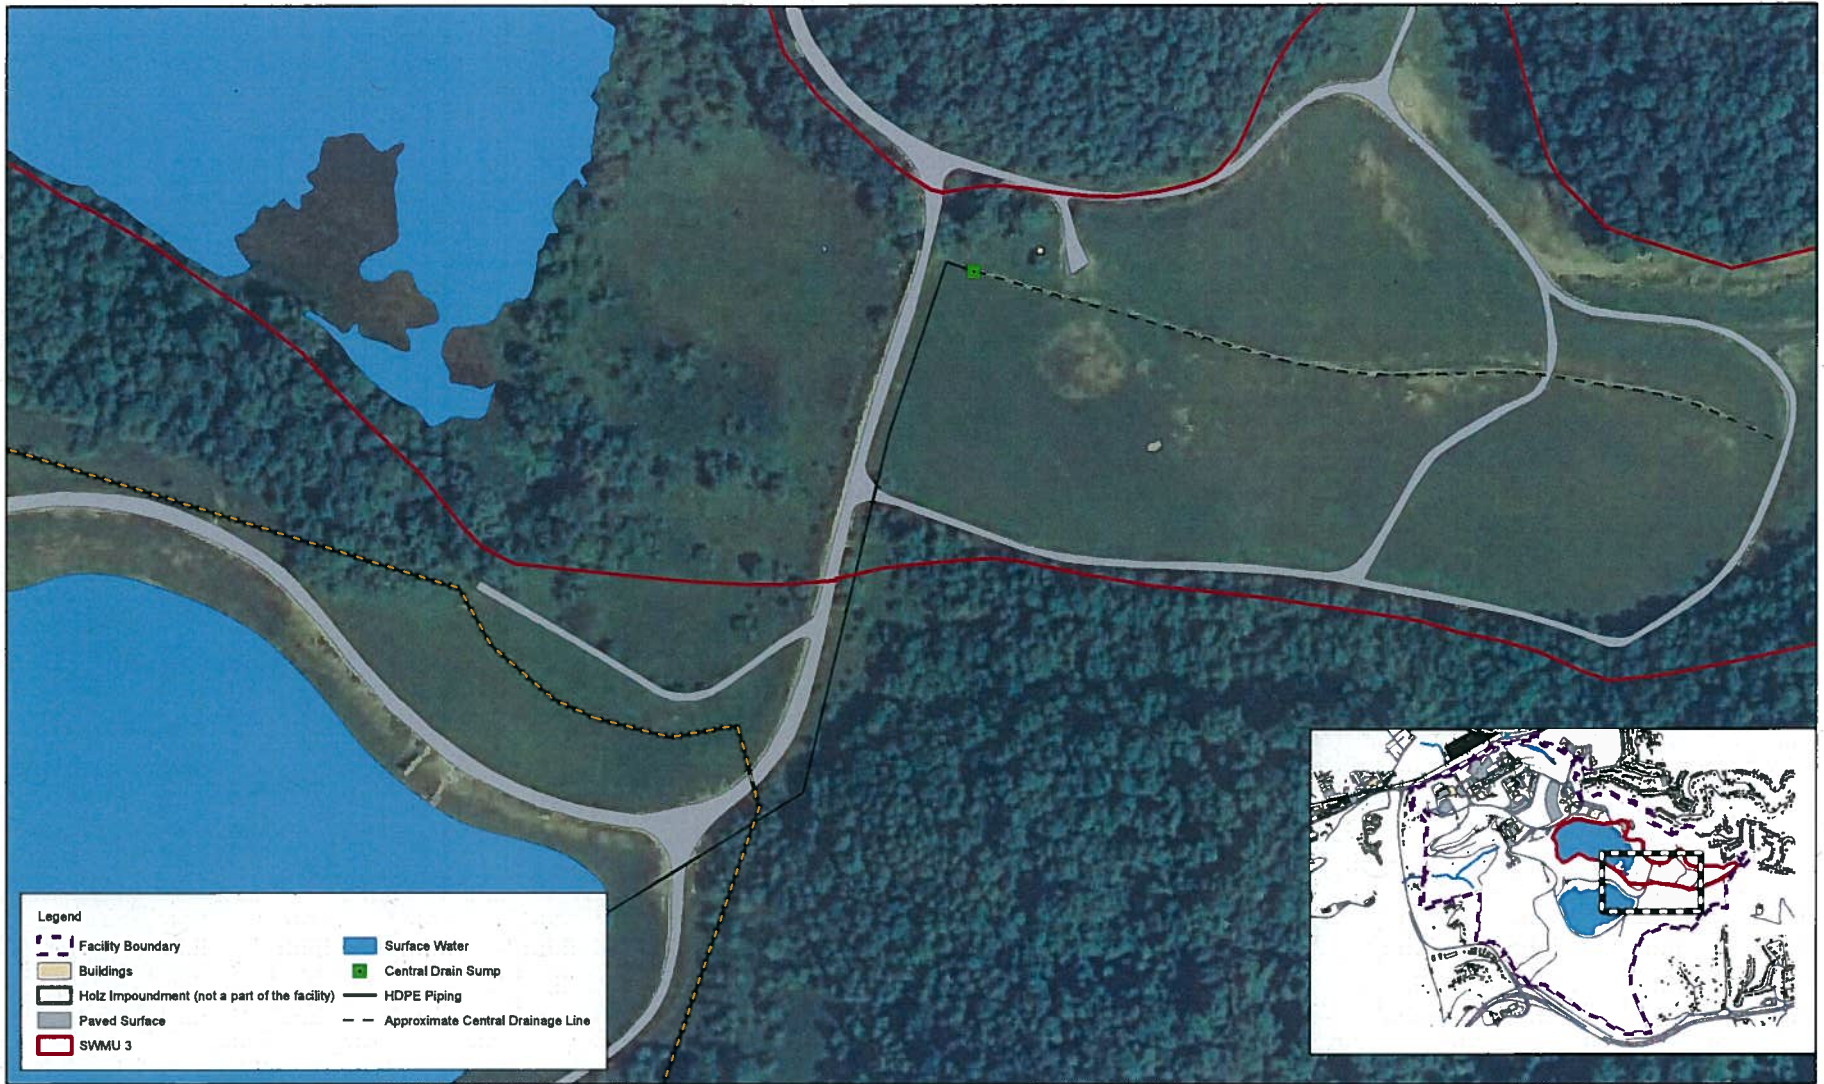
Figure 6
 Central Drain Sump and Associated Piping
 Statement of Basis
 UCC Technology Park
 South Charleston, West Virginia

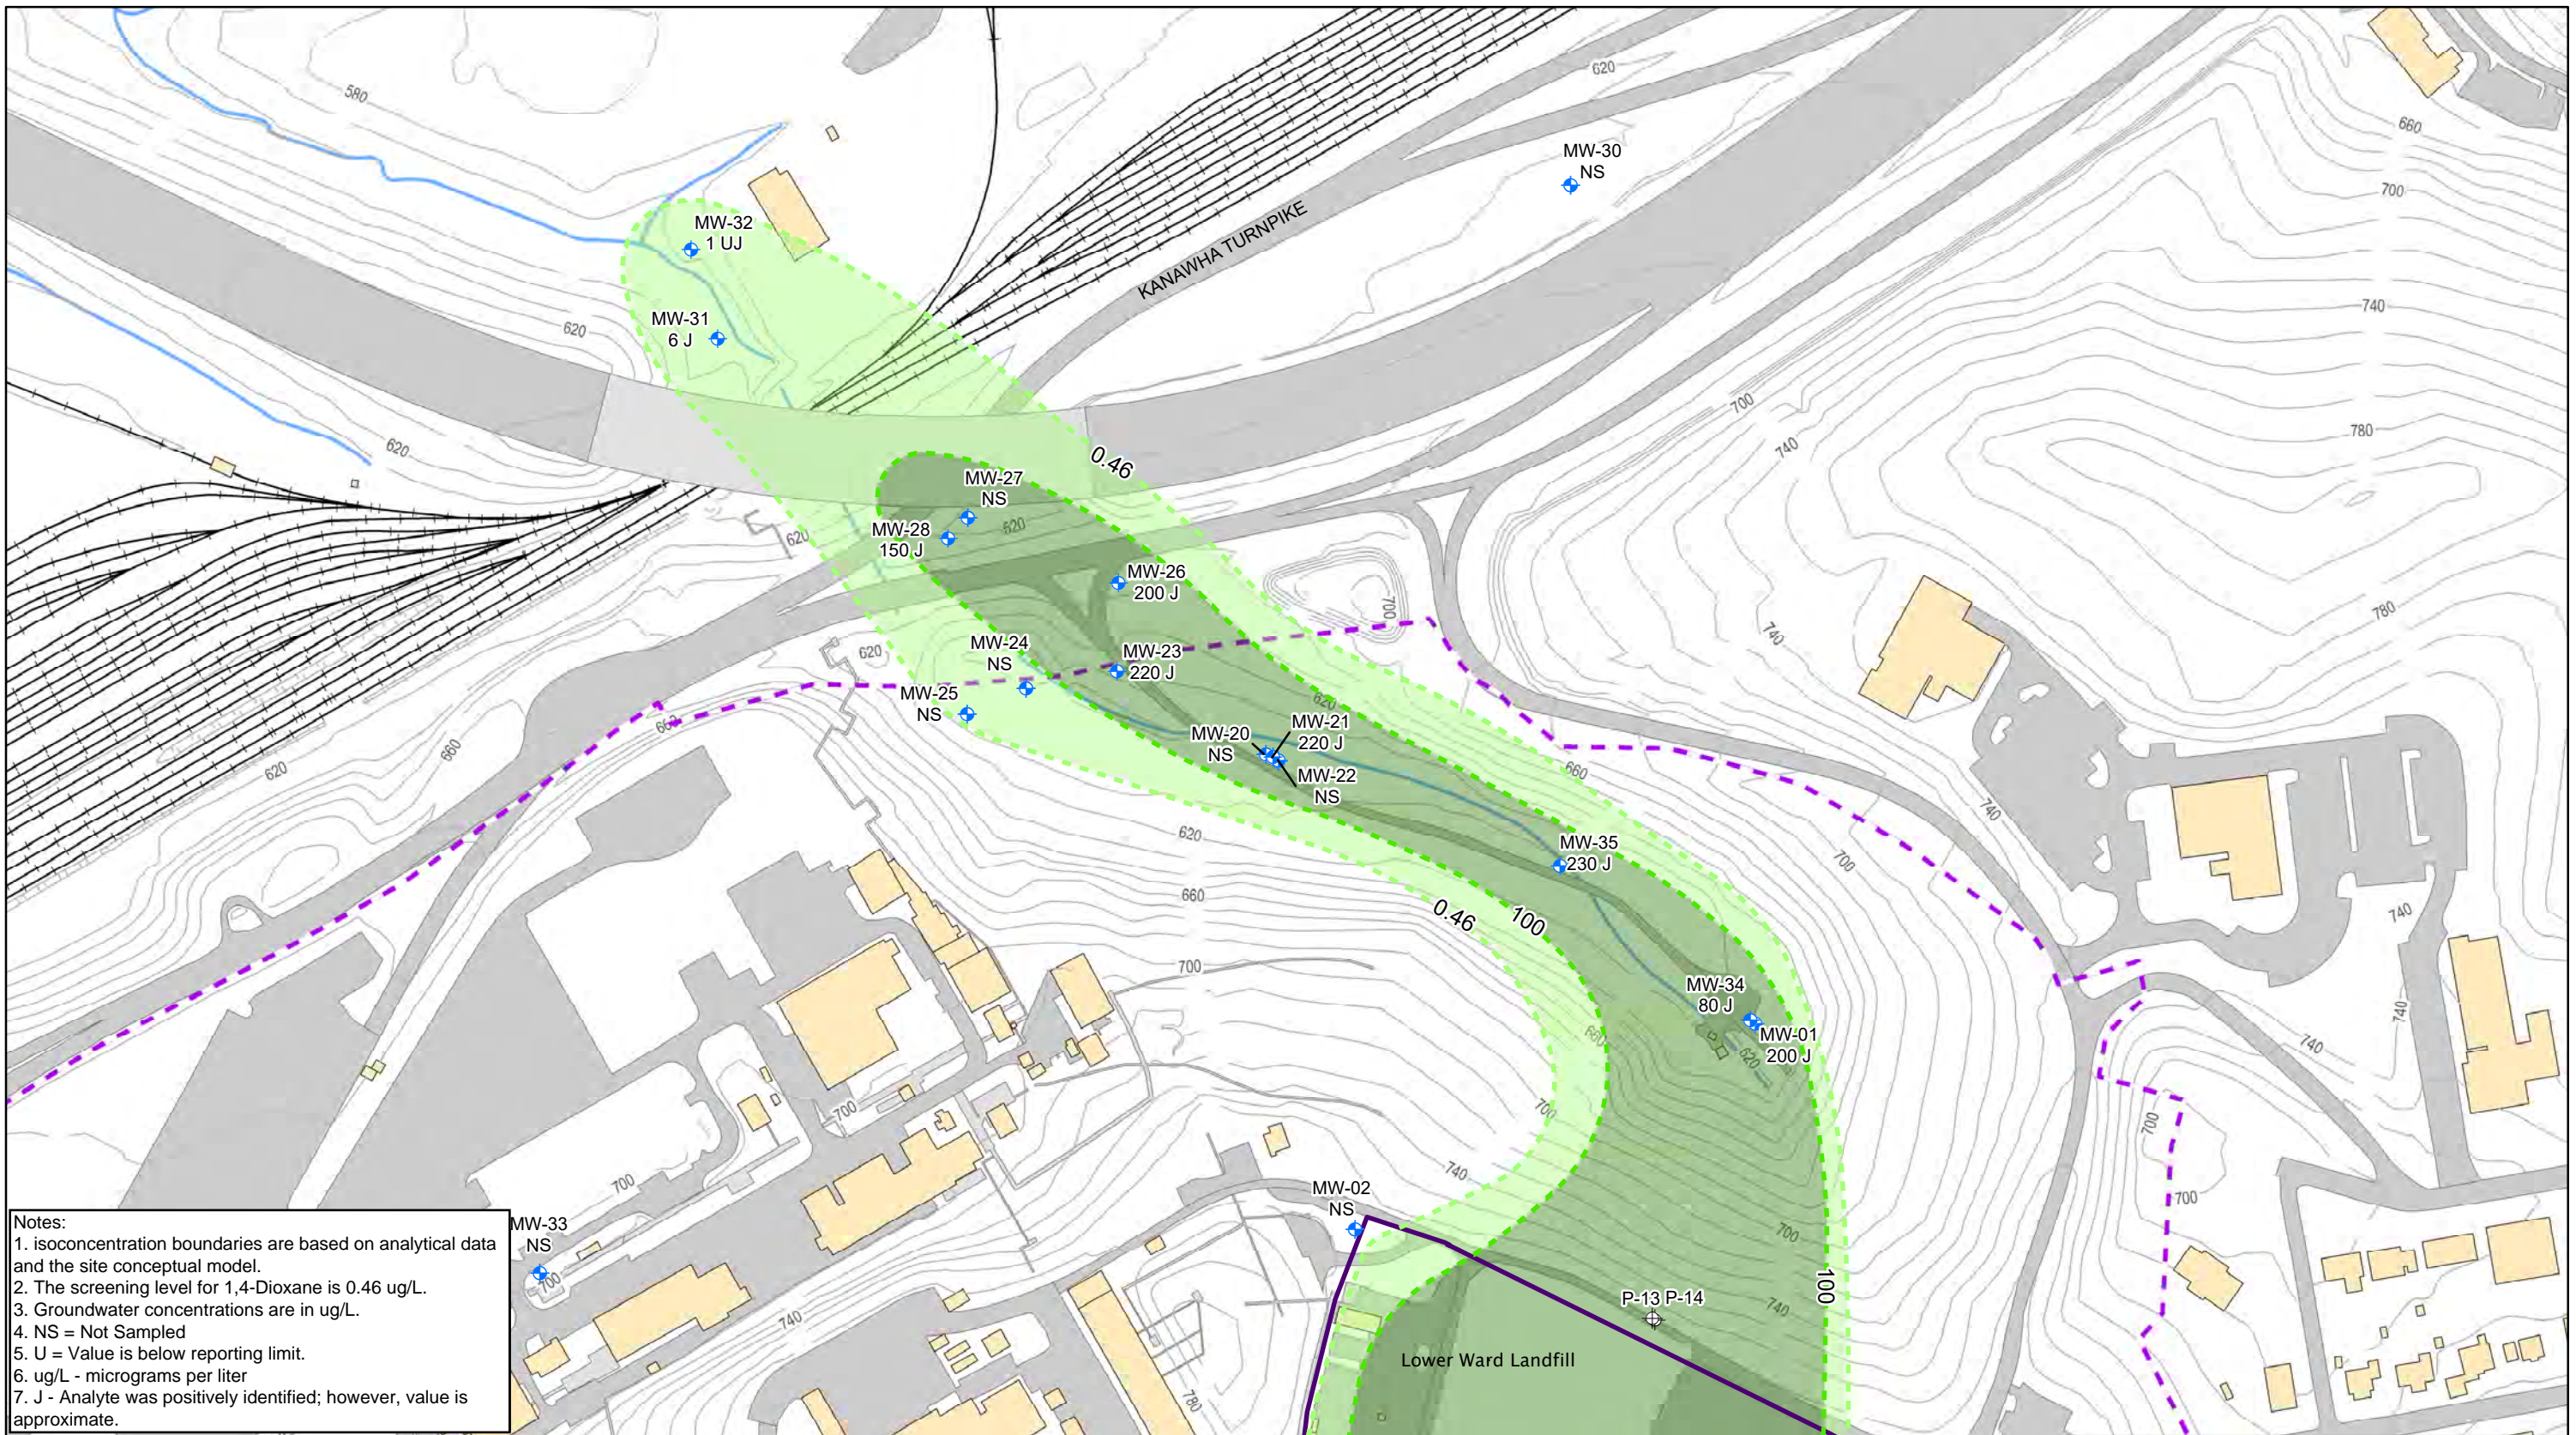
**FIGURE
4-3**

Notes:
 1. isoconcentration boundaries are based on analytical data and the site conceptual model.
 2. The screening level for 1,4-Dioxane is 0.46 ug/L.
 3. Groundwater concentrations are in ug/L.
 4. NS = Not Sampled
 5. U = Value is below reporting limit.
 6. ug/L - micrograms per liter
 7. J - Analyte was positively identified; however, value is approximate.

Note: Figure developed using the 8270 SIM Isotope Dilution Method.

**DECEMBER 2018 1,4-DIOXANE
 ISOCONCENTRATION MAP
 2018 GROUNDWATER MONITORING REPORT**

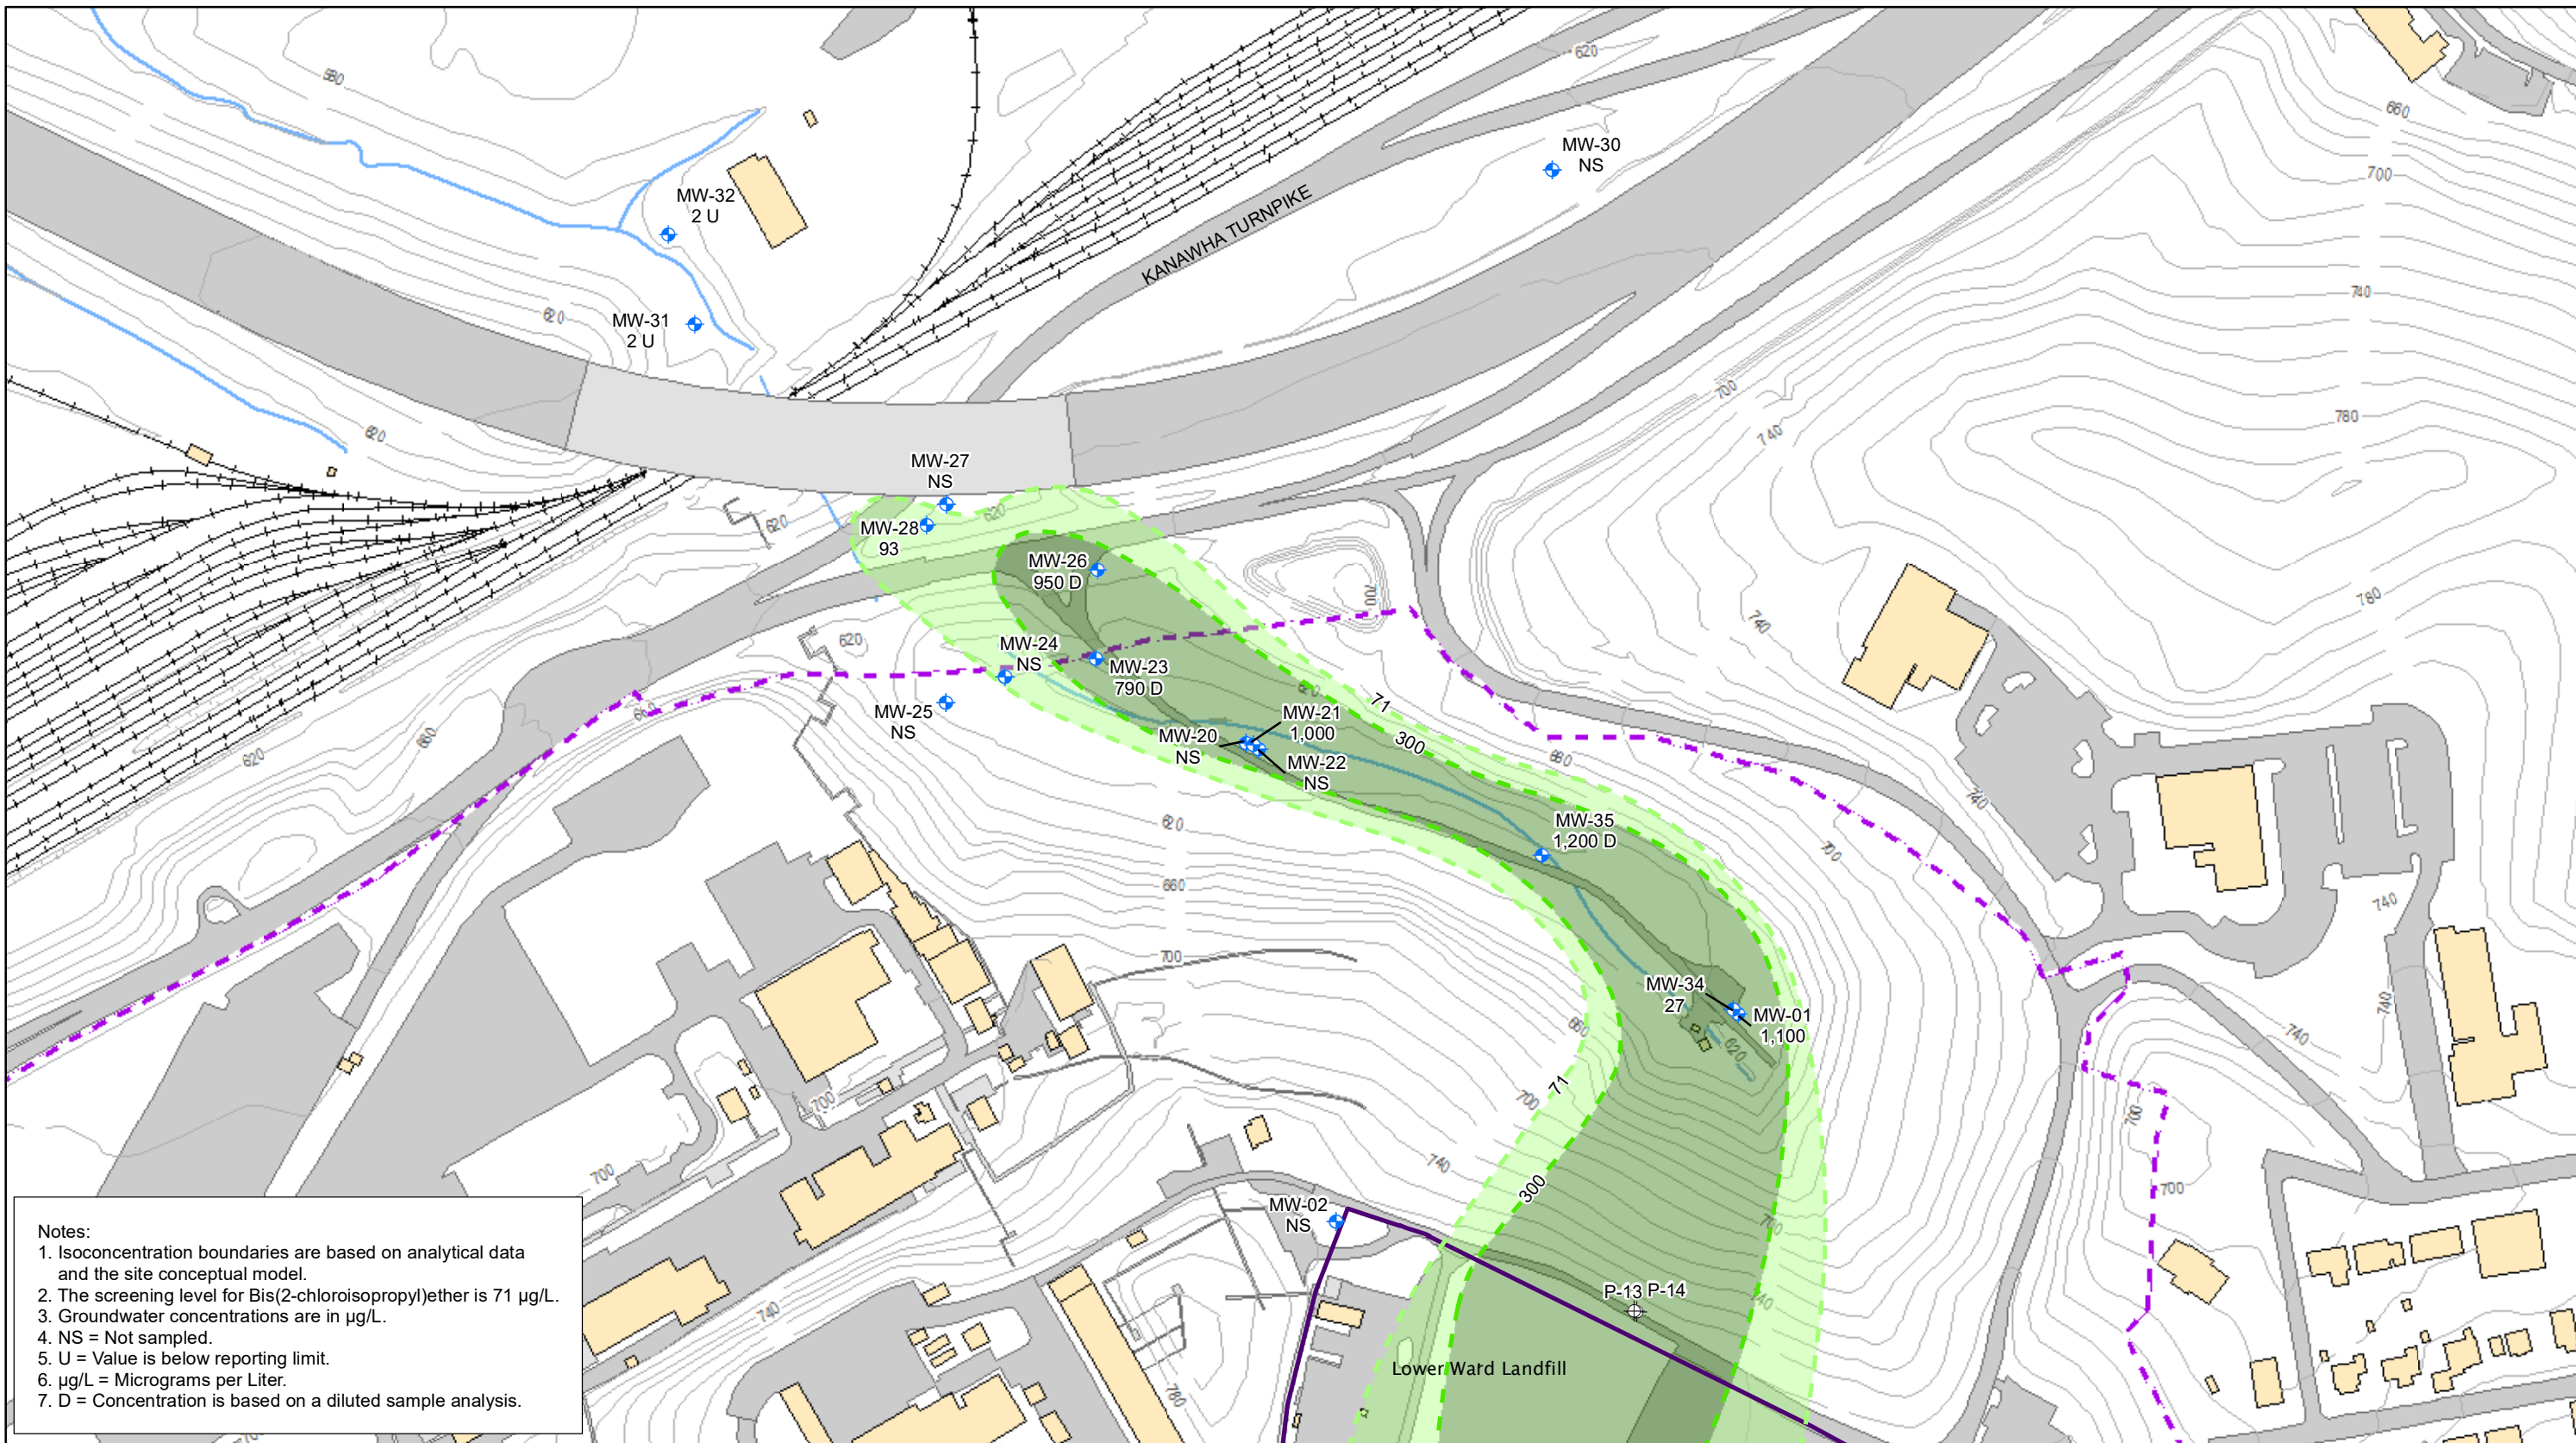
Design & Consultancy for natural and built assets
FIGURE	4-4

- Notes:**
1. Isoconcentration boundaries are based on analytical data and the site conceptual model.
 2. The screening level for Bis(2-chloroisopropyl)ether is 71 µg/L.
 3. Groundwater concentrations are in µg/L.
 4. NS = Not sampled.
 5. U = Value is below reporting limit.
 6. µg/L = Micrograms per Liter.
 7. D = Concentration is based on a diluted sample analysis.
