NONPOINT SOURCE SUCCESS STORY

Tuscarora Creek Relocation and Restoration Improves Biodiversity

EPA 841-F-19-001K
March 2019

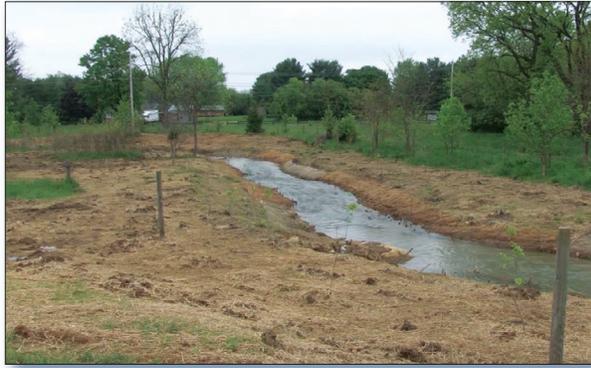
Figure 2. The new stream channel diverts water around a small concrete dam, now buried.

Using CWA section 319 funds, the Canaan Valley Institute (CVI) designed a stream restoration project that adjusted the stream's path to avoid the dam while also approaching the road culvert at a better angle (Figures 2 and 3). The new design added shallow riffles, deep pools, and vegetative bank stabilization to improve the benthic habitat for organisms as well. The project restored 448 feet of natural channel and established 1.5 acres of trees and shrubs. CVI obtained

a grant from National Fish and Wildlife Foundation to implement the dam removal portion of the project. In 2016 a portion of the spillway was removed, the remaining portion of the dam was abandoned and buried in place, and the stream was rerouted to flow around the abandoned dam site.

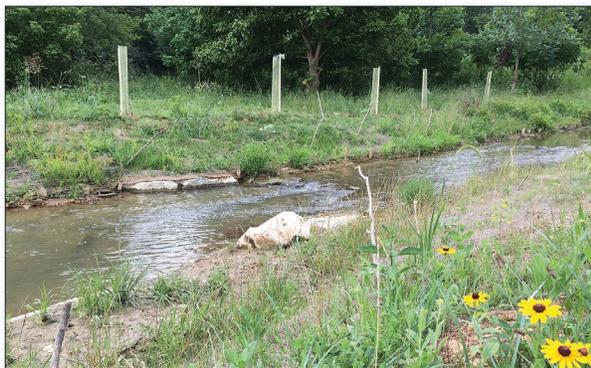
Figure 4. Upper portion of the restored reach.

Native plants in the new riparian buffer along the restored areas flourished quickly after project completion, stabilizing the area (Figures 4 and 5). In September 2017 (one year after the project was completed), DEP collected benthic macroinvertebrates with dip nets from several riffles along the project reach and found that the IBI score has significantly improved. The IBI score recorded on April 23, 2013 (before project implementation) was 31.5 (“poor” integrity). The IBI score recorded on September 12, 2017 (after project implementation), was 57.4 (“marginal” integrity)—a 58 percent increase.

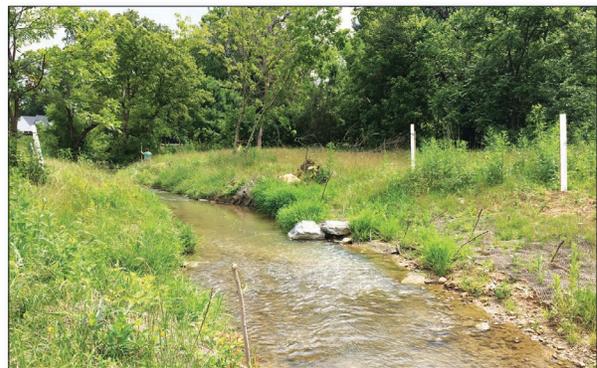
Figure 5. Lower portion of the restored reach.
