Muddy Creek Watershed Restoration

Biological Monitoring Status Report

February 26, 2020

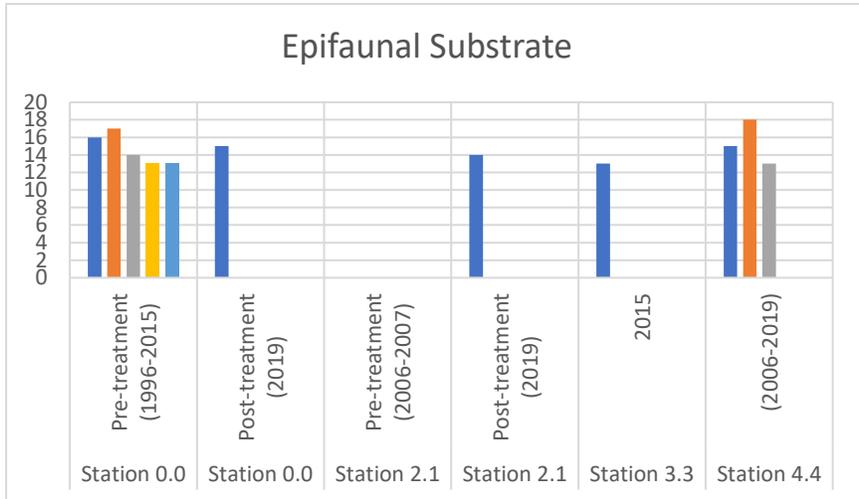
Figure 1- Pre- and post-treatment epifaunal substrate RBP ratings.

epifaunal substrate scores between any of the sample stations. Most sample stations exhibited scores in the middle sub-optimal category, with a few scores in the optimal category (Figure 1).

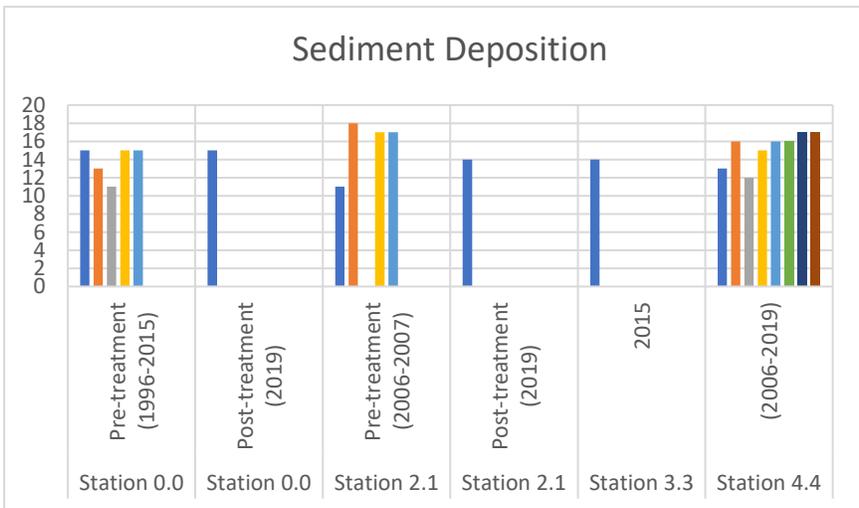
Figure 2- Pre- and post-treatment sediment deposition RBP ratings.

The sediment deposition category measures the amount of fine sediments that accumulate within typical depositional areas. This category focuses primarily on pool and run habitat deposition. Increased sediment deposits can be detrimental to aquatic organisms and serve to decrease habitat complexity. Pre- and post-treatment samples taken at all stations showed no notable differences between the two conditions. Most scores ranged from the middle to upper sub-optimal category into the optimal category (Figure 2).

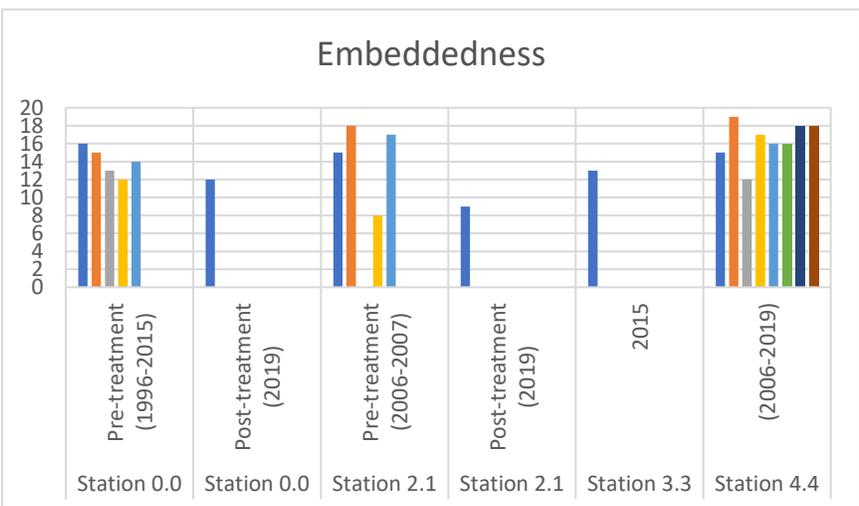
Figure 3- Pre- and post-treatment embeddedness RBP ratings.

The embeddedness category is a measure of the amount of interstitial space within riffle and run habitats. This is a very important category because it directly impacts the amount of usable space that benthic macroinvertebrates and benthic fishes have available. In general, there were no significant differences between pre-and post-treatment embeddedness scores. Although a few scores were in the marginal category, it is surmised that these lower scores could have been related to seasonal variability. This category responds similarly to epifaunal and sediment deposition in terms of seasonal variability, flow dynamics, and watershed scale activities. Figure 3 shows a comparison of these scores.

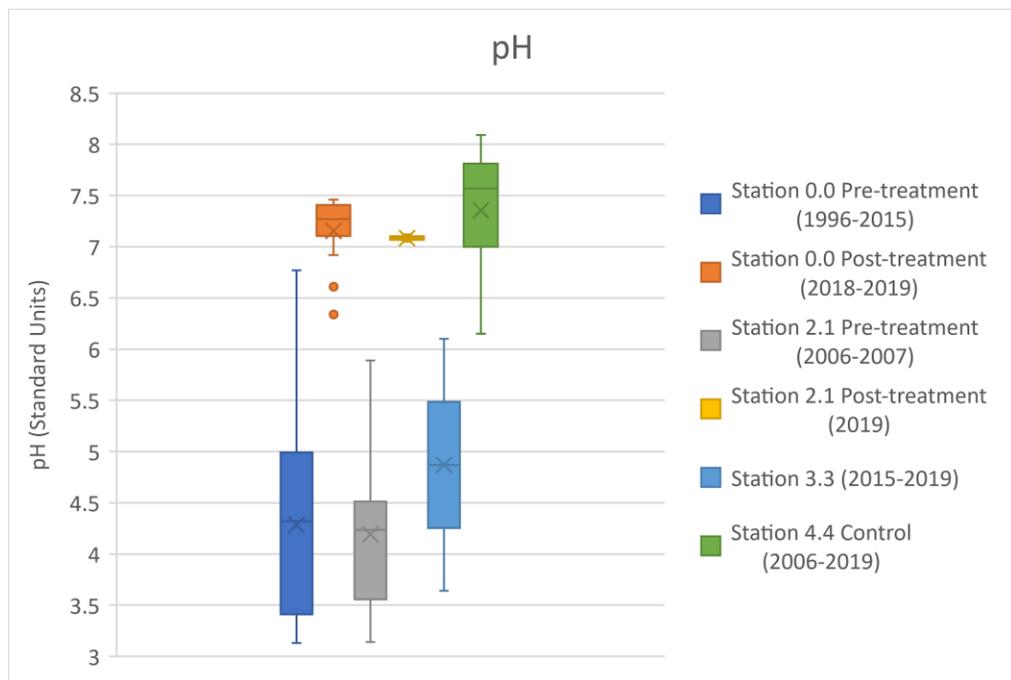
Figure 4- Pre- and post-treatment pH results.

A significant improvement in pH has occurred at Stations 0.0 and 2.1 following the onset of treatment. Post-treatment pH values at Stations 0.0 and 2.1 (downstream of treatment) closely resemble Station 4.4 values. Median pre-treatment pH at

Station 0.0 was 4.32. Station 2.1 showed a pre-treatment pH median of 4.24. Post-treatment pH medians at these stations were significantly higher. Station 0.0 and 2.1 median pH values were 7.27 and 7.09, respectively. In comparison, Station 4.4 pH median was 7.57 (Figure 4).

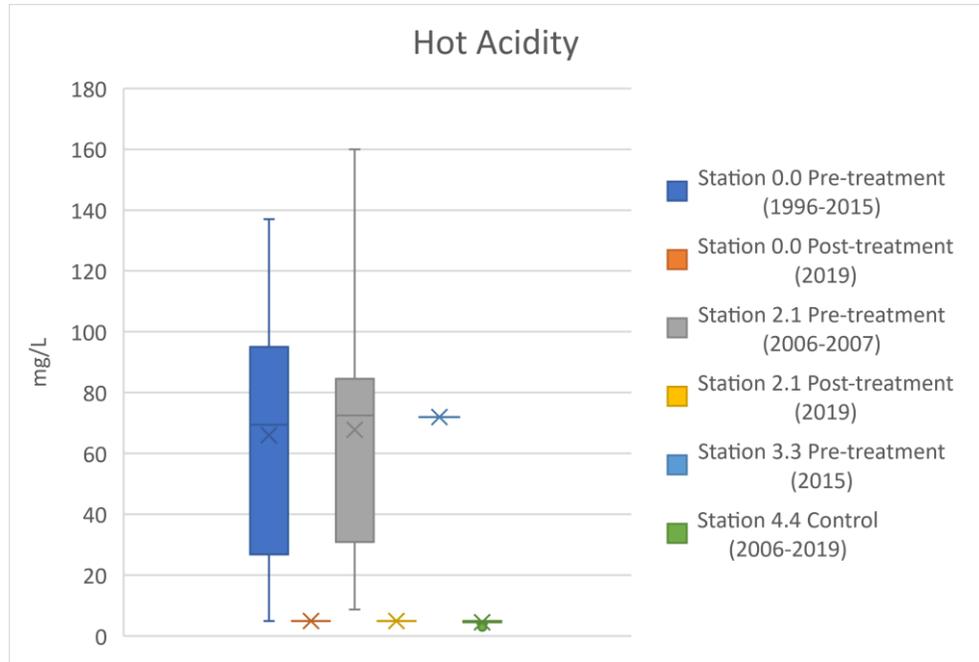
Figure 5- Pre- and post-treatment hot acidity results.

In addition to the increase in pH, hot acidity concentrations were substantially reduced. Station 0.0 showed pre-treatment median concentrations of hot acidity to be 69.5 mg/L, with a maximum concentration of 137 mg/L collected during one sampling event. Station 2.1 showed very similar characteristics. Station 2.1 had a median concentration of 72.5 mg/L, with a maximum

concentration of 160 mg/L collected. Post-treatment samples at these stations mirror conditions of Station 4.4. The minimum detection limit (MDL) of less than 5 mg/L have been achieved at Stations 0.0 and 2.1 (Figure 5).

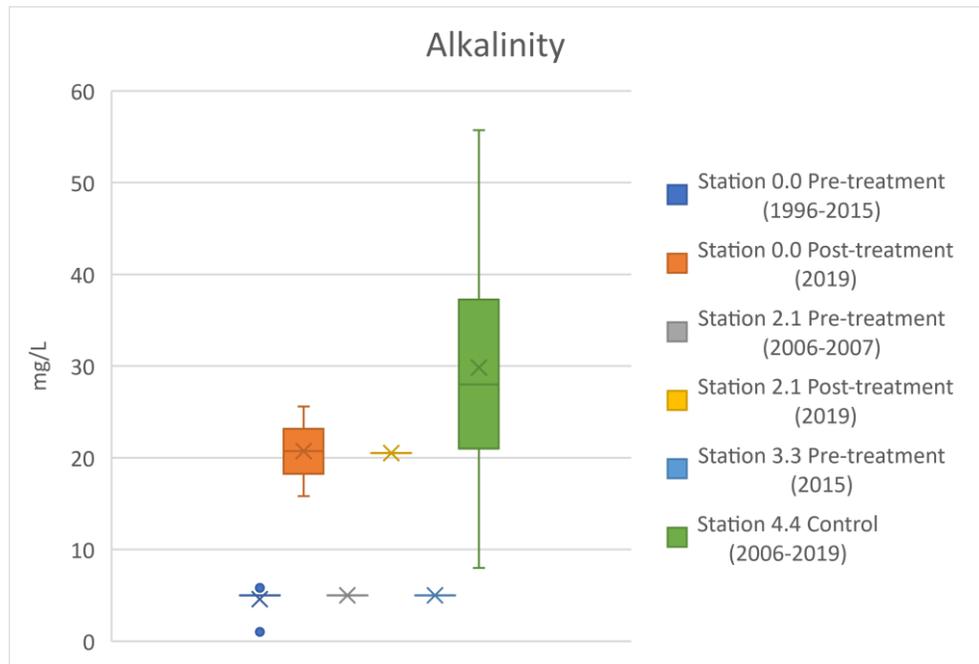
Figure 6-Pre- and post-treatment alkalinity results.

amount of alkaline material in a water sample. It measures the stream's ability to neutralize acidic conditions. Pre-treatment conditions at Stations 0.0 and 2.1 showed concentrations of alkalinity at the MDL of <5 mg/L. In contrast, samples from station 4.4 had a median concentration of 28 mg/L. Post-treatment samples at Stations 0.0 and 2.1 were similar to Station 4.4. Single sample concentrations of 20.7 mg/L and 20.5 mg/L were collected from stations 0.0 and 2.1, respectively. Figure 6 is a box and whisker plot illustrating the differences between pre- and post-treatment data.

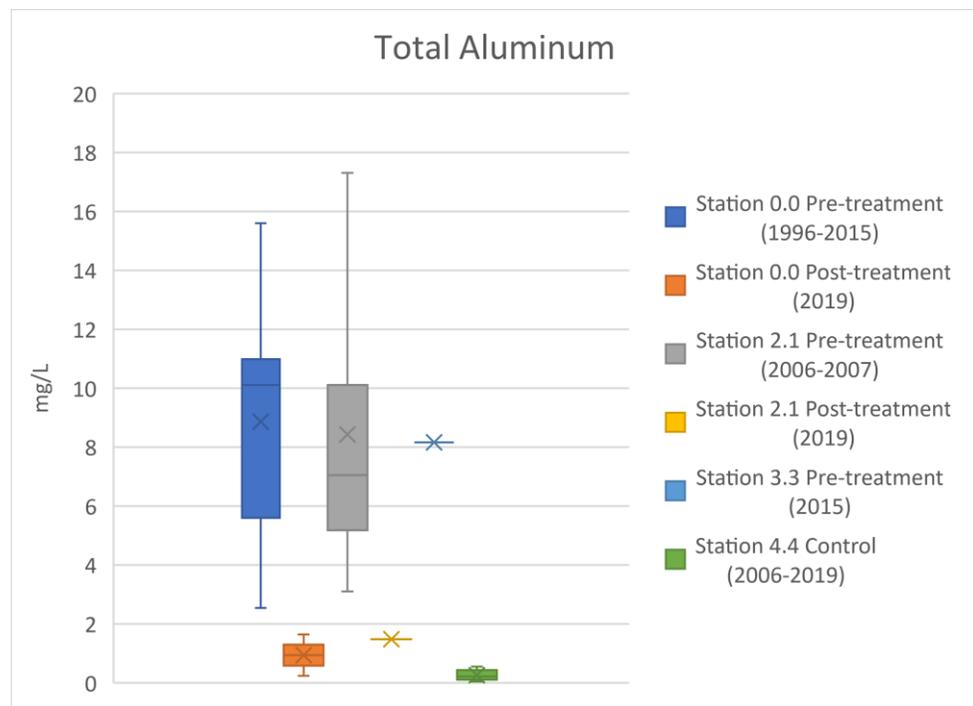
Figure 7- Pre- and post-treatment total aluminum results.

Station 0.0 had a median total aluminum concentration of 10.1 mg/L with a maximum of 15.6 mg/L. Station 2.1 had a median of 7.04 mg/L and maximum concentration of 17.3 mg/L. In contrast, station 4.4 had a median total aluminum

concentration of 0.209 mg/L. Median total aluminum concentrations for over 700 samples of WAB Level I and II reference sites revealed a concentration of 0.09 mg/L. It is important to note the MDL for total aluminum is 0.02 mg/L. Although WAB has taken few comprehensive water samples at Stations 0.0 and 2.1 since the onset of treatment, post-treatment aluminum concentrations were significantly reduced. Two samples taken at Station 0.0 revealed concentrations of 1.64 mg/L and 0.231 mg/L. Figure 7 shows total aluminum concentrations among the sample stations.

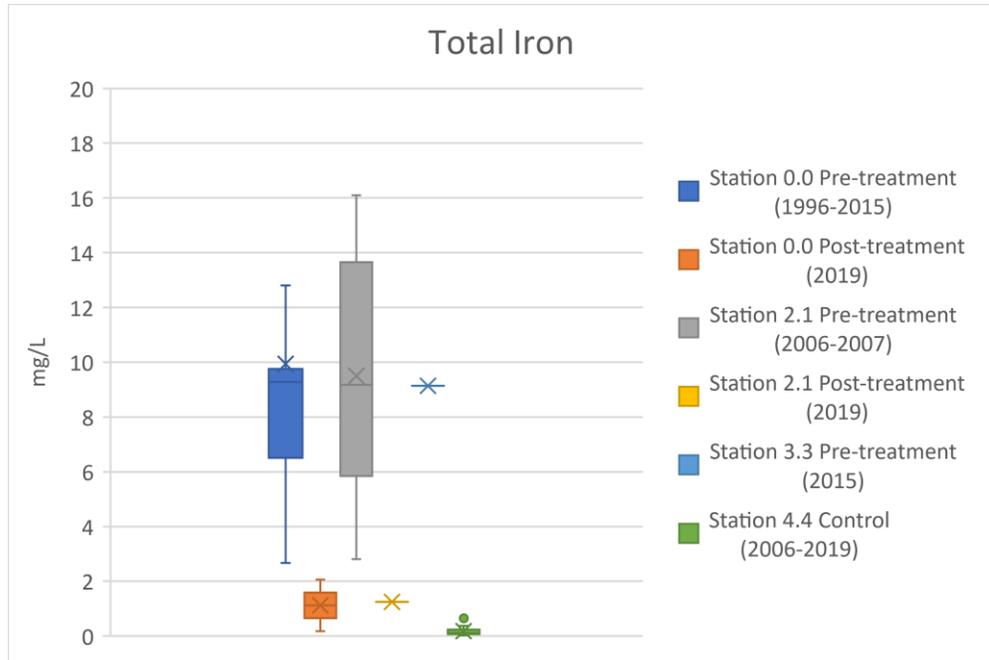
Figure 9- Pre- and post-treatment total iron results.

Total iron was significantly reduced at Stations 0.0 and 2.1 following the onset of treatment. Pre-treatment medians for Stations 0.0 and 2.1 were 9.28 mg/L and 9.17 mg/L, respectively. Two post-treatment samples taken at Station 0.0 exhibited concentrations of 2.06 mg/L and 0.18 mg/L. Station 2.1 had one sample taken with a concentration of 1.25 mg/L. In contrast, Station 4.4 had a median concentration of 0.109 mg/L (Figure 8).

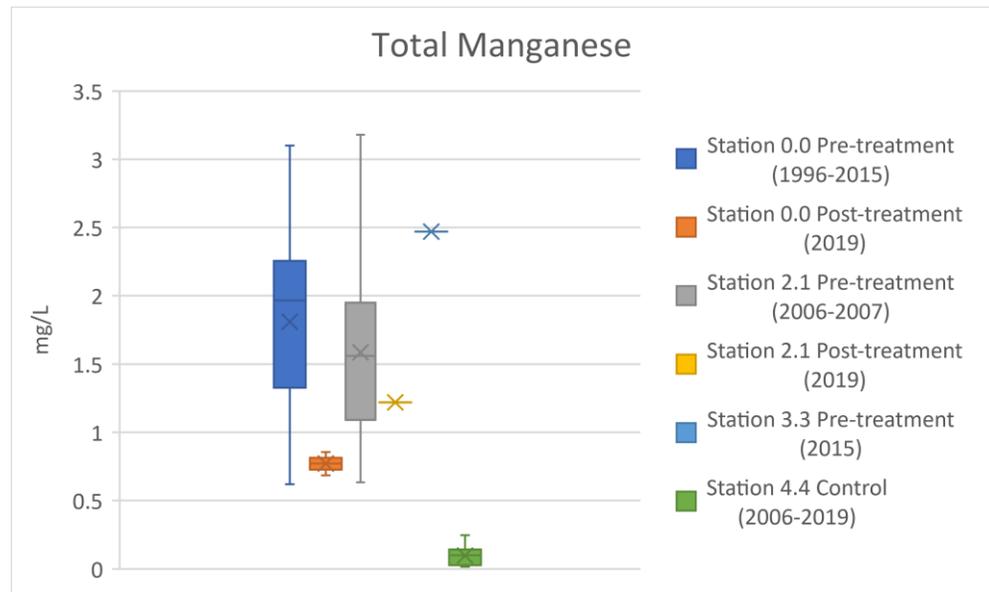
Figure 8- Pre- and post-treatment total manganese results.

Similar to aluminum and iron reductions, total manganese concentrations were also reduced. Pre-treatment samples at Stations 0.0 and 2.1 had median concentrations of 1.97 mg/L and 1.56 mg/L, respectively. After treatment, two samples from Station 0.0 had values of 0.685 mg/L and 0.856 mg/L. Station 2.1 had a post-treatment concentration of 1.25 mg/L. Station 4.4 had a sample median of 0.099 mg/L (Figure 9).

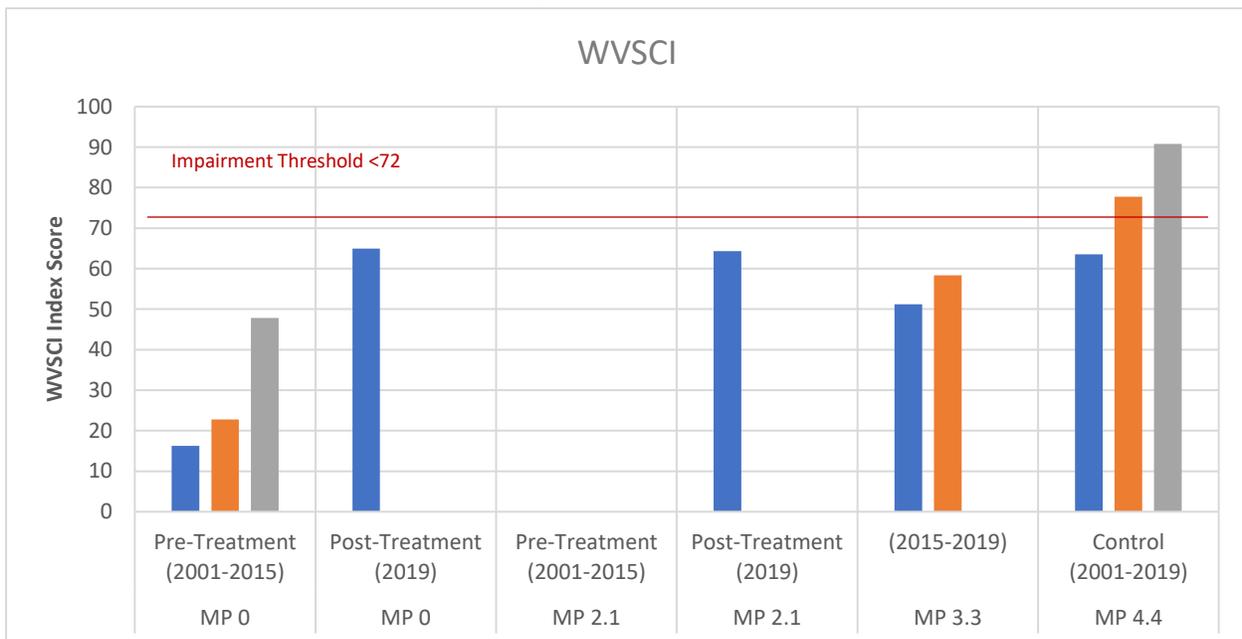
Figure 10- Pre-and post-treatment WVSCI scores.

assemblages to assess the biological condition of wadeable streams with riffle/run habitats. This index includes six biological metrics that represent elements of the structure and composition of benthic macroinvertebrate communities. Because larval macroinvertebrates are relatively stationary, they are susceptible to changes in water quality. This makes them an excellent indicator for stream health. It is important to note that benthic communities are very complex and are susceptible to many environmental factors including stream discharge, stream habitat in relation to sedimentation, localized disturbances, and even life history strategies of different families. At Station 0.0, the WVSCI score improved from a pre-treatment median score of 22.79 to a post-treatment score of 64.95. The impairment threshold for WVSCI is 72. This means that any score less than 72 is considered impaired. Sites scoring over 72 are considered unimpaired. Lower scores, like 22.79 for example, are considered severely impaired. Station 2.1

had a WVSCI score of 64.29. The sample median WVSCI score for Station 4.4 was 77.73 (Figure 10). It is important to note that pre-treatment WVSCI scores from Stations 0.0, 3.3 and post-treatment scores from Station 2.1 had benthic densities below 100 organisms. The WVSCI requires sites to have at least 100 organisms to provide an accurate score.

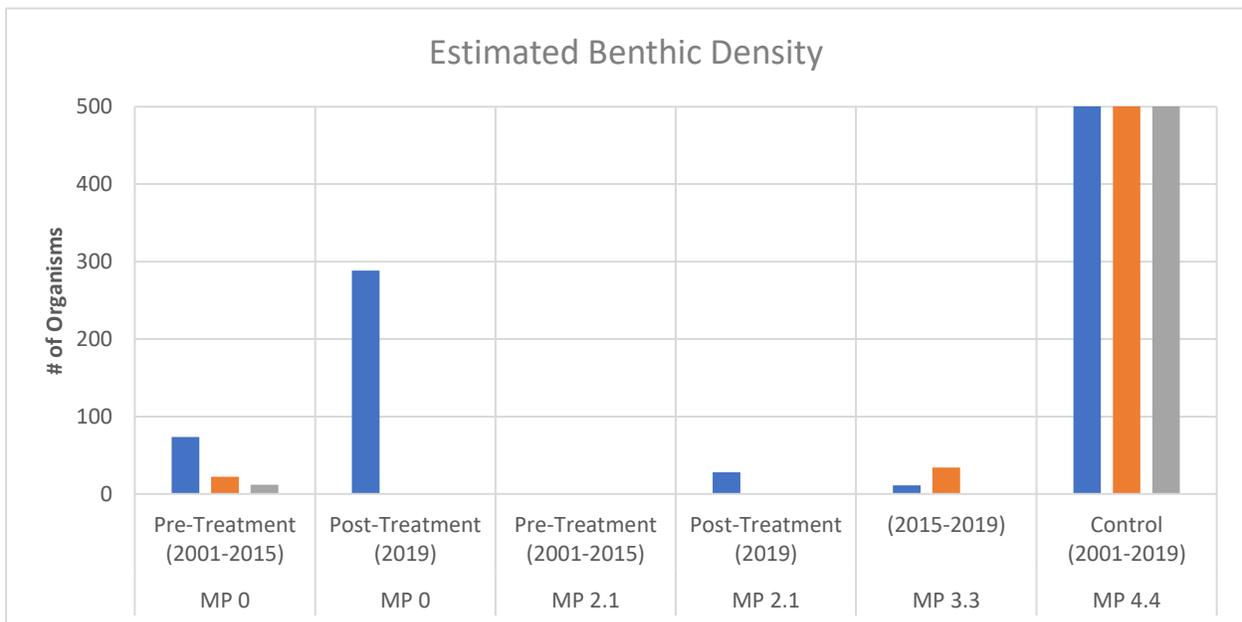
Figure 11- Pre-and post-treatment estimated benthic densities. Note: Station 4.4 densities are much higher than what is shown.

Benthic Density is an important component when assessing treated stream systems. In these types of streams, benthic densities are often significantly diminished. The WAB can estimate benthic macroinvertebrate density via an extrapolation technique from the area sampled in the stream. Density values indicate how many organisms per square meter are estimated to be present within the stream at a location. Looking further into available data showed some notable information about Stations 0.0 and 2.1. Pre-treatment samples at Station 0.0 and post-treatment samples at Station 2.1 revealed that benthic density was very low. These samples displayed benthic densities of less than 100 individual organisms. When densities are this low, the entire sample is picked. At Station 0.0, three samples taken between 2001 and 2015 exhibited densities of 73 organisms/m², 22 org/m², and 12 org/m². The post-treatment sample at Station 0.0 showed positive results. Benthic density estimates rose to 288 org/m². Post-

treatment samples at Station 2.1 did not show positive results, however. Only 28 total organisms were collected in the sample from 2019. For comparison purposes, Station 4.4 had a median benthic density estimate of 3,316 org/m² (Figure 11). The figure does not show the upper limits of estimated density for this station.

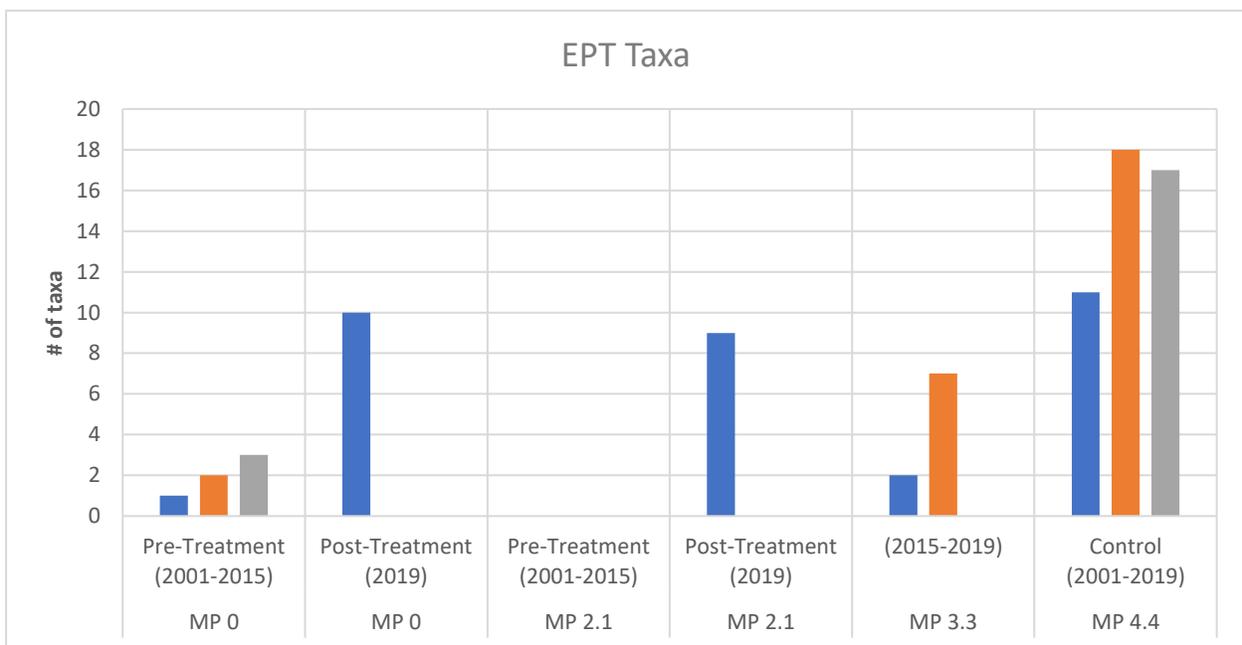
Figure 12- Pre-and post-treatment EPT taxa richness.

sample taken in 2019 showed a significant increase in EPT taxa richness, going from 2 taxa to 10 taxa. Nine EPT taxa were identified at Station 2.1. In comparison, Station 4.4 contained a median EPT taxa richness of 17 (Figure 12).

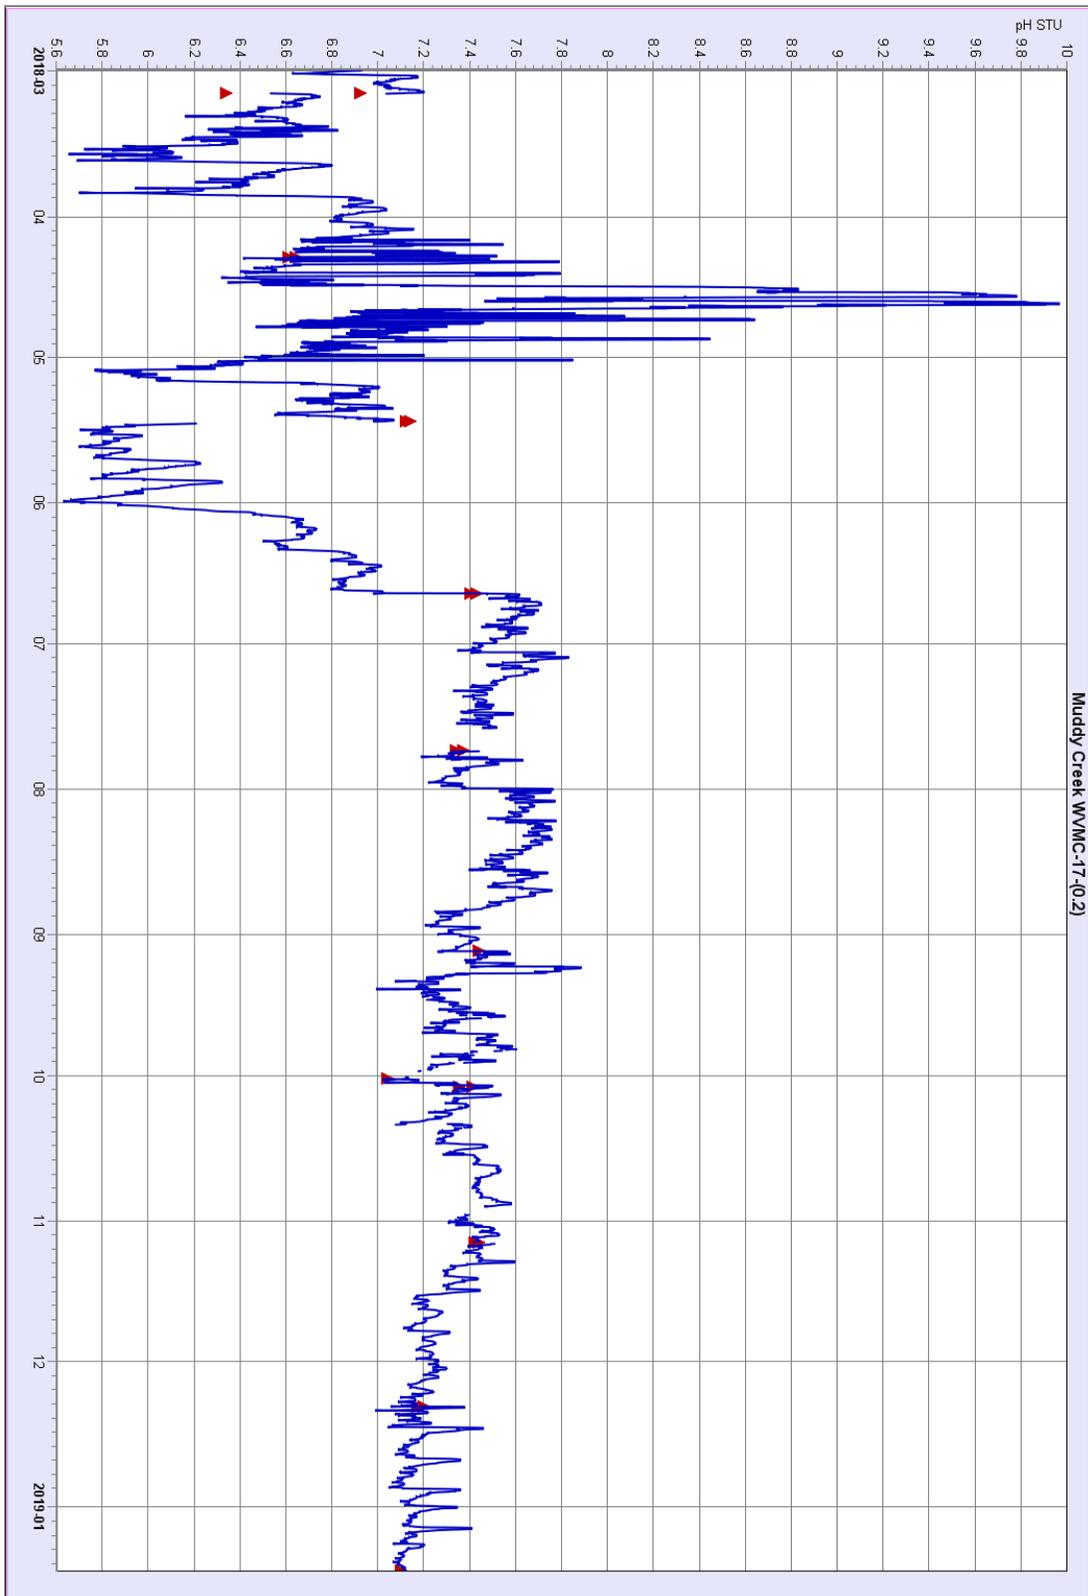
Figure 14- Continuous pH readings from mile 0.2 of Muddy Creek from March 2018 to January 2019.

The deployable datalogger at mile 0.2 collected hourly pH reading to assess the effectiveness of treatment from the facilities upstream. Figure 14 in appendix B is a graph created using the hourly readings from March 2018, when treatment began, to January of 2019. During the first few months of treatment, pH was highly variable at times. This variability is likely due to treatment station calibration. After this calibration period, the graph shows steady fluctuations between pH 7 and pH 7.8.

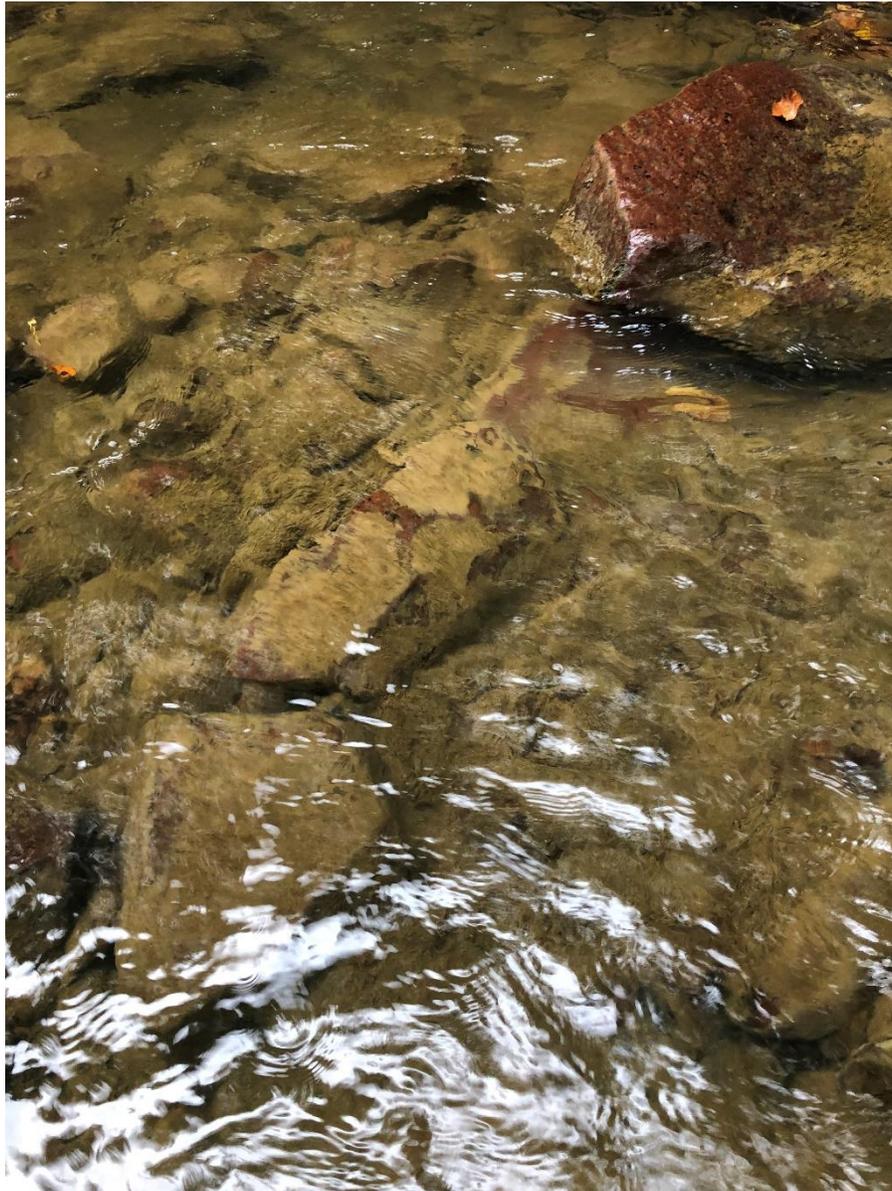
Figure 17-Precipitate mix at Station 0.0.

In 2019, WAB and OSR staff observed a precipitate formation on the substrate at Station 0.0. This precipitate is commonly found in treated systems and usually consists of metals, periphyton/algae, and sediments. A sample was taken by OSR staff and analyzed in a lab. Total aluminum, iron, and manganese concentrations were extremely high. A total aluminum concentration of 4,366 mg/kg was reported. Total iron and total manganese concentrations were 2,927 mg/kg and 429 mg/kg, respectively. Table 2 shows results from the sediment sample taken at Station 0.0. It is important to note the MDLs for these constituents: aluminum is 0.23 mg/kg, iron is 0.1 mg/kg, and manganese is 0.18 mg/kg.
