Anthony Creek Watershed Based Plan

Submitted April 2019

Prepared By: Jacob Lavender, Dennis Burns WVCA and Kenny Maiolo, WV Conservation Agency

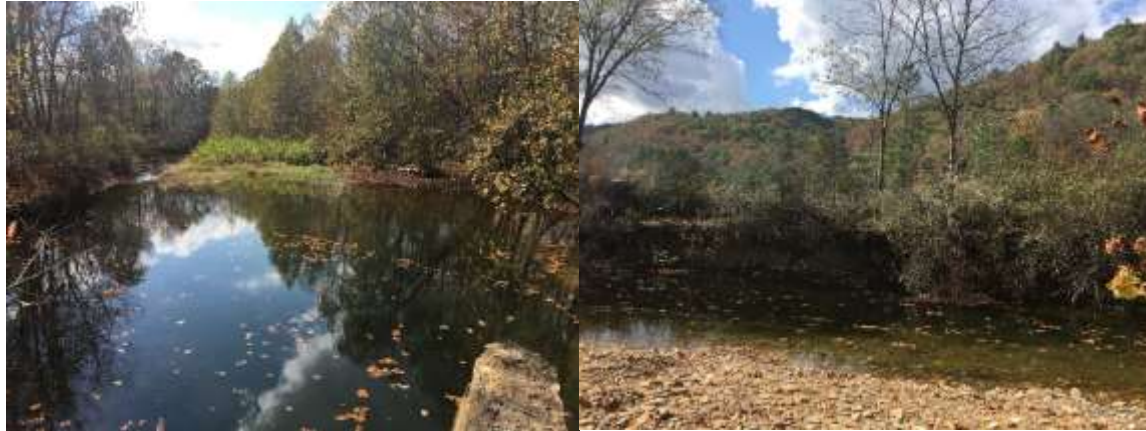
Figure 3. This point bar has developed over time and narrowed down the stream channel. It has restricted flow and created a large pool.

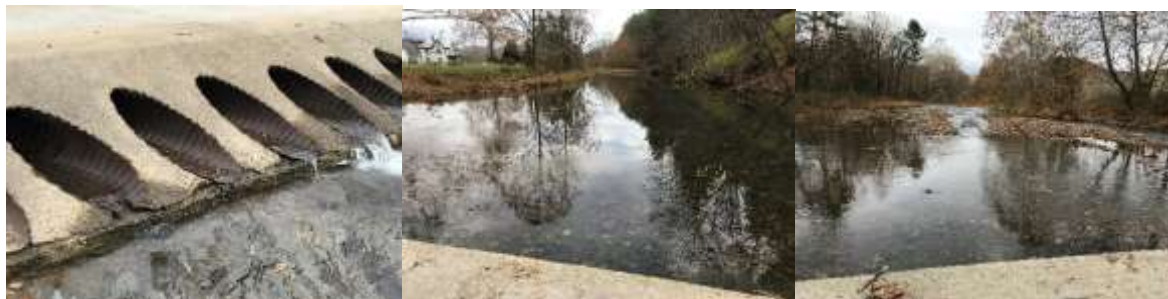
Figure 4. Left: fish passage barrier created by culvert low water crossing, Center: pool created by culvert low water crossing, Right: sediment build up created by culvert low water crossing.

Improper stream crossings typically in the form of a low water culverted crossing or a bridge that restricts high water flow may have varying results on a stream. To begin, culverts typically erode at the downstream end. This creates an aquatic organism passage barrier for any organism attempting to move above or below the crossing. These structures also disrupt the natural flow of bedload through the stream, creating large sediment bars usually below the structure. Low water crossings like these can also clog up creating a pool on the upstream end of the structure, saturating unstable streambank soils and leading to additional erosion.

When an improper stream crossing is in the form of a bridge, these structures often restrict water flow access to the floodplain. This re-routes flood water to areas of unstable soils causing excess erosion and can cause stream blockages by catching debris and forcing sediment to fall out in inappropriate locations.

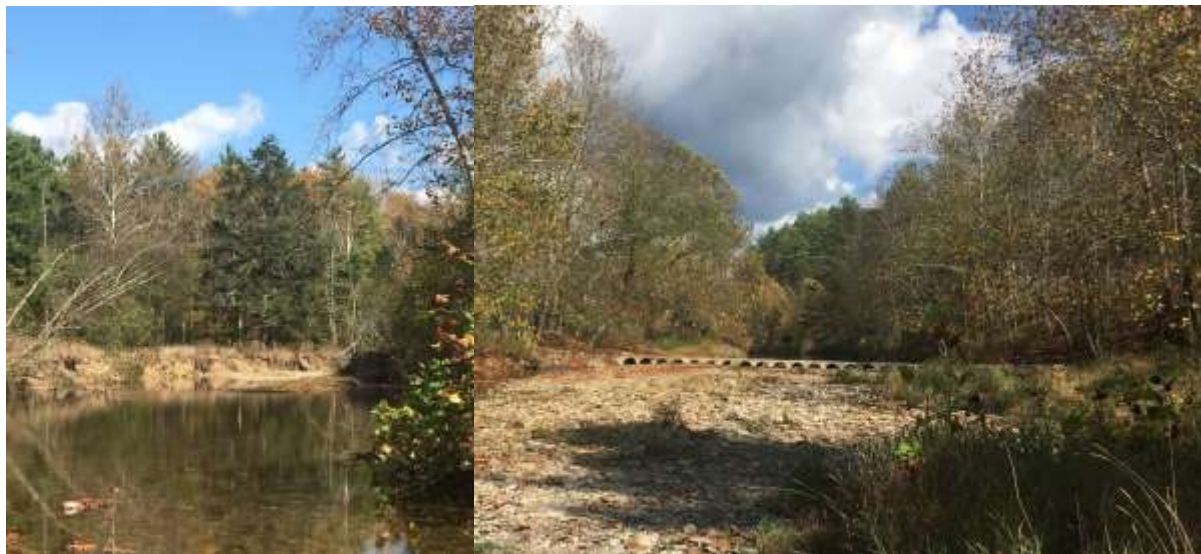
Figure 11. Left: Bank erosion causing excess sediment to build up and bars along the stream. Right: Low water Bridge preventing fish passage and causing excess sediment to build up.

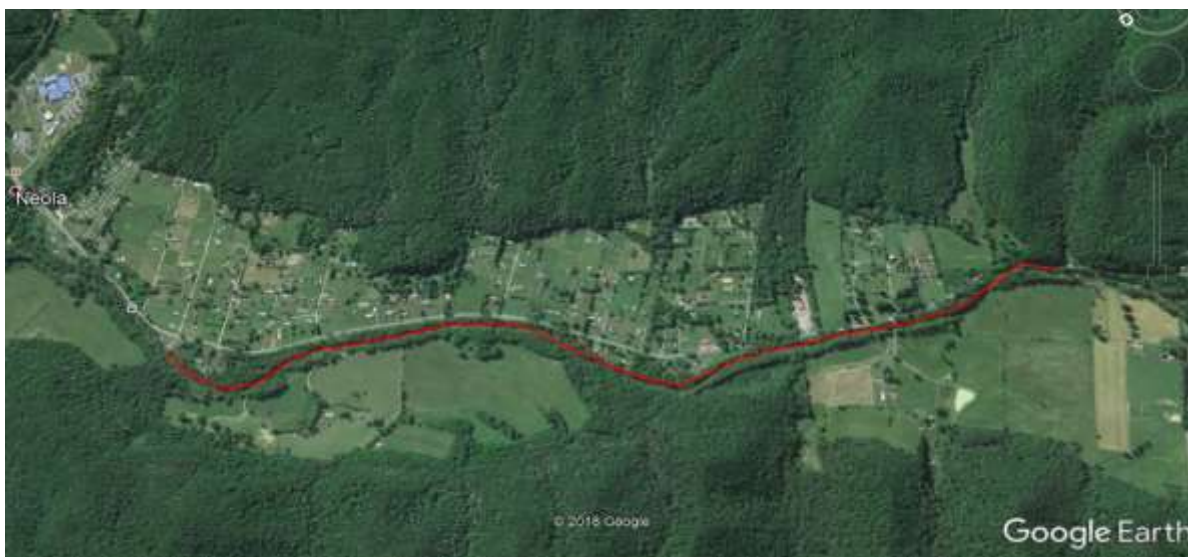
Figure 15. Shows the town of Neola, the red line is Anthony Creek, notice the lack of riparian buffer.

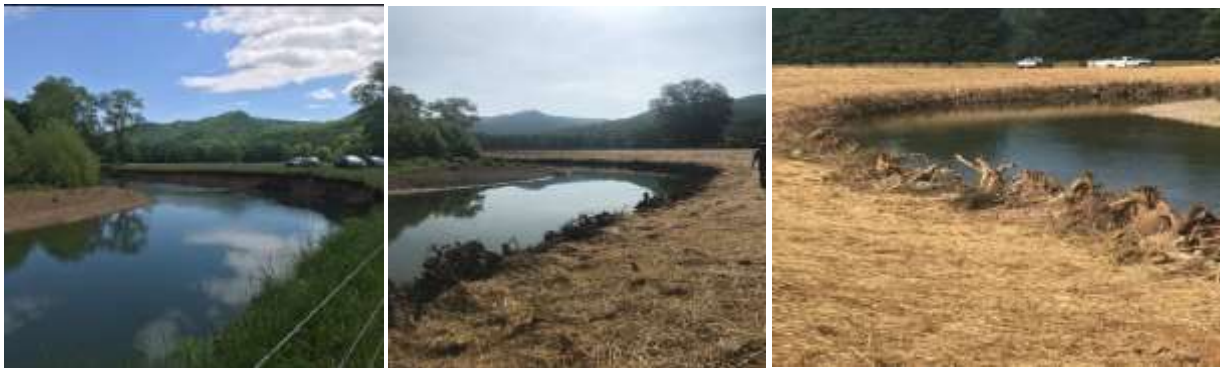
Figure 16. Before and after example of using toe wood structures to address streambank erosion along agricultural land in the Anthony Creek Watershed.

To show some examples of how wood anchoring can increase bank stabilization, and decrease erosion rates, the above images are some before and after pictures of a site that was done by the West Virginia Conservation Agency on Anthony Creek, just above Blue Bend. Before construction began on the site there was about a 6-foot-high vertical bank, which was eroding quickly and causing the land owner to lose his fence as well as is his land. To stabilize the bank, the bank height was reduced, and large root systems of trees were placed and anchored into the bank to allow relief. After the site was completed it was planted and will eventually grow a very strong riparian buffer to add some extra strength to the bank.

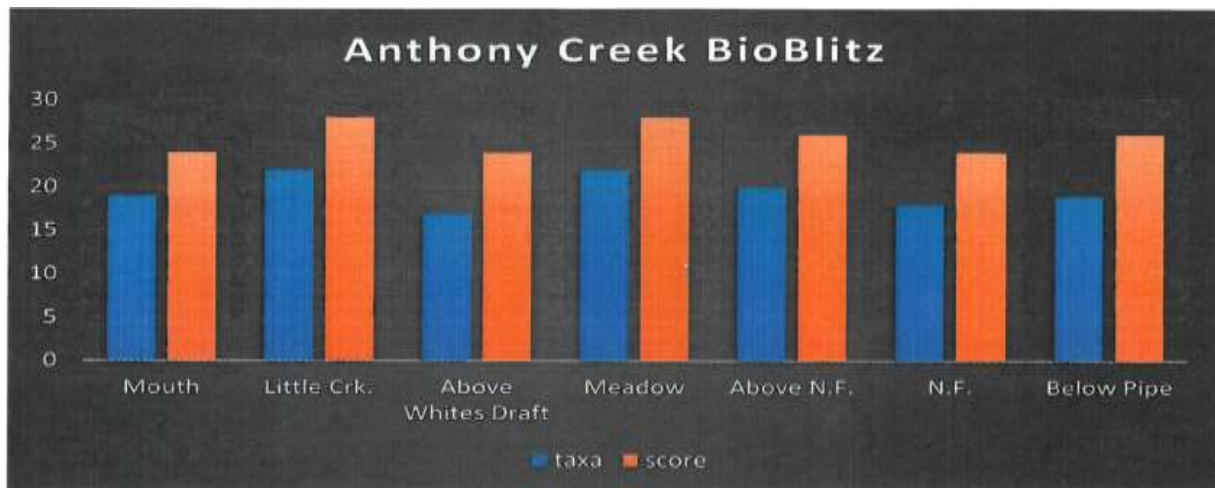
Figure 19. Findings throughout the watershed showing the site, stream score and taxa. The majority were in the suboptimal – optimal range.
