Elkhorn Creek Diesel Spill Study Design

Study Purpose

The purpose of the study is to examine the impacts of the diesel fuel spill on the benthic macroinvertebrate community in the effected area.

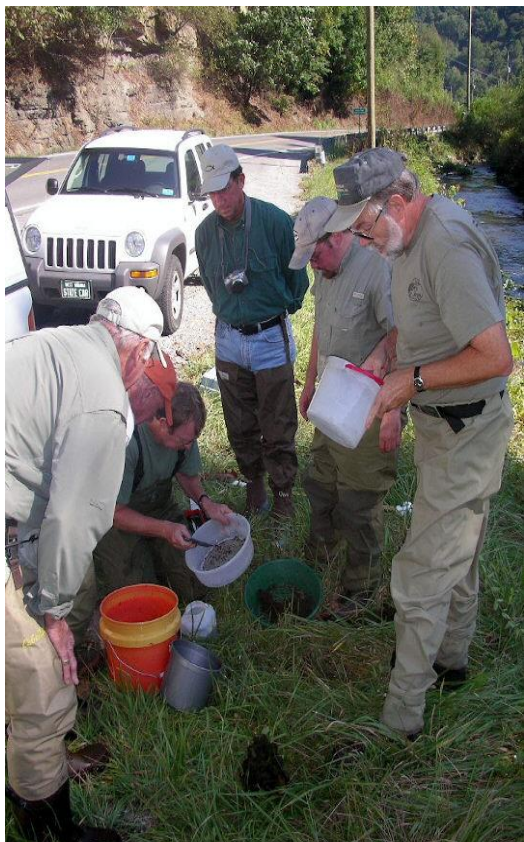
Project teams performs macroinvertebrate sorting and counting at the reference site

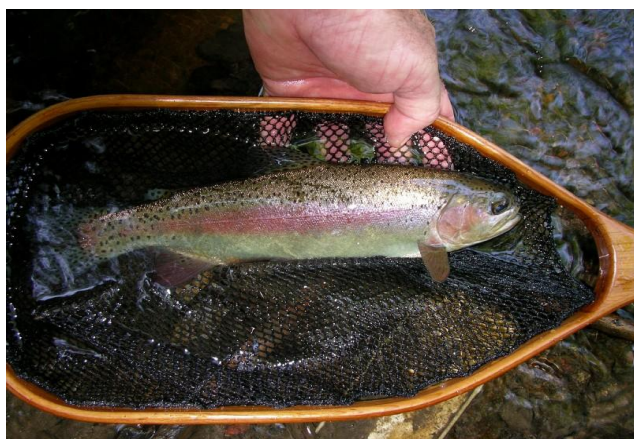
Fish were observed again at the impact site about one month after the spill.
