Kanawha Valley “Blue Haze” Incident of July 11, 2008

West Virginia
Department of Environmental Protection
Division of Air Quality

January 23, 2009

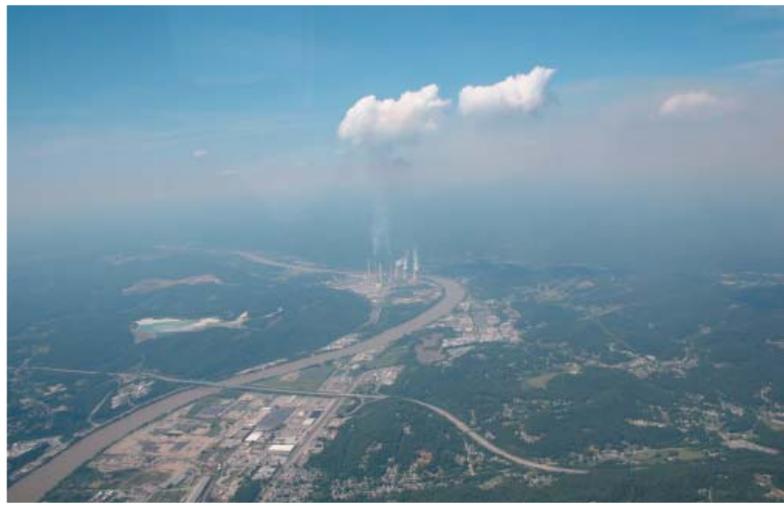
1. View of John E. Amos Power Plant (Amos plant), owned by American Electric Power Co. and operated by subsidiary Appalachian Power Co., taken from a state helicopter approximately above the Nitro-St. Albans area. For reference, note that the left-most stack from which blue smoke exhausts—the second stack from the left—is approximately 1,000 feet tall. Note, too, that the two large white cumulus clouds are not directly over the plant, but closer to the helicopter than the plant. Photograph taken at approximately 3:37 p.m. Eastern Daylight Time (EDT) July 11, 2008.

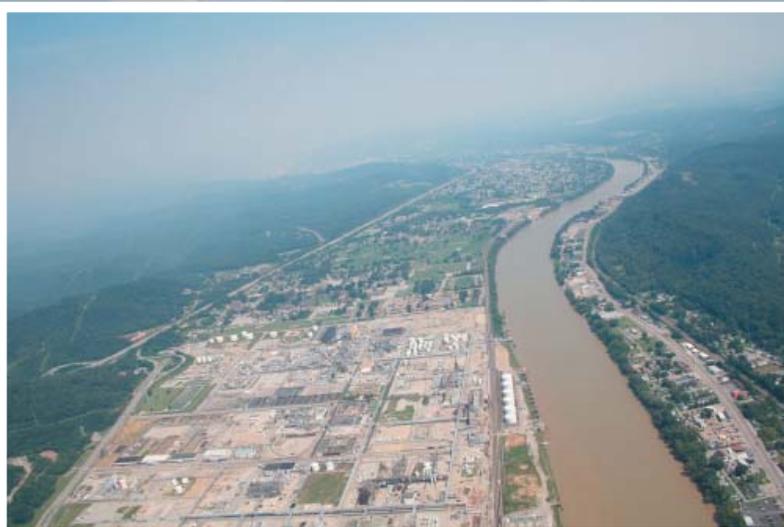
3. Looking east-southeast from above Nitro. Bayer CropScience in Institute is in the left foreground. South Charleston and Charleston are in the upper right quadrant of the photograph. The Amos plant is outside the frame of the photograph, southwest of the center of the photograph. Photograph taken at approximately 3:34 p.m. EDT July 11, 2008.

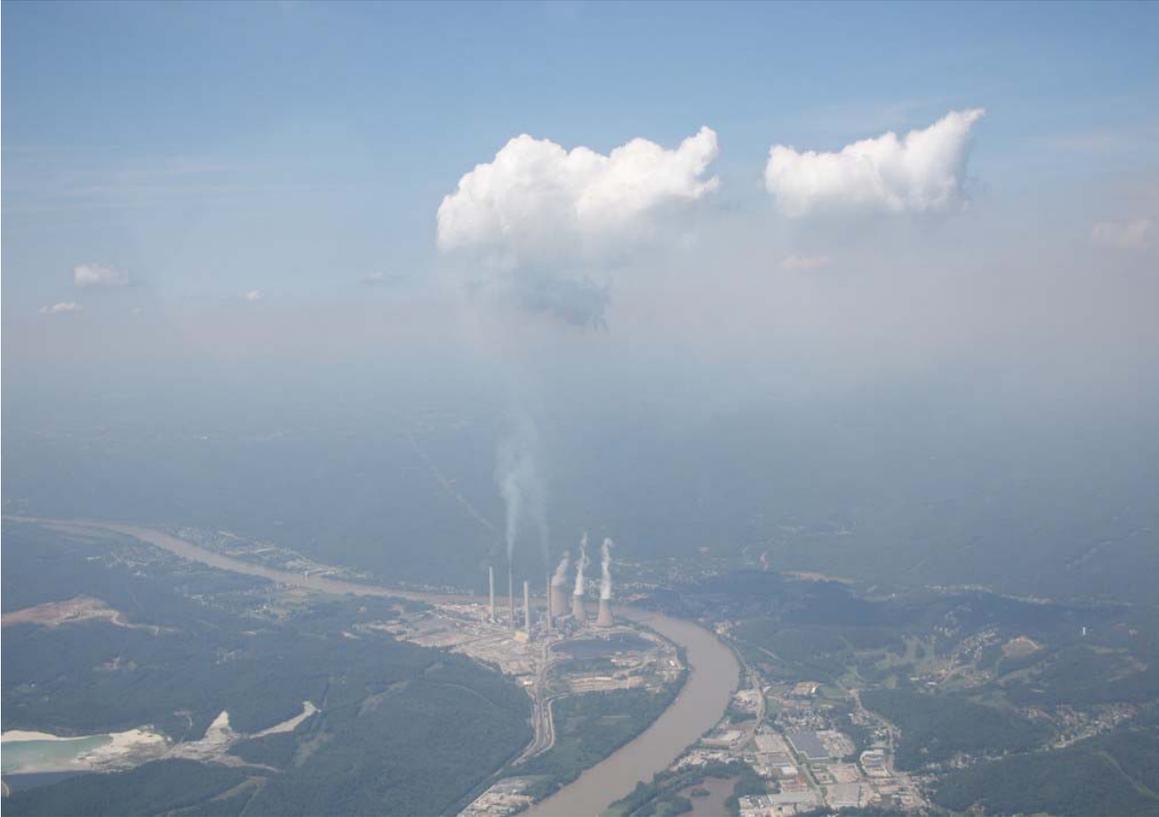
Photograph ES-1. View of Amos power plant taken from a state helicopter, approximately above the Nitro-St. Albans area. For reference, note that the left-most stack from which blue smoke exhausts—the second stack from the left—is approximately 1,000 feet tall. Note, too, that the two large white cumulus clouds are not directly over the plant, but closer to the helicopter than the plant. Photograph taken at approximately 3:37 p.m. EDT.

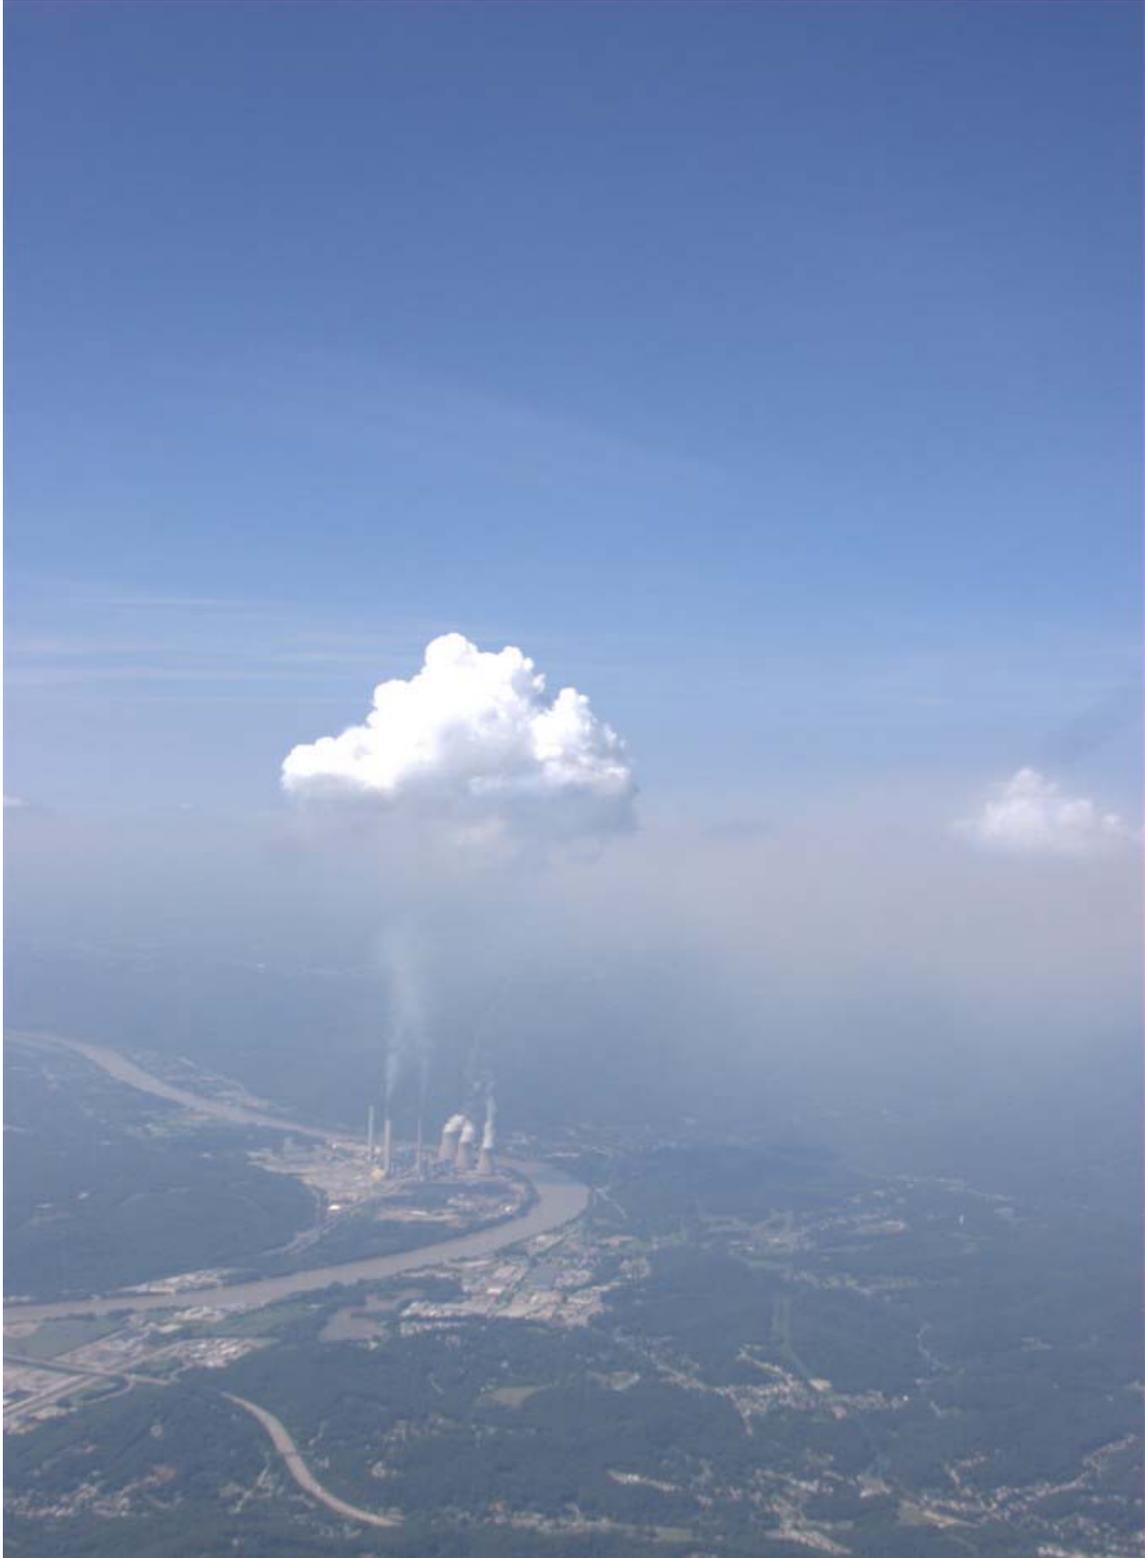
Photograph 1-1. View of Amos power plant taken from a state helicopter, approximately above the Nitro-St. Albans area. For reference, note that the left-most stack from which blue smoke exhausts—the second stack from the left—is approximately 1,000 feet tall. Note, too, that the two large white cumulus clouds are not directly over the plant, but closer to the helicopter than the plant. Photograph taken July 11 at approximately 3:37 p.m. EDT.

Photographs 1-1 and 1-2 show, respectively, their view that afternoon of the Amos plant and the inversion layer.

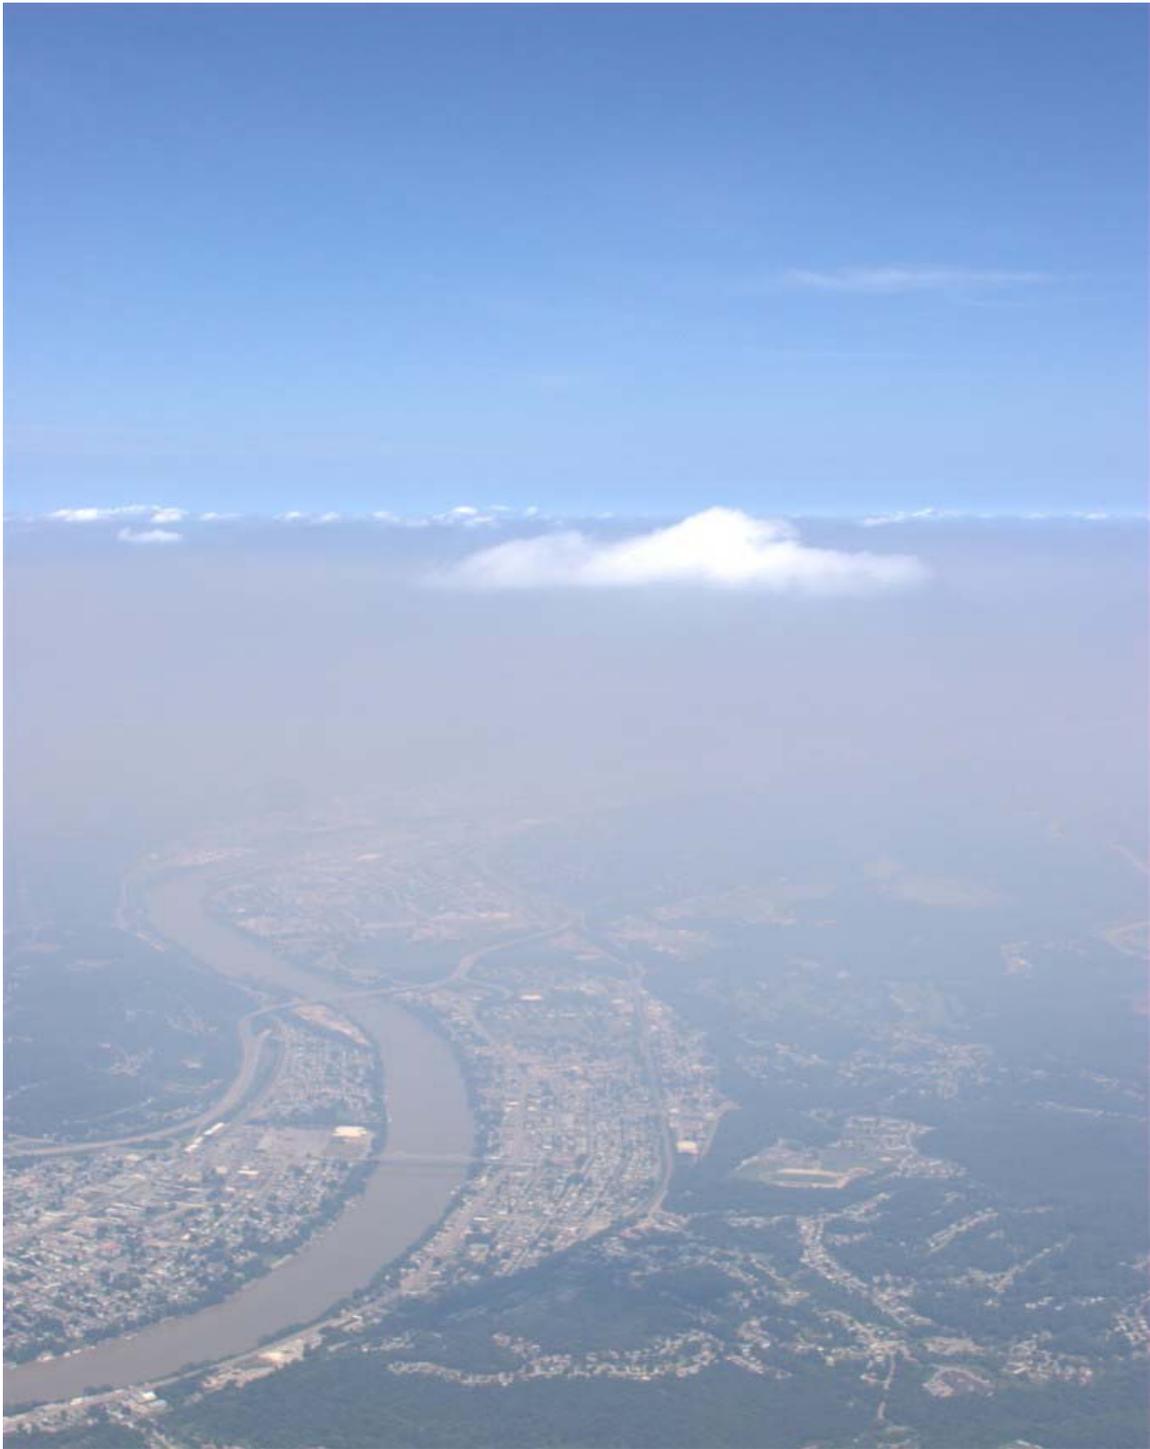
Photograph 1-2. Looking north of east from above Institute. Note Bayer CropScience in the extreme left-bottom corner; Interstate 64 runs from the left-bottom quadrant to the right-center; and South Charleston is at right center. Photograph taken July 11 at approximately 3:41 p.m. EDT.

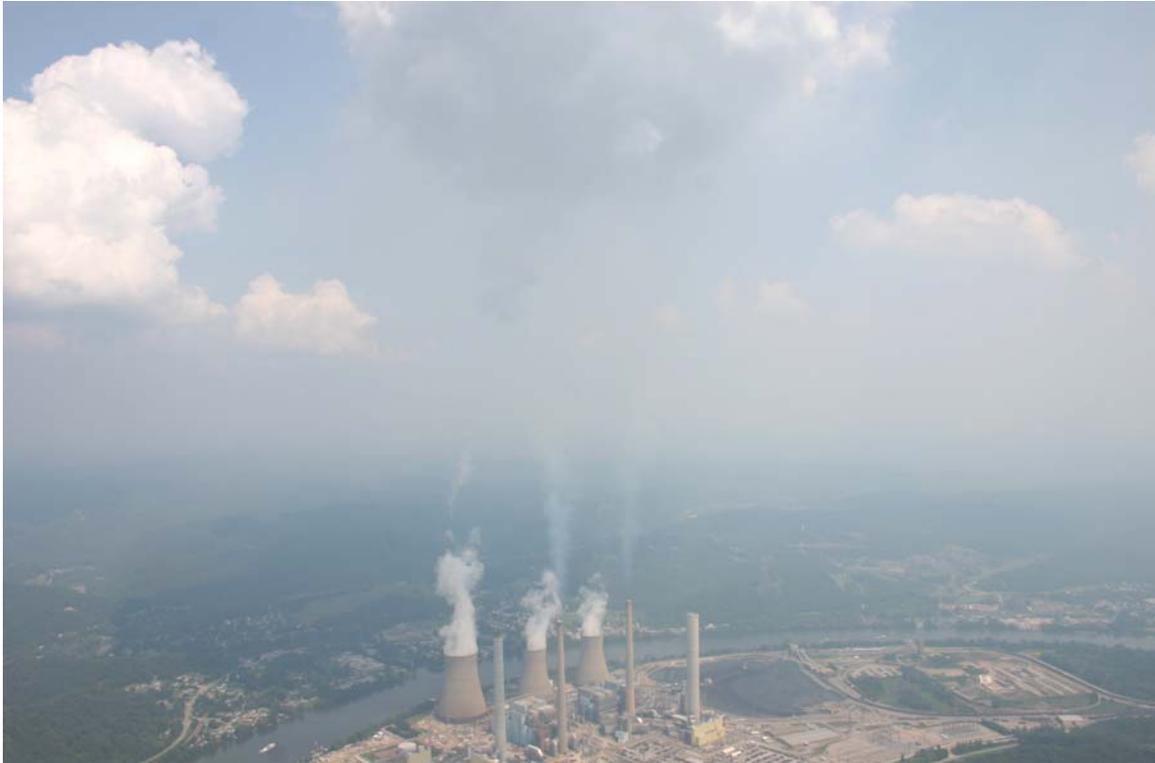
Photograph 1-3. Looking north-northeast from above the Winfield area. Steam is being emitted from the cooling towers. Of the four small stacks, the two outside ones are, respectively, the new one for Unit 3 and the new one for Units 1 and 2 combined. They will go in service when the new wet-flue-gas-desulfurization, or wet FGD, scrubbing units go online. The two inner taller stacks are respectively, from left to right, for Unit 3 and for Units 1 and 2 combined. Photo taken July 29 at approximately 3:15-3:20 p.m. EDT.

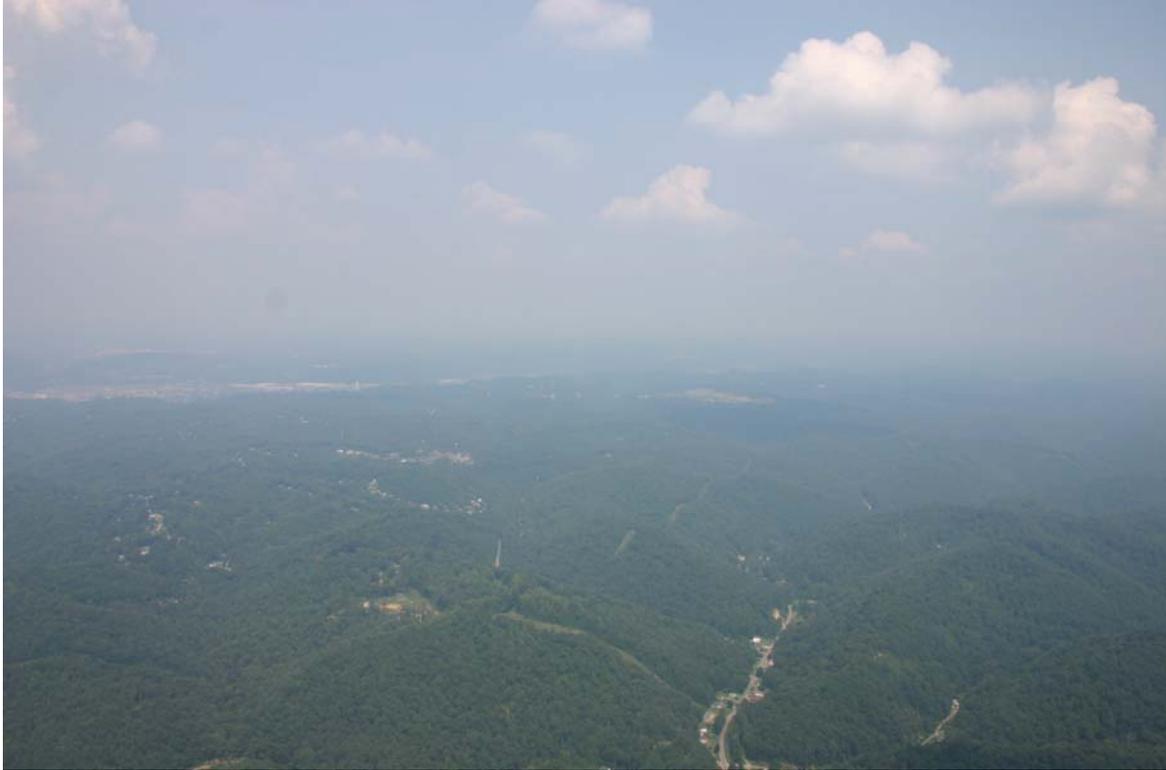
Photograph 1-4. Looking-northeast toward Kanawha City from above the Davis Creek area, which is east of Southridge. Photo taken July 29 at approximately 3:50 p.m. EDT.

- Two ground teams went into the St. Albans-Nitro area. The first left DEP headquarters in Kanawha City at approximately 1:49 p.m. EDT.
- The aerial team departed Yeager Airport at approximately 2:30 p.m. in a state helicopter. It flew to Poca, circled the Amos plant twice, then flew east-southeast to St. Albans. It hovered there briefly before proceeding upriver near South Charleston, then to the Southridge area. From there, the helicopter flew to the air space above Exit 95 on Interstates 64 and 77 in Kanawha City. Then the aircraft turned westerly to Yeager Airport, arriving there at approximately 3:30 p.m. EDT. Photographs 1-3 and 1-4 show, respectively, an aerial view of the Amos plant and the area east and northeast of Charleston.

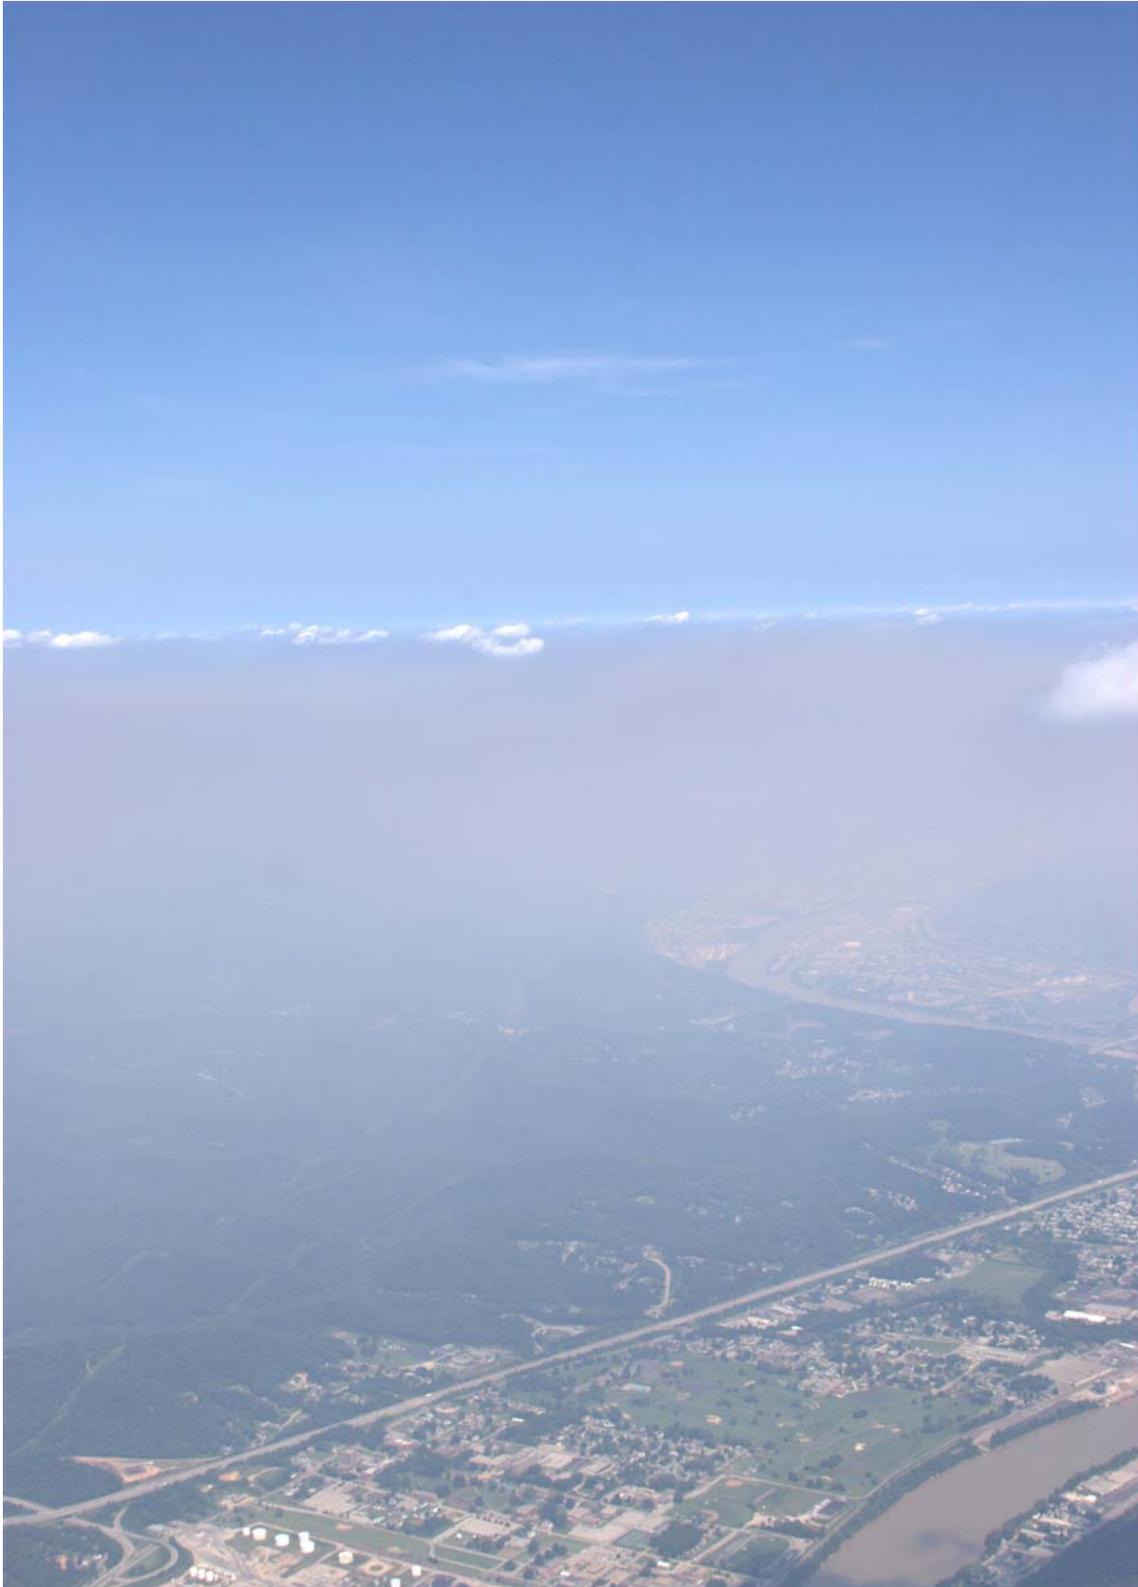
Photograph 2-1. Looking north of east from above Institute. Note Bayer CropScience in the extreme left-bottom corner; Interstate 64 runs from the left-bottom corner to the right-bottom quadrant; and South Charleston is at right center. Photograph taken at approximately 3:41 p.m. EDT.

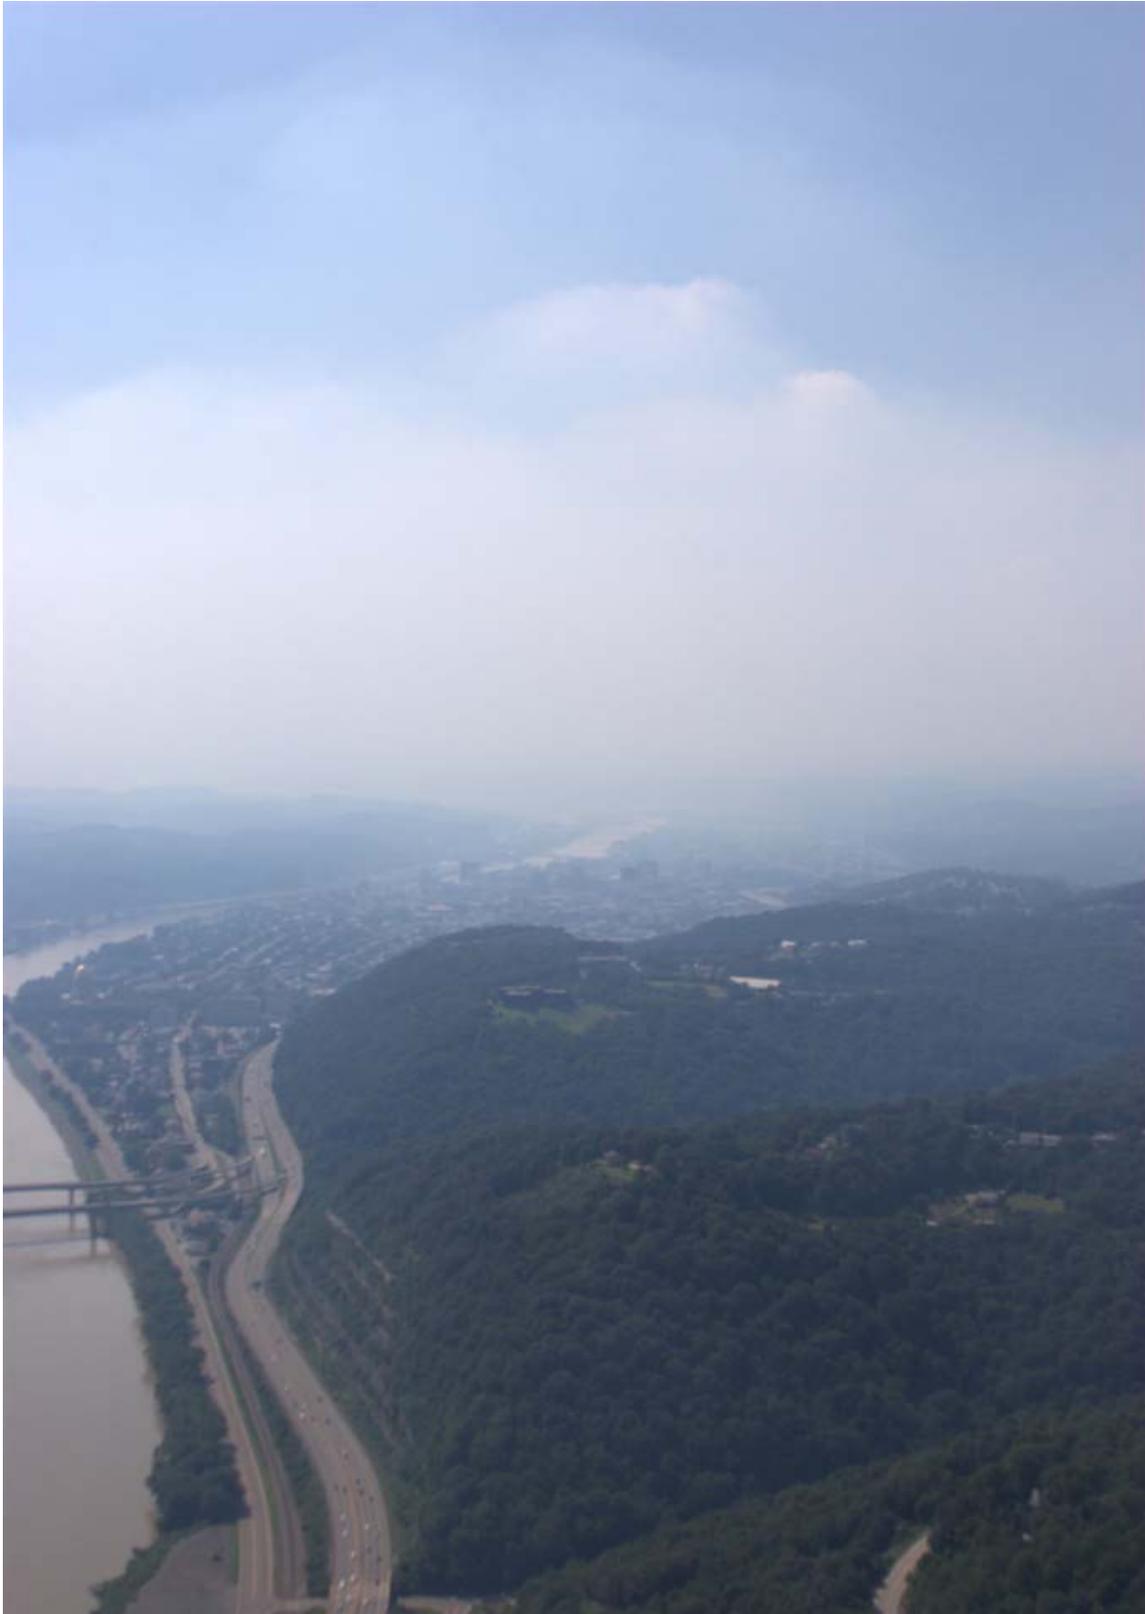
Photograph 2-2. Looking east of Charleston, toward South Charleston. The 36th and 35th Street bridges are in the left foreground, with the 36th being closer. The Kanawha River runs along the lower left quadrant until left center, when it turns diagonally toward the upper right-hand corner of the photograph. Photograph taken at approximately 3:58 p.m. EDT.

Photograph 2-2, one of the last photographs taken before the helicopter landed at Yeager, shows the downriver perspective at approximately 4 p.m. EDT. Note in the left foreground are the 36th and 35th Street bridges, as well as Interstates 64 and 77.

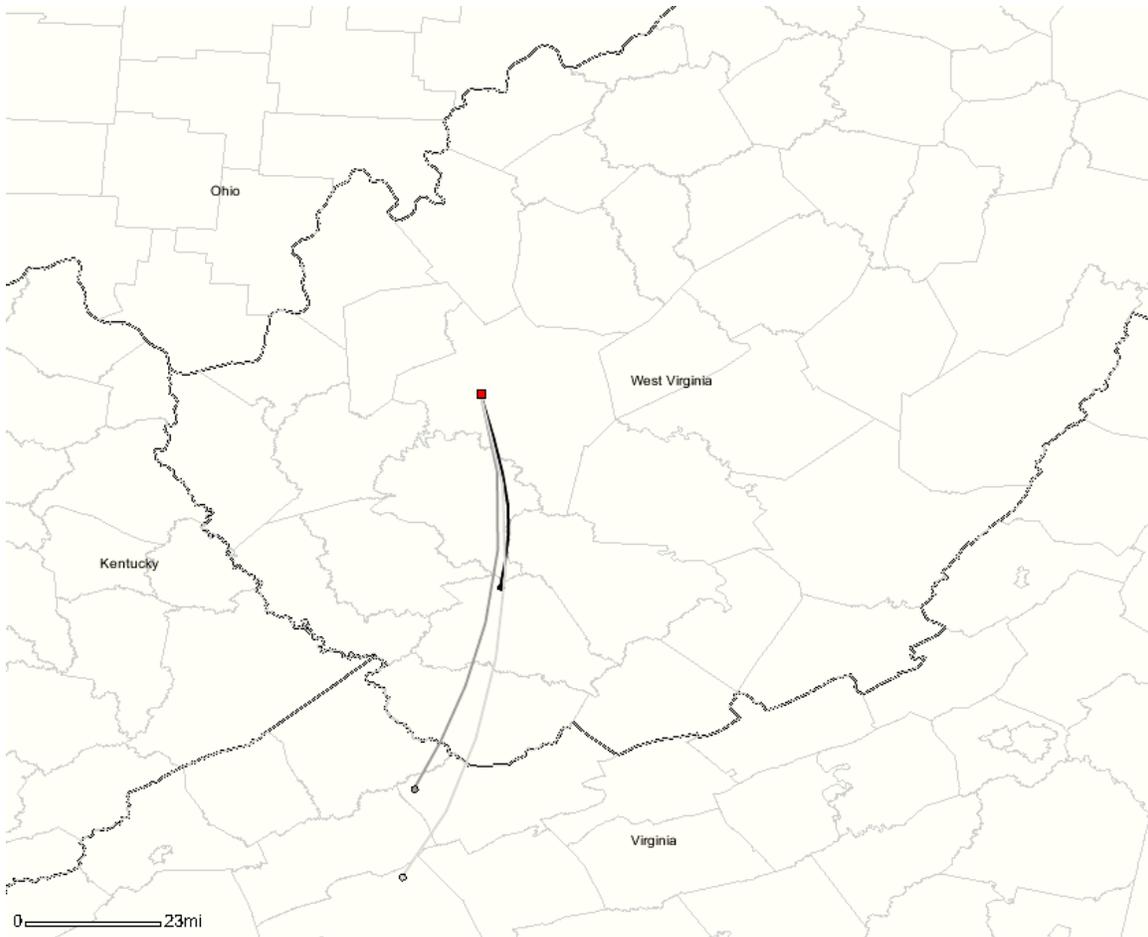
- The curved lines represent the trajectory or path of air moving across the region
- The red square dot to the left of "West Virginia" on the figure is Charleston
- The figure presents trajectories at three different elevations above ground level:
 - The darkest line represents 1,000 meters; or 3,281 feet of altitude
 - The next-darkest line represents 1,500 meters; or 4,921 feet of altitude

- The lightest line represents 2,000 meters; or 6,562 feet of altitude

- The lines south of Charleston, called forward-trajectories and extending into southern West Virginia and southwestern Virginia, represent a single six-hour interval. It begins at 11 a.m. Eastern Standard Time (EST)—or noon EDT—in Charleston to 5 p.m. EST (6 p.m. EDT)

Fig. 3-1. Forward trajectories of regional air flow over Charleston on July 11, 2008. Source: EPA AIRNow-Tech. The darkest line represents 1,000 meters (m) above ground level (AGL); the next-lightest, 1,500 m AGL; and the lightest, 2,000 m AGL.

Given the observations made during the aerial reconnaissance on July 11 by DAQ staff, as well as the satellite photograph of the Kanawha Valley, DAQ believes the data presented graphically in Fig. 3-1 confirm that the Amos plant emissions caused the haze incident.

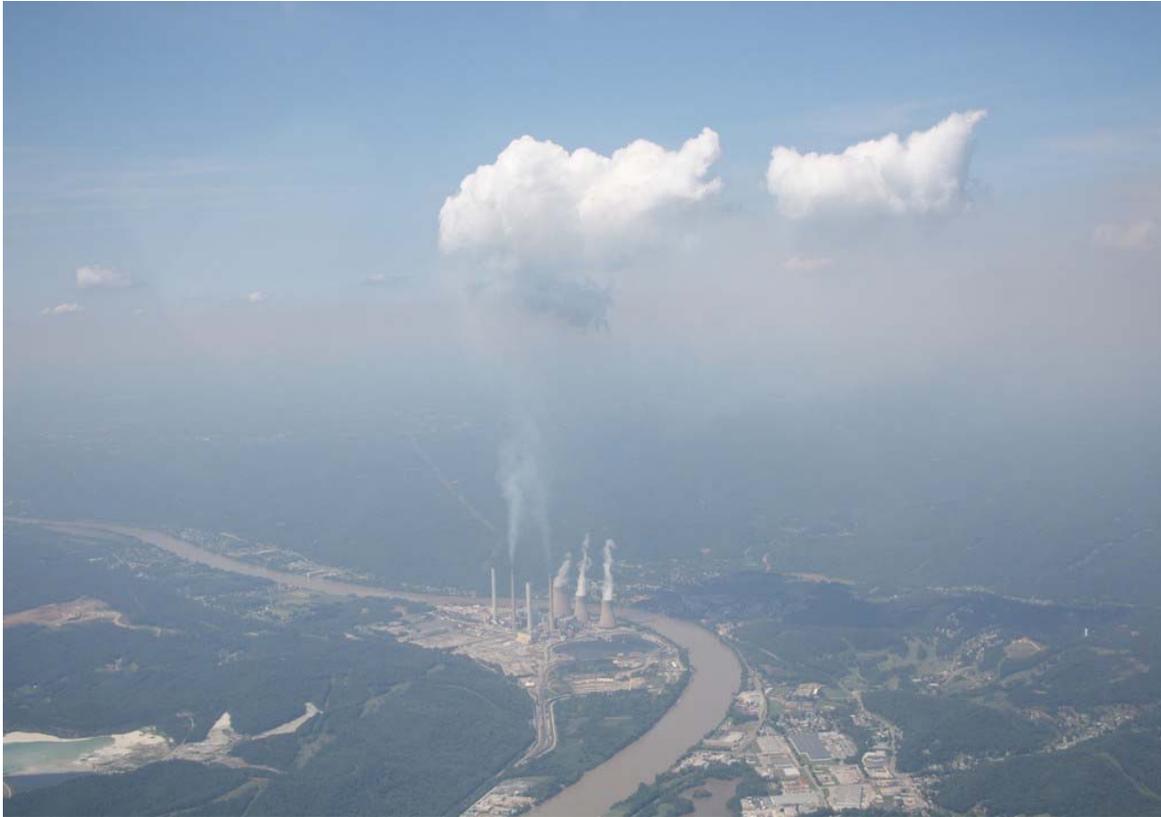
Photograph 3-2. View of Amos power plant taken from a state helicopter, approximately above the Nitro-St. Albans area. For reference, note that the left-most stack from which blue smoke exhausts—the second stack from the left—is approximately 1,000 feet tall. Note, too, that the two large white cumulus clouds are not directly over the plant, but closer to the helicopter than the plant. Photograph taken at approximately 3:37 p.m. EDT.

The first, Photograph 3-2, shown earlier as photograph ES-1, gives a perspective of the upper air flow and the top of the inversion layer.

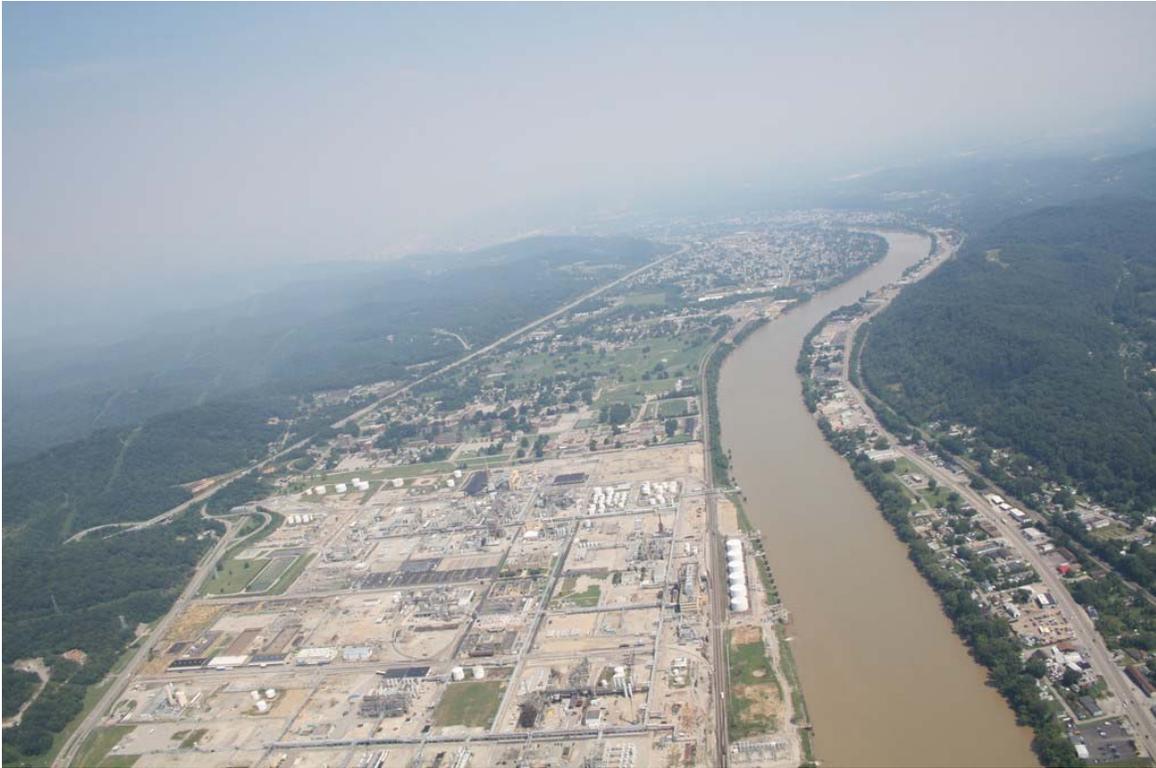
- In that photograph, to the left of the aircraft en route to Amos plant, a distinctly noticeable vertical boundary exists at the edge of the denser whitish cloud moving from the Amos plant—off the frame, to the left-center—to the south-southeast
- On the photograph, that line extends from the extreme left-center edge to approximately the upper right-hand corner

Photograph 3-3. Looking east-southeast from above Nitro. Bayer CropScience in Institute is in the left foreground. South Charleston and Charleston are in the upper right quadrant of the photograph. The Amos plant is outside the frame of the photograph, southwest of the center of the photograph. Note the Amos plume's edge, shown at leftmost center and running in an approximate straight line to rightmost corner. Photograph taken at approximately 3:34 p.m. EDT.

The second, Photograph 3-3, was taken above Institute at approximately the Bayer CropScience facility. Note that the Amos plant would be behind the aircraft, to its left.
