**CONSENT ORDER  
ISSUED UNDER THE  
WATER POLLUTION CONTROL ACT  
WEST VIRGINIA CODE CHAPTER 22, ARTICLE 11**

ORDER NO.: 10413

## Warm Springs PSD Photo Log

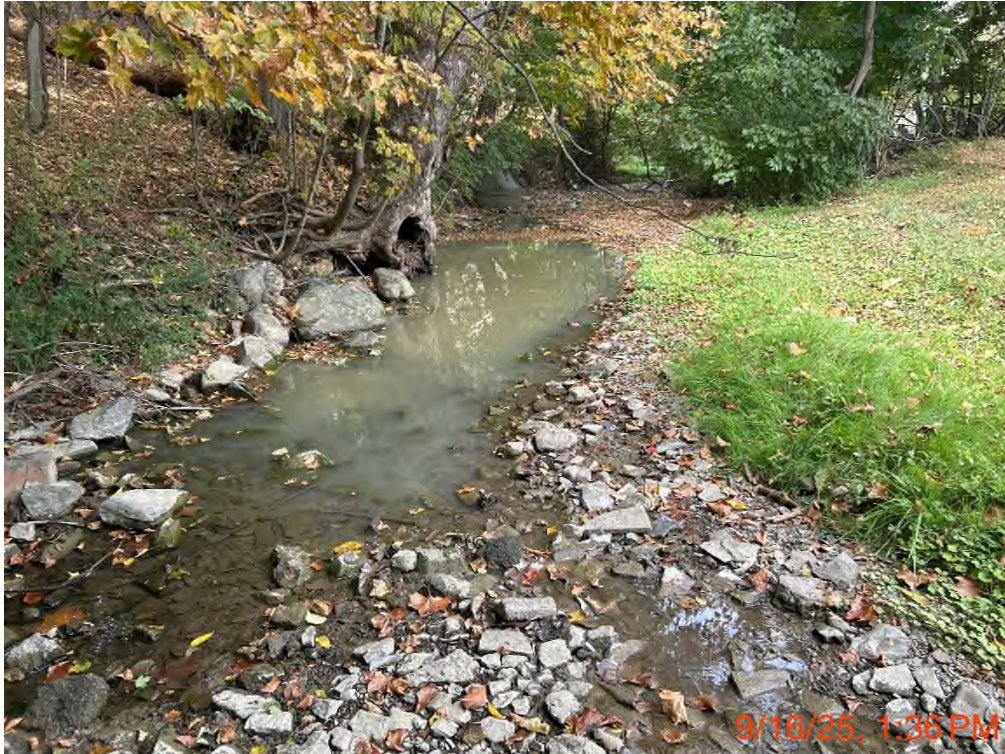
9/16/25

Conditions not allowable in Warm Springs Run.

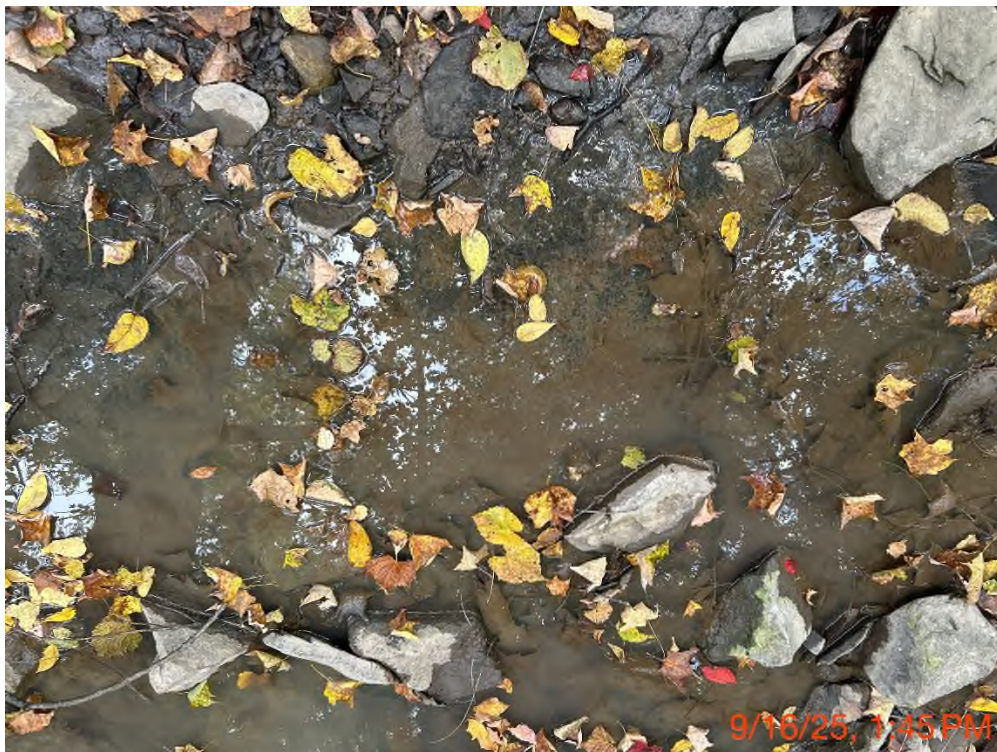
project, in response to a complaint regarding a fish kill (Spill Report No. 33-9162509). During the investigation, WVDEP personnel determined that sewage from a pump-around hose had been drained into Warm Springs Run on the previous day. In addition, violations of the following sections of the WV/NPDES Permit for Stormwater Associated with Construction Activities and WV Legislative Rules were observed and documented:

Sewage in Warm Springs Run from draining hoses.

Guyer Brother, Inc. took immediate action to prevent the spill any further by mending their failed temporary bypass pumping connection as well as beginning immediate cleanup operations.

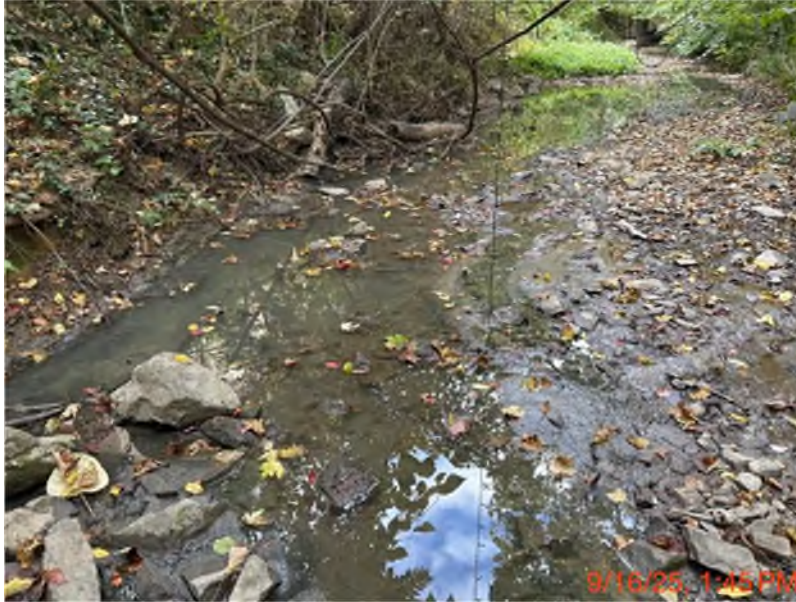
Sewage in Warm Springs Run from draining hoses.

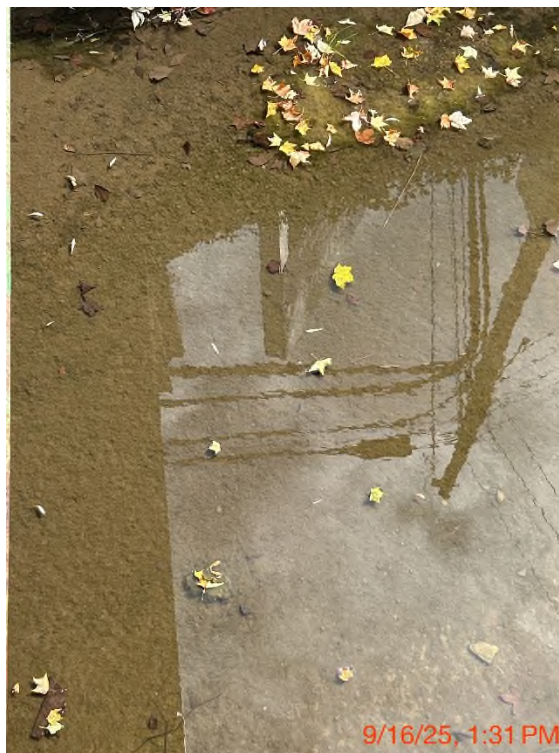
Dead fish in Warm Springs Run.

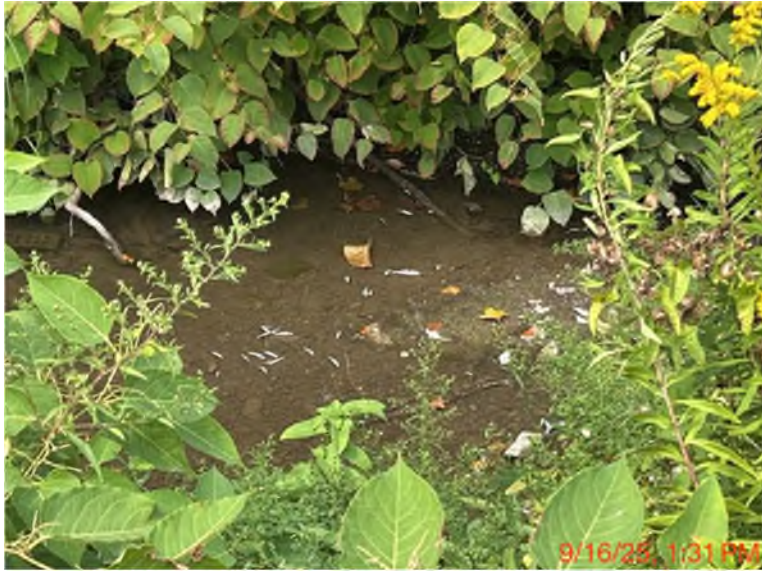
Dead fish in Warm Springs Run.

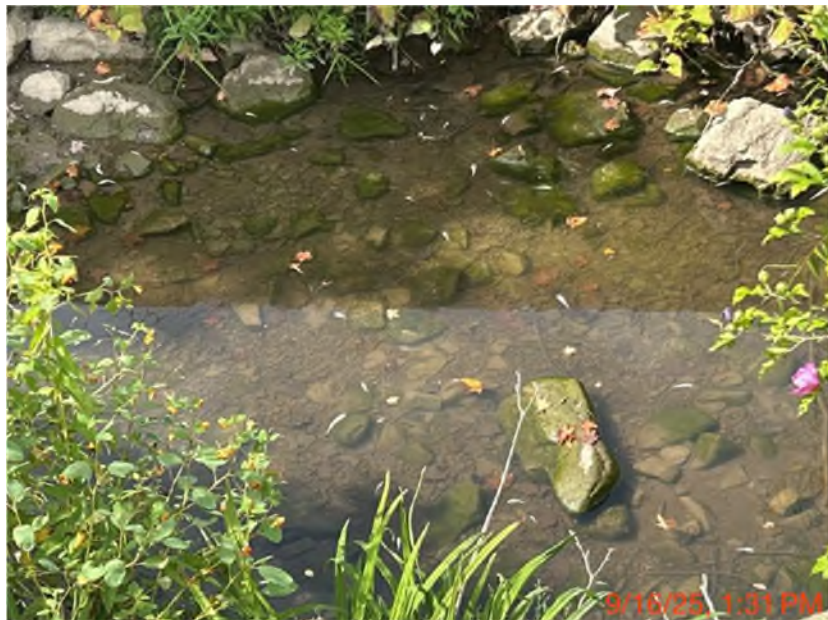
Dead fish in Warm Springs Run.

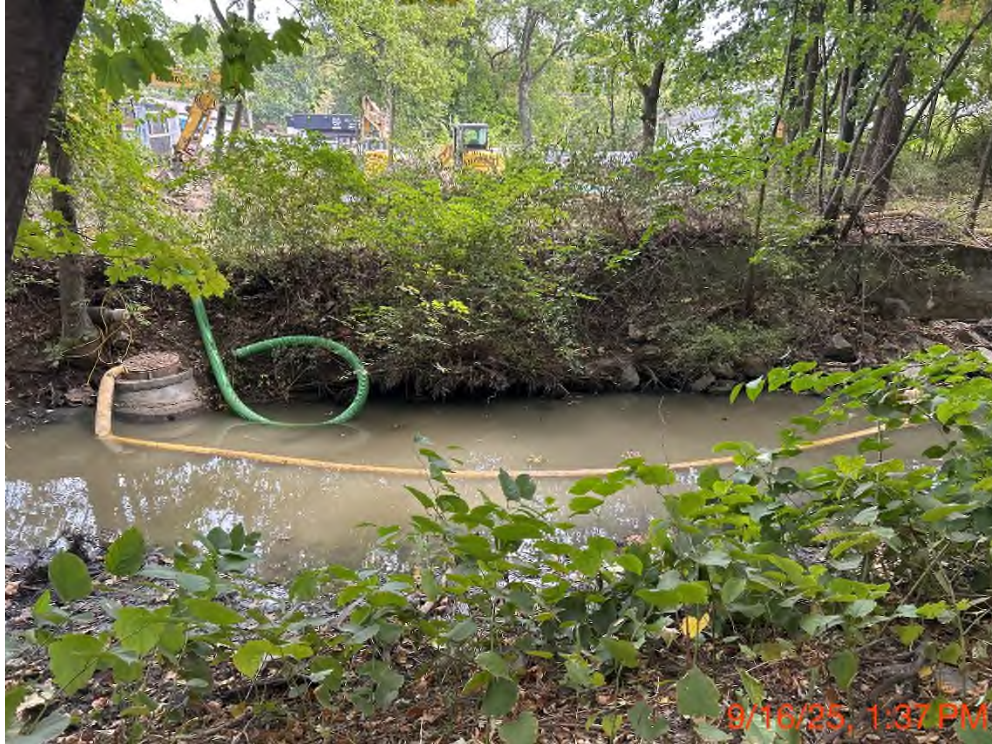
The sewer pump-around.

1. Replaced bypass pump hoses and gaskets that showed signs of wear. 11/18/2025
2. Discharged pump hoses into manholes that were outside the waterway when possible and added protection of silt socks between the hoses and stream in case of failure in the equipment. 11/18/2025 to completion on May 29, 2026.
3. Had a Vac Truck on-site at all times for use in the event of a spill. 11/18/2025 to completion on May 29, 2026.
4. Trained crew members on how to properly connect bypass hoses, proper pump set up, inspection of hoses and gaskets, how to identify failing equipment and emergency shutdown and containment procedures. 11/18/2025 to completion on May 29, 2026.
5. Had daily meetings and refreshers with crew regarding the above procedures. 11/08/2025 to completion on May 29, 2026.

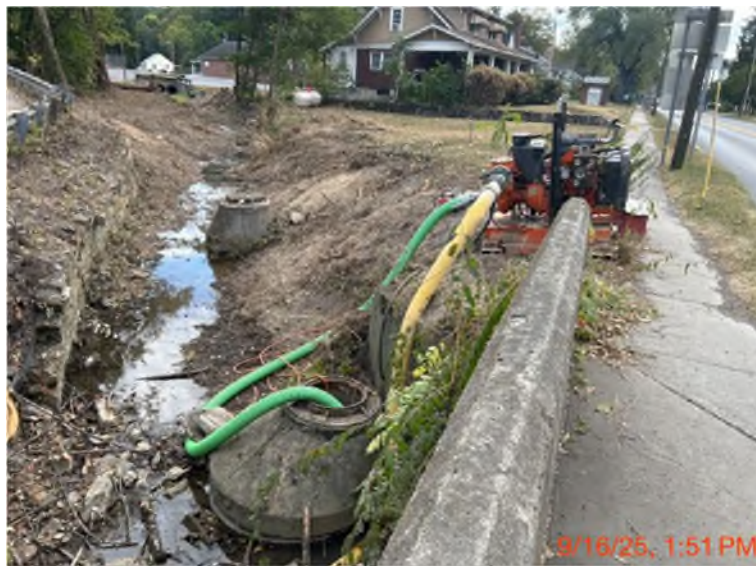
Sewer pump-around with no erosion and sediment controls in place.

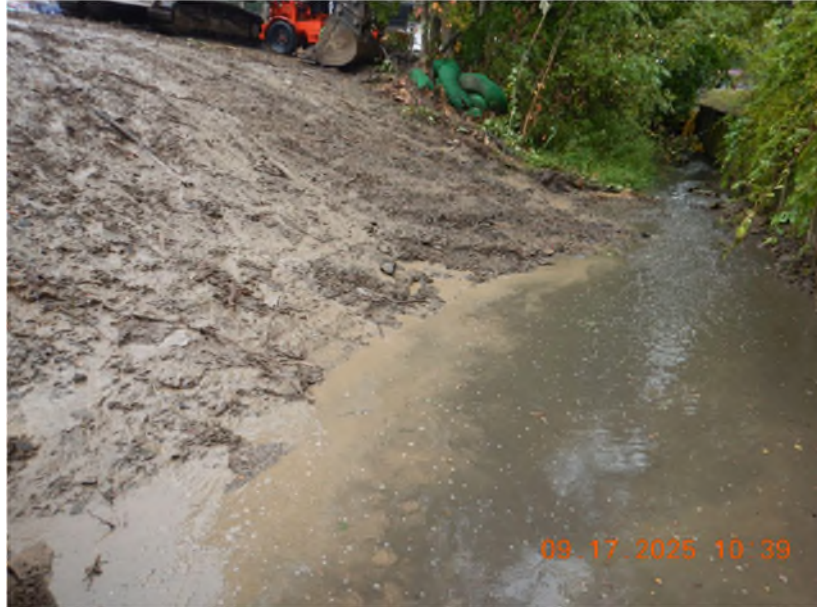
Sediment-laden water discharging into Warm Springs Run, due to BMPs not being installed or operated/maintained correctly.

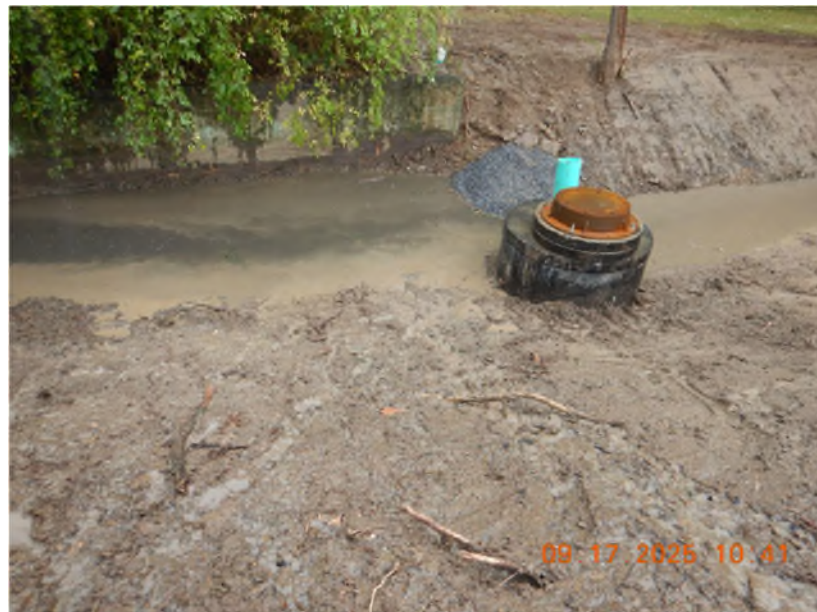
Sediment-laden water discharging into Warm Springs Run, due to BMPs not being installed or operated/maintained correctly.

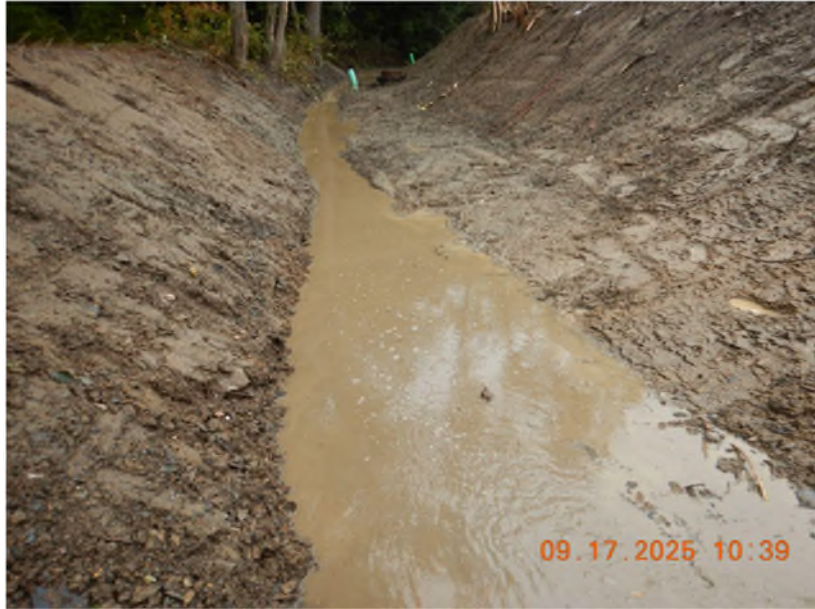
Sediment-laden water discharging into Warm Springs Run, due to BMPs not being installed or operated/maintained correctly.

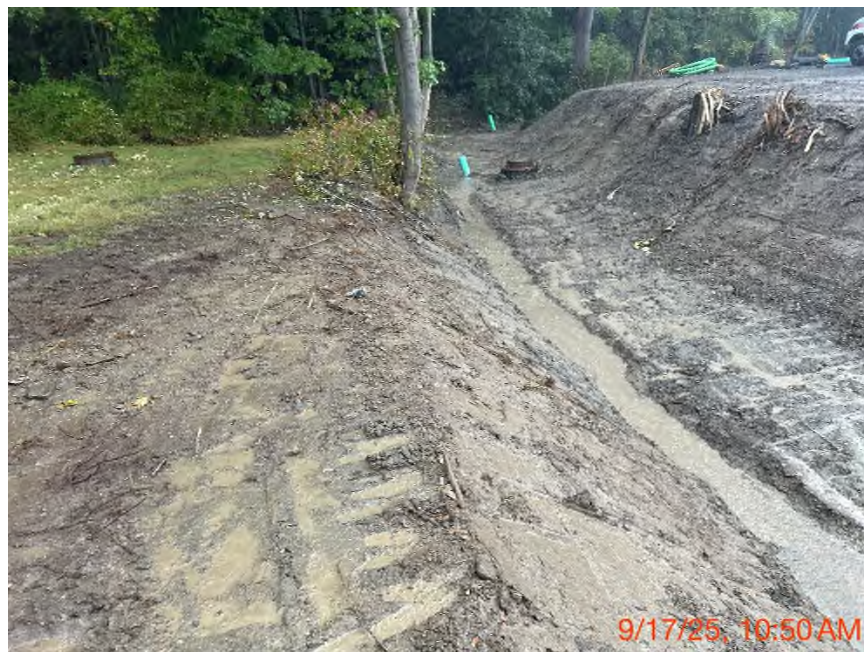
Conditions not allowable in Warm Springs Run. No erosion and sediment controls were in place.

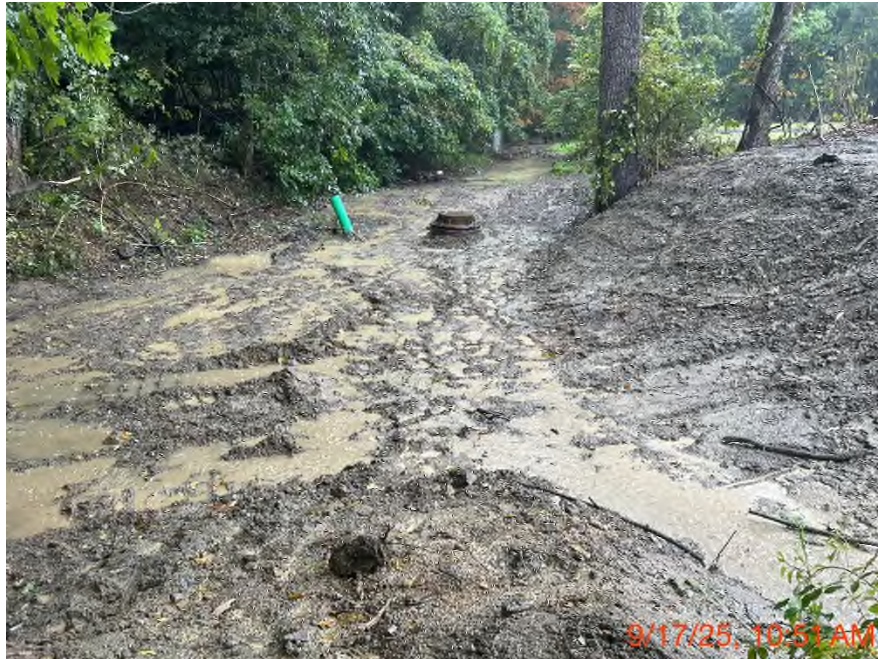
Conditions not allowable in Warm Springs Run. No erosion and sediment controls were in place.

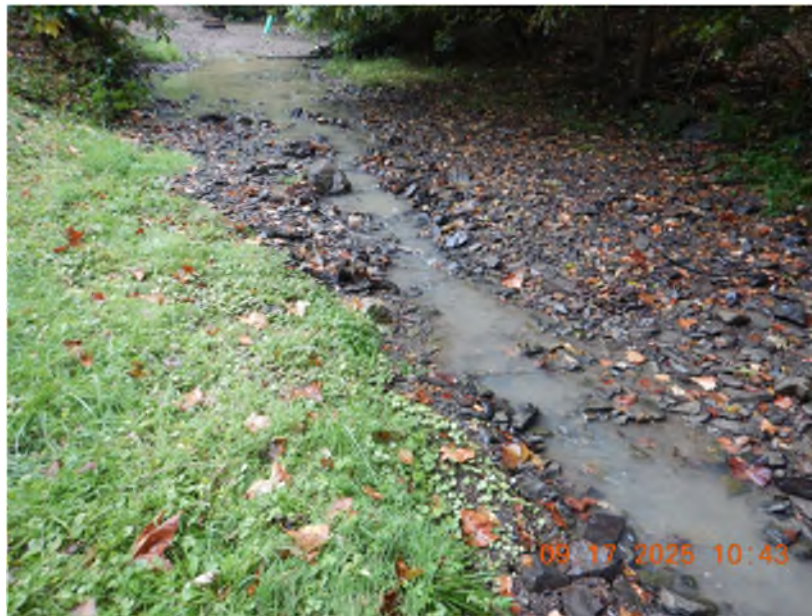
Offsite conditions not allowable in Warm Springs Run.

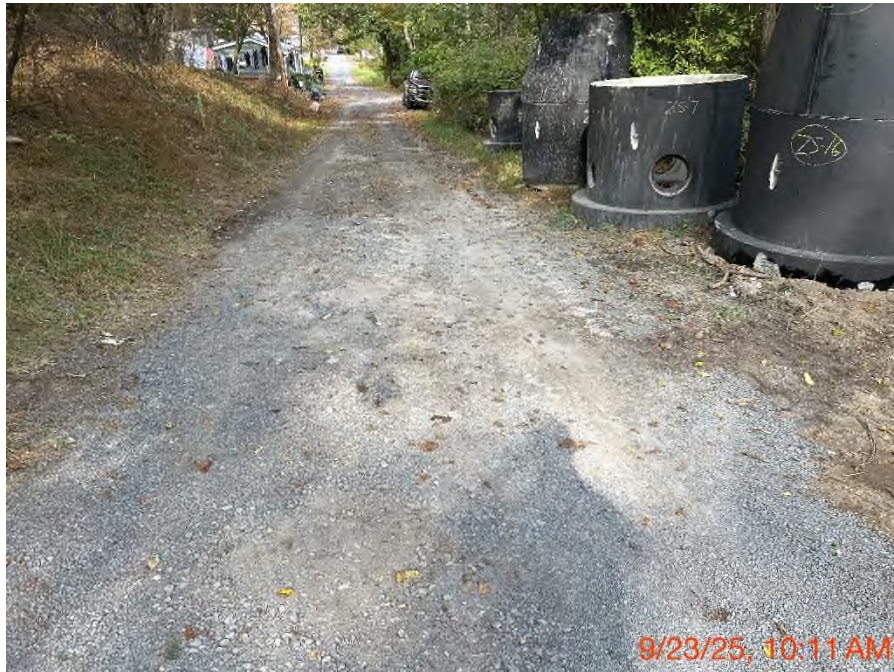
9/23/25

- 4. On September 23, 2025, WVDEP personnel conducted a partial inspection of the sanitary system improvement project, in response to a complaint. During the inspection, a violation of the following section of the WV/NPDES Permit for Stormwater Associated with Construction Activities was observed and documented:
  - a. Section I.G – Warm Springs failed to prohibit discharges of material other than stormwater. Concrete wastewater was not segregated from stormwater on the site. Concrete had been washed out onto the ground.

Concrete washout area along Biser St., beside an unnamed tributary to Warm Springs Run.

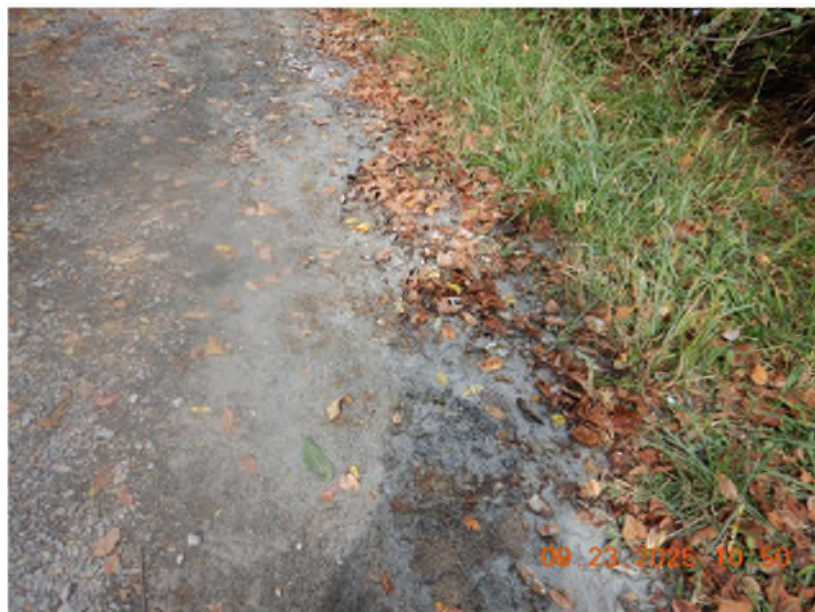
Concrete washed out onto the ground. No concrete washout control on site.

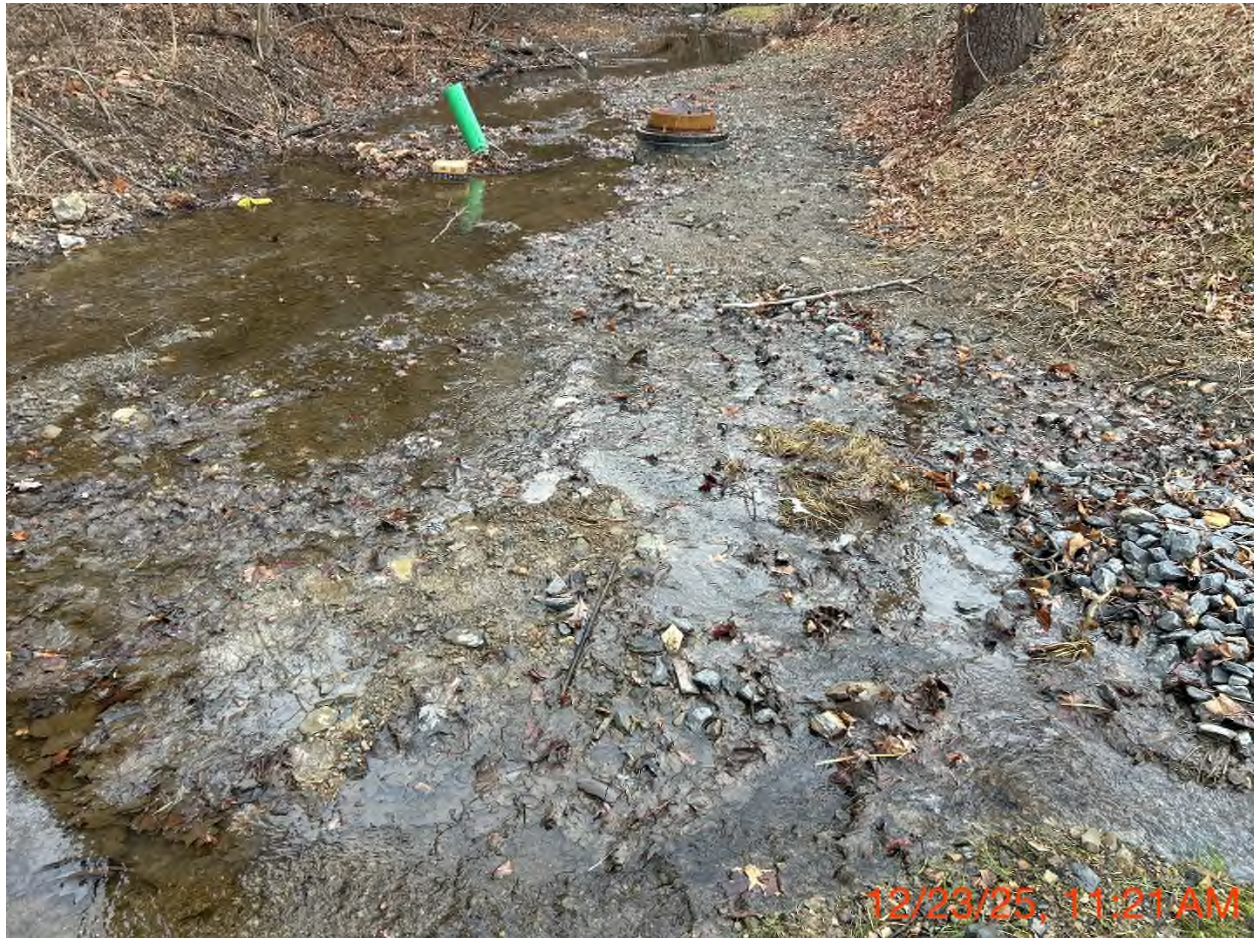
12/23/25

Continuing and/or ongoing impacts to Warm Springs Run due to the spillage of solids, as evidenced by excessive algal growth within the affected area downstream of construction activity.

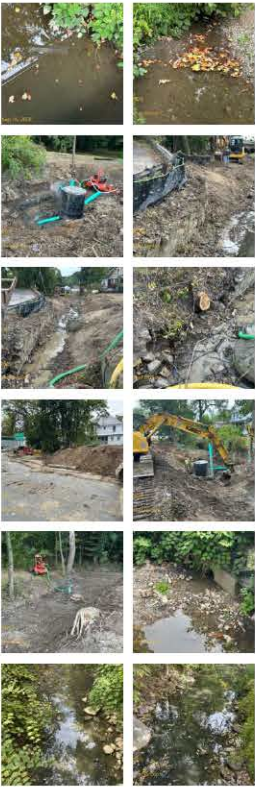
| Photo | Description | Location |
|---|---|---|
| | Guyer Brothers digging crew was onsite to install MH S-1. However due to improper pump around with the sewer system a spill occurred in the stream. A small release of sewage entered the stream. Because of this the WV Department of Environmental Protection was called and an investigation began. With the DEP on-site multiple violations were found and work was stopped until the clean up and other violations were addressed. | Sheet 1 |

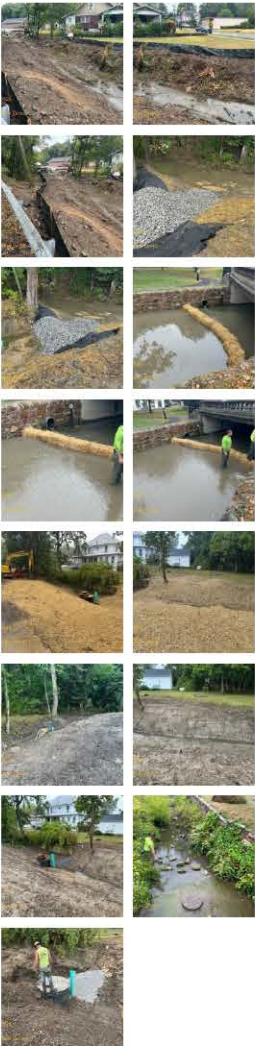
| Photo | Description | Location |
|---|---|---|
| <p>See photos attached at end of PDF</p> | <p>Guyer Brothers digging crew was onsite to continue clean up of the stream along 522. Guyer brothers also installed additional environmental controls after WVDEP recommendations. Due to rain no progress was made other than cleanup.</p> | <p>Sheet 1</p> |

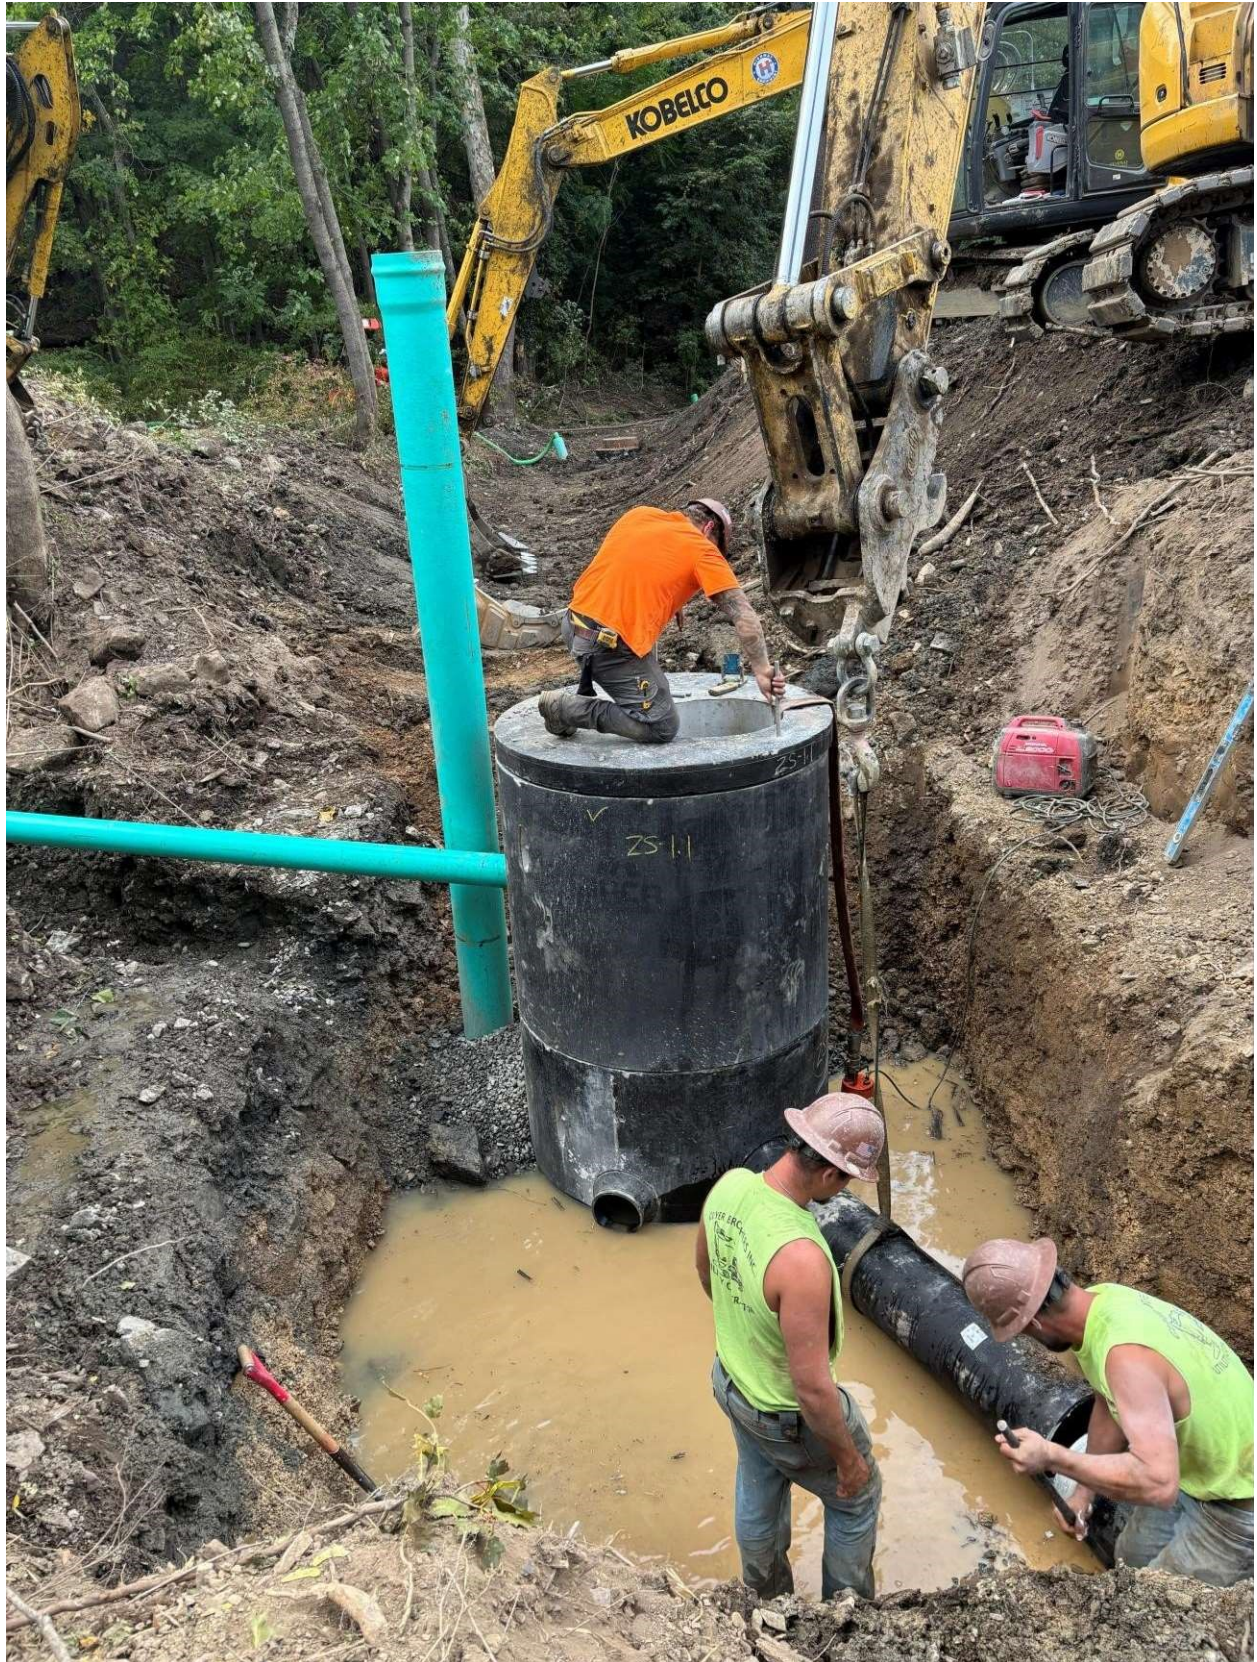
Figure 11

\*12:30 PM: The Crew worked on completing the manhole connection in the stream adjacent to the Coldwell Banker building parking lot so we could shut down the bypass and concentrate on the cleanup. While the crew was doing this, I began forming a proposed action plan. (See Fig. 11)

\*12:30 PM: The Guyer Bros. crew worked on completing the manhole connection in the stream adjacent to the Coldwell Banker building parking lot so Guyer Bros. could shut down the bypass and concentrate on the cleanup. While the crew was doing this, Jack Curley, Superintendent for Guyer Bros., began forming a proposed action plan. (See Fig. 11 in **Attachment C**).

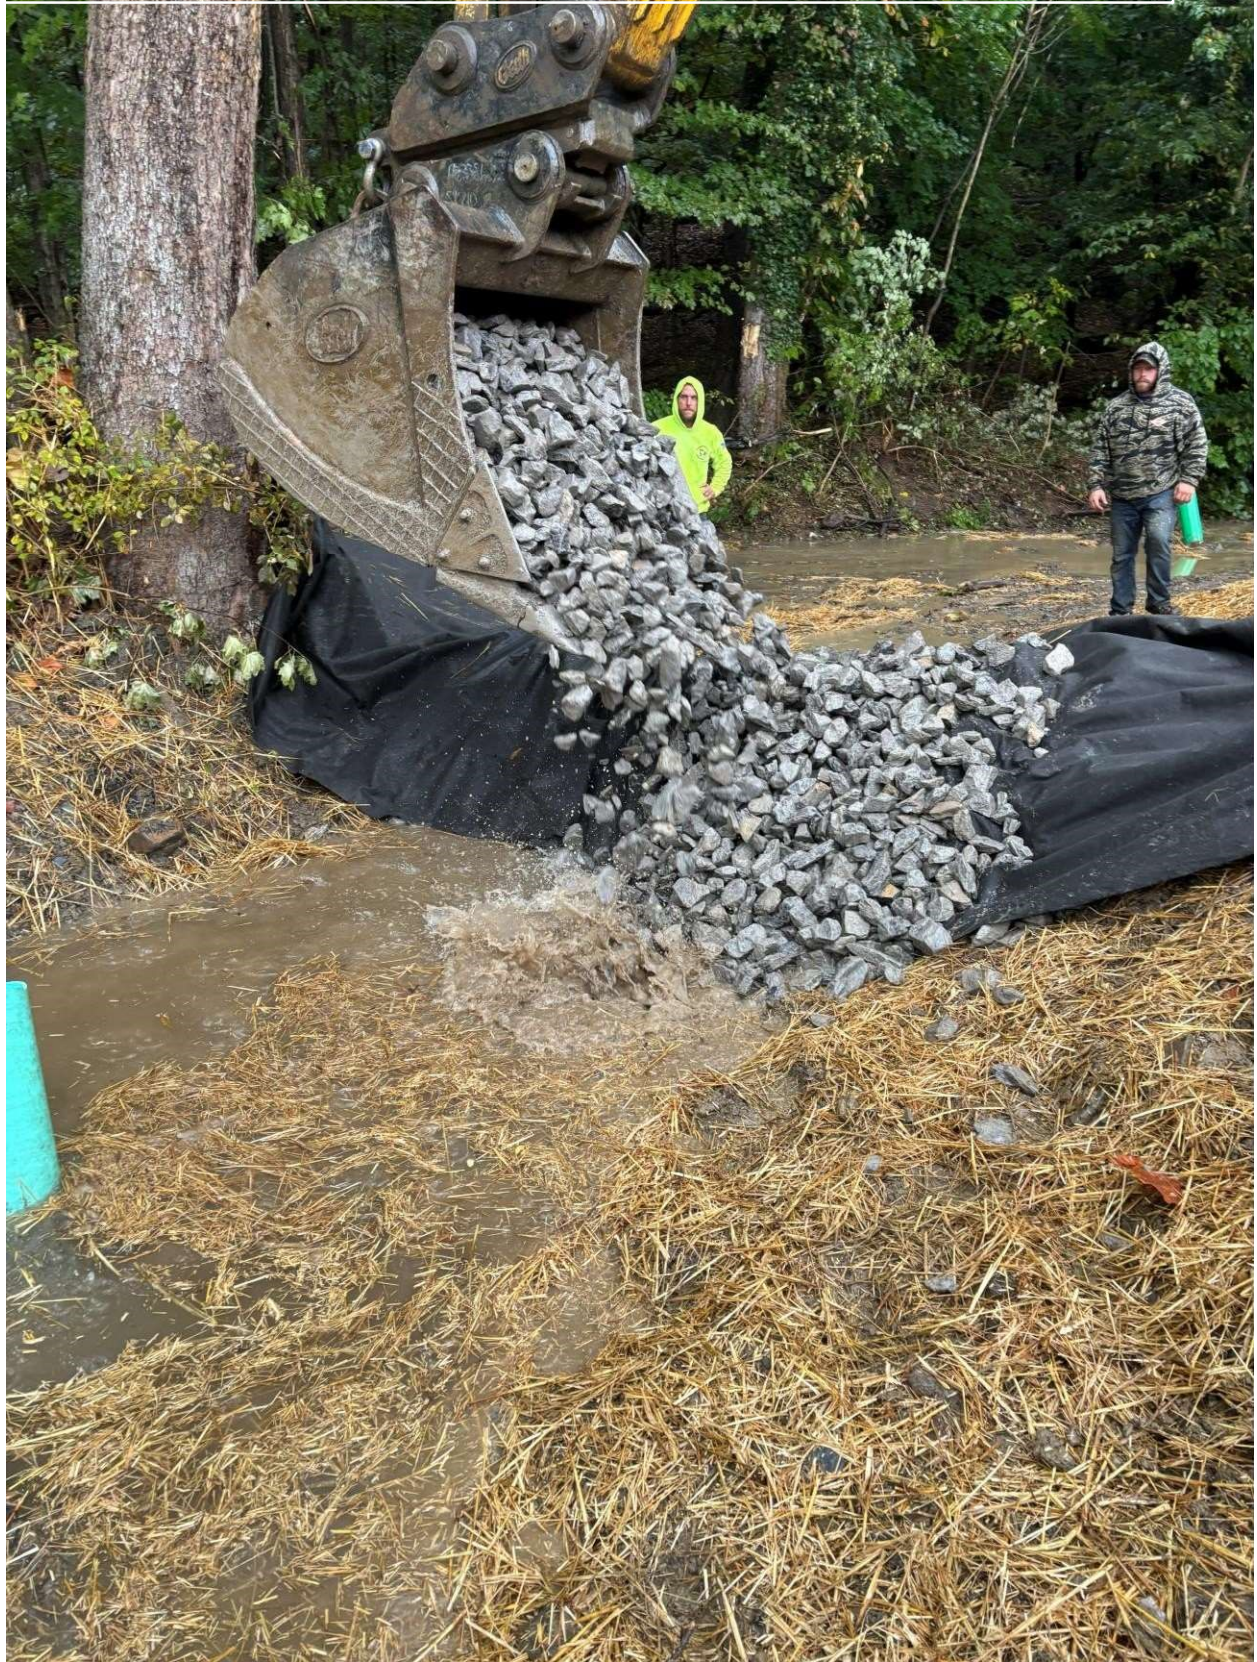
Figure 24

\*3:30 PM: I walked the lower portion of the stream through the park with representatives from the WSPSD to evaluate the effectiveness of the cleanup effort. The cleanup appeared successful, and there were no apparent signs of contamination in the stream. The Straw filter that was installed at the lower portion of the park was left in place and monitored for several days for signs of residual contaminants. There were no signs of contamination during this period and fish were observed in this portion of the stream on September 18th, 2025. (See Figures 24, 25 in **Attachment C**)
