**CONSENT ORDER  
ISSUED UNDER THE  
WATER POLLUTION CONTROL ACT  
WEST VIRGINIA CODE, CHAPTER 22, ARTICLE 11**

TO: Arsenal Resources LLC  
6031 Wallace Rd. Ext Suite 300  
Wexford PA 15090

DATE: October 8, 2020

ORDER NO.: 9923

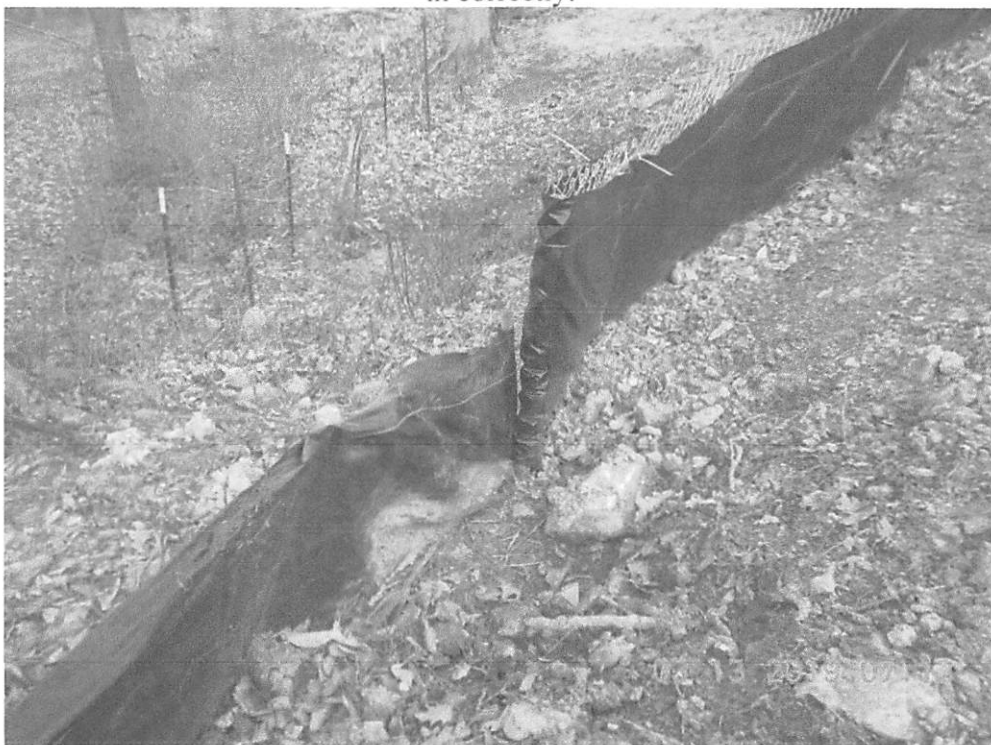
Stat. 217+25, Perimeter controls throughout site were nonfunctional due to bypasses. Silt fence not toed-in correctly.

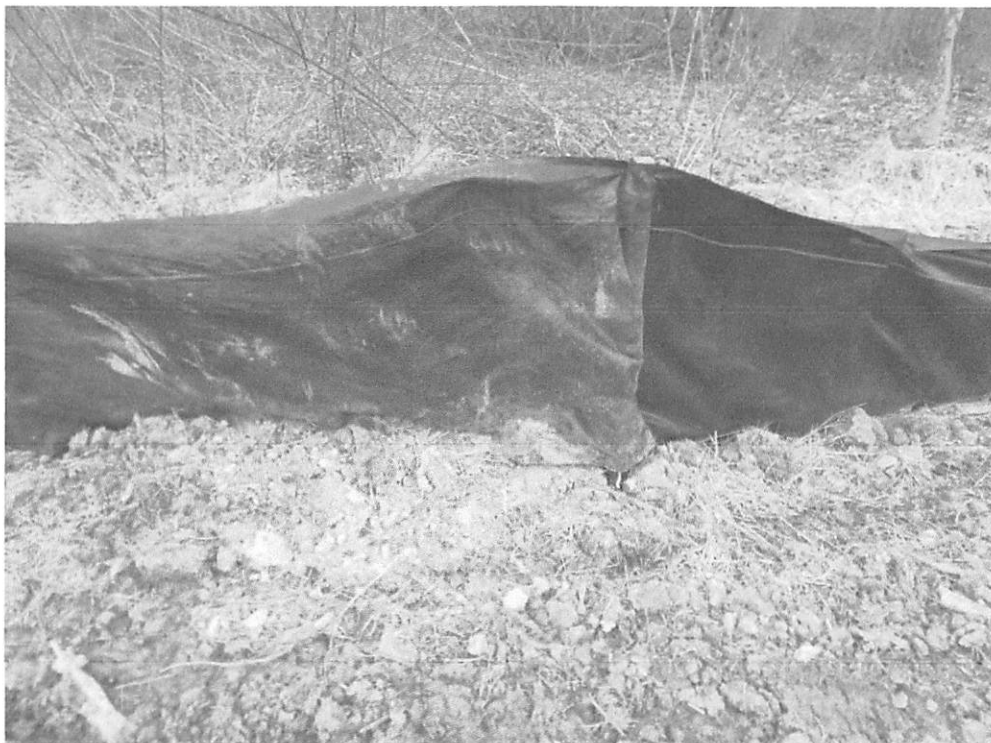
Stat. 213+75, SF not toed-in correctly.

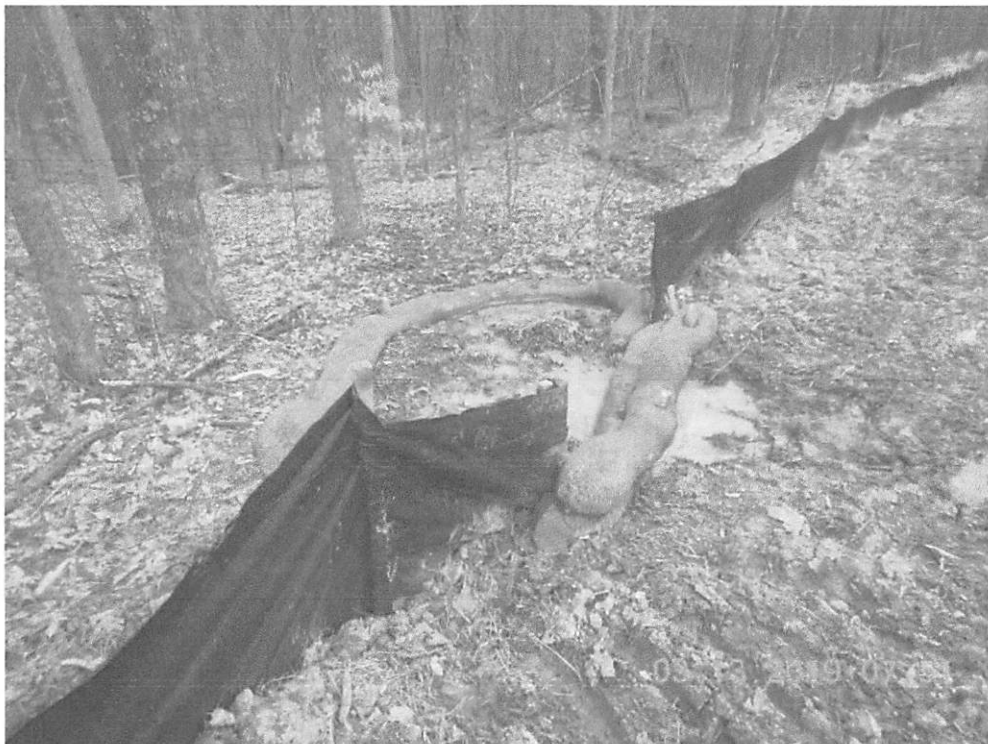
Stat. 193+00, SF failure from either not being conjoined or toed-in correctly.

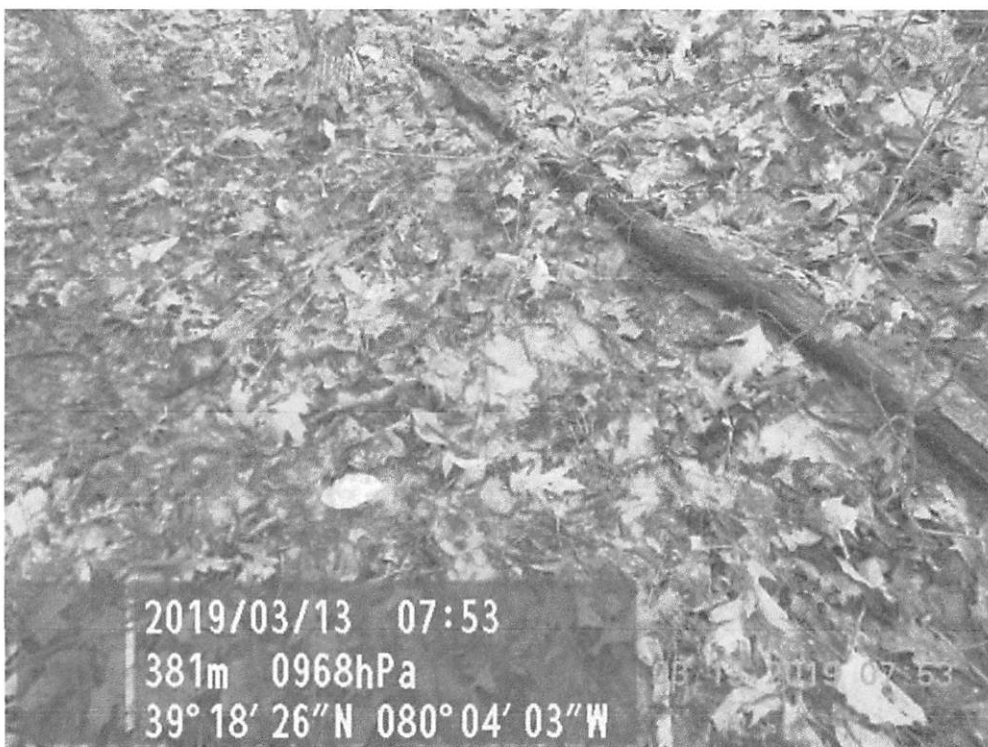
Stat. 192+75, CFS was not conjoined with SF correctly, creating a bypass. CFS was not in contact with the ground, creating bypasses.

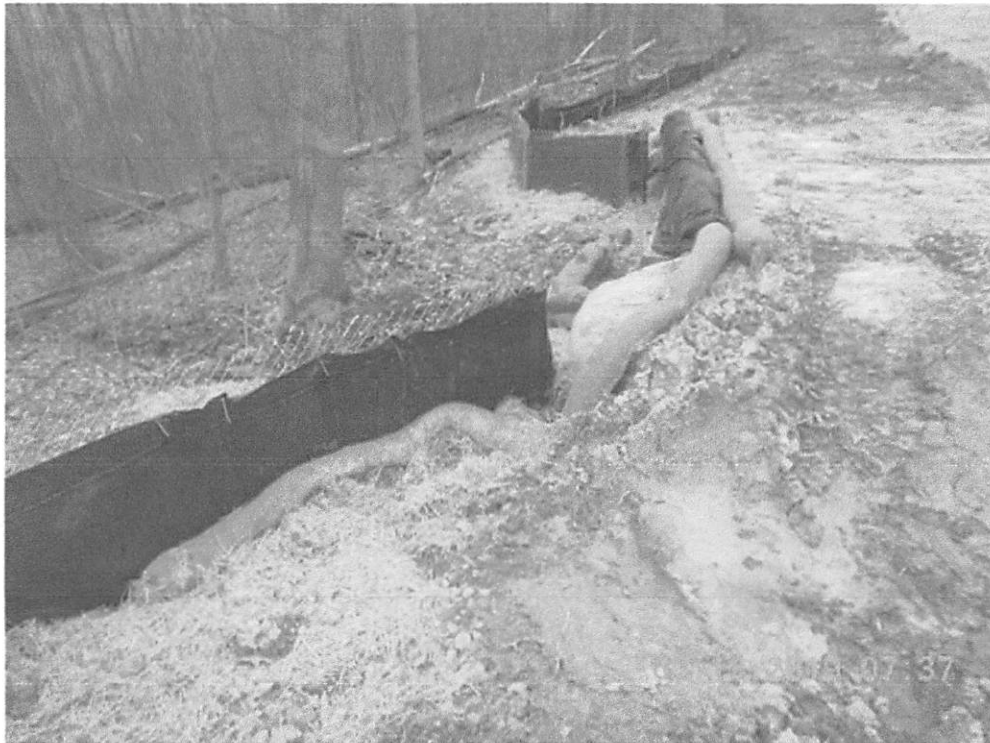
Stat. 192+75, Sediment deposit off site via bypasses in controls.

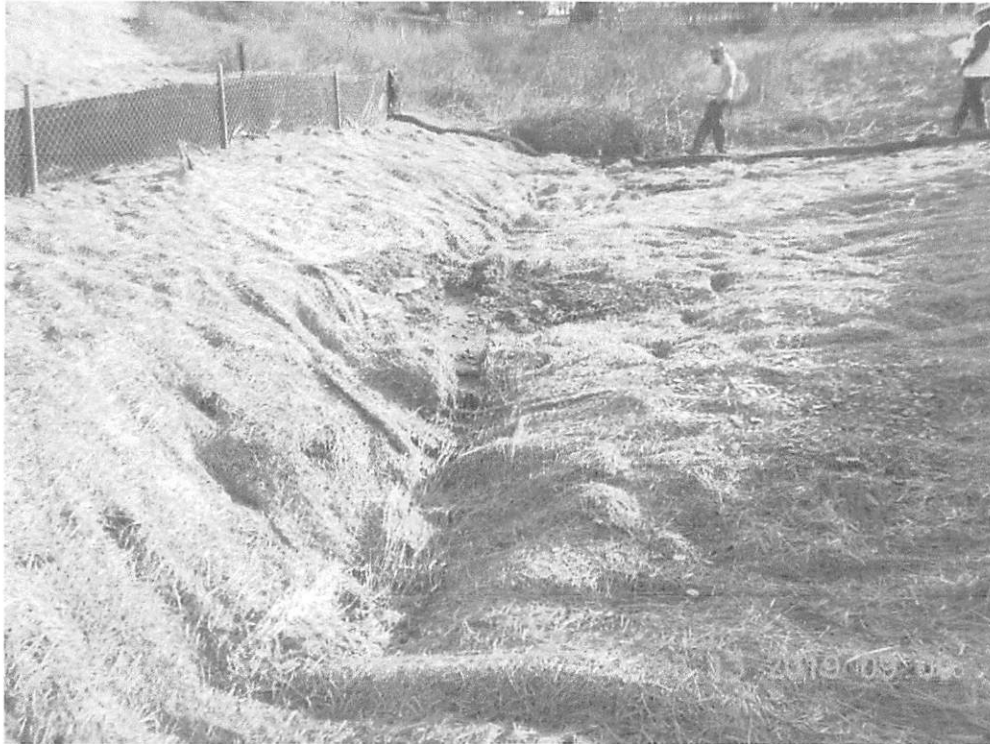
Stat. 164+00, CFS was not in contact with the ground, creating a bypass, allowing sediment laden water to leave site.

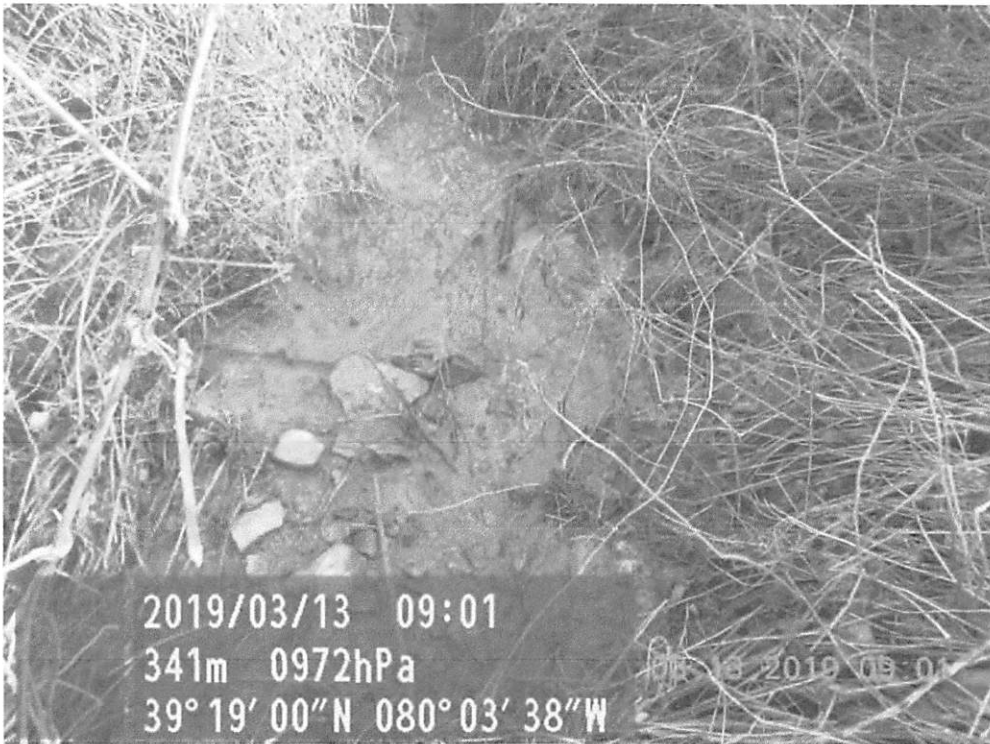
Stat. 156+00, UNT 17, Maintenance is lacking throughout project site.

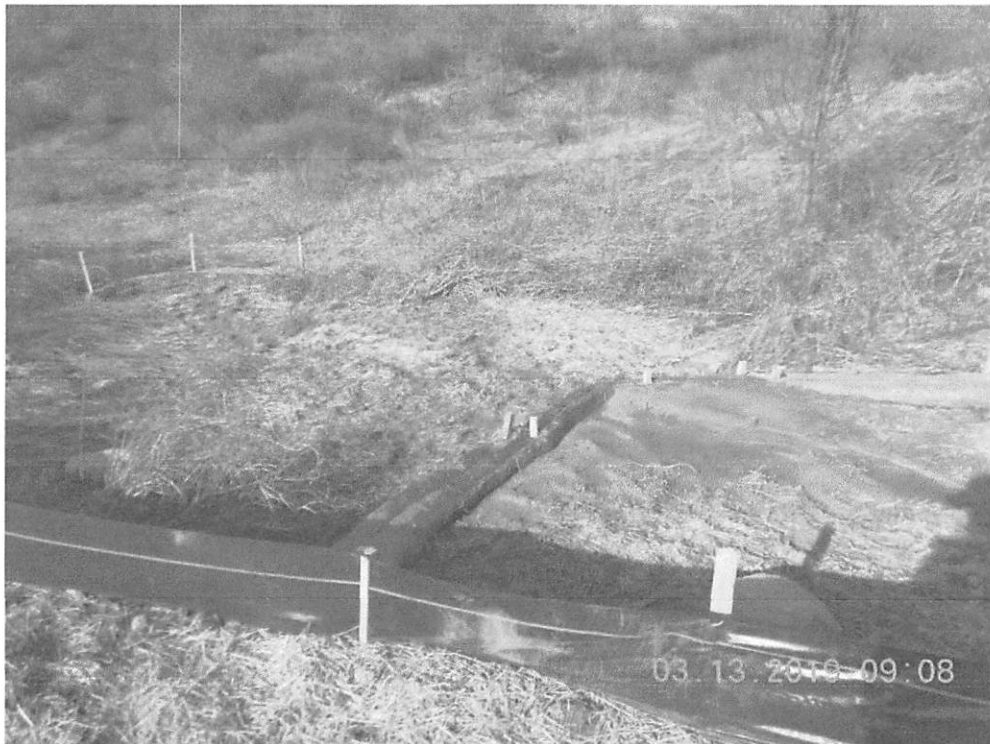
Stat. 156+00, UNT 17, Arsenal caused conditions not allowable in UNT of Shelby Run at 39°19'00" N 80°03'38" W

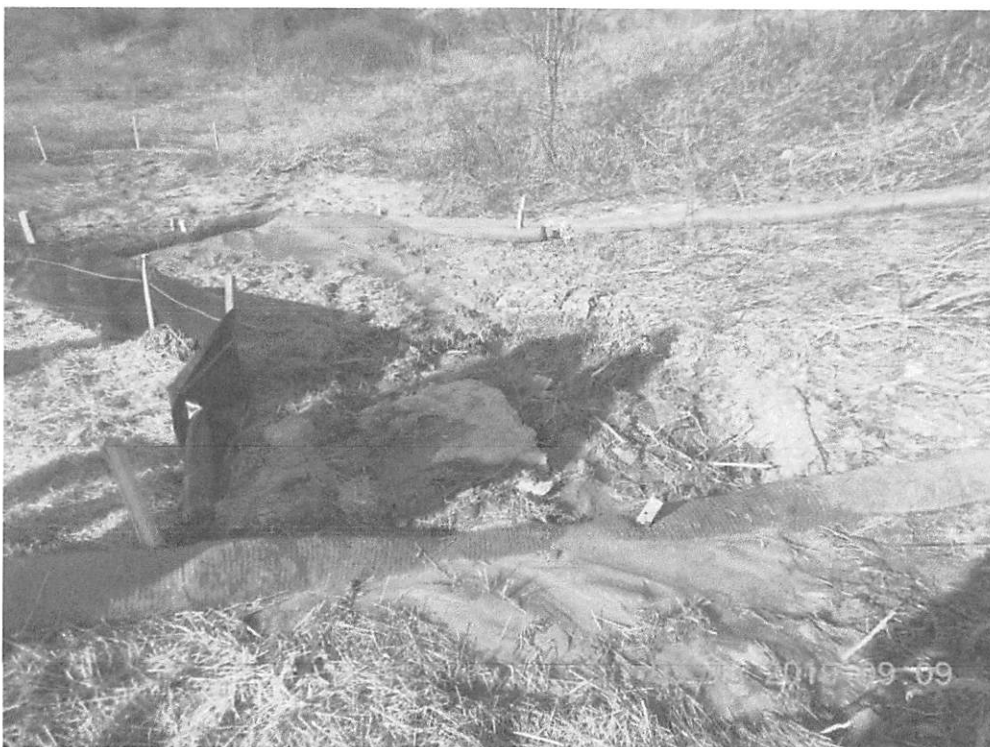
Stat. 155+50, Sediment deposit off site.

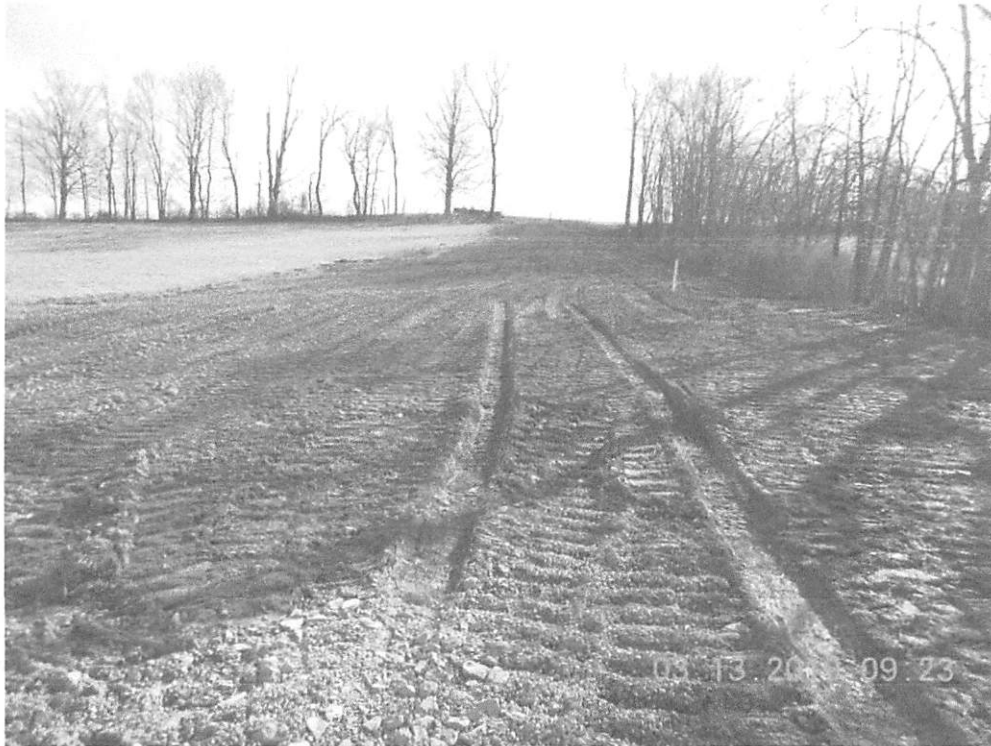
Maintenance is lacking throughout project site.

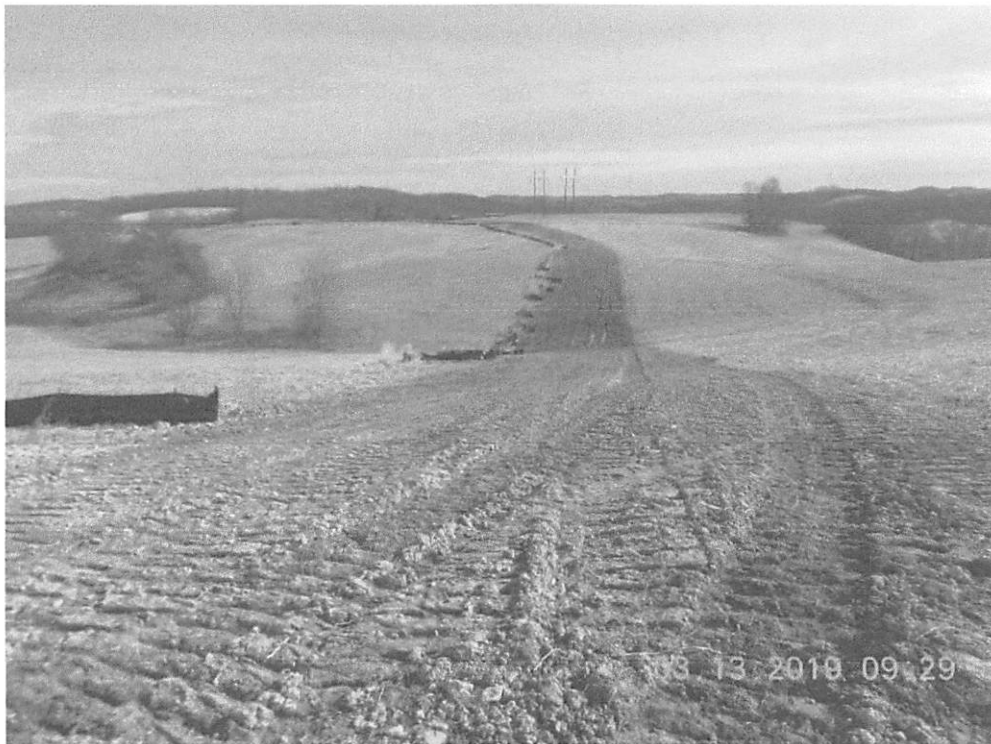
Stat. 142+00, Water bars were not installed as indicated in the SWPPP.

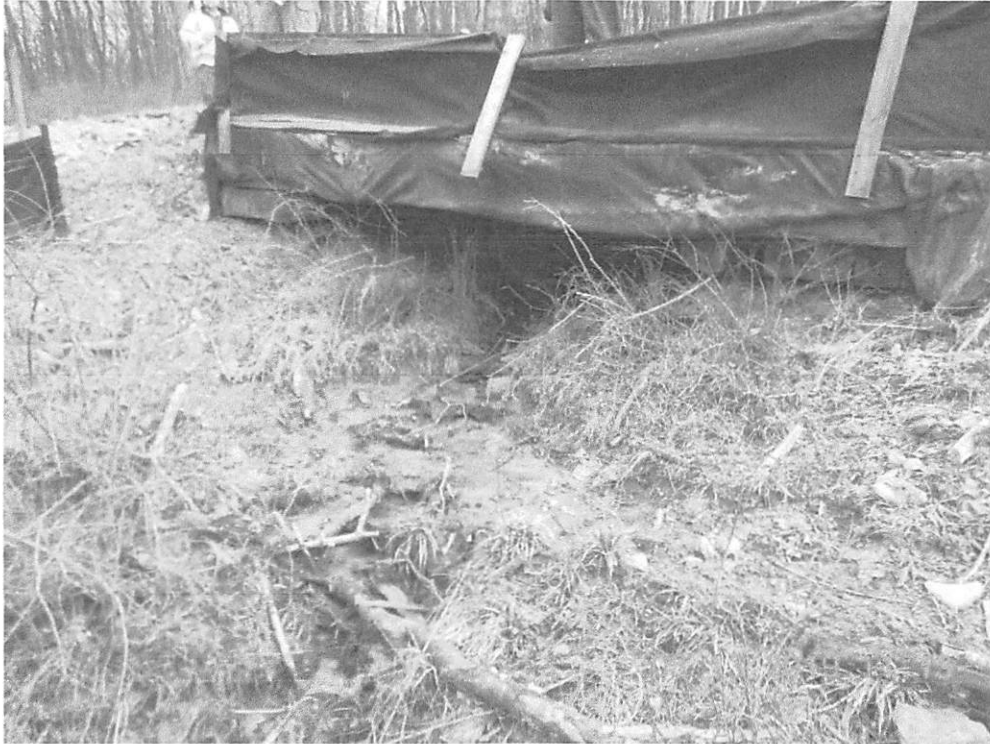
Stat. 112+00, Water bars terminus treatment was not implemented as detailed on page ENV D12 of the SWPPP.

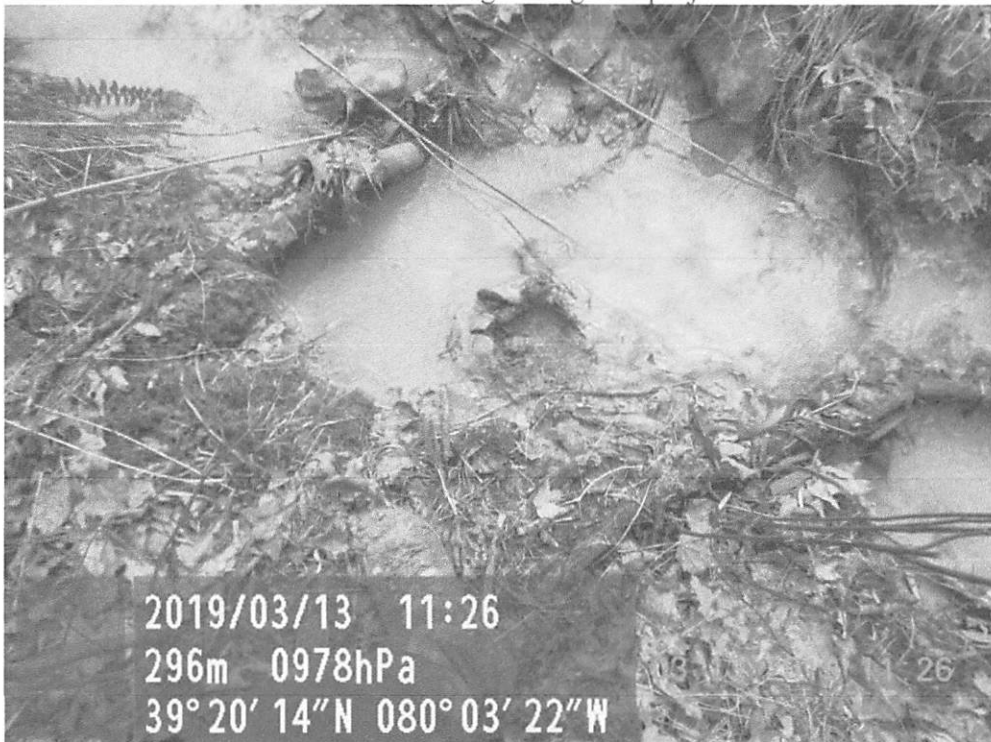
Maintenance is lacking throughout project site.

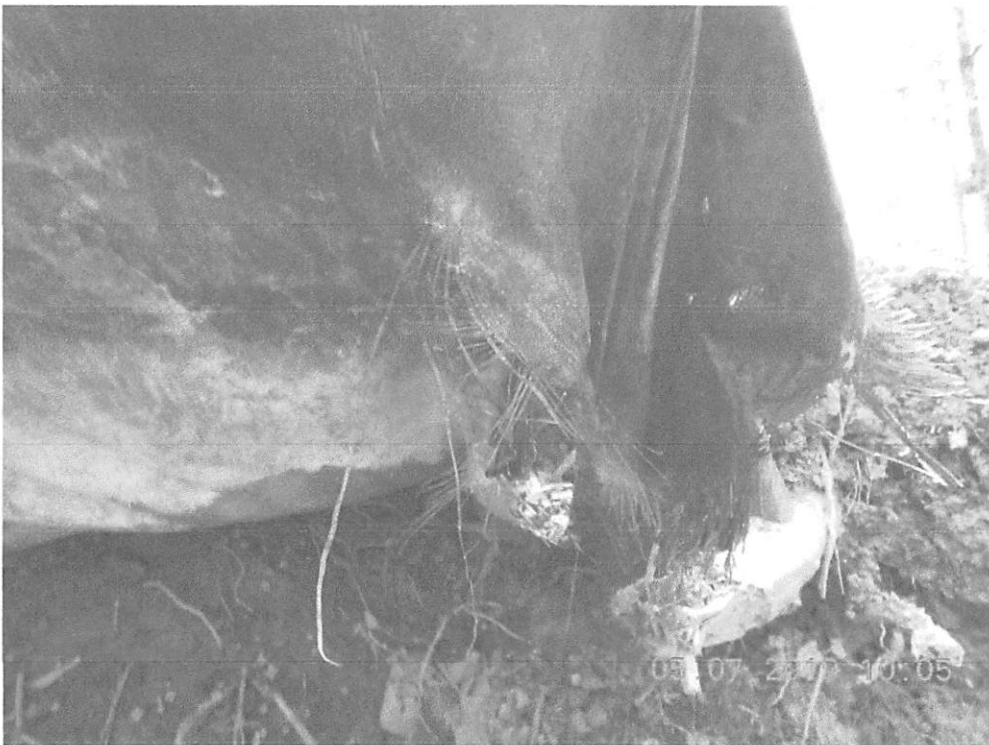
Maintenance at Station 185+00, bridge controls.

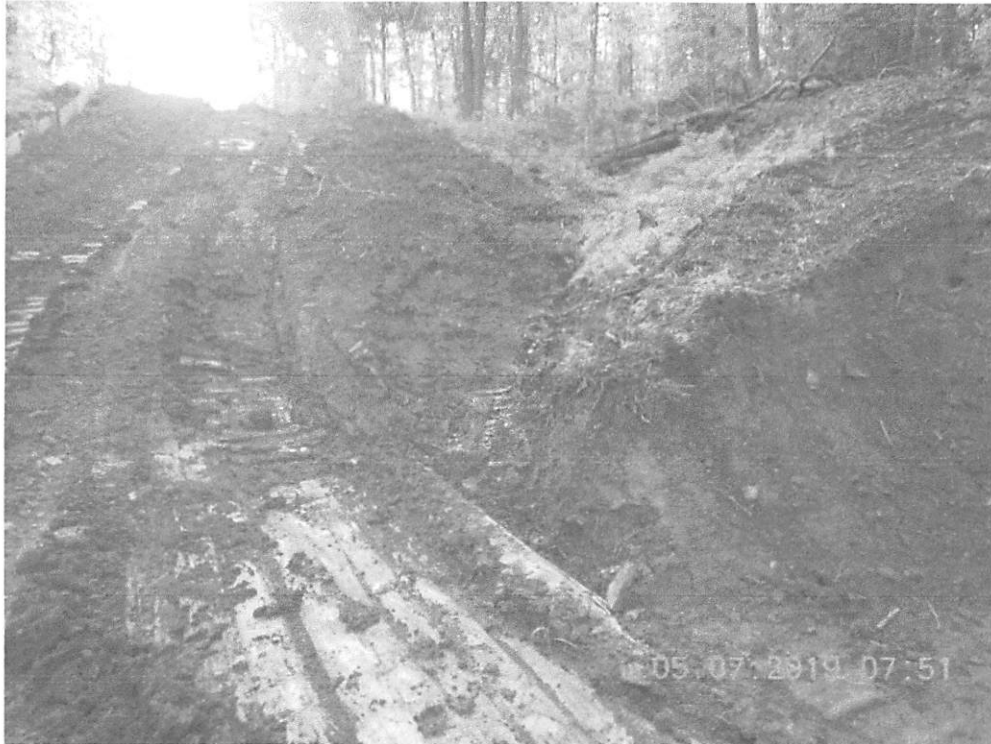
Maintenance at Station 34+15 UNT 3, bypasses on bridge controls.

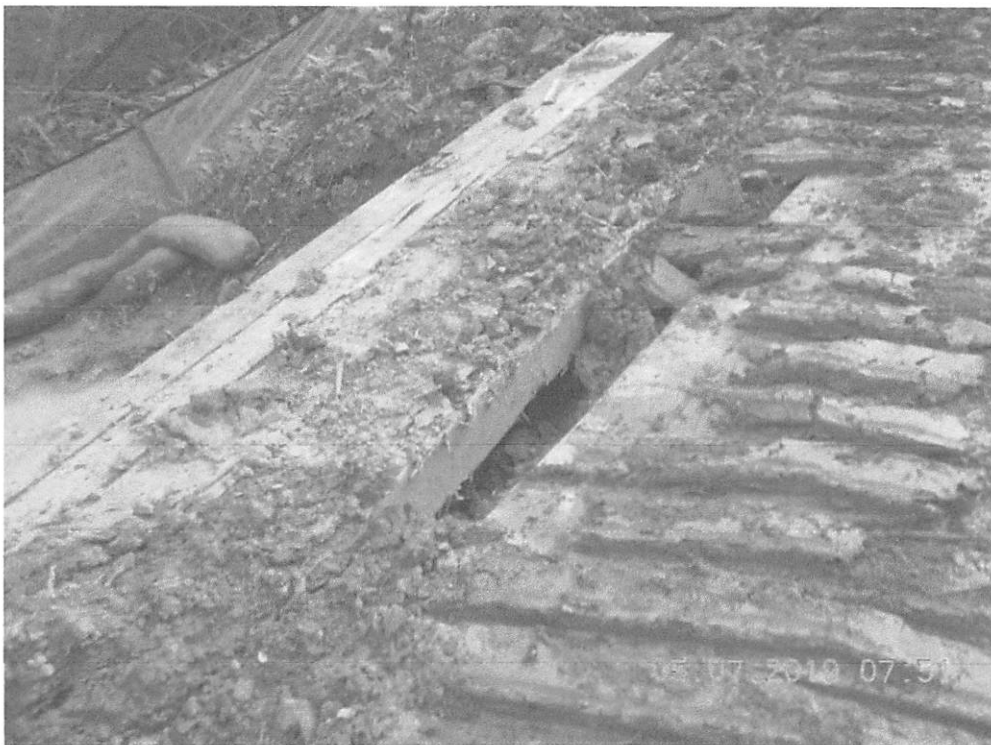
Station 211+00, unidentified UNT of Gabes Fork.

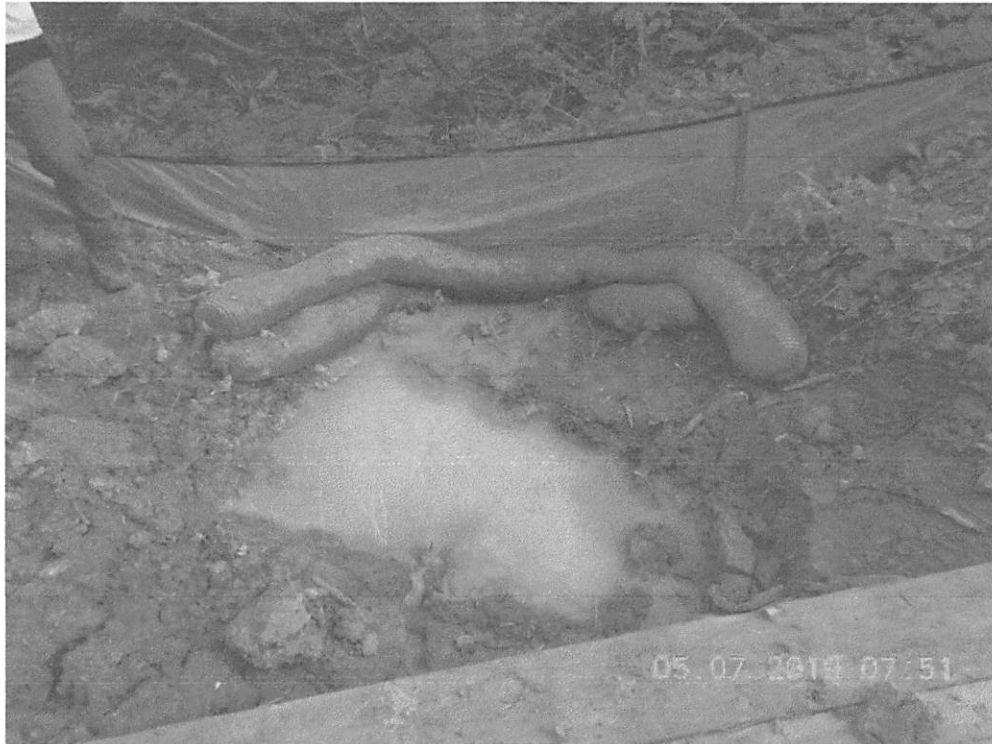
Bridge that was installed at Station 211+00 for UNT of Gabes Fork.

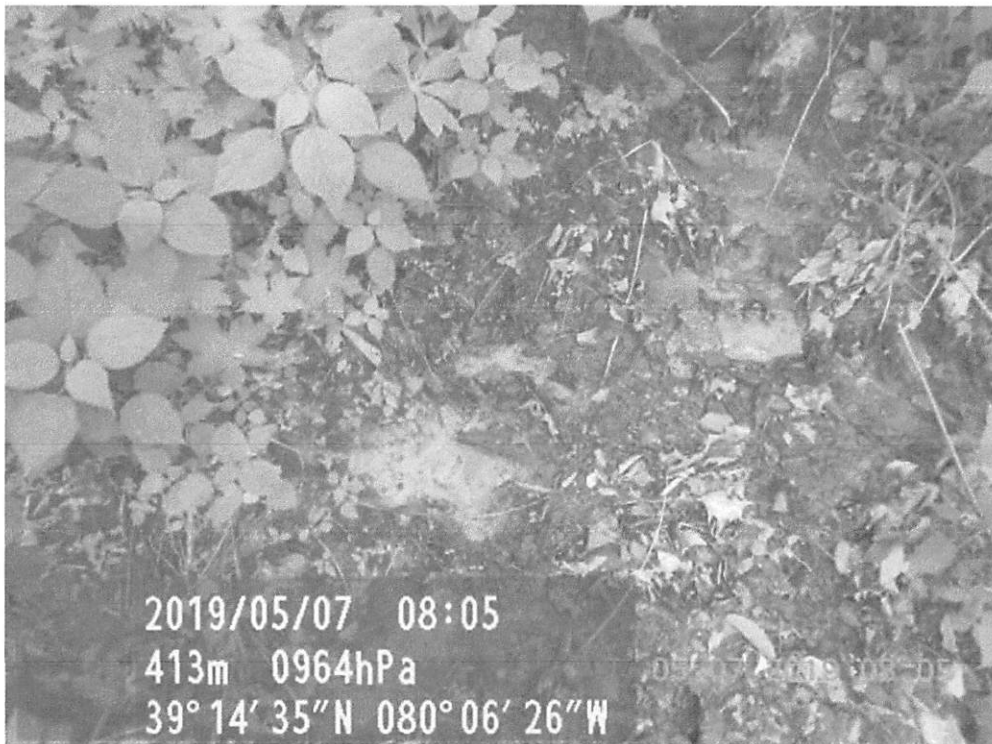
Below bridge installed at Station 211+00 of UNT of Gabes Run.

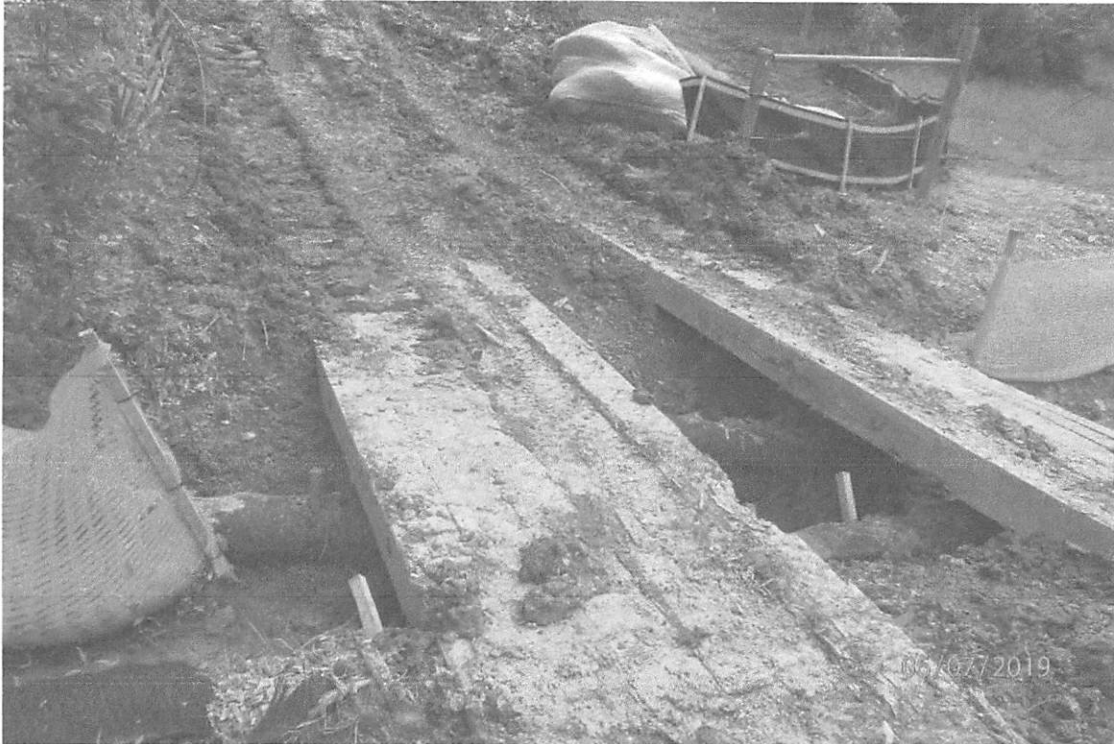
Sediment deposits on bottom of UNT of Gabes Run.

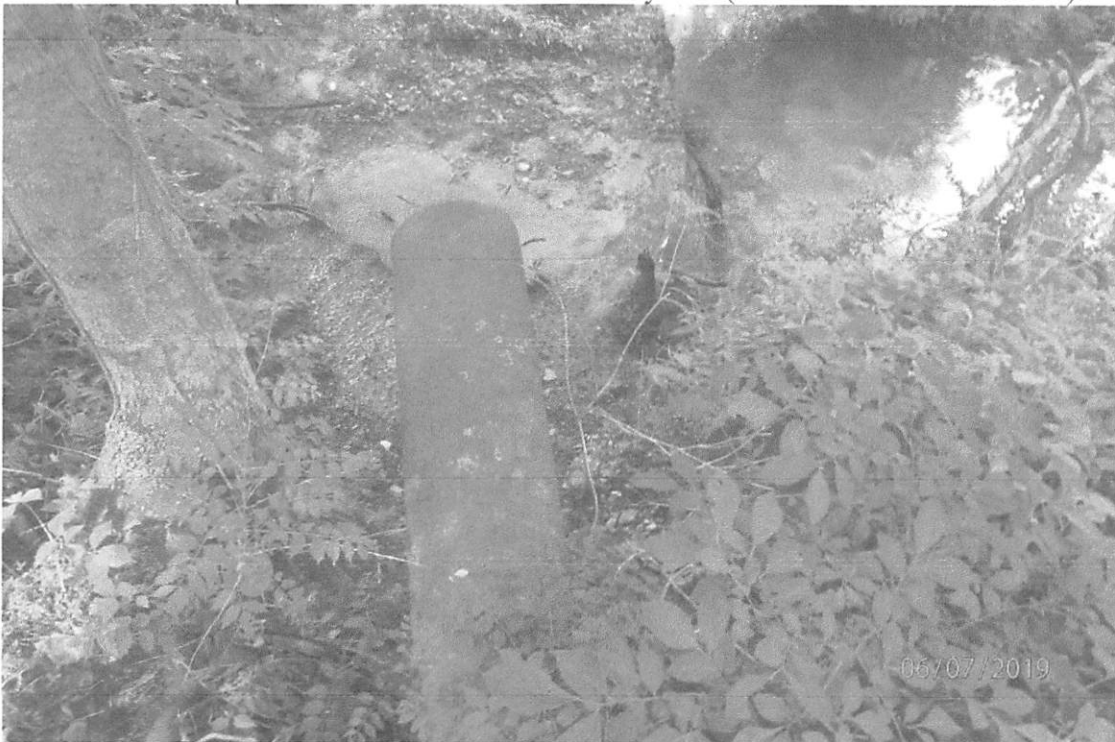
Offsite CNA deposits in UNT Beards Run conveyance (39° 15.023' X 80° 10.561').

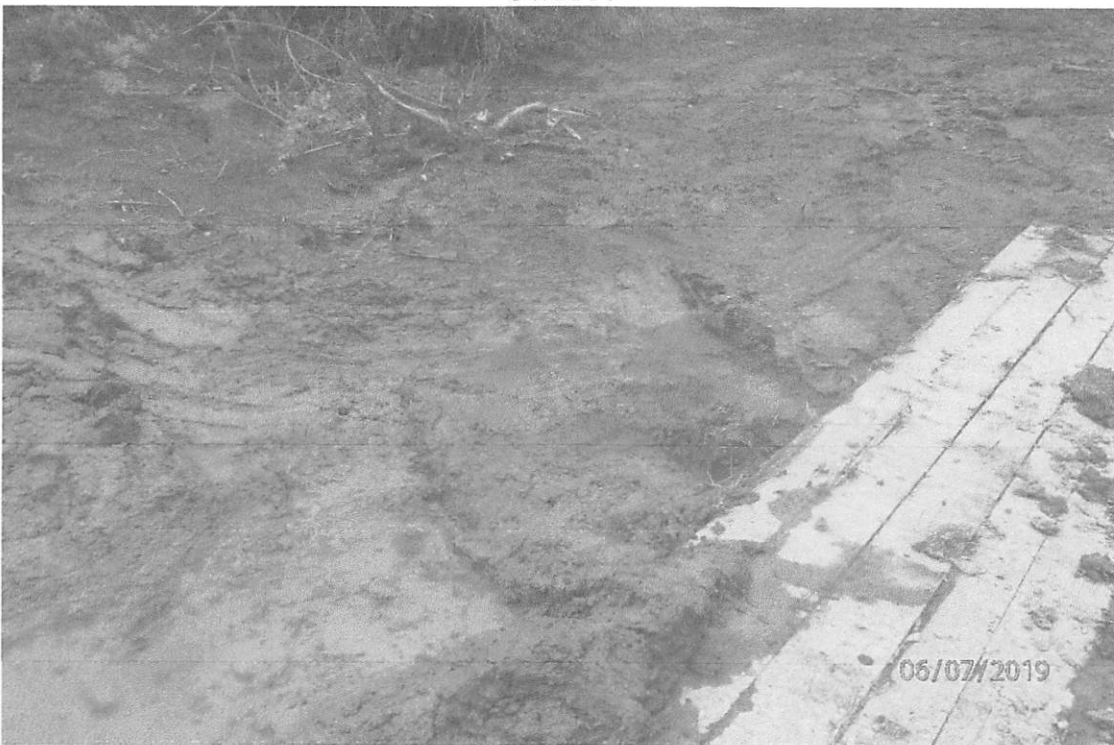
Wetland WL-28 showing the lack of installed perimeter controls that are indicated in the approved SWPPP.

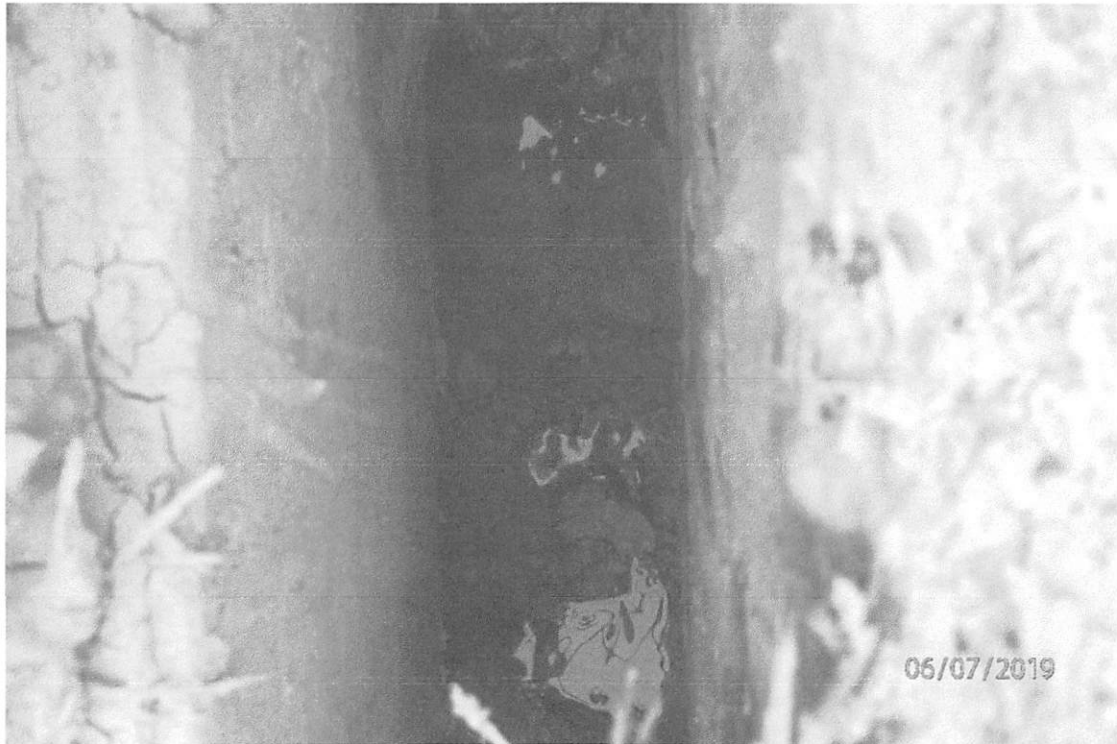
Stream of water in WL-28 that is not indicated in the approved SWPPP that lacks perimeter controls and an appropriate timber mat bridge BMP.

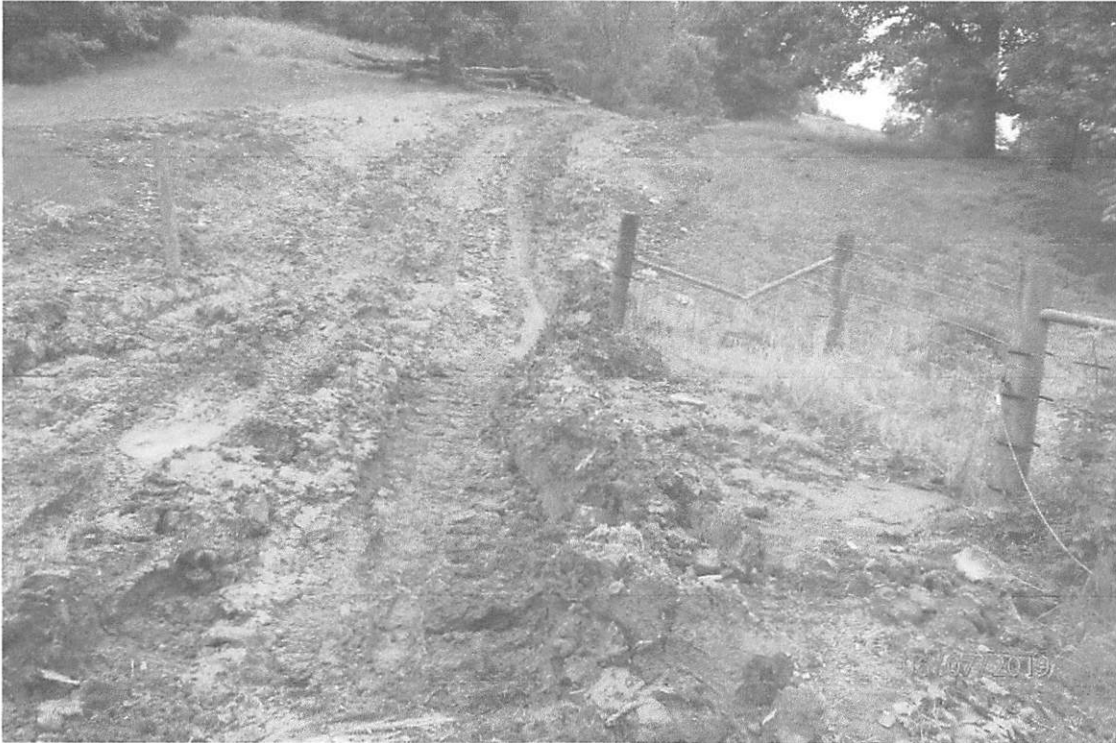
Area where sediment laden water leaves the site without going through an approved device.

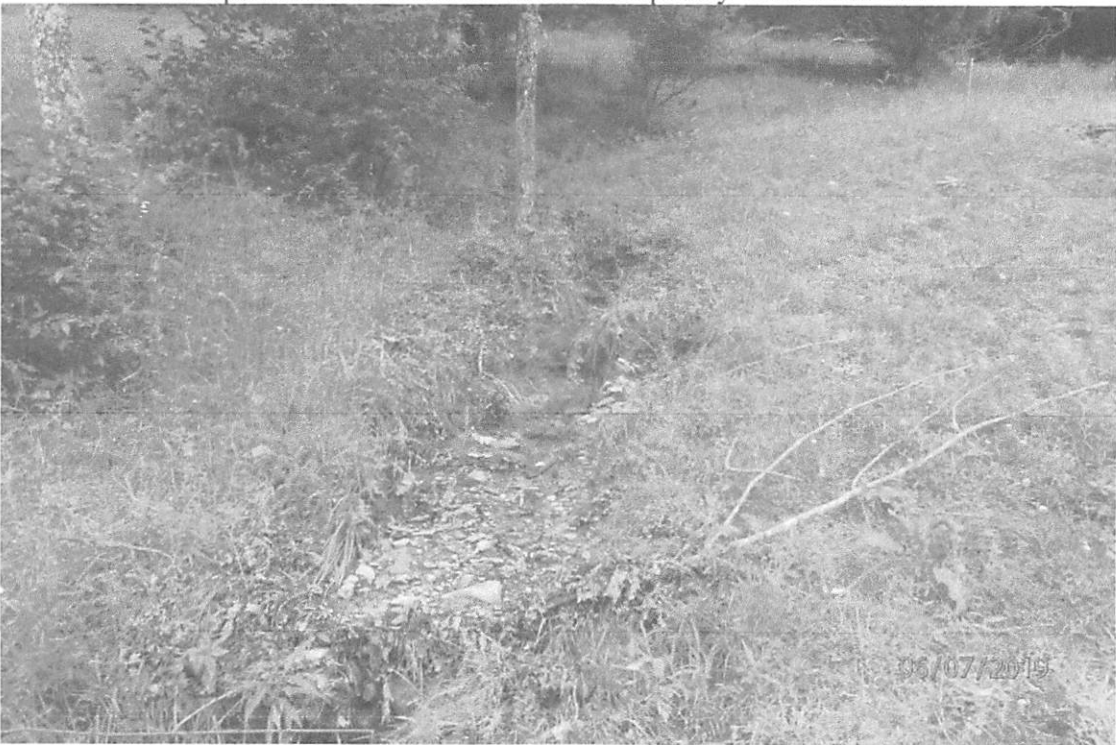
Project area adjacent to 482+85 showing the lack of installed silt saver 2 indicated in the approved SWPPP. The area past the fence is where a stream of run on stormwater is flowing across the project and the plan has not been modified to adequately handle the flow.

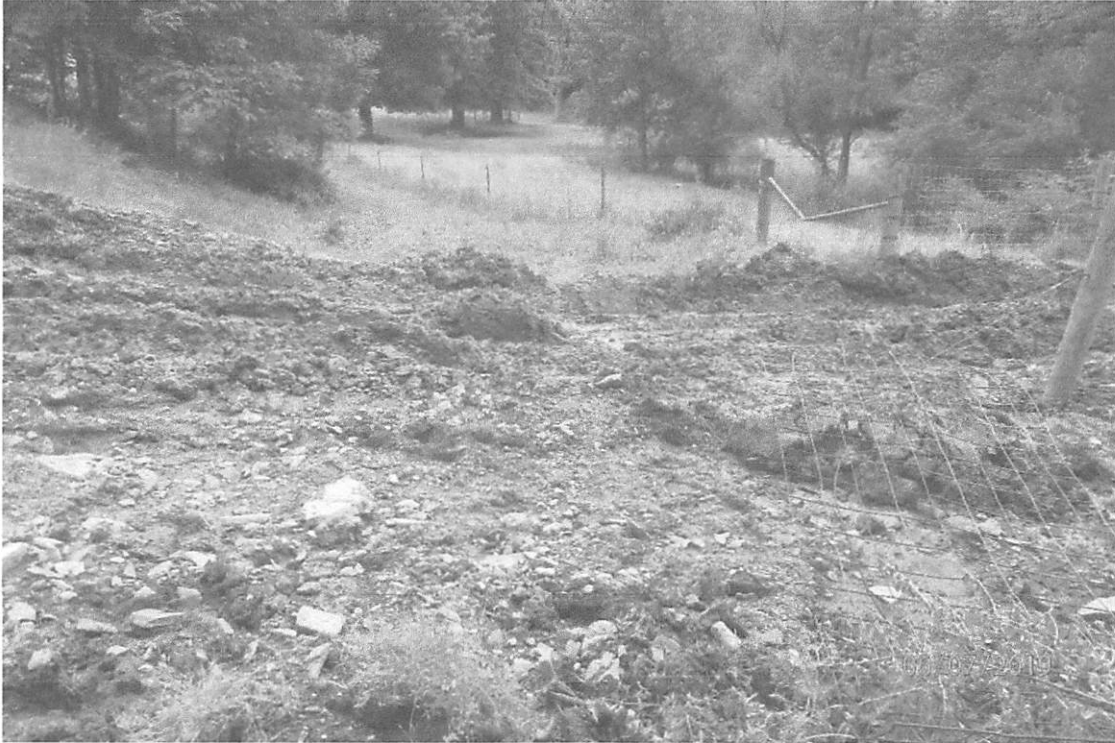
Project area adjacent to 482+85 showing the upslope stream channel that is not indicated in the approved SWPPP.

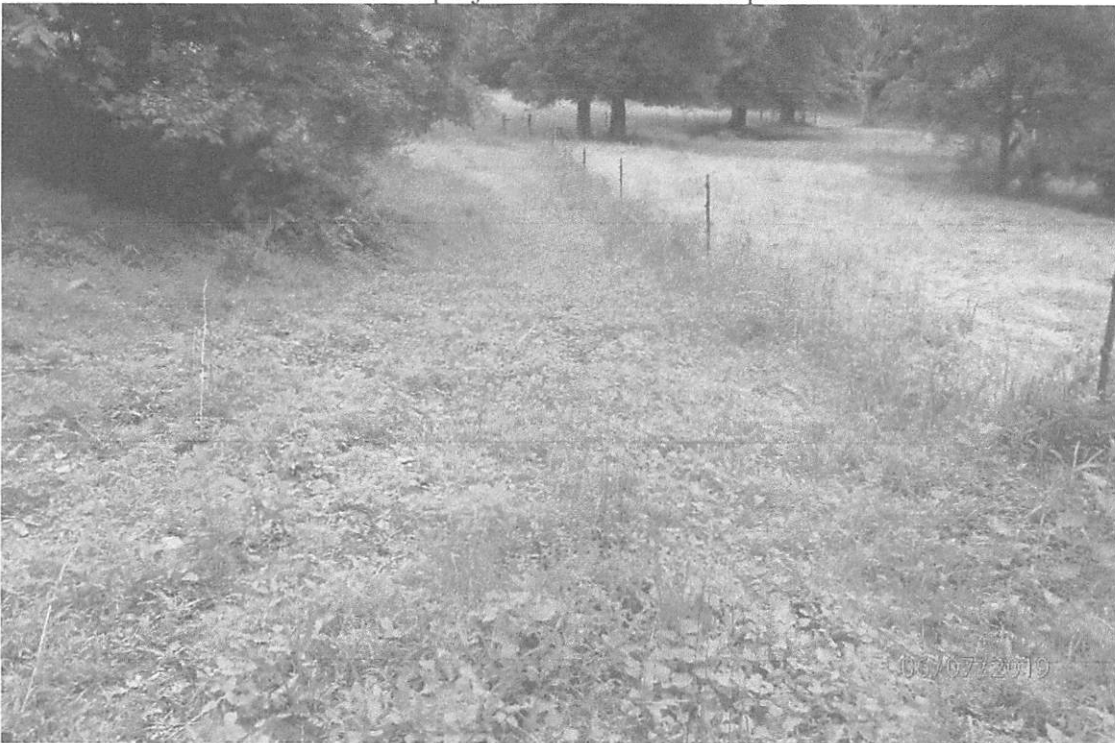
Project area adjacent to 482+85 showing the area where the upslope ephemeral stream is allowed to flow across the project with no BMPs in place.

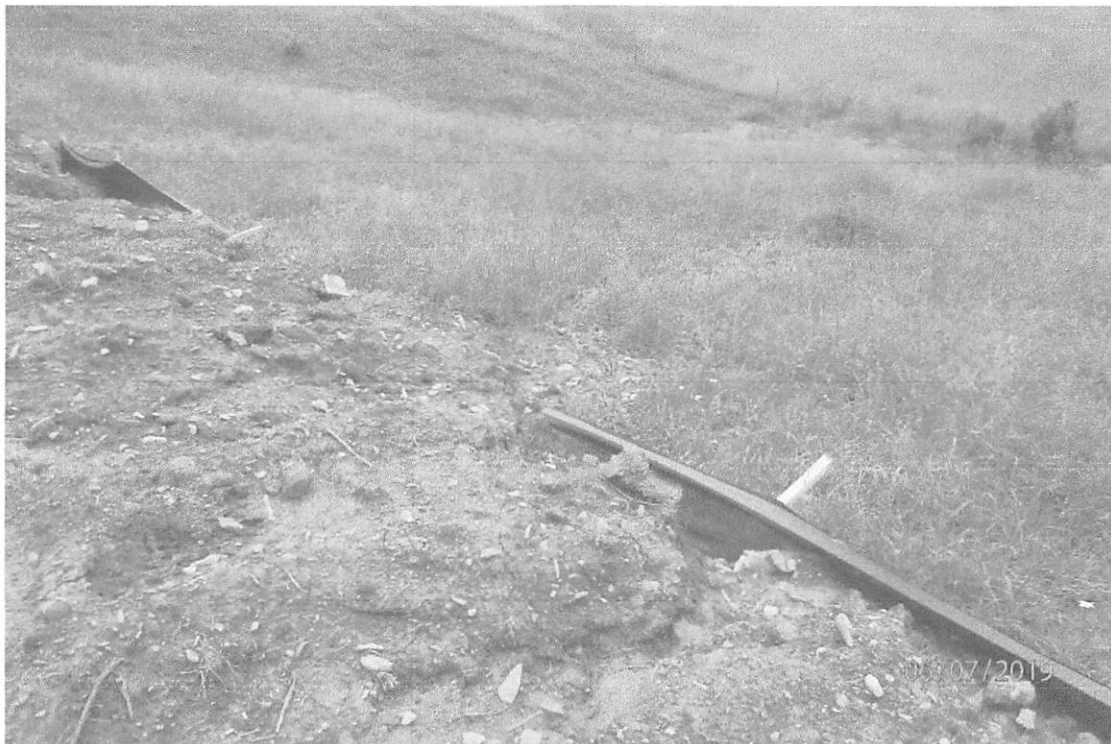
Offsite sediment deposits adjacent to 482+00 as a result of the lack of installed BMPs.

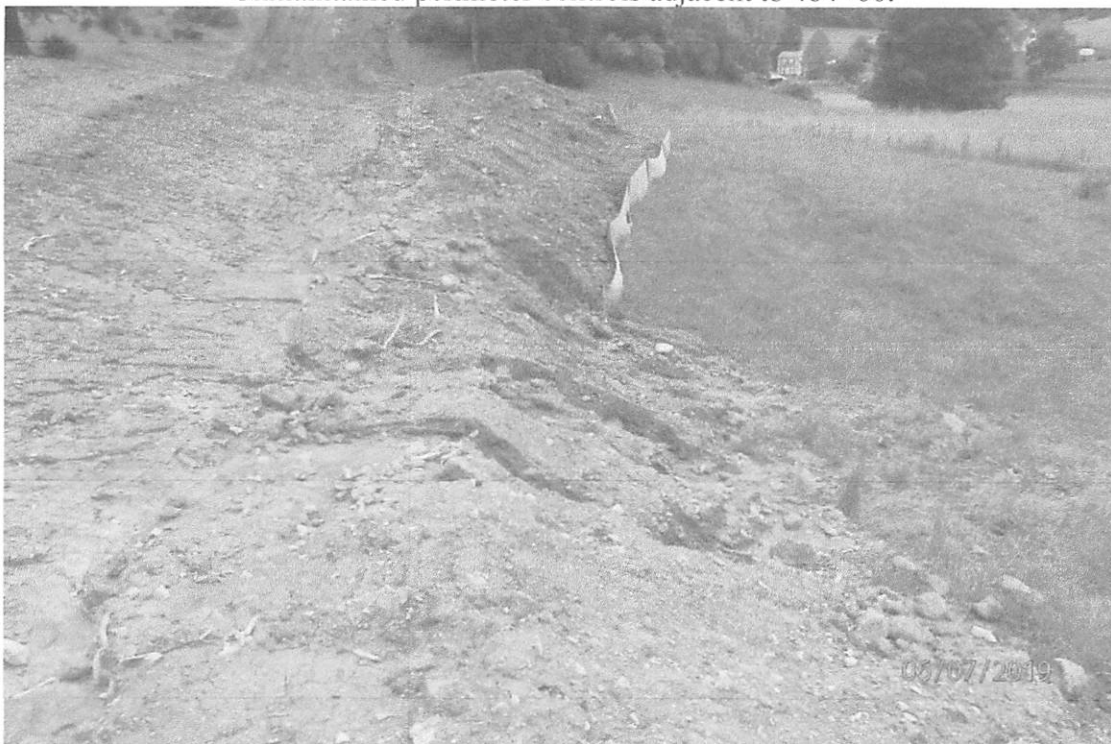
Unmaintained perimeter controls adjacent to 484+00.

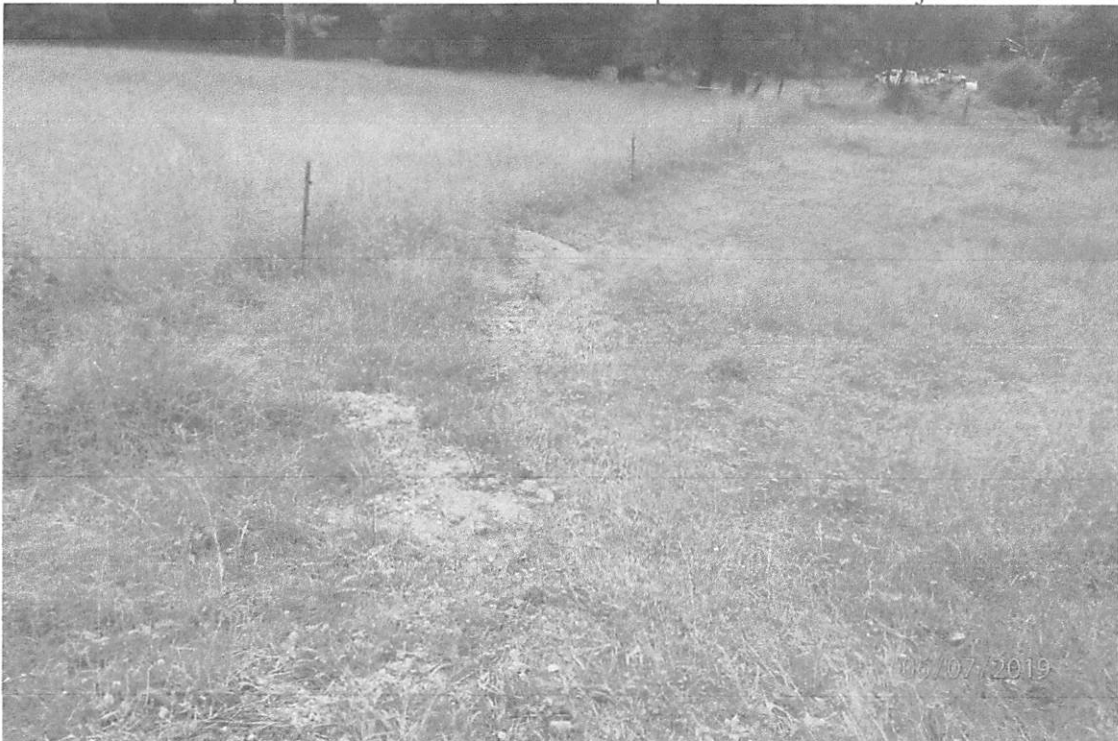
Offsite sediment deposits as a result of unmaintained perimeter controls adjacent to 485+00.
