**CONSENT ORDER  
ISSUED UNDER THE  
WATER POLLUTION CONTROL ACT  
WEST VIRGINIA CODE, CHAPTER 22, ARTICLE 11**

TO: Arsenal Resources LLC  
6031 Wallace Rd. Ext Suite 300  
Wexford PA 15090

DATE: October 8, 2020

ORDER NO.: 9923

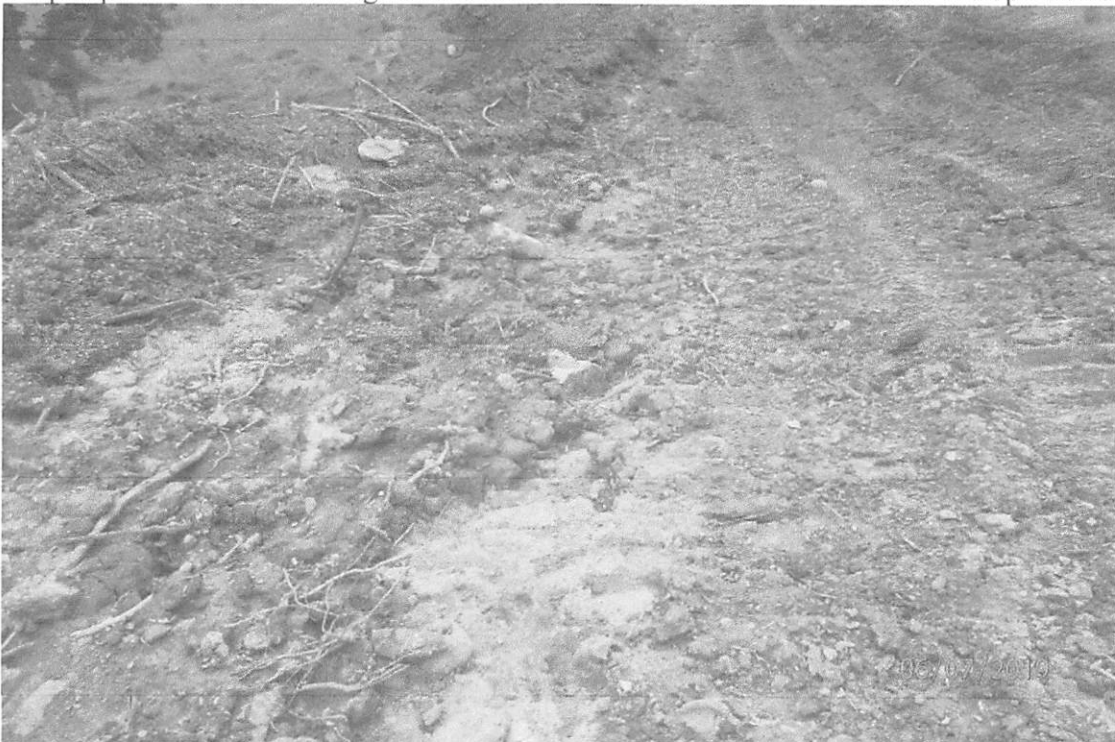
Hillside upslope of 490+00 showing the lack of installed water bars and silt saver 2 slope interceptors.

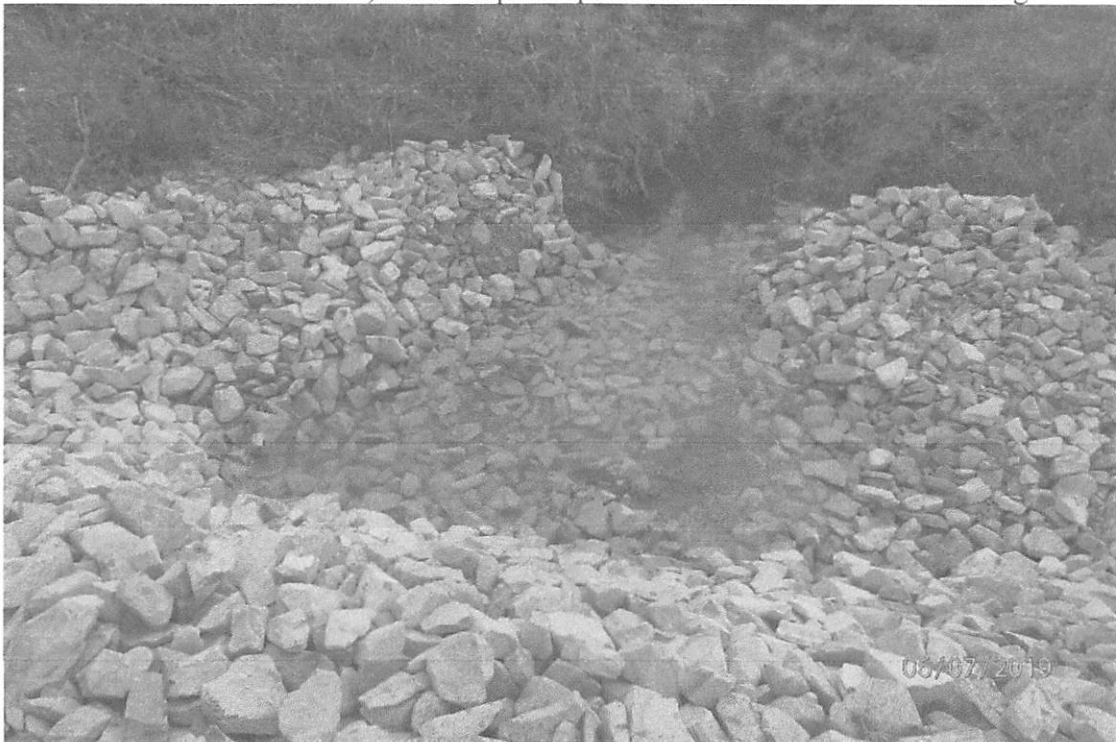
Stone that was placed in the stream by the site operator during the inspection at UNT Beards Run (39° 15.098' X 80° 10.735'). CNA deposits pictured downstream of the crossing.

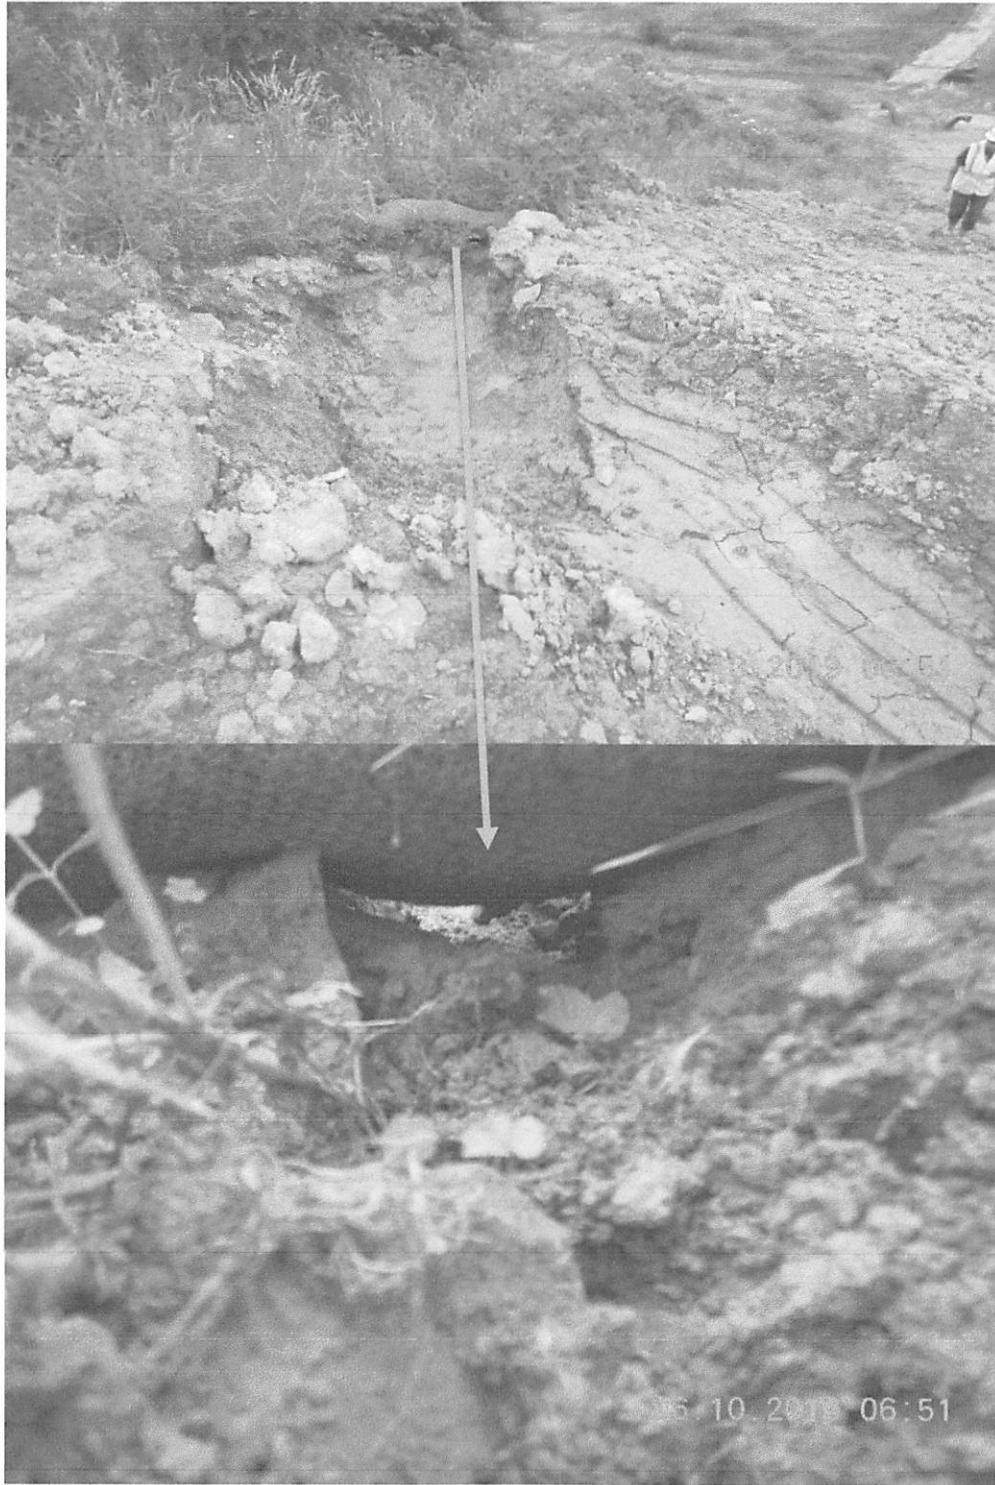
Bypass on water bar terminus treatment. 8 inch CFS installed, but SWPPP requires 18 inch.

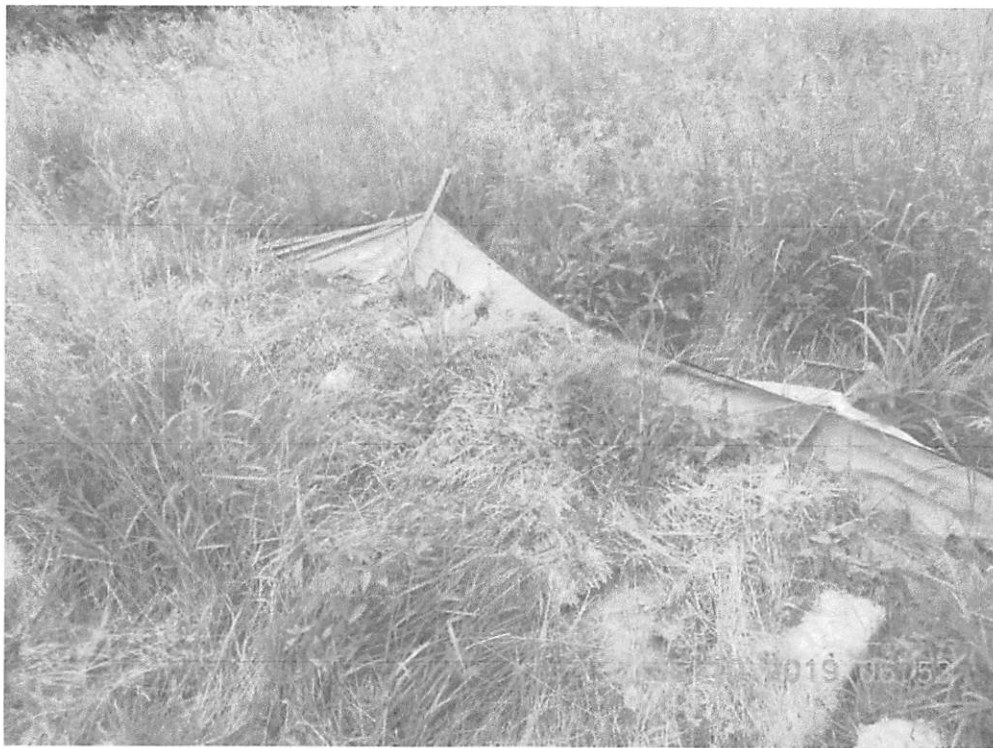
Station 192+50 to 195+50, 6 water bars should be installed with terminus treatment.

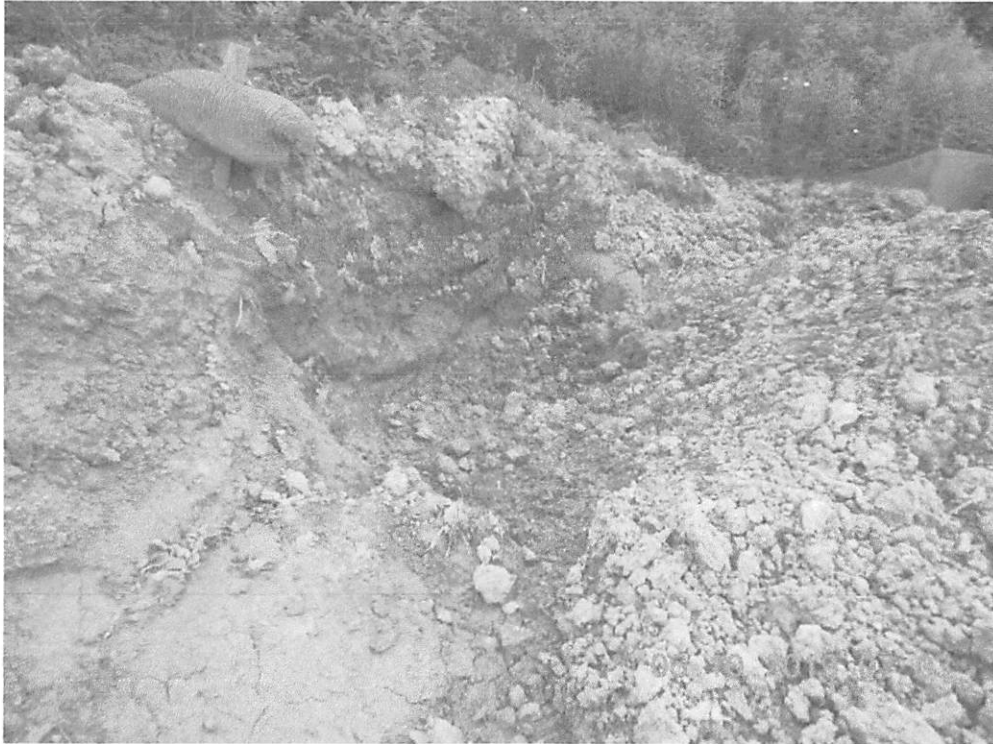
Station 192+00, Water bar terminus BMP not properly implemented, allowing sediment laden water to leave site.

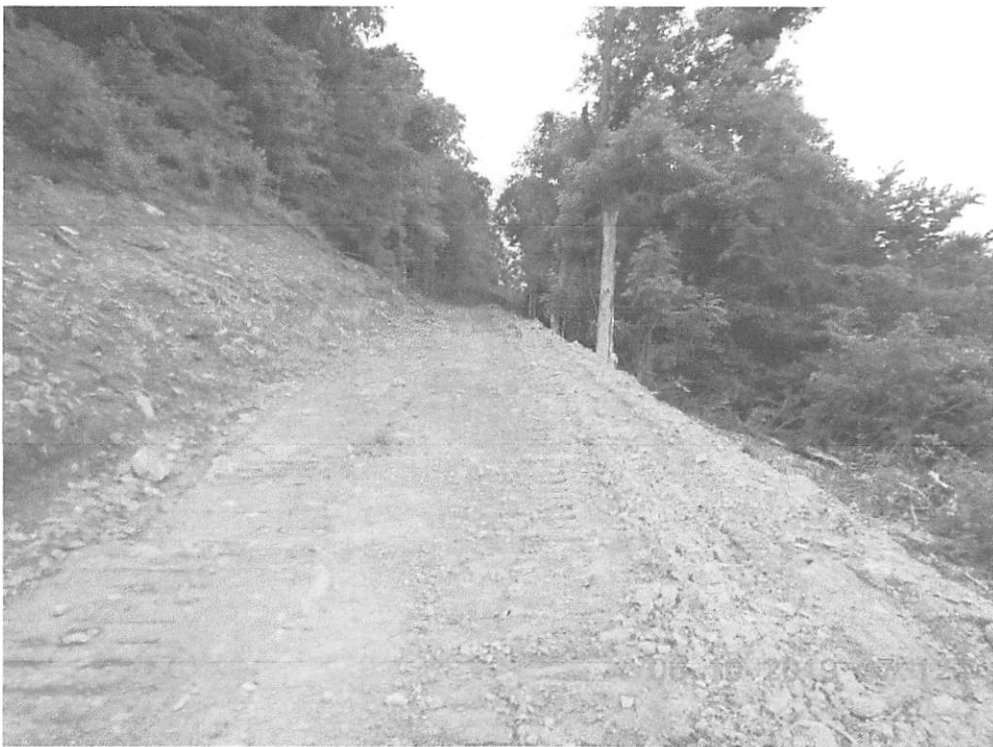
No water bar terminus treatment.

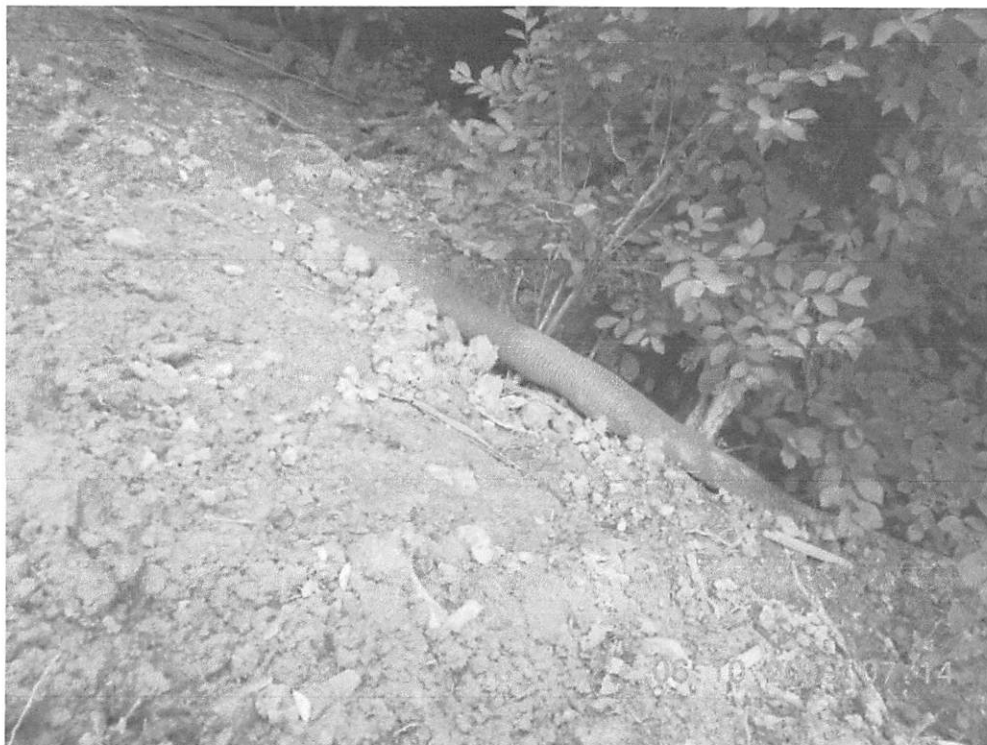
SWPPP requires 6 water bars along with SS P2 slope interceptors as perimeter controls. However, continuous 8" CFS was installed.

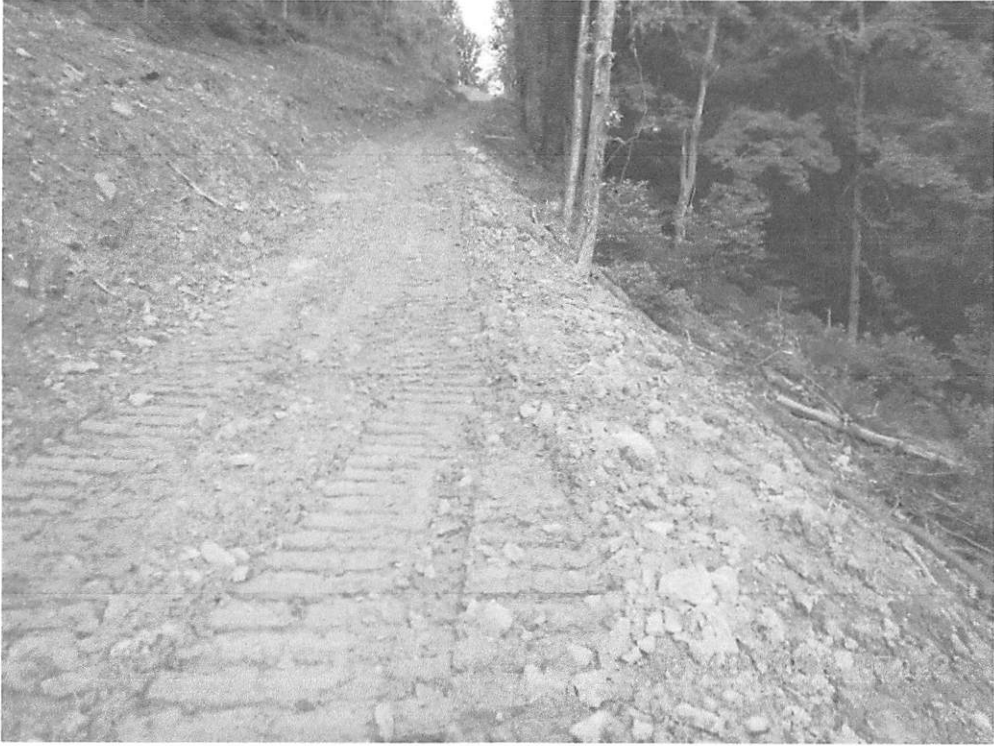
Inequivalent CFS was installed instead of SS2, as required by the SWPPP. CFS is riddled with bypasses and could allow sediment laden water to leave site.

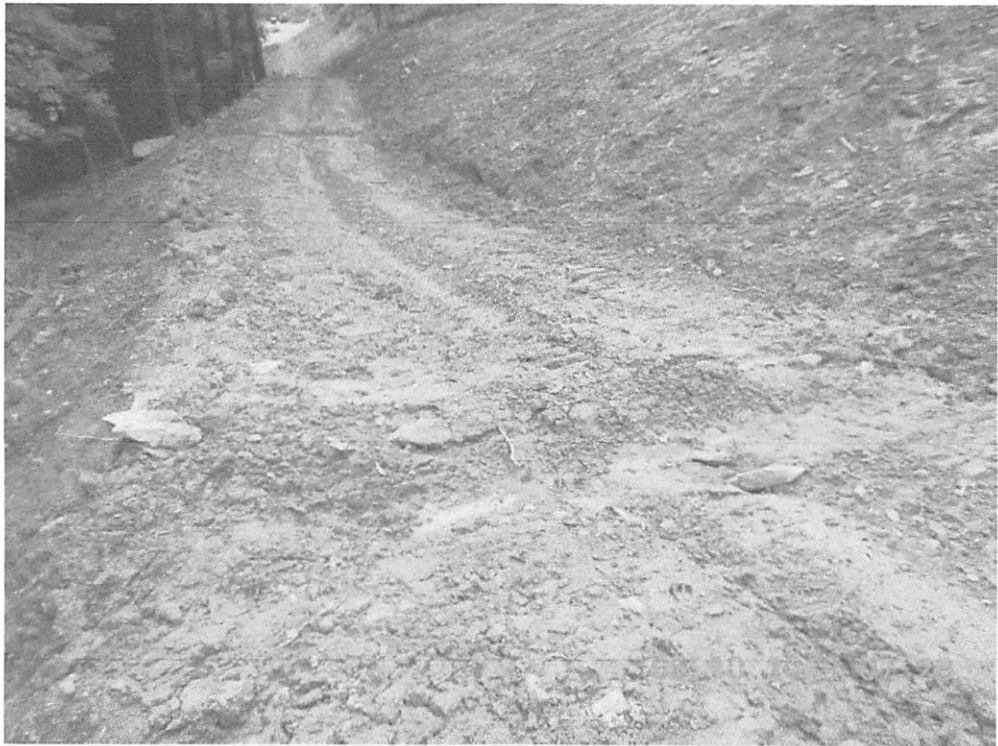
Station 199+50, No water bars installed. SWPPP requires SS2 slope interceptors.

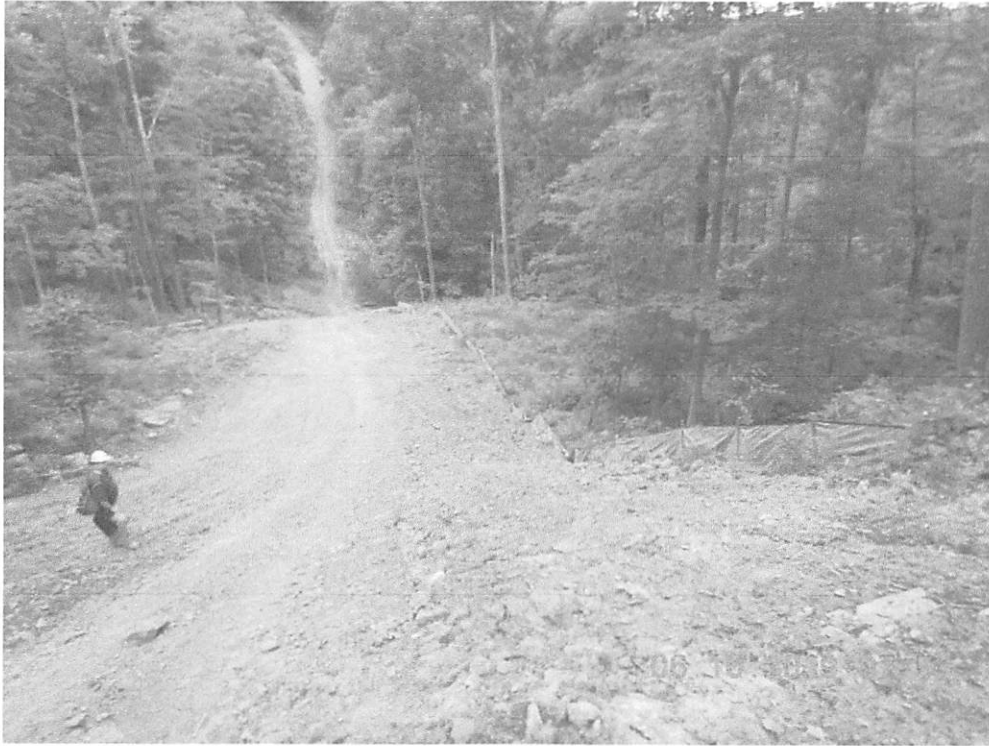
Station 205+00, Water bars with no terminus treatment installed.

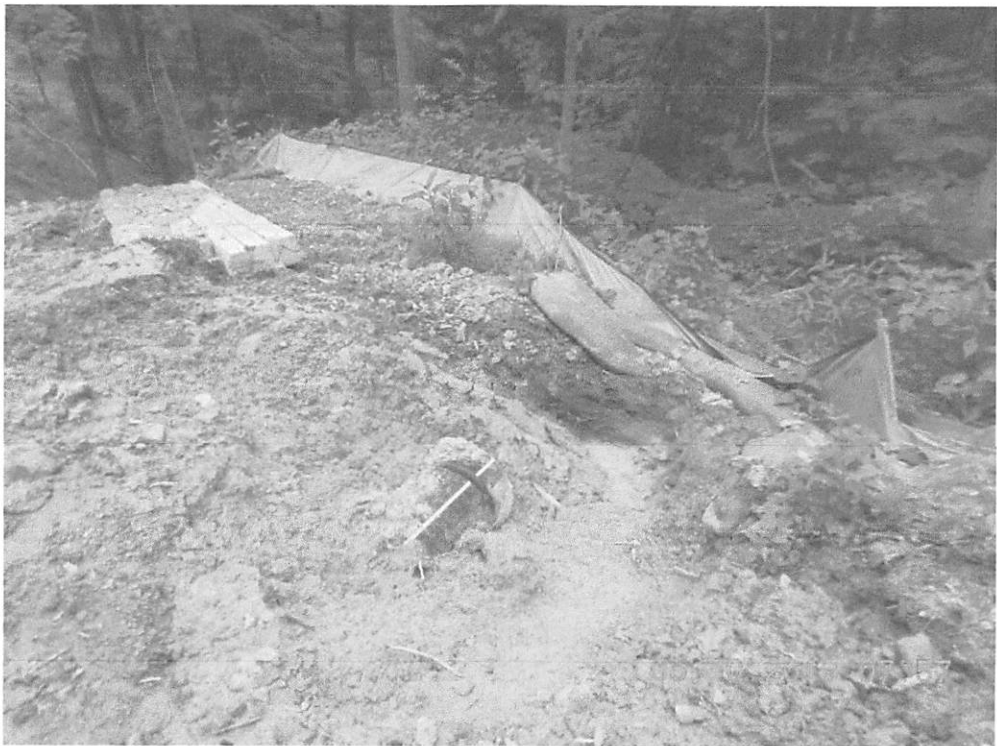
Station 208+00, Erosion rill is present, and SS2 is overwhelmed with sediment.

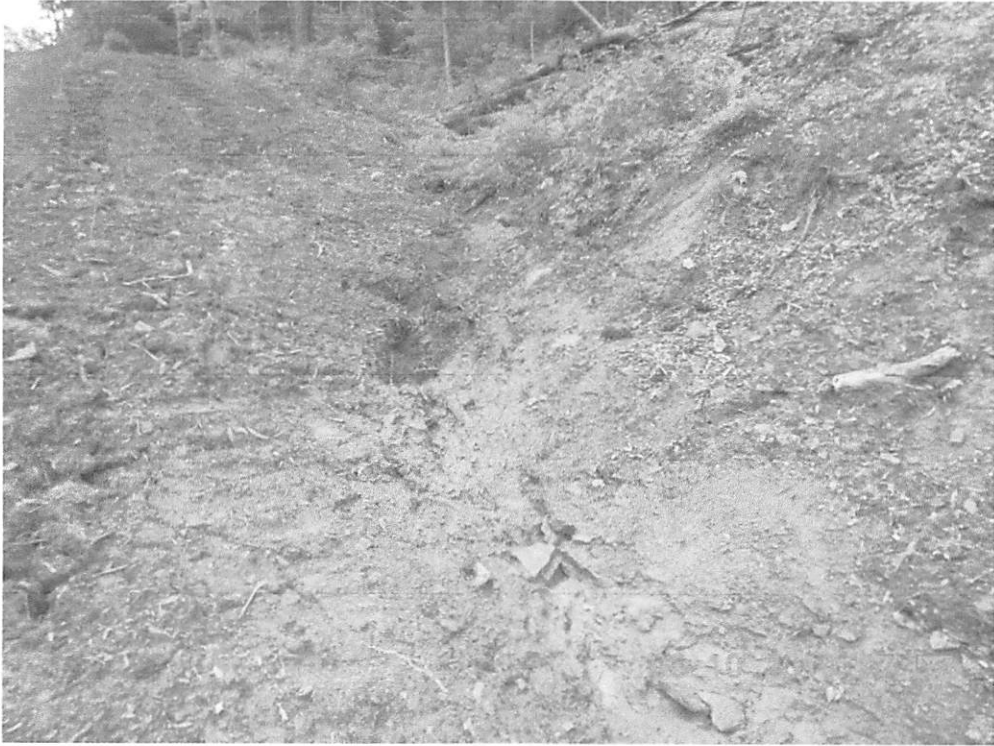
Station 211+00, Outfall for flume pipe for first unlabeled UNT at this location.

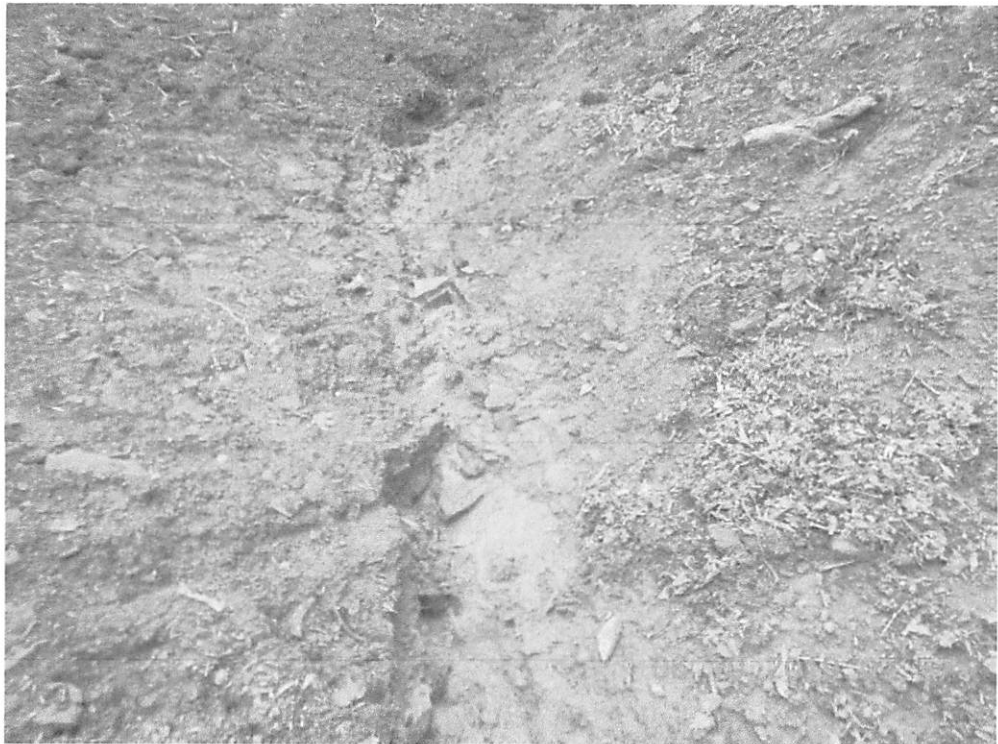
Head of first unlabeled UNT at Station 211+00 is blocked.

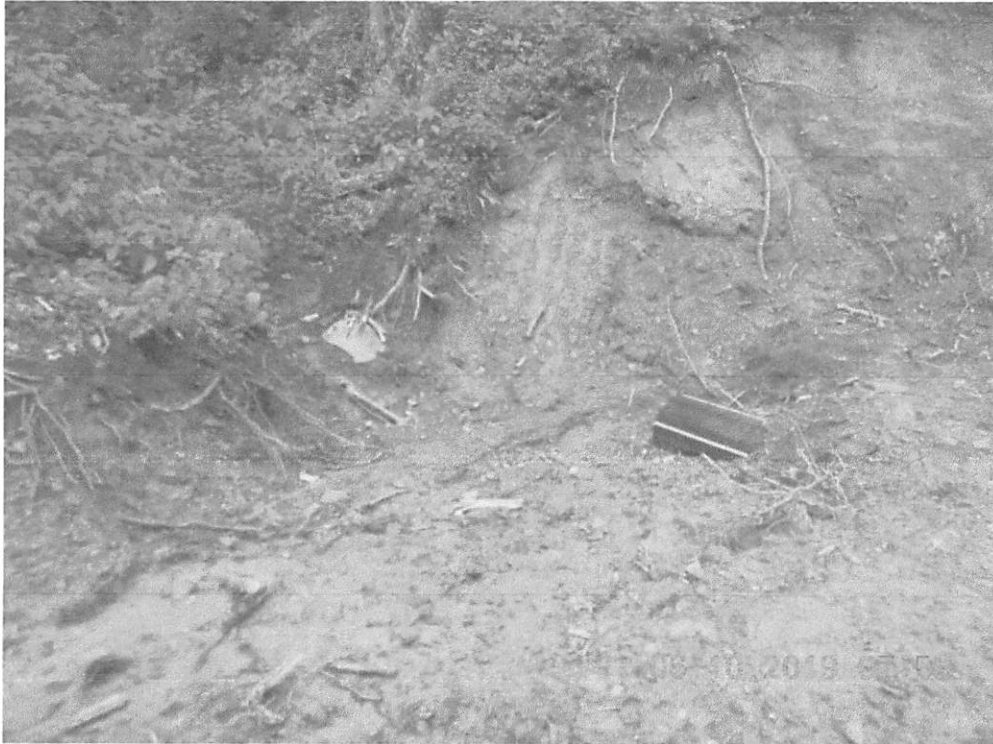
Clean water diversions at Station 211+00 between first and second unlabeled UNT.

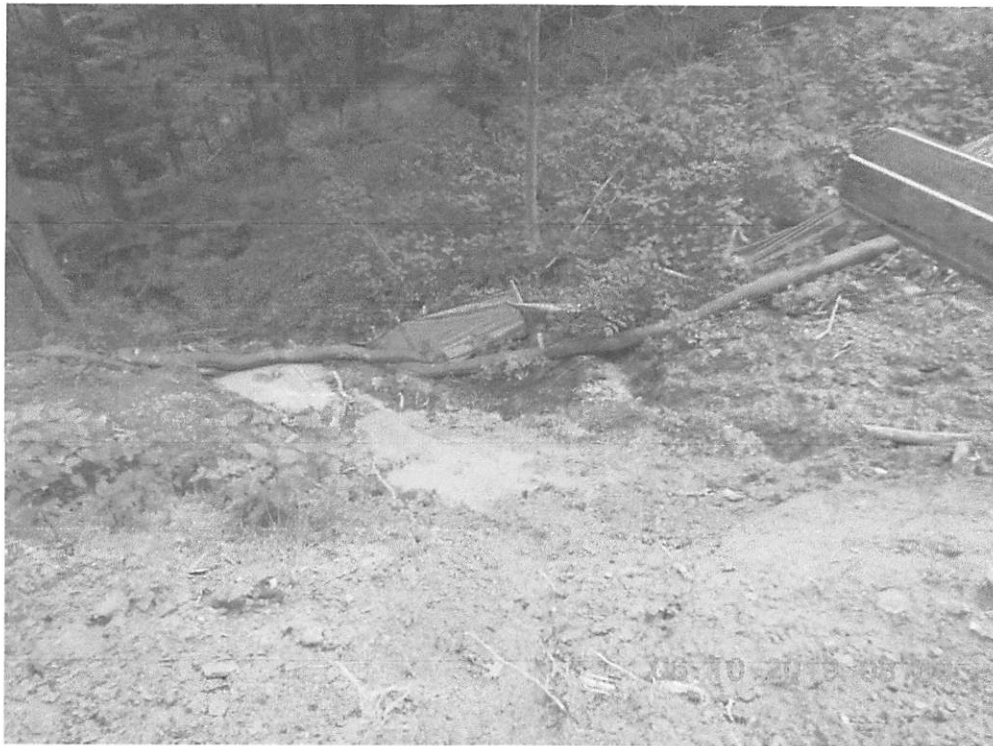
Second unlabeled UNT around Station 211+00. Head of culvert flume.

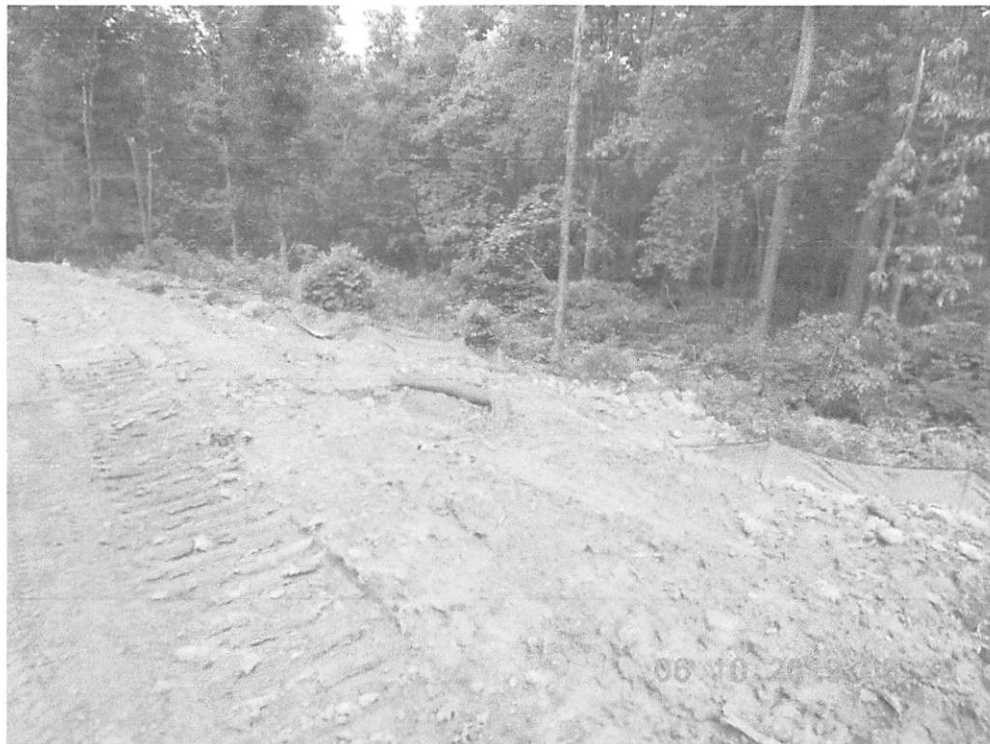
Station 214+00 to 219+50, SWPP calls for SS2 slope interceptors and 10 water bars with terminus treatment.

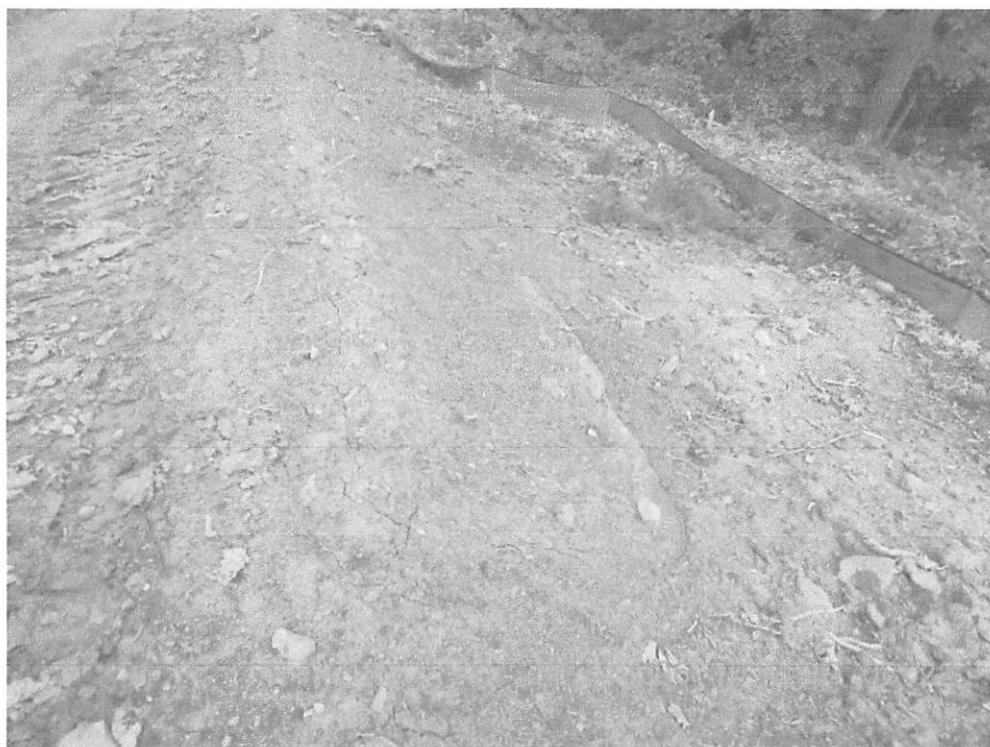
Station 220+00, Bypasses of perimeter controls.

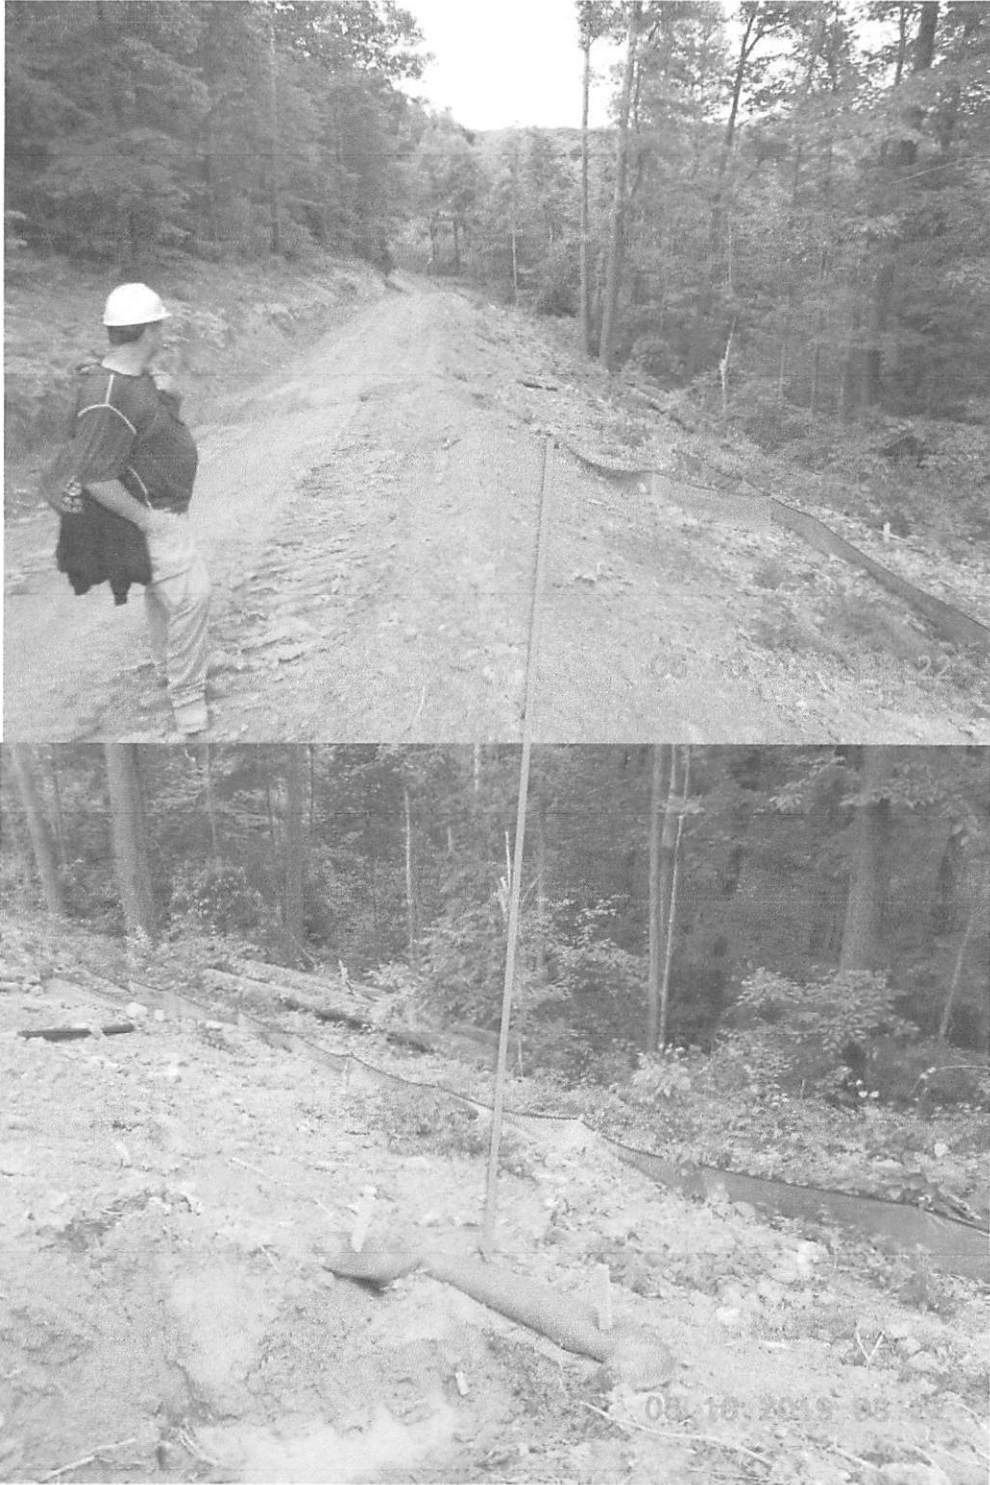
Station 220+50, Sumps needed maintenance.

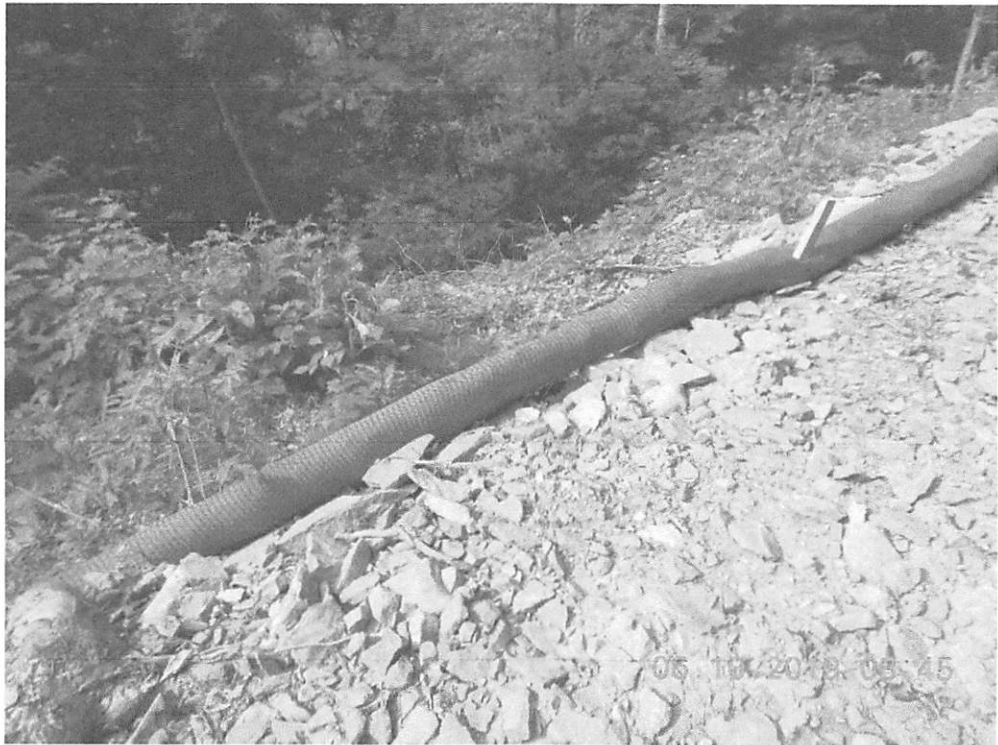
About Station 242+00, SWPPP calls for slope interceptor to be installed.

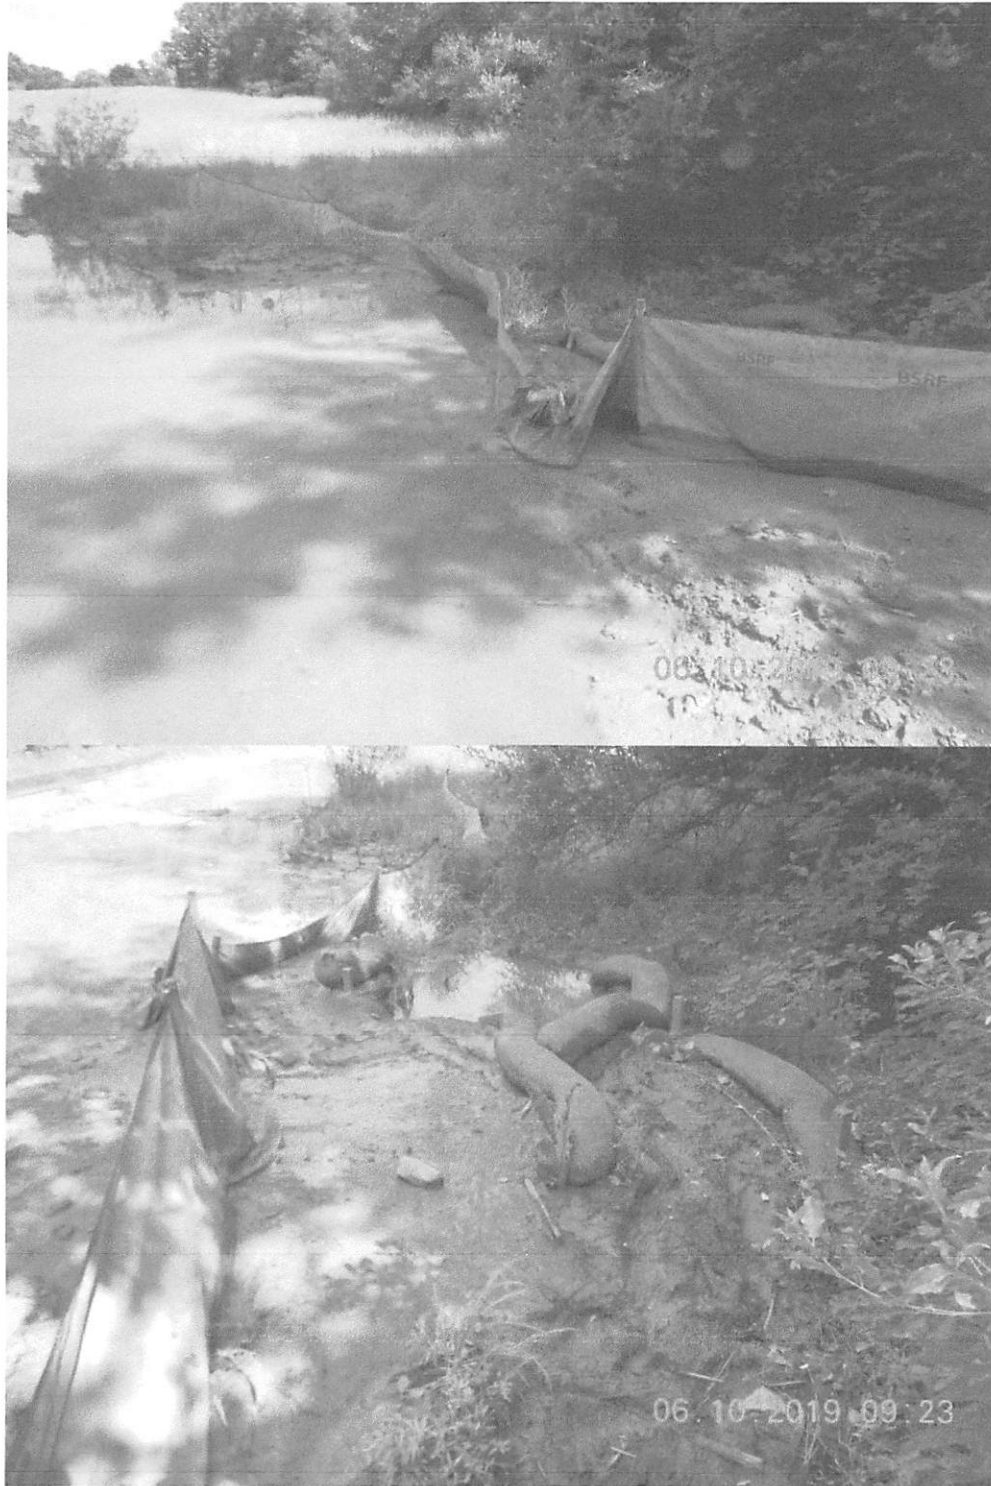
Station 274+00, SWPPP requires SS2 slope interceptors.

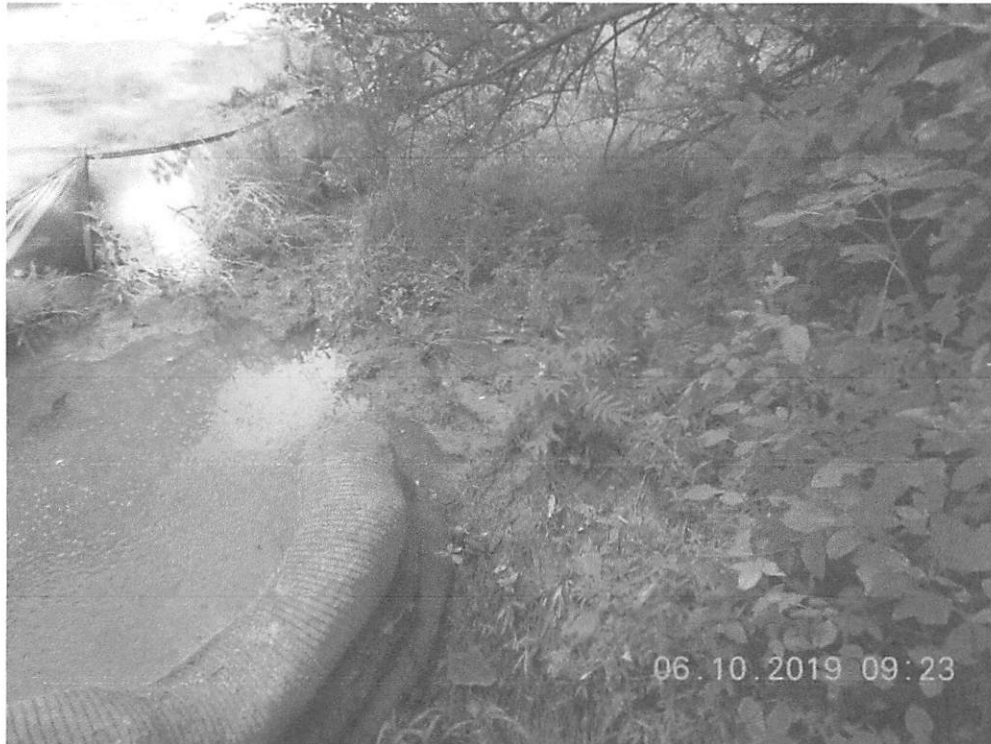
Station 258+00, WL 5 perimeter controls in disarray.

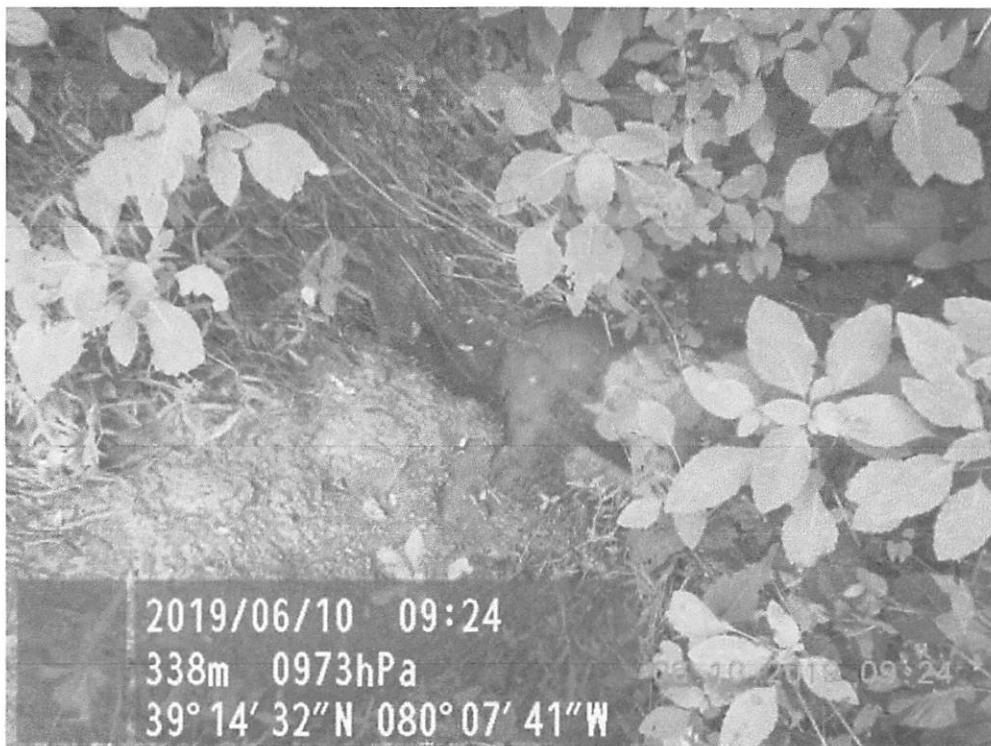
Bypass of WL5 perimeter controls

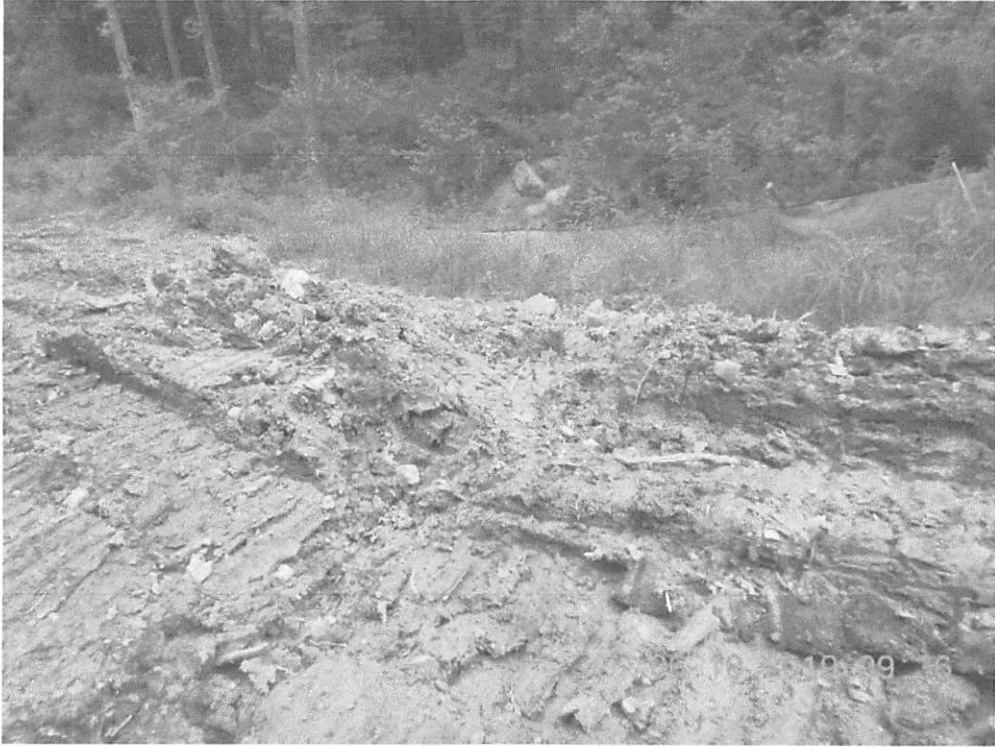
Station 301+00, Water bar with no terminus treatment. SWPPP requires SS2 slope interceptors.

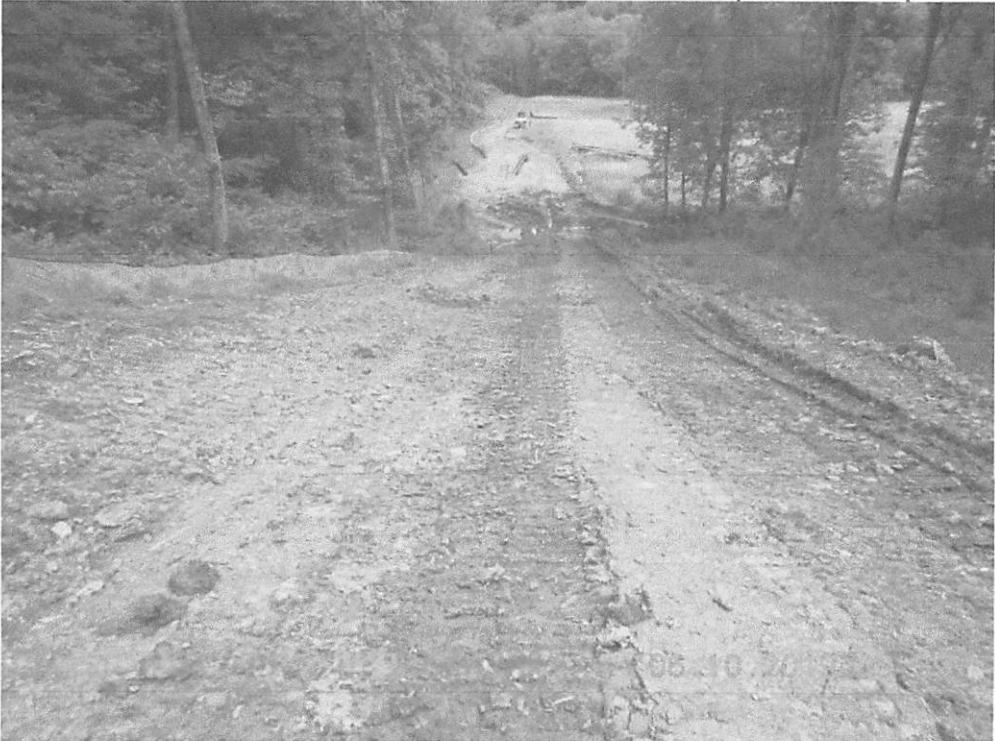
Station 304+00, WL 8, Required SS2 was not installed.

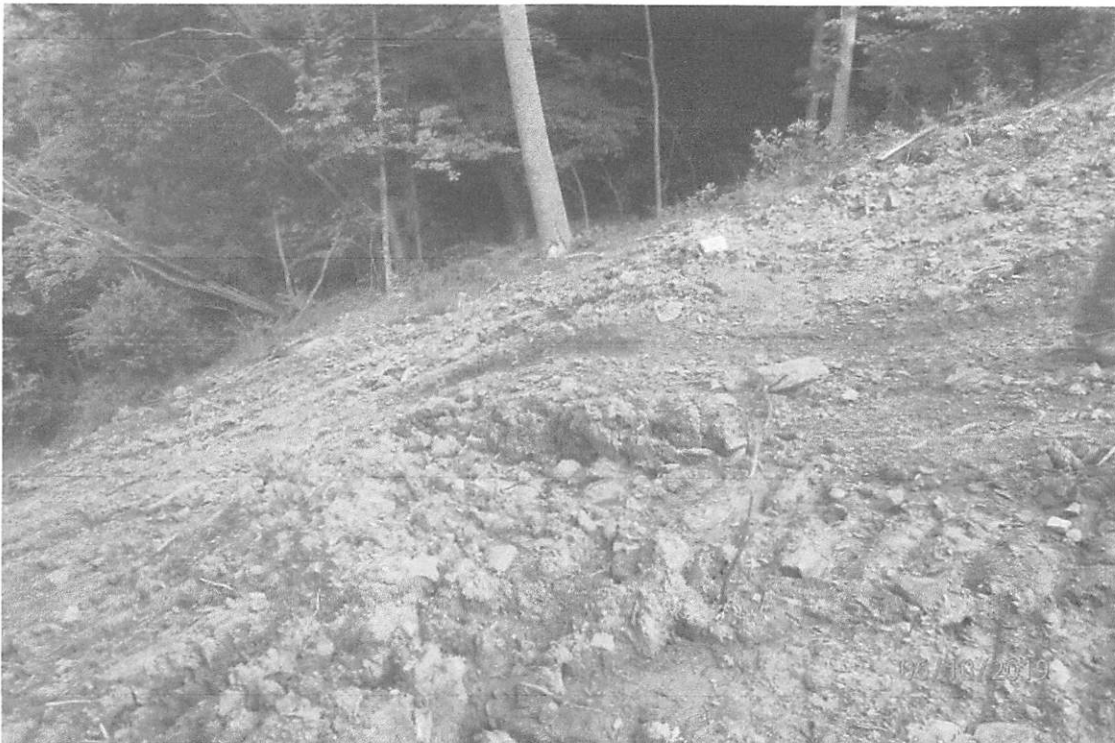
Waterbar in the Simpson Creek watershed that lacks waterbar terminus BMPs indicated in the approved SWPPP.

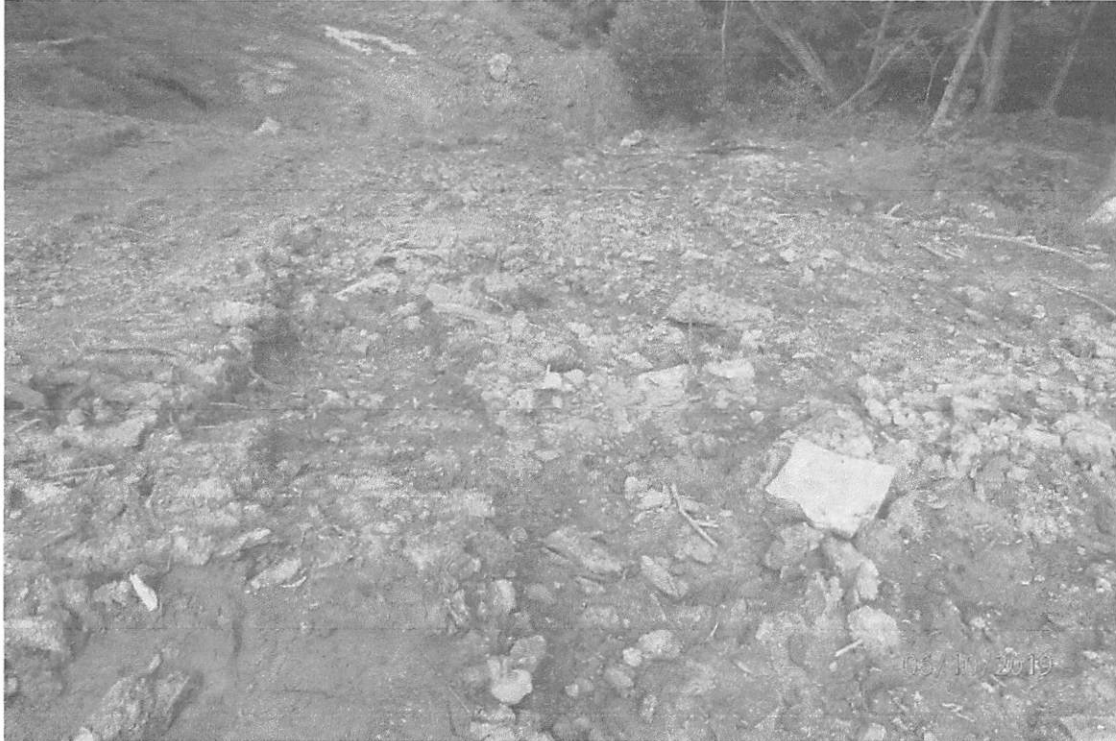
Project area upslope of 447+00 showing the lack of waterbars indicated in the approved SWPPP. The approved SWPPP indicates that 9 waterbars should be installed, but only 3 were in place.

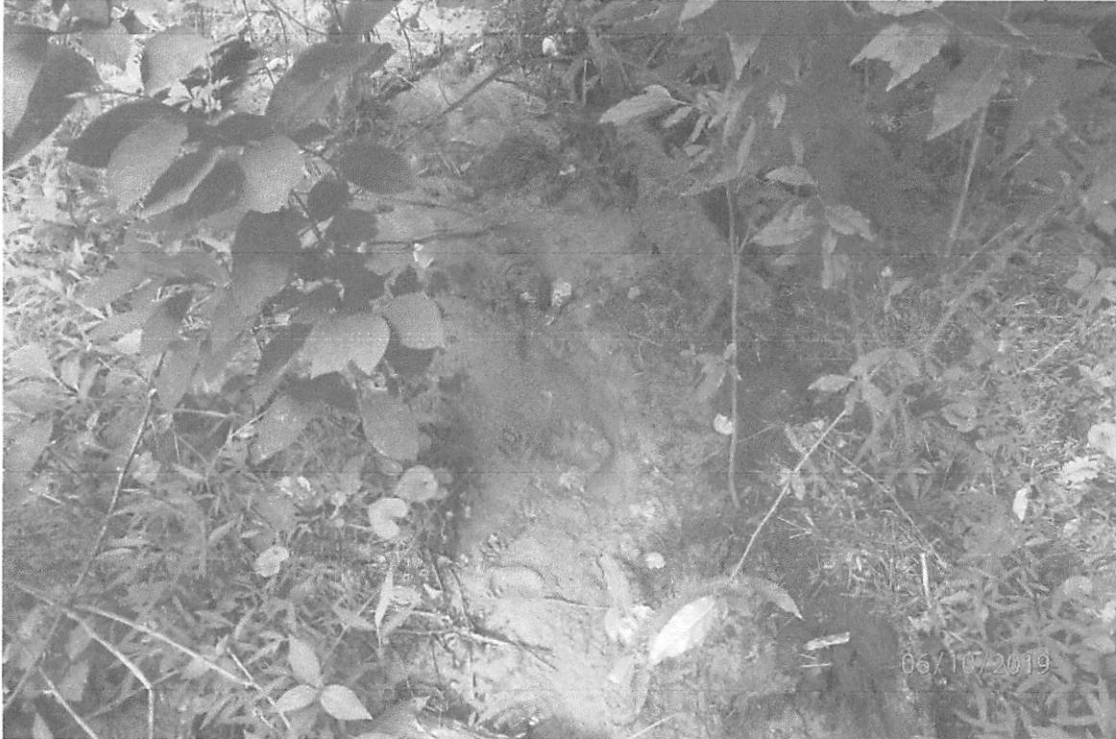
Offsite sediment deposits originating from the site adjacent to 447+00 as a result of the lack of installed waterbars and the associated fill slope erosion.
