**CONSENT ORDER  
ISSUED UNDER THE  
WATER POLLUTION CONTROL ACT  
WEST VIRGINIA CODE, CHAPTER 22, ARTICLE 11**

TO: Arsenal Resources LLC  
6031 Wallace Rd. Ext Suite 300  
Wexford PA 15090

DATE: October 8, 2020

ORDER NO.: 9923

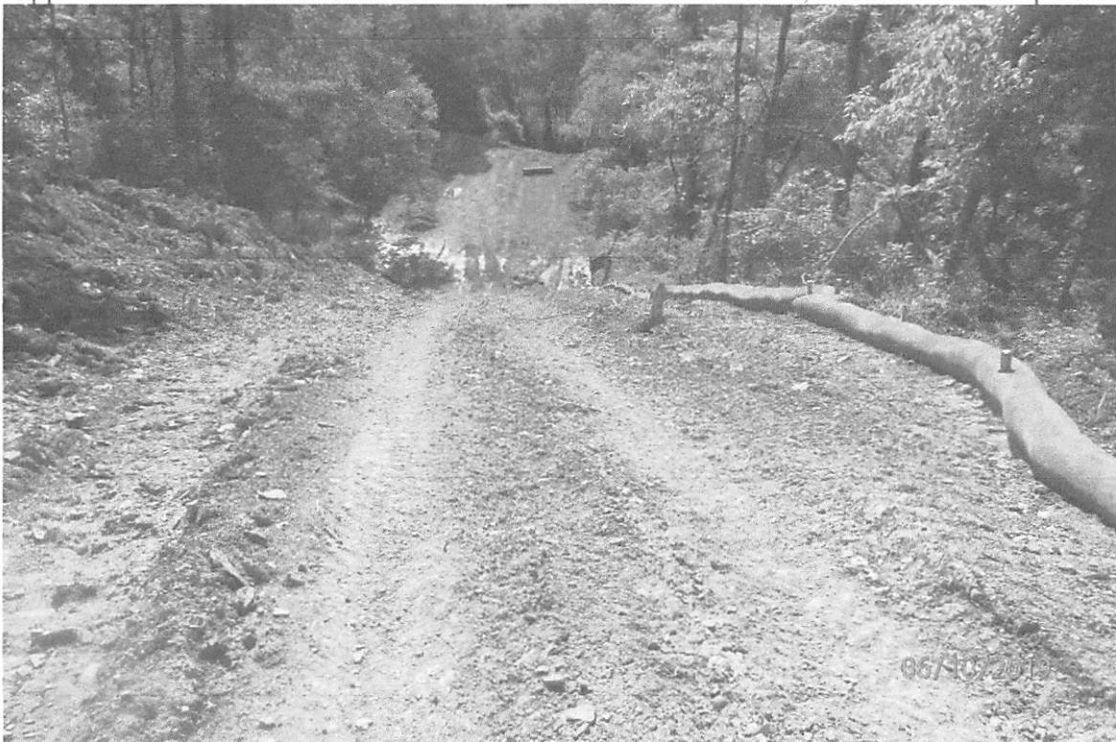
Project area upslope of 433+50 showing the lack of waterbars indicated in the approved SWPPP. The approved SWPPP indicates that 6 waterbars should be installed, but none were in place.

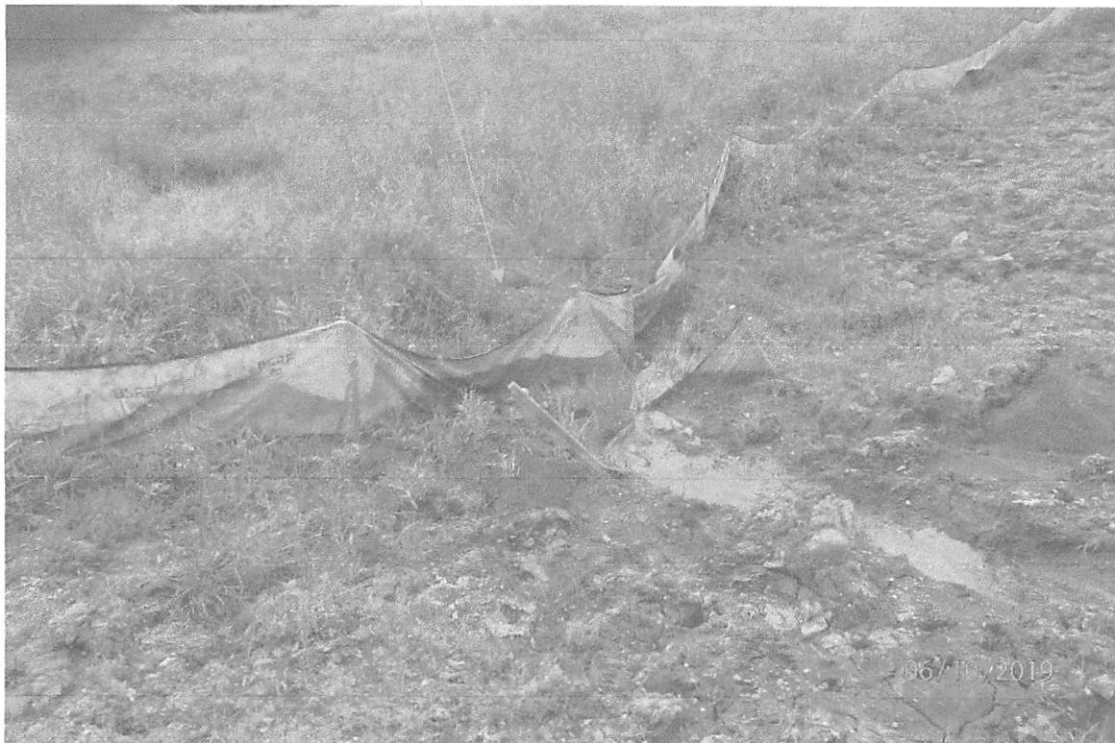
Installed BMPs adjacent to 400+50 that show evidence of being overtopped and are in need of maintenance.

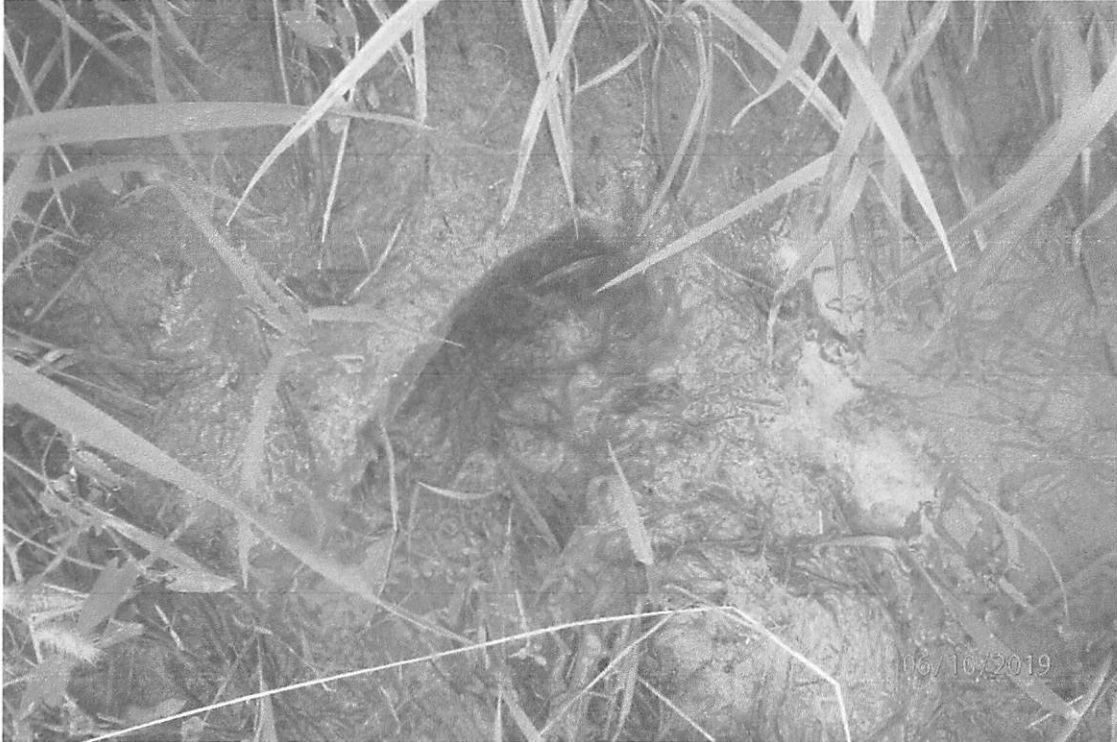
Offsite CNA deposits in UNT Simpson Creek (39° 15.086' X 80° 09.333') that originate from the site adjacent to 400+50.

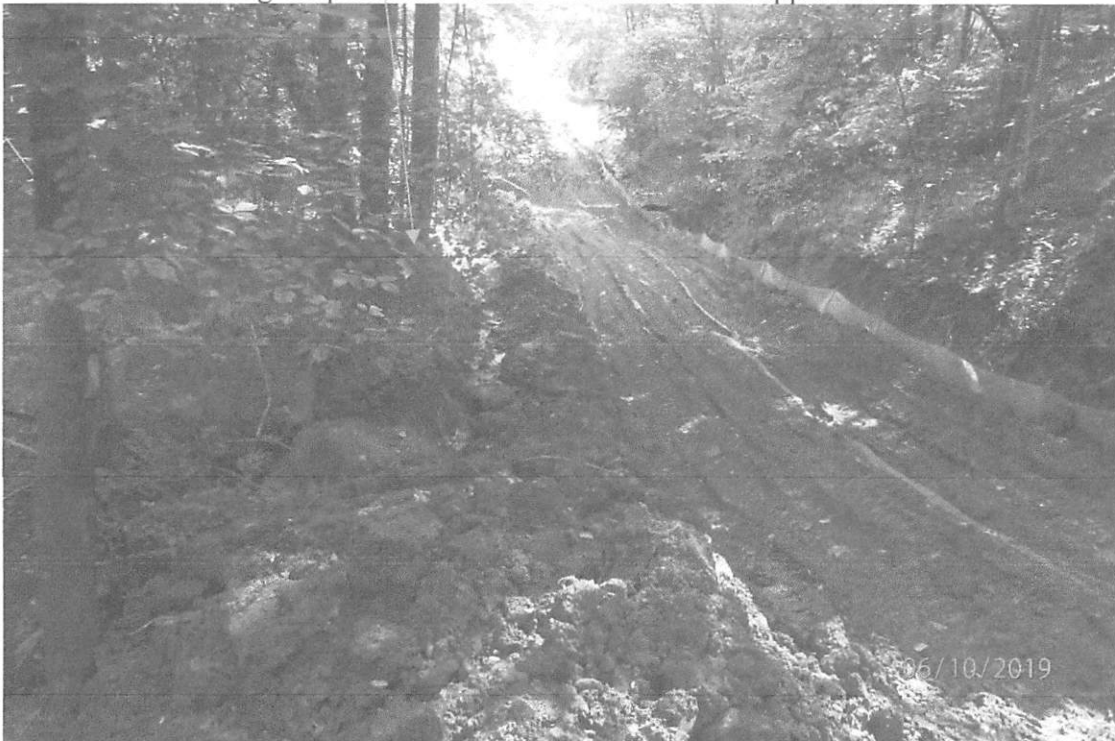
Access Road 7 showing the lack of installed perimeter controls indicated in the approved SWPPP.

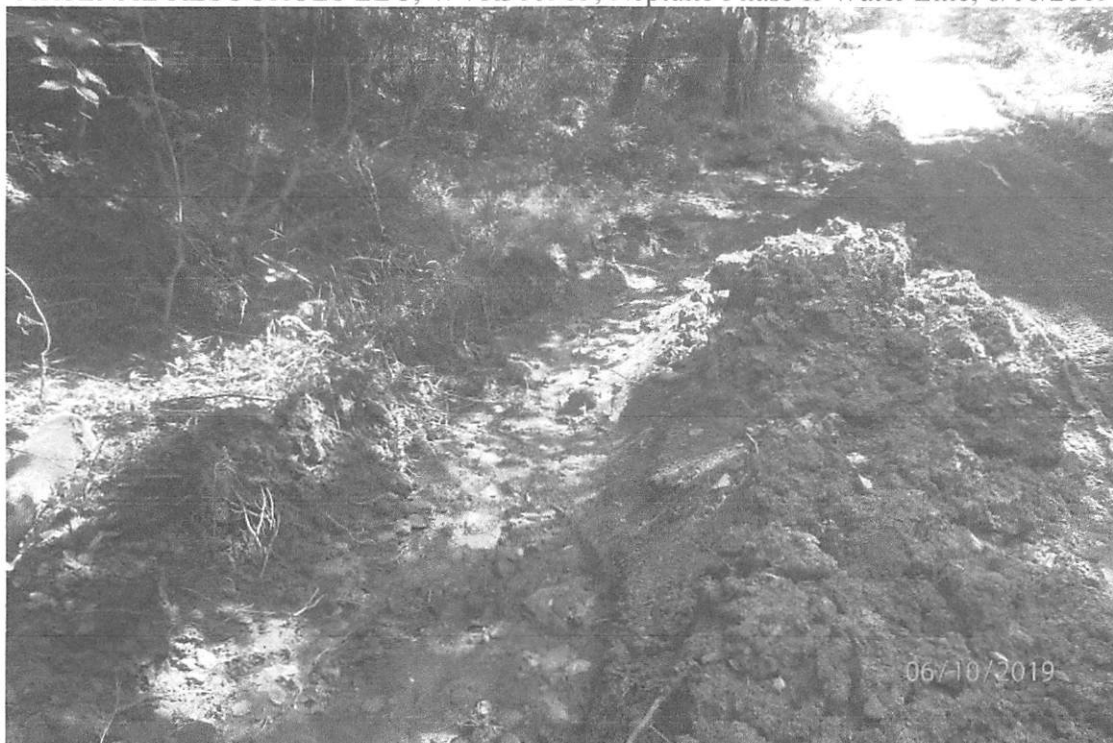
Ephemeral UNT Simpson Creek showing instream disturbance and the lack of installed BMPs to prevent sediment laden water from entering the stream.

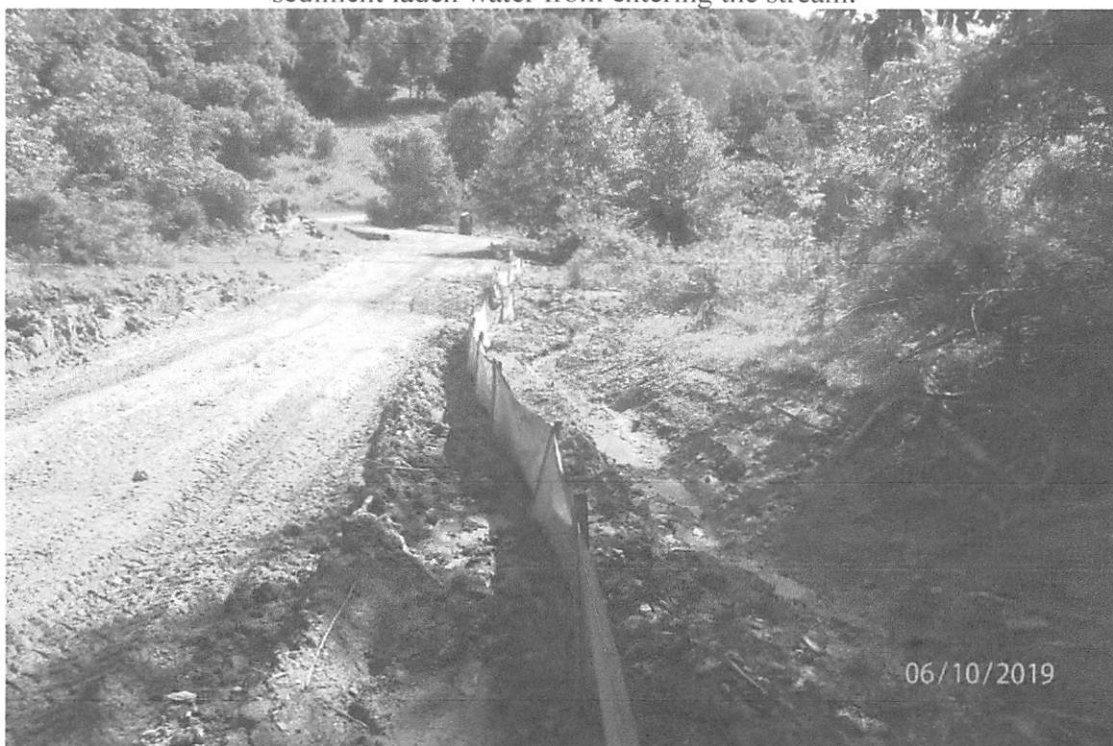
Access Road 7 showing the lack of a stabilized surface as indicated in the approved SWPPP.

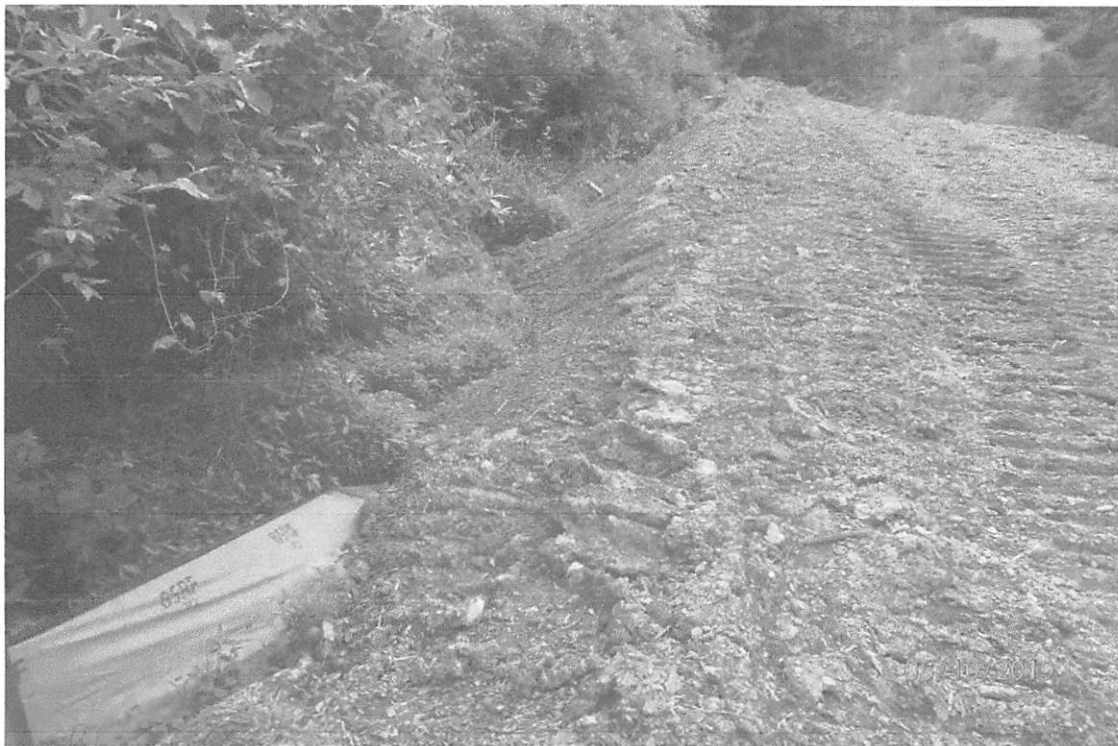
Perimeter control in need of maintenance in the Beards Run watershed.

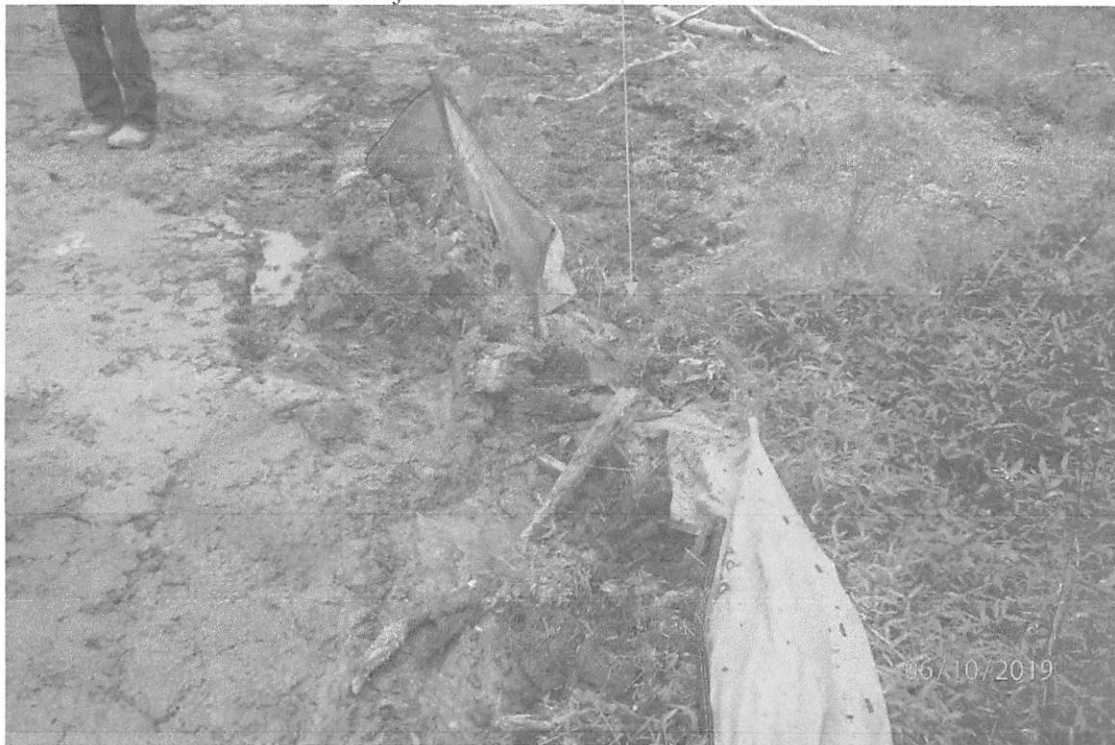
Perimeter control adjacent to WL-27 that is in need of maintenance.

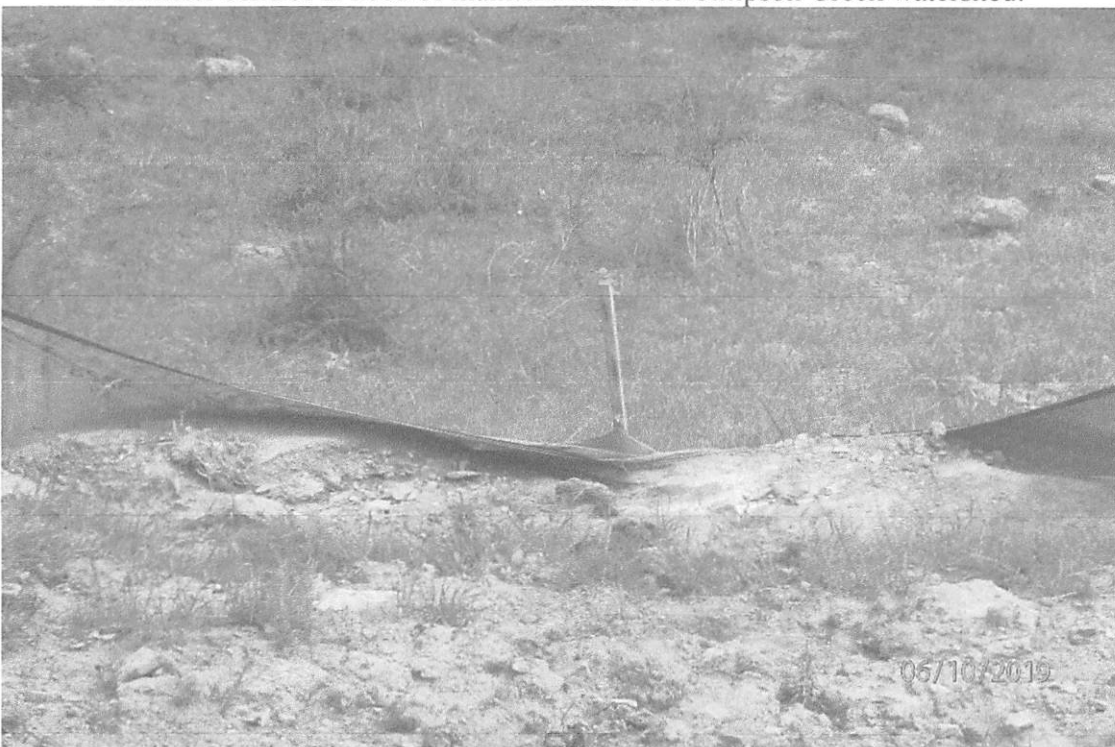
Perimeter control in need of maintenance in the Simpson Creek watershed.

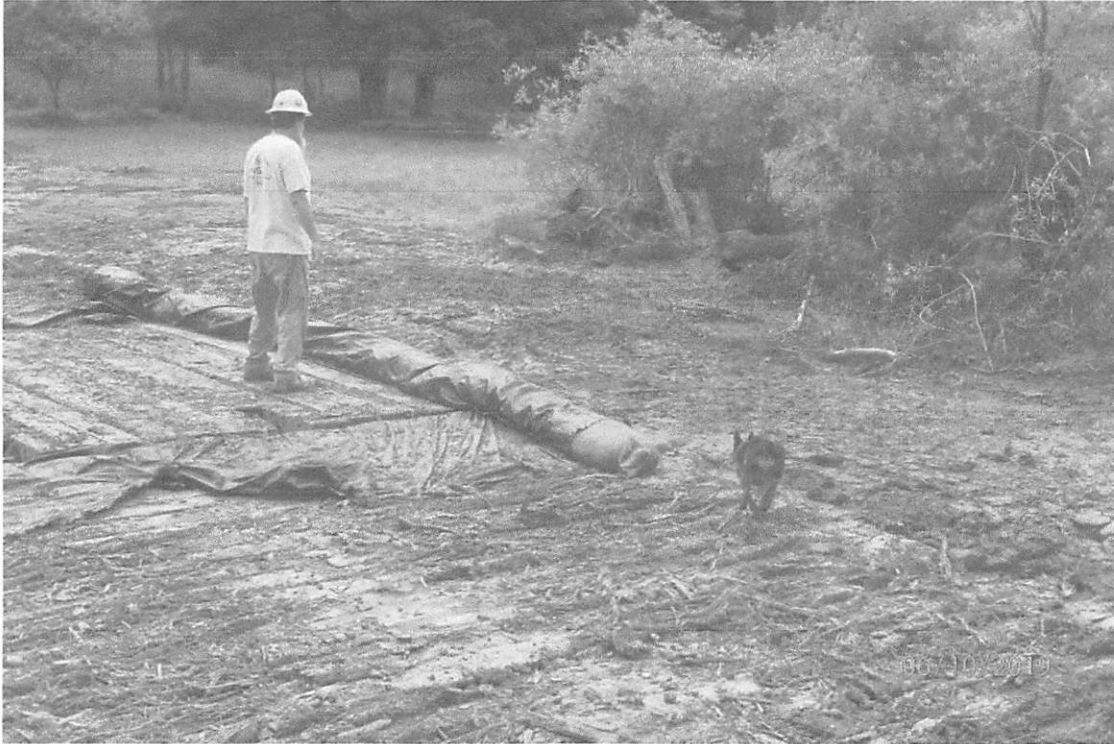
Wetland WL-28 showing an area where the approved SWPPP indicates the need for perimeter controls.

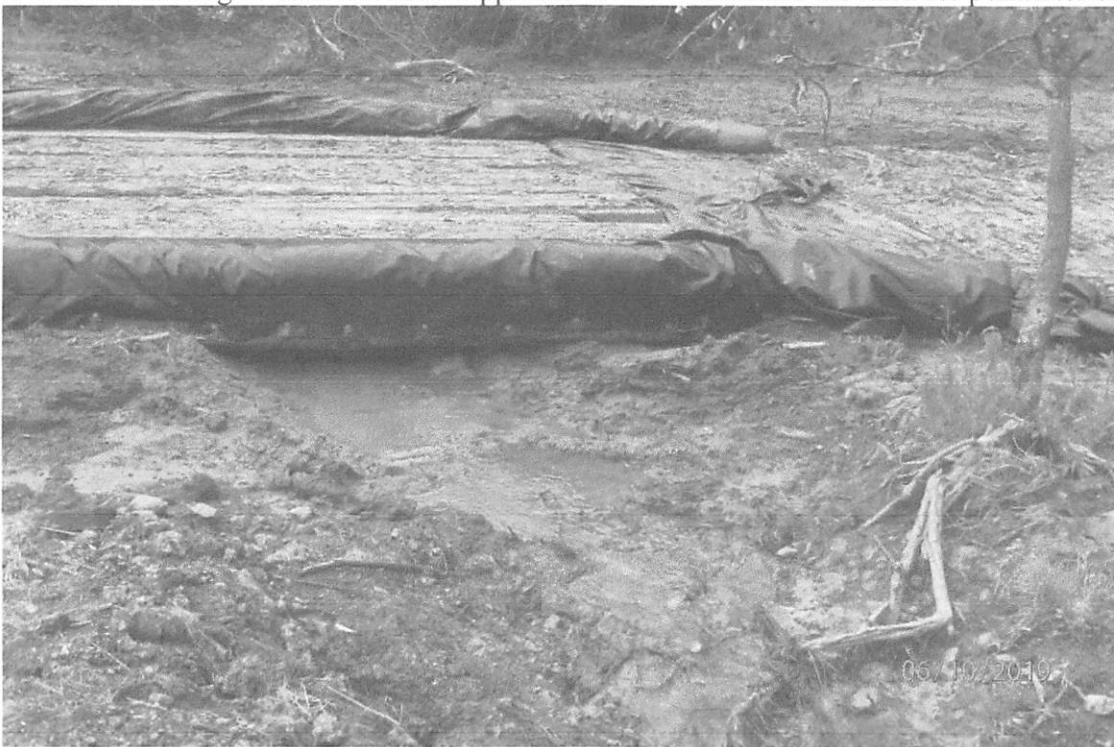
WL-28 showing the area where sediment laden water from the project is leaving the site without going through an approved device. The approved SWPPP does not indicate the need for BMPs in this area even though it is evident that a stream of water is present.

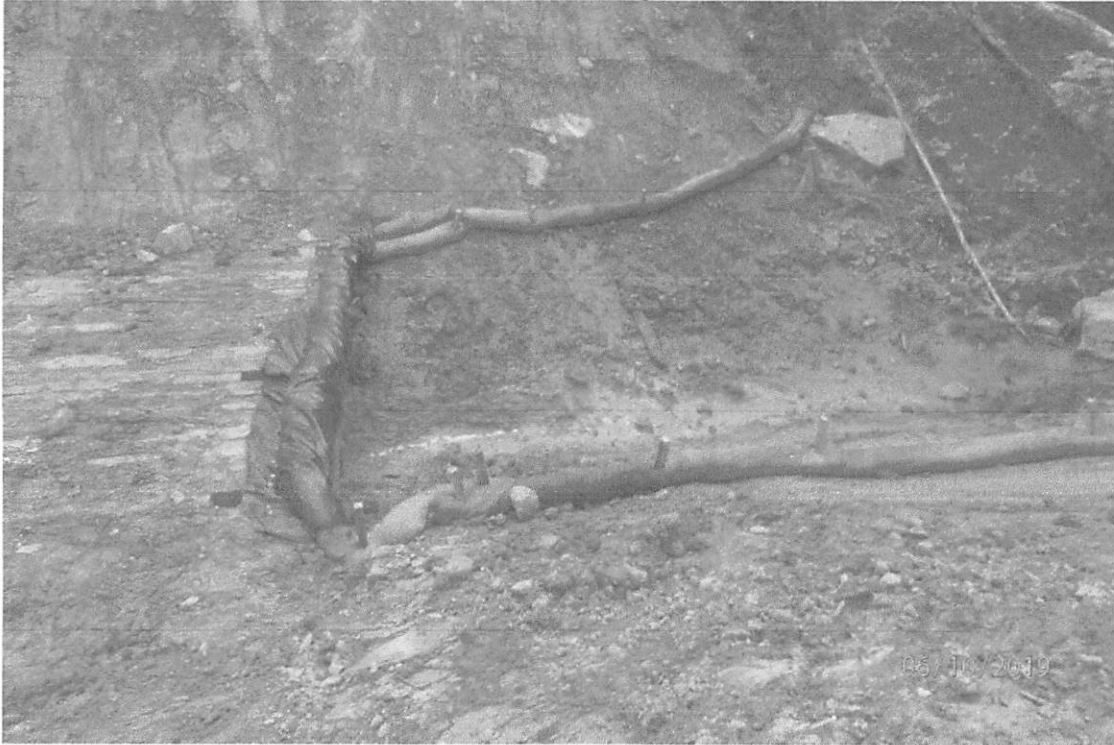
UNT 24 crossing showing the area where a stream crossing took place without the pump-around or flume crossing in place.

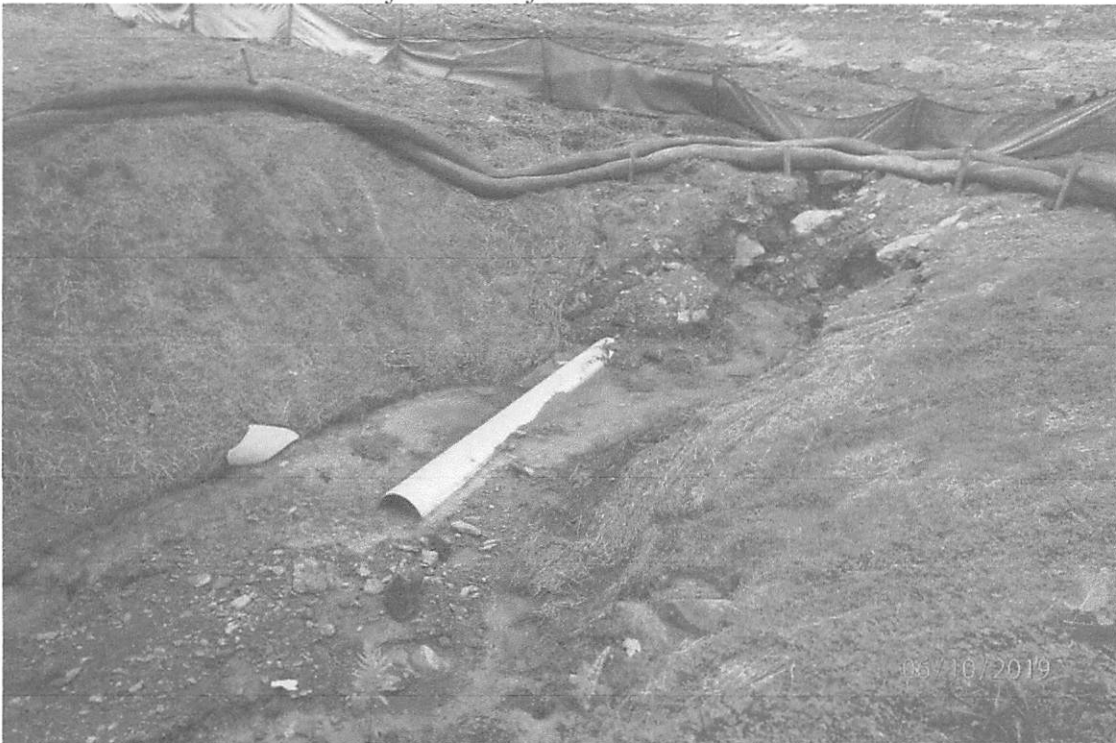
UNT – 14 showing area where groundwater from a coal mine opening flowed across the project area overwhelming the installed BMPs and causing deposits in the stream.

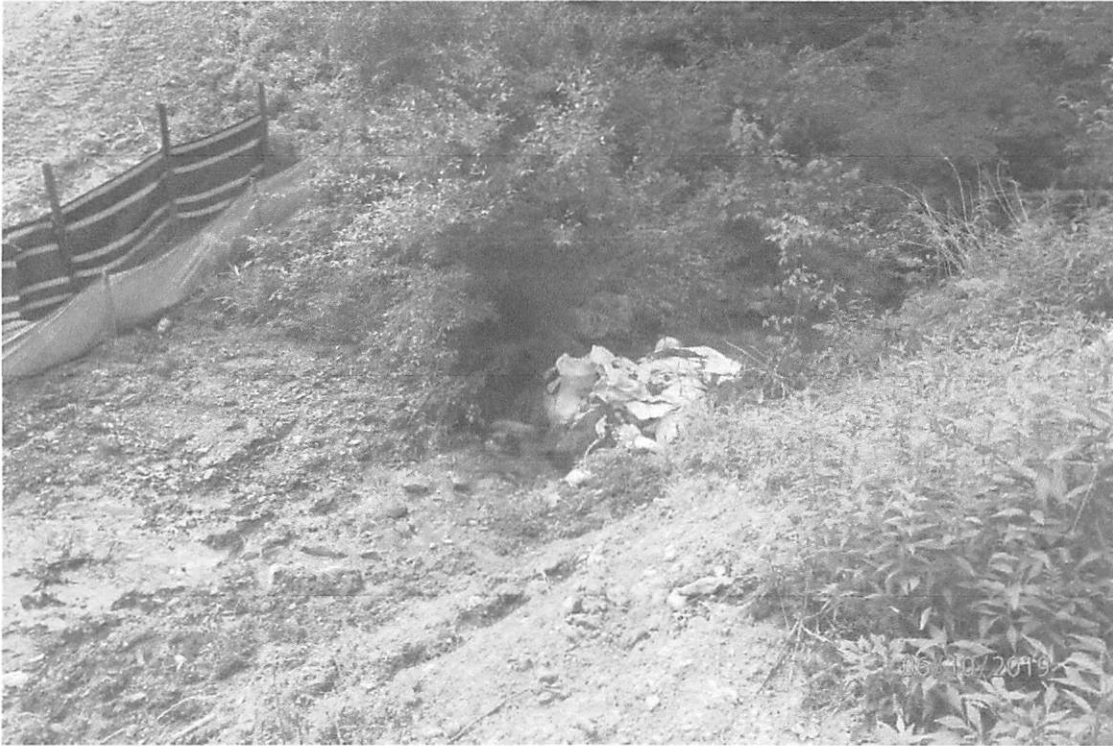
Instream solid waste in UNT 21 as a result of the contractor leaving the sand bag coffer dam in the stream after the stream crossing was completed.

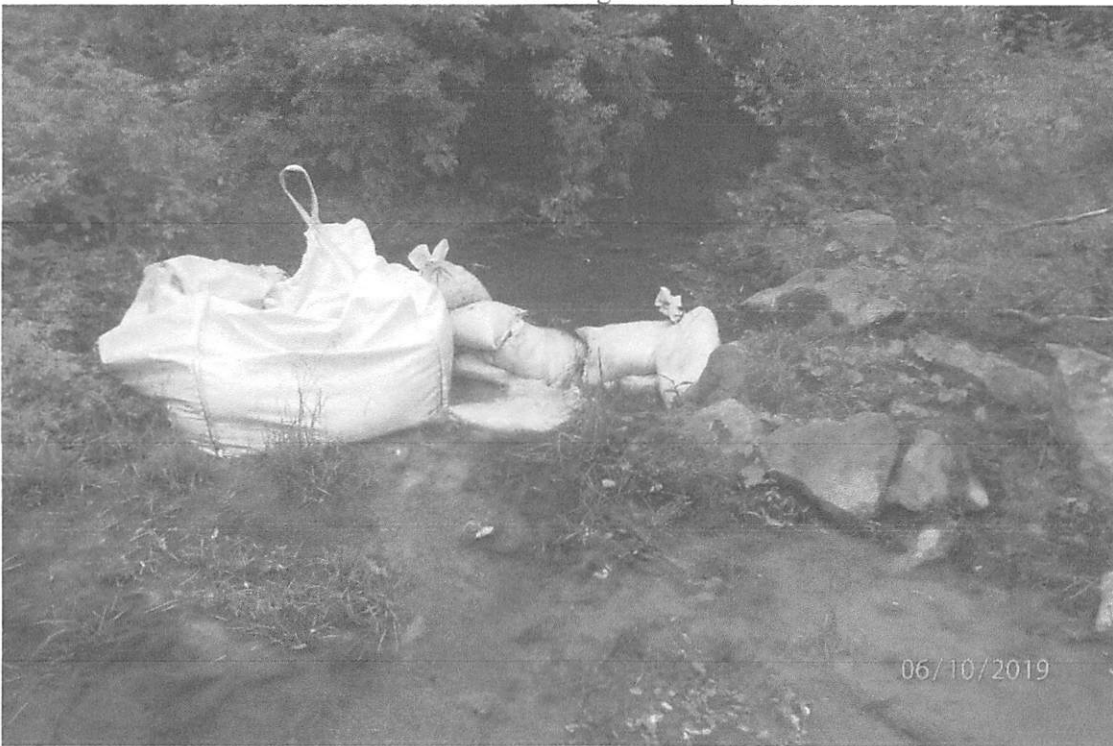
Instream solid waste in UNT 19 as a result of the contractor leaving the sand bag coffer dam in the stream after the stream crossing was completed.

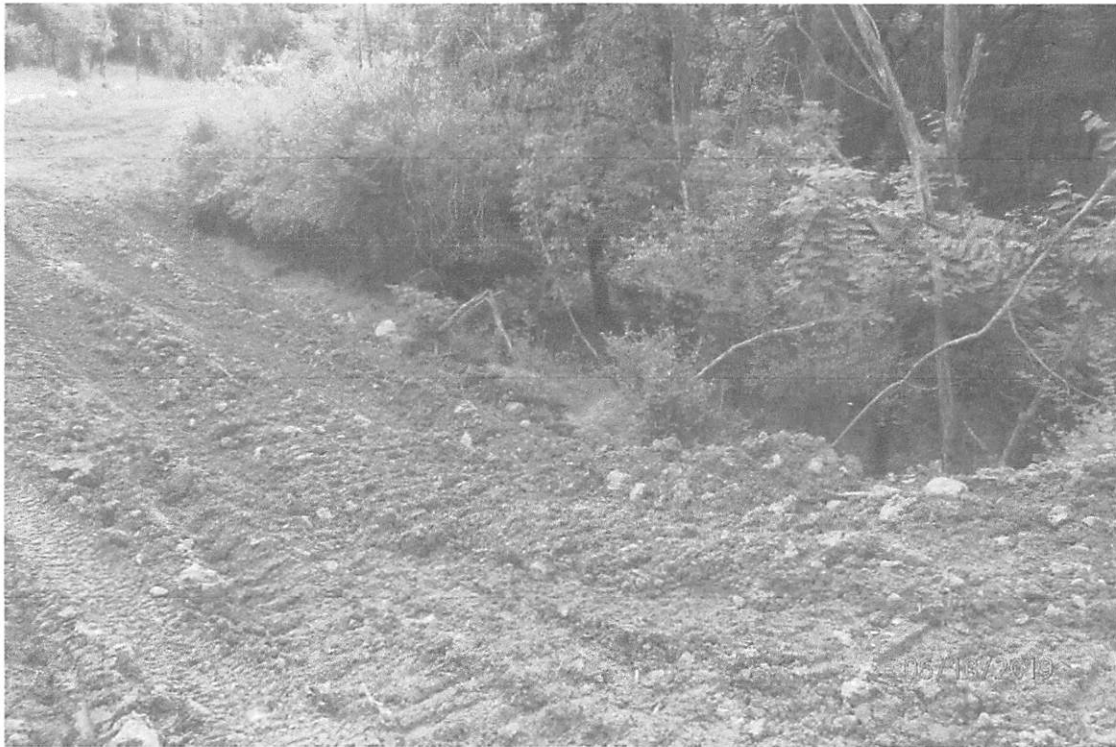
Project area showing the need for additional perimeter controls not indicated in the approved SWPPP adjacent to 467+00.

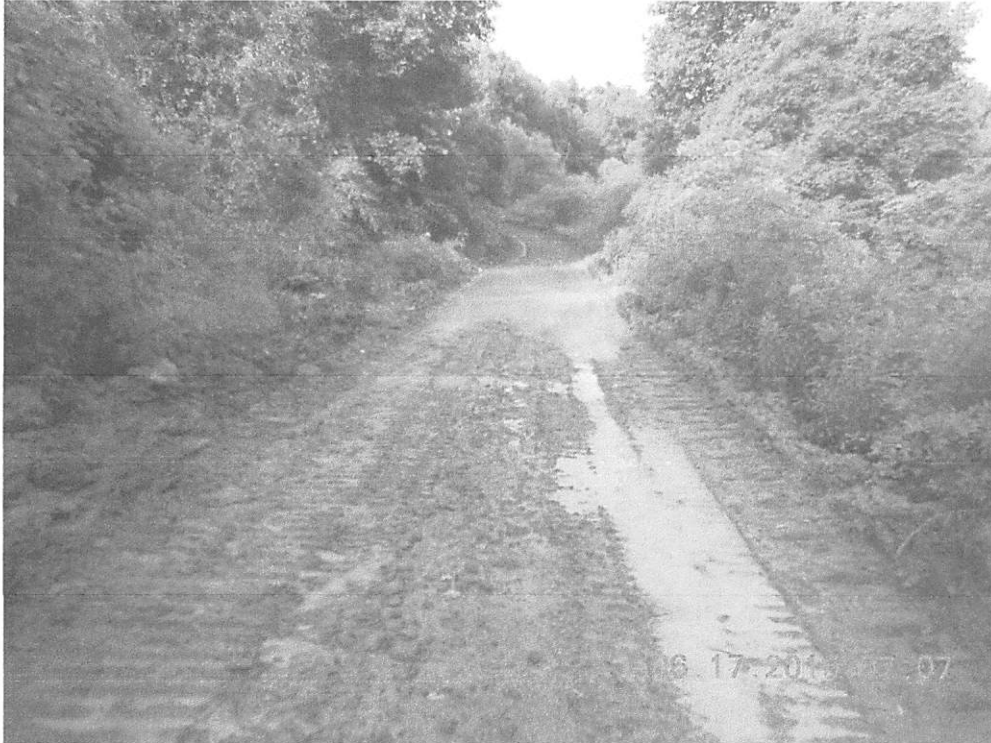
In places along AR 5, the CFS had been overtopped by sediment being pushed out by the equipment, or equipment ran over the CFS, making it ineffective, allowing sediment laden water to leave AR 5 without going through an appropriate device.

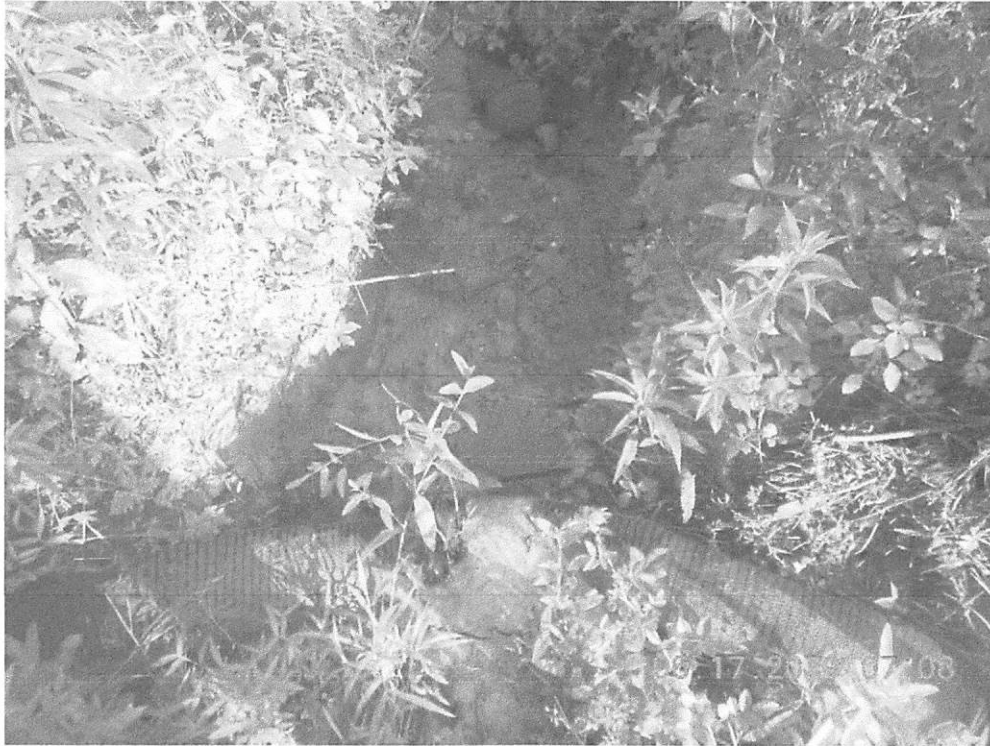
Sediment laden water entered the UNT of Simpson Creek at the mud hole that developed at the culvert where controls were not being maintained.

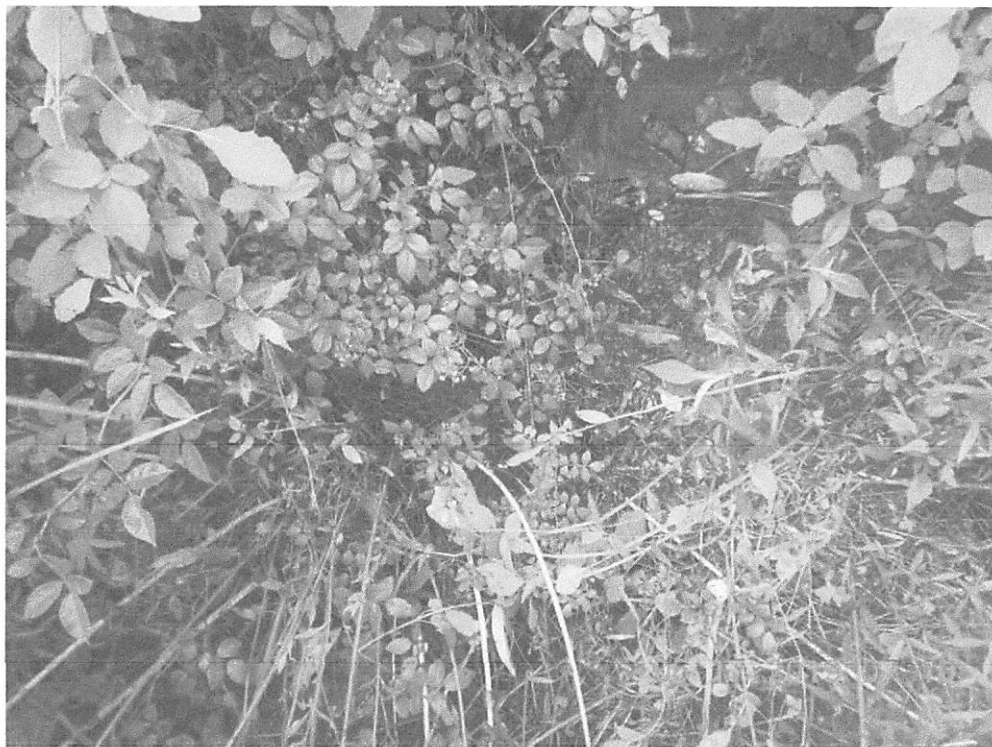
Culvert tail of UNT of Simpson Creek.

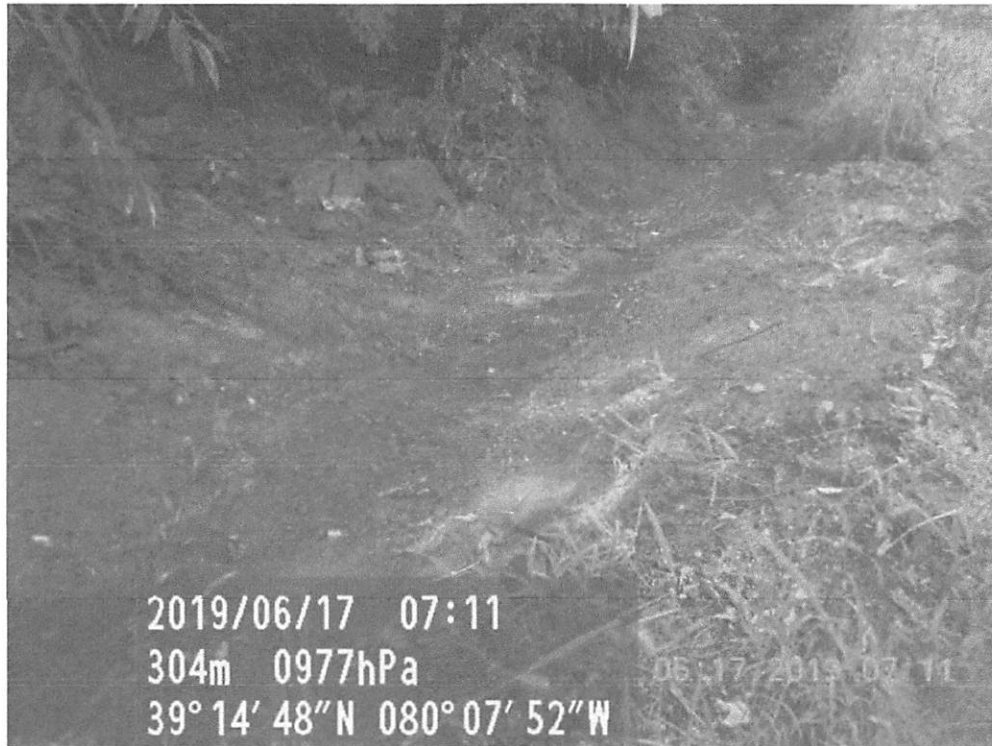
Culvert Head of UNT of Simpson Creek. Sediment controls were not installed at the culverts.

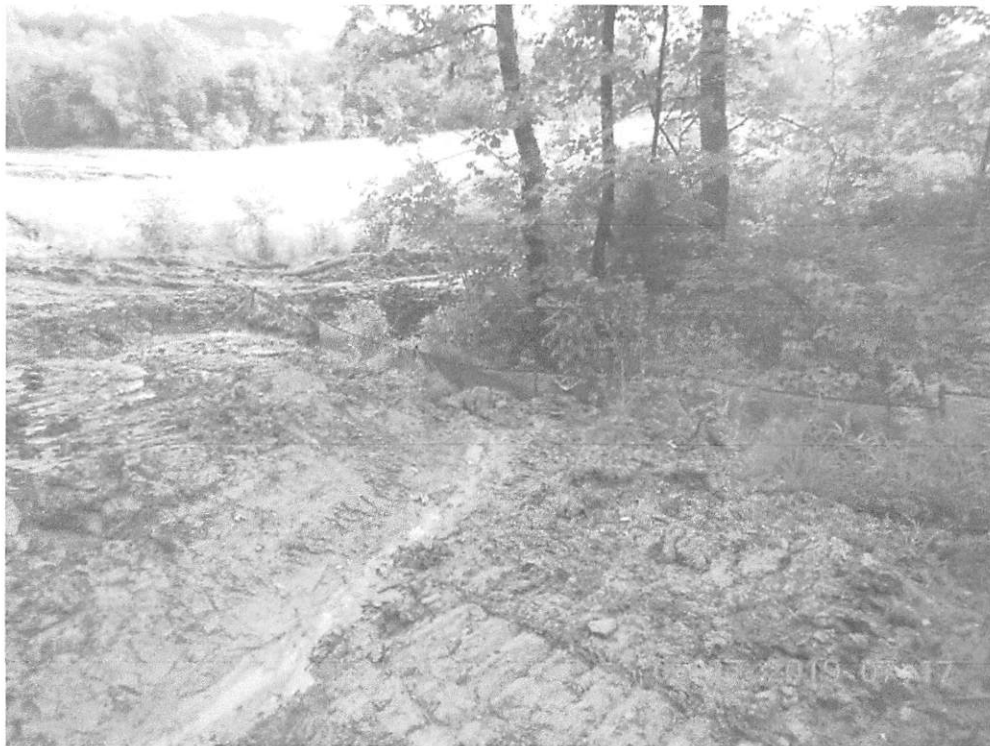
No controls were installed on this section of AR 5.

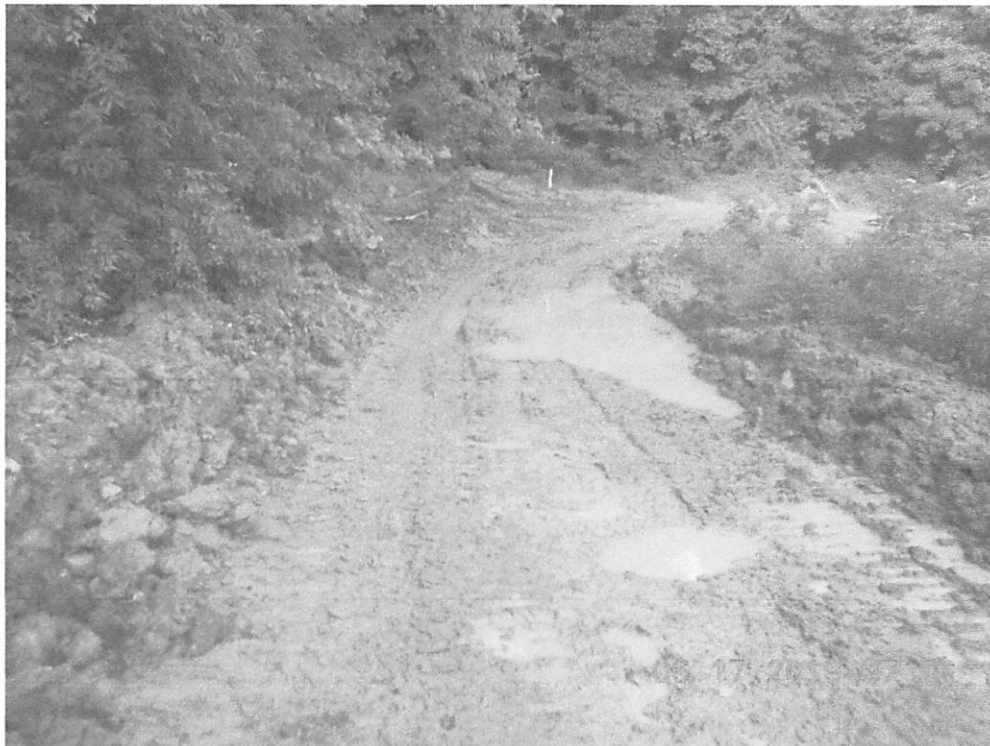
Lack of proper terminus treatment, as indicated in the SWPPP, along with SS2 slope interceptors.

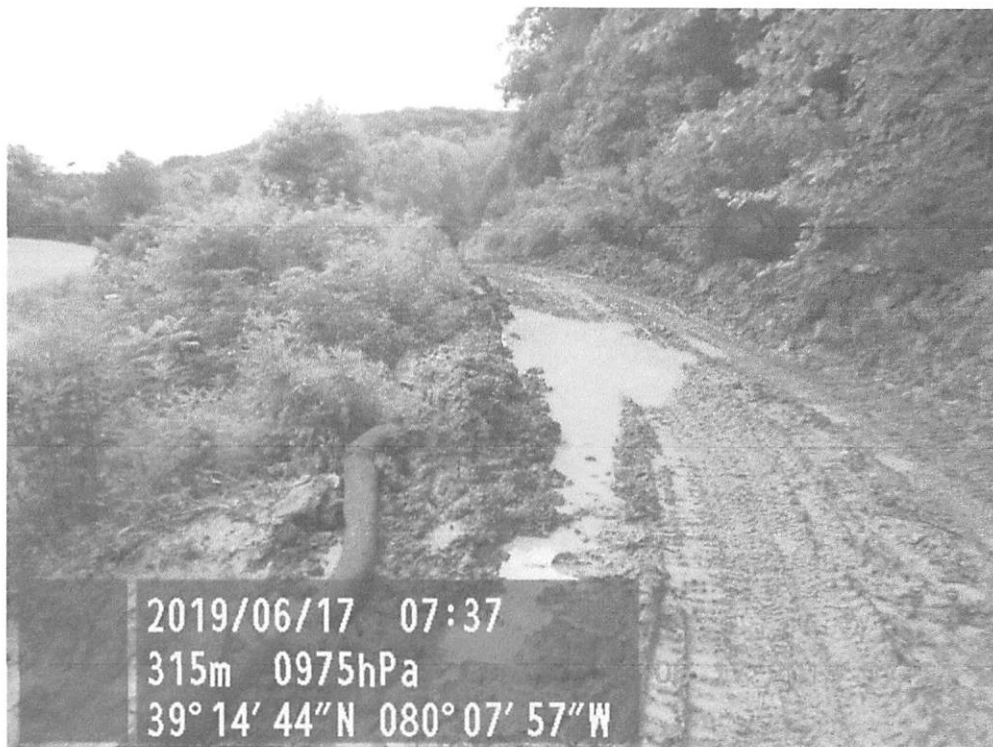
Ditchline from WL 8 along AR 5 is pinched shut.

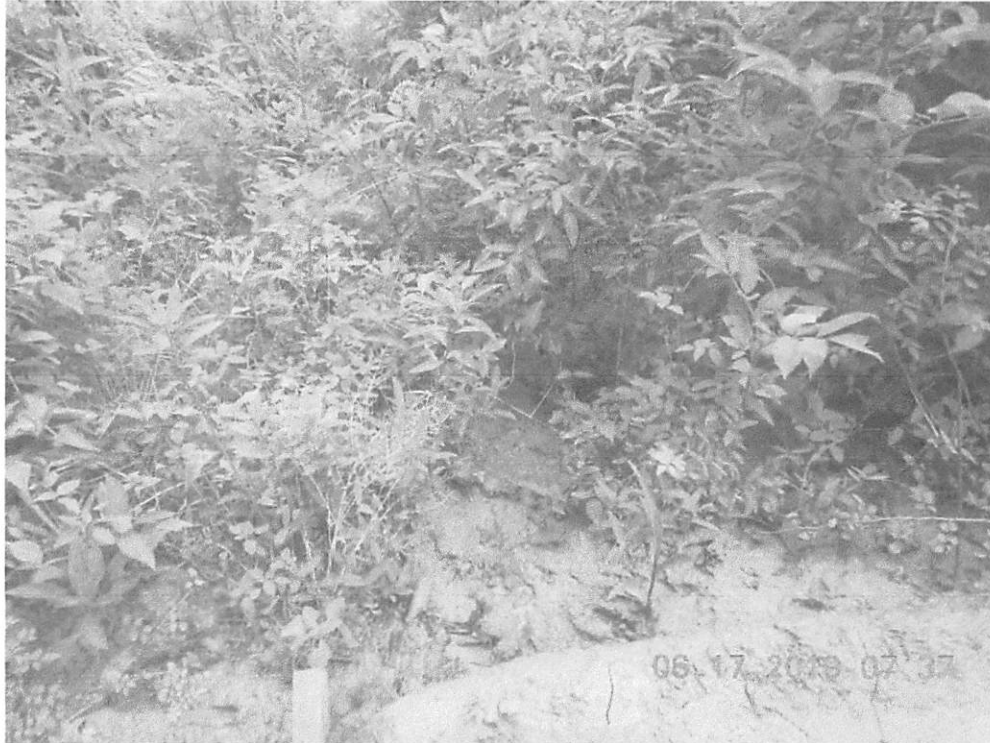
Controls overtopped by sediment on AR 5.

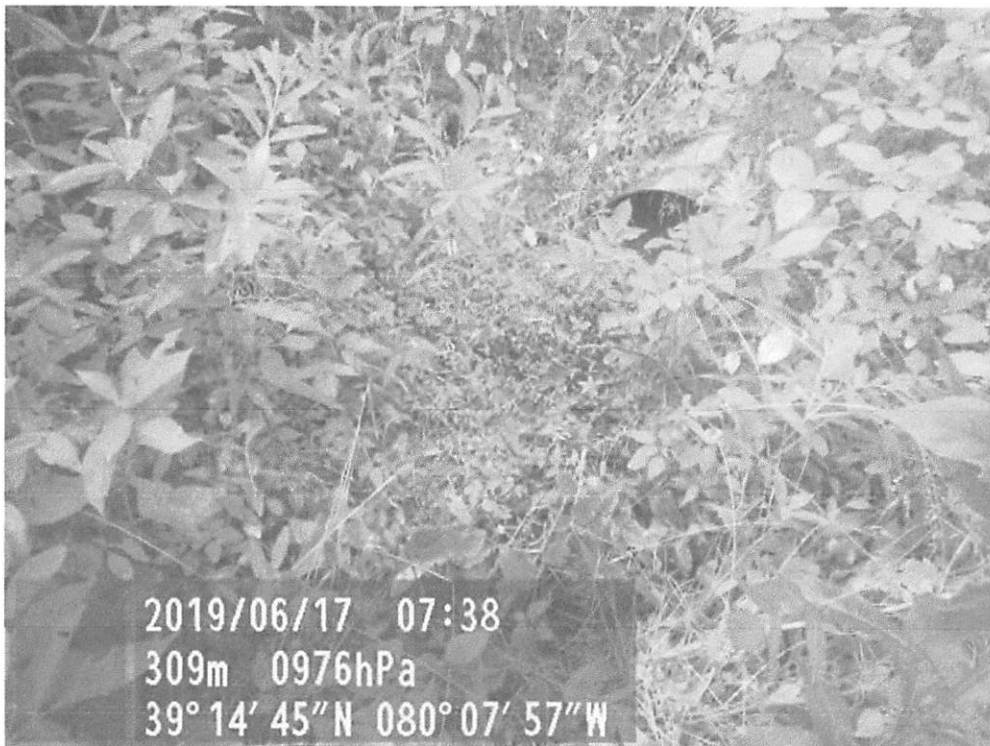
Culvert trail for WL 8 on AR 5.  
Maintenance needed on perimeter controls. Sediment deposited off LOD.

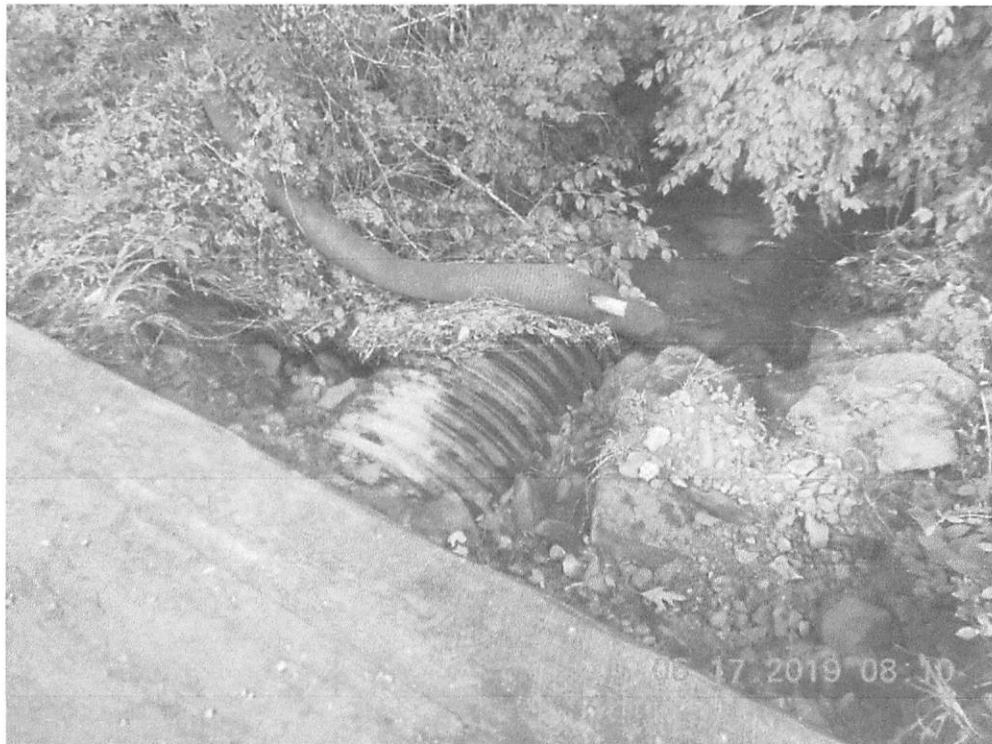
Culvert trail for WL 8 on AR 5.  
Controls were not installed at the culverts.

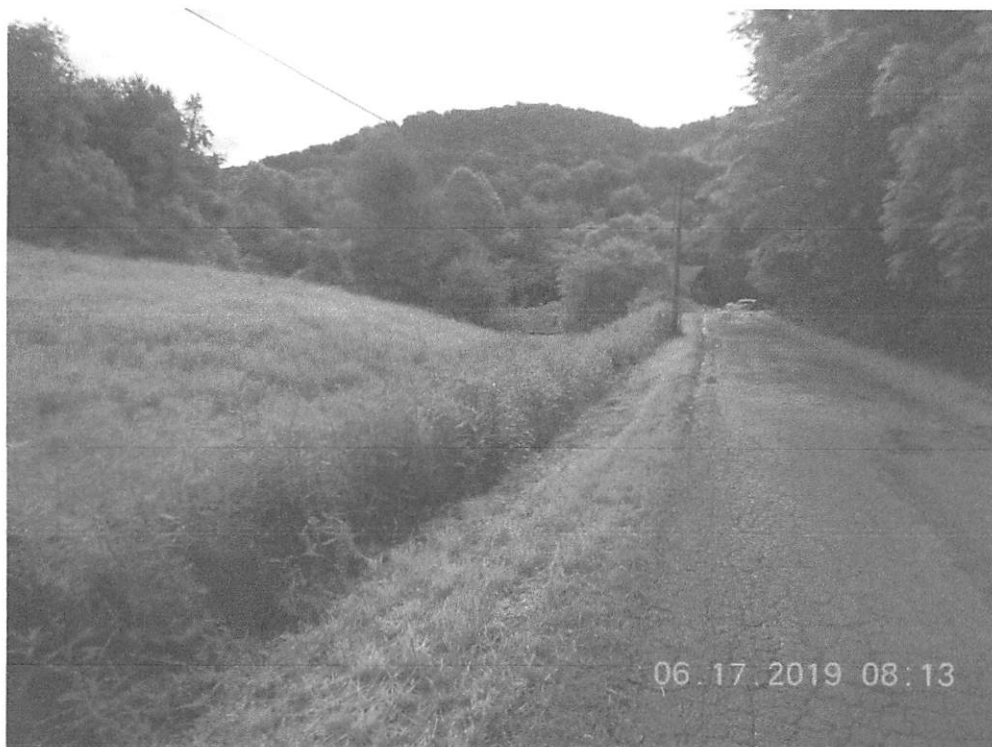
AR 5 construction entrance culvert overwhelmed.

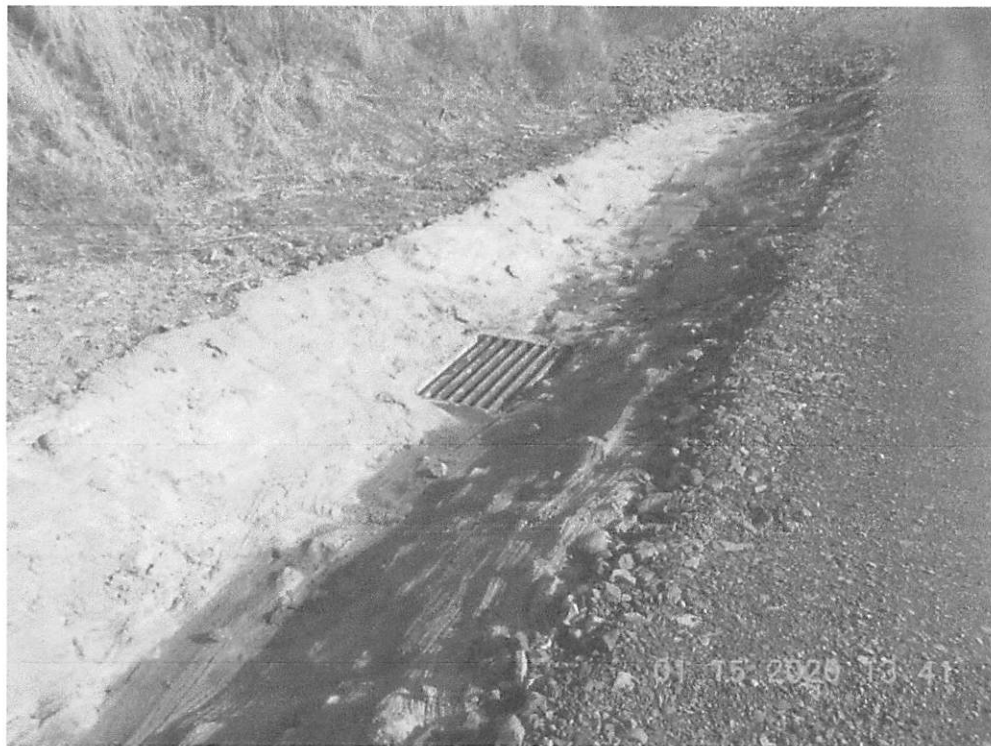
Drop inlet in concrete slurry diversion ditch with no inlet protection and sediment deposits present from unstable area above the diversion ditch.
