**CONSENT ORDER  
ISSUED UNDER THE  
WATER POLLUTION CONTROL ACT  
WEST VIRGINIA CODE, CHAPTER 22, ARTICLE 11**

TO: Arsenal Resources LLC  
6031 Wallace Rd. Ext Suite 300  
Wexford PA 15090

DATE: October 8, 2020

ORDER NO.: 9923

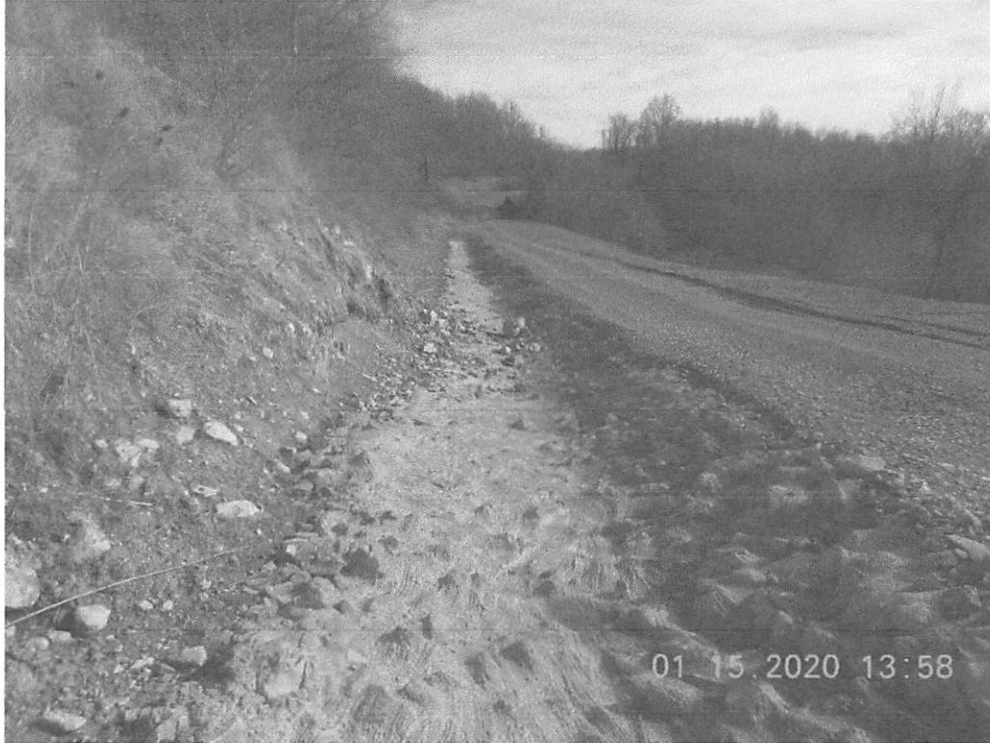
Drop inlet in concrete slurry diversion ditch with no inlet protection and sediment deposits present from unstable area above the diversion ditch.

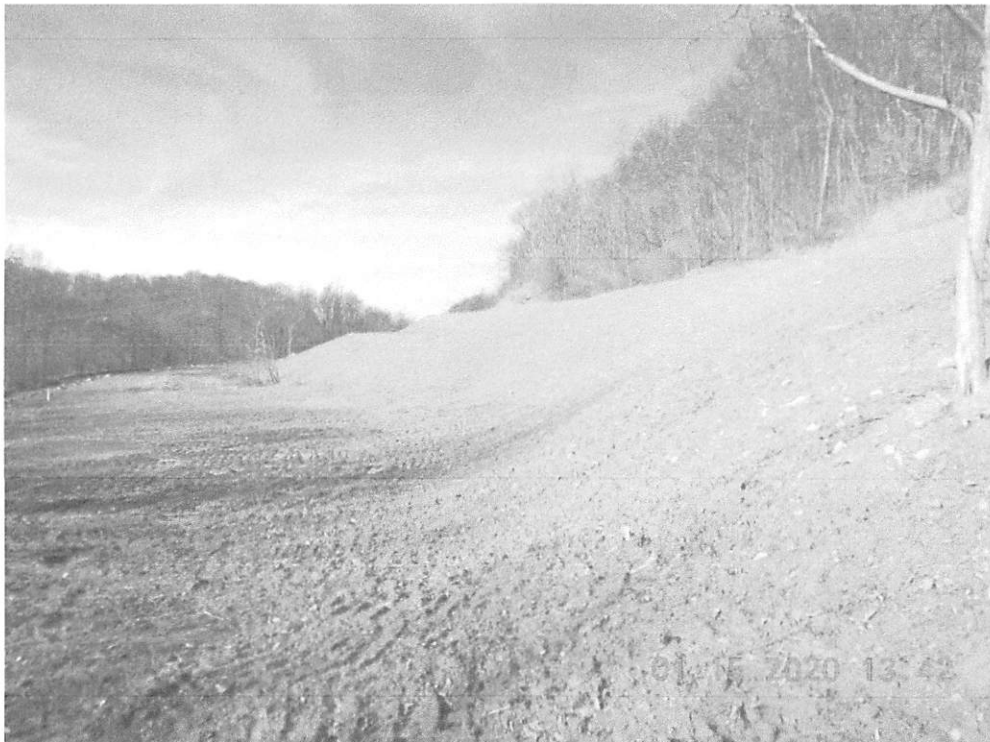
Rolling debris from unstable area above concrete slurry diversion ditch.

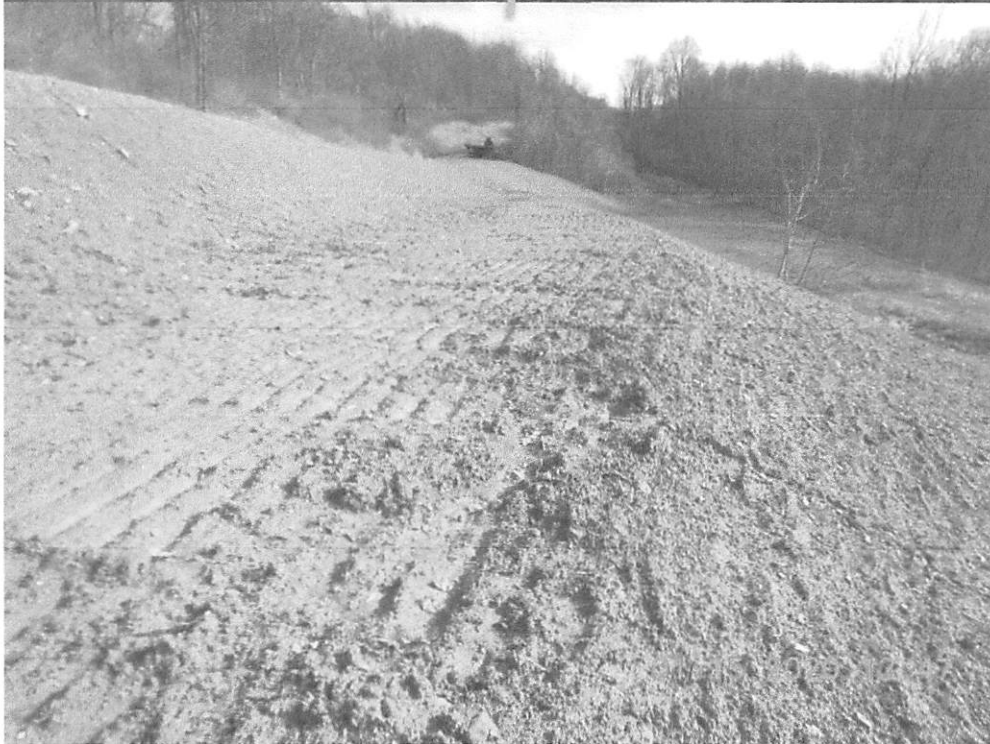
Disturbed area outside of controls.

Bypasses in controls.

Bypasses in perimeter controls with disturbance past the controls.
