**CONSENT ORDER
ISSUED UNDER THE
WATER POLLUTION CONTROL ACT
WEST VIRGINIA CODE CHAPTER 22, ARTICLE 11**

TO: Harrison County Coal Resources, Inc.
Attn: James R. Turner, Jr.
46226 National Road West
St. Clairsville, OH 43950

ORDER NO.: 10302

Rymer I & II Stream Restoration Site – WVR112355

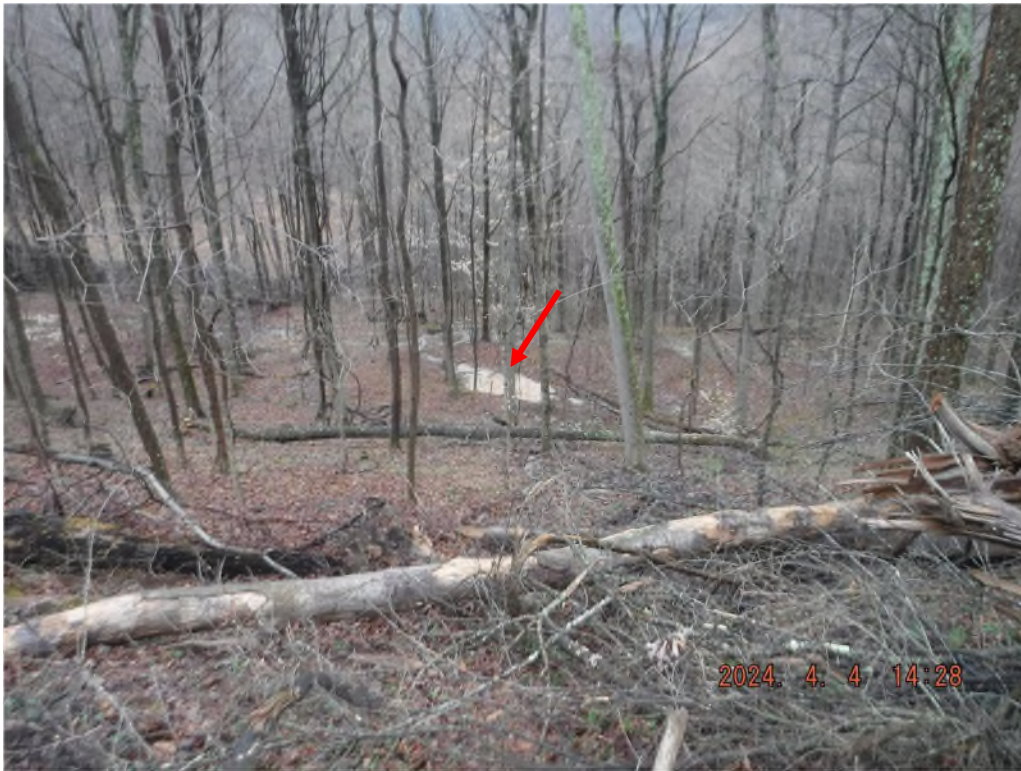
Photo # DSCF3913: Unpermitted access road between Buck Run Rd. and Pickenpaw Rd. at or near N 39° 31.0950', W 80° 30.9033' that lacks stabilization and BMPs.
