**CONSENT ORDER
ISSUED UNDER THE
WATER POLLUTION CONTROL ACT
WEST VIRGINIA CODE, CHAPTER 22, ARTICLE 11**

TO: Columbia Gas Transmission, LLC
Attn: Troy Tally, Vice President
1700 MacCorkle Ave
Charleston, WV 25314

DATE: October 1, 2020
ORDER NO.: 9061

1. Columbia Gas Transmission, LLC is conducting land disturbance activity associated with construction of the Mountaineer Xpress Project in Marshall, Wetzel, Tyler, Doddridge, Ritchie, Calhoun, Wirt, Roane, Jackson, Mason, Putnam, and Cabell Counties, West Virginia. On January 31, 2018, Columbia Gas Transmission, LLC was issued Water Pollution Control Permit No. WV0116815, Registration No. WVR310872, for Stormwater Associated With Oil and Gas Related Construction Activities.

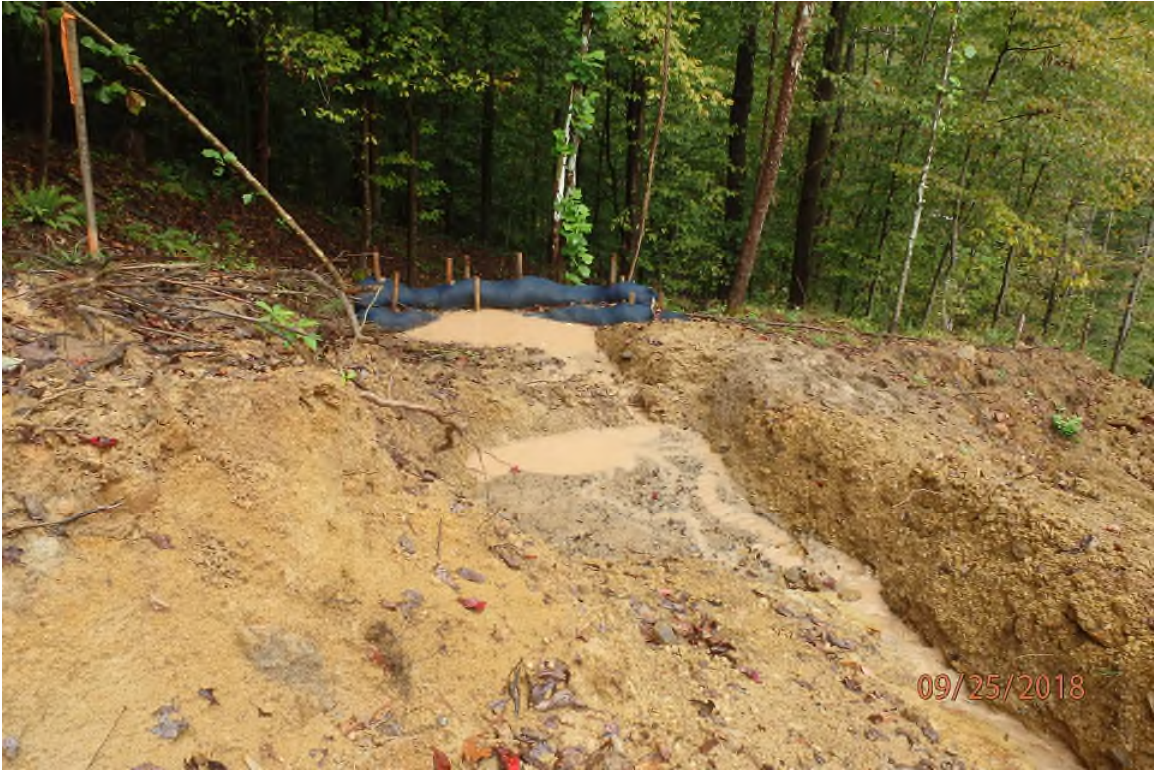
Water bar terminus BMP adjacent to 2275+00 allowing sediment laden water to bypass under the device.

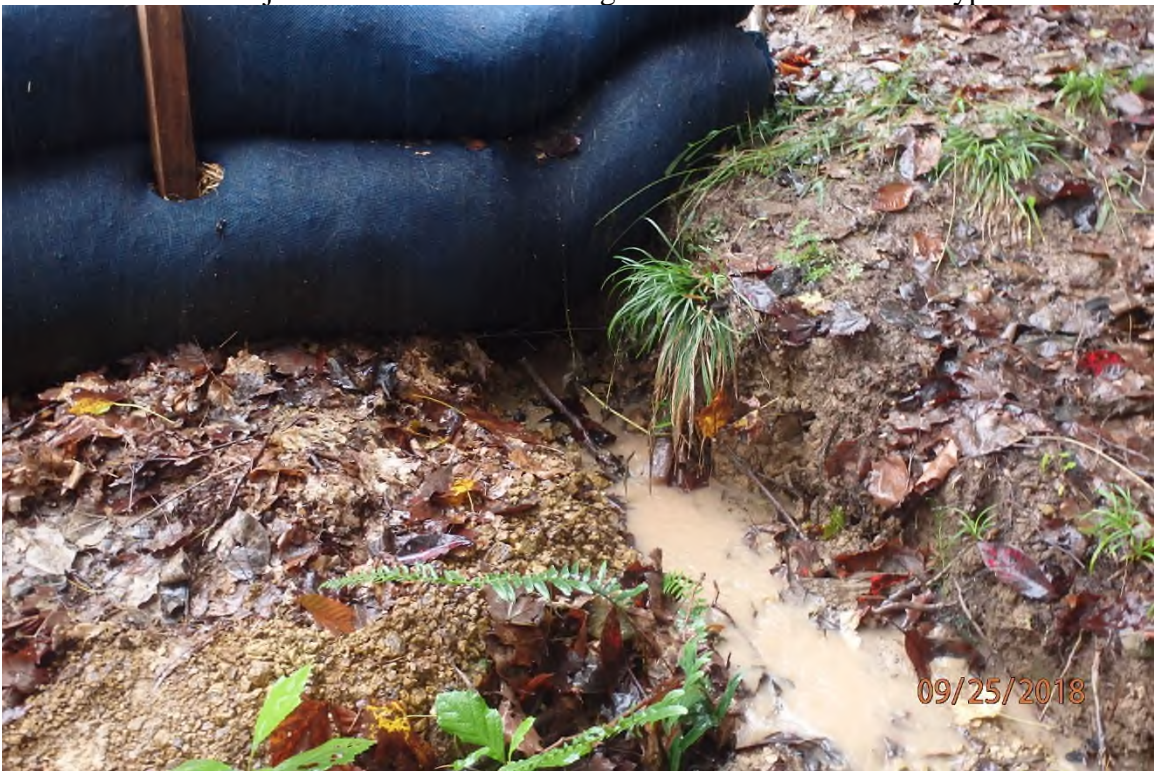
Water bar terminus BMP adjacent to 2275+00 allowing sediment laden water to bypass under the device, resulting in CNA distinctly visible settleable solids in UNT Neds Run ($39^{\circ} 21.099'$ X $80^{\circ} 41.670'$).

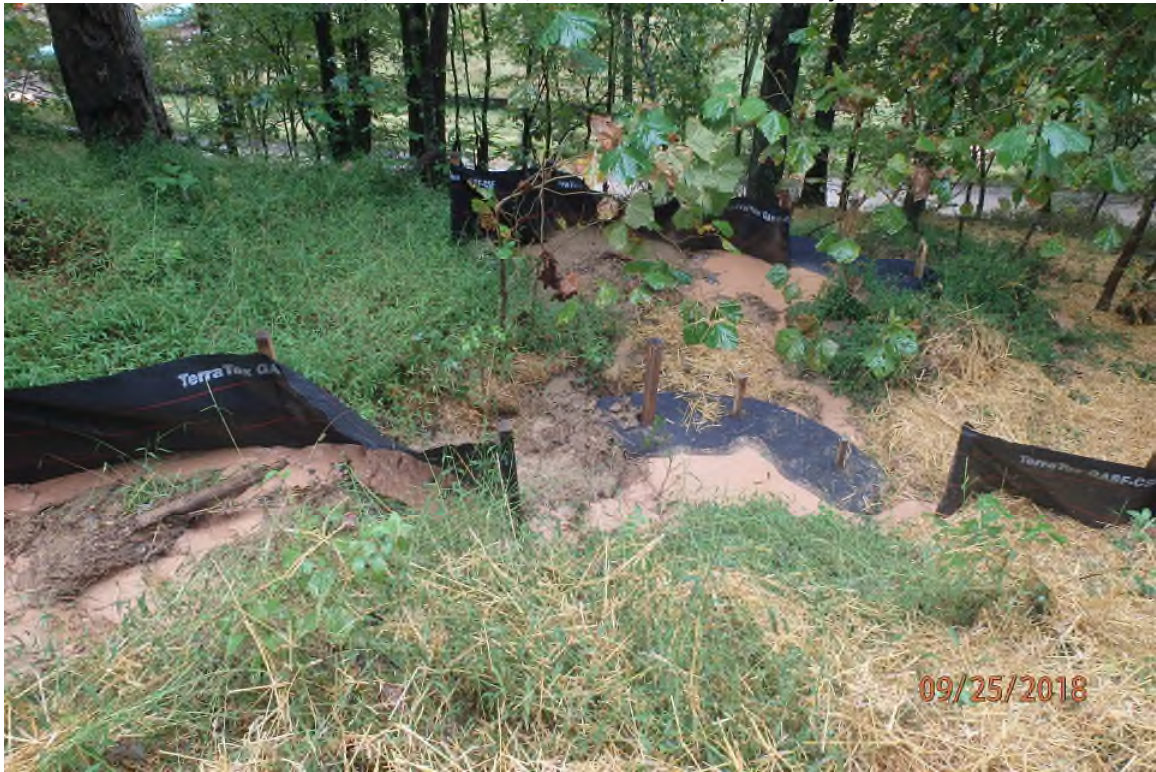
Installed BMPs adjacent to ARDO002.8 that are not being properly operated or maintained and are allowing sediment laden water to bypass the devices.

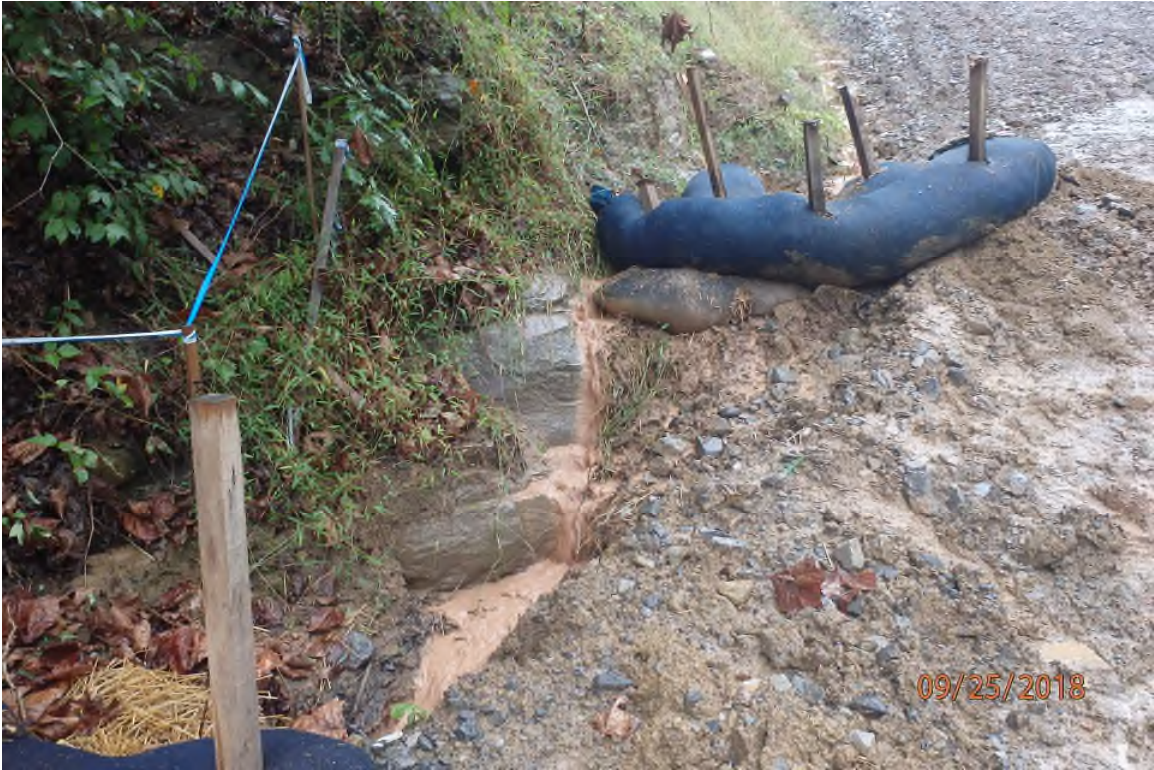
Ditch check along ARDO002.8 that is allowing a sediment laden water bypass.

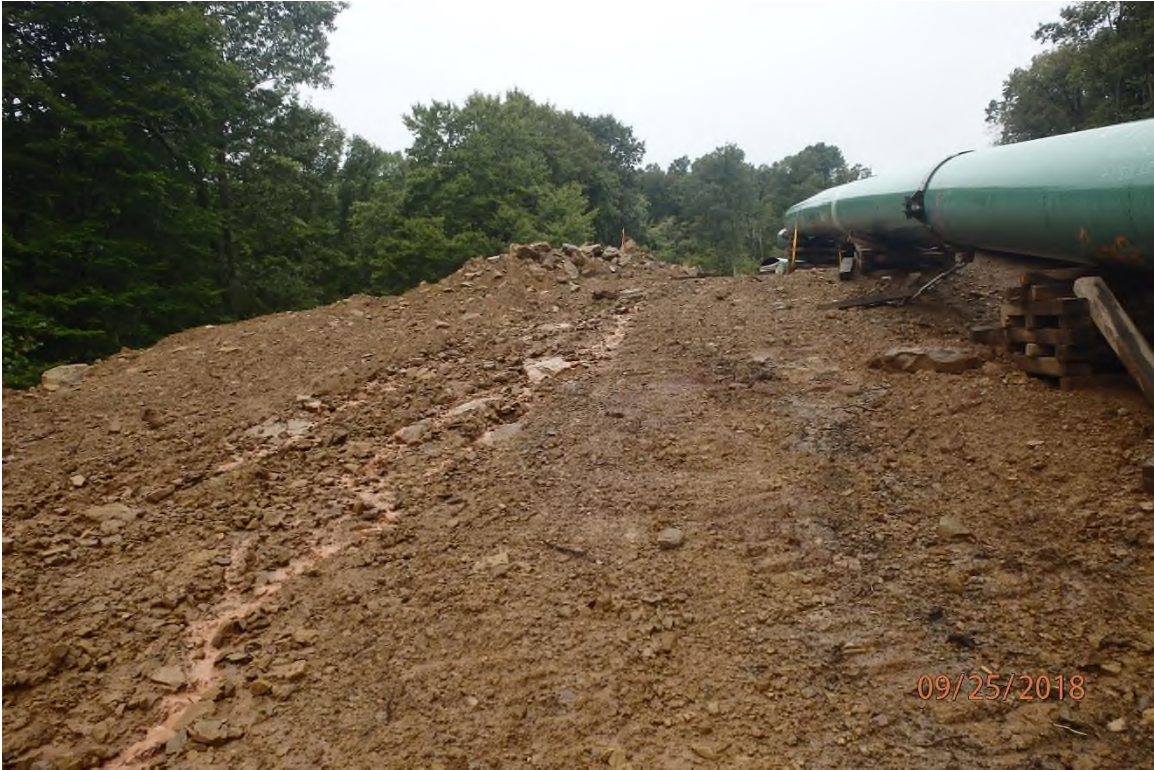
Concentrated flow being directed over fill slope adjacent to ARDO002.8 due to poorly maintained water bars.

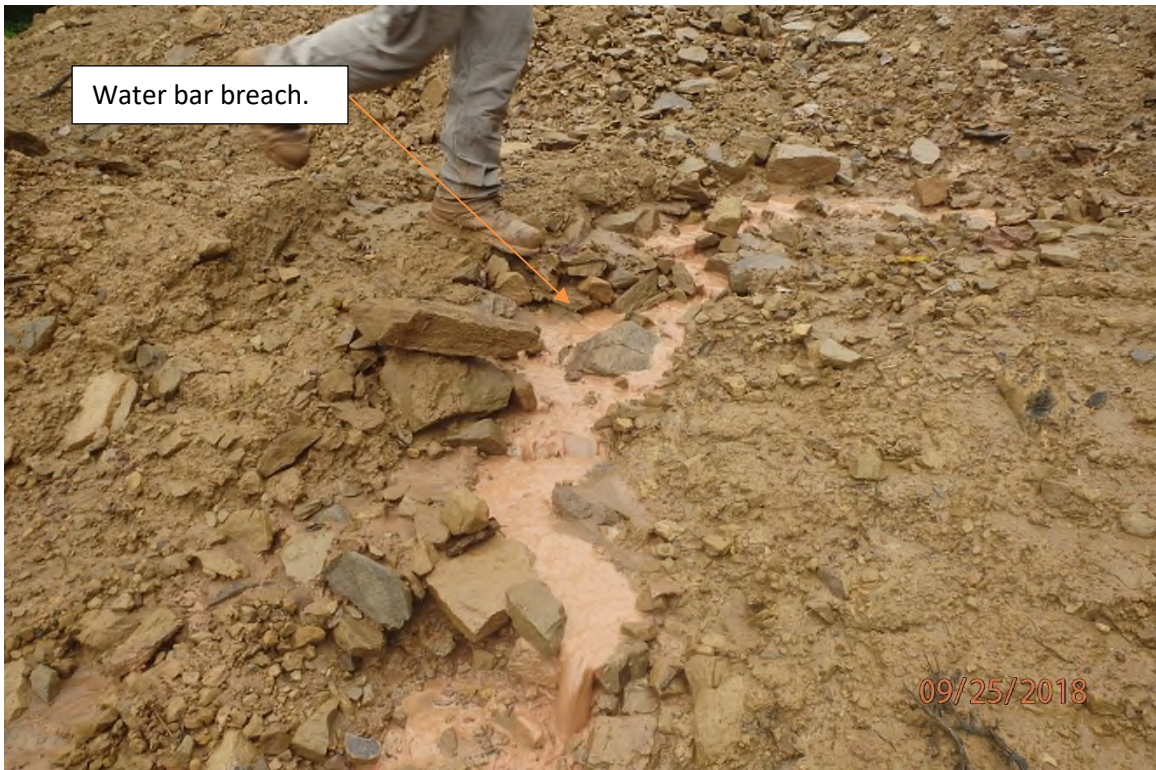
Poorly maintained water bar adjacent to ARDO002.8 that is placing concentrated flow over a fill slope.

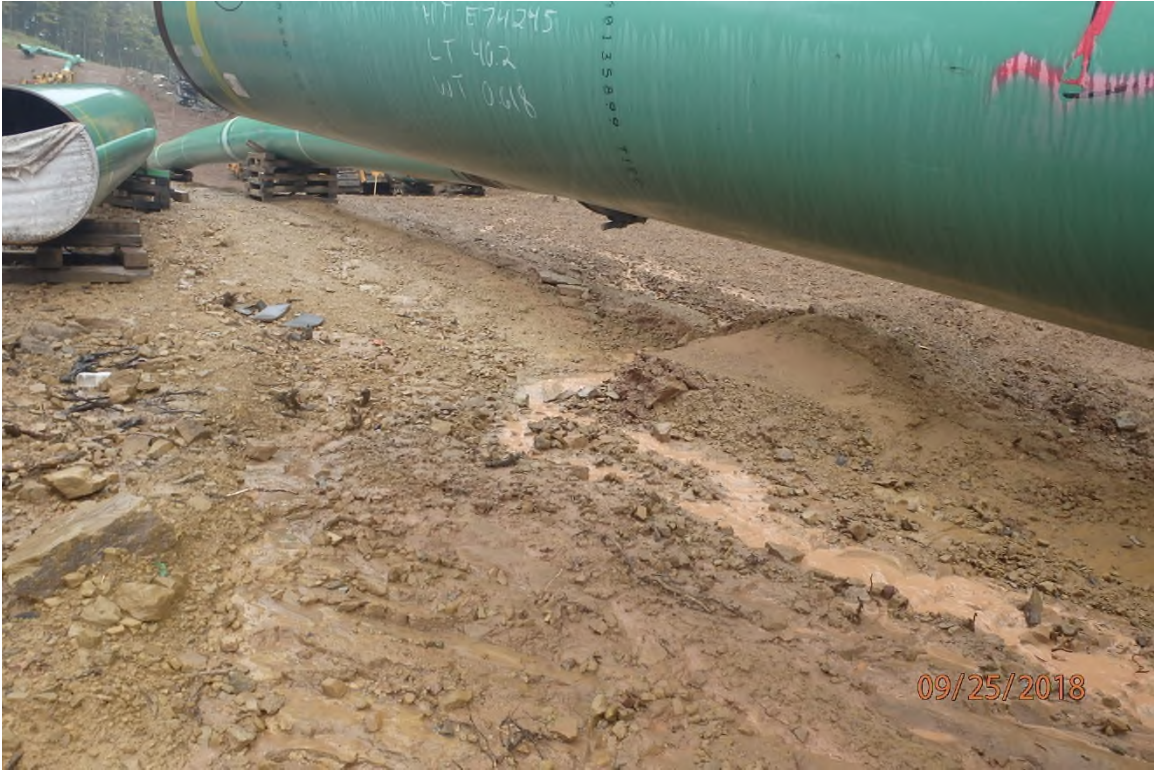
Concentrated flow being directed over fill slope due to poorly maintained water bars.

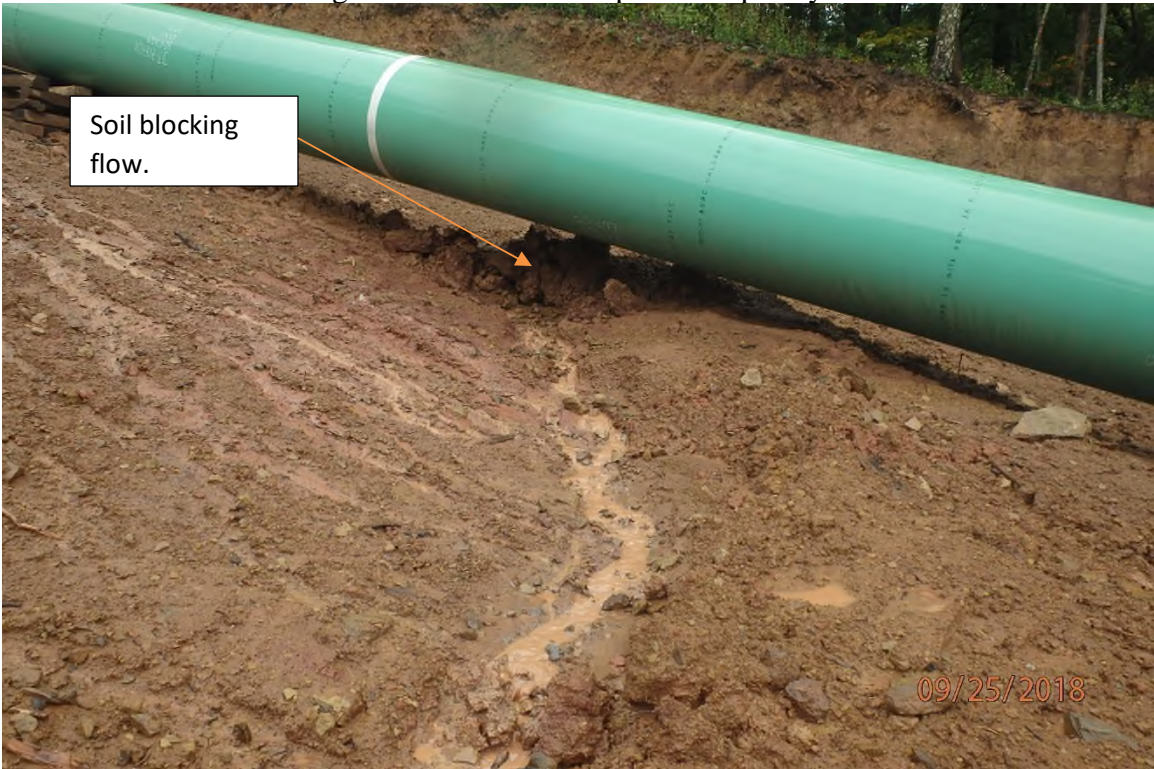
Poorly maintained water bar.

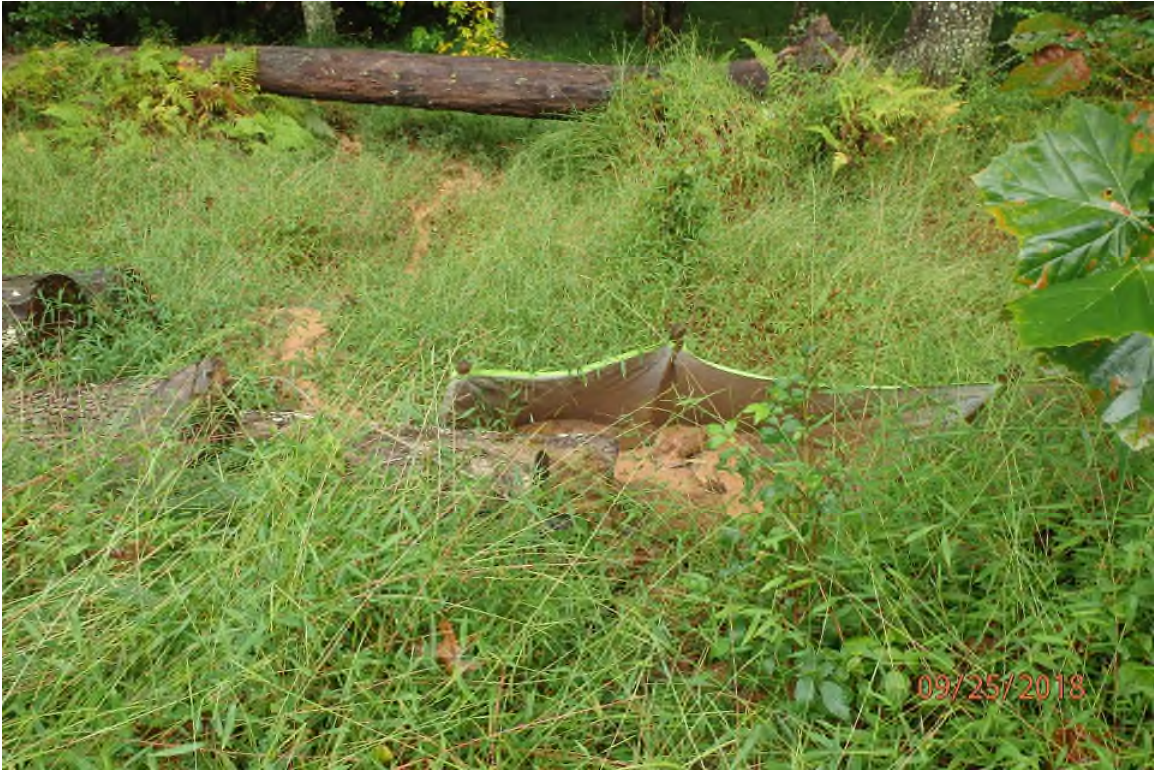
Sediment and diesel laden water bypassing a perimeter control.

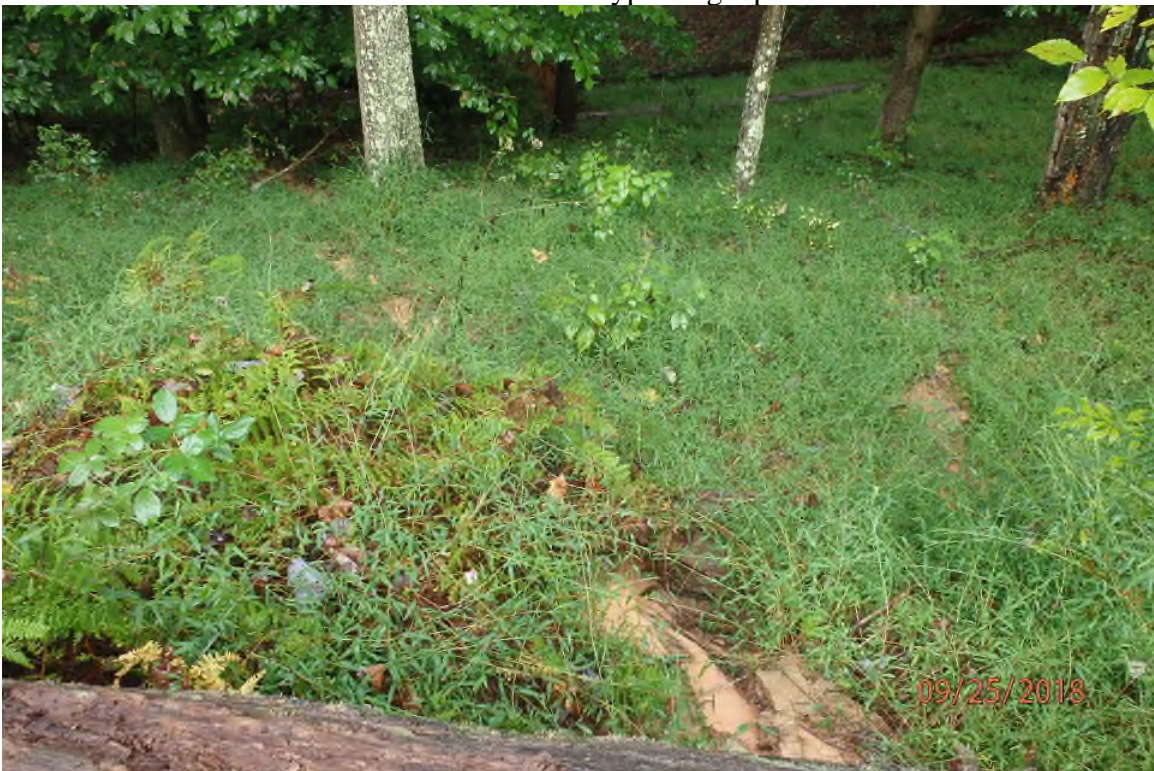
Sediment and diesel laden water traveling downslope to receiving stream.

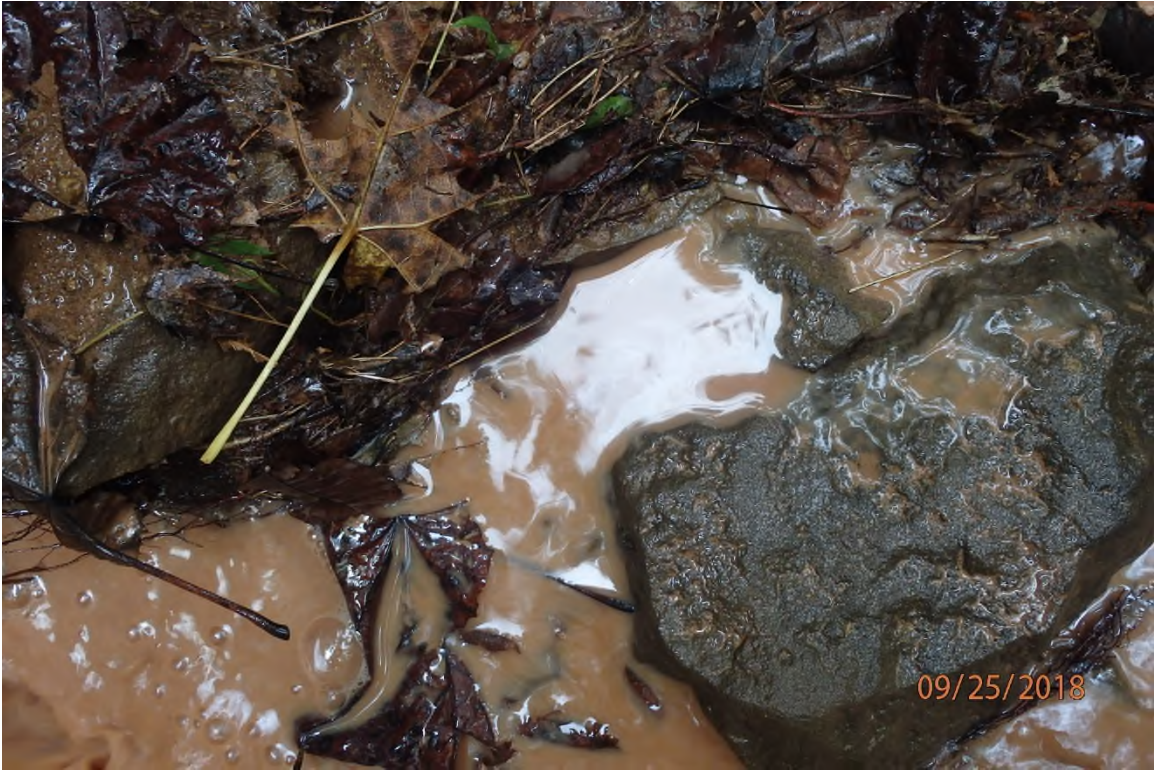
CNA oily slick, distinctly visible settleable solids and odors in the vicinity of UNT Neds Run (39° 21.175 X 80° 41.705').

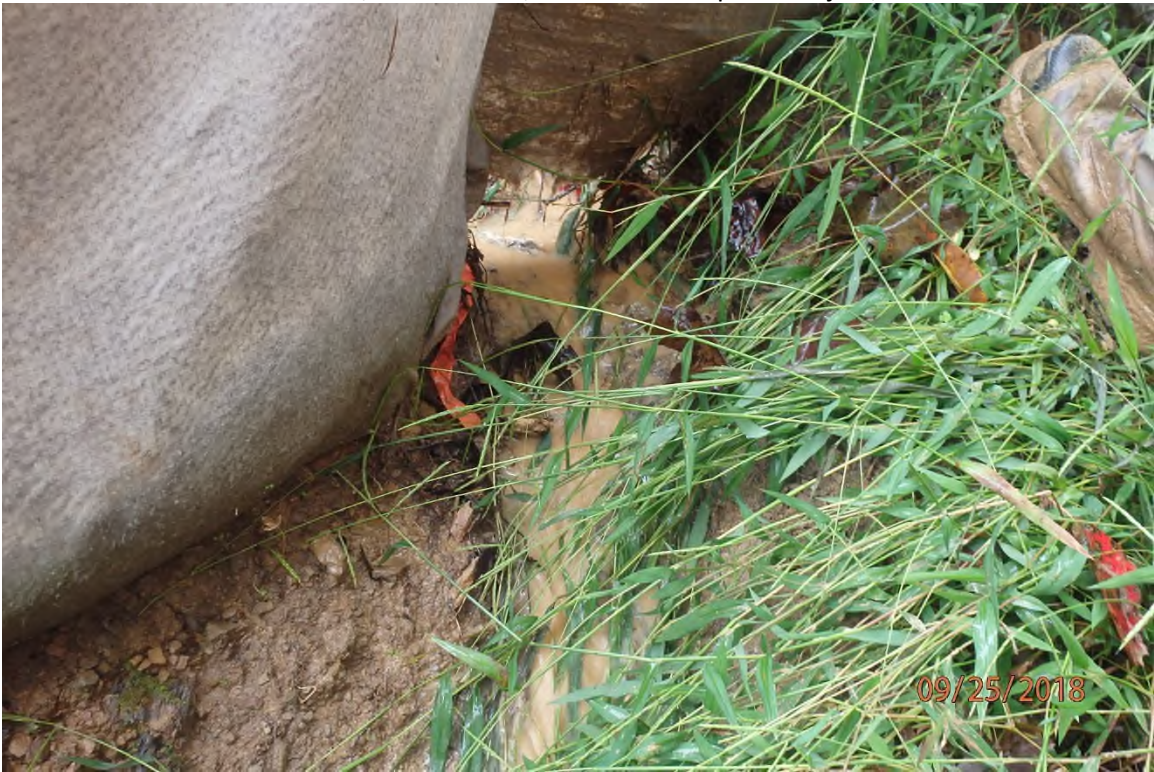
Stormwater bypass of perimeter control adjacent to 2260+00 due to poor maintenance.

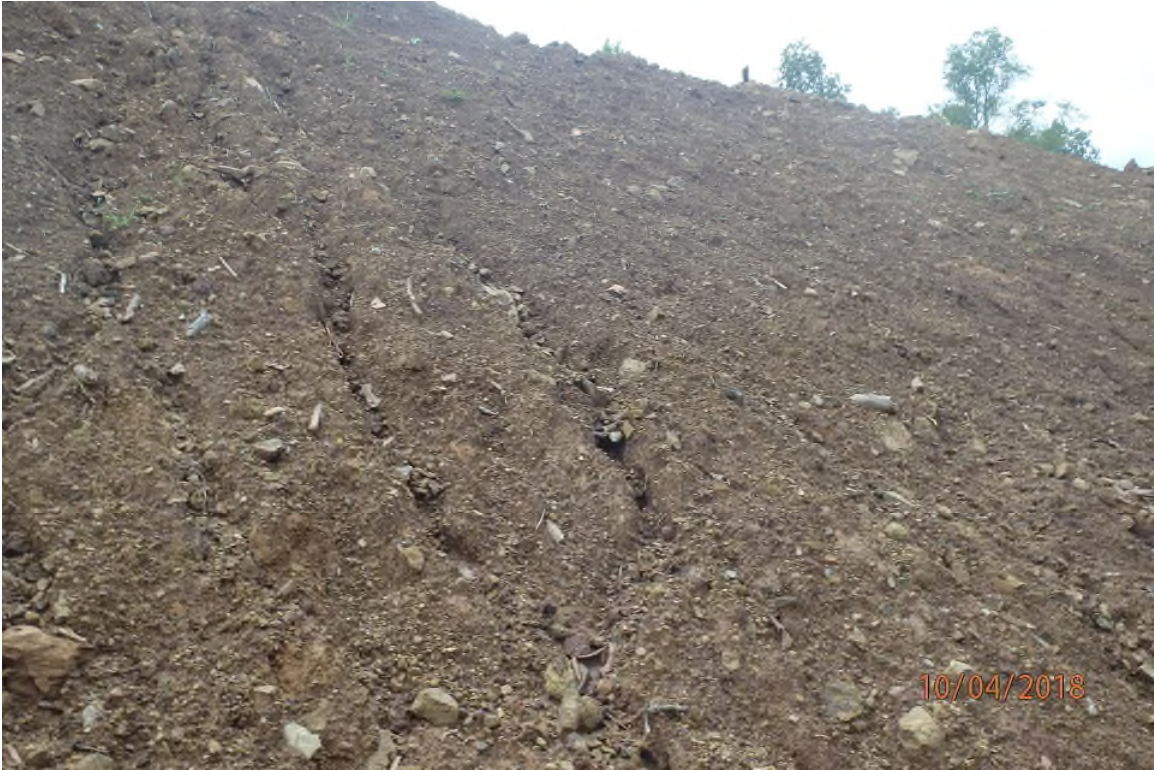
Fill slope erosion near 2065+00. The area has been idle for a long period of time and lacks temporary stabilization.

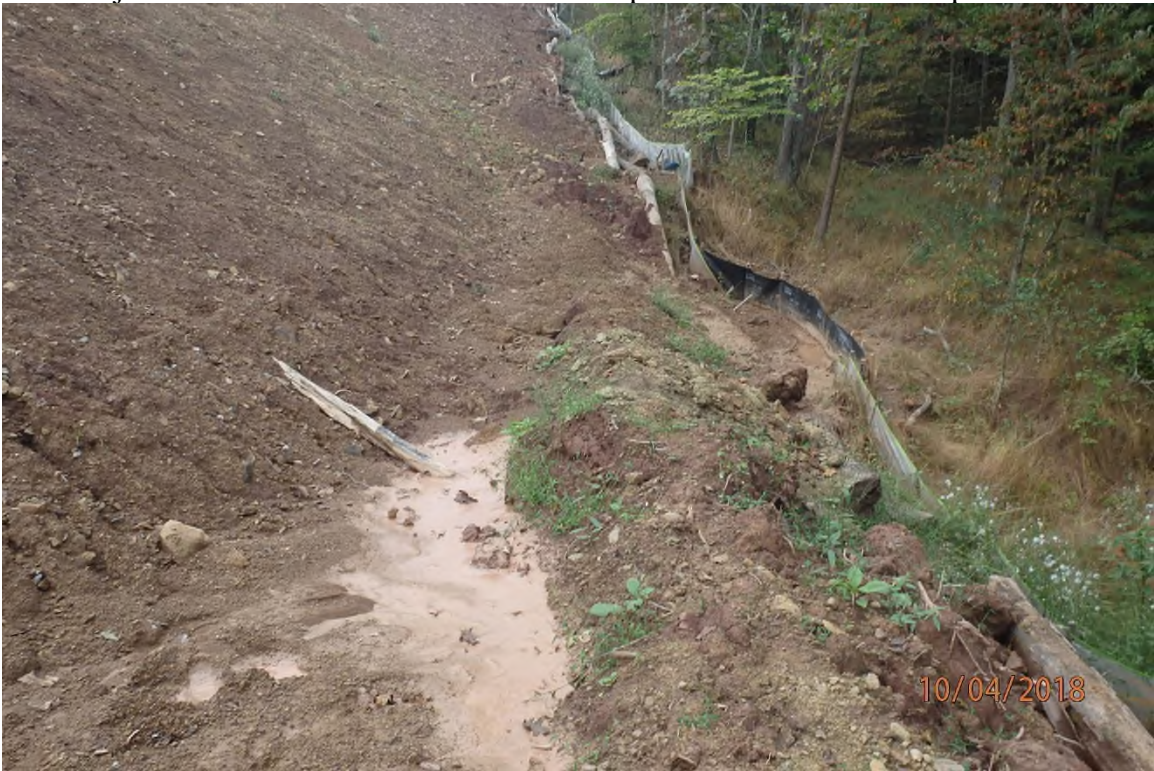
BMP adjacent to SDOI 008. Offsite sediment deposits and CNA downslope of the BMP.

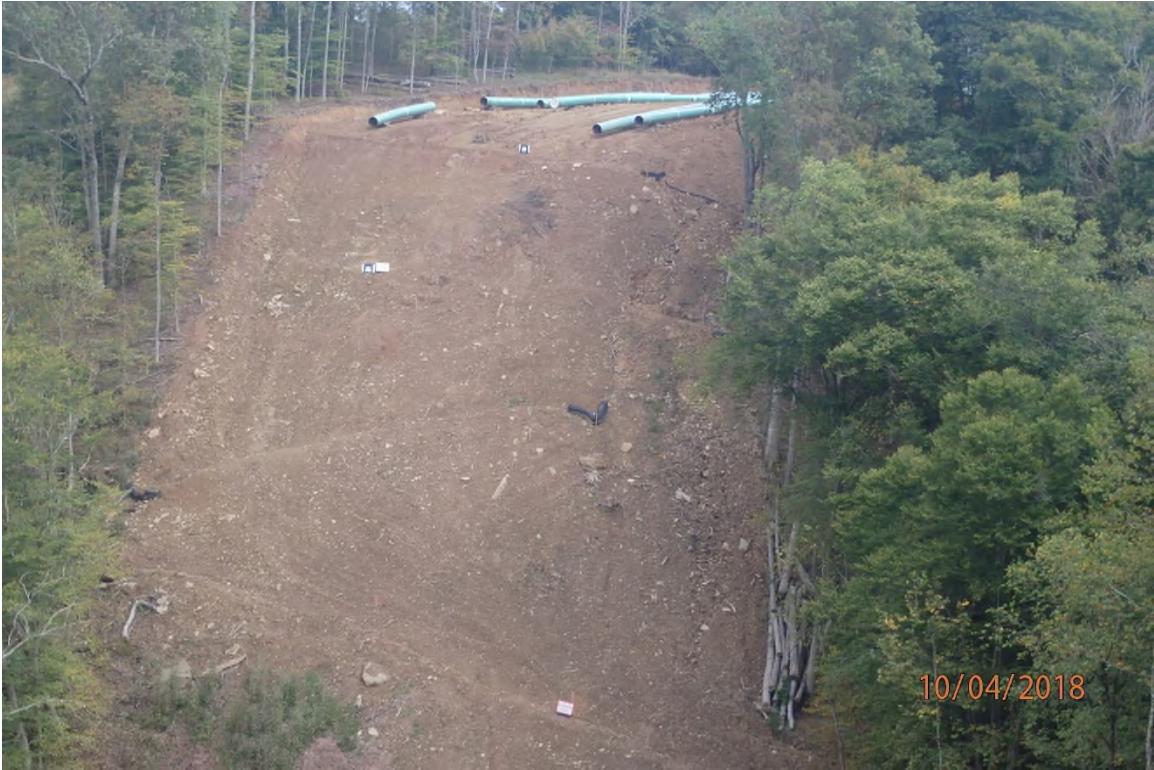
Improperly installed water bars and the associated fill slope erosion near SDOI008.

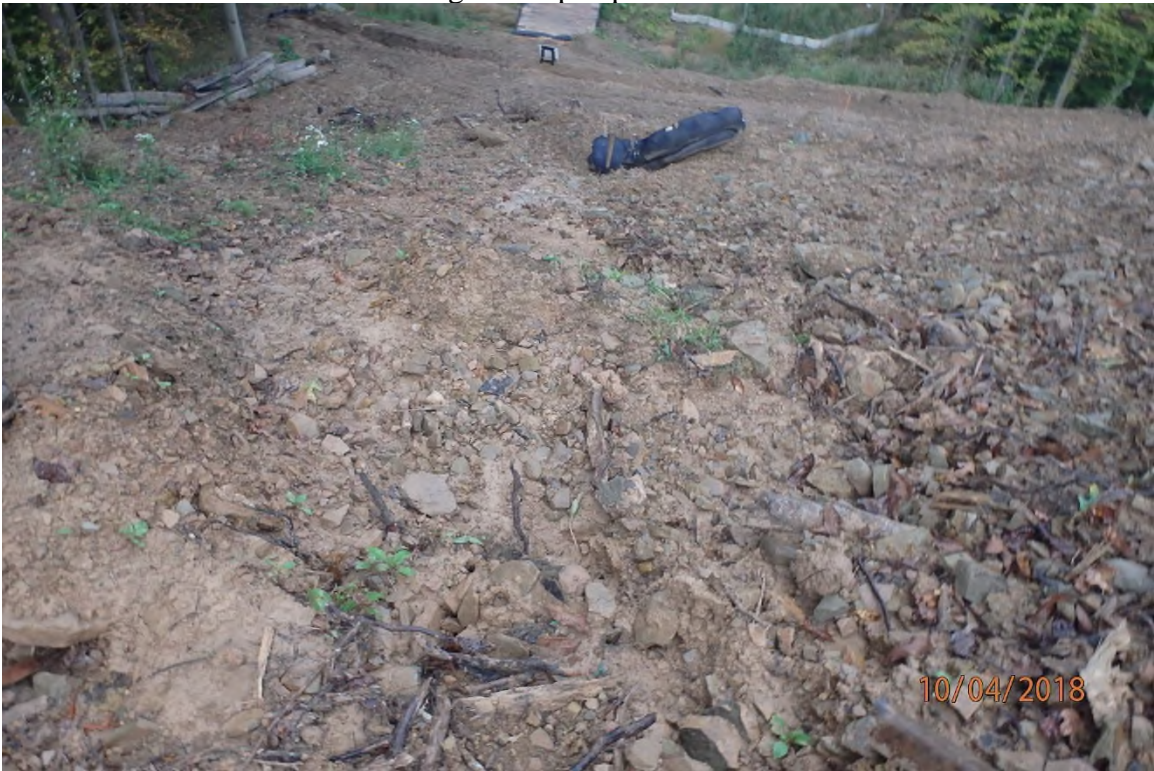
Erosion gullies upslope of SDOI008.

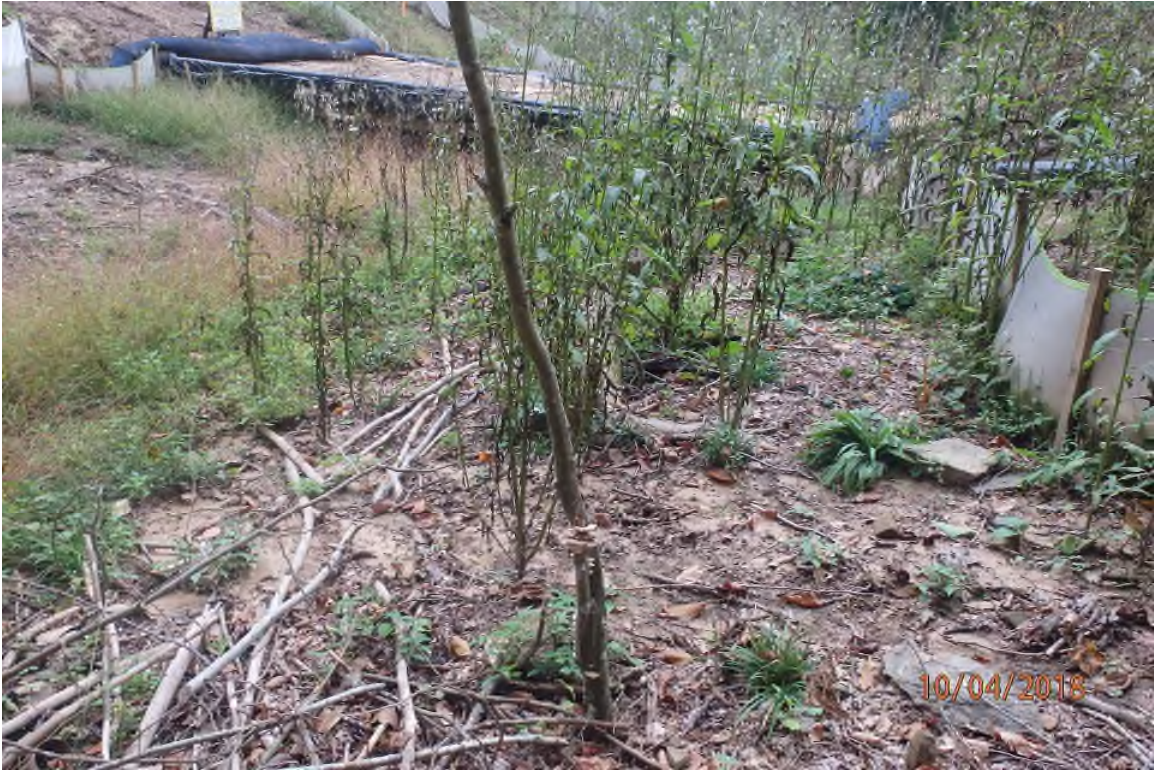
Sediment trail leading to the receiving stream as a result of the previously pictured improperly installed water bars and associated fill slope erosion near SDOI008.

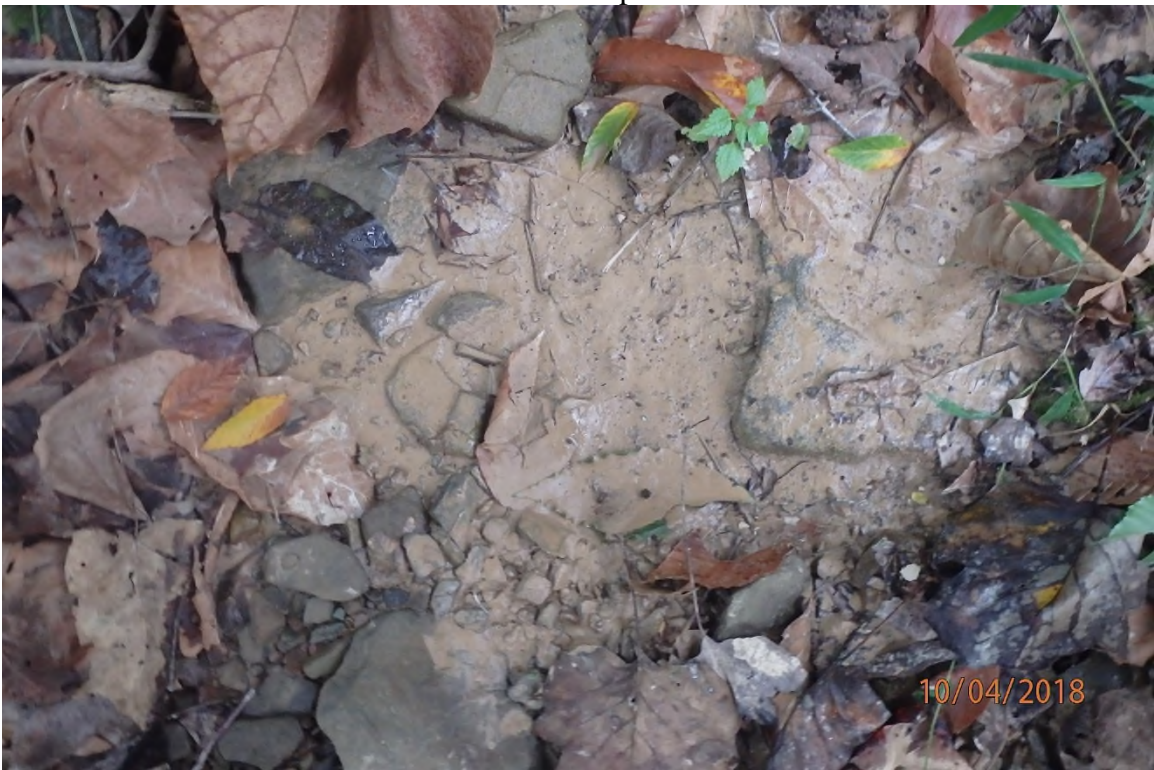
CNA deposits in UNT McElroy Creek (SDOI008) (39° 24.006' X 80° 40.906') as a result of the previously pictured deficiencies.

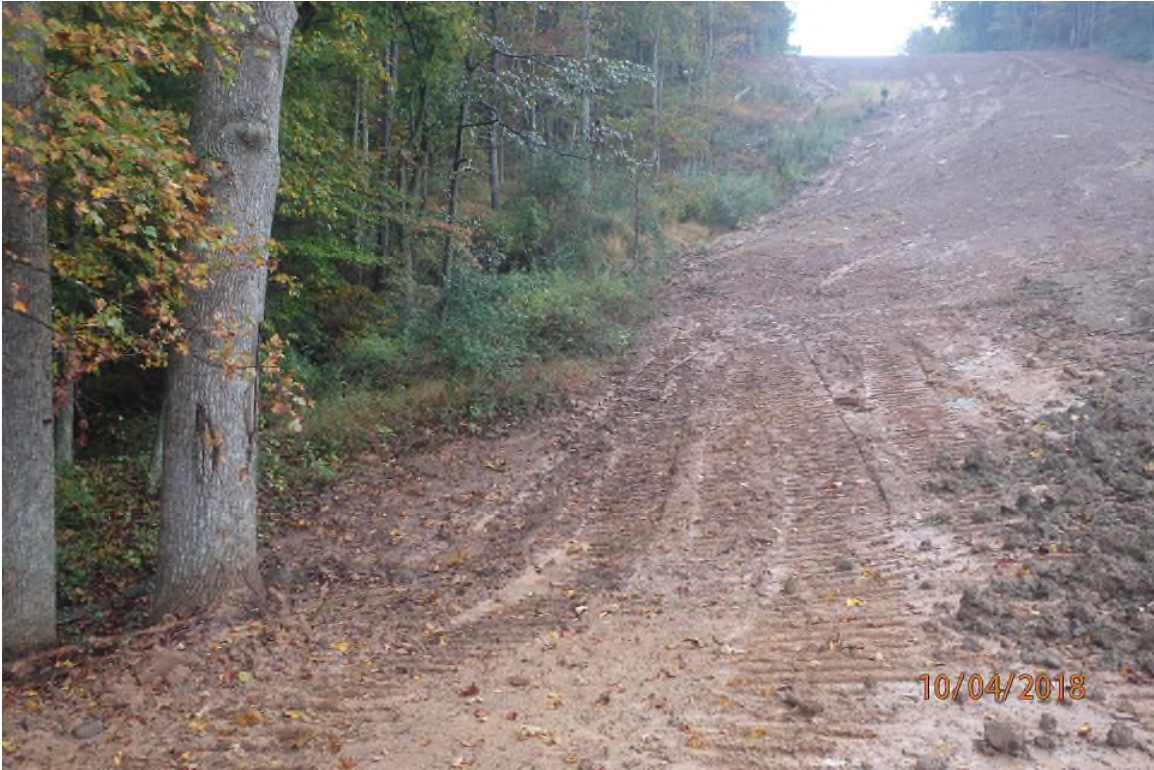
Project area near 2019+00 showing a lack of perimeter silt fence as indicated in the approved SWPPP.

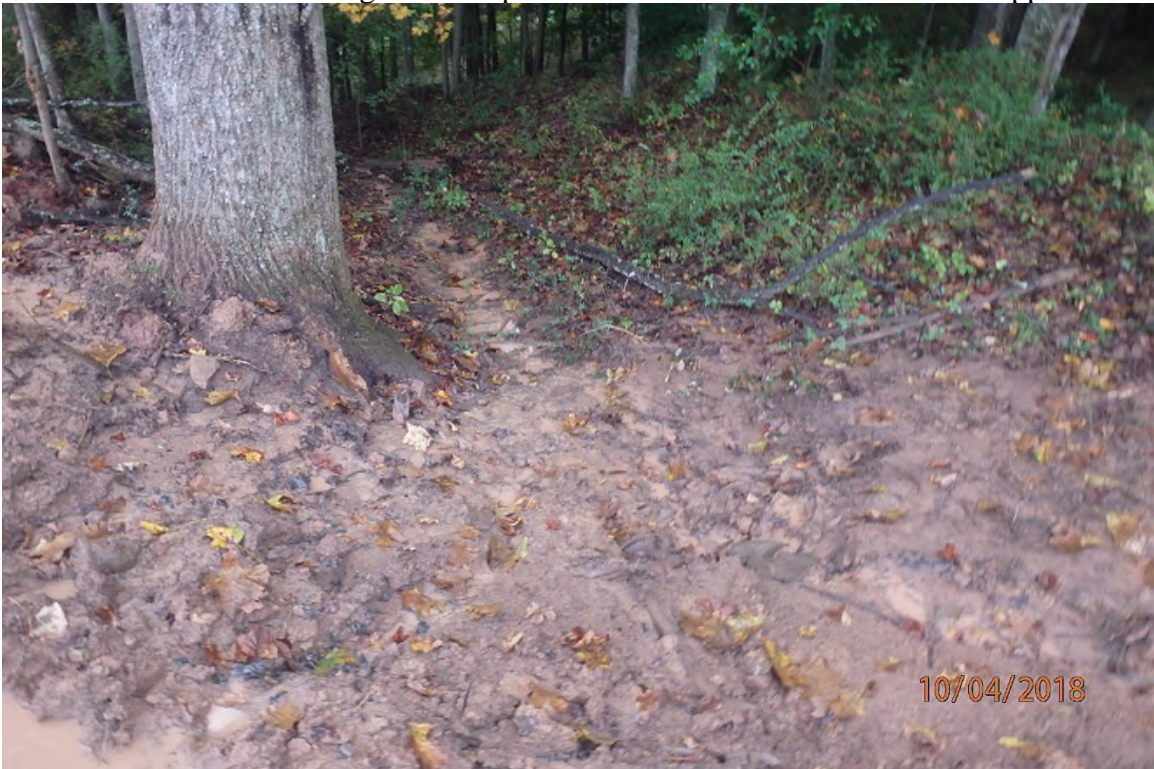
Sediment laden water leaving the site and CNA distinctly visible settleable solids in UNT McElroy Creek (SDOI202).

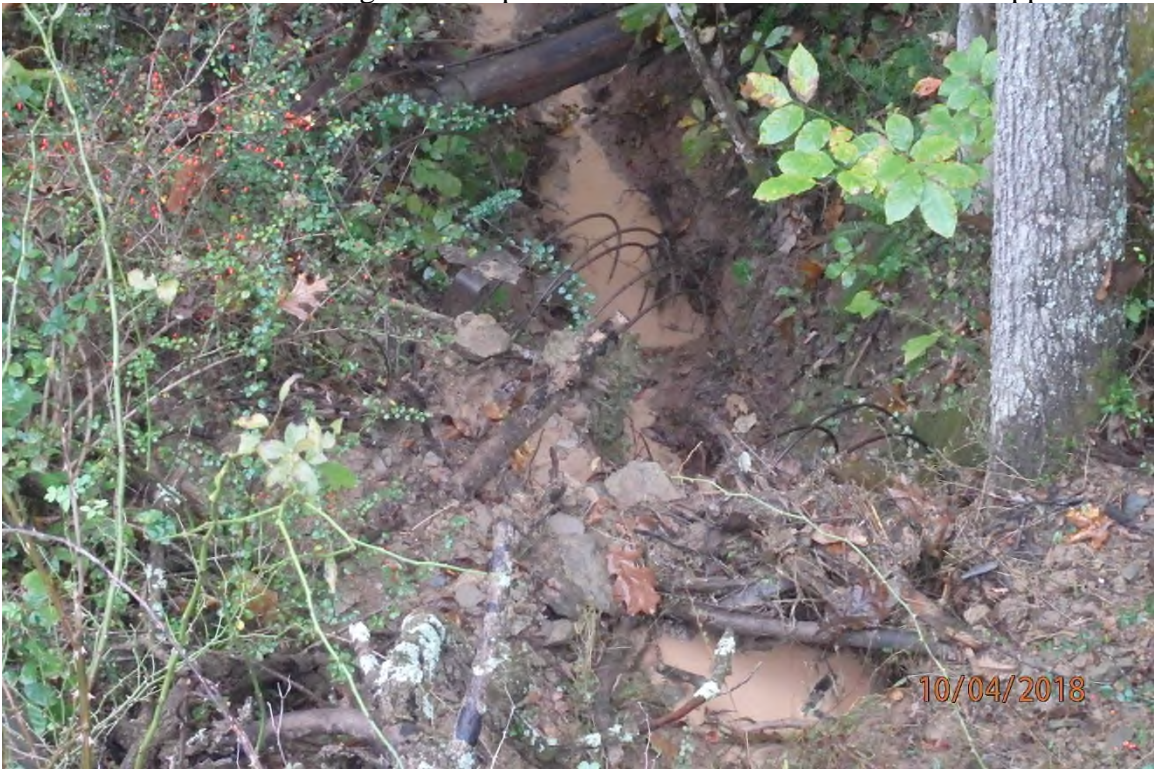
Sediment laden water leaving the site and CNA distinctly visible settleable solids in UNT McElroy Creek (SDOI201).

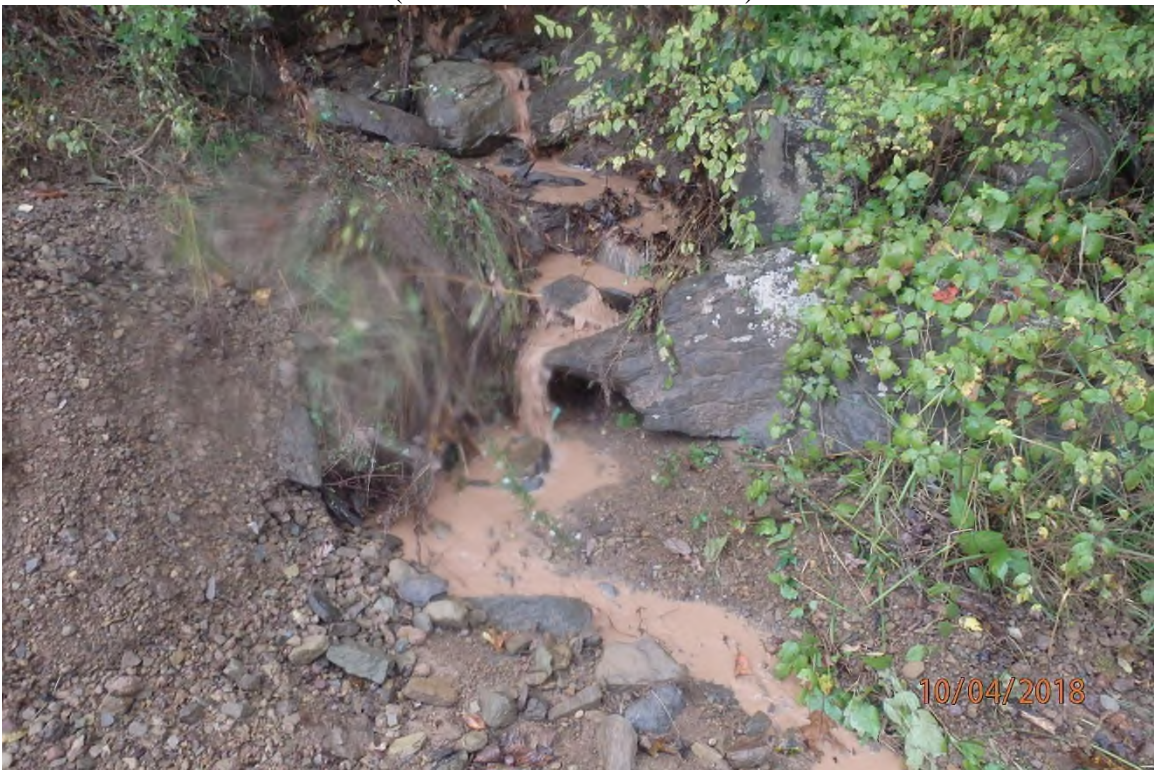
CNA distinctly visible settleable solids and deposits in UNT McElroy Creek (SDOI 201 & SDOI202) (39° 24.456' X 80° 40.816').

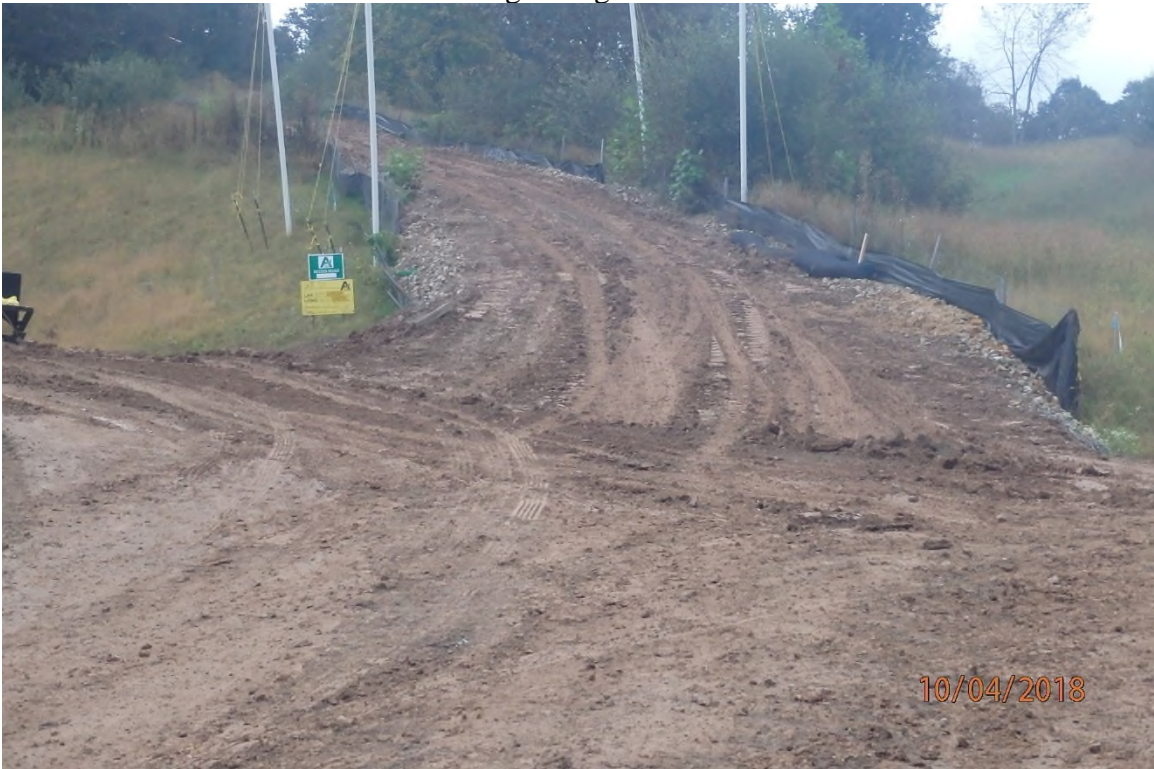
ARDO-001.5 at the intersection of CR 5 showing the lack of a stabilized construction entrance.

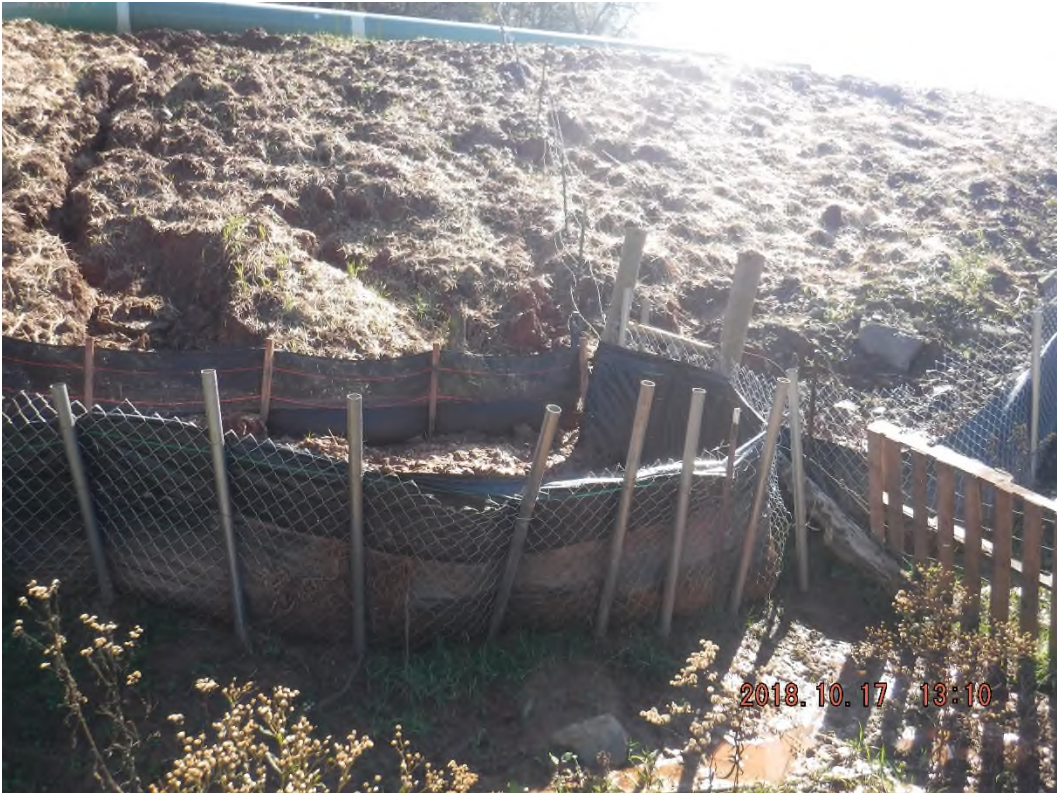
Super silt fence adjacent to the farm pond.

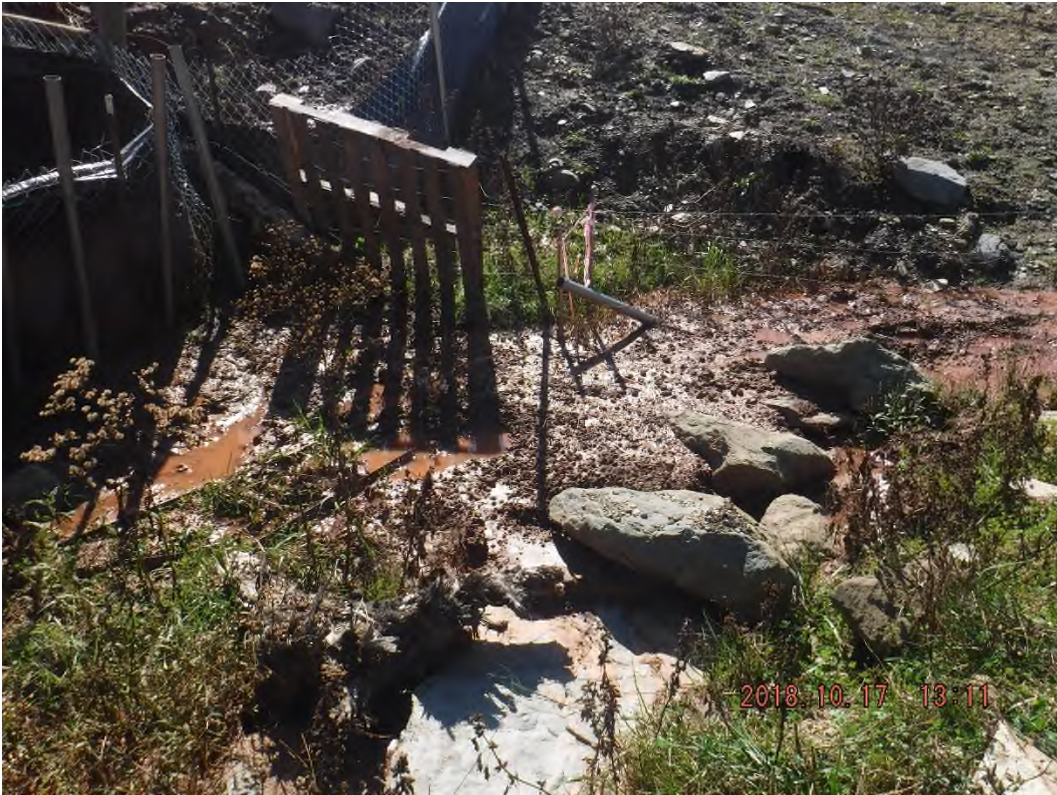
Sediment directly below silt fence.
