**CONSENT ORDER
ISSUED UNDER THE
WATER POLLUTION CONTROL ACT
WEST VIRGINIA CODE, CHAPTER 22, ARTICLE 11**

TO: Columbia Gas Transmission, LLC
Attn: Troy Tally, Vice President
1700 MacCorkle Ave
Charleston, WV 25314

DATE: October 1, 2020
ORDER NO.: 9061

1. Columbia Gas Transmission, LLC is conducting land disturbance activity associated with construction of the Mountaineer Xpress Project in Marshall, Wetzel, Tyler, Doddridge, Ritchie, Calhoun, Wirt, Roane, Jackson, Mason, Putnam, and Cabell Counties, West Virginia. On January 31, 2018, Columbia Gas Transmission, LLC was issued Water Pollution Control Permit No. WV0116815, Registration No. WVR310872, for Stormwater Associated With Oil and Gas Related Construction Activities.

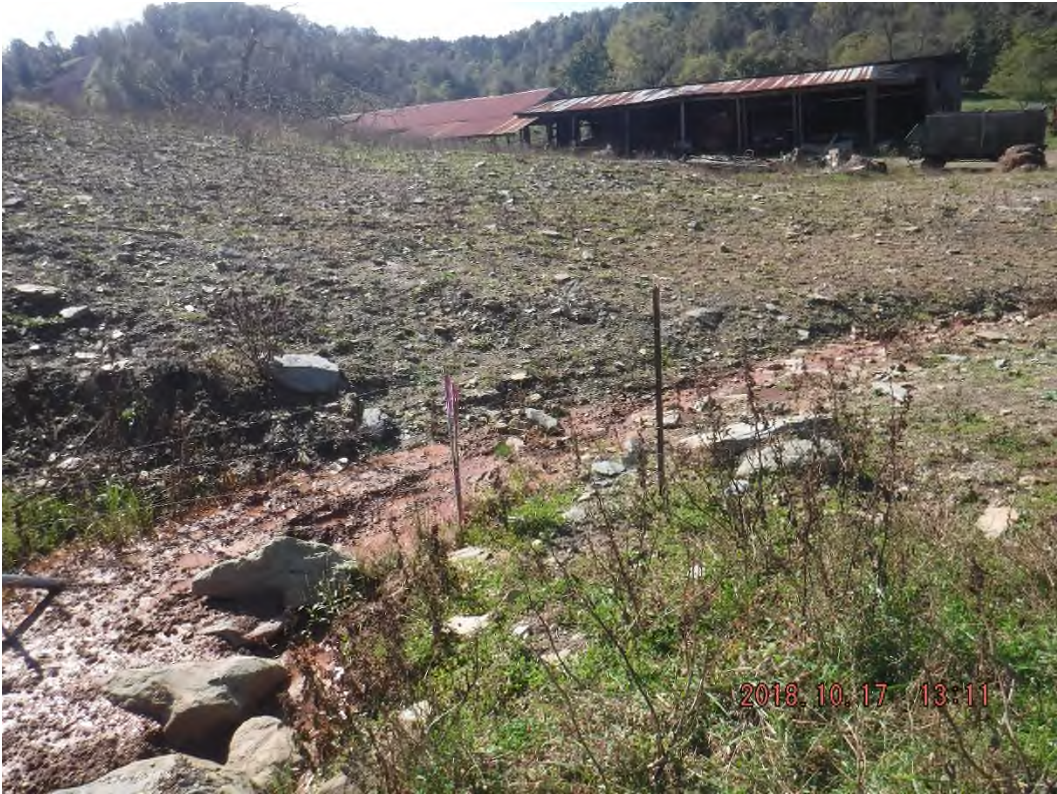
Sediment flow from silt fence.

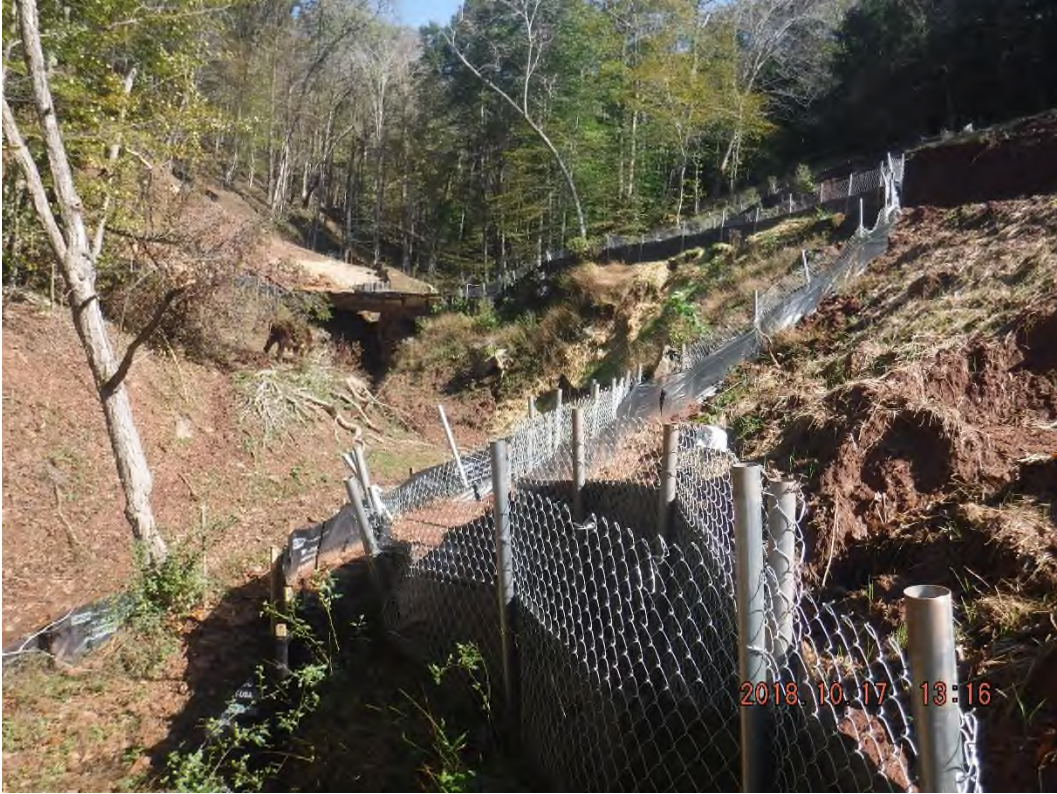
The crossing at Station 6705+00.

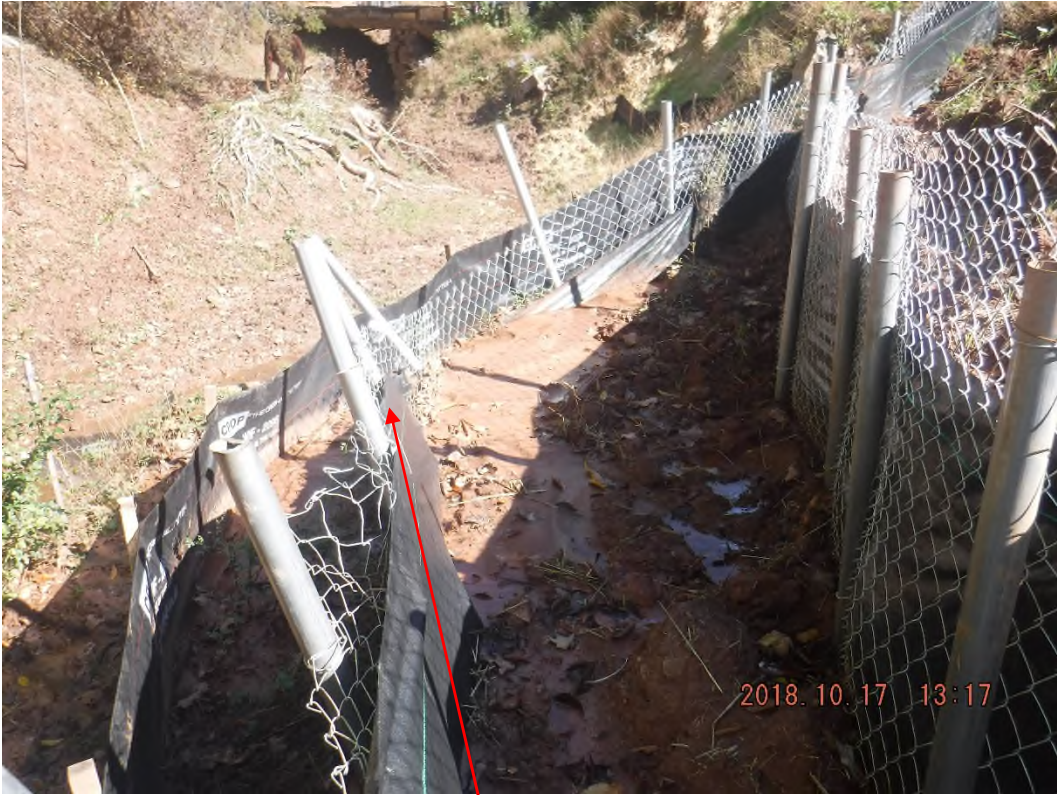
Sediment collected in silt fence.

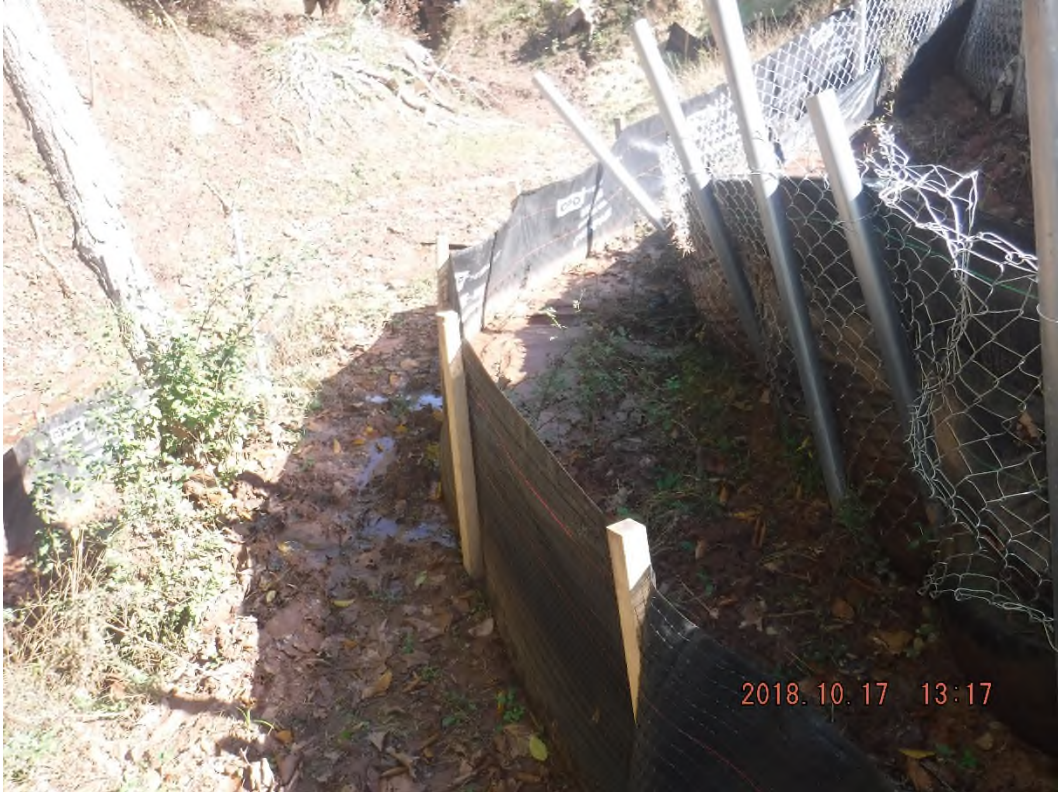
Build-up of sediment collected behind silt fence.

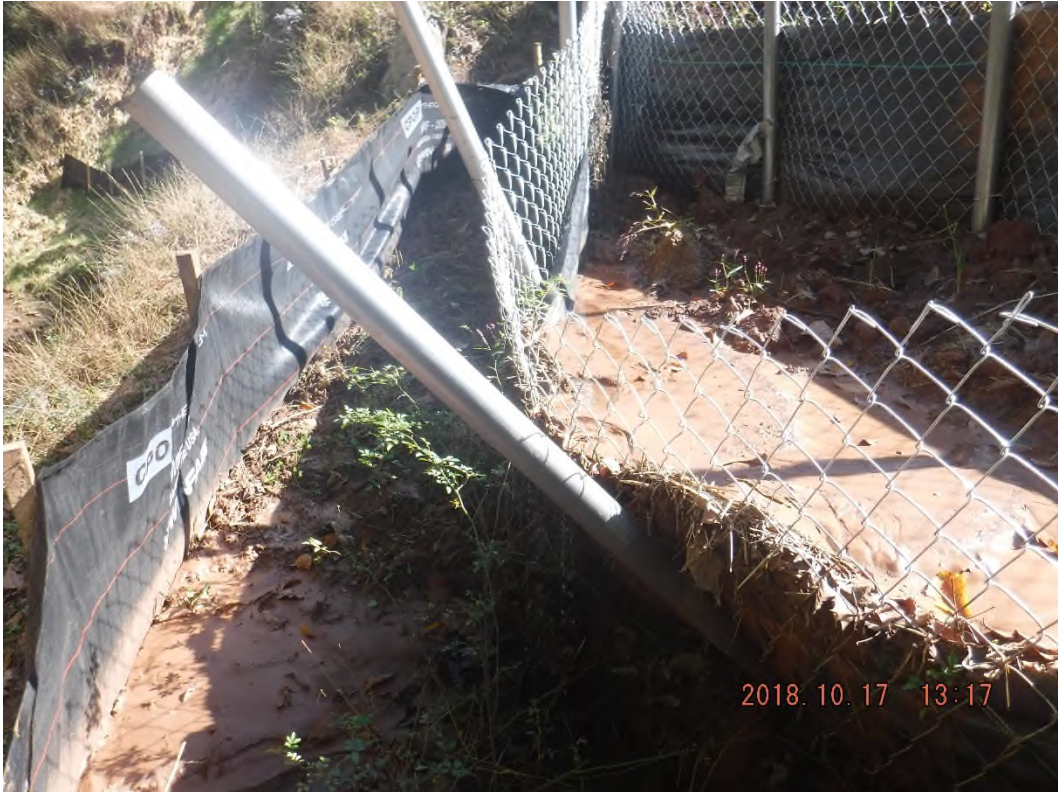
Sediment overtopping silt fence.

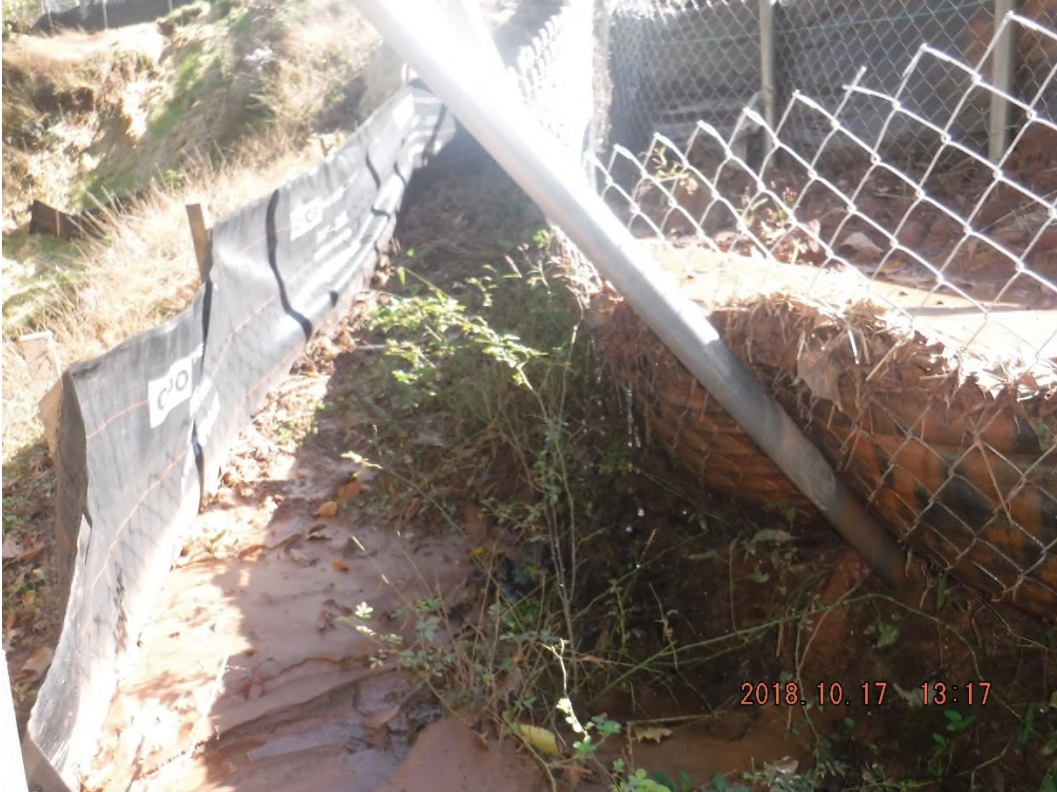
Sediment overtopping silt fence.

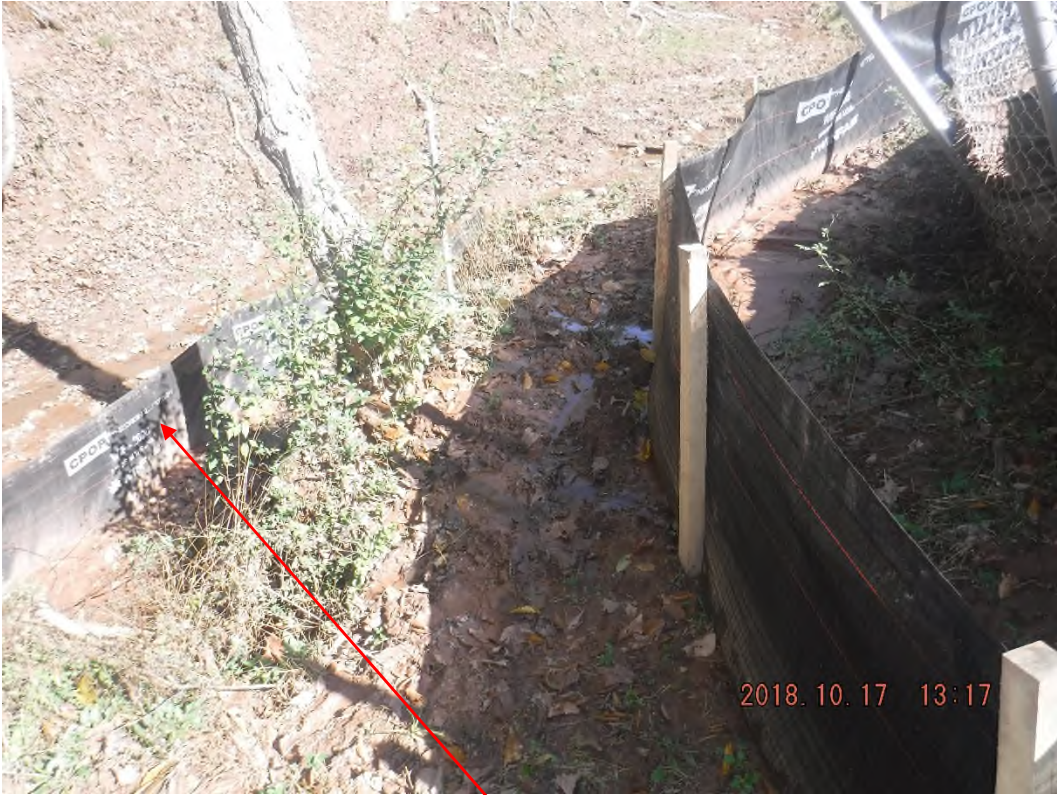
Silt fence that was installed in the stream after a rainfall event.

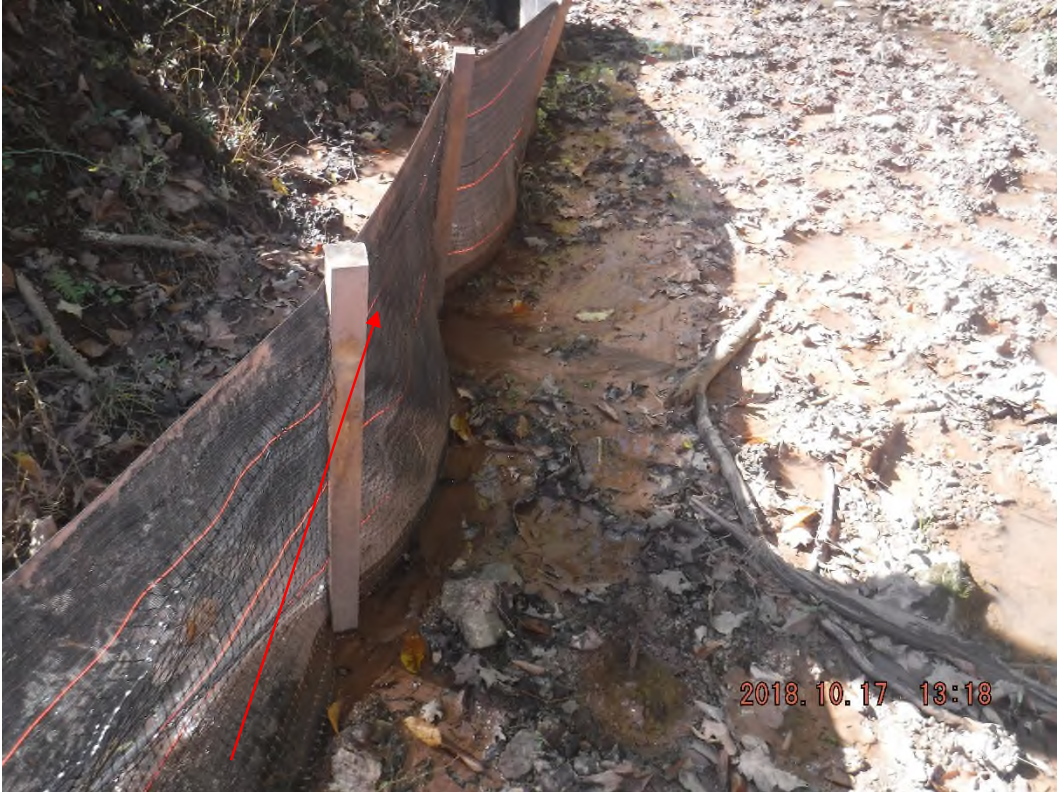
Sediment deposits in stream leading to the farm pond below.

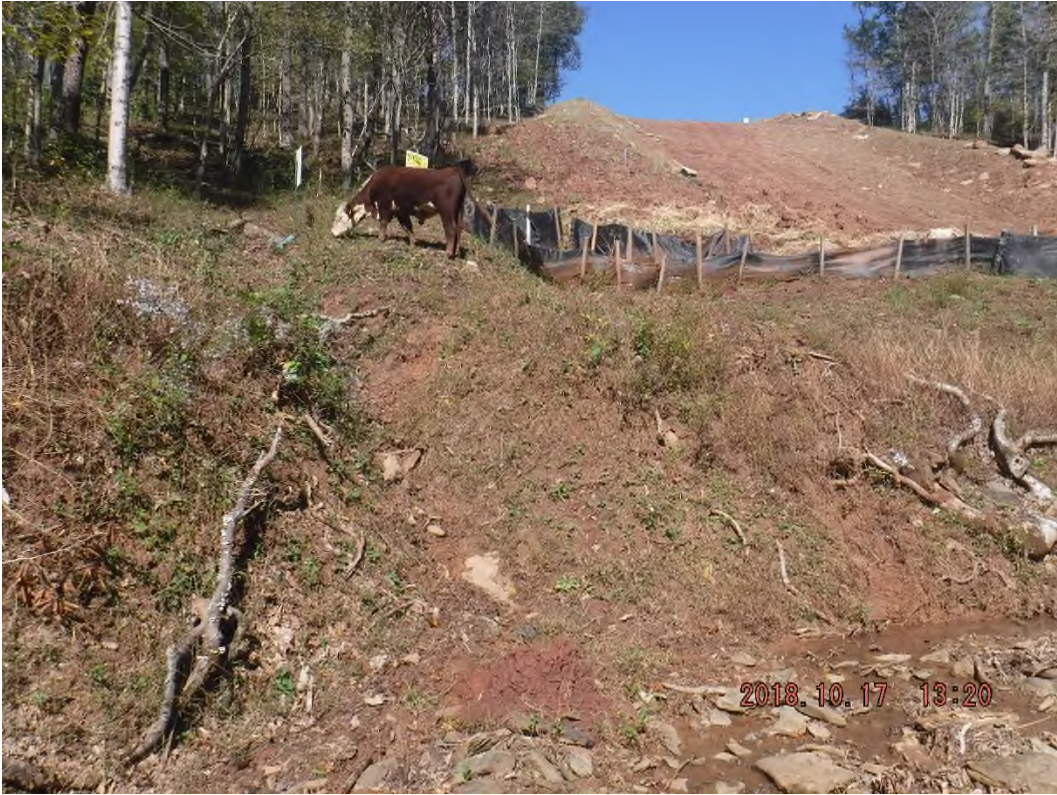
Station 6705+00, showing slope without installed water bars.

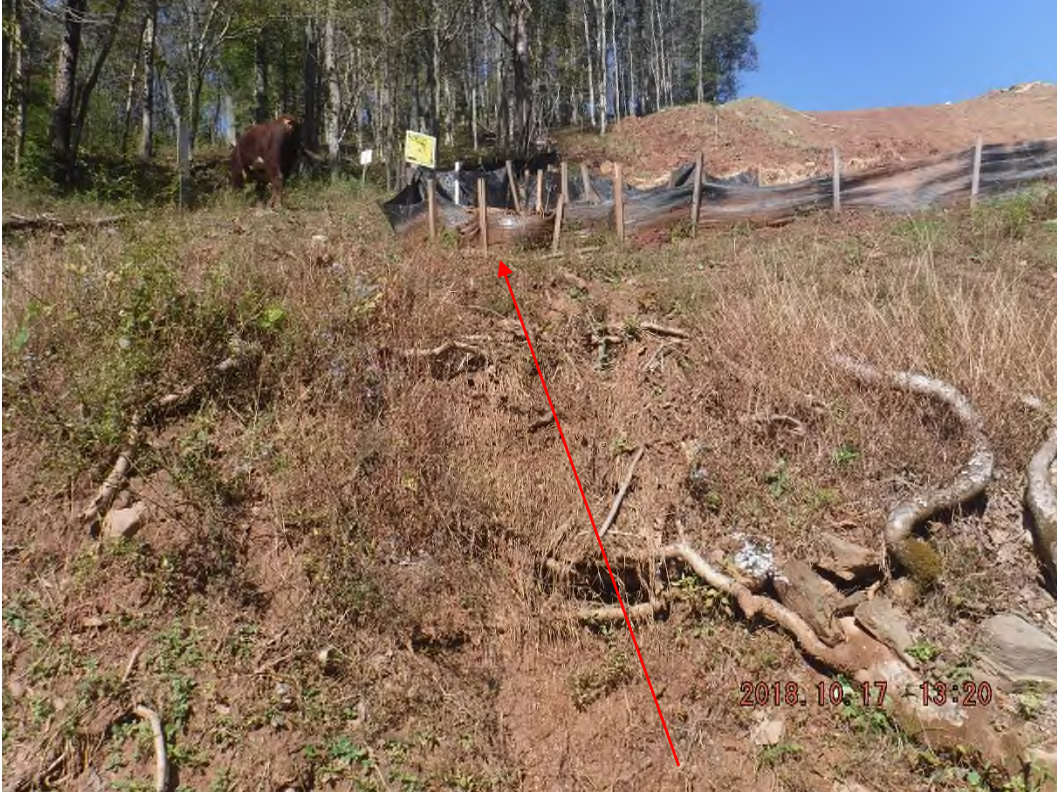
Station 6705+00, showing bulging silt fence.

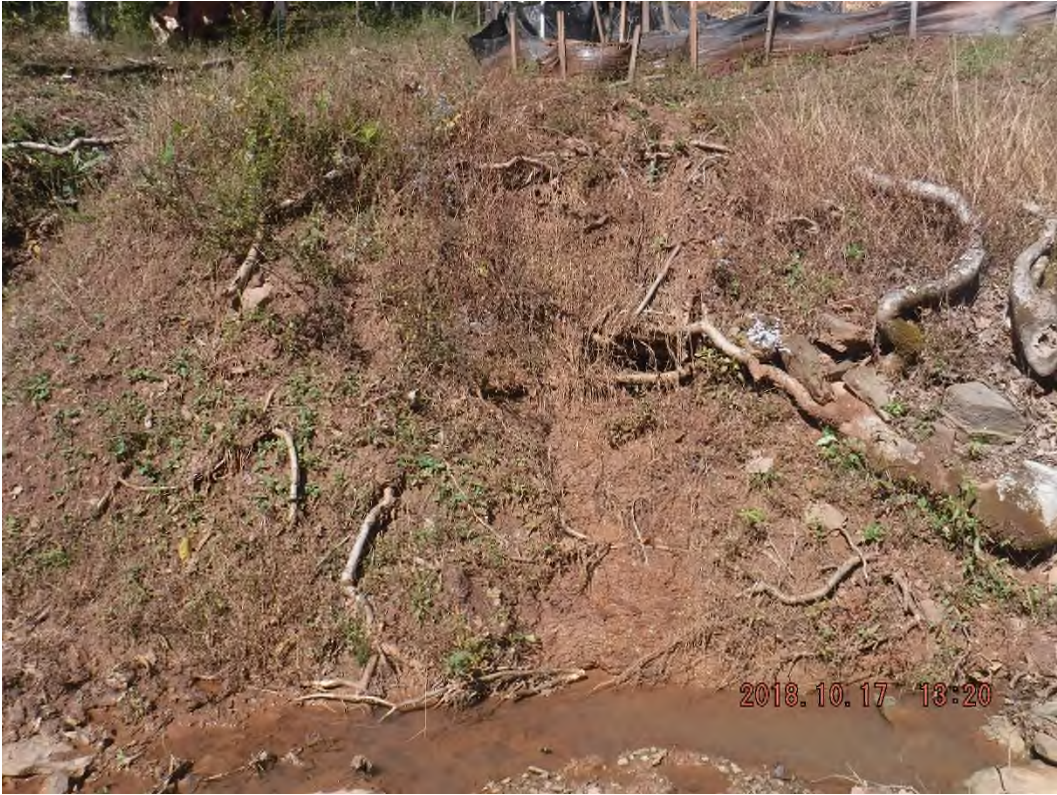
Evidence of a discharge of sediment laden water from silt fence above.

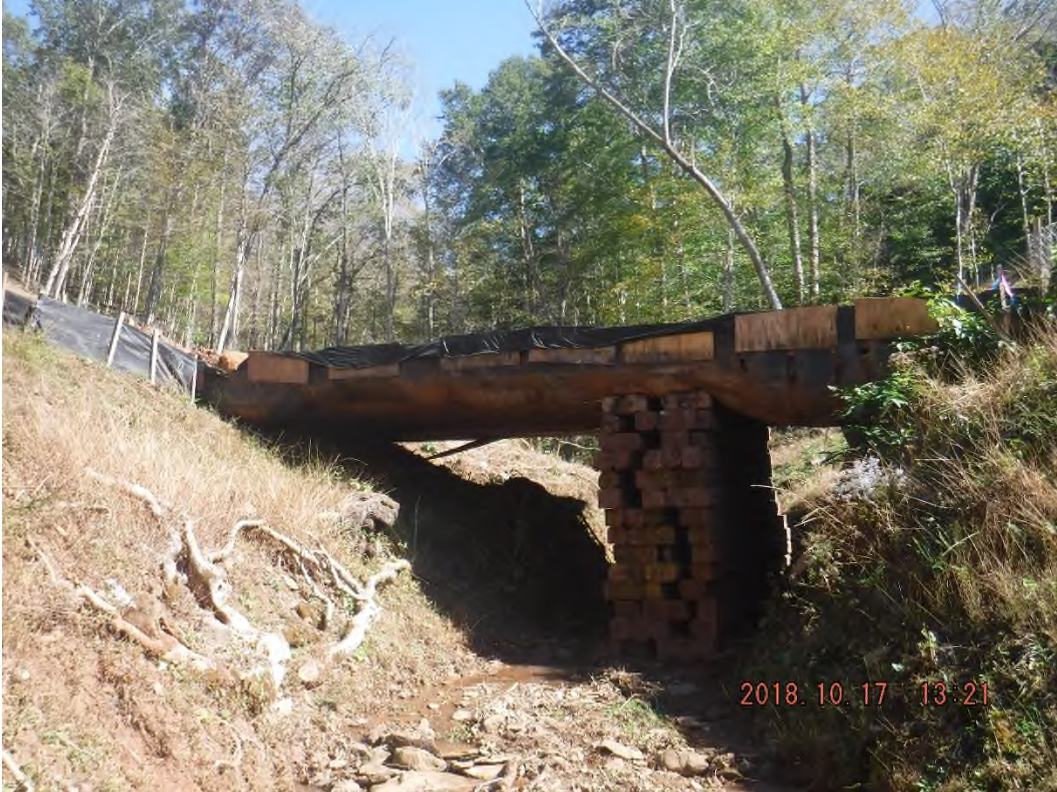
Crossing at Station 6705+00.

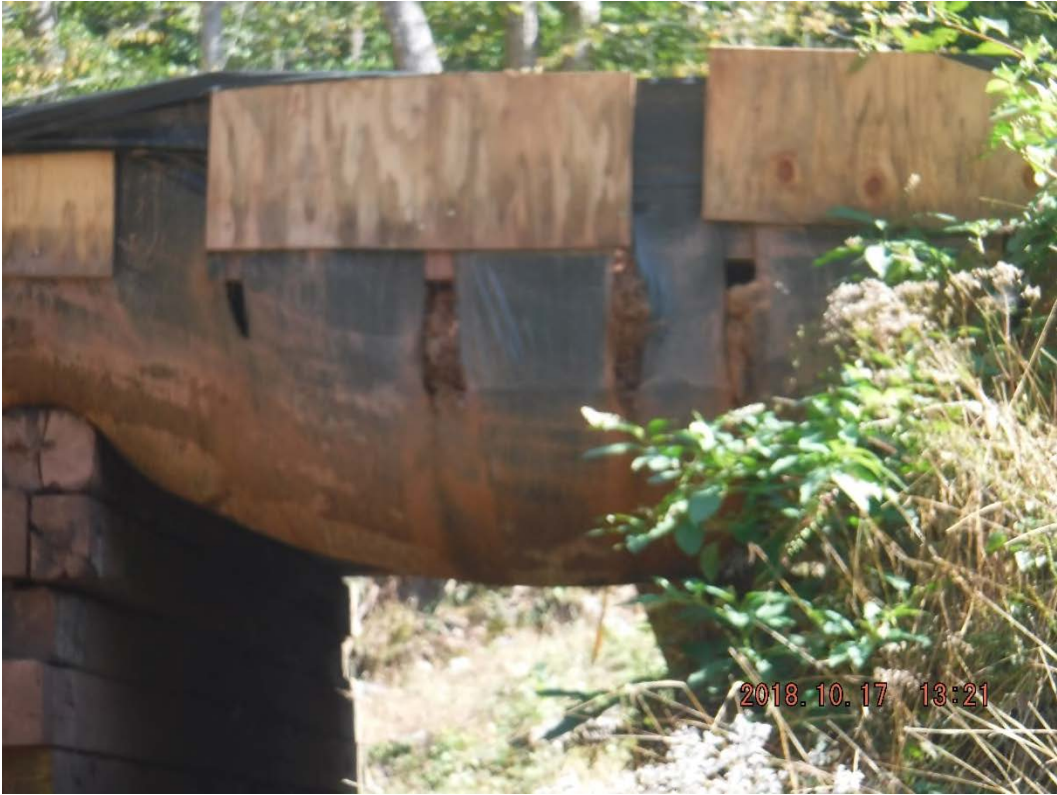
Sediment collected in fabric under timber mat bridge.

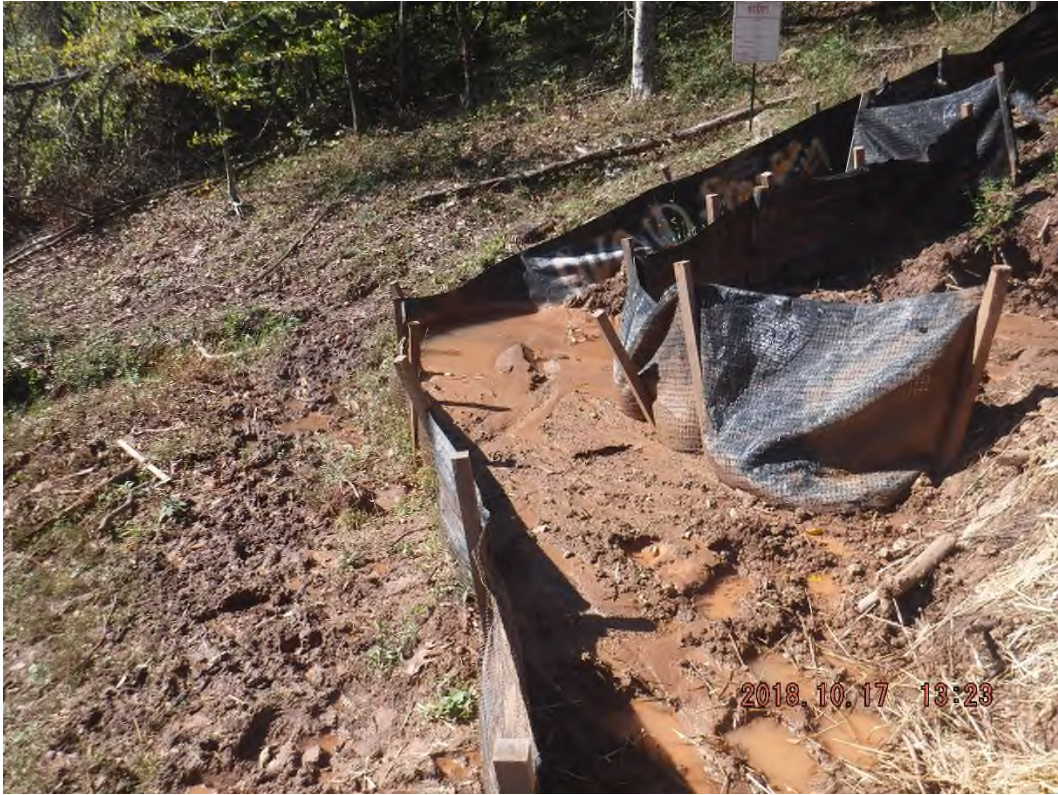
Sediment build-up in silt fence at Station 6705+00.

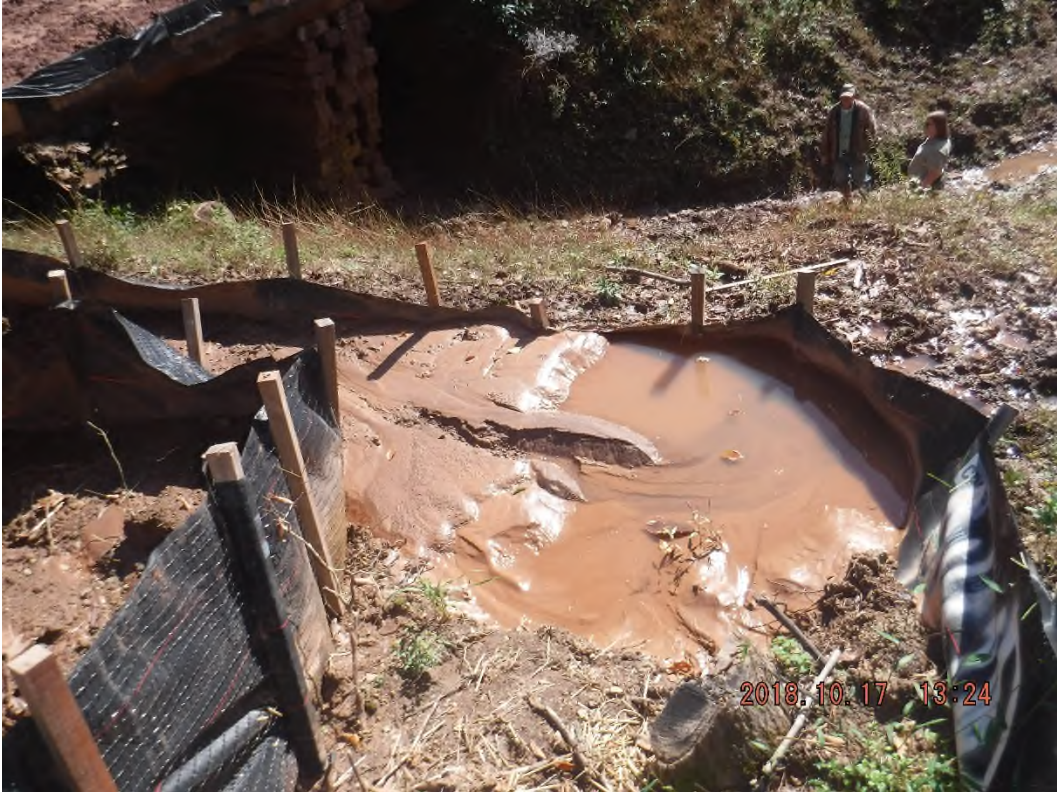
Sediment build-up in silt fence at Station 6705+00.

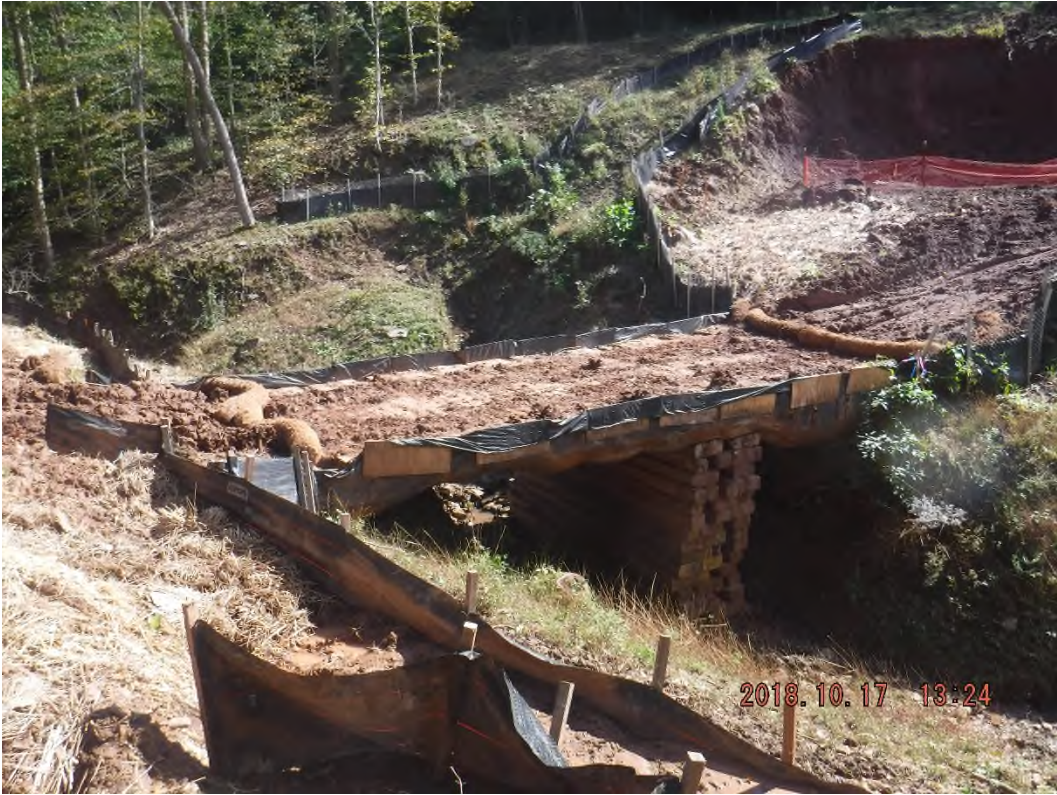
The crossing at Station 6705+00.

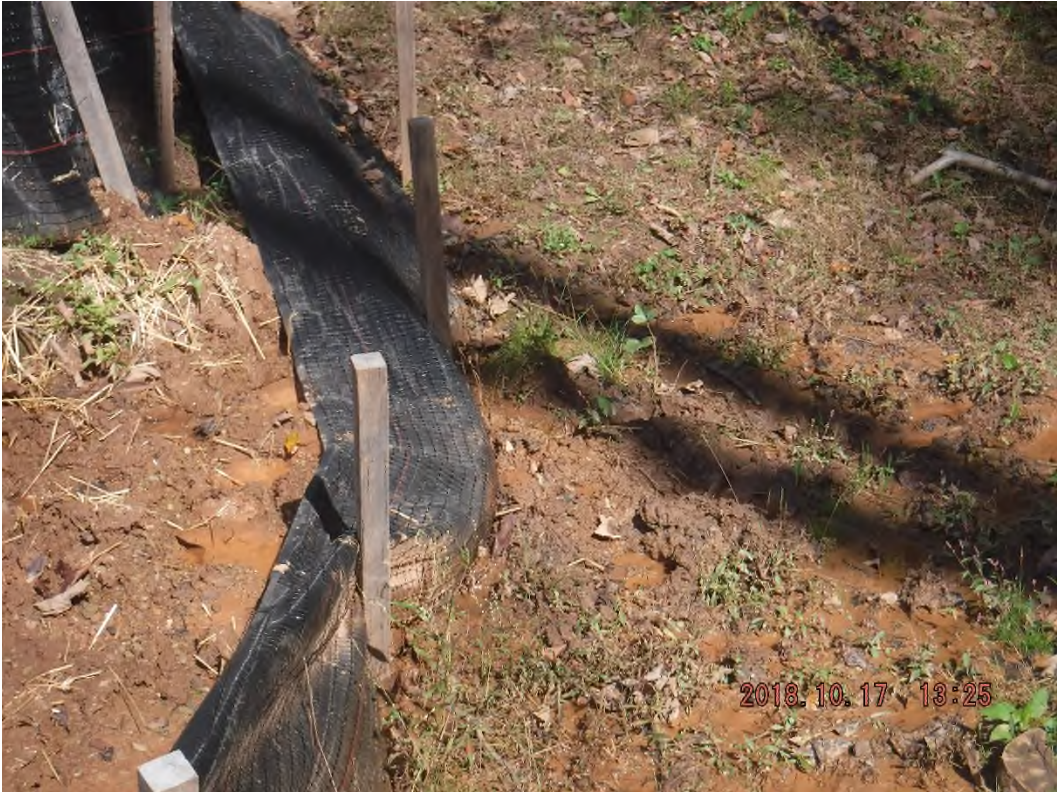
Silt fence in disrepair directly above crossing at Station 6705+00.

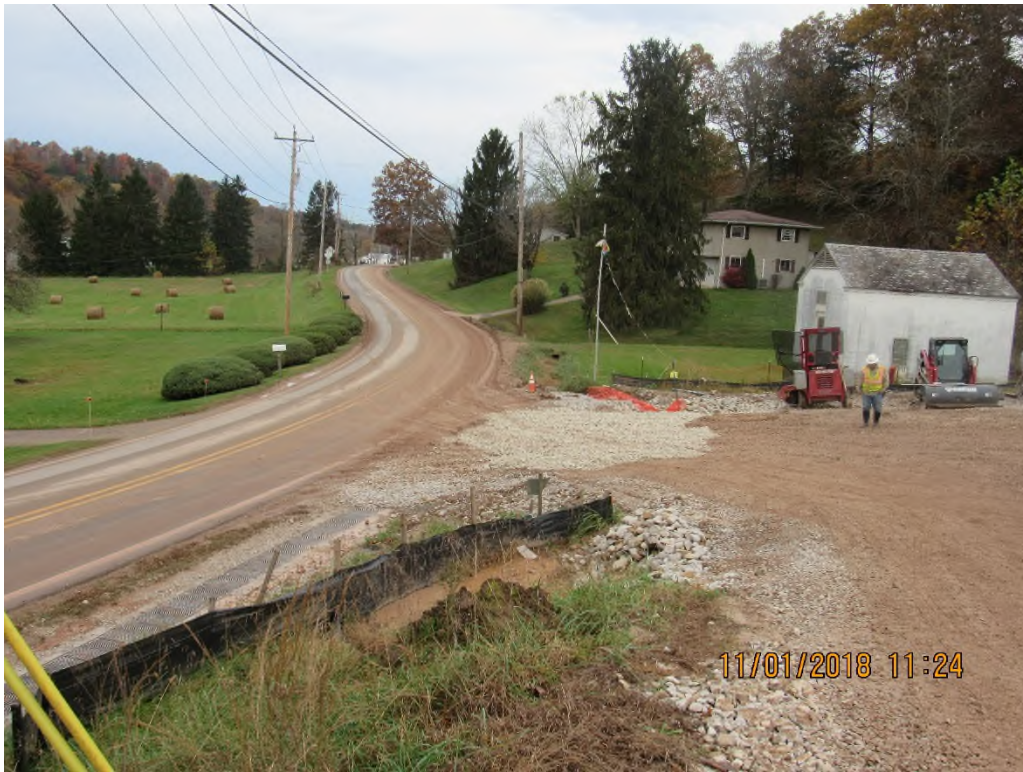
Rt 21 and construction entrance.

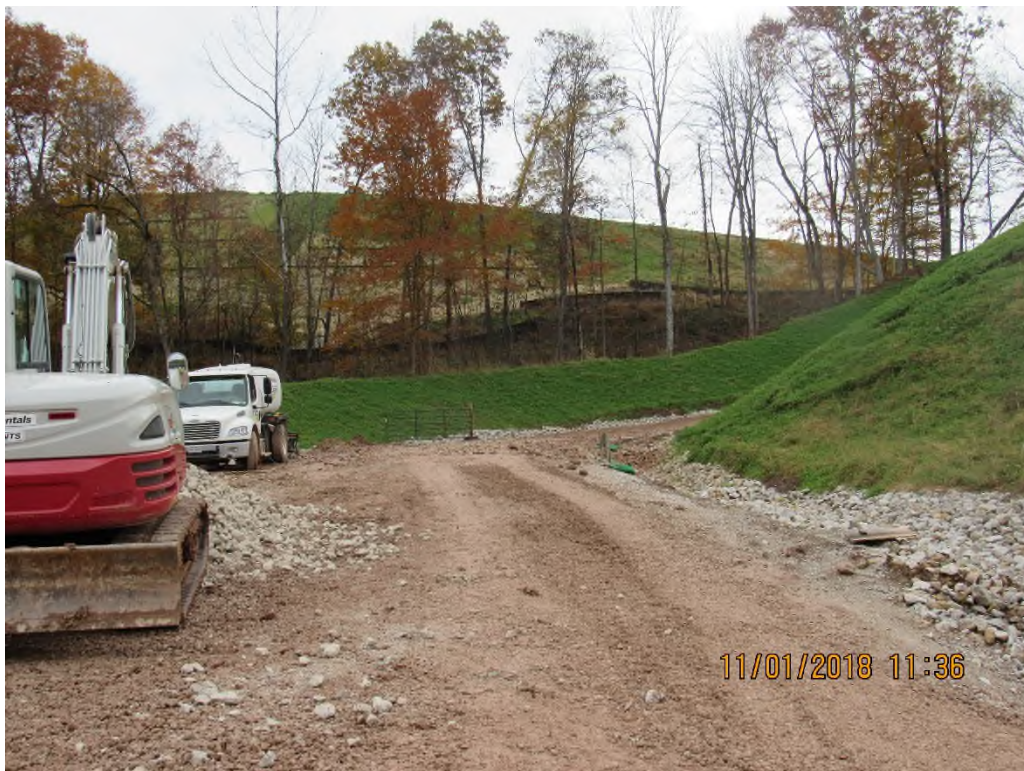
View of the "exit" road that passes through wash station.

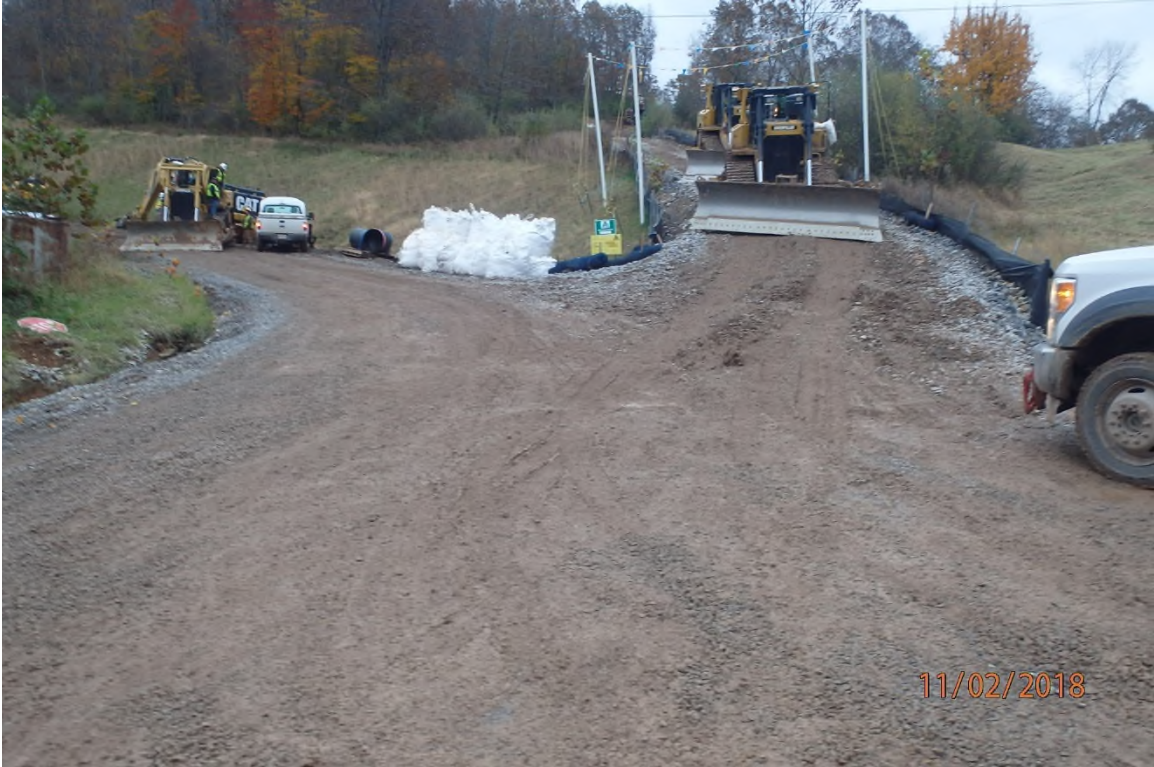
AR-20 (ARDO-001.5) showing an unstable construction entrance that is causing track-out onto the public road.

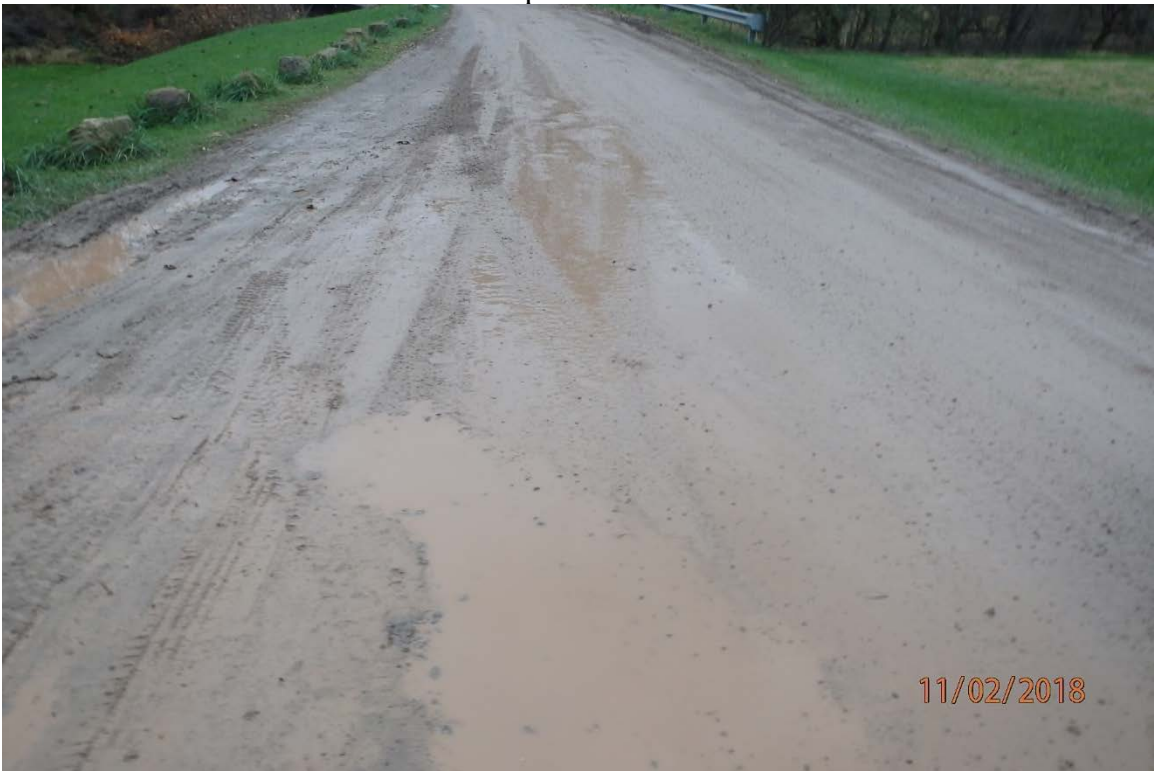
Mud on CR 5 (Riggins Run Road) that originates from AR-20 (ARDO-001.5).

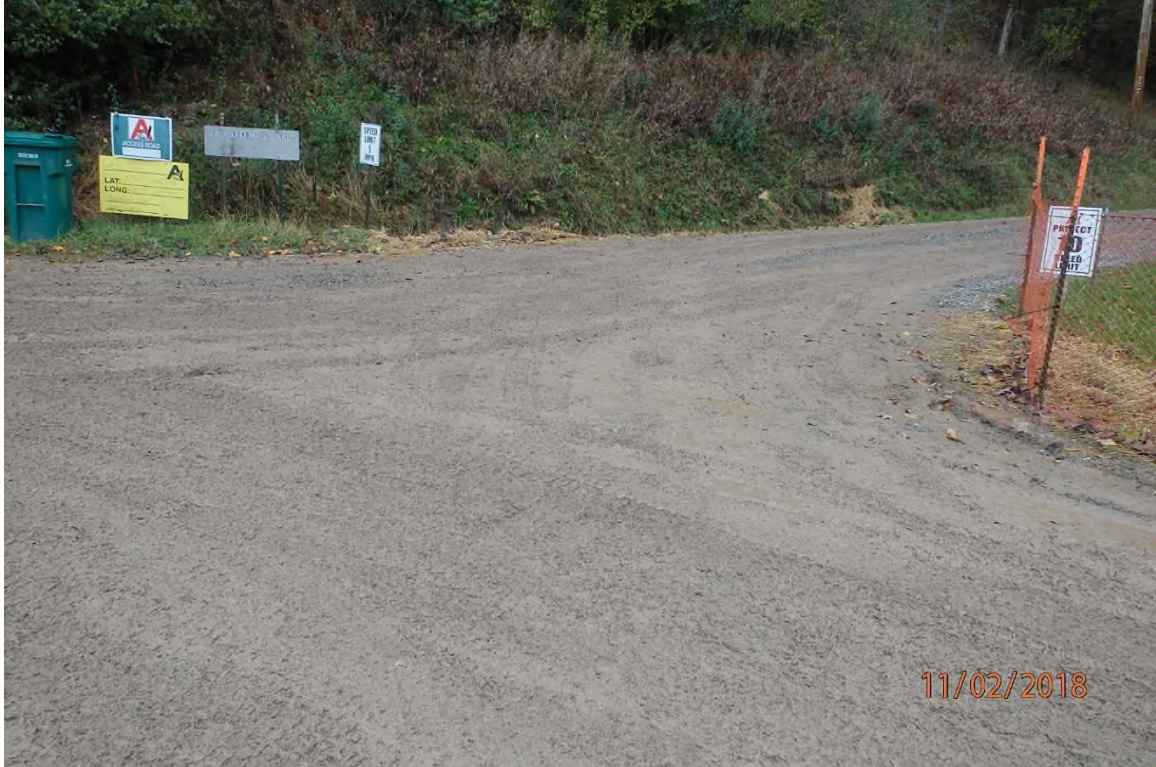
AR – 18 (ARDO002.7) showing an unstable construction entrance.

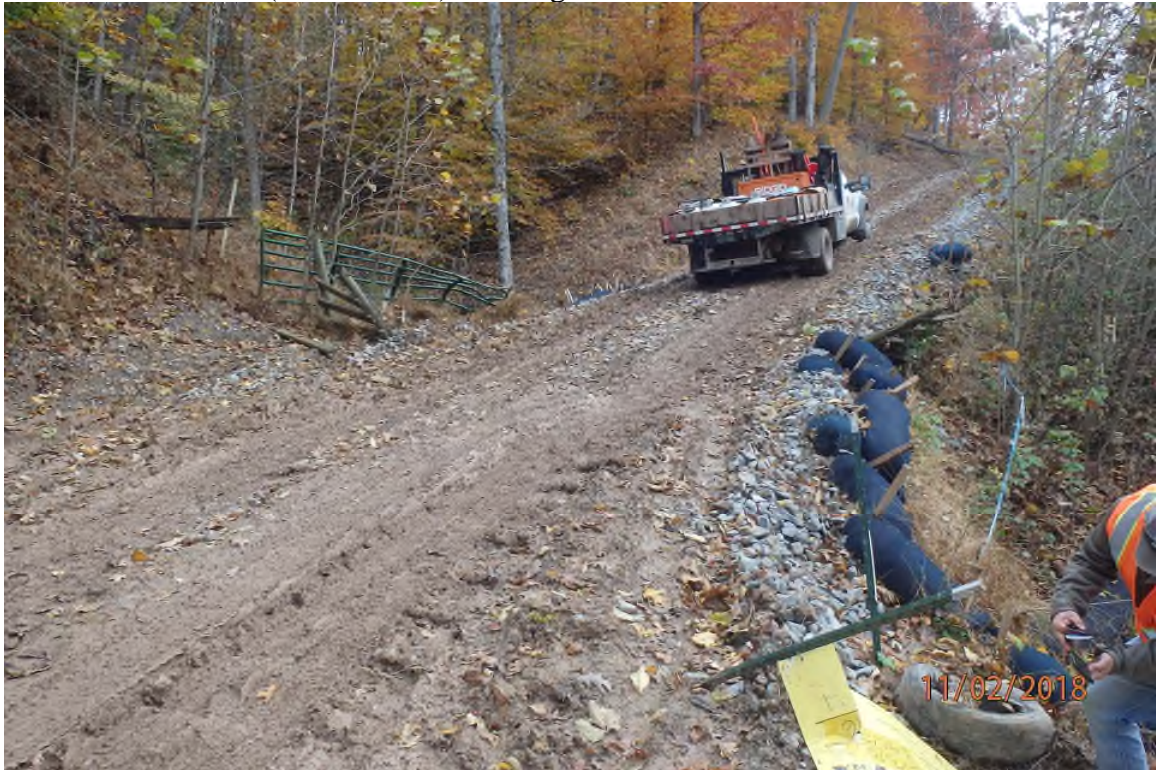
AR – 17 (ARDO002.8) showing an unstable construction entrance.

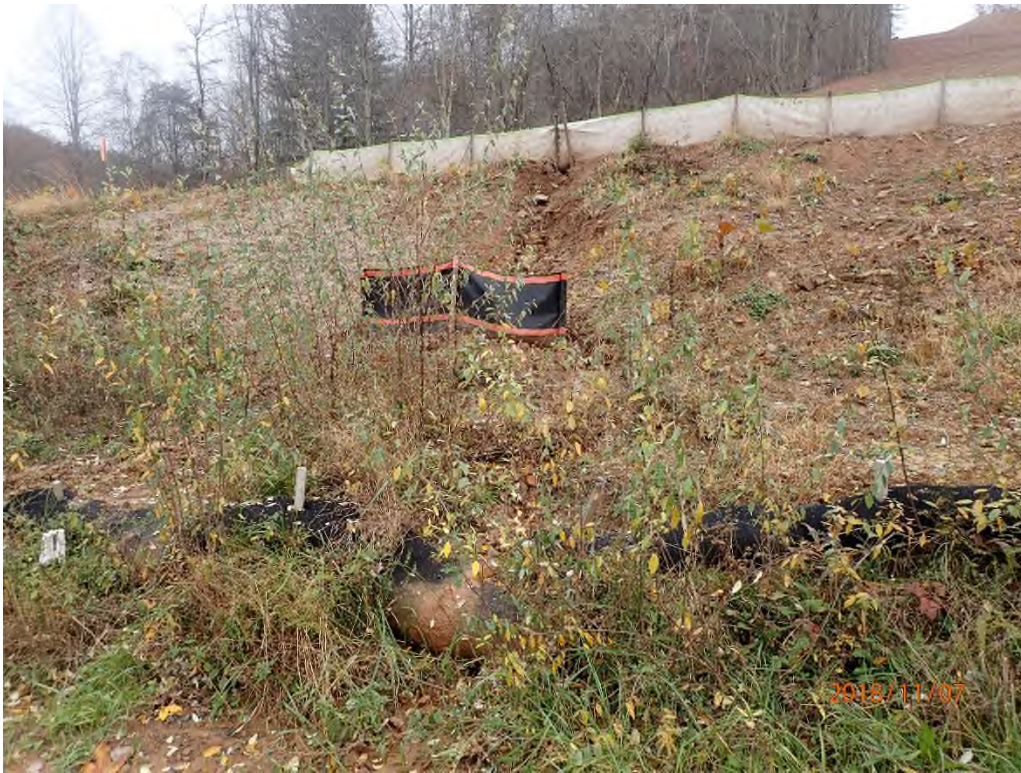
Sediment-laden water leaving the site through perimeter controls in need of maintenance.

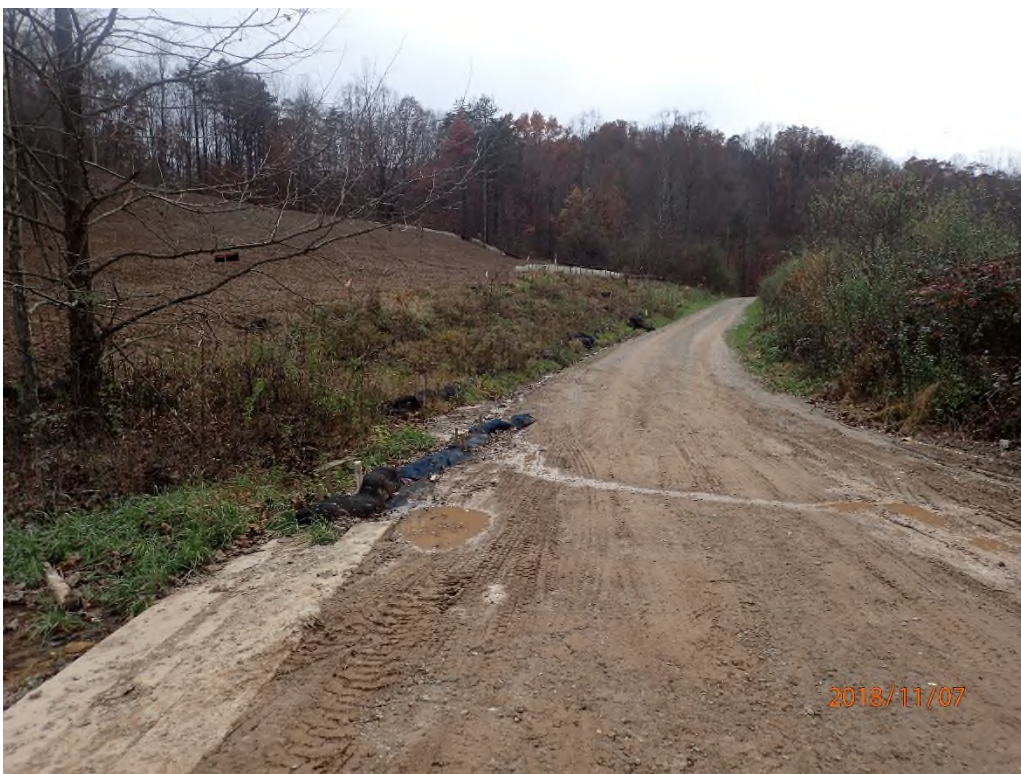
Sediment leaving the project on nearby access road.

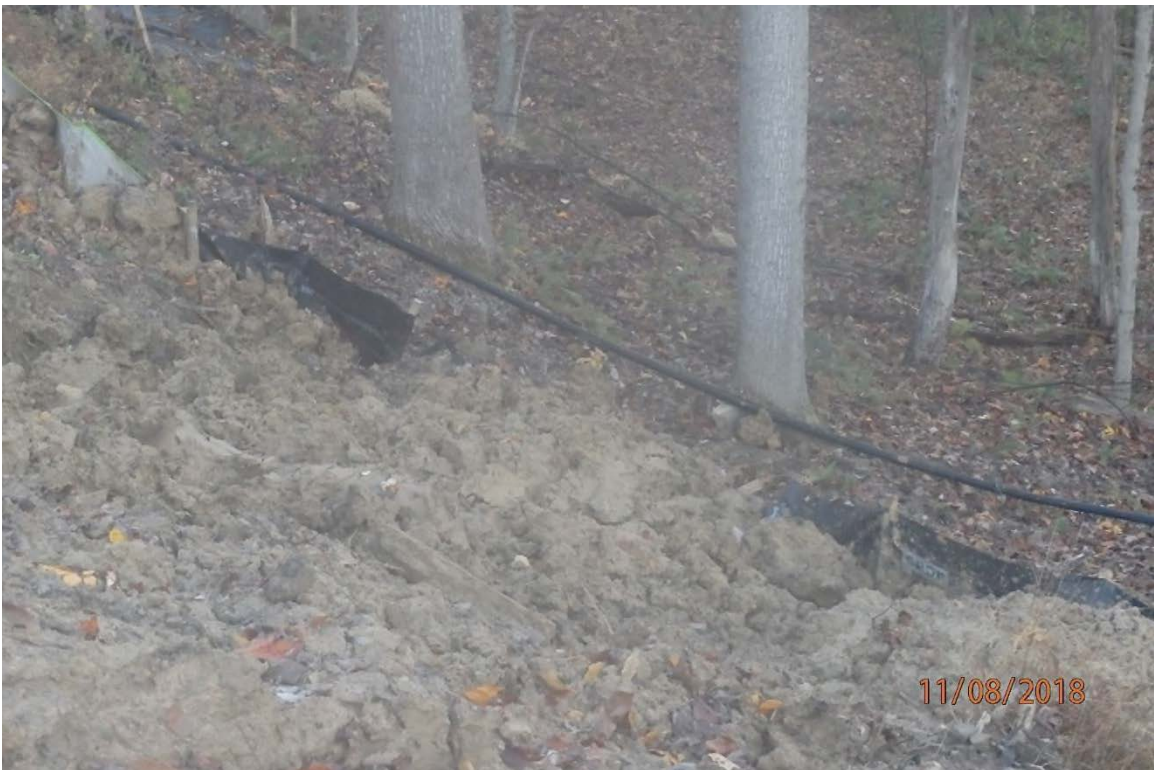
Unmaintained perimeter control and associated offsite sediment deposits in the Bluestone Creek watershed.

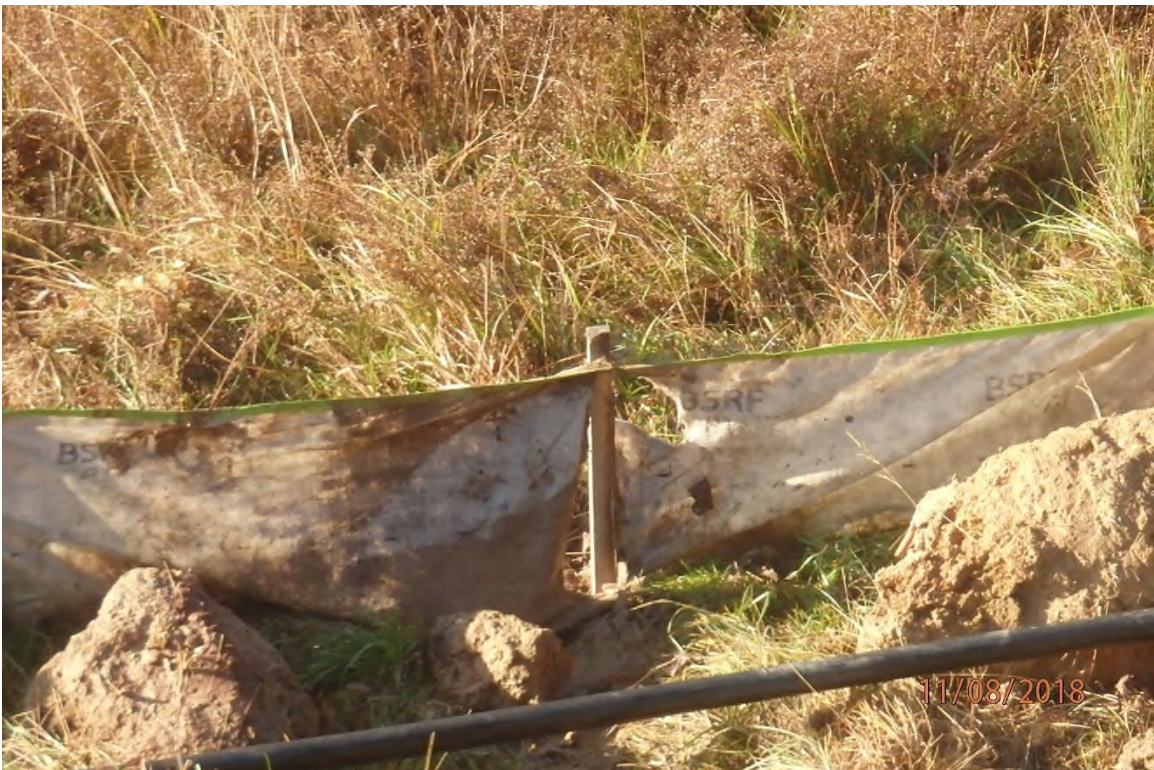
Unmaintained perimeter control in the Bluestone Creek watershed.
