**CONSENT ORDER
ISSUED UNDER THE
WATER POLLUTION CONTROL ACT
WEST VIRGINIA CODE, CHAPTER 22, ARTICLE 11**

TO: Columbia Gas Transmission, LLC
Attn: Troy Tally, Vice President
1700 MacCorkle Ave
Charleston, WV 25314

DATE: October 1, 2020
ORDER NO.: 9061

1. Columbia Gas Transmission, LLC is conducting land disturbance activity associated with construction of the Mountaineer Xpress Project in Marshall, Wetzel, Tyler, Doddridge, Ritchie, Calhoun, Wirt, Roane, Jackson, Mason, Putnam, and Cabell Counties, West Virginia. On January 31, 2018, Columbia Gas Transmission, LLC was issued Water Pollution Control Permit No. WV0116815, Registration No. WVR310872, for Stormwater Associated With Oil and Gas Related Construction Activities.

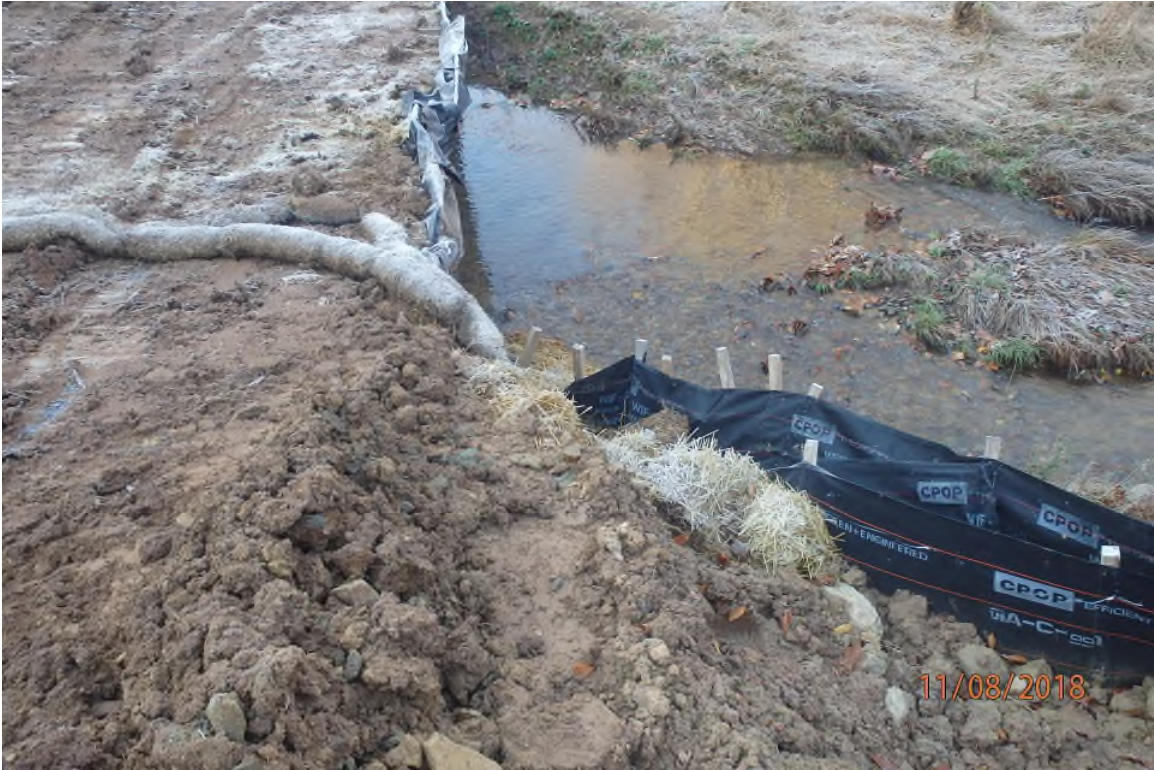
Unmaintained equipment bridge BMP in the Bluestone Creek watershed (SDOG537).

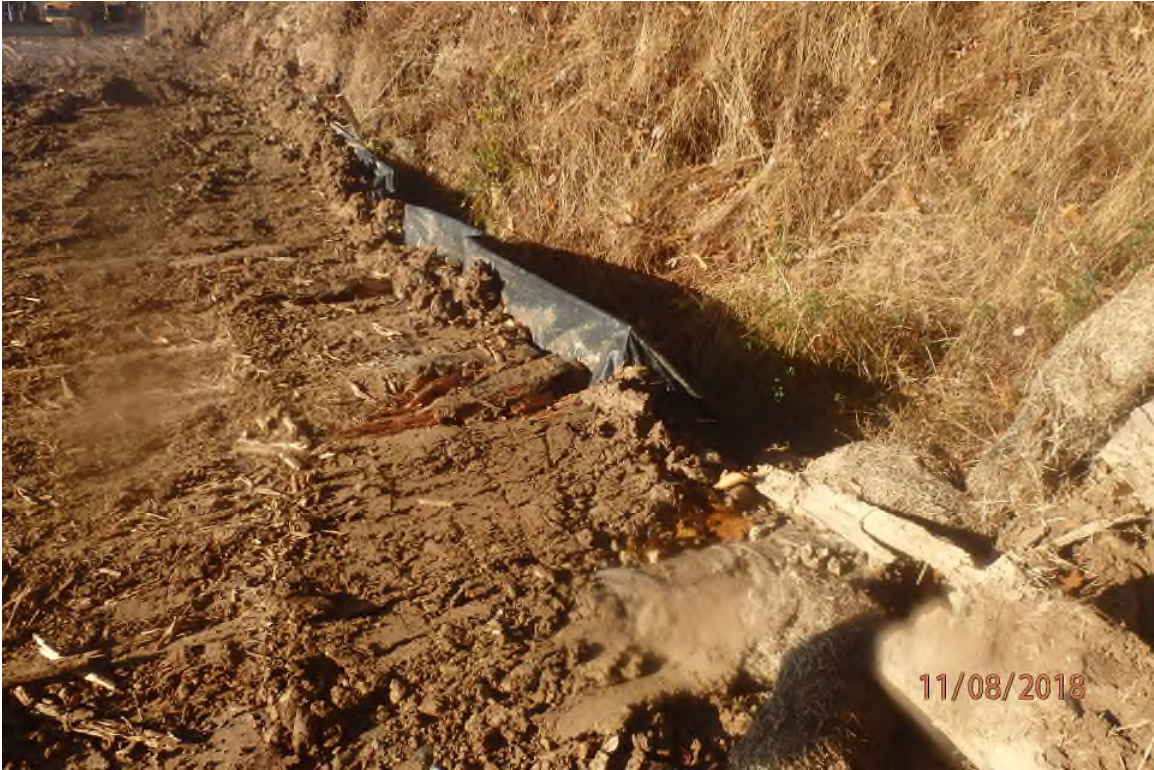
Unmaintained equipment bridge BMP in the Bluestone Creek watershed (SDOG543).

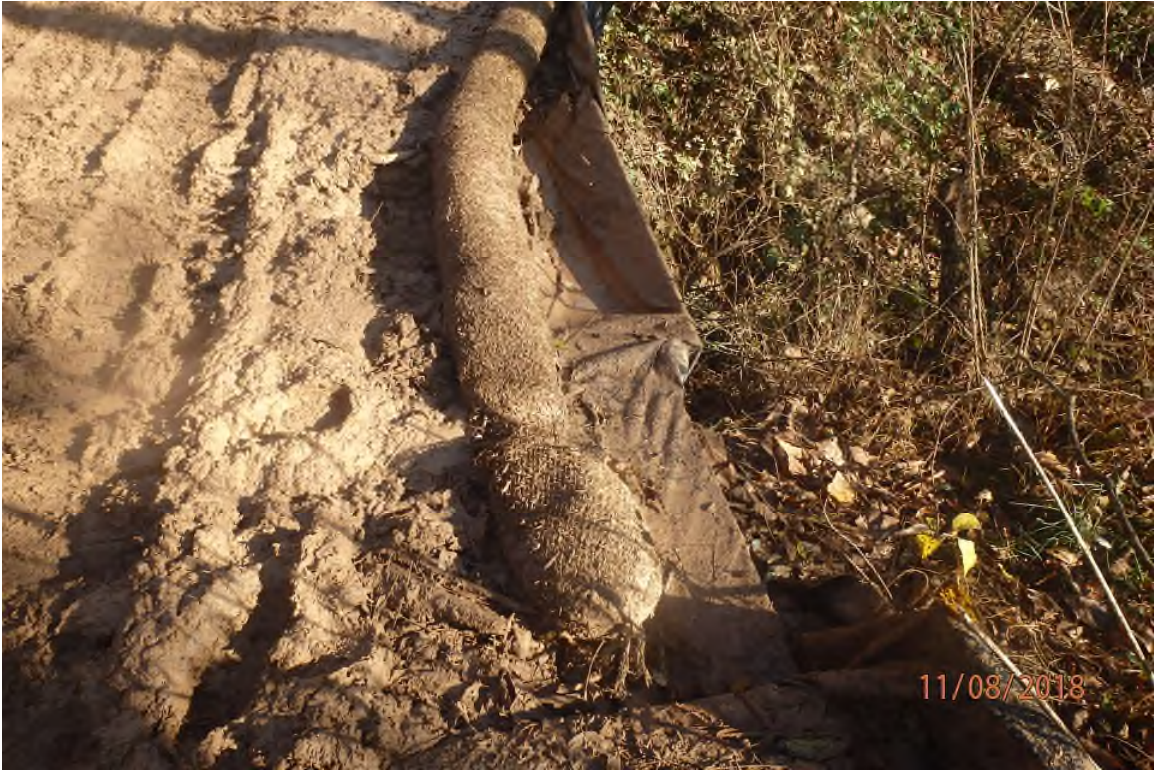
Unmaintained equipment bridge BMP in the Bluestone Creek watershed (SDOG201).

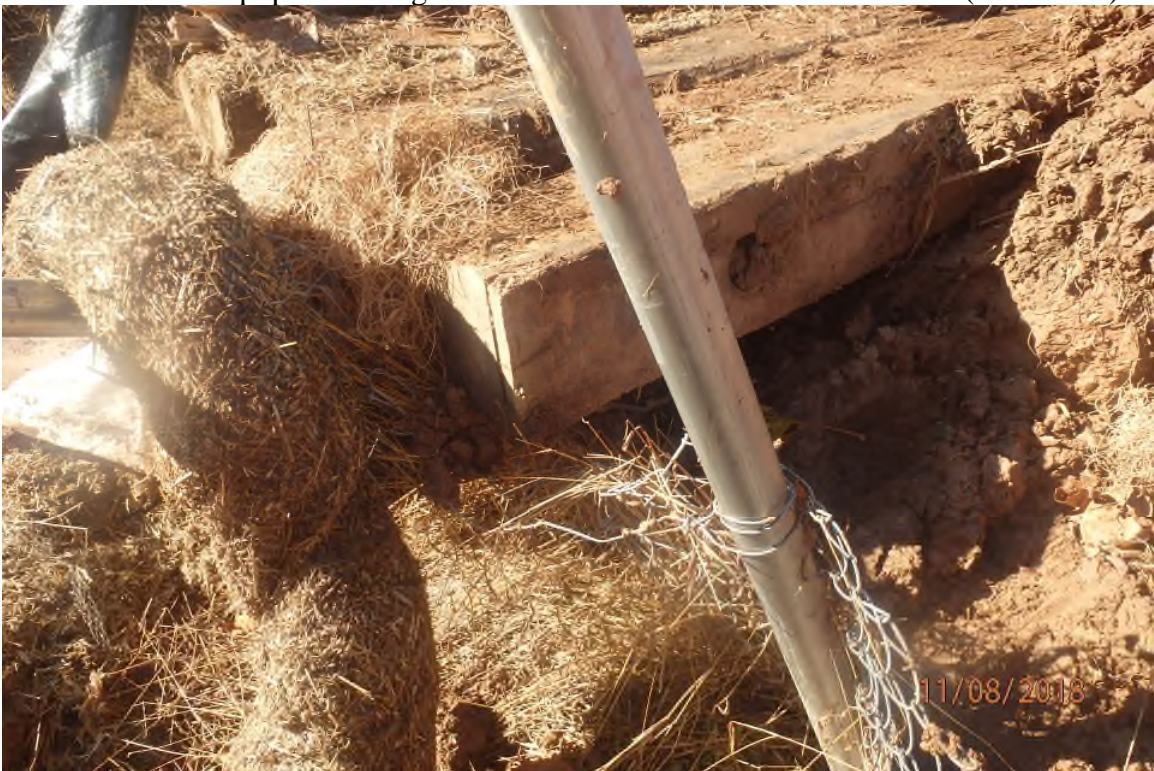
Unmaintained equipment bridge BMP in the Bluestone Creek watershed (SDOI205).

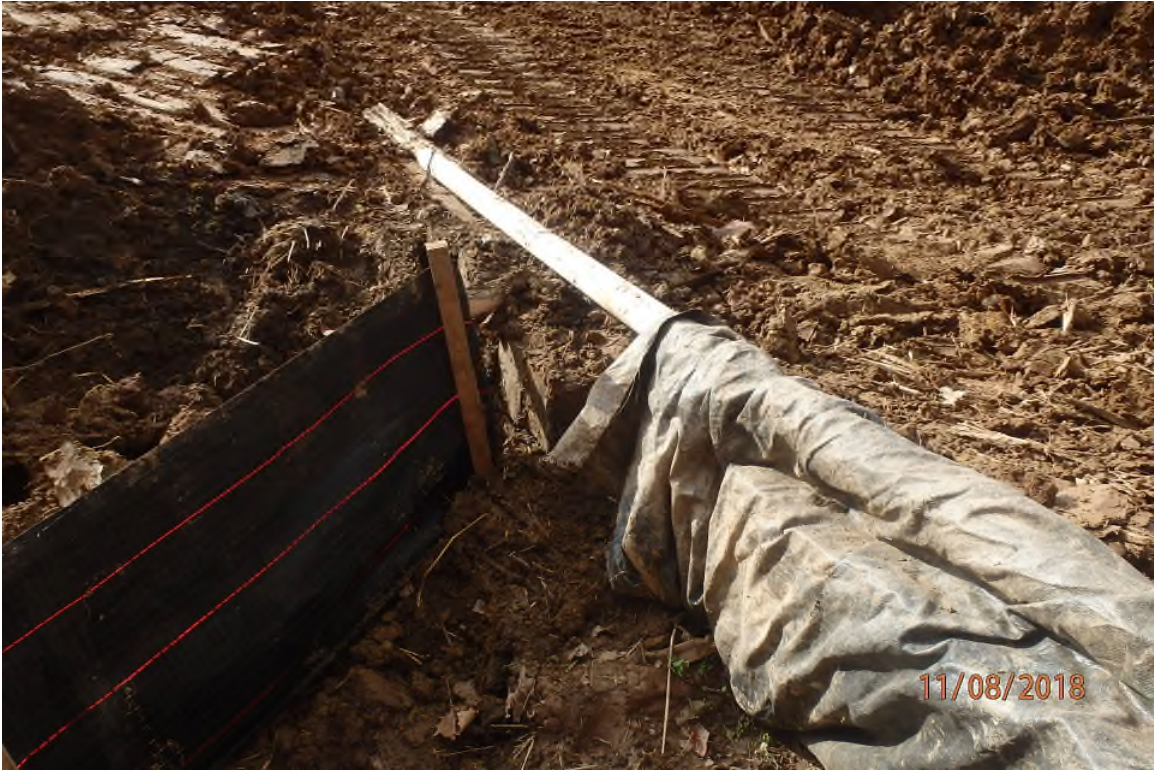
Unmaintained equipment bridge BMP in the Bluestone Creek watershed (SDOG0048).

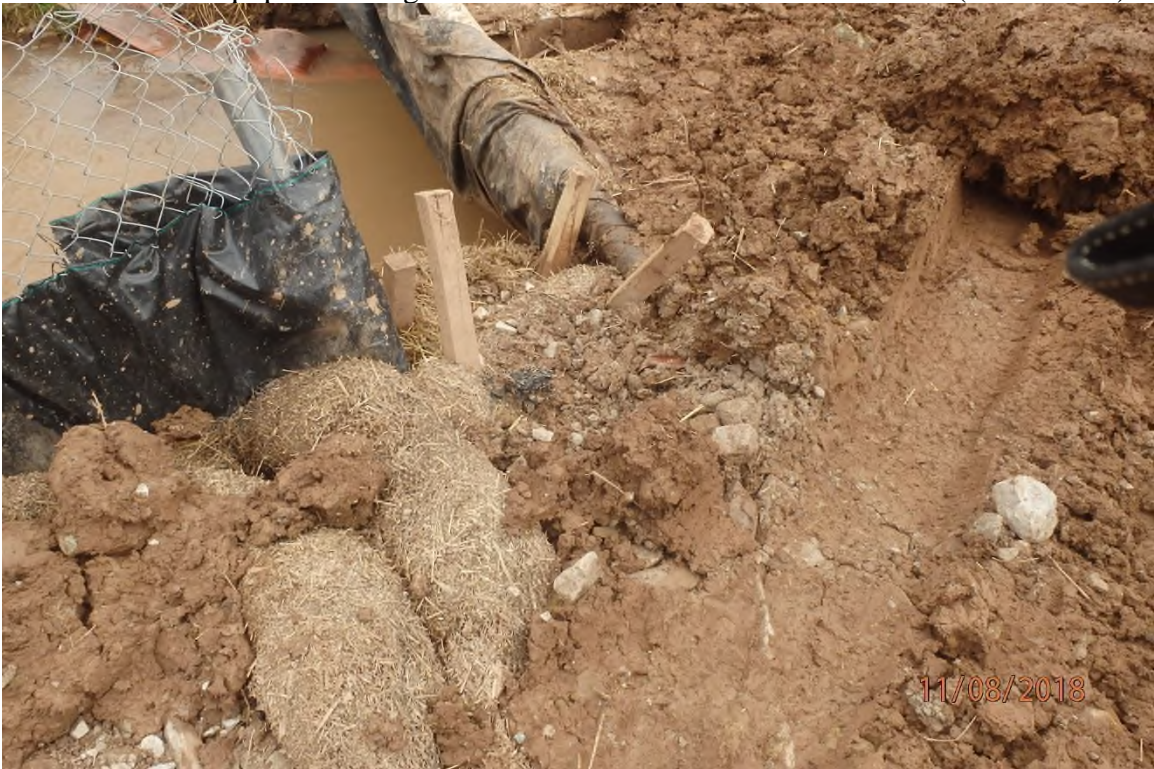
Unmaintained equipment bridge BMP in the Bluestone Creek watershed (SDOG0055).

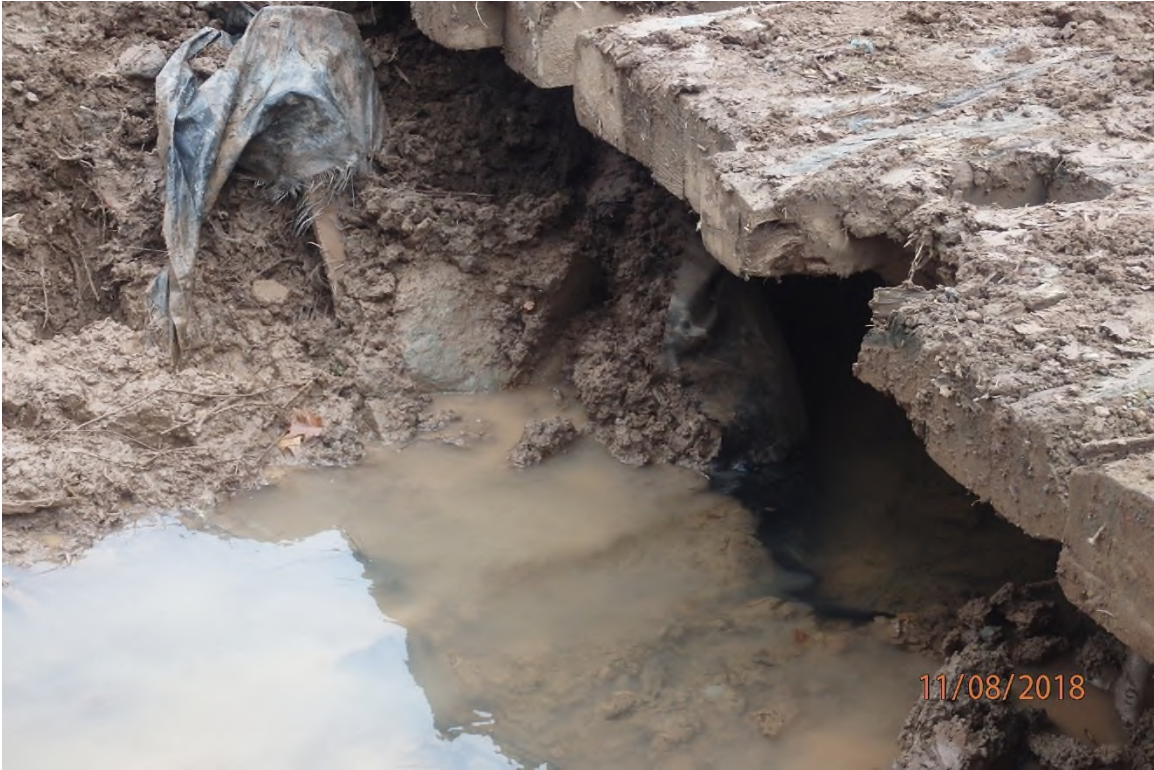
UNT Left Fork of Arnolds Creek (SDOG040) crossing showing a bridge in need of maintenance.

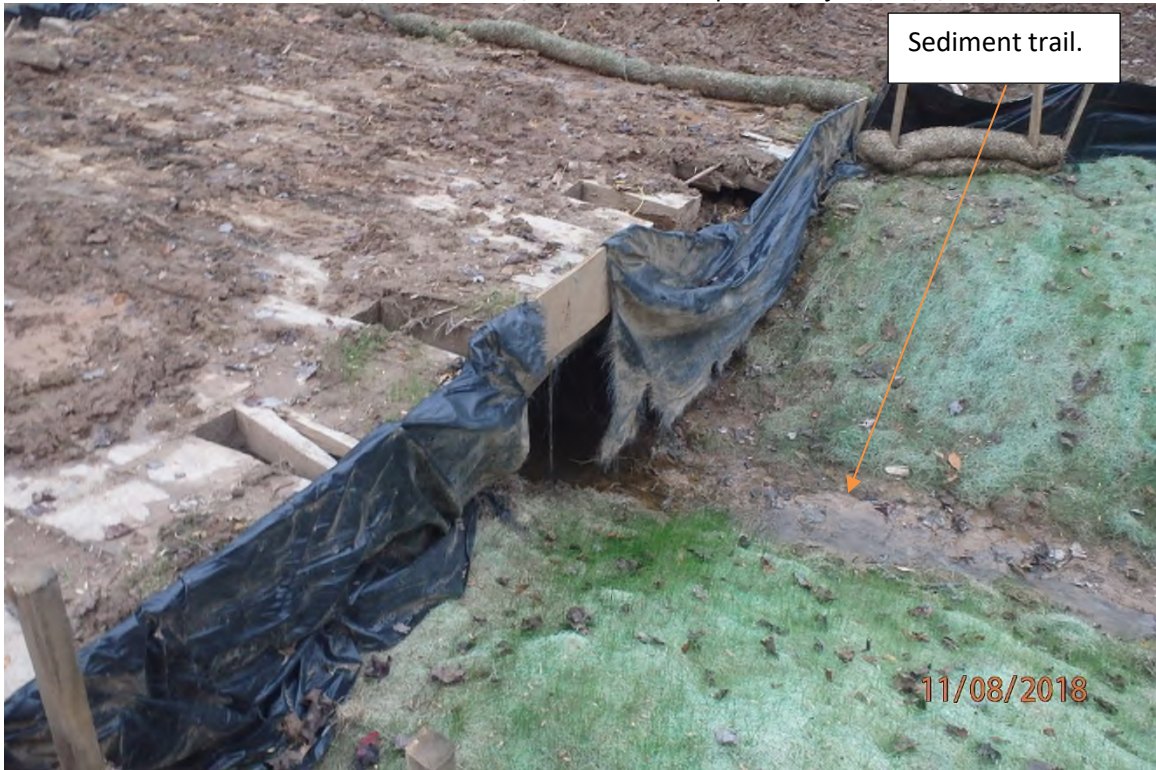
Equipment bridge BMP in need of maintenance at Taylor Drain (SDOG071) crossing.

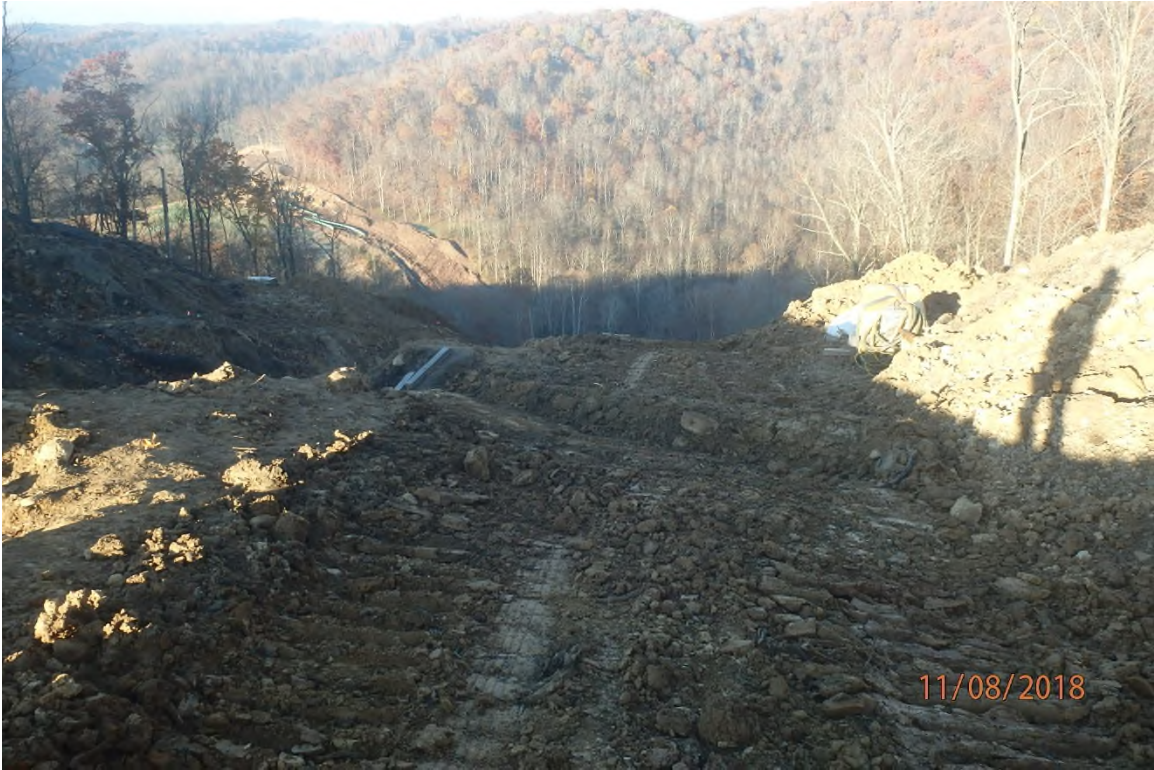
Improperly installed water bars in the Bluestone Creek watershed.

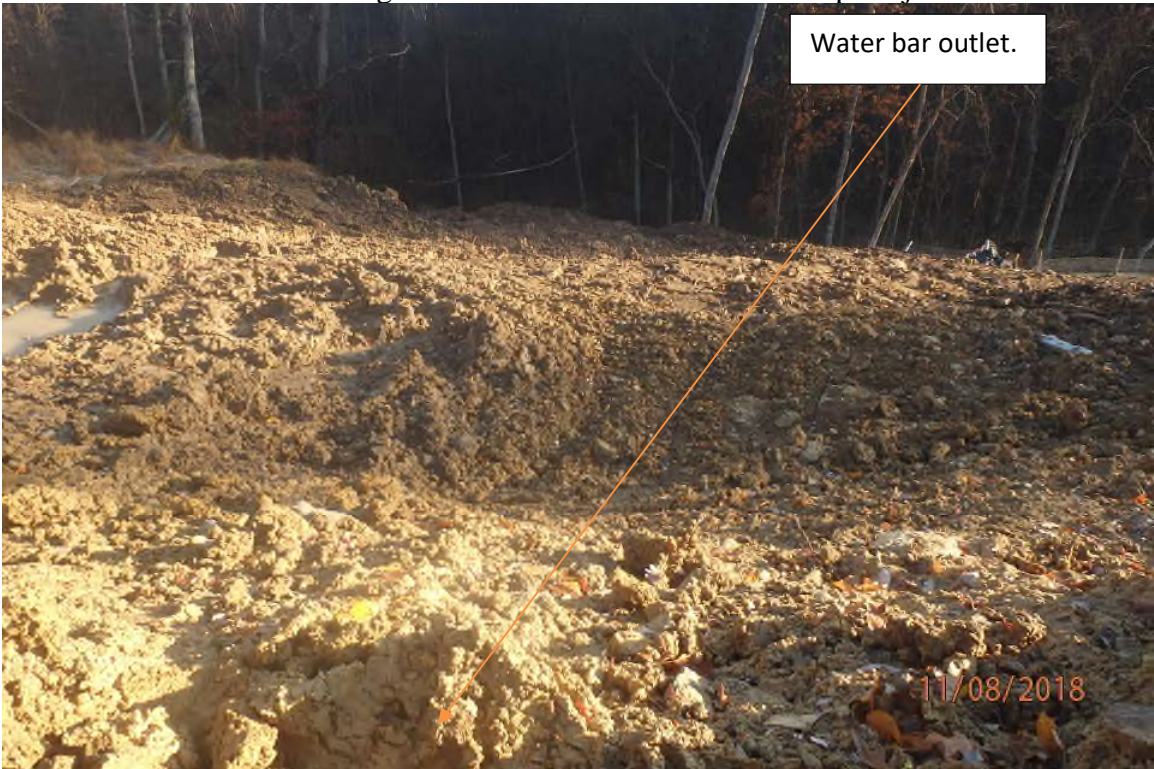
Water bar outlet that discharges concentrated flow over a fill slope adjacent to 2822+00.

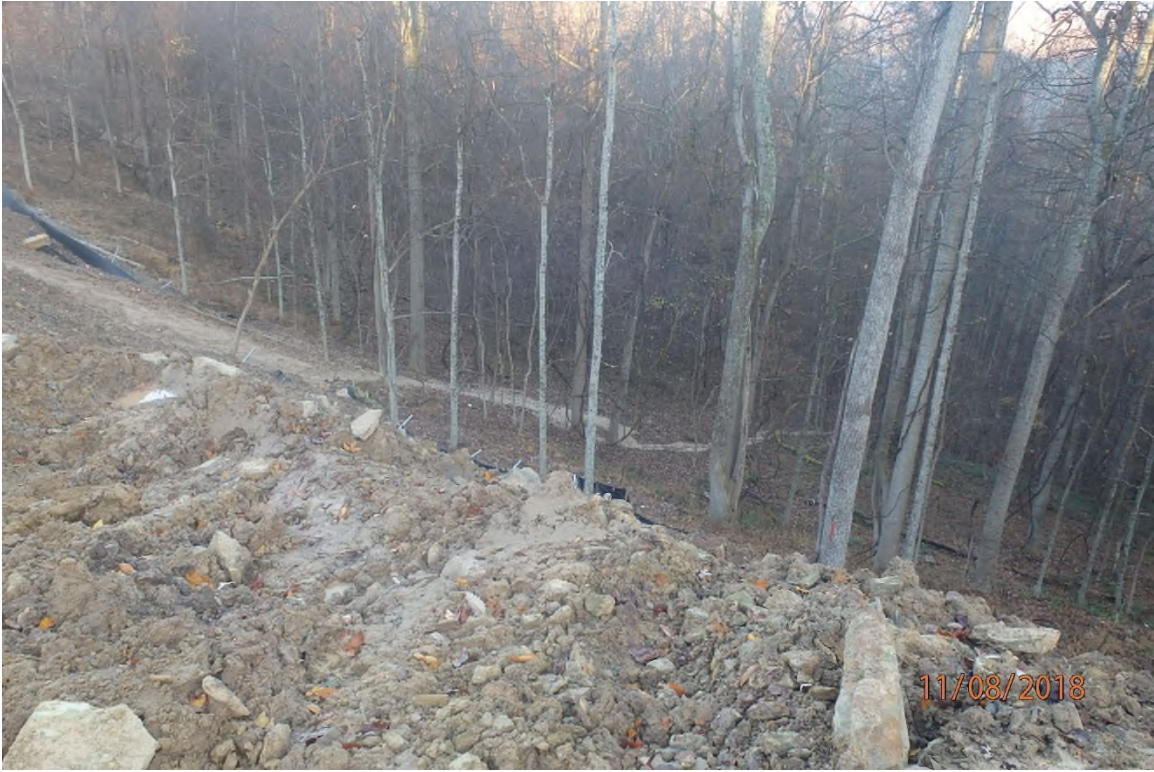
Slip and associated mud flow adjacent to 2822+00.

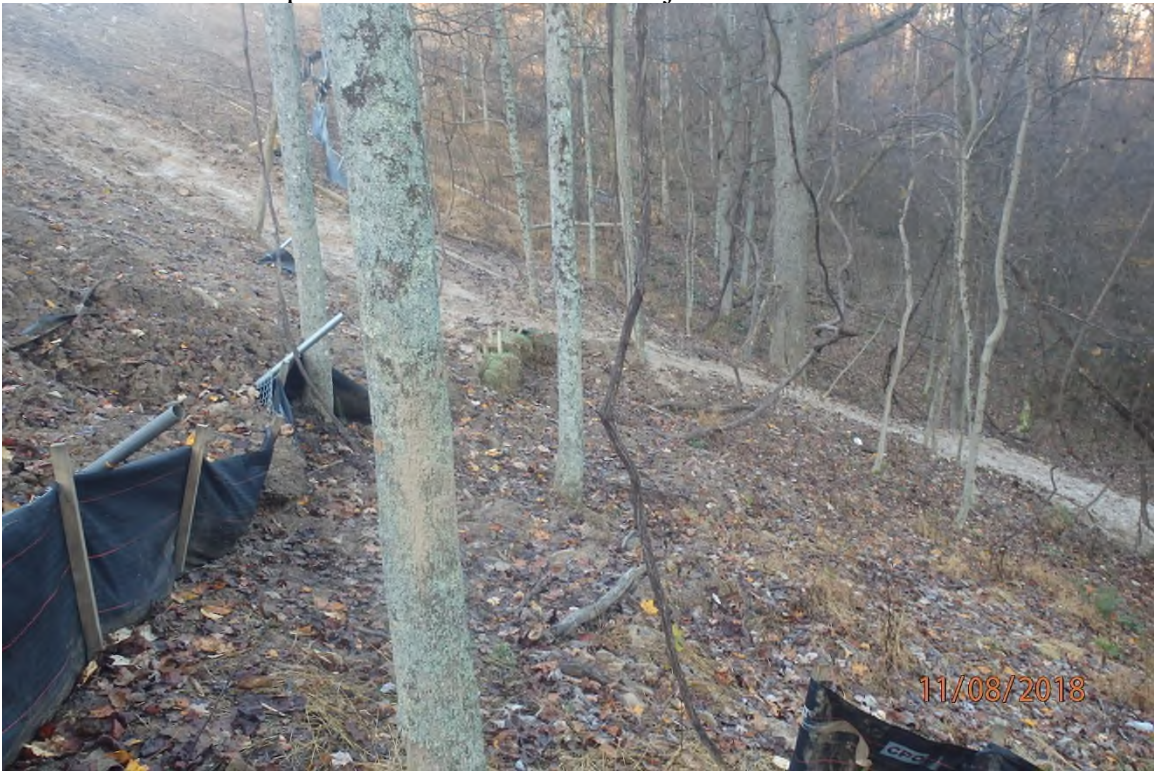
Slip and associated mud flow adjacent to 2822+00.

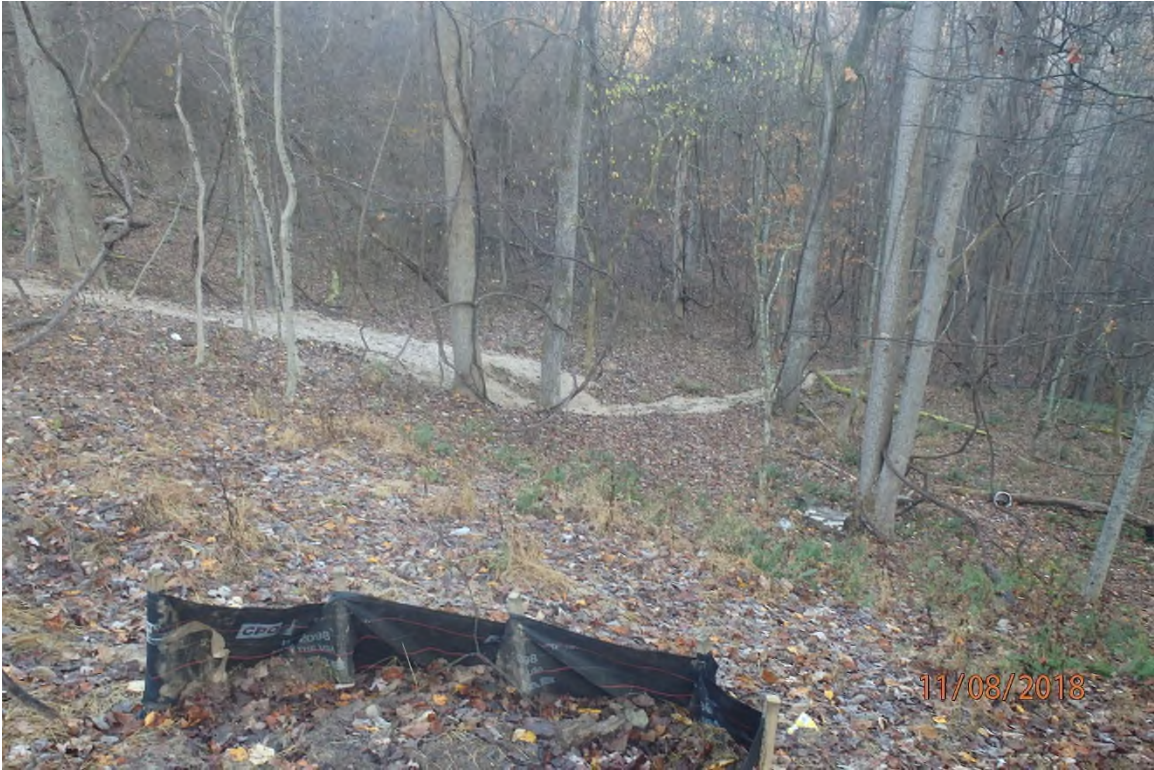
Slip and associated mud flow adjacent to 2822+00.

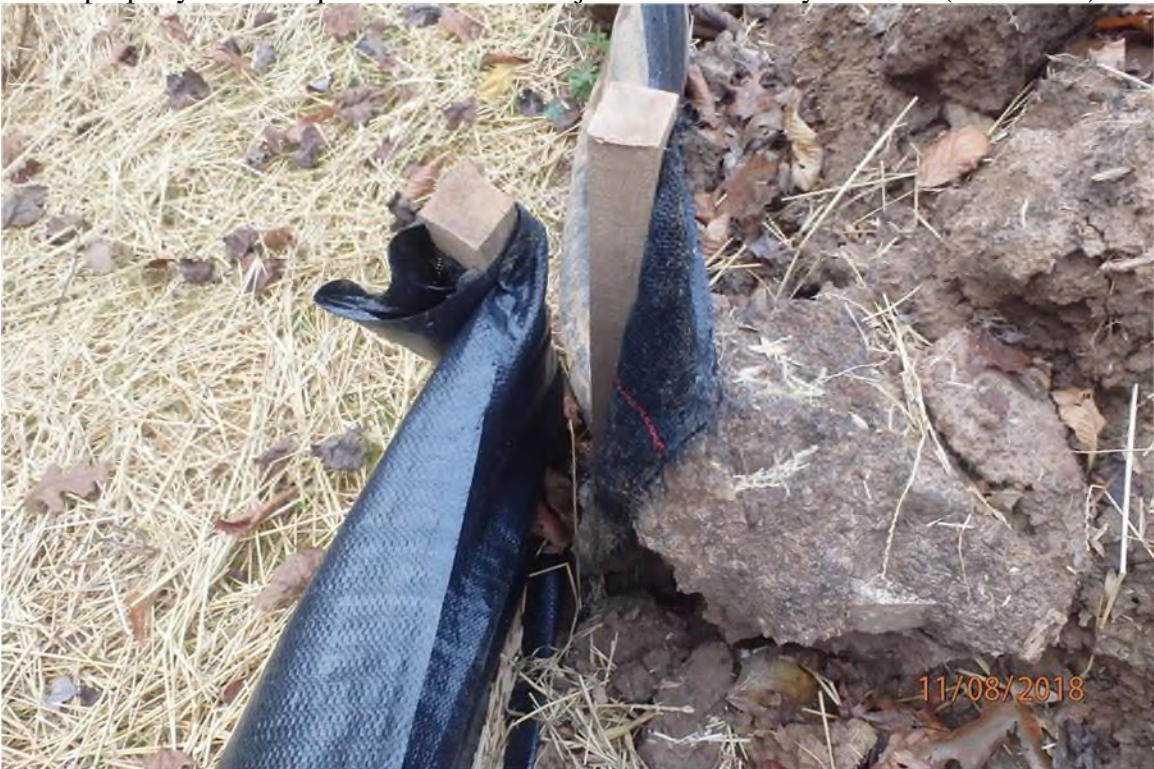
Improperly installed perimeter control adjacent to UNT Taylor Drain (SDOH012).

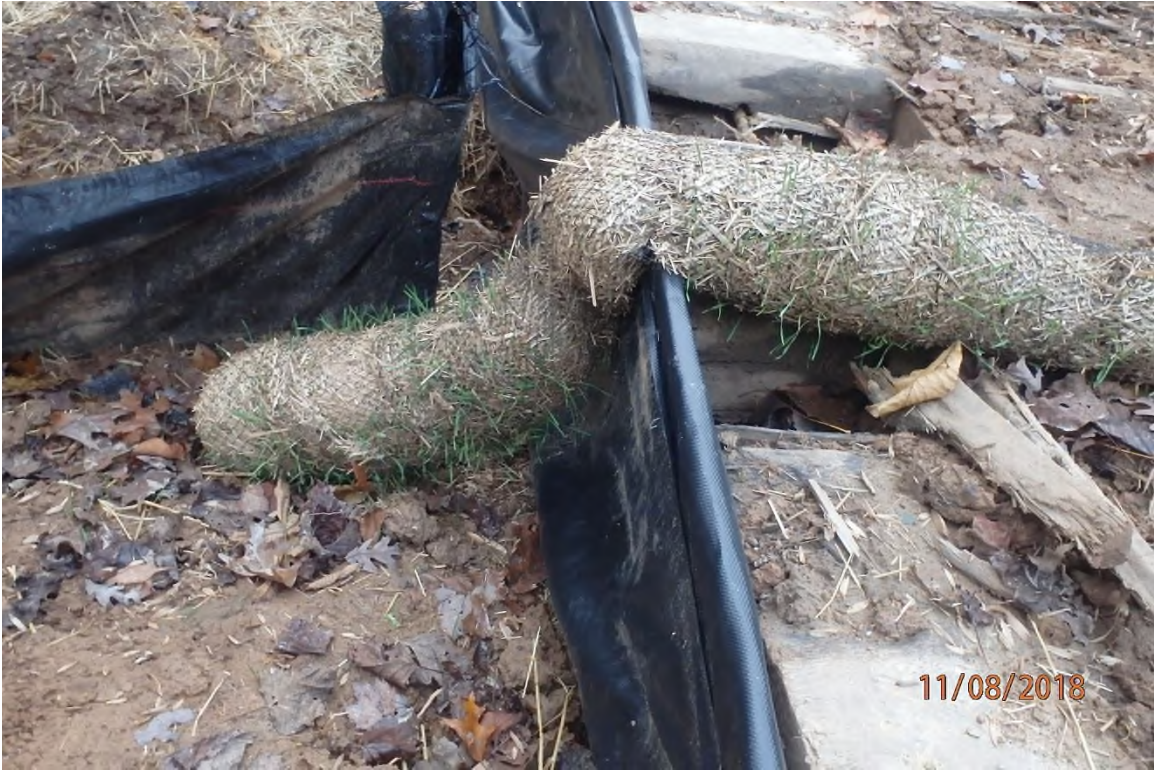
Improperly installed perimeter control equipment bridge tie-in adjacent to UNT Taylor Drain (SDOH012).

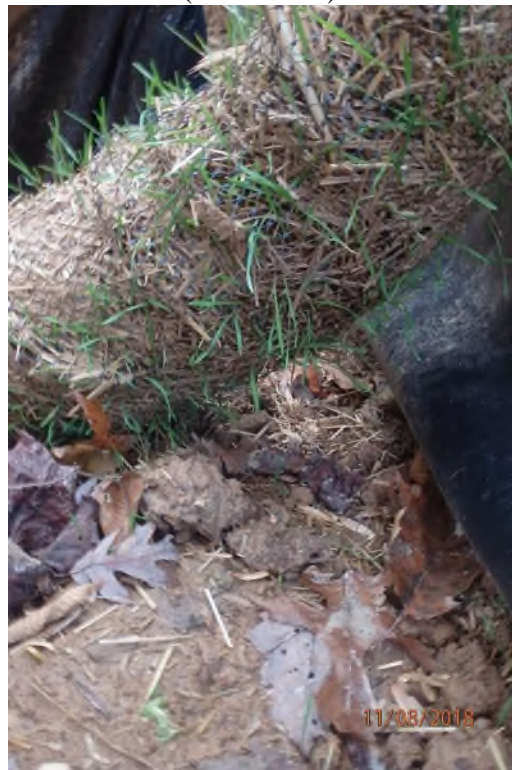
Improperly installed perimeter control equipment bridge tie-in adjacent to UNT Taylor Drain (SDOH012).

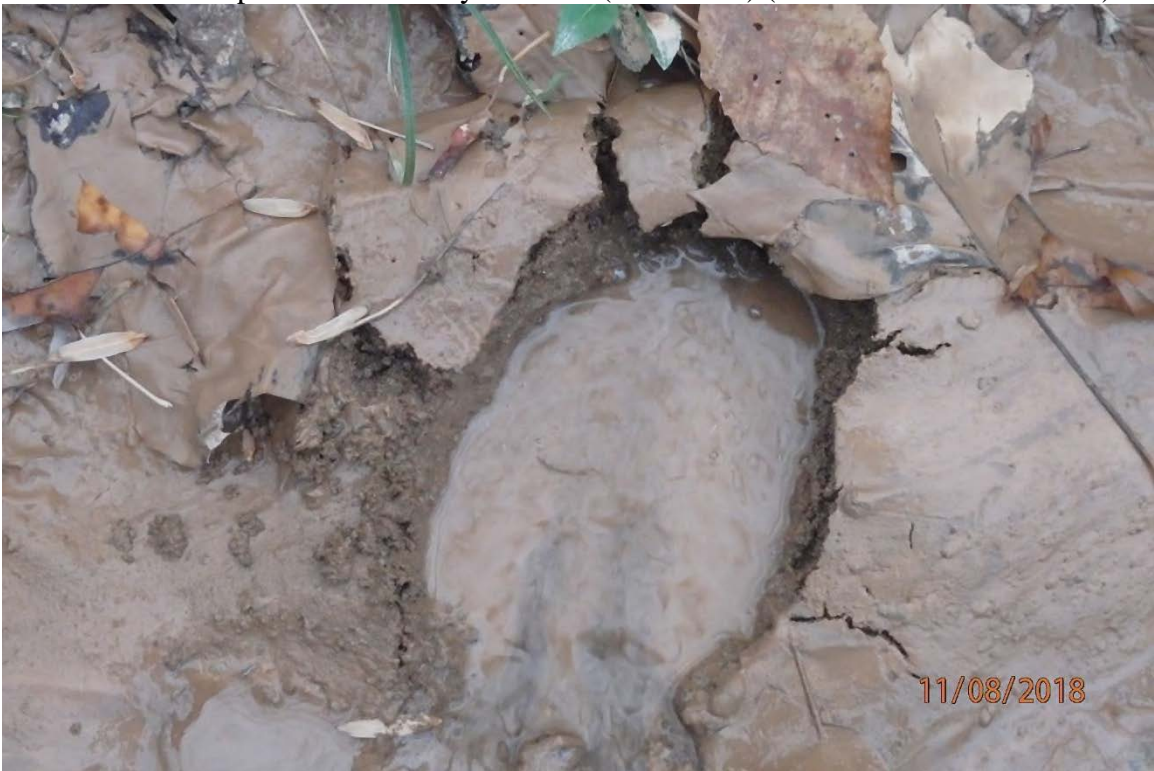
Offsite CNA deposits in UNT Taylor Drain (SDOH012) (39°11.386' X 80°50.309').

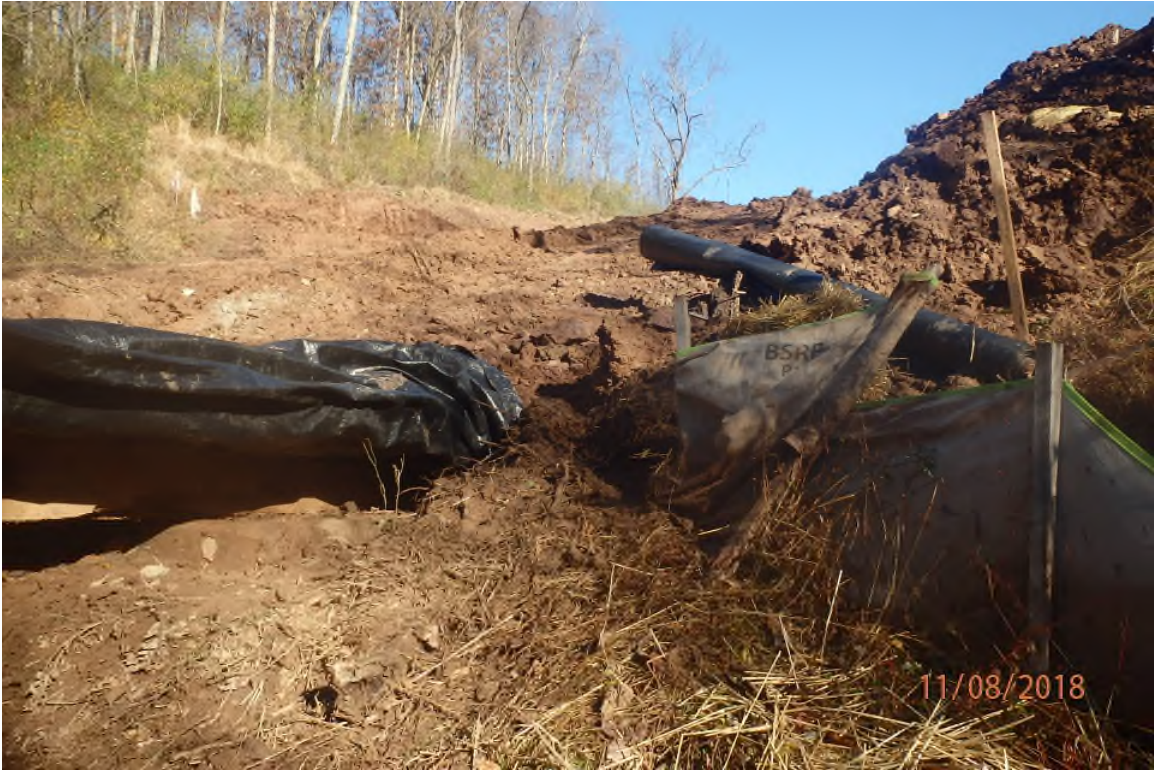
Improperly installed equipment bridge tie in adjacent to wetland UNT Bluestone (WDOG502) crossing.

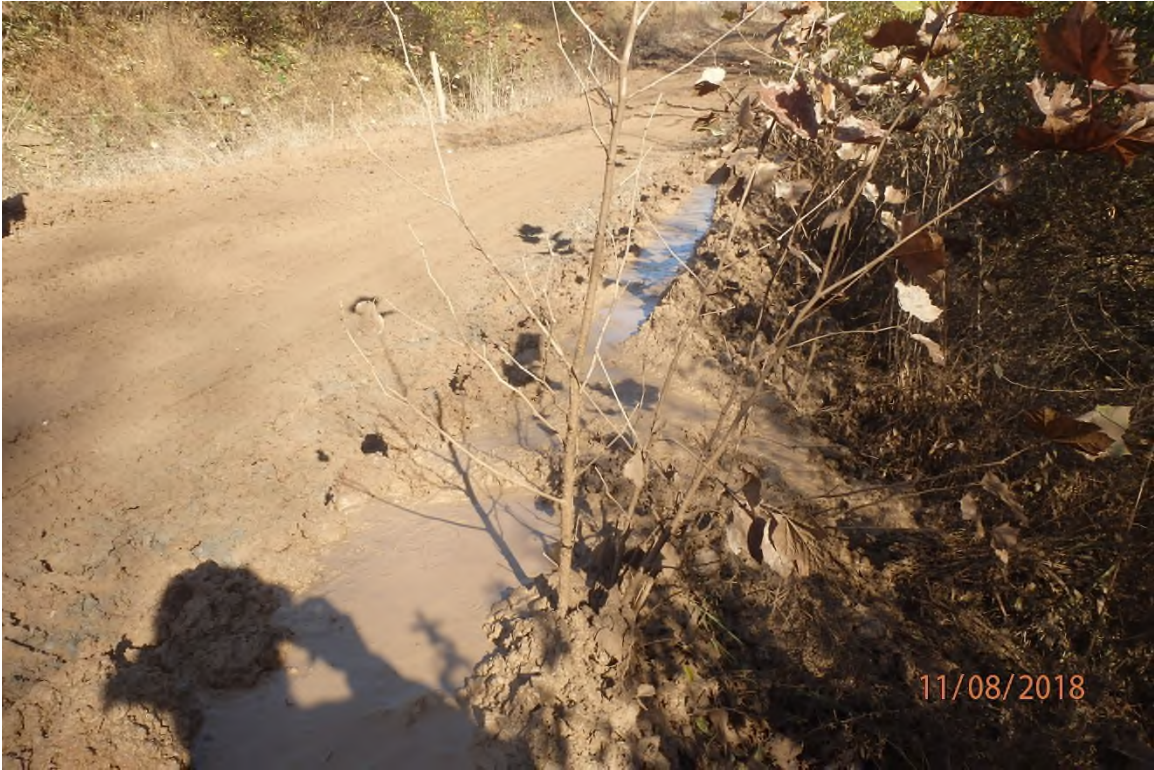
Existing access (ARDO9.3) that requires construction activity with no BMPs in place.

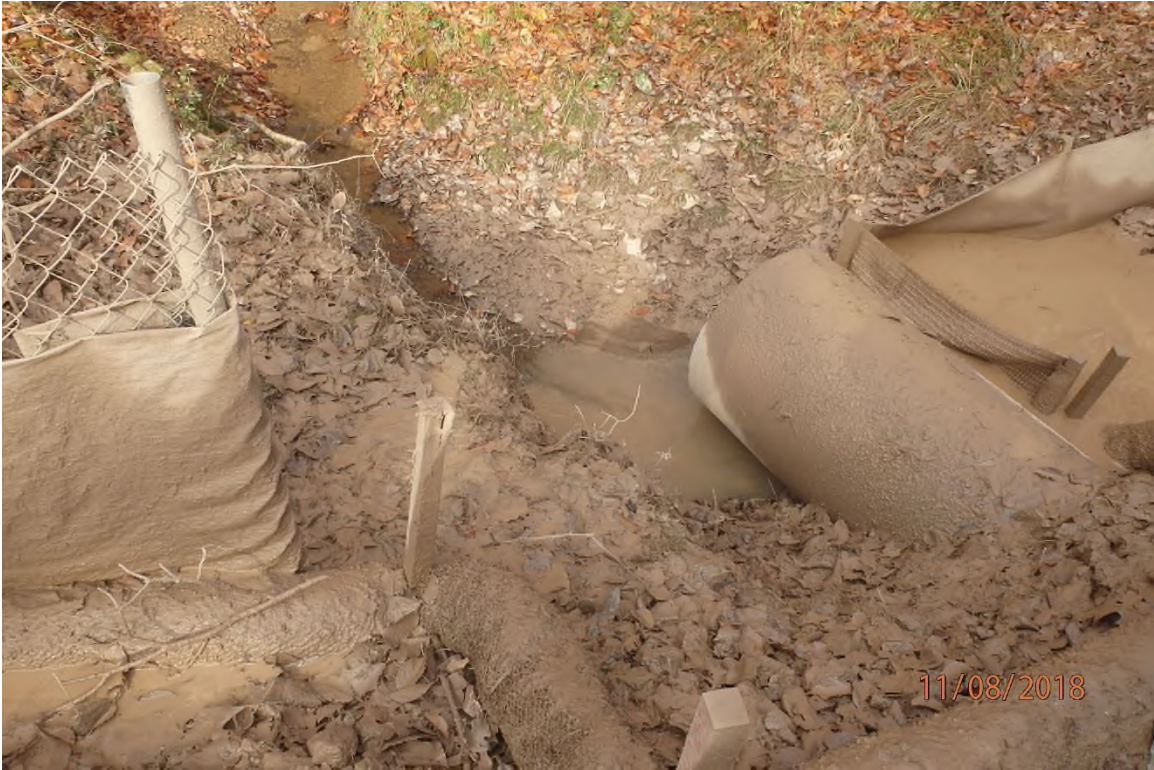
ARDO008.2 showing improperly installed controls and failure to follow SWPPP, resulting in CNA.

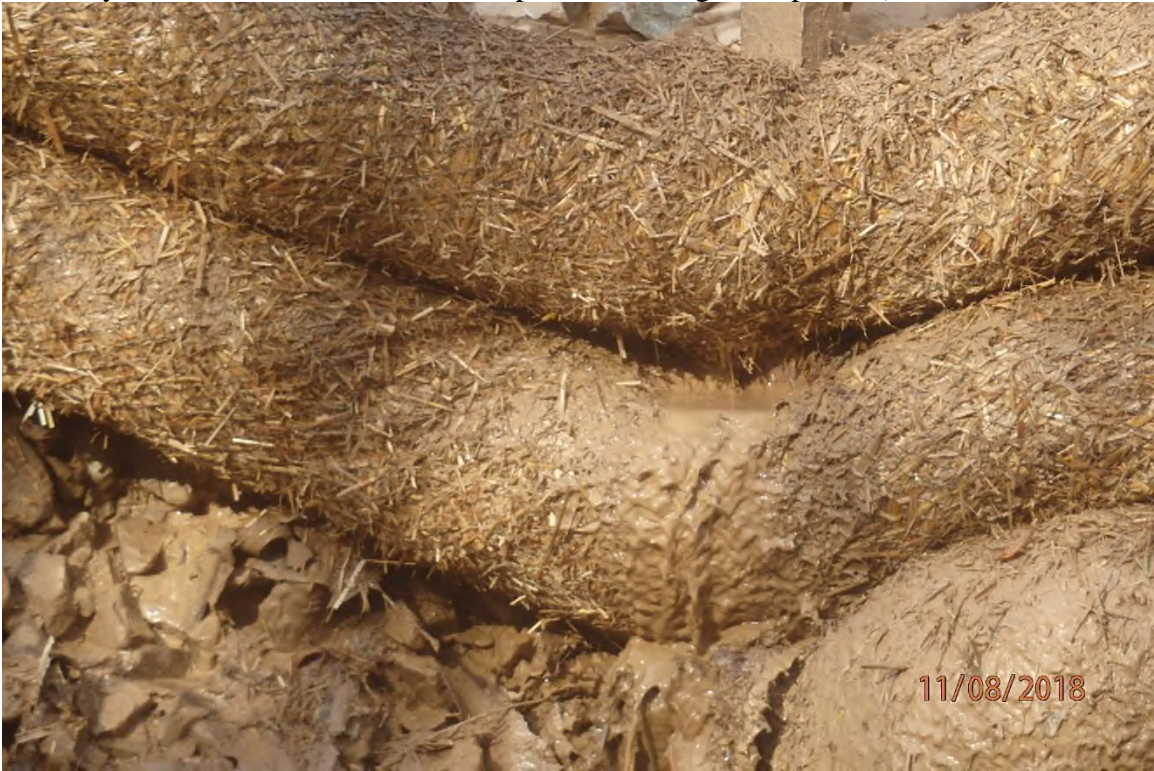
ARDO008.2 showing improperly installed controls that caused CNA.

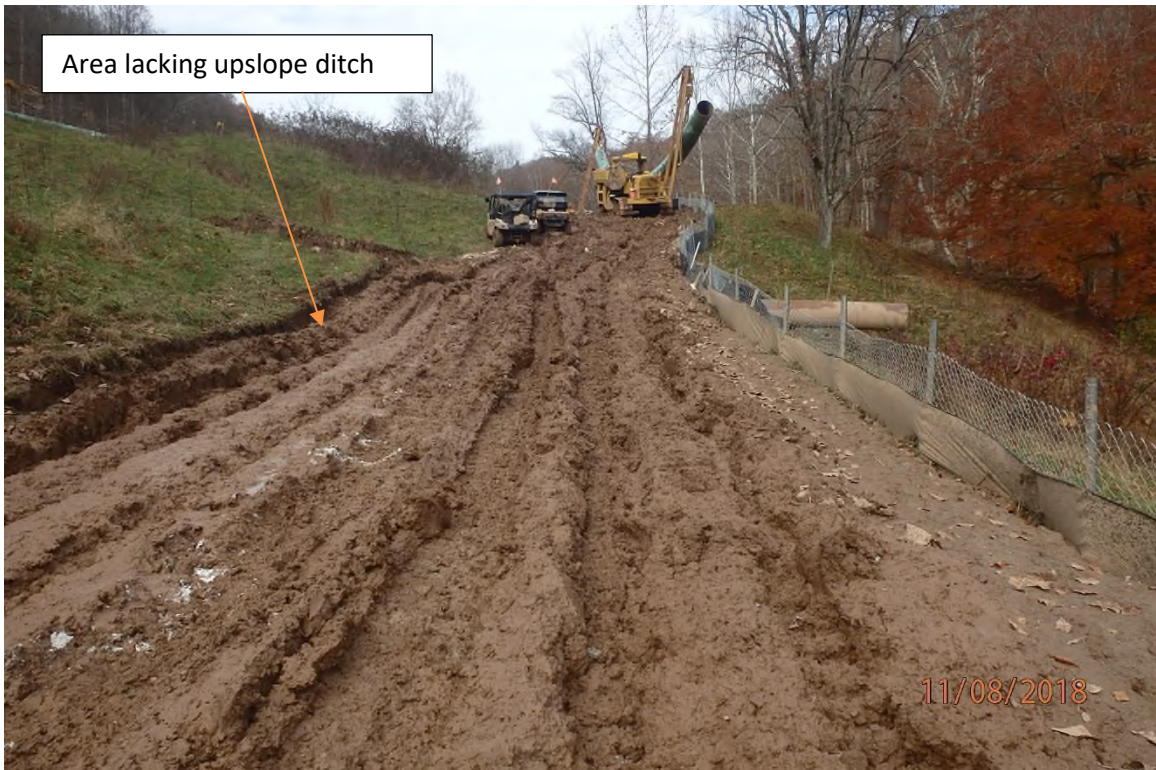
ARDO08.5 showing a lack of upslope ditches to collect run-on stormwater as indicated in the approved SWPPP.

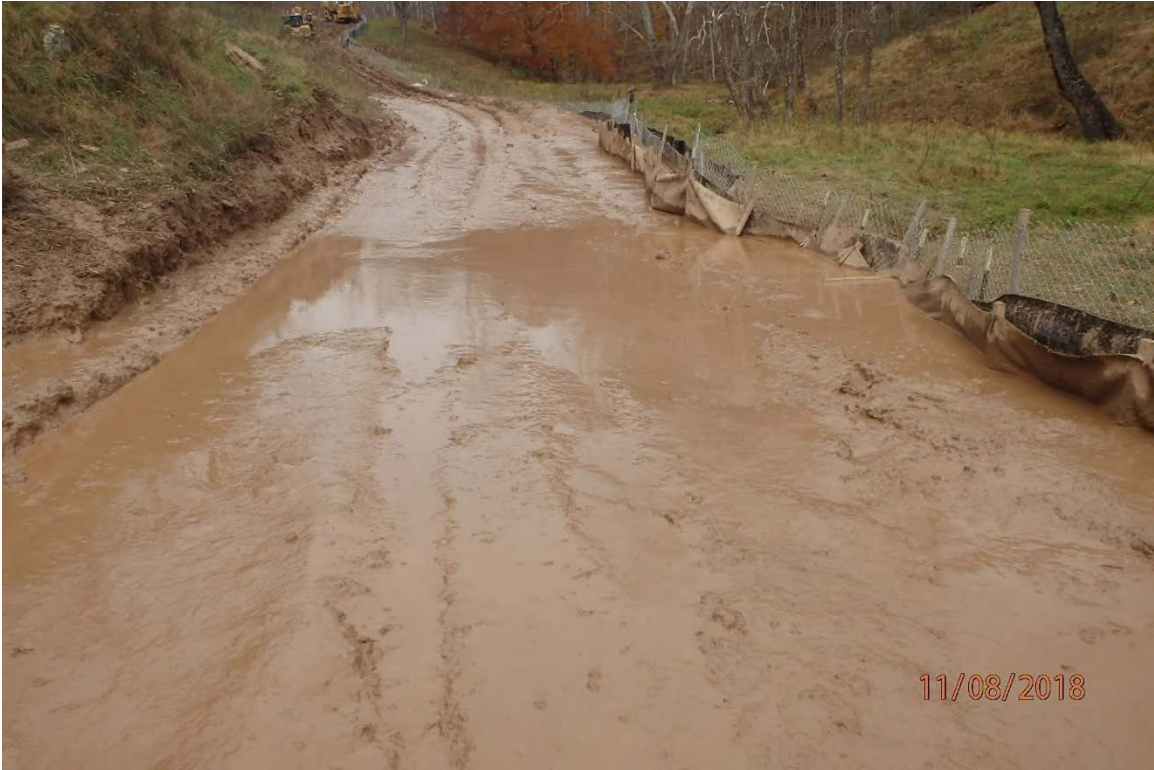
ARDO08.5 showing concentration of mud in a low area adjacent to the receiving stream due to a lack of upslope ditching to handle run-on stormwater and poor maintenance.

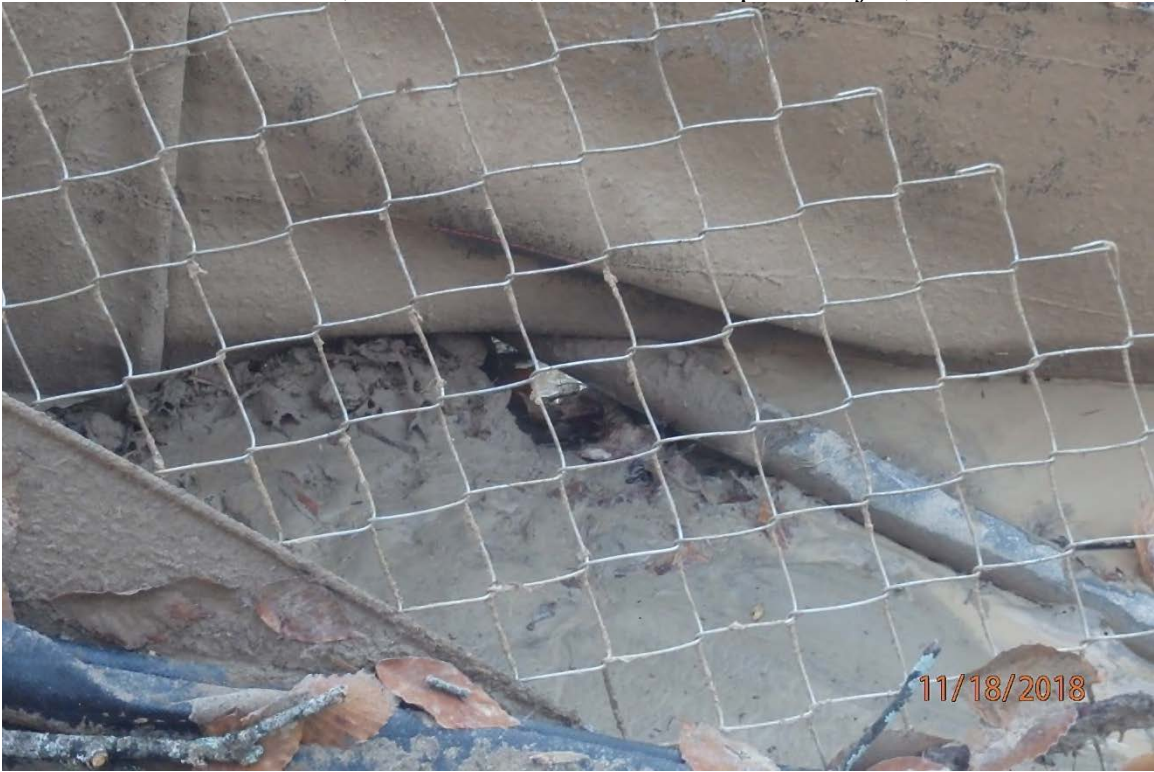
Unmaintained perimeter control and associated offsite sediment deposits on ARDO008.2.

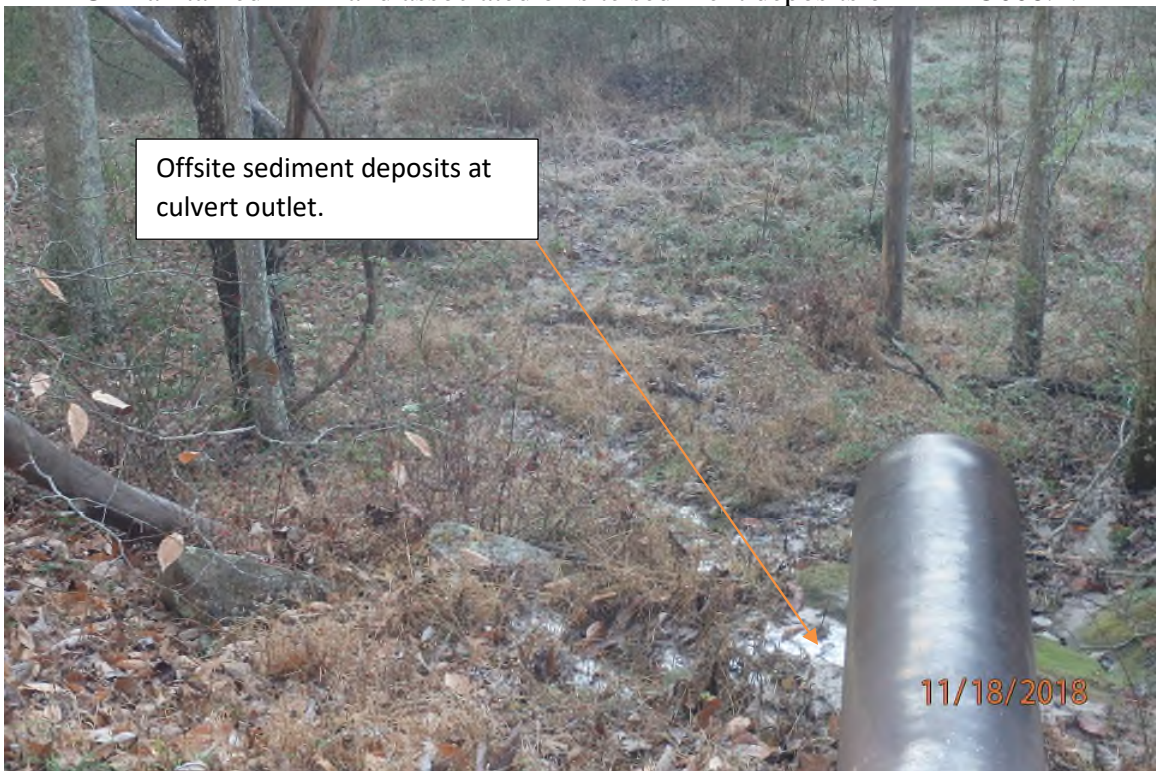
Unmaintained BMP and associated offsite sediment deposits on ARDO008.2.
