**CONSENT ORDER
ISSUED UNDER THE
WATER POLLUTION CONTROL ACT
WEST VIRGINIA CODE, CHAPTER 22, ARTICLE 11**

TO: Columbia Gas Transmission, LLC
Attn: Troy Tally, Vice President
1700 MacCorkle Ave
Charleston, WV 25314

DATE: October 1, 2020
ORDER NO.: 9061

1. Columbia Gas Transmission, LLC is conducting land disturbance activity associated with construction of the Mountaineer Xpress Project in Marshall, Wetzel, Tyler, Doddridge, Ritchie, Calhoun, Wirt, Roane, Jackson, Mason, Putnam, and Cabell Counties, West Virginia. On January 31, 2018, Columbia Gas Transmission, LLC was issued Water Pollution Control Permit No. WV0116815, Registration No. WVR310872, for Stormwater Associated With Oil and Gas Related Construction Activities.

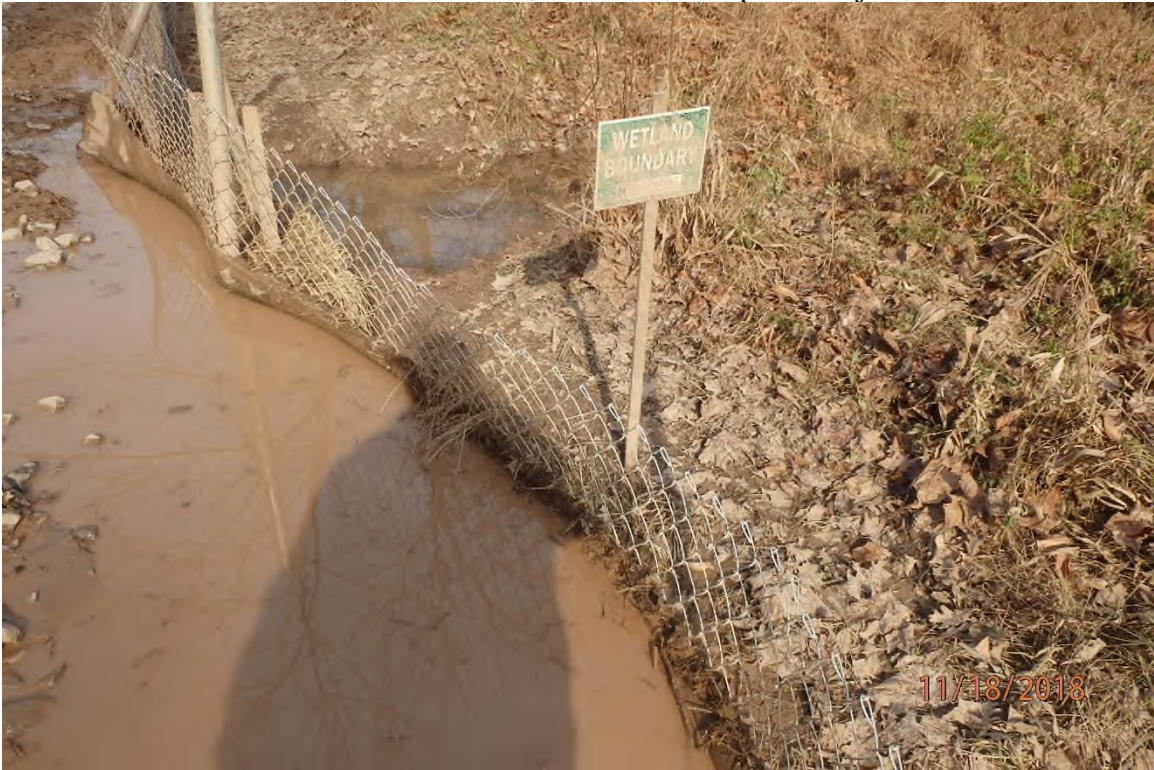
Unmaintained perimeter control and associated offsite sediment deposits on ARDO009.1.

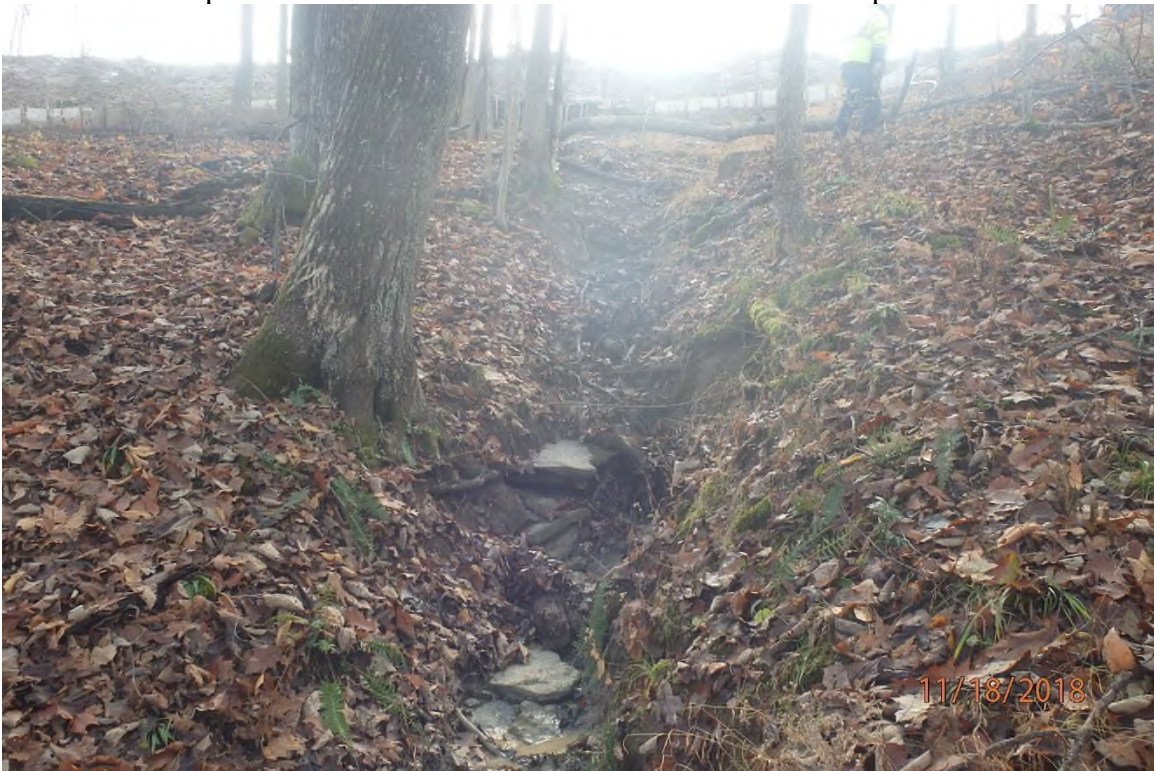
Unmaintained perimeter control and associated offsite sediment deposits near 2815+00.

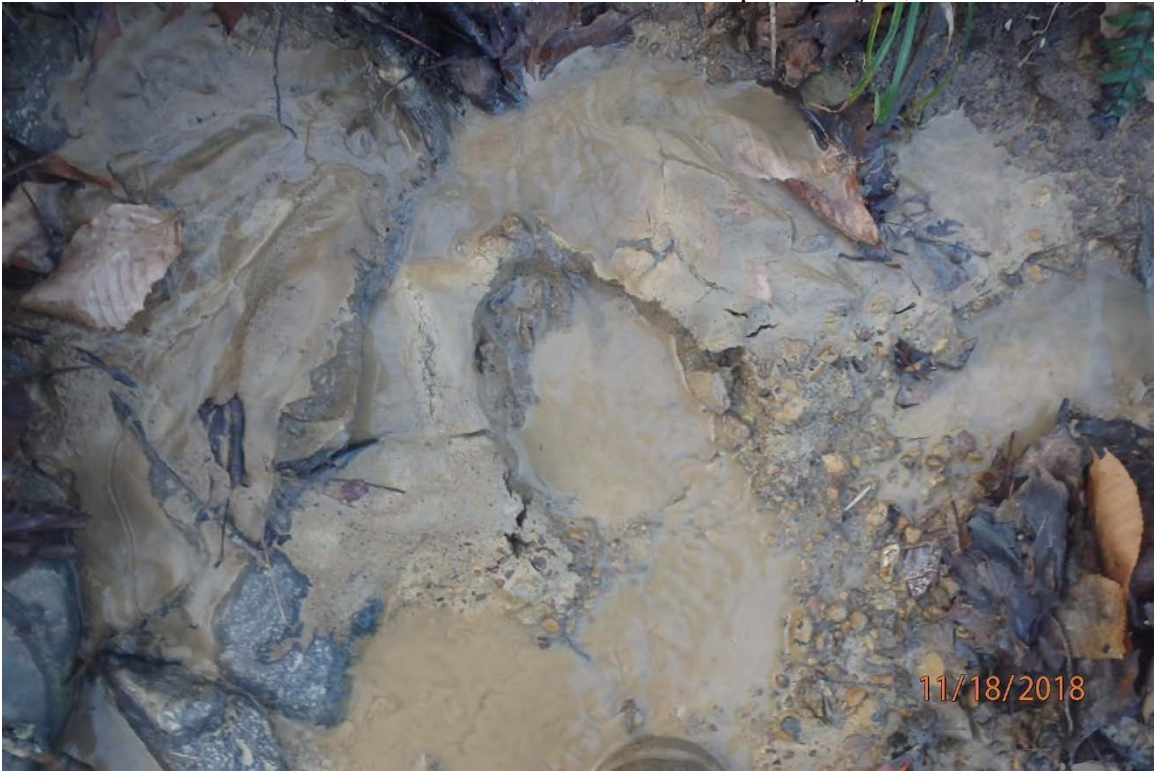
CNA deposits in UNT Bluestone Creek (39° 14.761' X 80° 45.019') near 2815+00 due to poor maintenance of perimeter control.

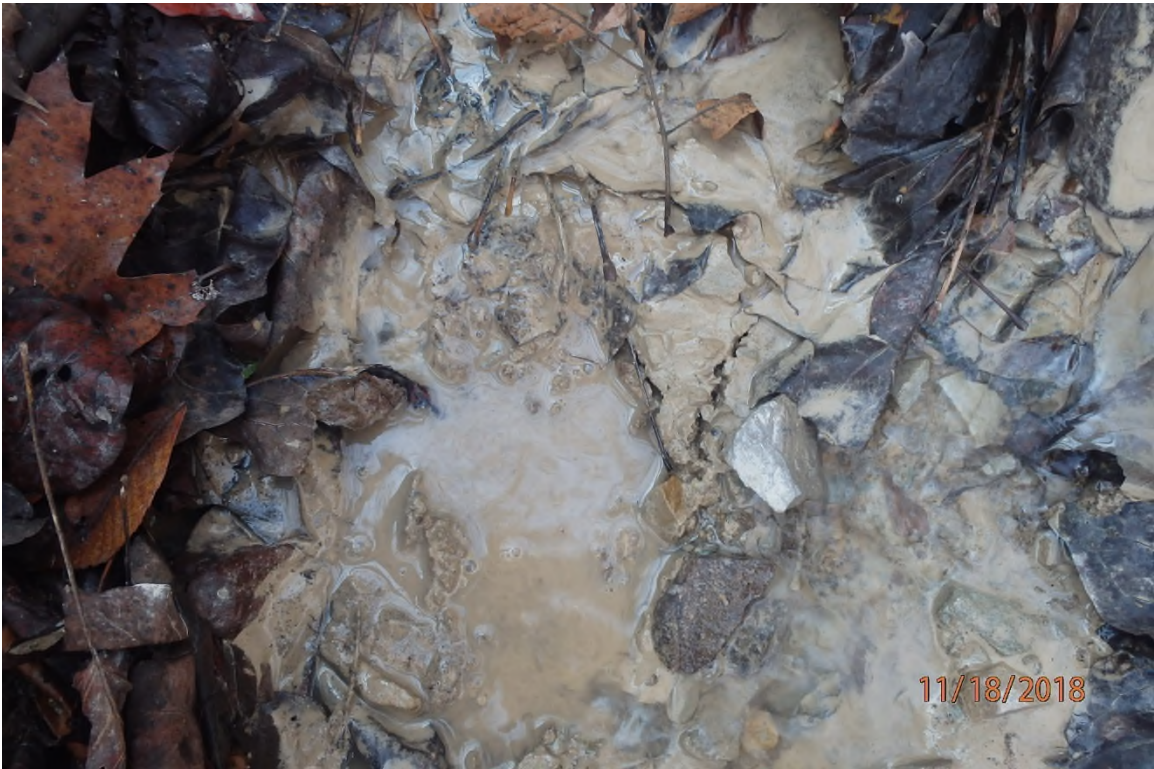
CNA deposits in UNT Georgescamp Run (39° 14.614' X 80° 44.951') on ARDO008.2 due to poor maintenance of installed BMP.

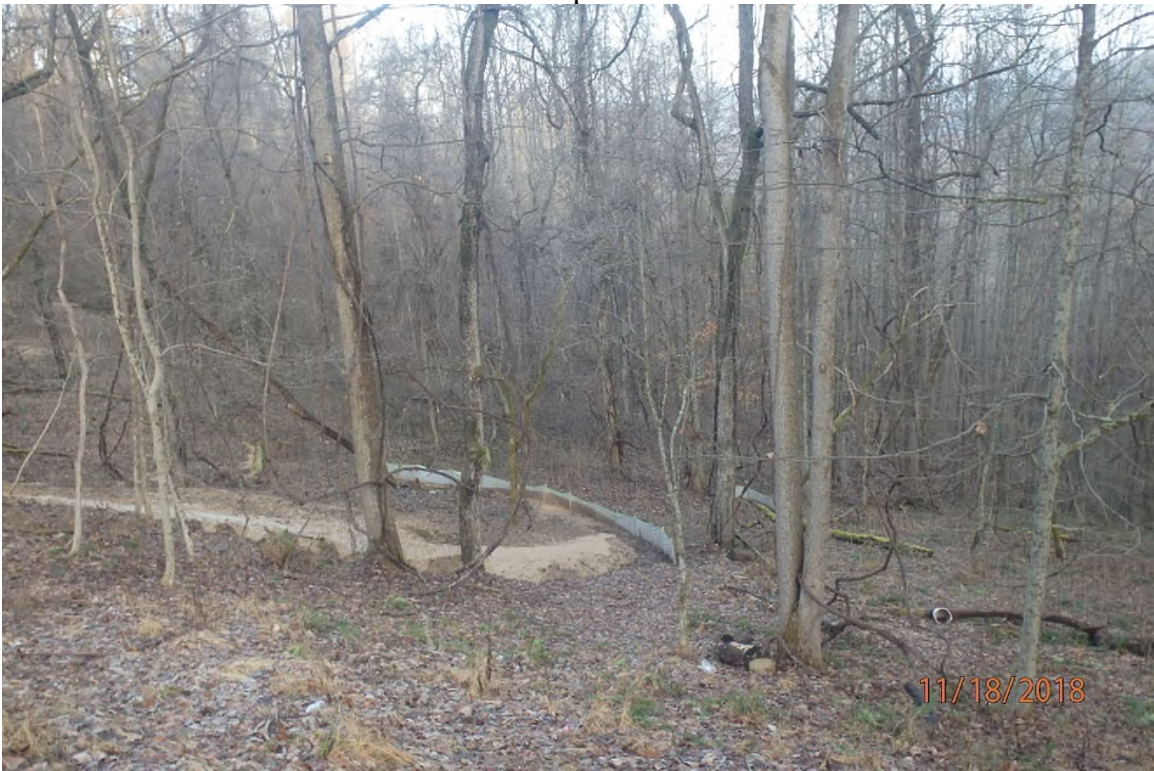
Mud flow and newly installed perimeter control on offsite slip near 2822+00.

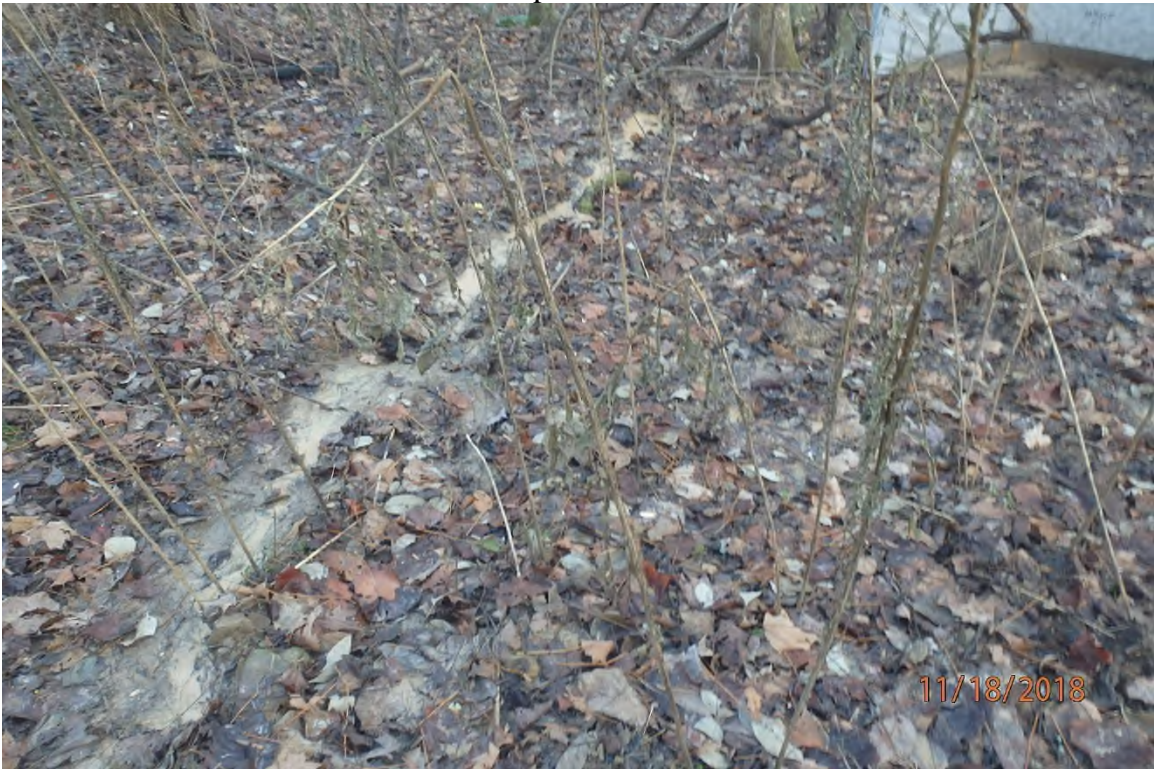
Flow of sediment laden water from the site to the receiving stream.

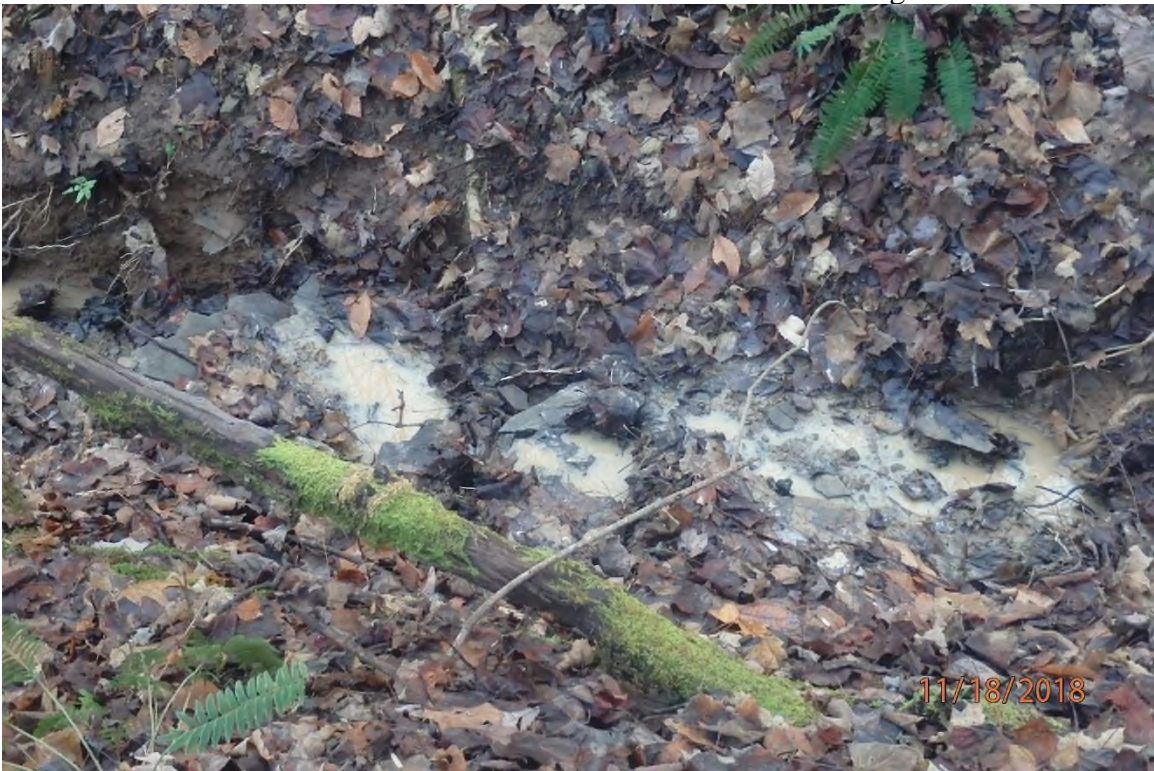
CNA distinctly visible settleable solids in UNT Bluestone Creek (SDOG215) ($39^{\circ}14.770'$ X $80^{\circ}45.130'$) as a result of the above pictured deficiency.

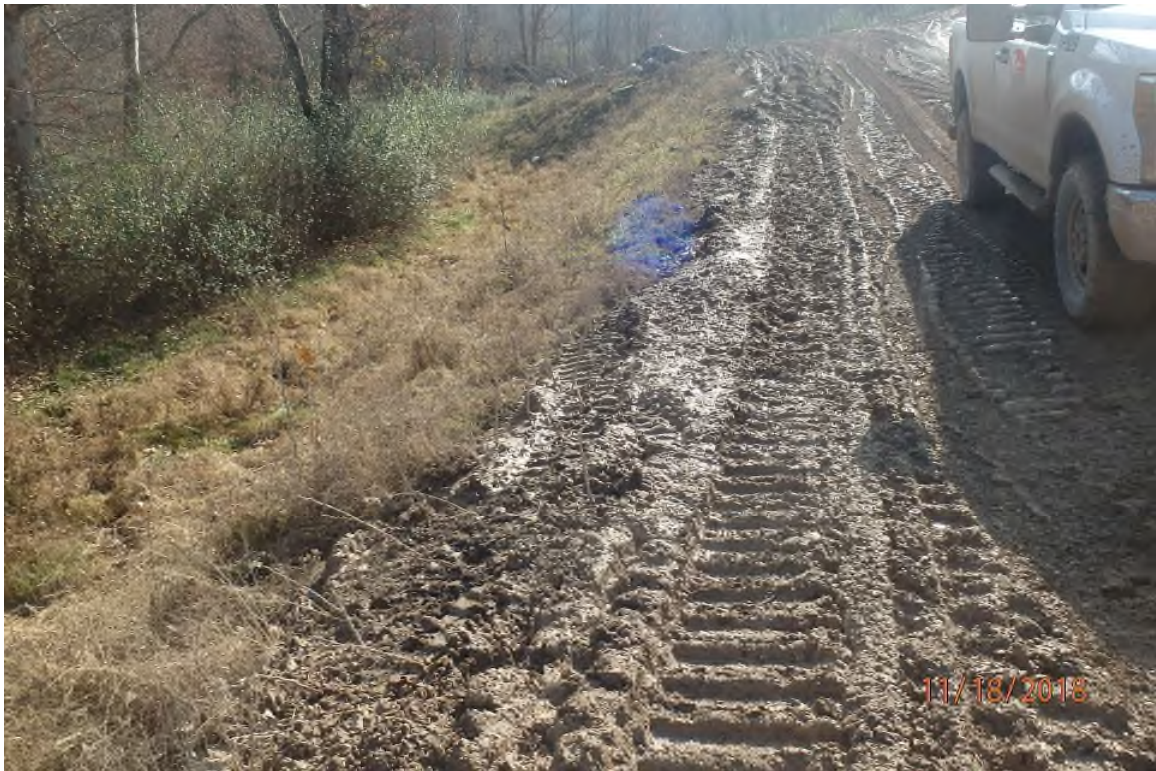
ARDO009.3 showing the lack of a graveled surface and the lack of perimeter controls, even though the road requires construction activity.

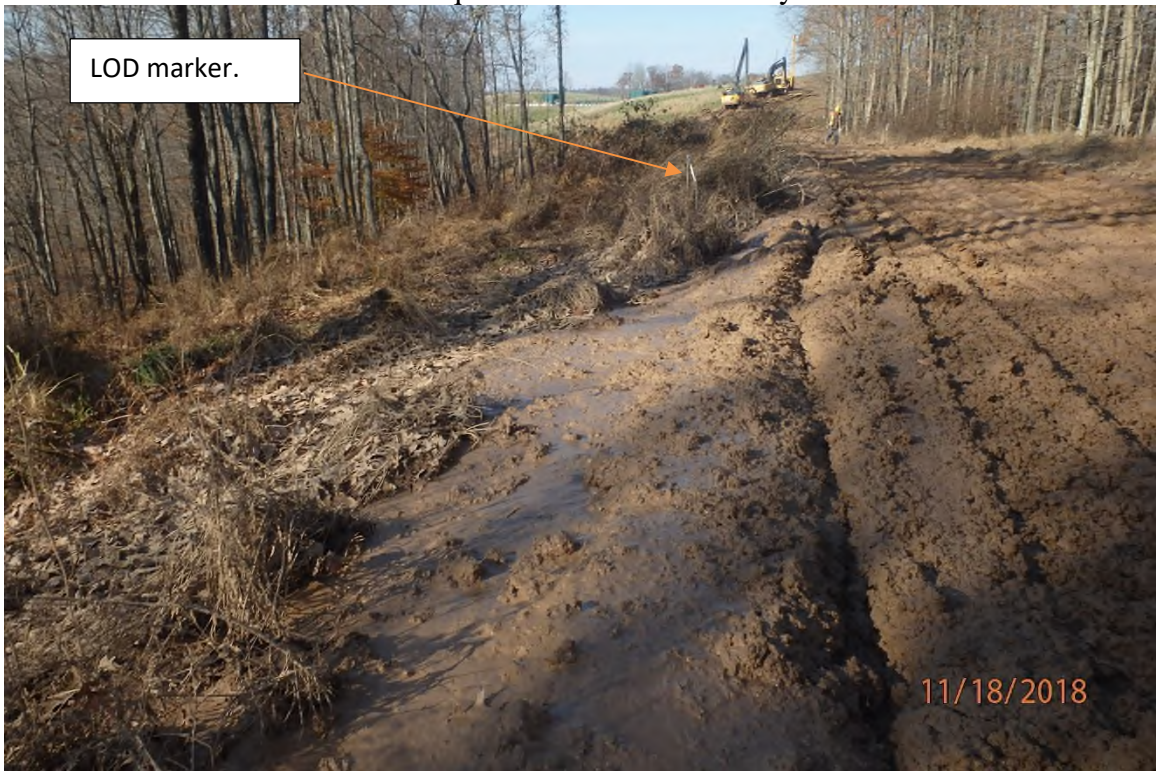
ARDO008.4 showing the lack of a graveled surface and the lack of perimeter controls, even though the road requires construction activity.

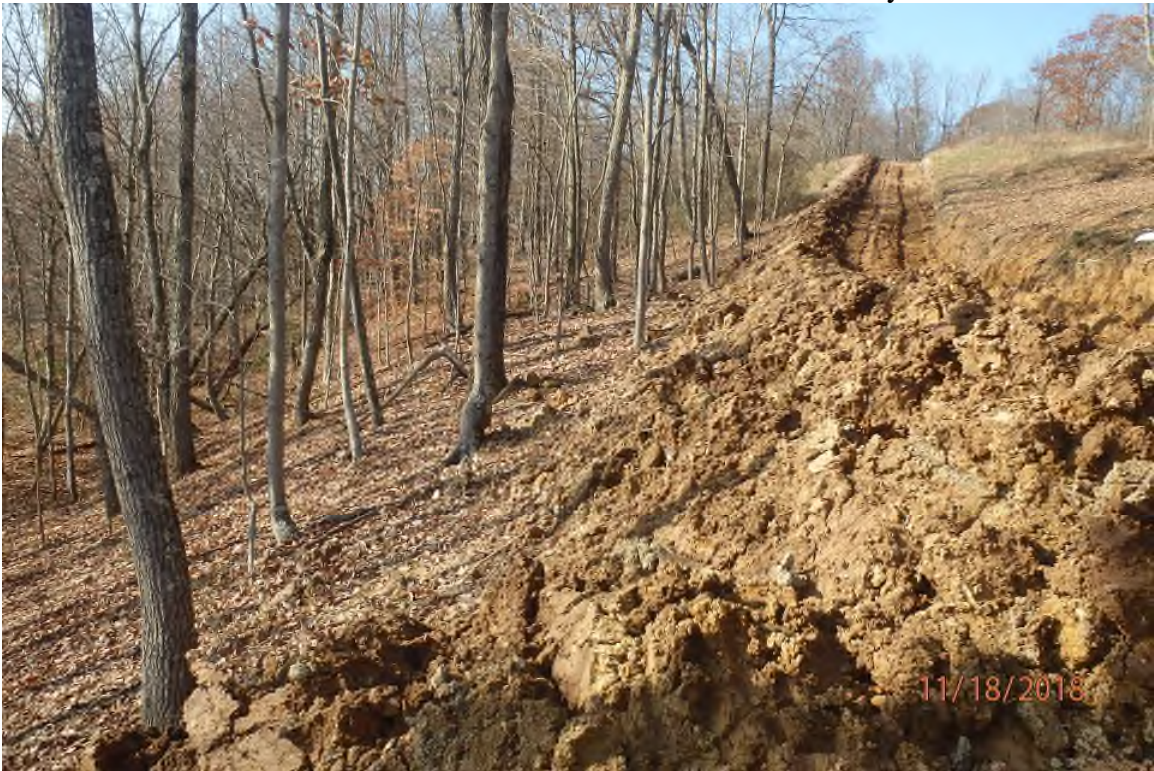
ARDO008.4 showing the lack of a graveled surface and the lack of perimeter controls, even though the road shows evidence of recent construction activity.

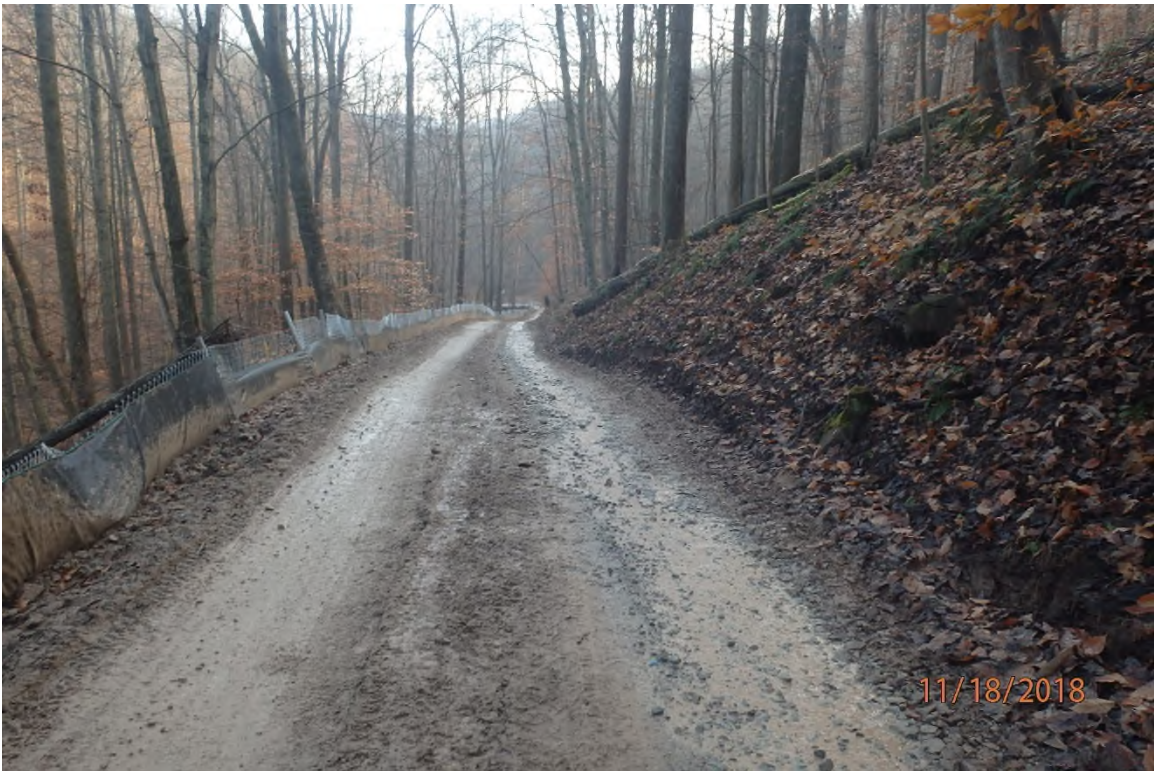
ARDO008.2 showing stormwater flow traveling downslope in ruts due to the lack of drainage as indicated in the approved SWPPP.

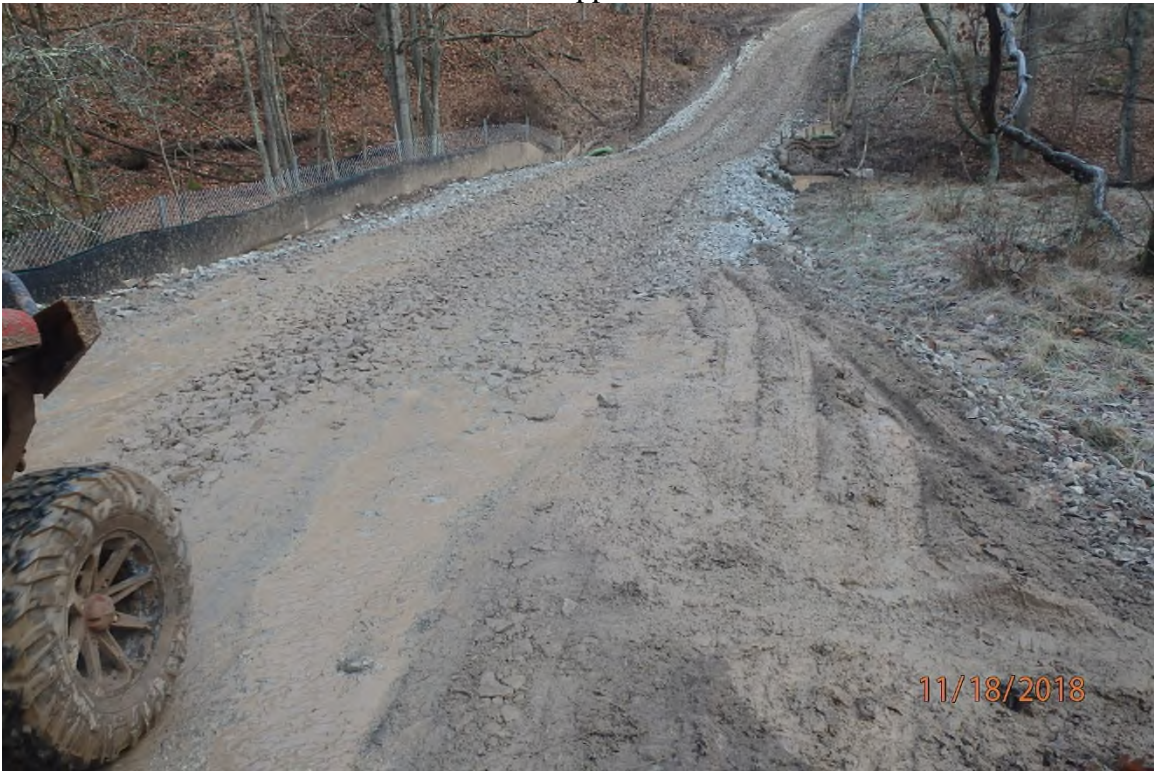
ARDO008.2 showing stormwater flow traveling downslope in ruts to the adjacent receiving stream due to the lack of drainage as indicated in the approved SWPPP.

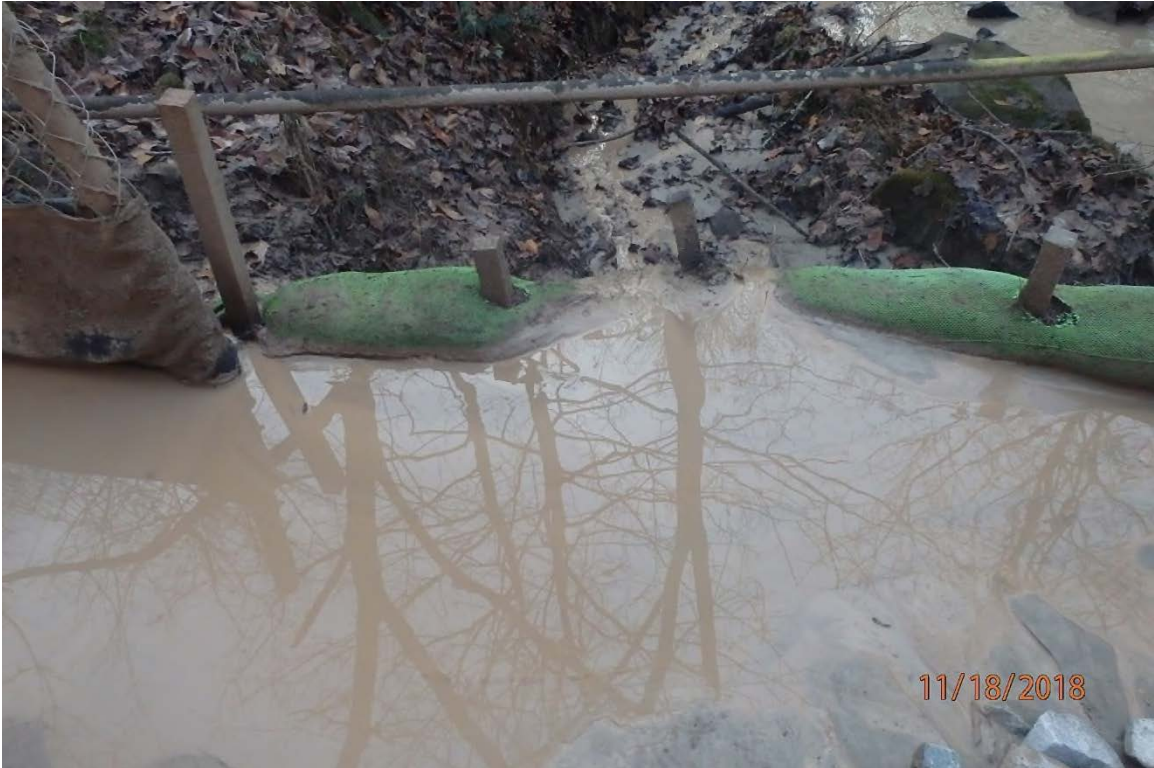
BMPS adjacent to Georgescamp Run that are overwhelmed due to the lack of drainage on the access road, causing sediment laden stormwater to bypass the devices.

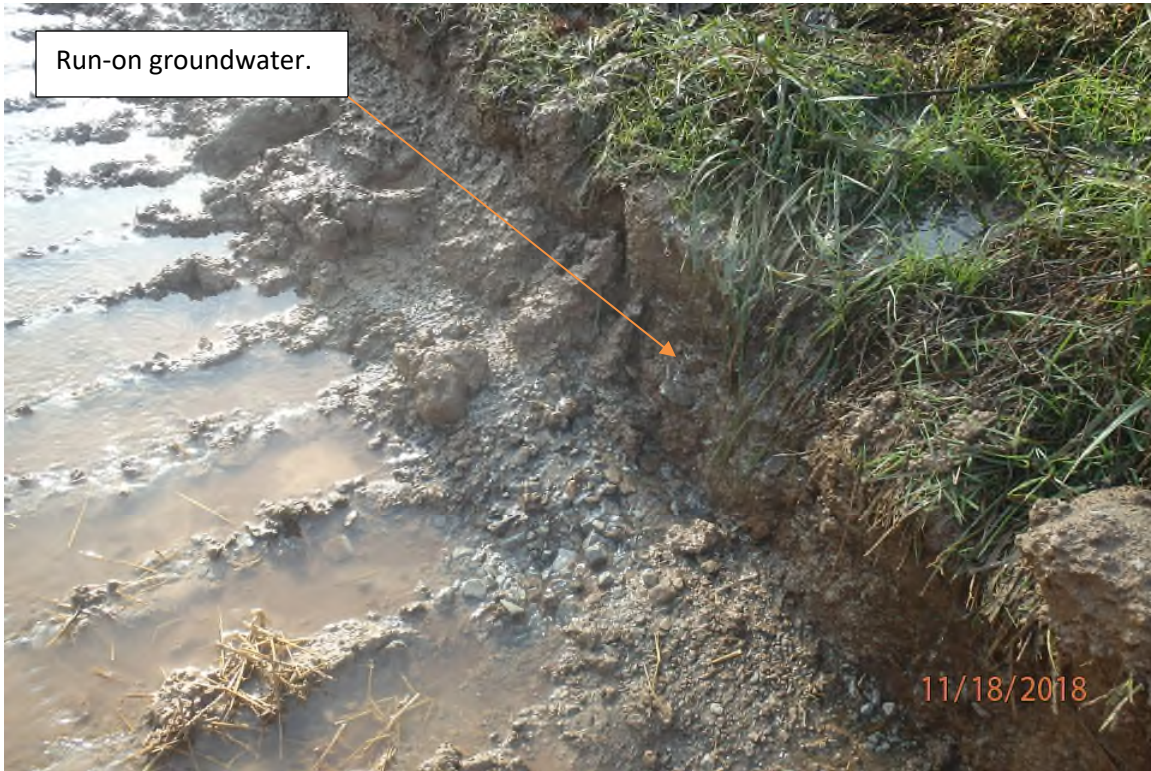
Run-on groundwater on ARDO008.5 that is running into the road surface contrary to the approved SWPPP.

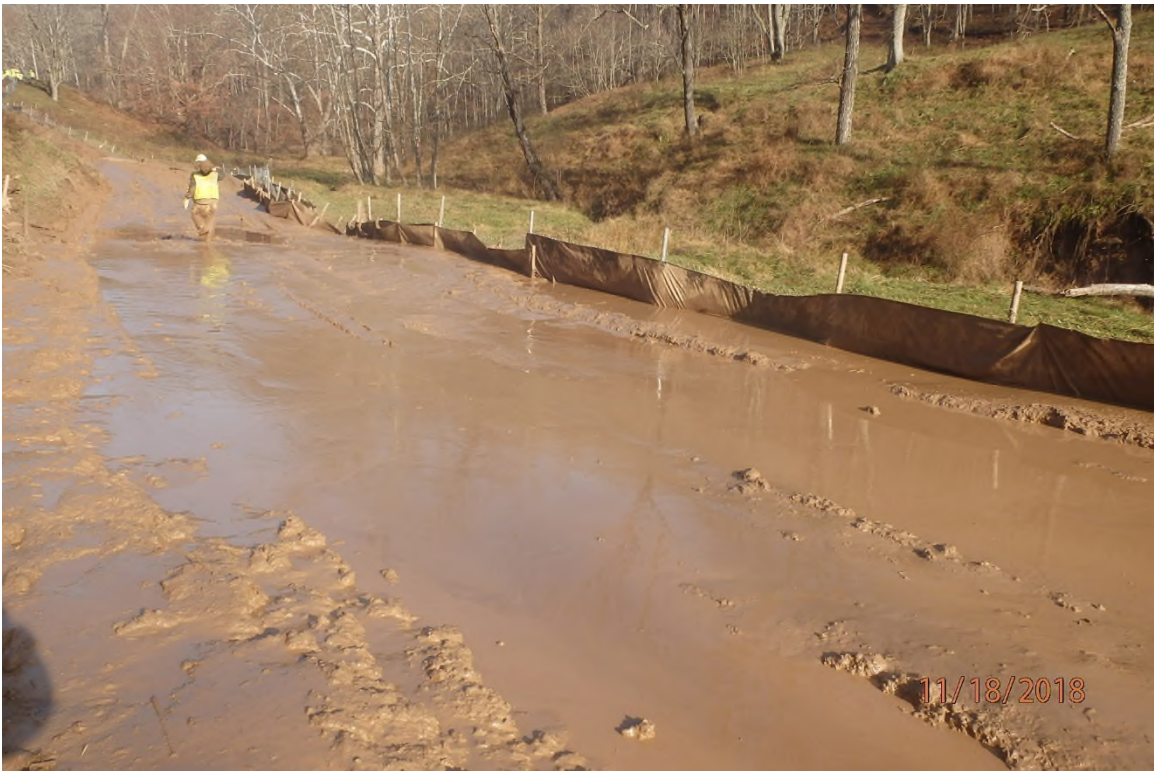
Condition of ARDO008.5 adjacent to the receiving stream.

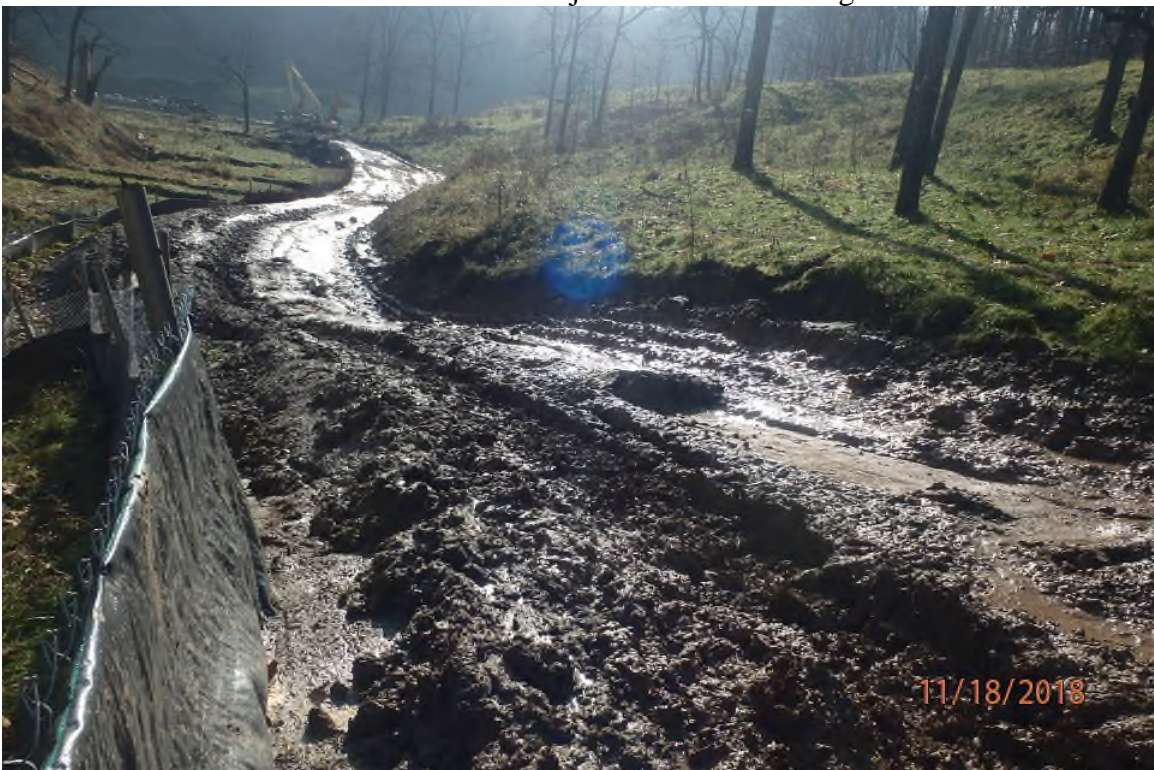
ARDO008.5 showing the lack of a graveled surface and the lack of adequate drainage.

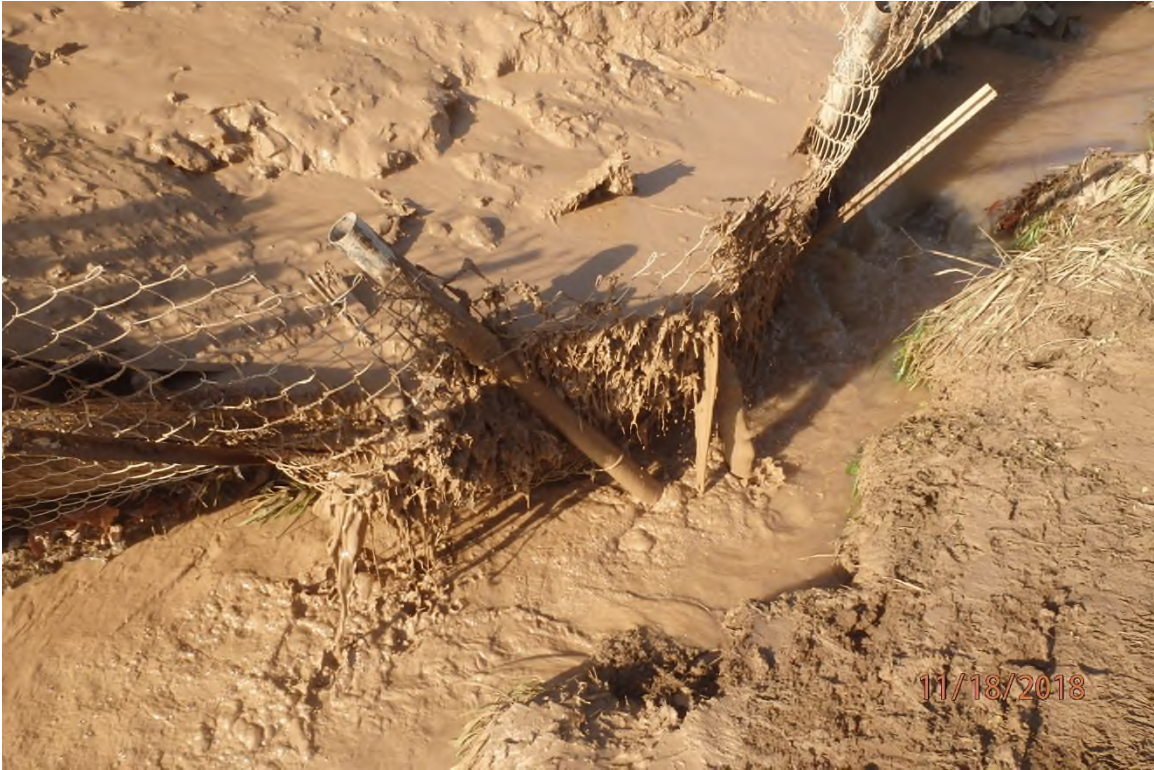
Perimeter control that has been overwhelmed and is causing CNA deposits and a distinctly visible plume in UNT Georgescamp Run (39°15.182' X 80° 44.033').

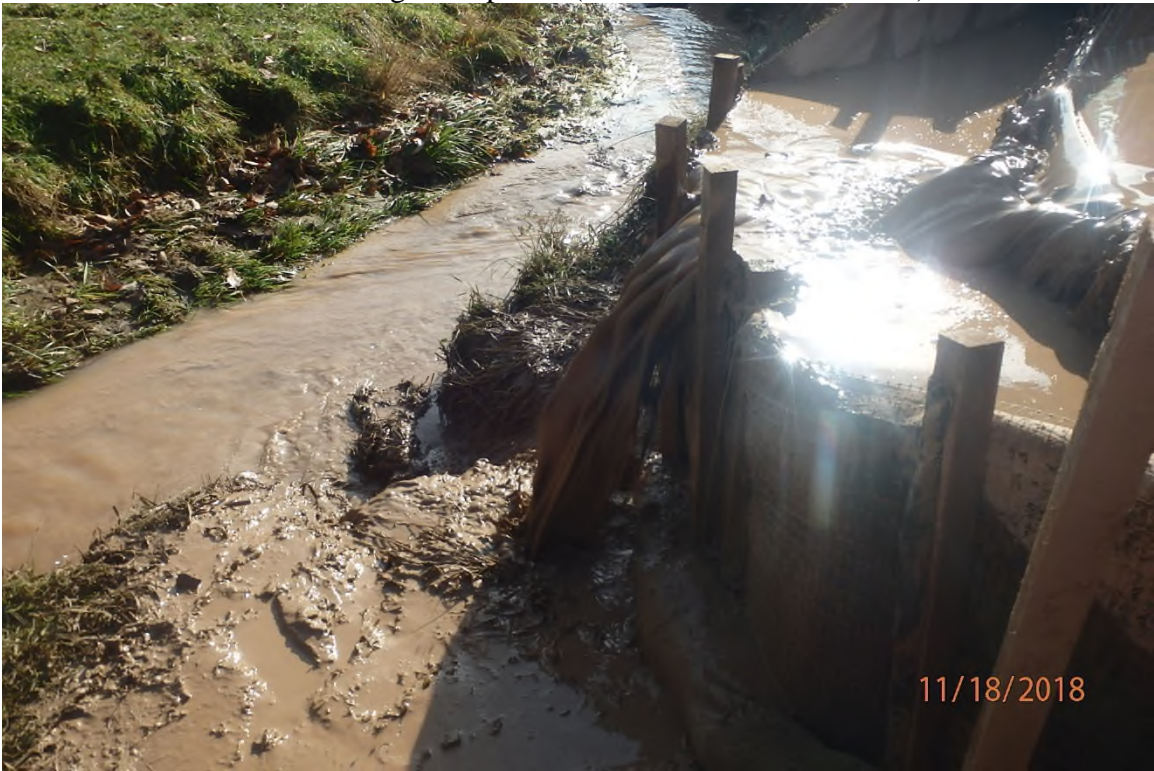
Second perimeter control that has been overwhelmed and is causing CNA deposits and distinctly visible plume in UNT Georgescamp Run (39°15.182' X 80° 44.033').

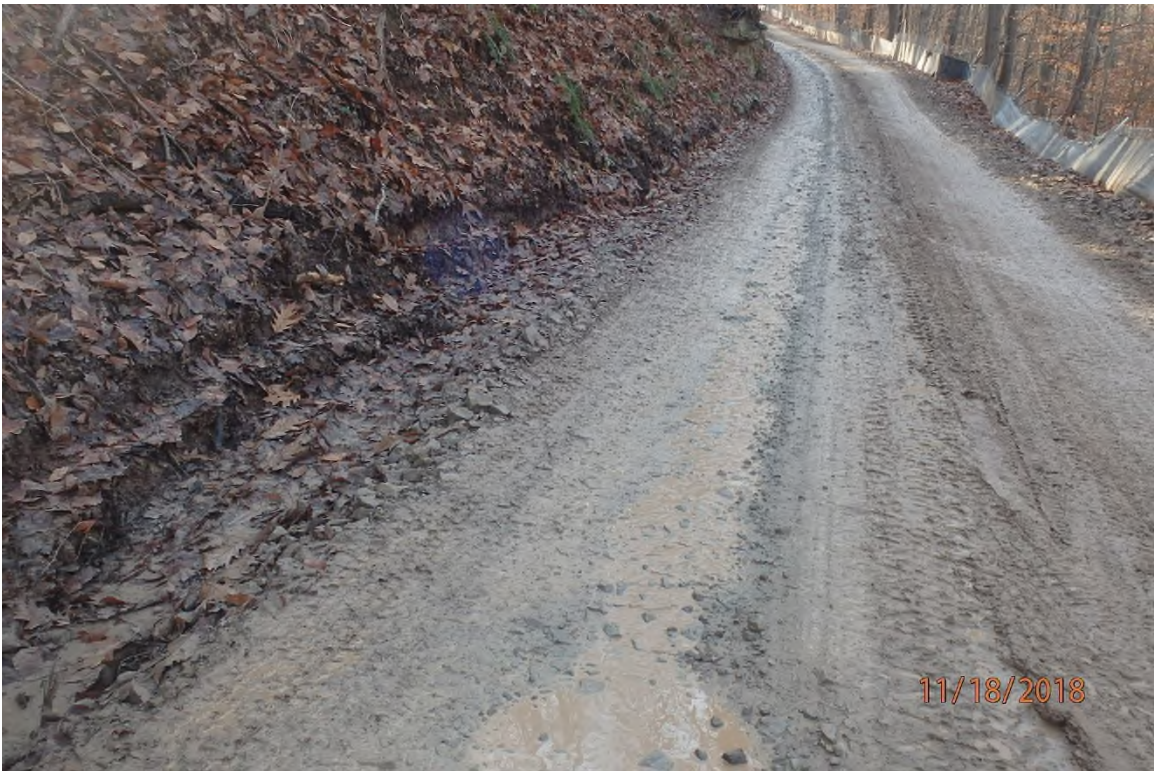
ARDO008.2 showing stormwater flowing downslope in ruts on the road surface due to the lack of adequate drainage.

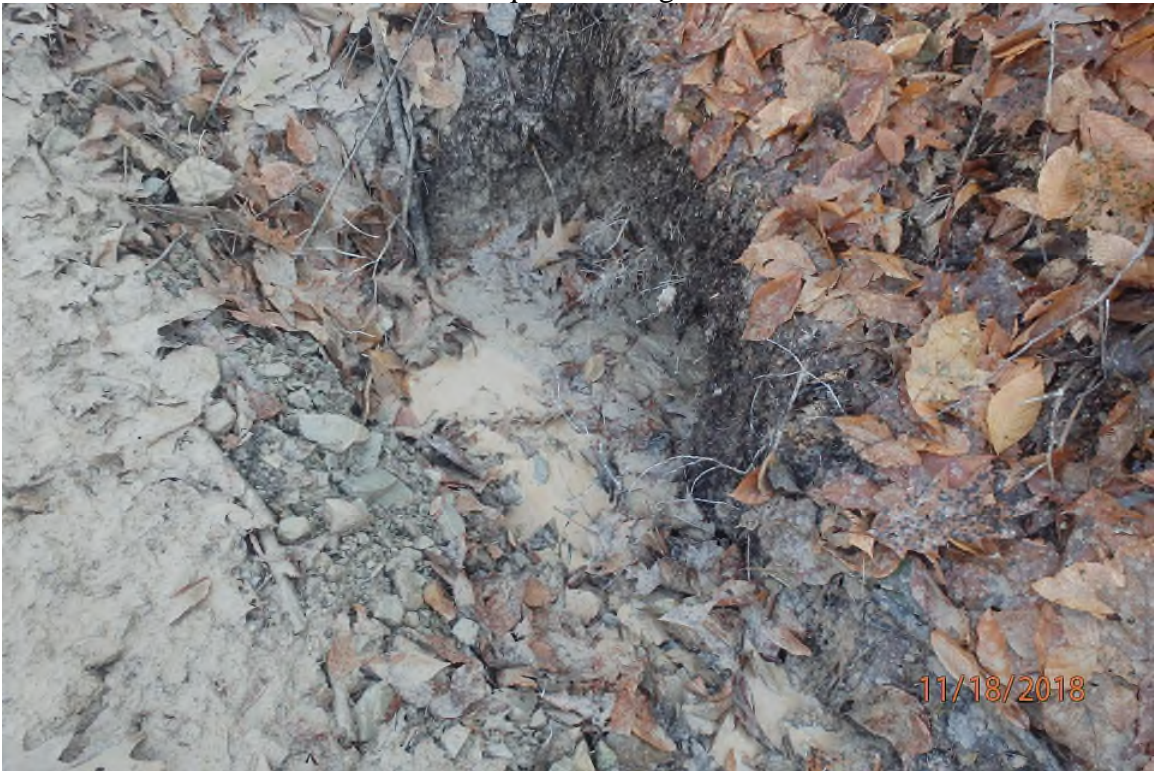
Culvert inlet on ARDO008.2 where the above pictured concentrated flow is directed.

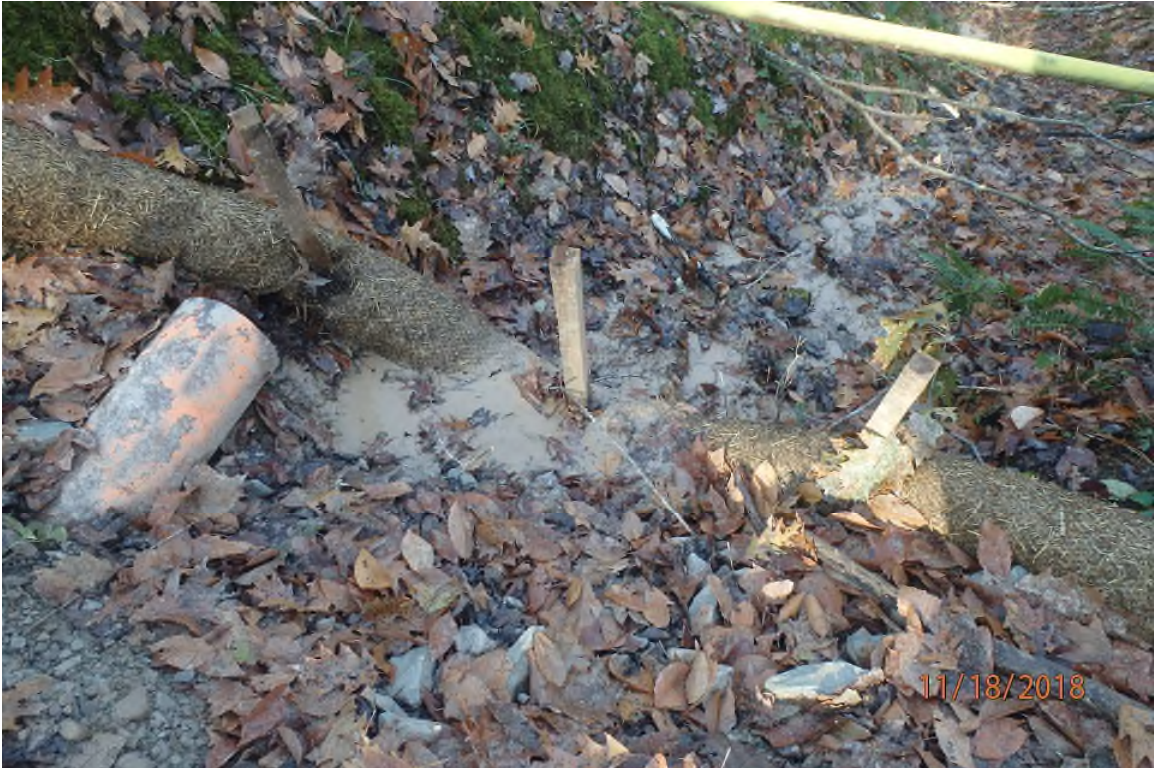
Outlet of the above pictured culvert outlet on ARDO008.2 showing sediment laden water bypassing the installed BMP that is in need of maintenance.

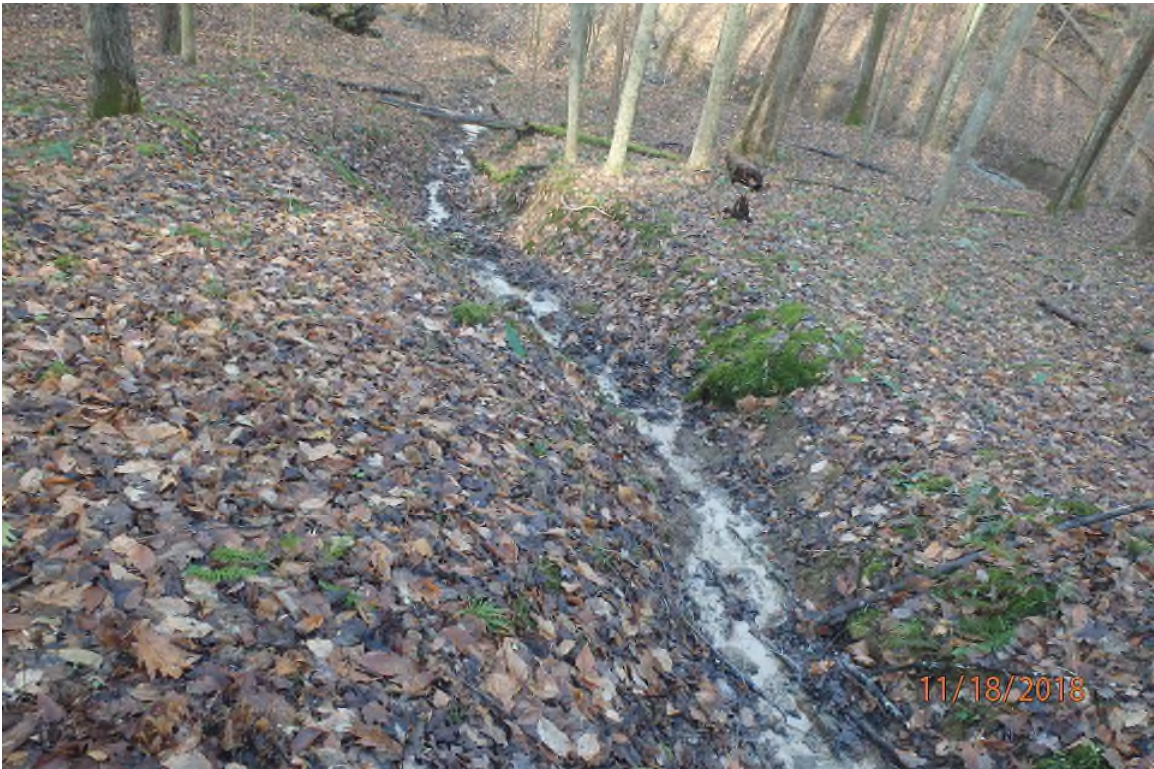
CNA distinctly visible settleable solids and deposits in UNT Georgescamp Run ($39^{\circ}14.764'$ X $80^{\circ}44.733'$) as a result of the above pictured deficiency.

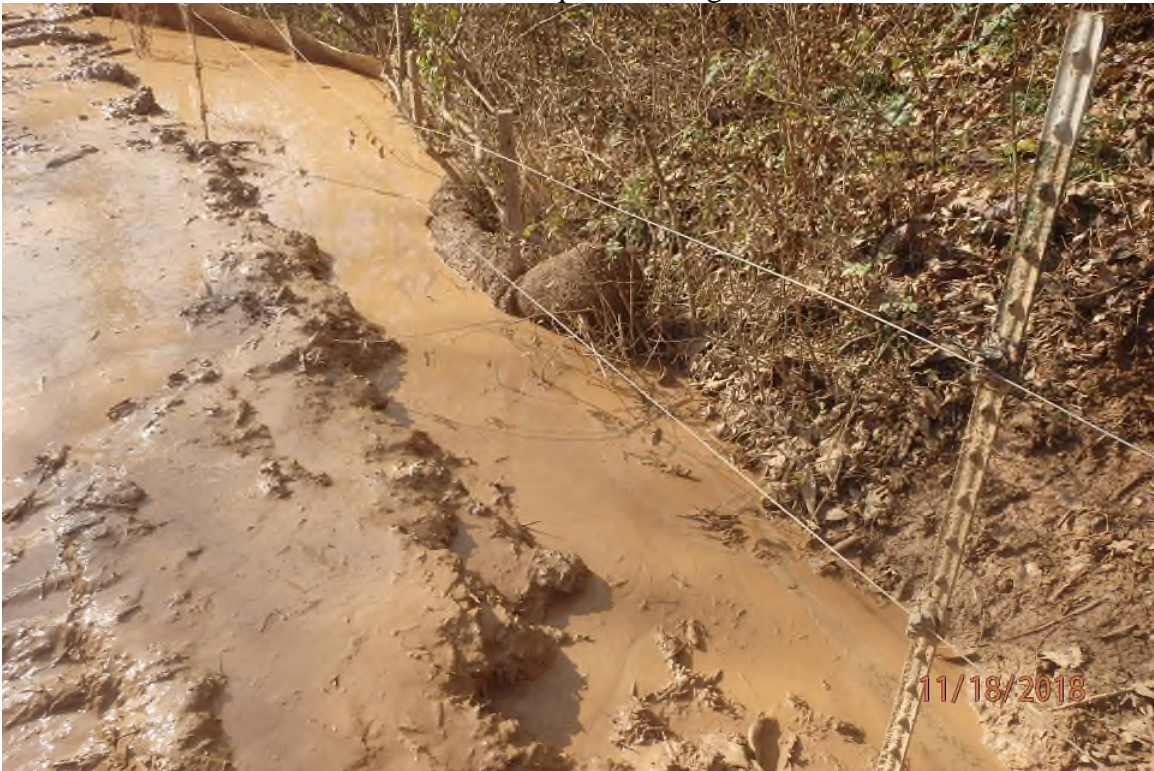
ARDO009.3 showing stormwater in an upslope ditch that is overflowing onto the road surface due to the lack of adequate drainage.

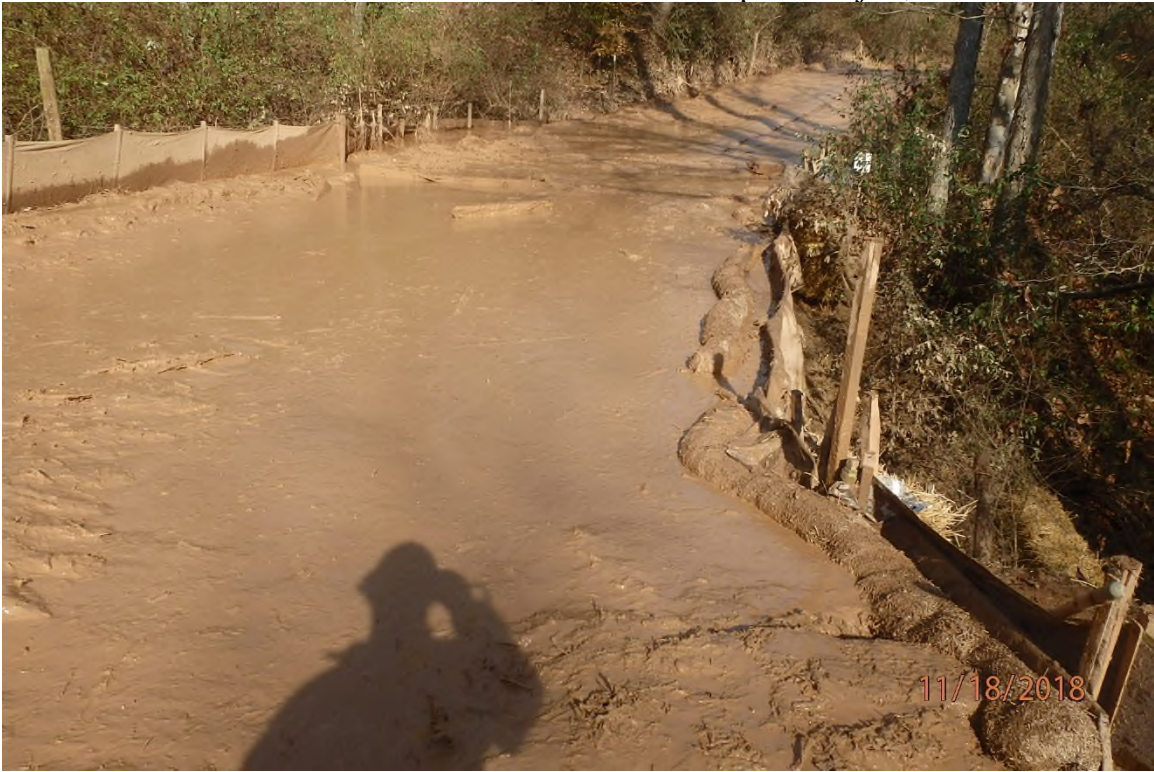
UNT Bluestone Creek equipment crossing on ARDO009.3 showing overwhelmed BMPs due to the lack of drainage indicated on the approved SWPPP.

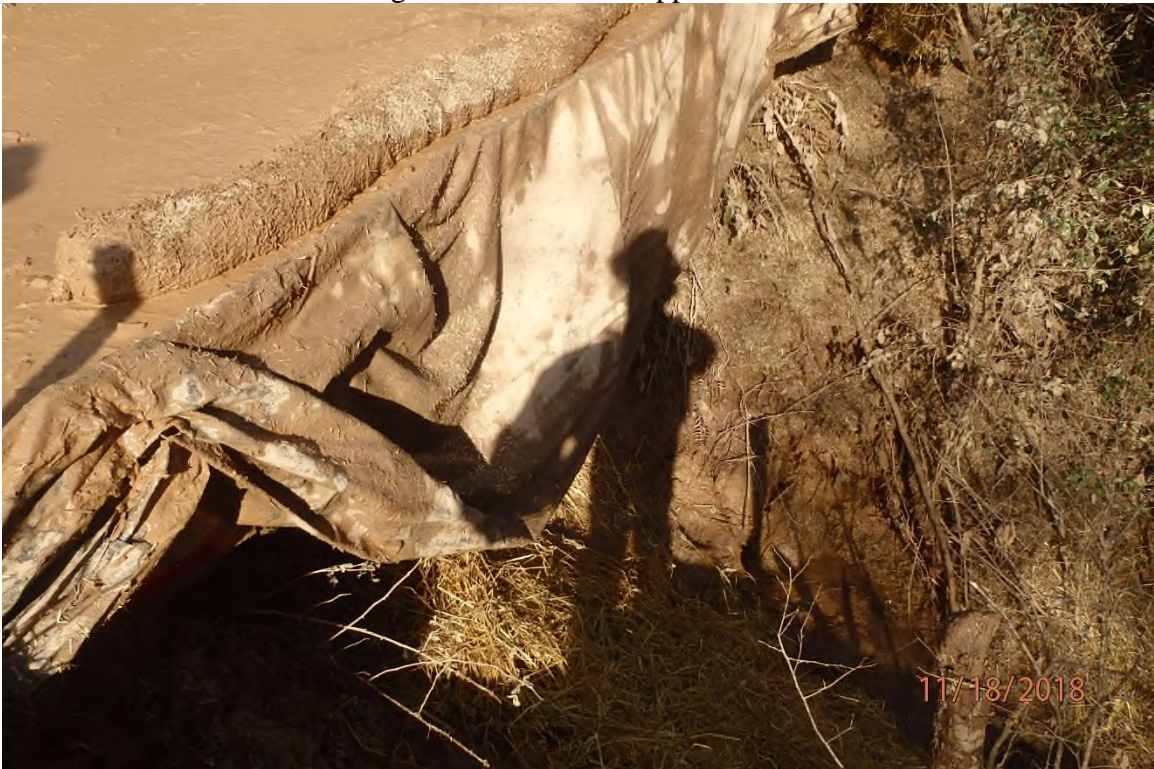
Equipment bridge BMP on the above pictured crossing showing the area of bypass.
