**CONSENT ORDER
ISSUED UNDER THE
WATER POLLUTION CONTROL ACT
WEST VIRGINIA CODE, CHAPTER 22, ARTICLE 11**

TO: Columbia Gas Transmission, LLC
Attn: Troy Tally, Vice President
1700 MacCorkle Ave
Charleston, WV 25314

DATE: October 1, 2020
ORDER NO.: 9061

1. Columbia Gas Transmission, LLC is conducting land disturbance activity associated with construction of the Mountaineer Xpress Project in Marshall, Wetzel, Tyler, Doddridge, Ritchie, Calhoun, Wirt, Roane, Jackson, Mason, Putnam, and Cabell Counties, West Virginia. On January 31, 2018, Columbia Gas Transmission, LLC was issued Water Pollution Control Permit No. WV0116815, Registration No. WVR310872, for Stormwater Associated With Oil and Gas Related Construction Activities.

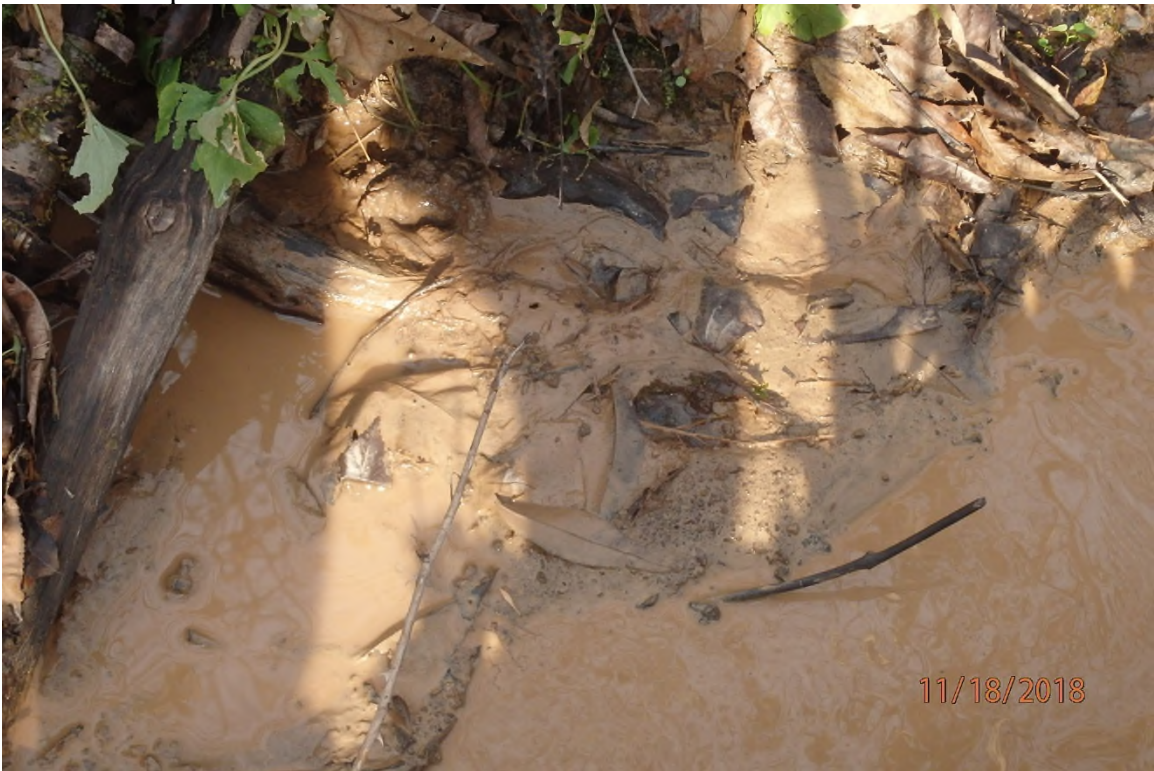
CNA distinctly visible settleable solids and deposits in UNT Bluestone Creek (39° 14.425' X 80° 45.817').

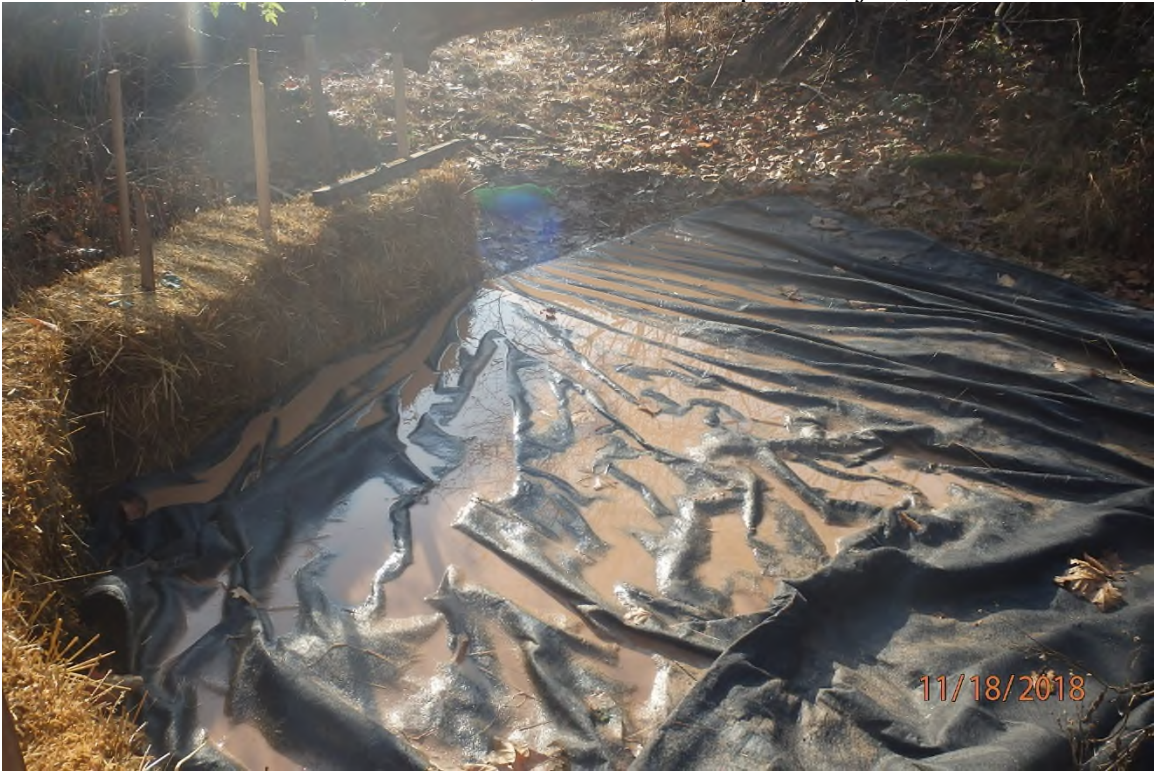
Dewatering bag associated with pipe trench dewatering adjacent to the SDOG048 stream crossing.

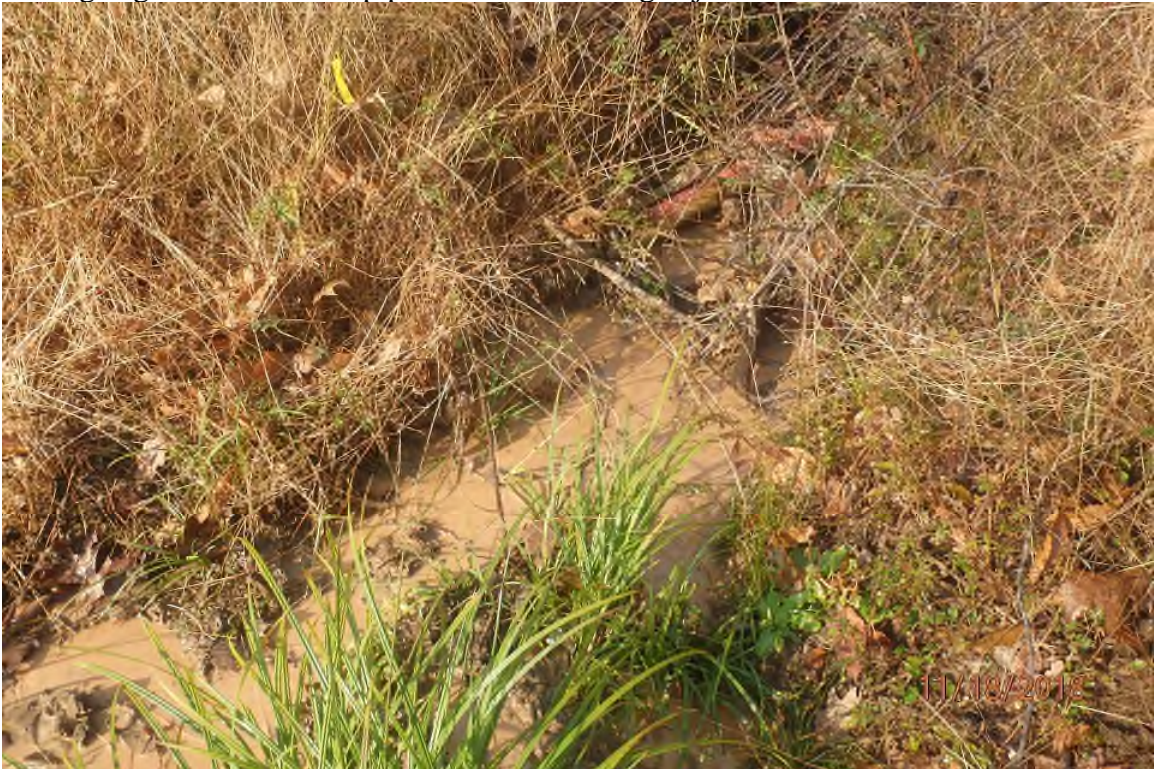
Stream of sediment laden water downslope of the above pictured dewatering bag that is flowing to the adjacent receiving stream.

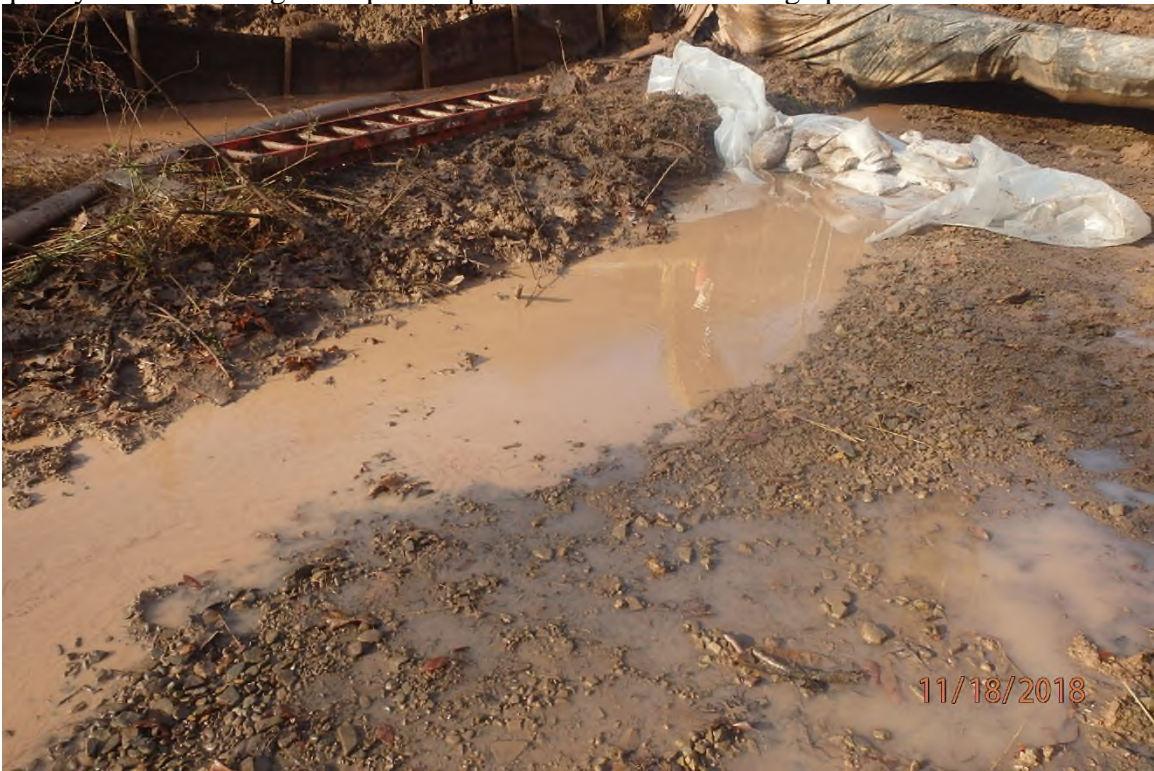
CNA distinctly visible settleable solids in UNT Georgescamp Run (SDOG048) (39° 15.261' X 80° 44.096) as a result of the above pictured dewatering.

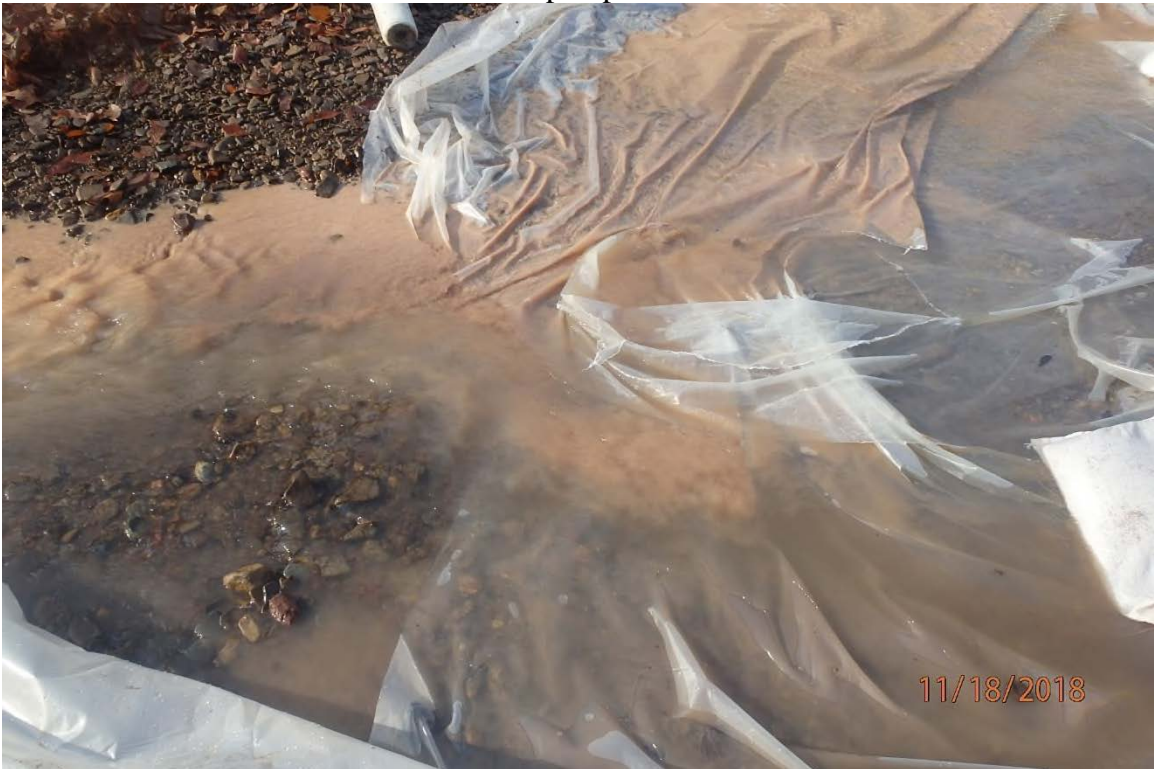
Visible plume in UNT Georgescamp Run (SDOG048) ($39^{\circ} 15.261'$ X $80^{\circ} 44.096'$) at outflow of the installed pump-around.

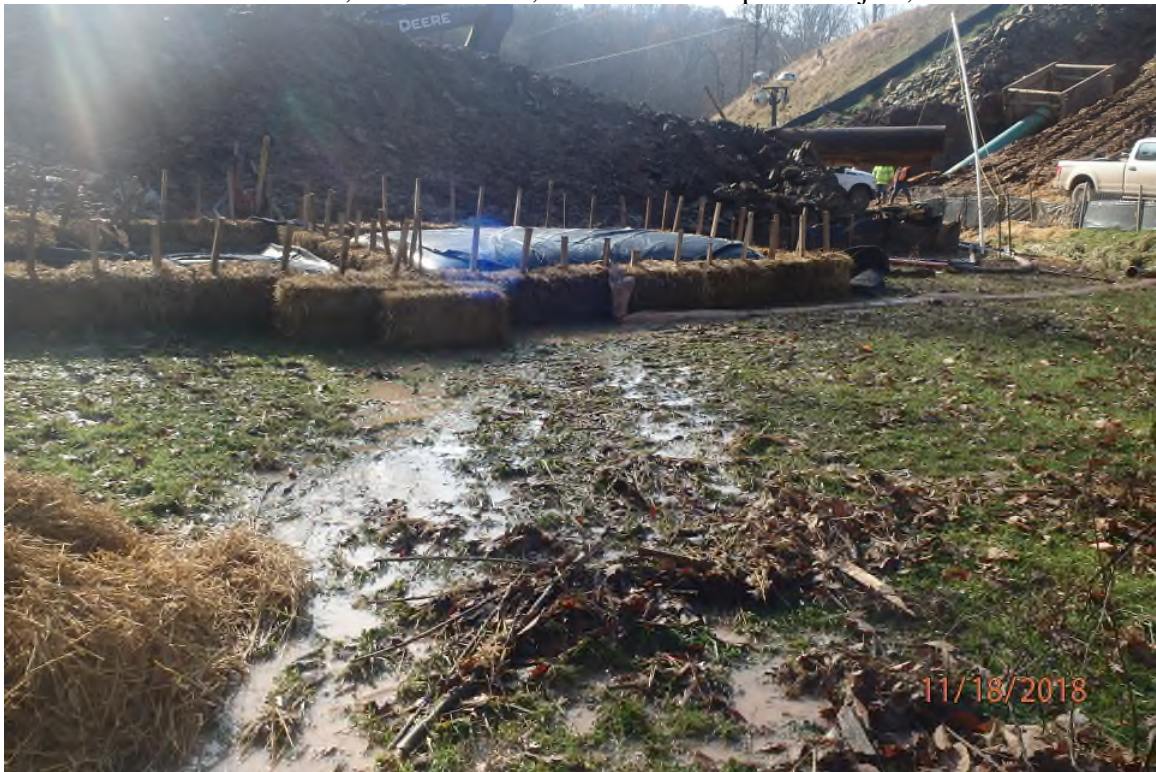
Dewatering bag associated with pipe trench dewatering adjacent to the SDOG055 stream crossing.

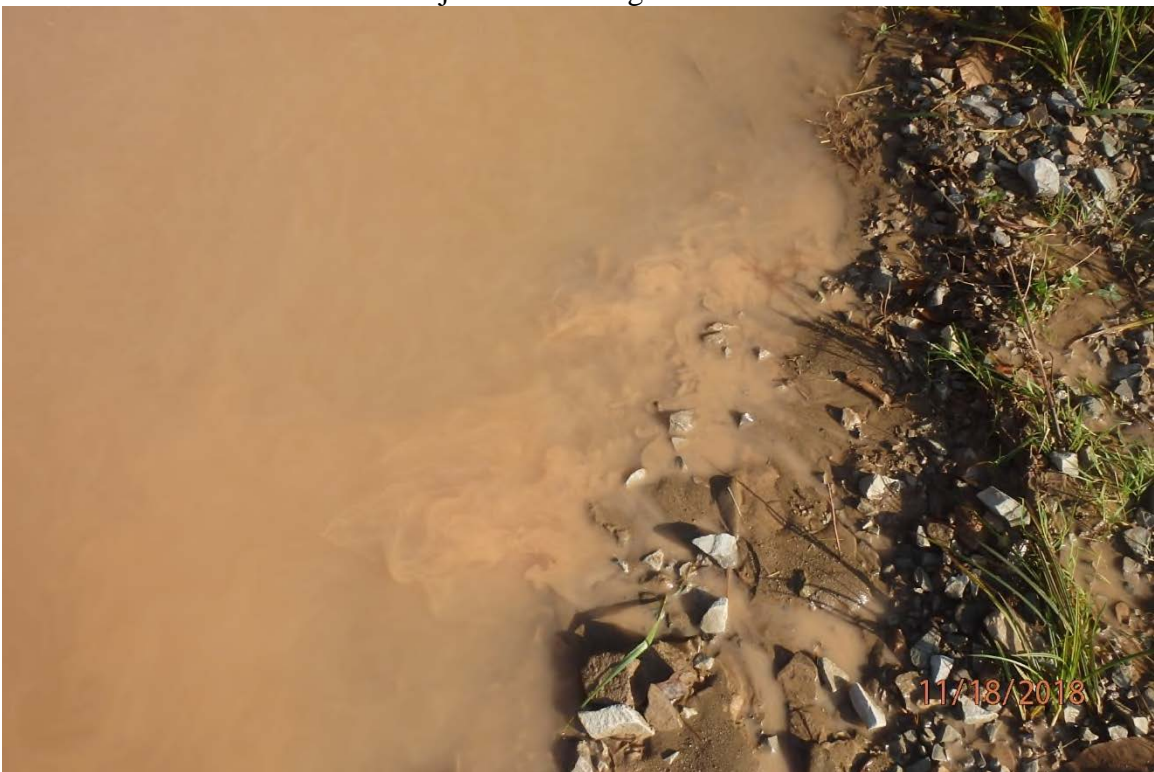
Stream of sediment laden water downslope of the above pictured dewatering bag that is flowing to the adjacent receiving stream.

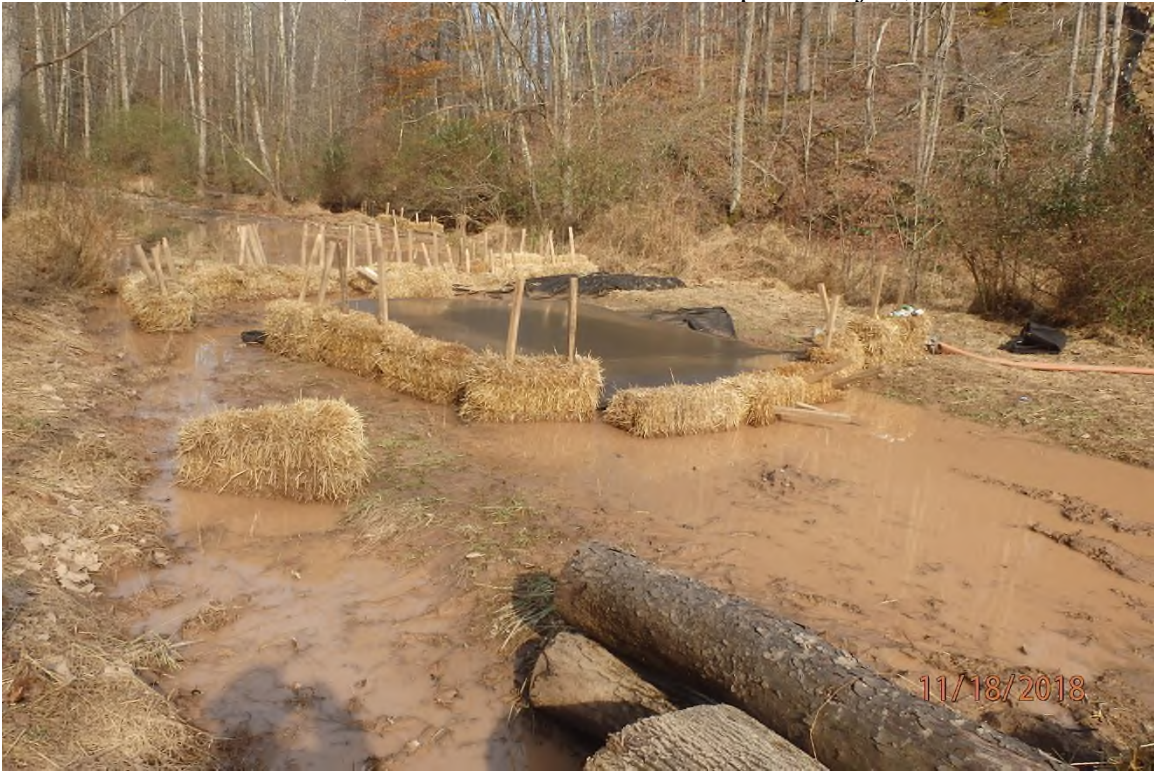
Visible plume in Georgescamp Run (SDOG055) (39° 15.467' X 80° 43.492') originating from the above pictured dewatering operation.

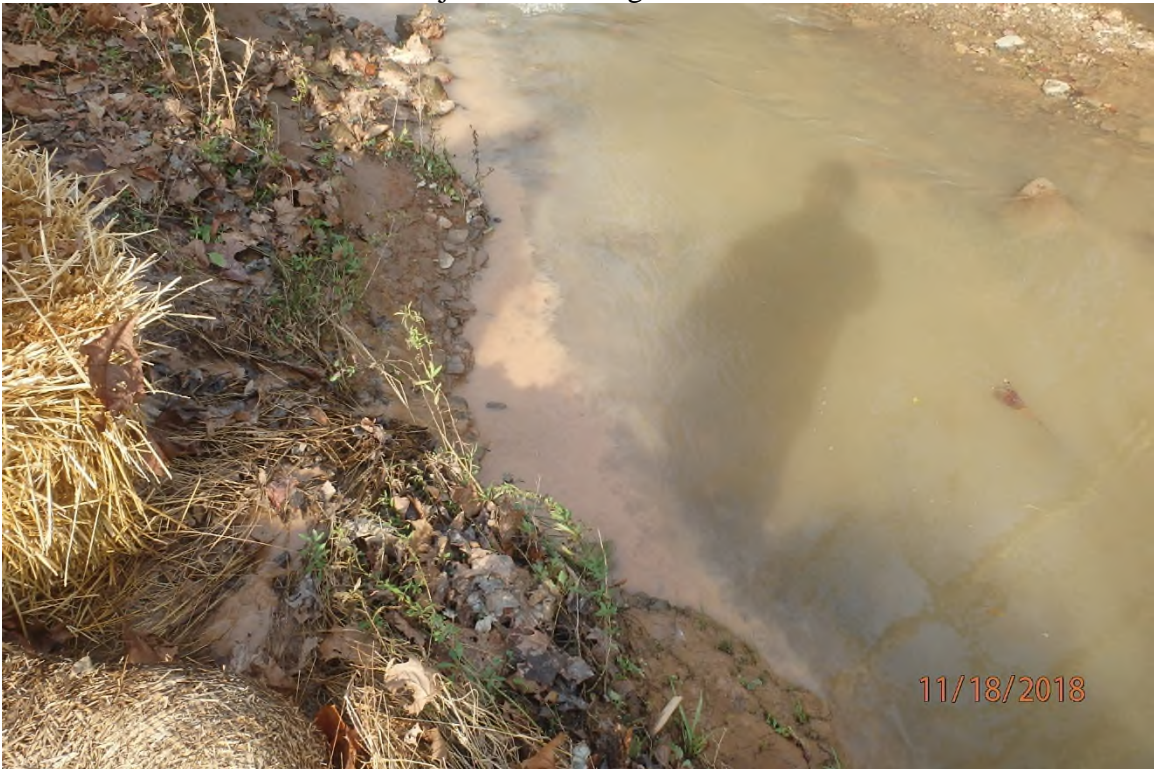
Stream of sediment laden water downslope of the above pictured dewatering bag that is flowing to the adjacent receiving stream.

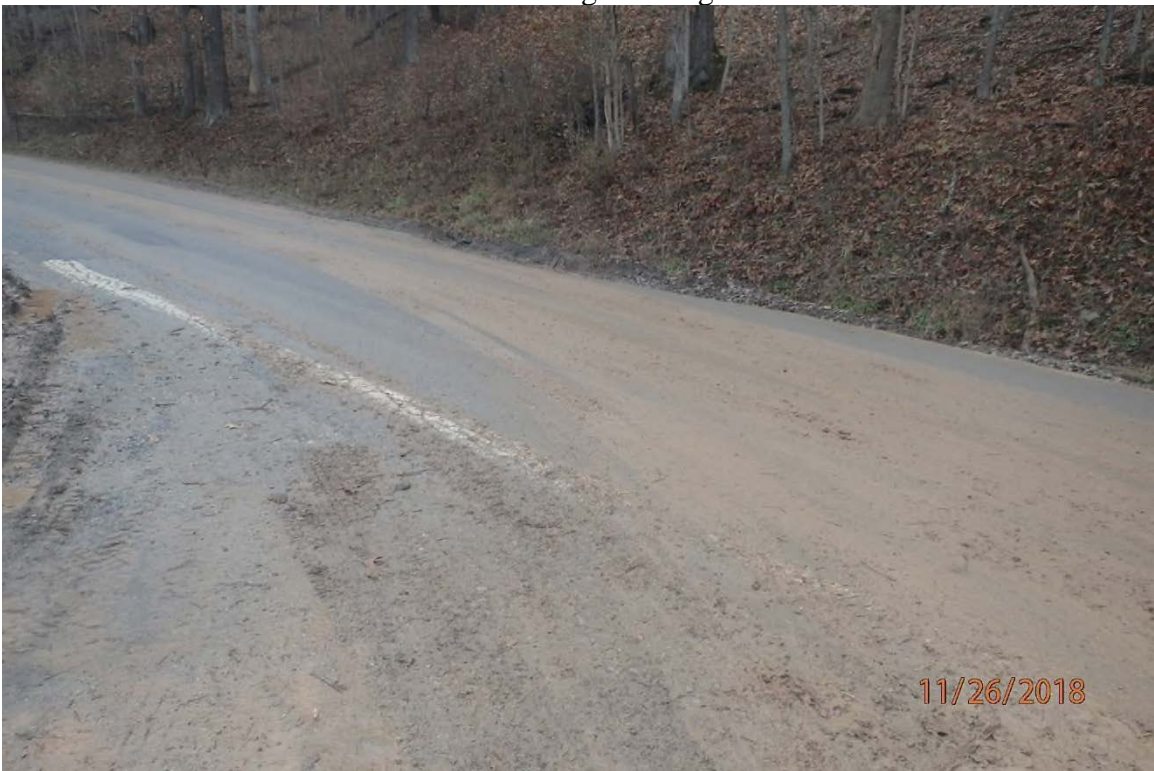
Construction entrance at the WV 23 crossing showing the lack of a stabilized entrance.

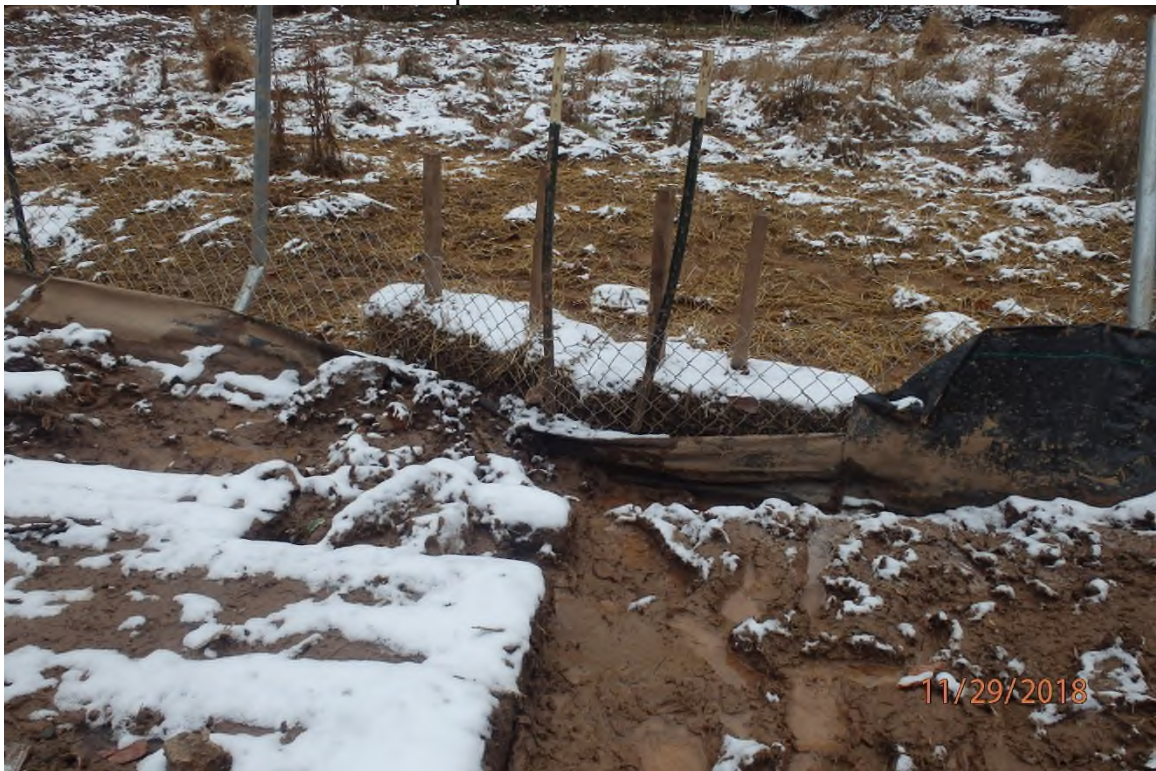
Unmaintained perimeter control on ARDO009.1.

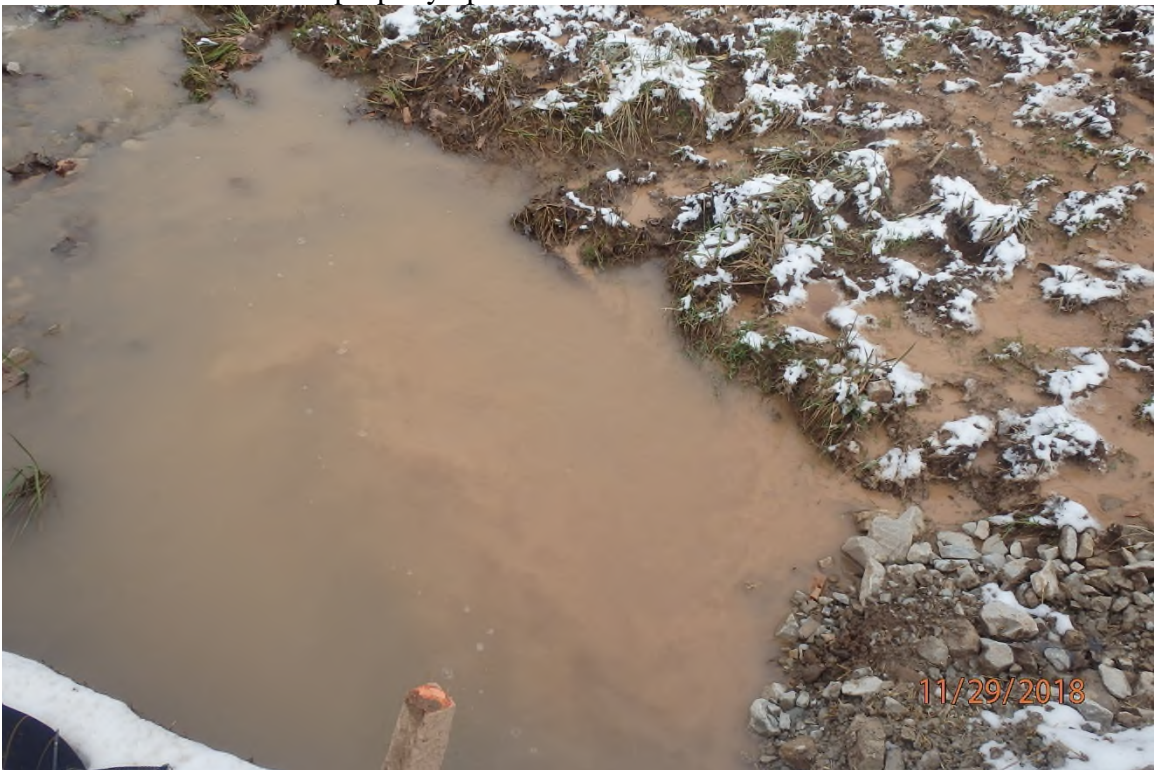
CNA in Georgescamp Run (39° 15.093' X 80° 43.982') that originates from the previously pictured improperly operated BMP on ARDO008.2.

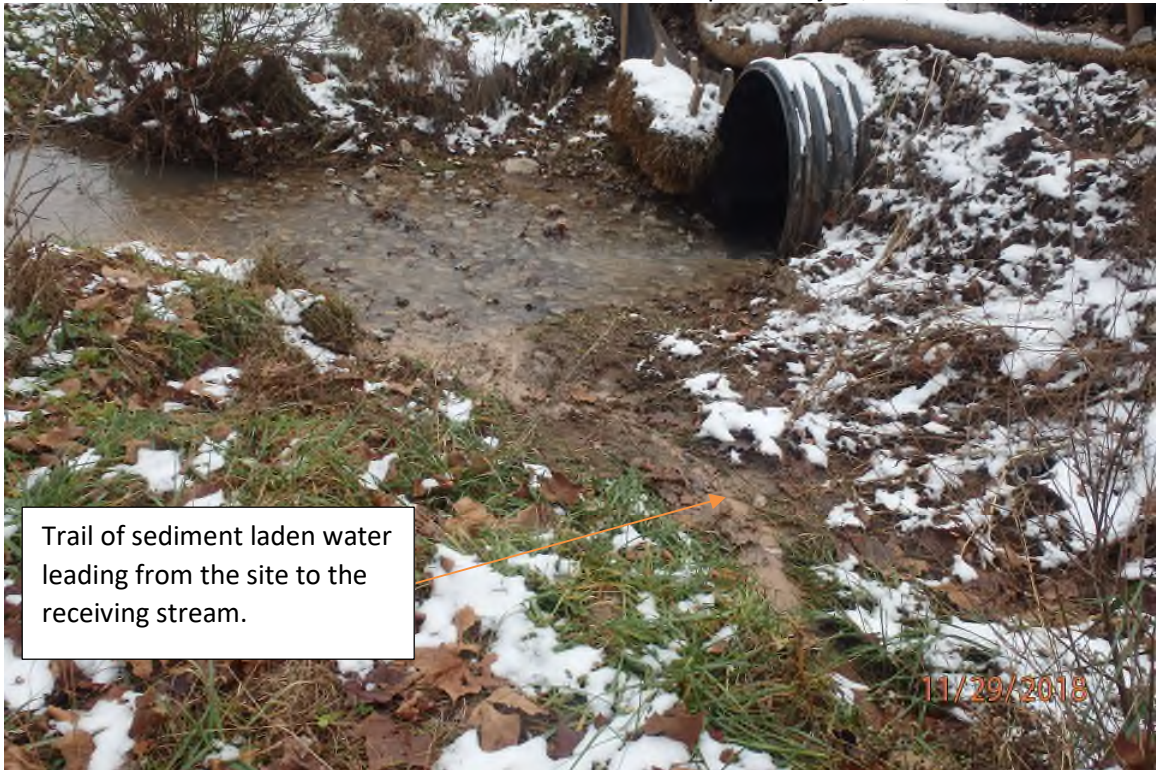
Improperly operated BMP on ARDO008.2 that is allowing sediment laden water to bypass the device.

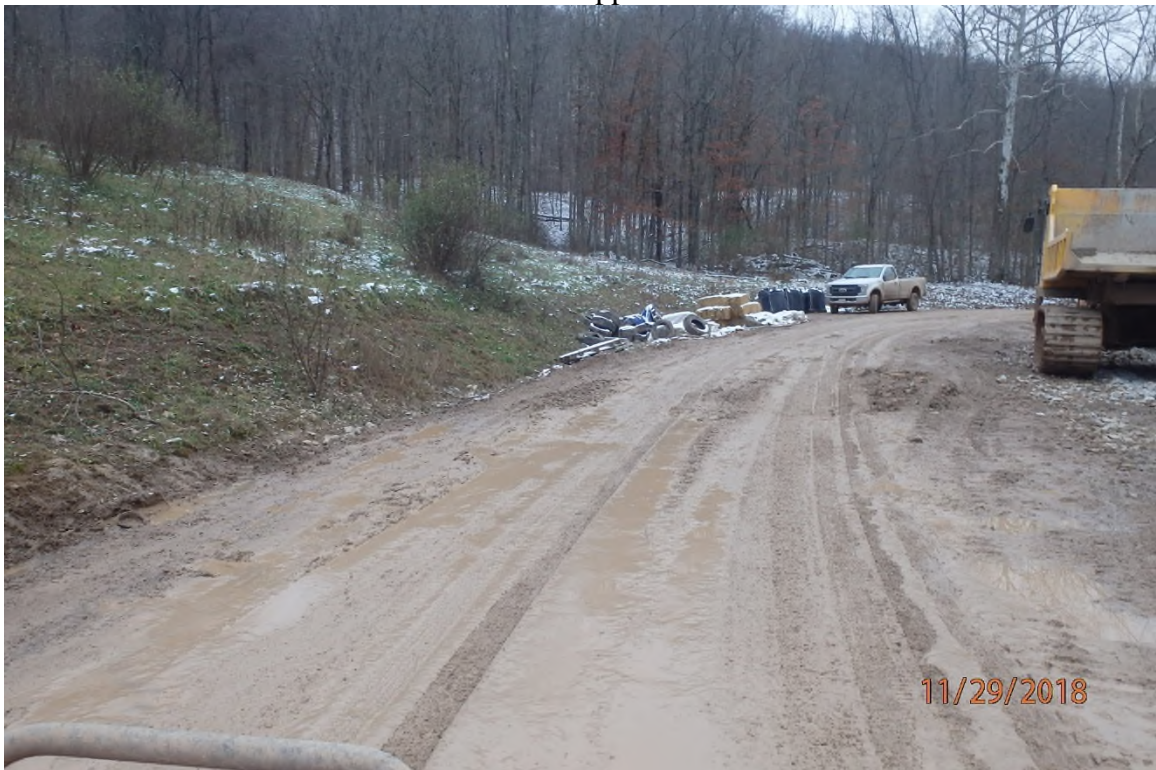
ARDO009.3 showing an unstable road surface that requires construction activity with no BMPs in place as indicated in the approved SWPPP.

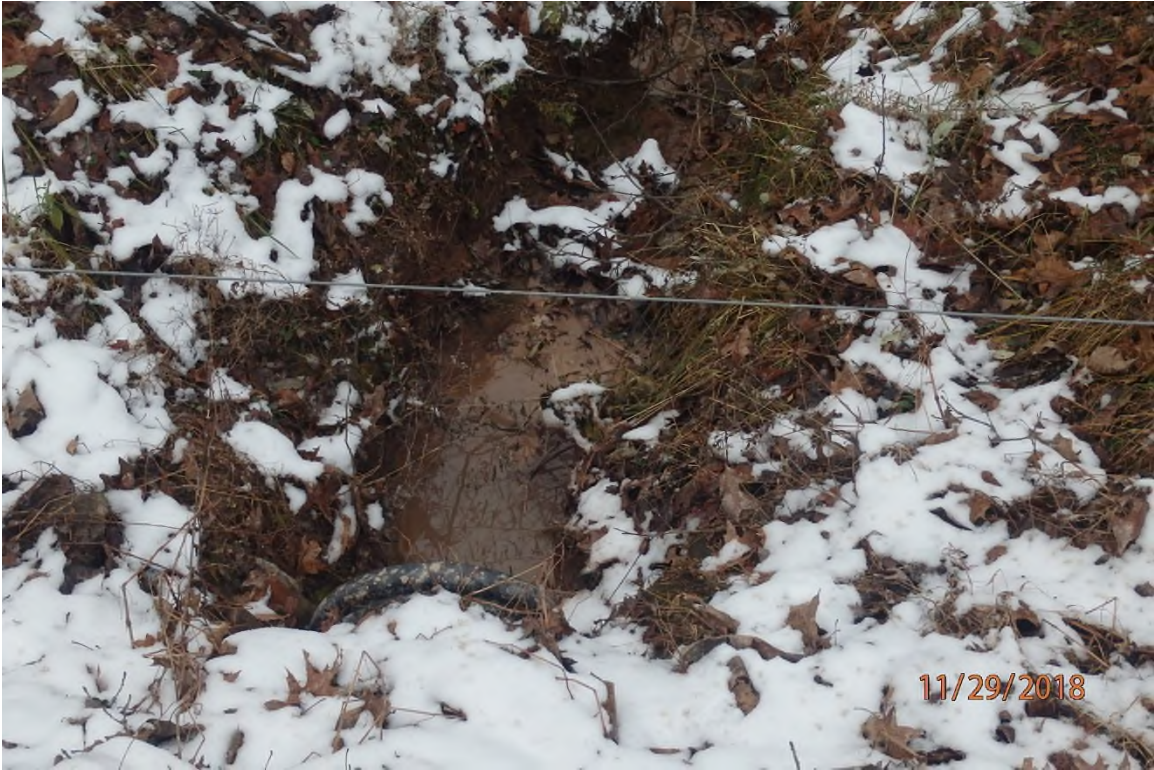
Trail of sediment laden water entering a culvert head just downslope of the area in the picture above on ARDO009.3.

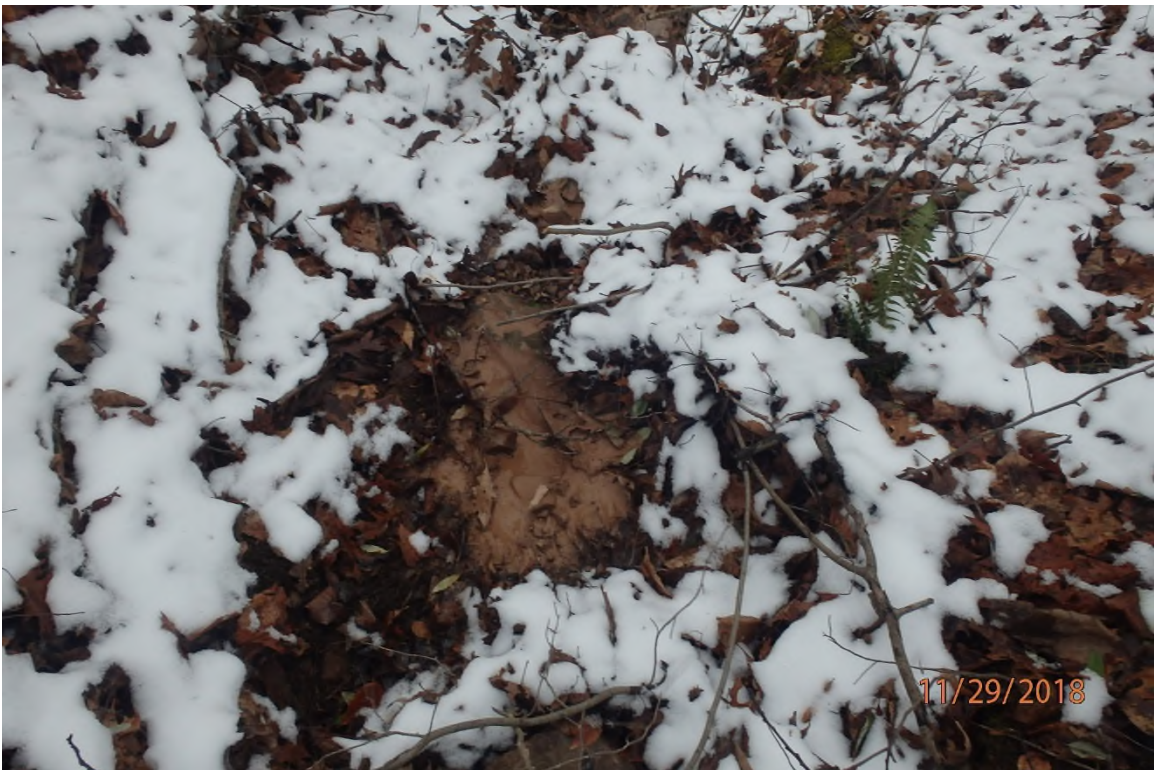
Culvert outlet showing offsite sediment deposits downslope of the previously pictured area on ARDO009.3.

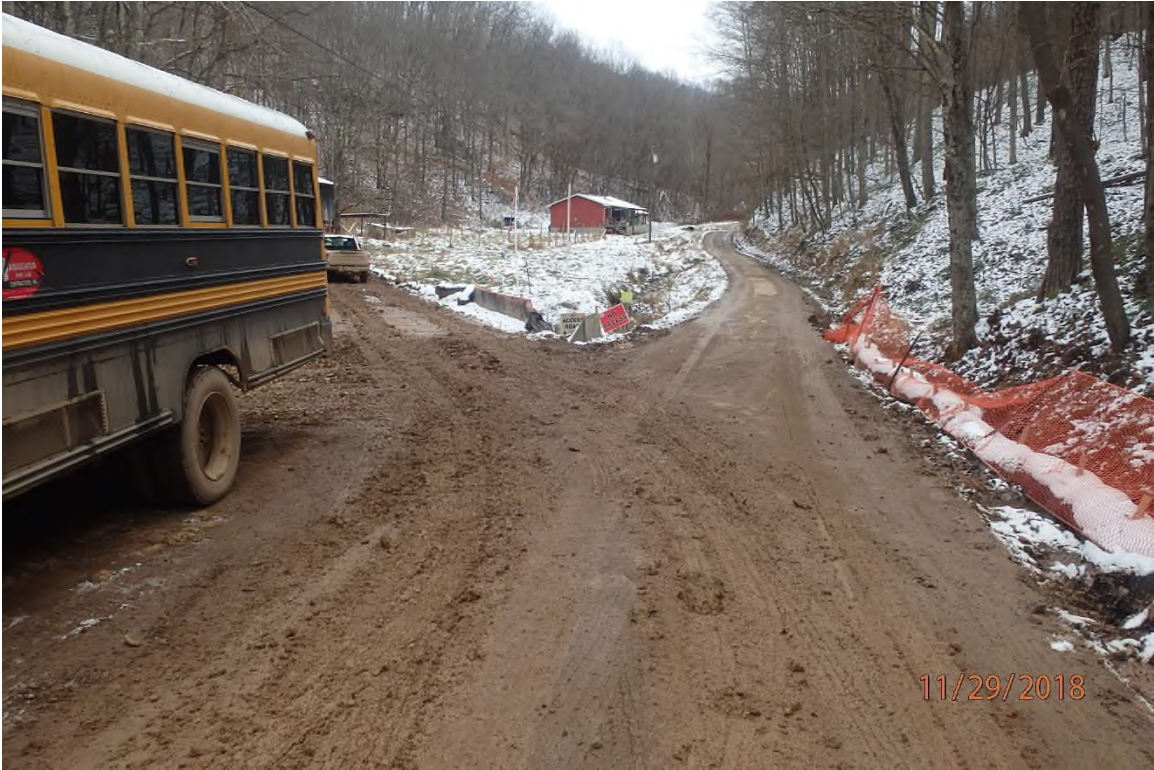
CNA deposits in UNT Bluestone Creek (39° 13.496' X 80° 45.815') that originate from the previously pictured area on ARDO009.3 that is unstable and lacks BMPs.

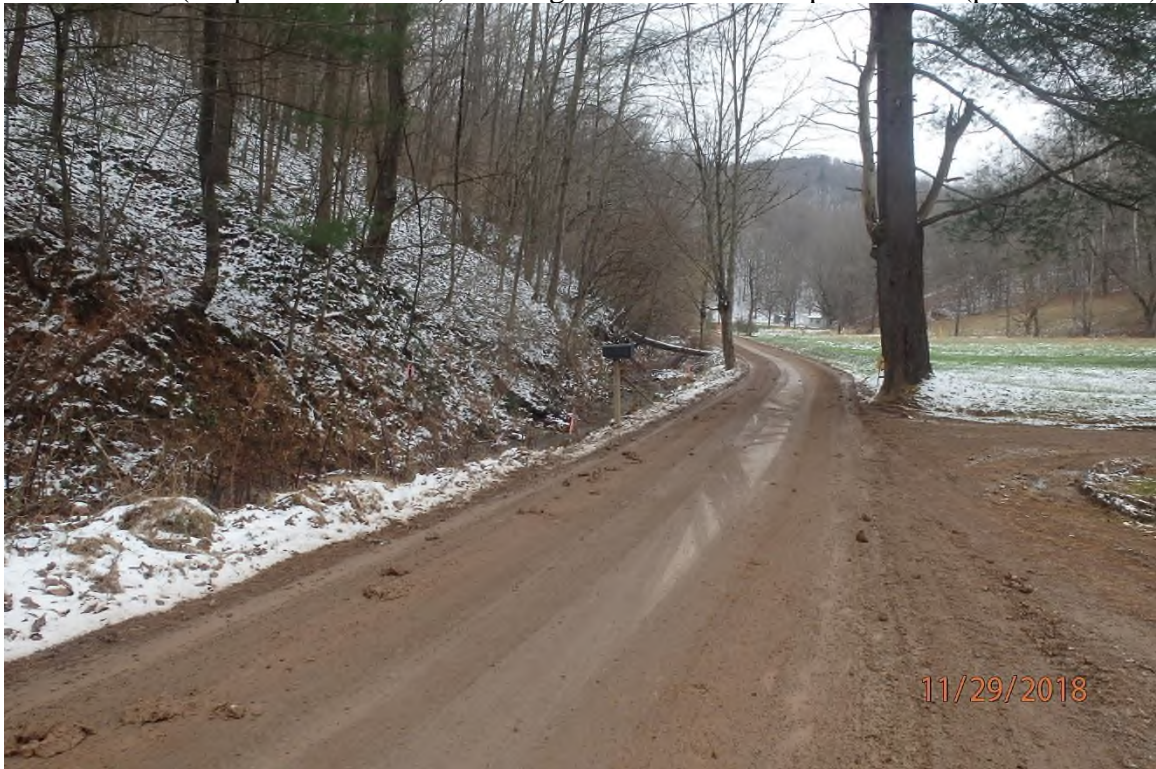
ARDO002.41 (Ralphs Run Access) showing track-out onto the public road (paved surface).

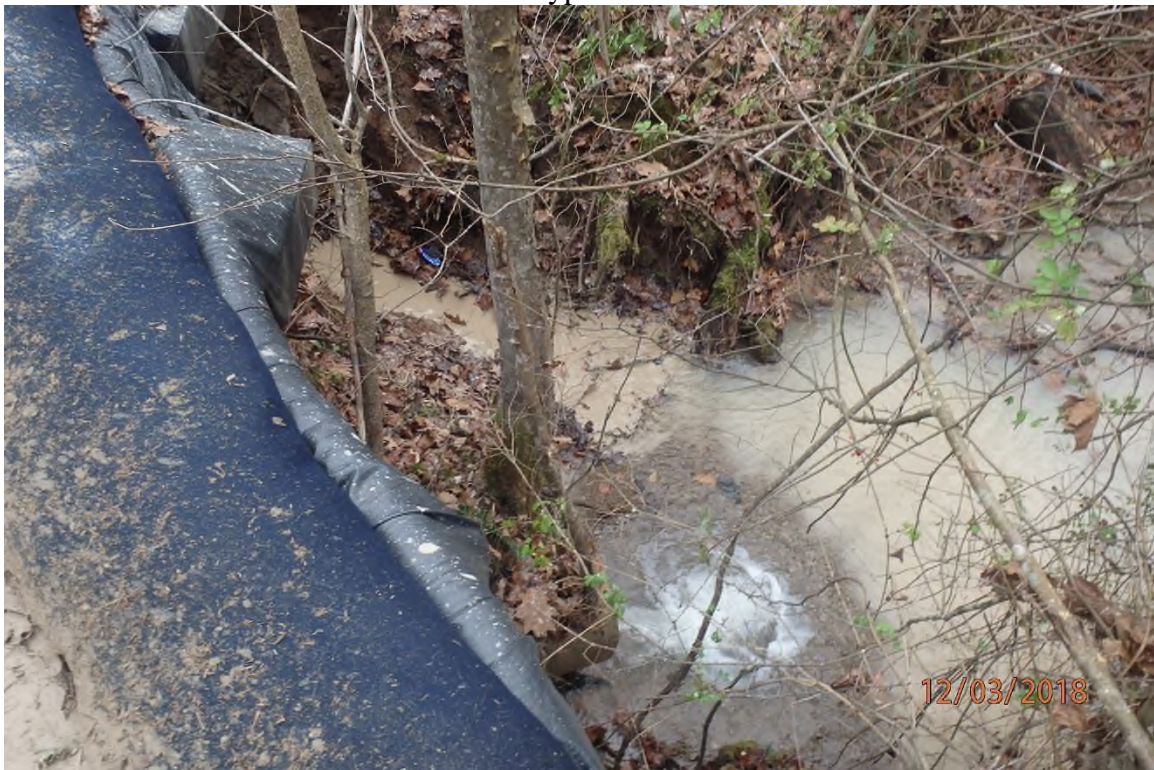
Equipment bridge BMP on ARDO007.6 in need of maintenance showing point of sediment laden water bypass.

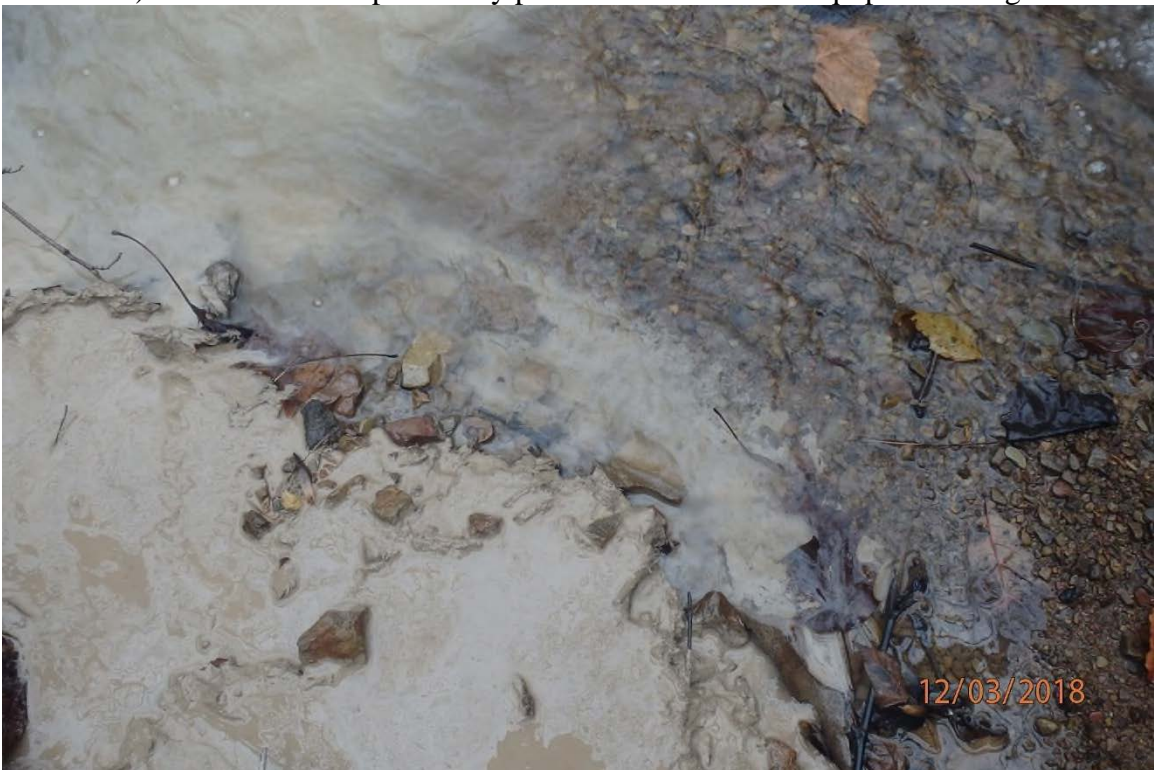
CNA distinctly visible settleable solids and deposits in UNT Douglascamp Run (39° 16.284' X 80° 42.421') as a result of the previously pictured unmaintained equipment bridge BMP.

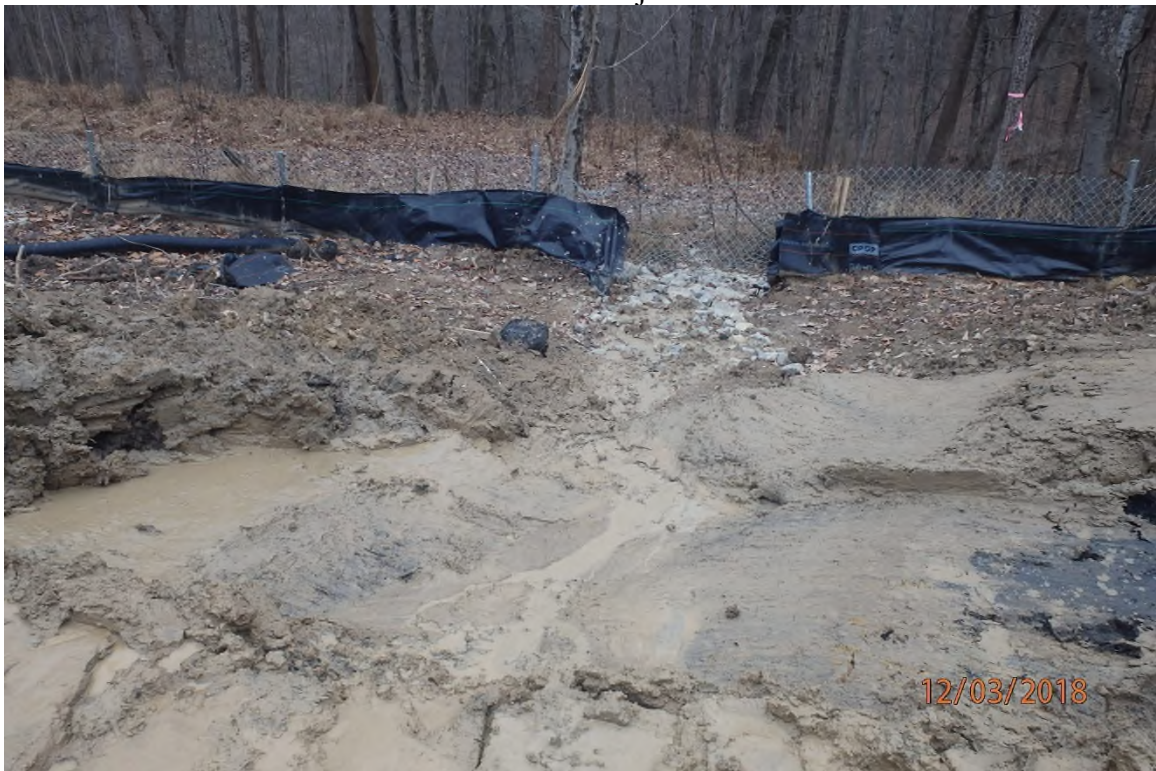
Overview of disturbance adjacent to 2611+00.

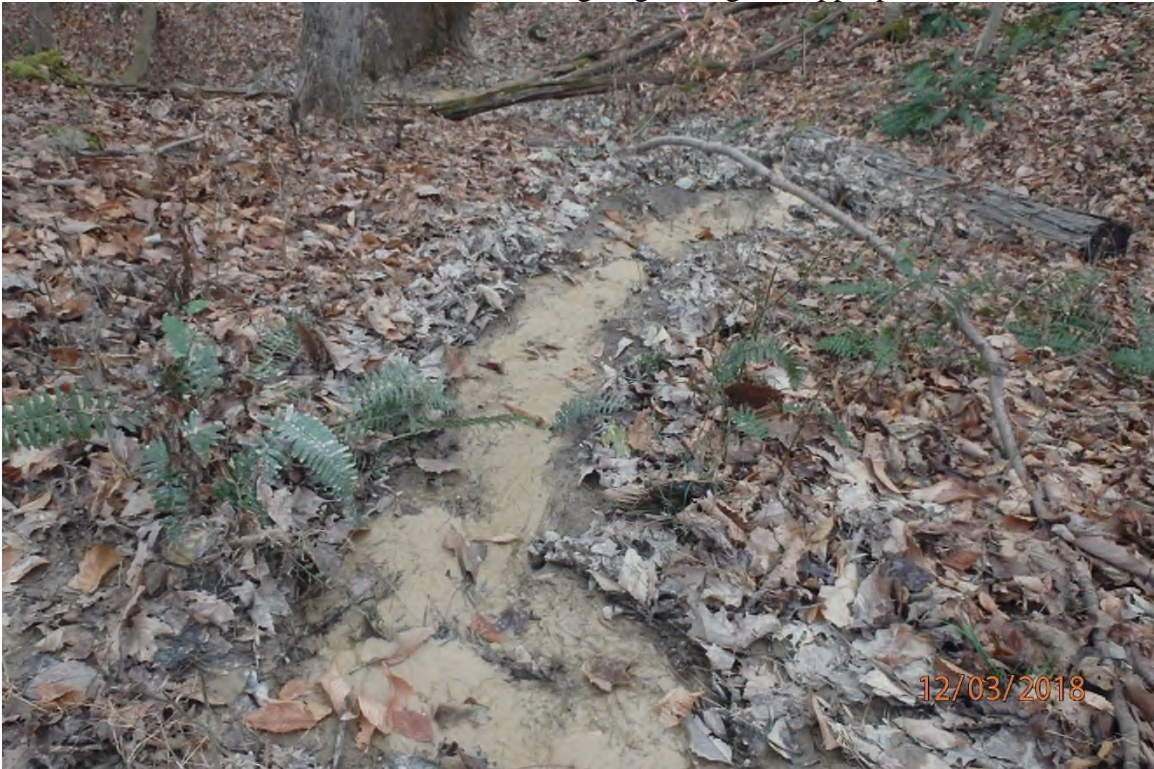
Project area adjacent to 2611+00 showing gaps in the installed perimeter control that allow sediment laden water to leave the site without going through an appropriate device.

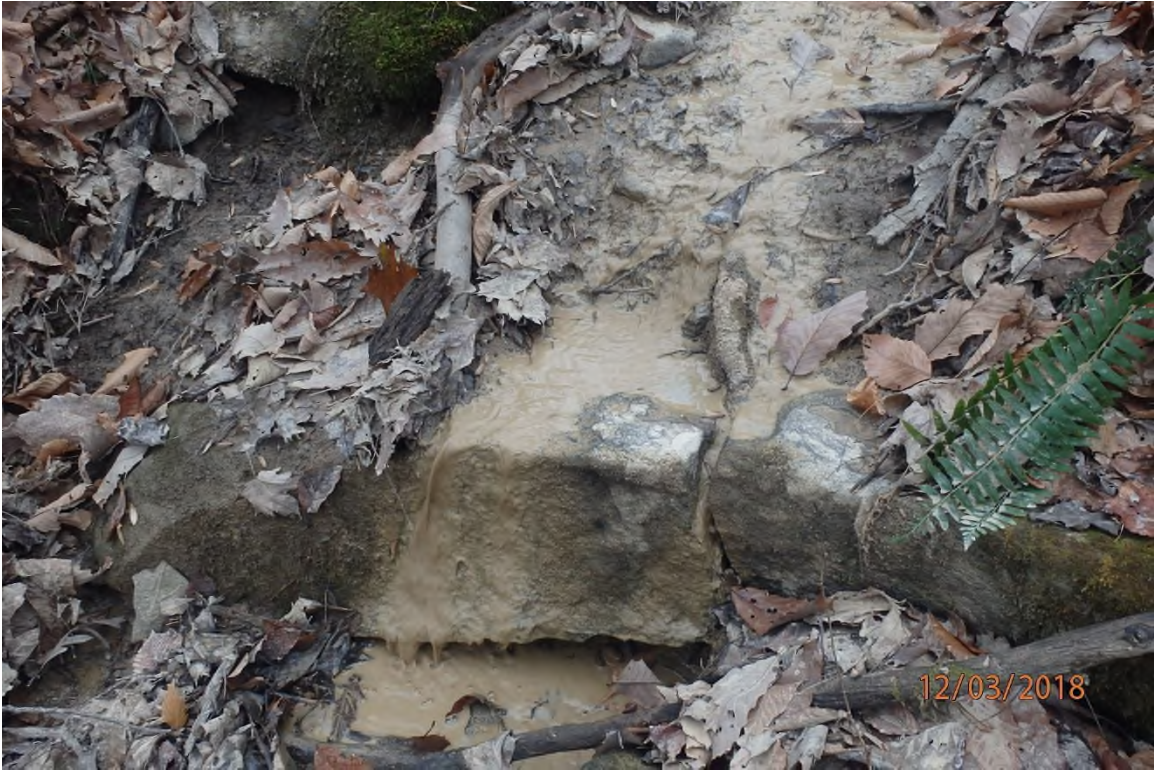
Offsite sediment laden water trail that originates from site near 2611+00 that is flowing toward the receiving stream.

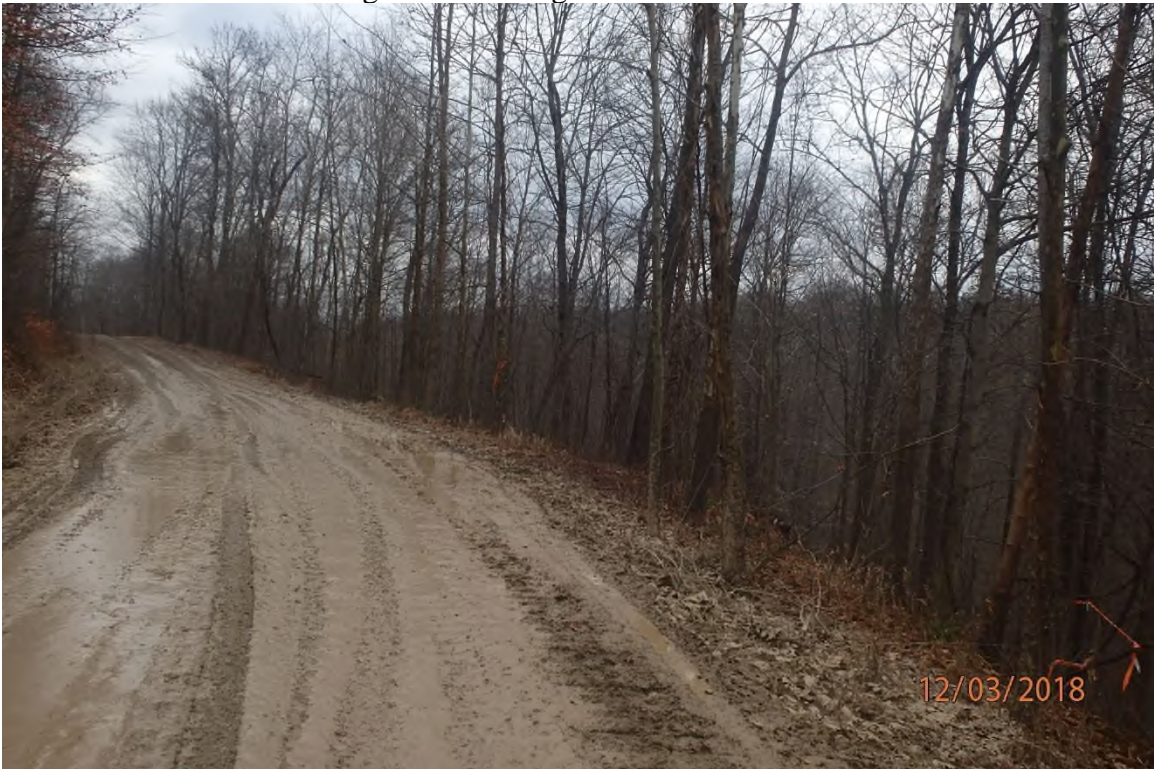
ARDO007.6 showing the lack of a graveled surface and the lack of BMPs.

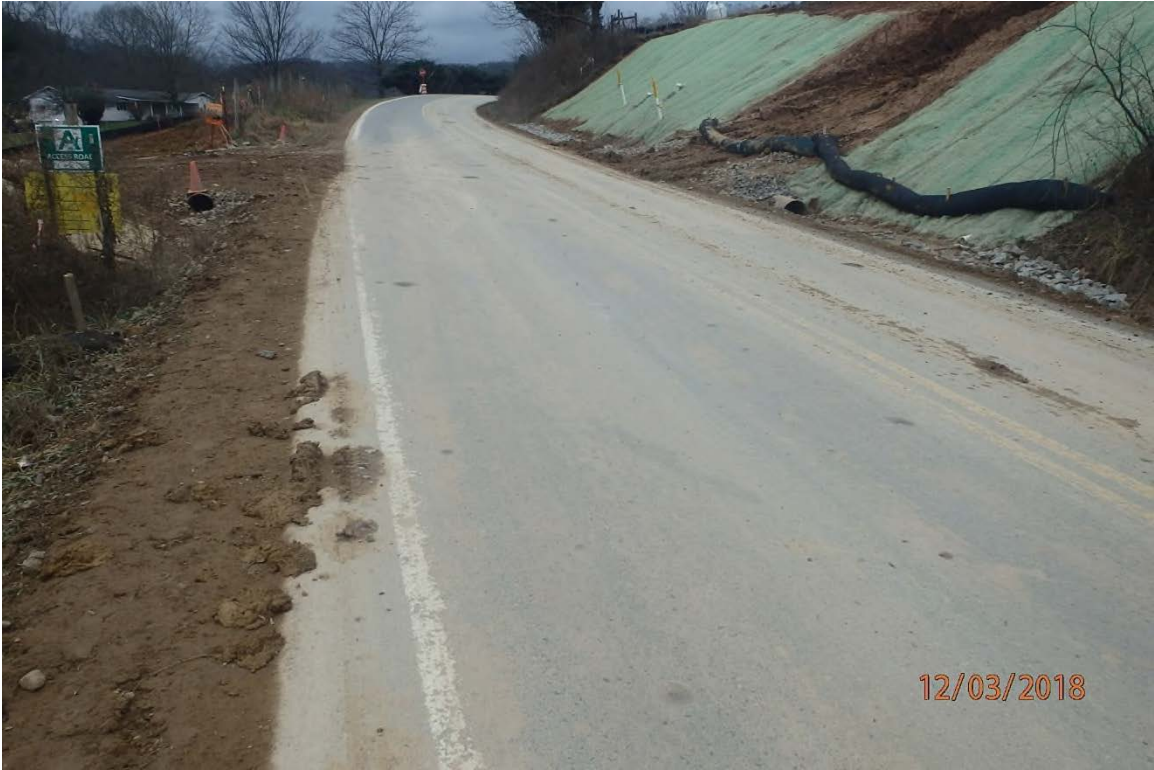
ARDO008/WV 18 crossing showing the lack of a stable construction entrance and the associated track-out onto the public roadway.
