**CONSENT ORDER
ISSUED UNDER THE
WATER POLLUTION CONTROL ACT
WEST VIRGINIA CODE, CHAPTER 22, ARTICLE 11**

TO: Columbia Gas Transmission, LLC
Attn: Troy Tally, Vice President
1700 MacCorkle Ave
Charleston, WV 25314

DATE: October 1, 2020
ORDER NO.: 9061

1. Columbia Gas Transmission, LLC is conducting land disturbance activity associated with construction of the Mountaineer Xpress Project in Marshall, Wetzel, Tyler, Doddridge, Ritchie, Calhoun, Wirt, Roane, Jackson, Mason, Putnam, and Cabell Counties, West Virginia. On January 31, 2018, Columbia Gas Transmission, LLC was issued Water Pollution Control Permit No. WV0116815, Registration No. WVR310872, for Stormwater Associated With Oil and Gas Related Construction Activities.

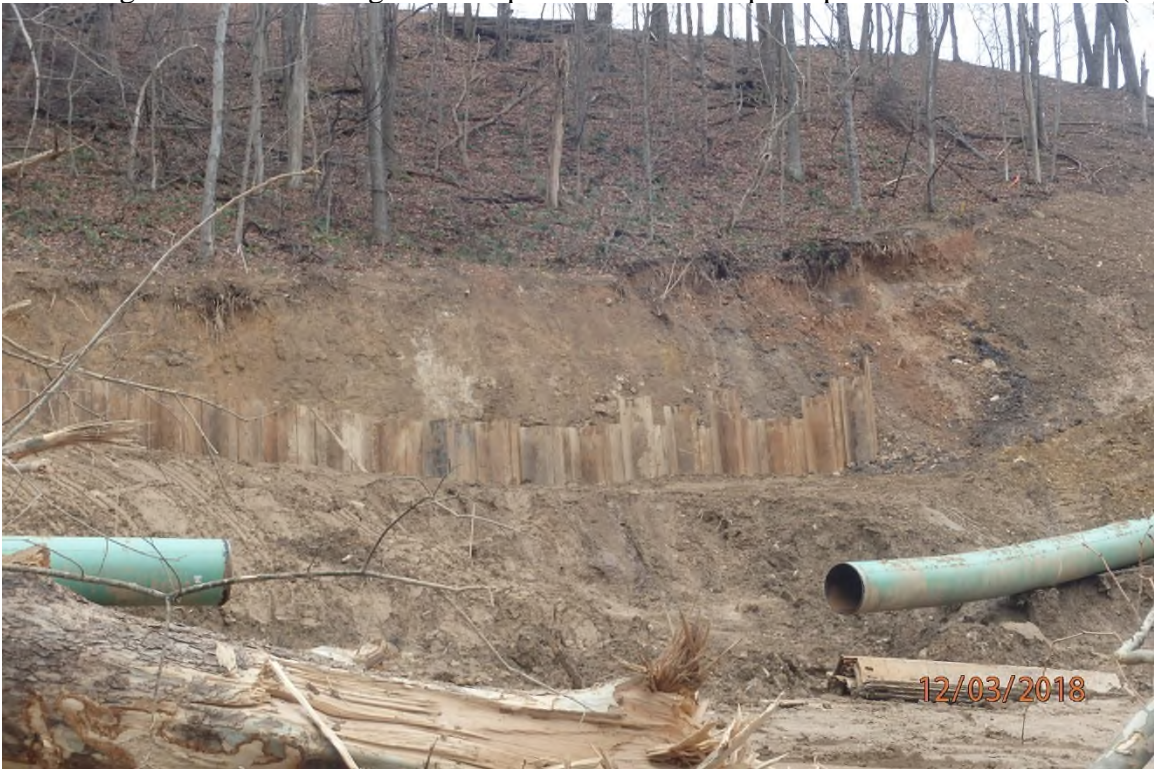
Sheet piling installed upslope of the installed pipe to protect pipe integrity on the slip associated with spill report number 09-83236 (A).

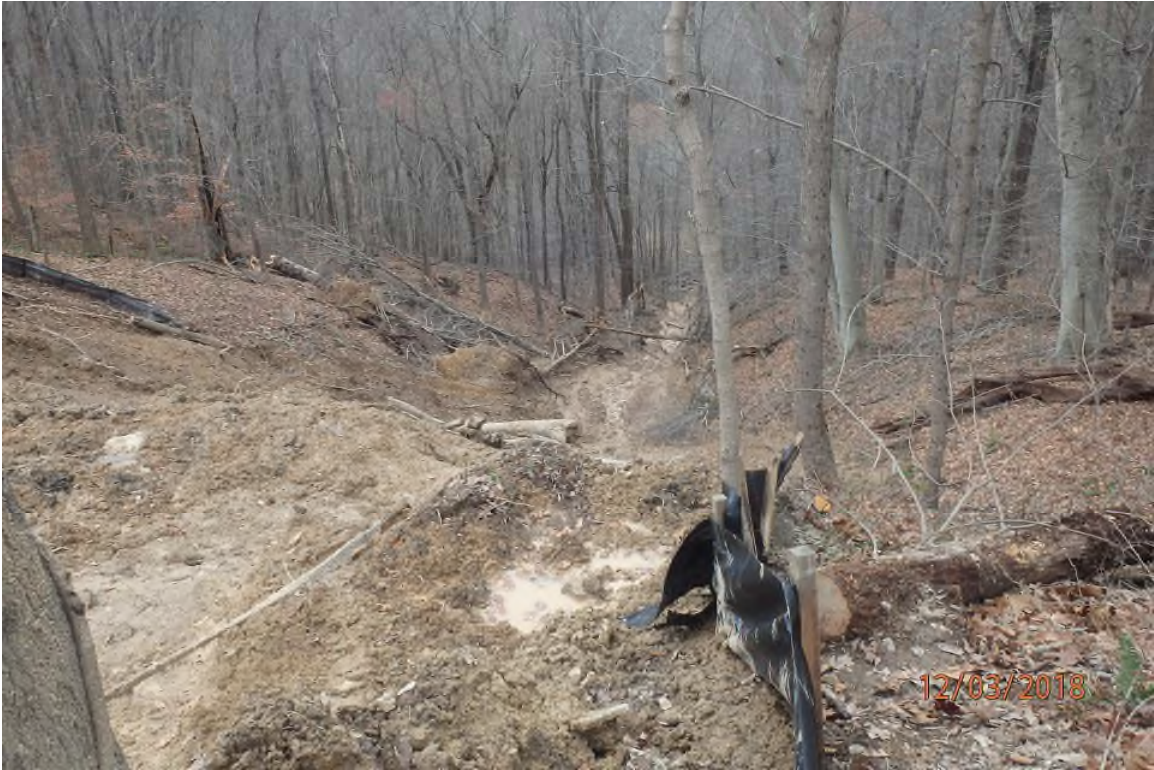
Lower portion of the slip associated with spill report number 09-83236 (A) showing remnants of recently installed silt fence and the lack of installed sheet piling. The pictured mud flow downslope of the slip is in the ephemeral UNT of Meathouse Fork.

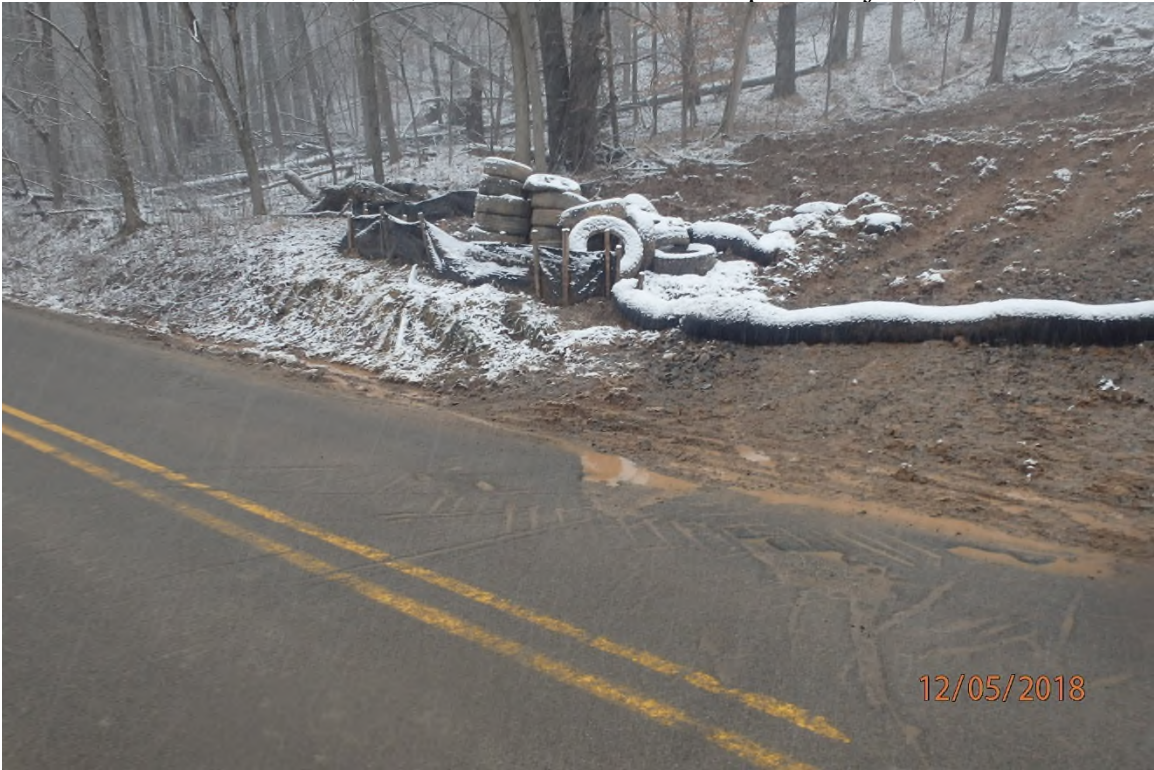
ARDO002.9 showing improperly installed perimeter control that allows sediment laden water to bypass under the device.

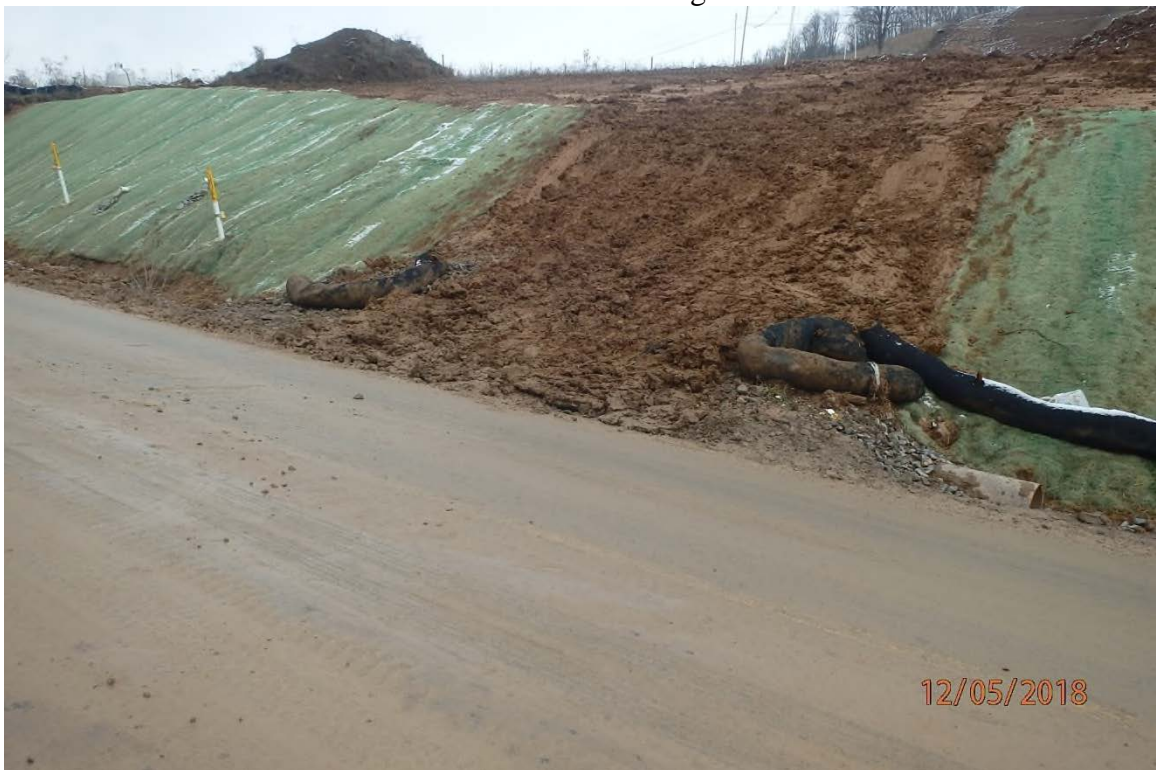
Unstable construction entrance at the WV 18 crossing and the associated track out/slick film of mud that originates from site.

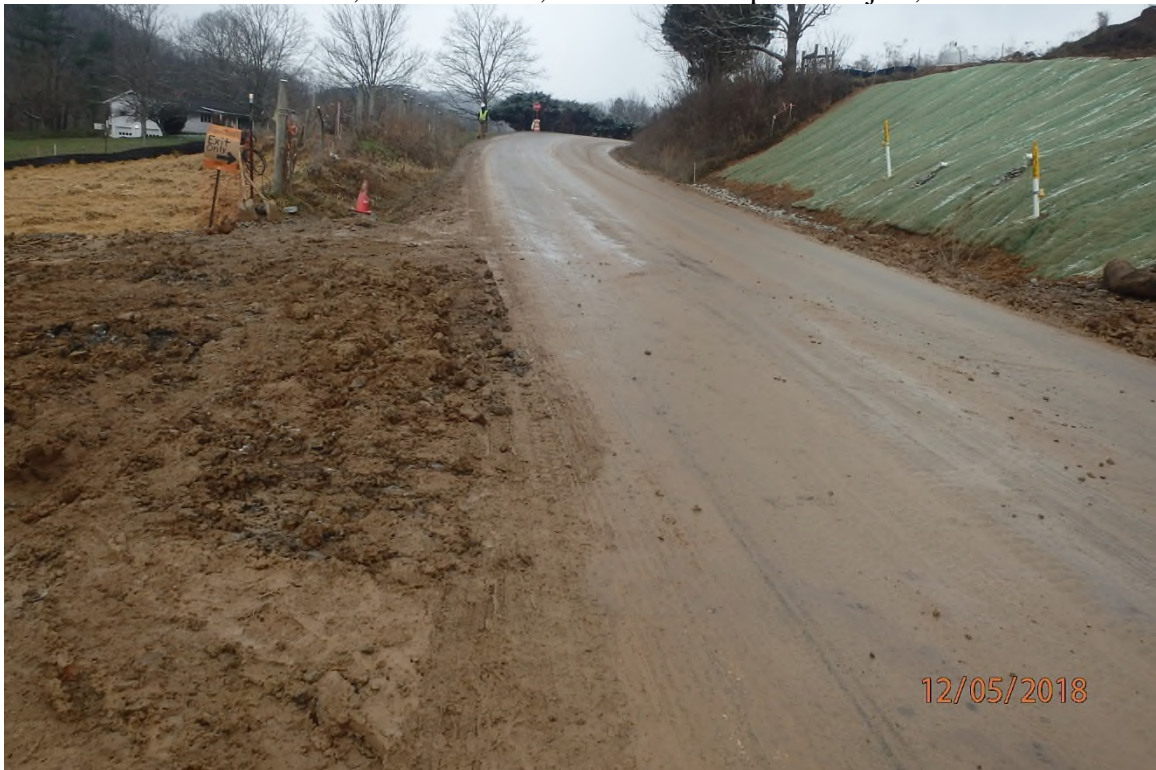
ARDO008 / WV18 crossing accesses showing the lack of a stable construction entrance and the associated track out/slick film of mud that originates from site.

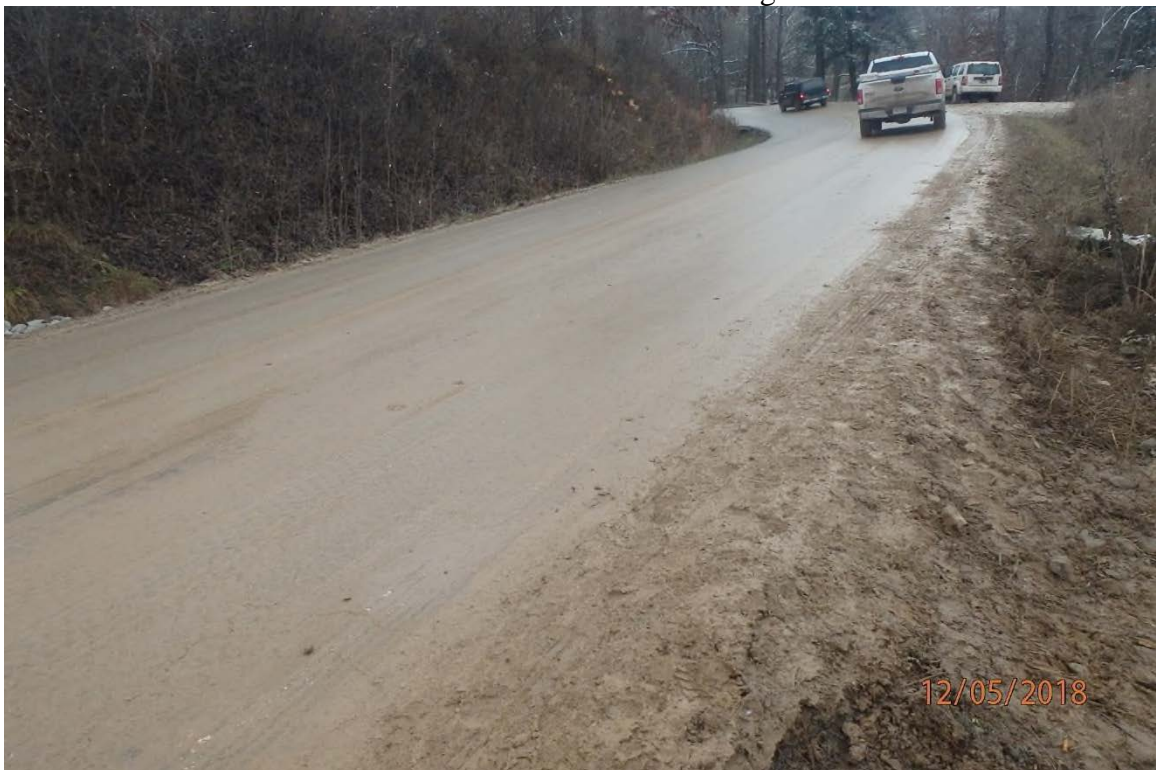
WV 18 showing track out and slick film of mud on the public roadway.

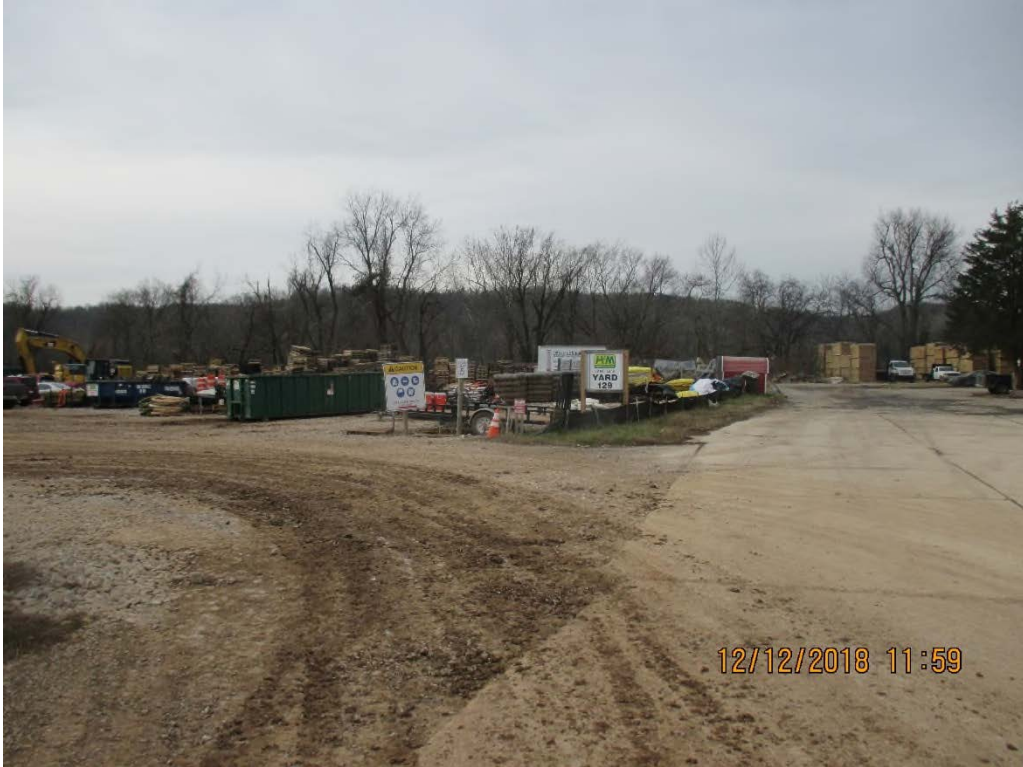
Tracking occurring from contractor yard onto access road that leads to Route 62.

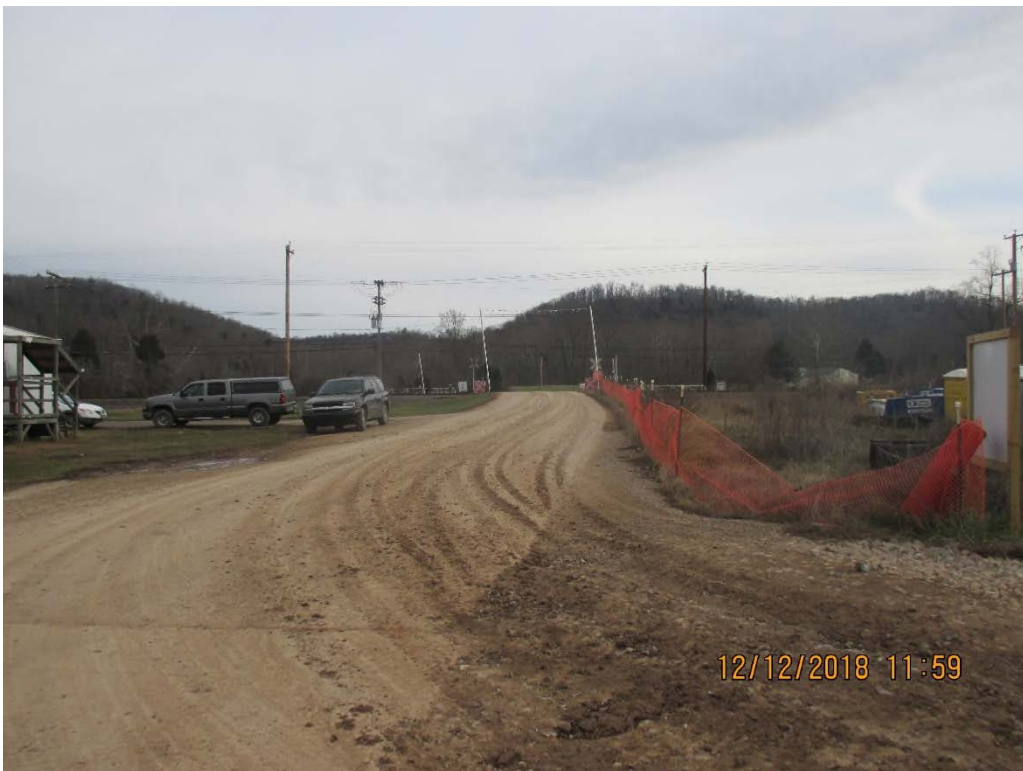
Tracking occurring onto access road, facing North towards Route 62.

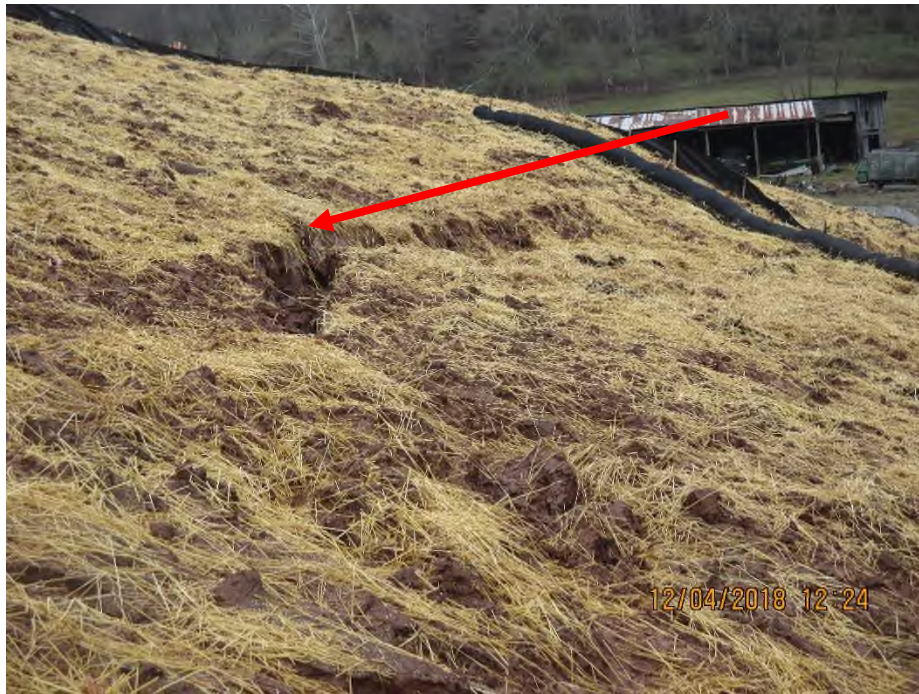
Area where slip was beginning to occur above stream SJAG 316 on 12/04/18.

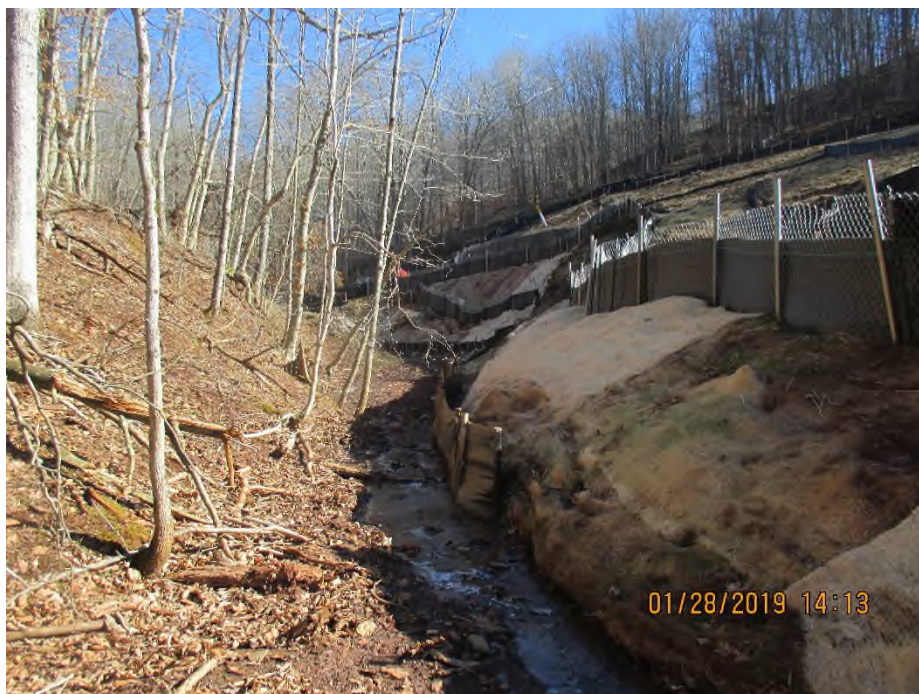
Stream SJAG 316 facing upstream where slips are occurring and impacting stream.

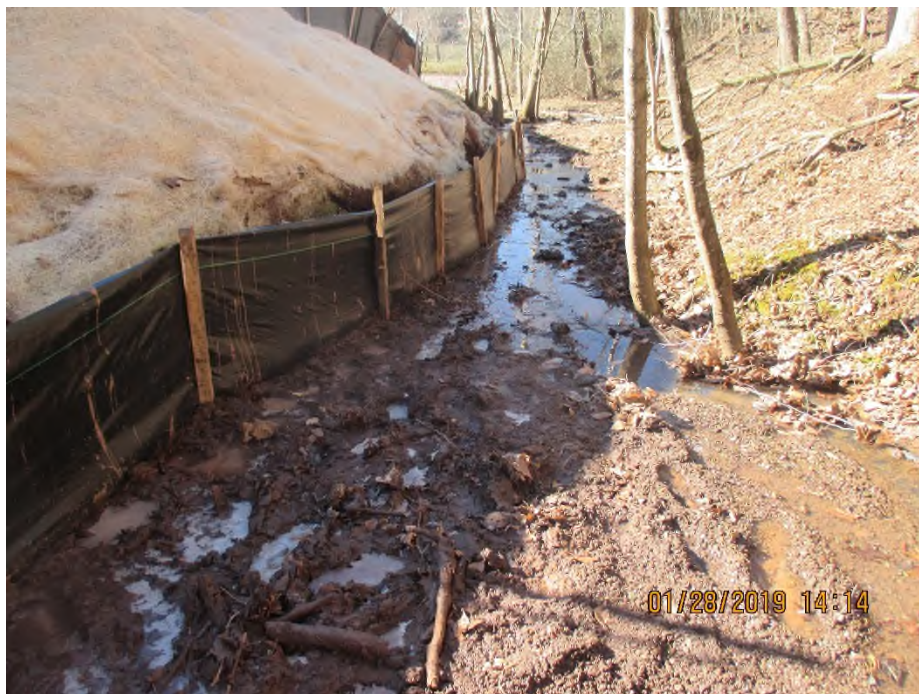
Area where slipped material was removed from Stream SJAG316.

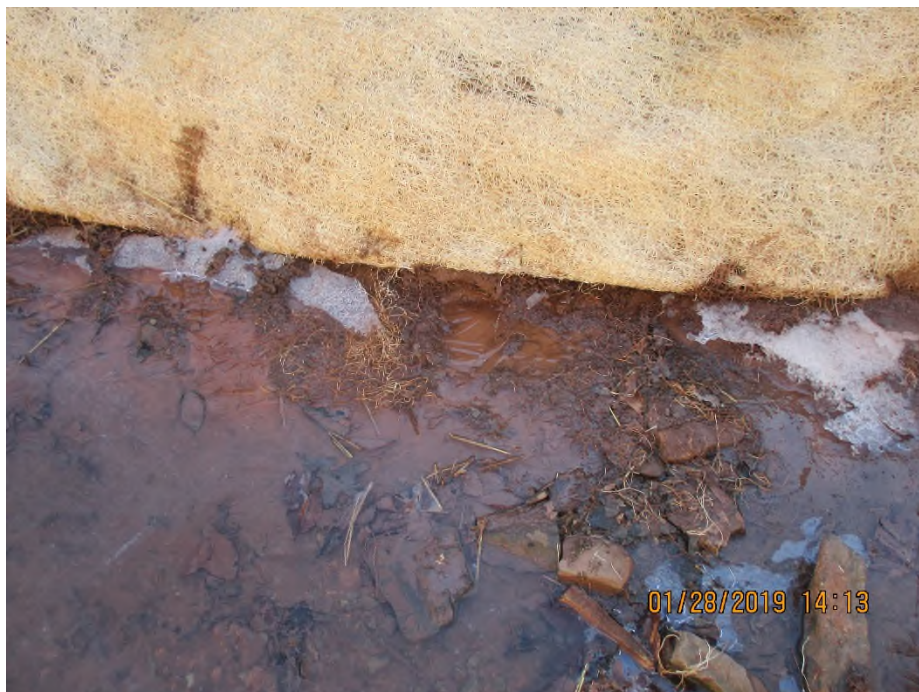
Area where erosion control blankets were added at edge of stream bank.

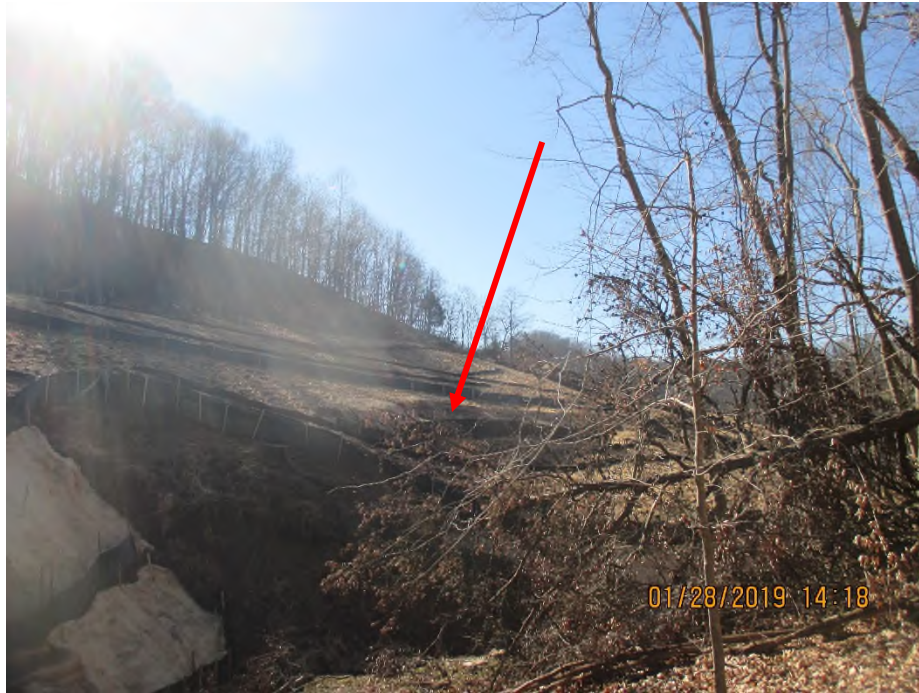
Area upslope of Stream SJAG316 where slips have reoccurred. This area has slipped approximately 2 vertical feet.

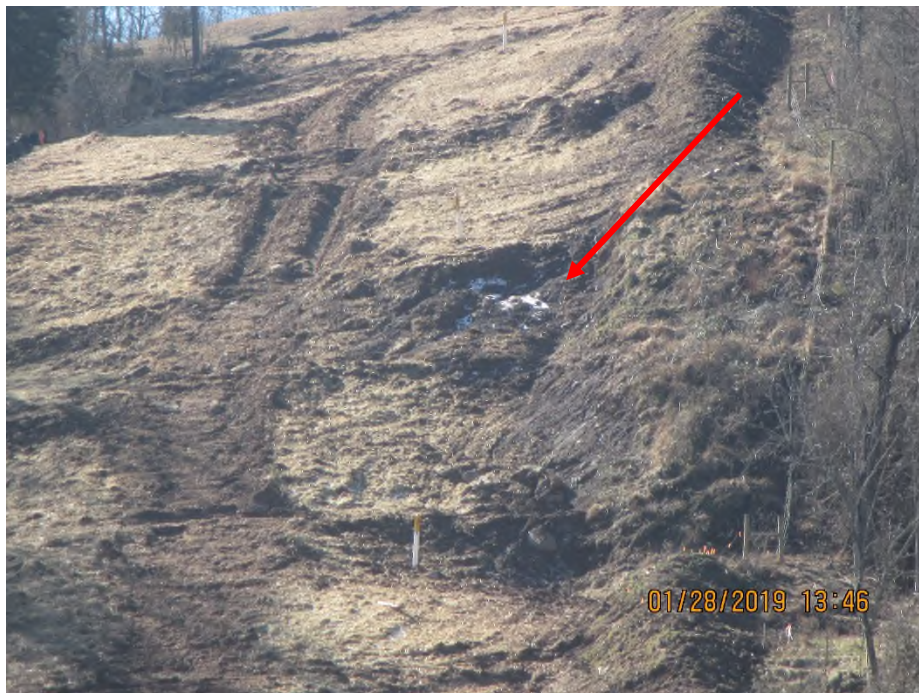
Section of ROW above Shamblin Run where topsoil pile had slipped, and material was deposited into waterbar.

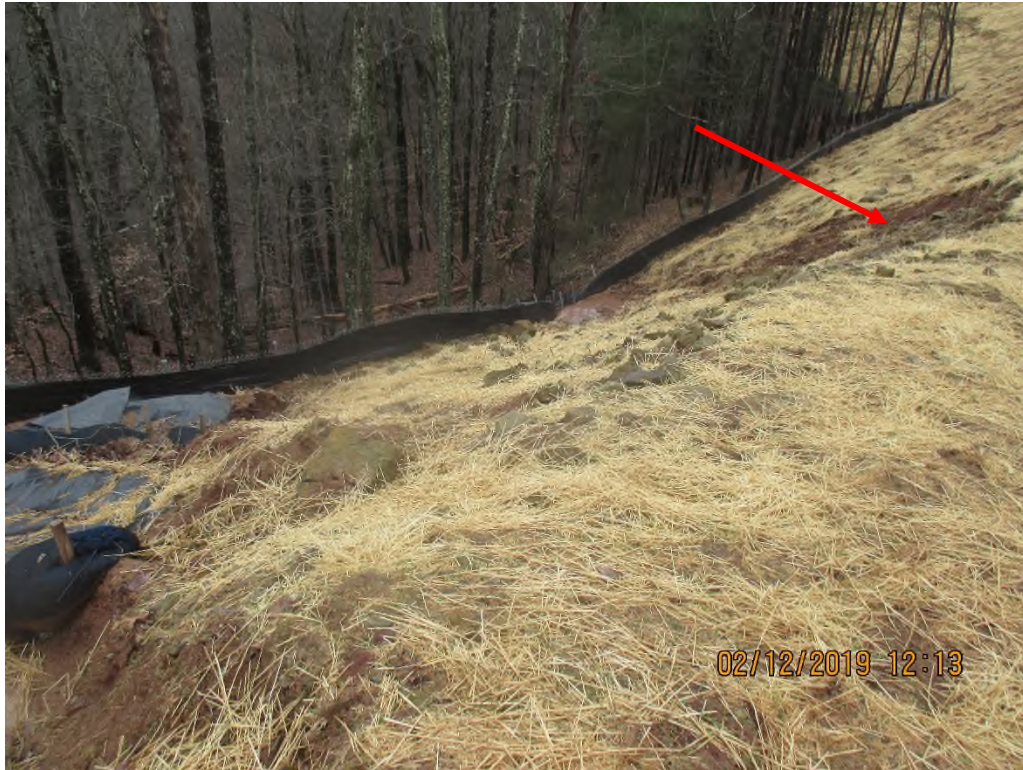
Waterbar terminus leading to perimeter control. Slope eroding above control.

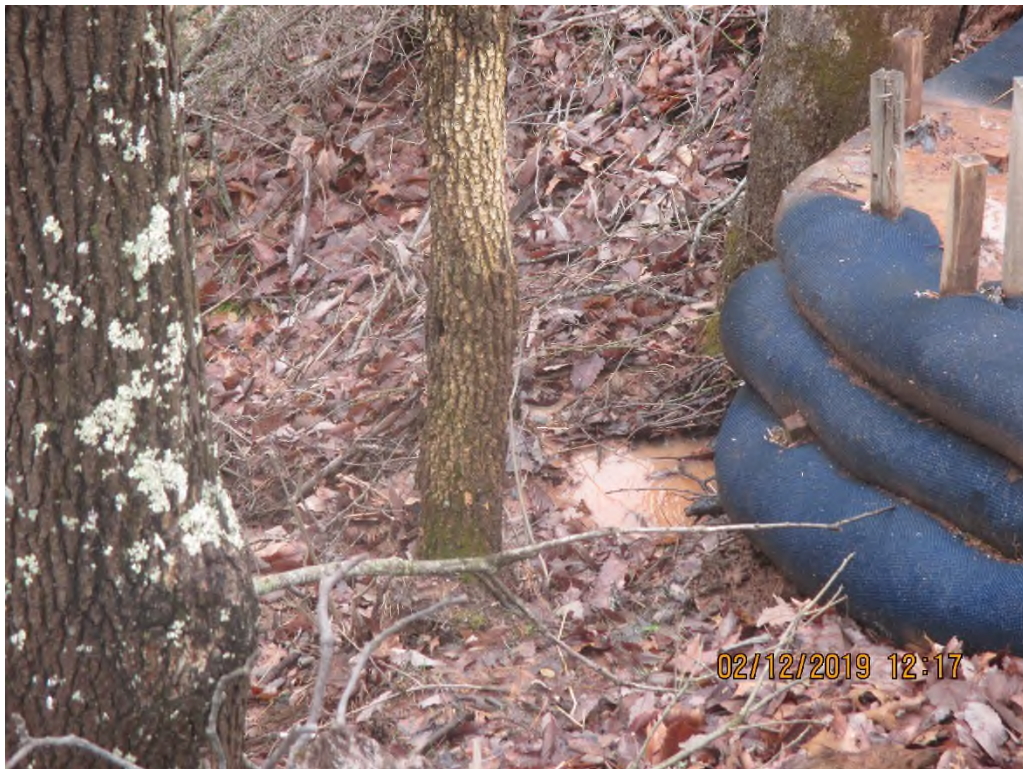
Perimeter control at station #5359+00

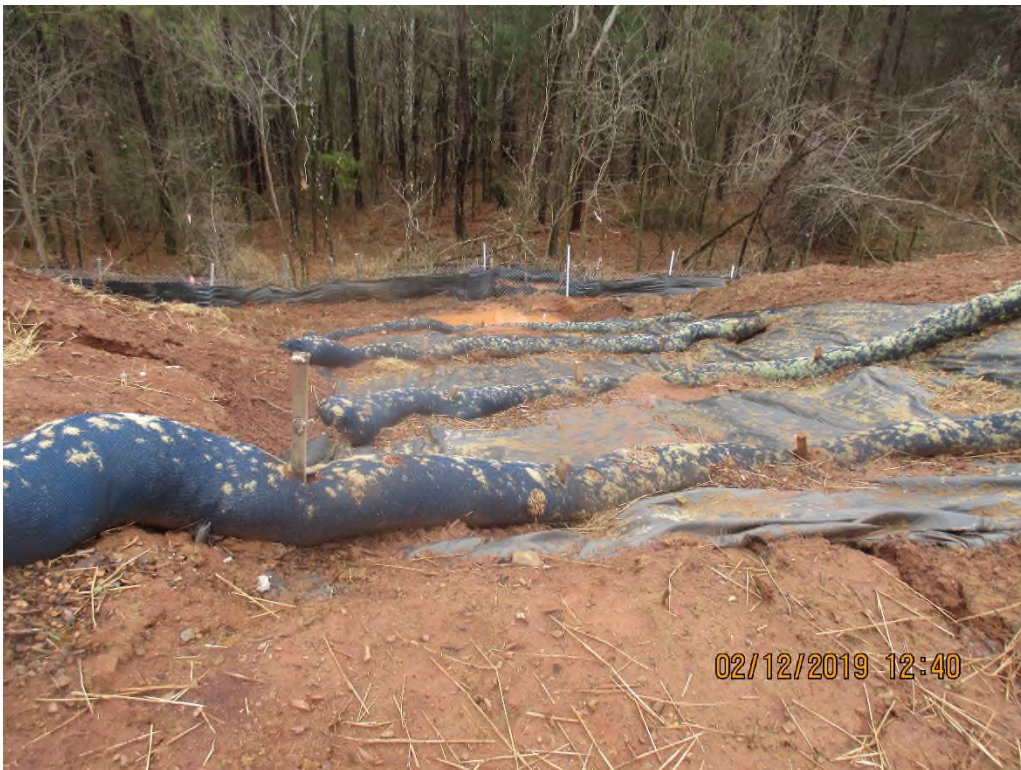
Facing South towards waterbar outlet at station 5376+00

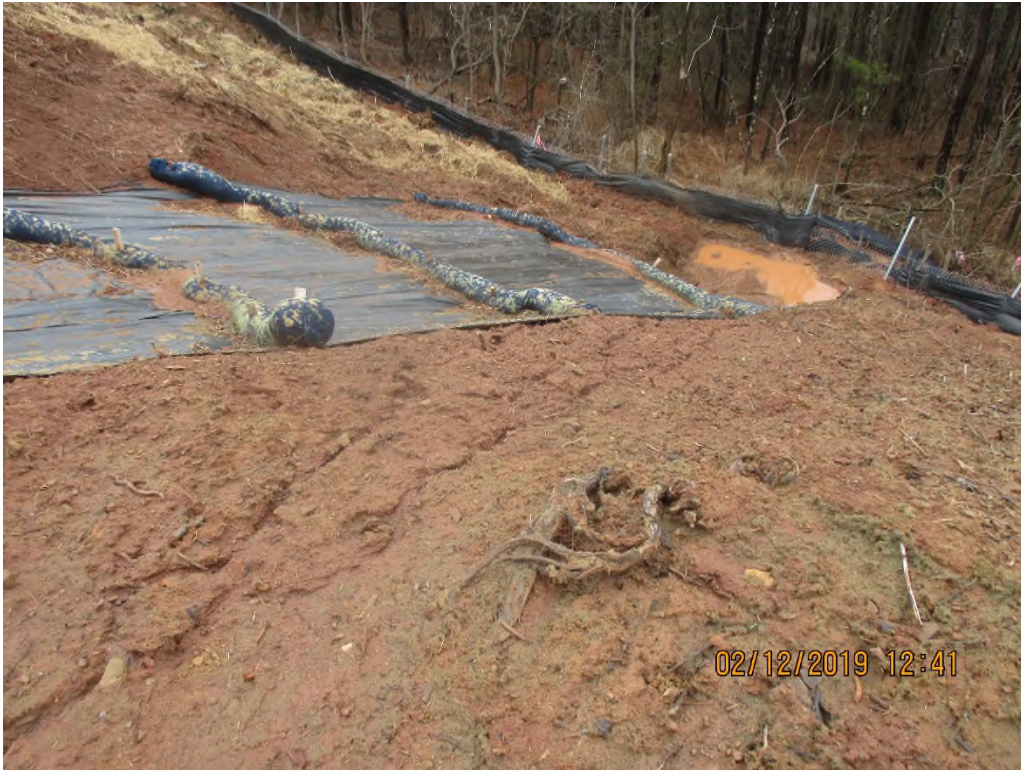
Waterbar outlet at station 5376+00

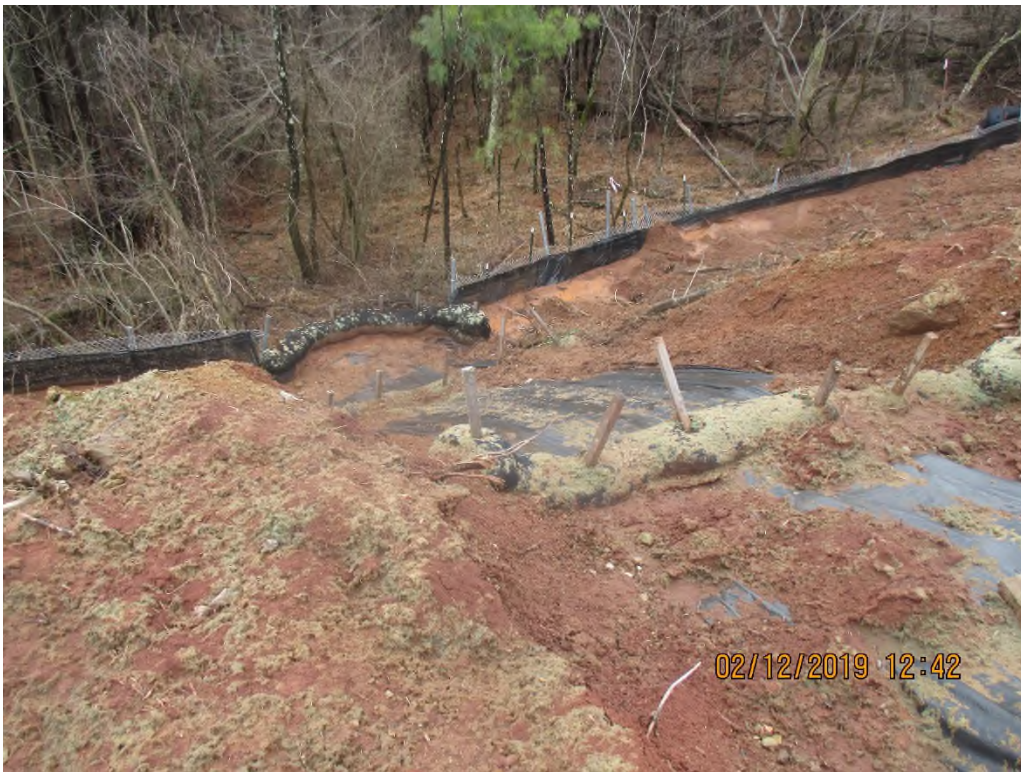
Waterbar outlet near station 5376+00

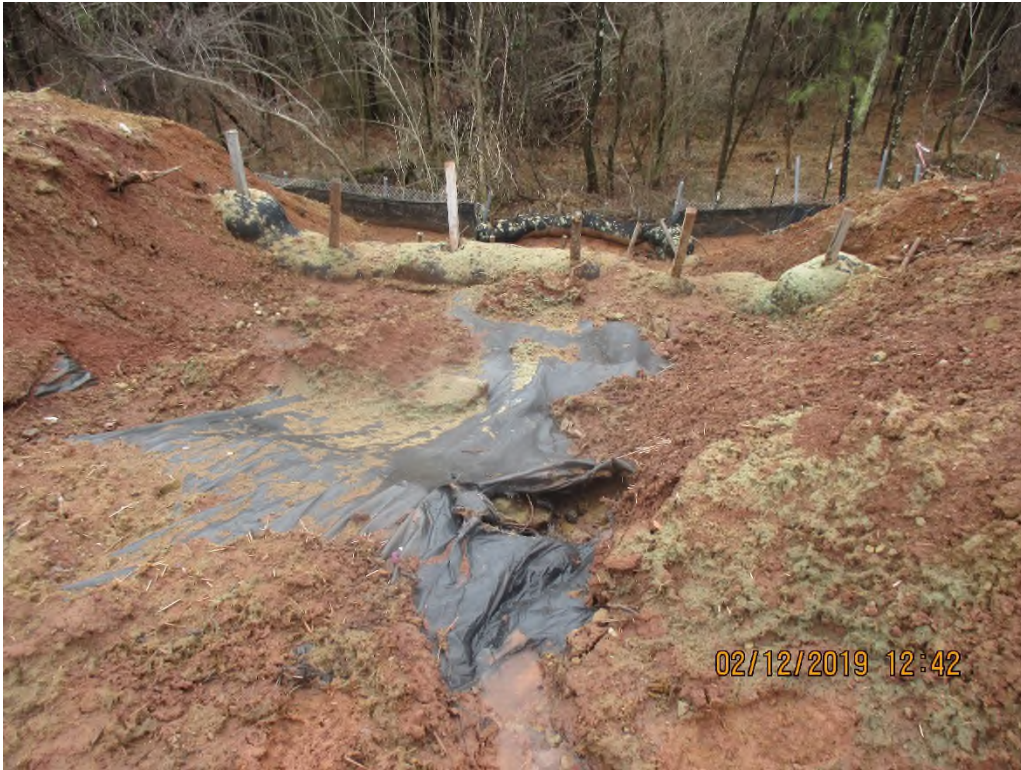
Waterbar outlet near station 5376+00.

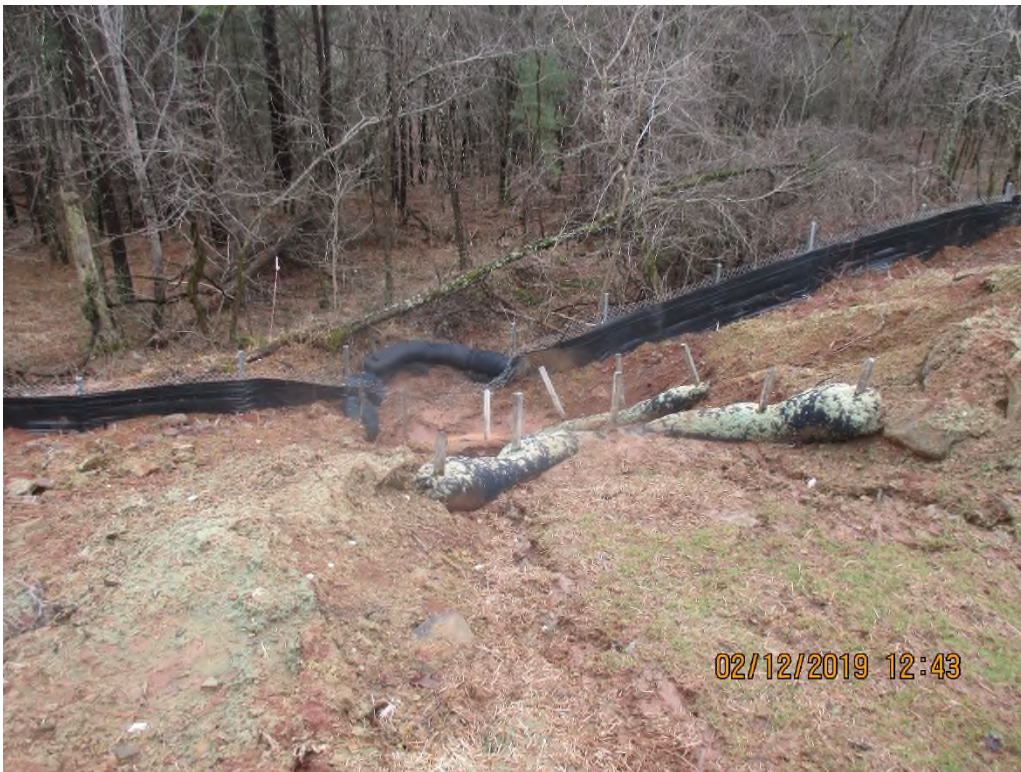
Waterbar outlet near station 5376+00

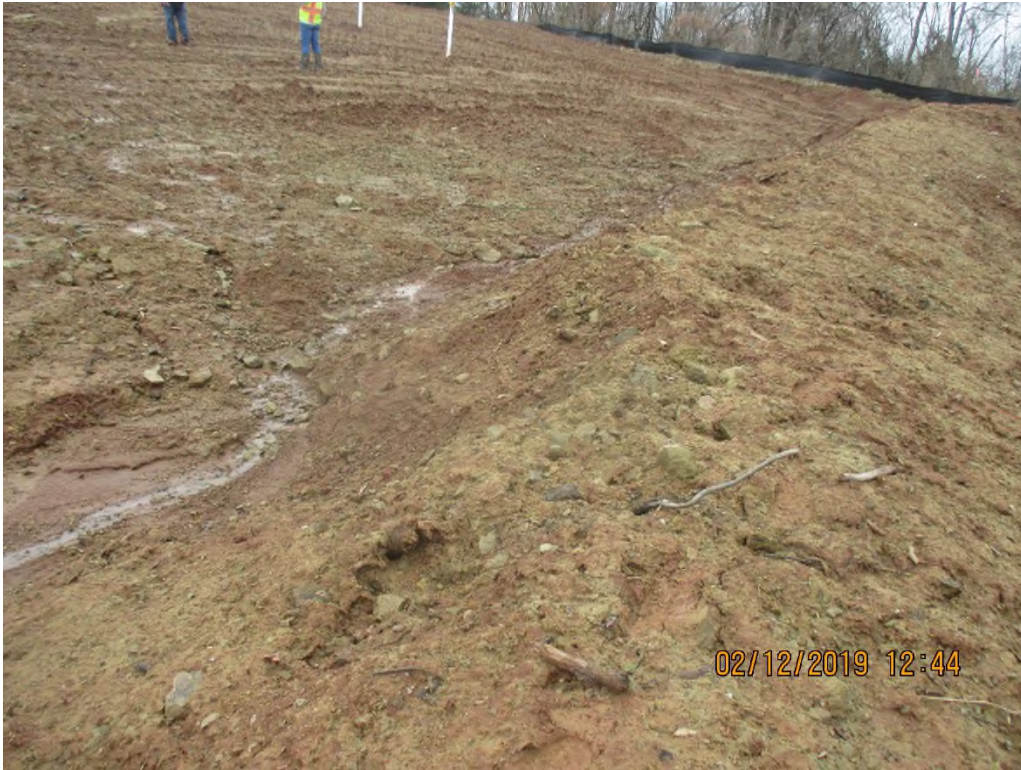
Waterbar outlet near station 5376+00

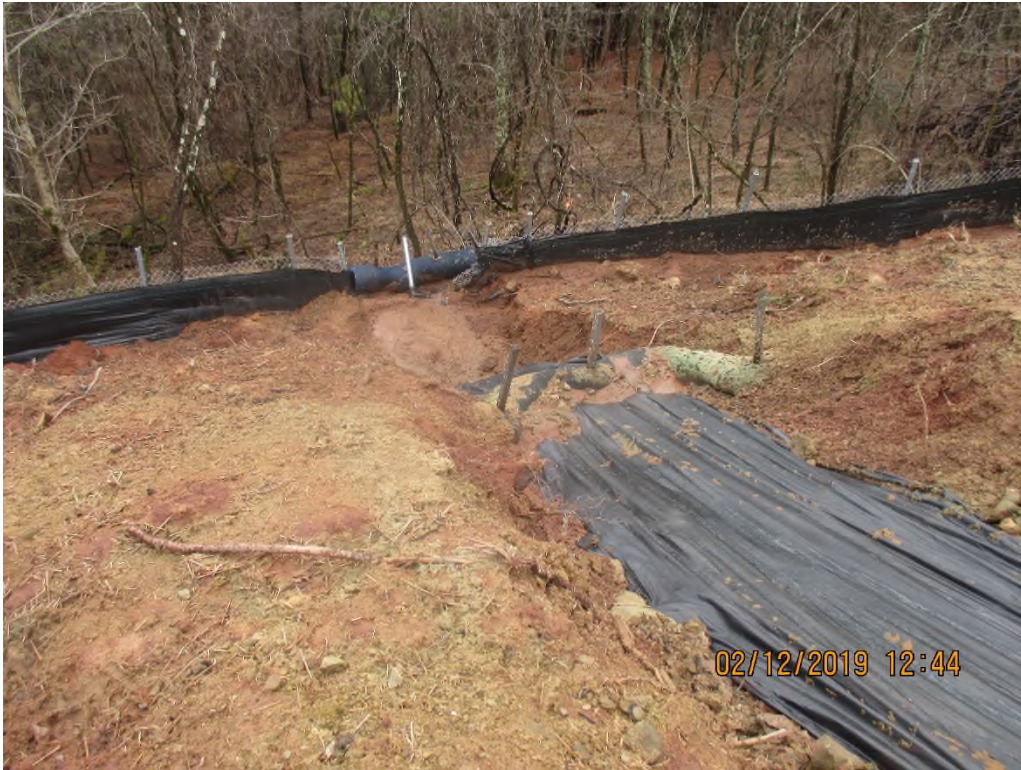
Above mentioned waterbar terminus at top of slope near station #5376+00

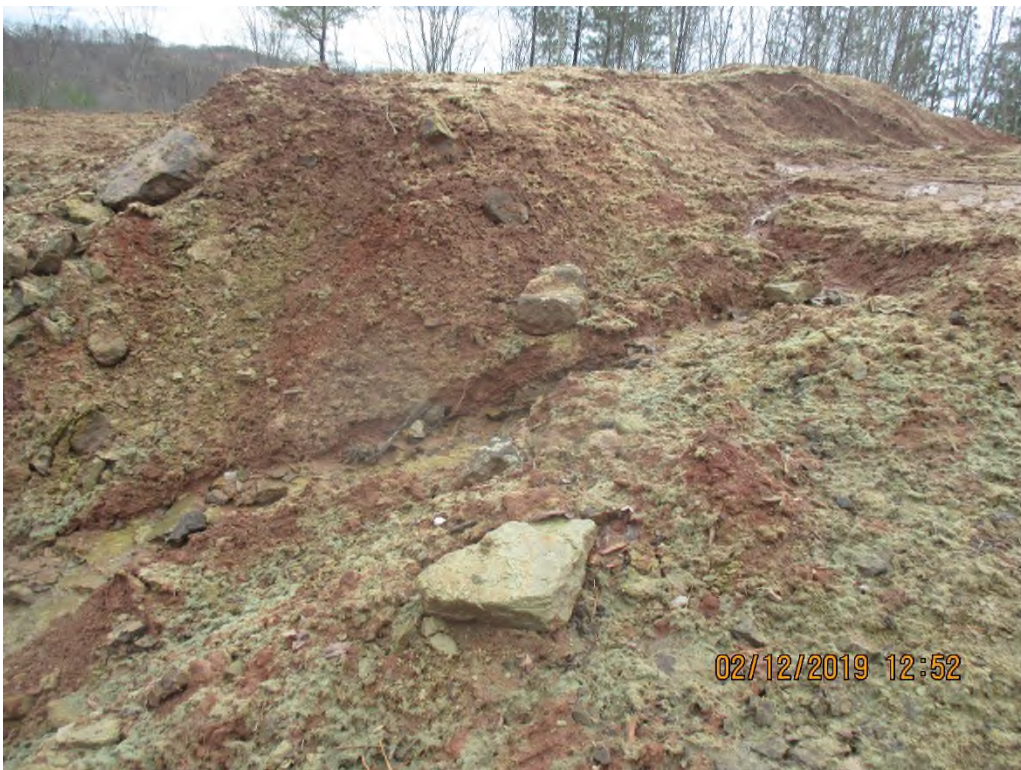
Waterbar outlet at perimeter control. Ephemeral stream impacted with SLW past LOD near station 5376+00

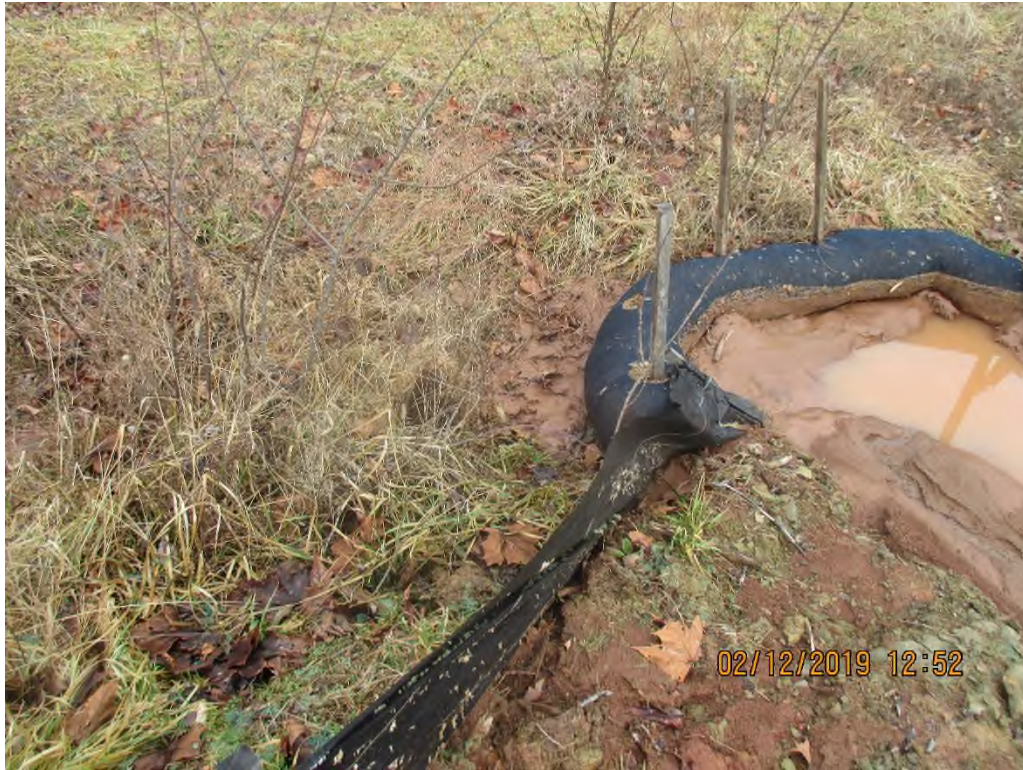
Erosion occurring on slope leading to perimeter control near station 5388+00

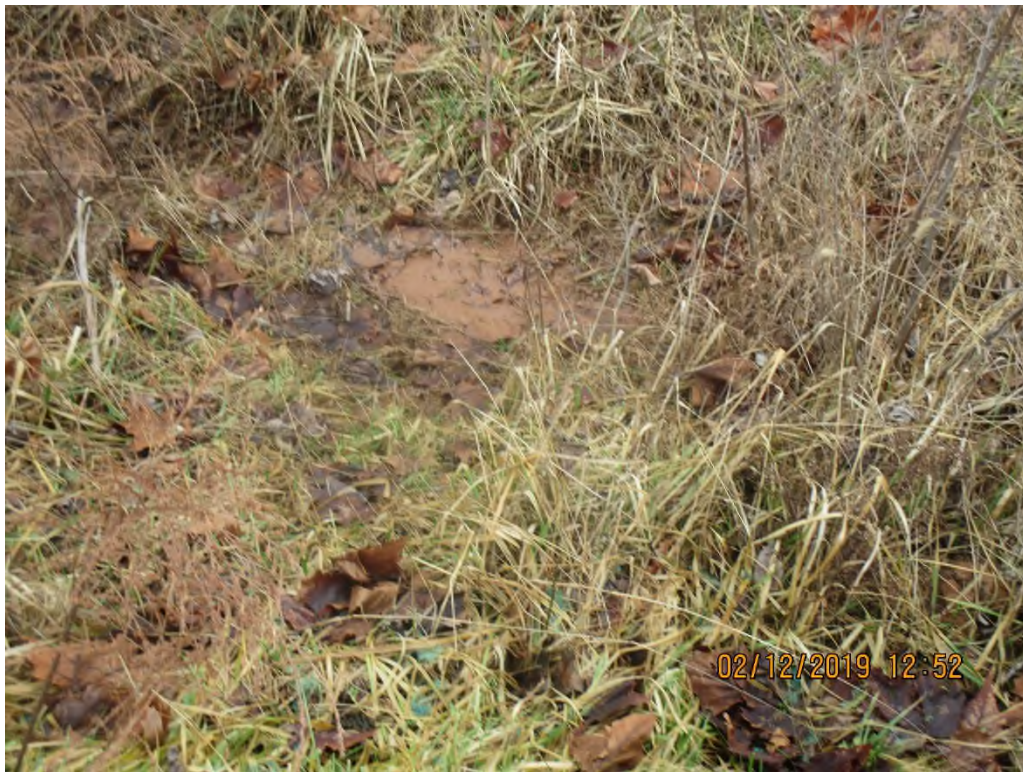
Perimeter control near station 5388+00

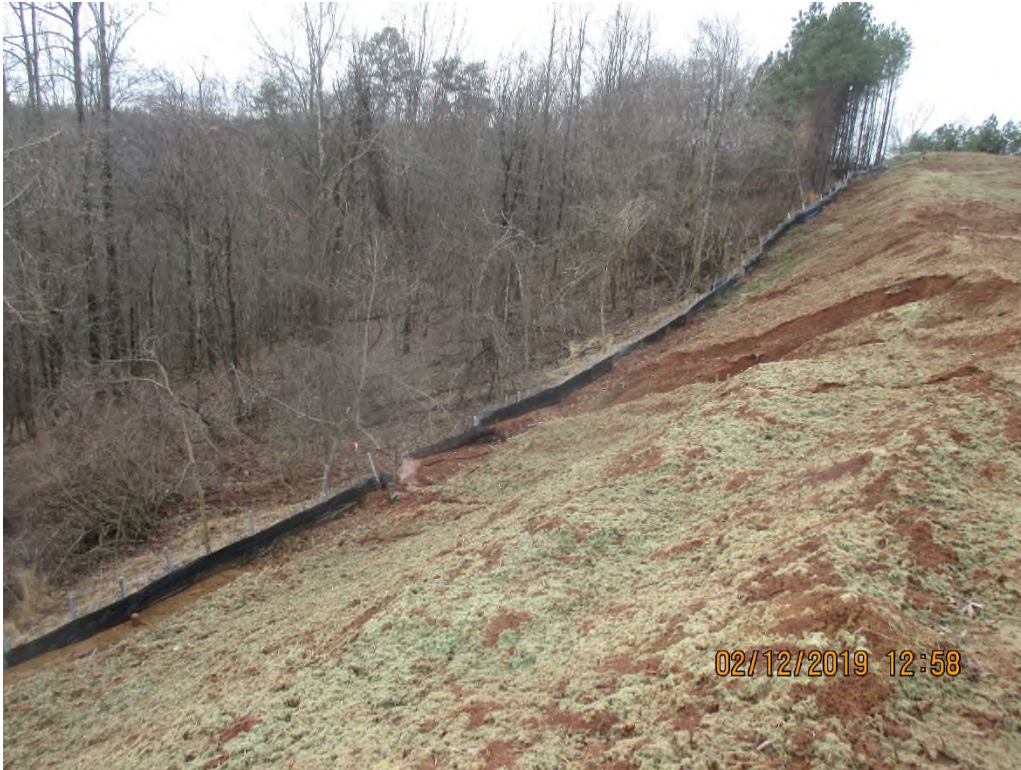
Sediment deposits in conveyance past perimeter controls near station 5388+00

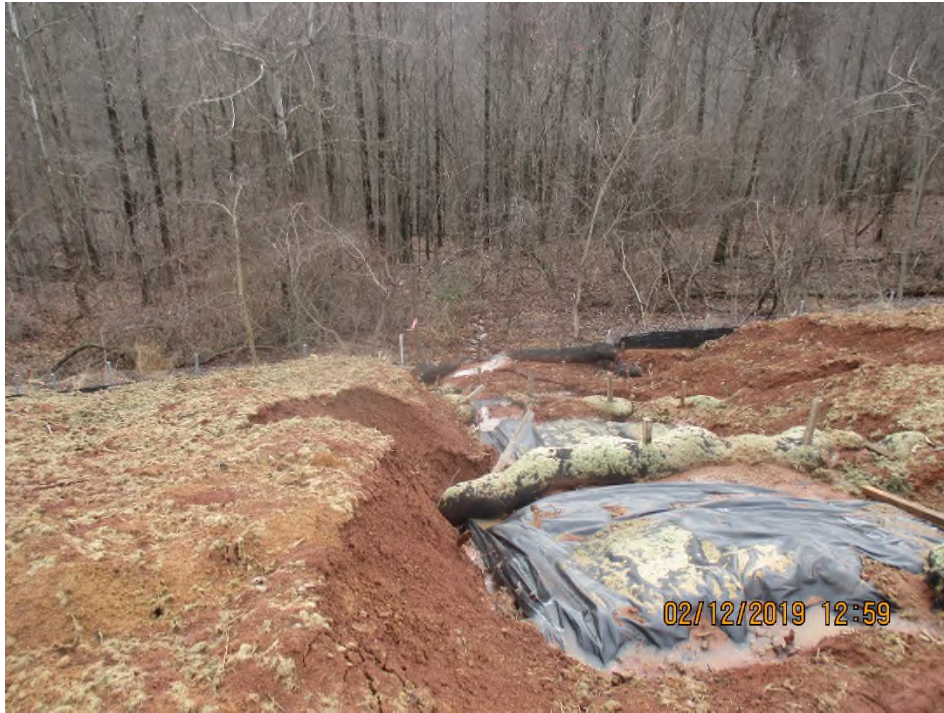
Facing downslope at station 5388+00 at perimeter controls from top of slope

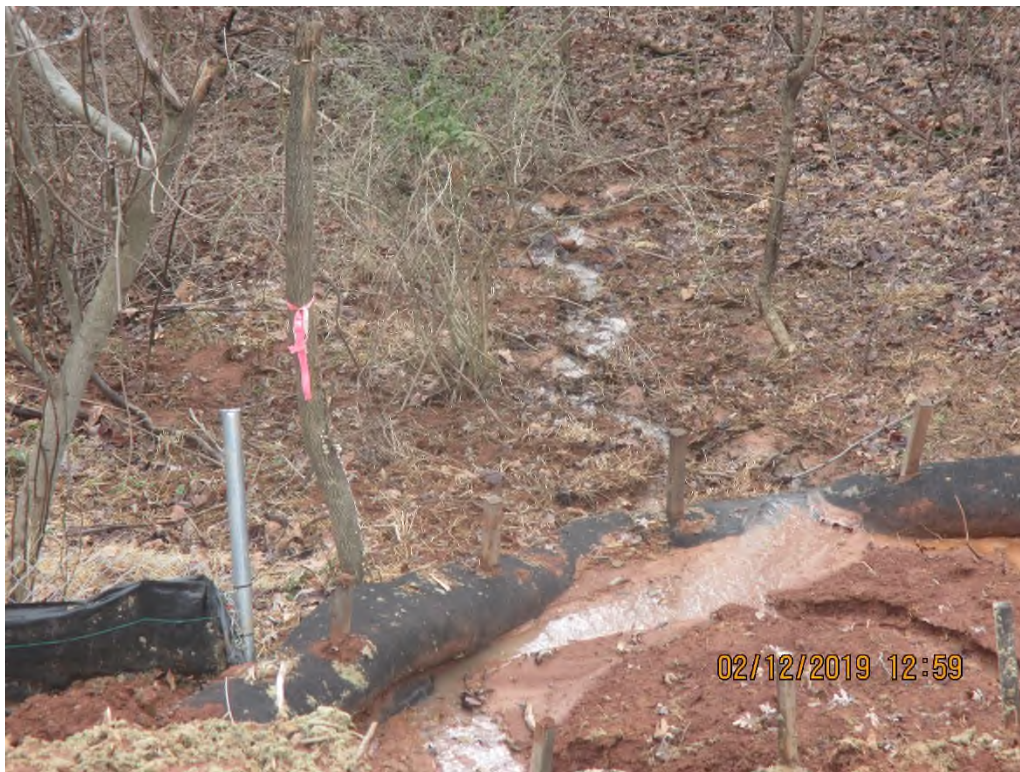
Facing downslope at station 5388+00 at perimeter controls from top of slope
