**CONSENT ORDER
ISSUED UNDER THE
WATER POLLUTION CONTROL ACT
WEST VIRGINIA CODE, CHAPTER 22, ARTICLE 11**

TO: Columbia Gas Transmission, LLC
Attn: Troy Tally, Vice President
1700 MacCorkle Ave
Charleston, WV 25314

DATE: October 1, 2020
ORDER NO.: 9061

1. Columbia Gas Transmission, LLC is conducting land disturbance activity associated with construction of the Mountaineer Xpress Project in Marshall, Wetzel, Tyler, Doddridge, Ritchie, Calhoun, Wirt, Roane, Jackson, Mason, Putnam, and Cabell Counties, West Virginia. On January 31, 2018, Columbia Gas Transmission, LLC was issued Water Pollution Control Permit No. WV0116815, Registration No. WVR310872, for Stormwater Associated With Oil and Gas Related Construction Activities.

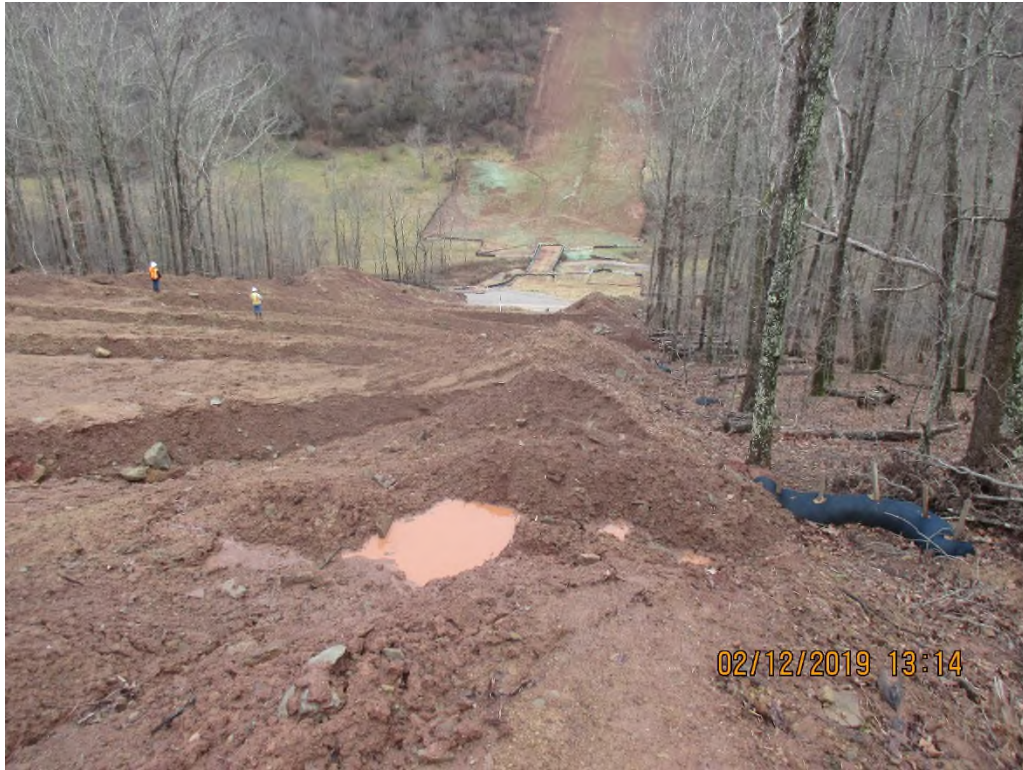
Facing downslope at station 5388+00 at perimeter controls from top of slope. SLW flowing past controls and into ephemeral stream

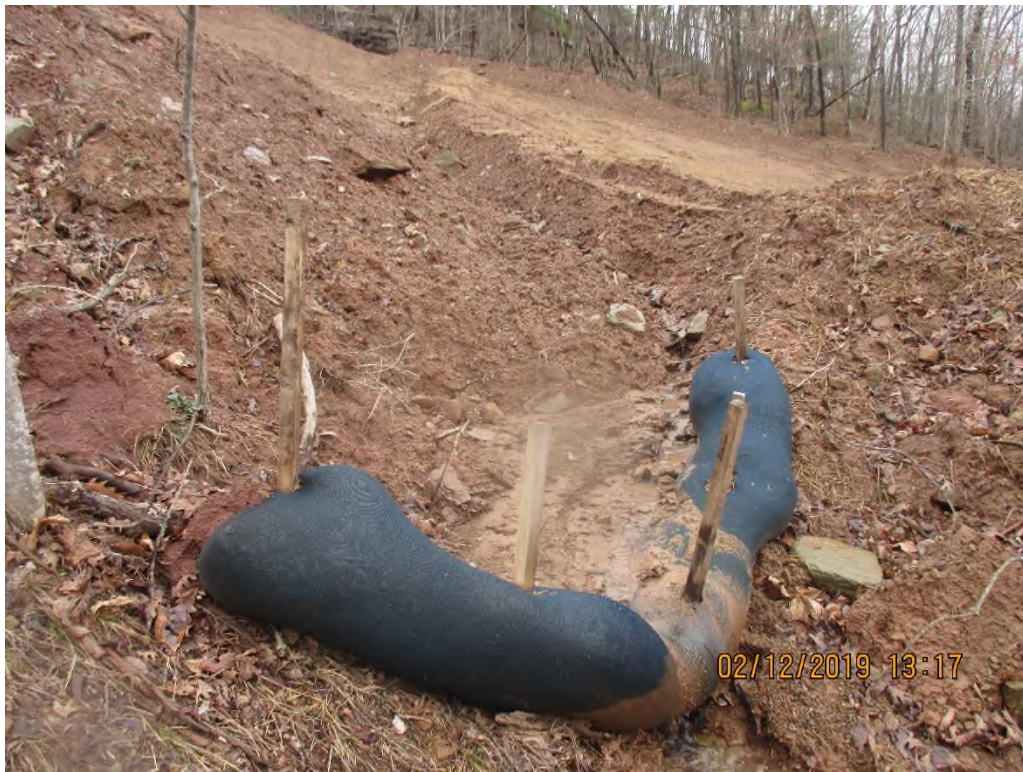
Waterbar outlets near station #5398+00 facing South

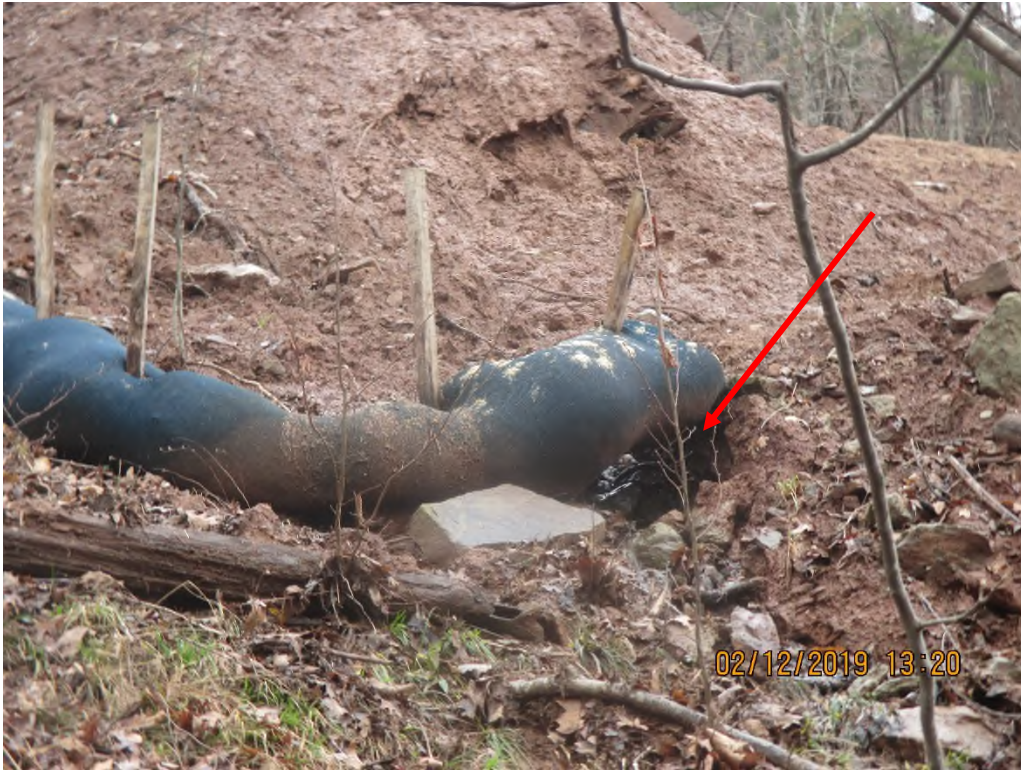
Waterbar Outlet #1 near station #5398+00 facing upslope

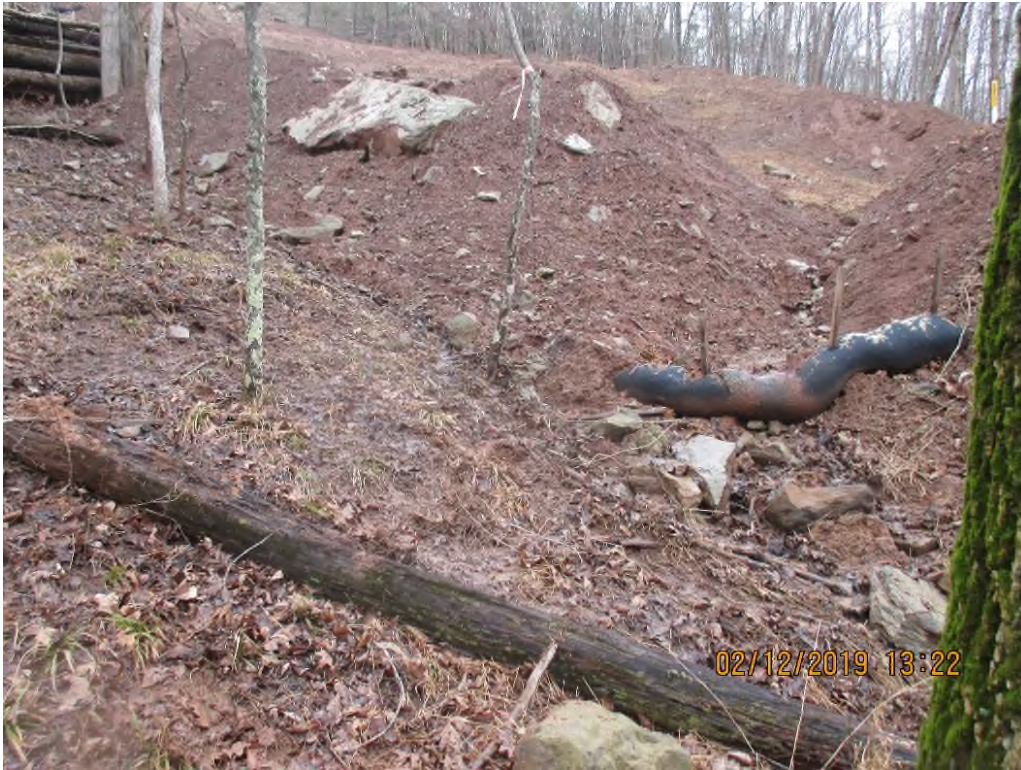
Runoff from waterbar outlet running downslope towards log pile off LOD

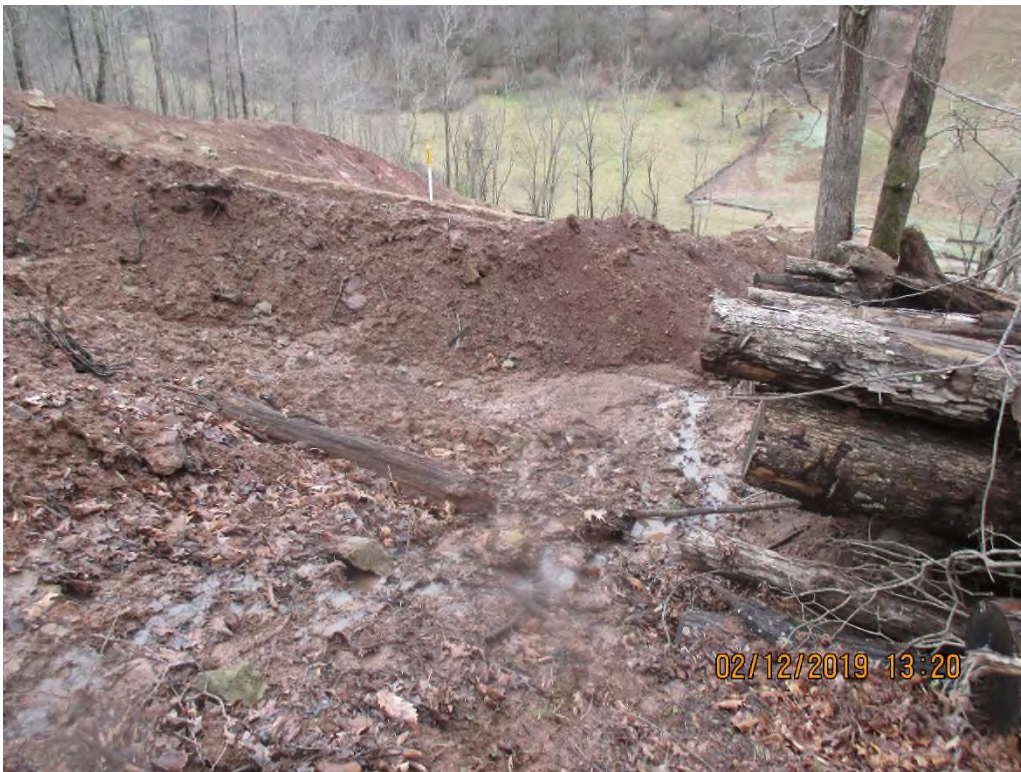
Waterbar outlet downslope of log pile near station 5400+00.

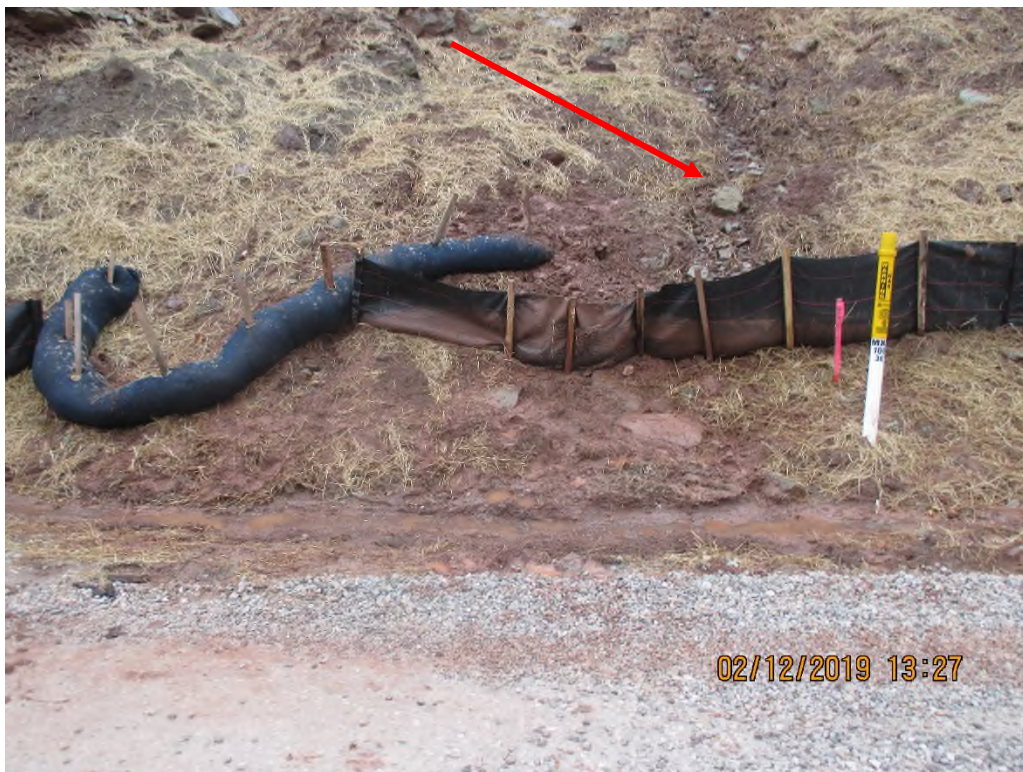
Facing North upslope at Munchausen Road crossing station #5407+07

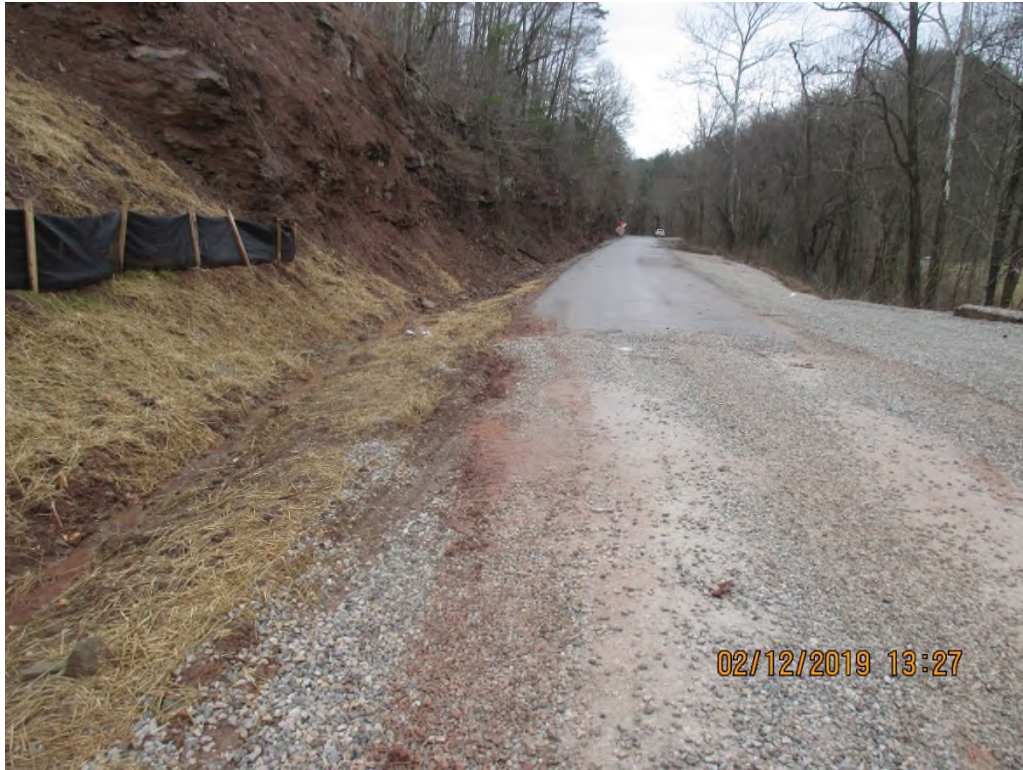
Sediment deposits present along Munchausen Road ditch station #5405+07. Erosion occurring above controls on ROW.

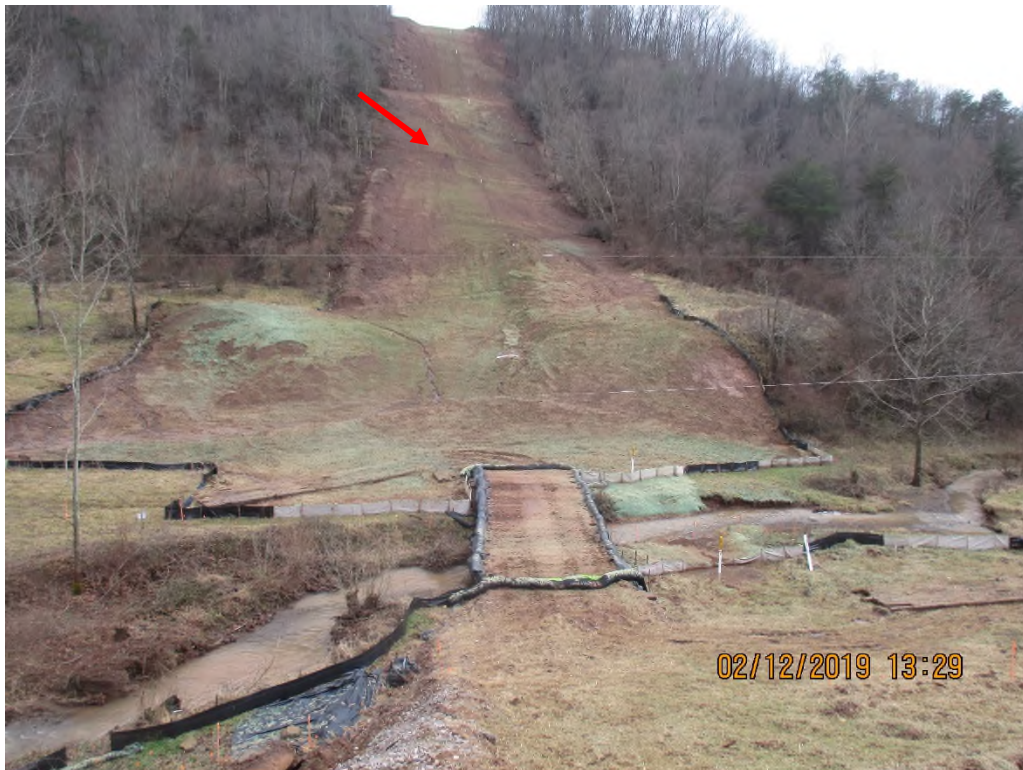
Munchausen Road crossing at station #5407+07 facing East

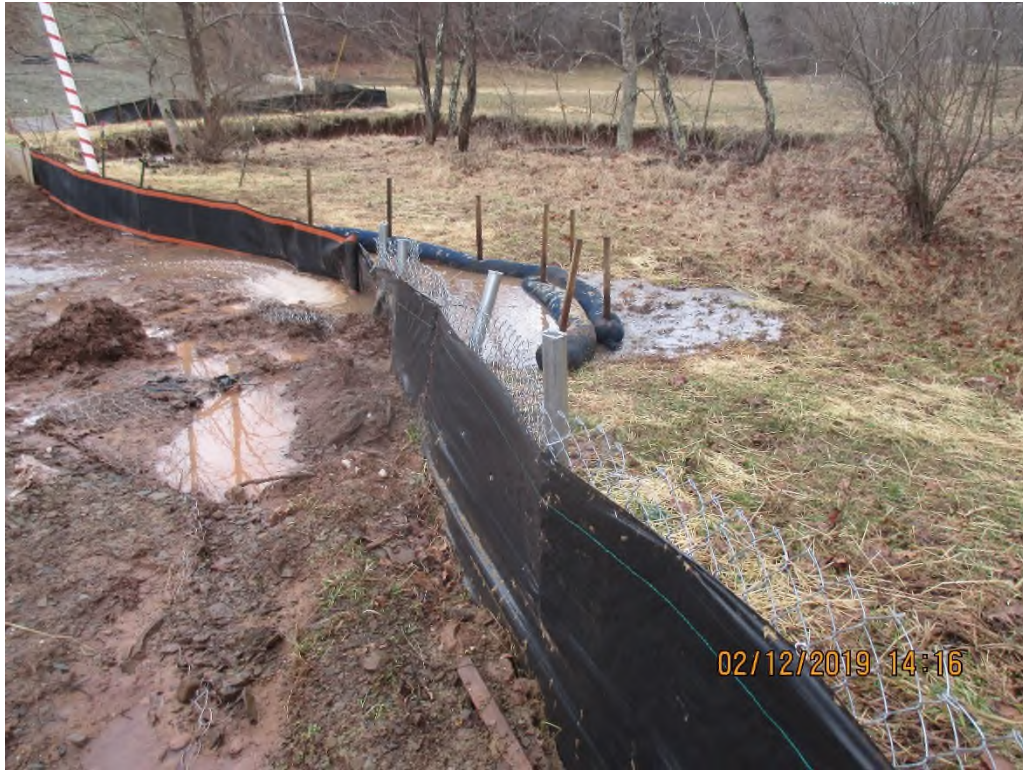
Stutler Road Crossing at station 5453+84 facing south at stream SROC-002

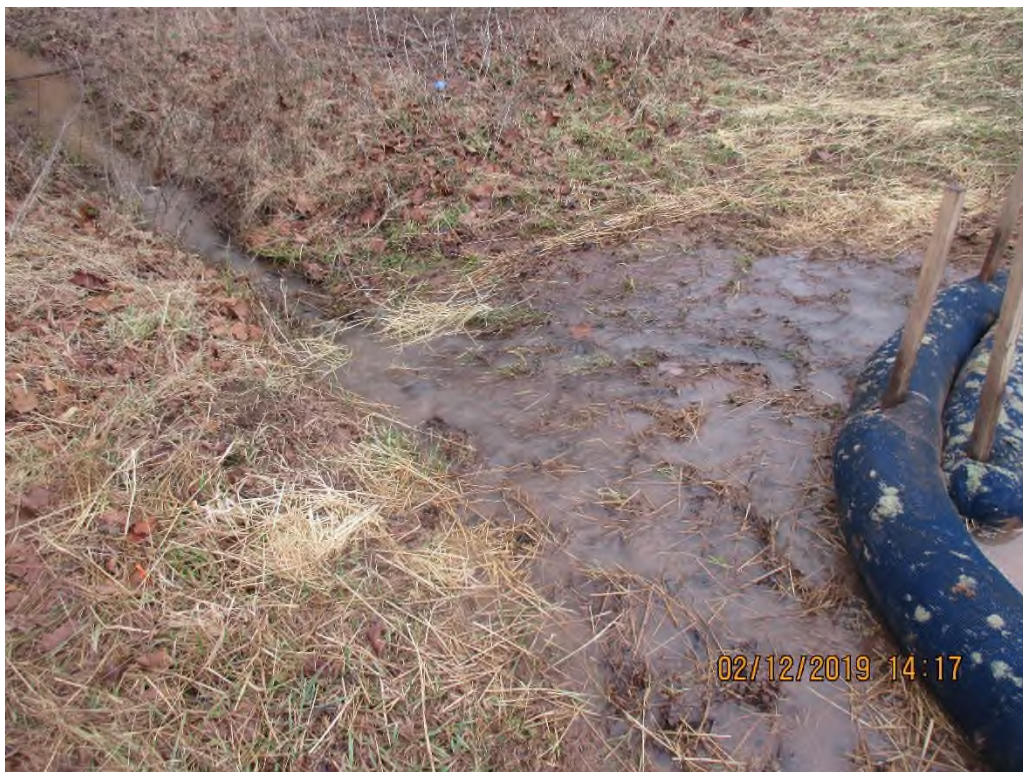
Stutler Road Crossing at station 5453+84 facing south at stream SROC-002

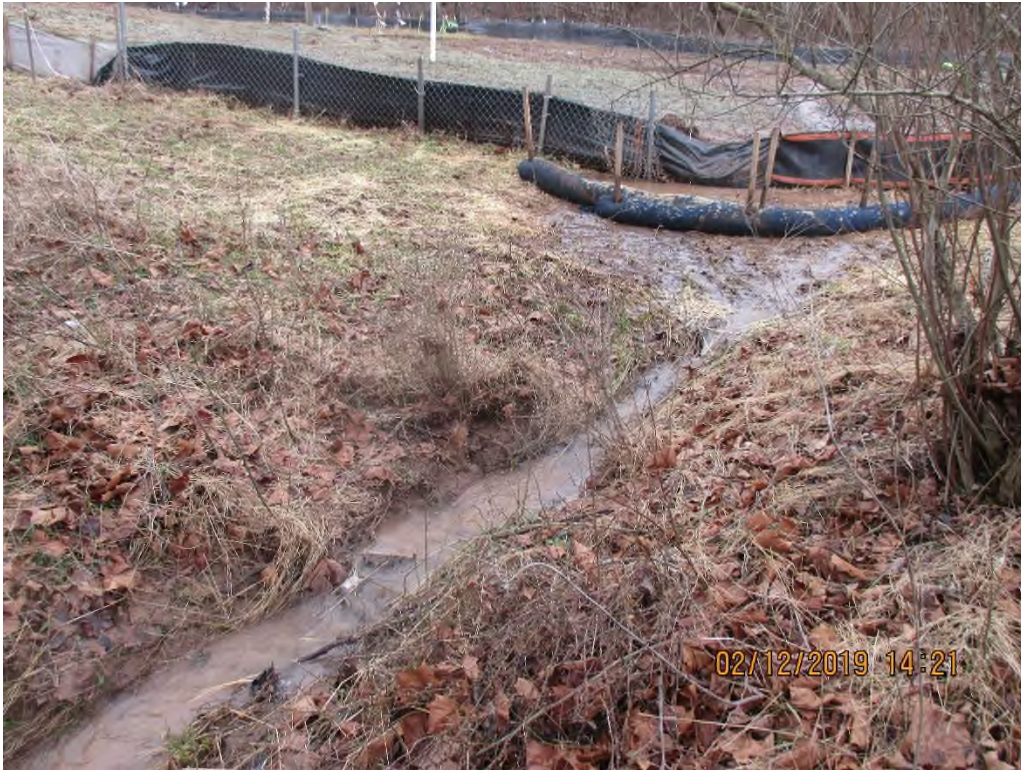
SLW flowing under controls at station #5453+84

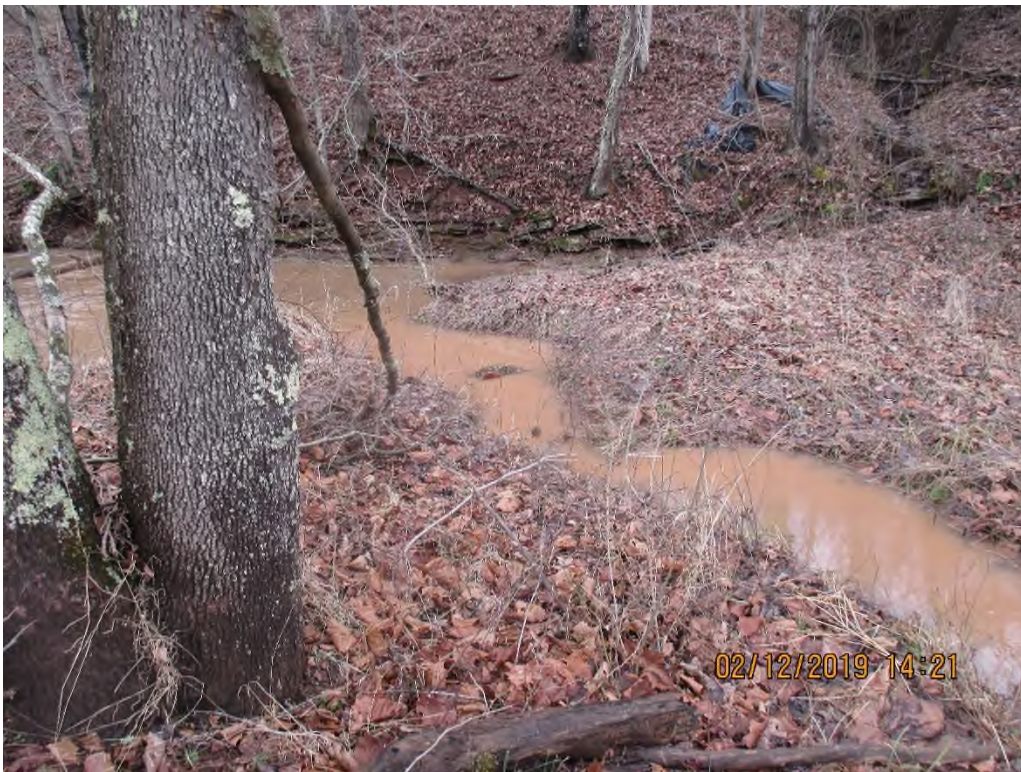
Near station 5453+84 facing upslope at controls

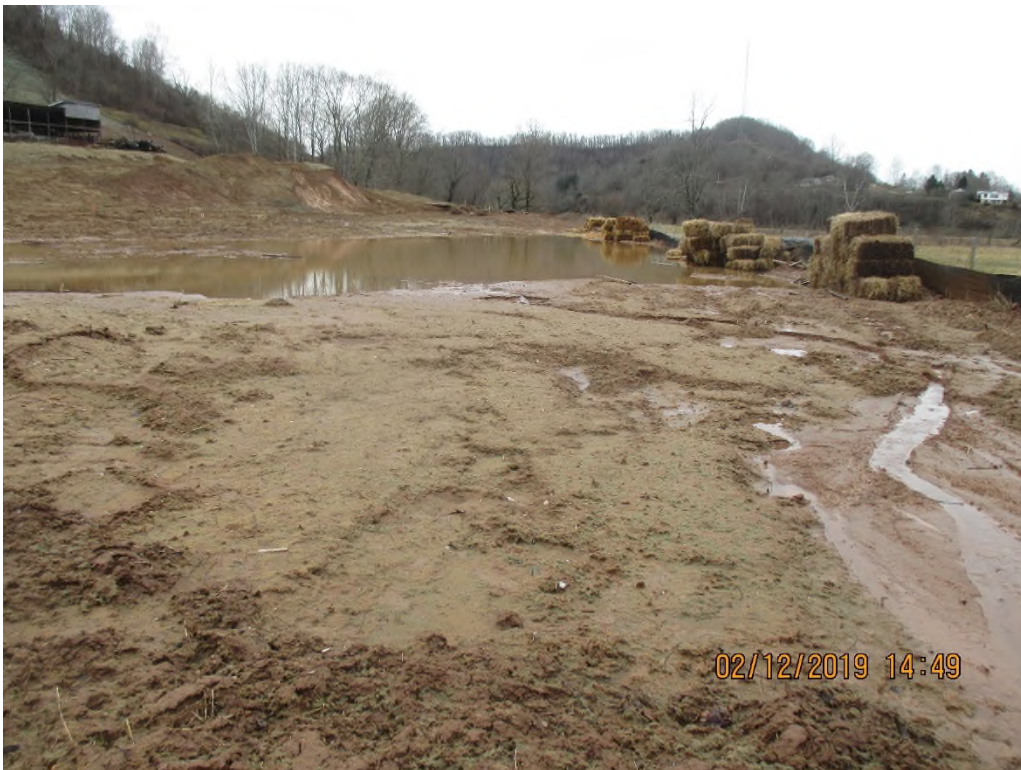
Standing at stream SROC-030 facing South at Hwy 14 crossing

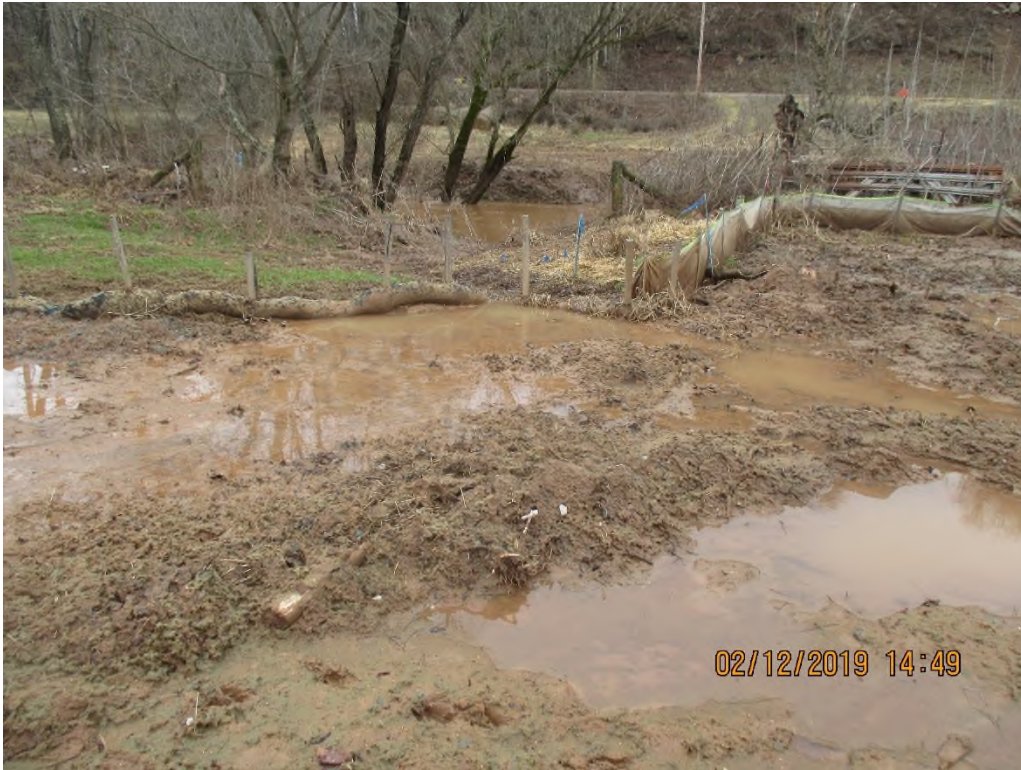
Work space below MXP ROW facing Northeast

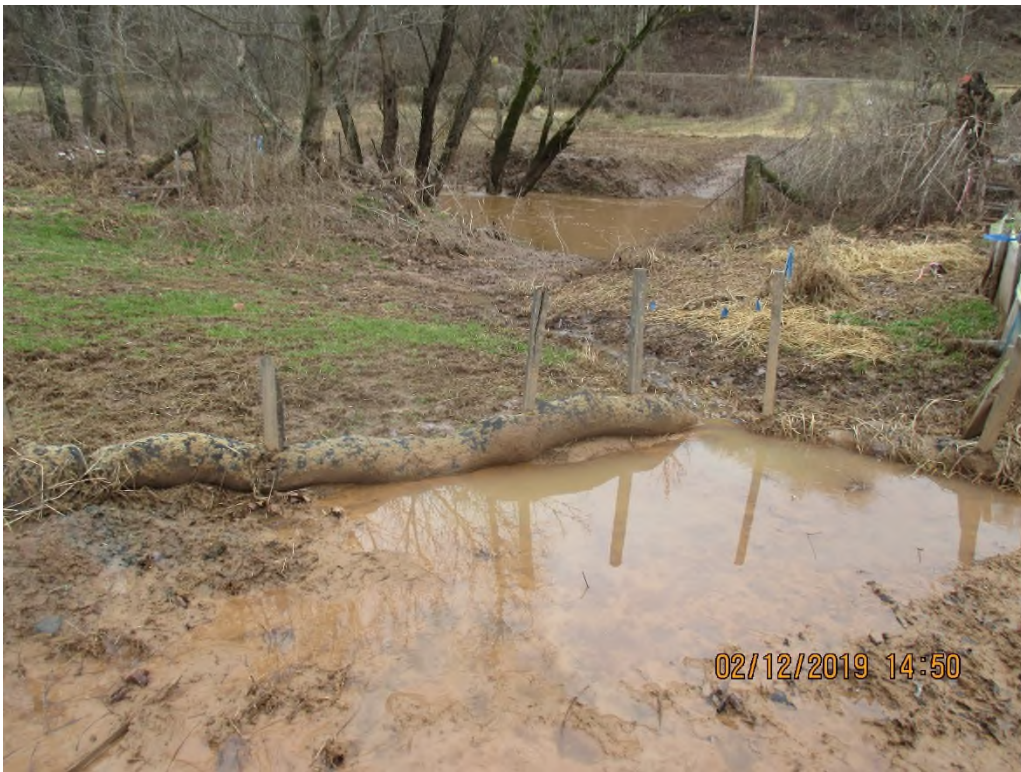
North Side stream SROC-030 facing South at controls

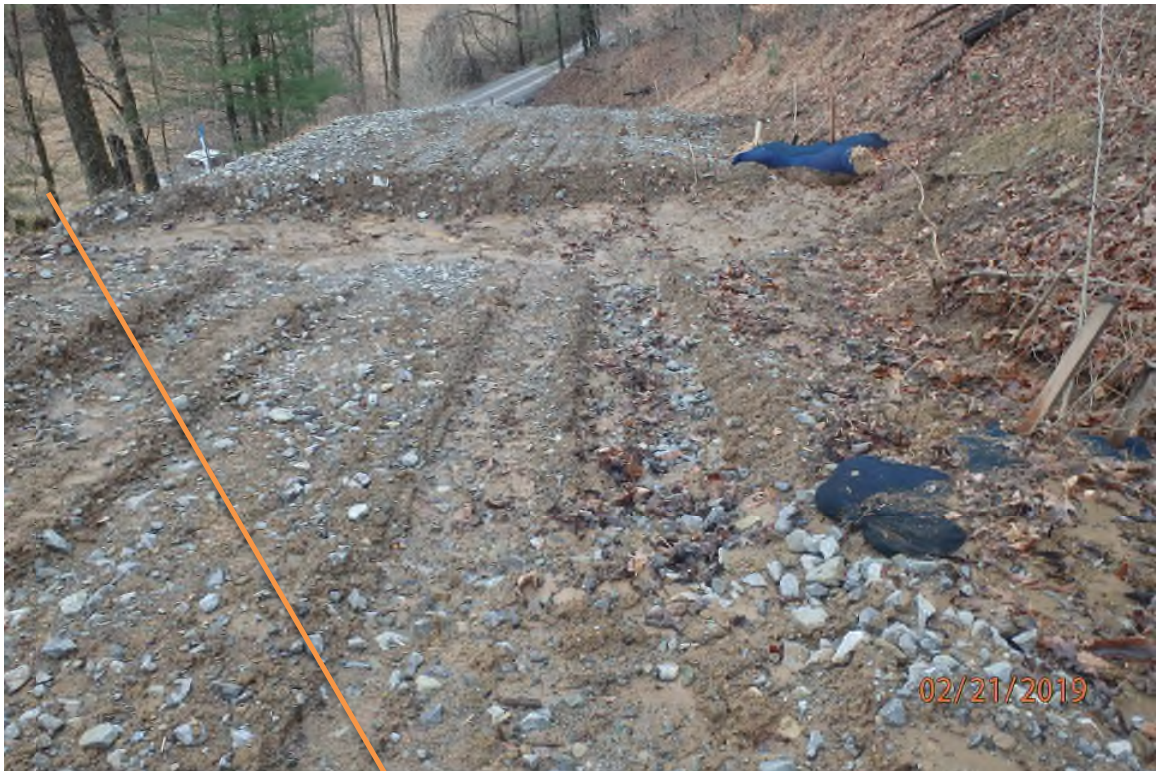
SLW leaving site upslope of Stream SROC-030

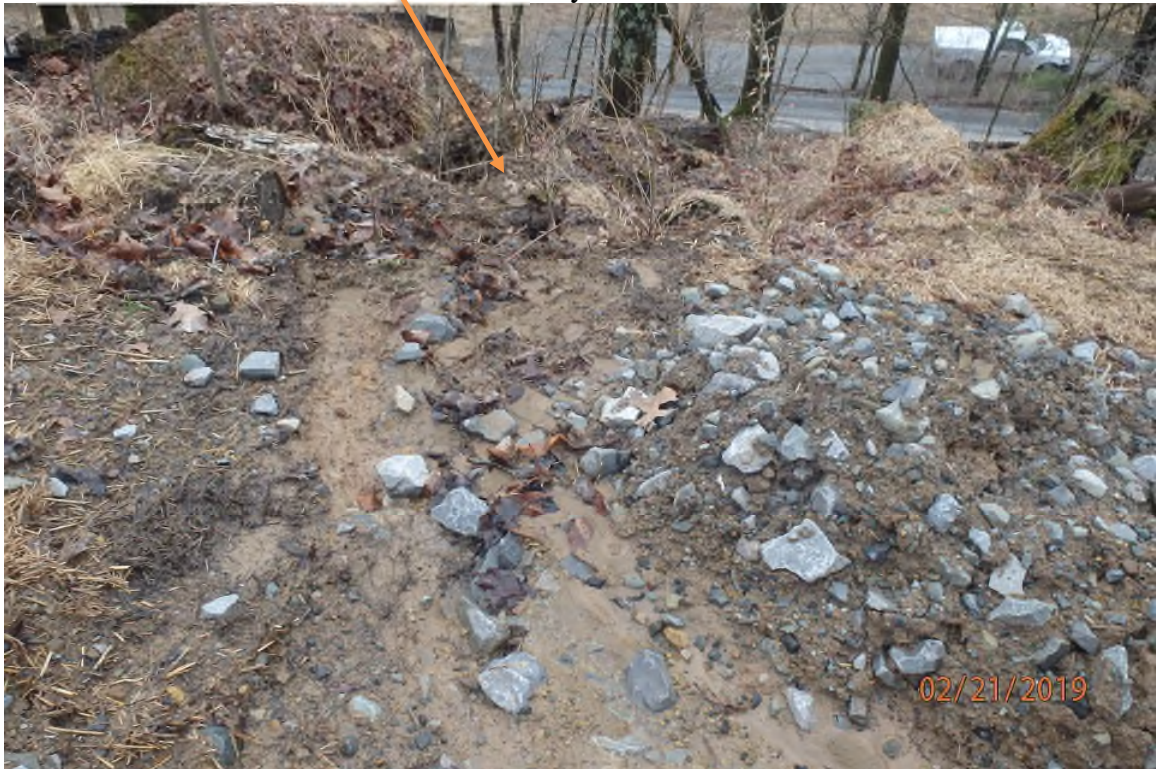
ARDO002.8 - lack of culverts to carry stormwater beneath the road surface.

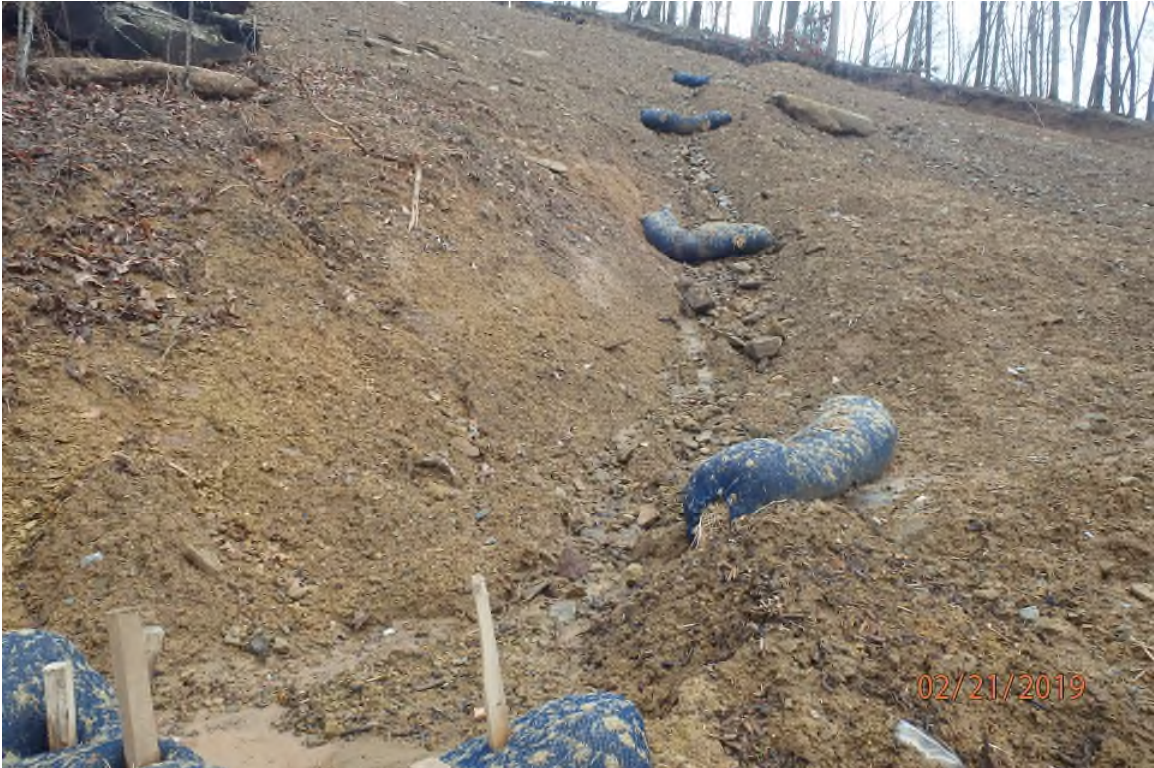
Water bar outlet on ARDO002.8 that lacks a water bar terminus BMP.

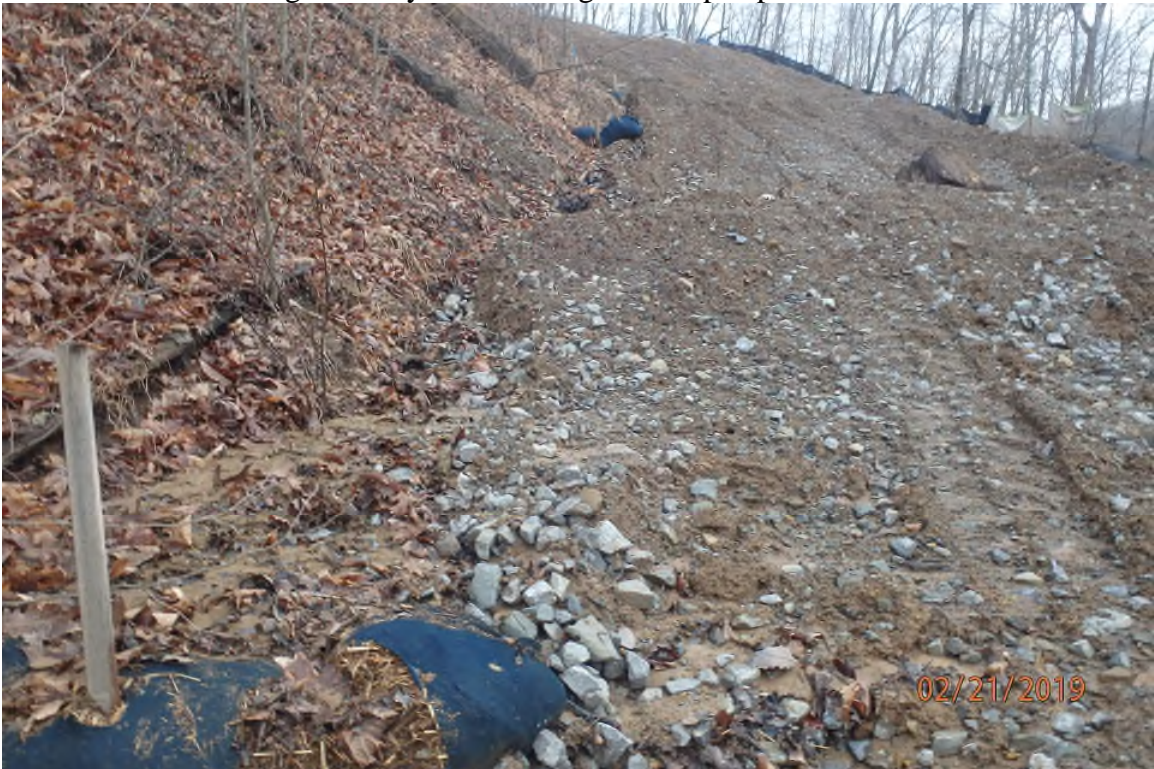
Water bar on right of way that discharges into upslope ditch of ARDO002.8

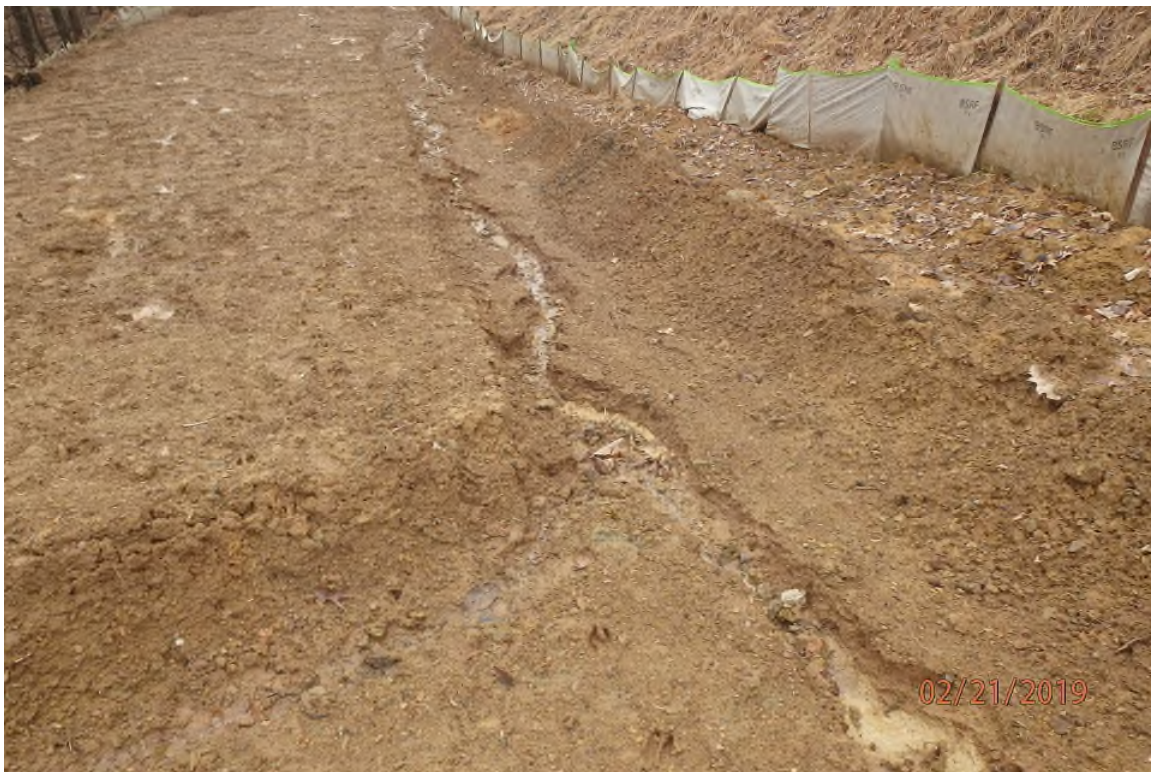
Project area adjacent to 2256+00 showing improperly installed water bars and the associated fill slope erosion.

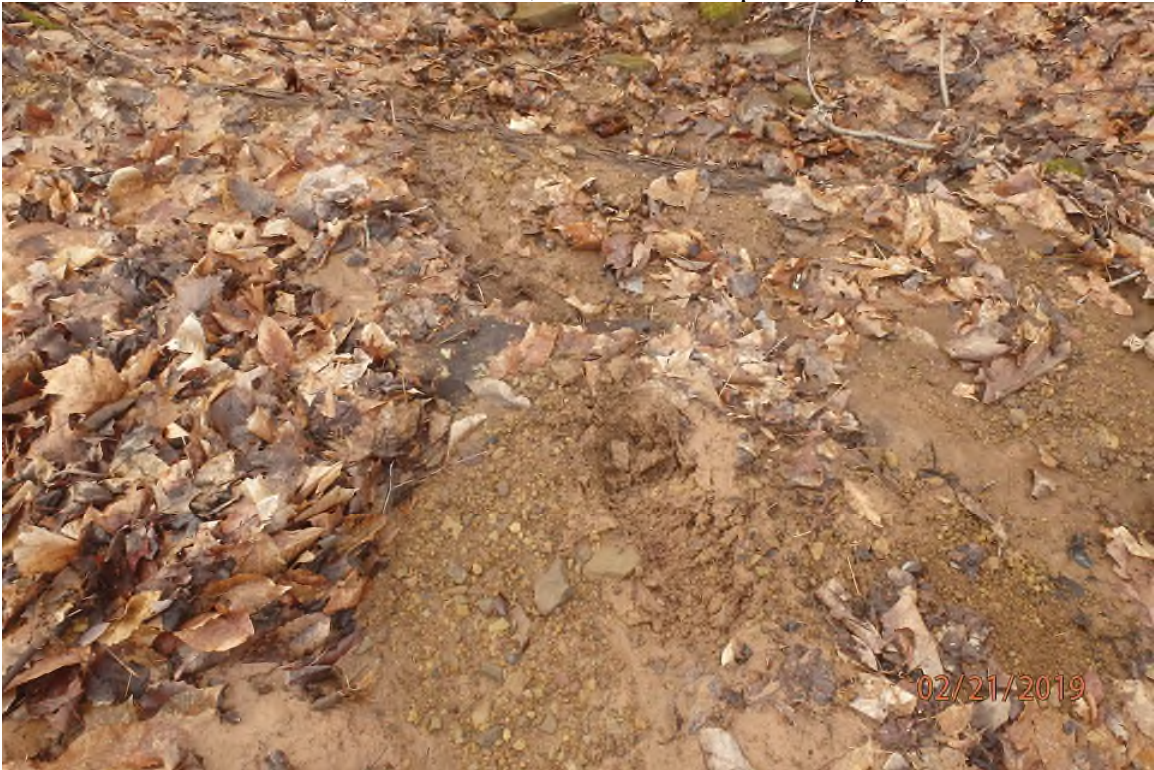
Improperly installed perimeter control adjacent to 2260+00 that allows sediment laden water to bypass the device.

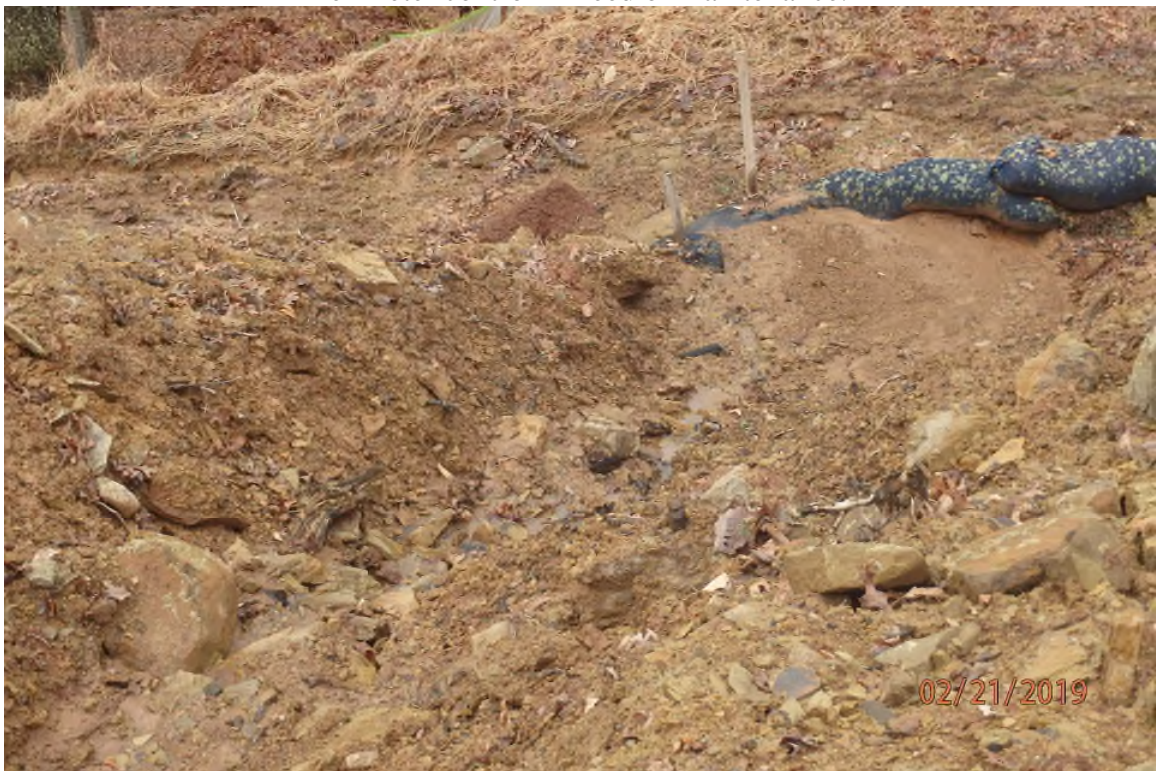
Perimeter control in need of maintenance.

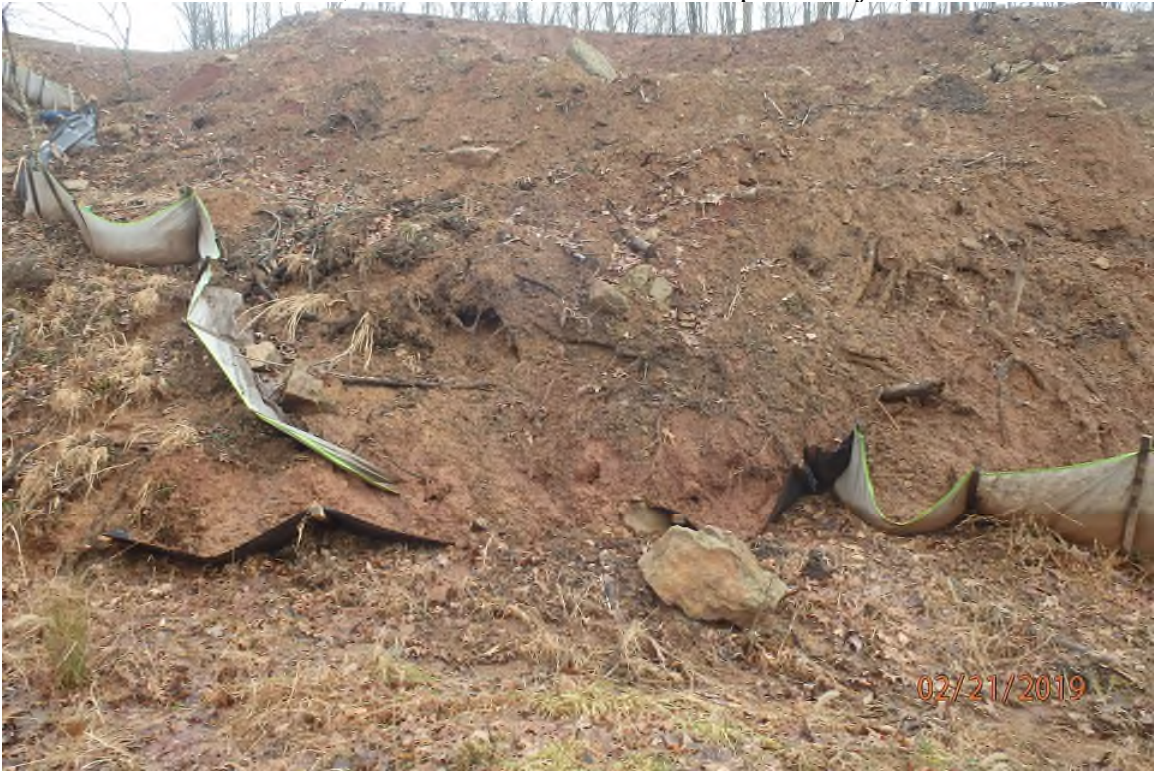
Water bar terminus BMP in need of maintenance.

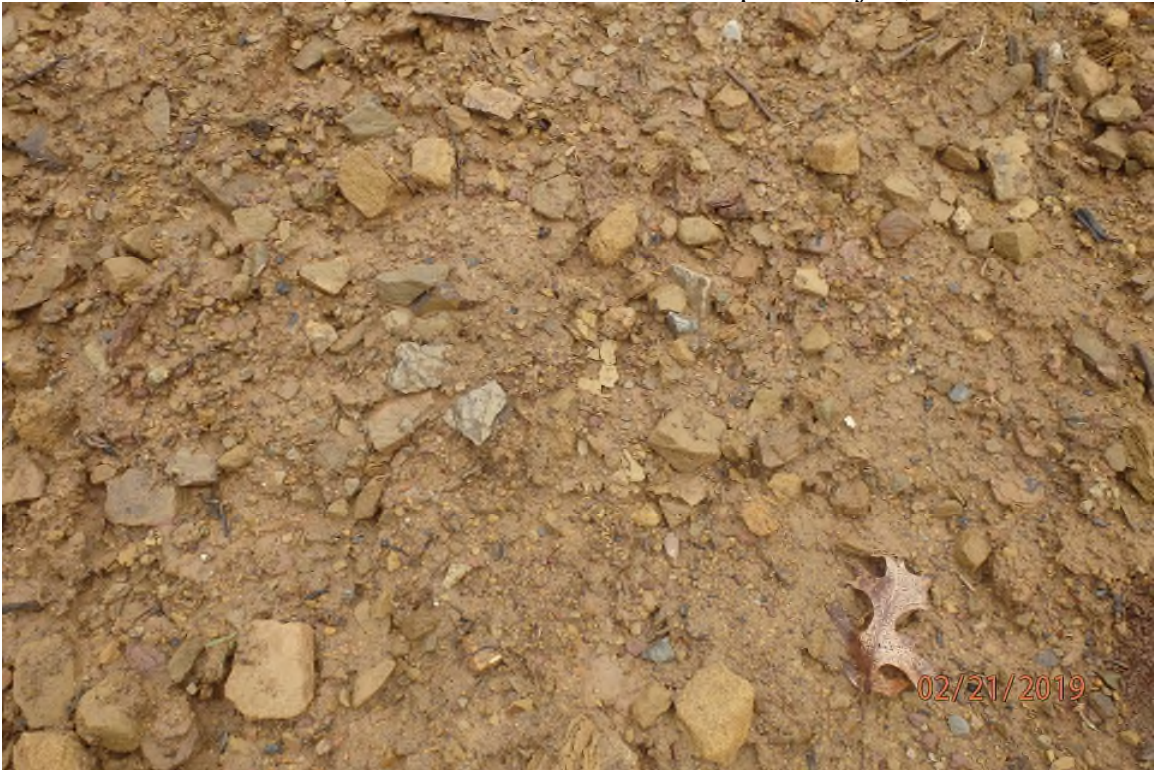
Project area showing the need for maintenance of temporary stabilization.

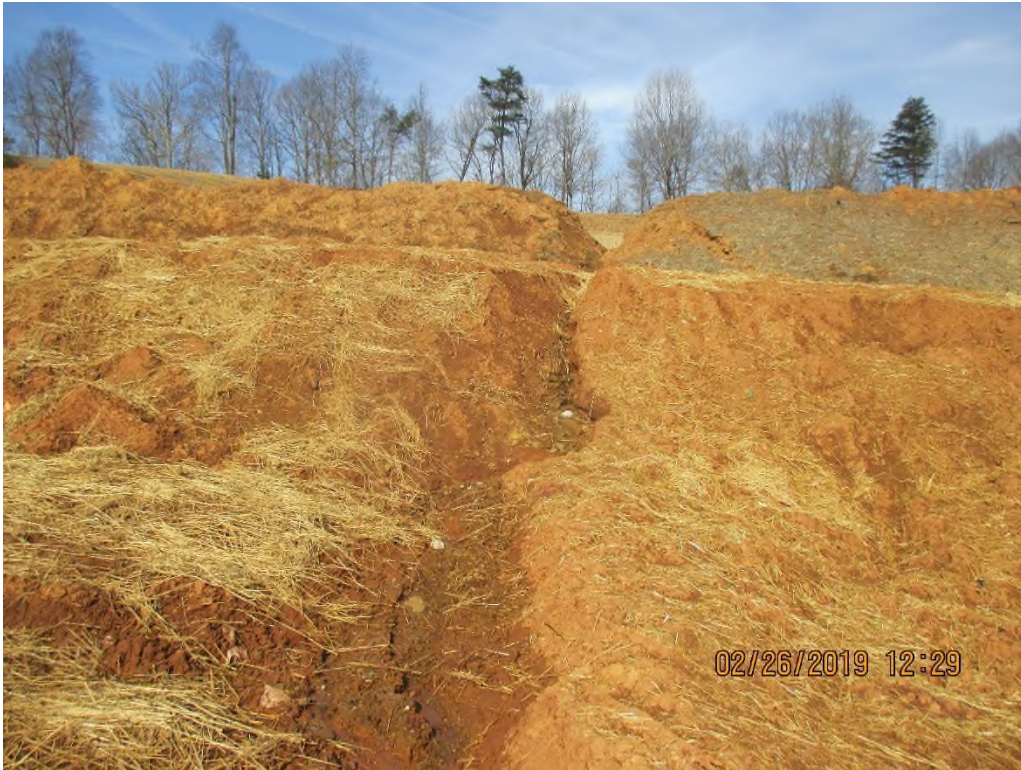
Project area showing the need for maintenance of temporary stabilization.

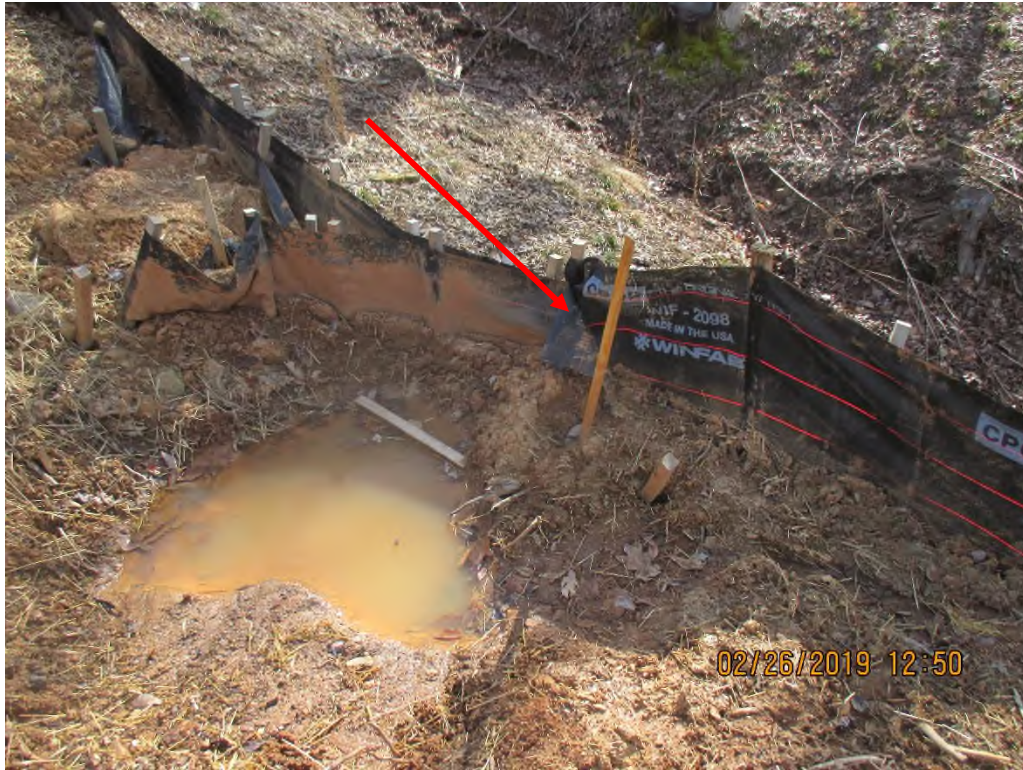
Waterbar above SJAD-009 facing upslope

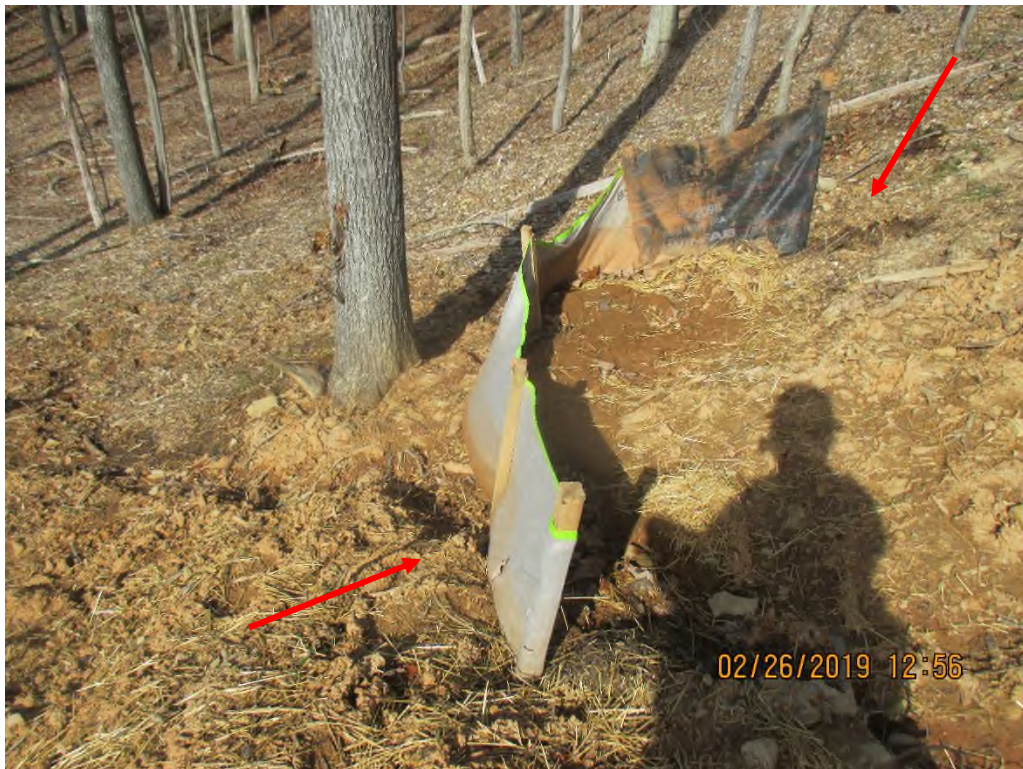
Waterbar outlet above stream SJAD-009. Silt fence not tied into each other.
