**CONSENT ORDER
ISSUED UNDER THE
WATER POLLUTION CONTROL ACT
WEST VIRGINIA CODE, CHAPTER 22, ARTICLE 11**

TO: Columbia Gas Transmission, LLC
Attn: Troy Tally, Vice President
1700 MacCorkle Ave
Charleston, WV 25314

DATE: October 1, 2020
ORDER NO.: 9061

1. Columbia Gas Transmission, LLC is conducting land disturbance activity associated with construction of the Mountaineer Xpress Project in Marshall, Wetzel, Tyler, Doddridge, Ritchie, Calhoun, Wirt, Roane, Jackson, Mason, Putnam, and Cabell Counties, West Virginia. On January 31, 2018, Columbia Gas Transmission, LLC was issued Water Pollution Control Permit No. WV0116815, Registration No. WVR310872, for Stormwater Associated With Oil and Gas Related Construction Activities.

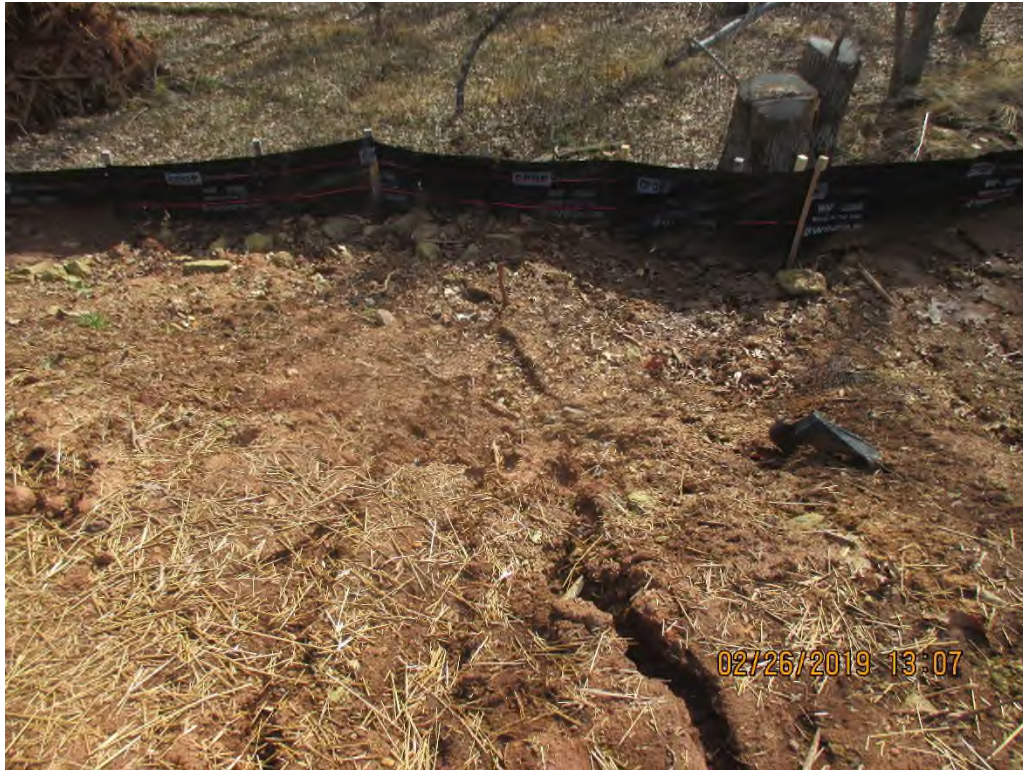
Waterbar outlet above SJAD stream complex at station #6770+75. Silt fence was undermined, and erosion was occurring on downslope side of the control and on the side of the control due to run-off flowing around it.

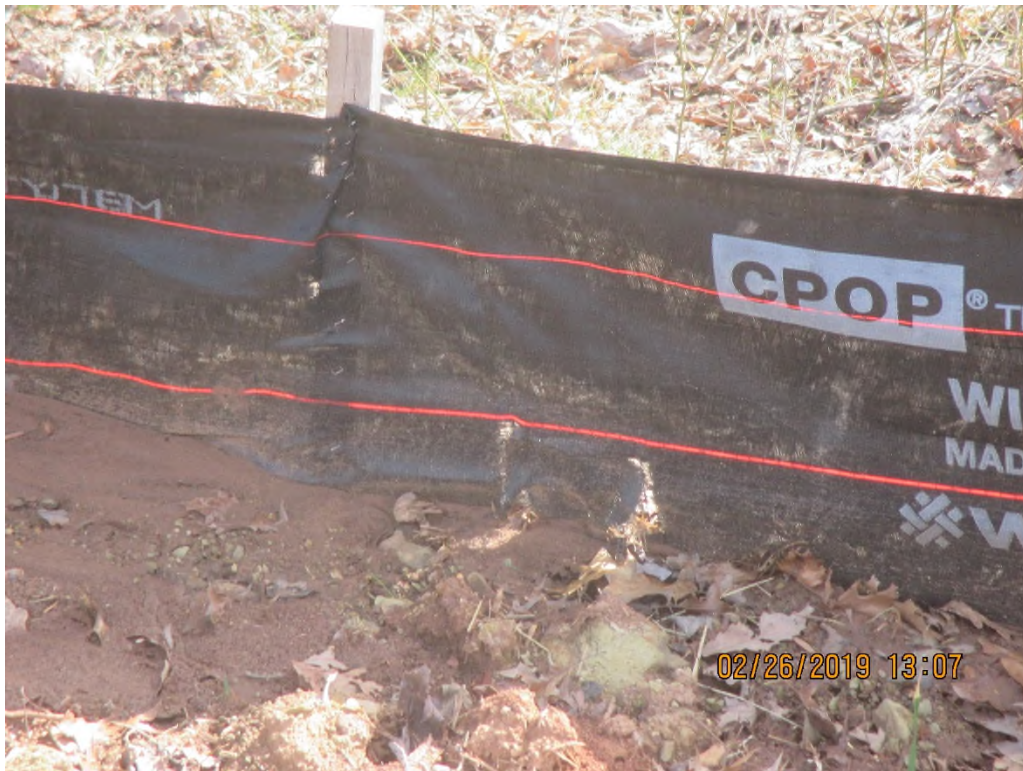
Erosion on slope above perimeter control at station #6766+60. Silt fence had multiple holes.

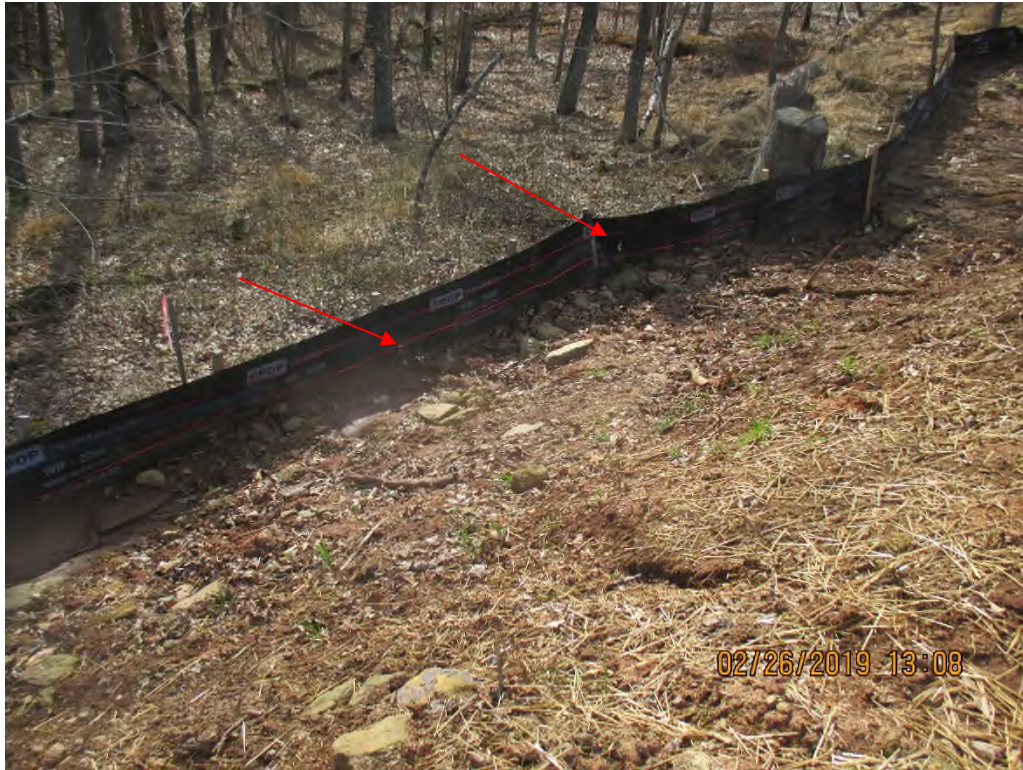
Silt fence at station #6766+60 with holes.

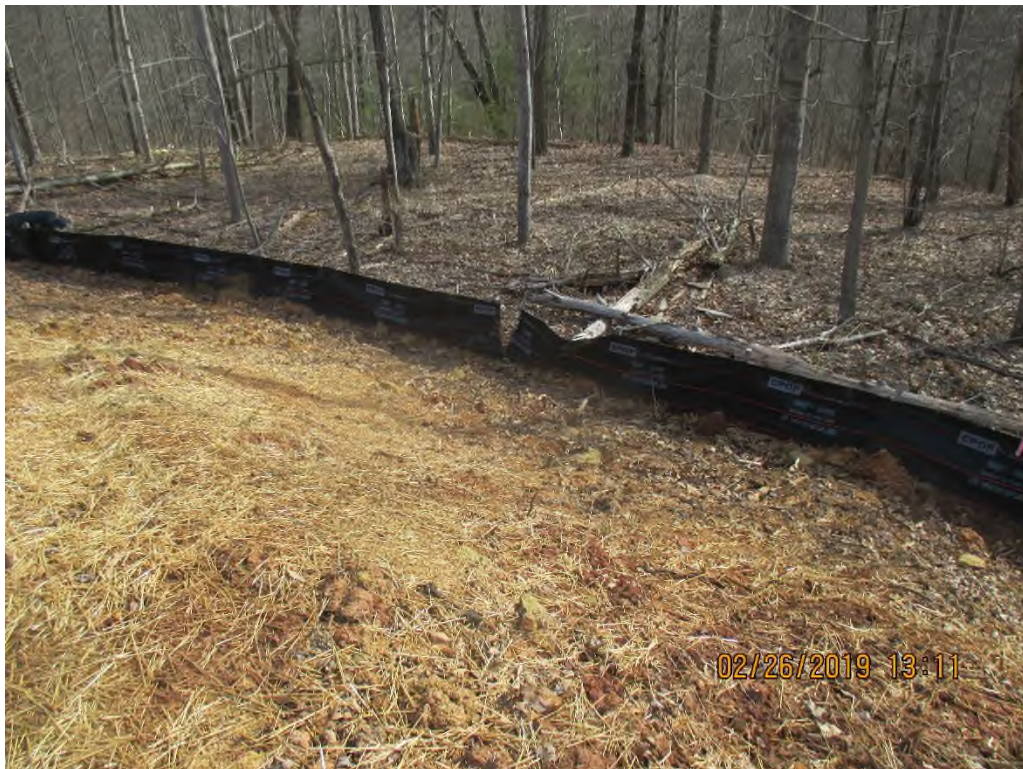
Silt fence with multiple holes near station 6766+60

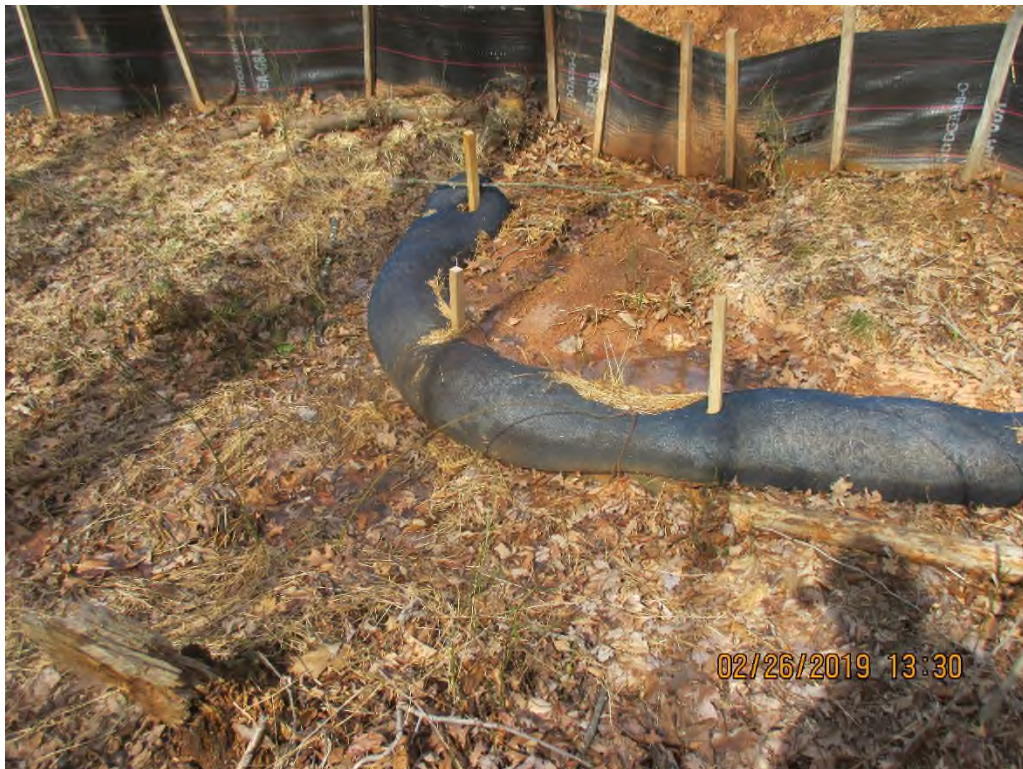
Topsoil pile eroding due to seep, entering waterbar, and causing erosion at station #6760+00

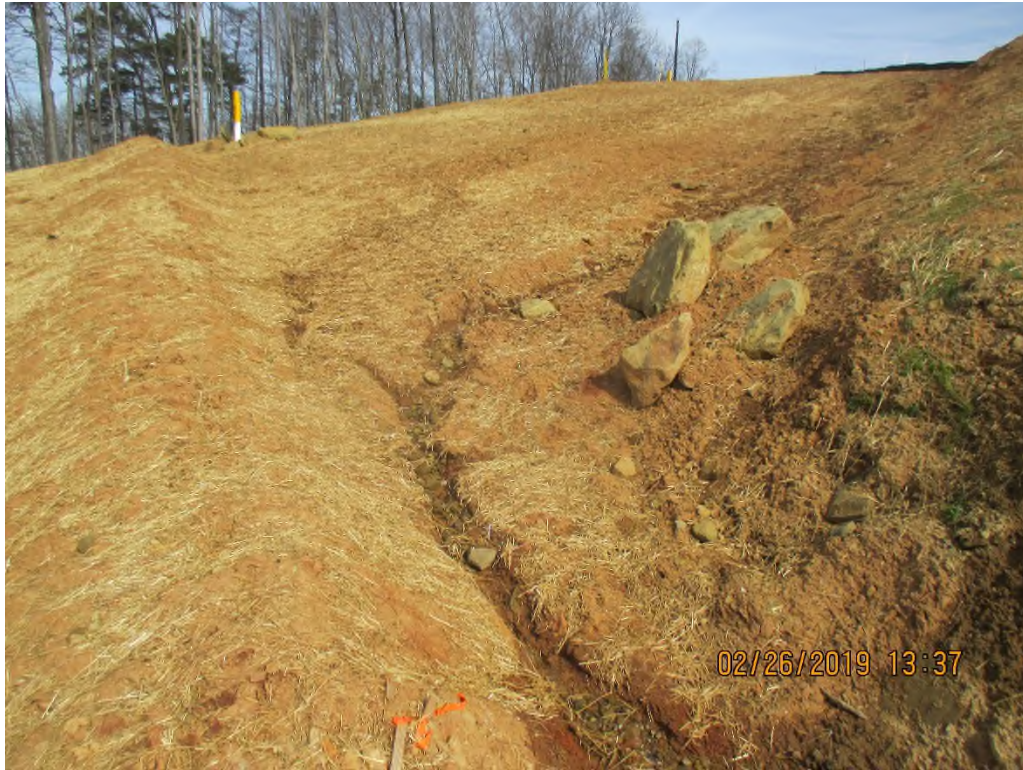
Waterbar terminus at station #6752+00. Evidence of concentrated flow due to control being undermined and erosion occurring between devices.

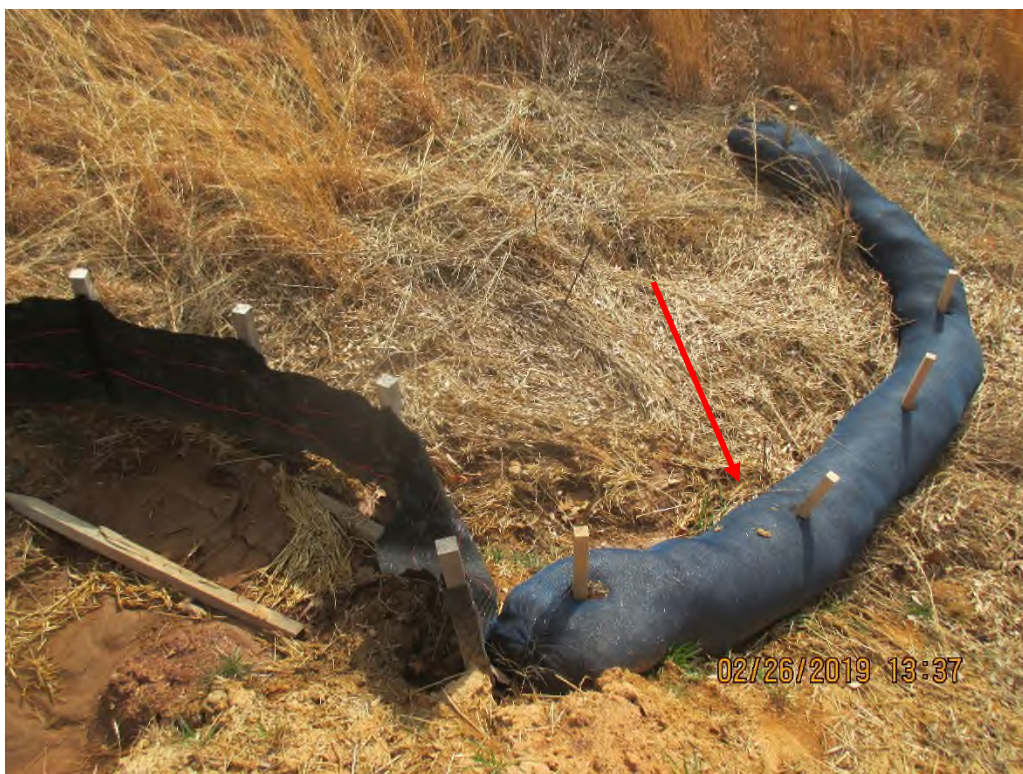
Waterbar terminus at station #6753+94. Evidence of concentrated flow due to erosion occurring along the slope.

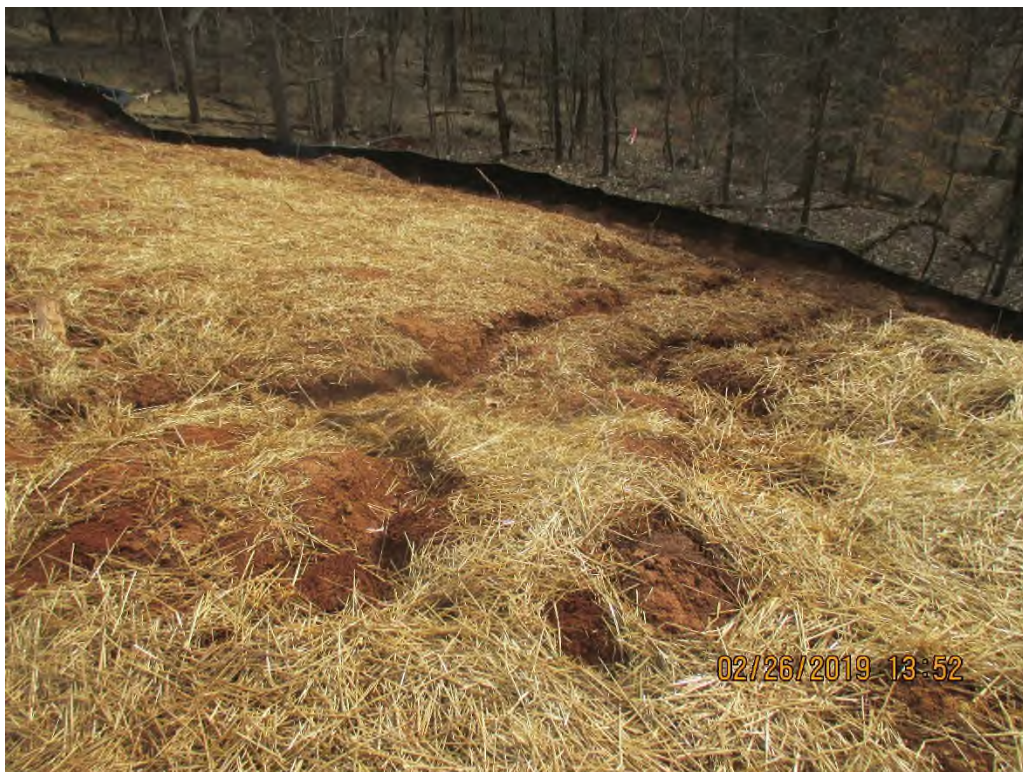
Run-on from adjacent field flowing across ROW and creating rill erosion near station#6742+60.

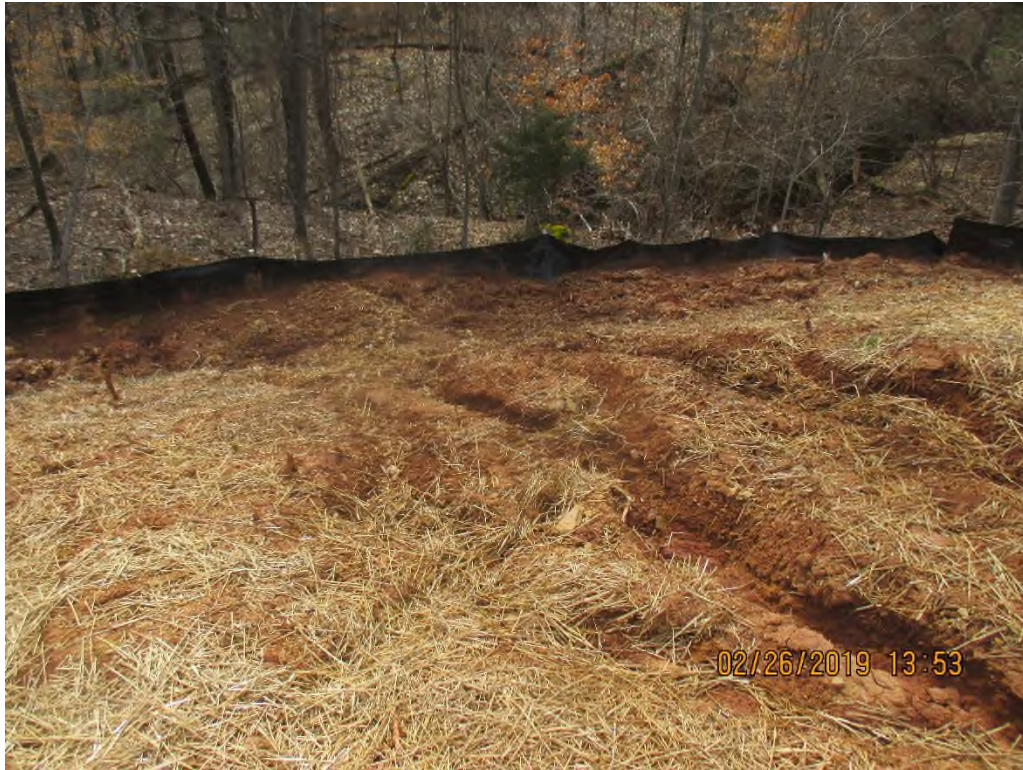
Run-on from adjacent field flowing across ROW and creating rill/gully erosion on slope near station #6742+60.

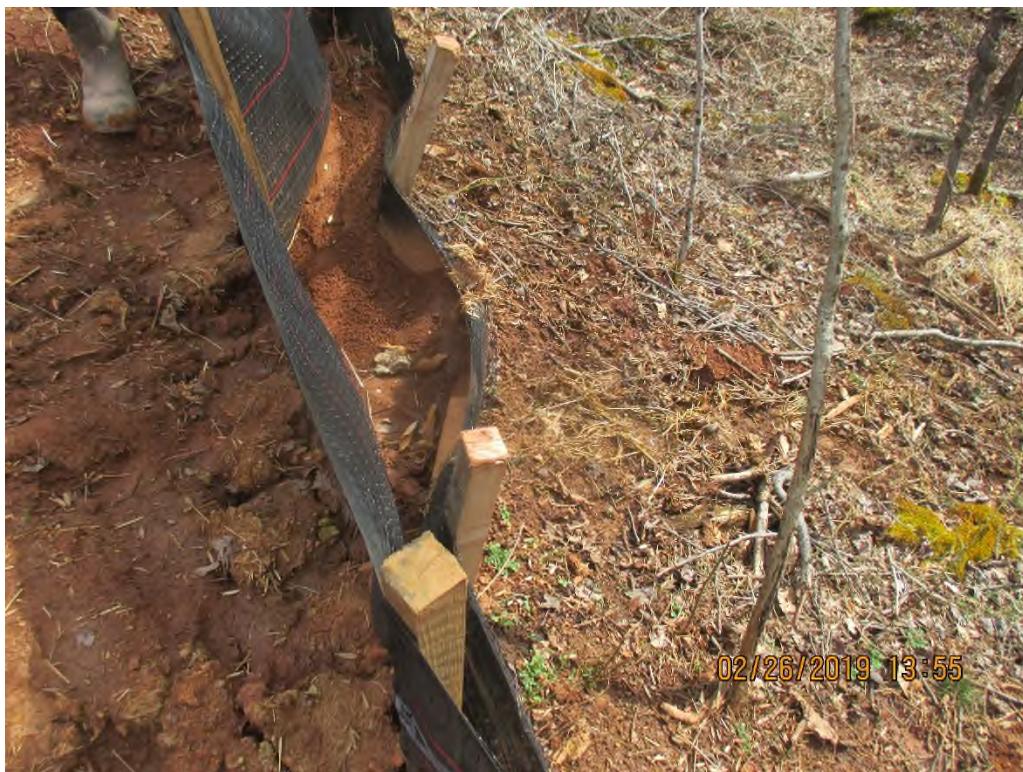
Run-on from adjacent field flowing across ROW, creating rill/gully erosion on slope near station #6742+60 and sediment being deposited against perimeter control.

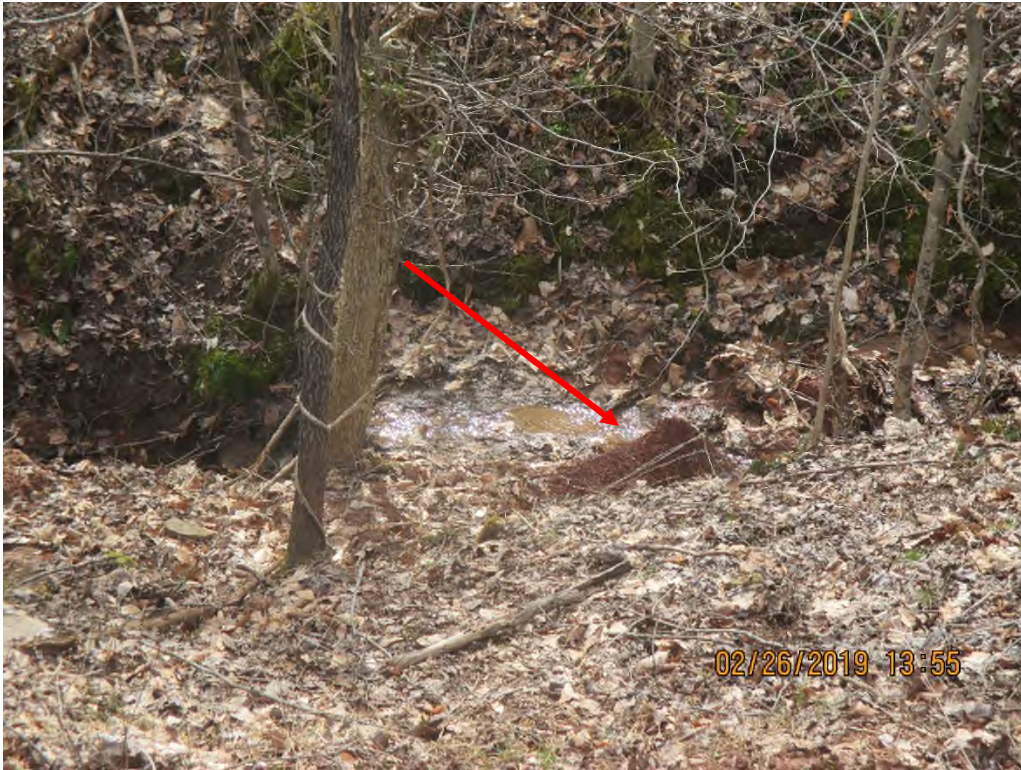
Near station #6742+60. Sediment being deposited against perimeter control and evidence of sediment being deposited past control.

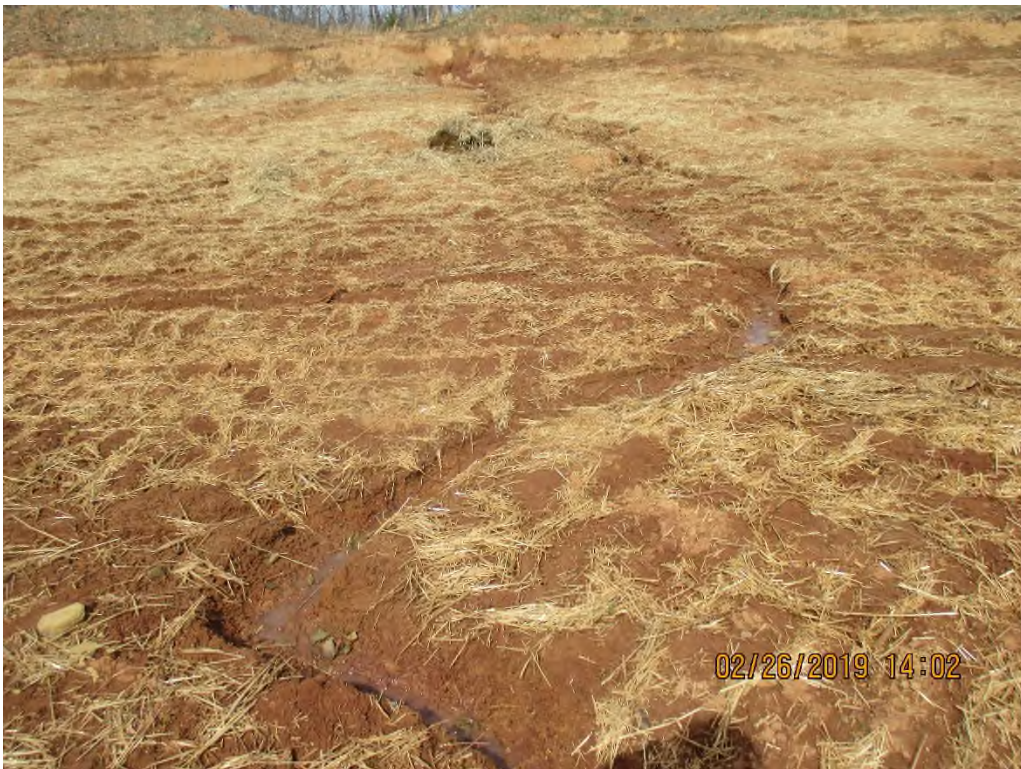
Near station #6742+60. Sediment being deposited past perimeter control and present in stream SJAA-040

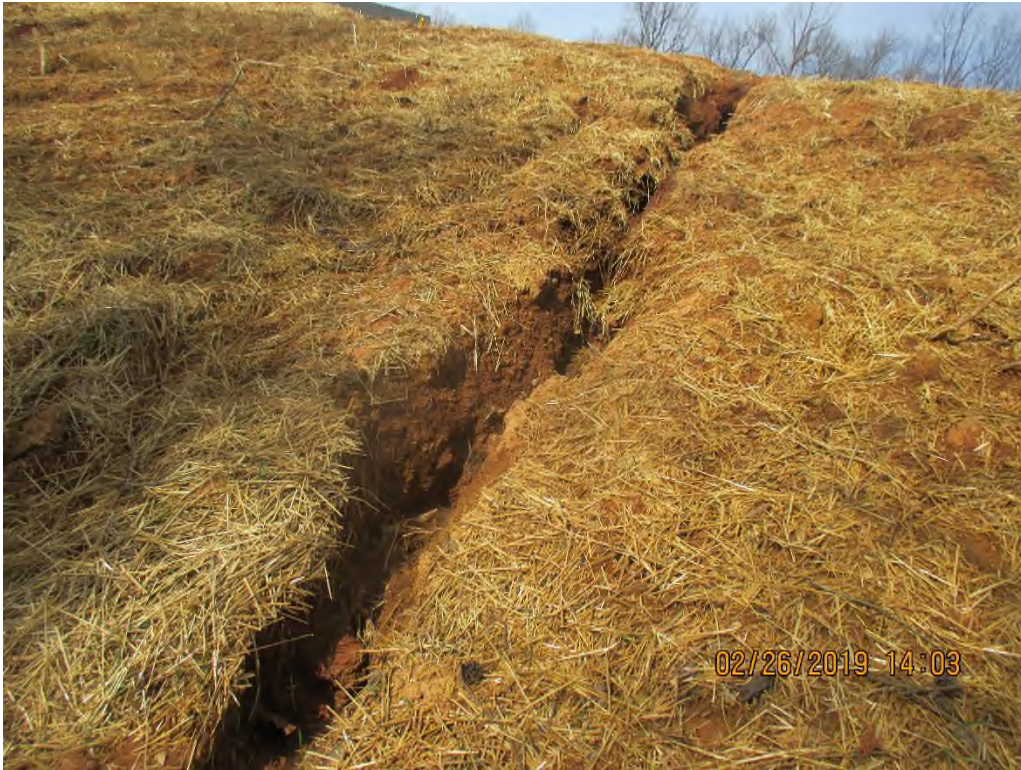
Near station #6620+00 (per SWPPP). Seep intersecting ROW and causing erosion.

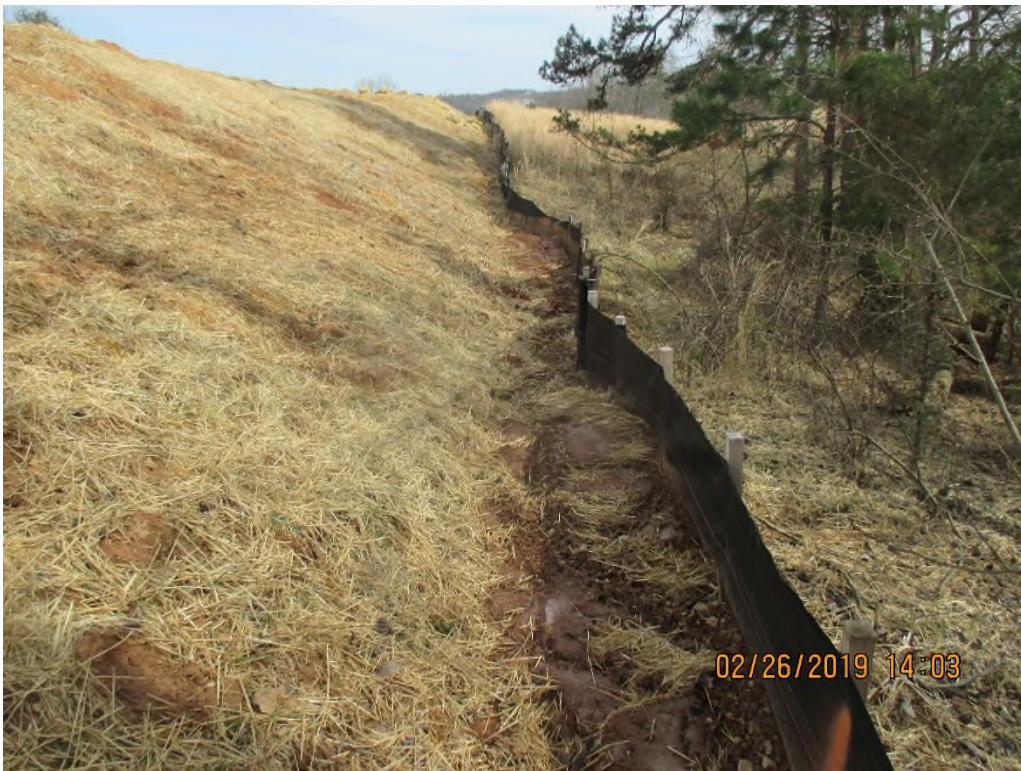
Facing downslope along perimeter control where sediment is backing up against controls due to erosion occurring on slope near station #6620+00 (per SWPPP).

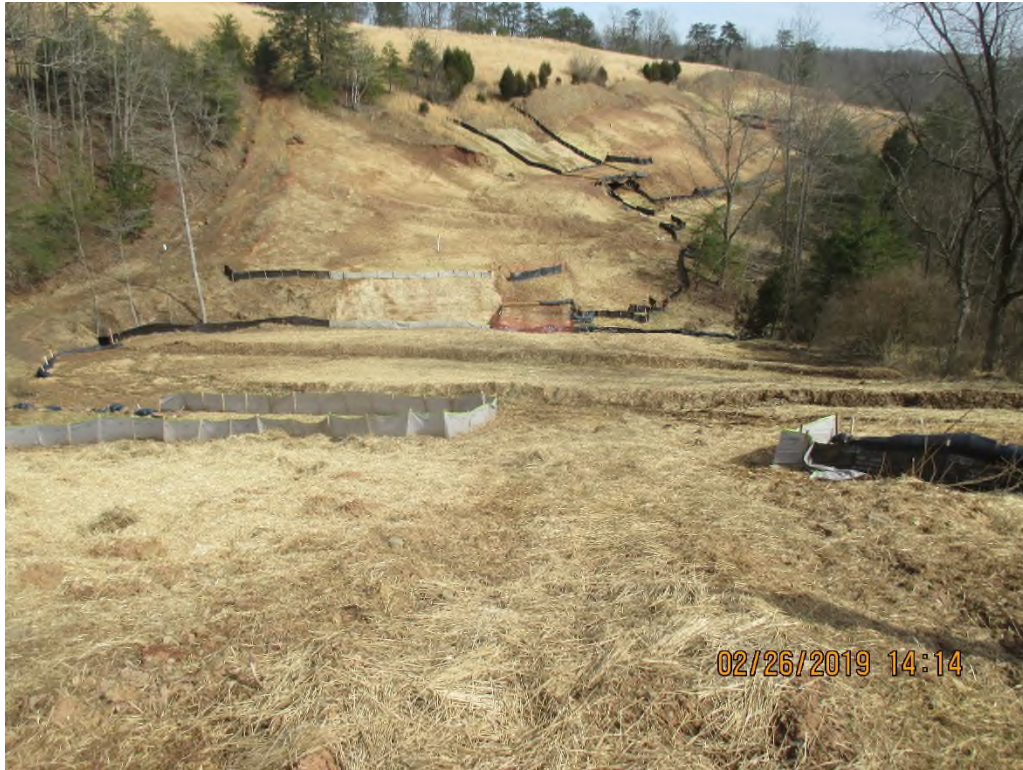
Facing NE toward multiple stream crossings including SJAG-352, 359, and 351 near station #6732+60

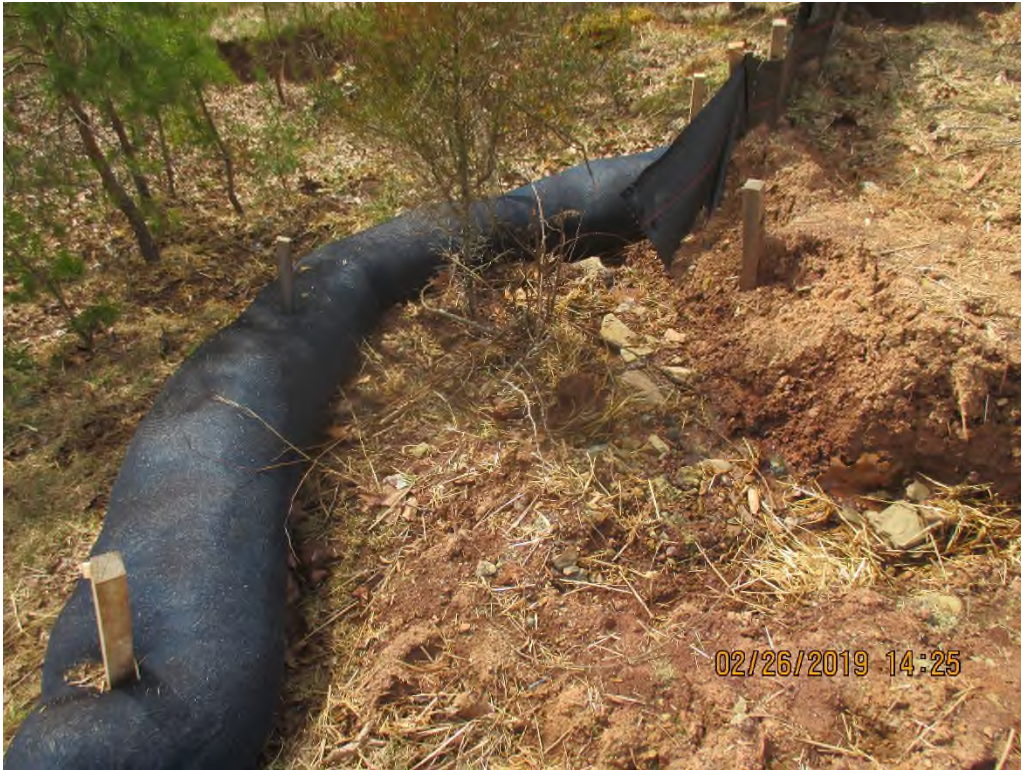
Waterbar terminus at station #6730+05. Erosion occurring above terminus.

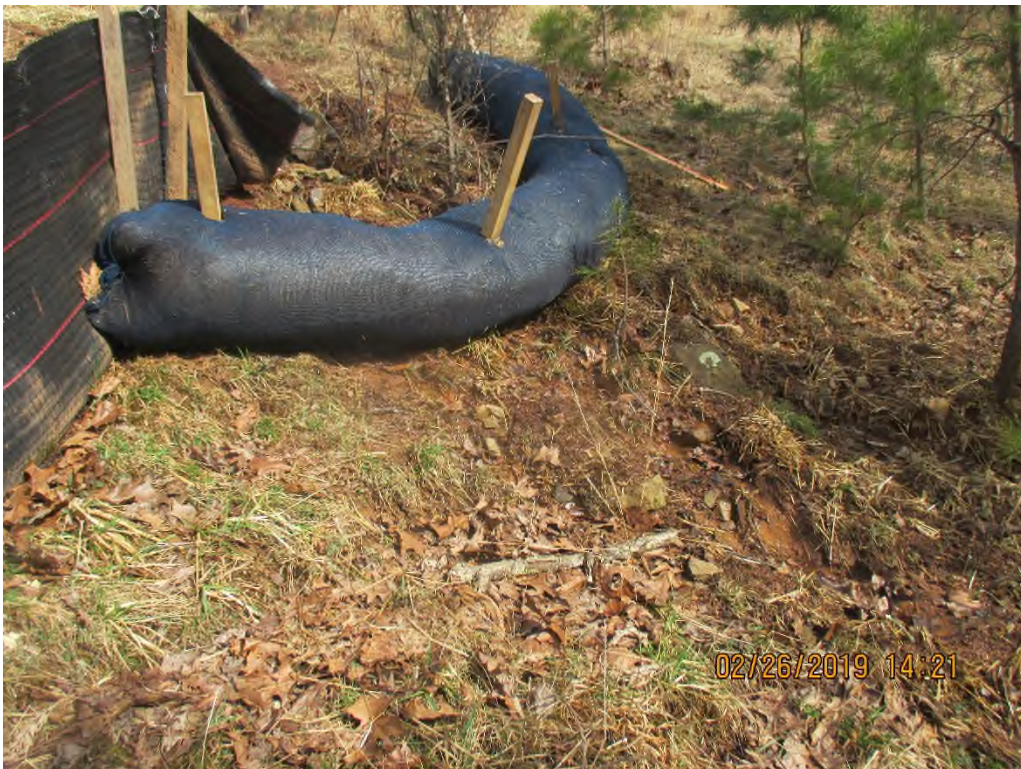
Waterbar terminus at station #6730+05. Compost filter sock undermined and evidence of sediment deposits past LOD.

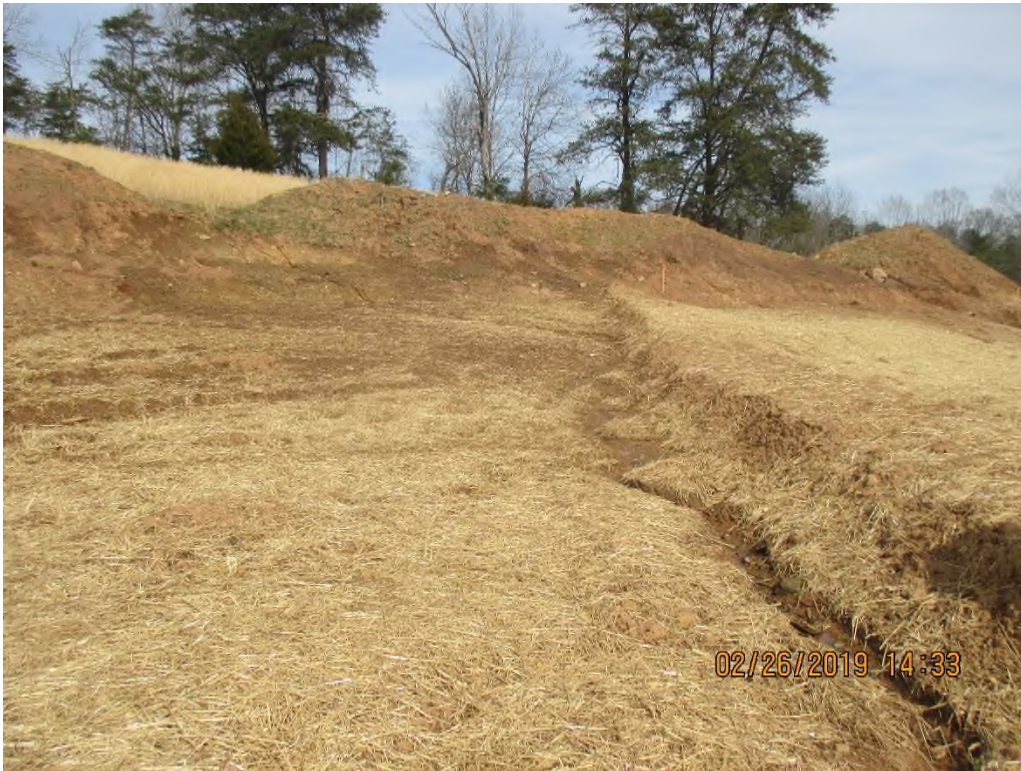
Seep near waterbar causing erosion in waterbar.

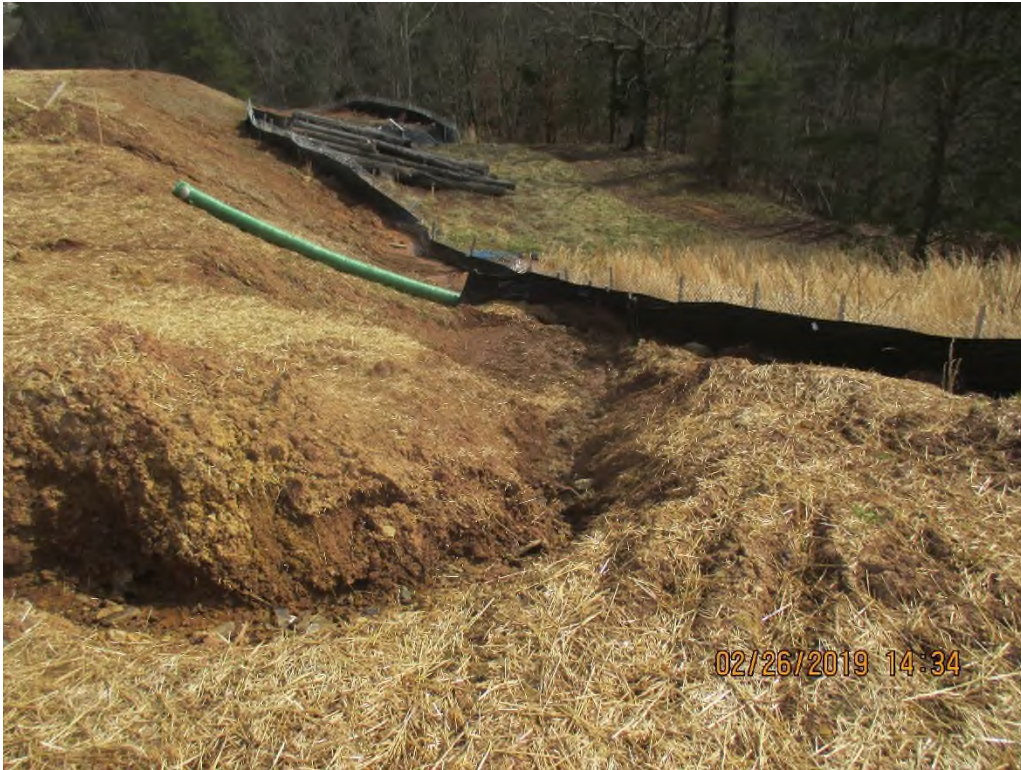
Waterbar terminus with gully erosion present leading toward perimeter controls near station #6727+53

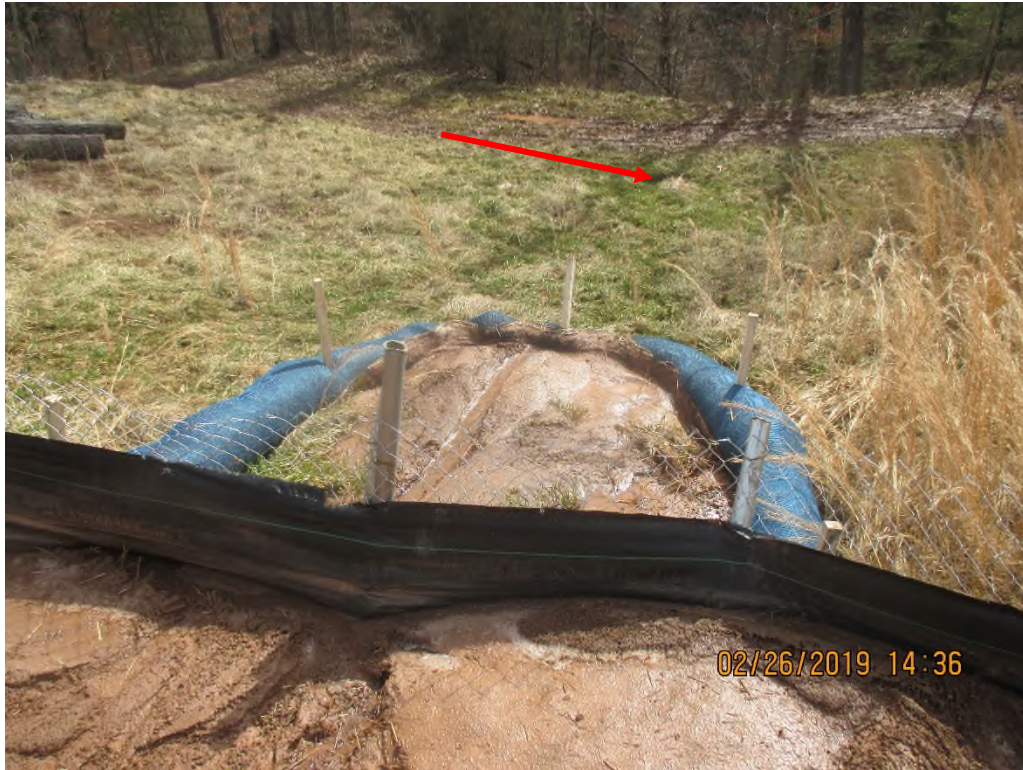
Perimeter controls near station #6727+53. Sediment deposits present and water flowing into culvert depicted by arrow.

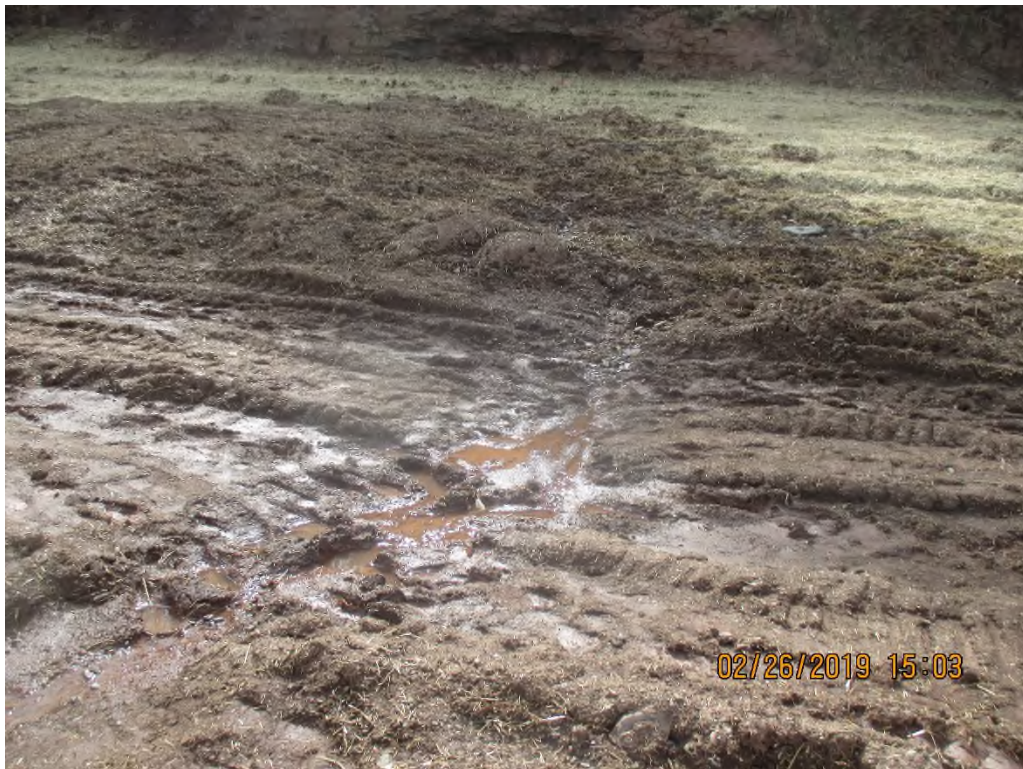
Saturated section of ROW near station #6720+60 leading to erosion downslope of travel lane.

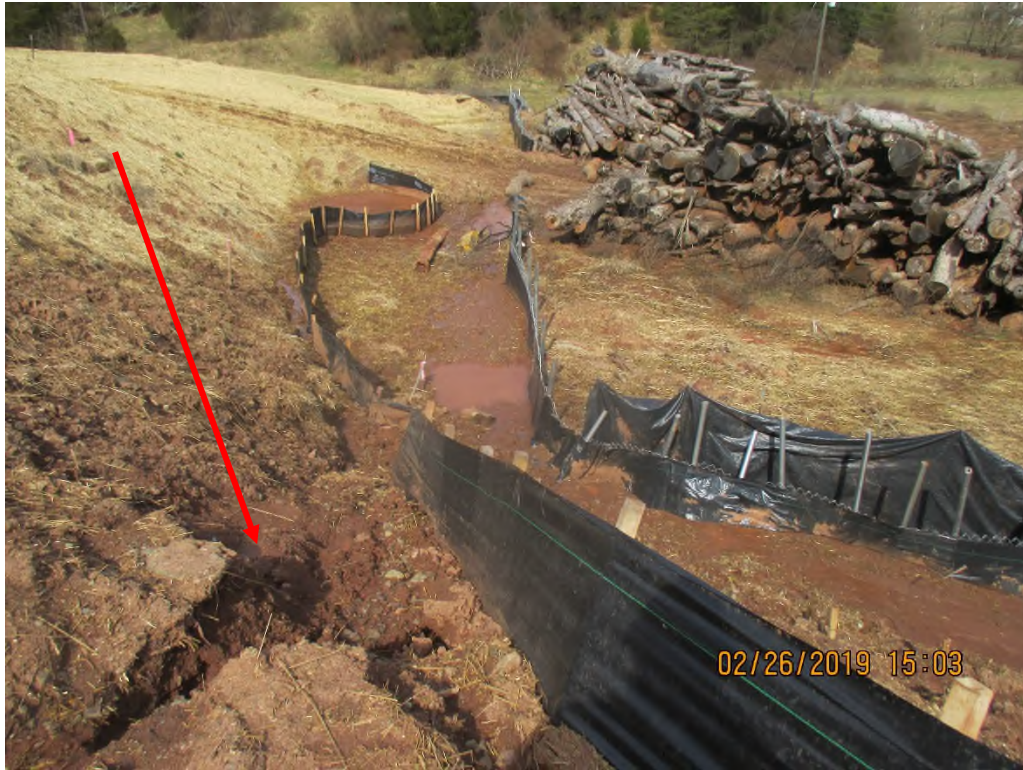
Slope near station #6720+60 facing downslope. Erosion occurring from run-on flowing across ROW.

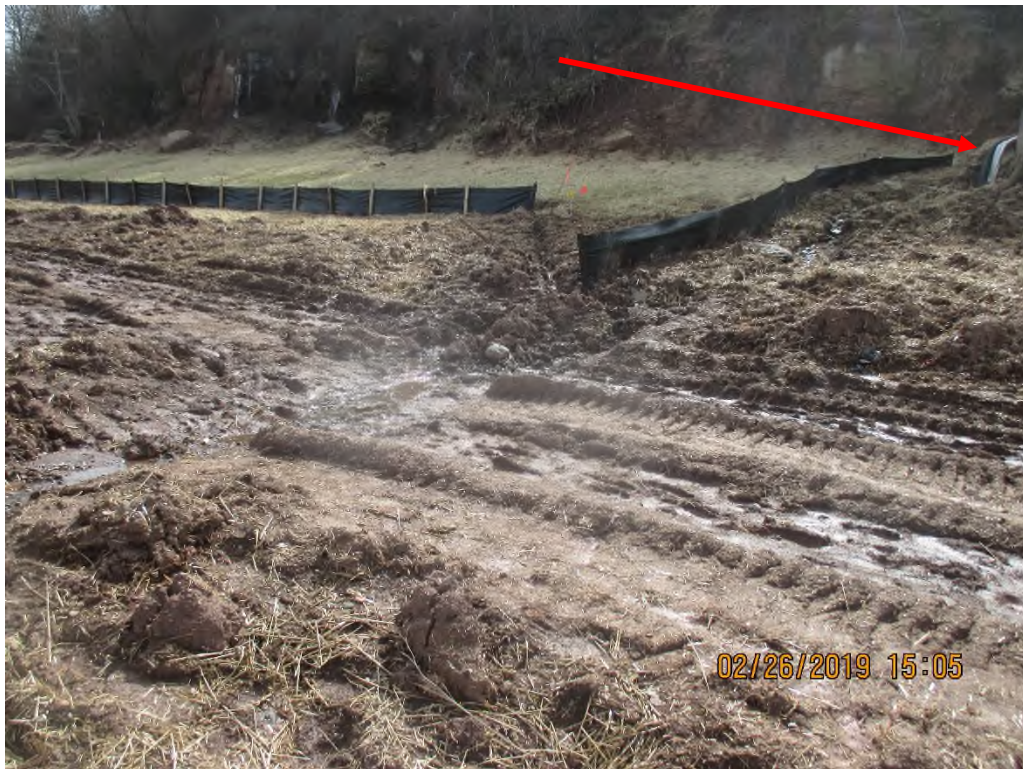
Saturated section of ROW impacting travel lane. Erosion and slips occurring downslope of station #6702+30. Slope drain installed at red arrow.

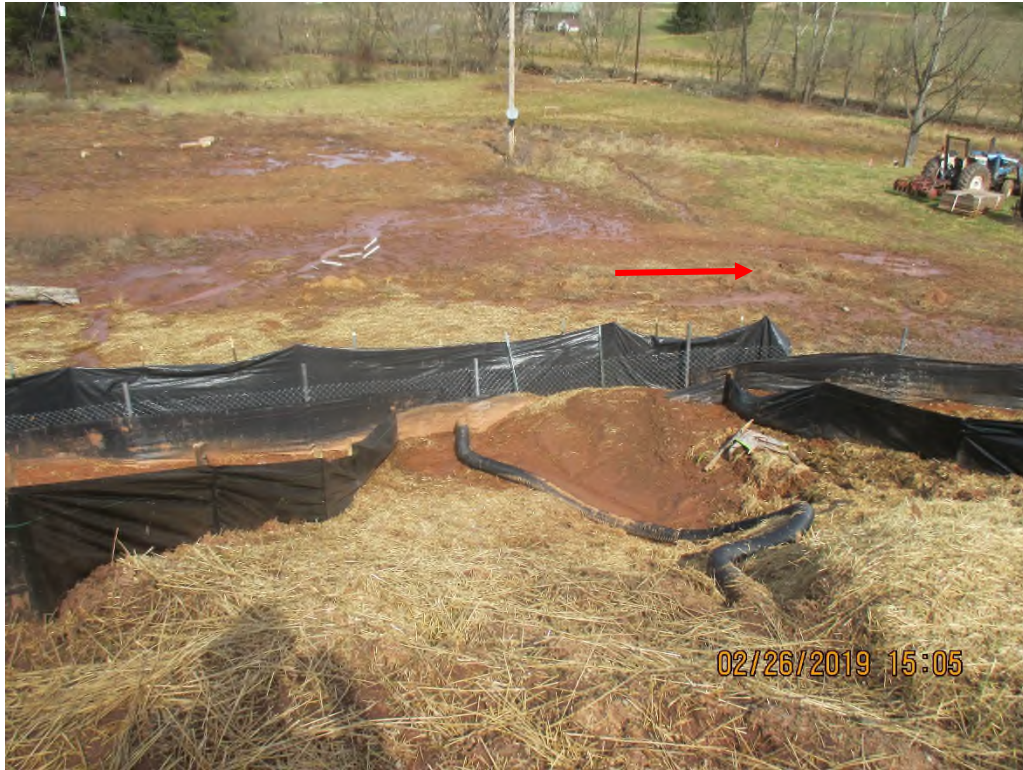
Downslope of station #6702+30. Slope drain outlet terminating into perimeter controls. Culvert installed under additional workspace. No controls installed in this area.

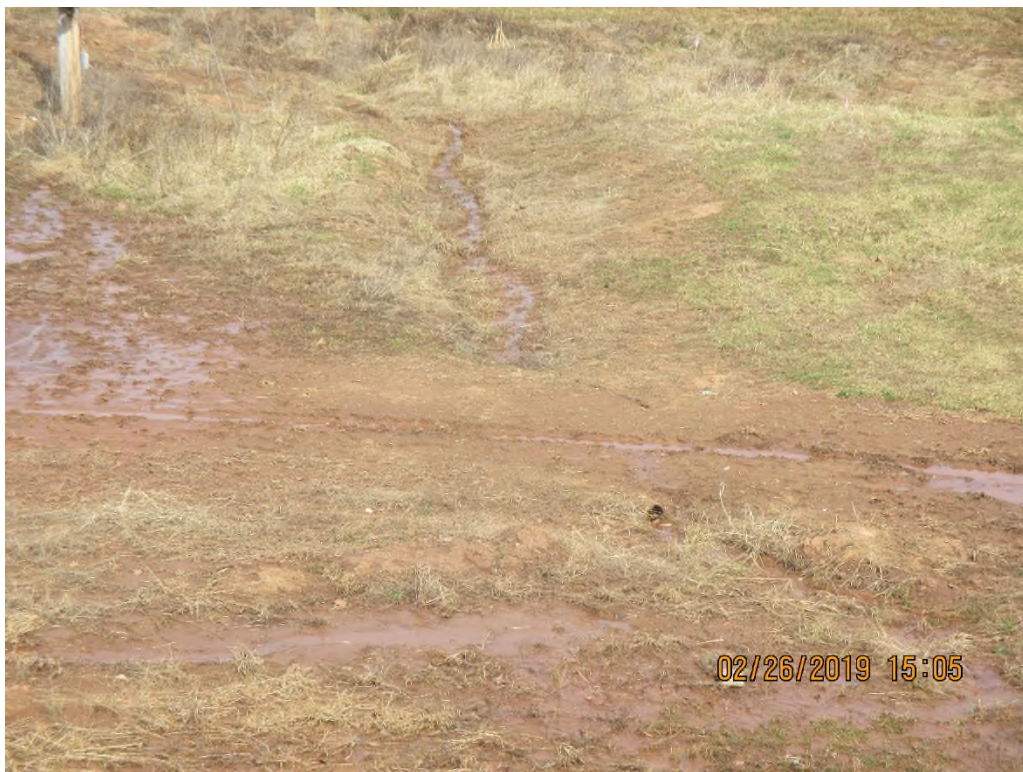
Downslope of station #6702+30. Culvert installed under additional workspace. No controls installed in this area.

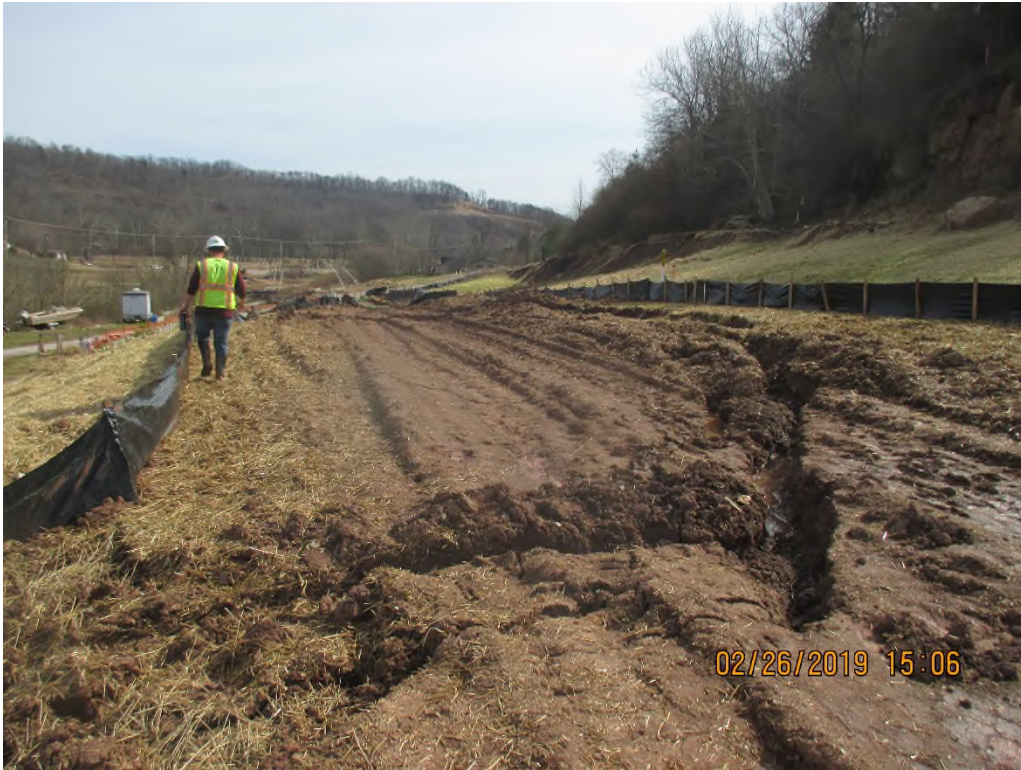
Section of ROW between Ripley regulator station and Rt. 21 with multiple slips on ROW.

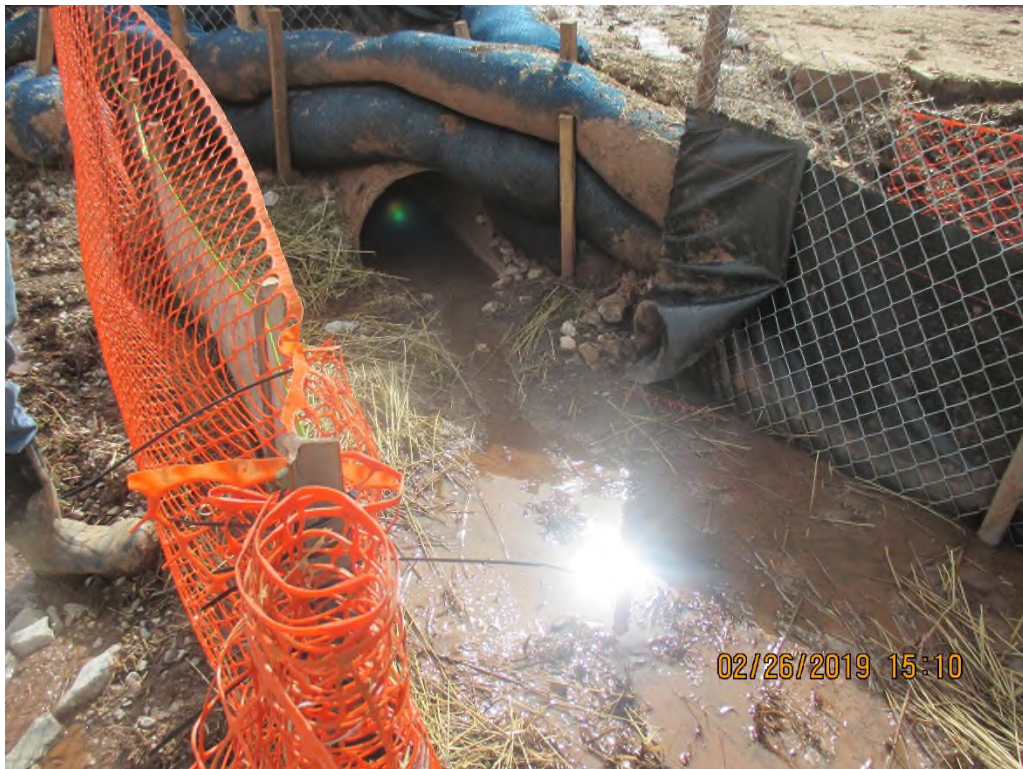
SJAG-346 facing upslope at station #6702+30. Sediment present in stream.

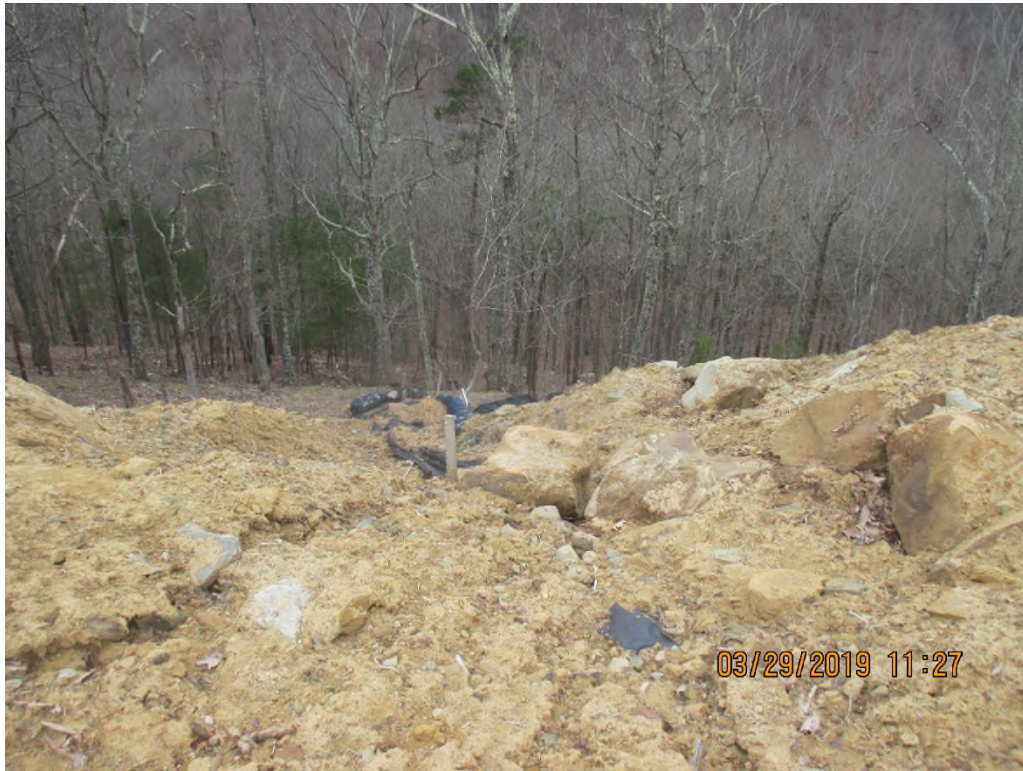
Waterbar terminus with erosion on slope near station #5148+00 facing downslope towards perimeter.
