**CONSENT ORDER
ISSUED UNDER THE
WATER POLLUTION CONTROL ACT
WEST VIRGINIA CODE, CHAPTER 22, ARTICLE 11**

TO: Columbia Gas Transmission, LLC
Attn: Troy Tally, Vice President
1700 MacCorkle Ave
Charleston, WV 25314

DATE: October 1, 2020
ORDER NO.: 9061

1. Columbia Gas Transmission, LLC is conducting land disturbance activity associated with construction of the Mountaineer Xpress Project in Marshall, Wetzel, Tyler, Doddridge, Ritchie, Calhoun, Wirt, Roane, Jackson, Mason, Putnam, and Cabell Counties, West Virginia. On January 31, 2018, Columbia Gas Transmission, LLC was issued Water Pollution Control Permit No. WV0116815, Registration No. WVR310872, for Stormwater Associated With Oil and Gas Related Construction Activities.

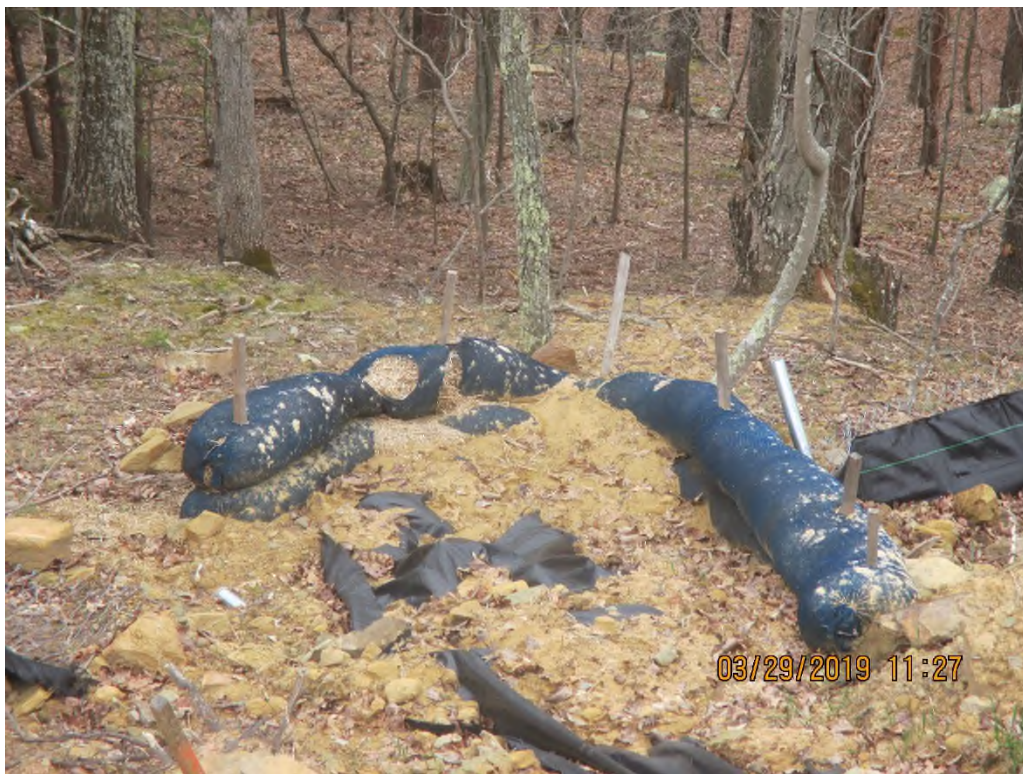
Perimeter controls being overwhelmed with sediment downslope of waterbar terminus near station #5148+00. Sediment deposits were present past controls and LOD.

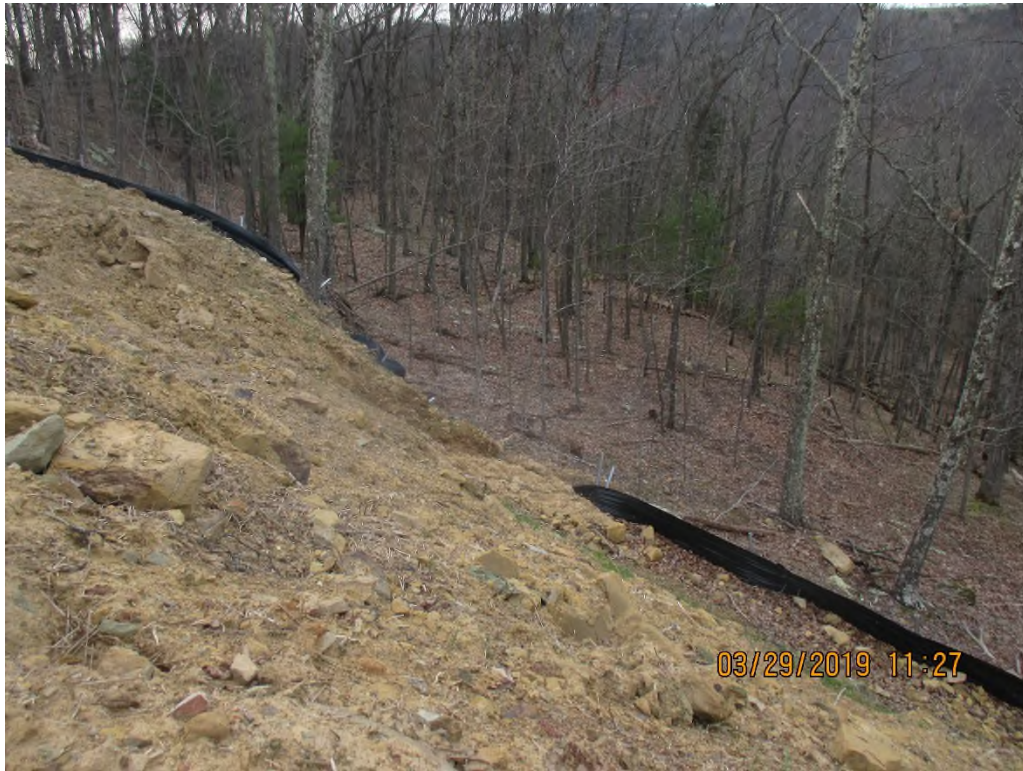
Perimeter controls being overwhelmed with sediment near station #5148+00.

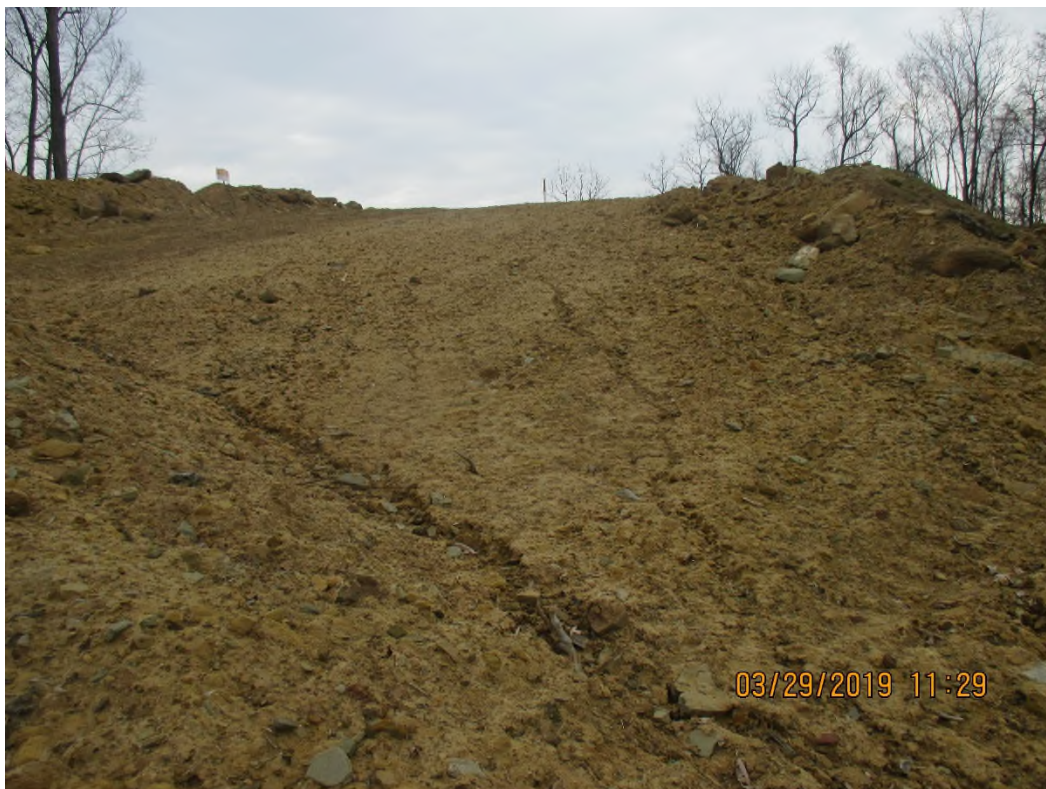
Erosion on slope near station #5148+00 leading to waterbar outlet over slope.

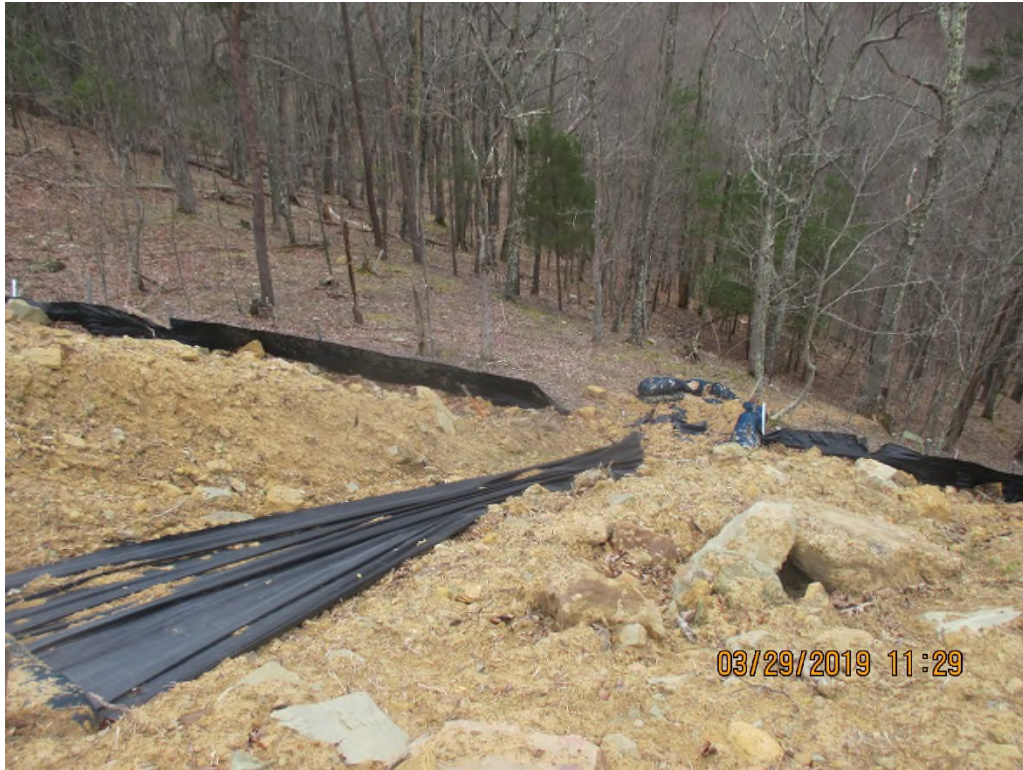
Waterbar outlet near station #5148+00. Erosion occurring on slope around geo mat and perimeter controls being overwhelmed with sediment.

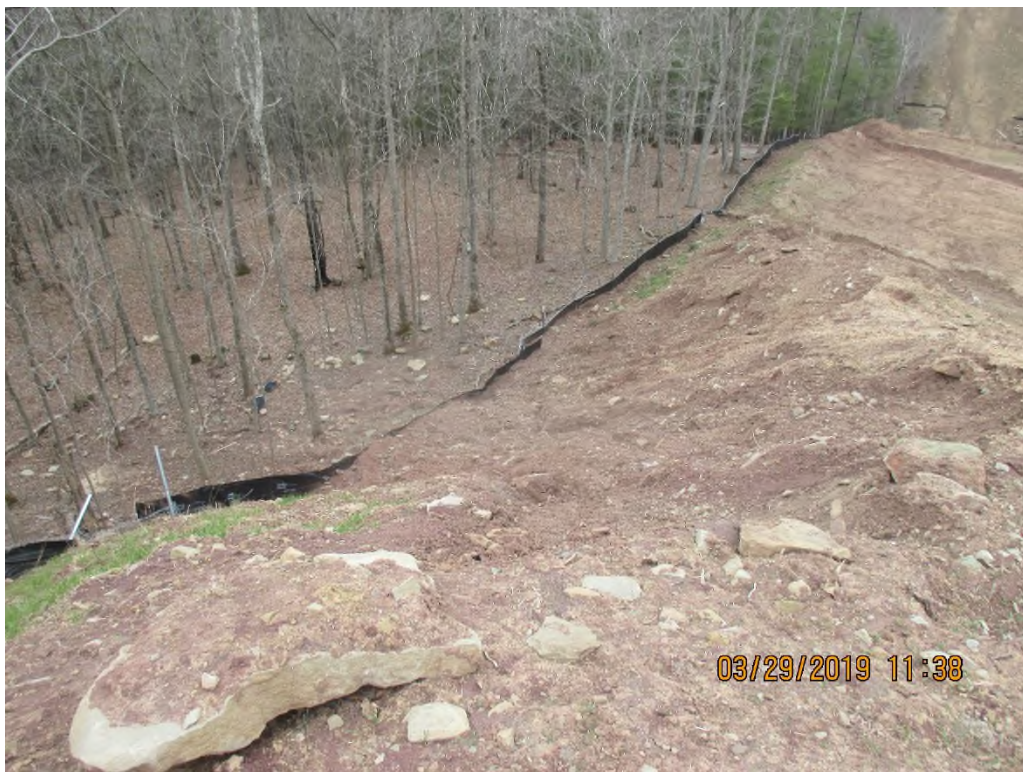
Fill slope eroded above stream SWIF-057. Sediment deposits overwhelming controls and being deposited past LOD near station #5163+50.

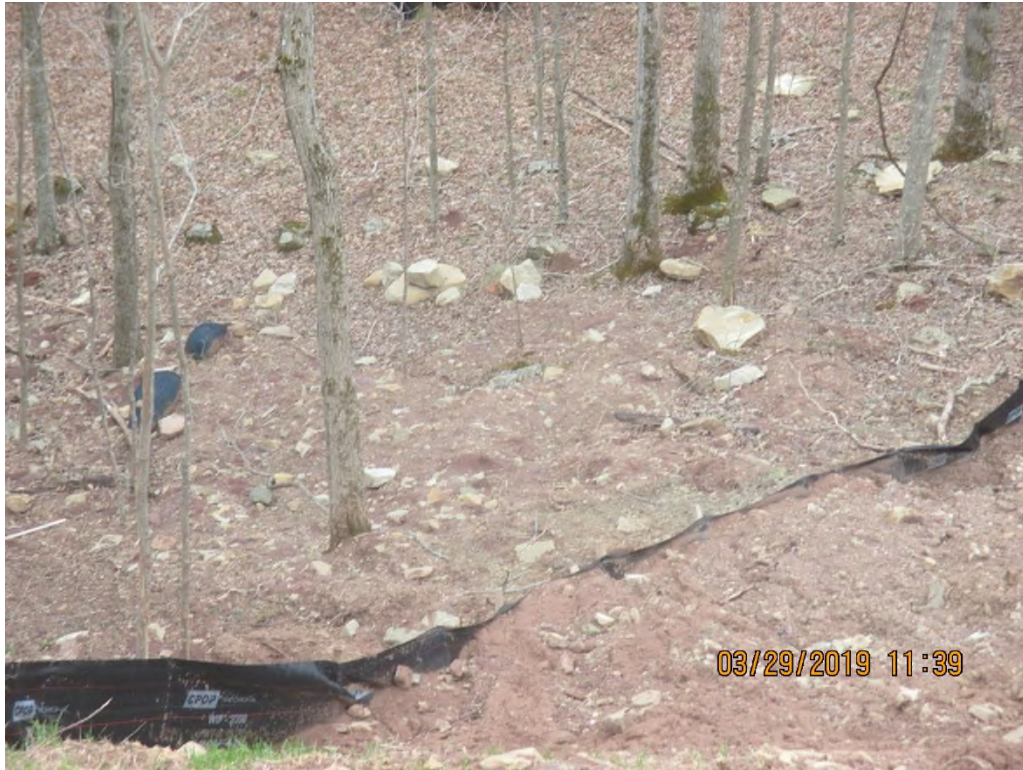
Sediment overwhelming controls and being deposited past LOD near station #5163+50

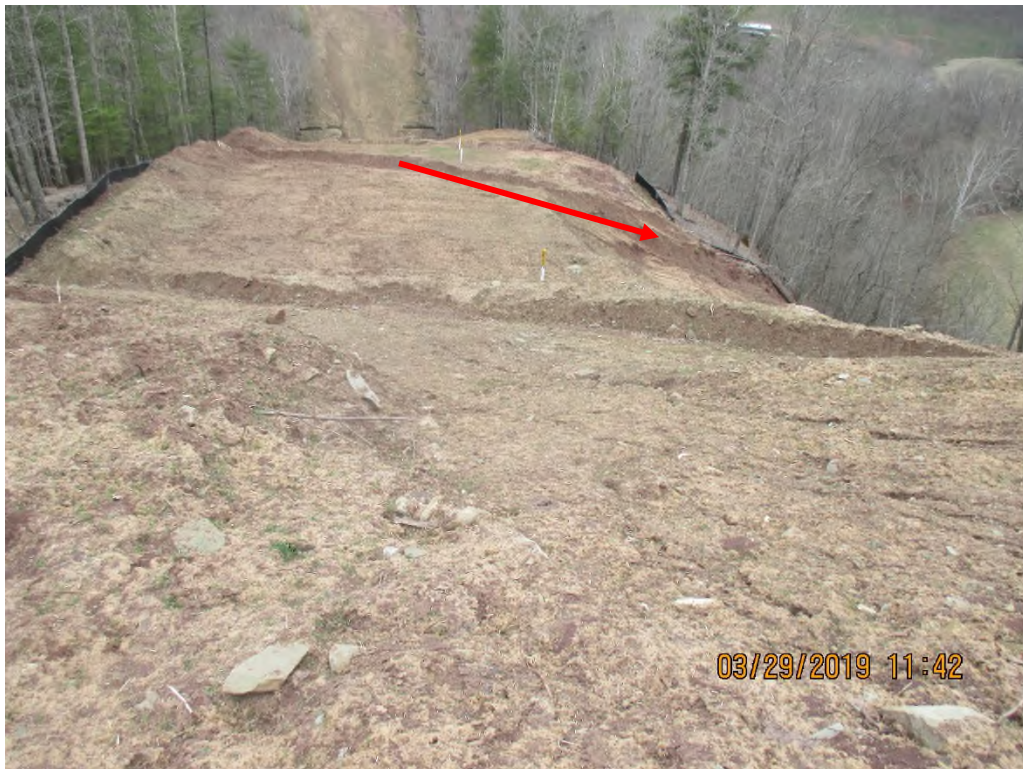
ROW facing South above Stream SWIF-057 near station #5163+50. Arrow depicts additional slipped area of slope above stream.

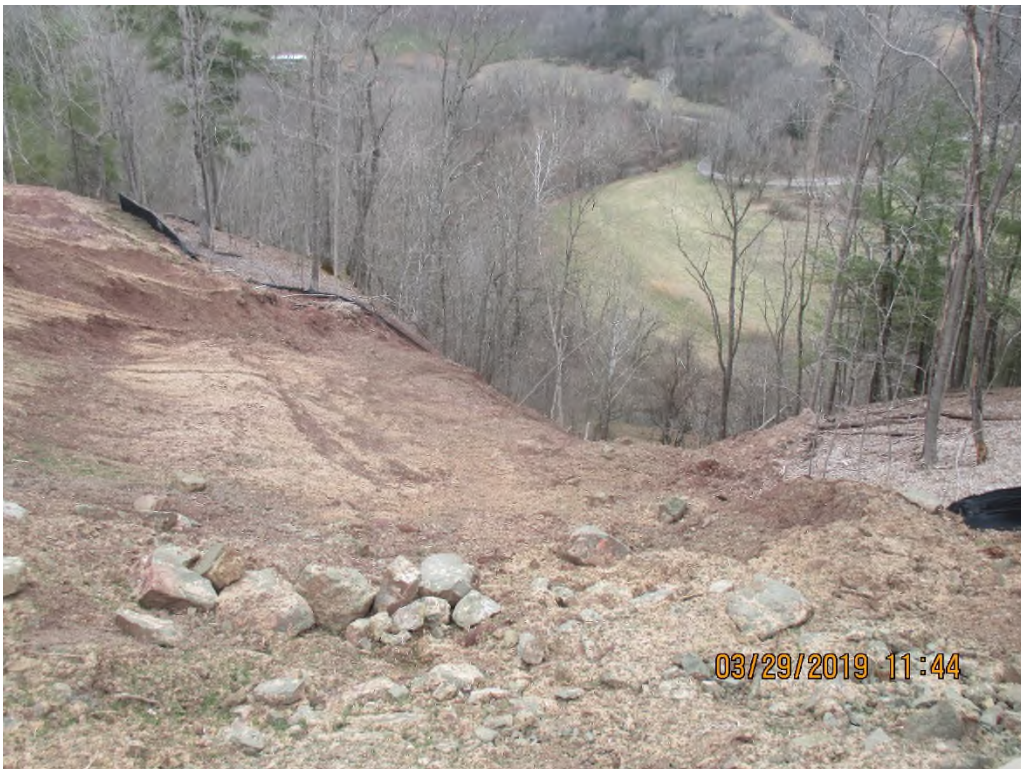
Slip on slope above stream SWIF-057 near station #5163+50

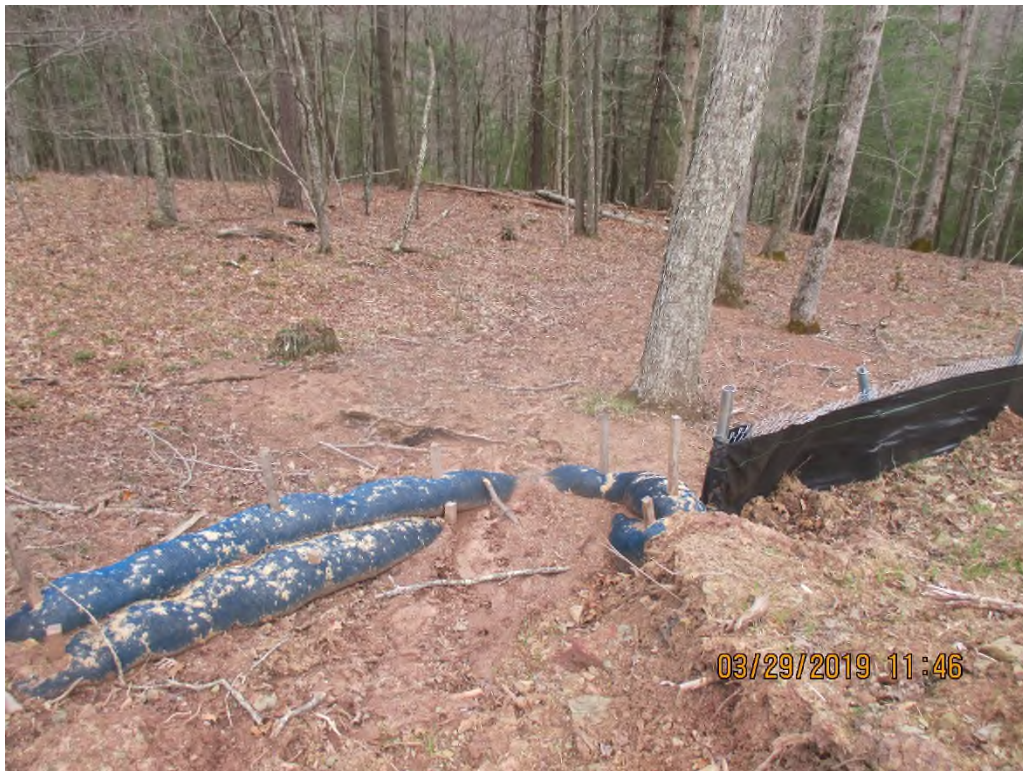
Waterbar terminus above stream SWIF-057 near station #5163+50. Sediment overwhelming controls and being deposited past LOD.

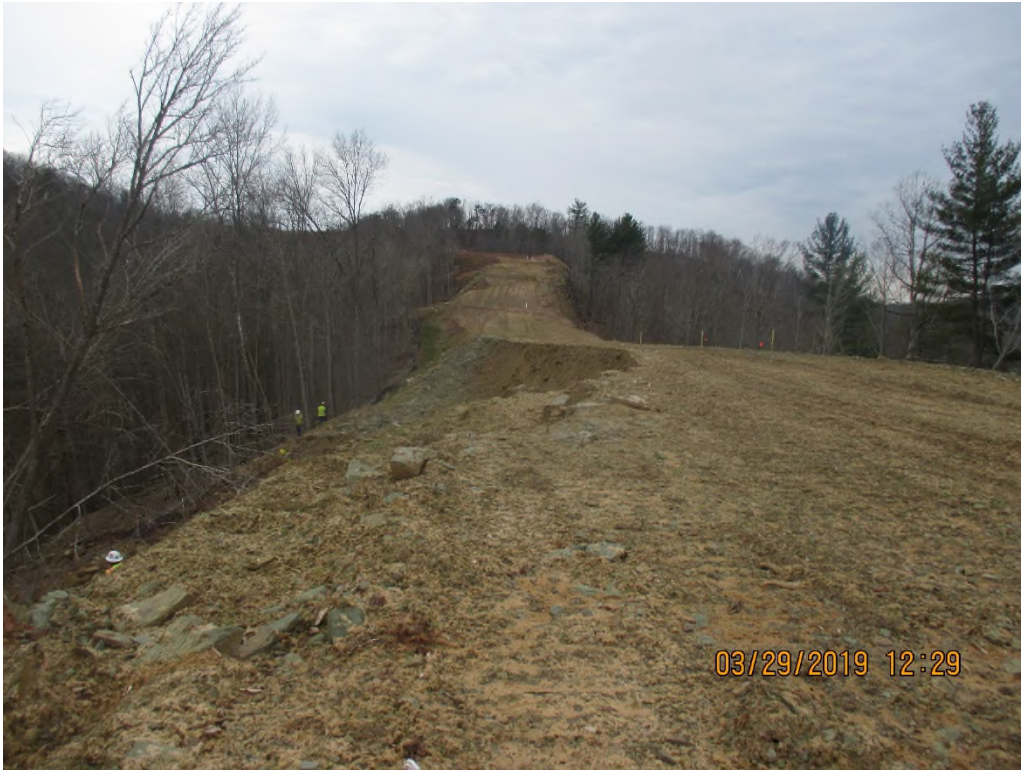
Station #5163+50 facing South at section of Row that slipped into Stream SWIF-057

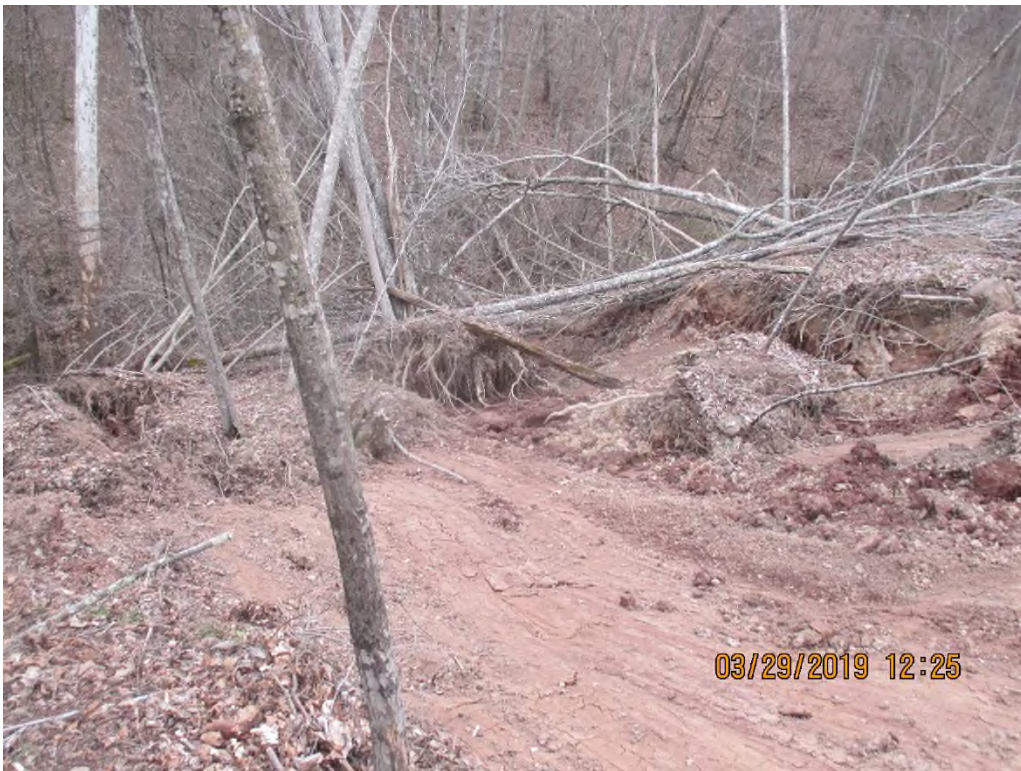
Station #5163+50 facing downslope toward material that slipped into Stream SWIF-057

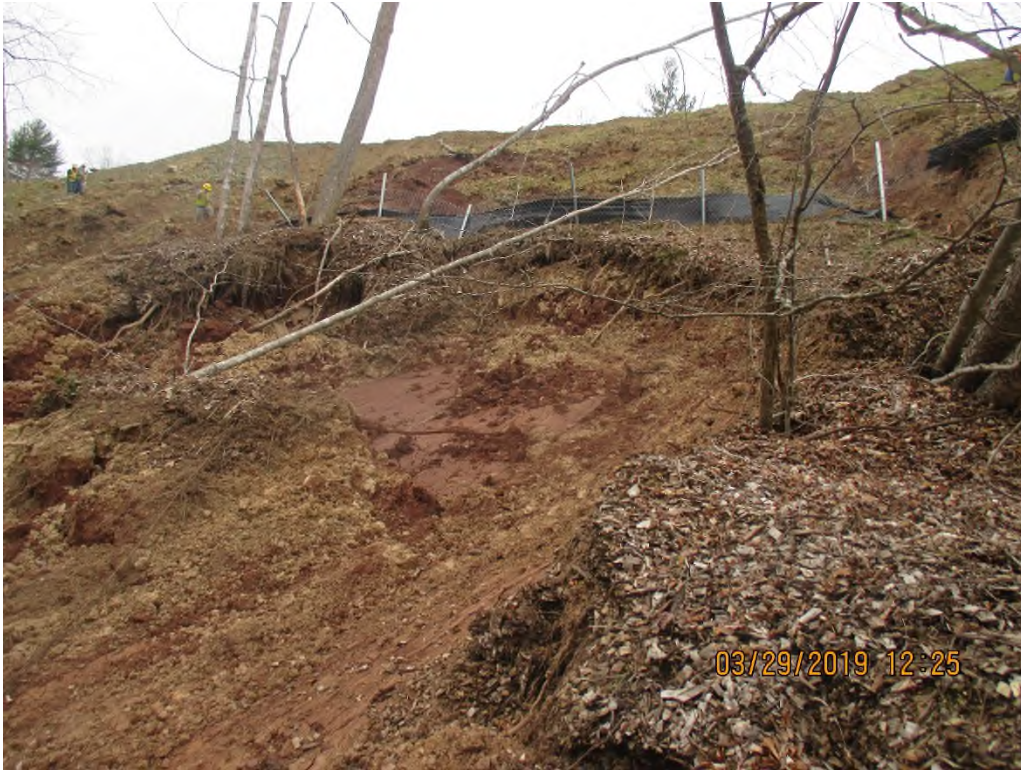
Facing upslope at section of ROW that slipped into stream SWIF-057

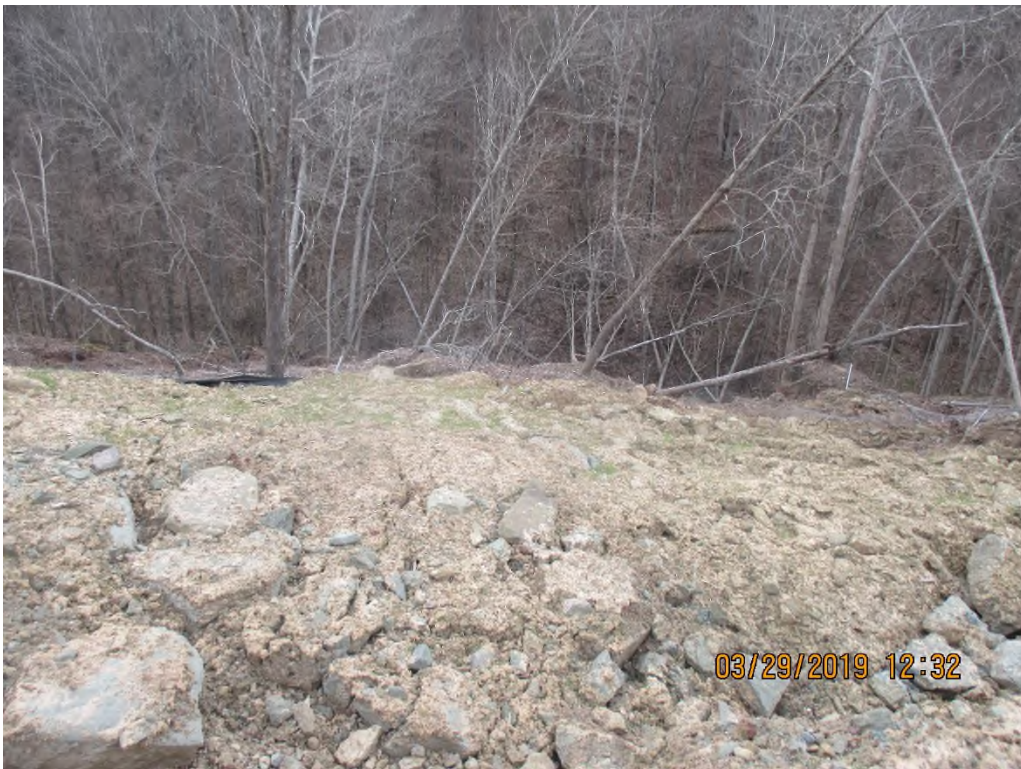
Erosion on fillslope at station #5162+60. Sediment overwhelmed perimeter controls and was deposited past LOD.

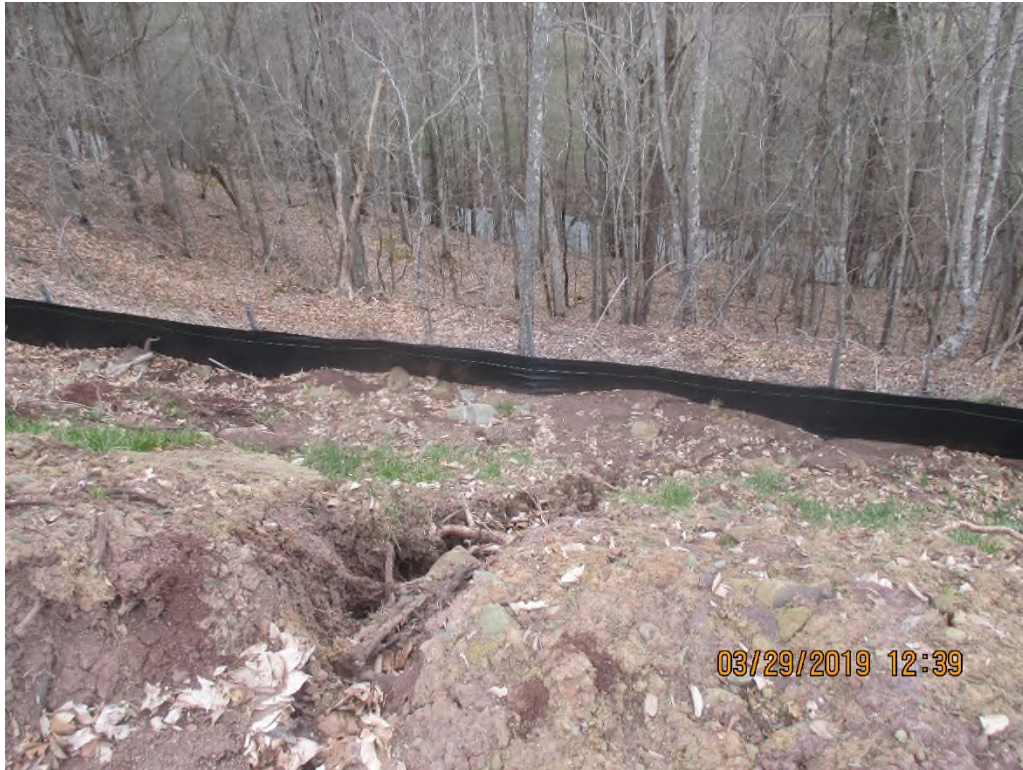
Erosion on fill slope with sediment being deposited against perimeter controls near station #5162+60

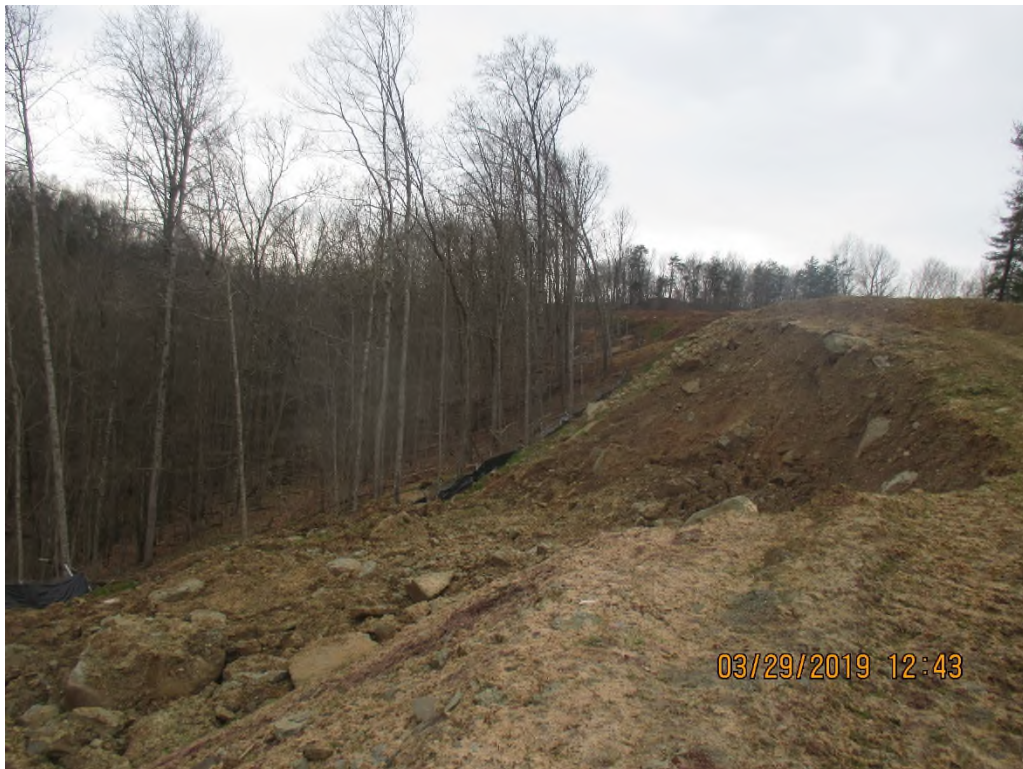
Slip at station #5168+80 facing South. Sediment deposited past LOD

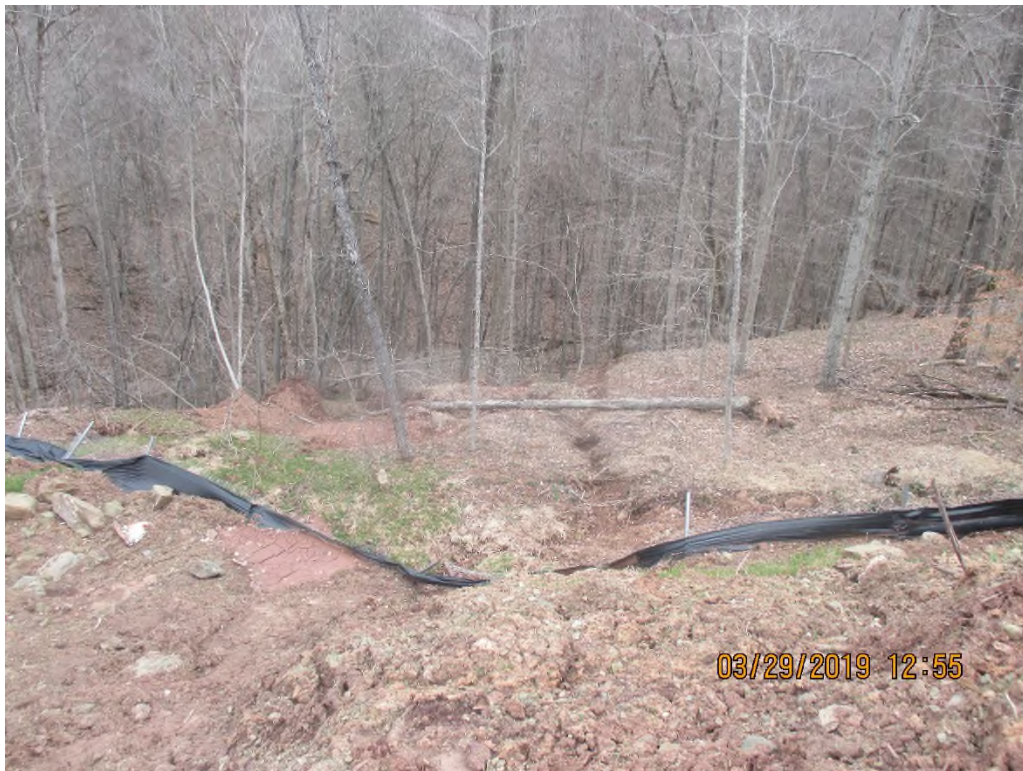
Slip at station #5171+34 facing South. Sediment deposited past LOD

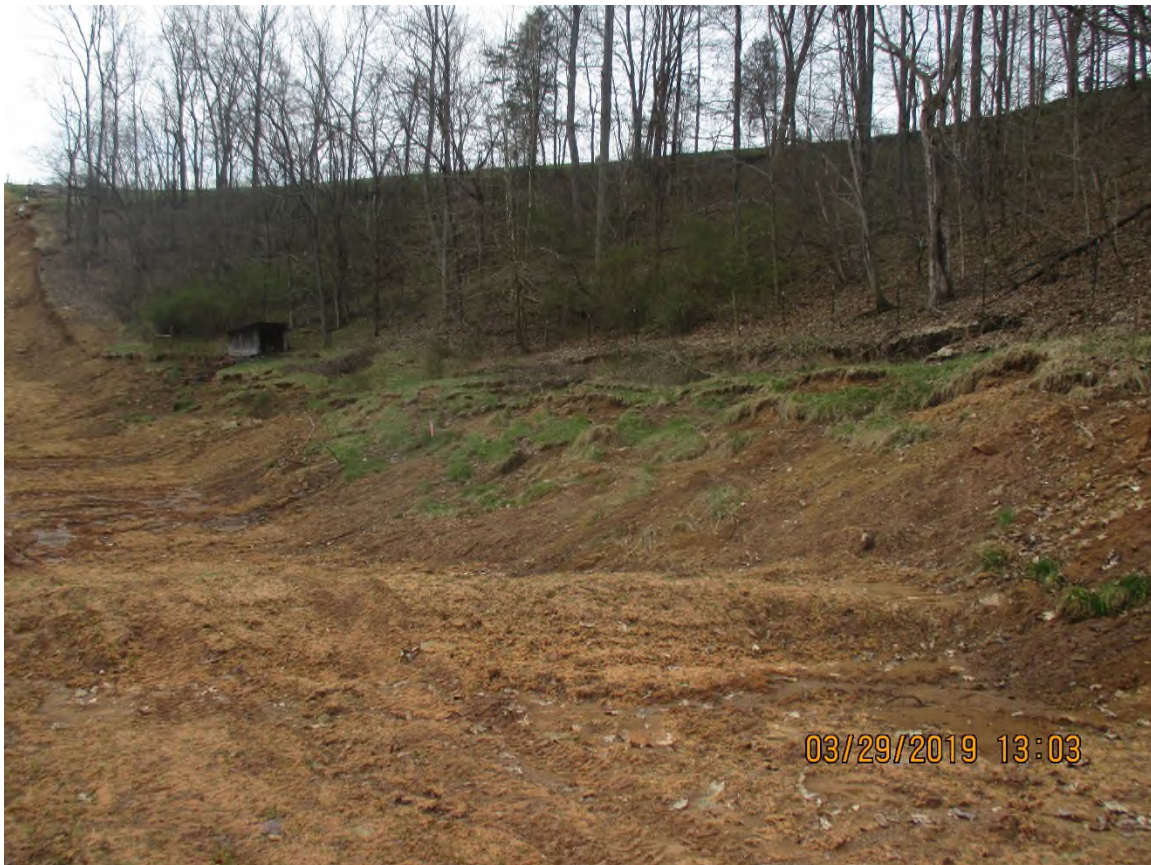
Section of ROW with multiple slips near station #5180+43.

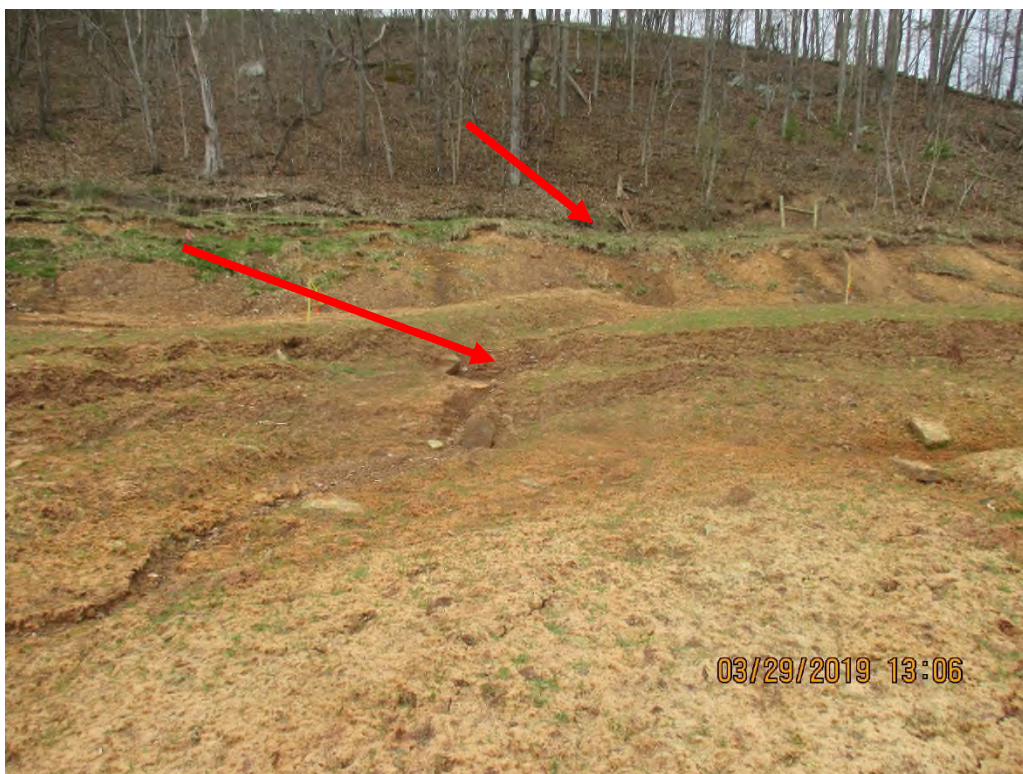
Downslope of controls near station #5180+43. Erosion occurring between and around controls leading to perimeter controls being overwhelmed with sediment.

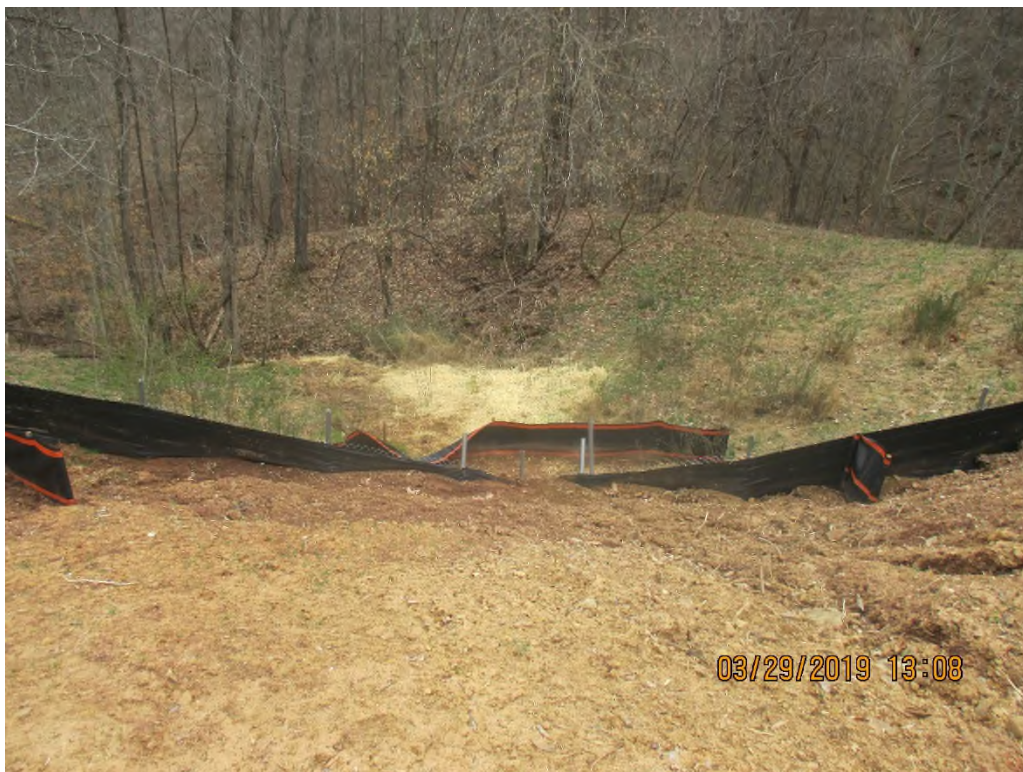
Downslope of controls near station #5180+43. Erosion occurring between and around controls leading to perimeter controls being overwhelmed with sediment.

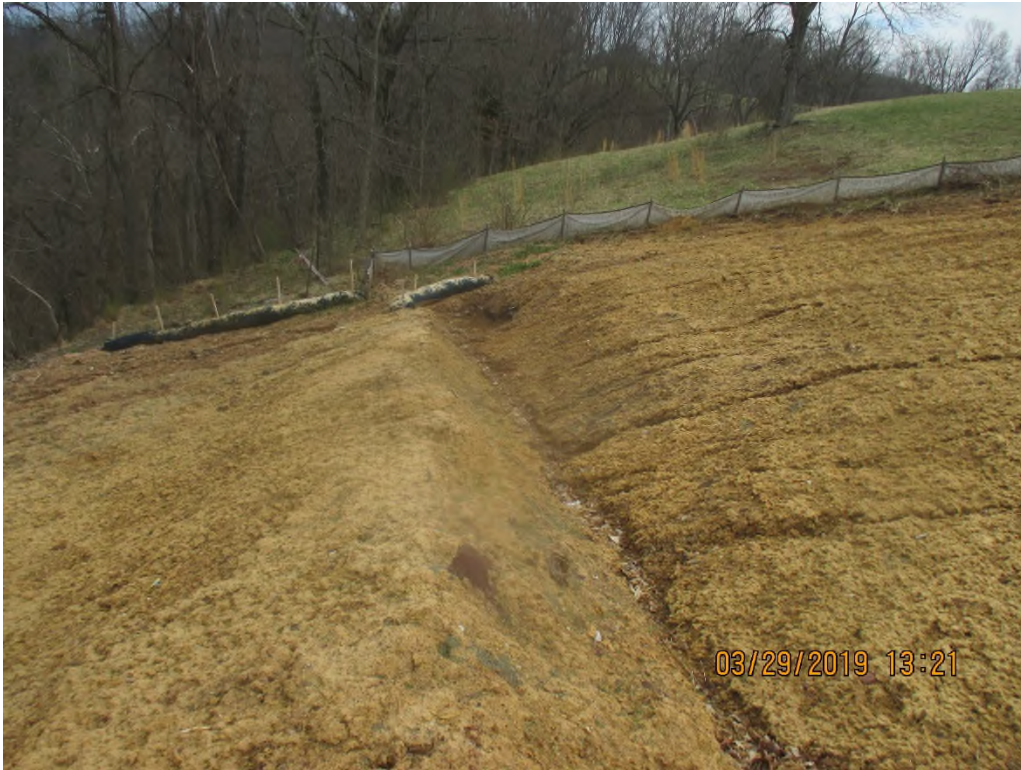
Downslope of controls near station #5180+43. Erosion occurring between and around controls leading to perimeter controls being overwhelmed with sediment.

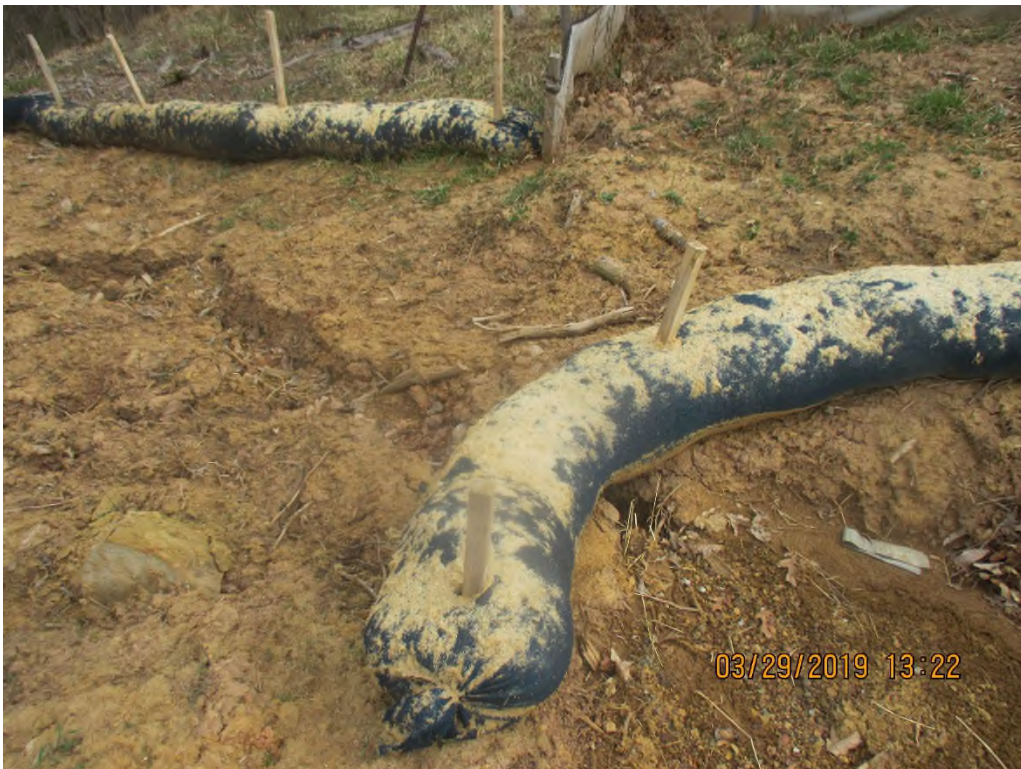
Waterbar near station #5180+43. Erosion occurring in the waterbar.

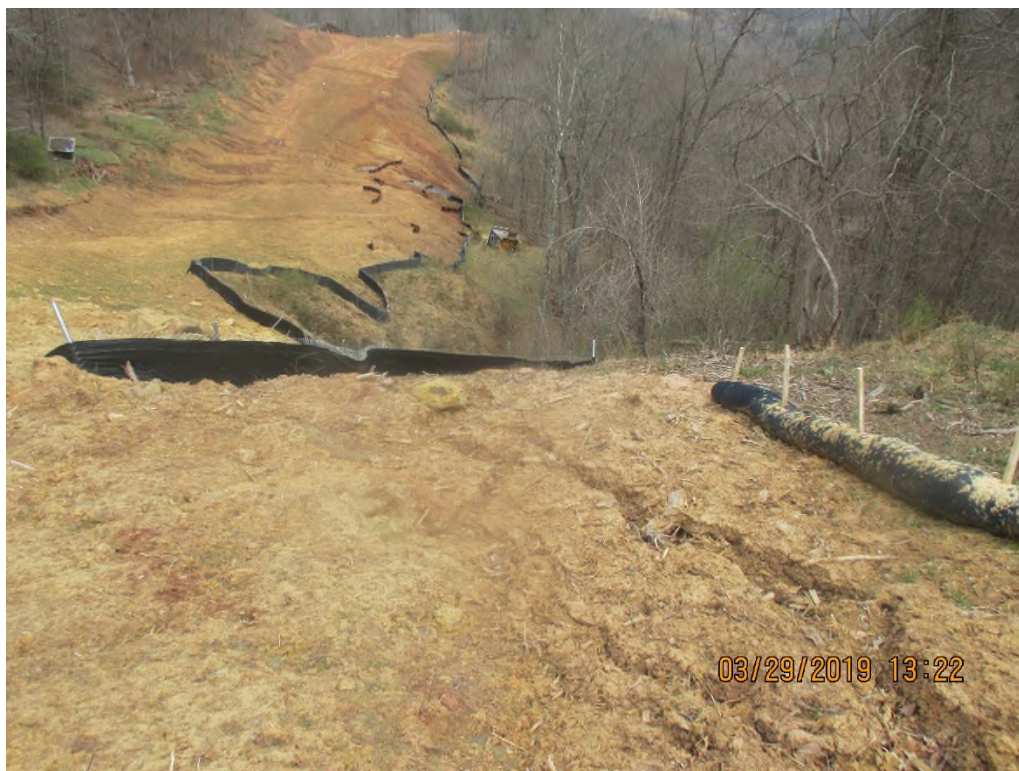
Waterbar terminus near station #5180+43. CFS is being undercut and erosion is occurring downslope of the control along the perimeter.

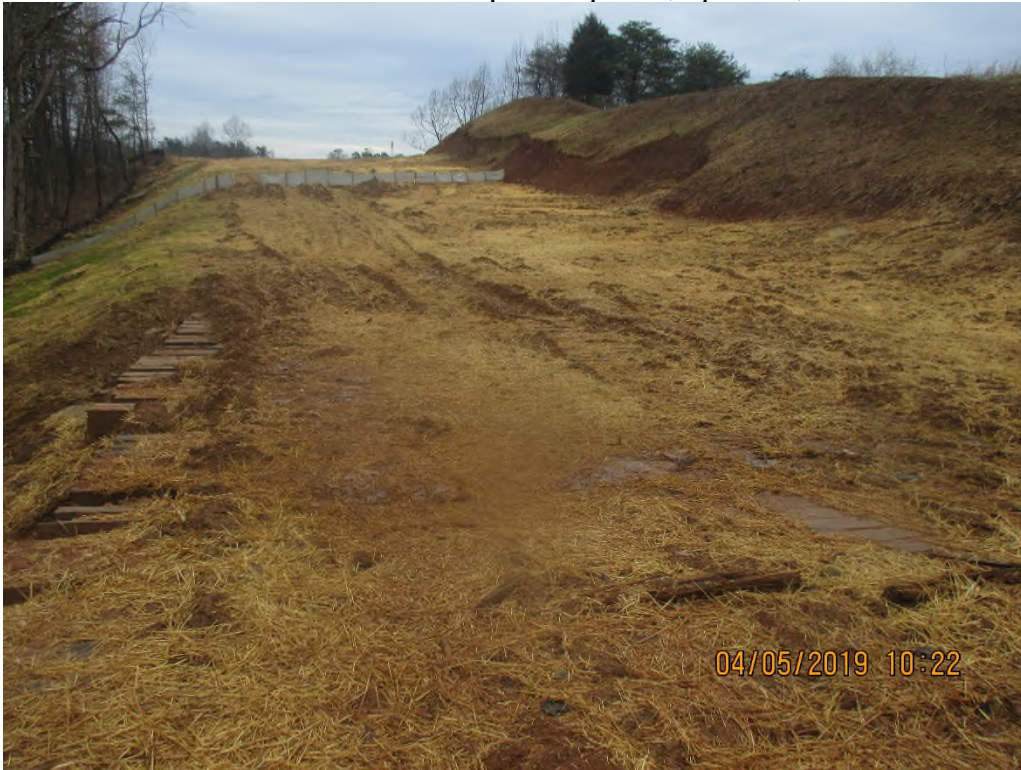
Downslope of waterbar near station #5180+43. Erosion occurring along perimeter.

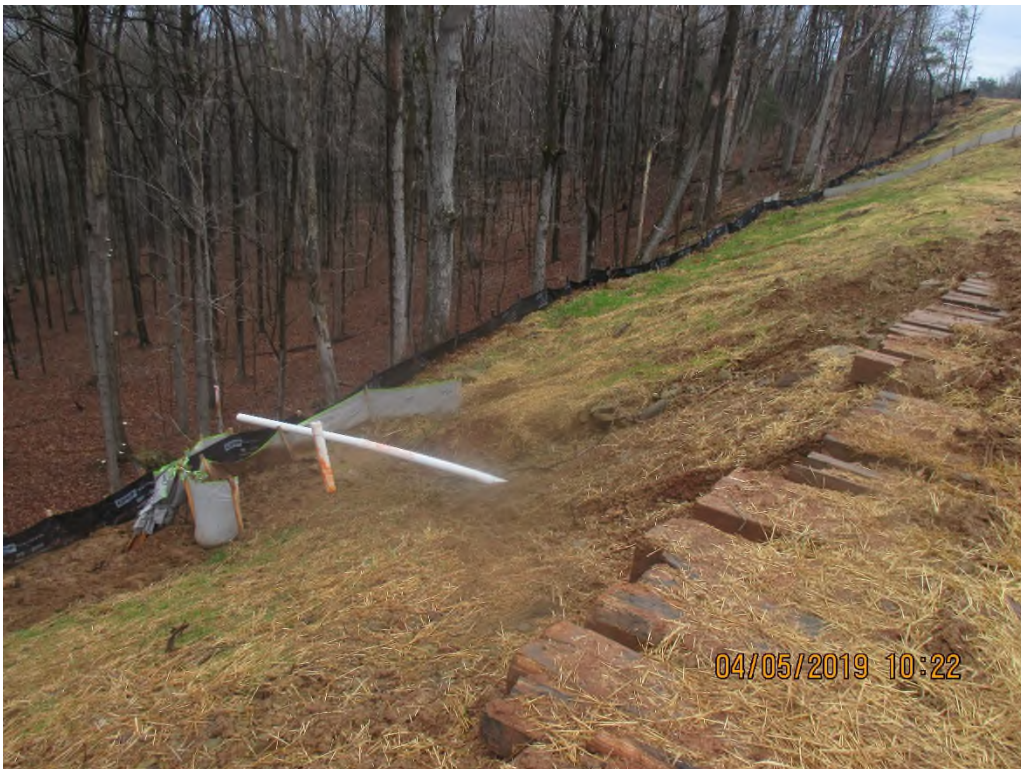
Near station #6781+55 facing South at low spot in ROW where water was accumulating. A pipe slope drain had been installed in this area. However, erosion was occurring on the slope below where timber mats had been installed.

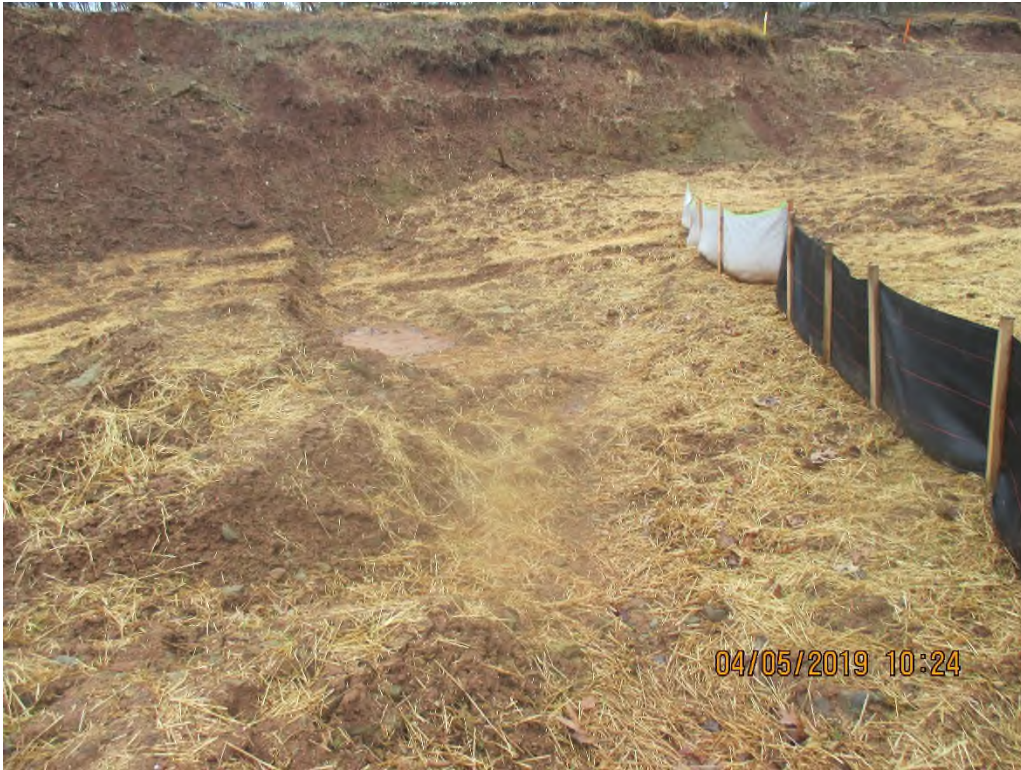
Pipe slope drain outlet near station #6781+55.

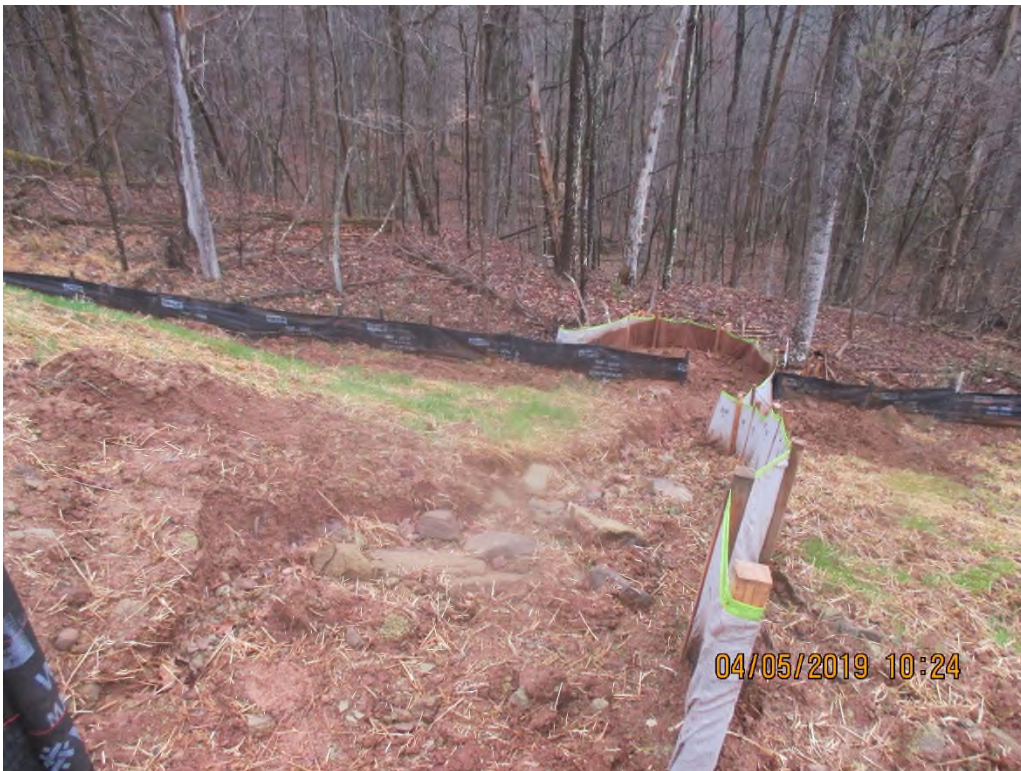
Waterbar near station #6781+55. Ponding present in Waterbar.

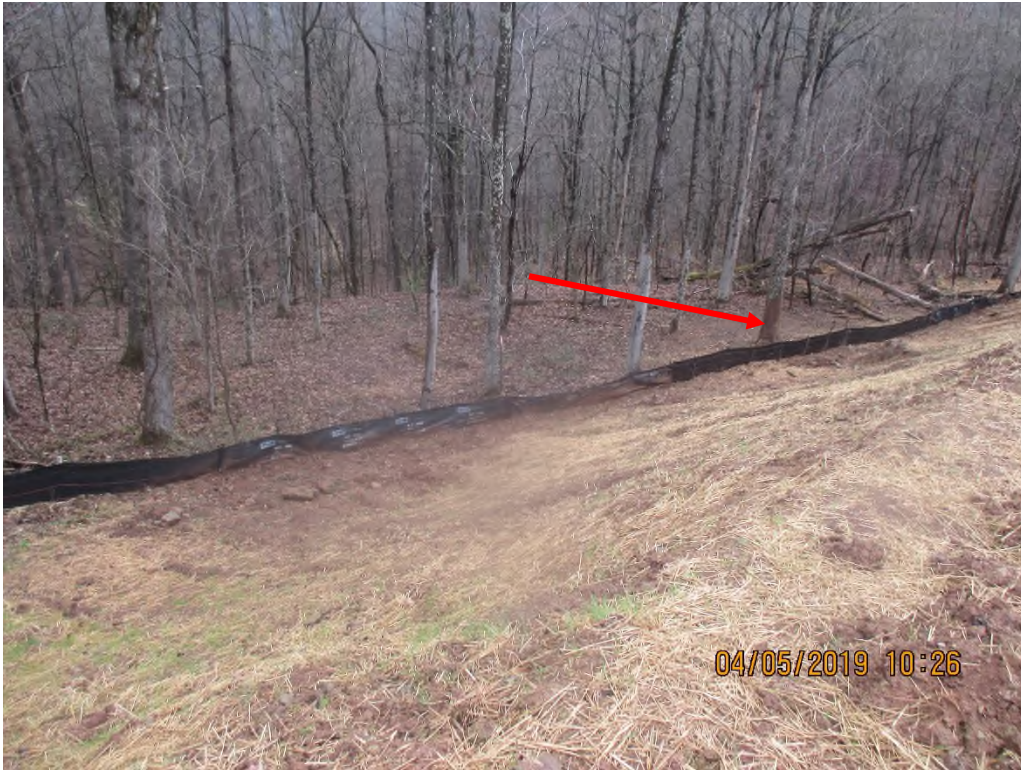
Waterbar terminating on fill slope. Erosion present on fill slope with sediment being deposited behind perimeter controls.

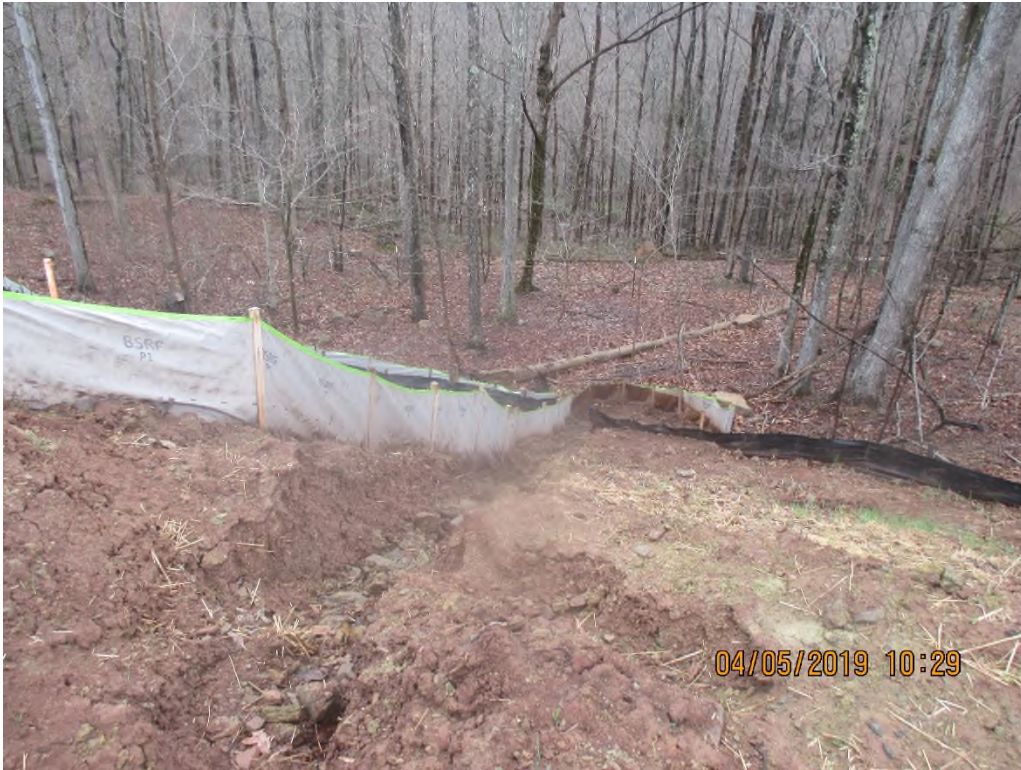
Waterbar with ponding present. Sediment from topsoil pile slipping into waterbar near station #6795+55.
