**CONSENT ORDER
ISSUED UNDER THE
WATER POLLUTION CONTROL ACT
WEST VIRGINIA CODE, CHAPTER 22, ARTICLE 11**

TO: Columbia Gas Transmission, LLC
Attn: Troy Tally, Vice President
1700 MacCorkle Ave
Charleston, WV 25314

DATE: October 1, 2020
ORDER NO.: 9061

1. Columbia Gas Transmission, LLC is conducting land disturbance activity associated with construction of the Mountaineer Xpress Project in Marshall, Wetzel, Tyler, Doddridge, Ritchie, Calhoun, Wirt, Roane, Jackson, Mason, Putnam, and Cabell Counties, West Virginia. On January 31, 2018, Columbia Gas Transmission, LLC was issued Water Pollution Control Permit No. WV0116815, Registration No. WVR310872, for Stormwater Associated With Oil and Gas Related Construction Activities.

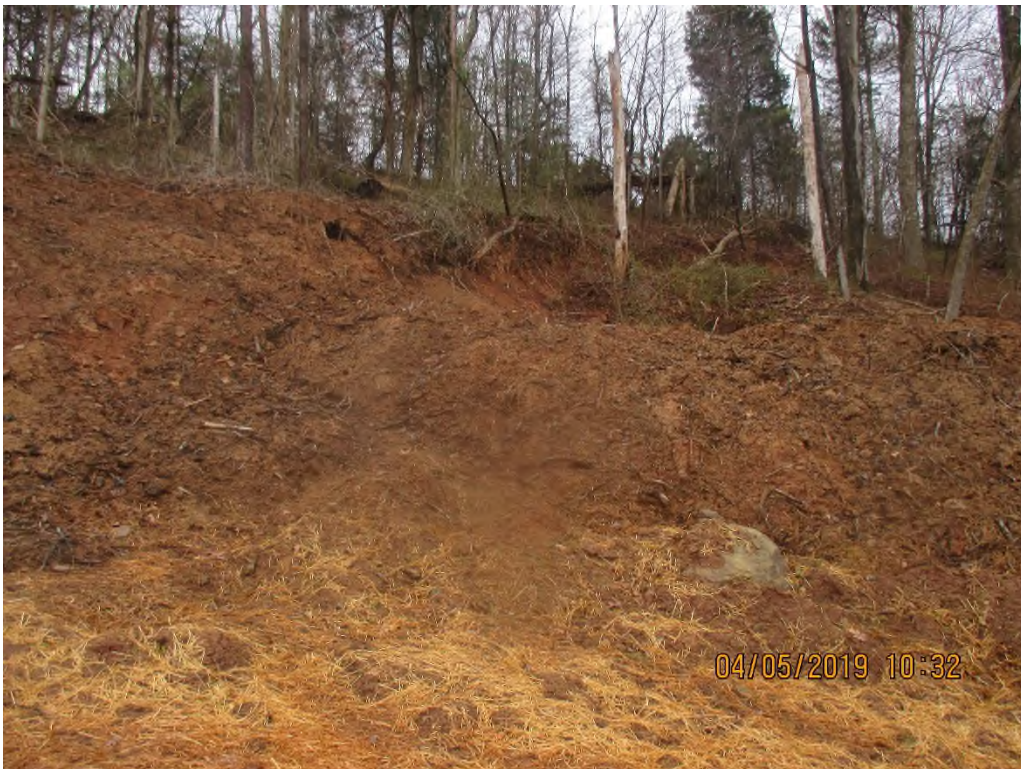
Waterbar outlet near station #6795+40. Waterbar terminating on fill slope causing erosion on slope.

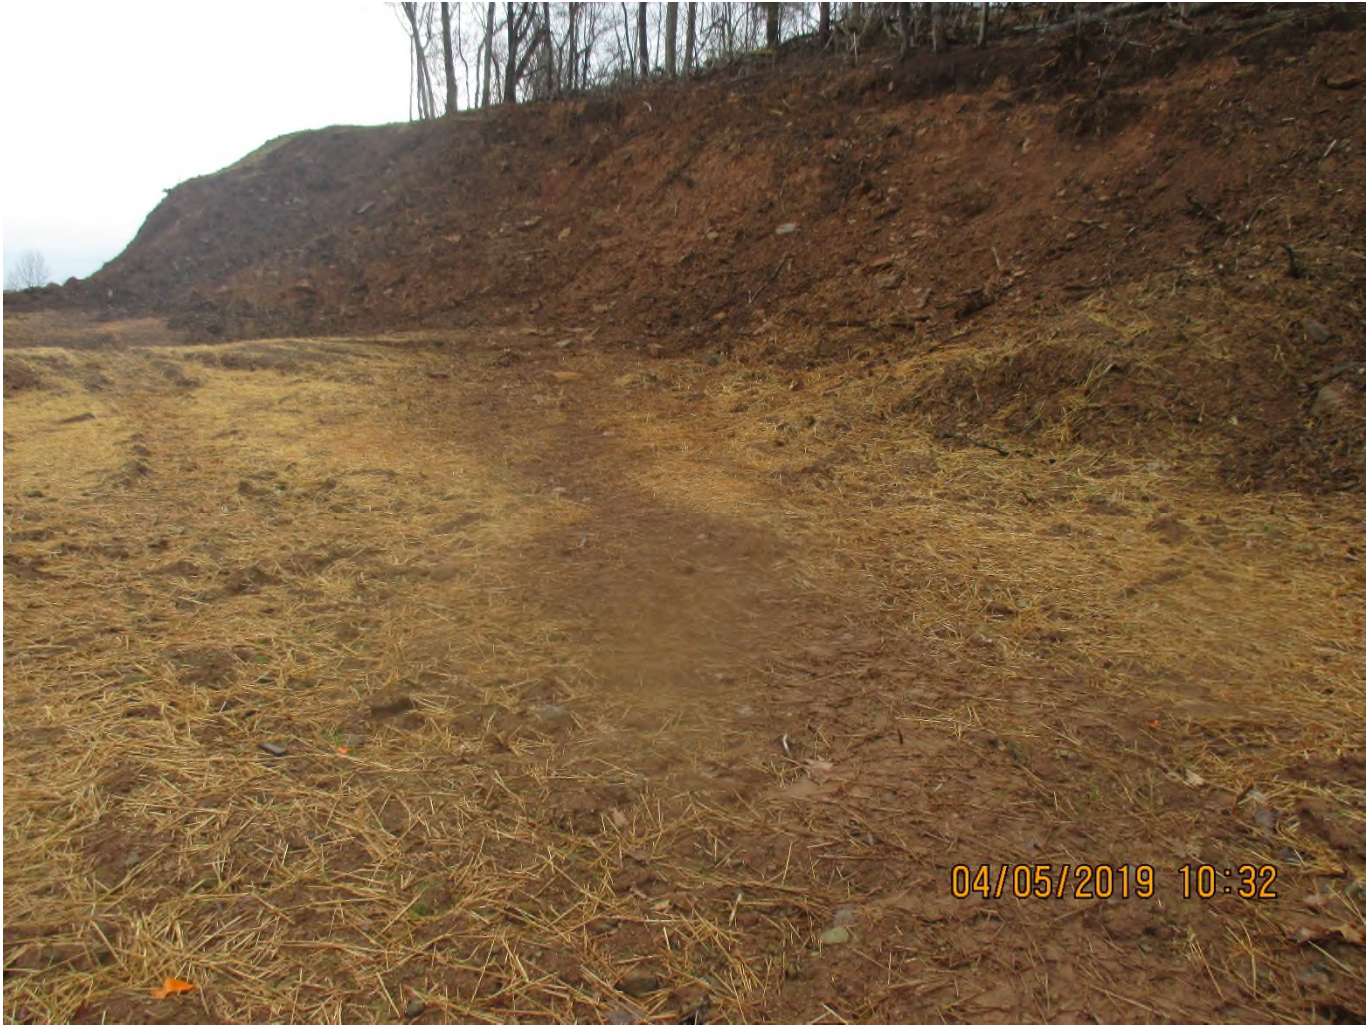
Slip upslope of MXP ROW at station #6792+40 slipping into ROW.

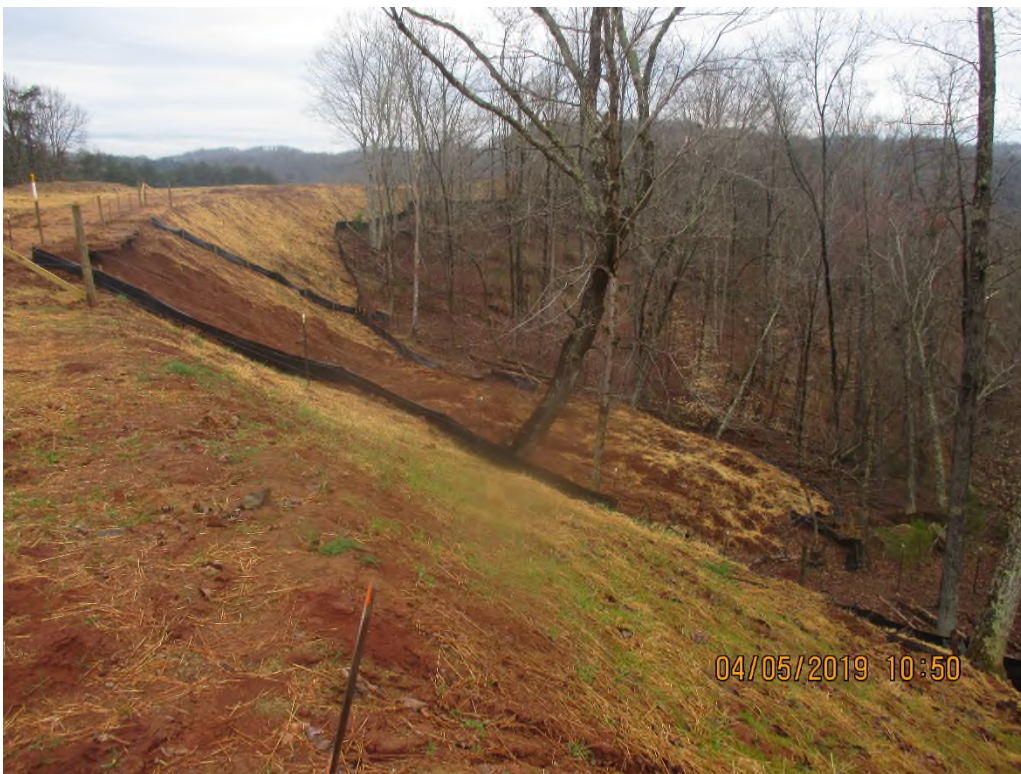
Downslope of slip occurring above ROW at station #6792+40. Scouring of temporary stabilization occurring.

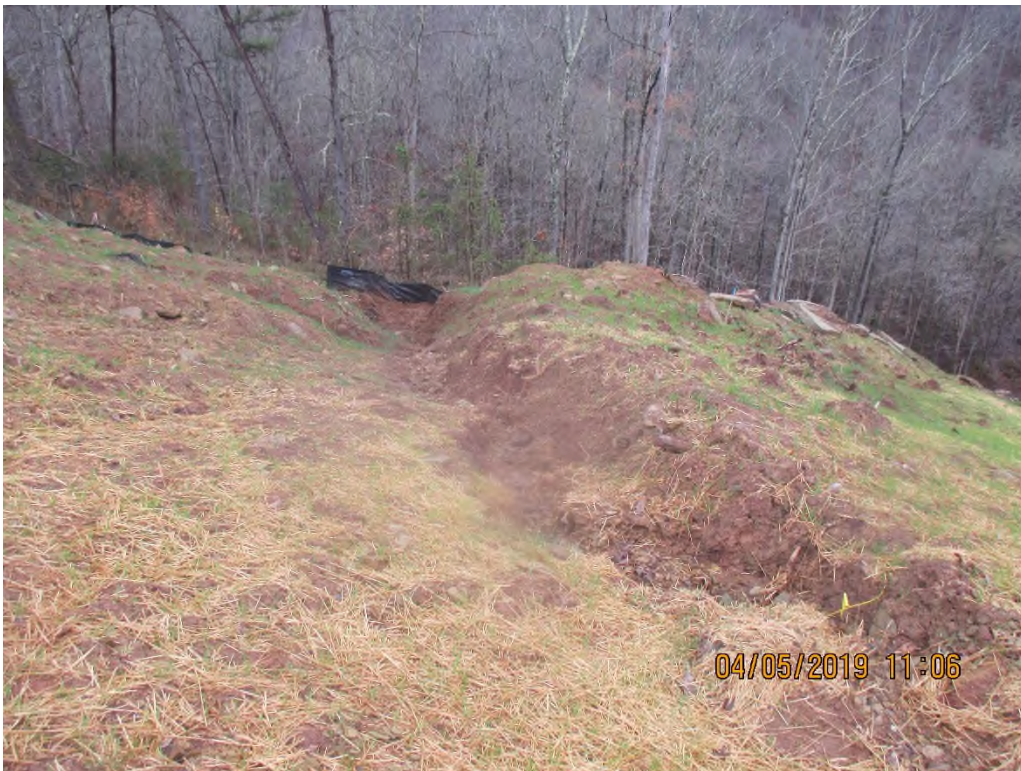
Waterbar near station #6810+00. Erosion present in waterbar and slope at terminus.

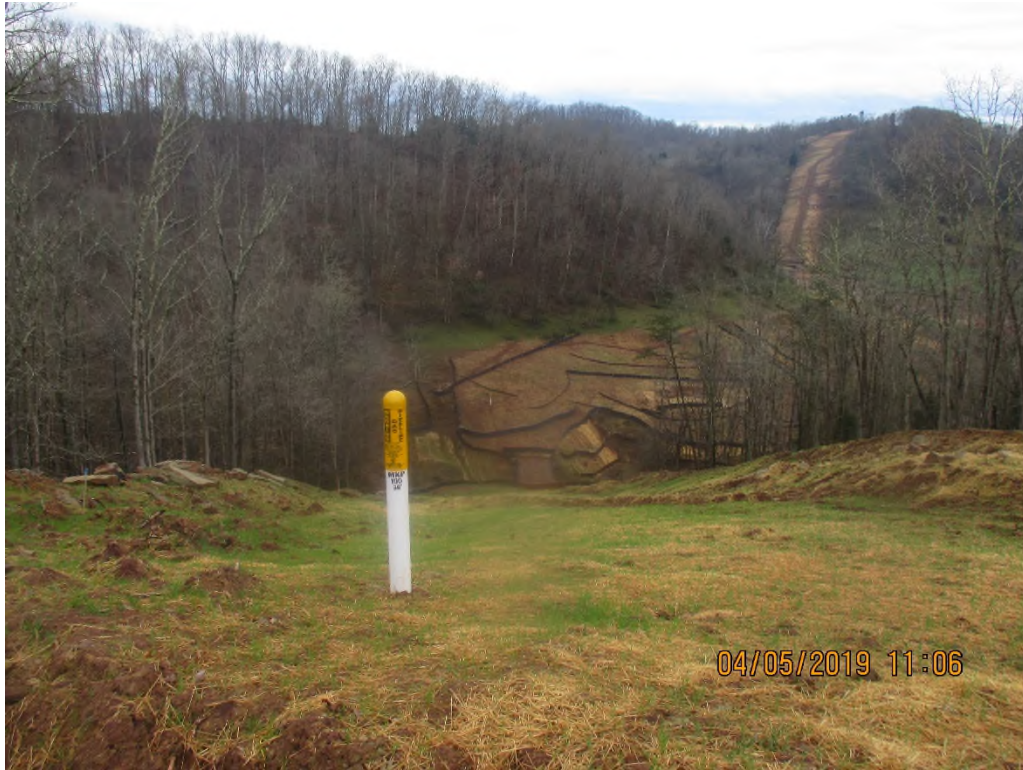
Waterbar near station #6810+00. Erosion present in waterbar and slope at terminus.

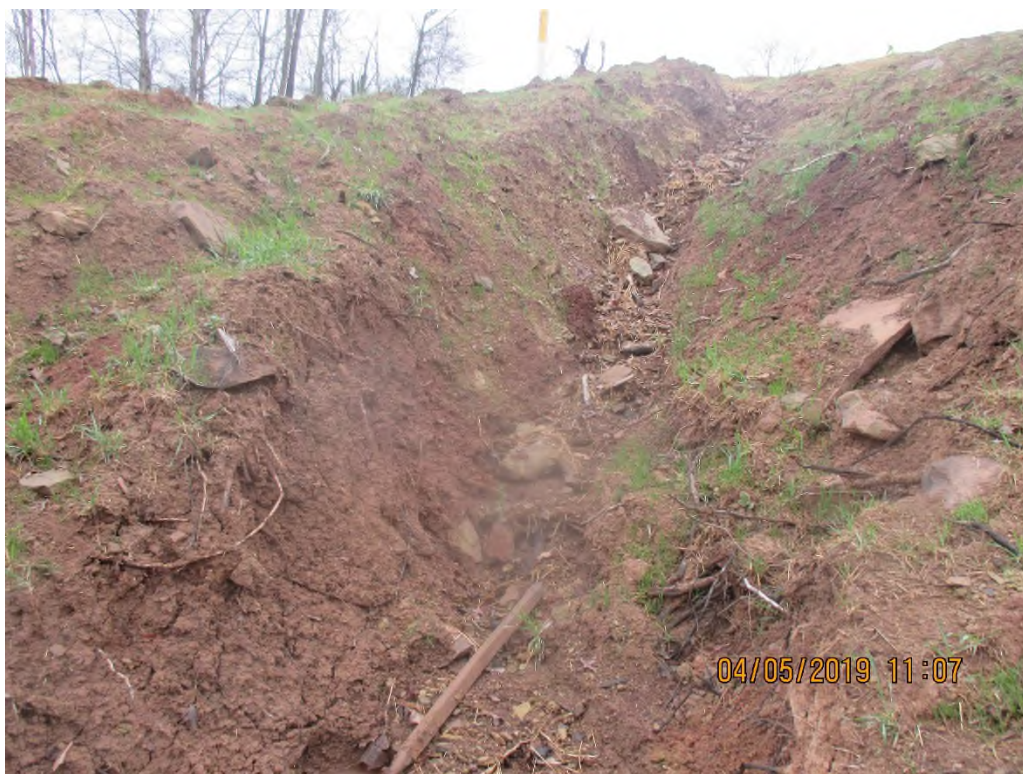
Facing towards SJAG 316 and the Shamblin Run Road crossing where multiple slips have occurred on ROW.

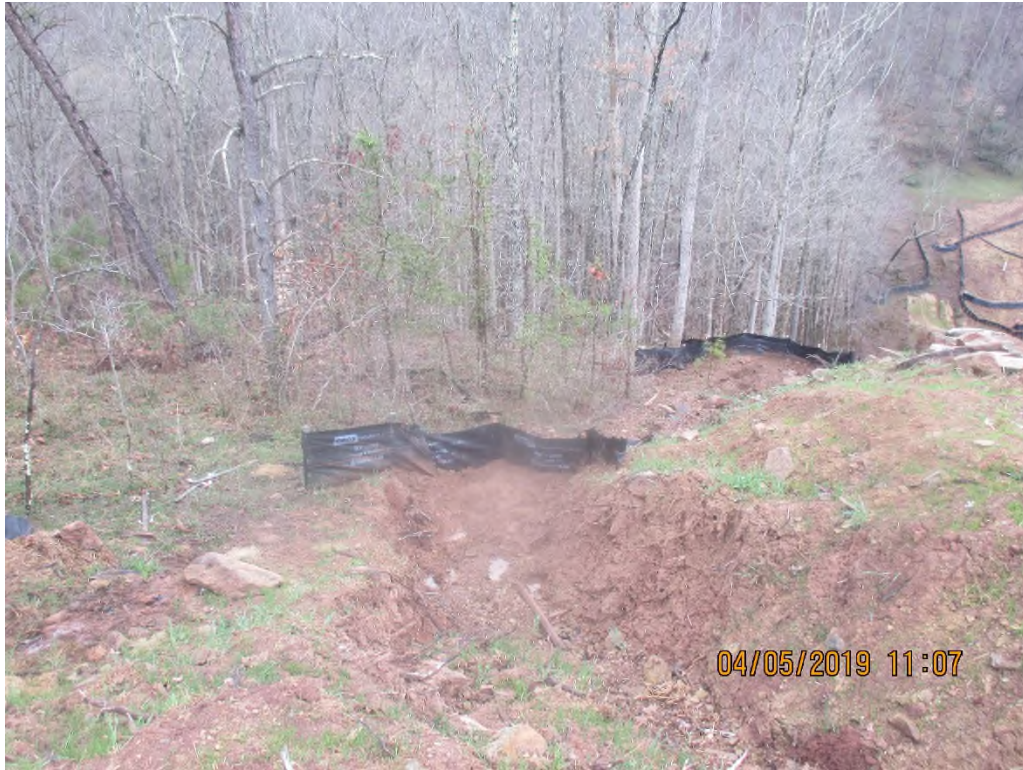
Waterbar terminating onto fill slope above stream SJAG 316. Erosion present in waterbar.

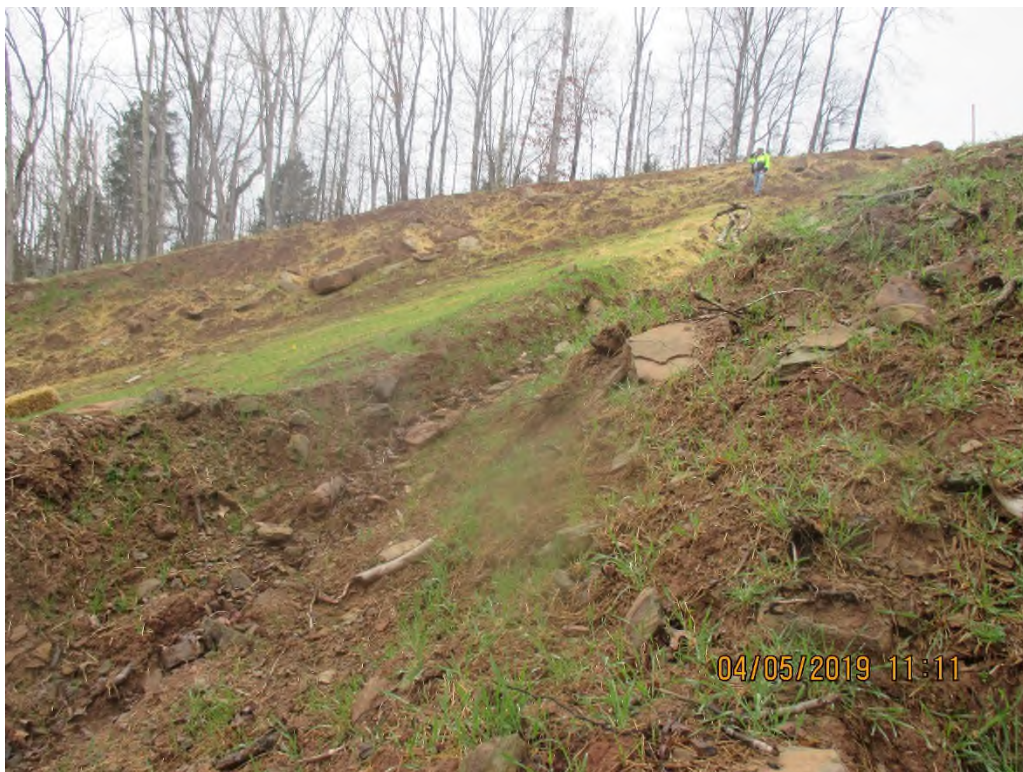
Waterbar terminating onto slope. Downslope of terminus facing controls along perimeter above stream SJAG-316.

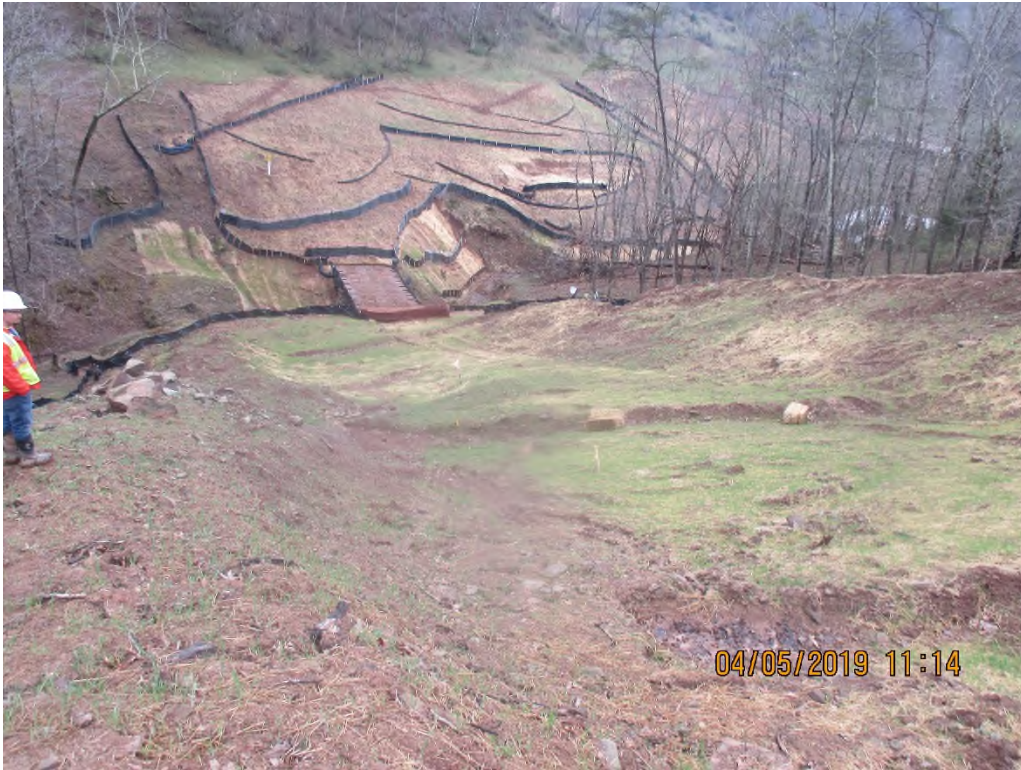
Waterbar above stream SJAG-316 terminating into topsoil pile.

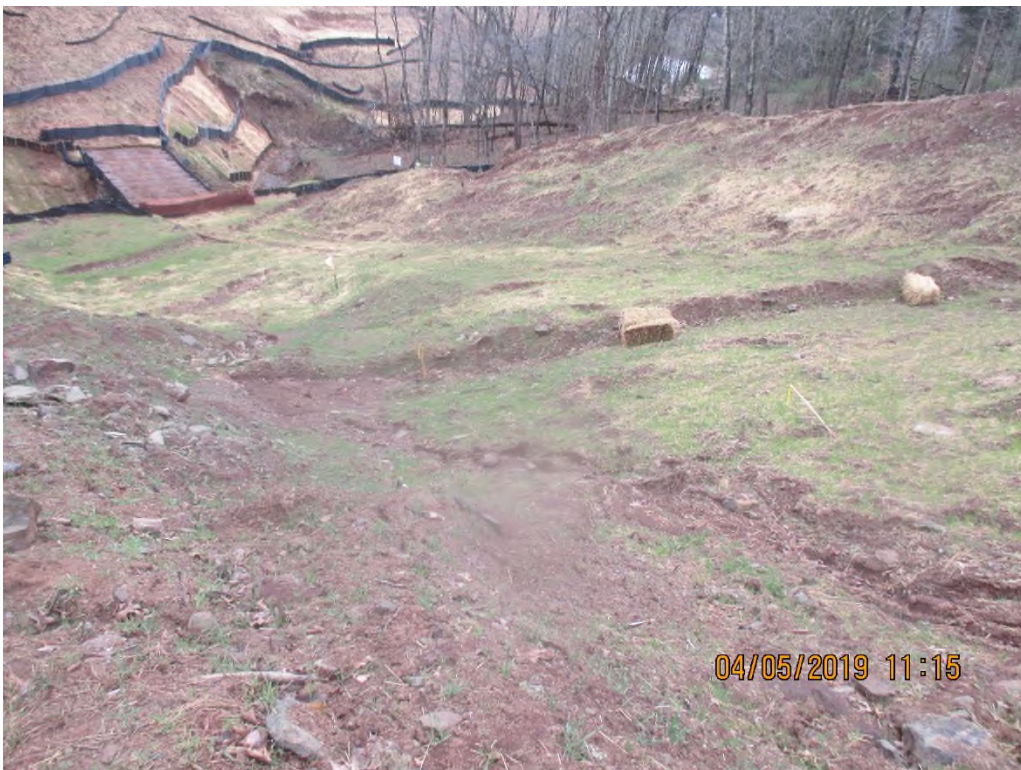
Waterbar above stream SJAG-316 terminating into topsoil pile. Erosion occurring below waterbar on ROW due to concentrated flow overtopping the waterbar at the terminus and running downslope along topsoil pile.

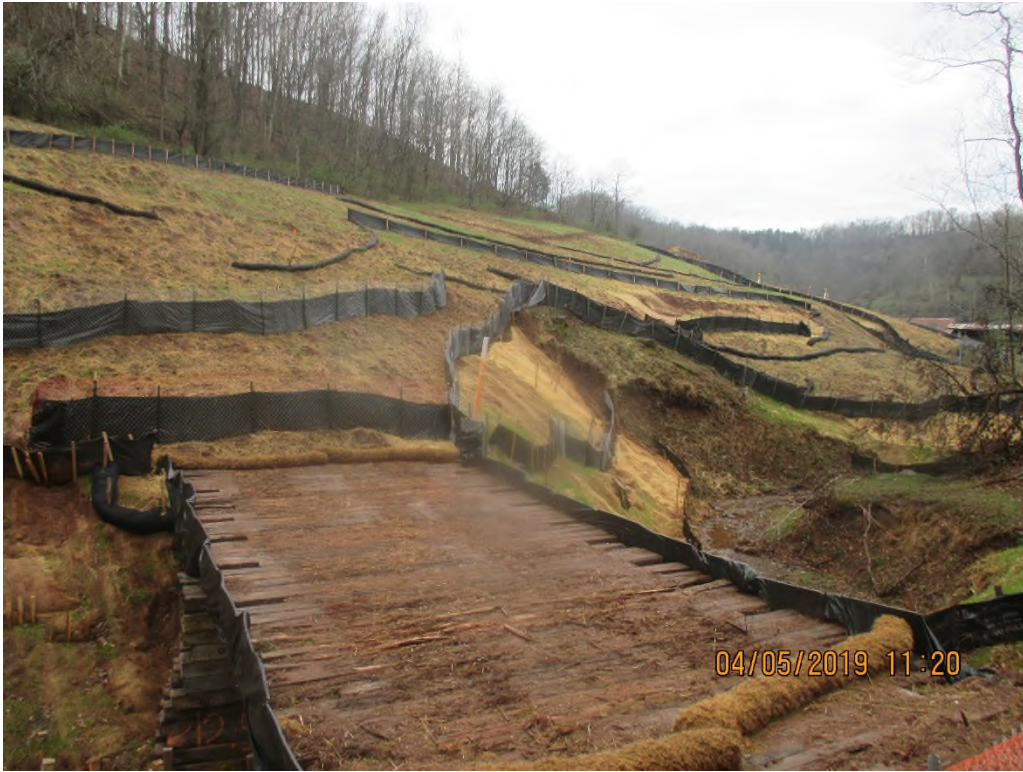
Erosion occurring on ROW between the waterbars above stream SJAG-316. These waterbars were terminating into the topsoil pile and not being diverted off the ROW.

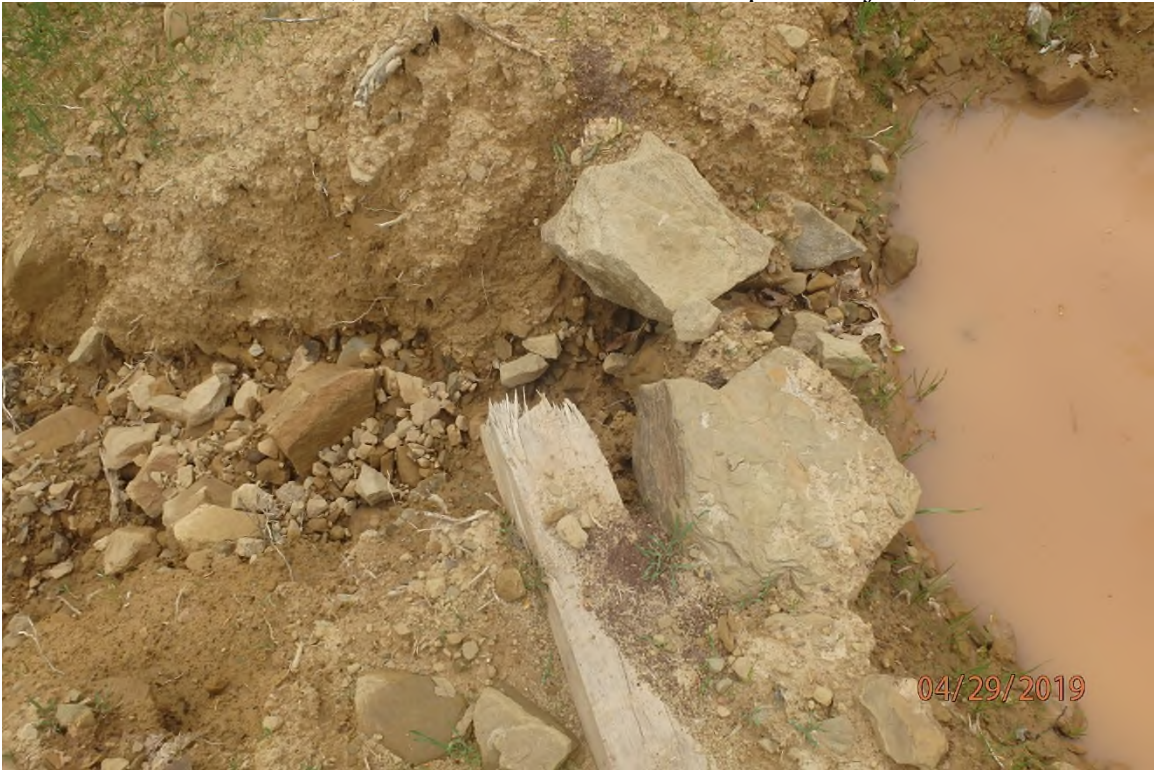
Stream SJAG-316 crossing where multiple slips have been reported.

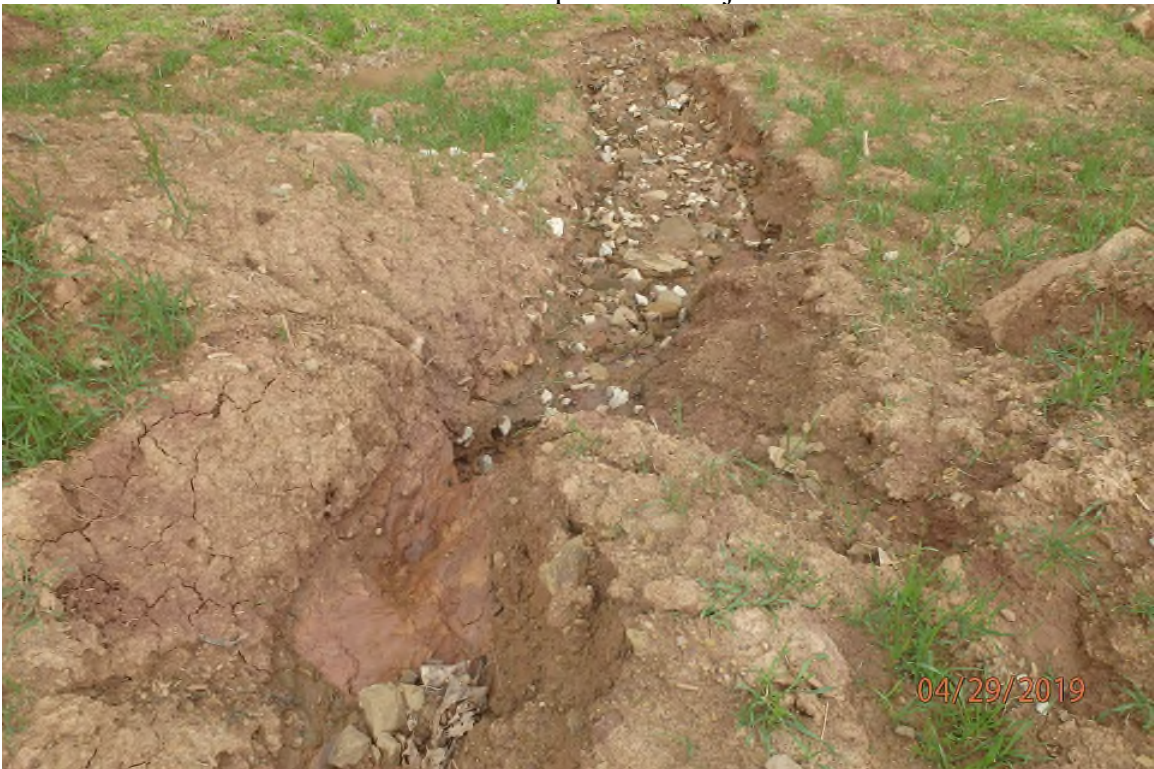
Water bar outlet with fill slope erosion adjacent to 2268+00.

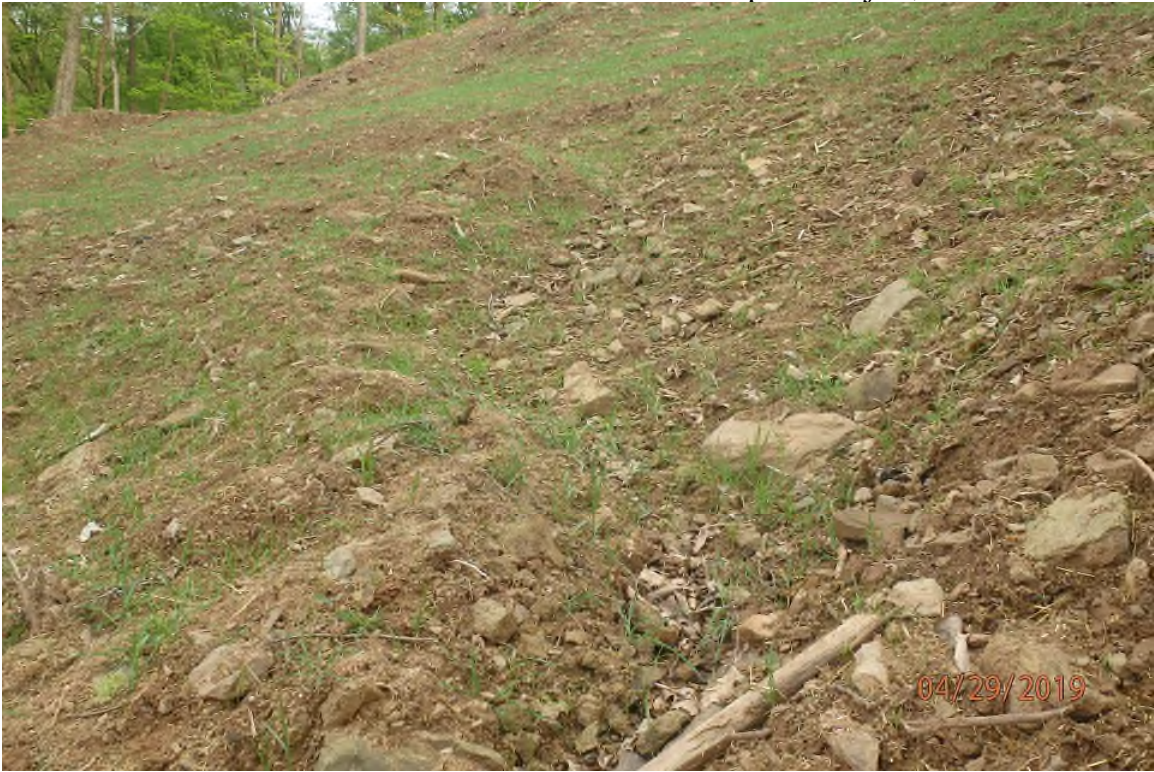
Erosion gully downslope of the above pictured water bar adjacent to 2226+50.

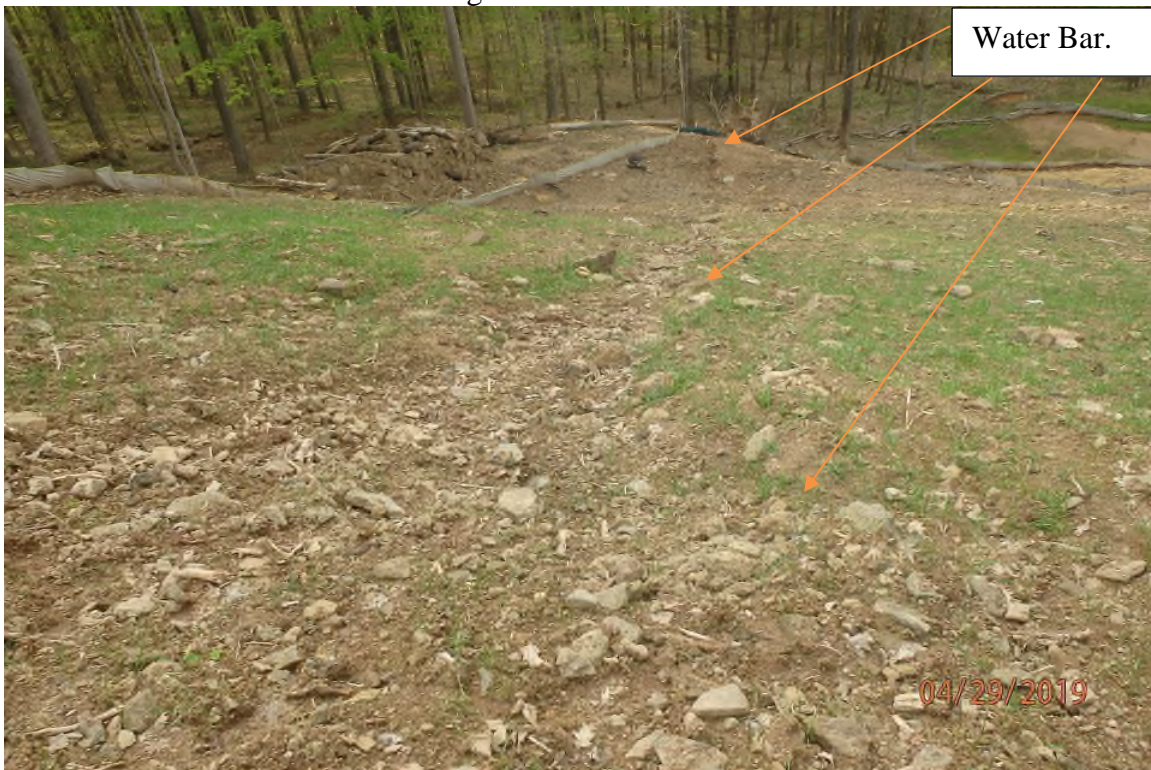
Water bar with varying angles adjacent to 2225+00. A portion of the water bar is installed at an angle greater than 12%.

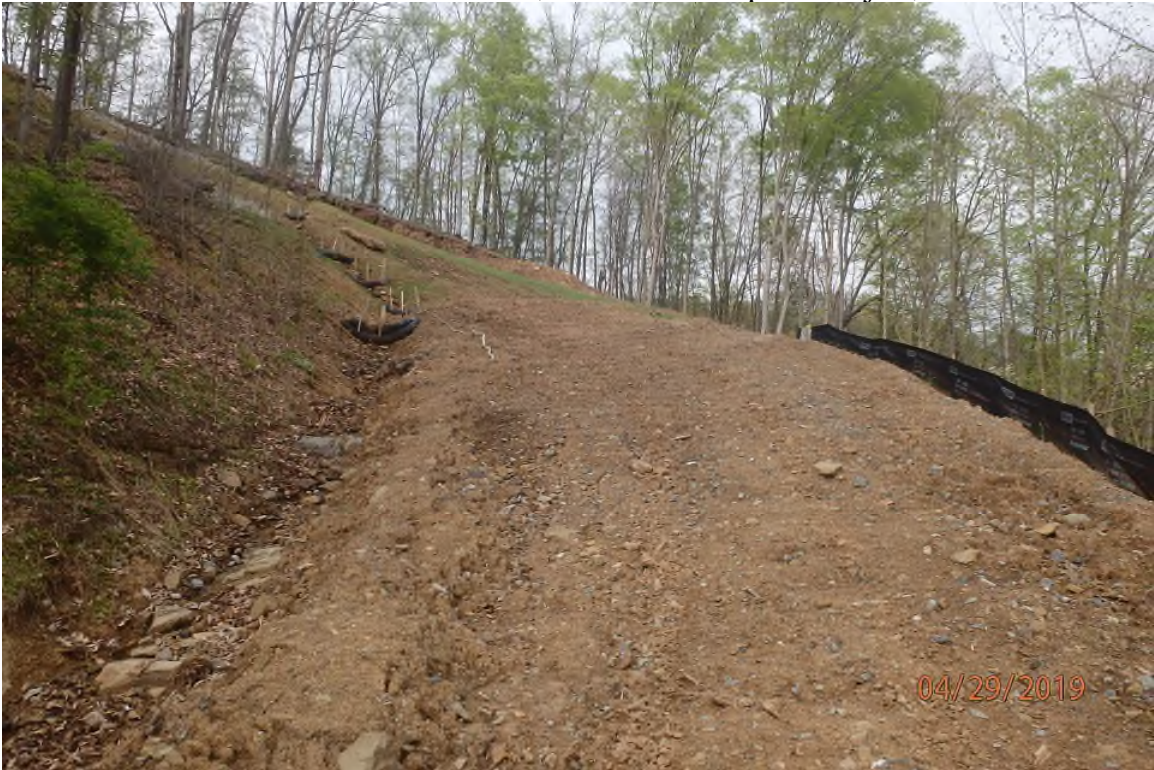
Water bar adjacent to 2225+00 installed at an angle greater than 12%.

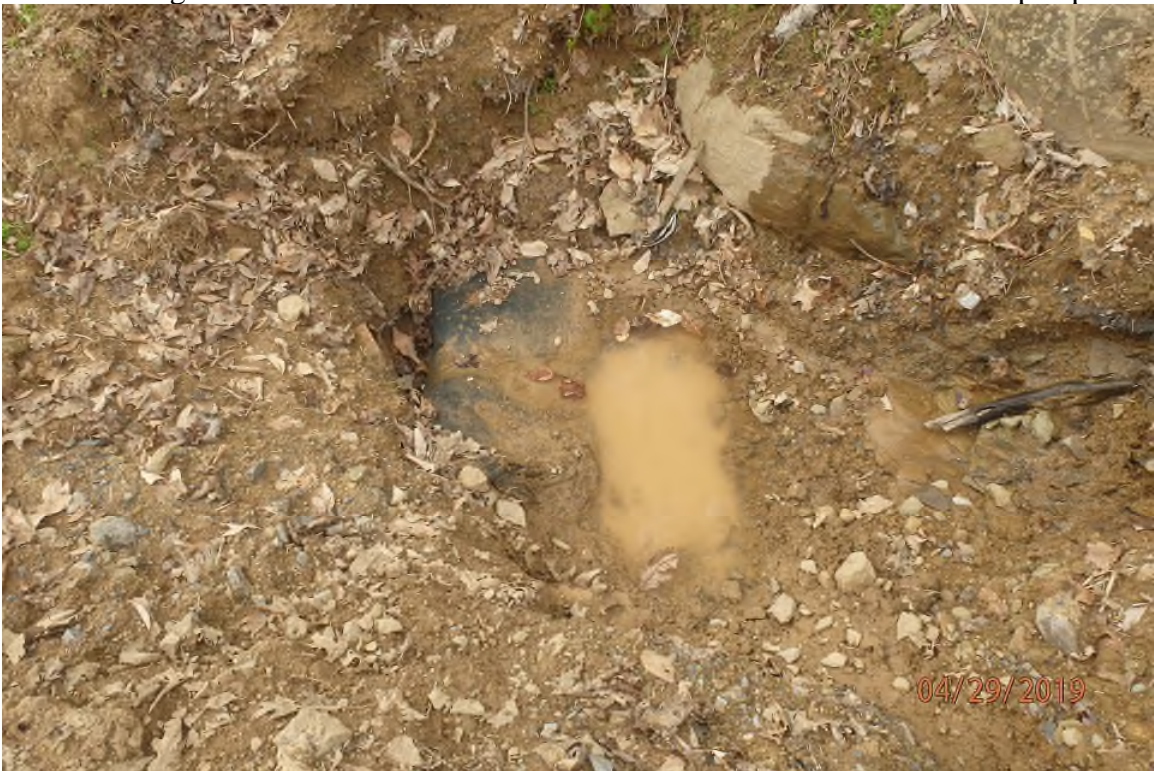
AR -17 showing the need for maintenance to the stabilized road surface and the upslope ditch.

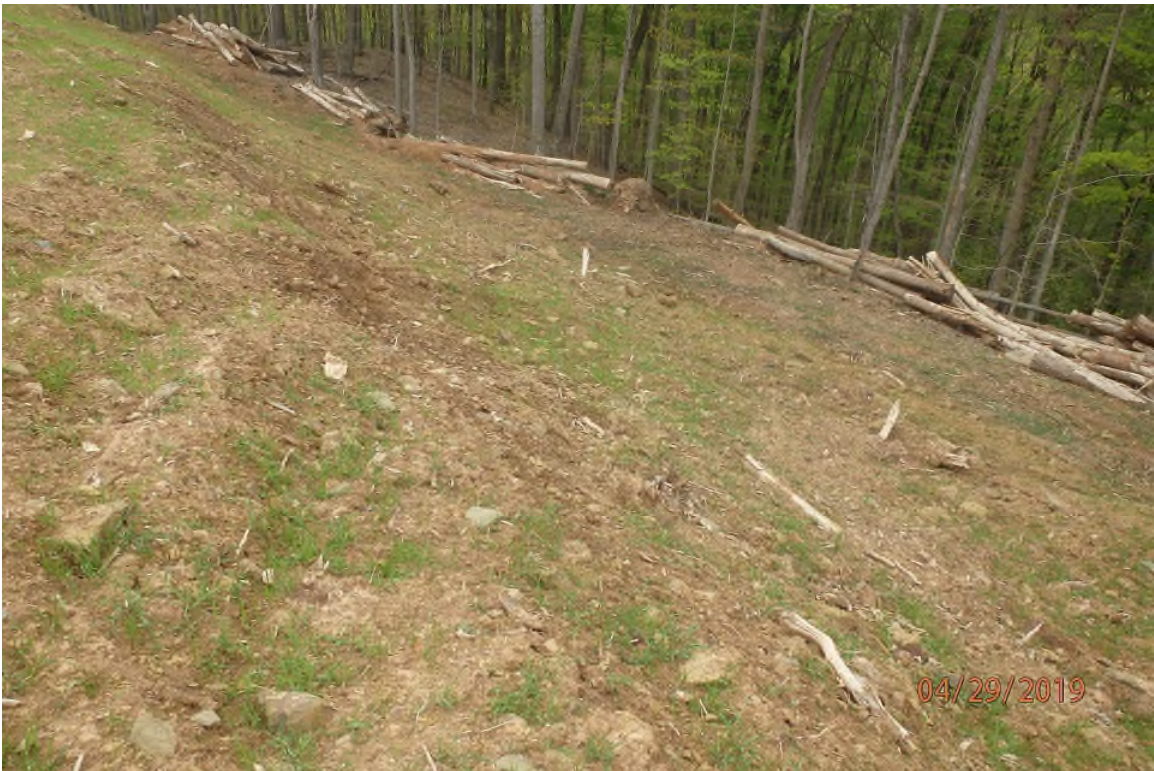
AR - 17 showing the need for maintenance to the ditch check upslope of the interceptor culvert.

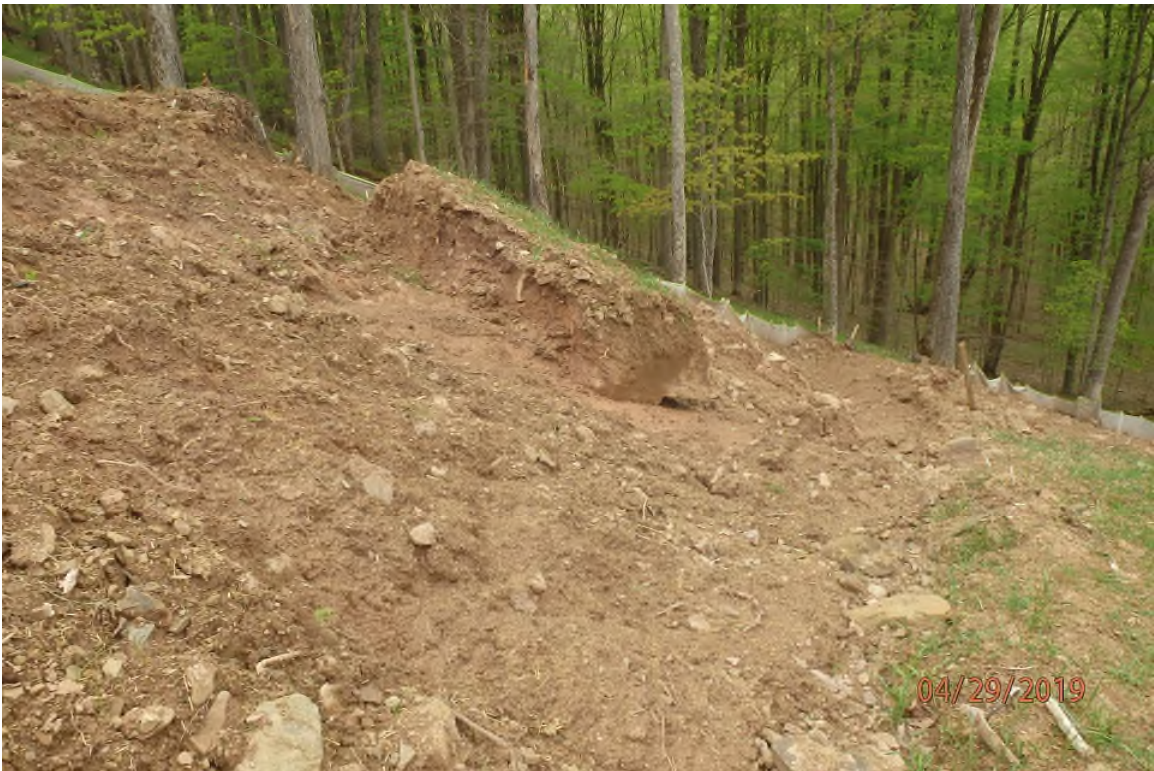
Project area adjacent to 2229+00 showing the need for perimeter controls where the approved SWPPP does not indicate the need.

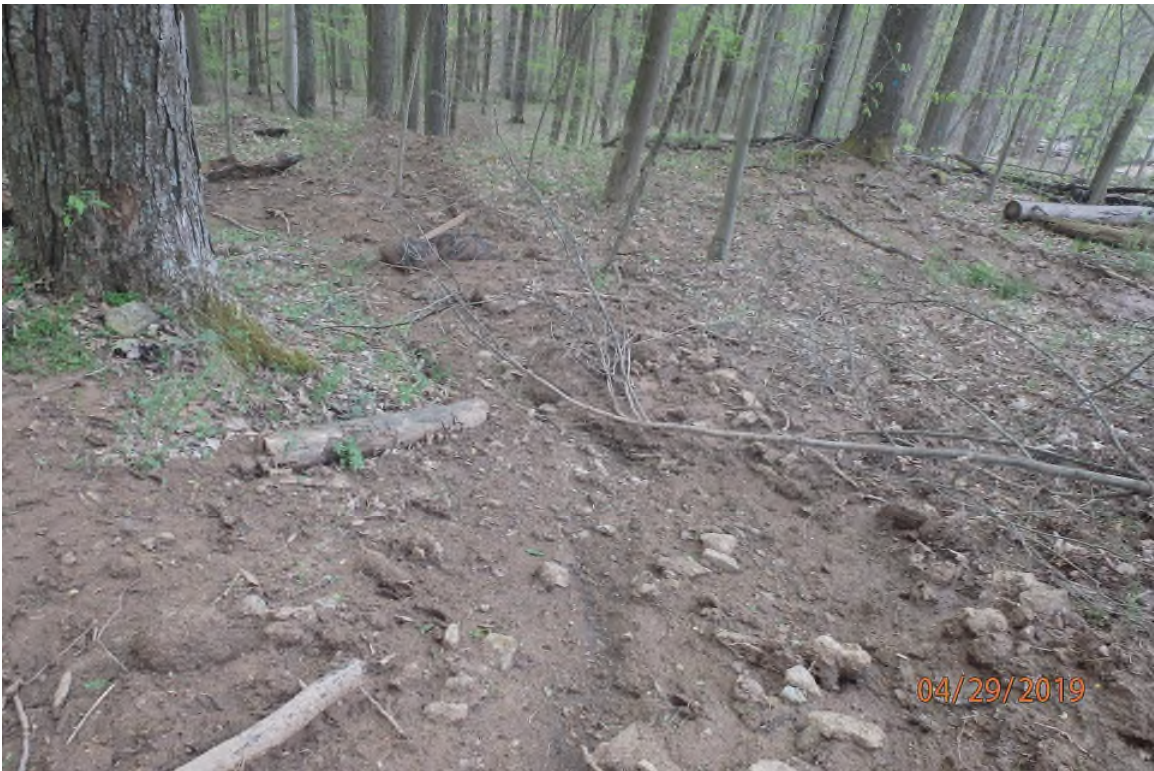
Offsite sediment downslope of the previously pictured slip.

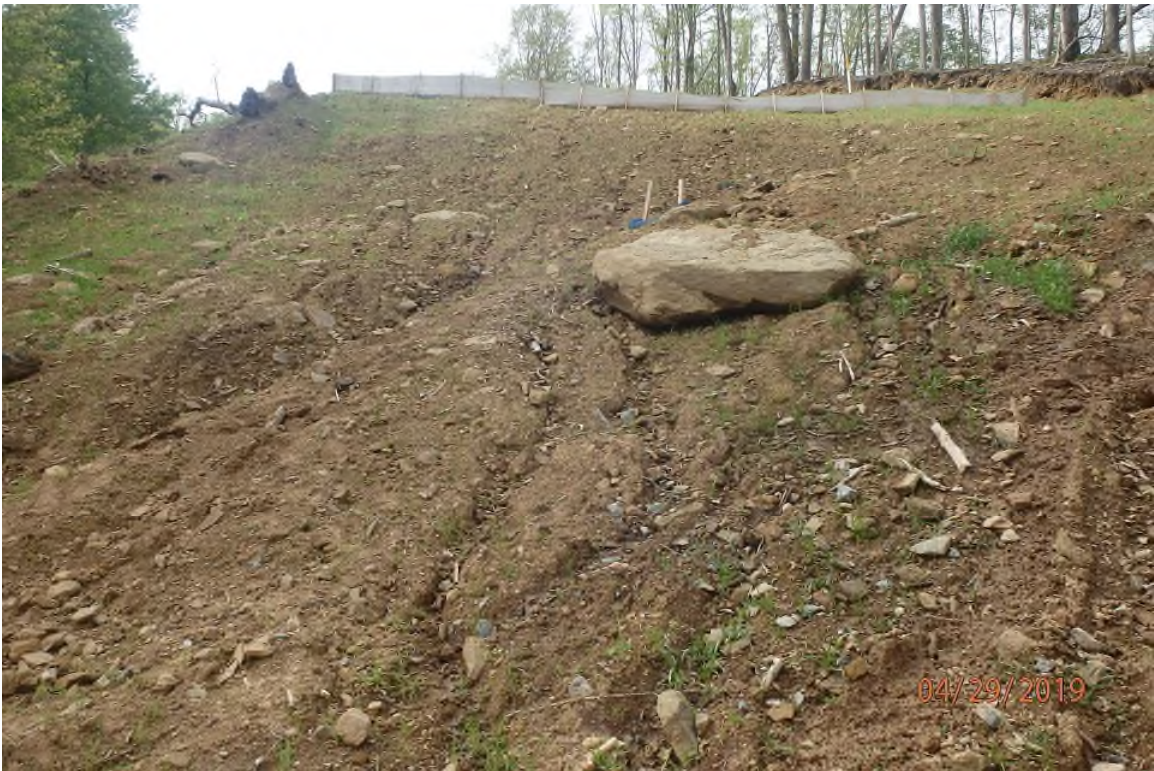
Disturbed areas of the project that are in need of reseeding.

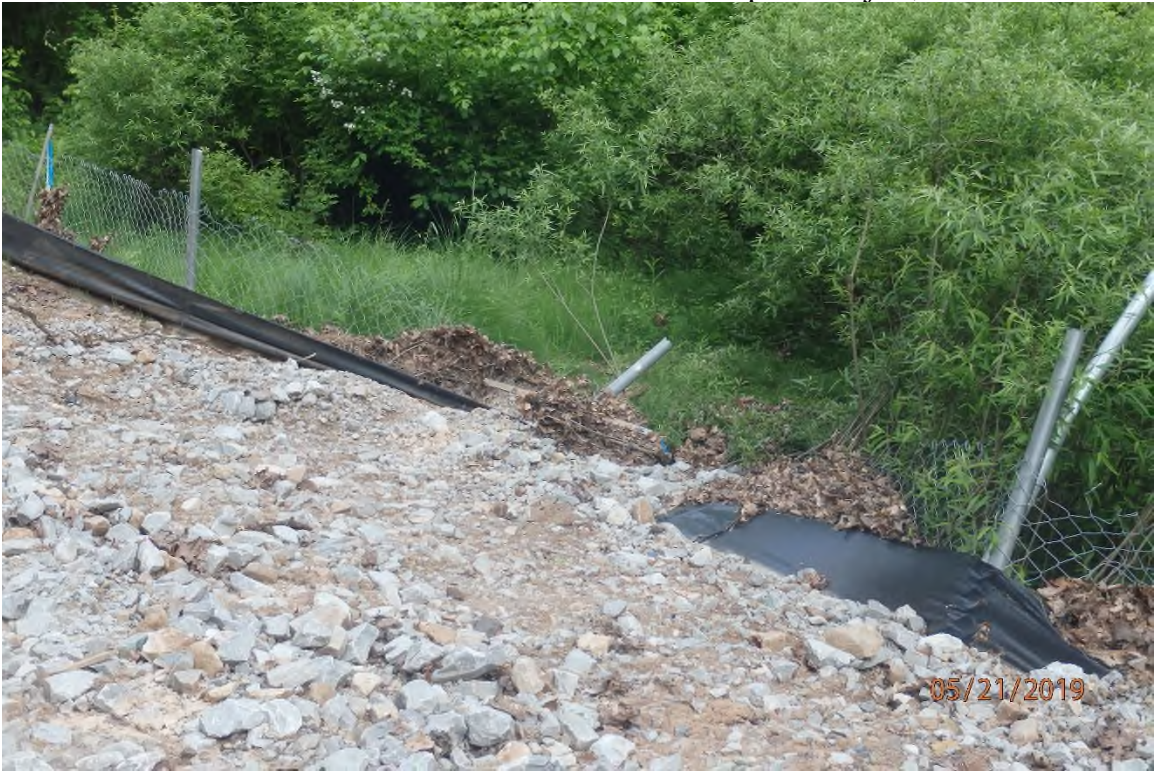
Unmaintained BMP on ARDO016.

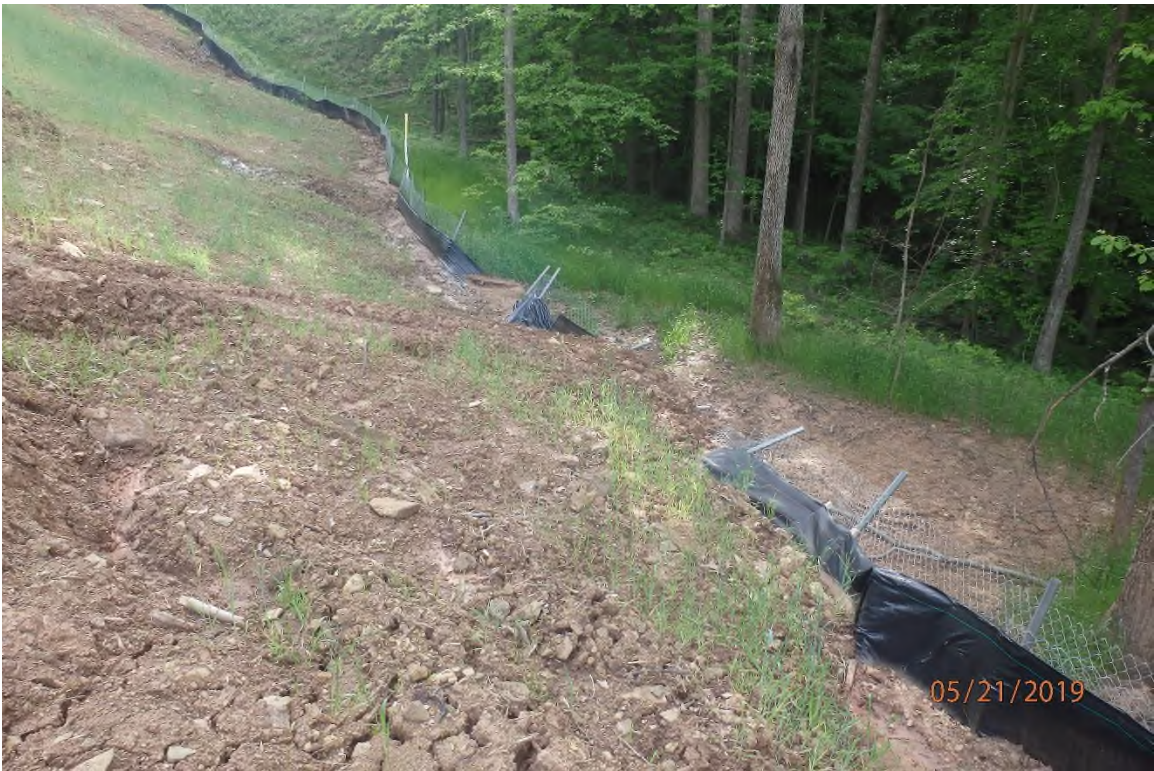
Unmaintained BMP in the Sugar Run watershed.

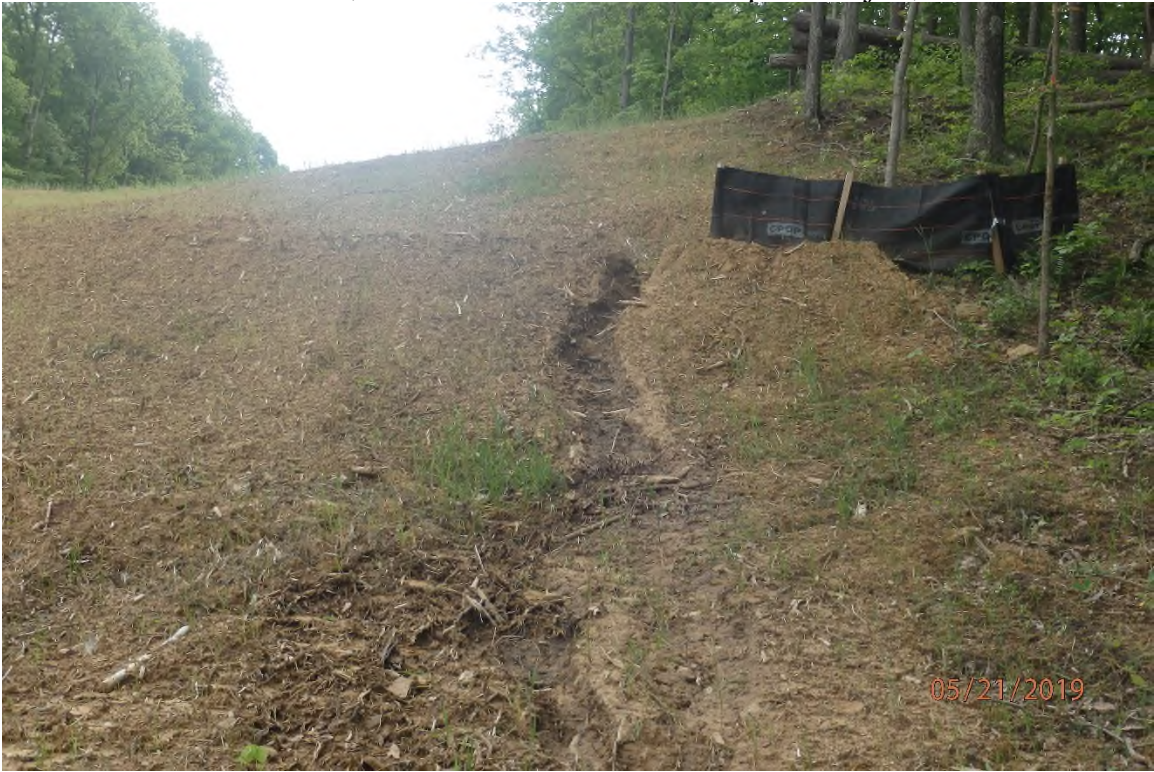
Unmaintained BMP in the Sugar Run watershed and the associated fill slope erosion.

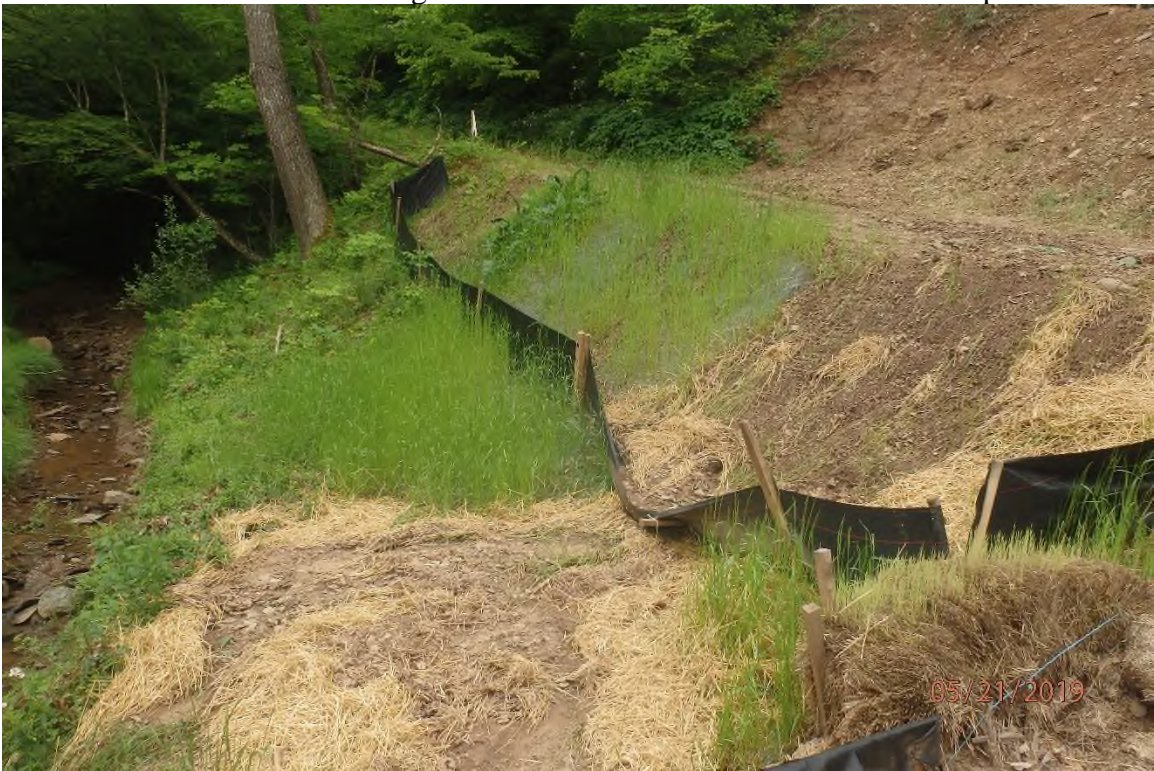
Unmaintained BMP in the UNT S. Fork of Hughes River watershed.
