**CONSENT ORDER
ISSUED UNDER THE
WATER POLLUTION CONTROL ACT
WEST VIRGINIA CODE, CHAPTER 22, ARTICLE 11**

TO: Columbia Gas Transmission, LLC
Attn: Troy Tally, Vice President
1700 MacCorkle Ave
Charleston, WV 25314

DATE: October 1, 2020
ORDER NO.: 9061

1. Columbia Gas Transmission, LLC is conducting land disturbance activity associated with construction of the Mountaineer Xpress Project in Marshall, Wetzel, Tyler, Doddridge, Ritchie, Calhoun, Wirt, Roane, Jackson, Mason, Putnam, and Cabell Counties, West Virginia. On January 31, 2018, Columbia Gas Transmission, LLC was issued Water Pollution Control Permit No. WV0116815, Registration No. WVR310872, for Stormwater Associated With Oil and Gas Related Construction Activities.

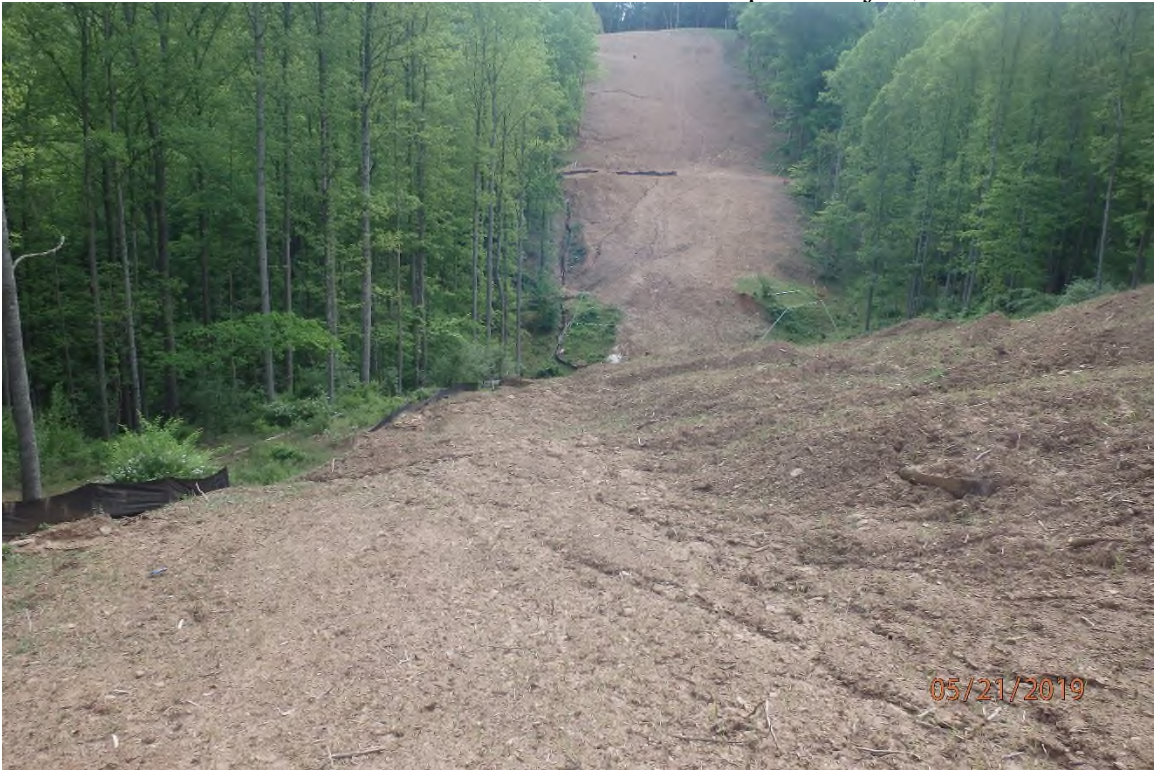
Unmaintained water bars in the Taylor Drain watershed and the associated fill slope erosion.

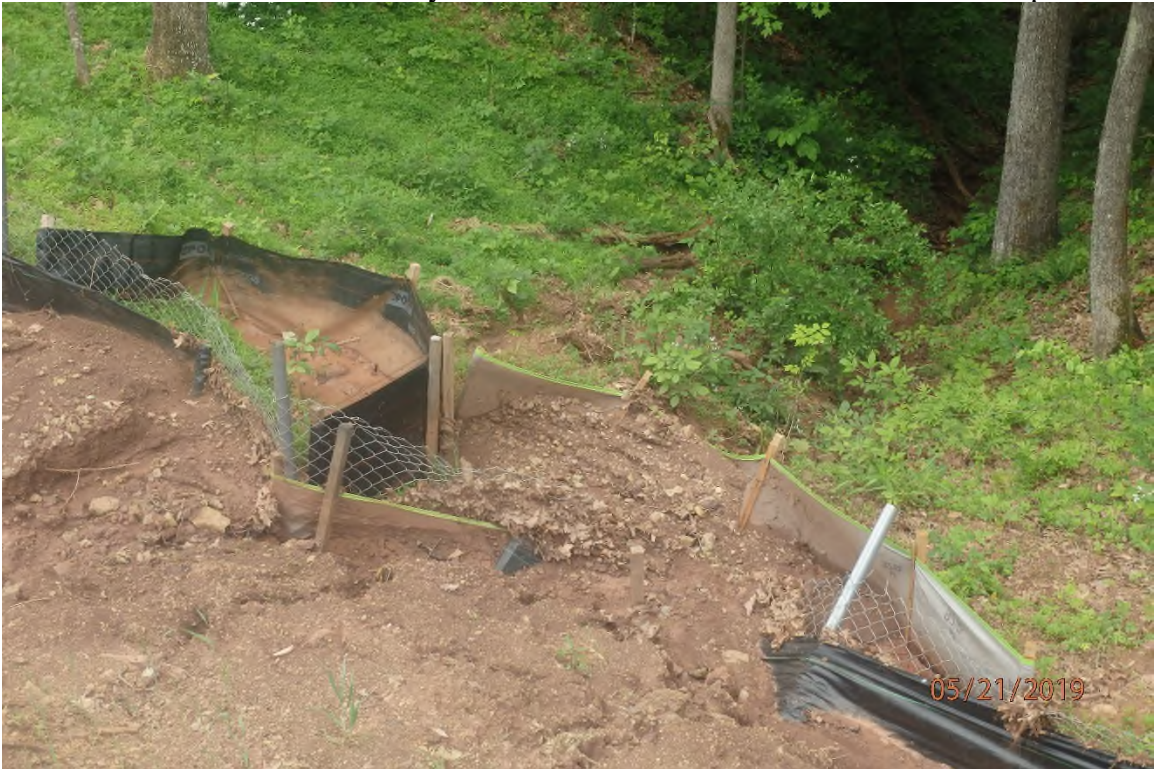
Unmaintained BMP in the Jims Run watershed.

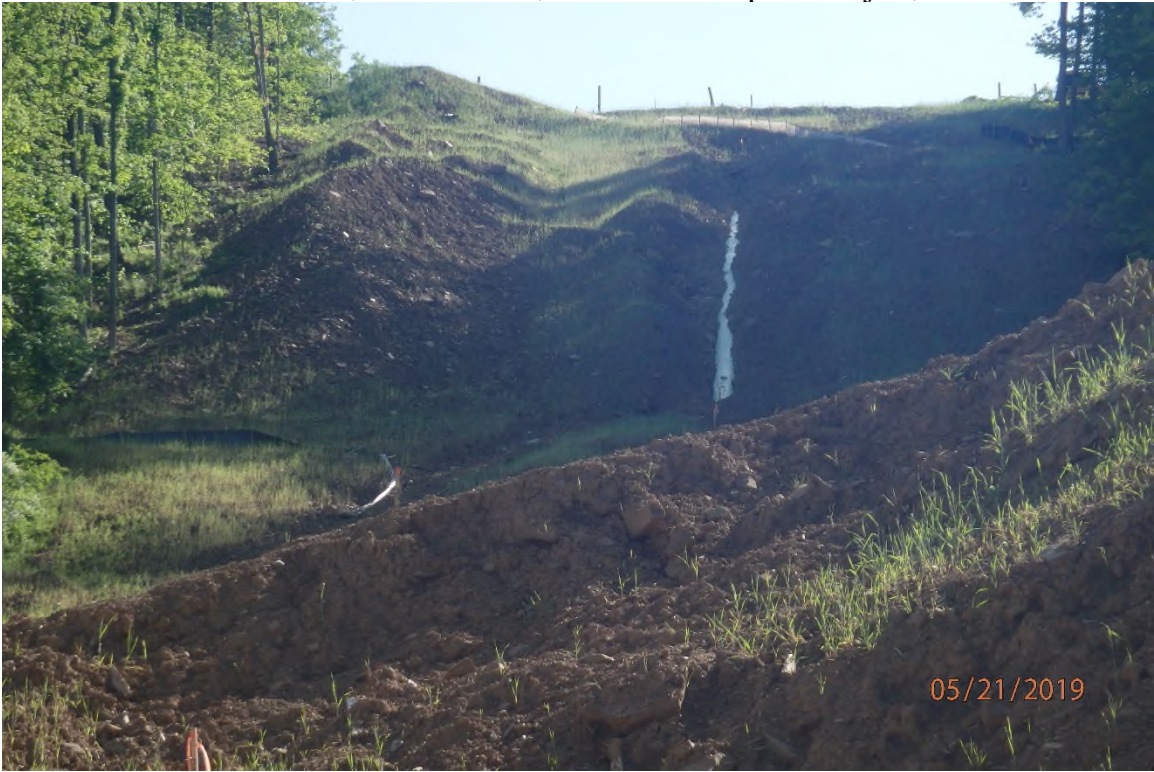
Unmaintained water bars in the Georgescamp Run watershed that have led to the exposure of the installed pipe.

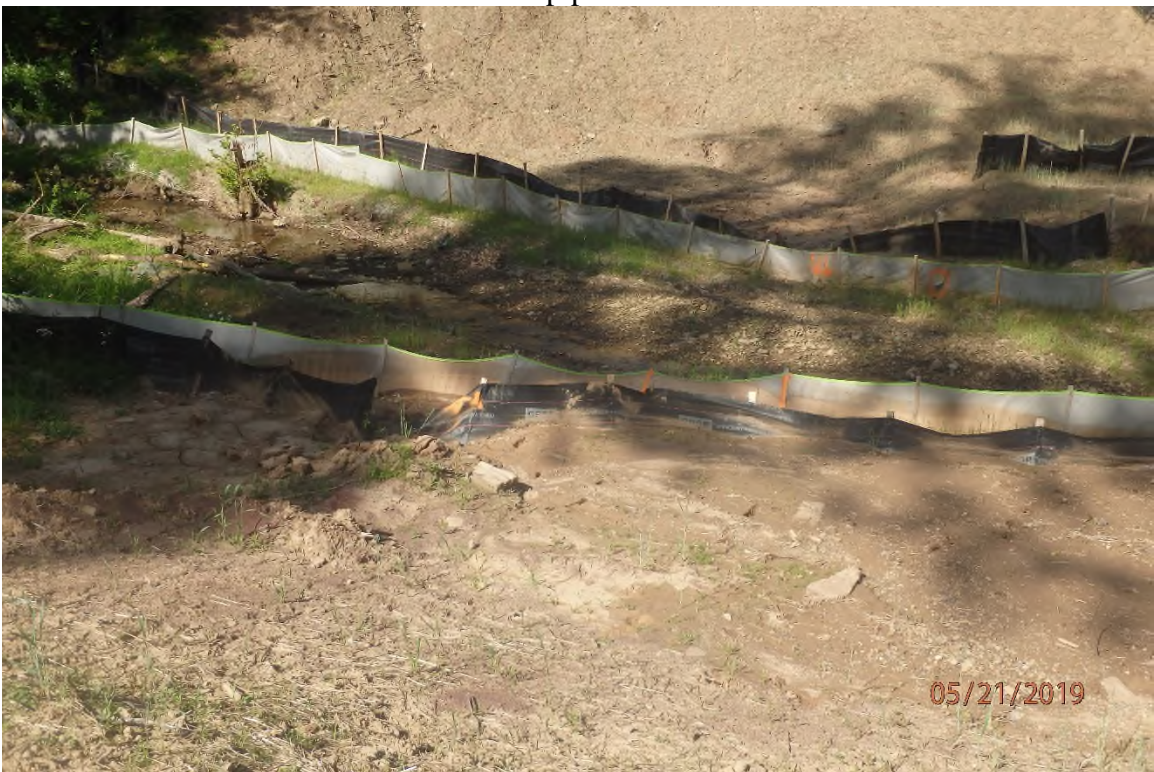
Unmaintained BMP in the Georgescamp Run watershed.

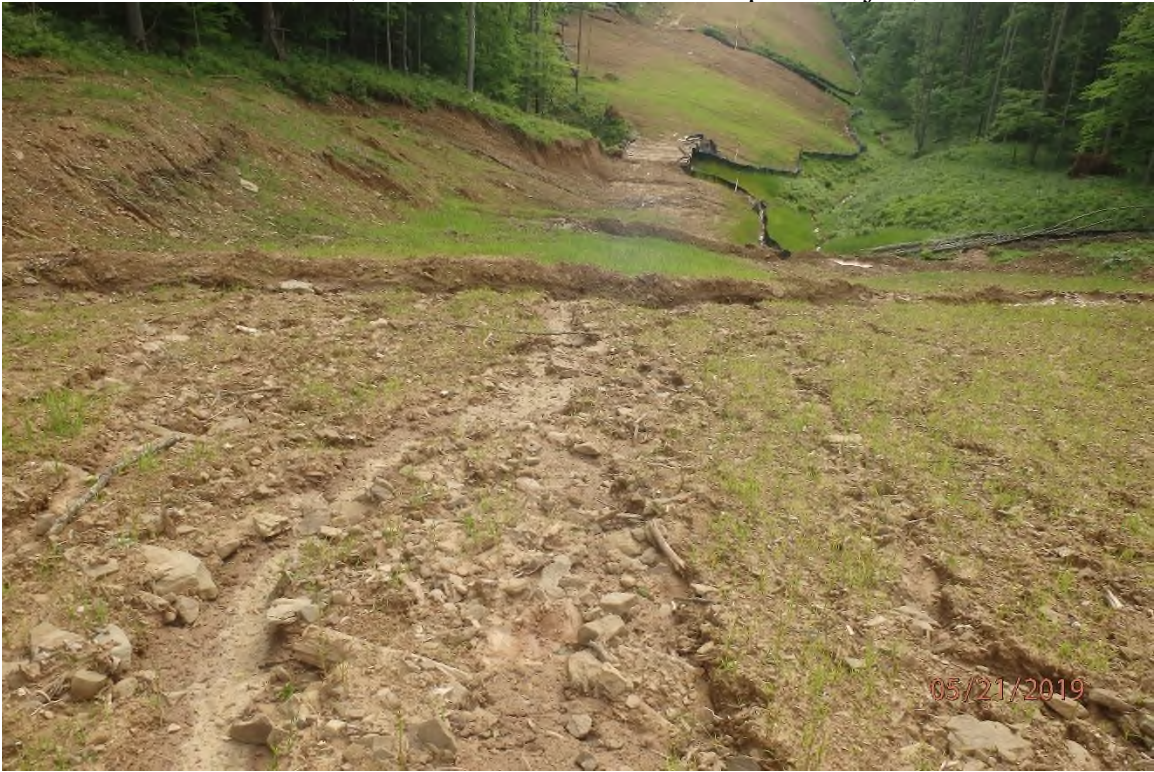
Unmaintained water bars in the UNT Sugar Run watershed.

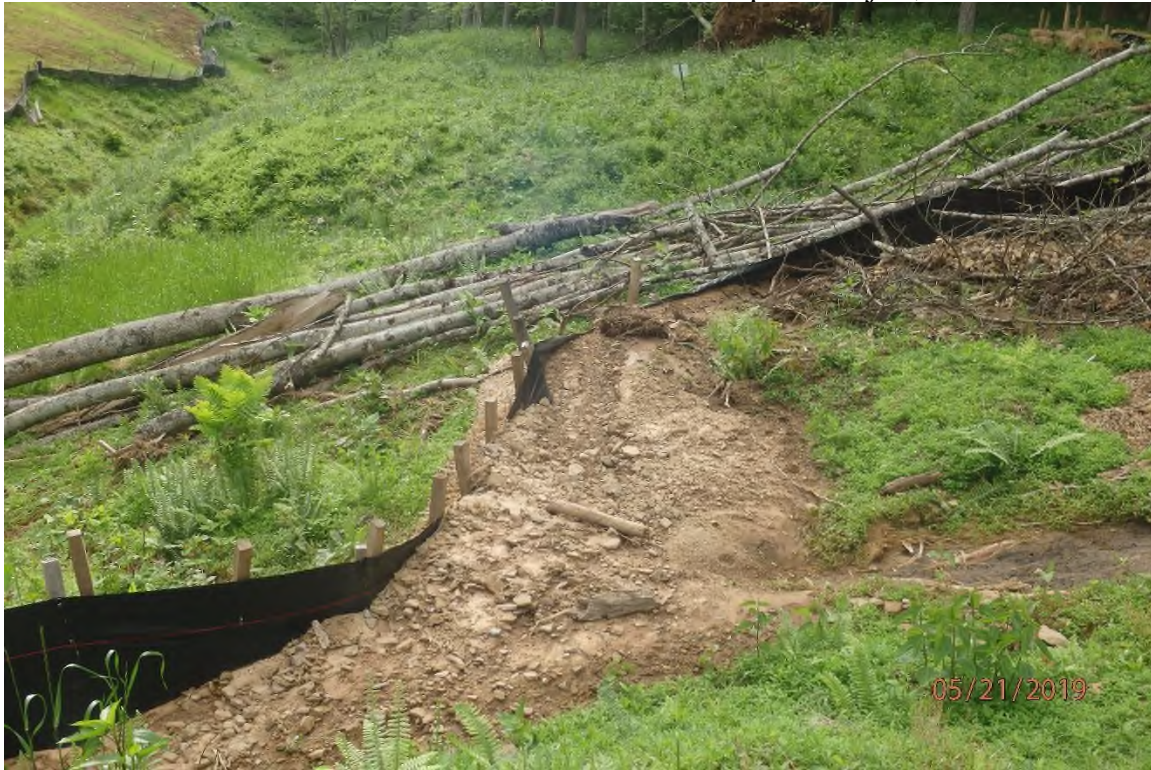
Perimeter control adjacent to UNT Sugar Run that is inundated with sediment as a result of the previously pictured water bar failures upslope.

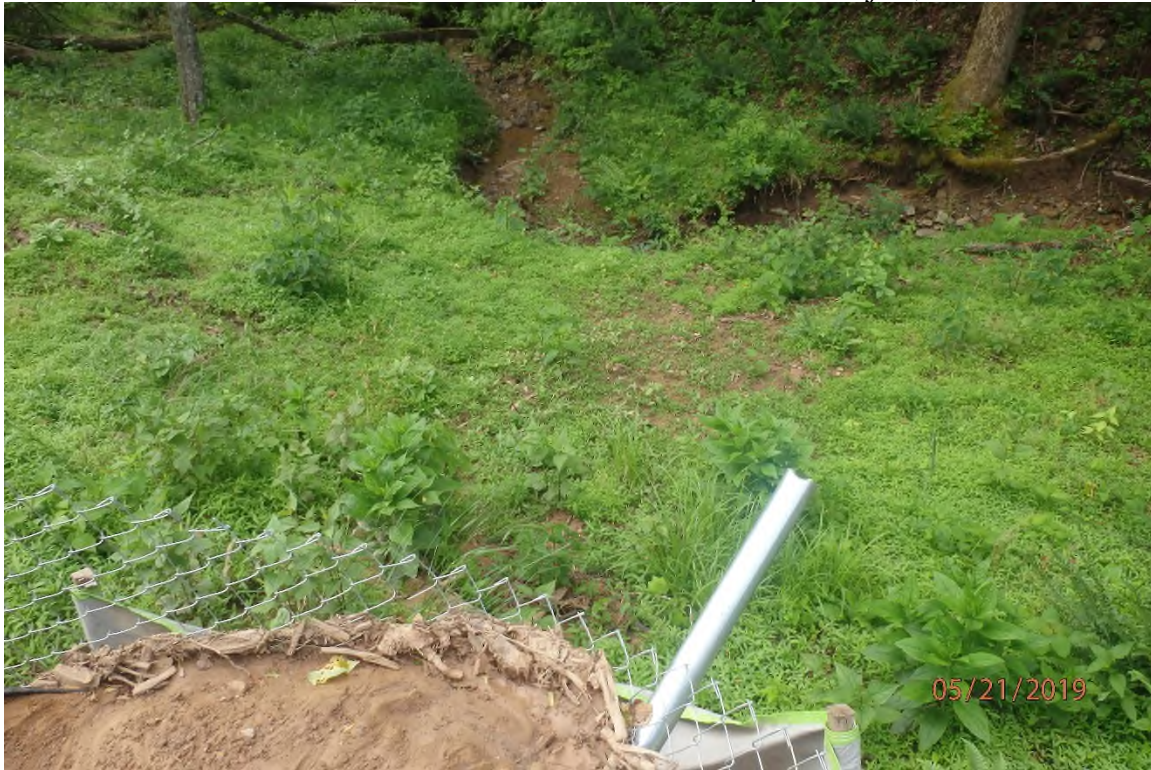
Unmaintained BMP in the UNT Sugar Run watershed and the sediment trail that leads to the receiving stream.

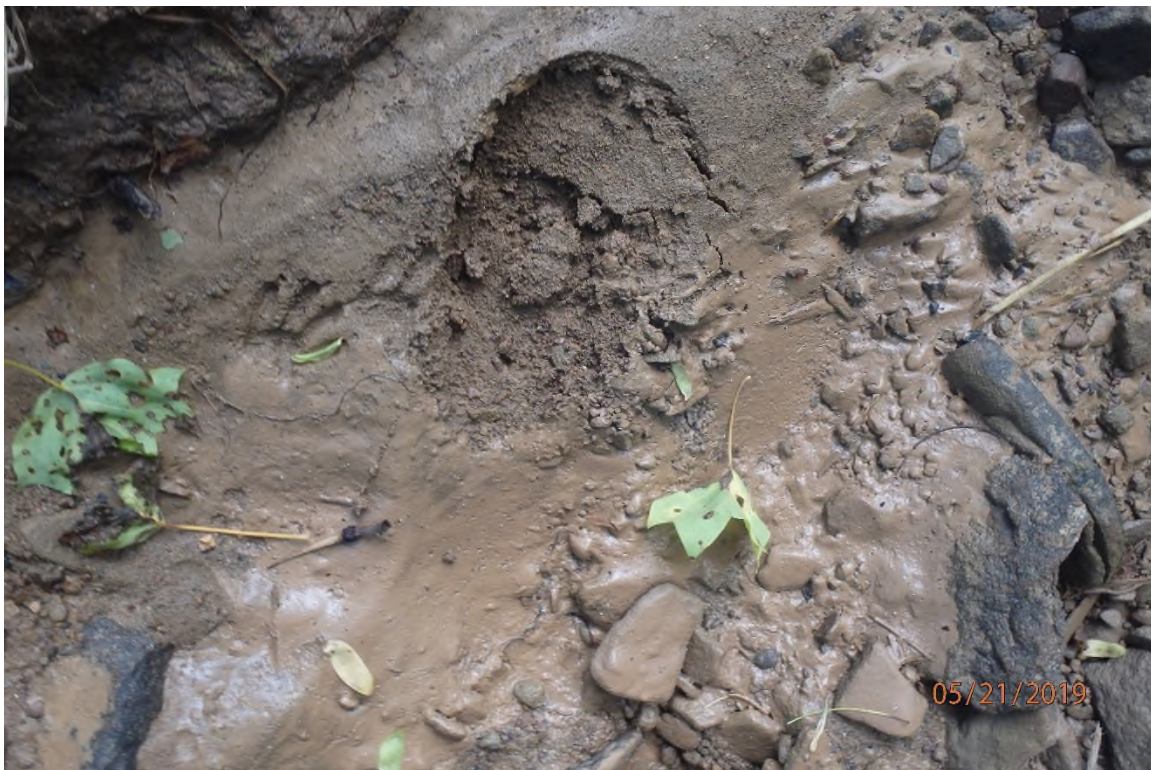
Offsite CNA deposits in UNT Sugar Run (39° 11.075' X 80° 51.108') as a result of the previously pictured deficiencies.

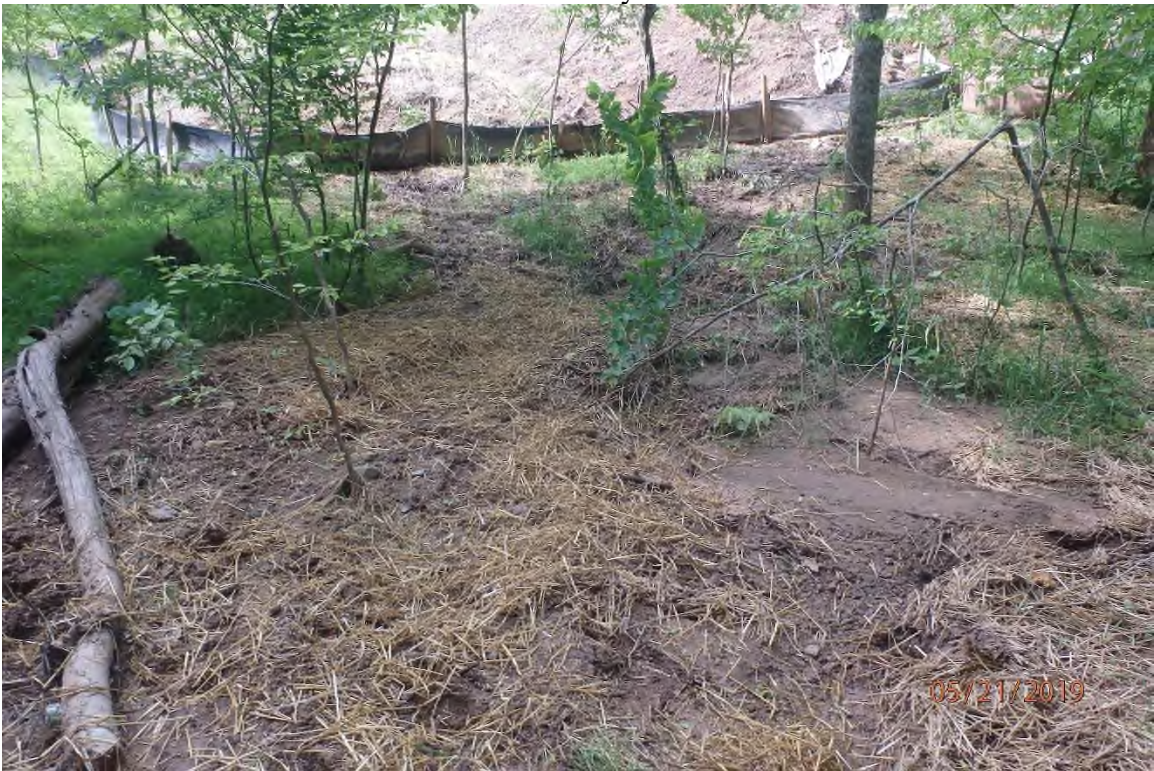
Unmaintained BMP in the Tylor Drain watershed and the sediment trail that leads to the receiving stream.

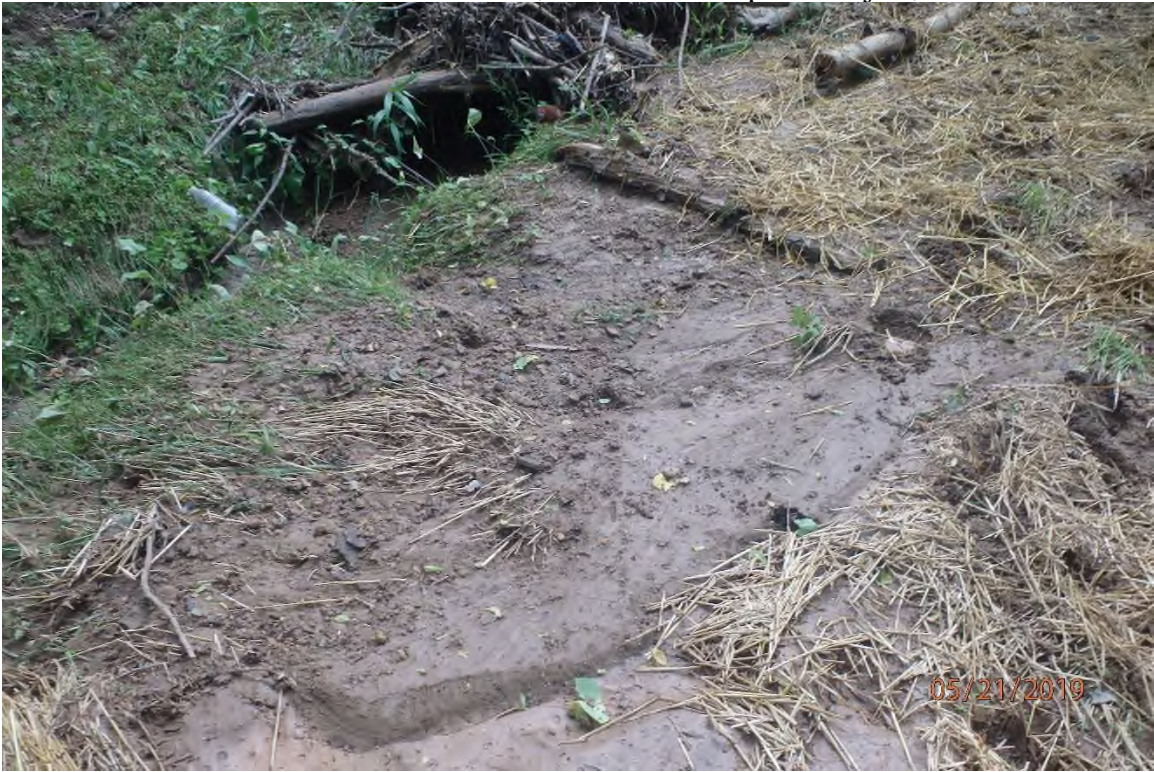
Sediment trail that leads to the receiving stream from the previously pictured unmaintained BMP in the Taylor Drain watershed.

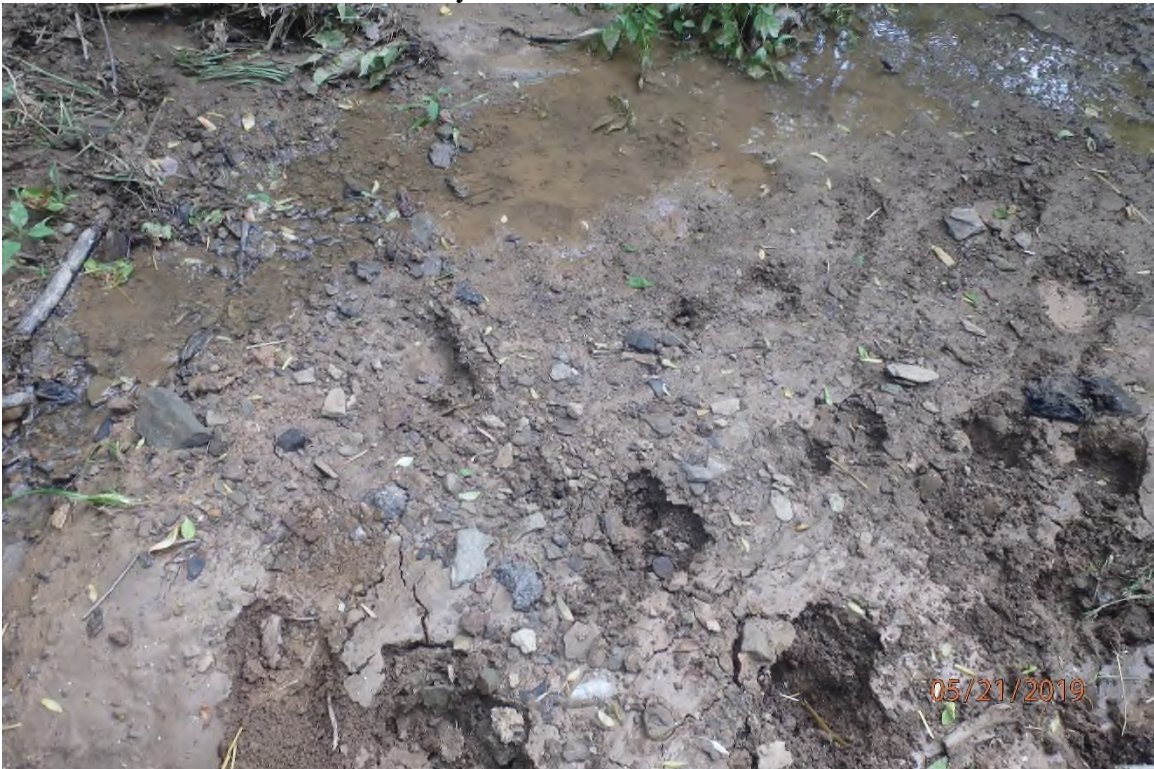
Offsite CNA deposits in Taylor Drain (39° 11.446' X 80° 50.167') that originate from site.

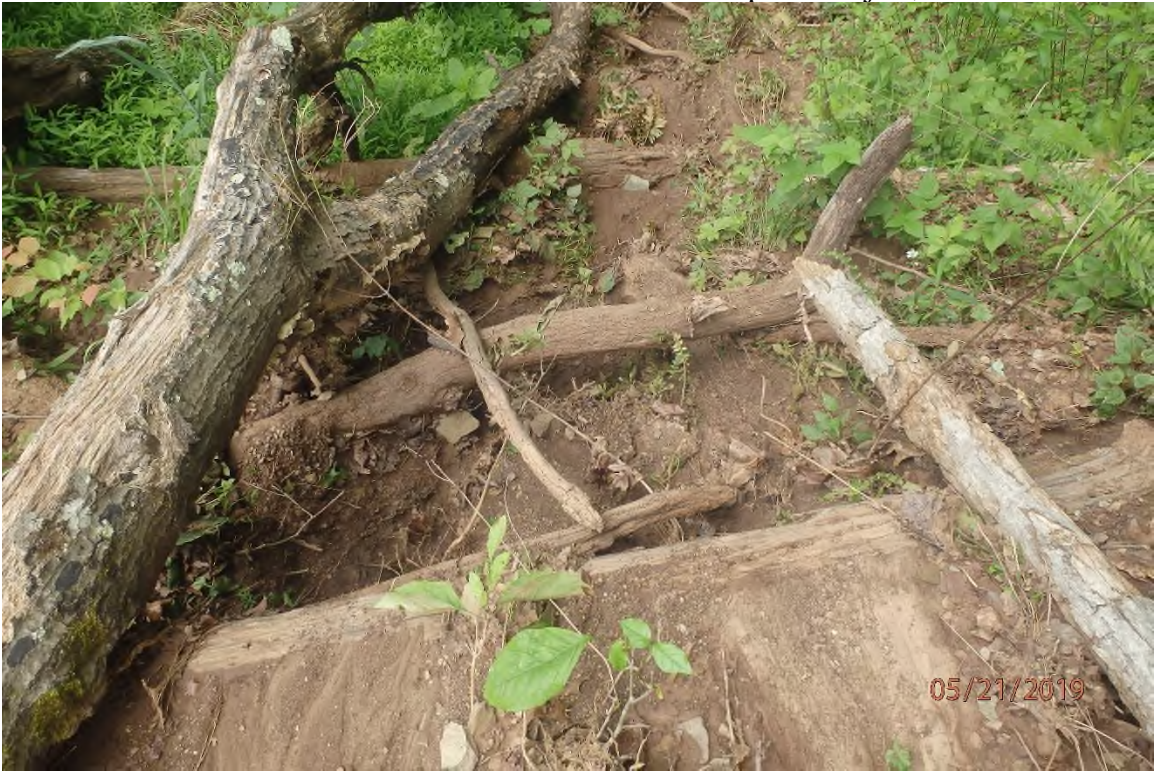
Offsite sediment trail leading to UNT S. Fork of Hughes River.

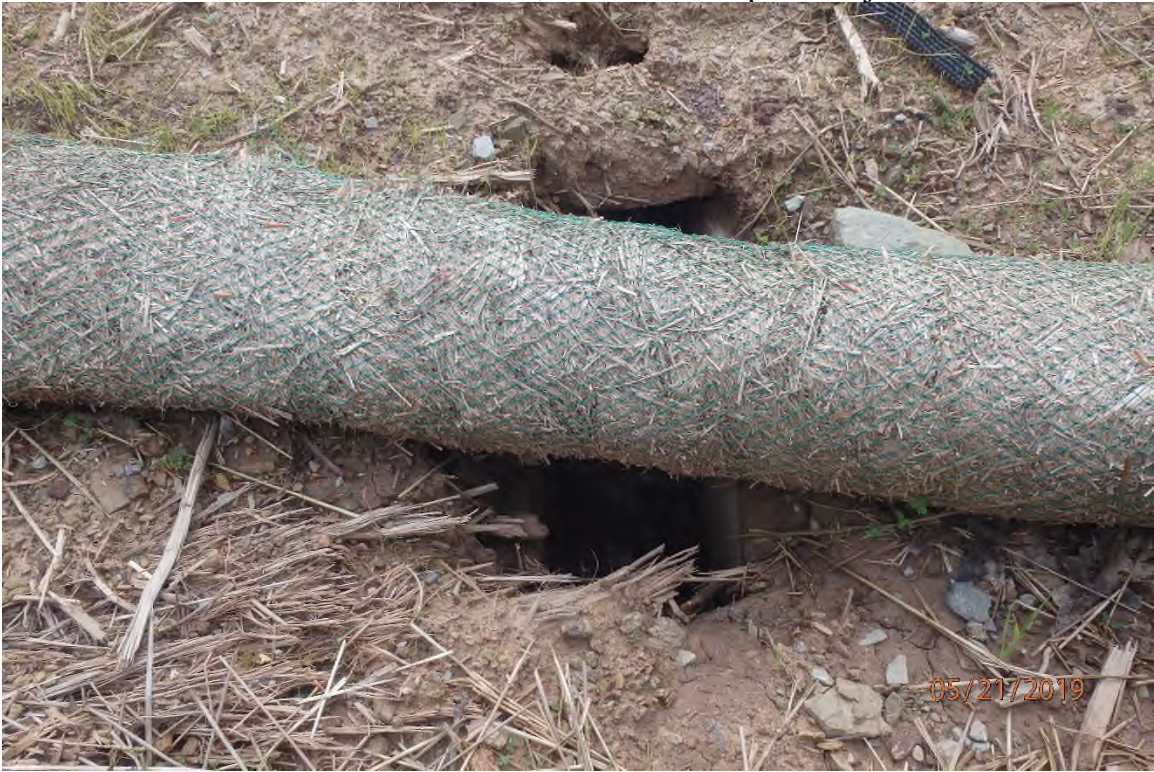
Unmaintained timber mat equipment BMP at the Sugar Run crossing (SDOH009).

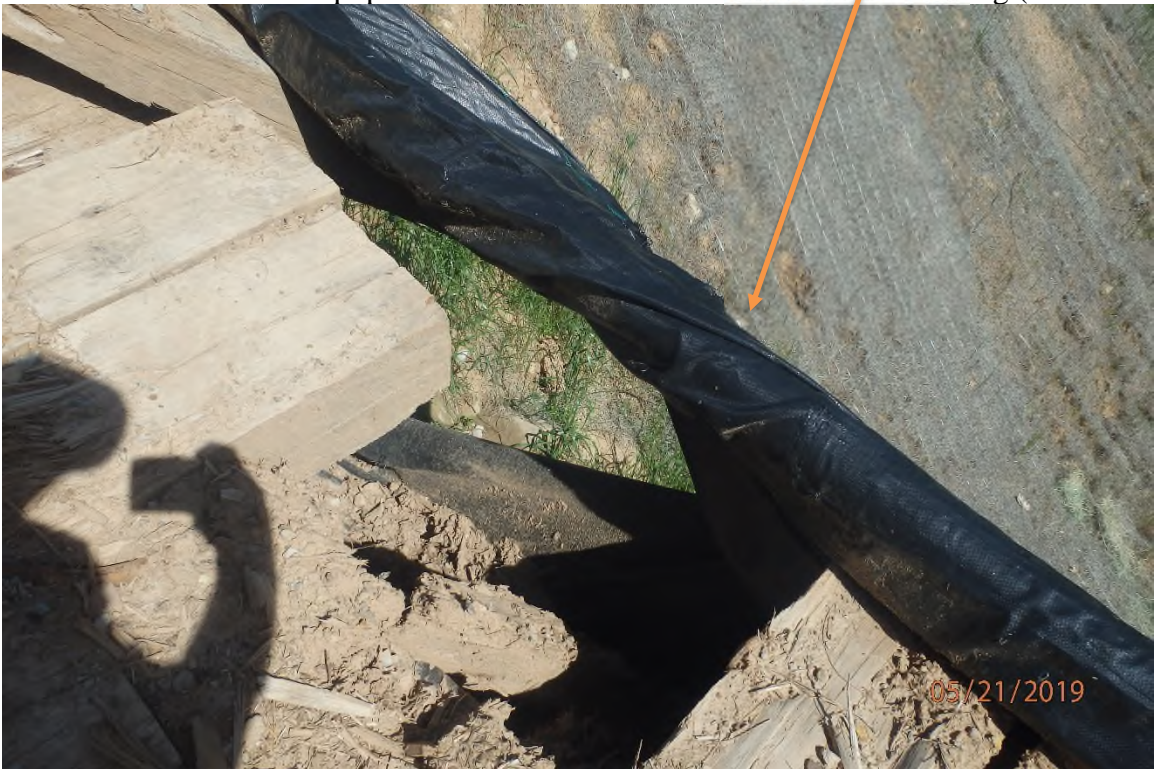
Unmaintained timber mat equipment BMP at the UNT Bluestone Creek crossing (SDOG539).

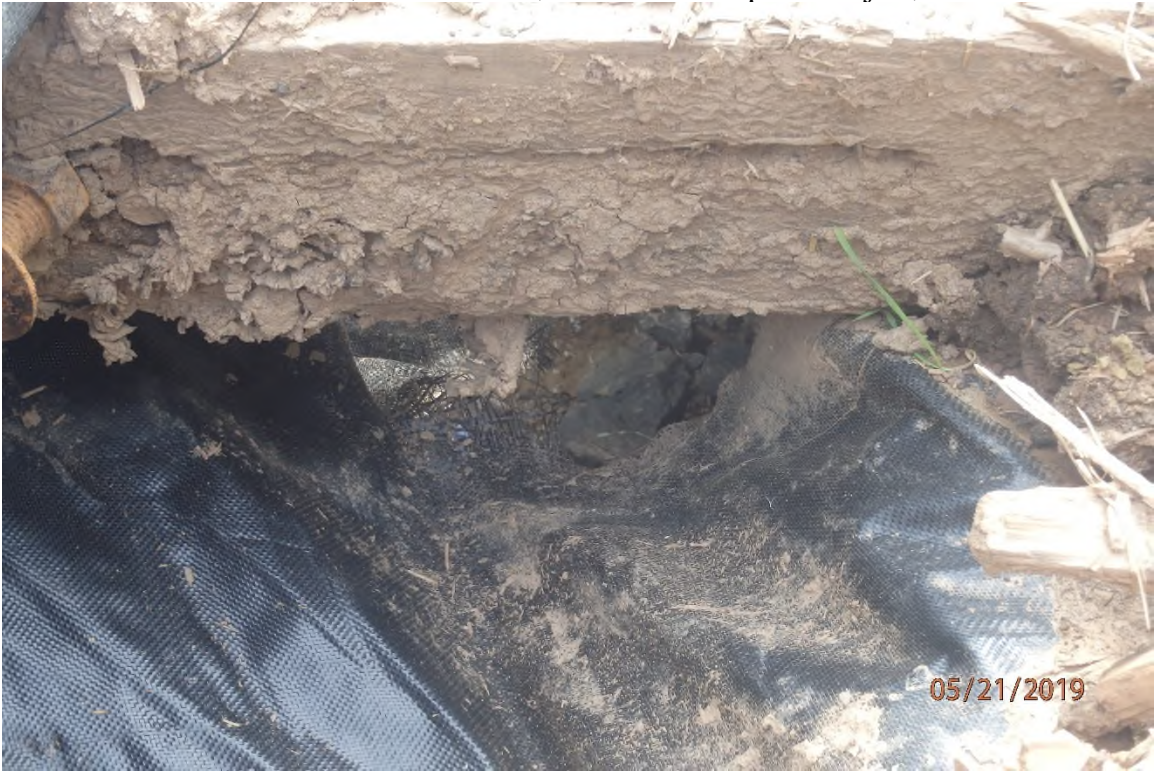
Unmaintained timber mat equipment BMP at the Taylor Drain crossing (SDON837).

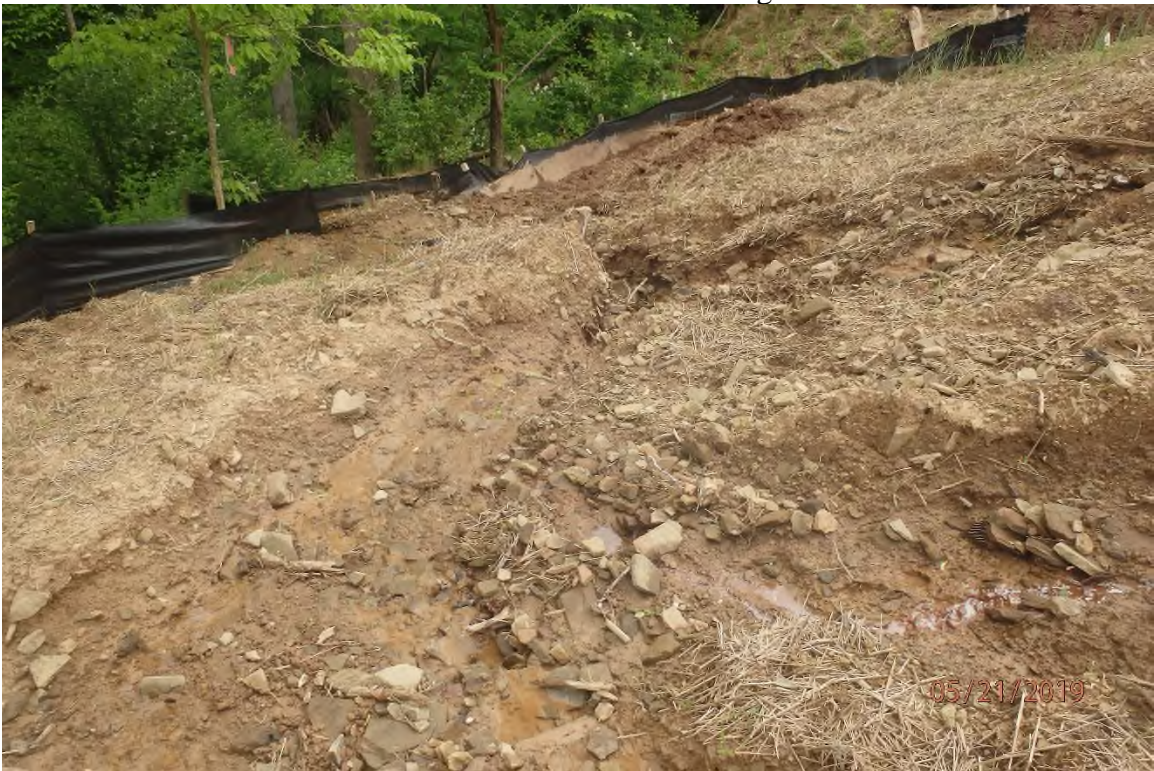
Unmaintained BMP in the UNT S. Fork of the Hughes River watershed.

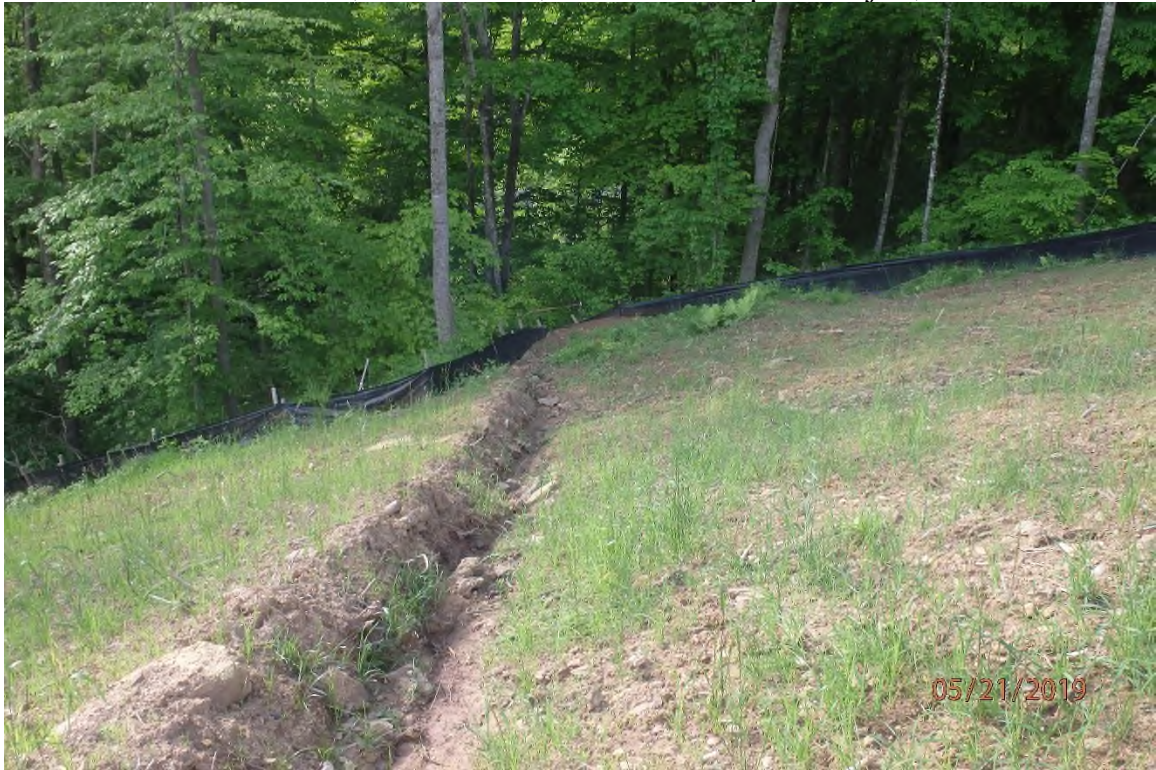
Sheet flow BMP installed in a concentrated flow area in the Sugar Run watershed. Pictured silt fence is not designed for concentrated flow treatment.

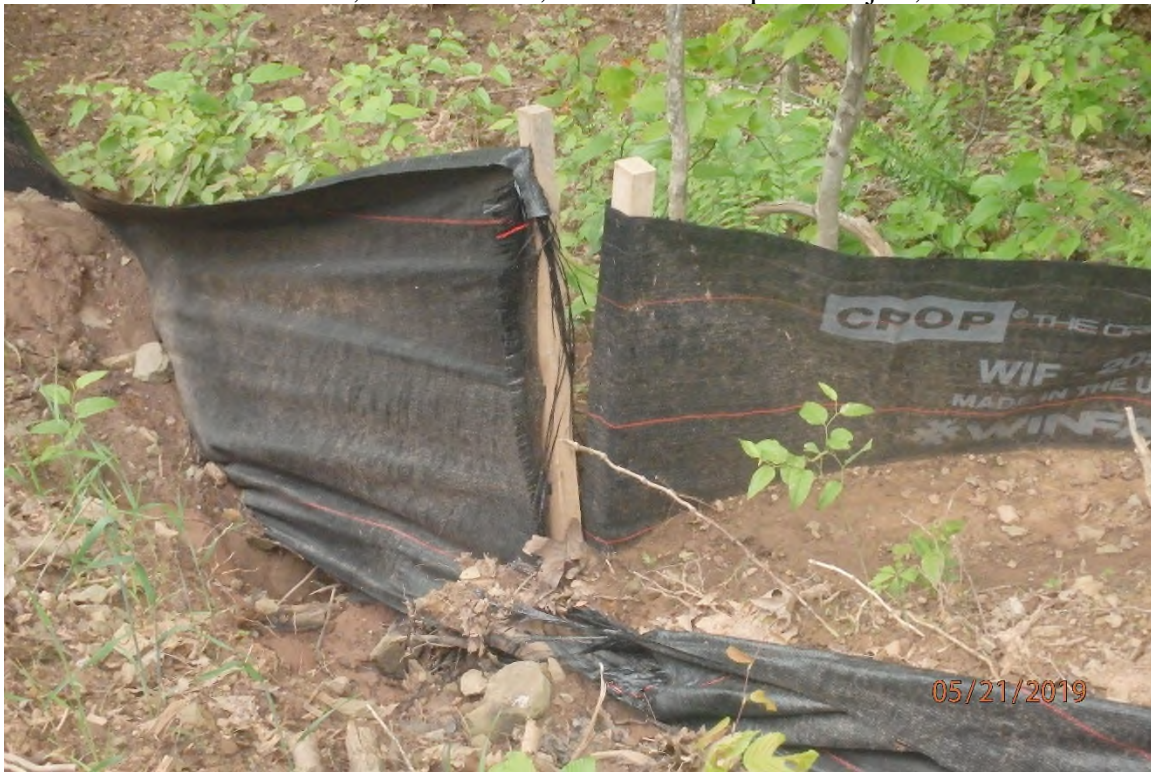
Improperly merged perimeter controls in the S. Fork of Hughes River watershed.

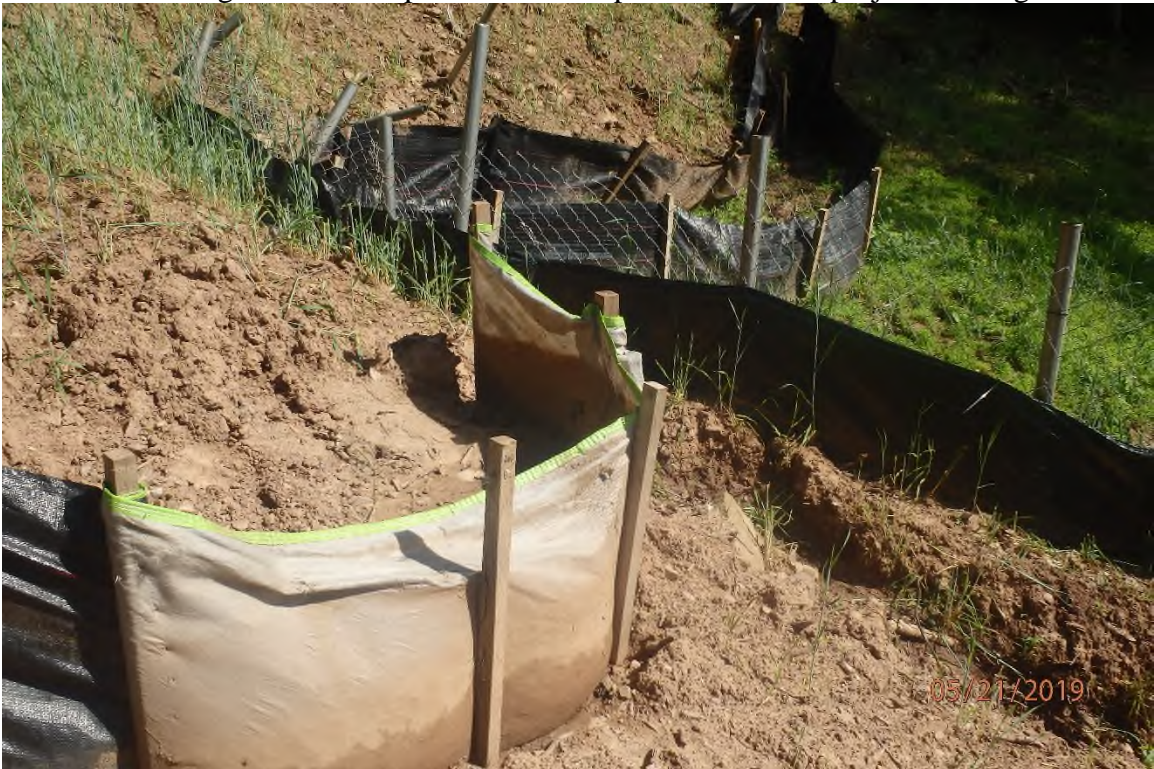
Improperly installed water bar in the Georgescamp Run watershed. Water bar installed at a steep angle and discharges over an unprotected fill slope instead of off project as designed.

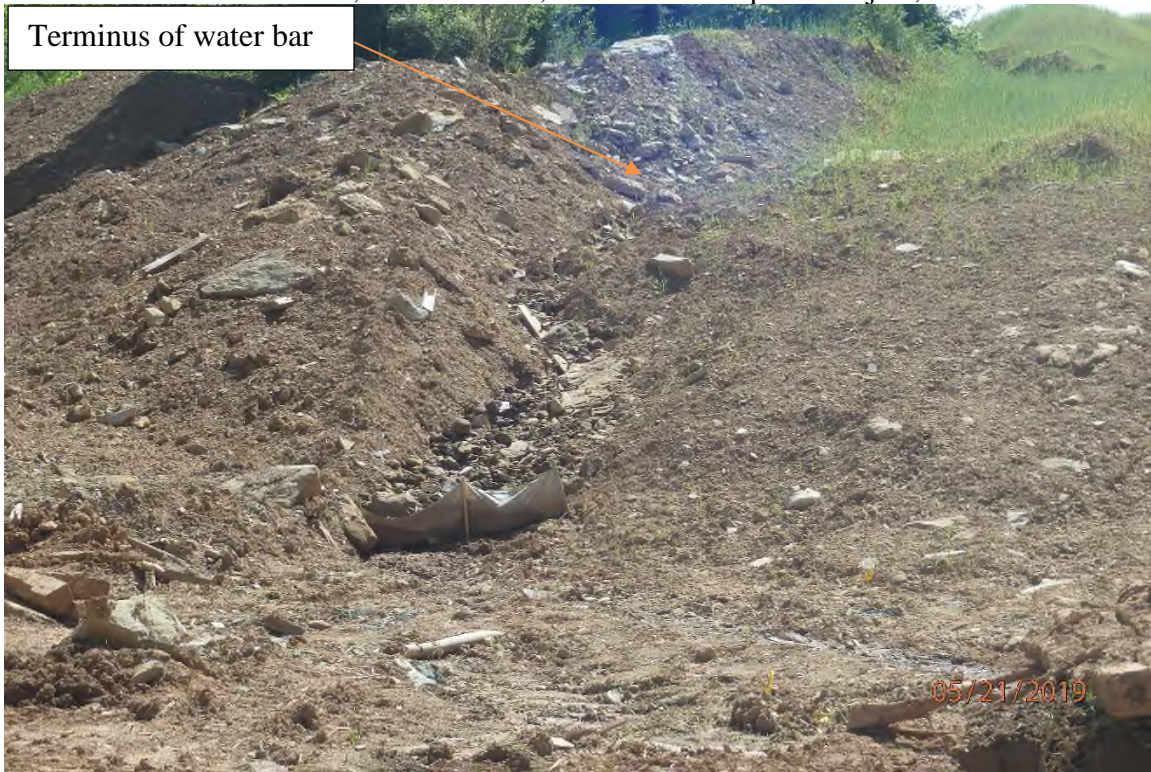
Improperly installed water bar in the Bluestone Creek watershed. Water bar discharges over an unprotected fill slope instead of off project as designed.

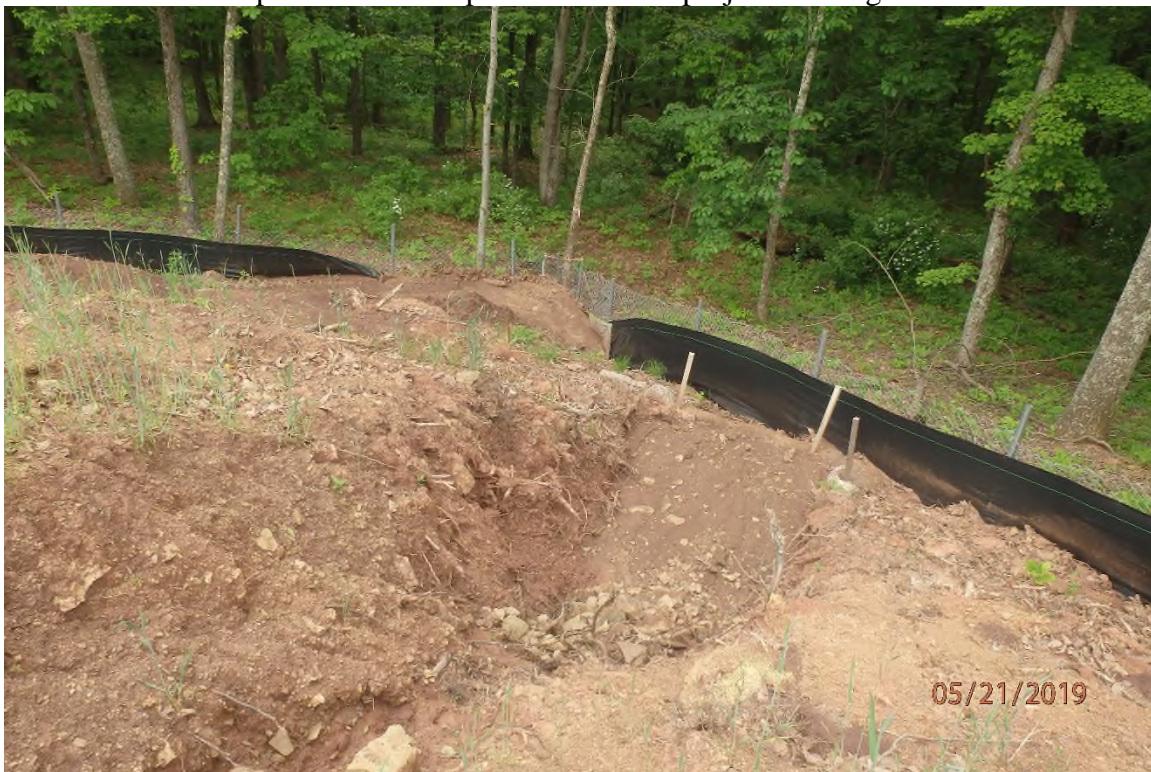
Improperly installed water bar in the Jims Run watershed. Water bar outlet discharges inside of the installed perimeter control and an appropriate outlet was not provided.

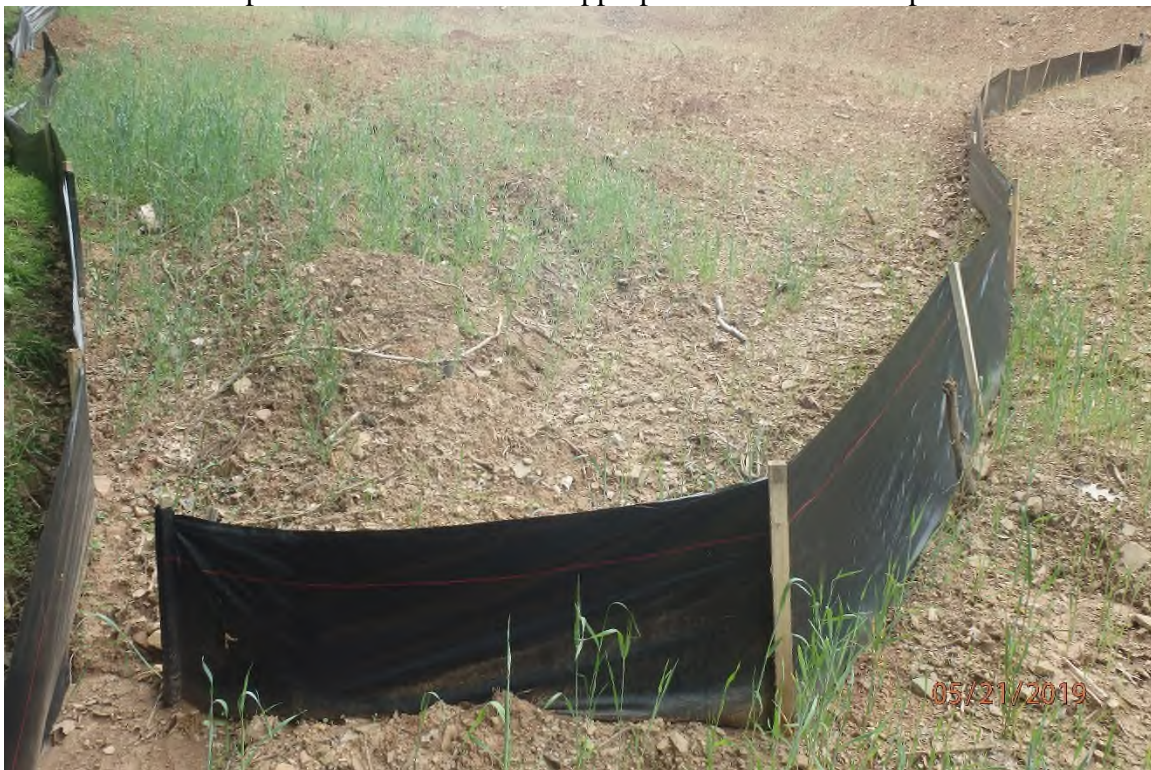
Improperly installed water bar in the Taylor Drain watershed. Water bar outlet discharges inside of the installed perimeter control and an appropriate outlet was not provided.

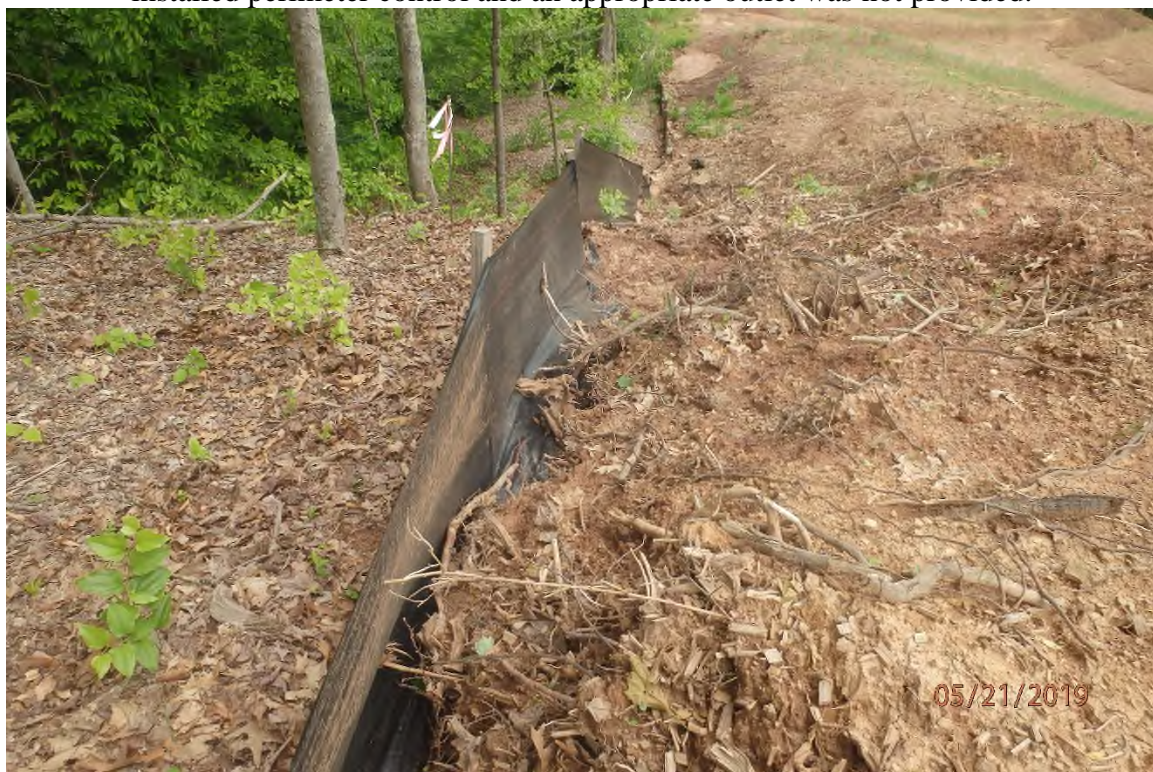
Concentrated flow area along the installed perimeter control downslope of the above pictured BMP.

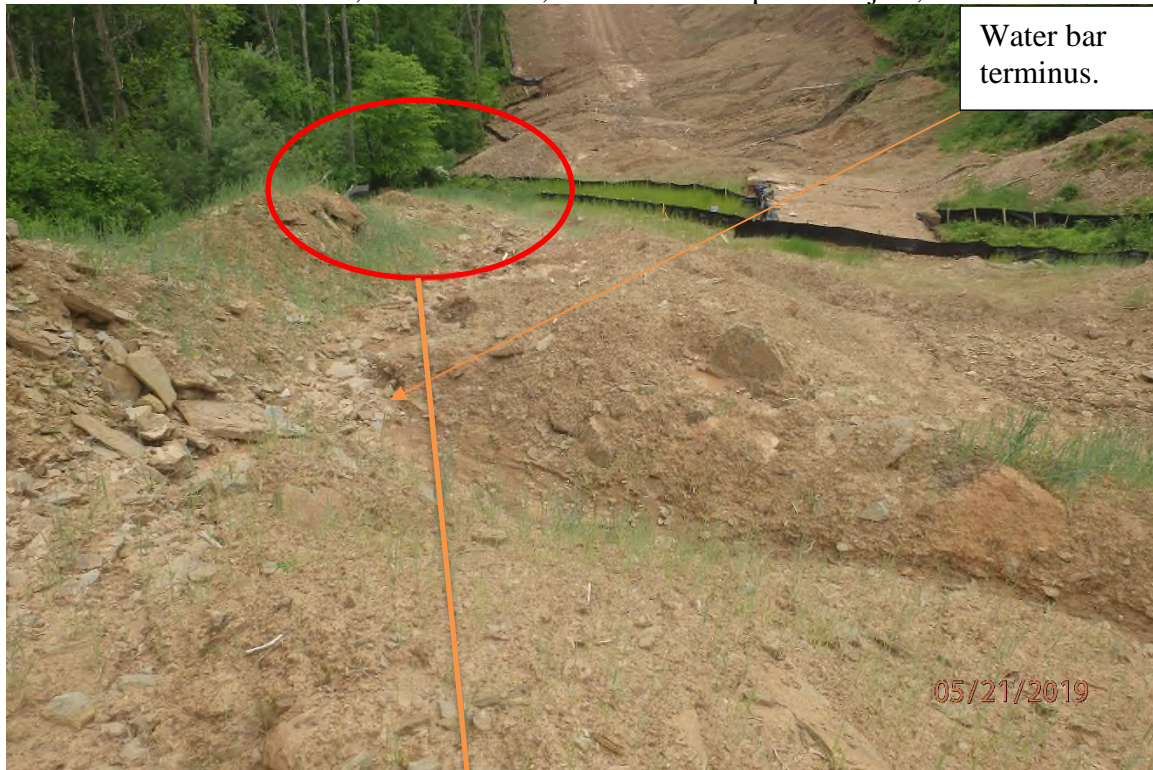
Improperly installed water bar in the S. Fork of Hughes River watershed. Water bar discharges over an unprotected fill slope.

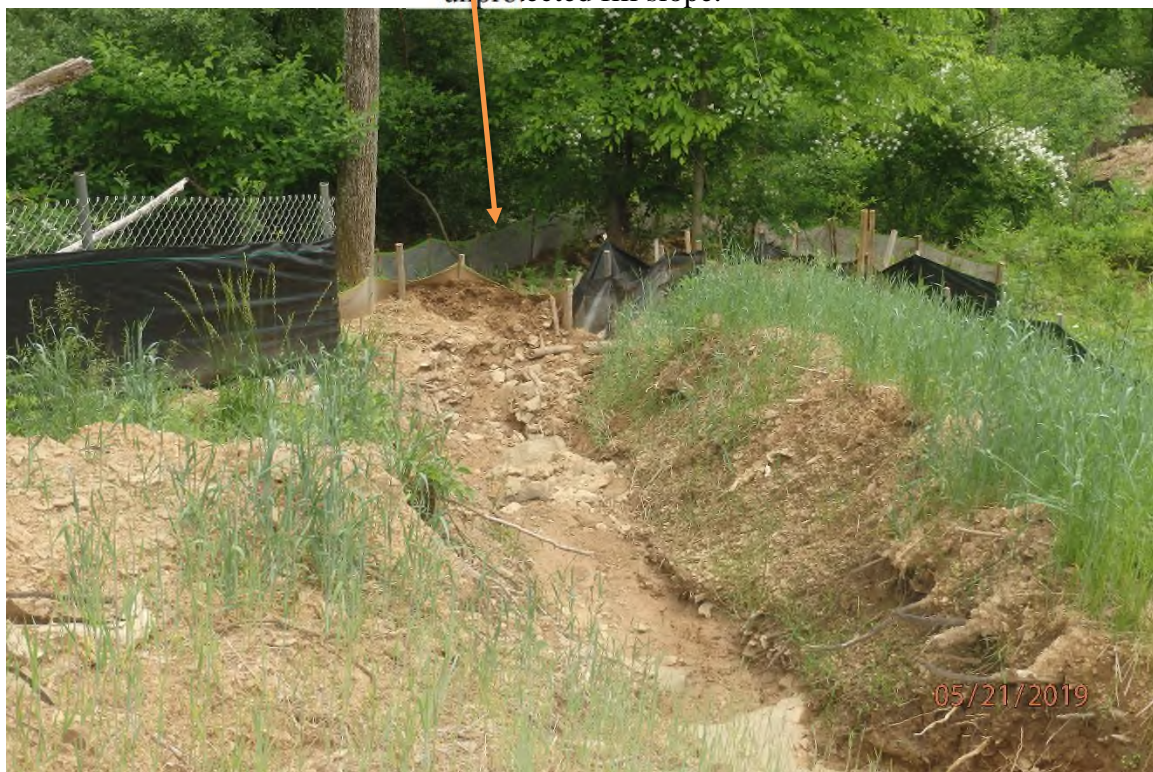
Outlet treatment that is overwhelmed due to stormwater flow from multiple water bars being directed at it. Maintenance of the BMP is poor. The contractor is adding additional layers of BMPs instead of conducting maintenance work. The furthest layer of BMPs is offsite.
