**CONSENT ORDER
ISSUED UNDER THE
WATER POLLUTION CONTROL ACT
WEST VIRGINIA CODE, CHAPTER 22, ARTICLE 11**

TO: Columbia Gas Transmission, LLC
Attn: Troy Tally, Vice President
1700 MacCorkle Ave
Charleston, WV 25314

DATE: October 1, 2020
ORDER NO.: 9061

1. Columbia Gas Transmission, LLC is conducting land disturbance activity associated with construction of the Mountaineer Xpress Project in Marshall, Wetzel, Tyler, Doddridge, Ritchie, Calhoun, Wirt, Roane, Jackson, Mason, Putnam, and Cabell Counties, West Virginia. On January 31, 2018, Columbia Gas Transmission, LLC was issued Water Pollution Control Permit No. WV0116815, Registration No. WVR310872, for Stormwater Associated With Oil and Gas Related Construction Activities.

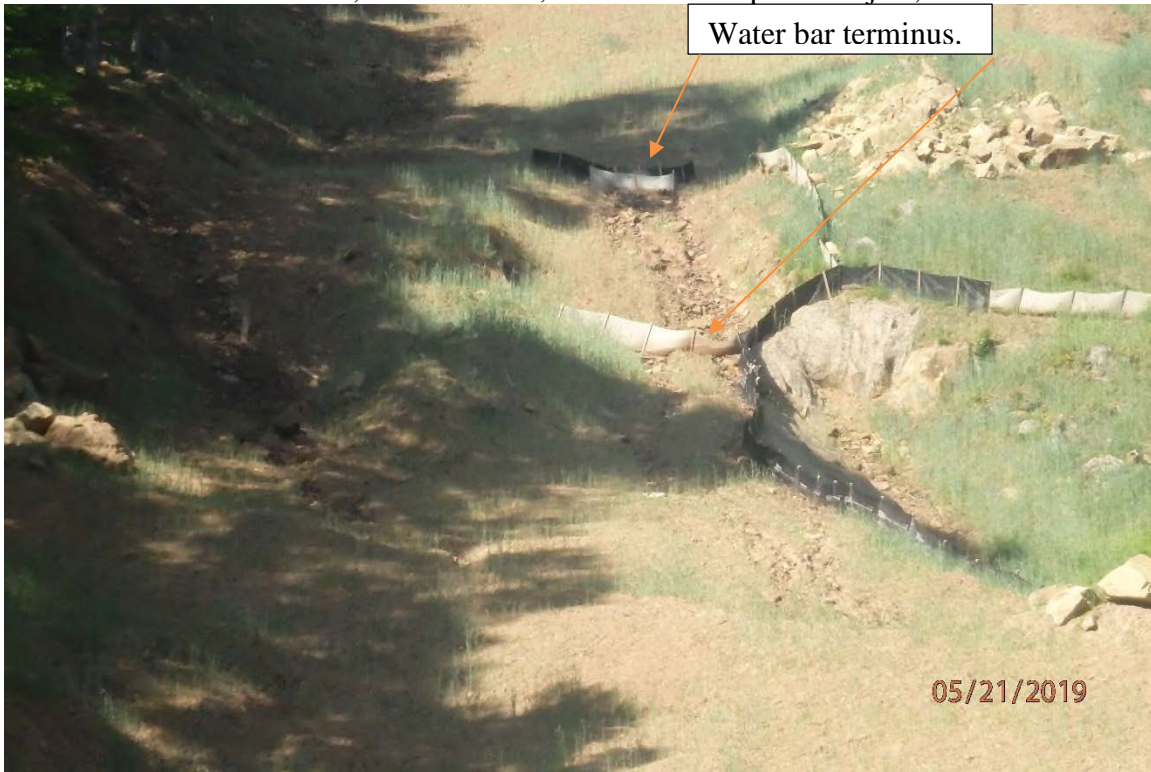
Improperly installed water bars in the UNT Georgescamp Run watershed.

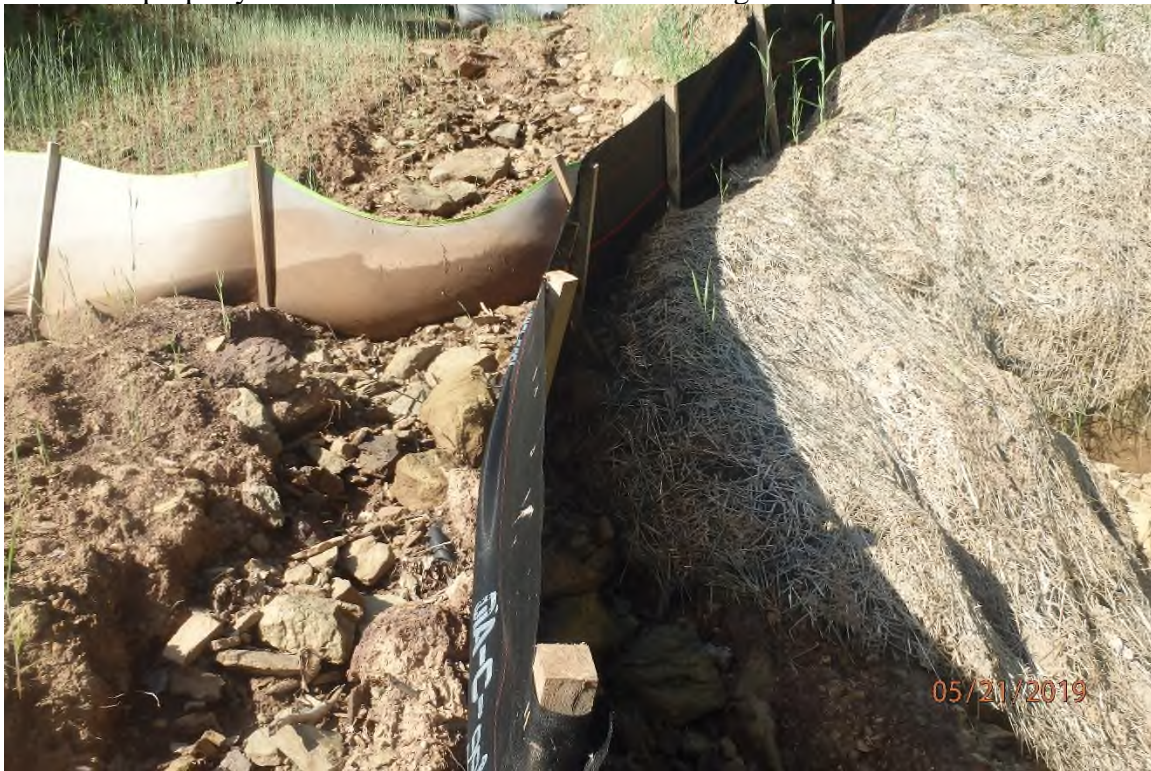
Fill slope erosion and recently repaired perimeter control downslope of the above pictured deficiency.

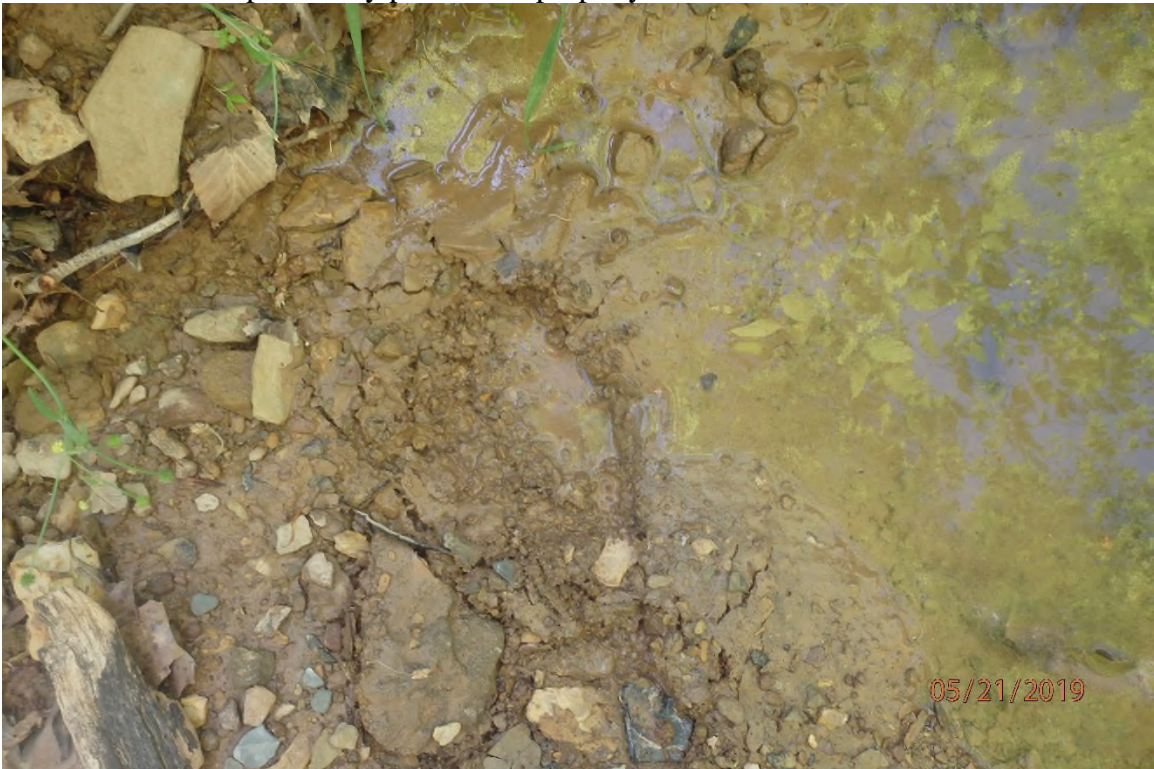
Offsite CNA deposits in UNT Georgescamp Run (39° 15.134' X 80° 44.327') that originate from the previously pictured improperly installed water bars.

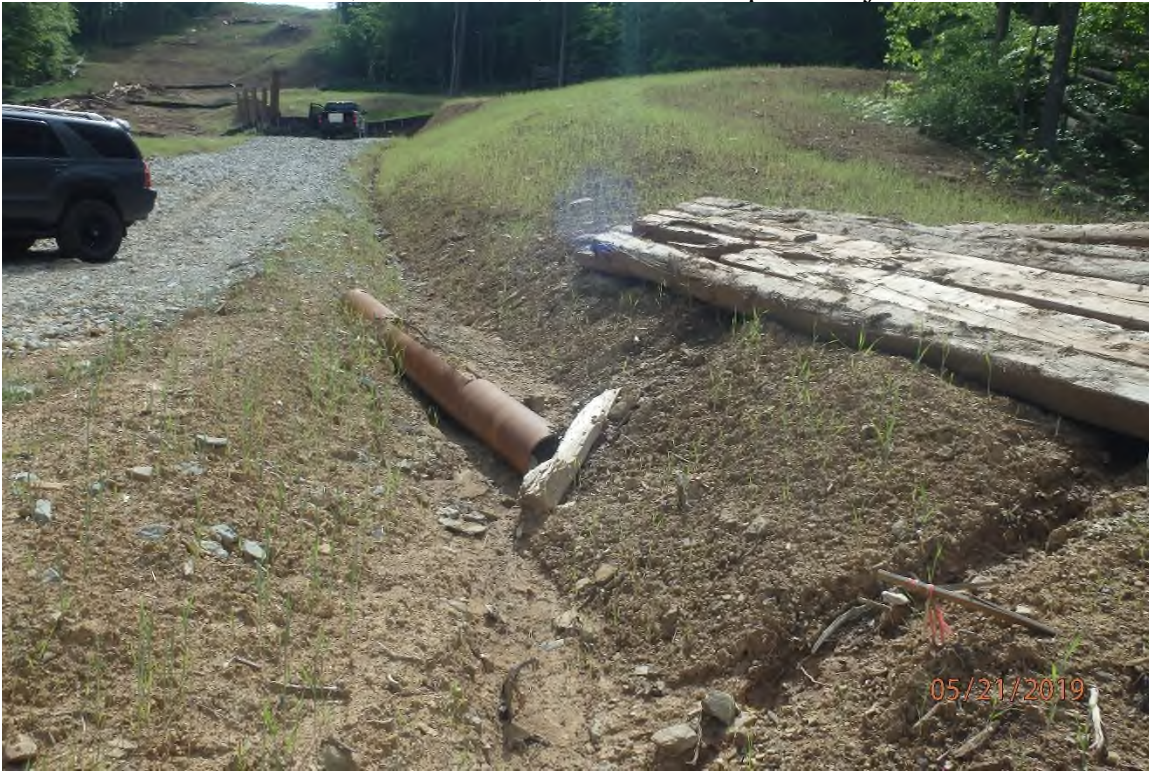
Area where two water bars are indicated in the approved SWPPP in the Taylor drain watershed that are not in place.

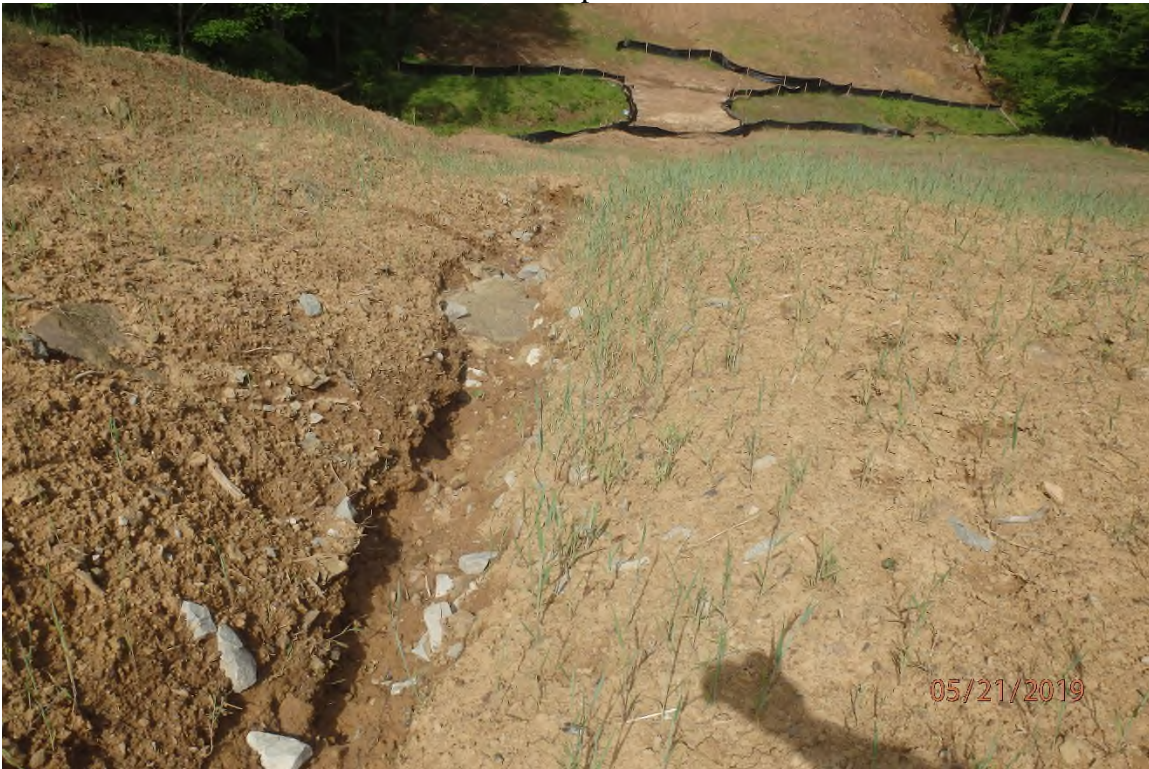
Associated fill slope erosion downslope of the above pictured area lacking water bars that are indicated in the approved SWPPP.

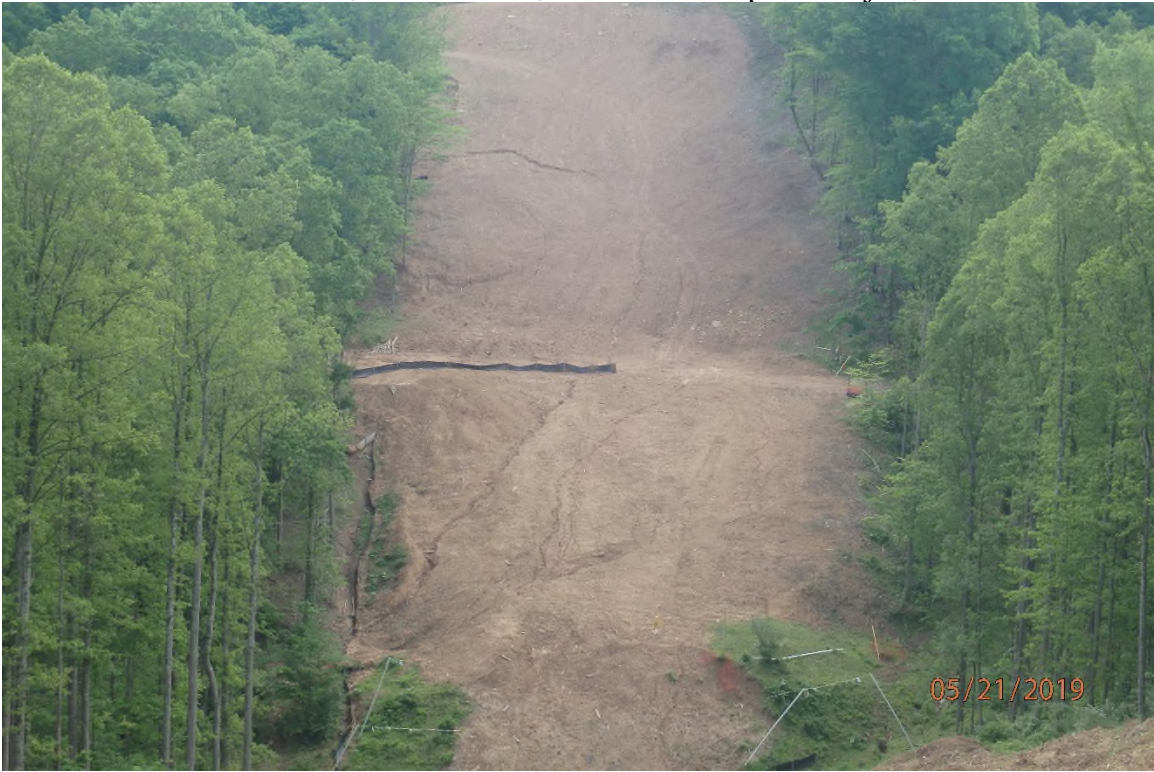
Slope adjacent to UNT Taylor Drain where water bars that are in the approved SWPPP are not in place.

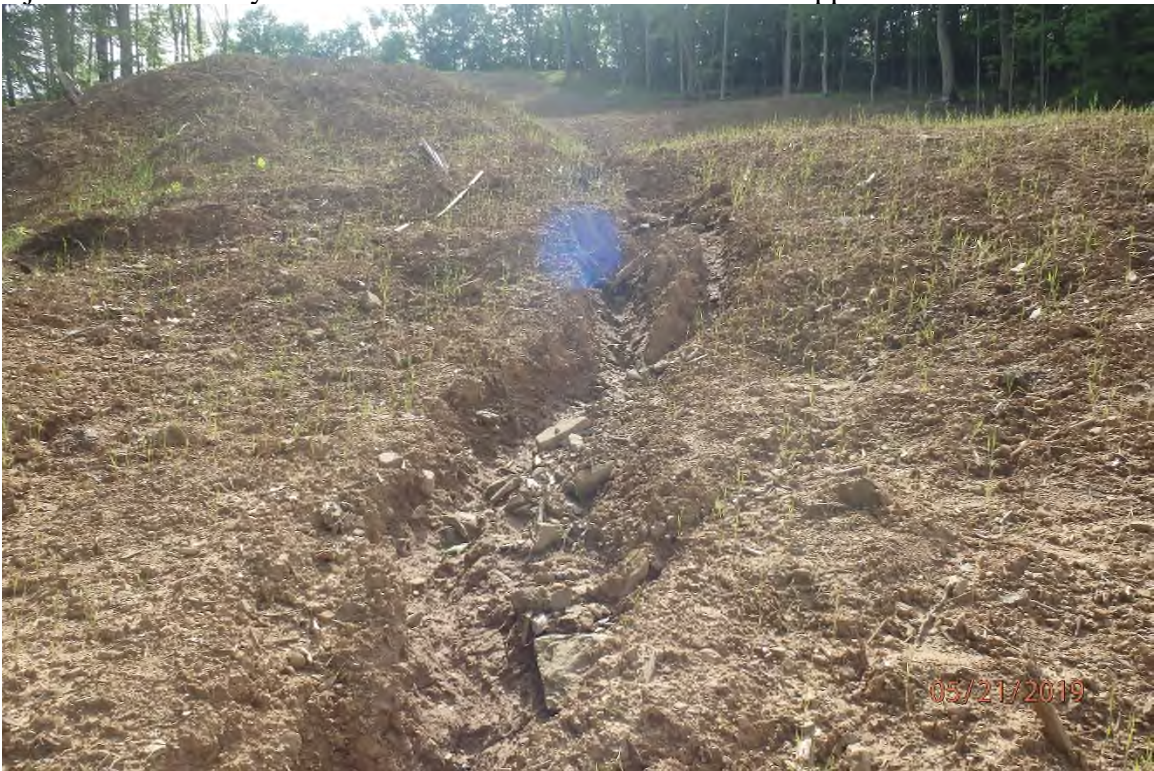
Fill slope erosion as a result of the above pictured deficiency.

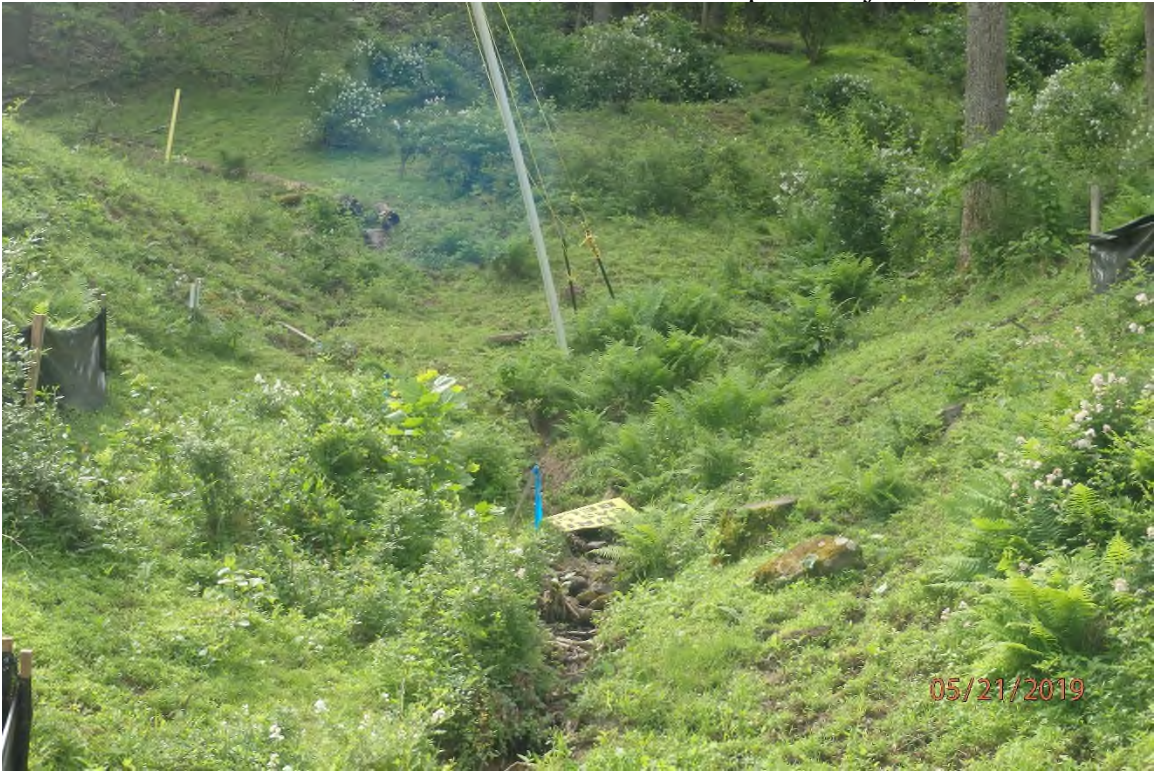
UNT Taylor Drain upstream of the project.

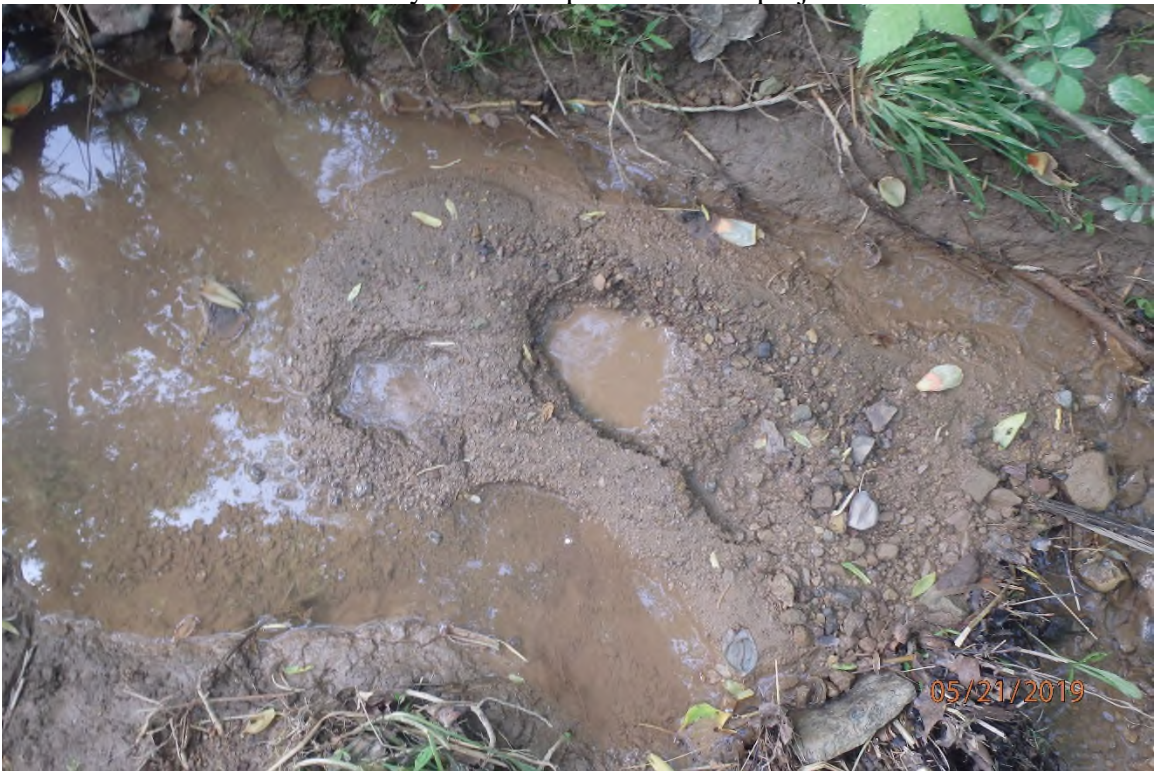
CNA deposits in in UNT Taylor Drain (39° 11.391' X 80° 50.386') as a result of the previously pictured deficiencies from a failure to install water bars.

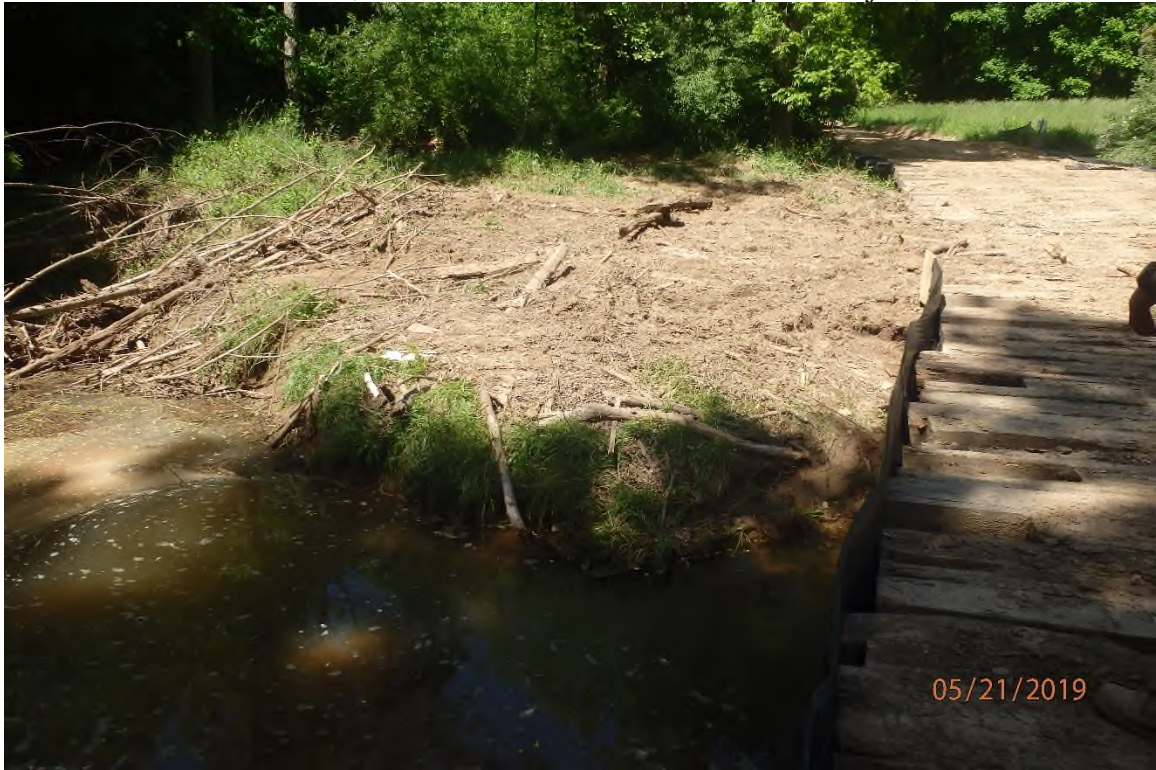
BMP that has been recently removed adjacent to ARDO009.1 and has not been replaced.

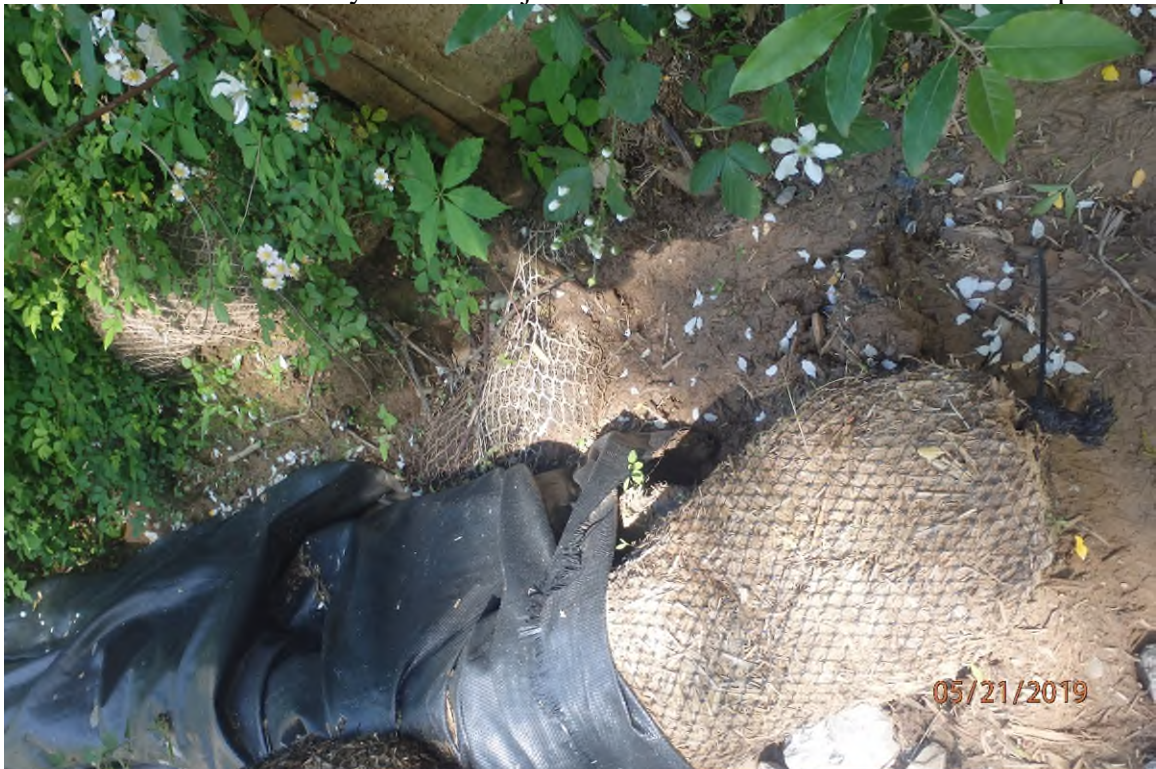
Installed BMP that is in need of maintenance on to ARDO009.1.

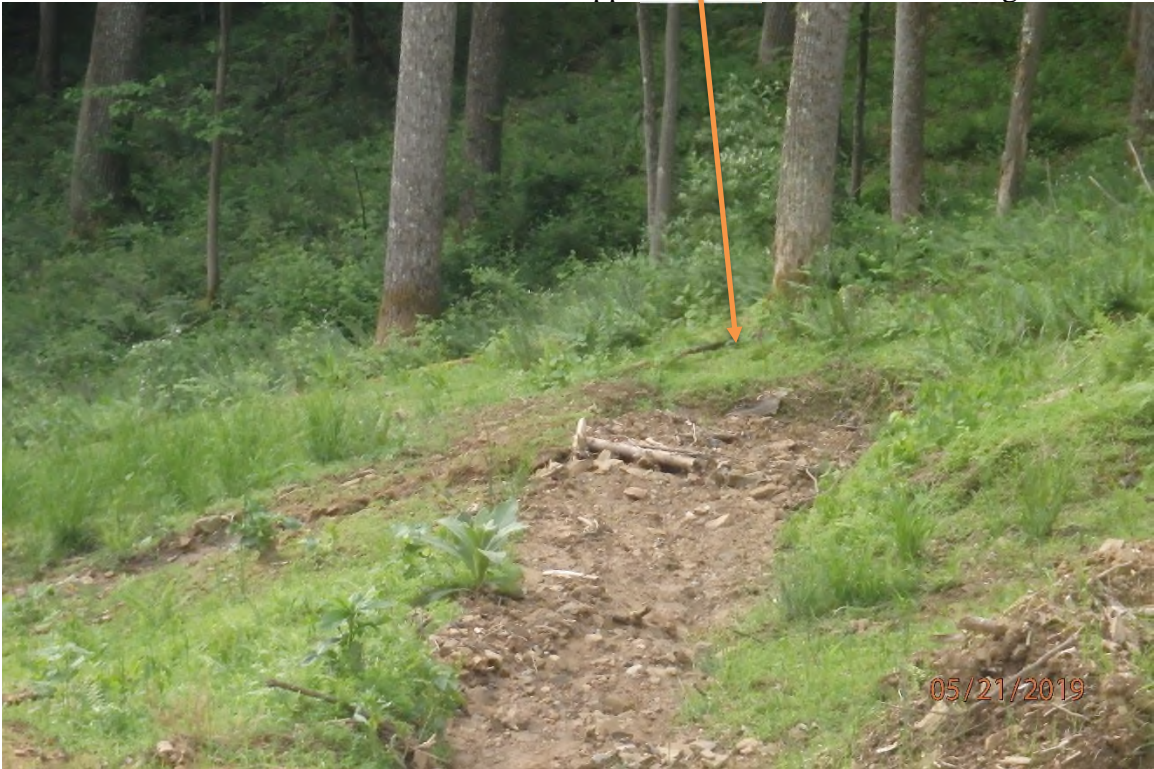
Water bar that lacks the outlet BMP indicated in the approved SWPPP in the UNT Sugar Run watershed.

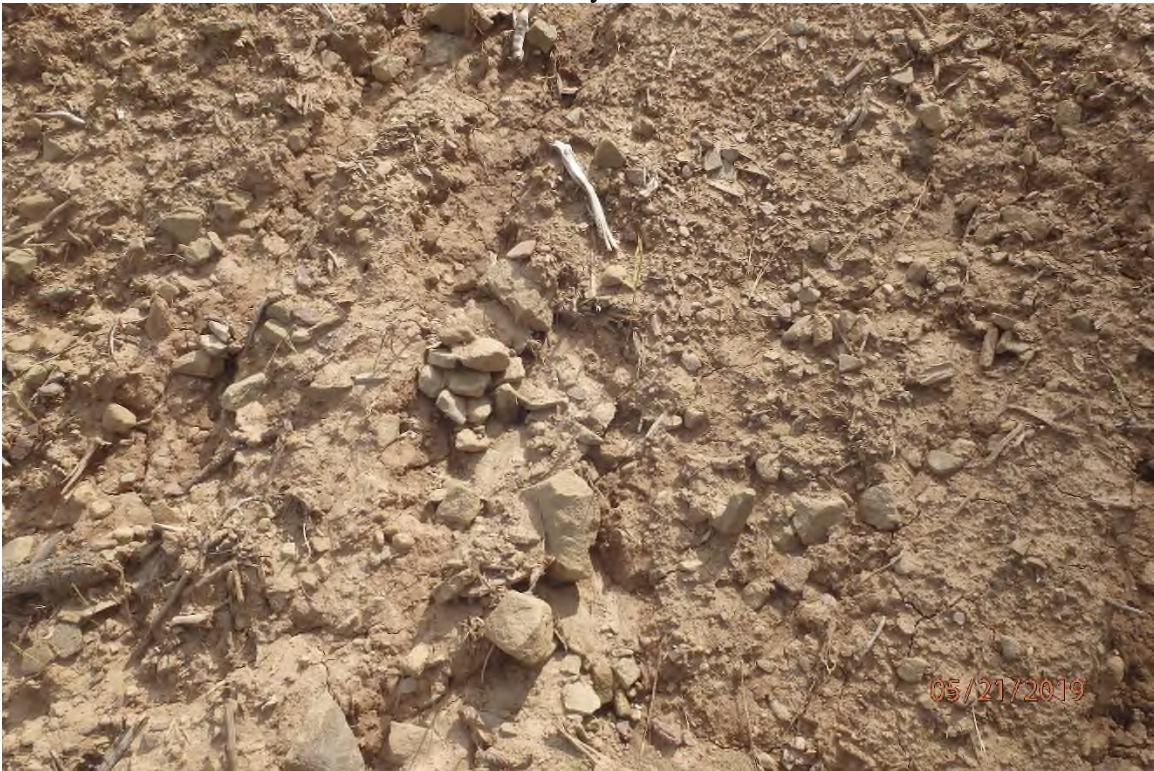
Areas of disturbance that were temporarily stabilized in December that have not germinated and have not been reseeded in the Taylor Drain watershed.

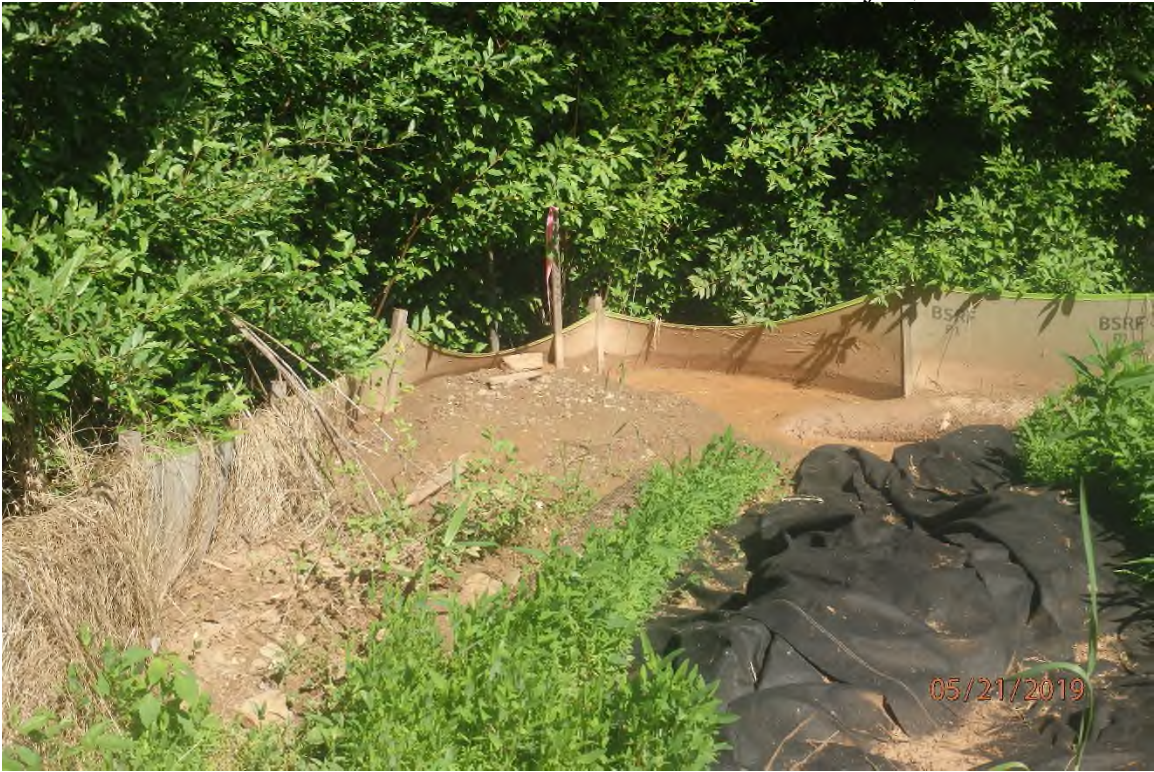
Discarded dewatering bag in the Bluestone Creek watershed.

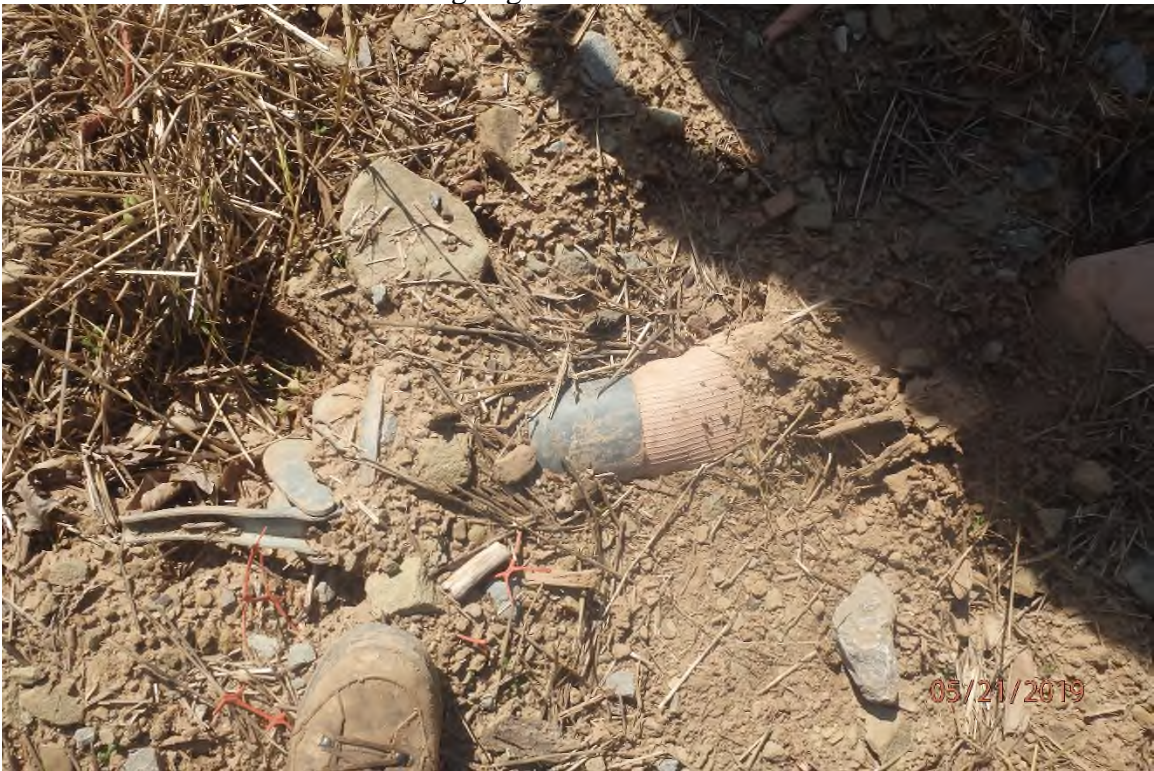
Discarded dewatering hose in the Georgescamp Run watershed.

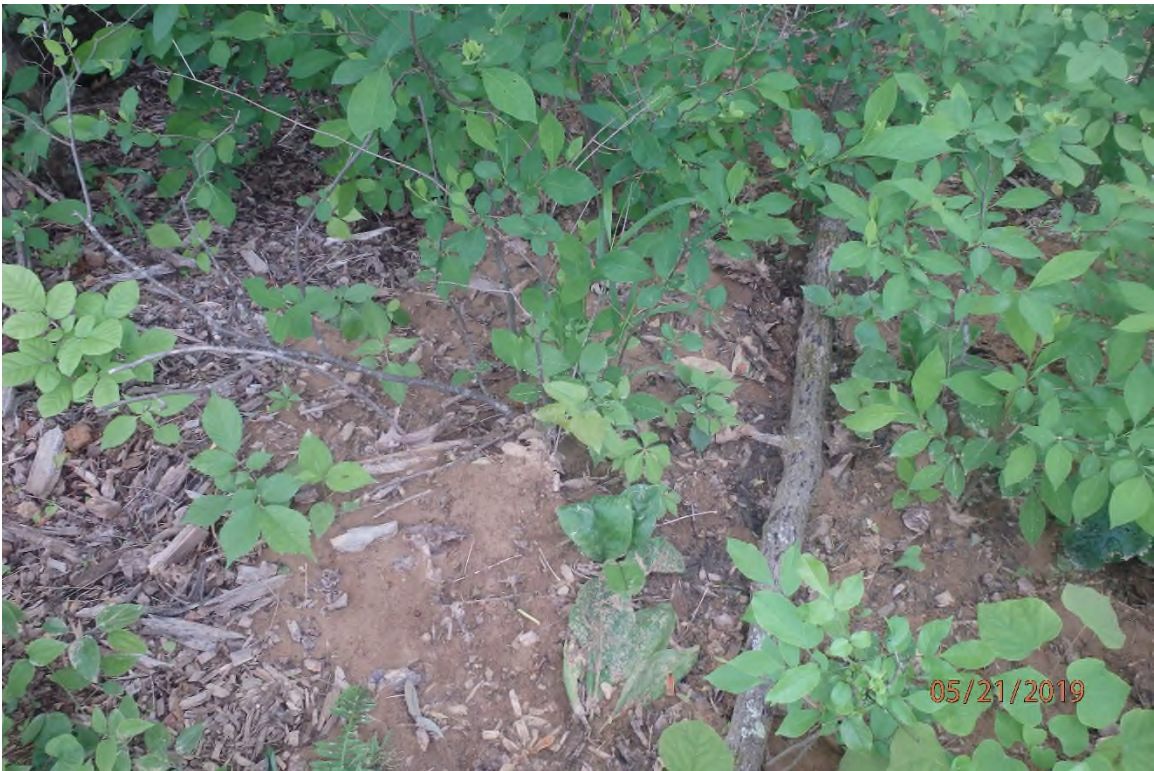
Area adjacent to 3314+00 where the approved SWPPP does not indicate the need for perimeter controls and the plan has proved inadequate. Offsite sediment deposits documented in lower photo.

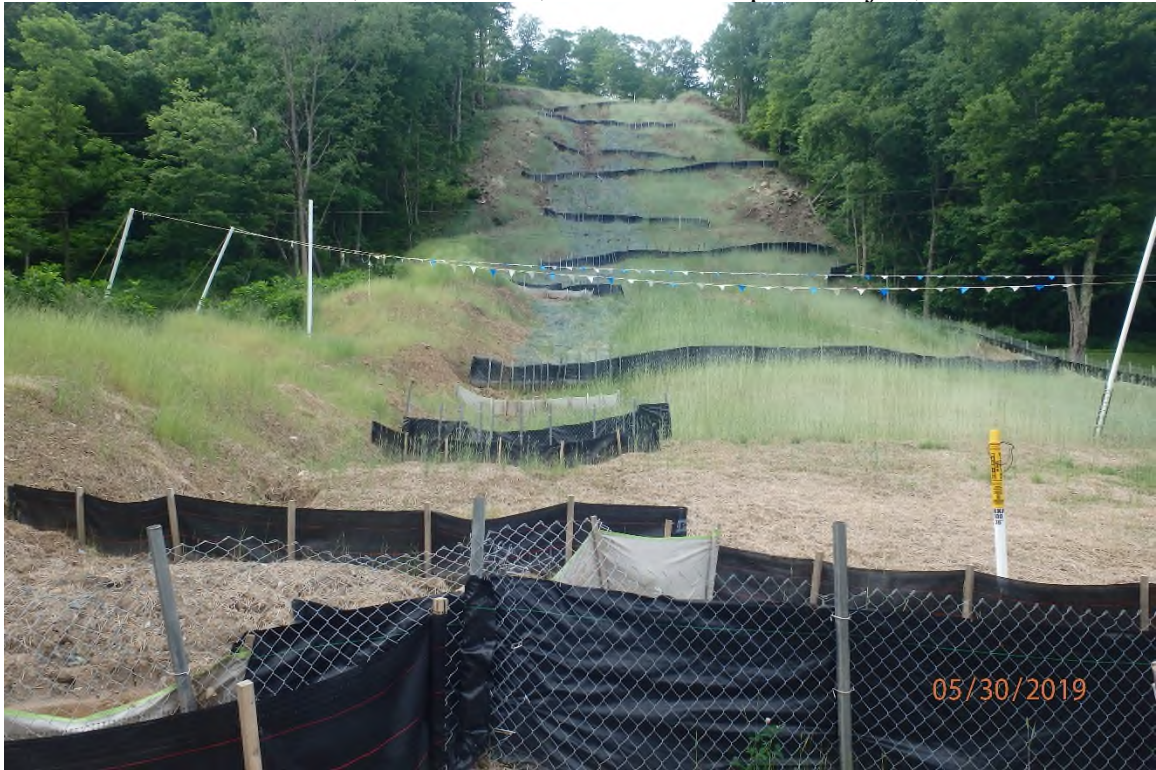
Overview of area of improperly installed water bars from 2590+00 to 2595+00.

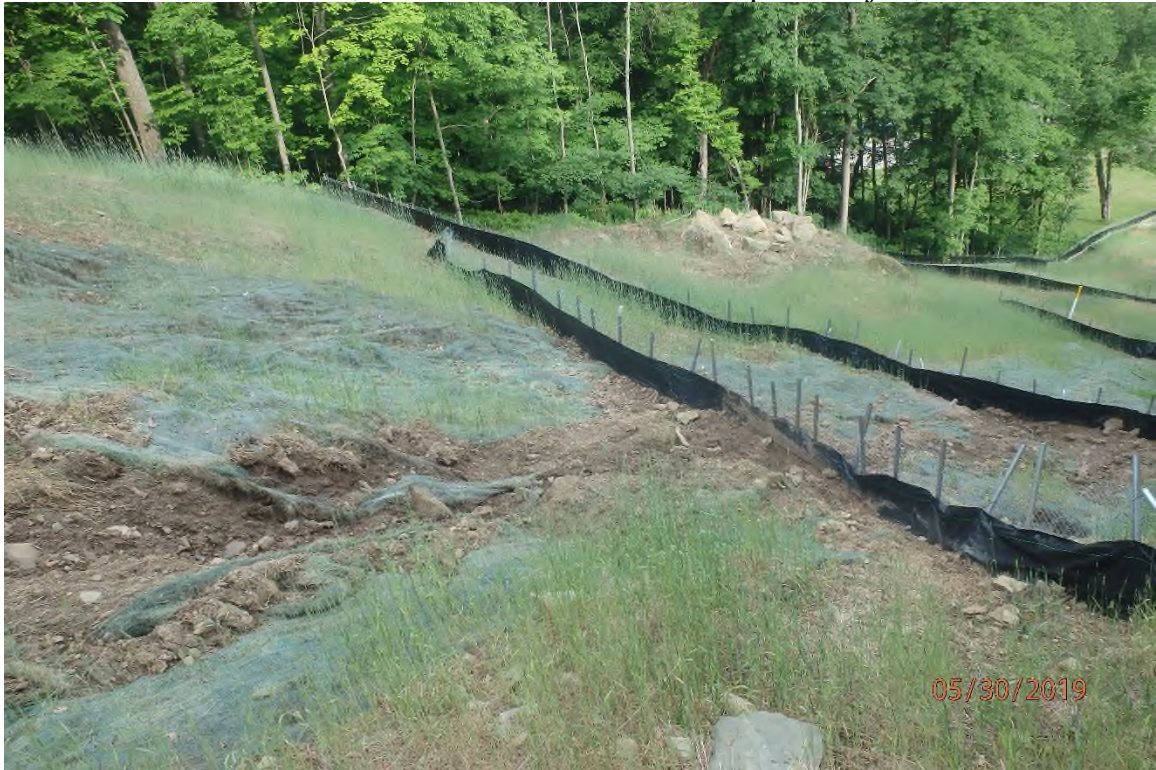
Fill slope erosion below an improperly installed water bar adjacent to 2592+50.

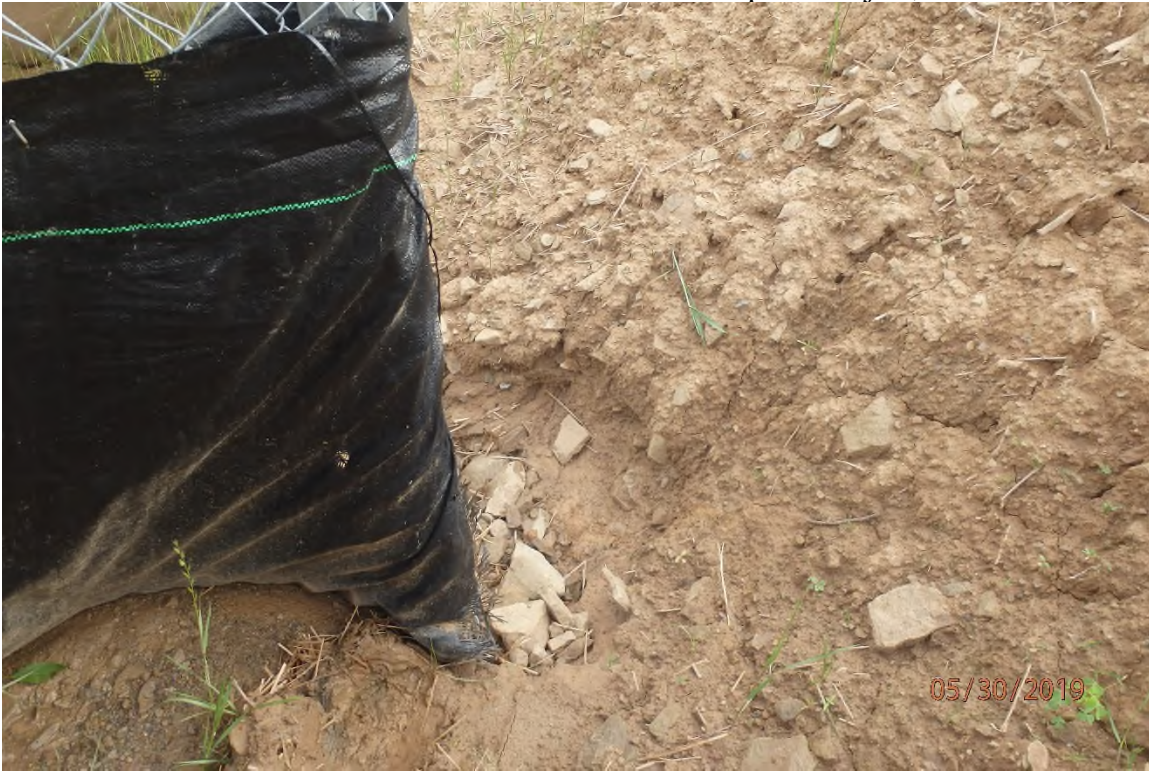
Water bar terminus adjacent to 2591+00 showing the area where concentrated flow is directed over the unprotected fill slope.

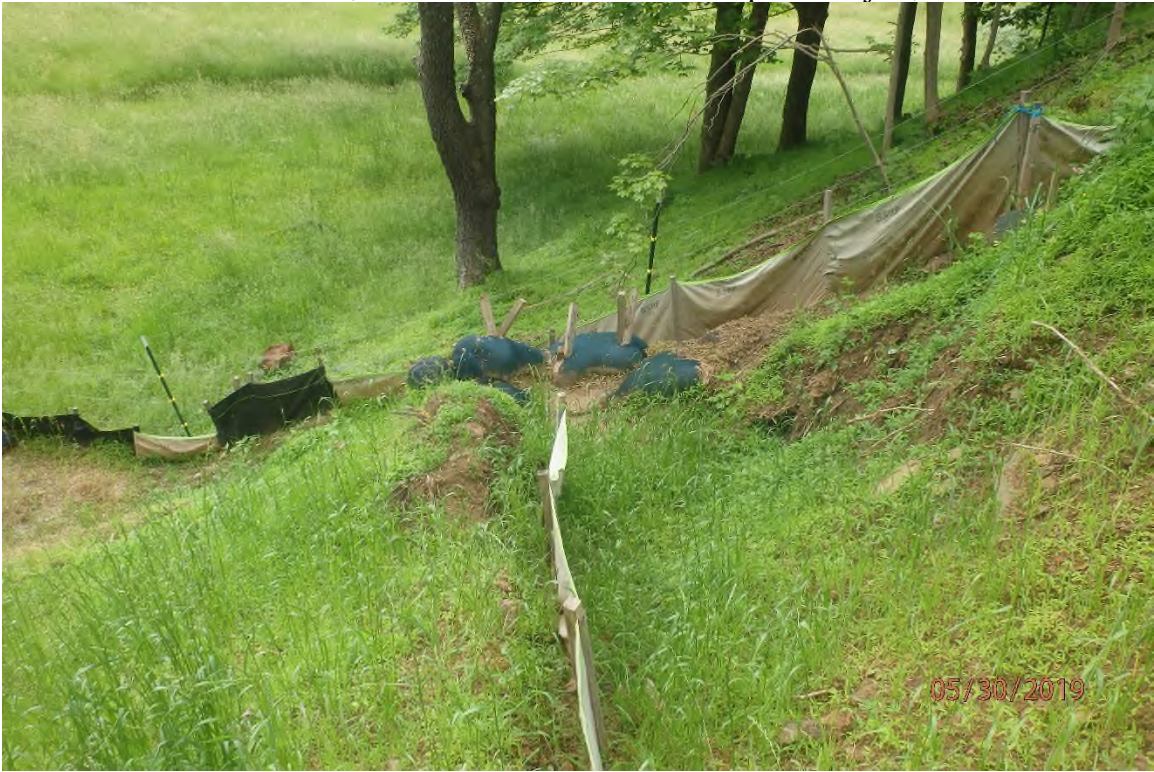
Water bar that terminates inside of the installed perimeter control adjacent to 2452+14.

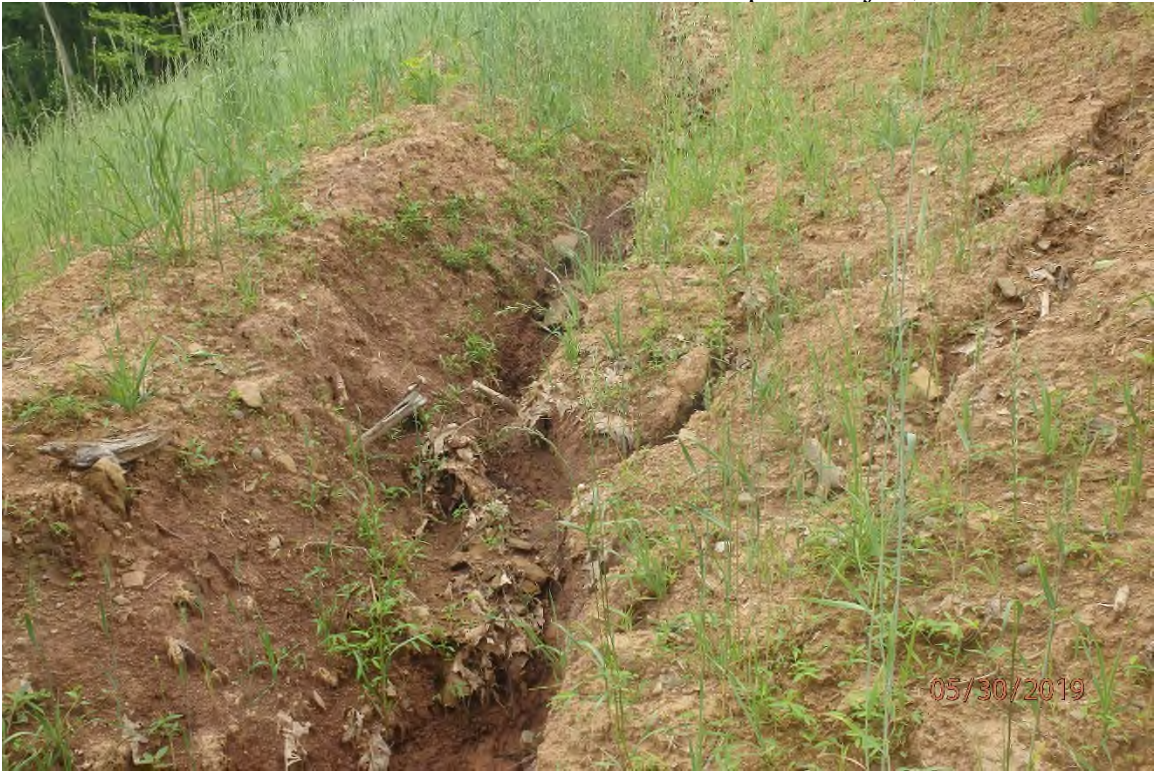
Fill slope erosion downslope of the above pictured water bar.

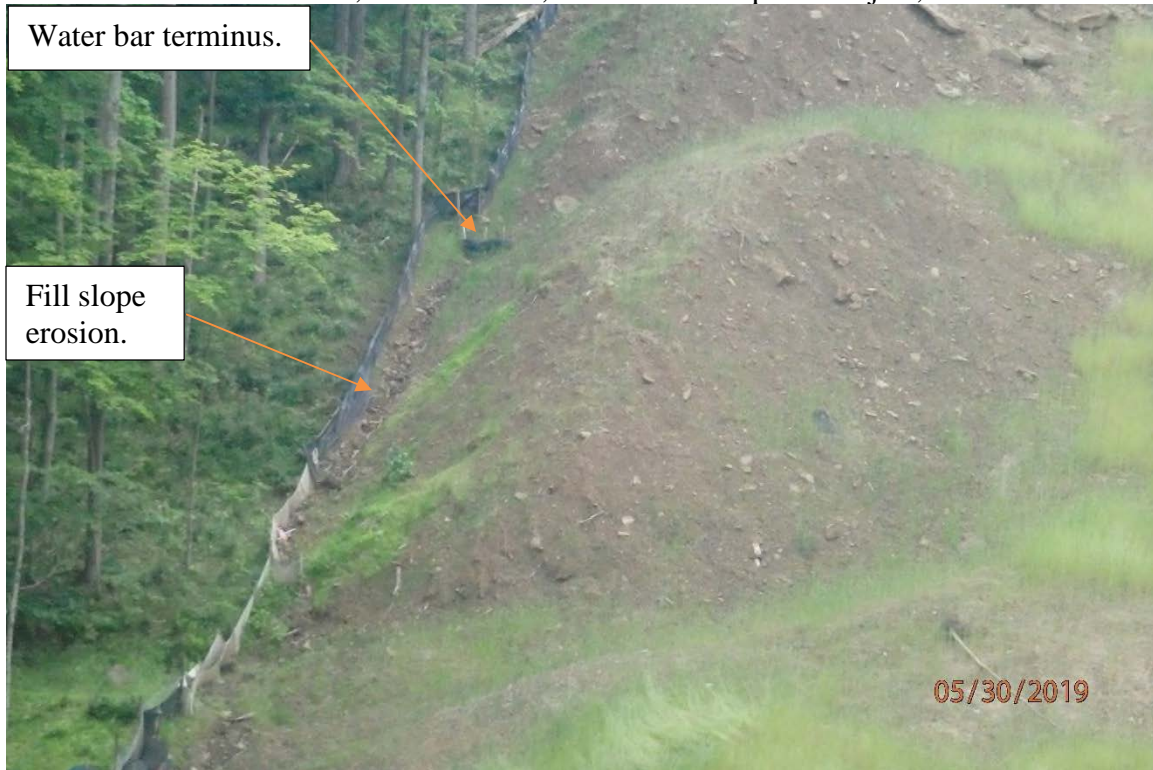
Improperly installed water bars in the Wolfepen Run watershed.

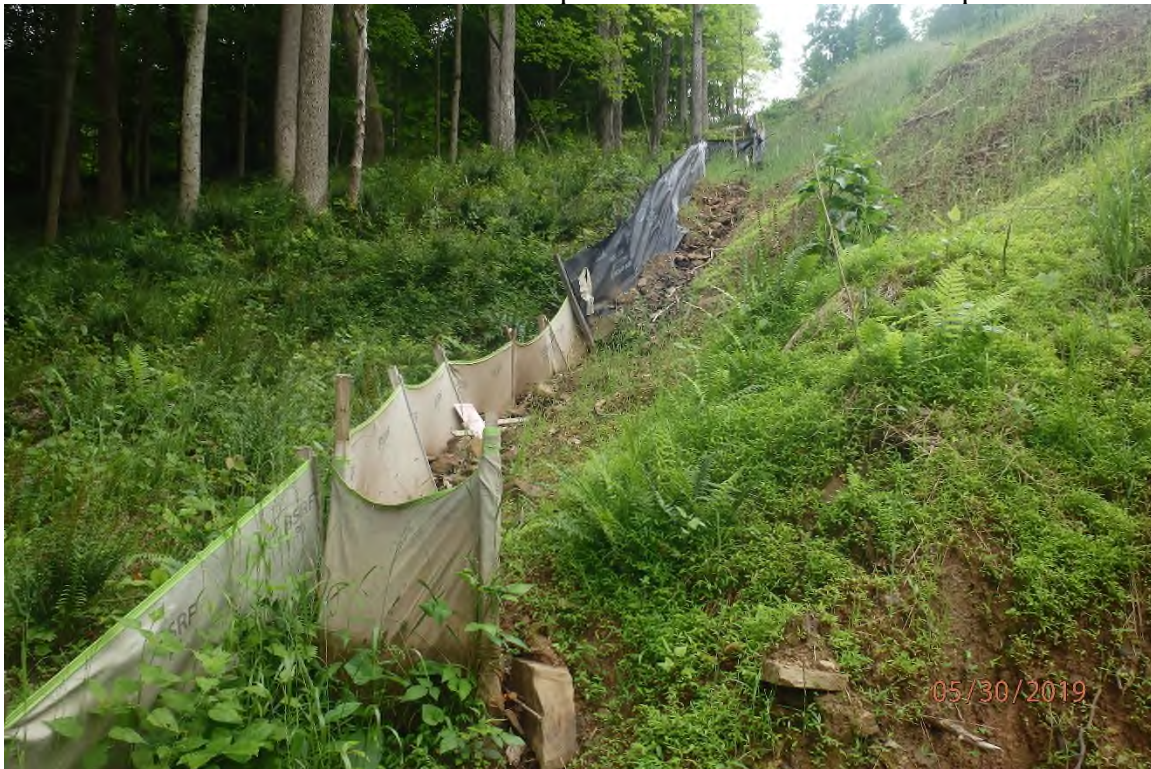
Water bar that terminates inside of the installed perimeter controls in the Wolfepen Run watershed.

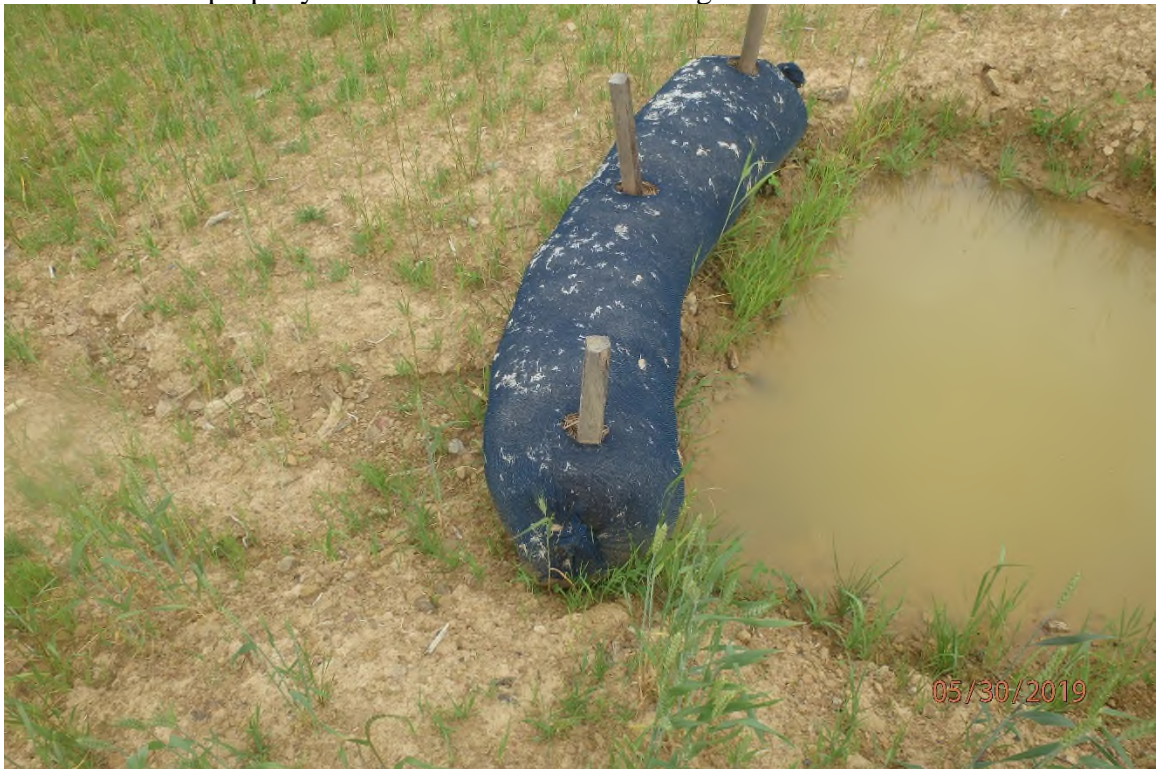
Improperly installed water bars in the Englands Run watershed.

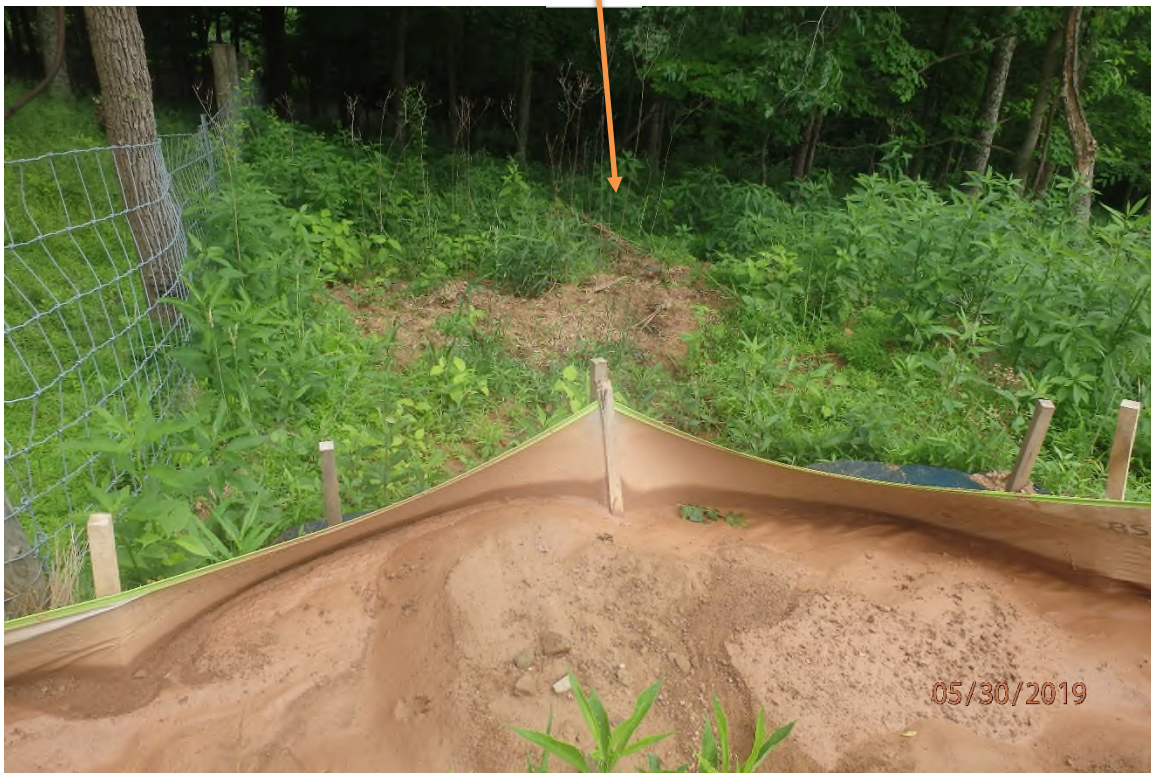
Above pictured water bars showing fill slope erosion downslope of the outlet.
