**CONSENT ORDER
ISSUED UNDER THE
WATER POLLUTION CONTROL ACT
WEST VIRGINIA CODE, CHAPTER 22, ARTICLE 11**

TO: Columbia Gas Transmission, LLC
Attn: Troy Tally, Vice President
1700 MacCorkle Ave
Charleston, WV 25314

DATE: October 1, 2020
ORDER NO.: 9061

1. Columbia Gas Transmission, LLC is conducting land disturbance activity associated with construction of the Mountaineer Xpress Project in Marshall, Wetzel, Tyler, Doddridge, Ritchie, Calhoun, Wirt, Roane, Jackson, Mason, Putnam, and Cabell Counties, West Virginia. On January 31, 2018, Columbia Gas Transmission, LLC was issued Water Pollution Control Permit No. WV0116815, Registration No. WVR310872, for Stormwater Associated With Oil and Gas Related Construction Activities.

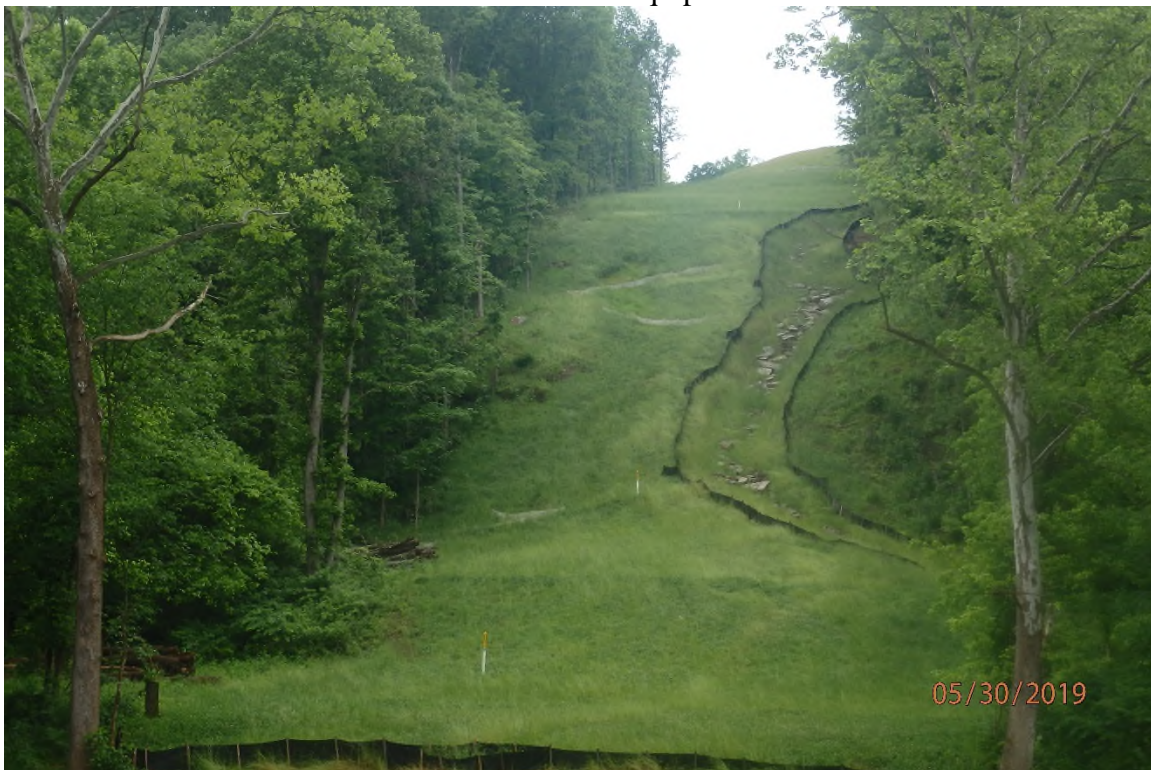
Water bars in the Neds Run watershed that have been temporarily repaired with silt fence and need to be reestablished with equipment.

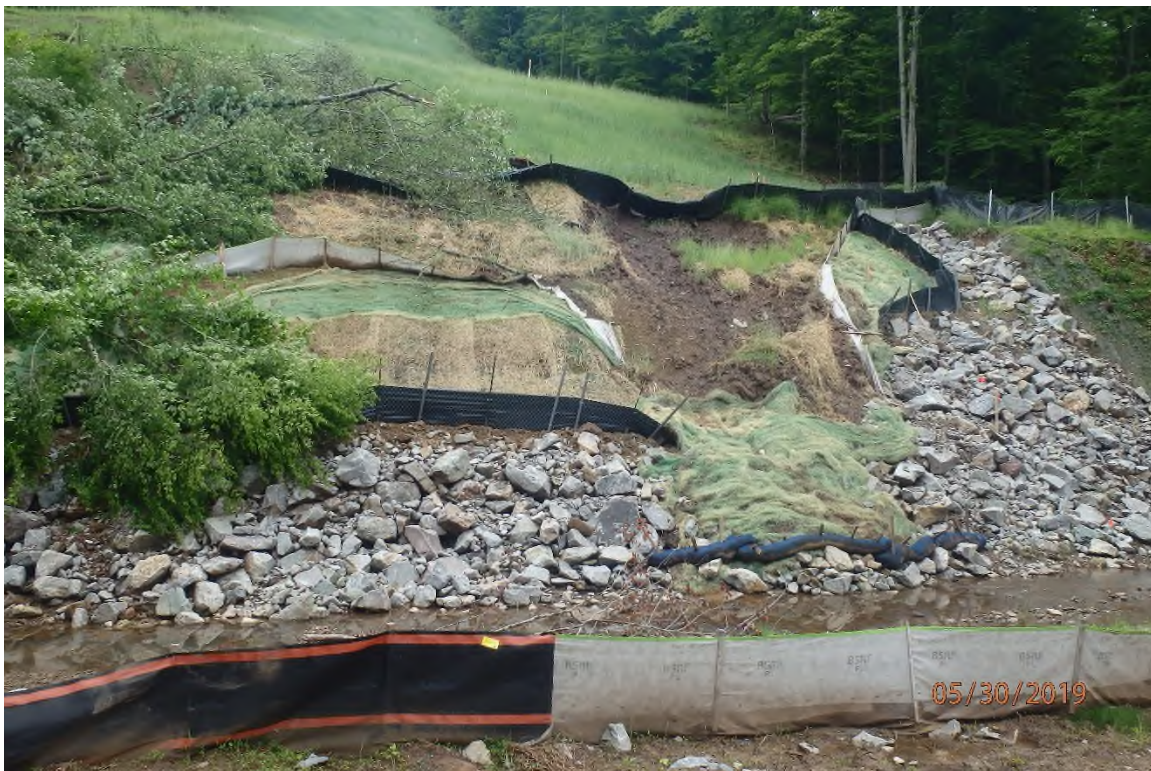
Water bars in the Meathouse Fork watershed that have been temporarily repaired with silt fence and need to be reestablished with equipment.

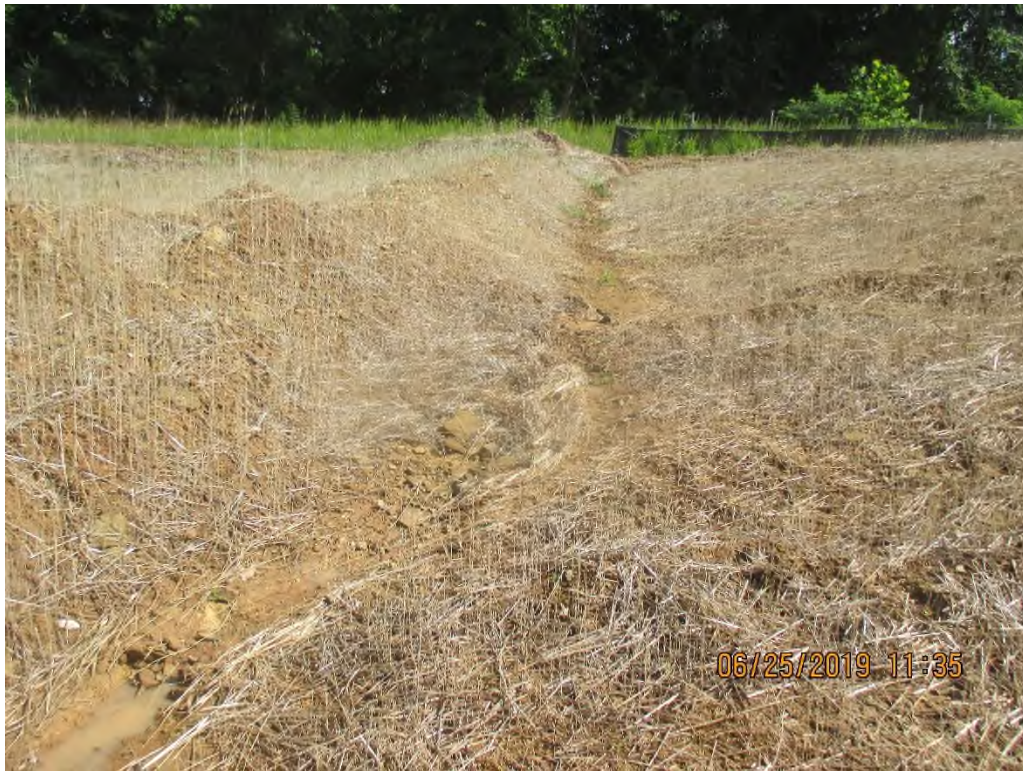
Overview of the slip associated with spill report #-09-90266 (A) showing the need for maintenance to the installed BMPs.

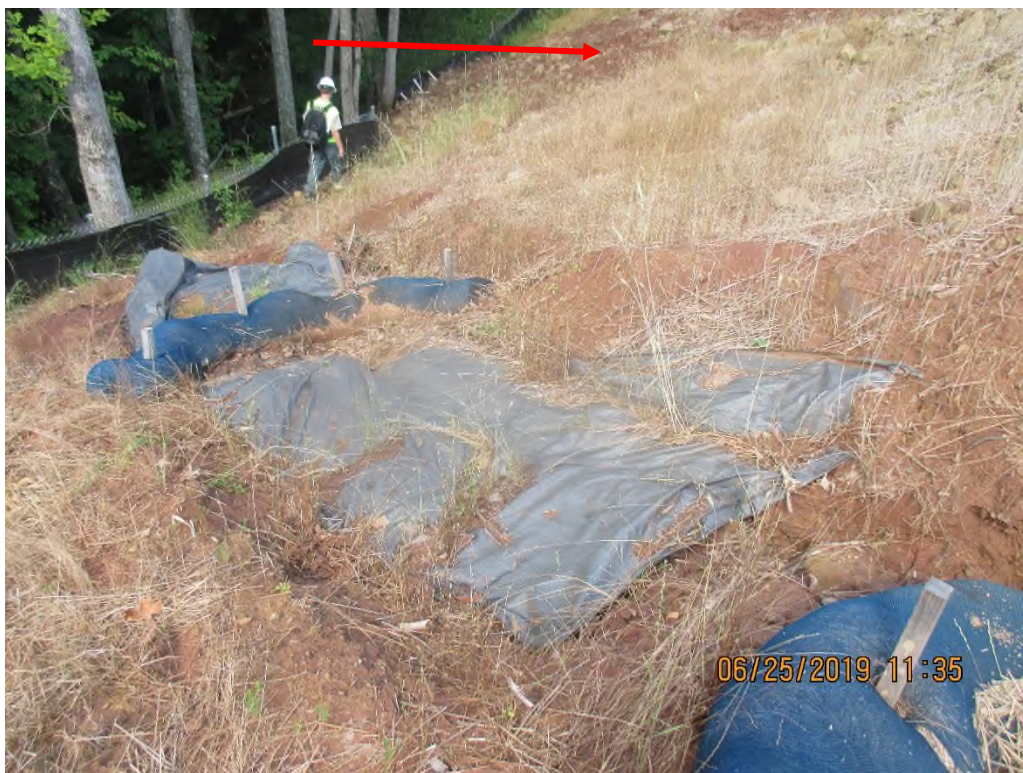
Upslope at station No. 5355+67. Erosion present in waterbar.

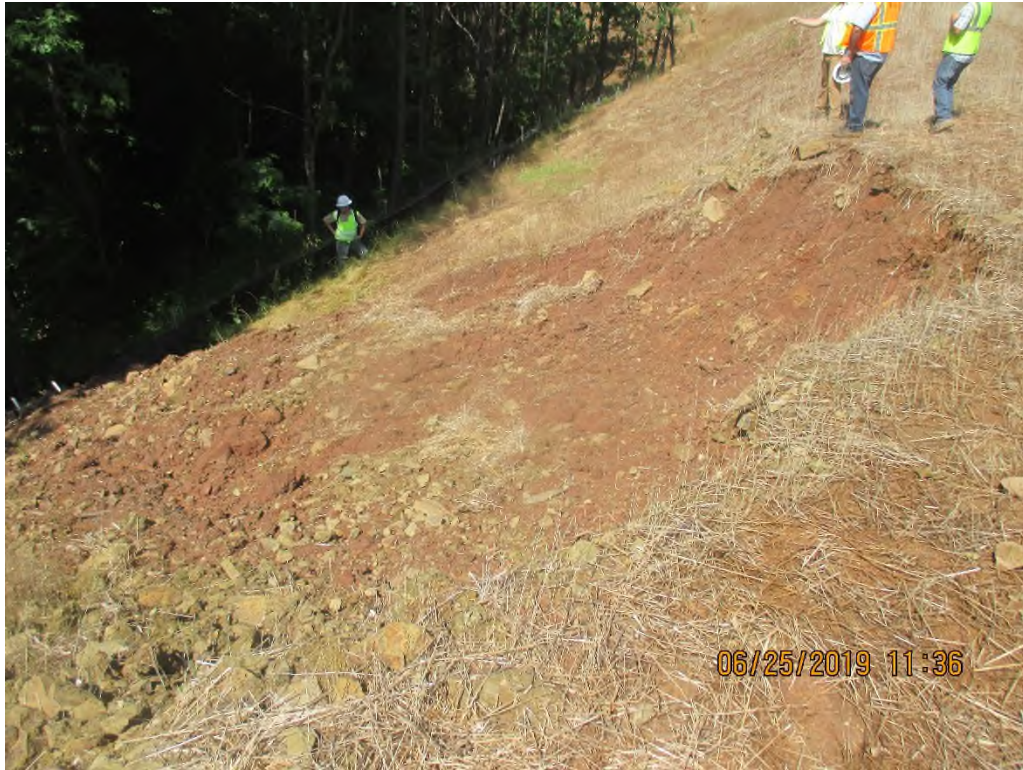
Controls below waterbar outlet terminating onto fill slope causing erosion on slope at station No. 5355+67. Arrow depicts slip area next to outlet.

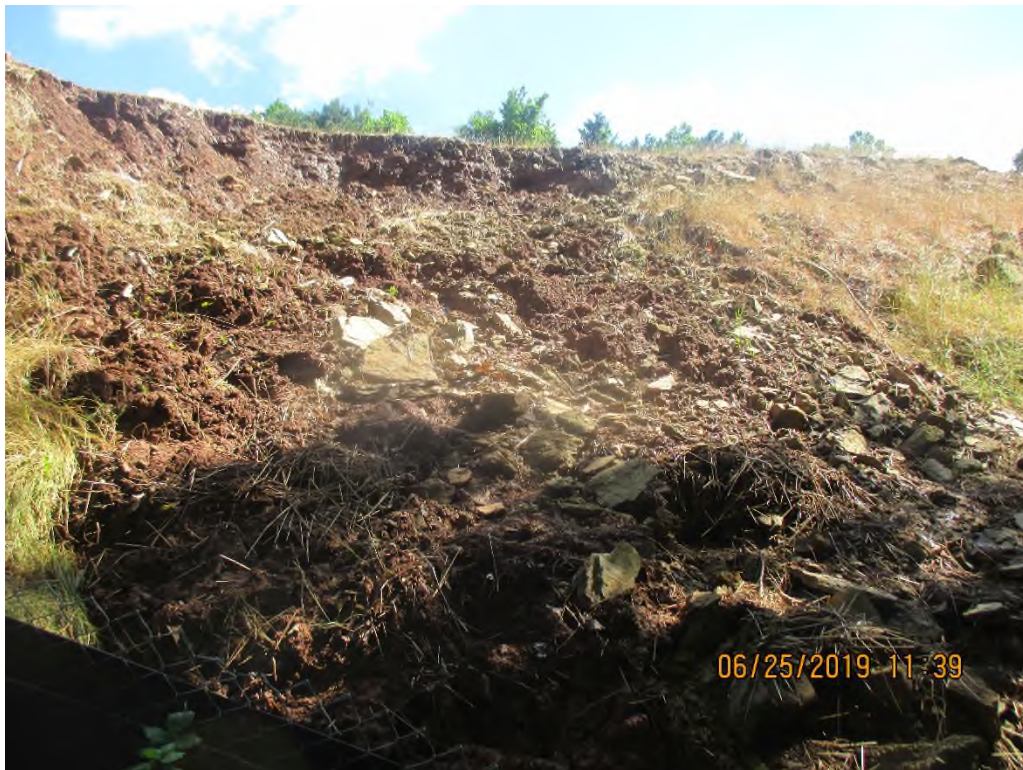
Slip area next to waterbar terminating onto slope at station No. 5355+67.

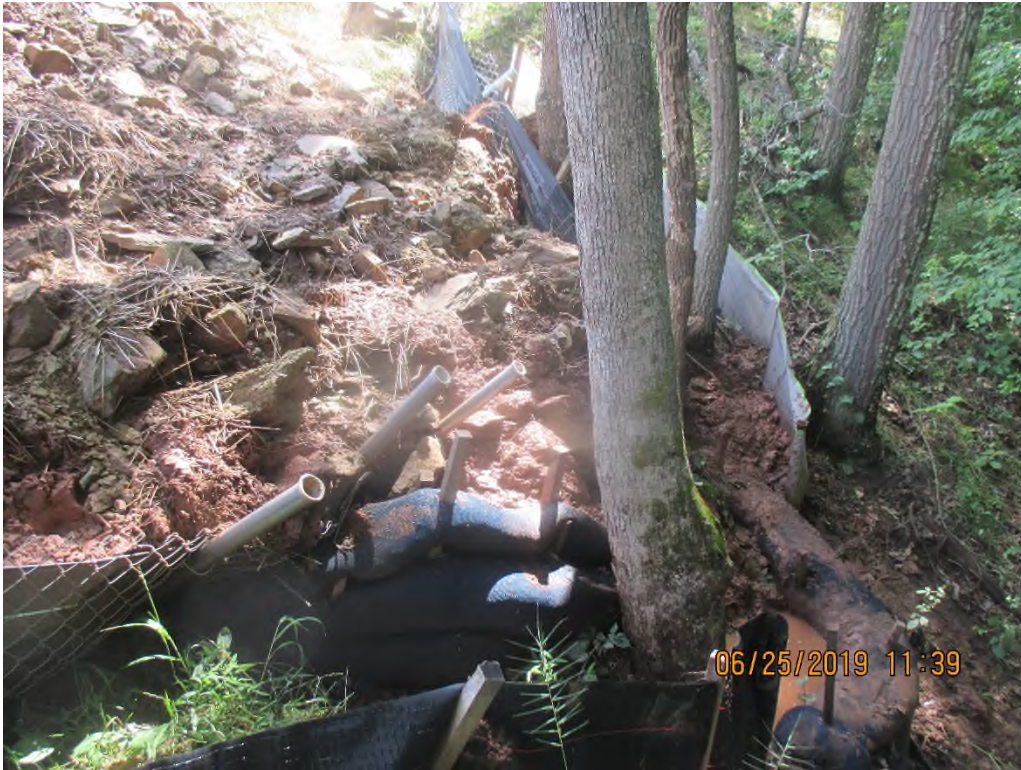
Facing upslope at station No. 5355+67 where slip was occurring and depositing sediment against and over perimeter controls.

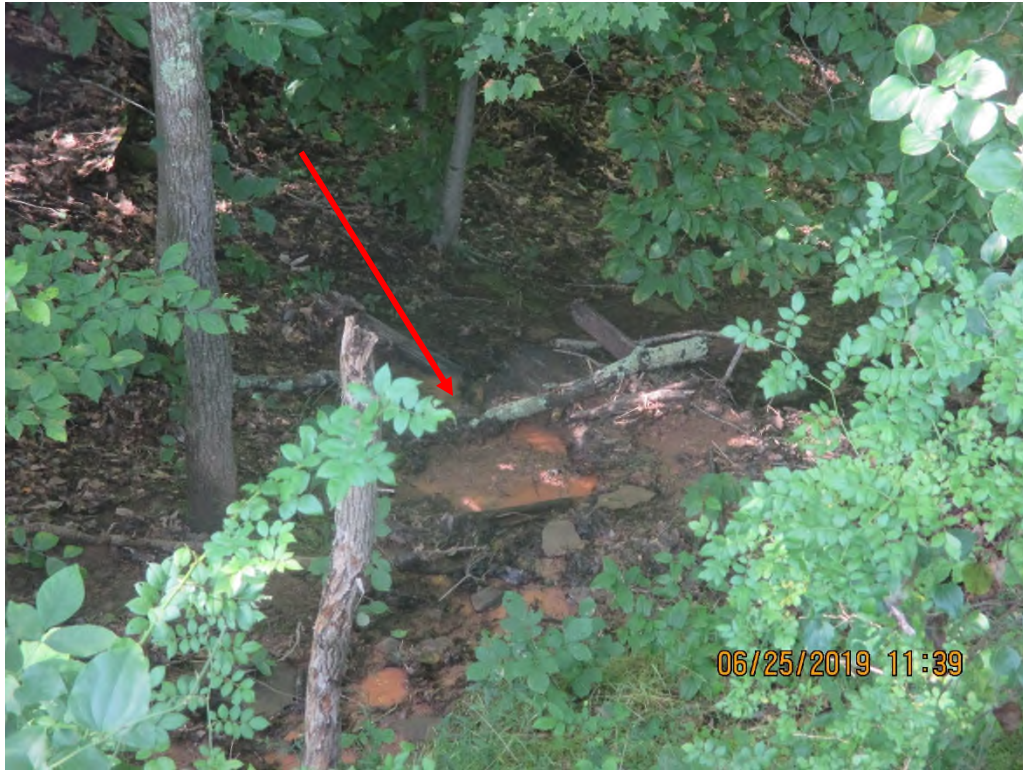
Perimeter controls overwhelmed with sediment downslope of slip area at station No. 5355+67

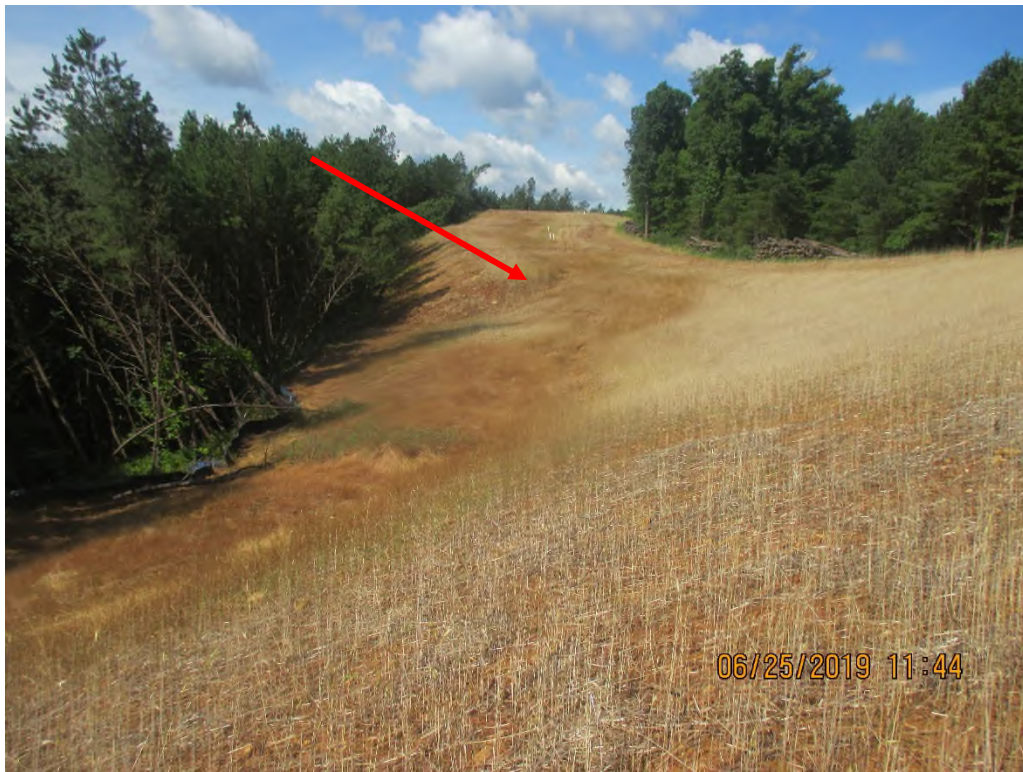
Sediment laden water leaving the site at station No. 5355+67 downslope of slip area.

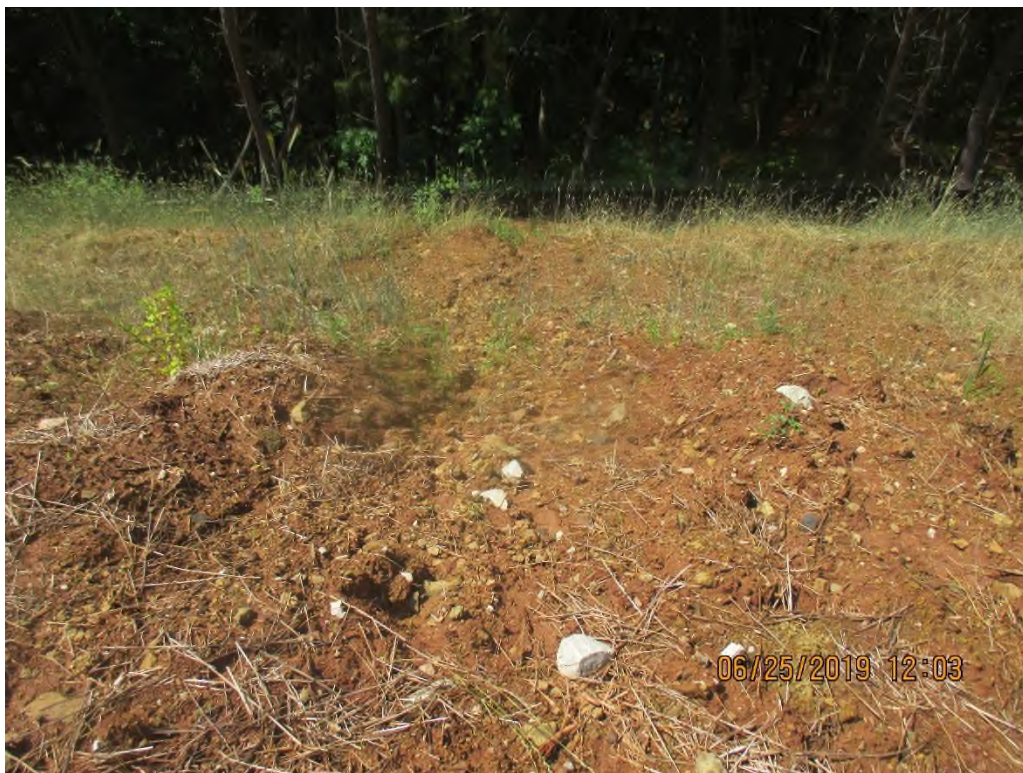
Erosion occurring on slope next to topsoil pile near station No. 5355+67.

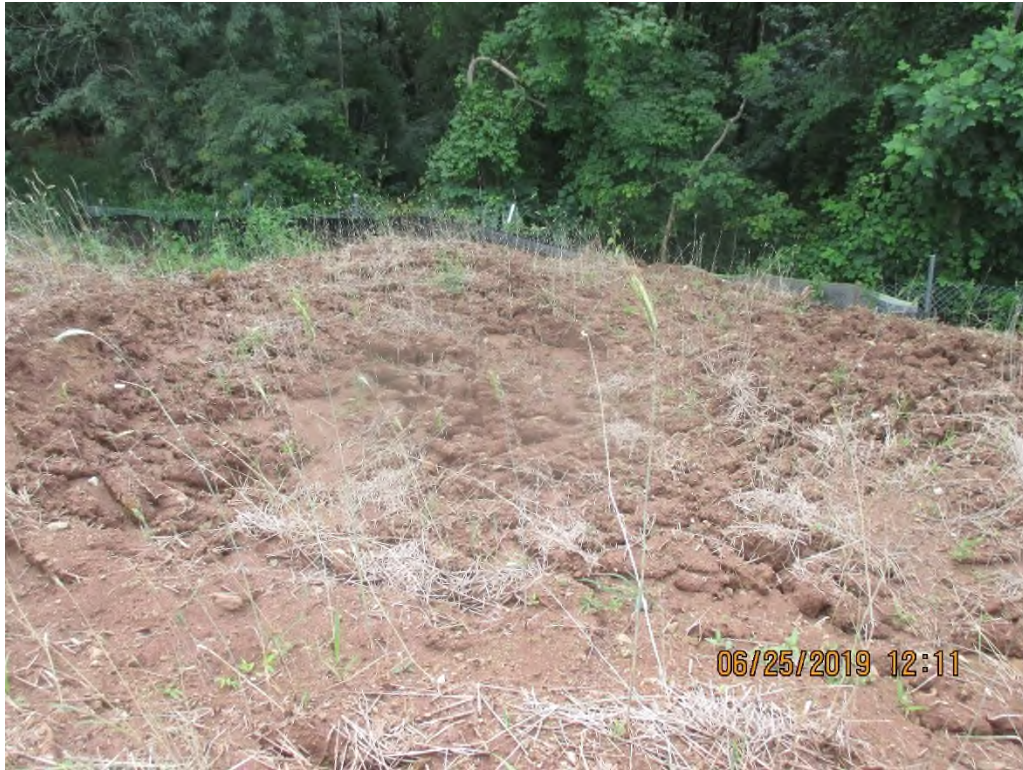
Slip area below Access Road ARWI 024 facing downslope at perimeter controls at station No. 5372+00.

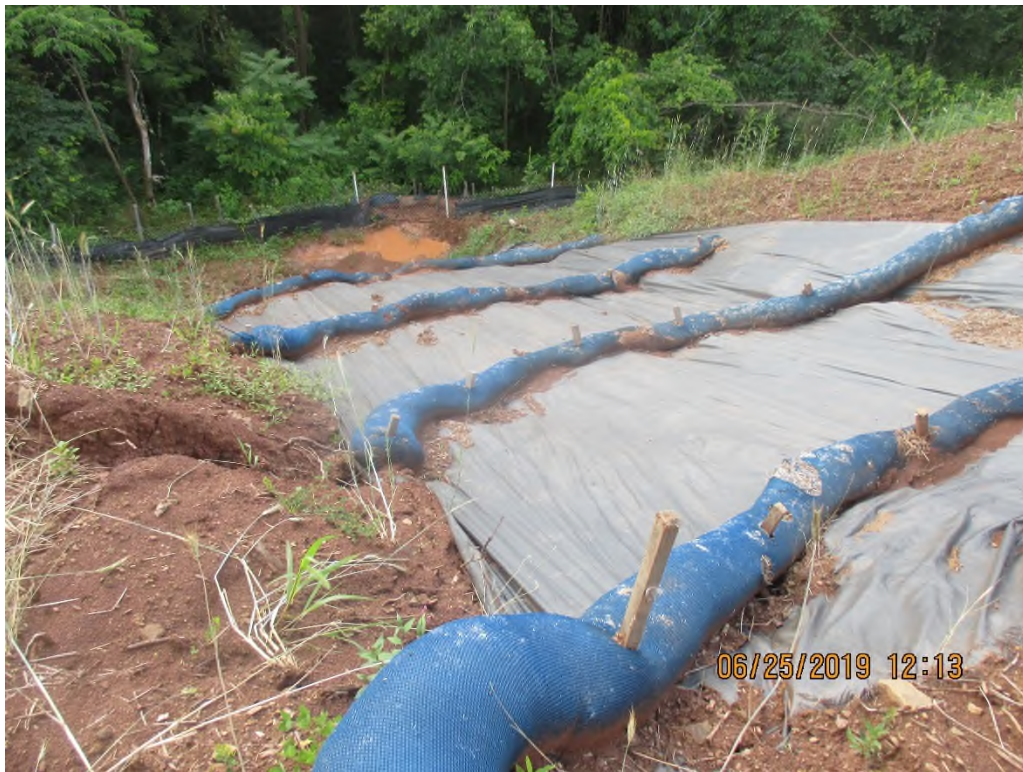
Slip present near station No. 5372+00 south of ARWI 024.

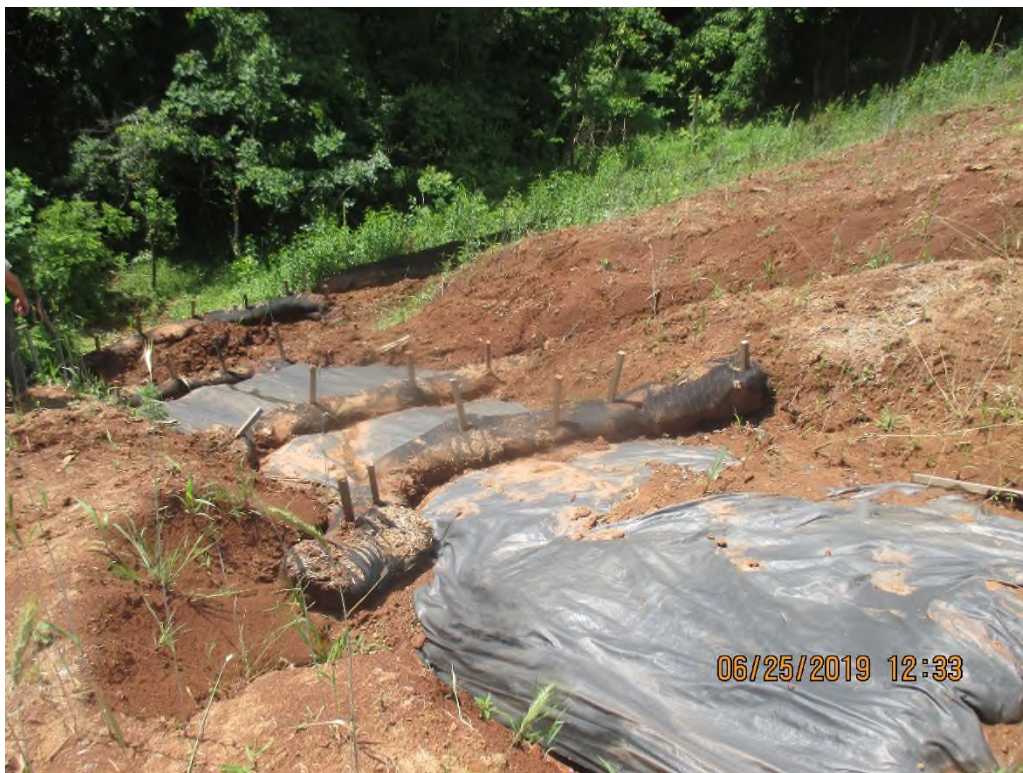
Waterbar outlet controls on slope south of ARWI 024 near station 5372+00. Perimeter controls overwhelmed with sediment. Erosion occurring under and next to Geotech fabric.

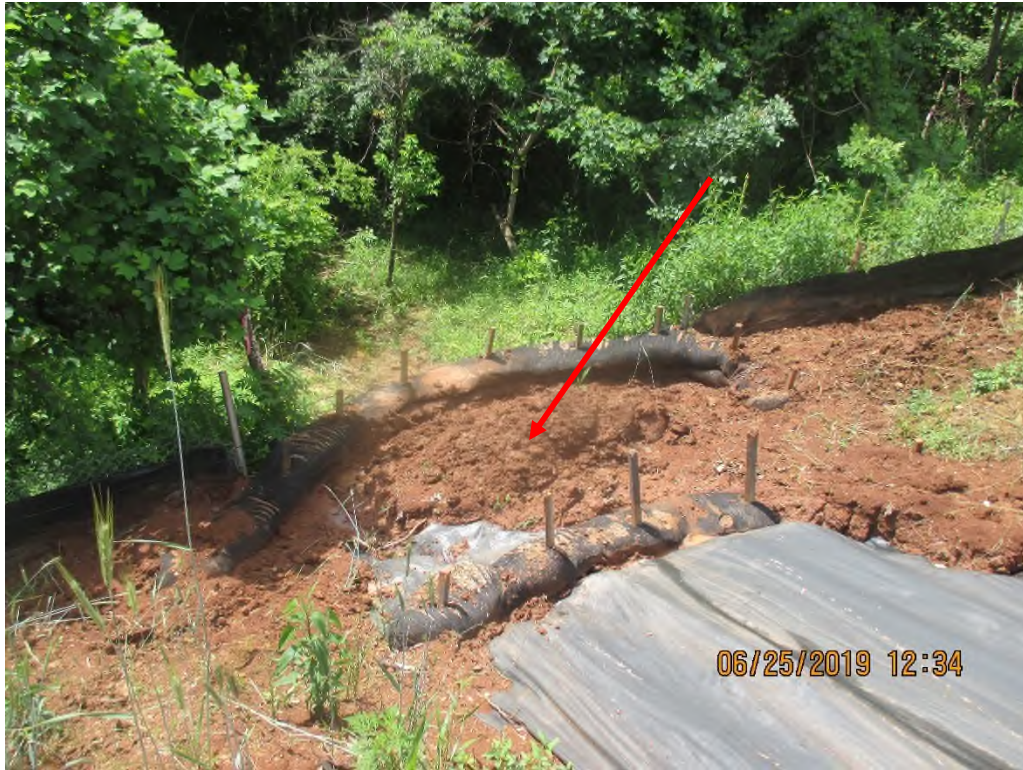
Waterbar outlet controls on slope south of ARWI 024 near station 5396+00. Perimeter controls overwhelmed with sediment. Erosion occurring under and next to Geotech fabric.

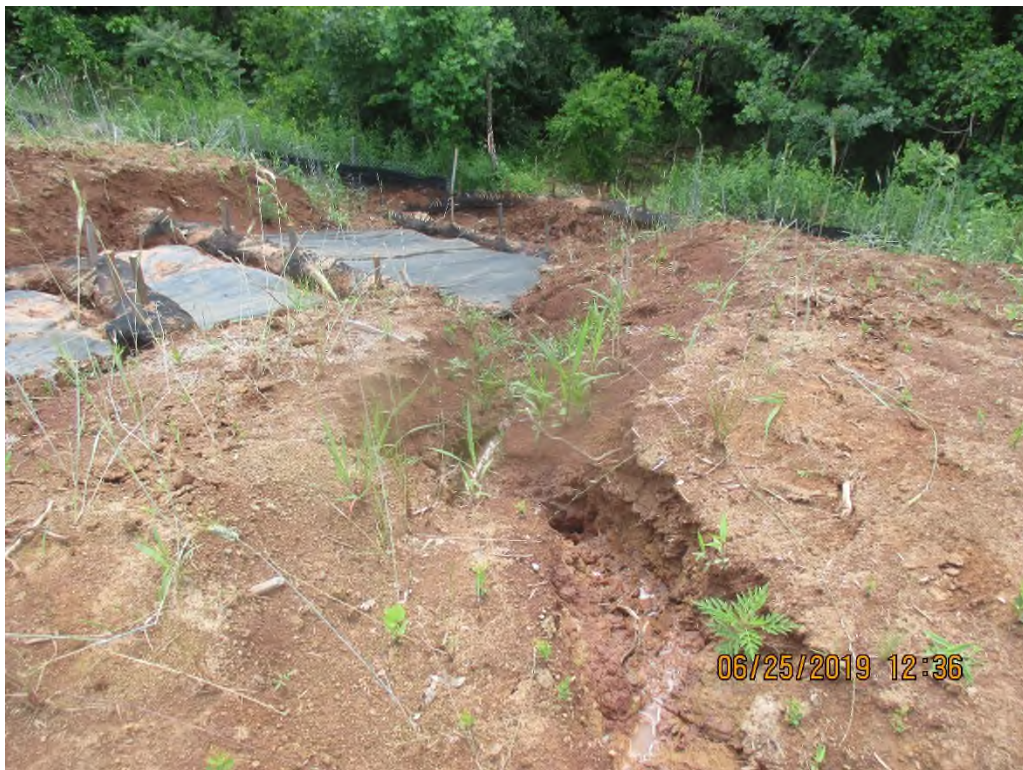
Waterbar outlet controls on slope south of ARWI 024 near station 5372+00. Perimeter controls overwhelmed with sediment. Erosion occurring under and next to Geotech fabric. Sediment removed from behind controls and placed in pile several feet behind controls. Deposits observed past the LOD.

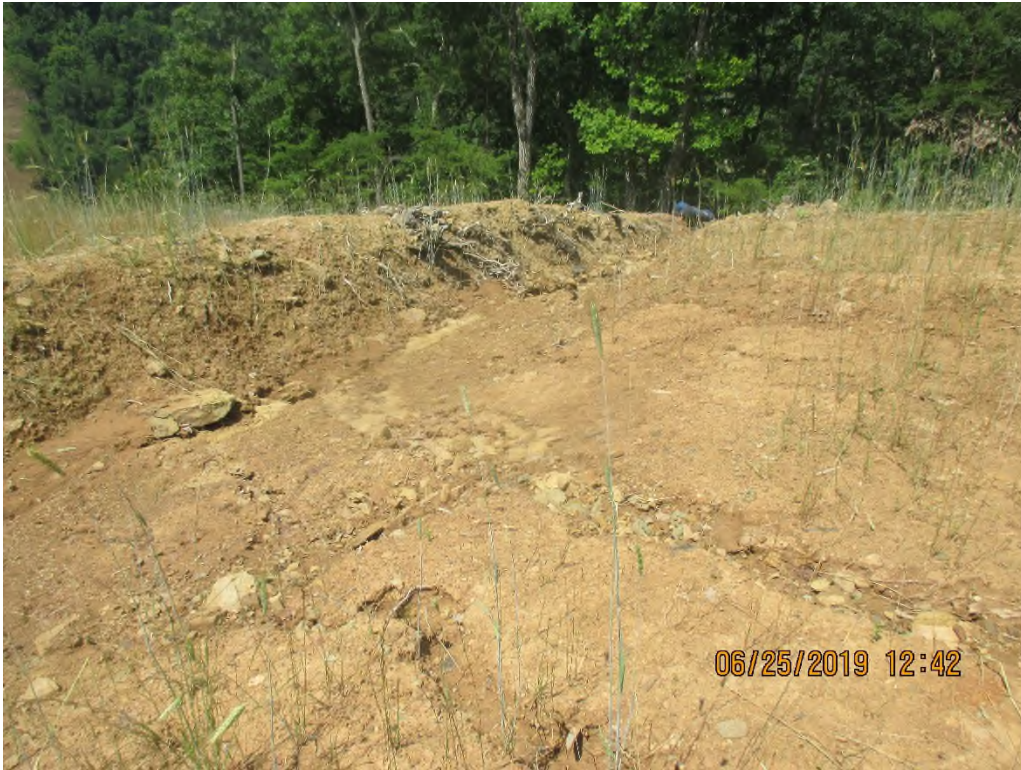
Waterbar outlet controls on slope south of ARWI 024 near station 5372+00. Perimeter controls overwhelmed with sediment. Erosion occurring under and next to Geotech fabric.

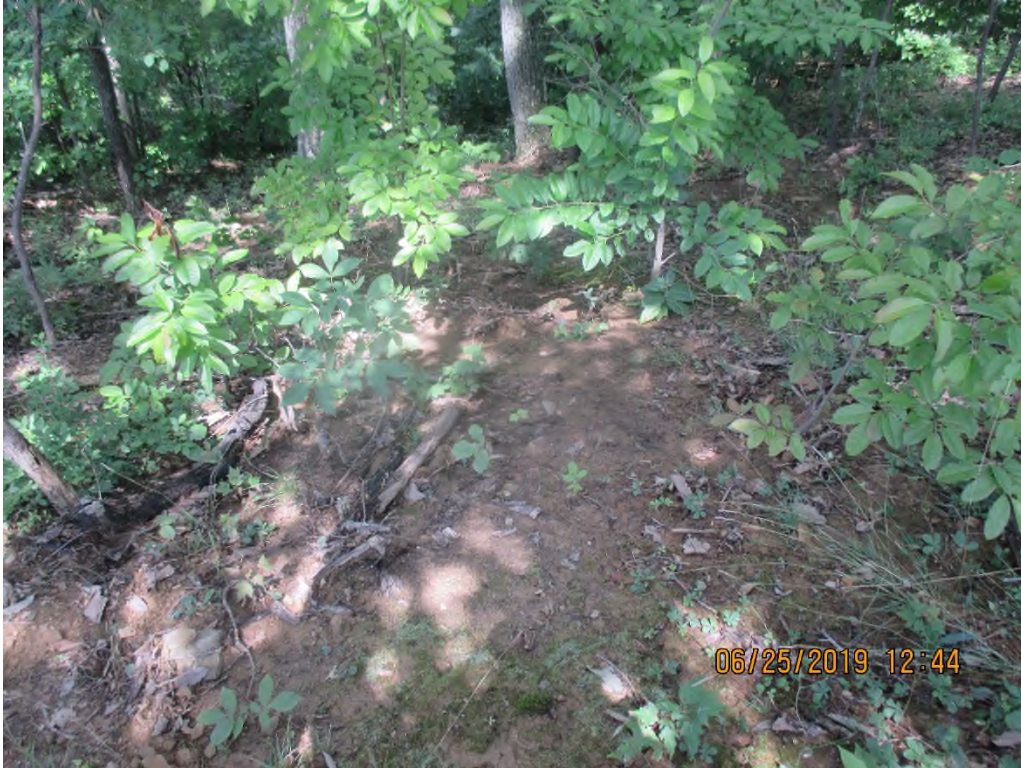
Erosion occurring below where waterbar was eroded. Sediment being deposited past LOD at station No. 5396+00.

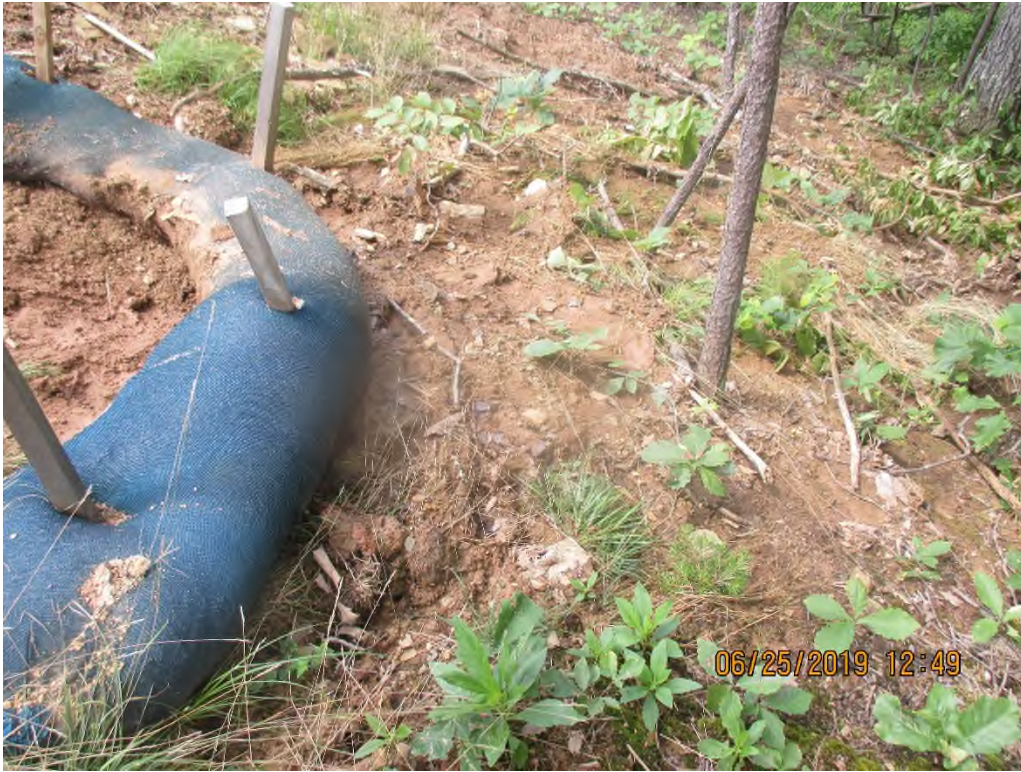
South of Station No. 5396+00. Waterbar with erosion present leading to overwhelmed controls.

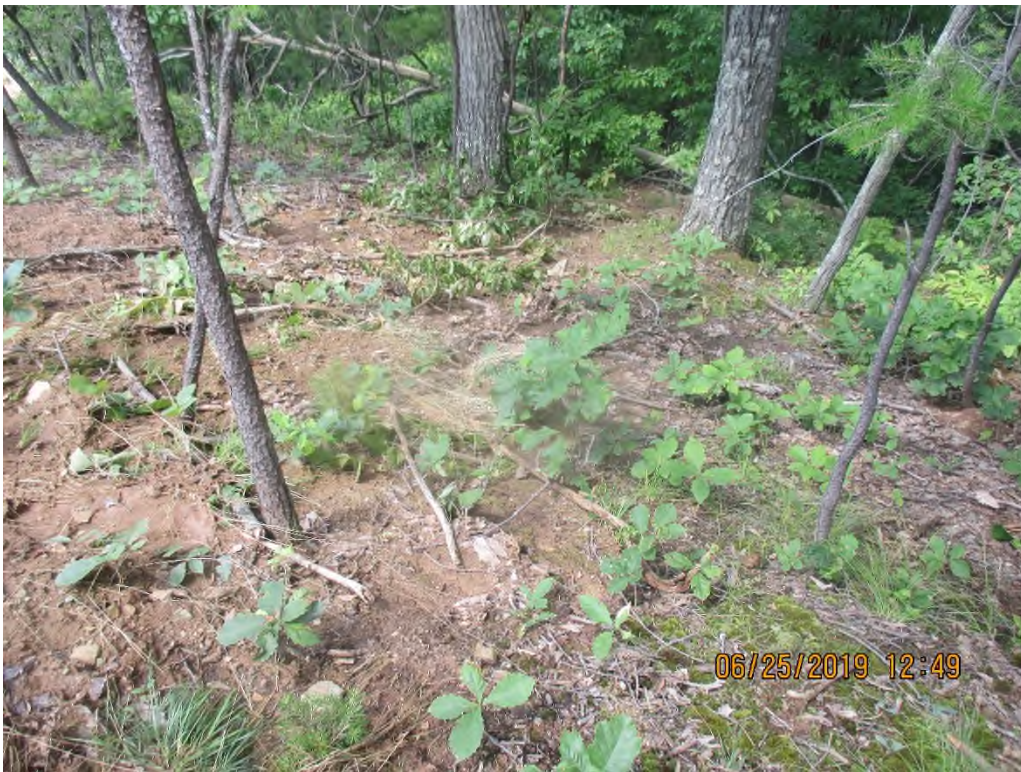
South of Station No. 5396+00. Waterbar outlet controls overwhelmed with sediment deposits past LOD.

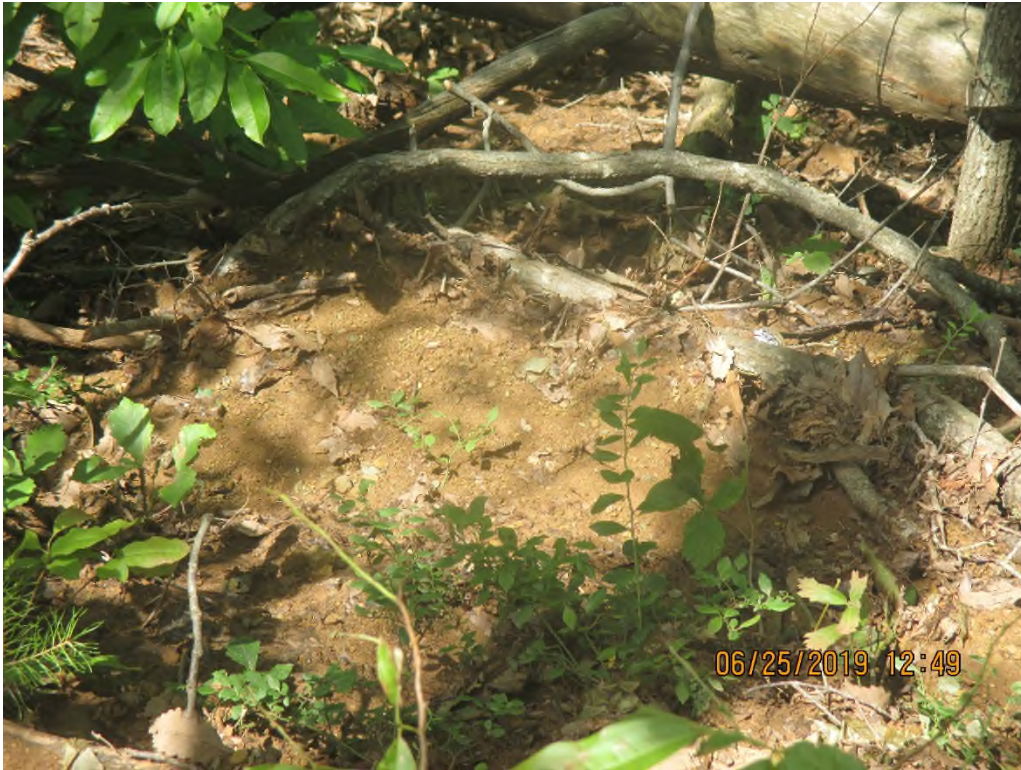
South of Station No. 5396+00. Downslope of overwhelmed Waterbar outlet controls with sediment deposits past LOD.

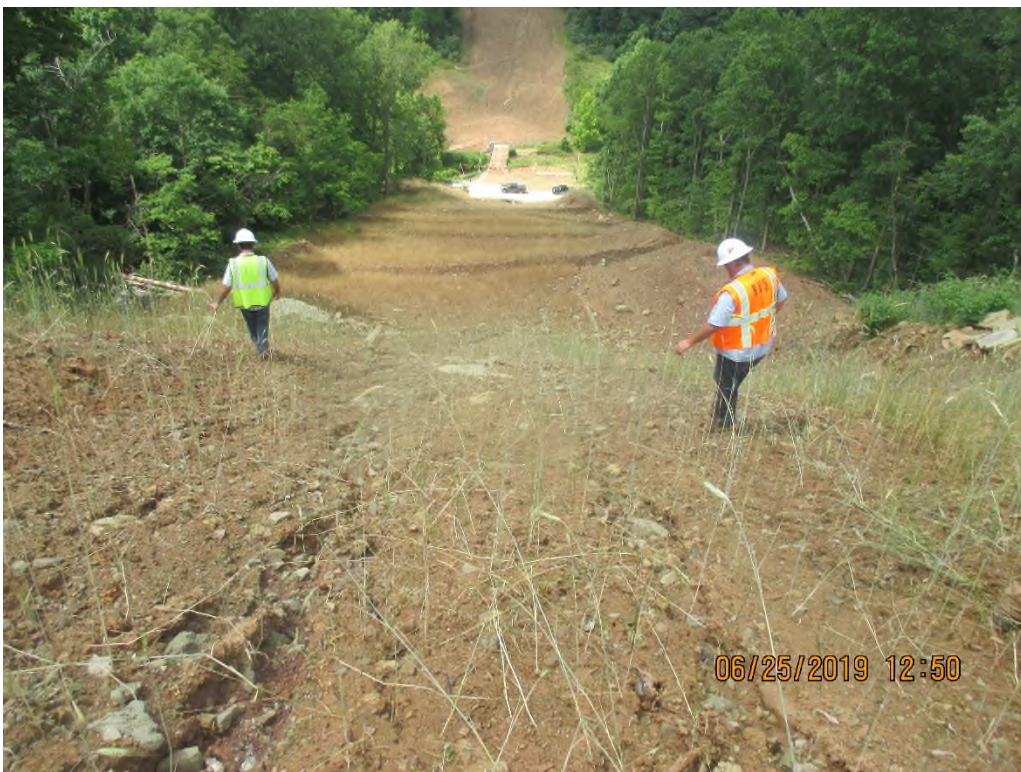
South of Station No. 5396+00. Sediment deposits past LOD.

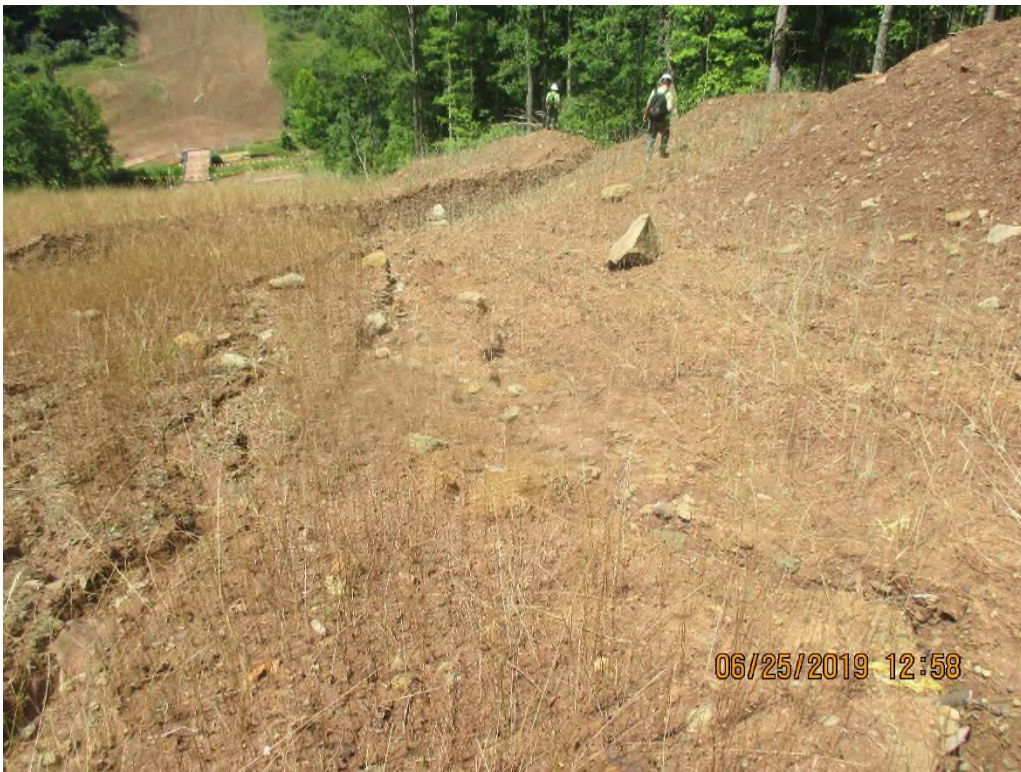
South of Station No. 5396+00. Erosion on slope above Munchausen Road Crossing.

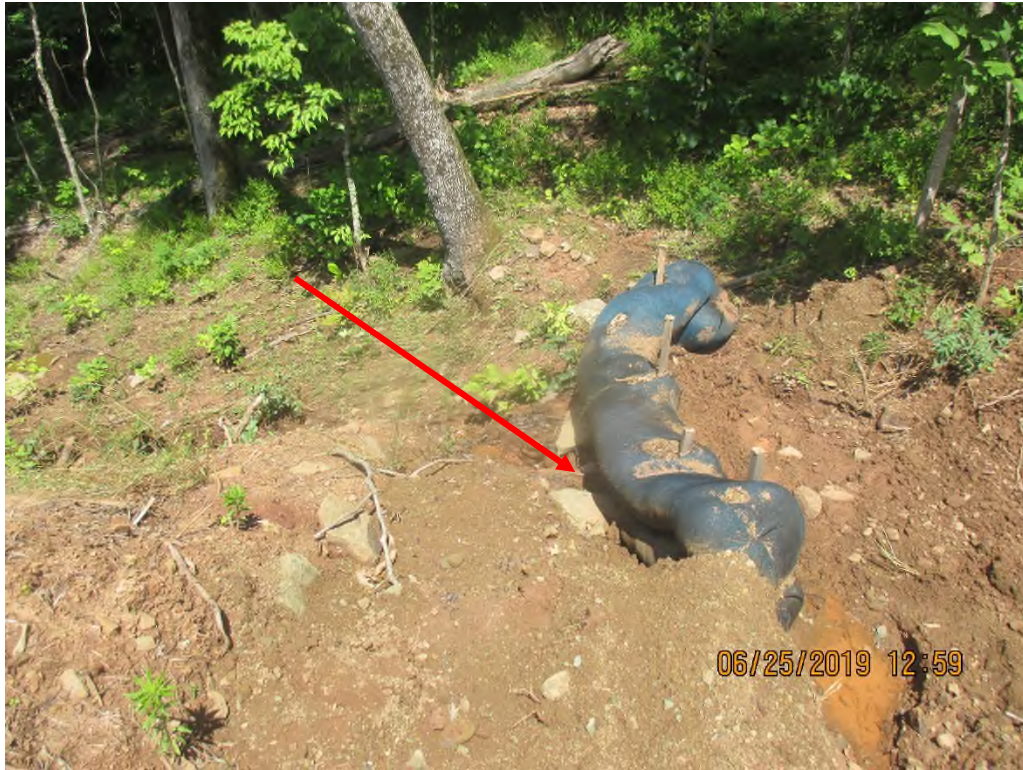
South of Station No. 5396+00. Erosion on slope above Munchausen Road Crossing leading towards waterbar and perimeter controls.

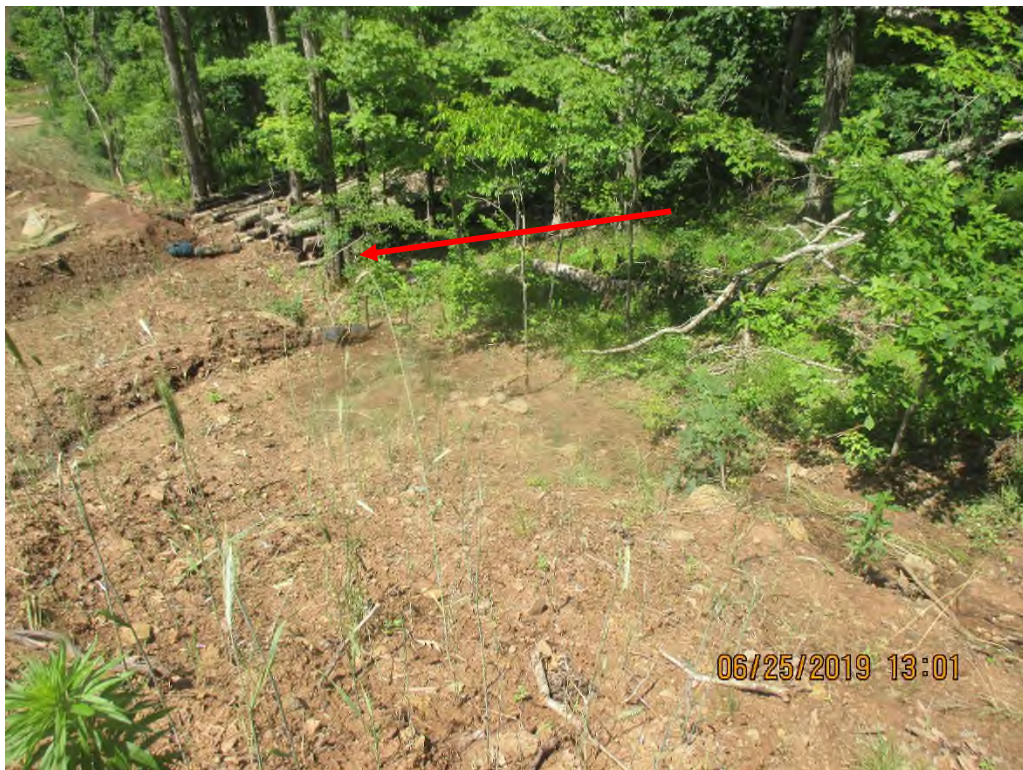
South of Station No. 5396+00. Erosion on slope above Munchausen Road Crossing leading toward waterbar and perimeter controls. Controls in need of maintenance. Arrow depicts where controls are undercut.

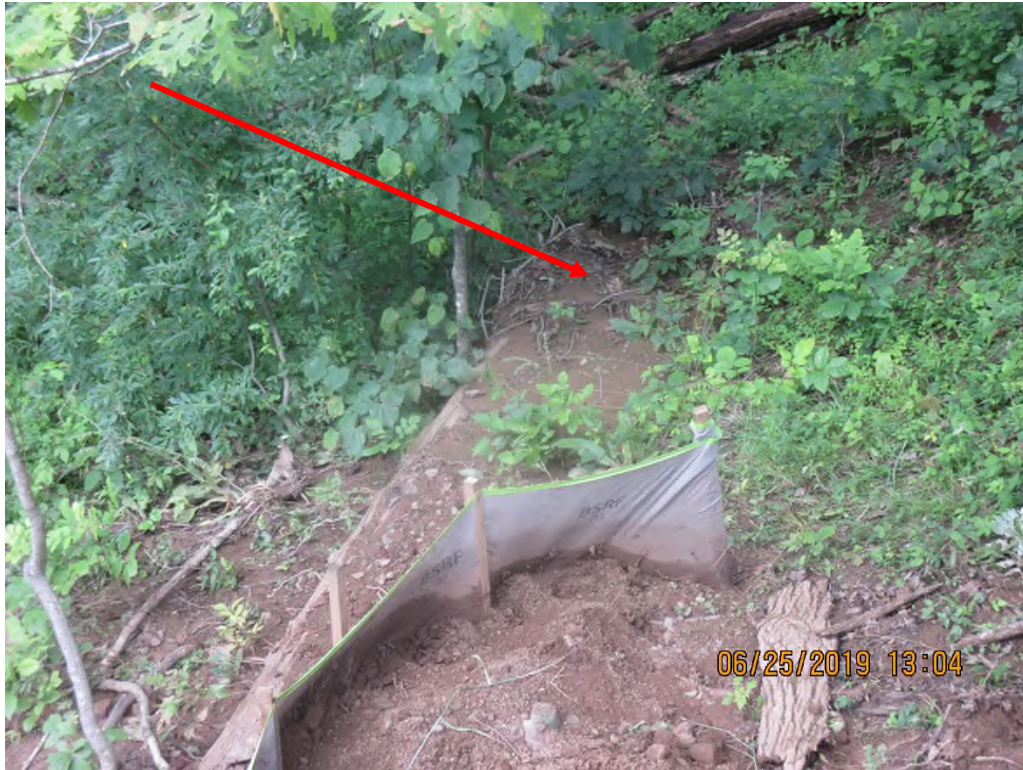
South of Station No. 5396+00. Slope above Munchausen Road Crossing leading toward waterbar and perimeter controls. Sediment being deposited against log piles past LOD.

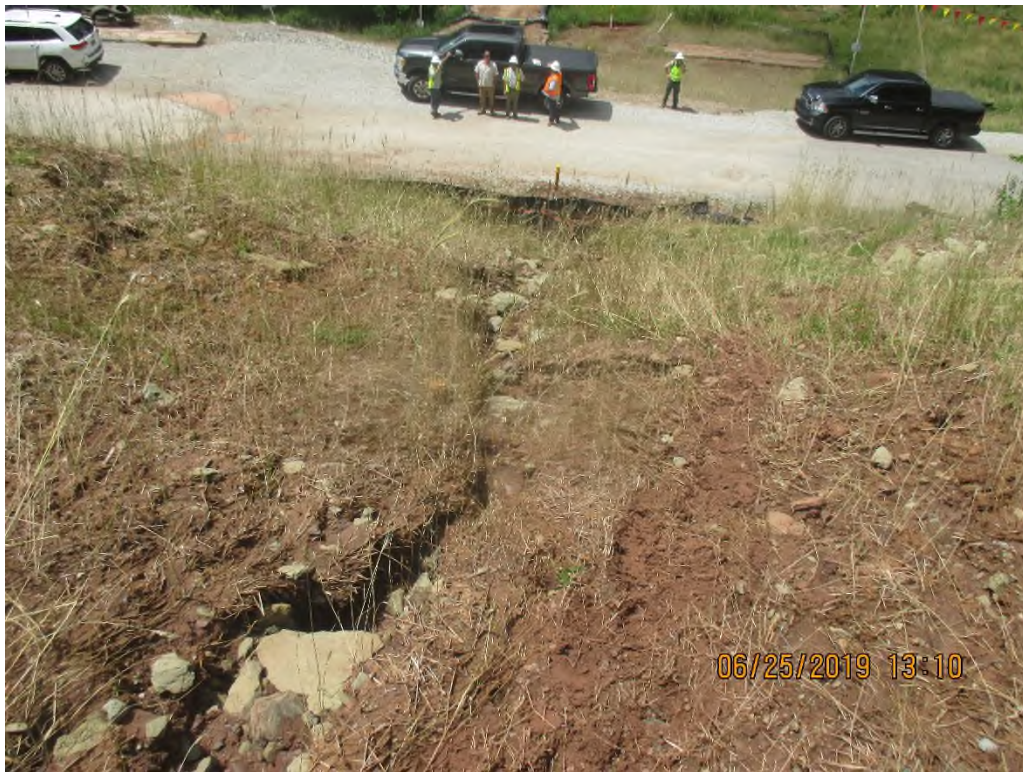
South of Station No. 5396+00. Sediment being deposited past log piles beyond LOD.

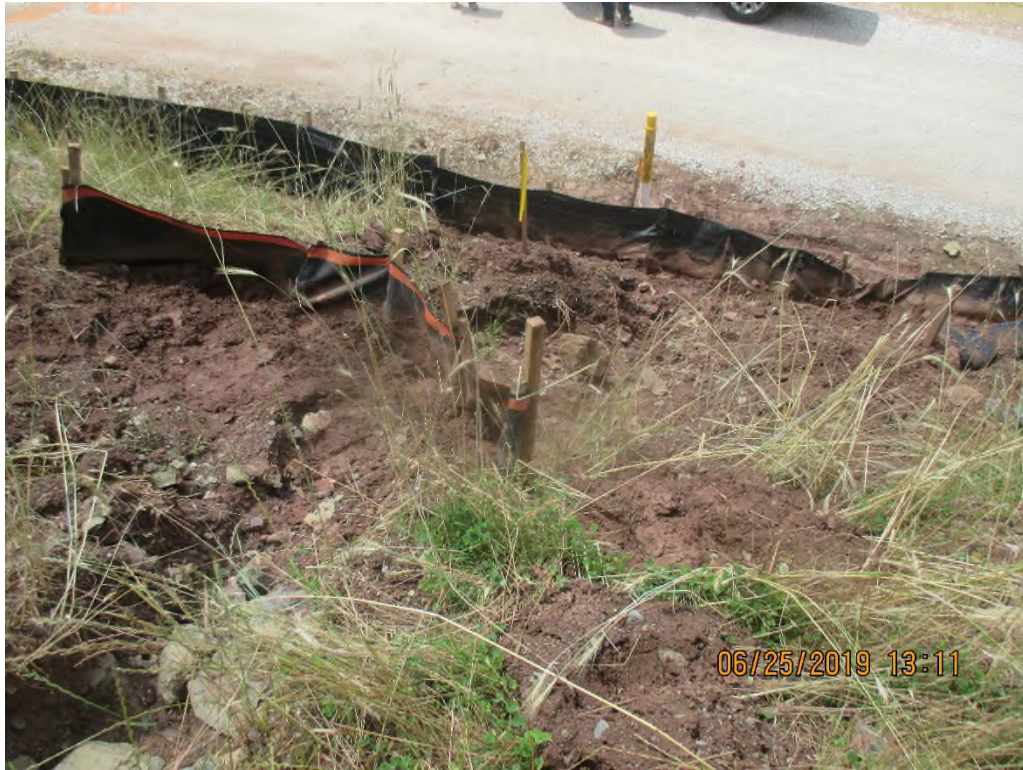
Erosion on slope above Munchausen Road crossing.
