**CONSENT ORDER
ISSUED UNDER THE
WATER POLLUTION CONTROL ACT
WEST VIRGINIA CODE, CHAPTER 22, ARTICLE 11**

TO: Columbia Gas Transmission, LLC
Attn: Troy Tally, Vice President
1700 MacCorkle Ave
Charleston, WV 25314

DATE: October 1, 2020
ORDER NO.: 9061

1. Columbia Gas Transmission, LLC is conducting land disturbance activity associated with construction of the Mountaineer Xpress Project in Marshall, Wetzel, Tyler, Doddridge, Ritchie, Calhoun, Wirt, Roane, Jackson, Mason, Putnam, and Cabell Counties, West Virginia. On January 31, 2018, Columbia Gas Transmission, LLC was issued Water Pollution Control Permit No. WV0116815, Registration No. WVR310872, for Stormwater Associated With Oil and Gas Related Construction Activities.

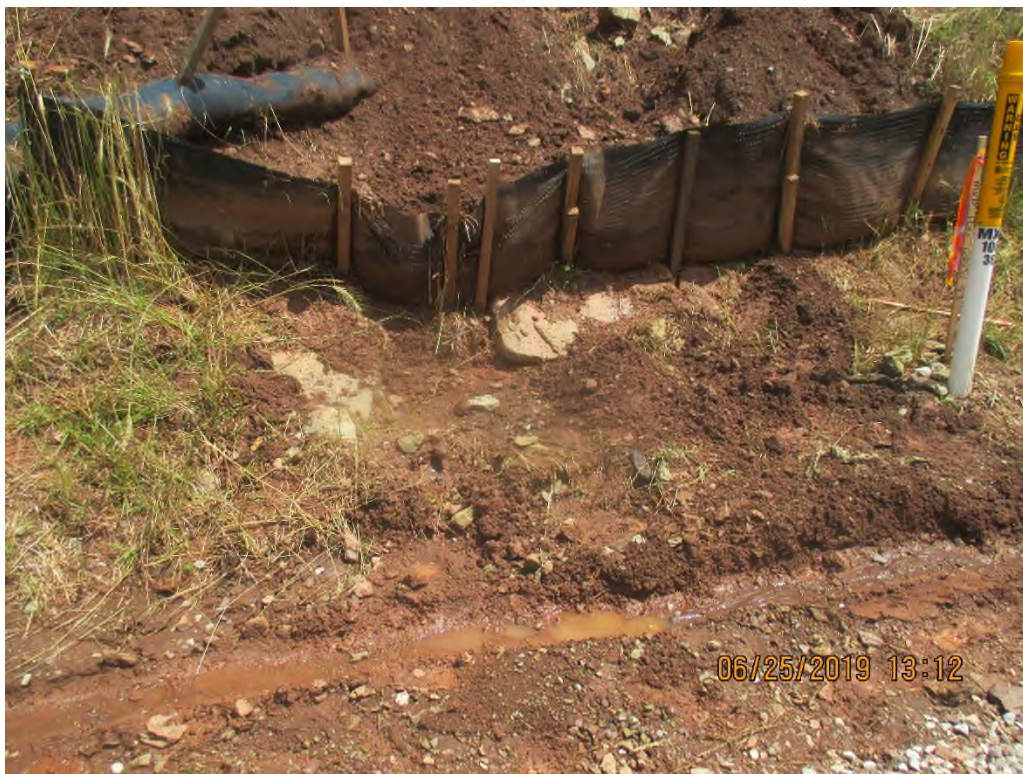
Erosion above and between controls above the Munchausen Road crossing.

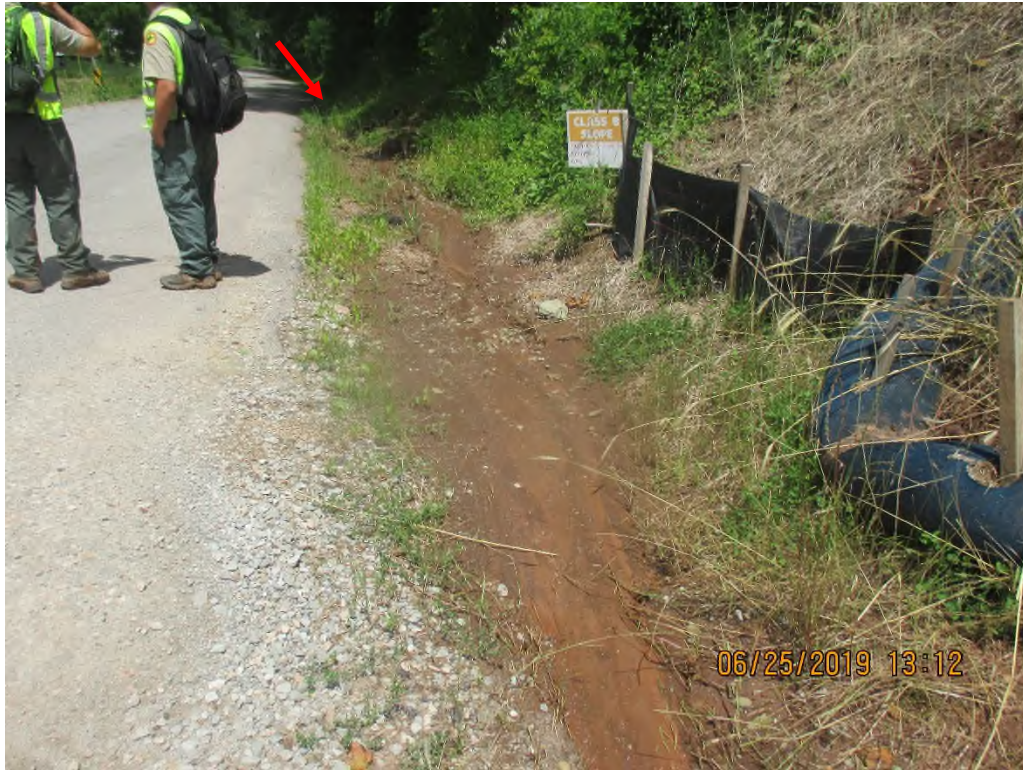
Facing upslope at controls above ditch line that parallels Munchhausen road. Sediment laden water and deposits present in ditch.

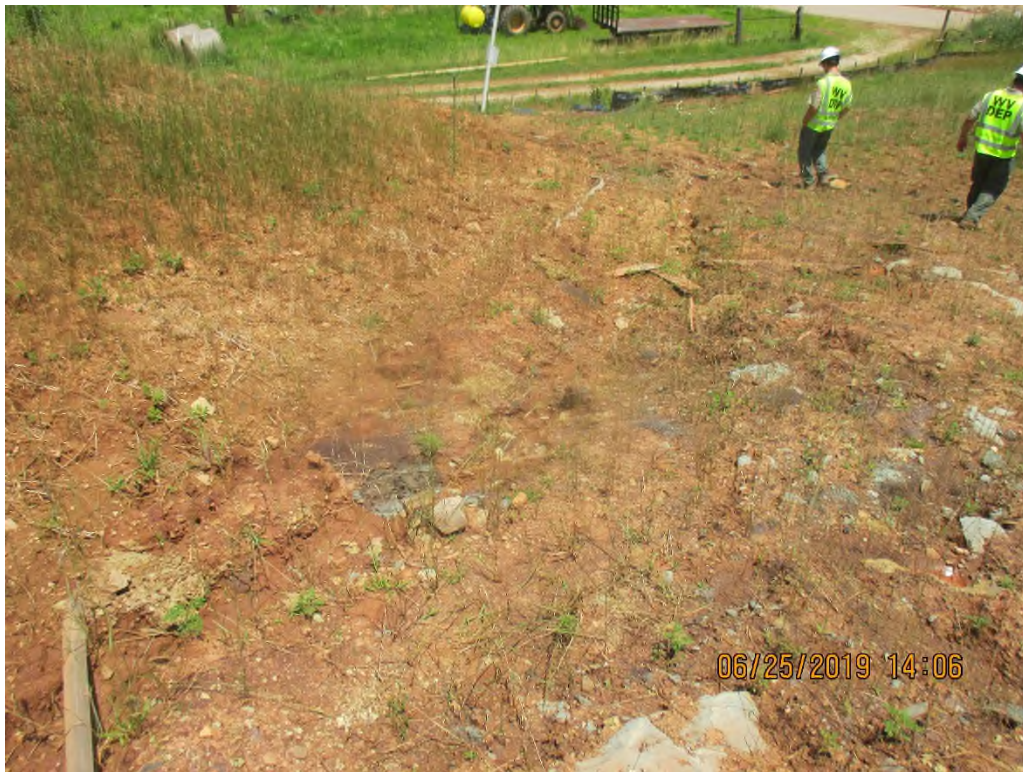
Across from Munchausen road crossing adjacent slope. Pipe trench drain terminating onto unprotected slope.

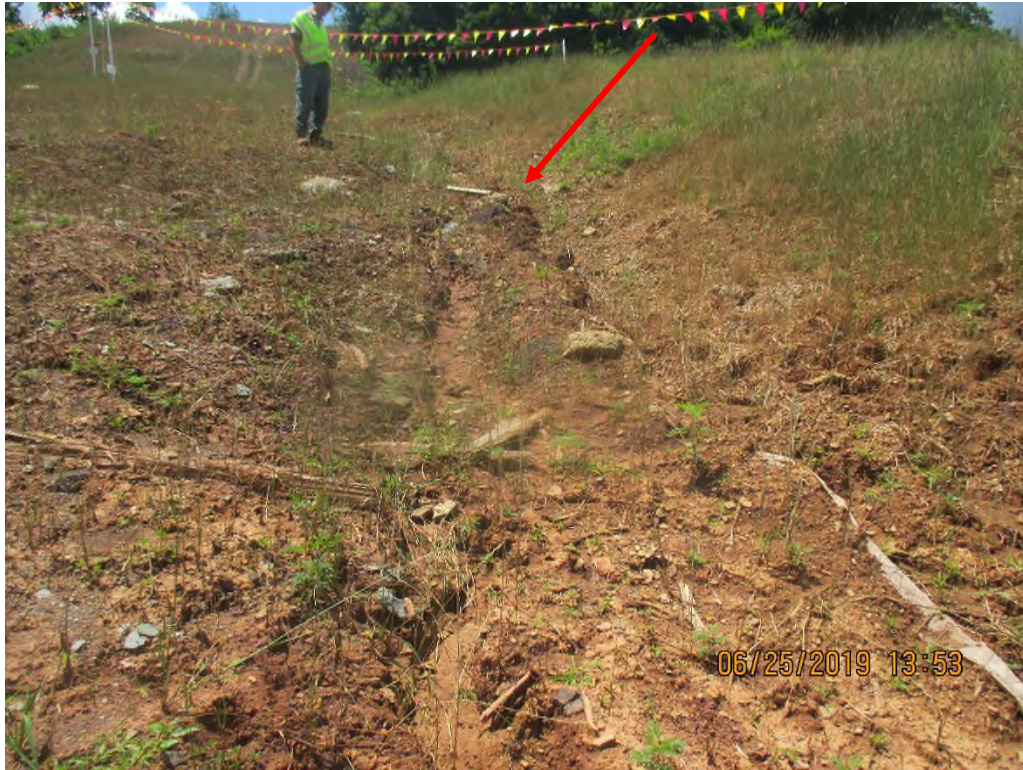
Middle Fork Road Crossing at station No. 5643+50 above stream SRUA 005 facing downslope. Waterbars eroded out where they were tied into topsoil pile.

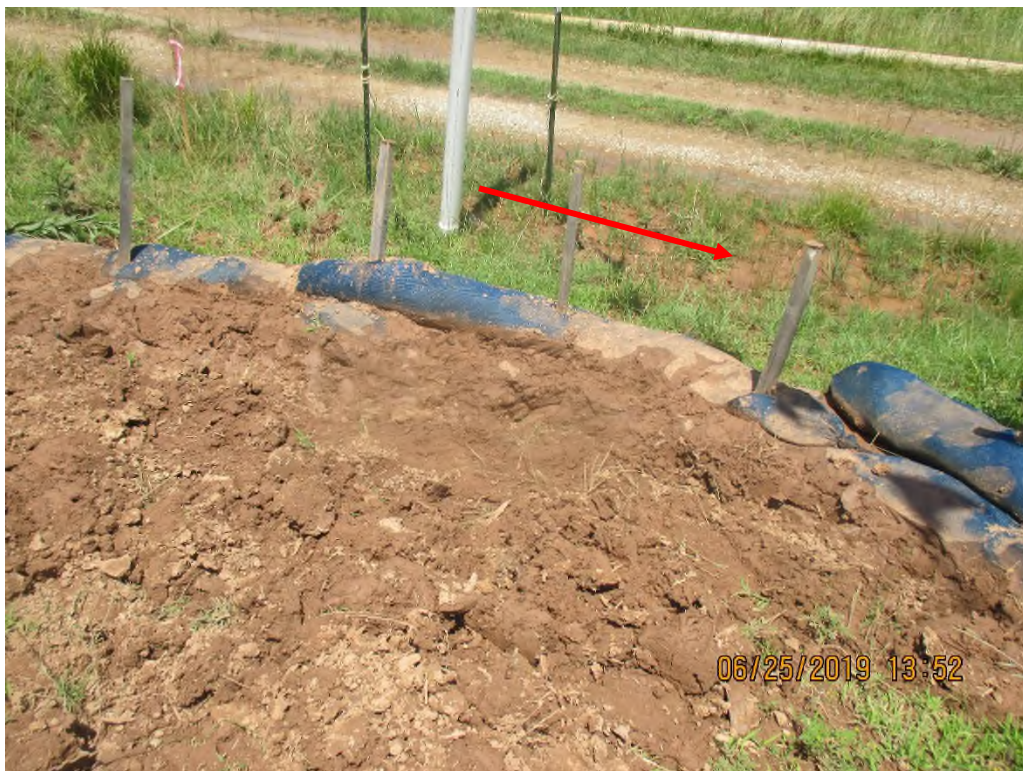
Middle Fork Road Crossing at station No. 5643+50 above stream SRUA 005. Waterbars eroded out where they were tied into topsoil pile.

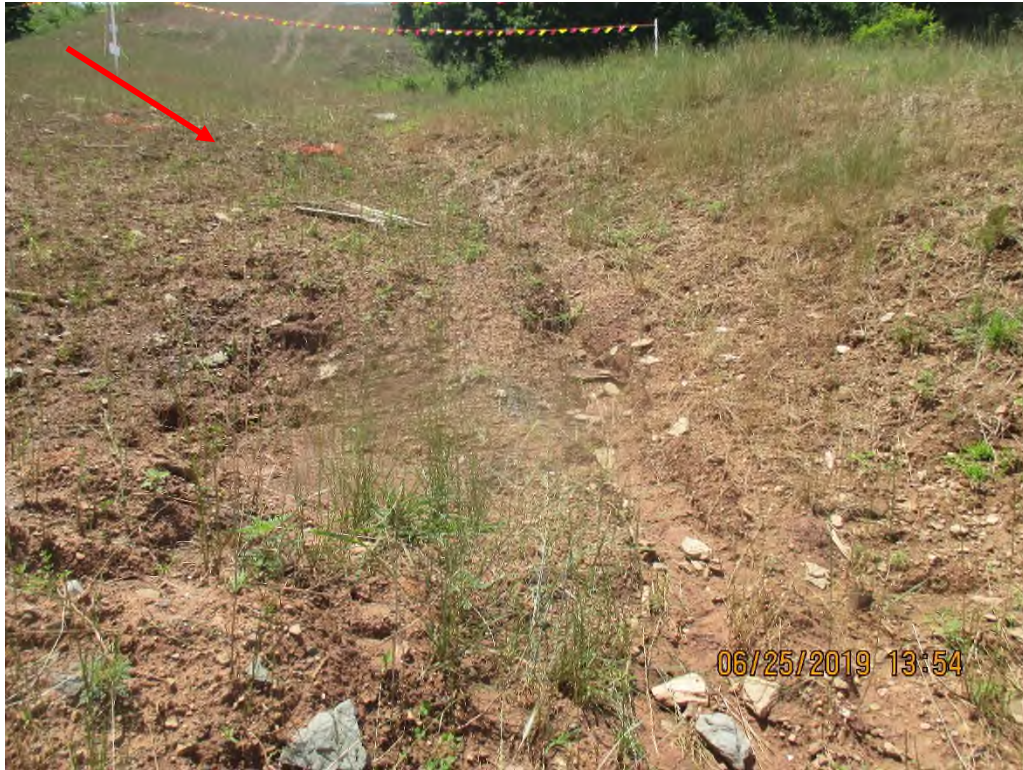
Middle Fork Road Crossing at station No. 5643+50 above stream SRUA 005 facing perimeter controls downslope of where Waterbars were eroded. Controls not maintained, with sediment deposits past LOD.

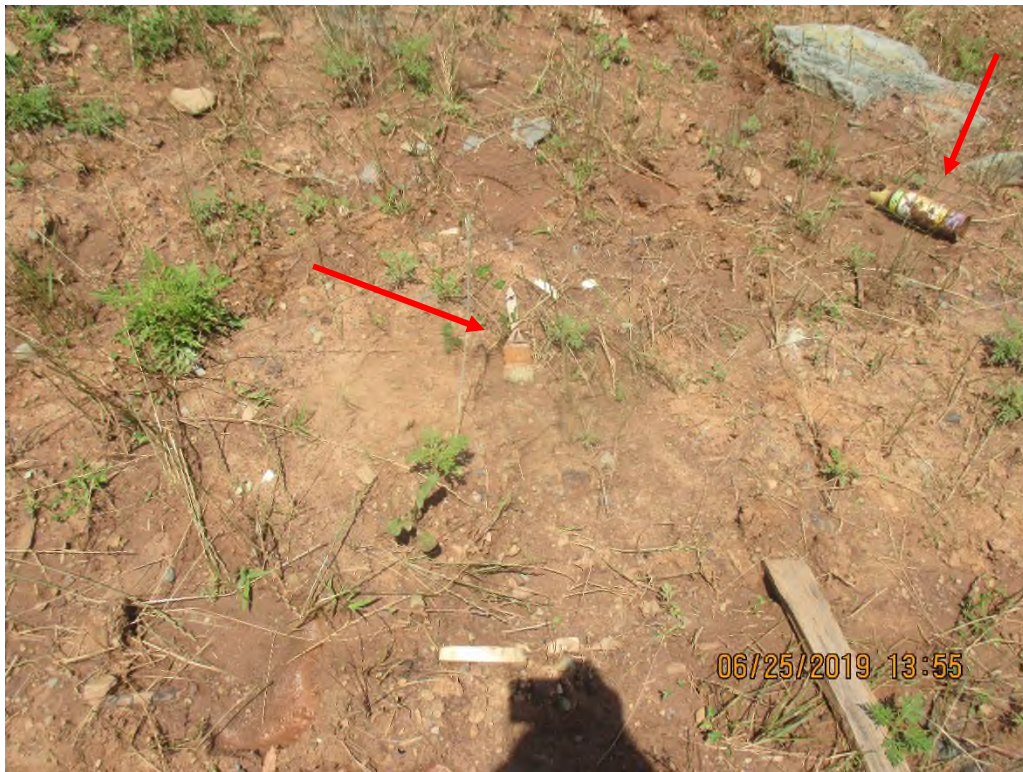
Middle Fork Road Crossing at station No. 5643+50 above stream SRUA 005 facing upslope at solid waste.

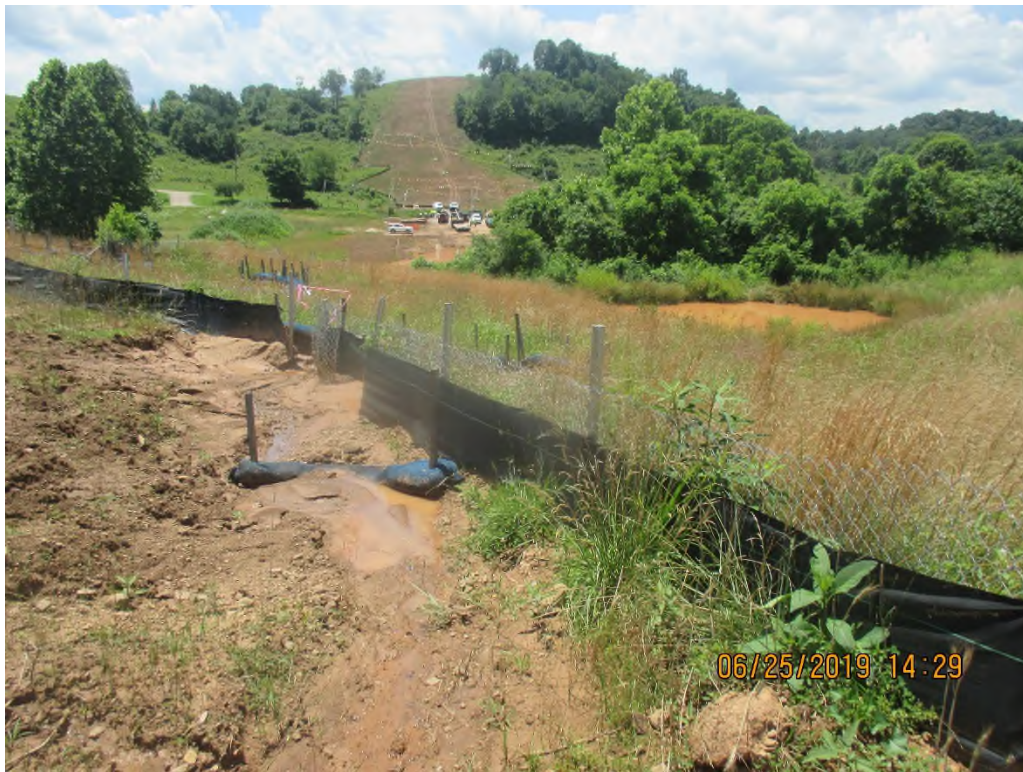
Waterbar terminating into perimeter controls at station No. 5638+46. Erosion present on slope above controls.

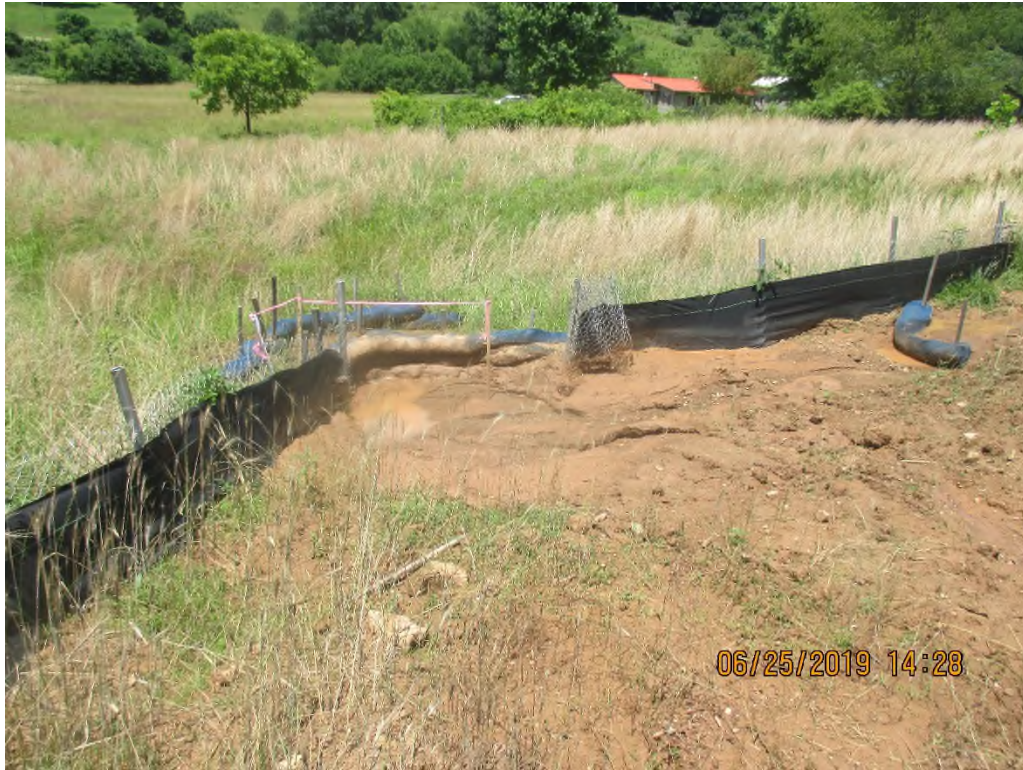
Facing South towards Stream SROC 029 at station No. 5638+46 below waterbar with erosion present on slope.

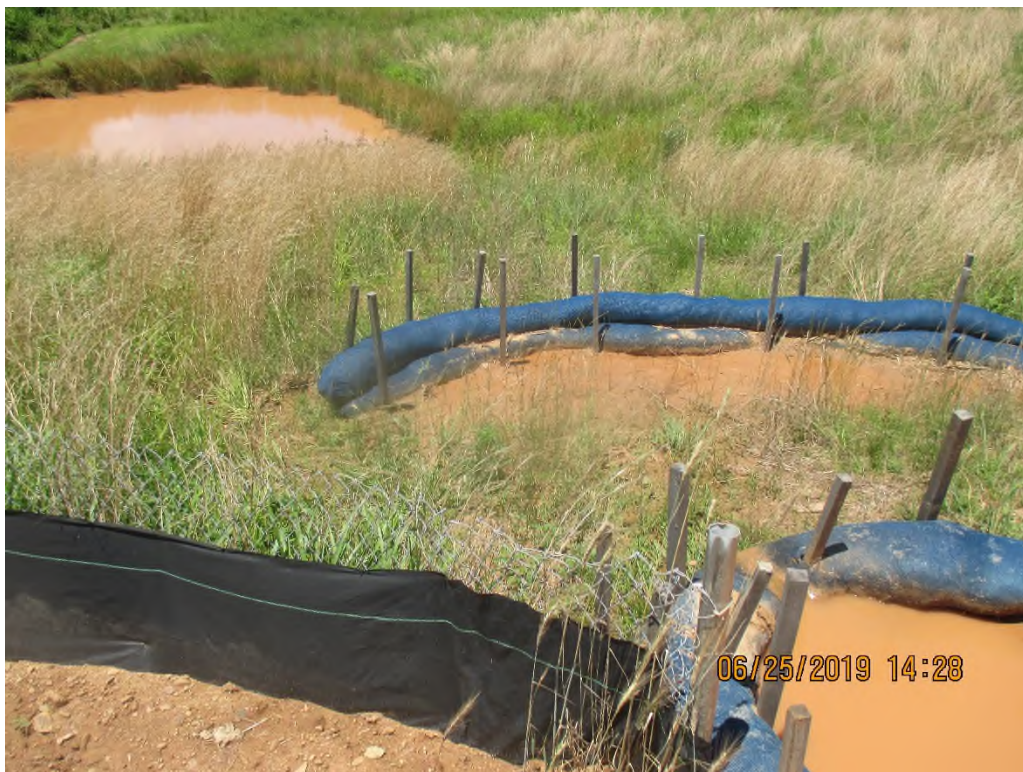
Perimeter controls at station No. 5638+46.

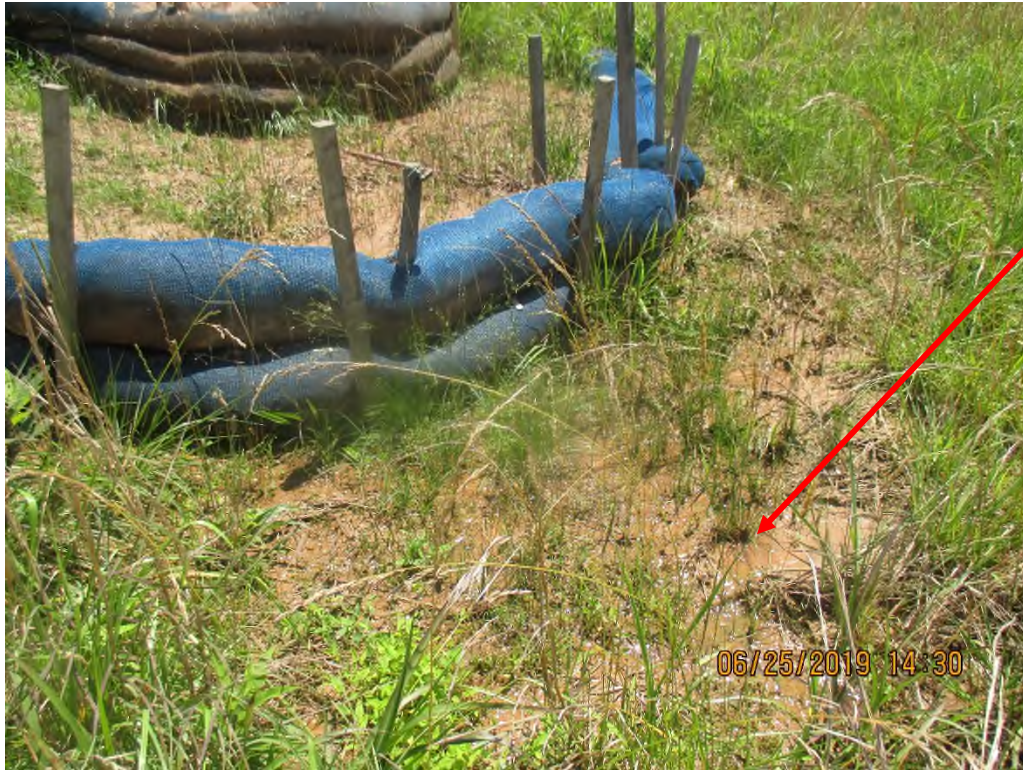
Perimeter controls at station No. 5638+46. Impacted pond downslope of controls.

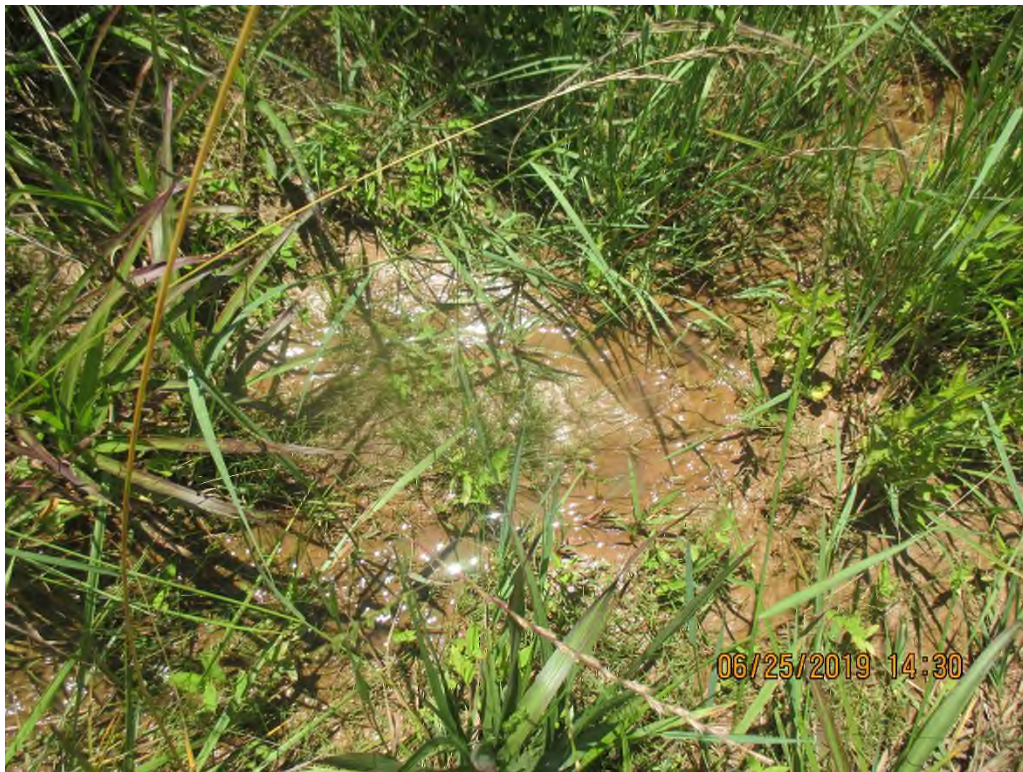
Sediment deposits past controls and LOD at station No. 5638+46. Deposits present above impacted pond.

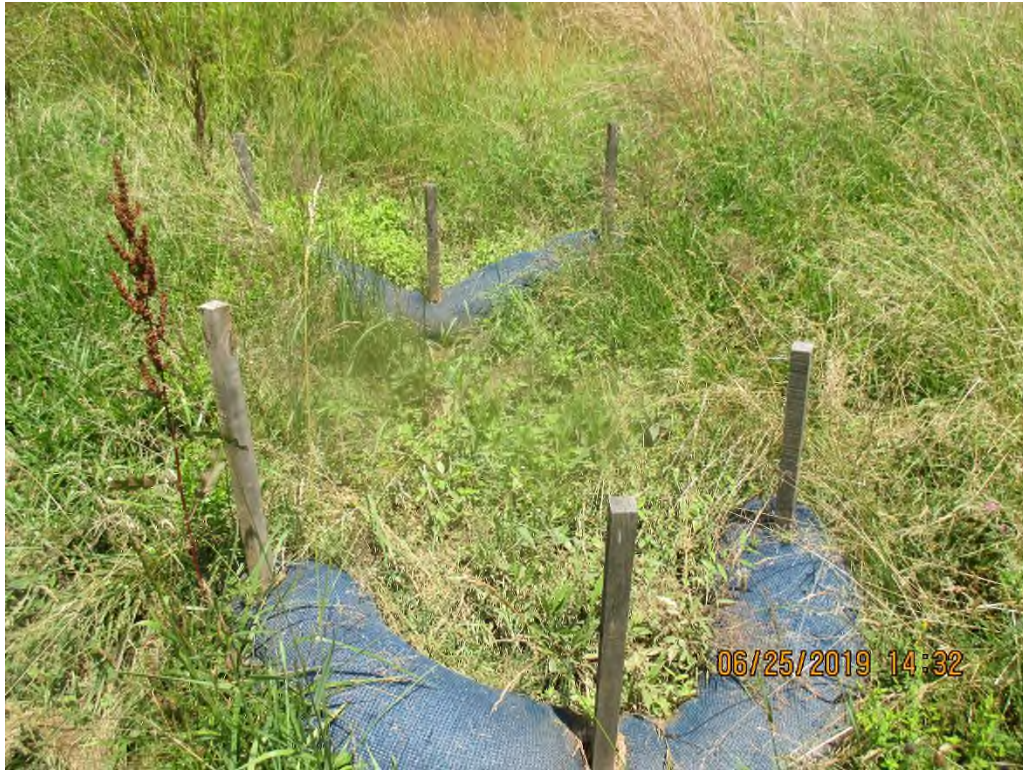
Sediment laden water and deposits being transported towards impacted pond at station No. 5638+46.

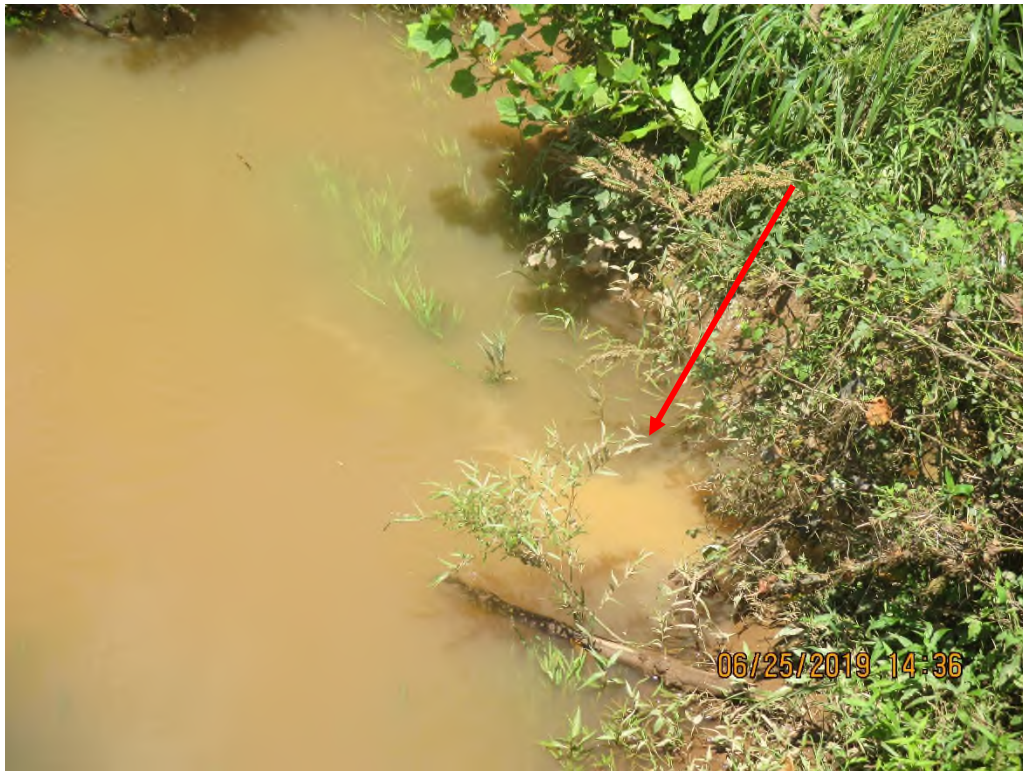
Stream SROC 029 crossing facing North near station No. 5638+47. Arrow depicts distinct sediment plume observed on day of inspection.

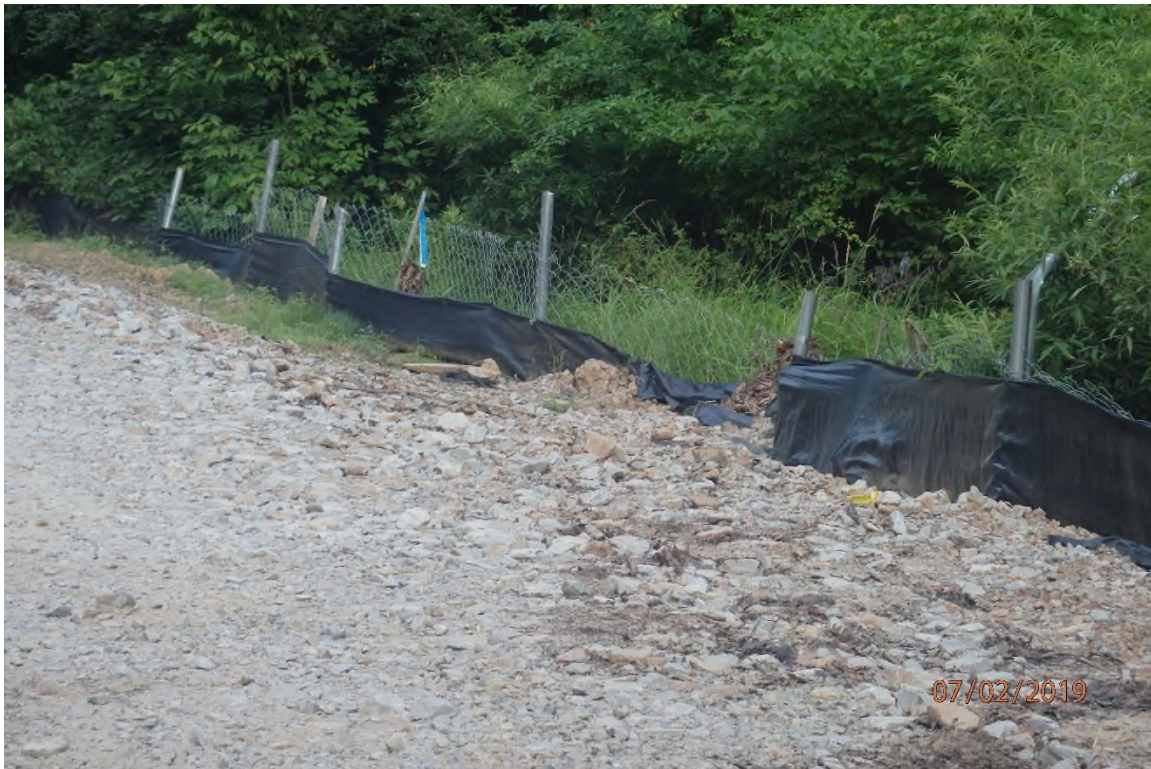
Controls overwhelmed with sediment at bridge crossing (North side) of Stream SROC 029 near station No. 5638+46.

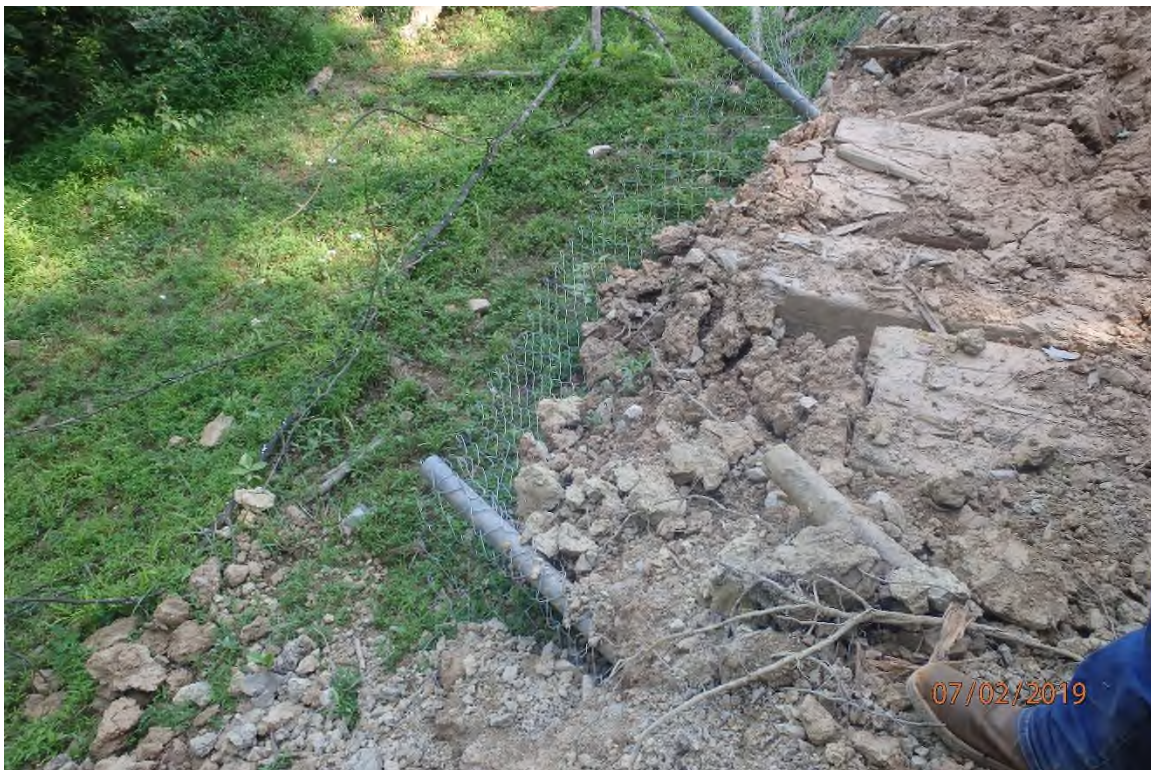
Perimeter control in need of maintenance at ARDO016.

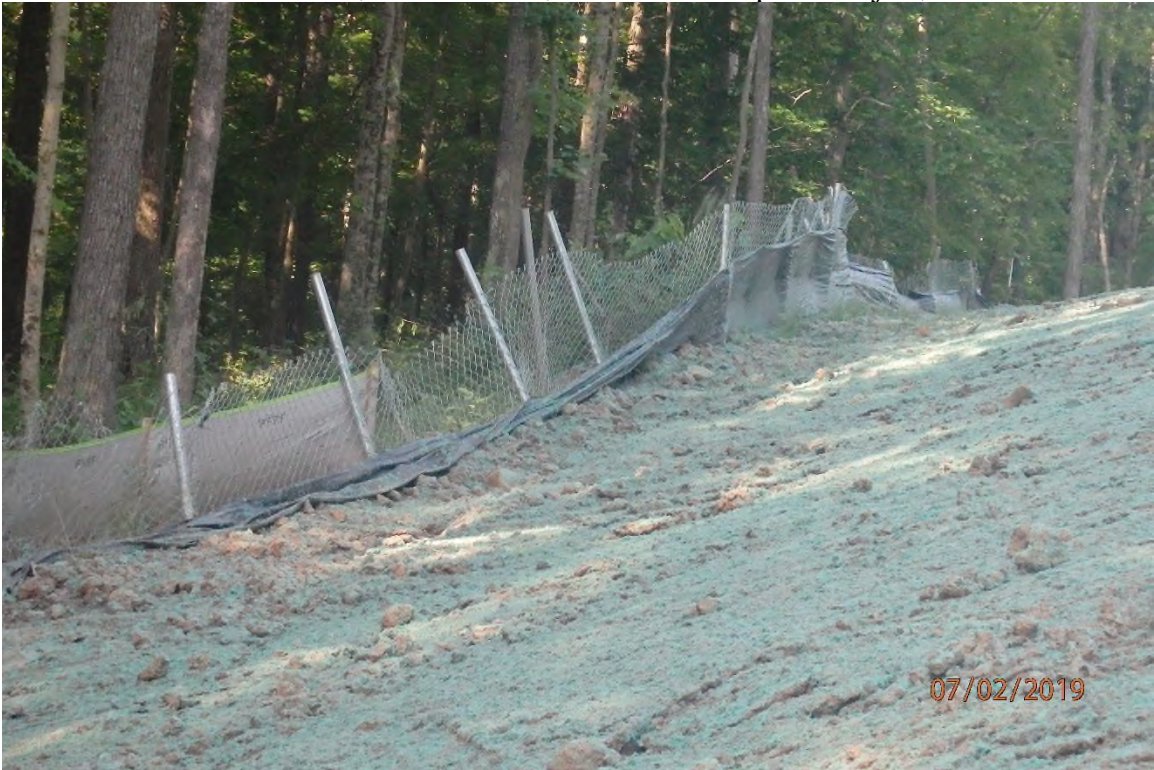
Perimeter control in need of maintenance at ARDO015.12.

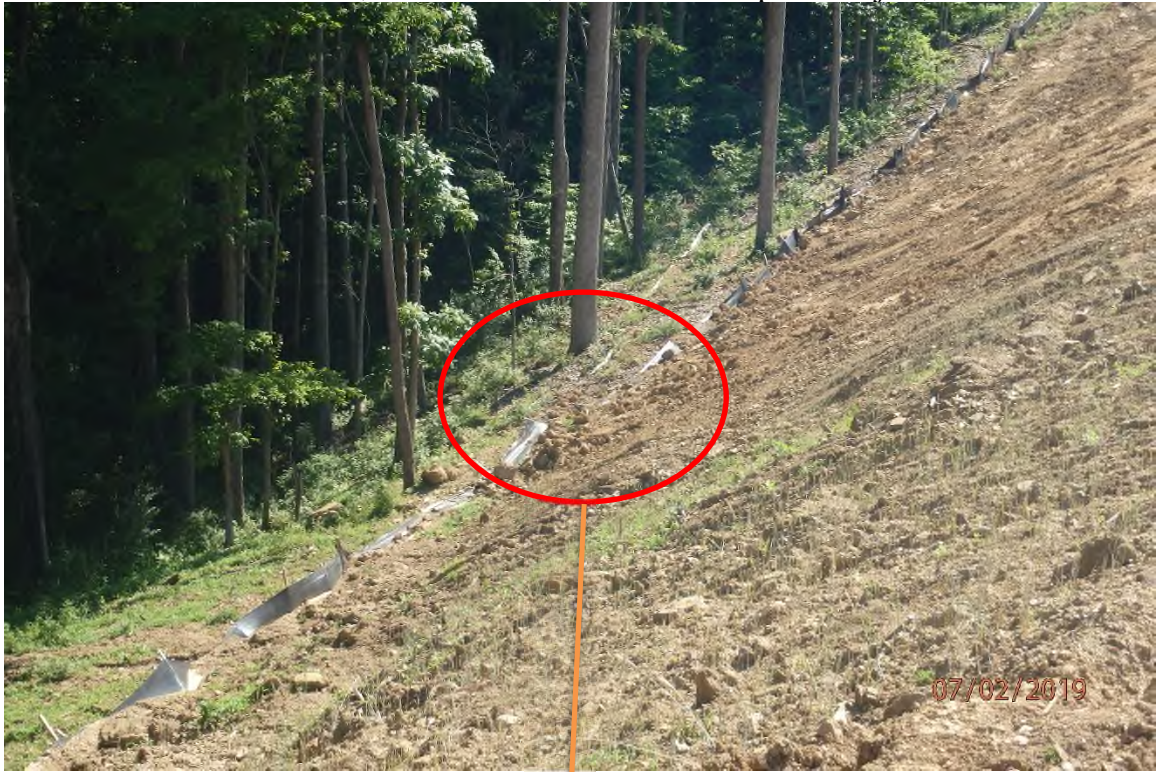
Perimeter control in need of maintenance in the Sugar Run watershed.

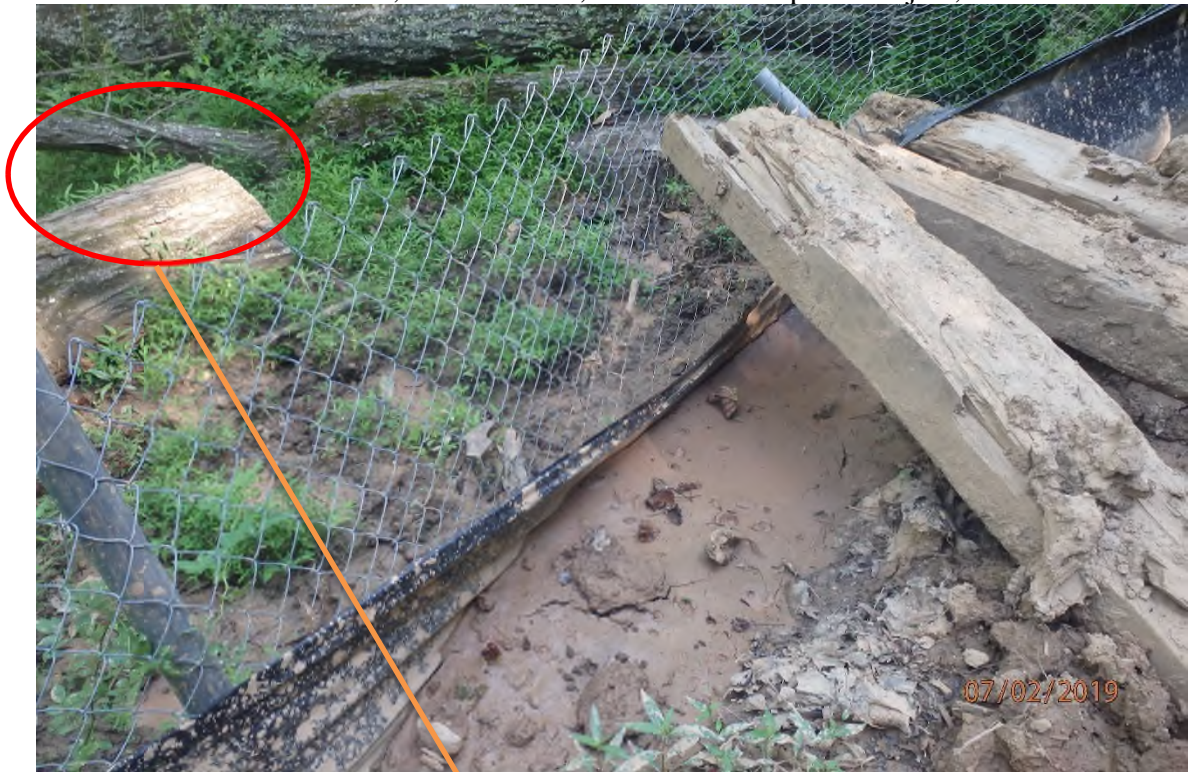
Perimeter control in need of maintenance in the Taylor Drain watershed.

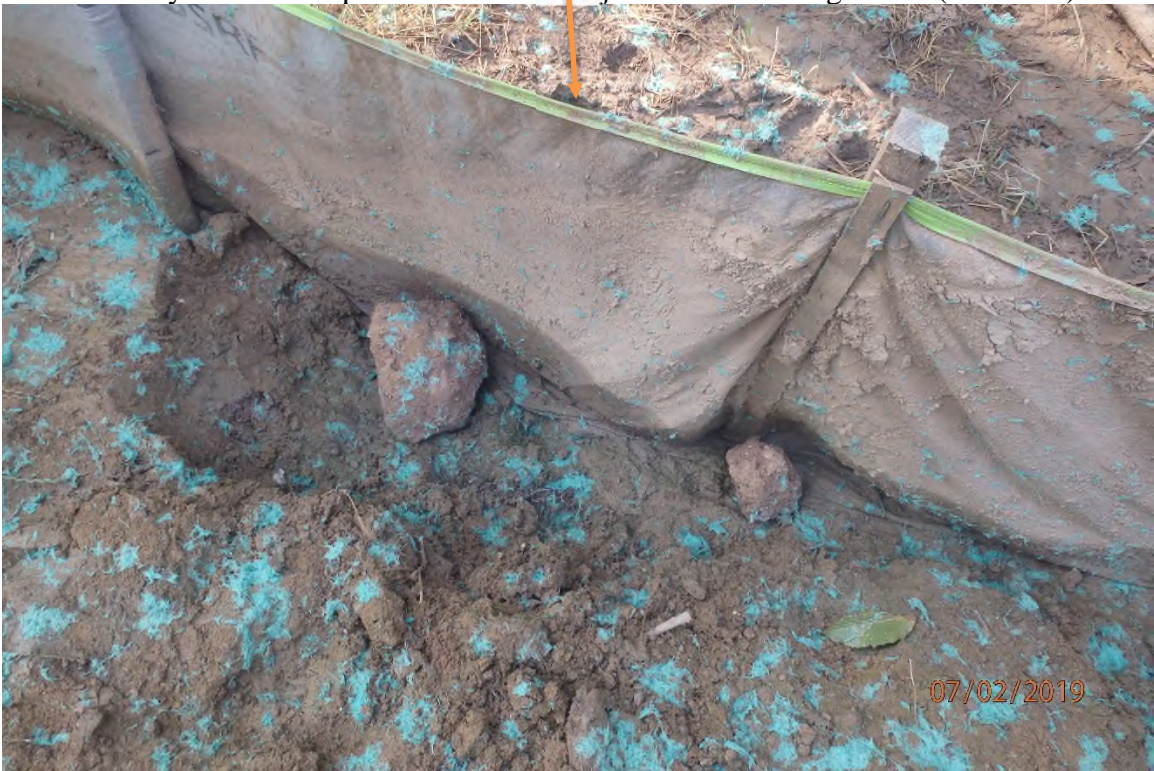
Additional maintenance needed to the above pictured BMP. Dirt clods placed on the silt fence flap and not repaired properly.

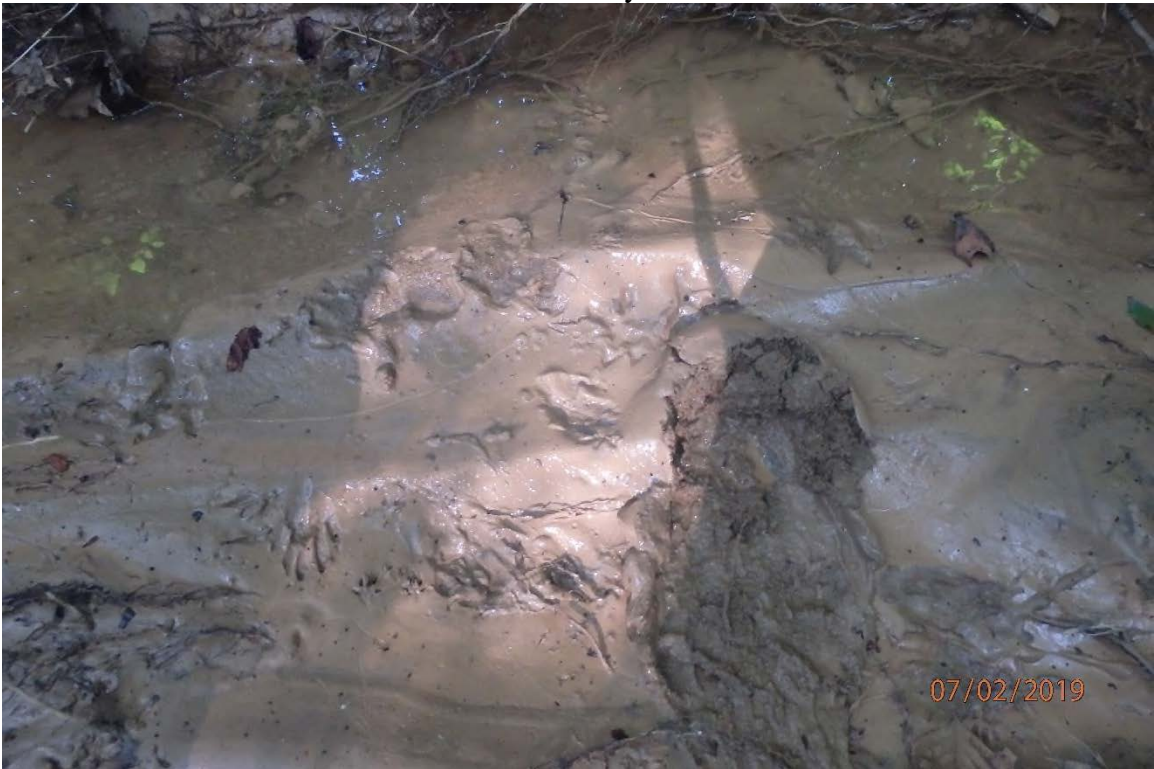
Offsite CNA deposits in UNT Sugar Run (SDOH11) (39° 11.151' X 80° 50.816') as a result of the previously pictured deficiency.

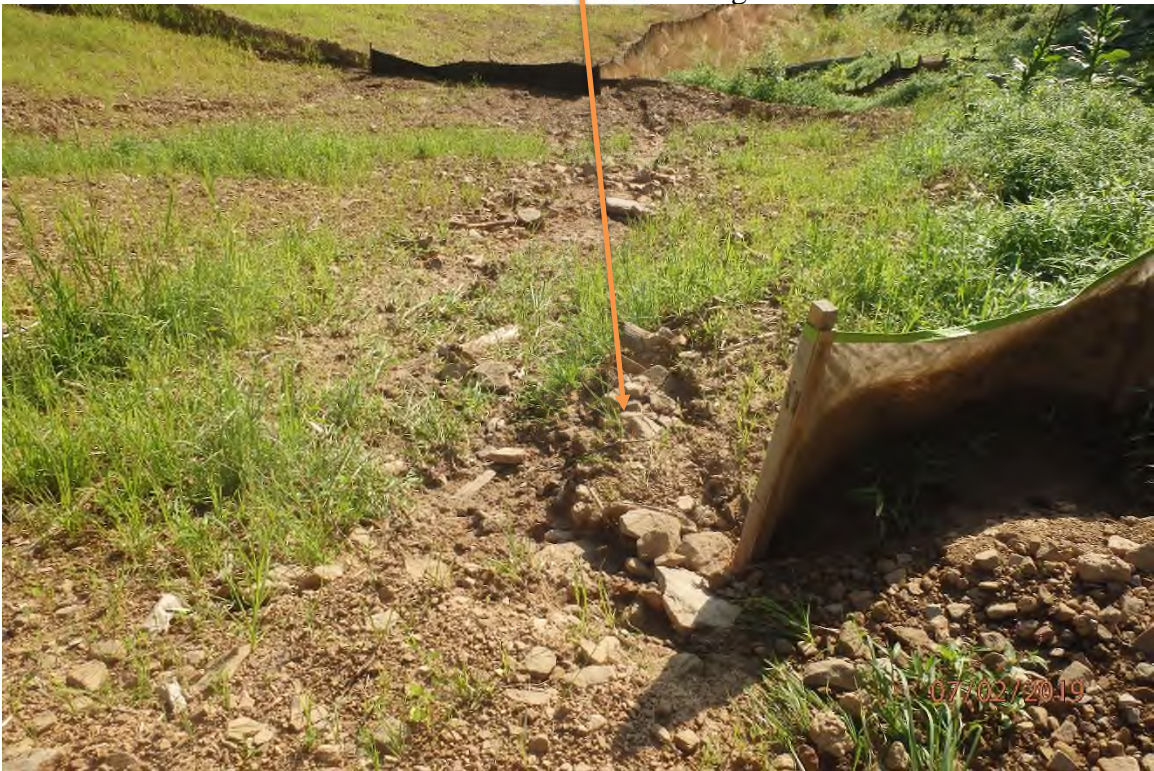
Associated fill slope erosion.

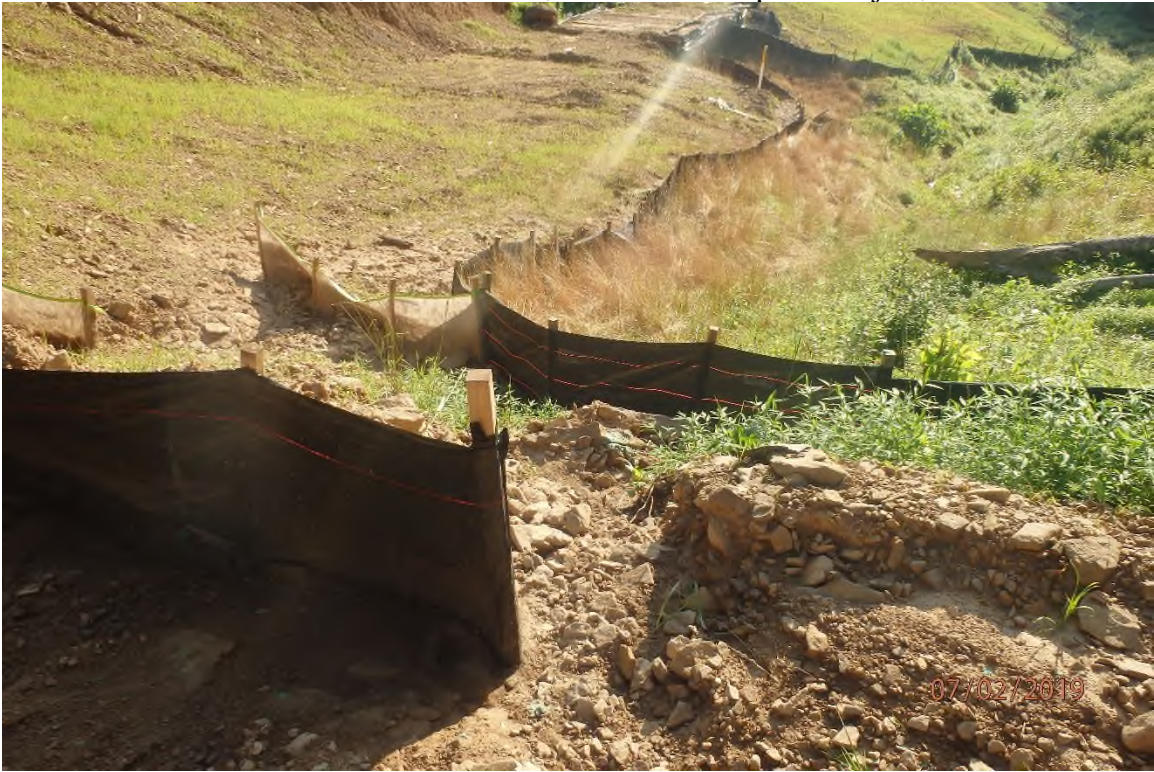
Fill slope erosion downslope of the previously pictured unmaintained water bar.

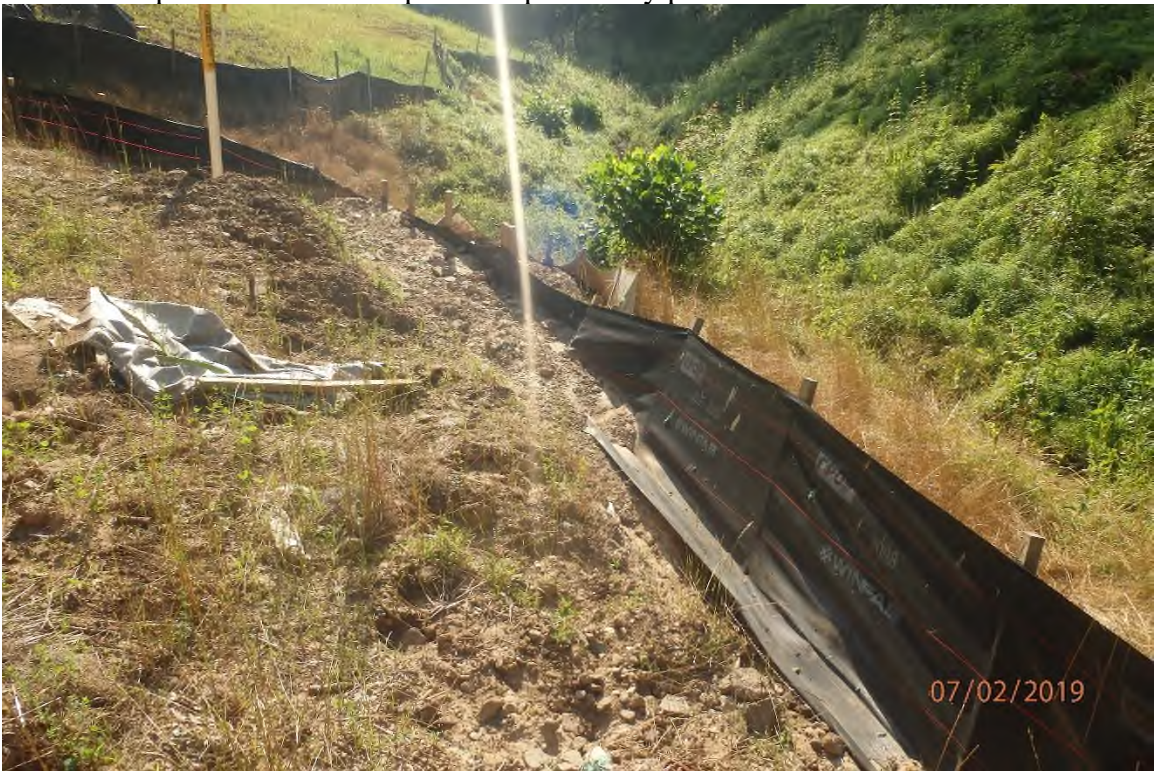
Installed perimeter control downslope of the above pictured fill slope erosion that has been overwhelmed and is placing sediment into ephemeral UNT Sugar Run (onsite stream pictured).

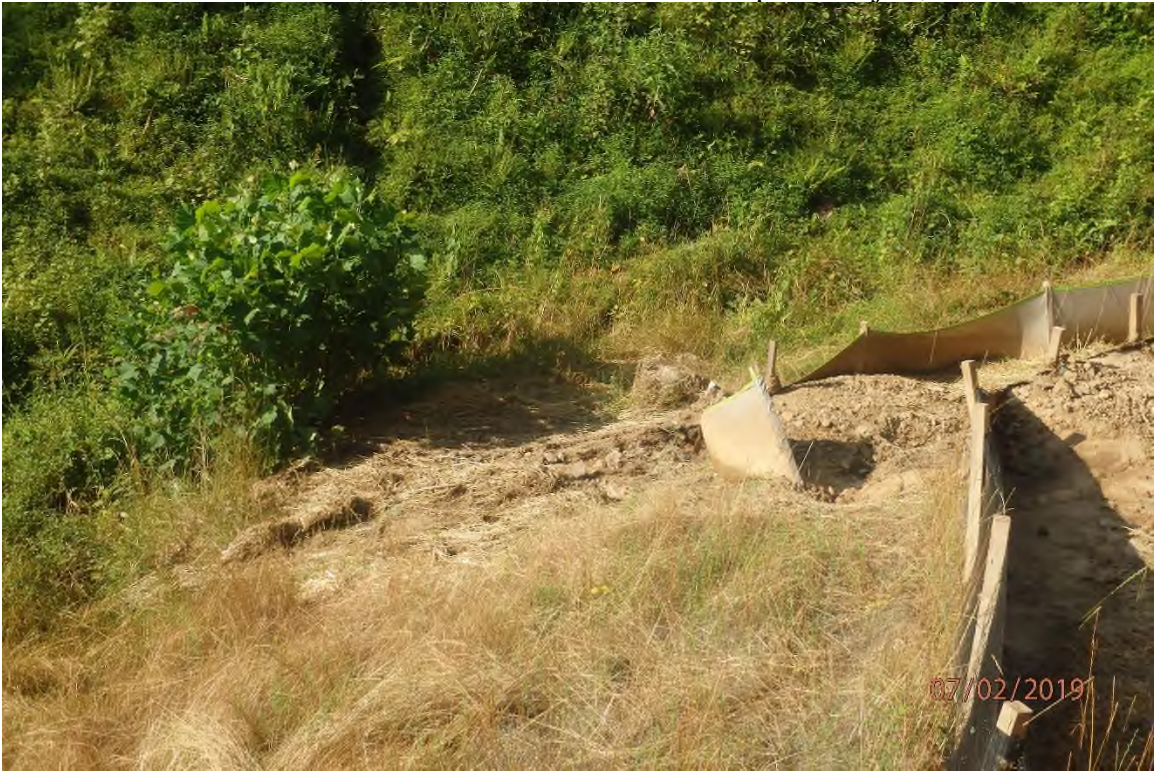
Unmaintained perimeter control in the Sugar Run watershed that is placing sediment into onsite ephemeral UNT Sugar Run.

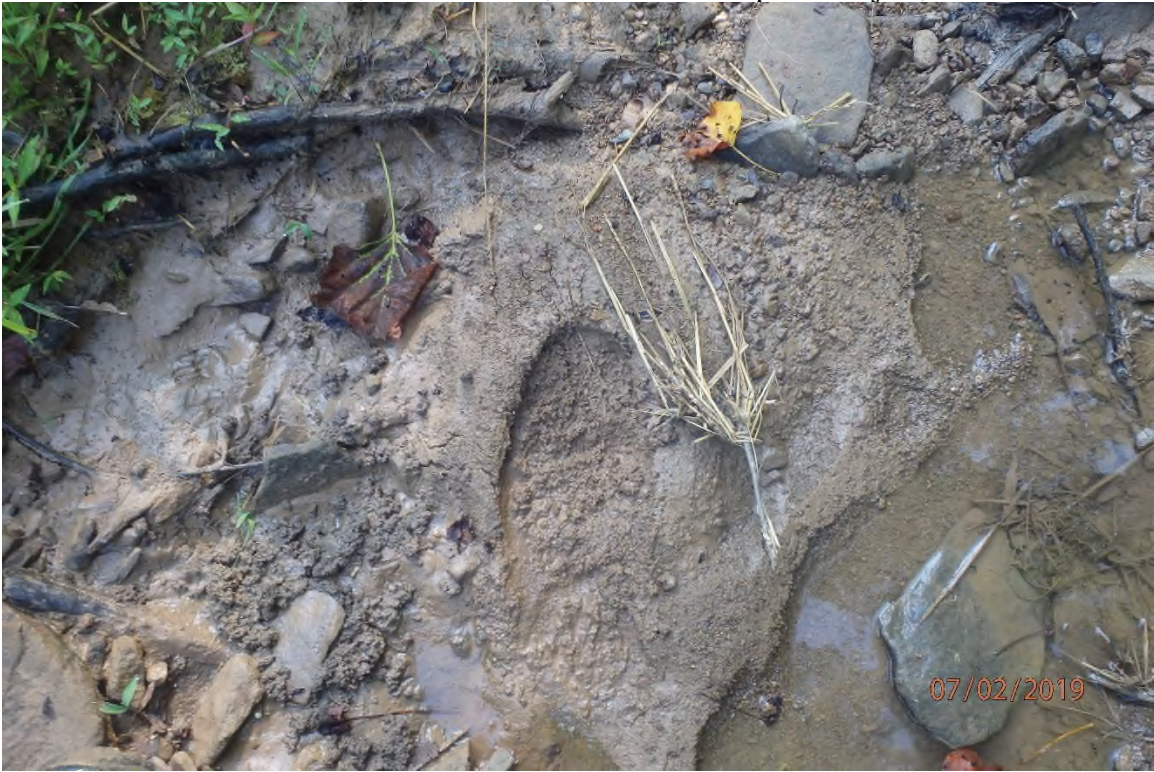
Offsite CNA deposits in UNT Sugar Run (39° 11.075' X 80° 51.108') as a result of the three previously pictured unmaintained perimeter controls.
