**CONSENT ORDER
ISSUED UNDER THE
WATER POLLUTION CONTROL ACT
WEST VIRGINIA CODE, CHAPTER 22, ARTICLE 11**

TO: Columbia Gas Transmission, LLC
Attn: Troy Tally, Vice President
1700 MacCorkle Ave
Charleston, WV 25314

DATE: October 1, 2020
ORDER NO.: 9061

1. Columbia Gas Transmission, LLC is conducting land disturbance activity associated with construction of the Mountaineer Xpress Project in Marshall, Wetzel, Tyler, Doddridge, Ritchie, Calhoun, Wirt, Roane, Jackson, Mason, Putnam, and Cabell Counties, West Virginia. On January 31, 2018, Columbia Gas Transmission, LLC was issued Water Pollution Control Permit No. WV0116815, Registration No. WVR310872, for Stormwater Associated With Oil and Gas Related Construction Activities.

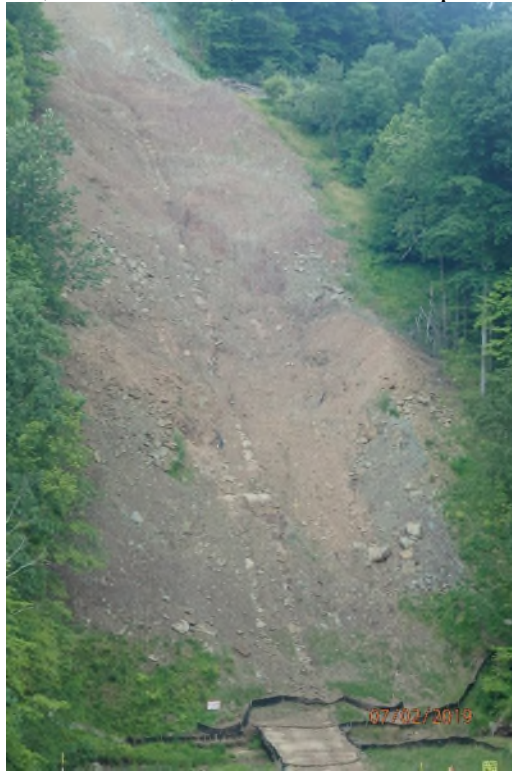
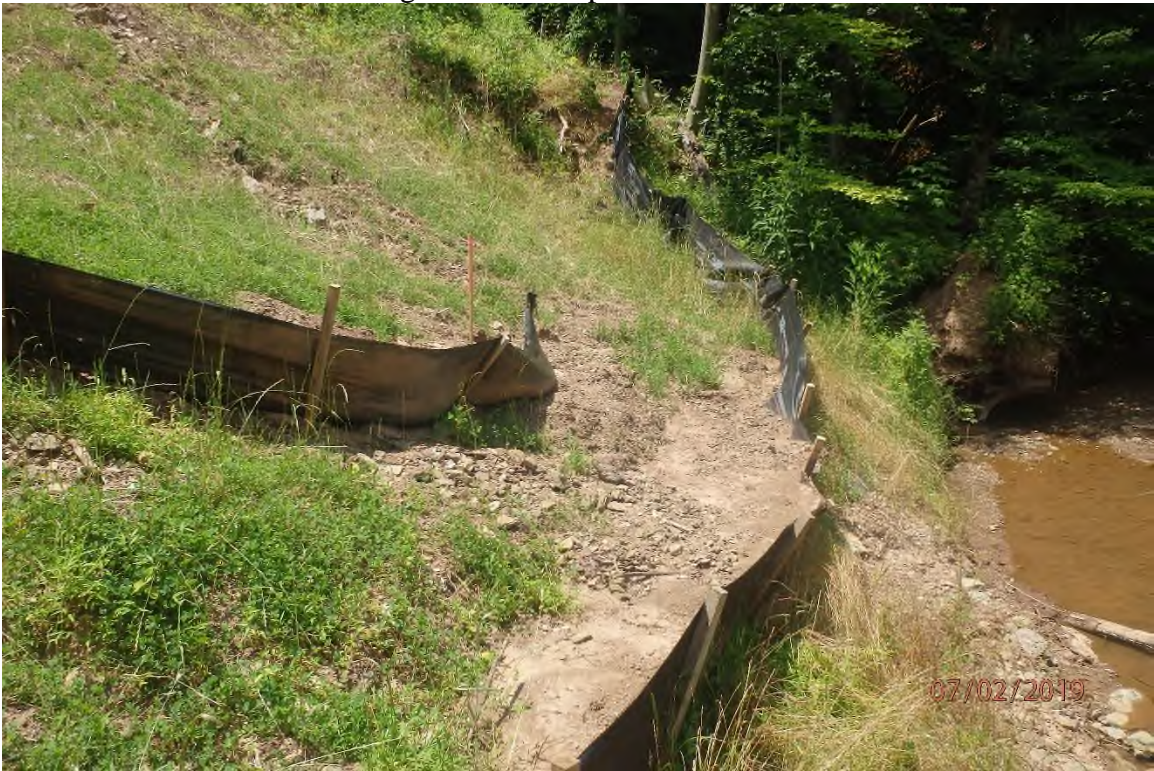
Erosion gullies that run from the top of the slope to the bottom of the slope adjacent to UNT Left Fork of Arnolds Creek (SDOG040) due to poor maintenance of installed water bars. Concentrated flow stormwater is overwhelming the installed perimeter controls at the base of the hill.

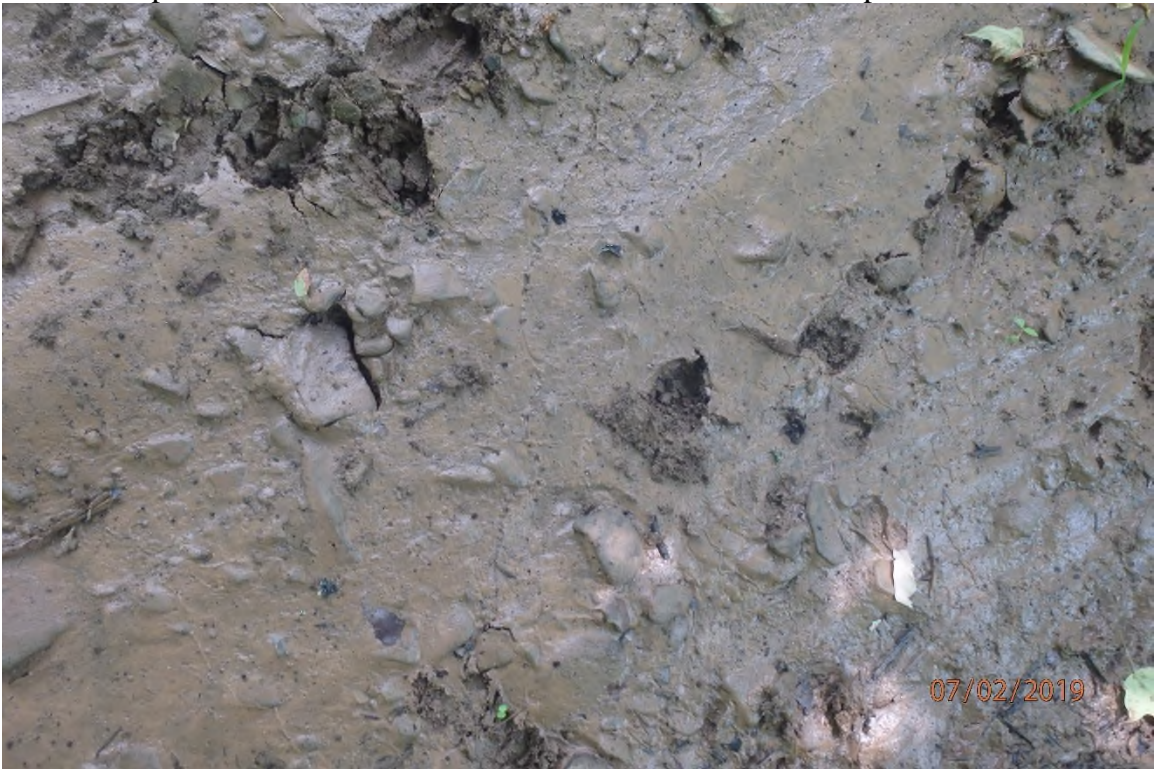
Offsite CNA deposits in UNT Left Fork of Arnolds Creek (SDOG040) as a result of the previously pictured unmaintained water bars and associated fill slope erosion.

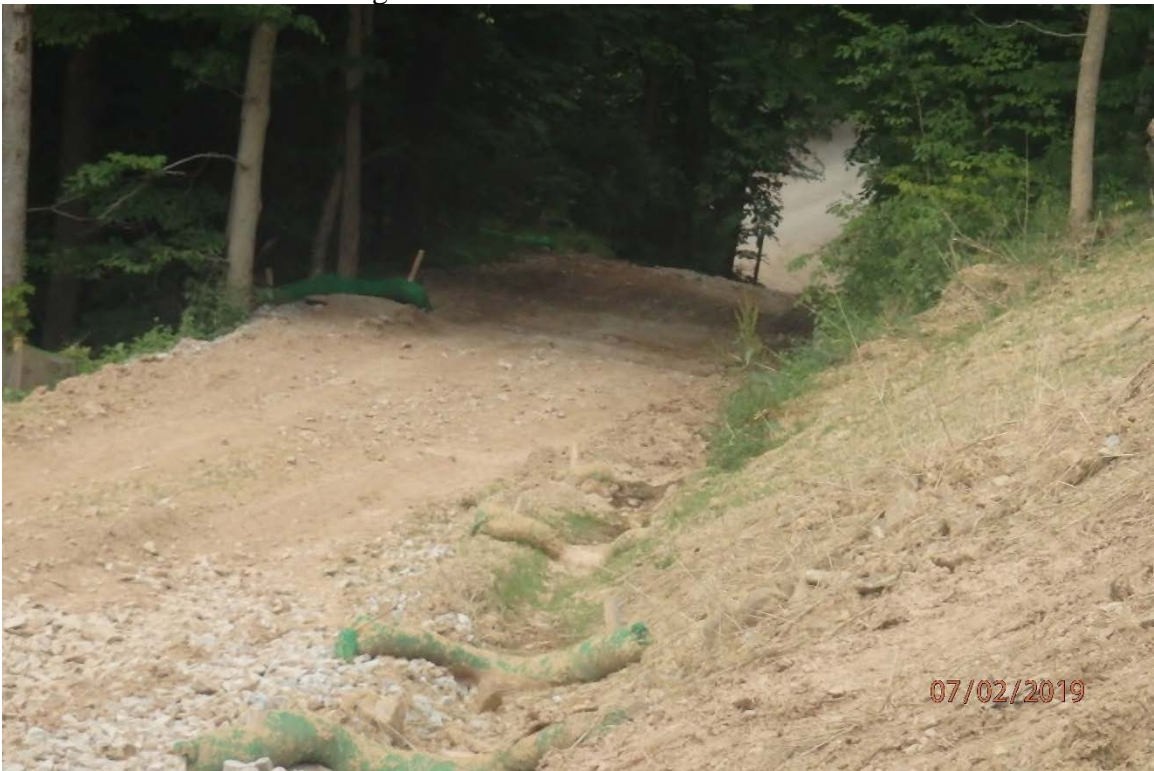
ARDO13.5 showing the need for maintenance to the stabilized surface.

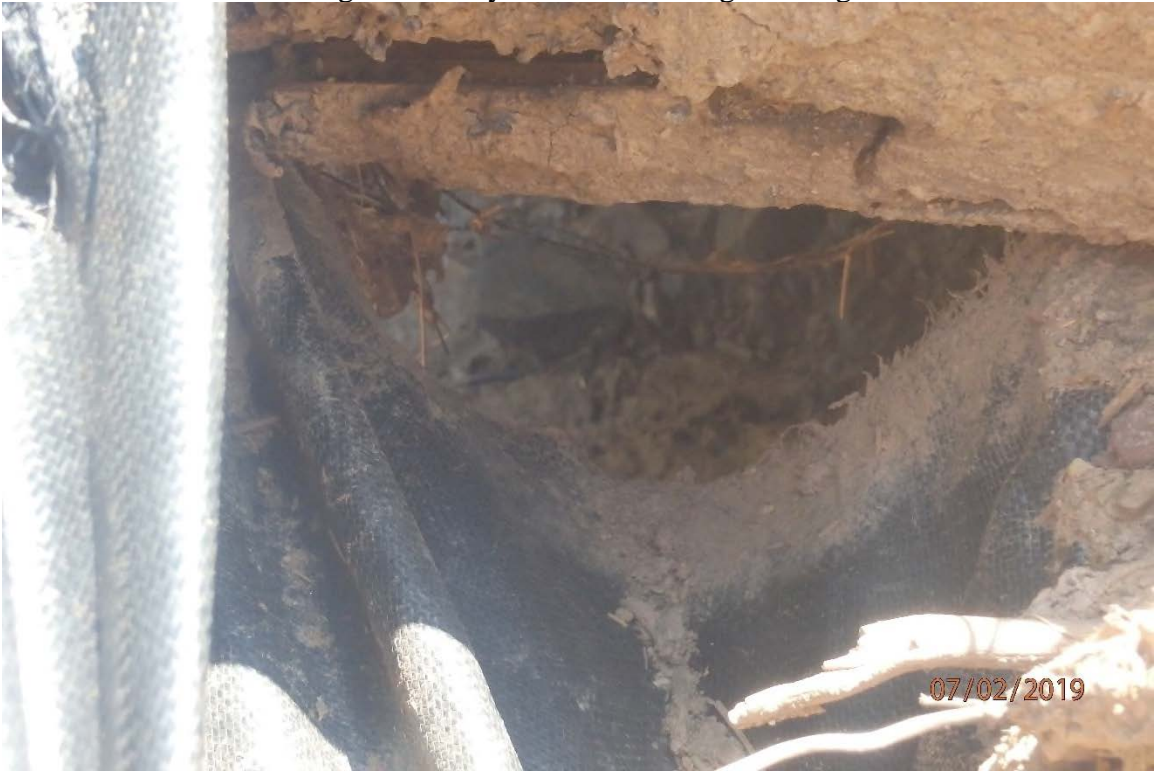
The installed timber mat bridge at the Taylor Drain crossing showing the need for maintenance.

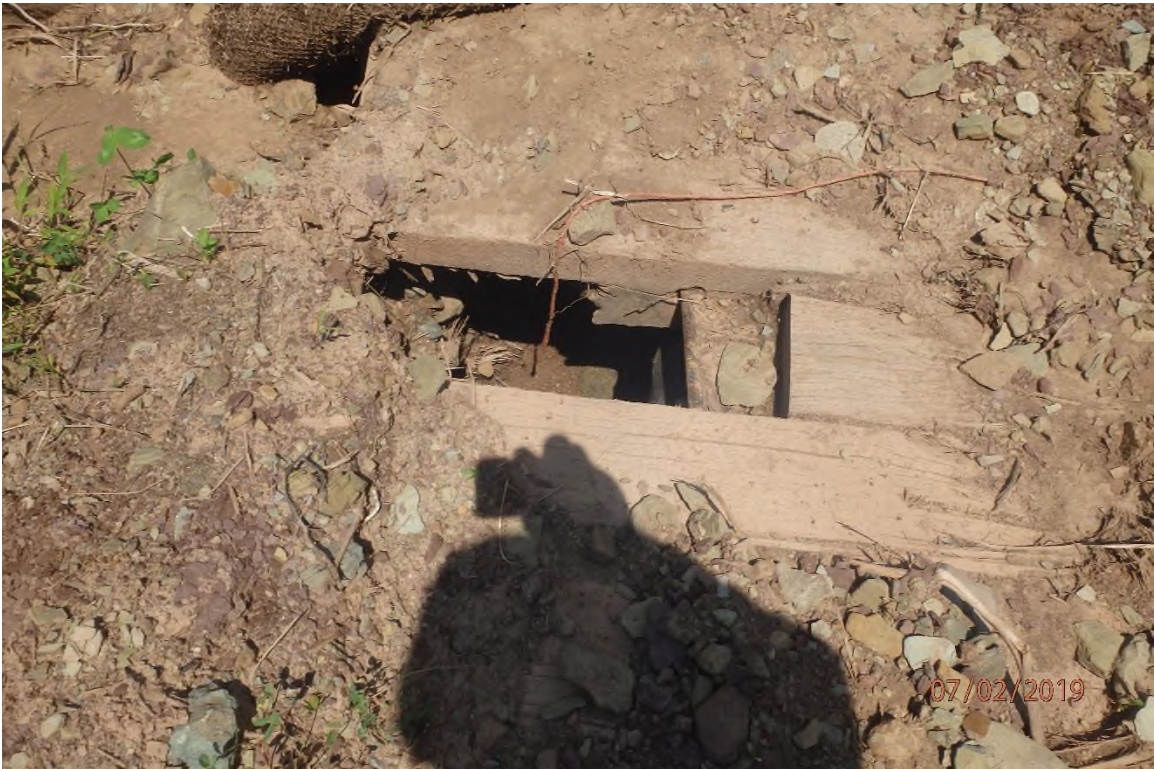
The installed timber mat bridge at the UNT Left Fork of Arnolds Creek (SDOG040) crossing showing the need for maintenance.

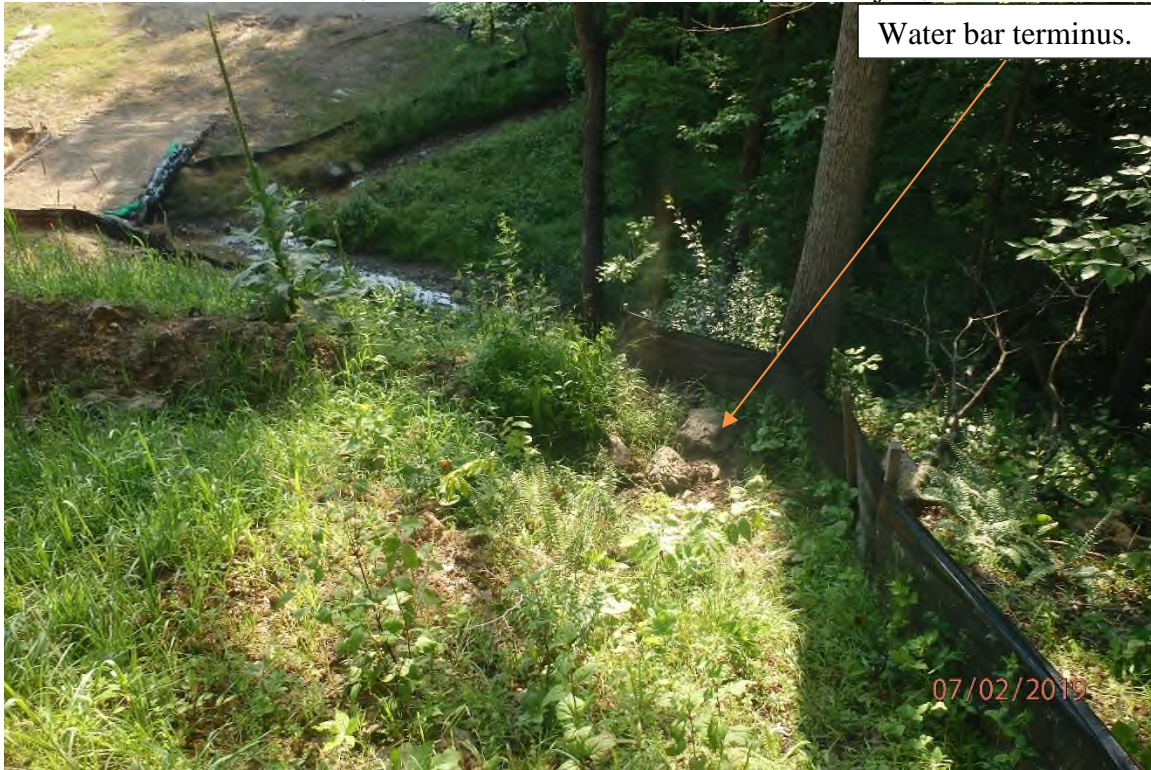
Sheet flow silt fence placed in a concentrated flow area at the terminus of a water bar in the Sugar Run watershed.

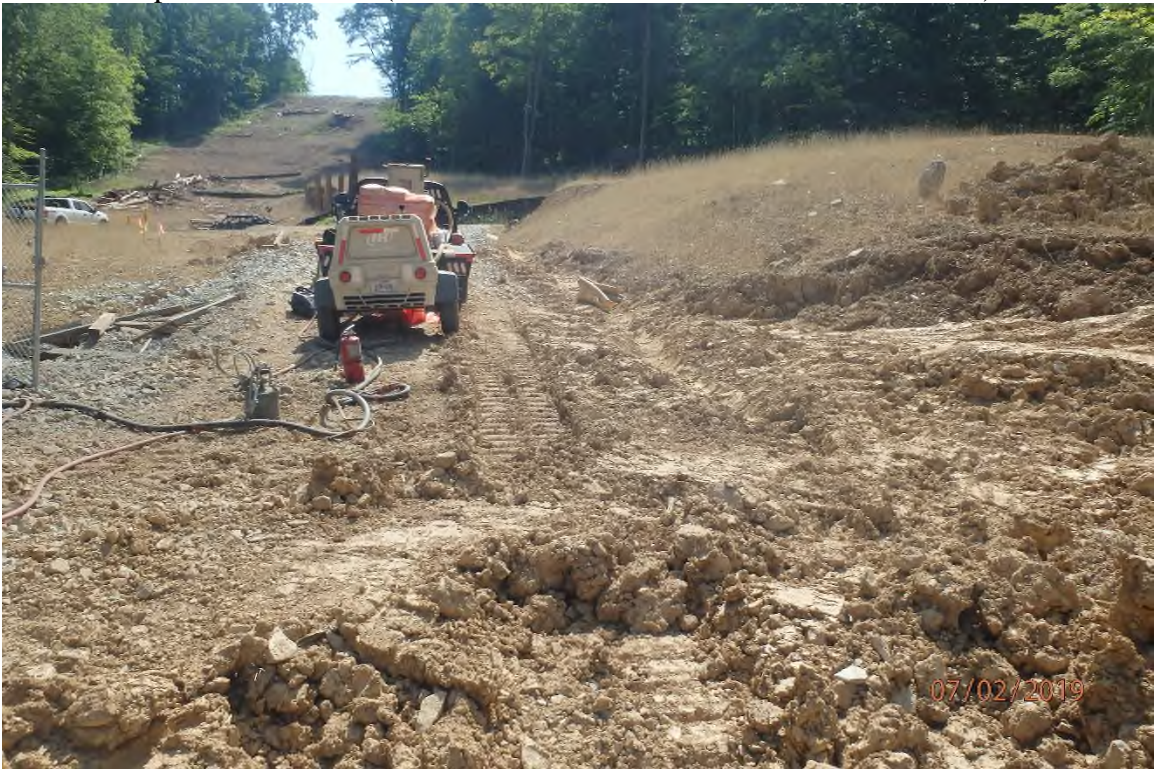
Water bar installed at varying angles in the Taylor Drain watershed.

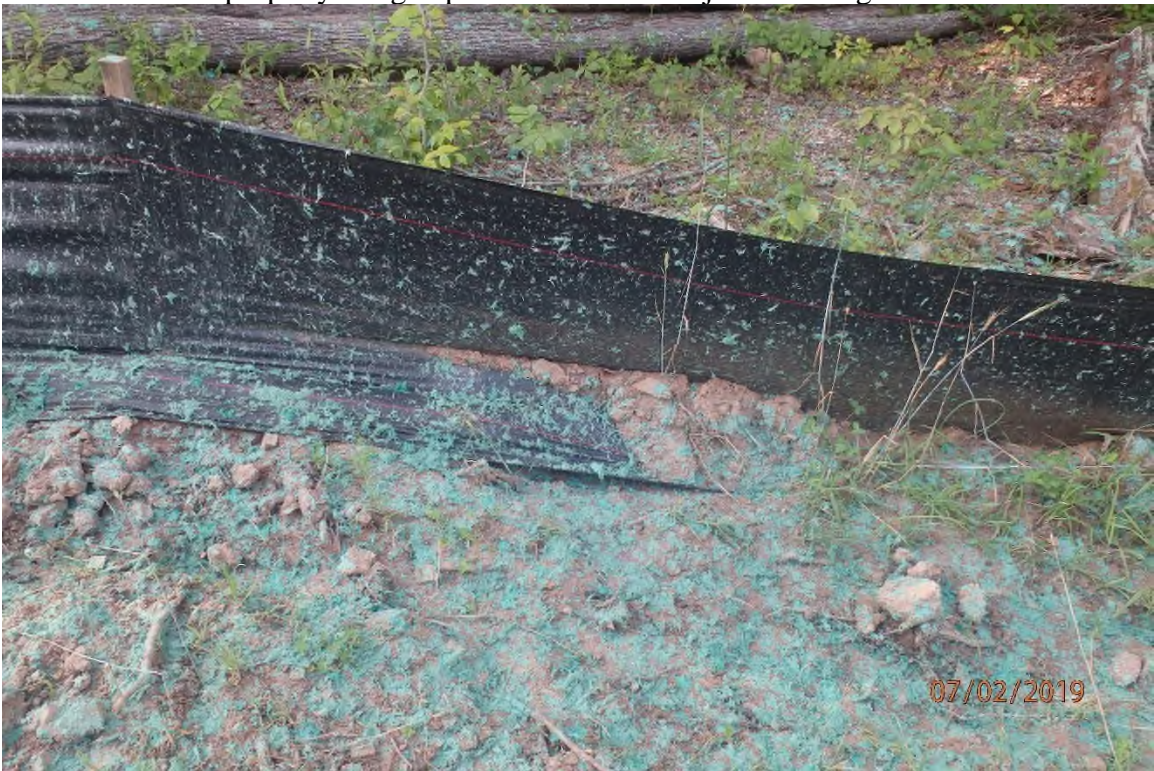
Improperly installed perimeter control in the Sugar Run watershed.

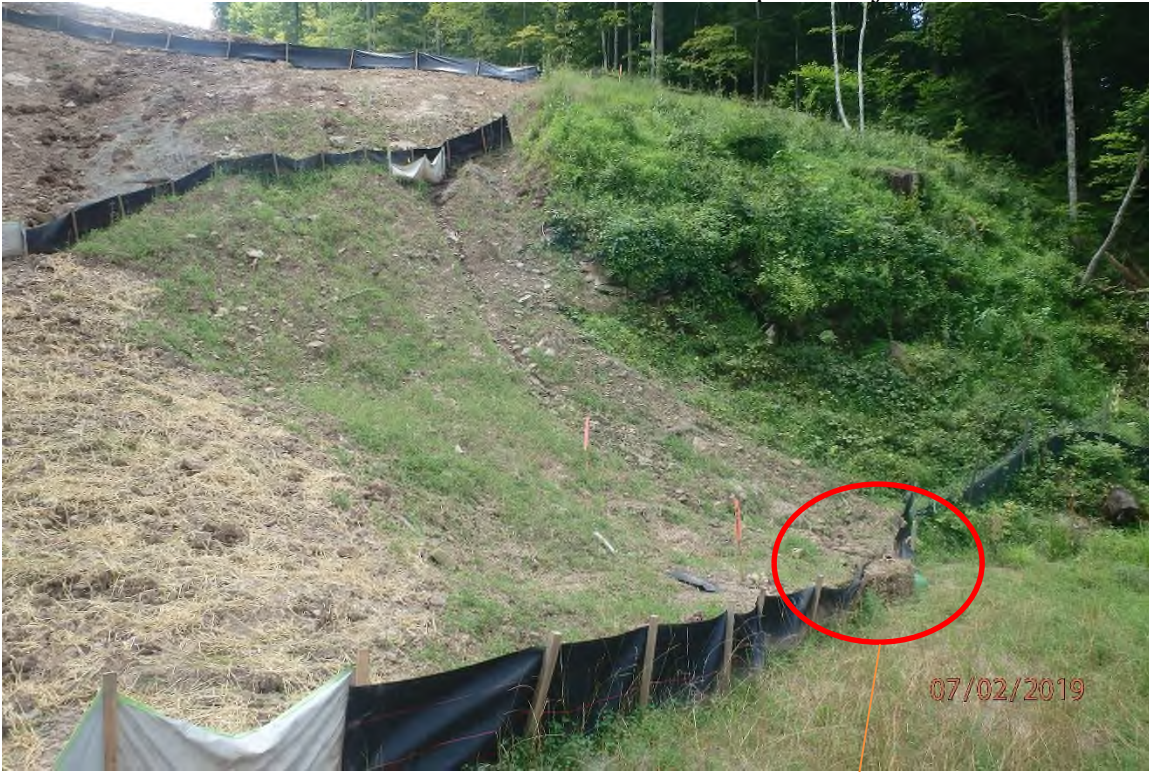
Area of concentrated flow that has caused fill slope erosion. Evidence of a recently altered perimeter control was noted due to the perimeter control being overwhelmed.

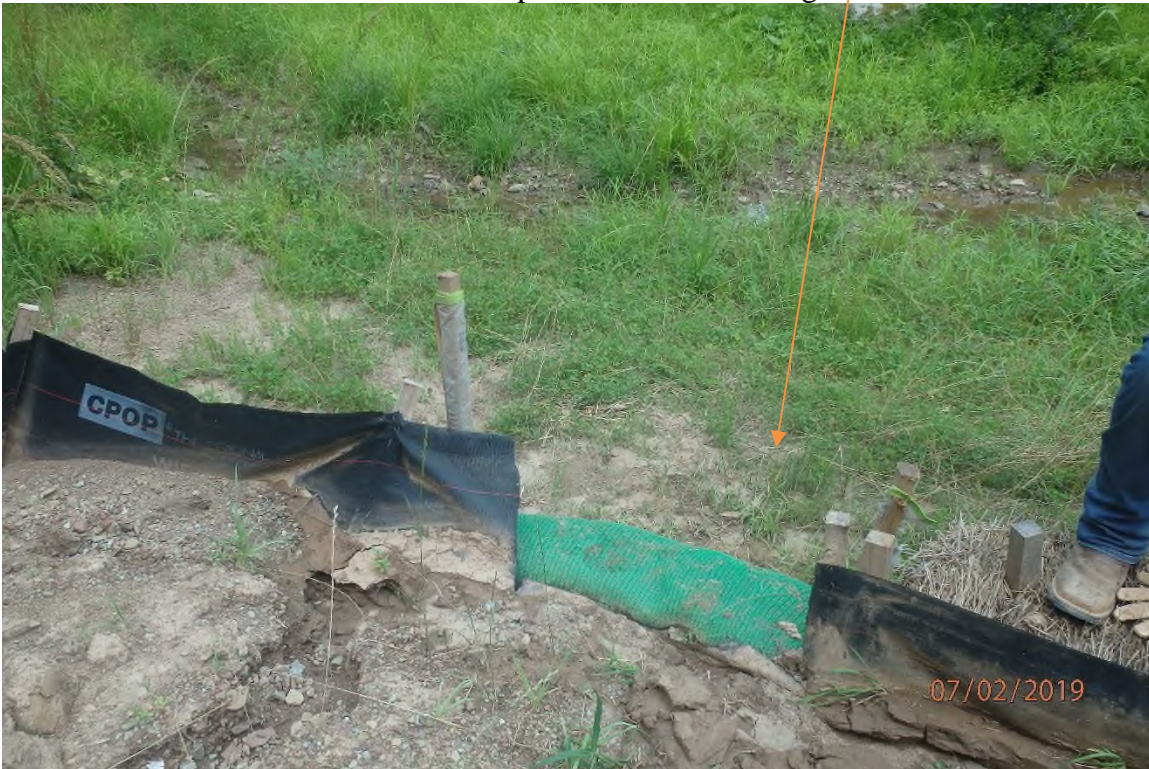
Perimeter control that was recently altered. An inequivalent 8" compost filter sock is being utilized to replace a concentrated flow silt fence in an area where the silt fence had previously failed.

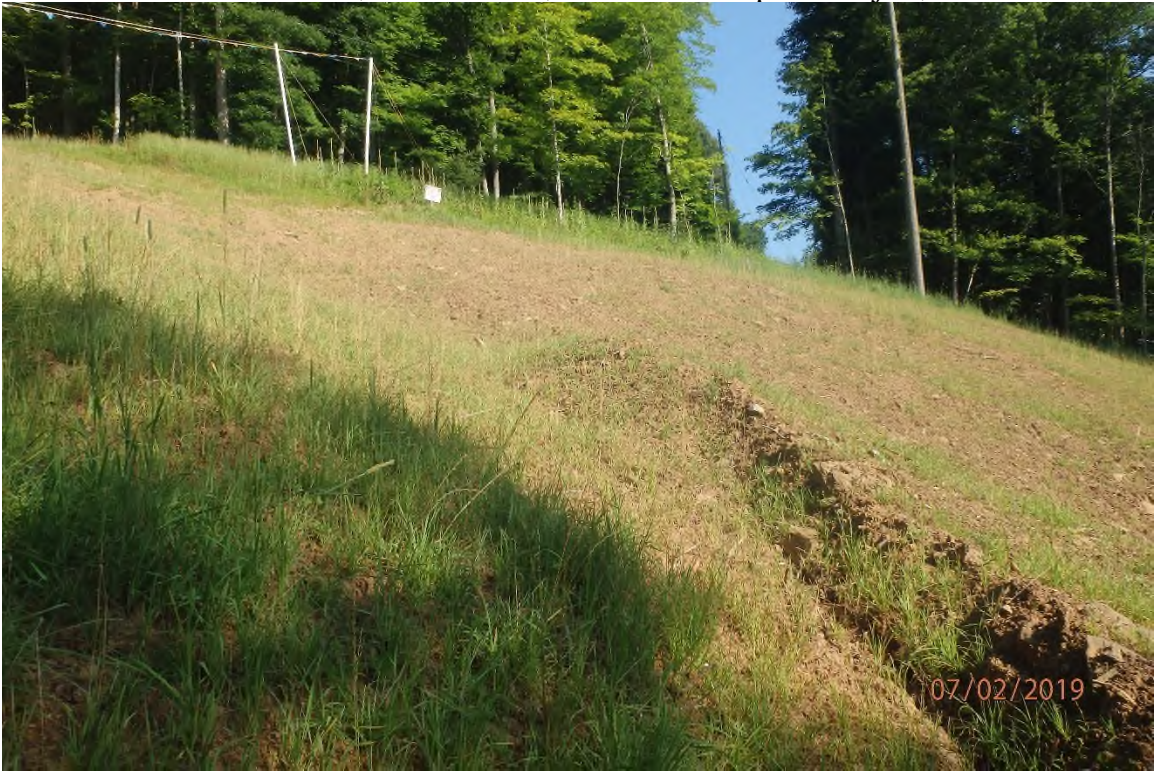
Improperly installed water bar in the Sugar Run watershed. Water bar does not extend across the entire disturbed width of the right of way as indicated in the approved SWPPP.

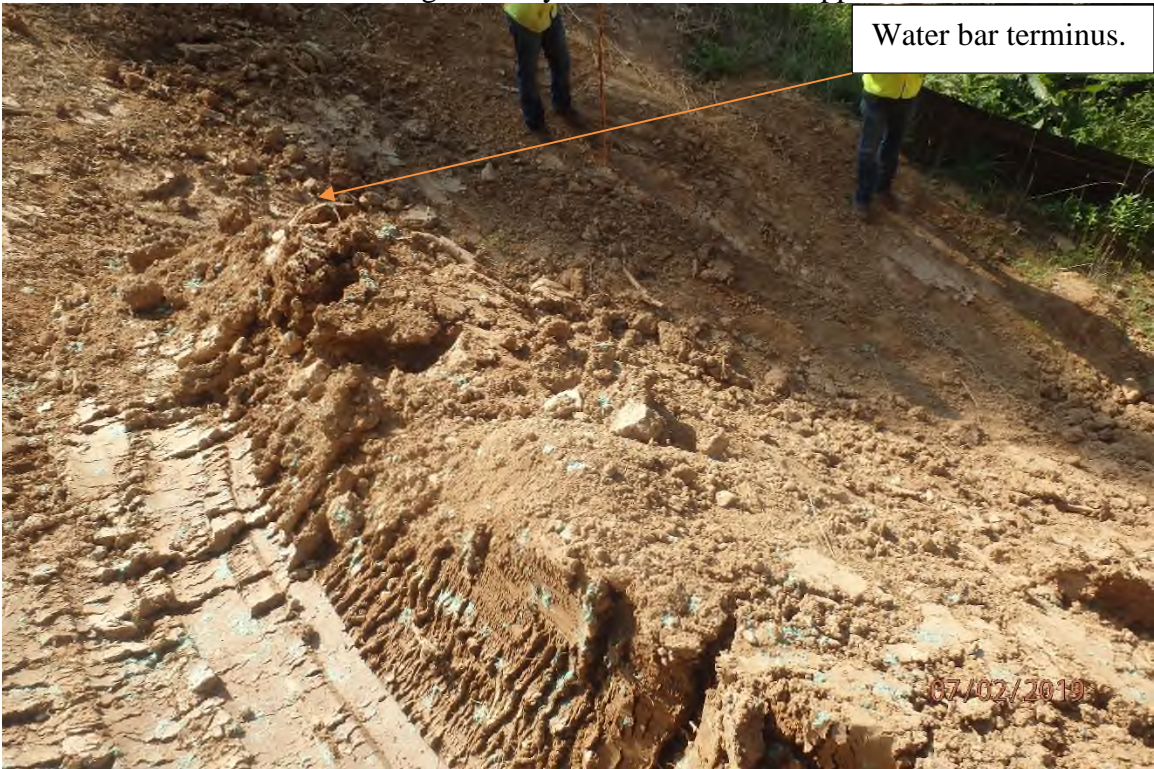
Improperly installed water bar in the Sugar Run watershed. Water bar does not extend across the entire disturbed width of the right of way as indicated in the approved SWPPP and is placing concentrated flow stormwater over an unprotected fill slope.

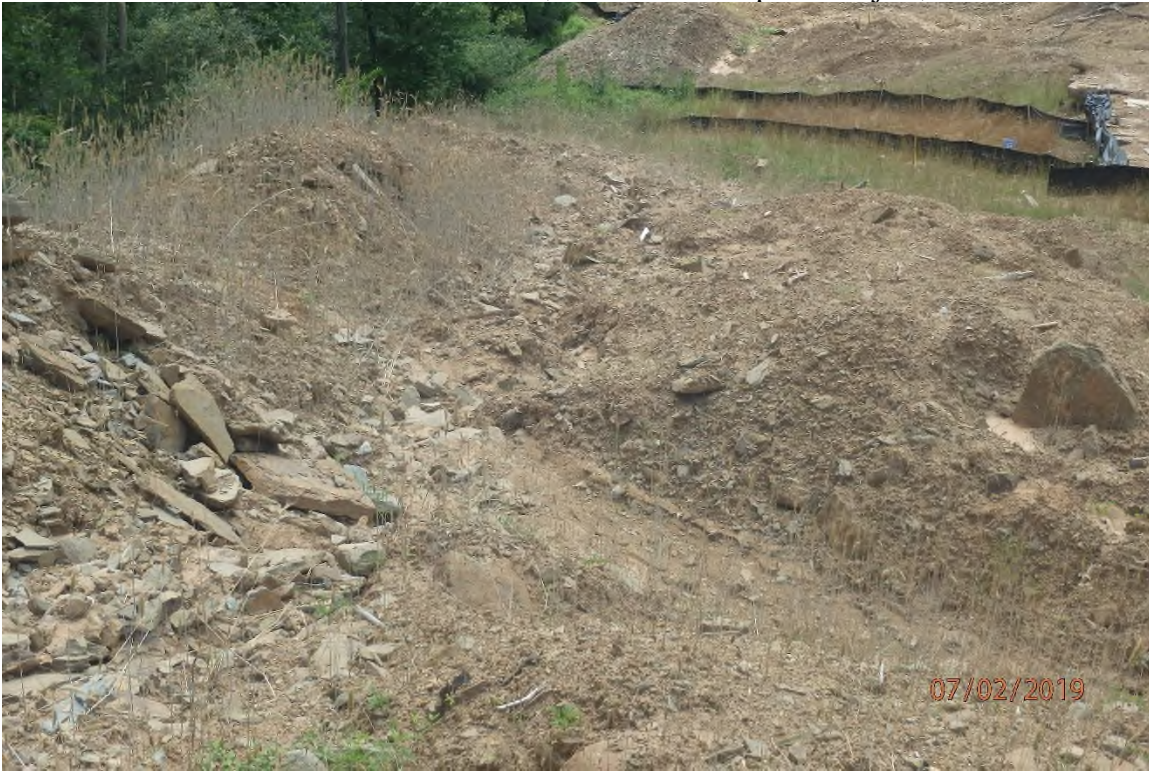
Improperly installed water bar in the Trap Run watershed. Water bar does not extend across the entire disturbed width of the right of way as indicated in the approved SWPPP and is placing concentrated flow stormwater over an unprotected fill slope.

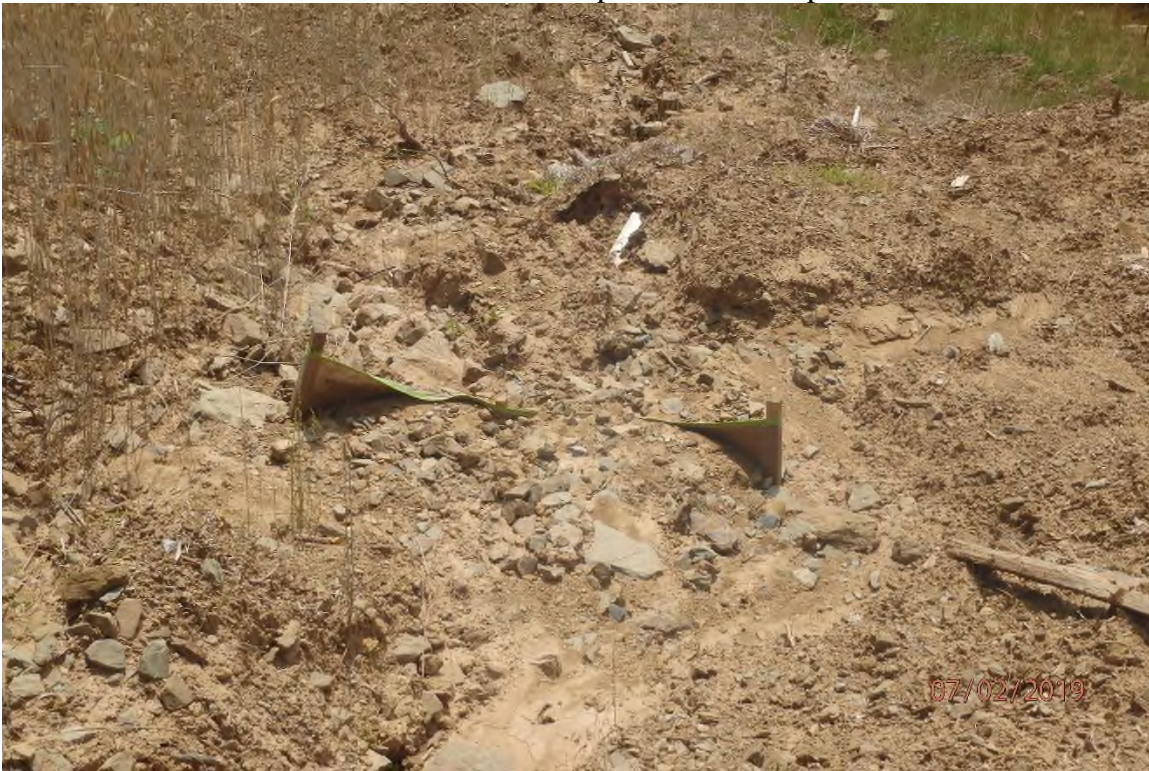
Fill slope erosion downslope of the above pictured deficiency. Silt fence ditch check in the erosion gully has become inundated with sediment.

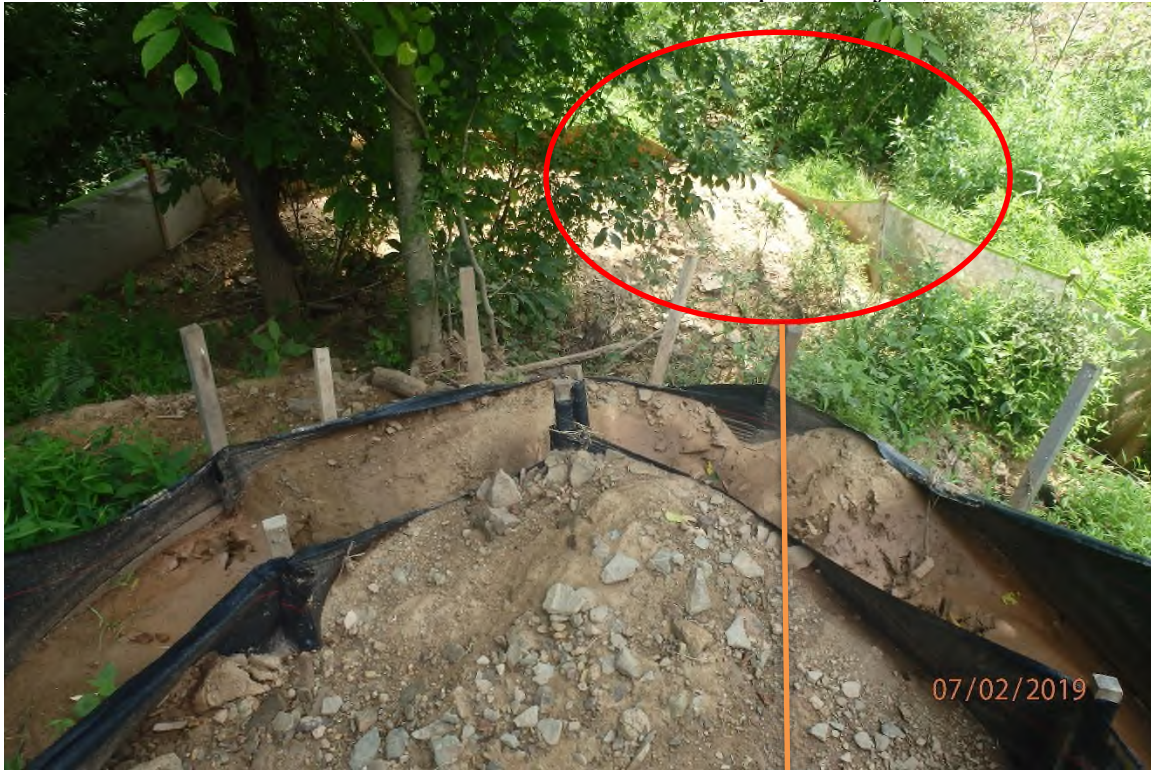
Perimeter controls downslope of the previously pictured deficiency in the Trap Run watershed that has become inundated with sediment as a result of poorly installed water bars.

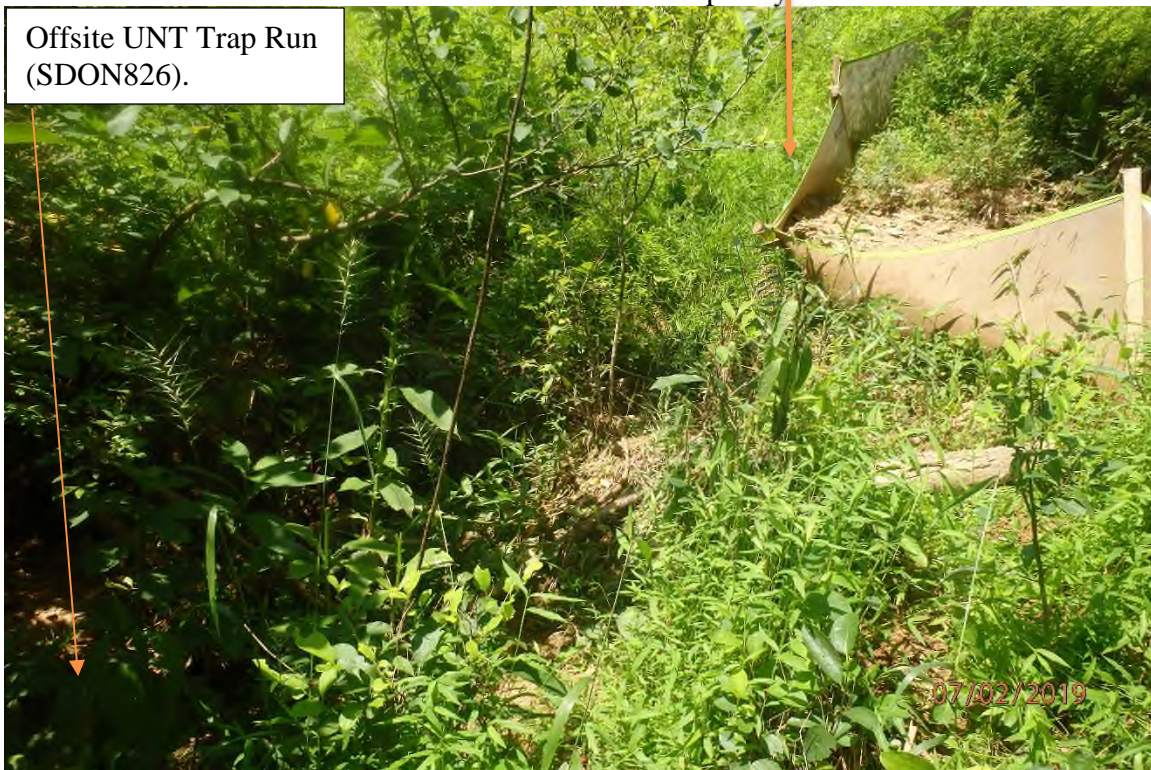
Perimeter controls downslope of the previously pictured deficiency in the Trap Run watershed that has become inundated with sediment as a result of poorly installed water bars. Area where sediment laden water is leaving the site is pictured.

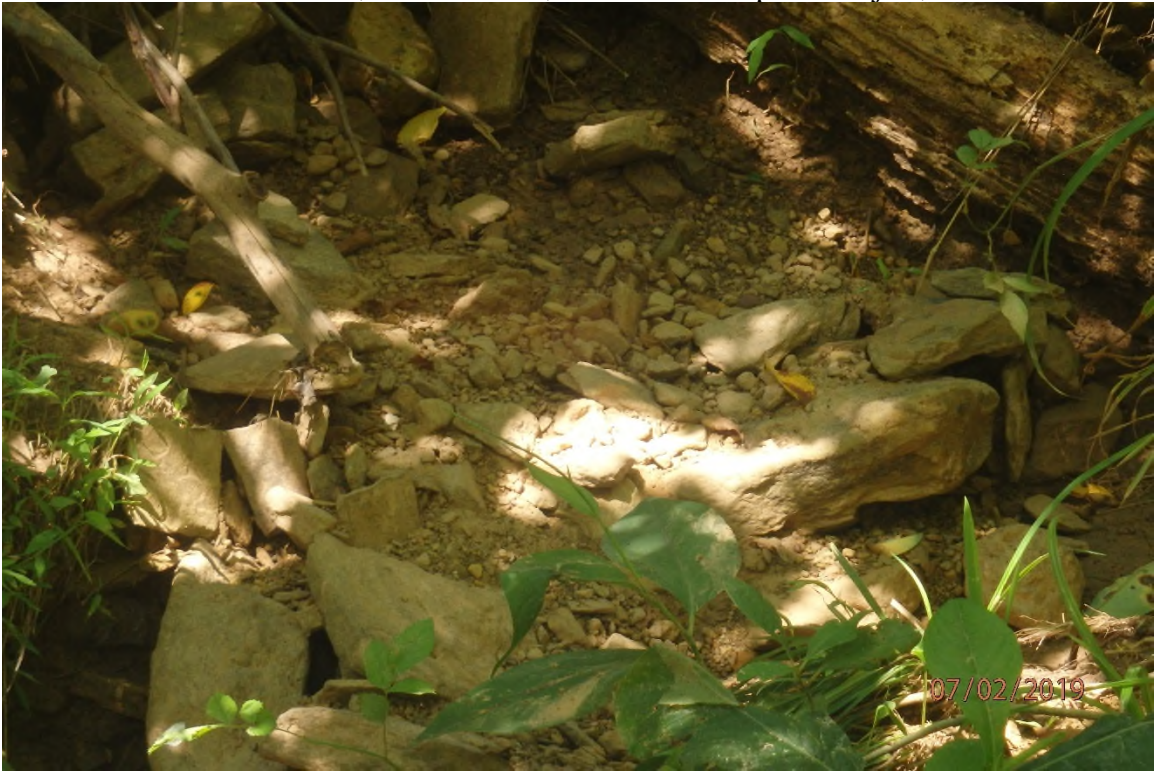
Offsite CNA deposits in UNT Trap Run (SDON826) as a result of the previously pictured improperly installed water bars and associated fill slope erosion.

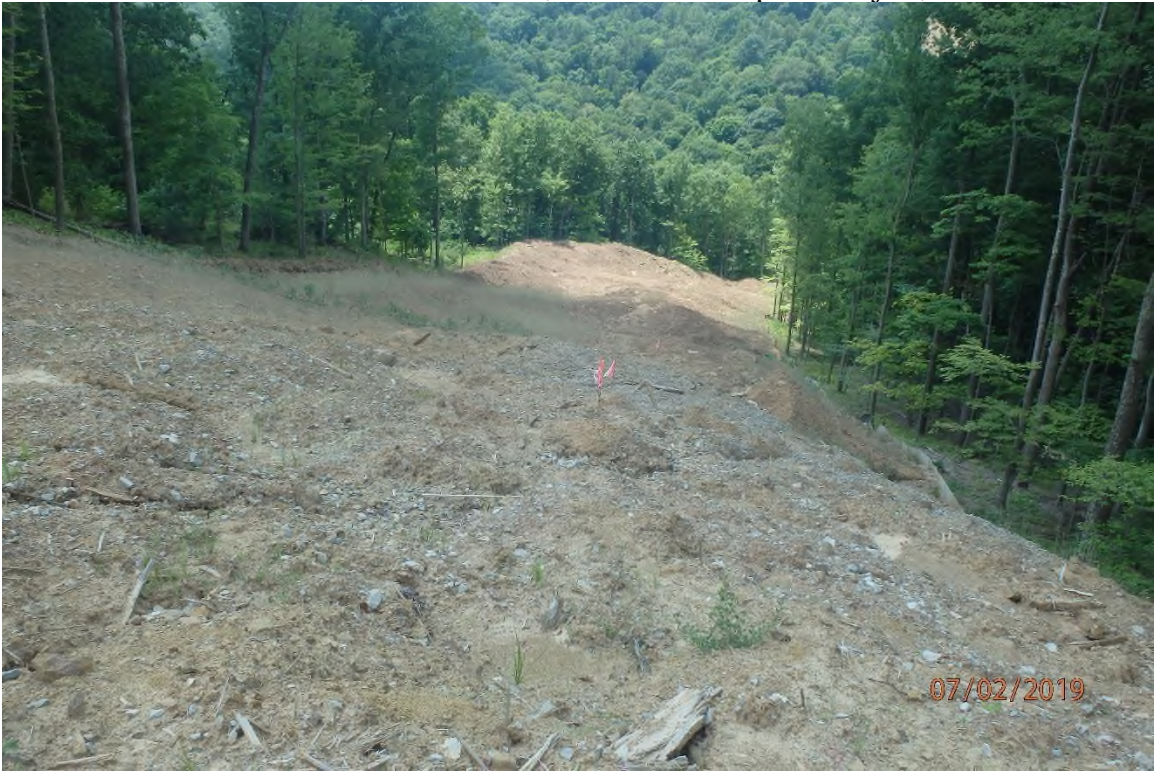
Improperly installed water bar in the UNT Left Fork of Arnolds Creek watershed. Water bar is installed at a shallow depth and a steep angle.

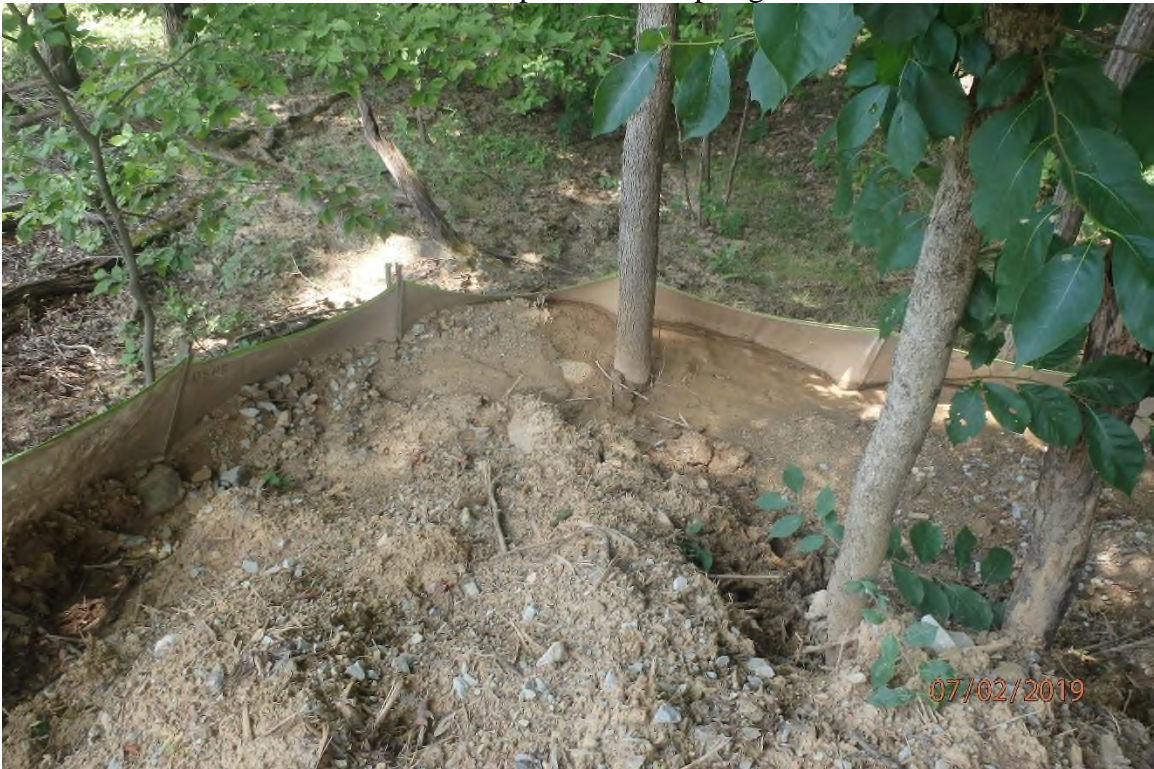
Area adjacent to the above pictured water bar showing offsite sediment deposits associated with a previous mud flow that Columbia Gas attempted to contain with silt fence. The silt fence is in need of maintenance.

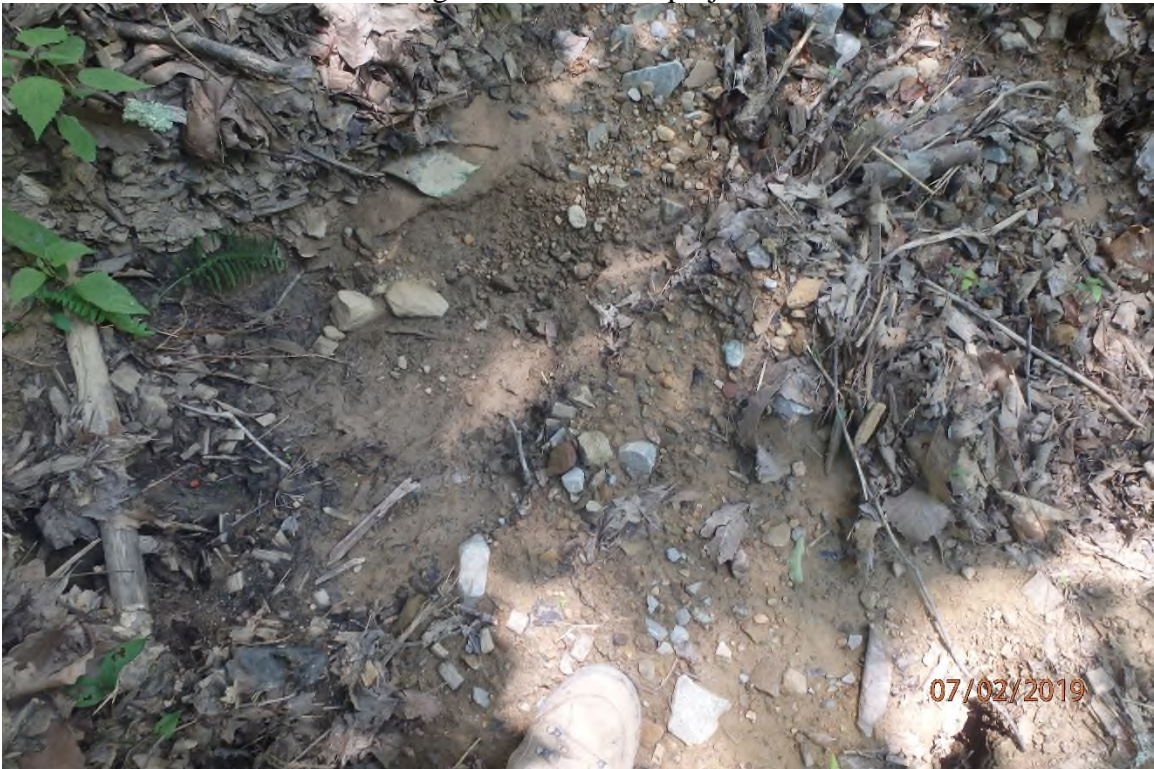
Area downslope of the previously pictured mud flow showing the trail of sediment deposits leading to the receiving stream from the project area.

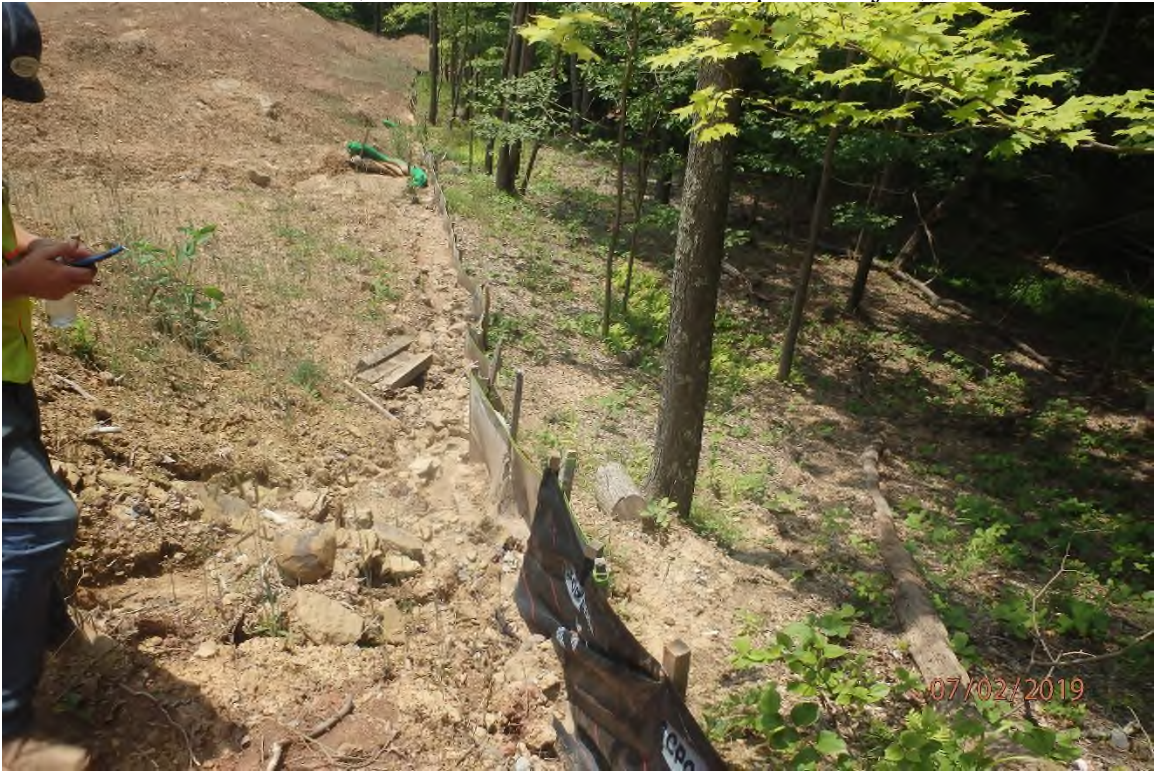
Offsite CNA deposits in UNT Left Fork of Arnolds Creek (SDOG056) (39° 13.388' X 80° 46.813') as a result of the previously pictured improperly installed water bars and unmaintained perimeter controls adjacent to the offsite mud flow.

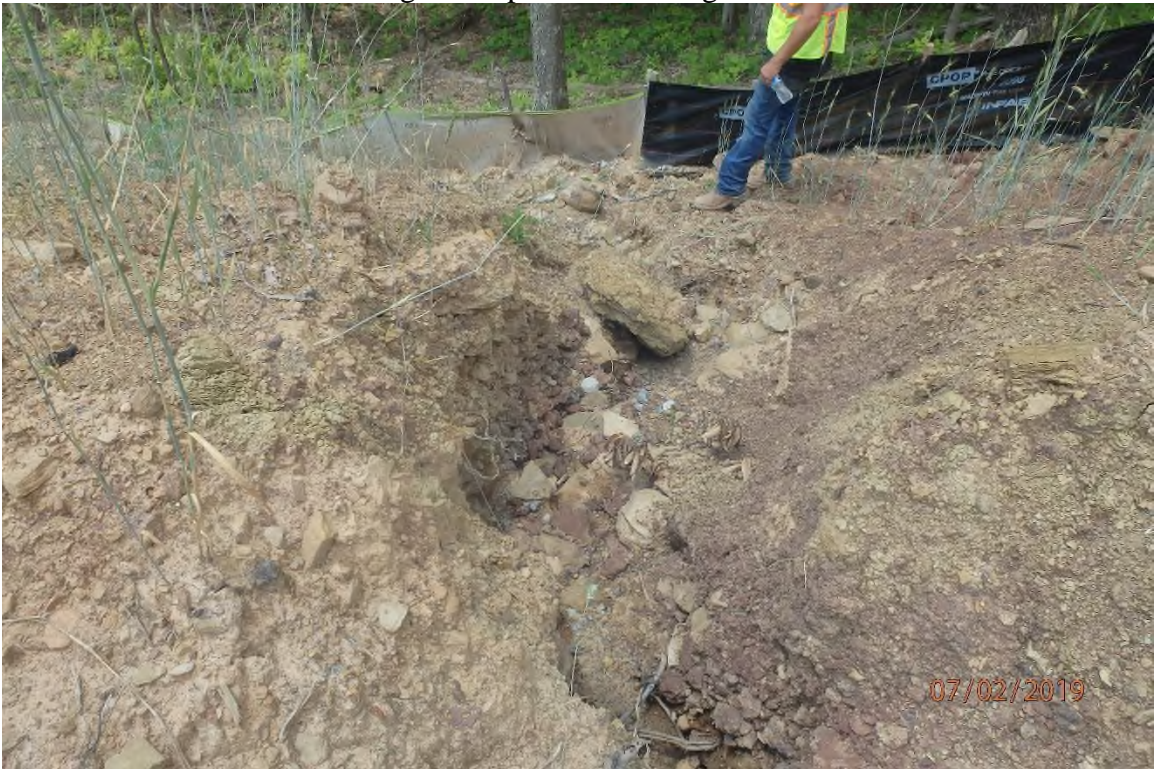
Water bars that do not extend past the installed perimeter controls in the UNT Left Fork of Arnolds Creek watershed showing fill slope erosion along the silt fence trench.

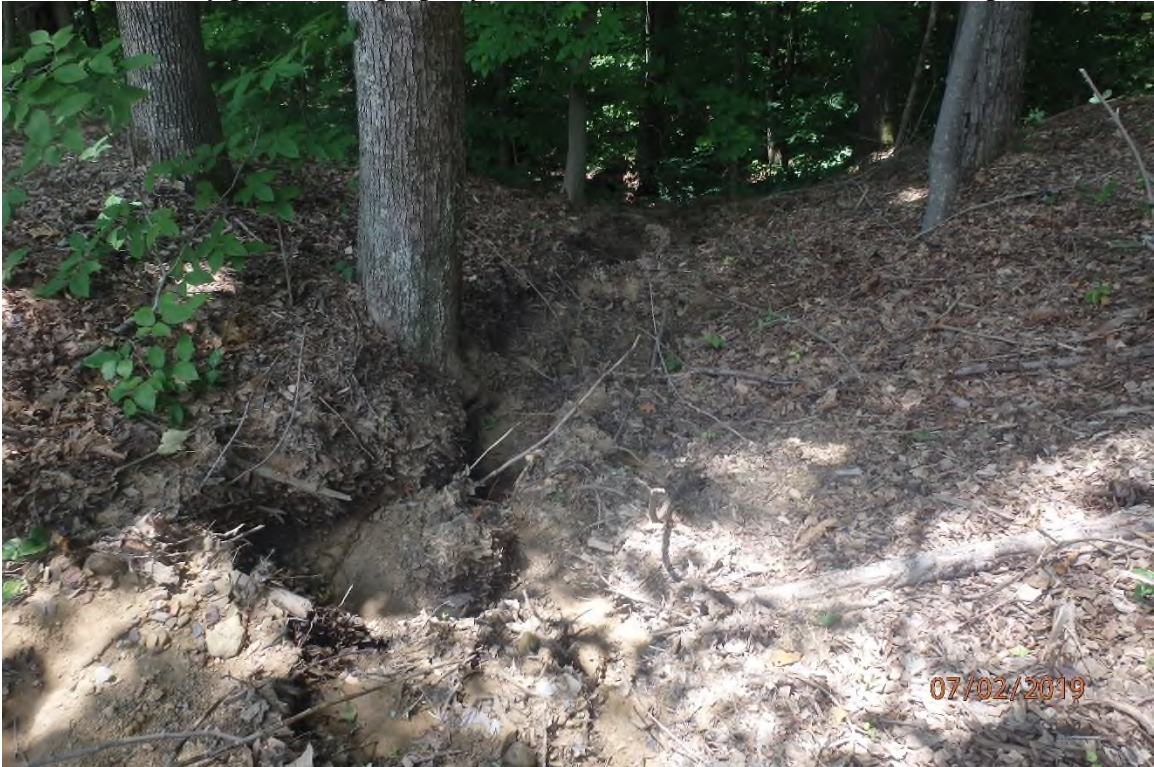
Offsite CNA deposits in UNT Left Fork of Arnolds Creek (SDOG057) (39° 13.355' X 80° 46.851') as a result of the previously pictured improperly installed water bars and unmaintained perimeter controls.

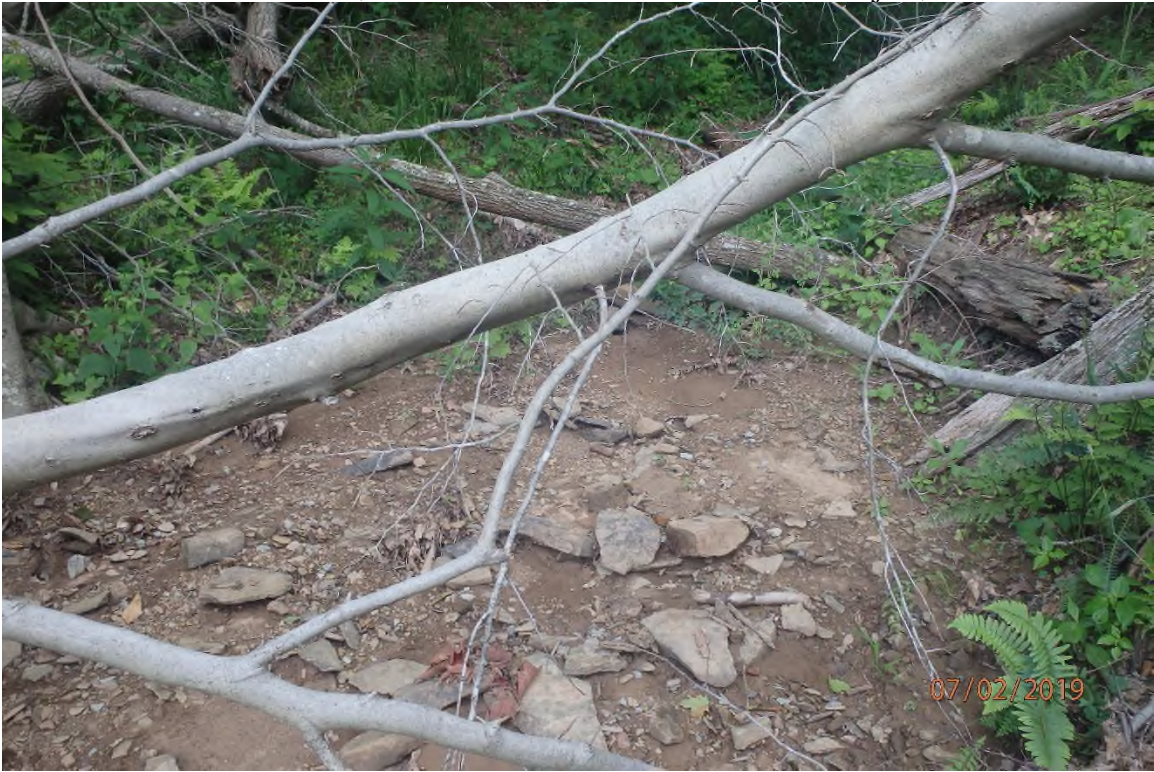
Offsite CNA deposits in UNT Left Fork of Arnolds Creek (SDOG057) (39° 13.355' X 80° 46.851') as a result of the previously pictured improperly installed water bars and unmaintained perimeter controls.
