**CONSENT ORDER
ISSUED UNDER THE
WATER POLLUTION CONTROL ACT
WEST VIRGINIA CODE, CHAPTER 22, ARTICLE 11**

TO: Columbia Gas Transmission, LLC
Attn: Troy Tally, Vice President
1700 MacCorkle Ave
Charleston, WV 25314

DATE: October 1, 2020
ORDER NO.: 9061

1. Columbia Gas Transmission, LLC is conducting land disturbance activity associated with construction of the Mountaineer Xpress Project in Marshall, Wetzel, Tyler, Doddridge, Ritchie, Calhoun, Wirt, Roane, Jackson, Mason, Putnam, and Cabell Counties, West Virginia. On January 31, 2018, Columbia Gas Transmission, LLC was issued Water Pollution Control Permit No. WV0116815, Registration No. WVR310872, for Stormwater Associated With Oil and Gas Related Construction Activities.

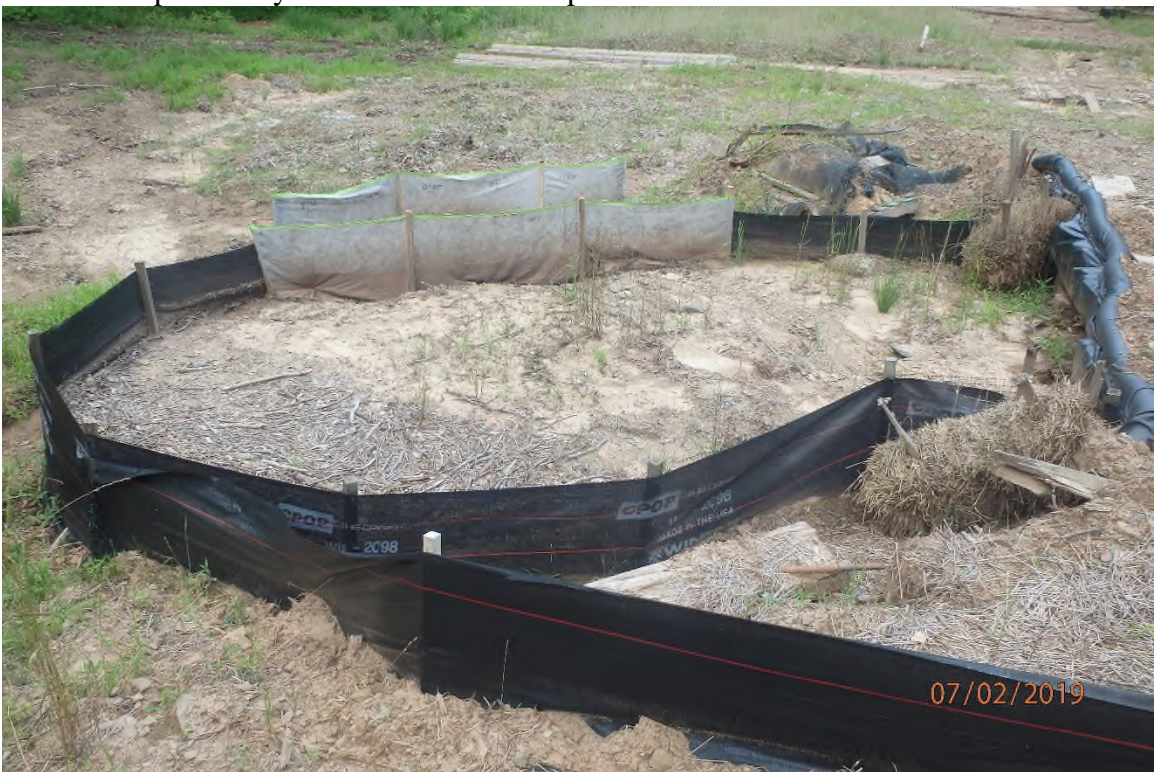
UNT Left Fork of Arnolds Creek (SDOG057) showing offsite sediment deposits that originate from the previously documented CNA deposits in SDOG056 & SDOG057.

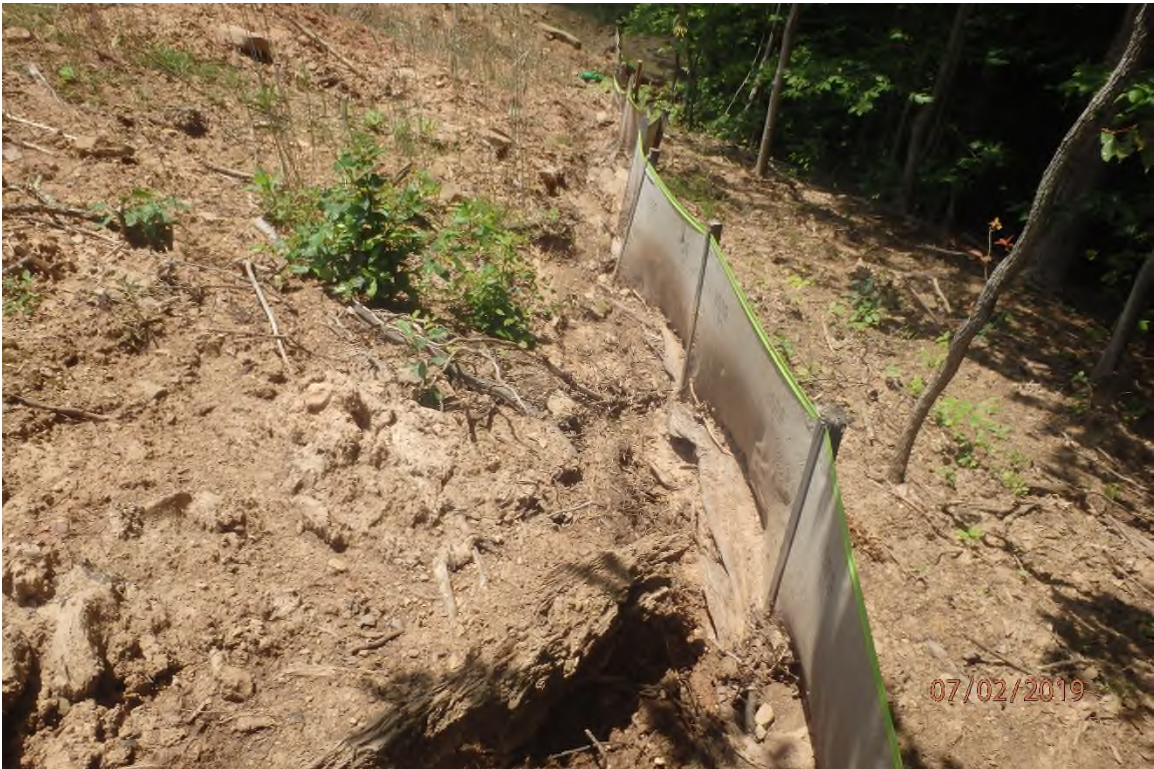
Water bar that does not extend past the installed perimeter controls in the UNT Left Fork of Arnolds Creek watershed.

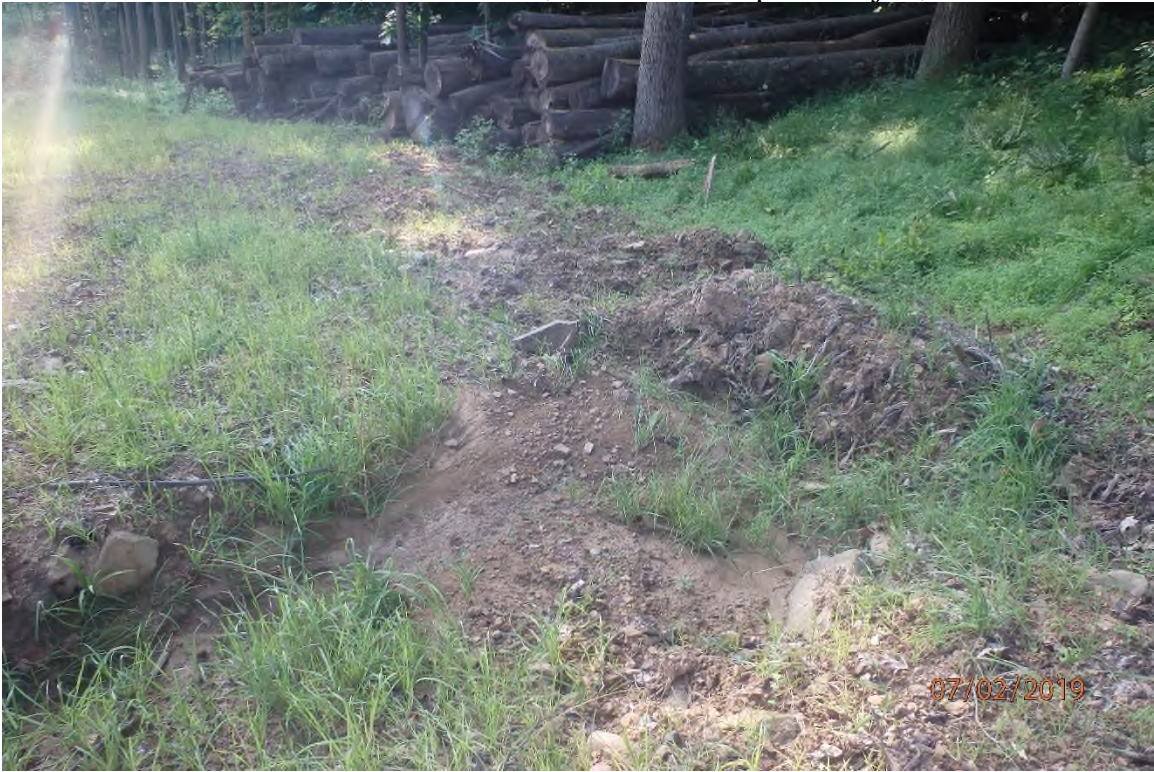
Fill slope erosion along the installed silt fence trench as a result of the above pictured deficiency.

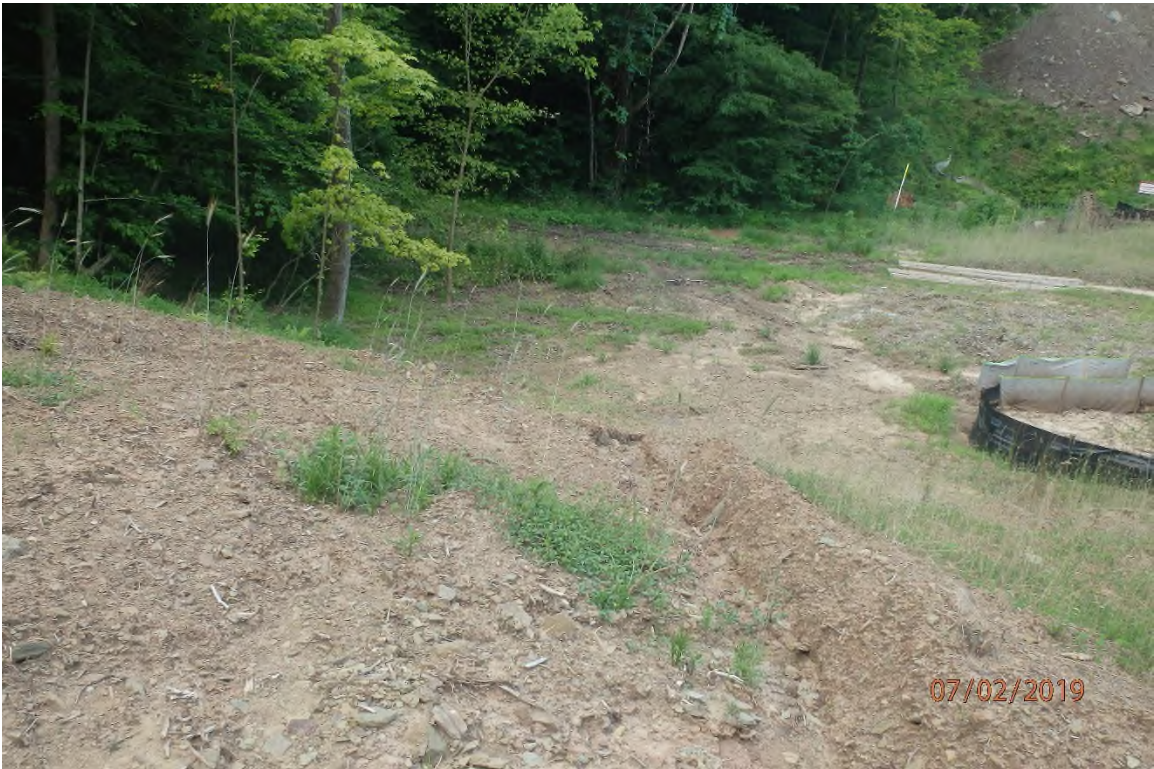
Water bar that lacks the water bar terminus BMP indicated in the approved SWPPP in the Sugar Run watershed.

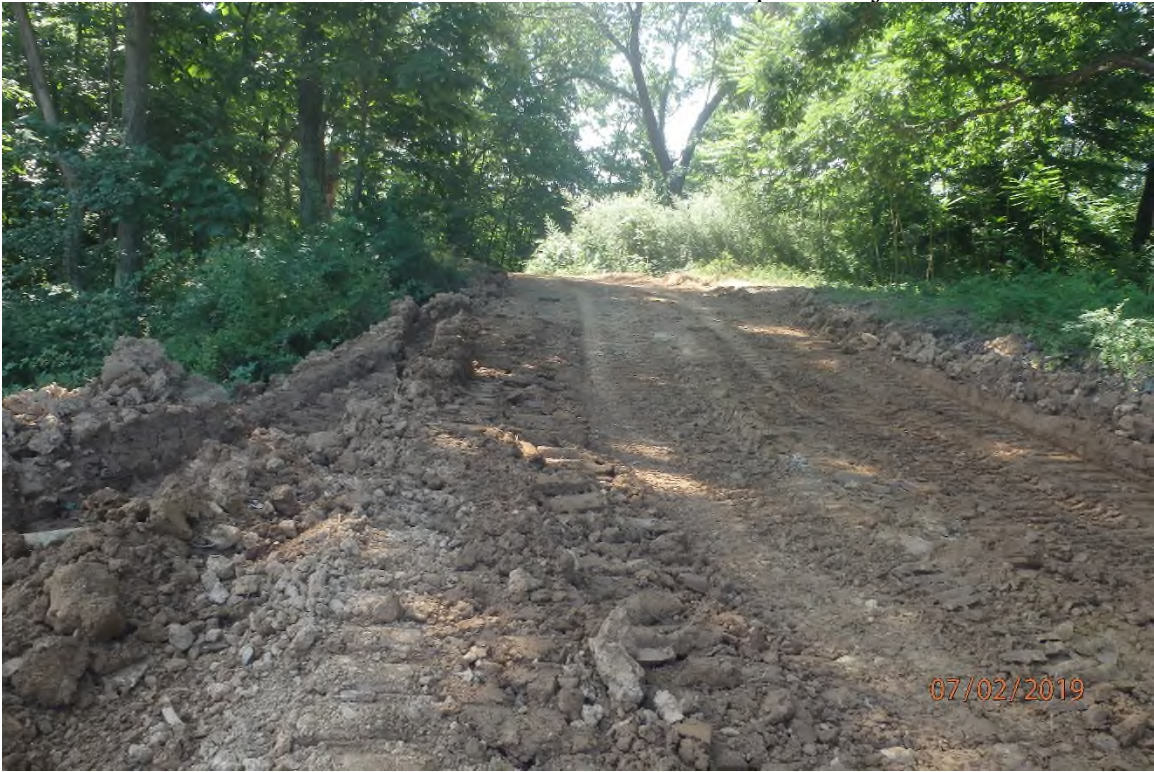
Offsite sediment deposits downslope of the previously pictured water bar that lacks the water bar terminus BMP indicated in the approved SWPPP in the UNT Left Fork of Arnolds Creek watershed.

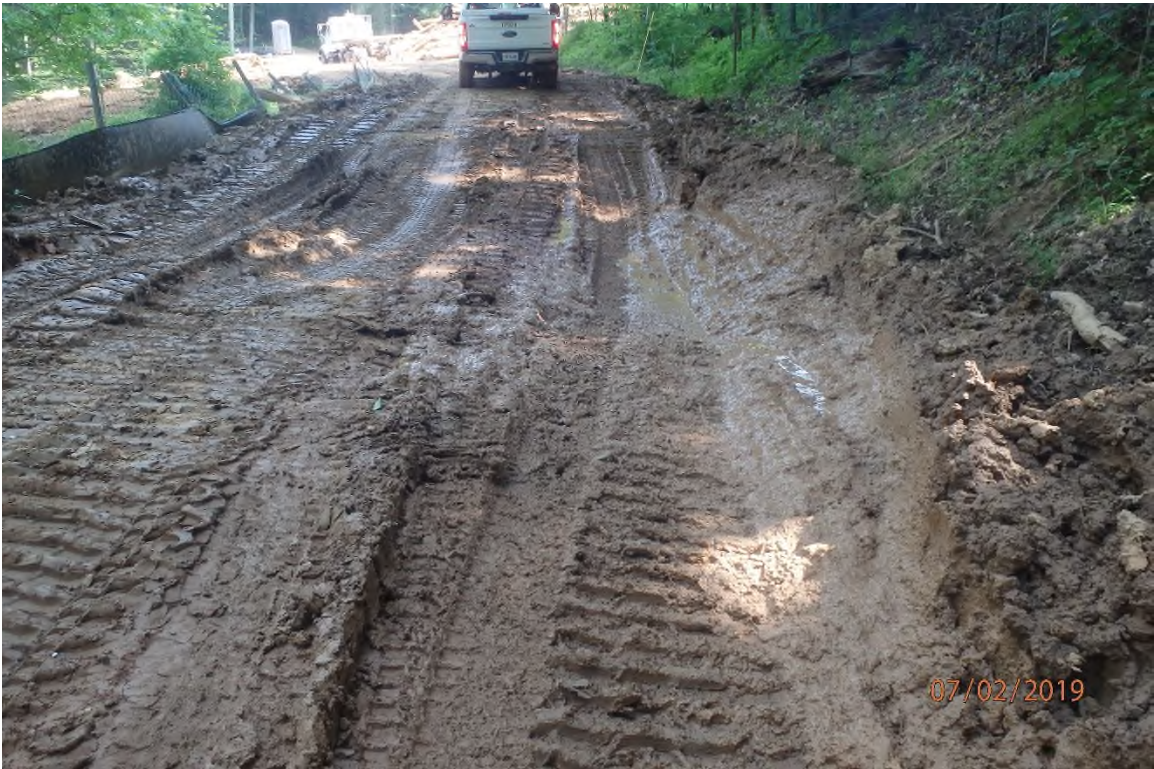
ARDO015.12 - lack of installed BMPs and lack of a graveled surface as indicated in the approved SWPPP.

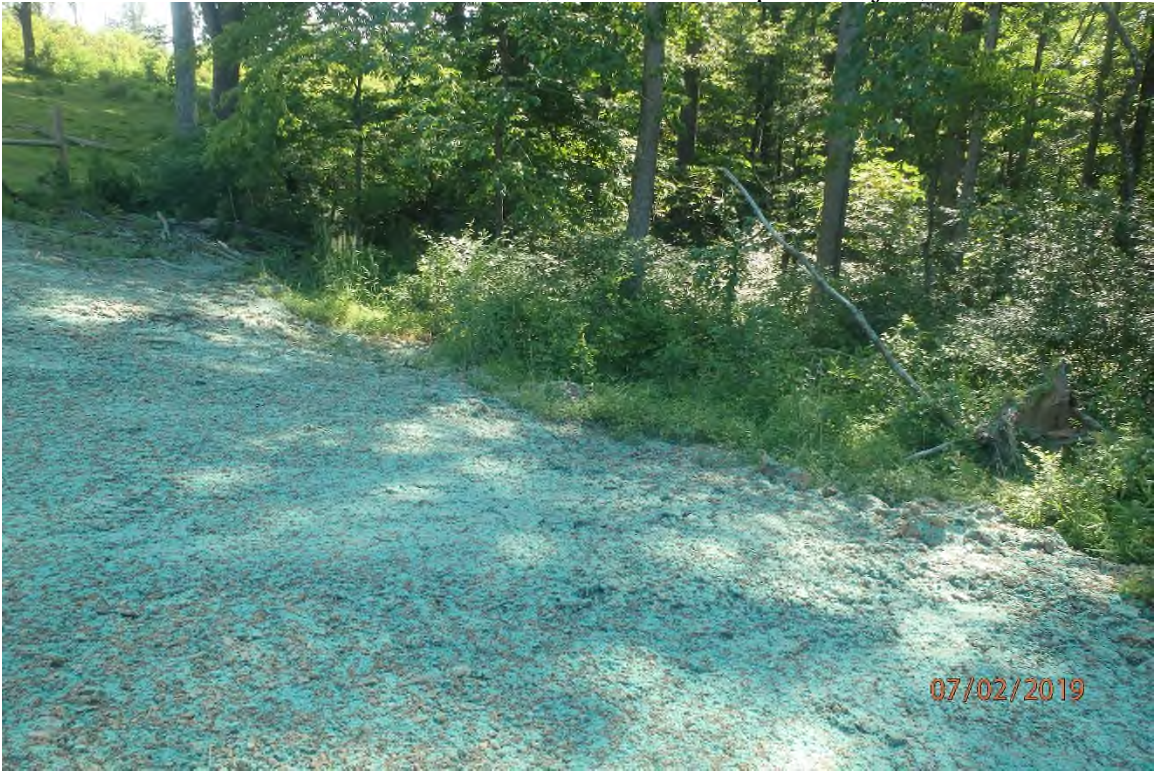
ARDO015.12 - lack of installed upslope ditching and the associated cross drains as well as lack of a graveled surface as indicated in the approved SWPPP.

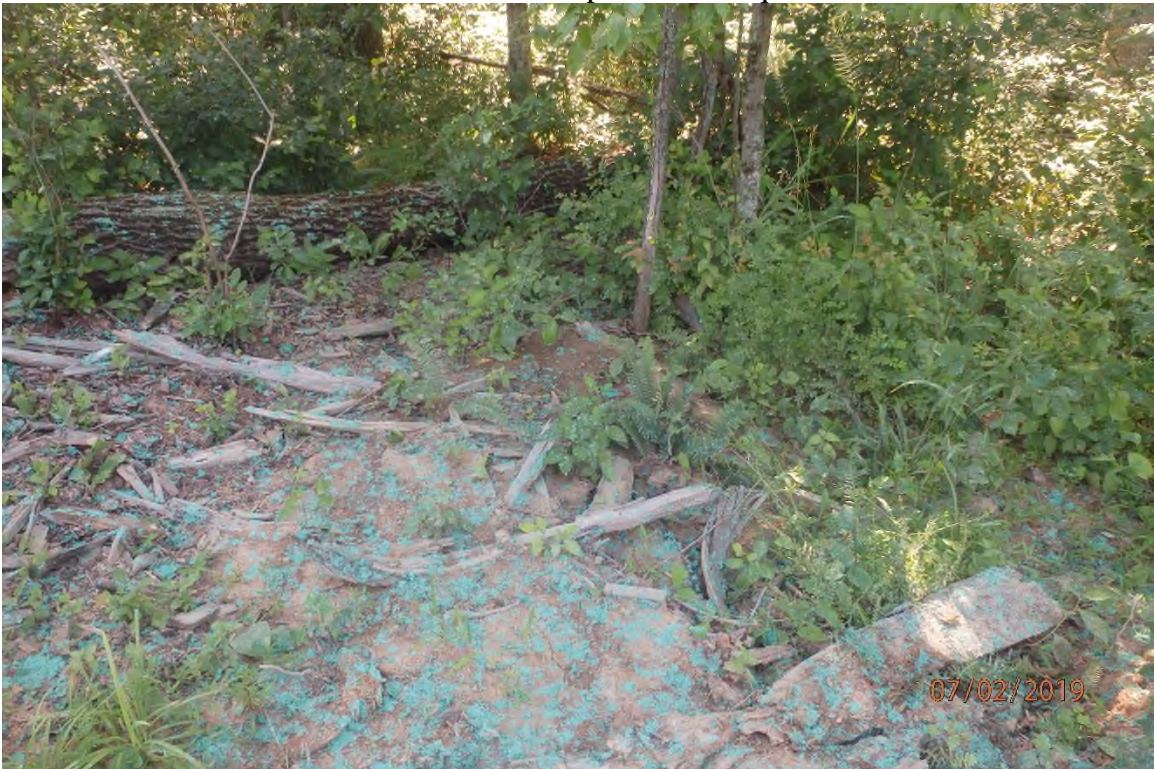
Area adjacent to 3314+00 where the approved SWPPP does not indicate the need for perimeter controls and the SWPPP has proved inadequate.

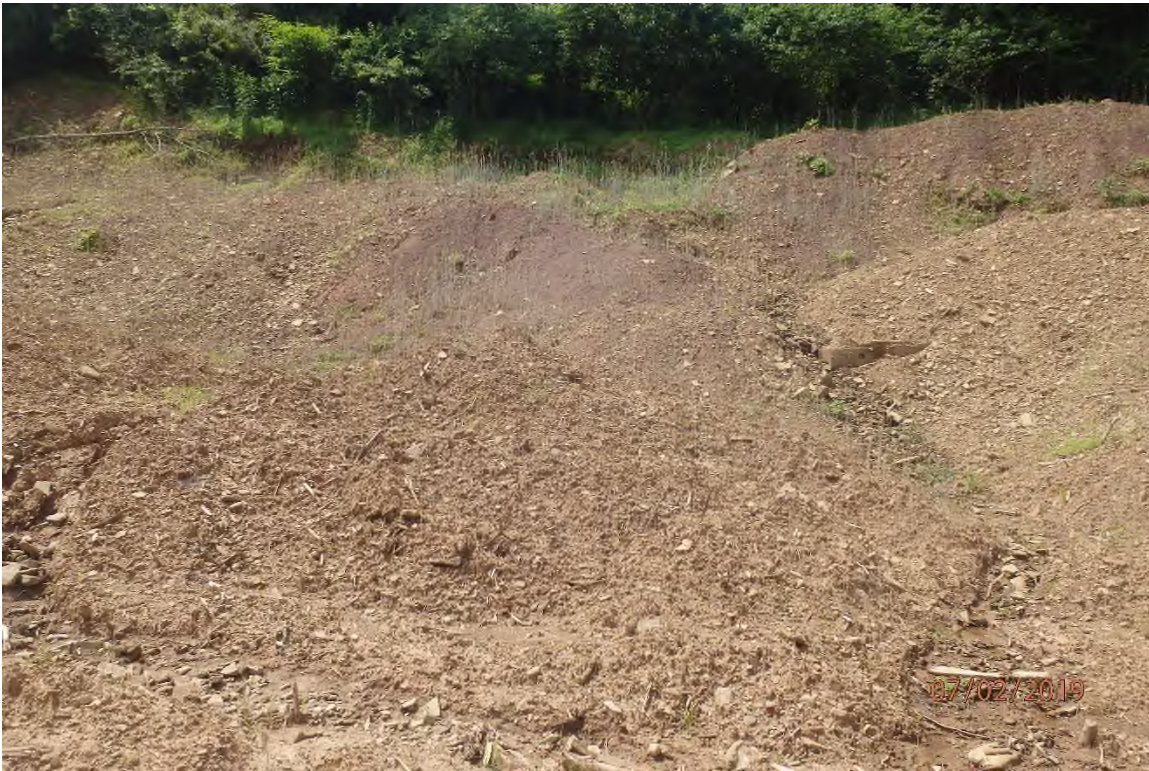
Project area adjacent to 3214+00 showing erosion gullies associated with concentrated flow run on stormwater. The approved SWPPP does not address this situation and the plan has not been modified in this area.

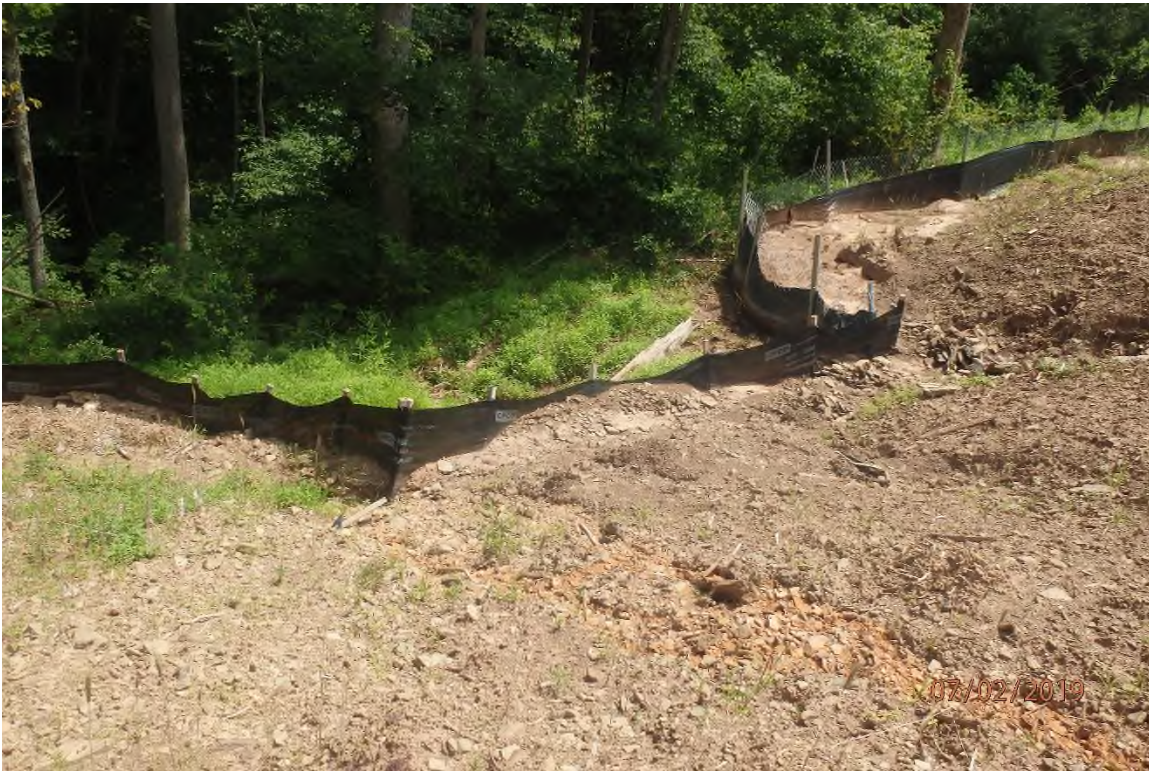
Project area adjacent to 3214+00 showing erosion gullies associated with concentrated flow run on stormwater. The approved SWPPP does not address this situation and the plan has not been modified in this area.

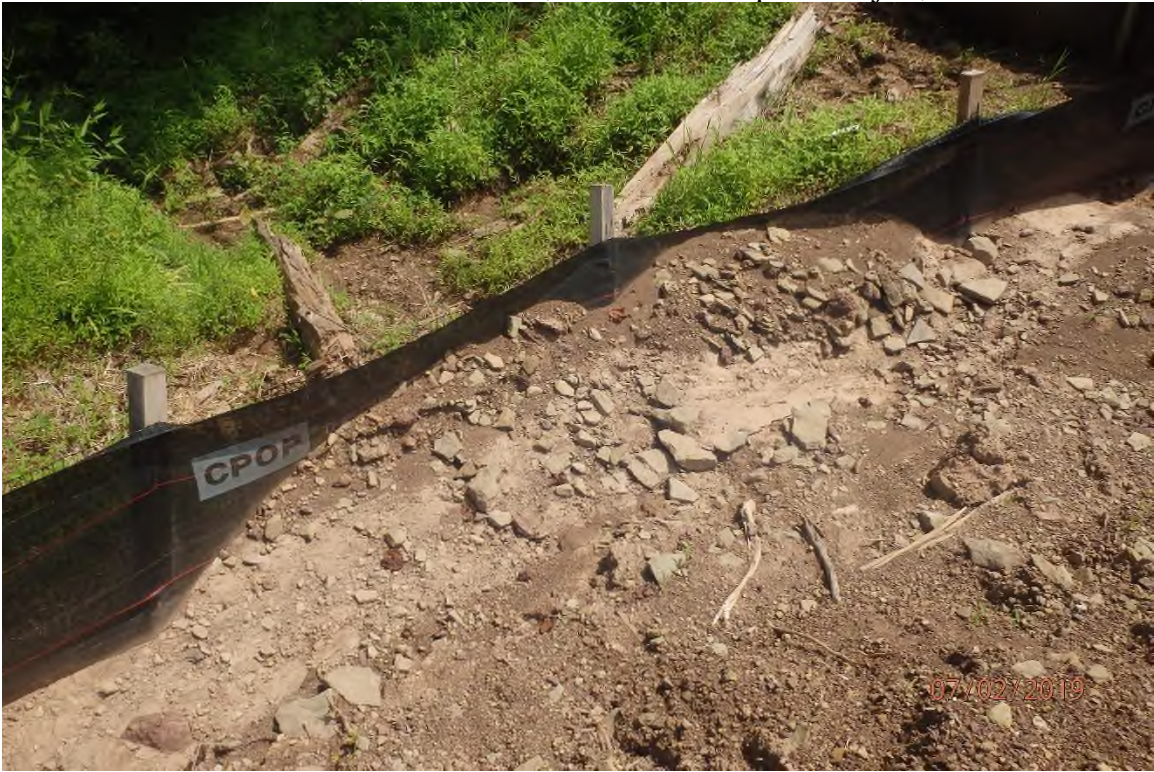
Perimeter controls adjacent to 3214+00 that are inundated with sediment and in need of maintenance as a result of the above pictured deficiency.

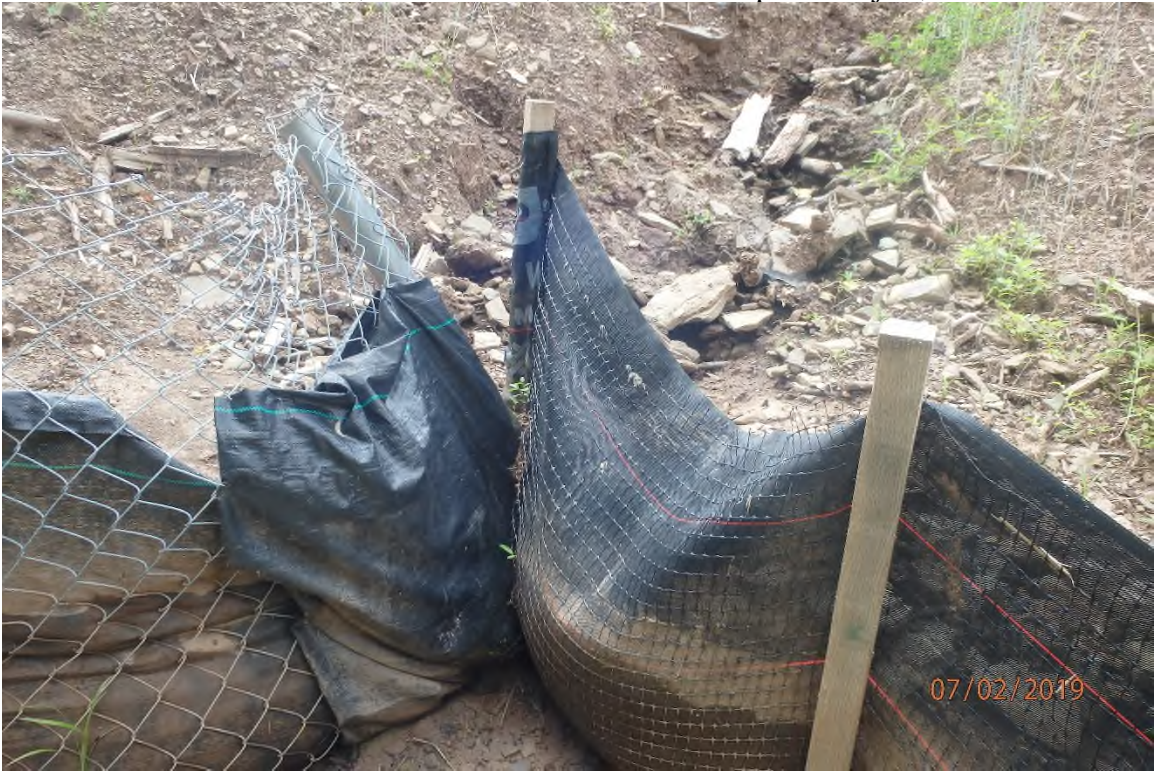
Improperly installed perimeter controls adjacent to 3214+00 that are inundated with sediment and in need of maintenance as a result of the previously pictured deficiency.

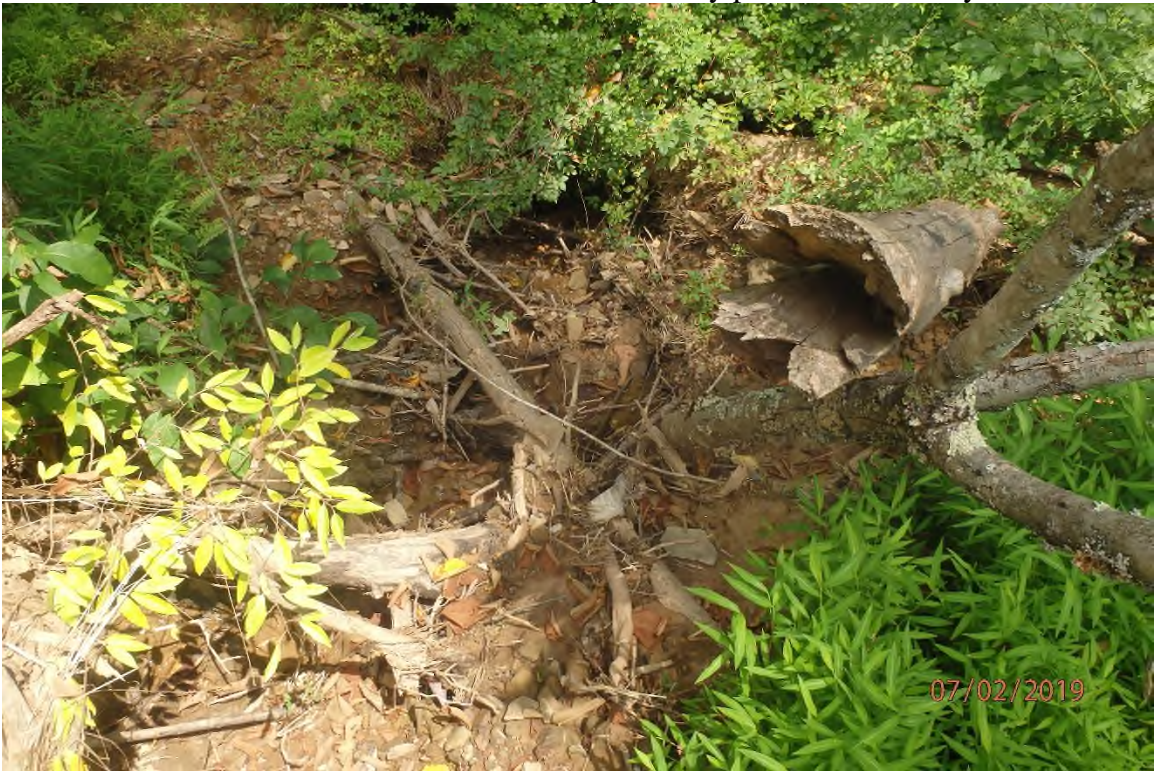
Improperly installed perimeter controls adjacent to 3214+00 that are inundated with sediment and in need of maintenance as a result of the previously pictured deficiency.

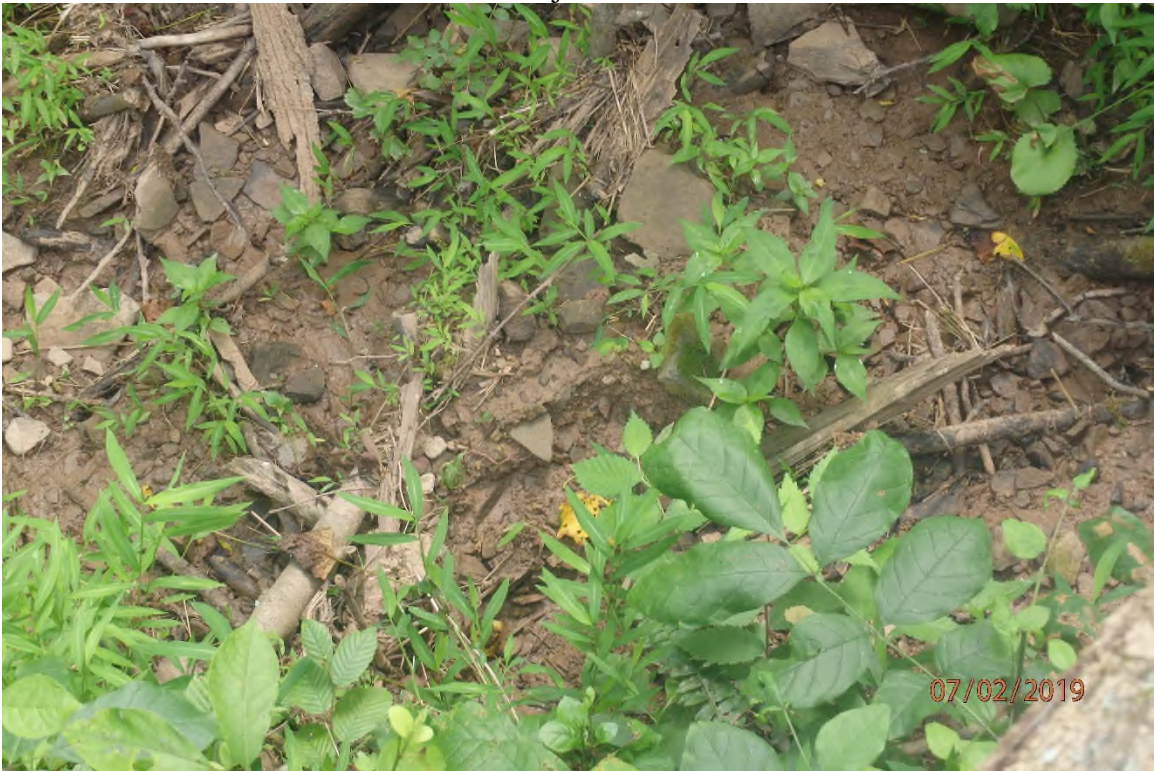
Trail of offsite sediment deposits leading to UNT Trap Run (SDON829) from the previously pictured deficiencies adjacent to 3214+00.

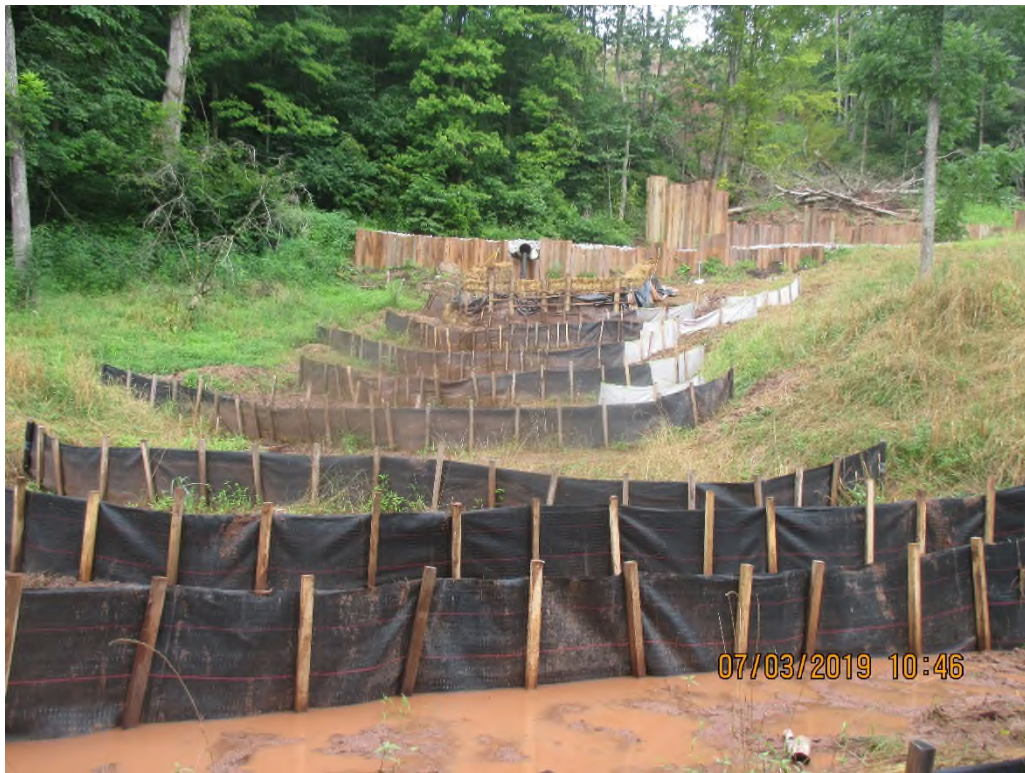
Culvert outlet downslope of Sulu Road leading to multiple controls upslope of 18-Mile creek.

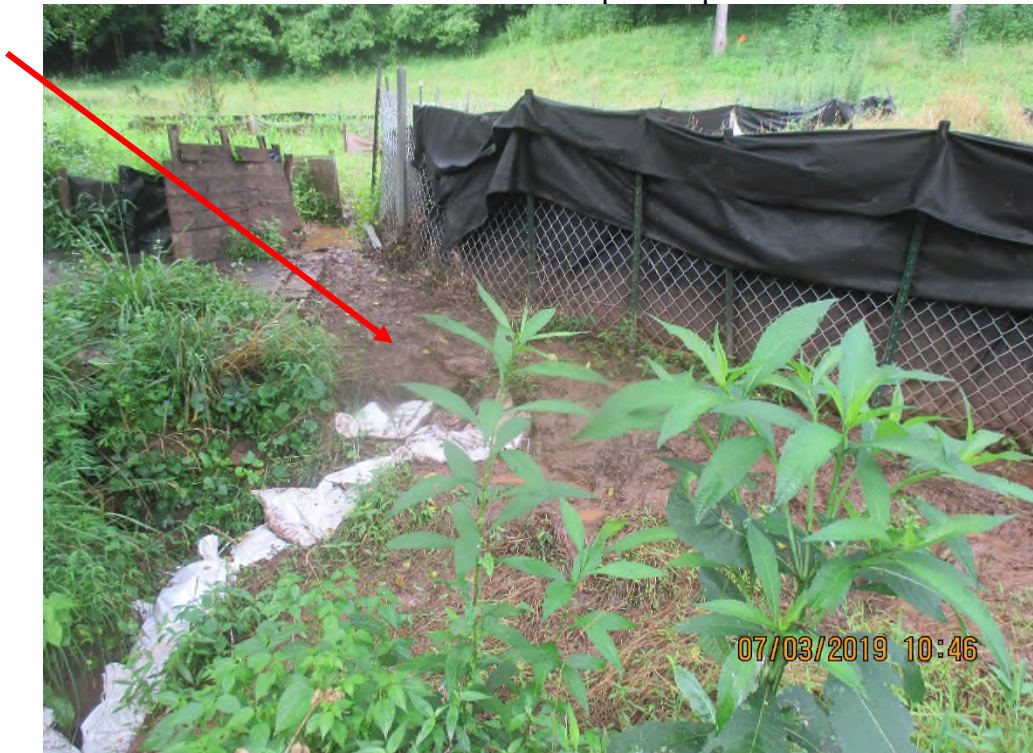
Last silt fence above 18-Mile Creek, upslope at Sulu road and slip.

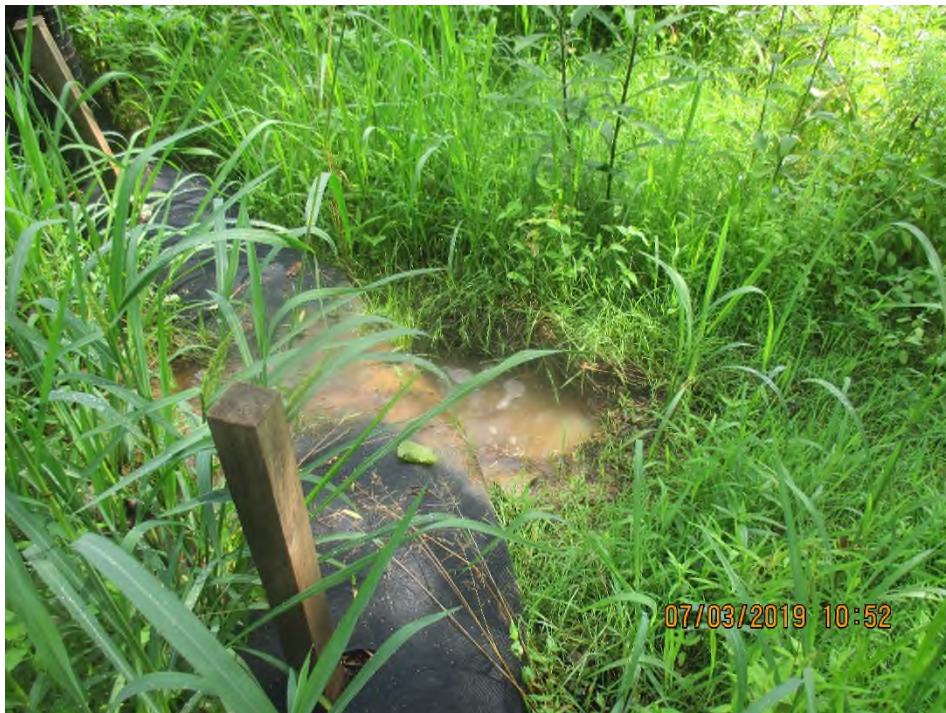
Second culvert outlet that covers under Sulu road and was receiving sediment laden water from ditch line impacted by slip.

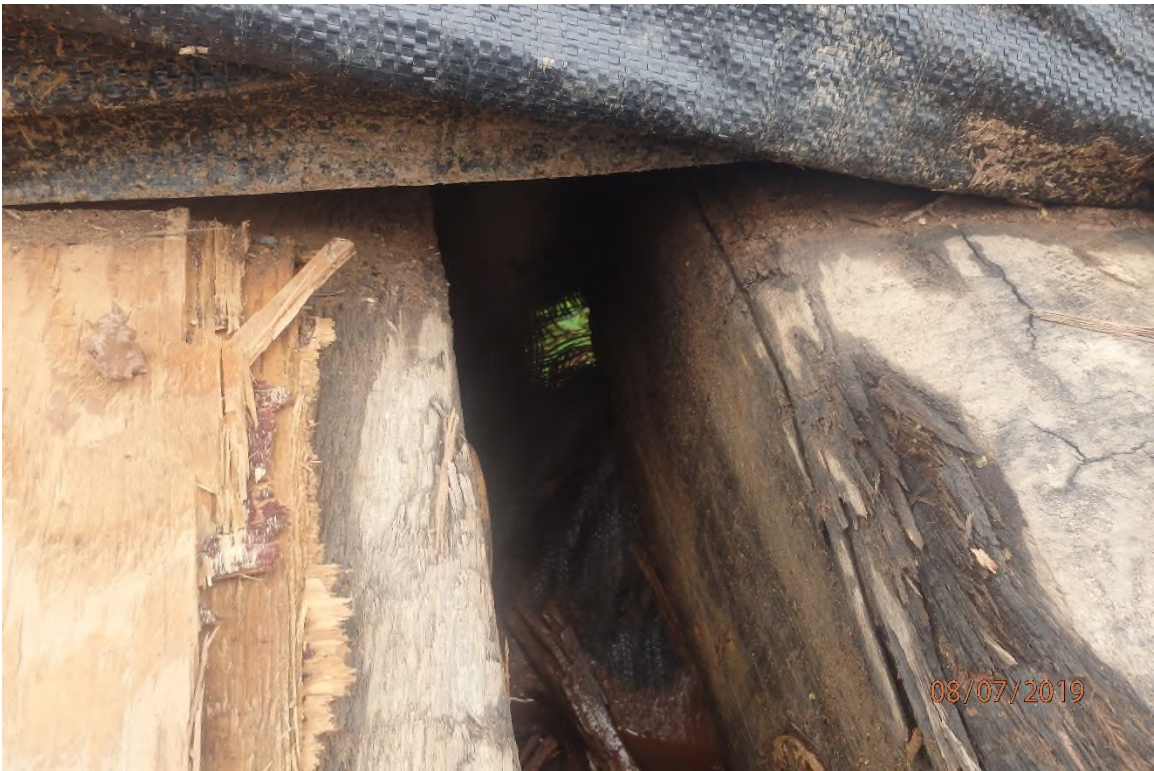
Installed timber mat equipment bridge at UNT Riggins Run (SDOG902) showing the need for maintenance.

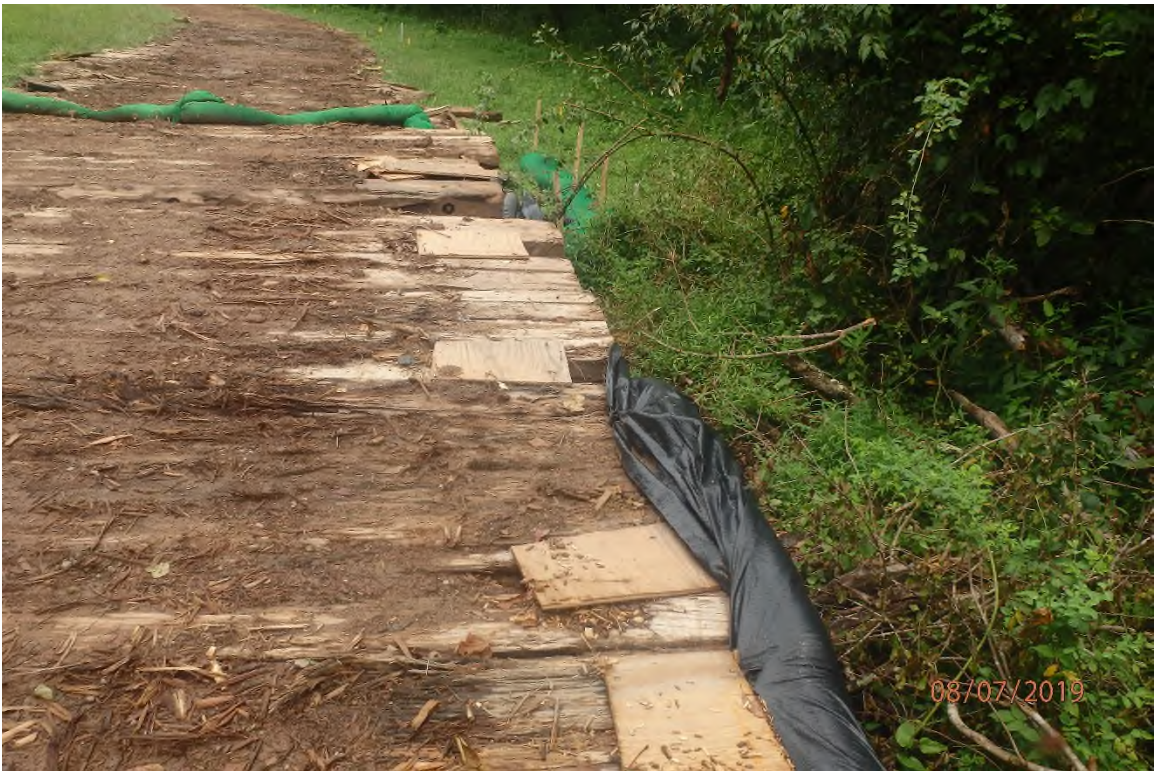
Installed timber mat equipment bridge at UNT Riggins Run (SDOG903) showing the need for maintenance.

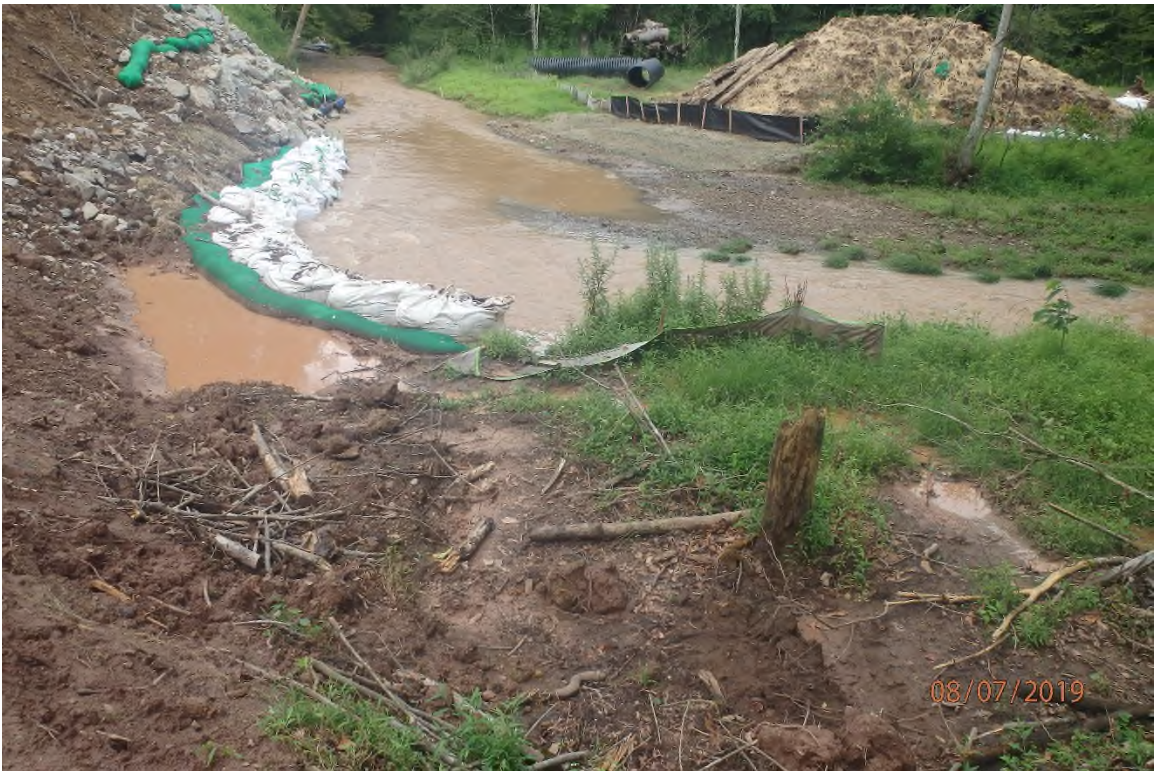
Perimeter controls at the slip repair site showing the need for maintenance.

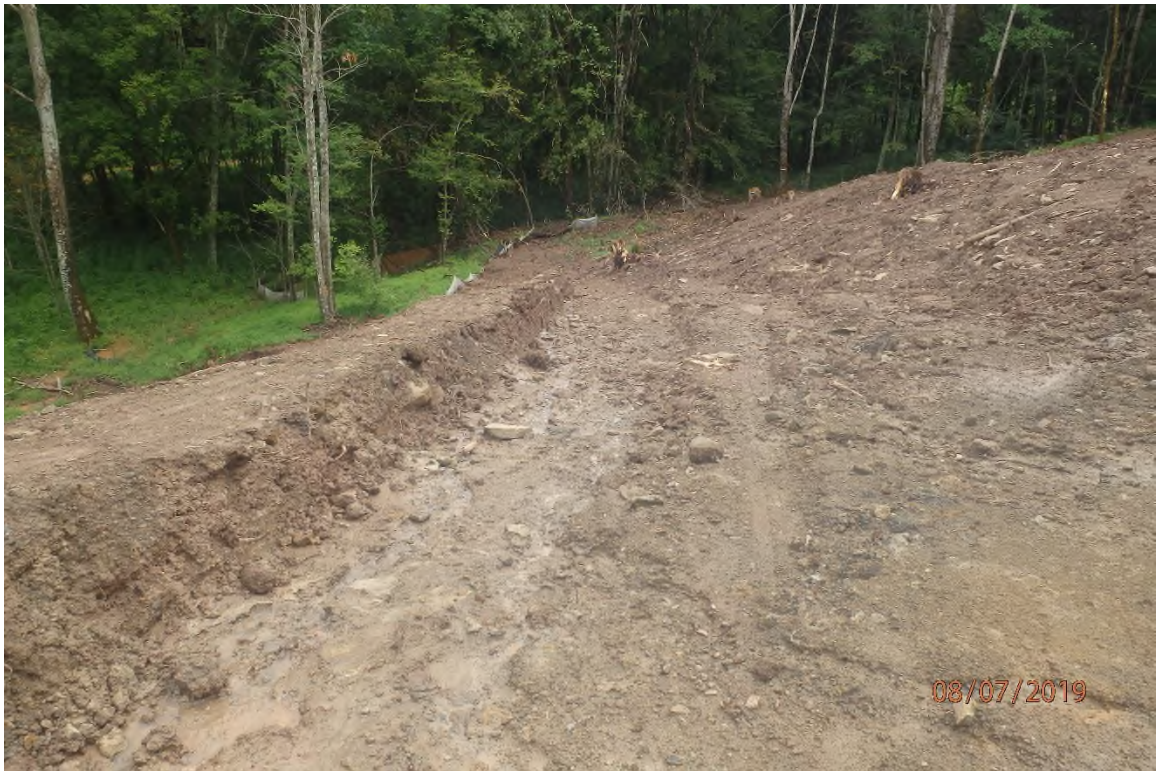
Water bars that were installed at steep angles in the Riggins Run watershed.

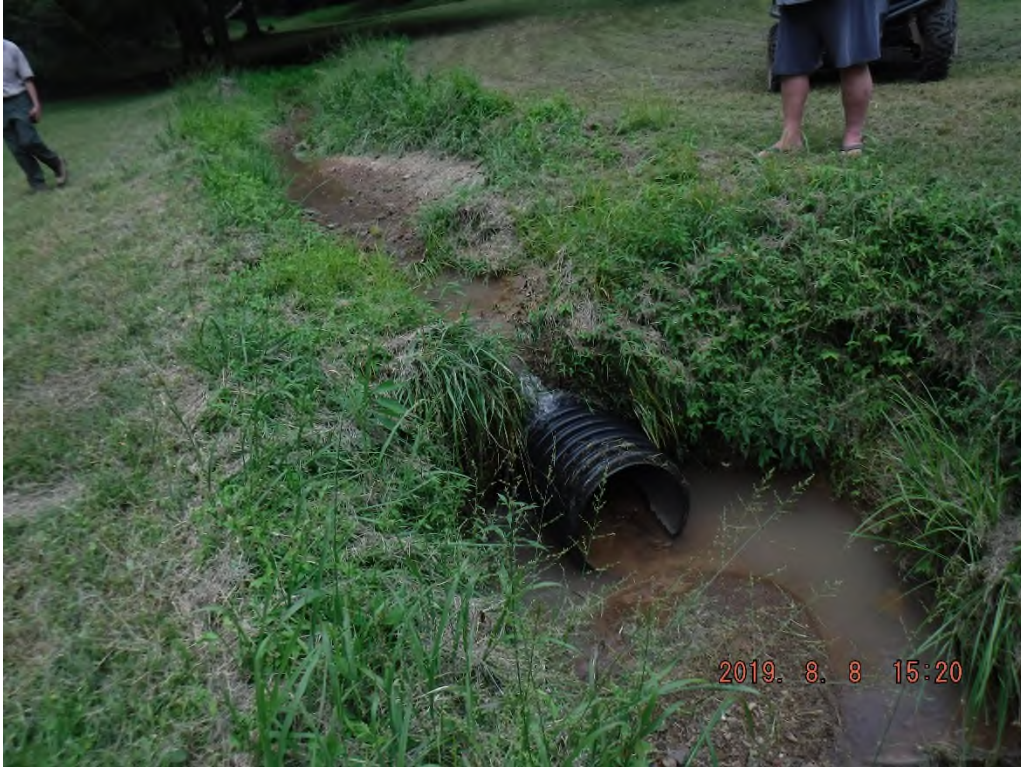
Culvert on west side showing sediment deposits from ROW runoff.

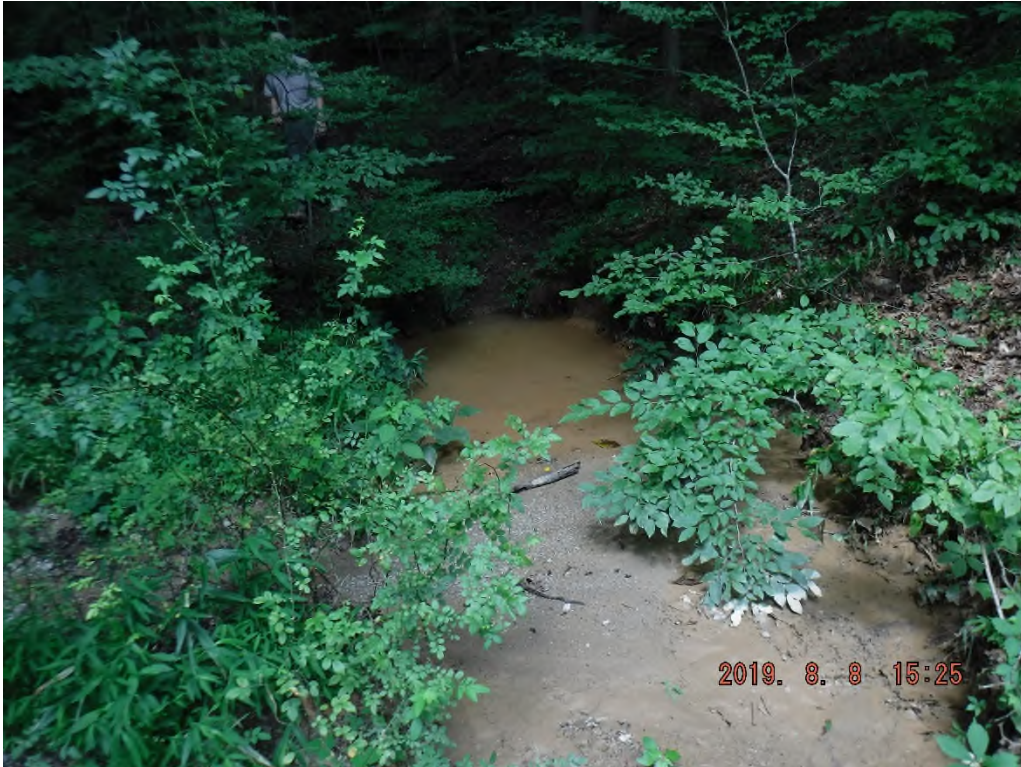
Culvert inlet below ROW on east side filled with sediment from runoff.

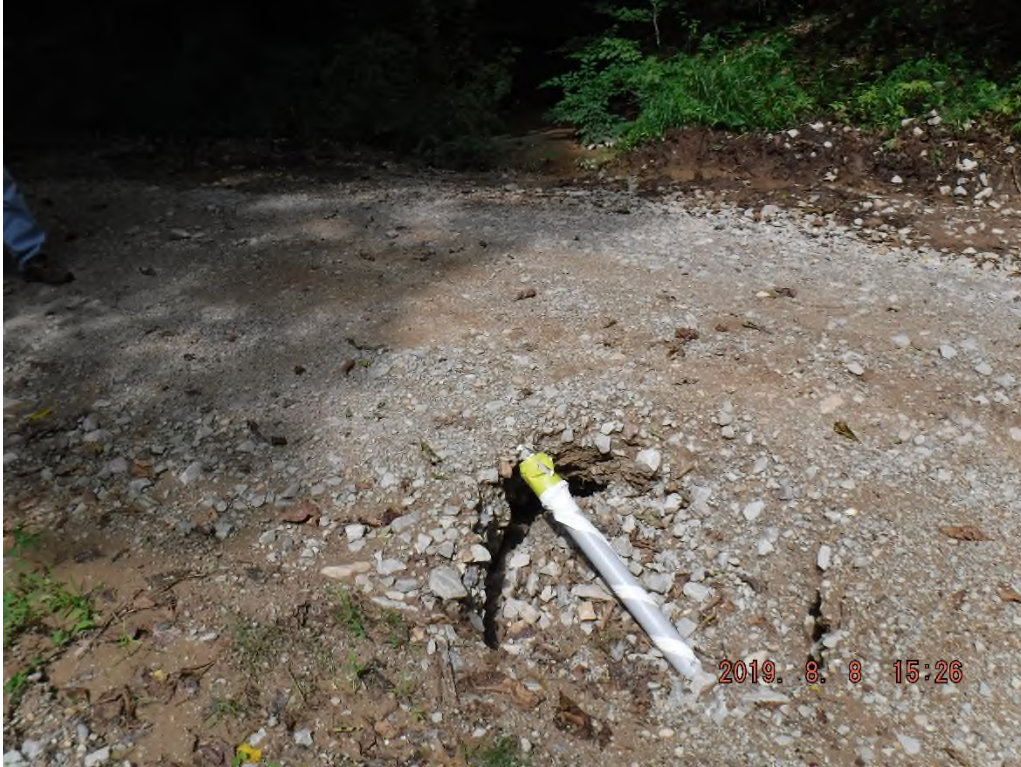
Runoff undermined the road, causing the slip.

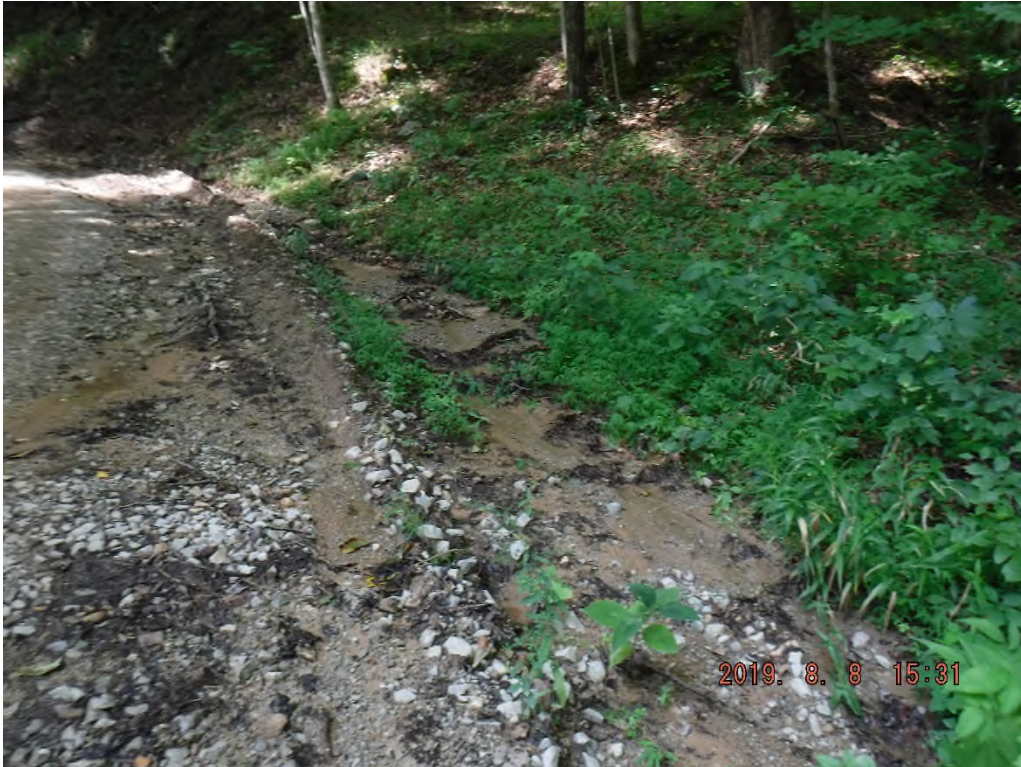
East side ditch filled with sediment from ROW runoff.

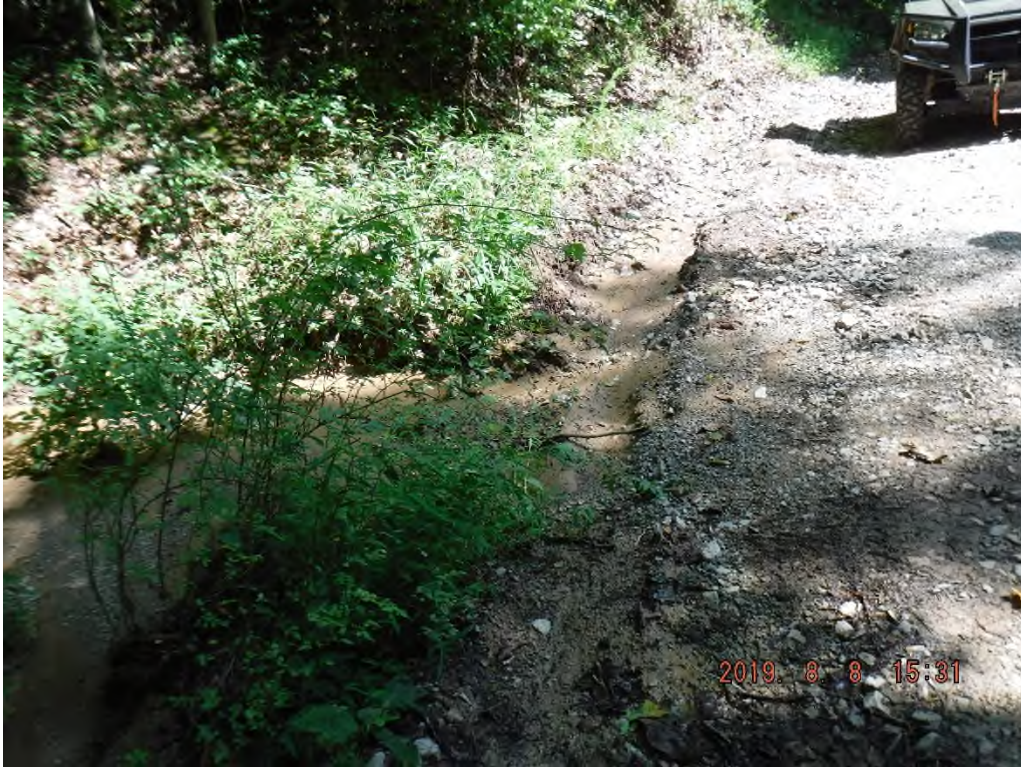
East ditchline at ROW filled with sediment from runoff.
