**CONSENT ORDER
ISSUED UNDER THE
WATER POLLUTION CONTROL ACT
WEST VIRGINIA CODE, CHAPTER 22, ARTICLE 11**

TO: Columbia Gas Transmission, LLC
Attn: Troy Tally, Vice President
1700 MacCorkle Ave
Charleston, WV 25314

DATE: October 1, 2020
ORDER NO.: 9061

1. Columbia Gas Transmission, LLC is conducting land disturbance activity associated with construction of the Mountaineer Xpress Project in Marshall, Wetzel, Tyler, Doddridge, Ritchie, Calhoun, Wirt, Roane, Jackson, Mason, Putnam, and Cabell Counties, West Virginia. On January 31, 2018, Columbia Gas Transmission, LLC was issued Water Pollution Control Permit No. WV0116815, Registration No. WVR310872, for Stormwater Associated With Oil and Gas Related Construction Activities.

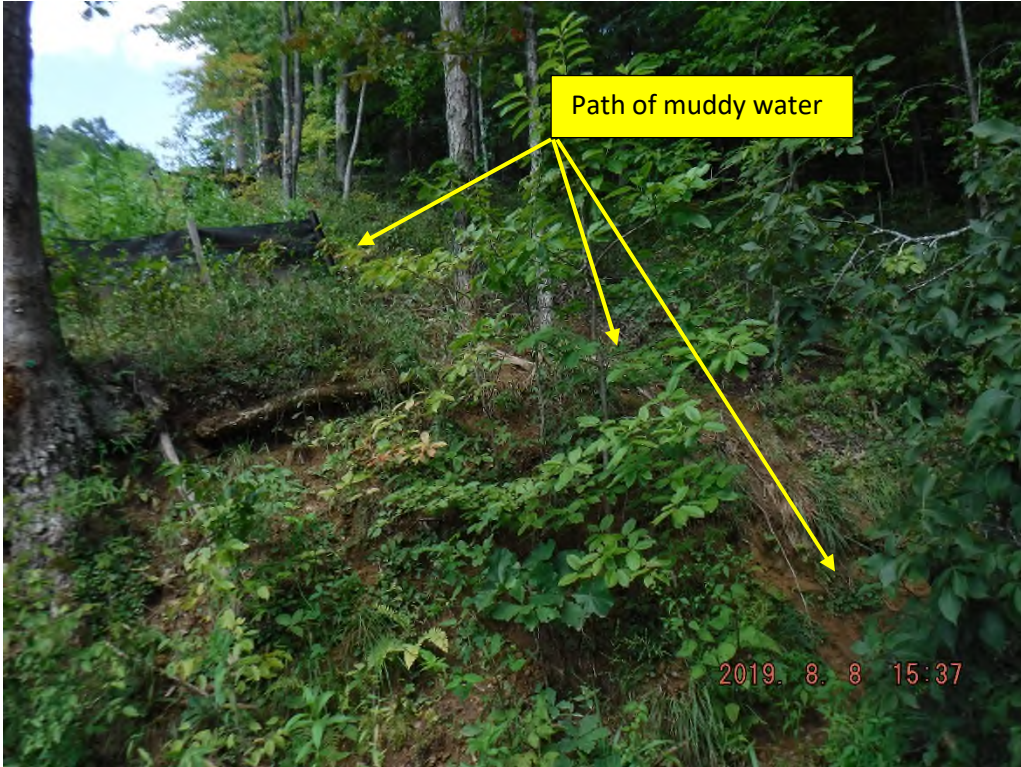
Path of sediment laden water detoured around silt fence resulting in sediment deposits.

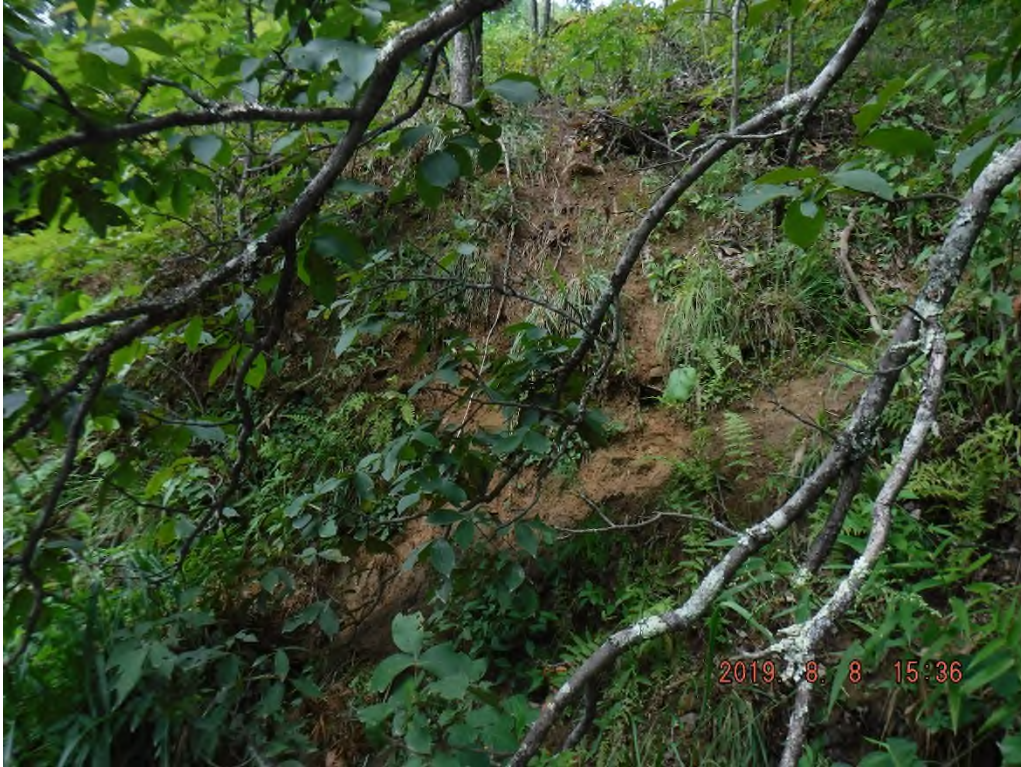
Path of sediment laden water and deposits above east side road ditch.

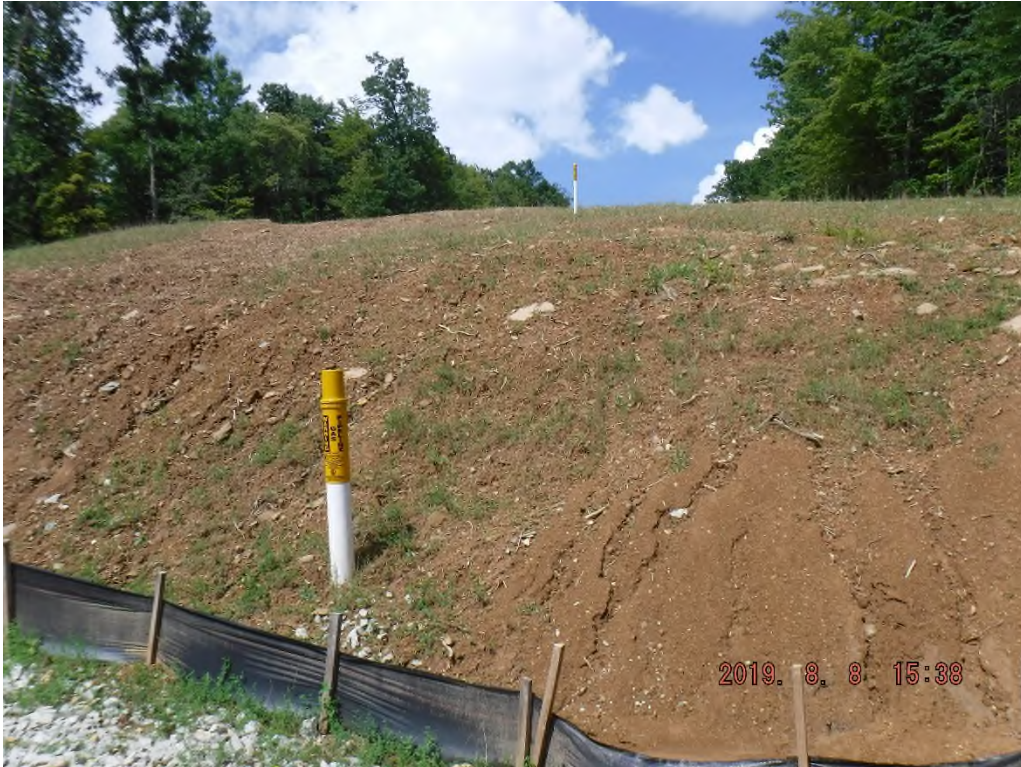
Erosion gullies on fill slope.

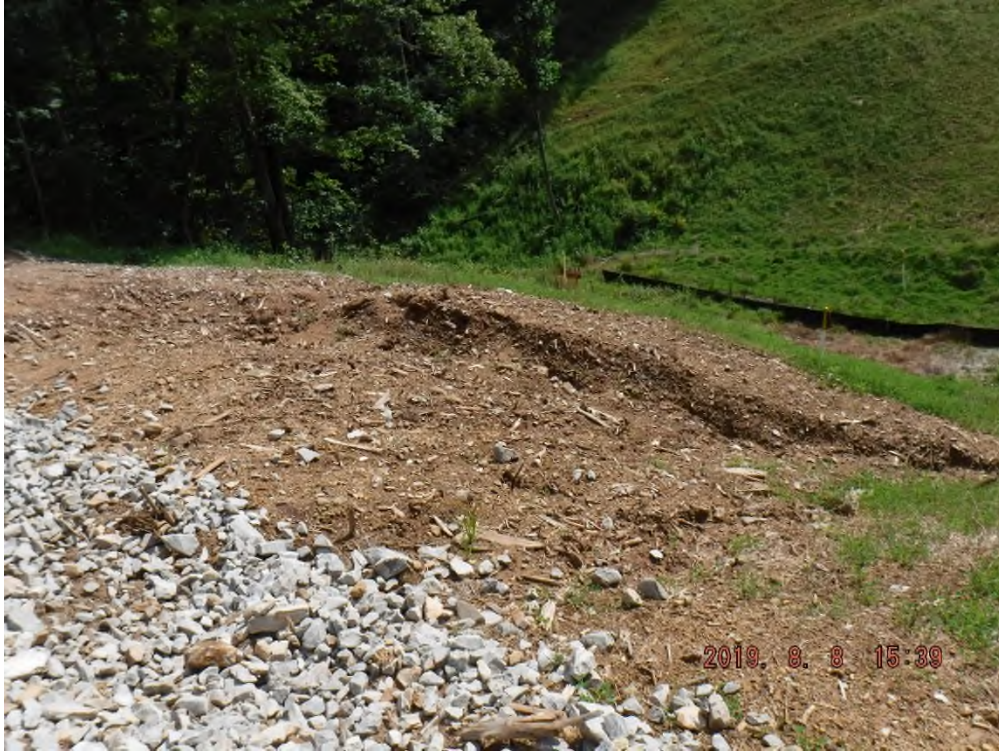
Water bar not installed correctly.

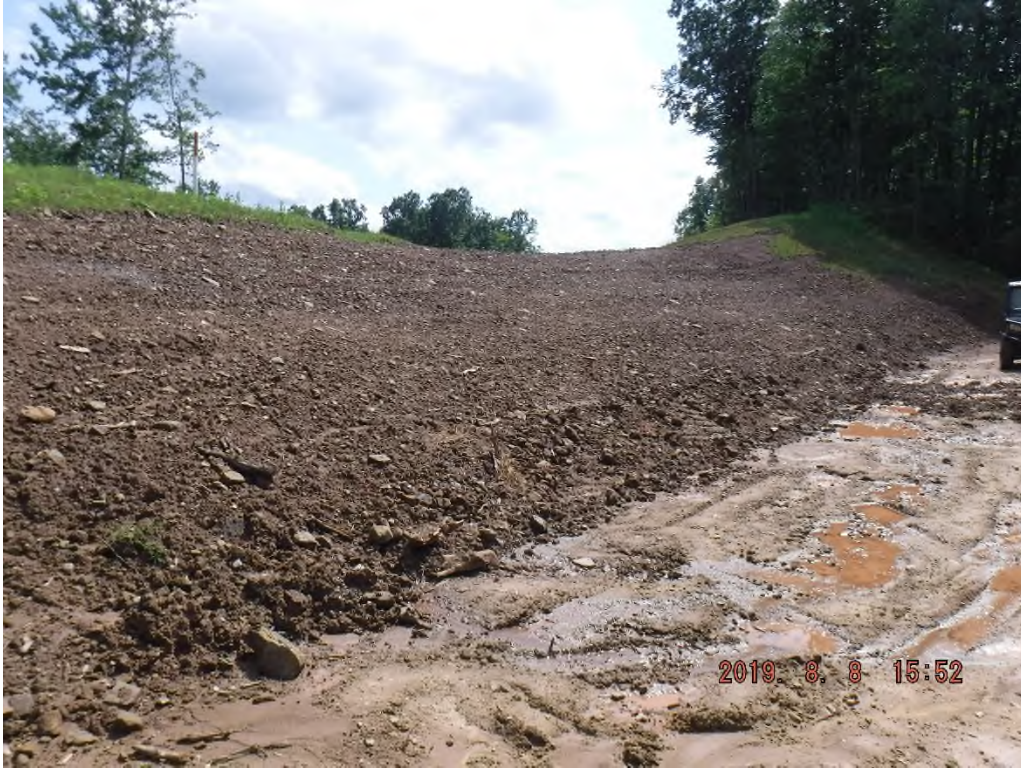
No controls were installed along access road, and seed failed to germinate.

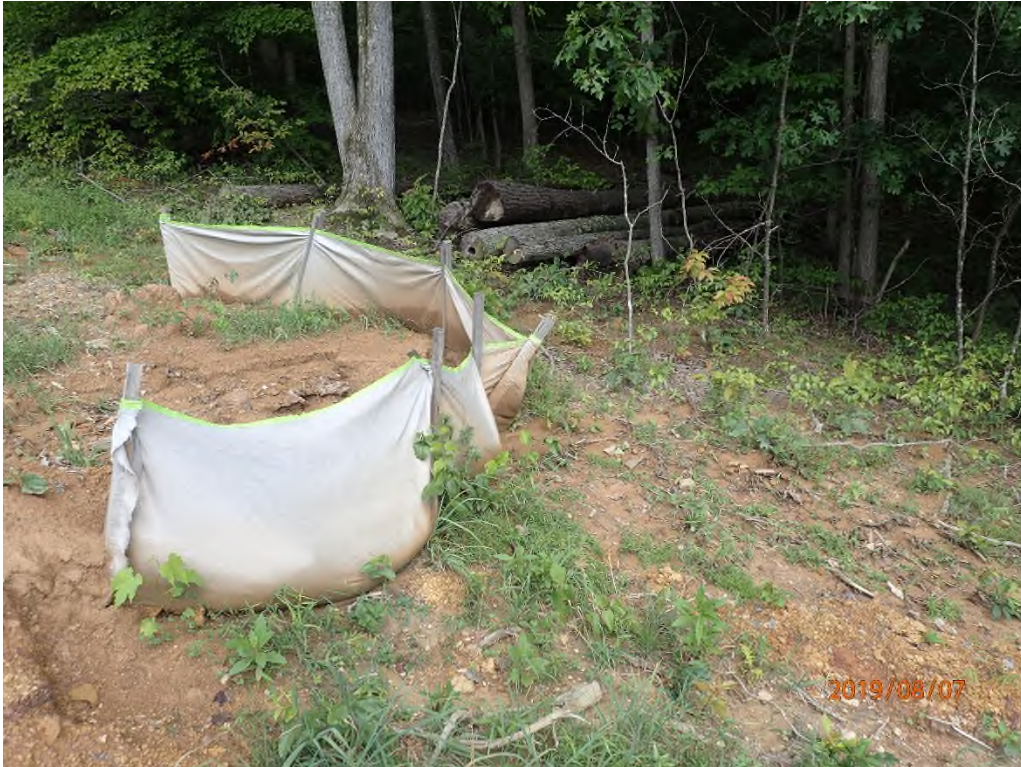
Sump not maintained. Several were noted along the inspected ROW.

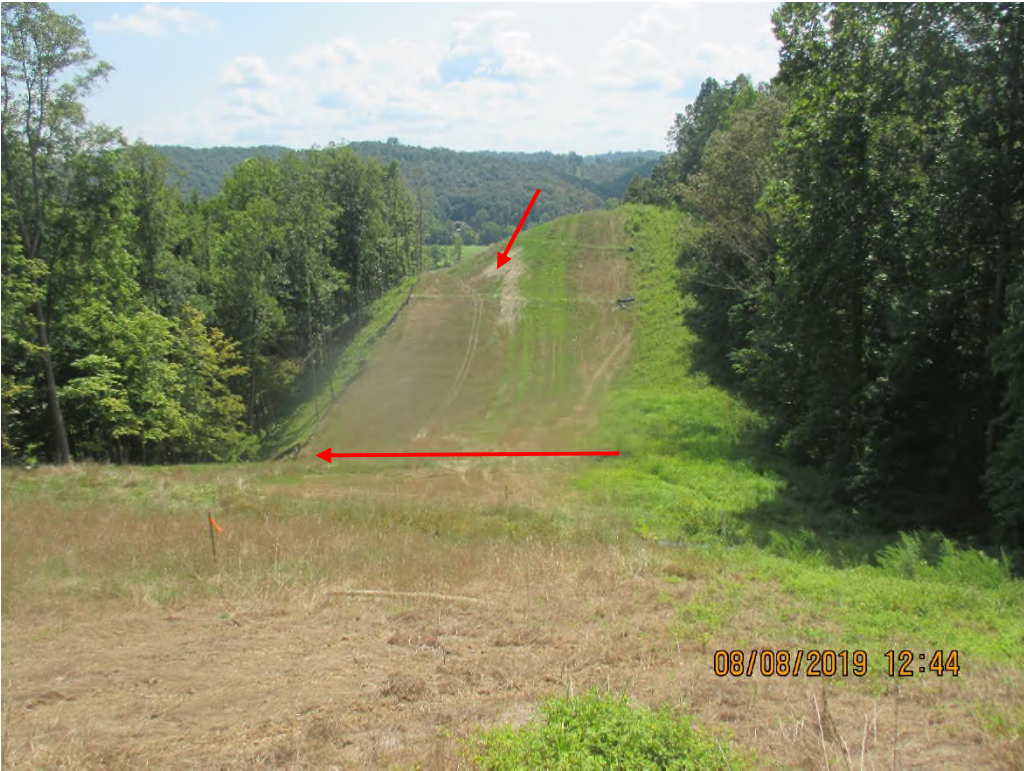
Near station No. 8772+72 facing South. Arrow depicts slip area and drainage point in between slopes leading to overwhelmed perimeter controls.

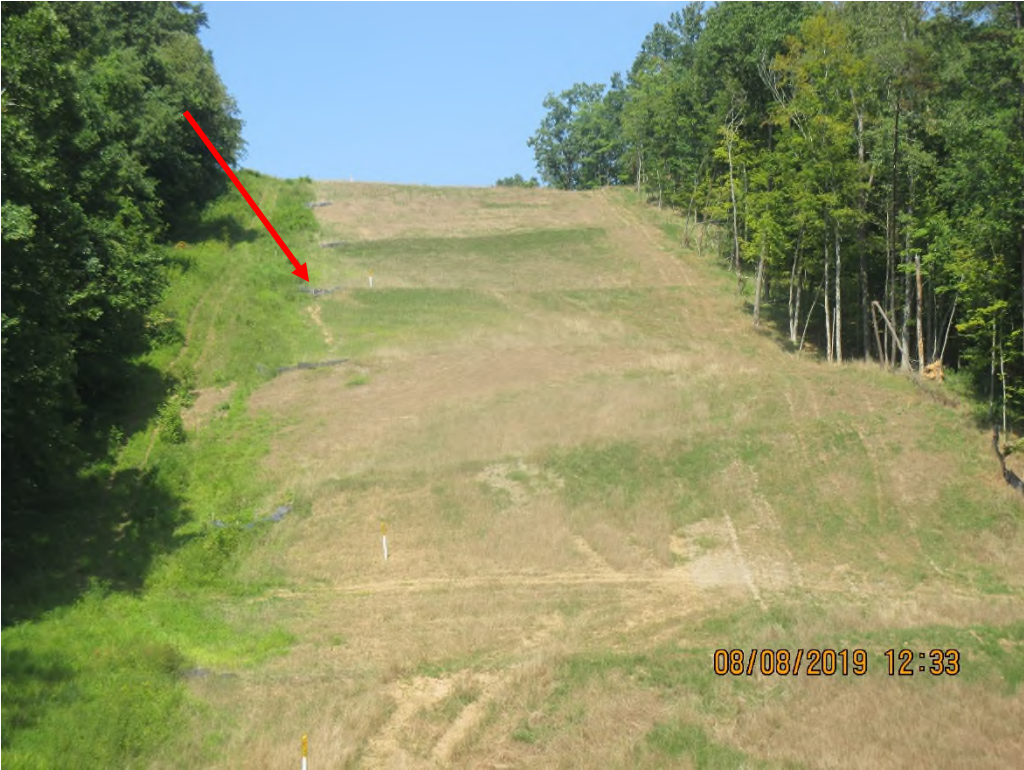
Adjacent slope facing North. Arrow depicts waterbar outlet control failure causing erosion on slope.

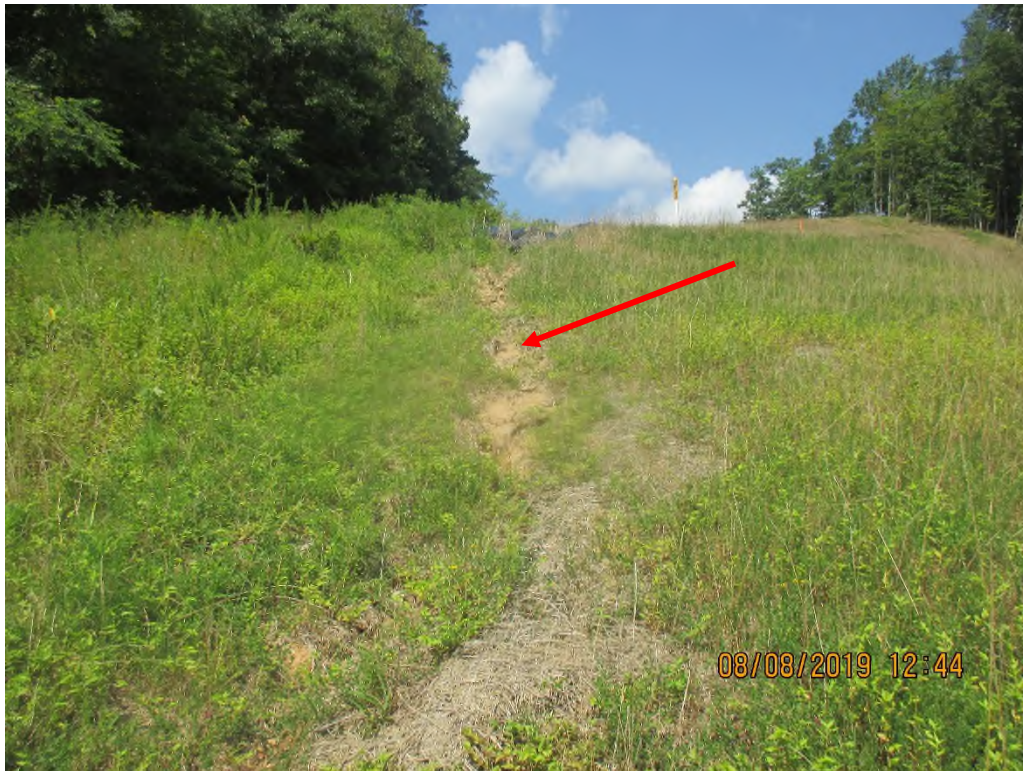
Facing upslope towards waterbar outlet controls. Arrow depicts erosion caused by outlet control failure.

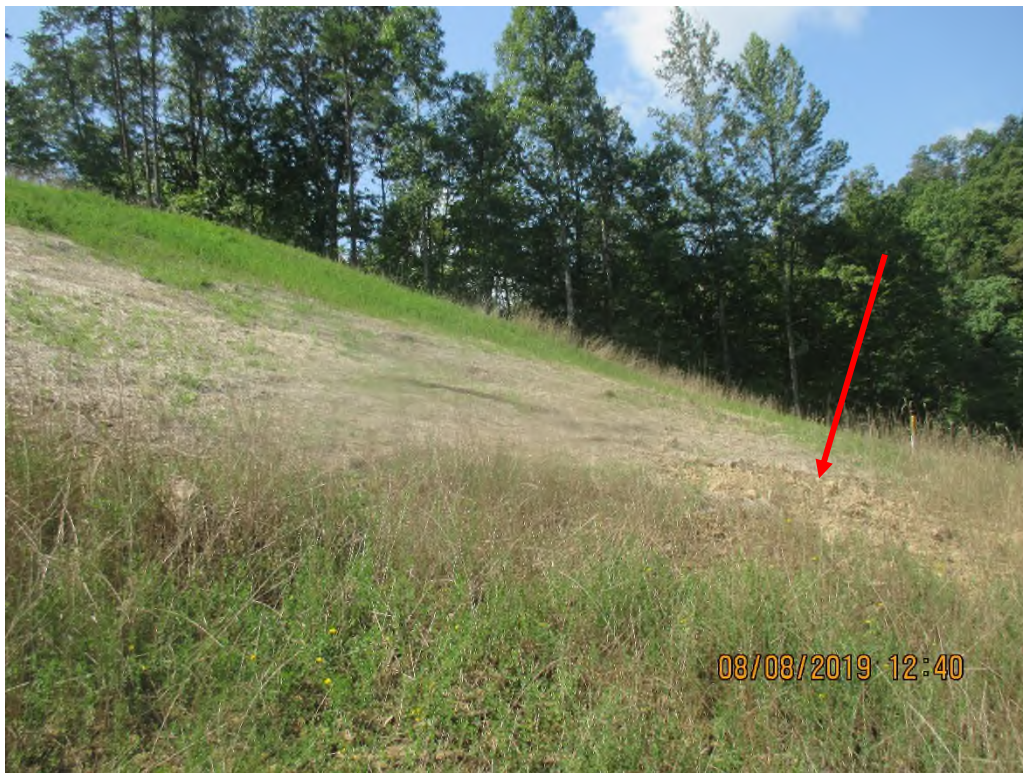
Area where curlex had been added to stabilize slope. Soil was slipping from under the curlex and being transported downslope towards perimeter controls. Arrow depicts slipped material.

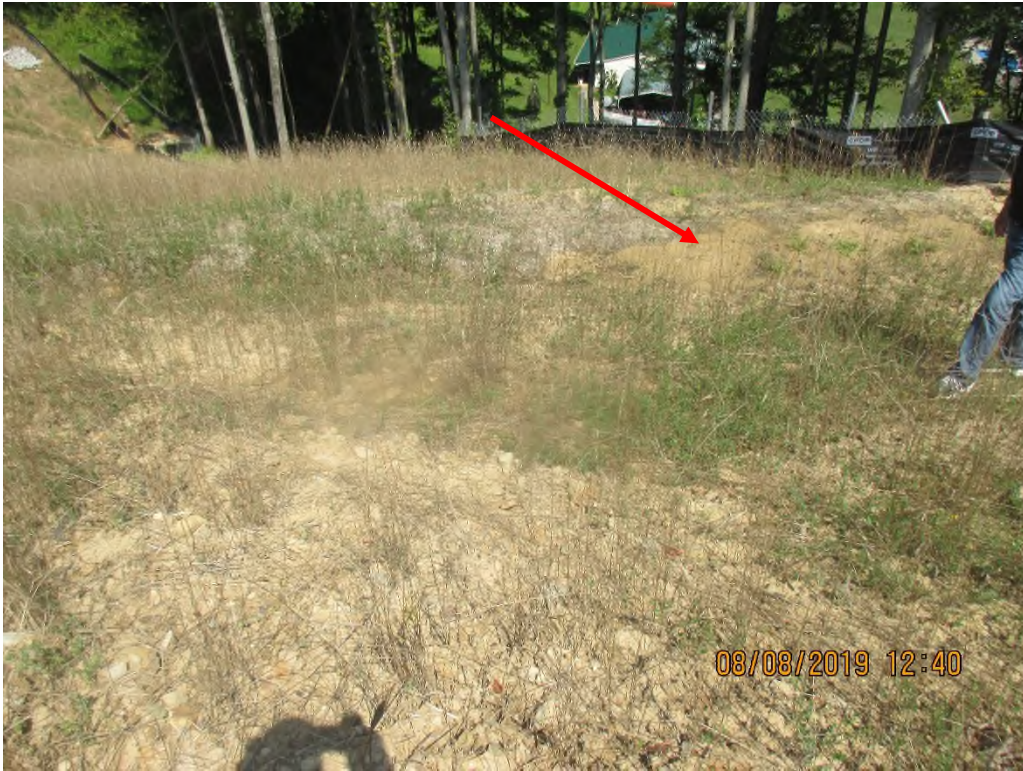
Downslope of slipped material. Sediment being transported into waterbar towards perimeter controls. Arrow depicts sediment accumulation in waterbar.

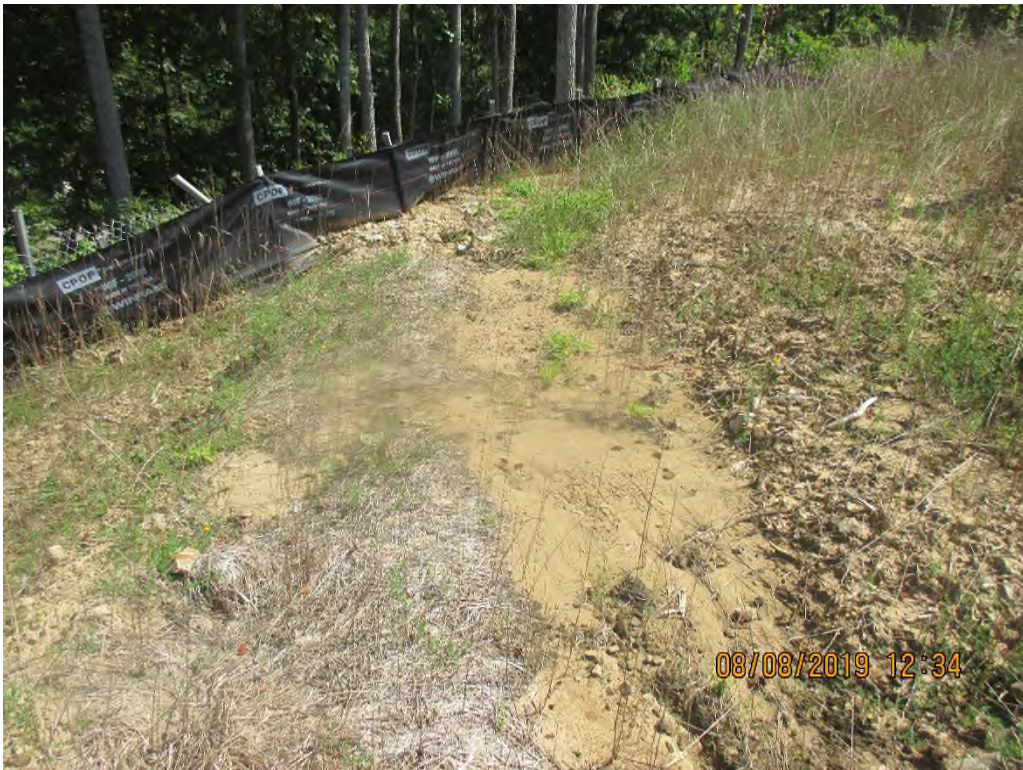
Slipped material accumulating in waterbar at edge of LOD with no outlet control at waterbar terminus near station No. 8772+72.

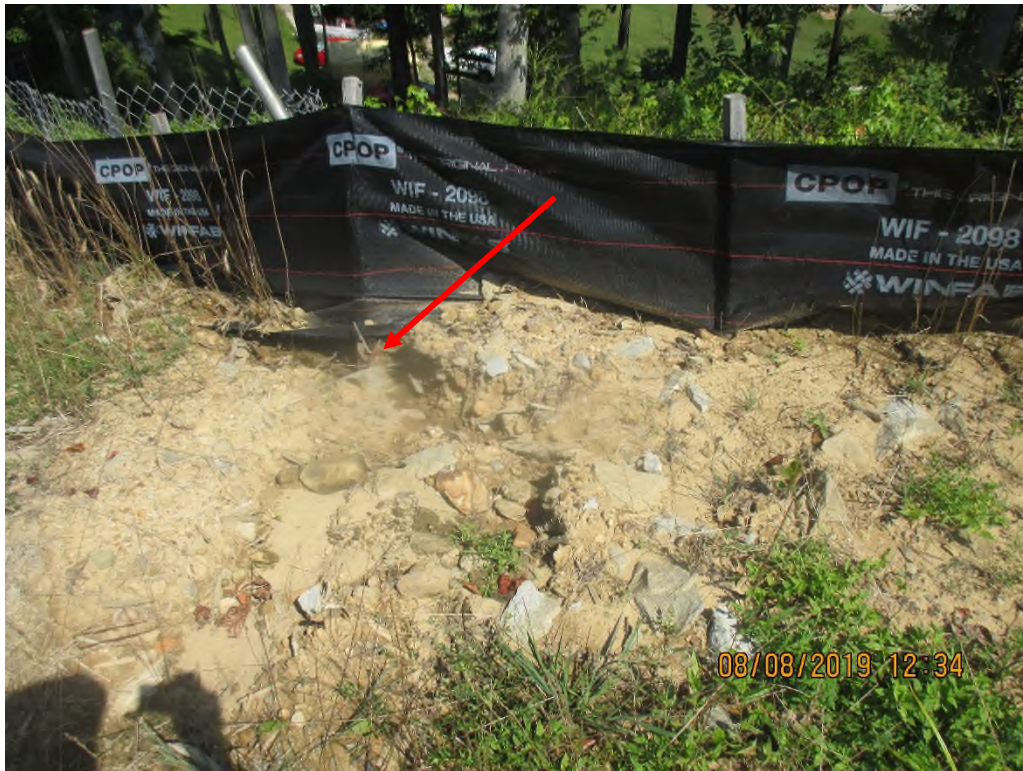
Perimeter control at Waterbar termini downslope of slipped material. Perimeter control overwhelmed and undermined due to concentrated flow.

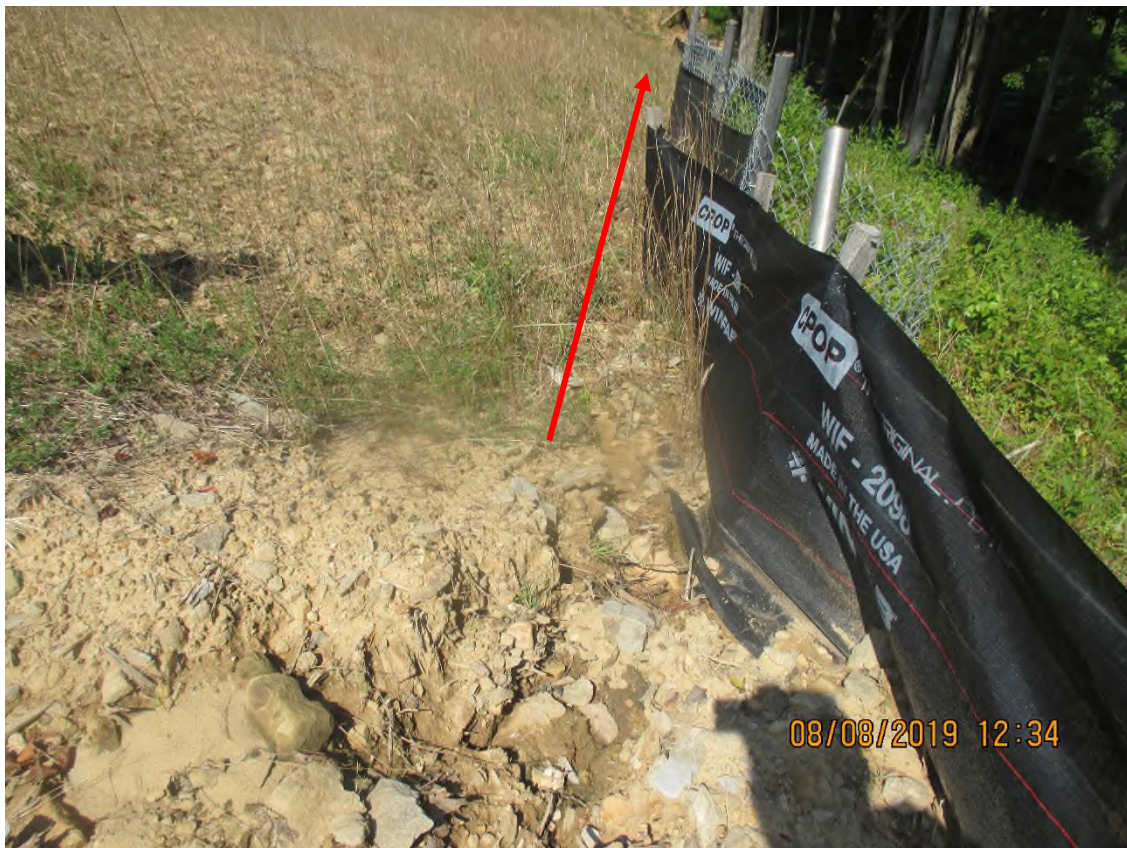
Arrow depicts where erosion was present along perimeter controls flowing towards drainage with overwhelmed outlet controls.

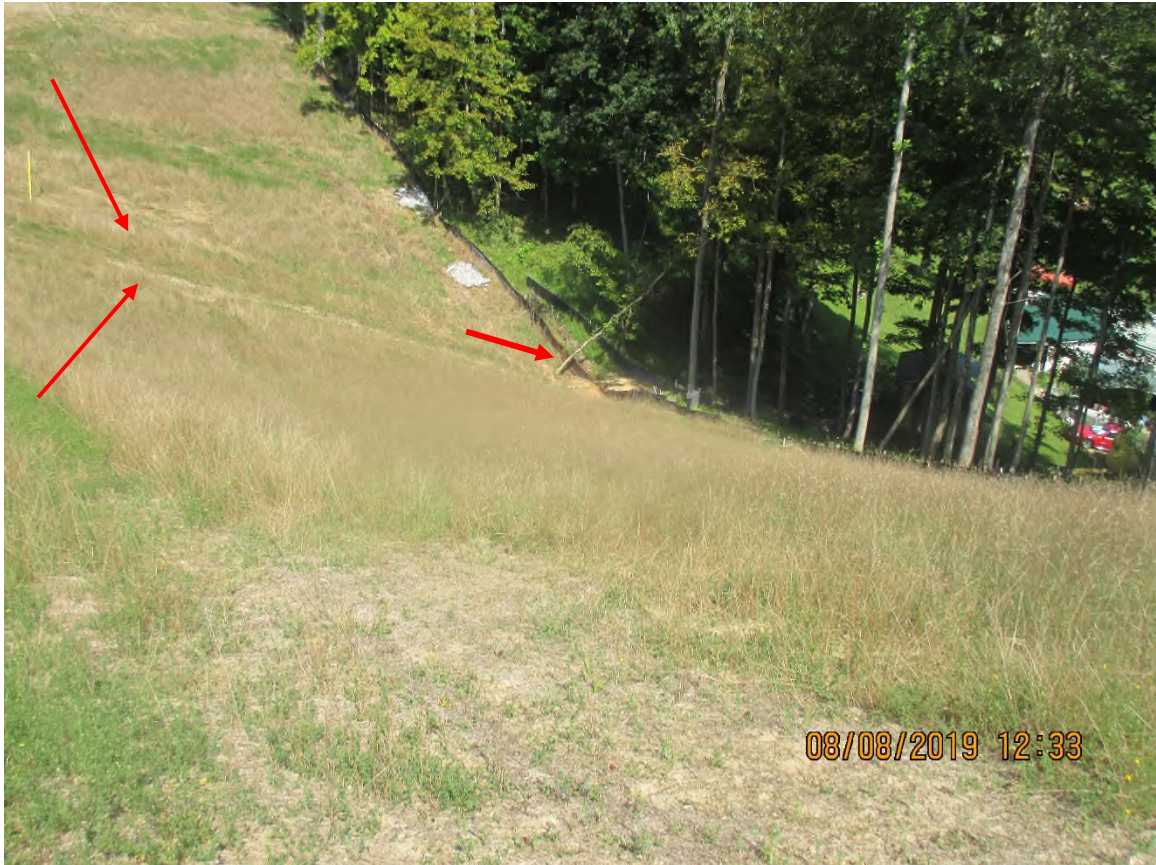
Drainage area between the two slopes facing North. Arrow depicts where erosion was occurring and overwhelming perimeter controls.

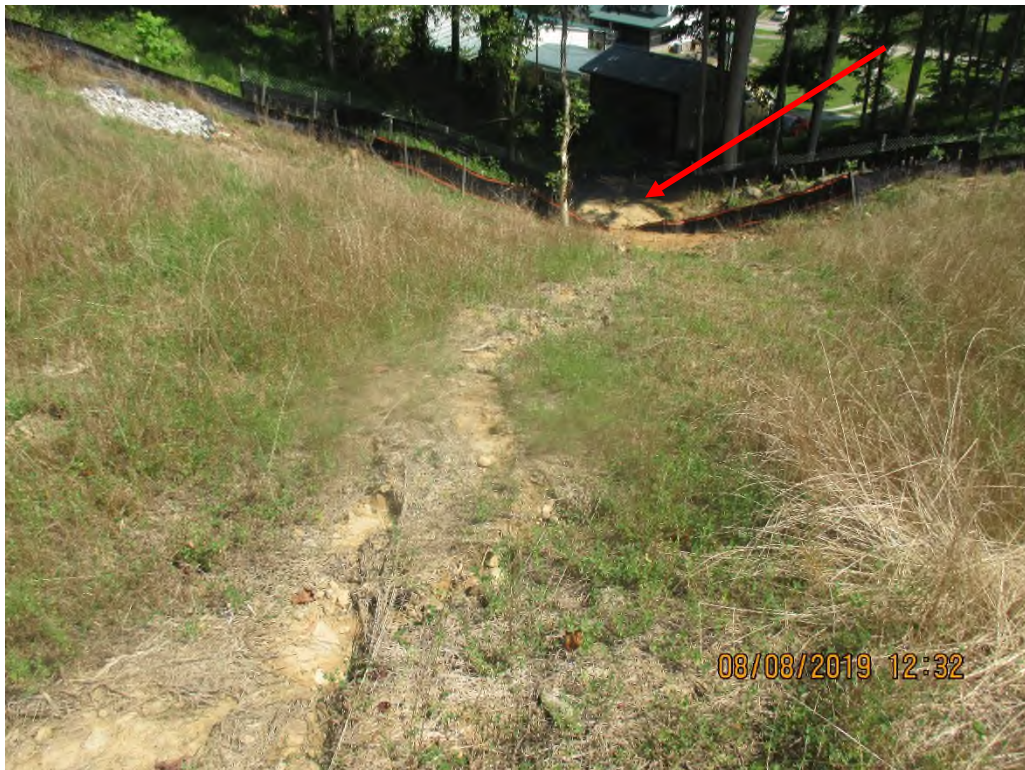
Drainage point between two slopes where erosion was present. Arrow depicts controls overwhelmed with sediment.

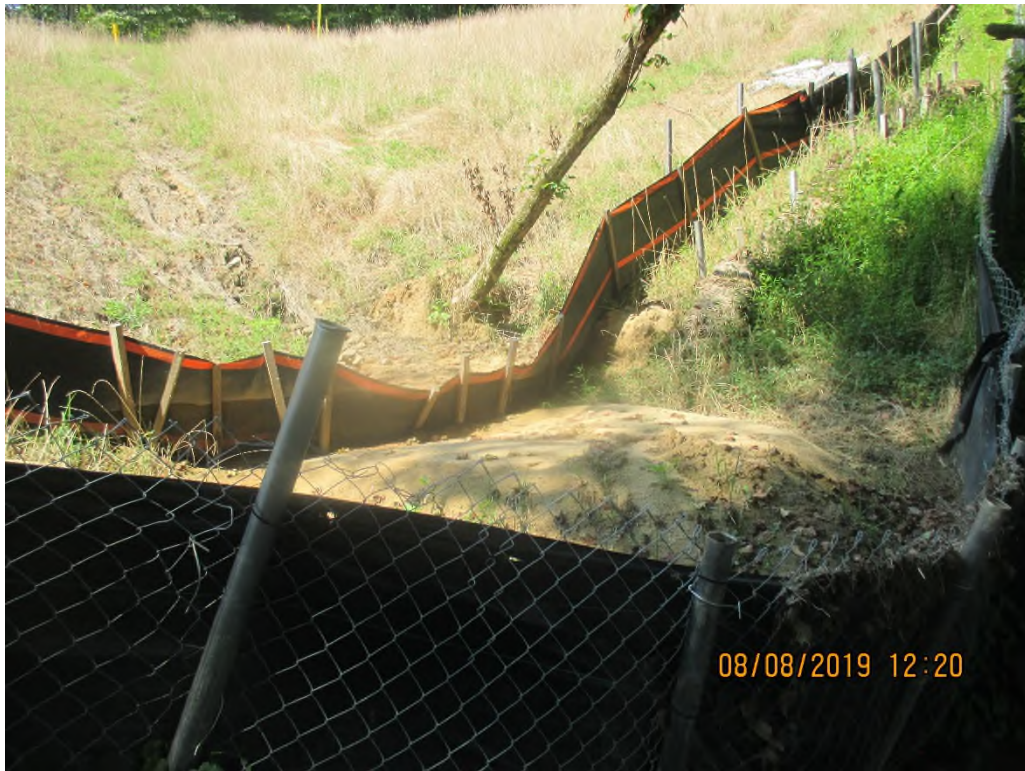
Perimeter controls overwhelmed with sediment due to erosion on slopes near station No. 8772+72.

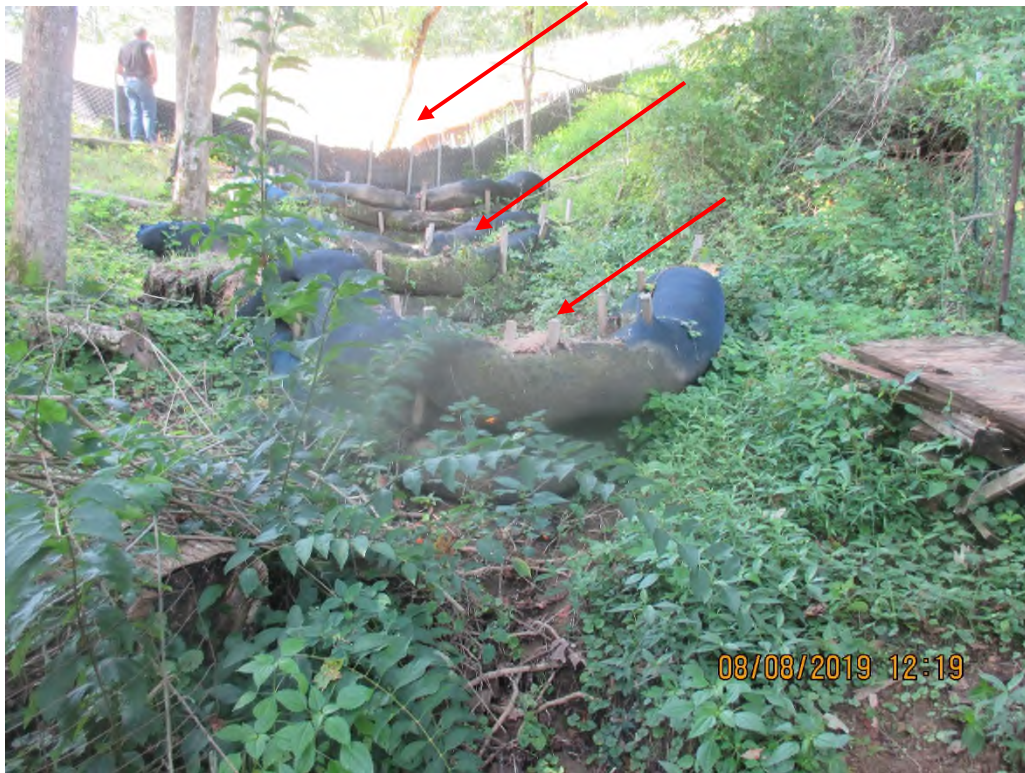
Perimeter Controls that were overwhelmed with sediment.

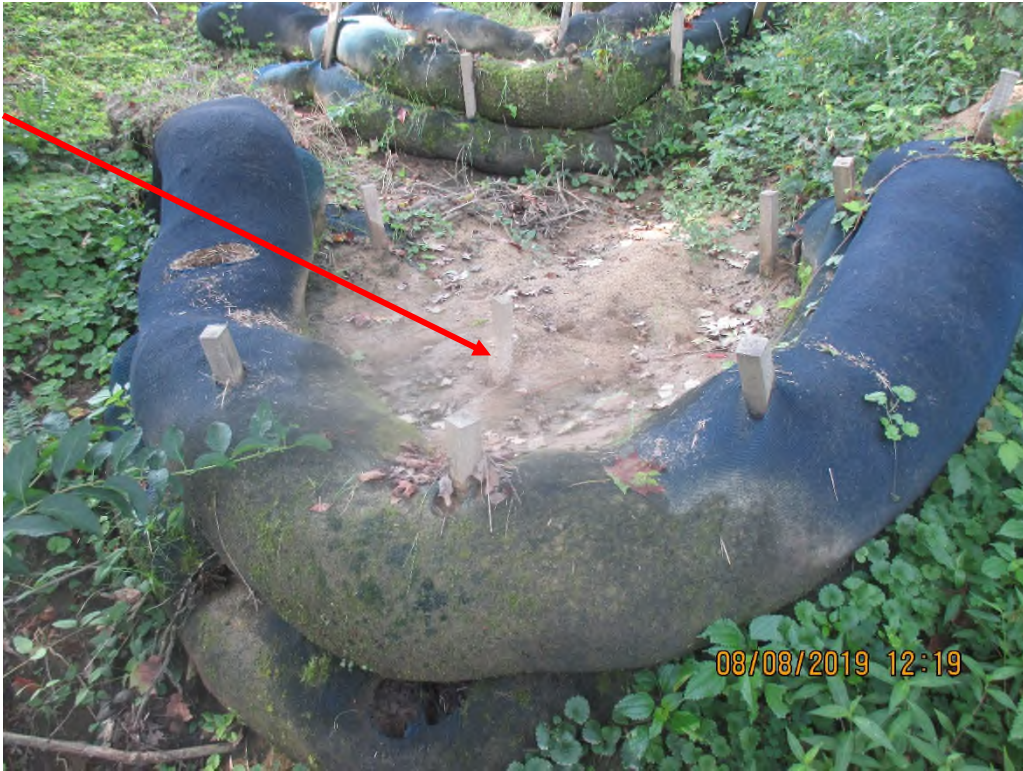
Perimeter controls overwhelmed with sediment and not being maintained.

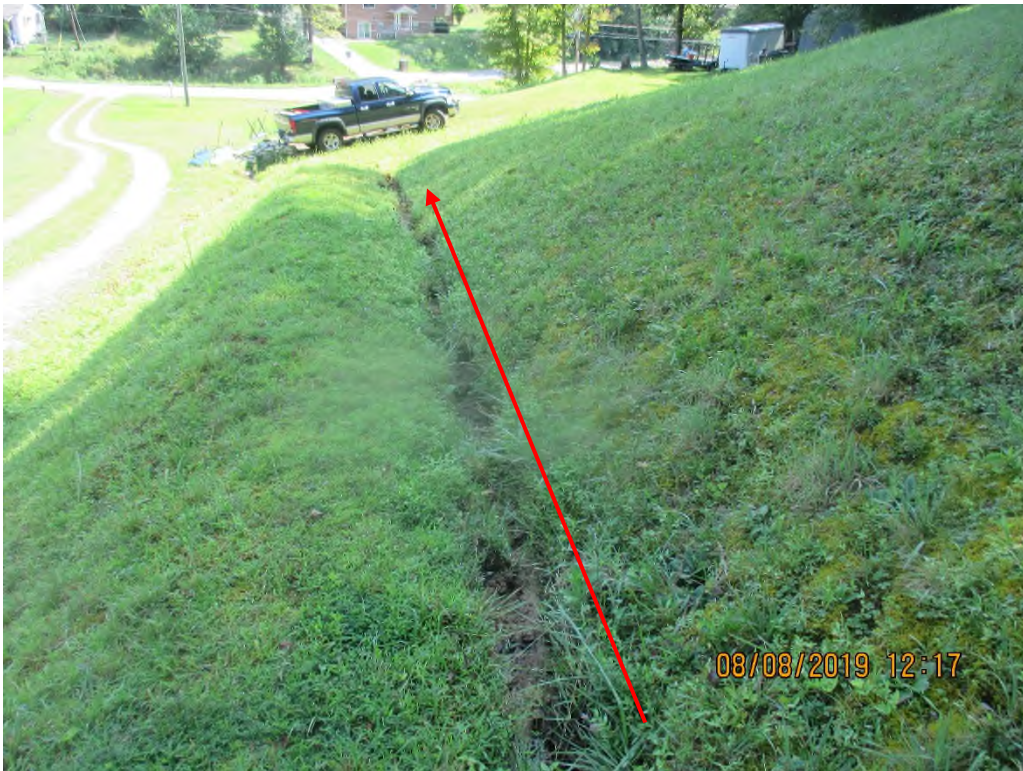
Ditch line conveying across complainants' yard towards Charles Creek Road.

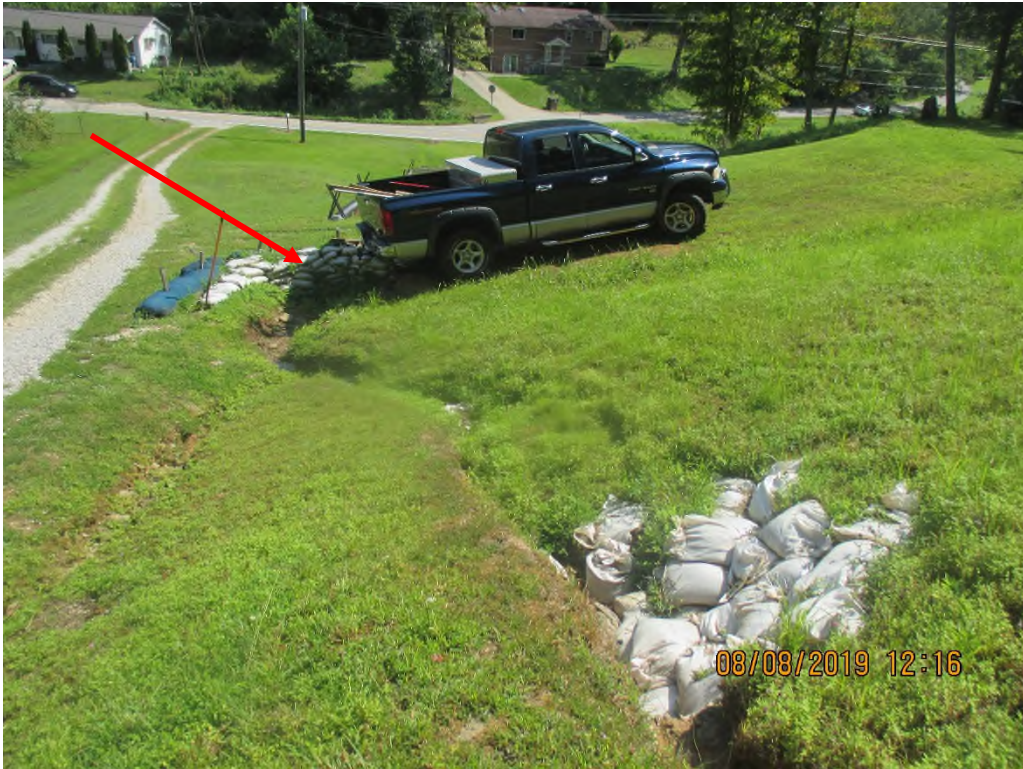
Sandbags installed to stabilize ditch. Arrow depicts where slope drain inlet was located.

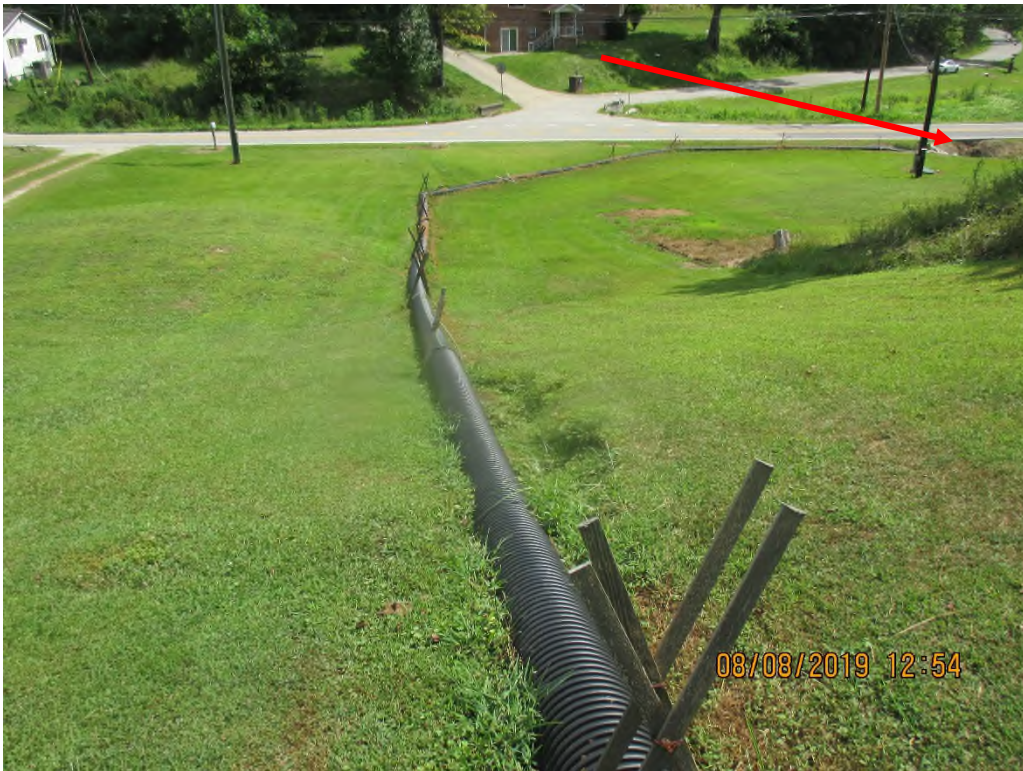
Slope drain conveying across complainants' yard and into roadside ditch. Arrow depicts where slope drain terminated into culvert that conveys under Charles Creek Road.

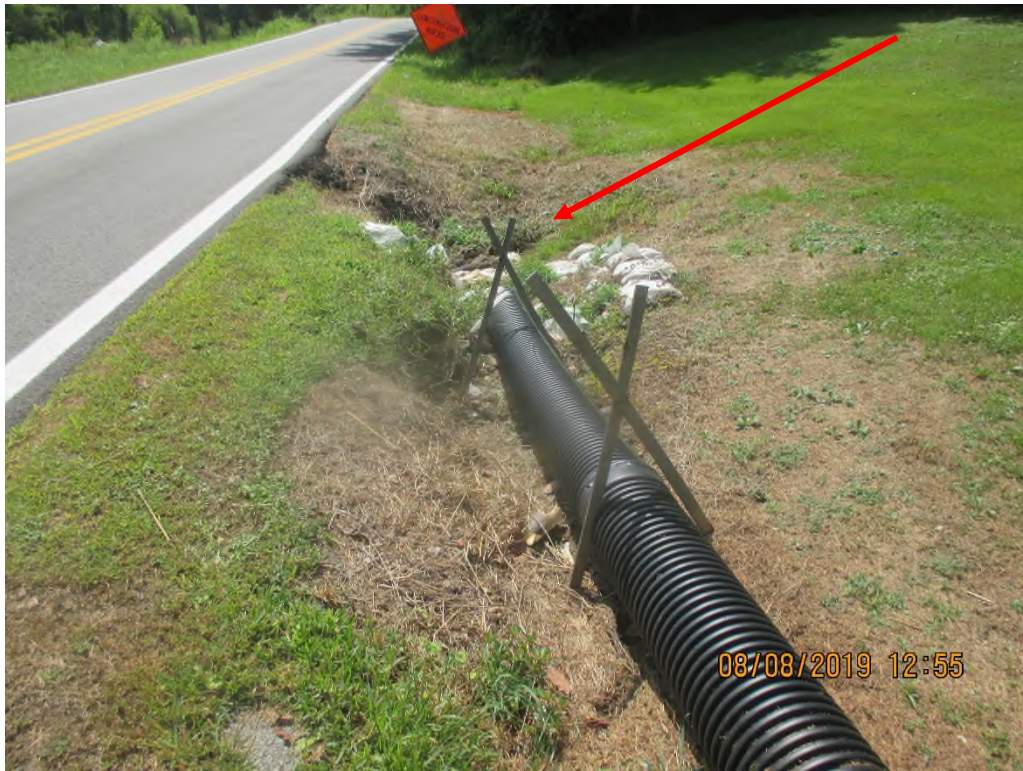
Slope drain outlet above culvert that conveys under Charles Creek Road.

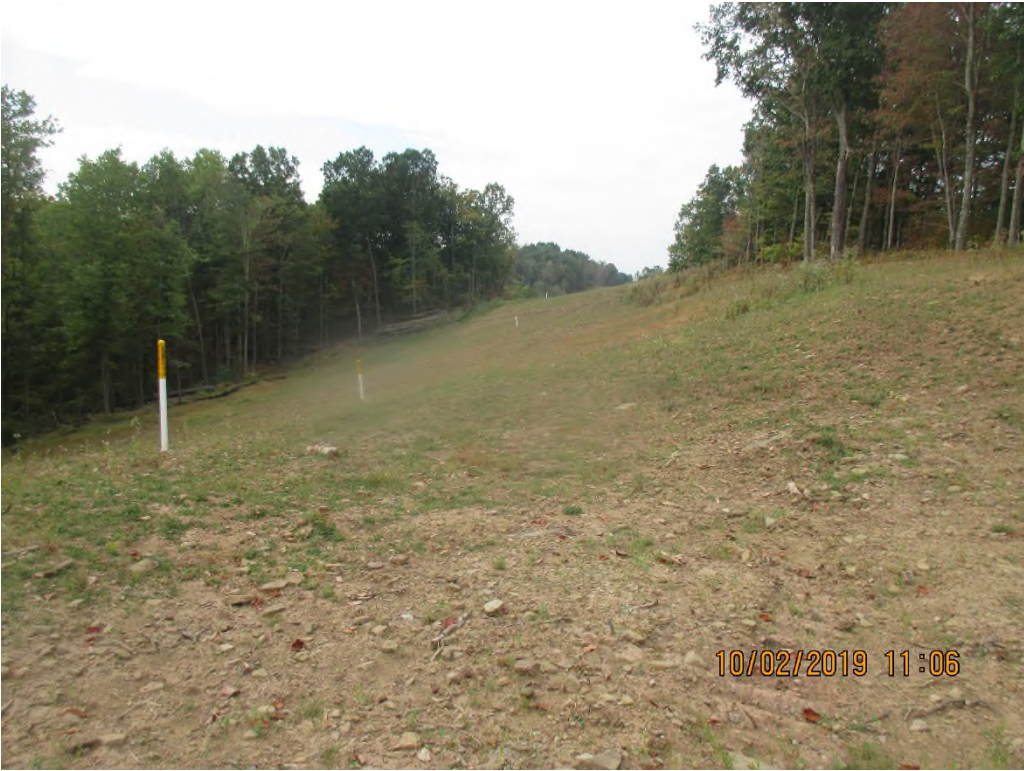
Standing near station No. 3368+00 facing south at MXP ROW.

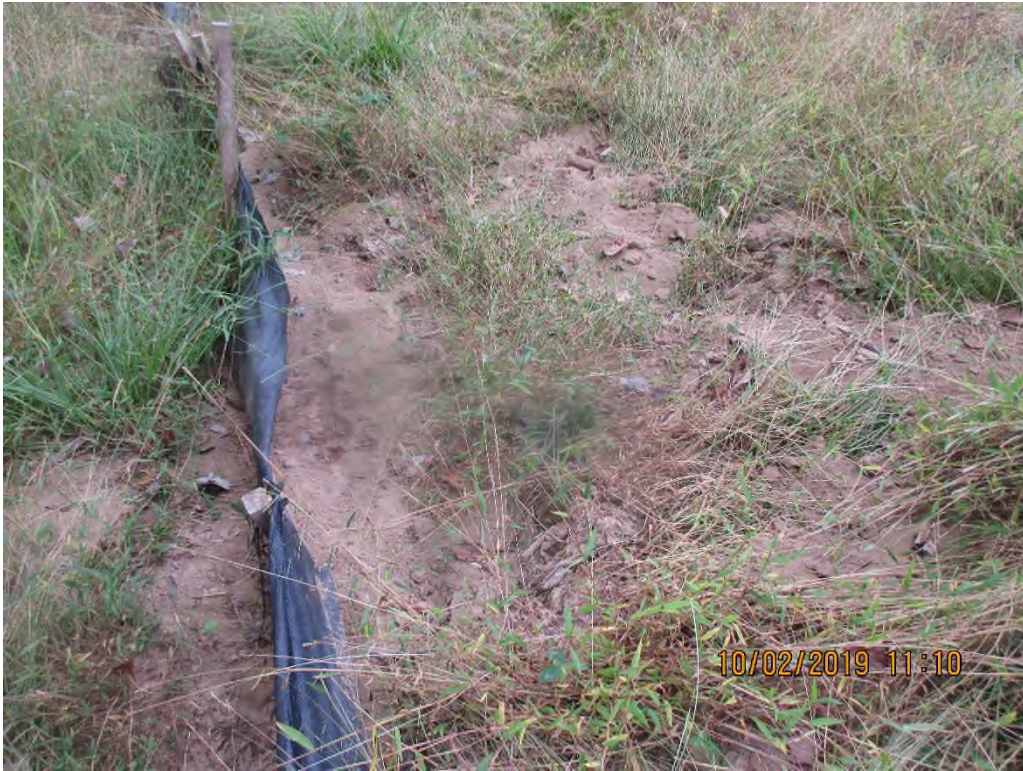
Sediment being deposited behind and past controls near station No. 3368+00.

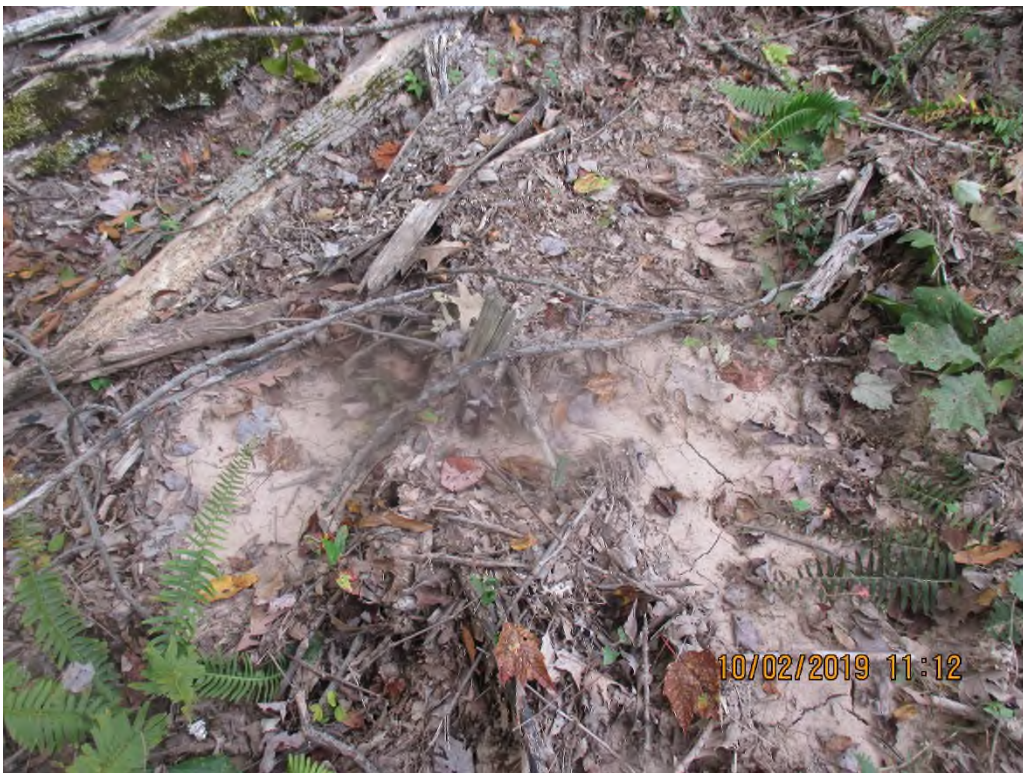
Sediment deposits past the LOD and controls near station No. 3368+00.

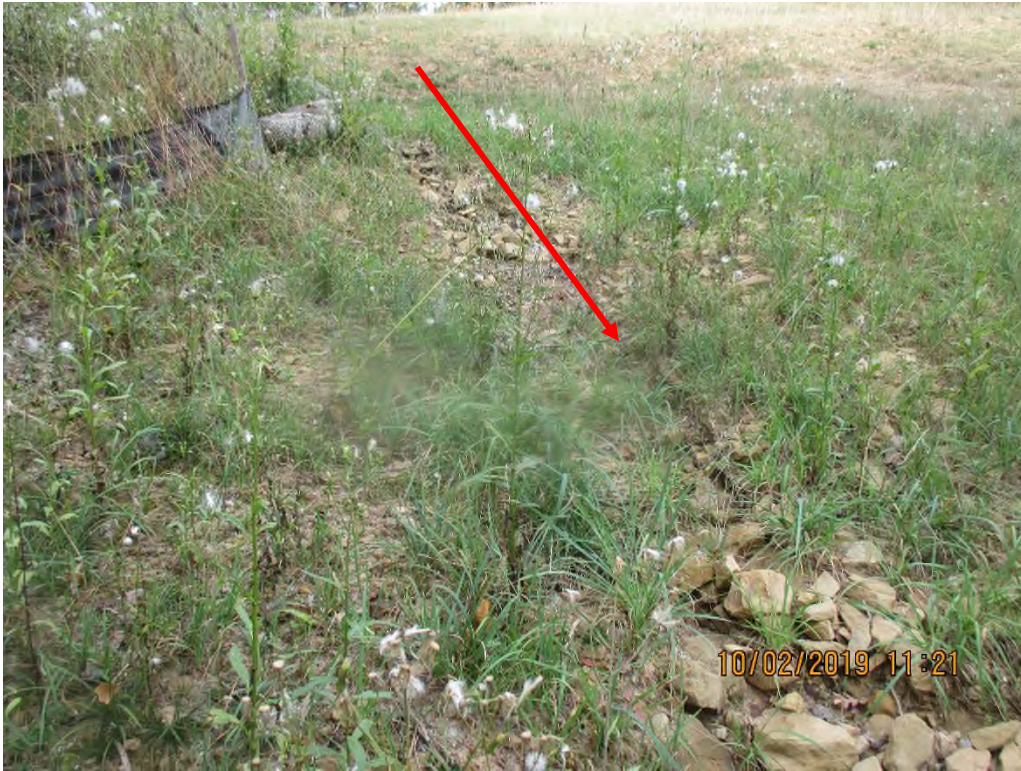
Waterbar terminating into perimeter controls near Station No. 3368+00 causing erosion downslope of controls. Arrow depicts gully erosion on slope.
