**CONSENT ORDER
ISSUED UNDER THE
WATER POLLUTION CONTROL ACT
WEST VIRGINIA CODE, CHAPTER 22, ARTICLE 11**

TO: Columbia Gas Transmission, LLC
Attn: Troy Tally, Vice President
1700 MacCorkle Ave
Charleston, WV 25314

DATE: October 1, 2020
ORDER NO.: 9061

1. Columbia Gas Transmission, LLC is conducting land disturbance activity associated with construction of the Mountaineer Xpress Project in Marshall, Wetzel, Tyler, Doddridge, Ritchie, Calhoun, Wirt, Roane, Jackson, Mason, Putnam, and Cabell Counties, West Virginia. On January 31, 2018, Columbia Gas Transmission, LLC was issued Water Pollution Control Permit No. WV0116815, Registration No. WVR310872, for Stormwater Associated With Oil and Gas Related Construction Activities.

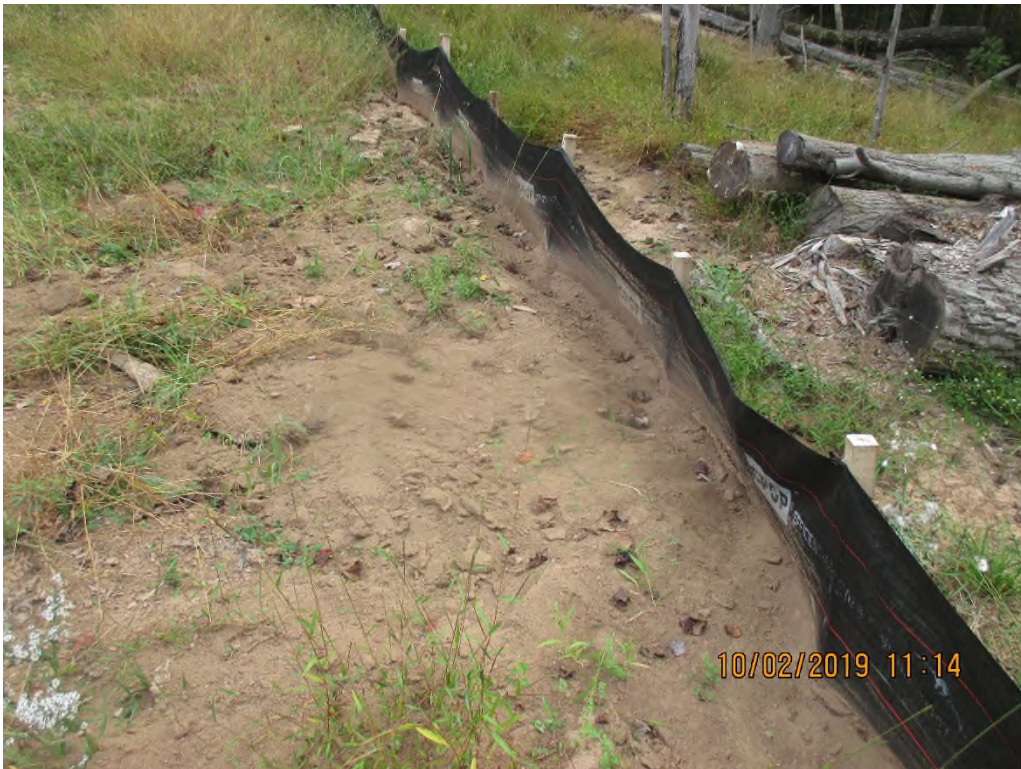
Downslope of gully erosion occurring on slope. Sediment deposited behind and past controls near station No. 3368+00.

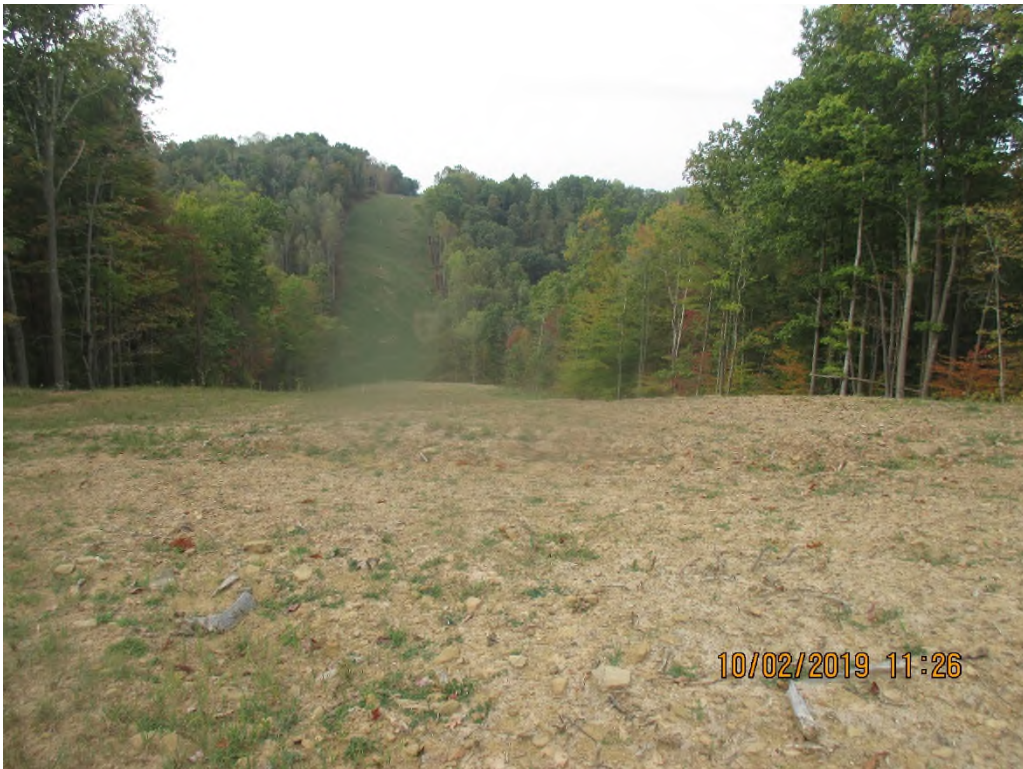
Facing south toward Bear Run and (CR 22/1) near station No. 3380+84. ROW not stabilized.

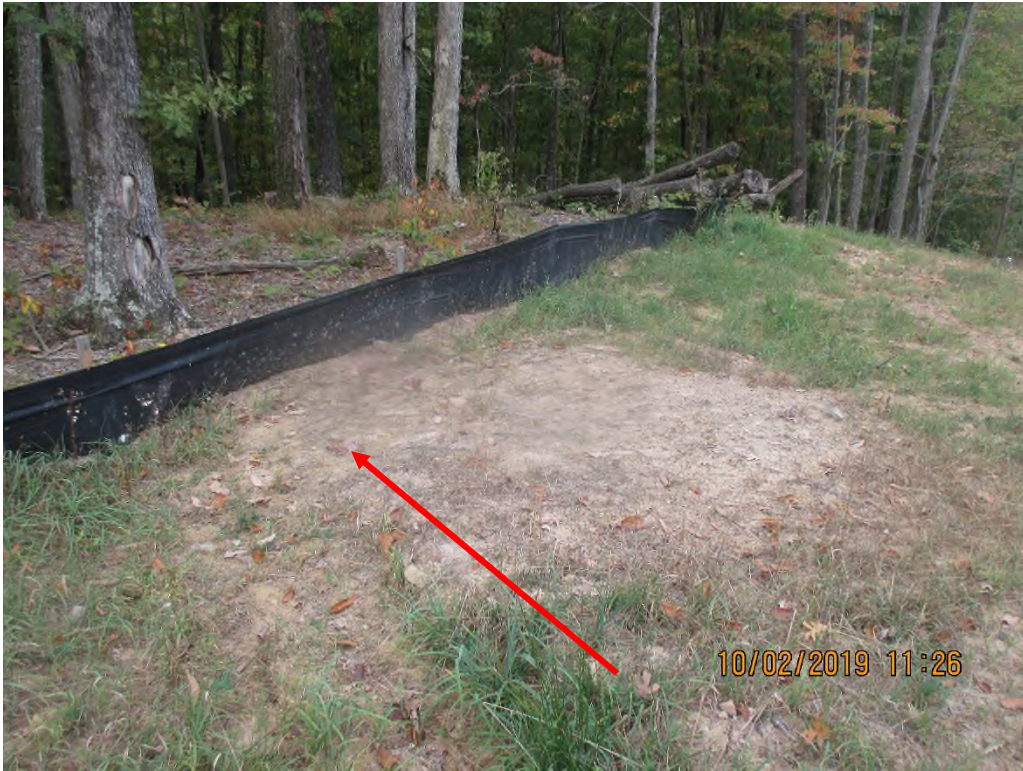
Waterbar terminating into perimeter controls near station No. 3380+84. Sediment being deposited against controls. Arrow depicts waterbar flow.

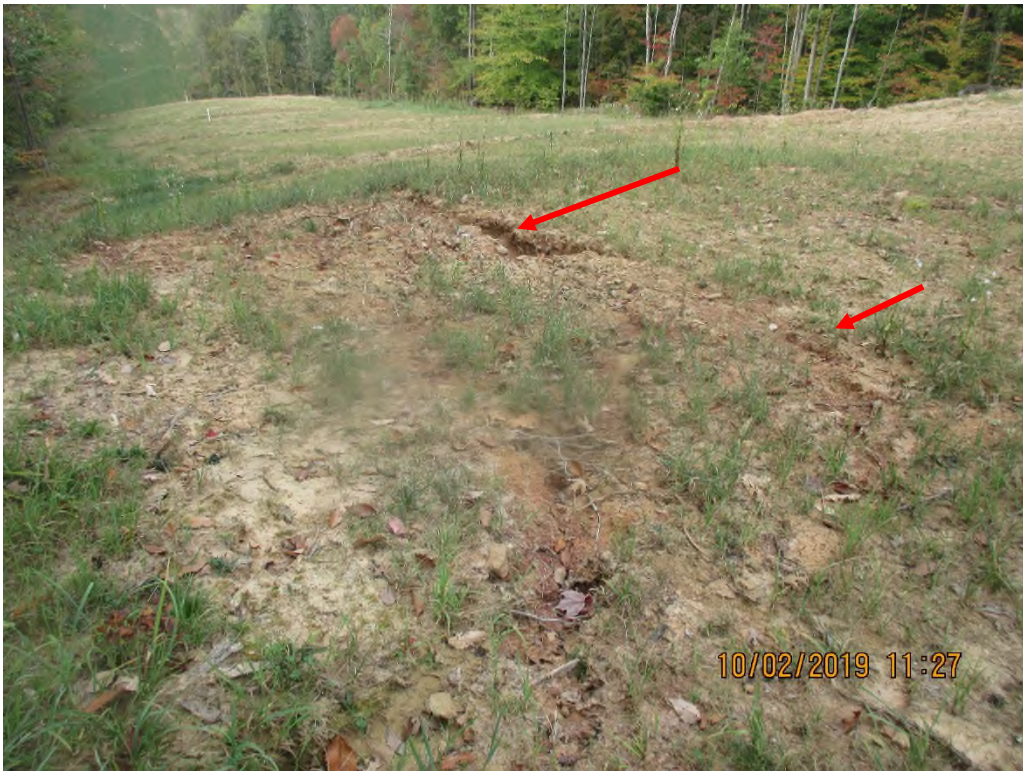
Gully erosion present between waterbars near station No. 3380+84. No waterbar outlet or perimeter controls observed.

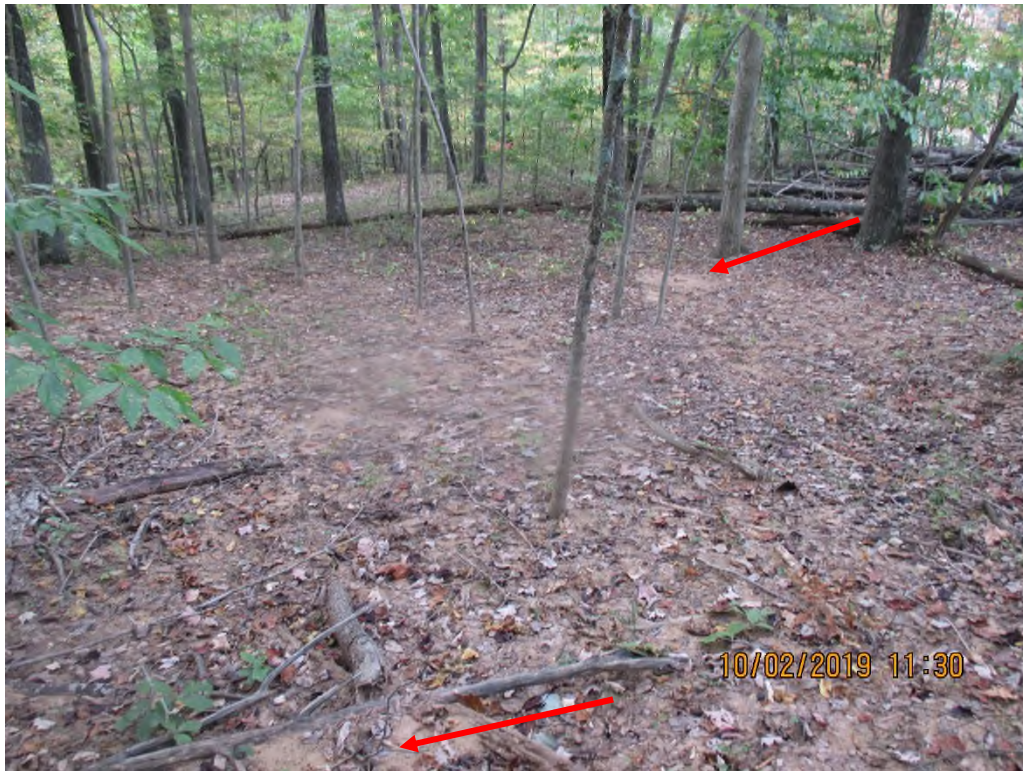
Sediment deposits observed past the LOD downslope from where gully erosion was occurring, and no waterbar outlet or perimeter controls were observed. Arrow depicts sediment deposits observed.

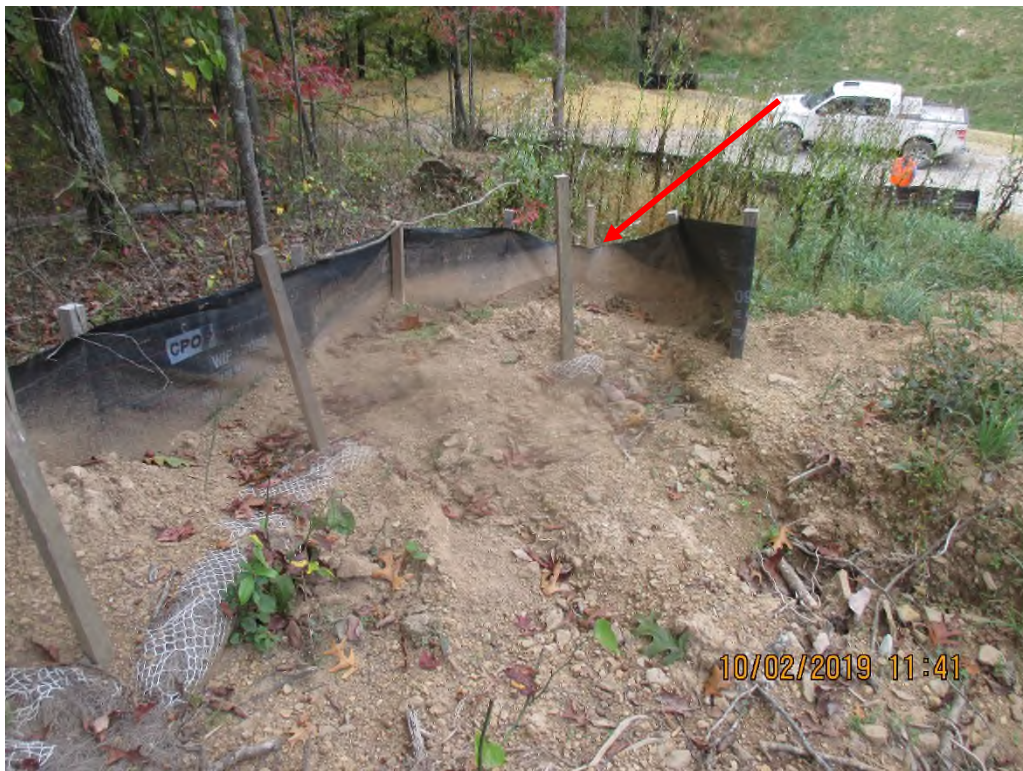
Standing above CR 22/1 facing South. A previous NOV was issued due to failures in this area. Waterbar outlet controls were not maintained, and there was evidence of sediment laden water overtopping controls.

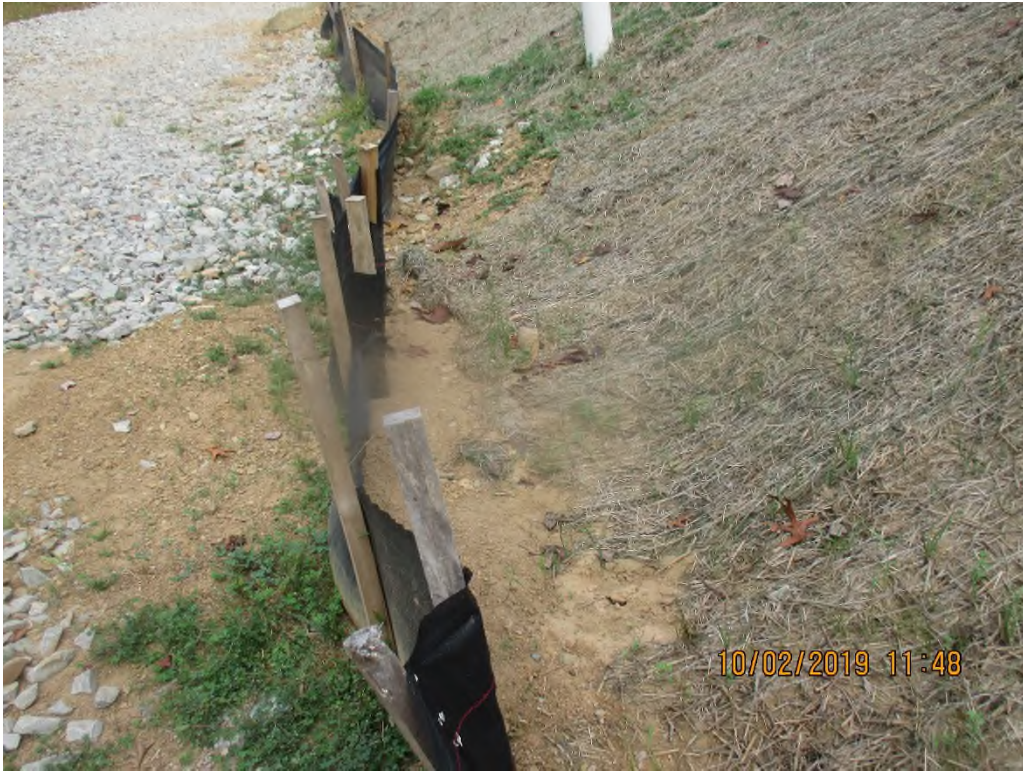
Perimeter controls along CR 22/1 with sediment deposits behind and past controls. Hole present in silt fence.

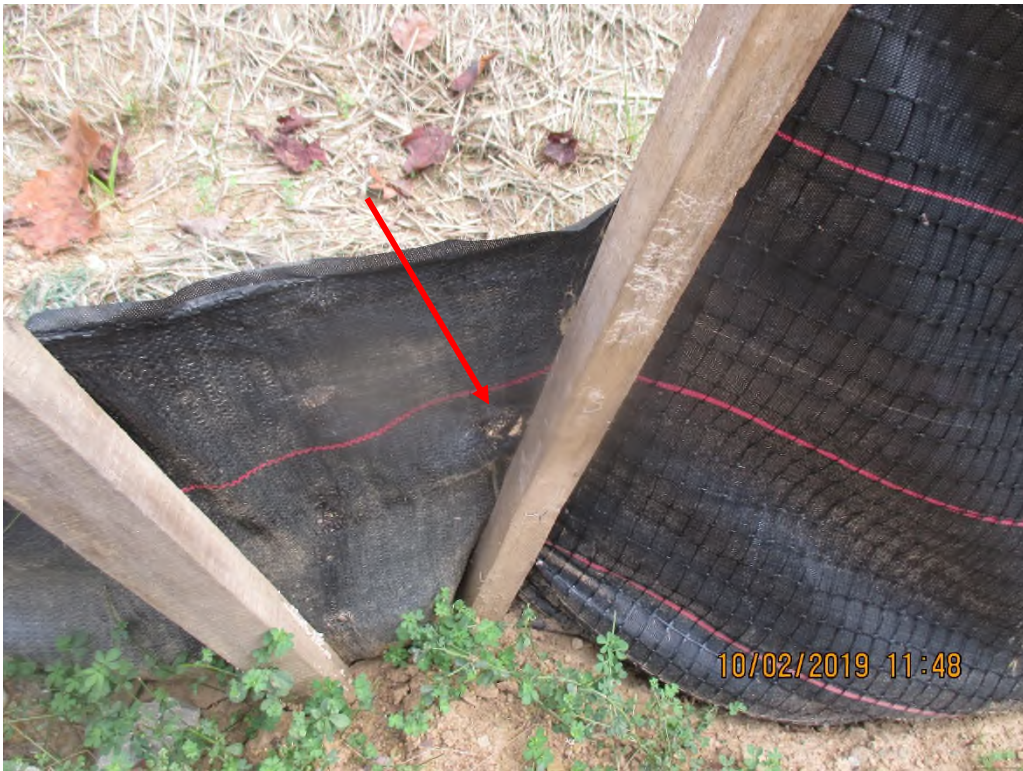
Perimeter controls along CR 22/1 near station No. 3380+84 with sediment deposits behind and past controls. Hole present in silt fence.

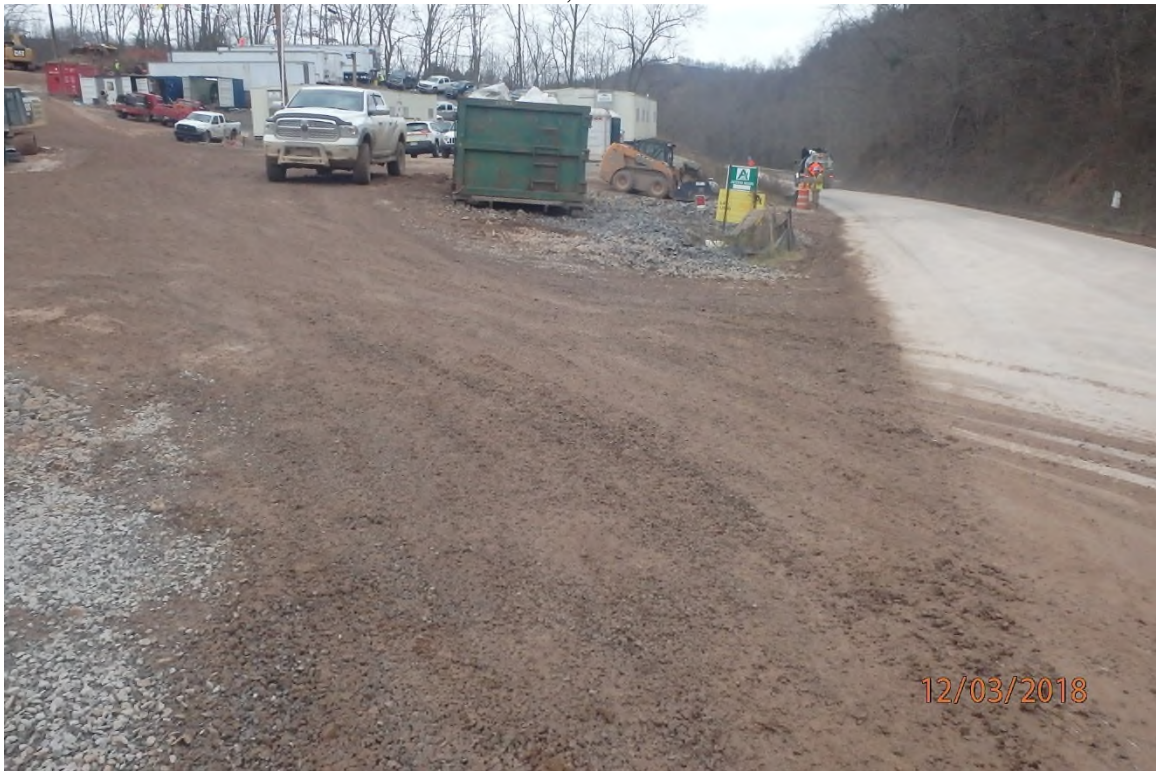
The construction access road to WV 18 showing the lack of a stable construction entrance and the associated track-out onto the public roadway.

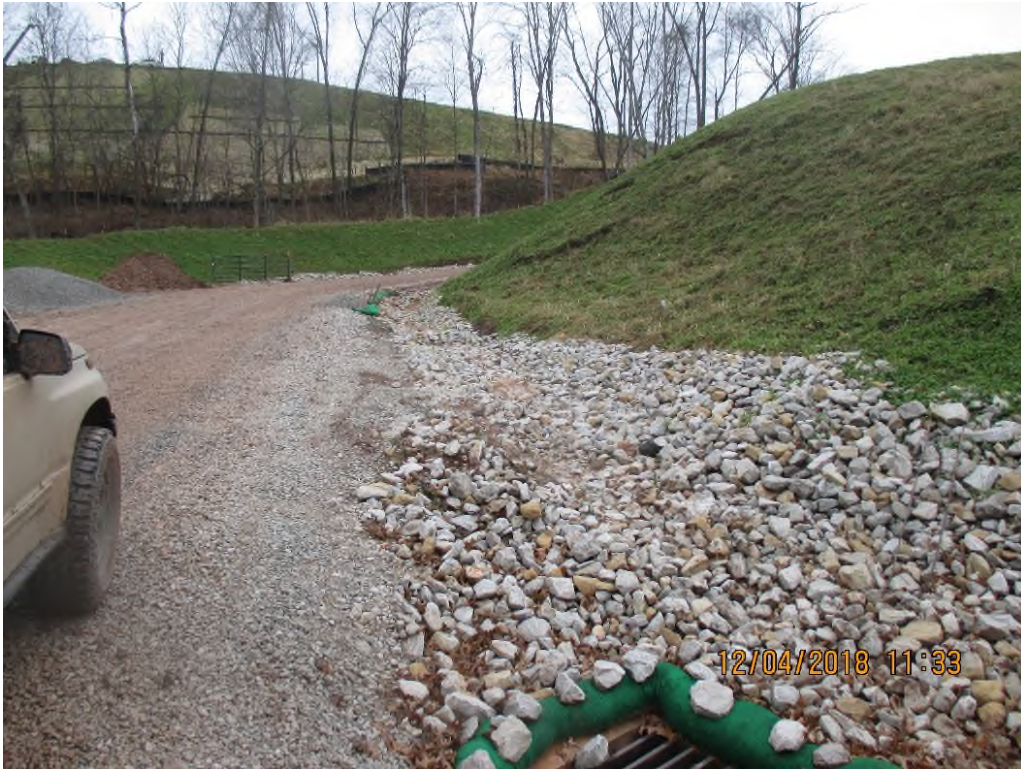
Drop inlet where sediment laden water was entering from pressure wash station.

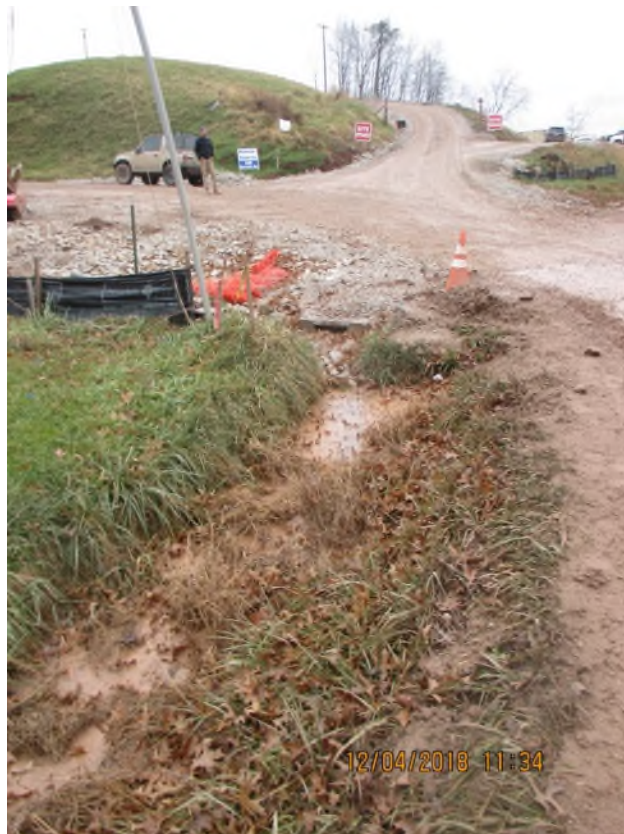
Facing toward drop inlet and sediment trap that was overflowing into ditch.

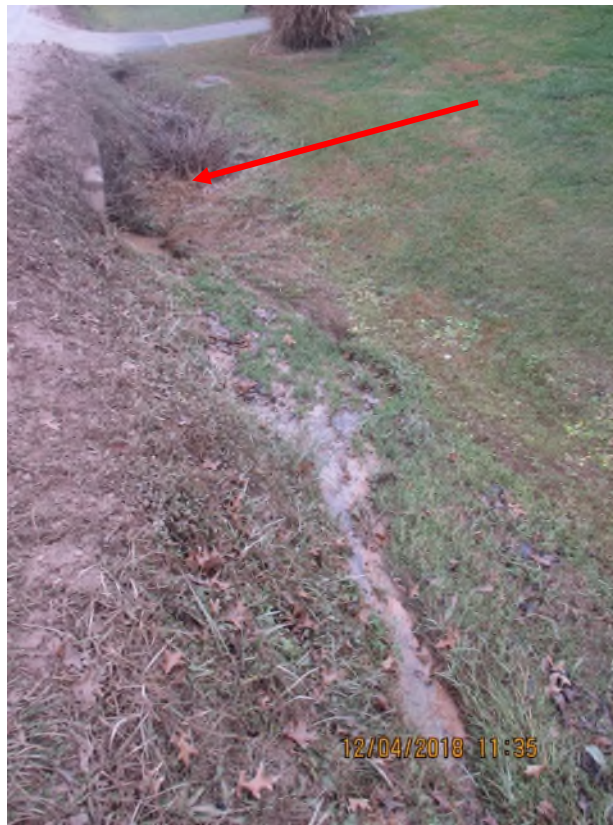
Sediment laden water entering ephemeral stream that crosses under route 21. Arrow shows culvert that crosses under Route 21.

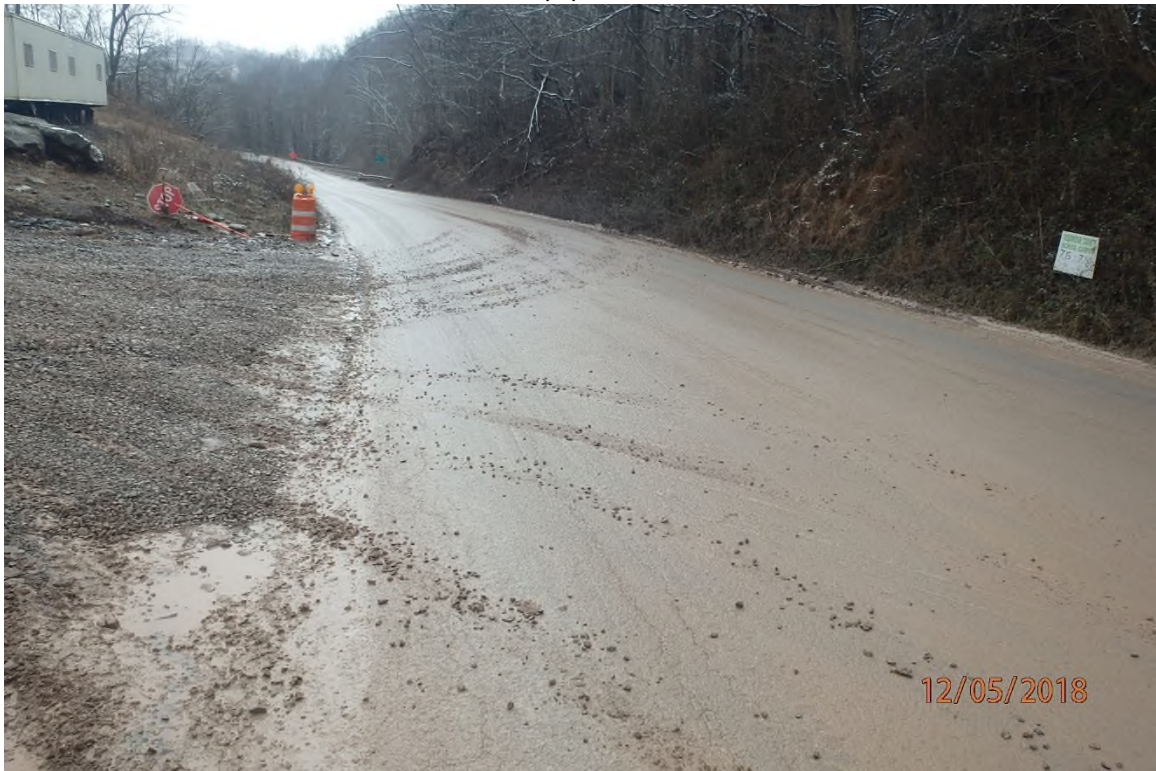
The construction access road to WV 18 showing the ineffectiveness of the construction entrance at preventing track-out onto the public roadway.

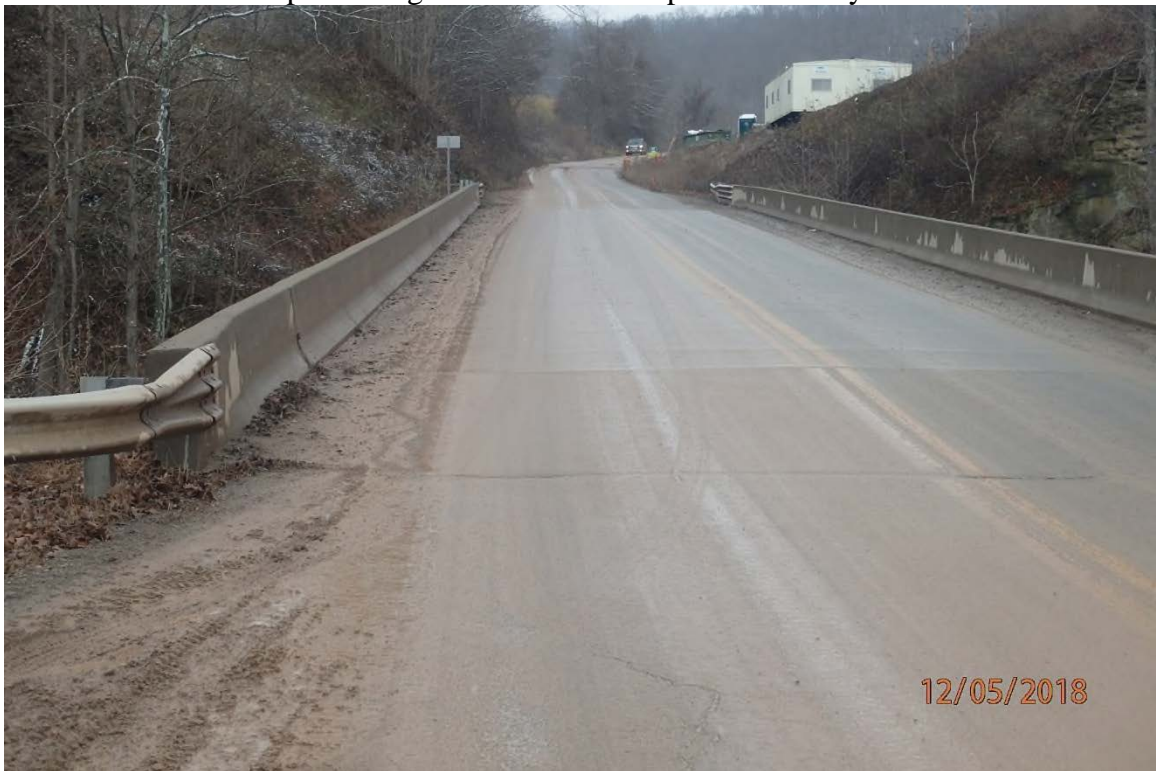
WV 18 showing track-out and slick film of mud on the public roadway that originates from project.

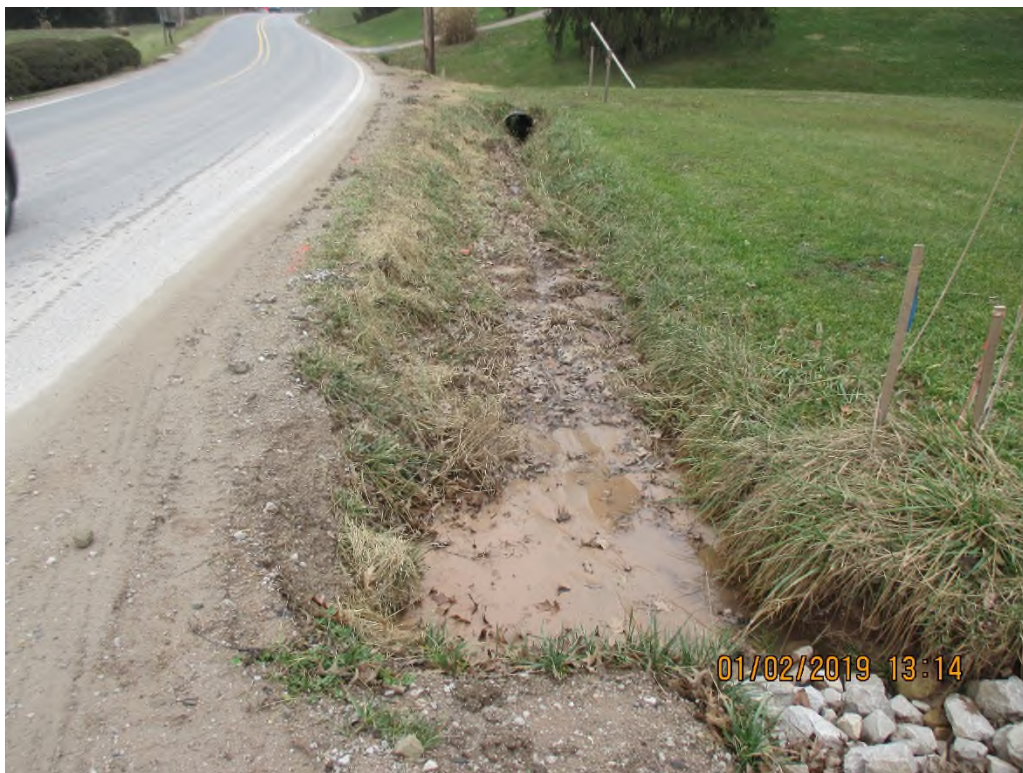
Off-site sediment deposits present in roadside ditch along route 21.

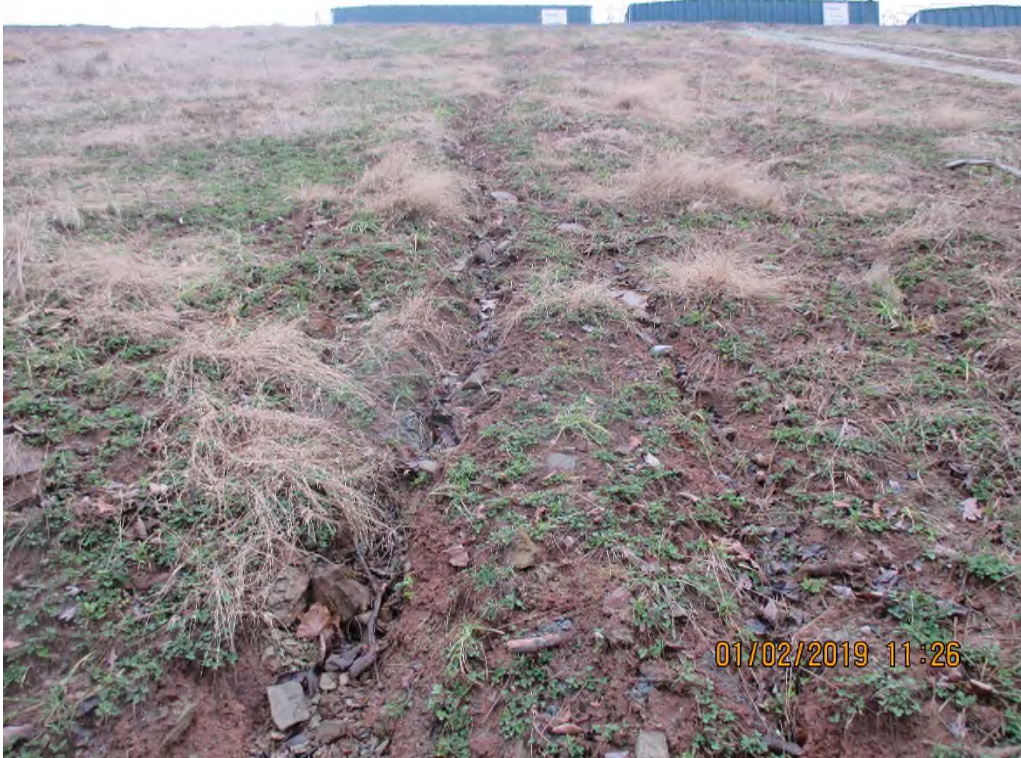
Facing toward compressor station. Erosion rills occurring along south slope.

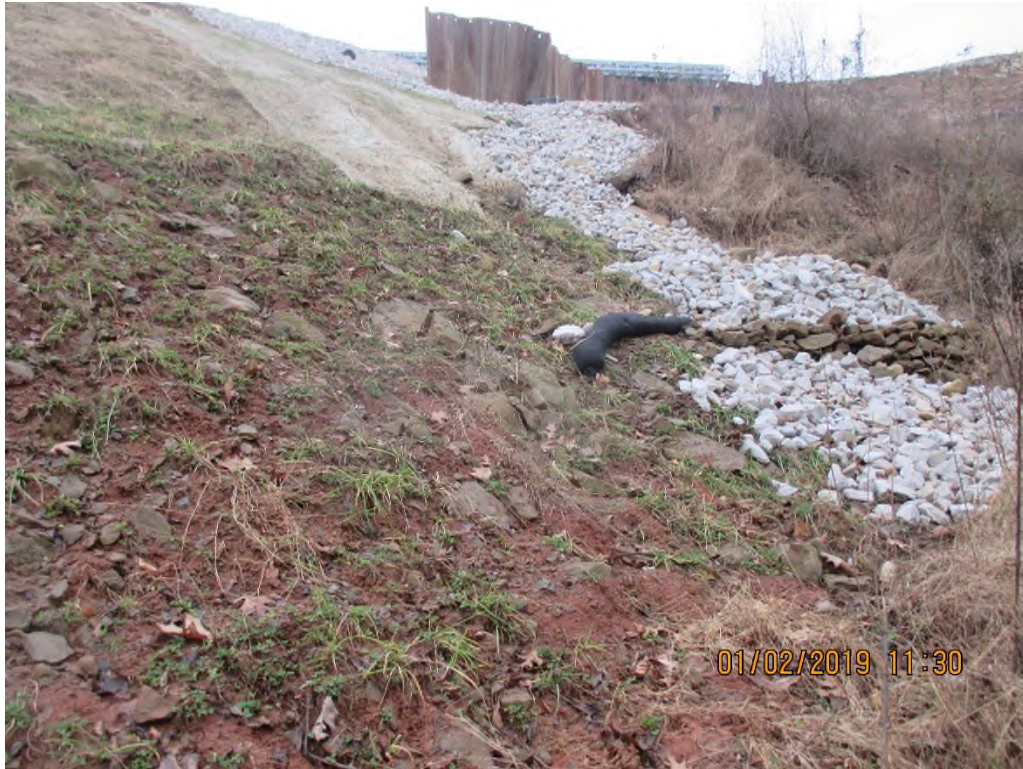
Armored channel on south slope facing station access road.

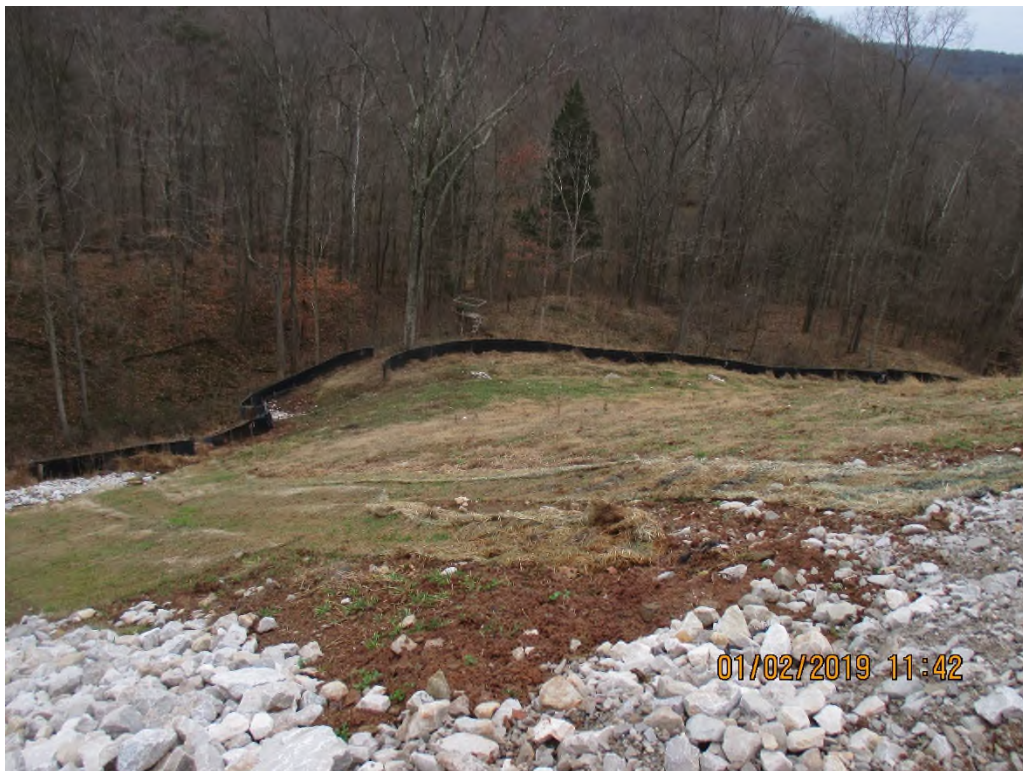
Facing section of south slope from access road.

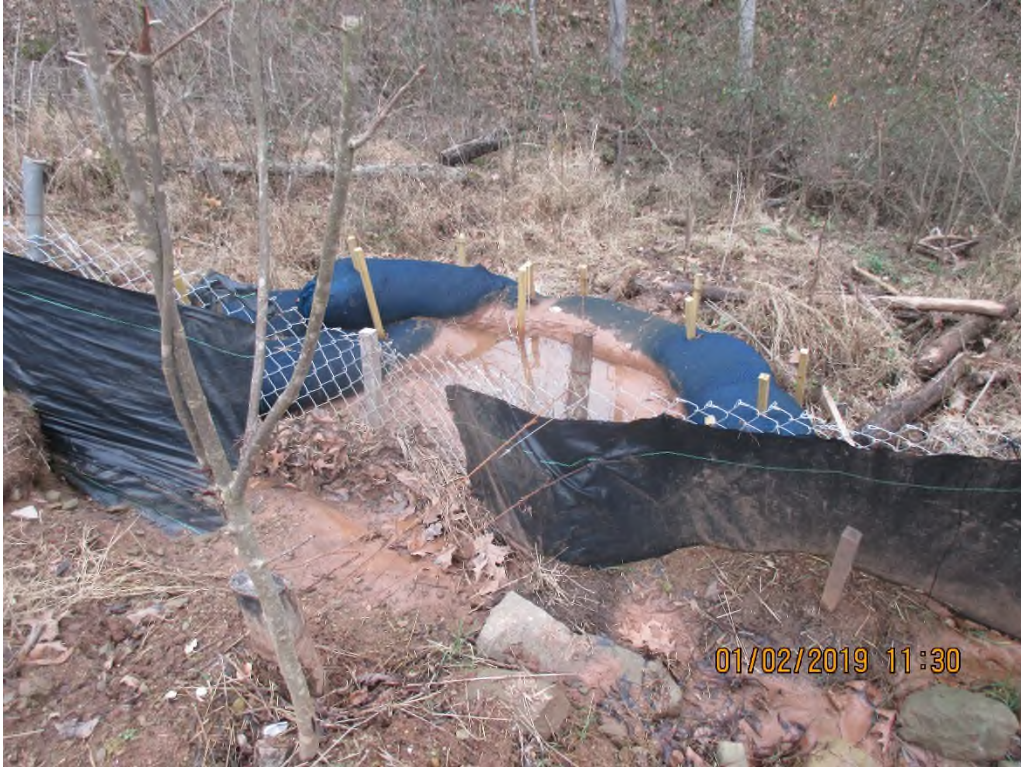
Southern slope armored channel terminus with evidence of concentrated flows and BMP being overwhelmed during rain events.

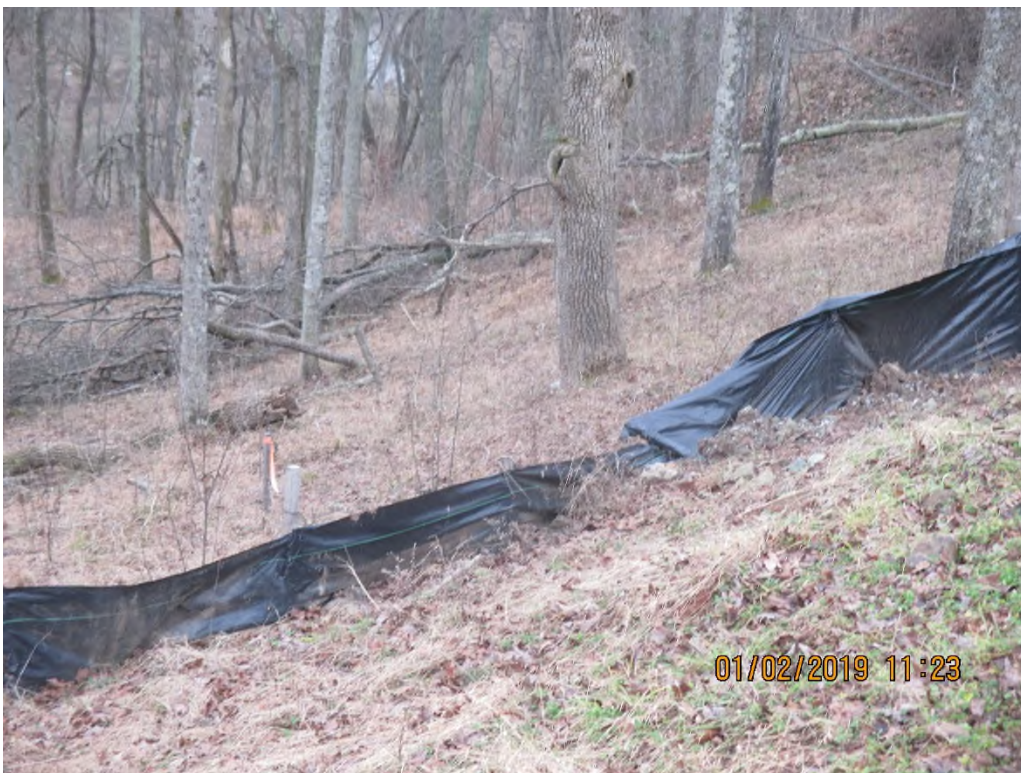
Silt fence along south slope parameter needing maintenance.

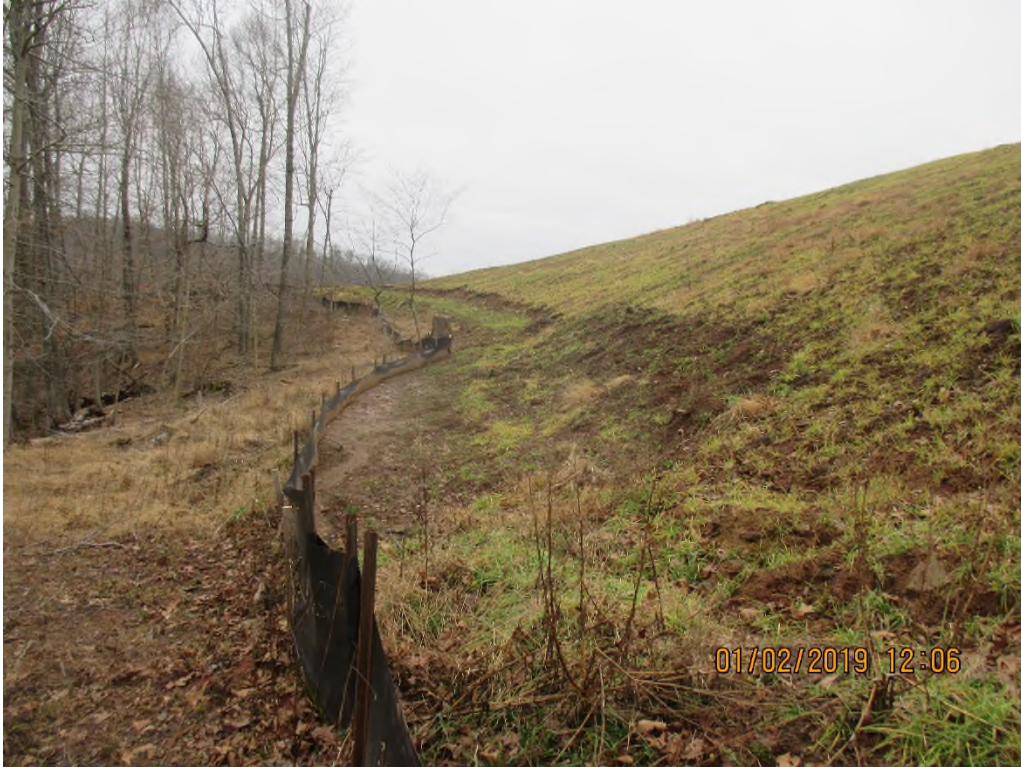
North west slope. Slope is eroding above silt fence.

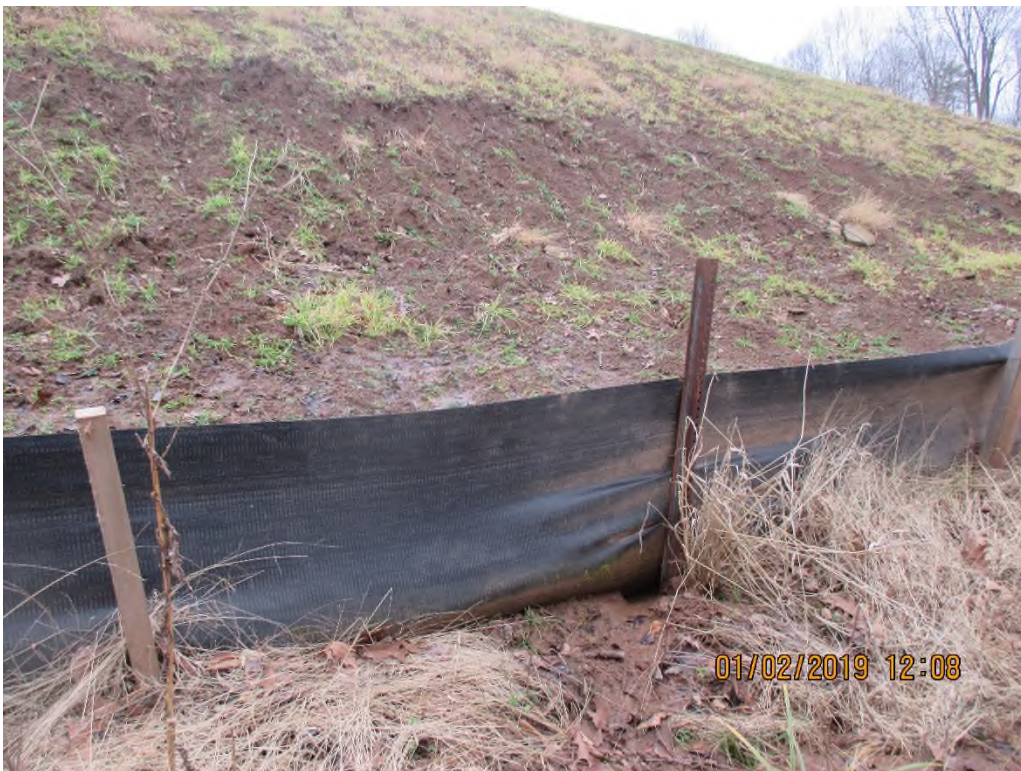
Silt fence being undermined where sediment has concentrated behind fence.

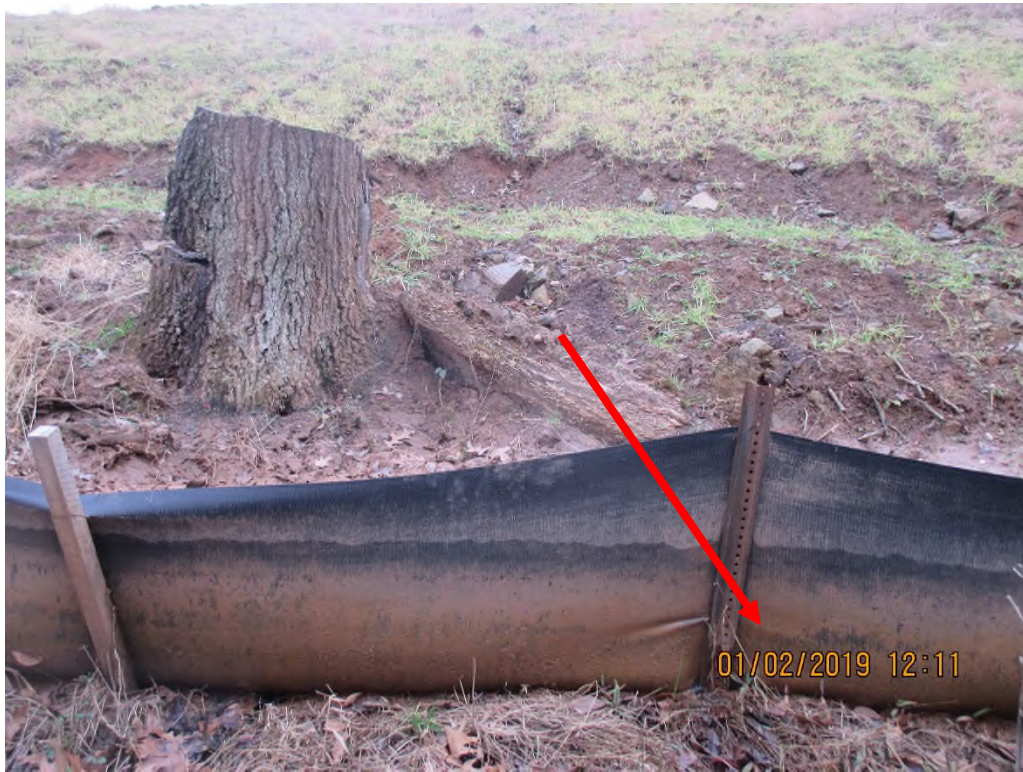
Silt fence with hole.

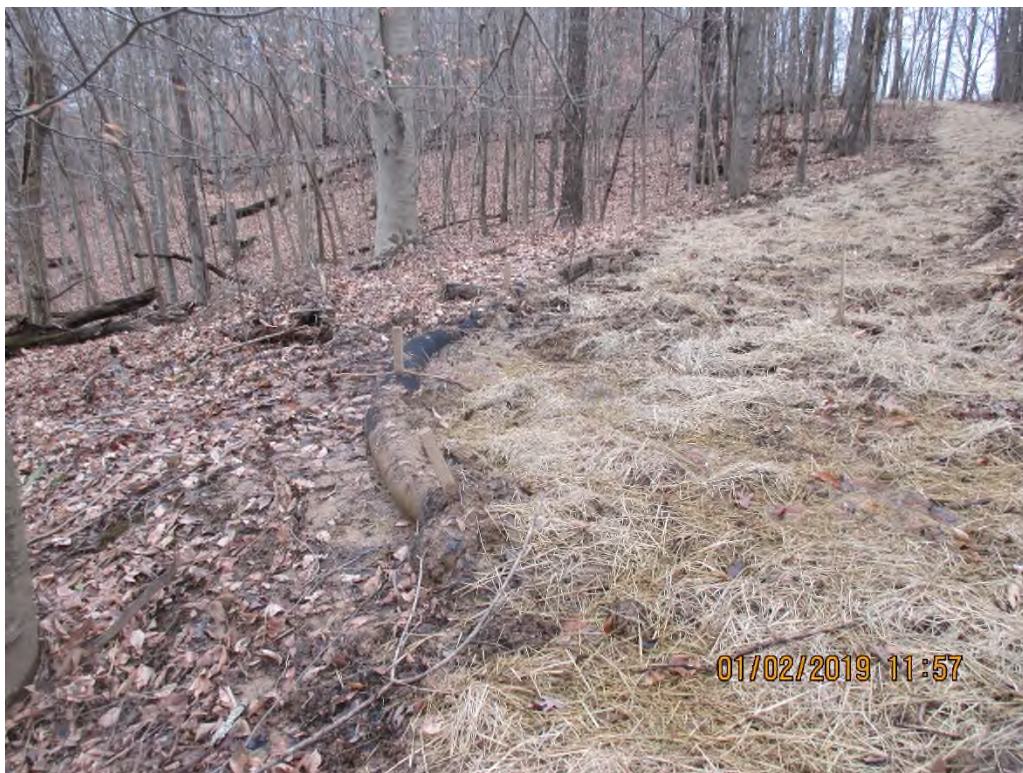
Access road with BMP being overwhelmed and needing maintained or enhanced.

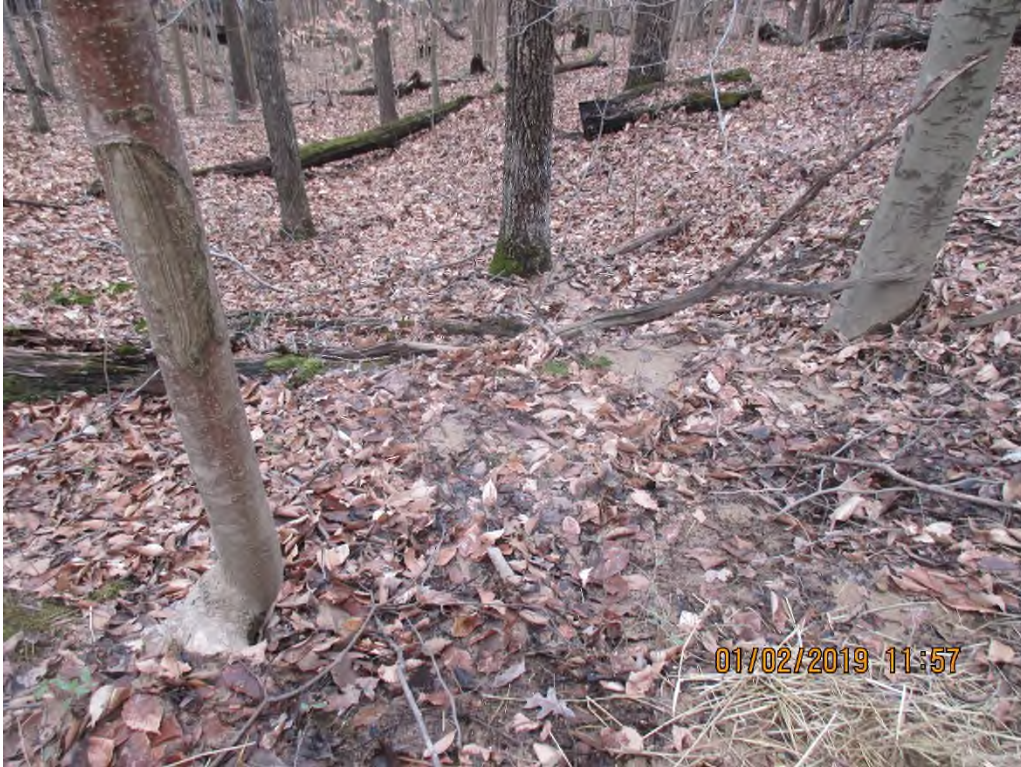
Sediment deposits beyond LOD and BMP along access road.

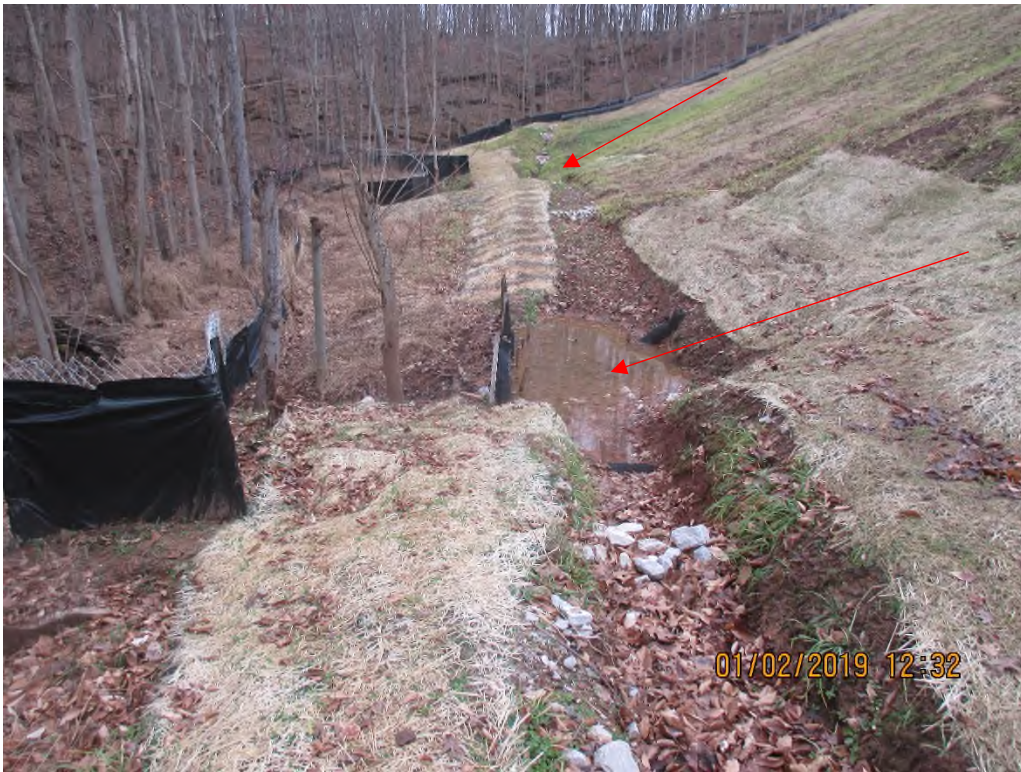
North slope of project where several discharge points (silt fences labeled as 23 and 24) are located along diversionary berm.

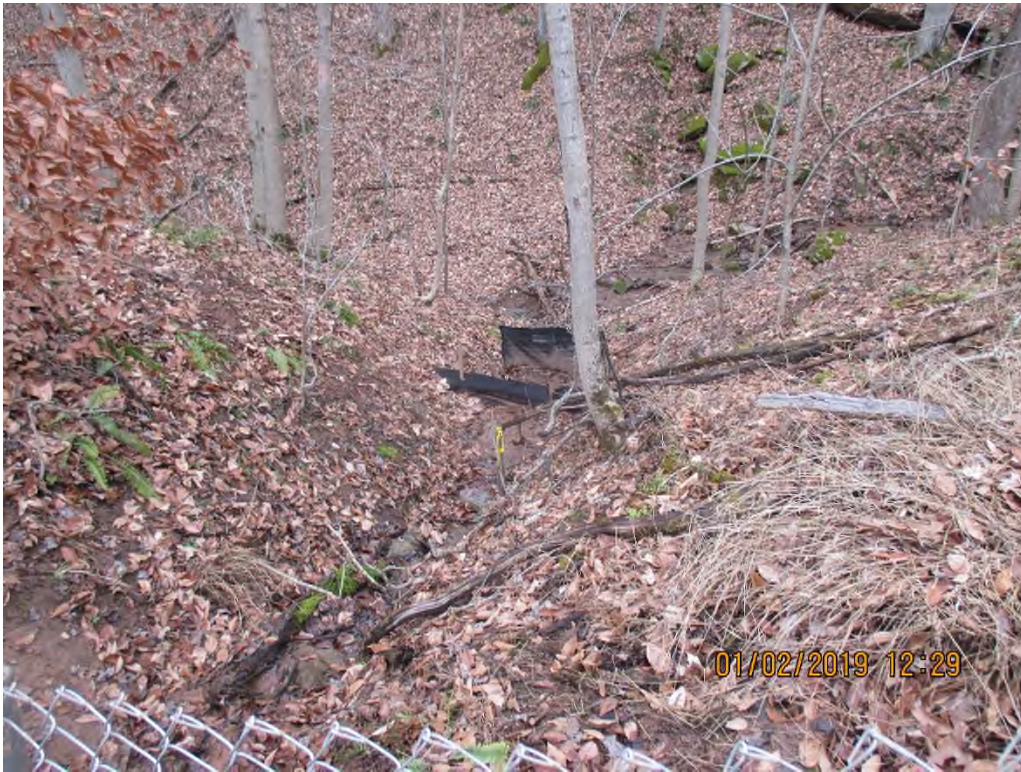
Discharge point (silt fence 23) on North slope that flows into UNT of Grasslick Creek.

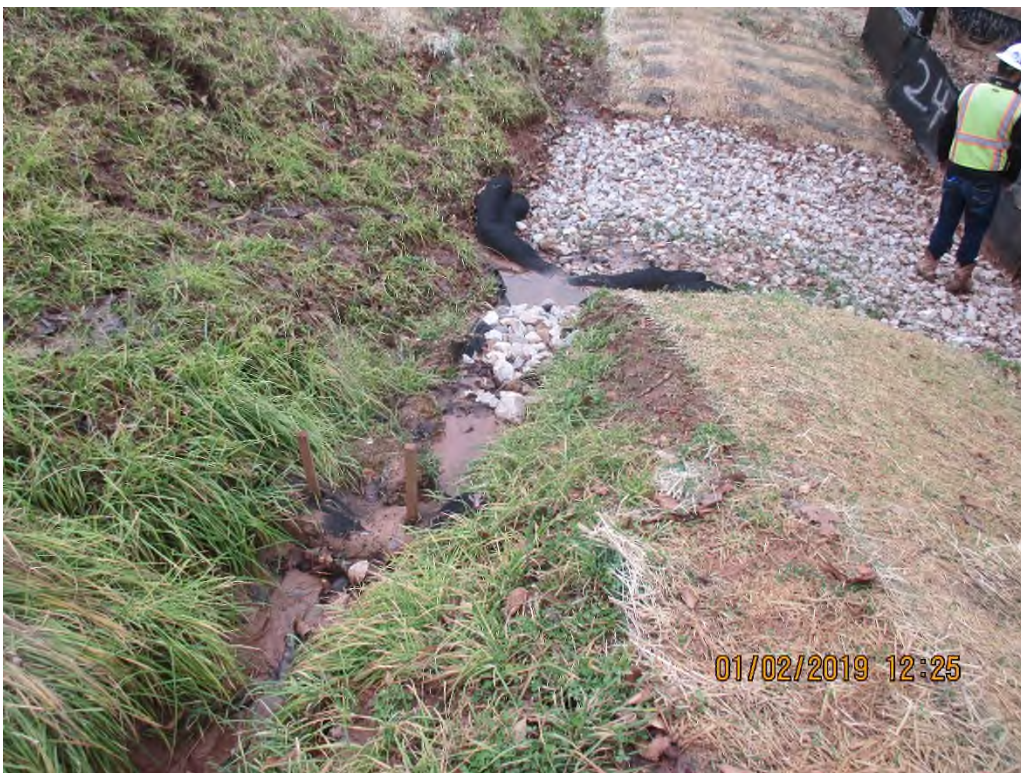
Diversion ditch flowing into discharge point at silt fence 24.
